Inspection Photos

Operator: LOCIN OIL CORPORATION- 51130

Location Name: FULLER USA #18-12

Inspection Date: 10/31/2024 Inspection Doc#: 693807894

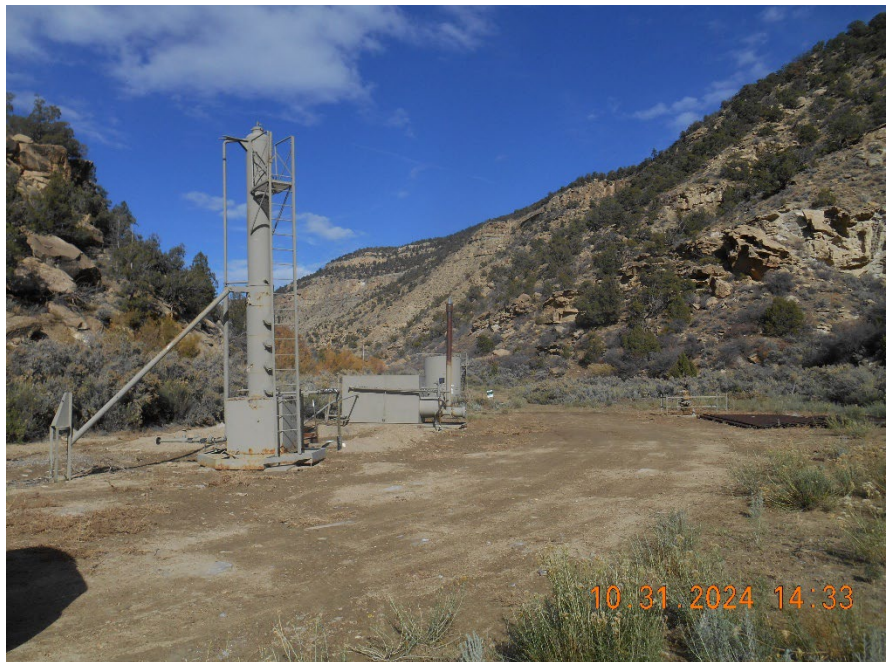
Location overview looking N

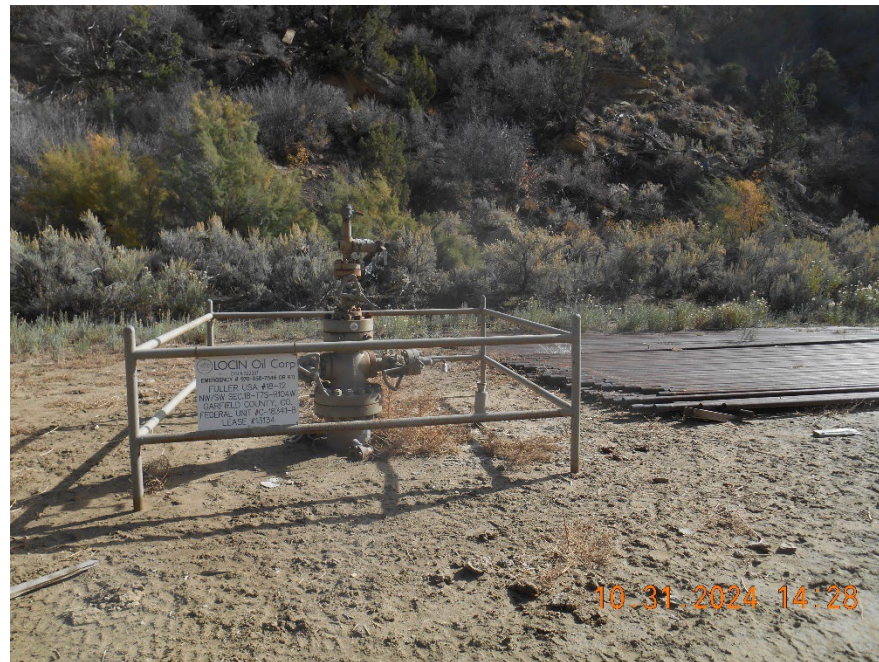
Wellhead with sign
