Inspection Photos

Location: QB ENERGY KEINATH FEDERAL-68S96W/18SWNE

Location ID: 334316

Date: 10/31/2024

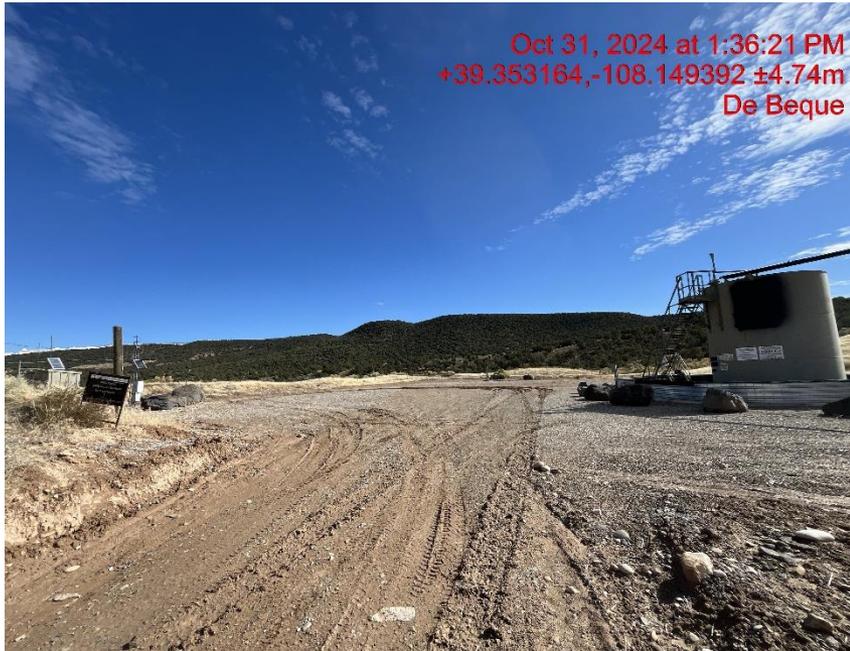
Photo # 8517 Entrance to location

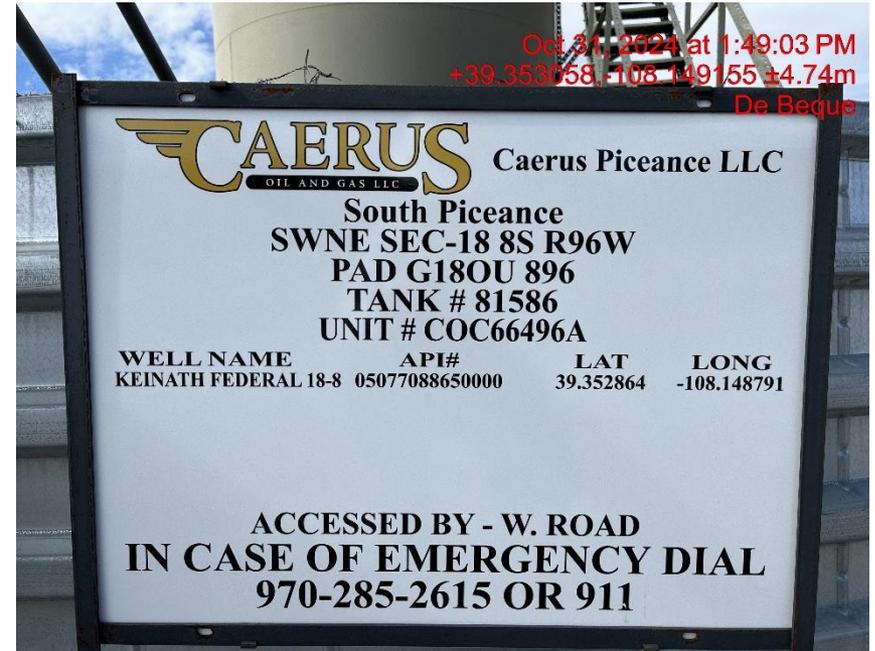
Photo # 8535 Location

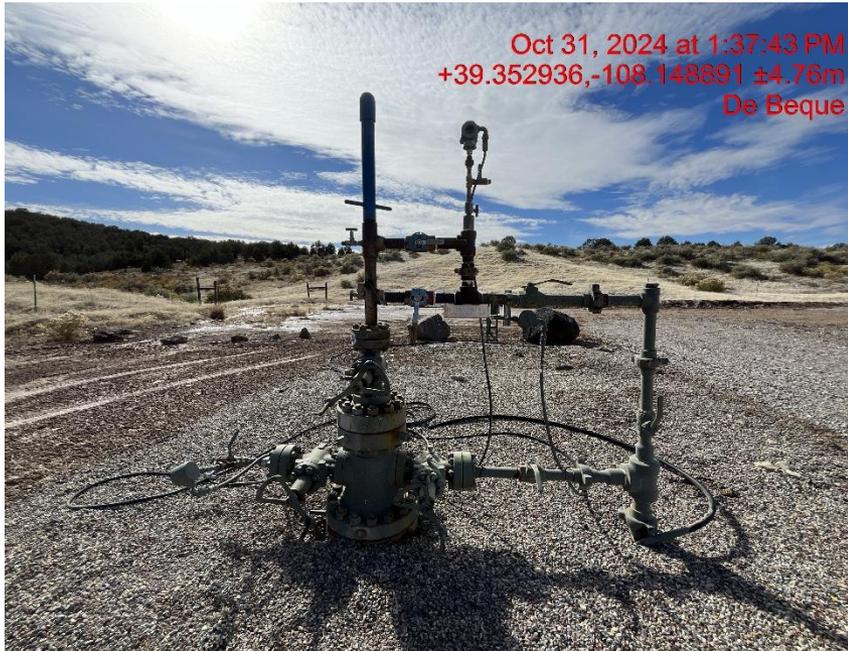
Photo # 8519 Location

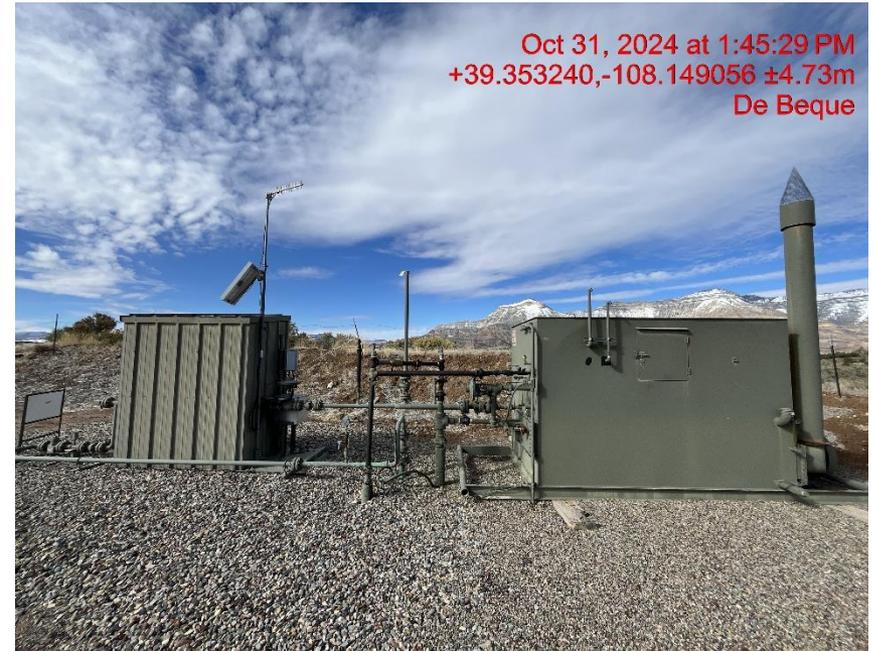
Photo # 8527 Location

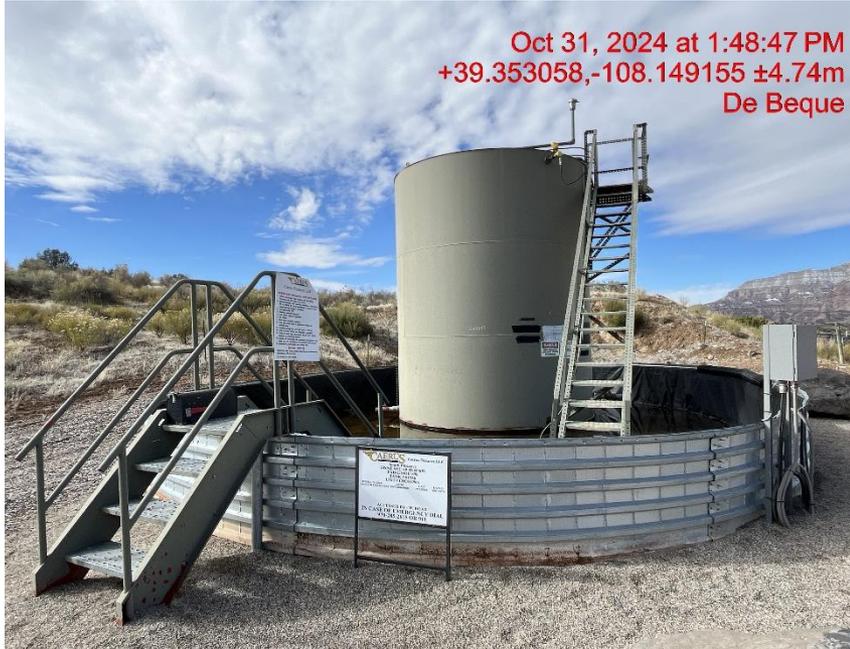
Photo # 8534 Location

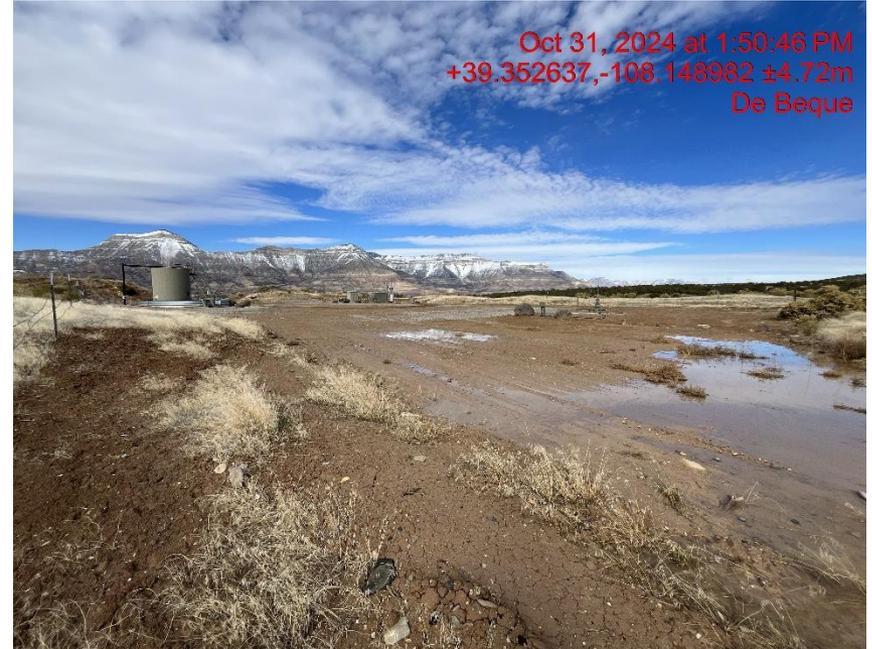
Photo # 8539 SW corner of location

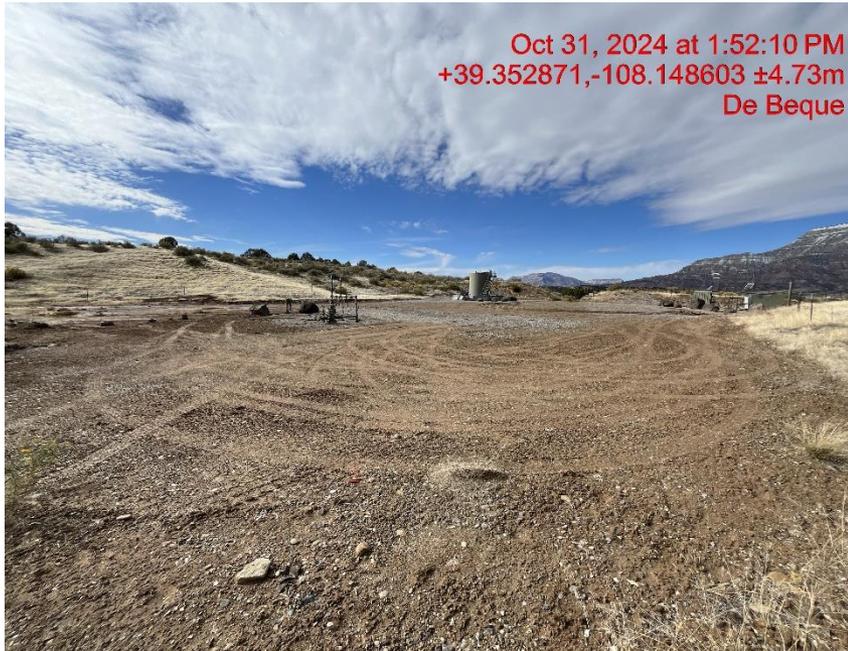
Photo # 8540 SE corner of location

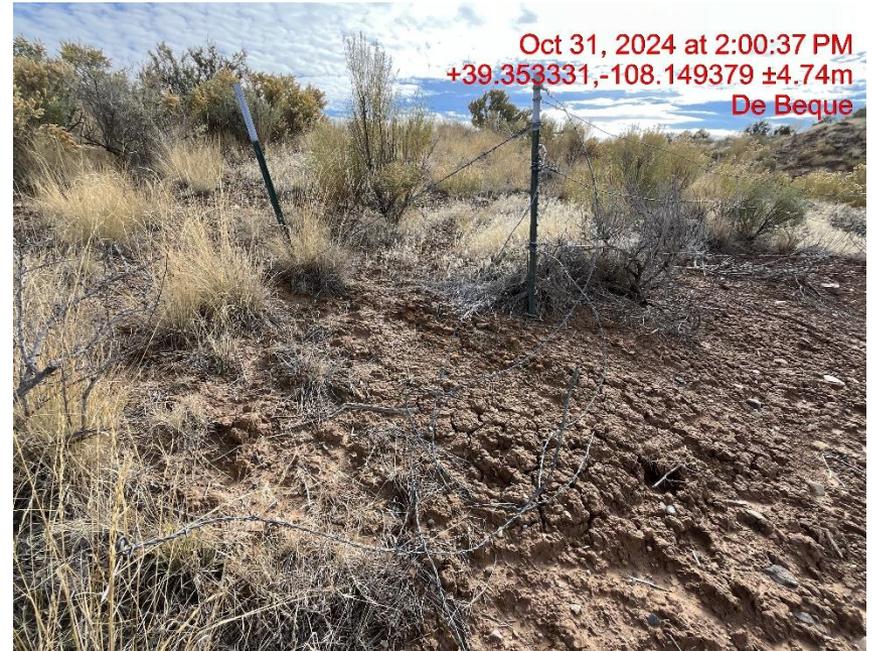
Photo # 8547 Loose barbed wire fencing/wildlife hazard
NW/NE side of entrance to location

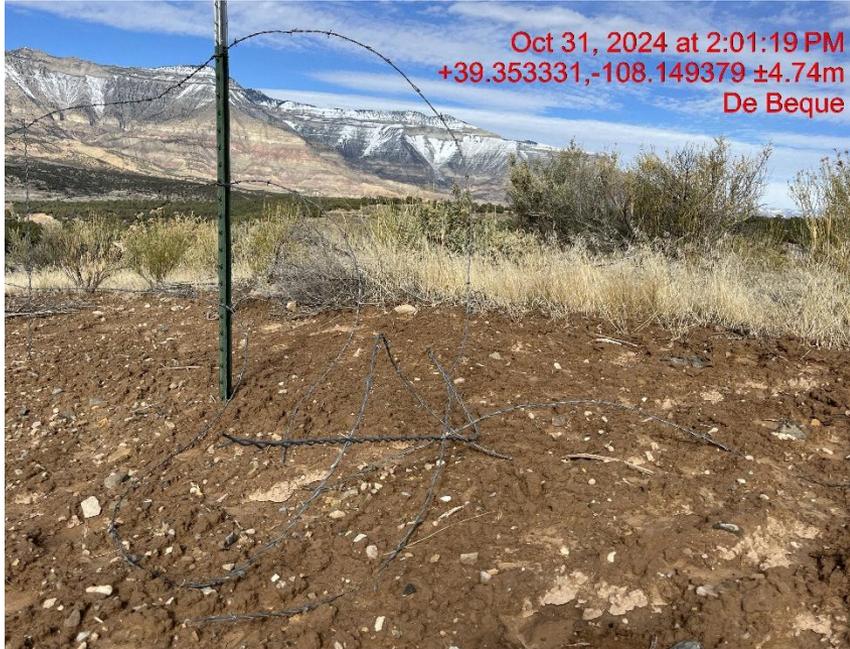
**Photo # 8549 Loose barbed wire fencing/wildlife hazard
NW/NE side of entrance to location**

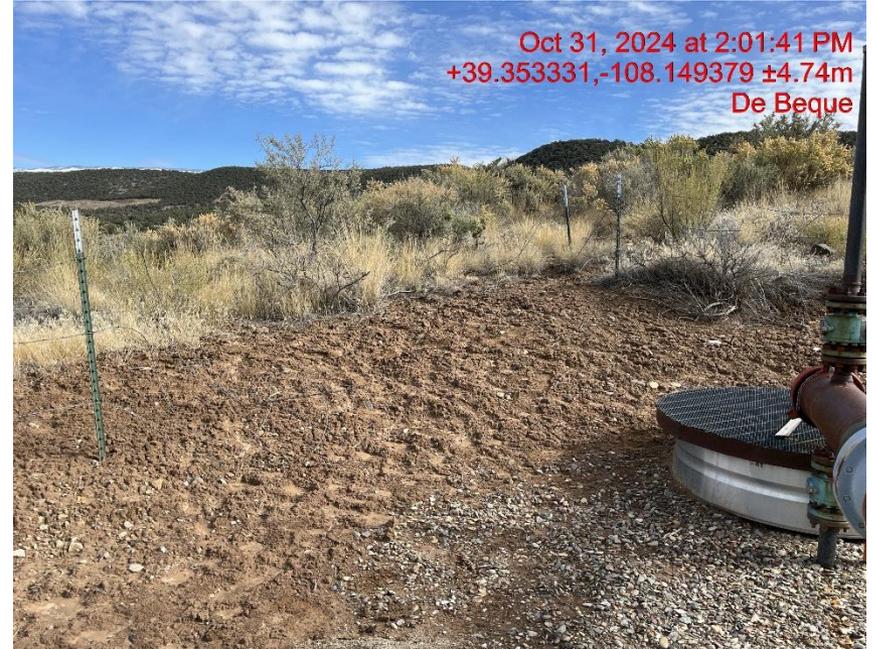
**Photo # 8550 Loose barbed wire fencing/wildlife hazard
NW/NE side of entrance to location**

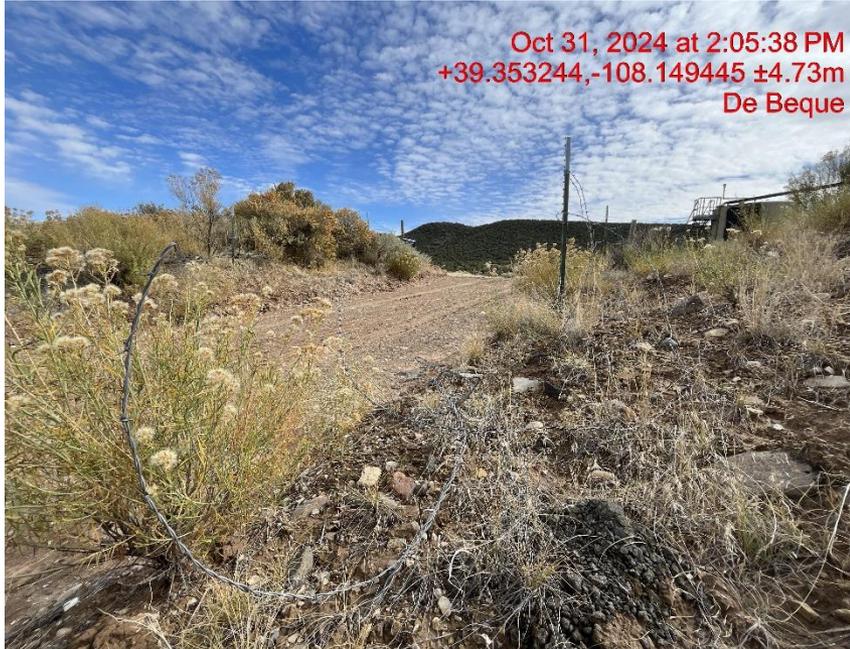
**Photo # 8561 Loose barbed wire fencing/wildlife hazard
NW/NE side of entrance to location**

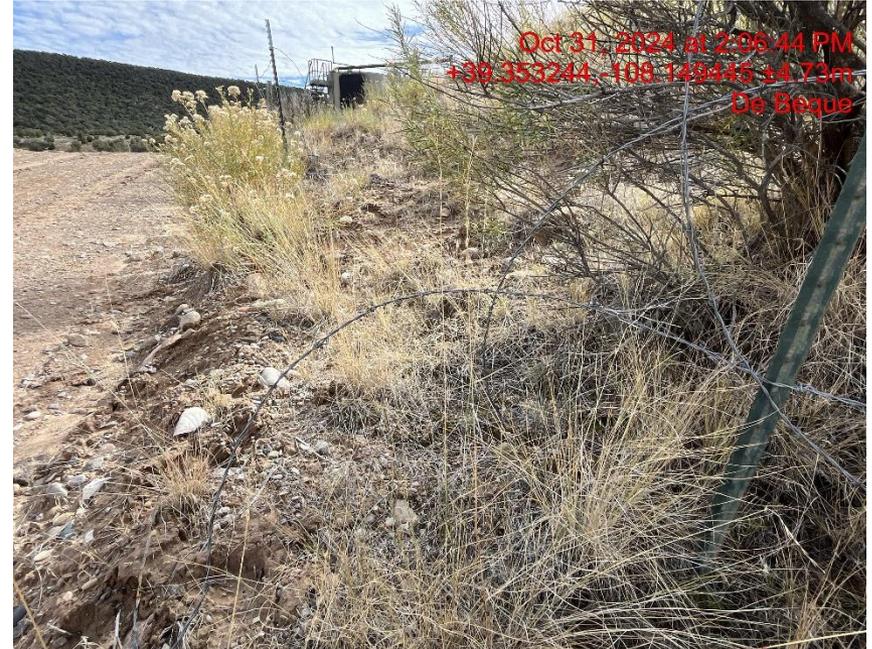
**Photo # 8564 Loose barbed wire fencing/wildlife hazard
NW/NE side of entrance to location**

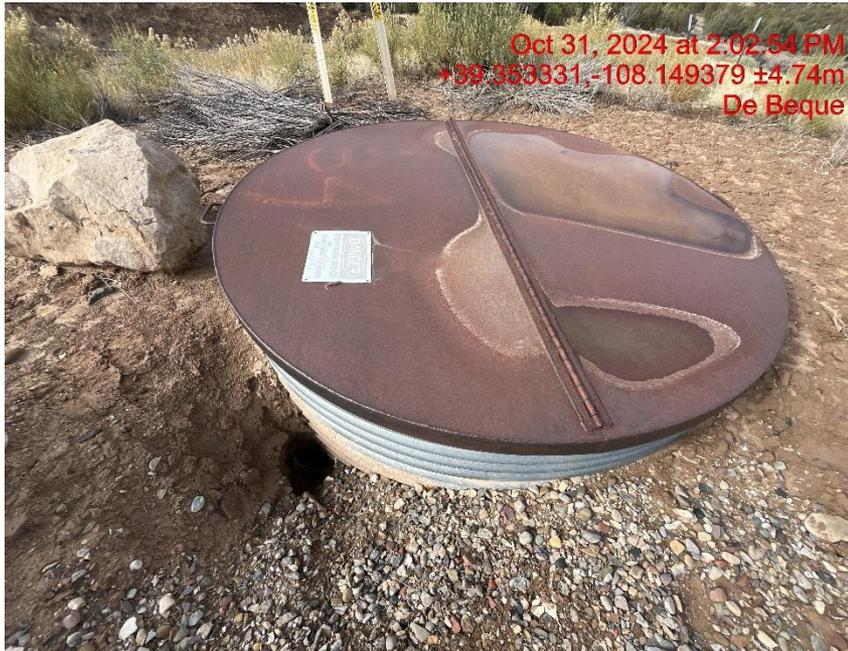
Photo # 8553 Tunnel erosion around cellar is also a wildlife/personal safety hazard near NE side of entrance to location

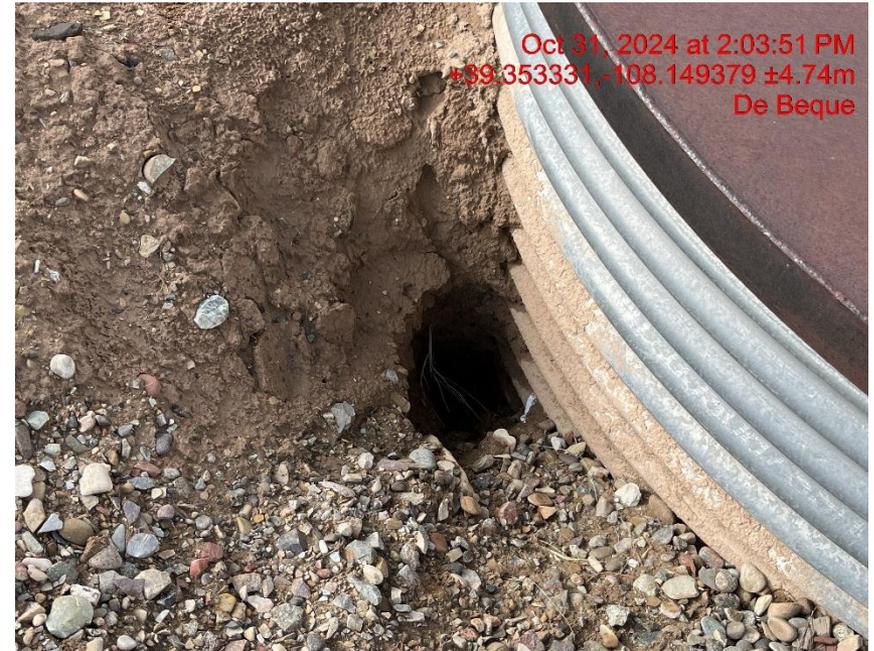
Photo # 8557 Tunnel erosion around cellar is also a wildlife/personal safety hazard near NE side of entrance to location
