Inspection Photos

API: 073-06449

Operator: WIEPKING-FULLERTON ENERGY

Inspection Date: 11/5/2024

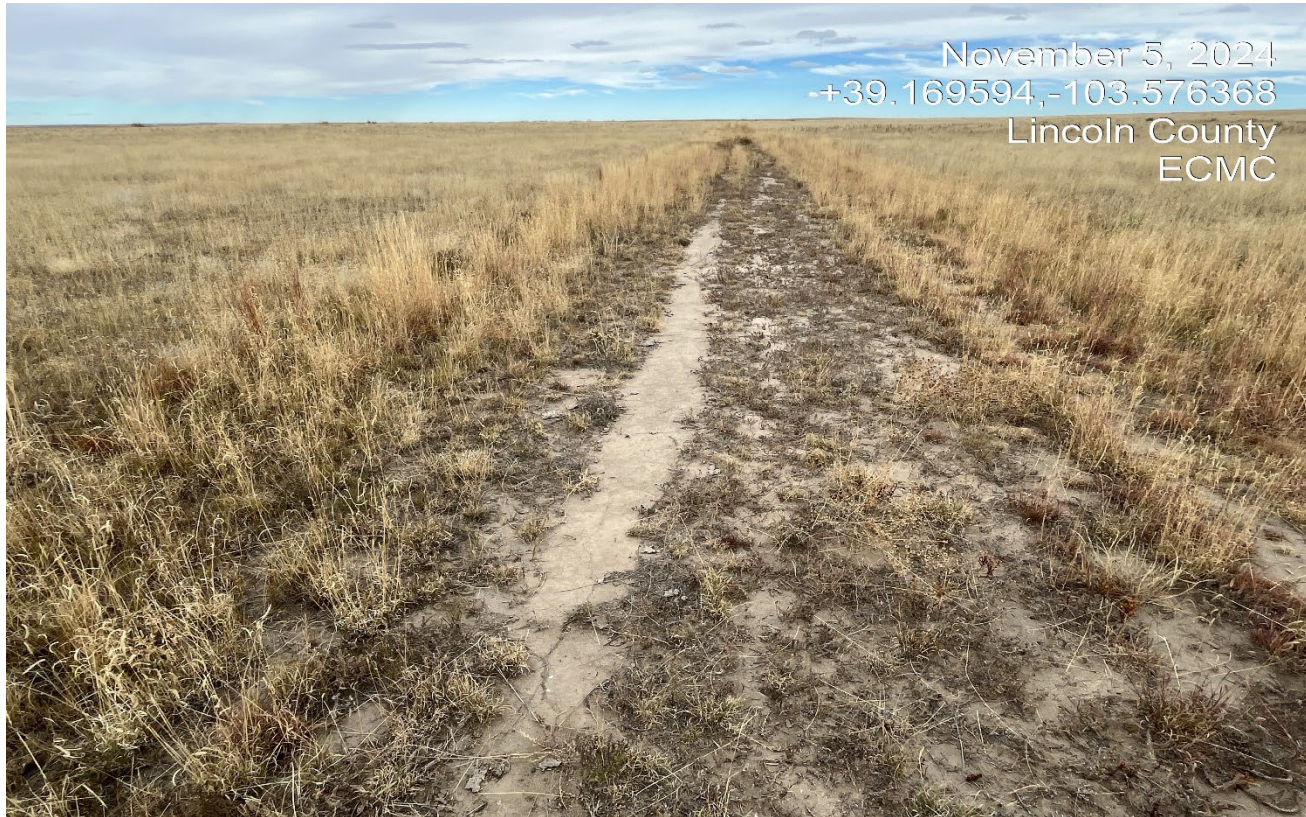
Photo 1. Facing east toward the former access road. There are areas along the road that have not established perennial vegetation.

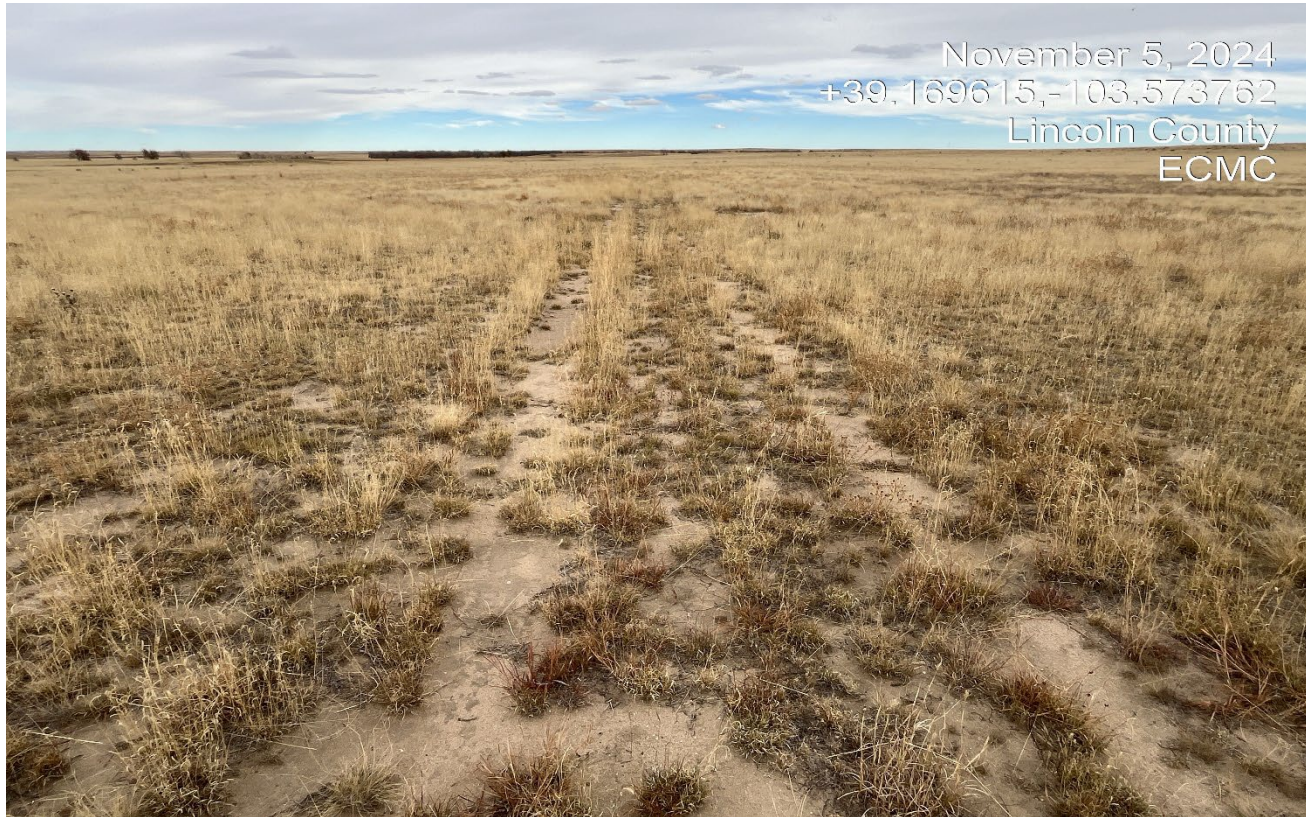
Photo 4. Facing east along the former road toward the location.

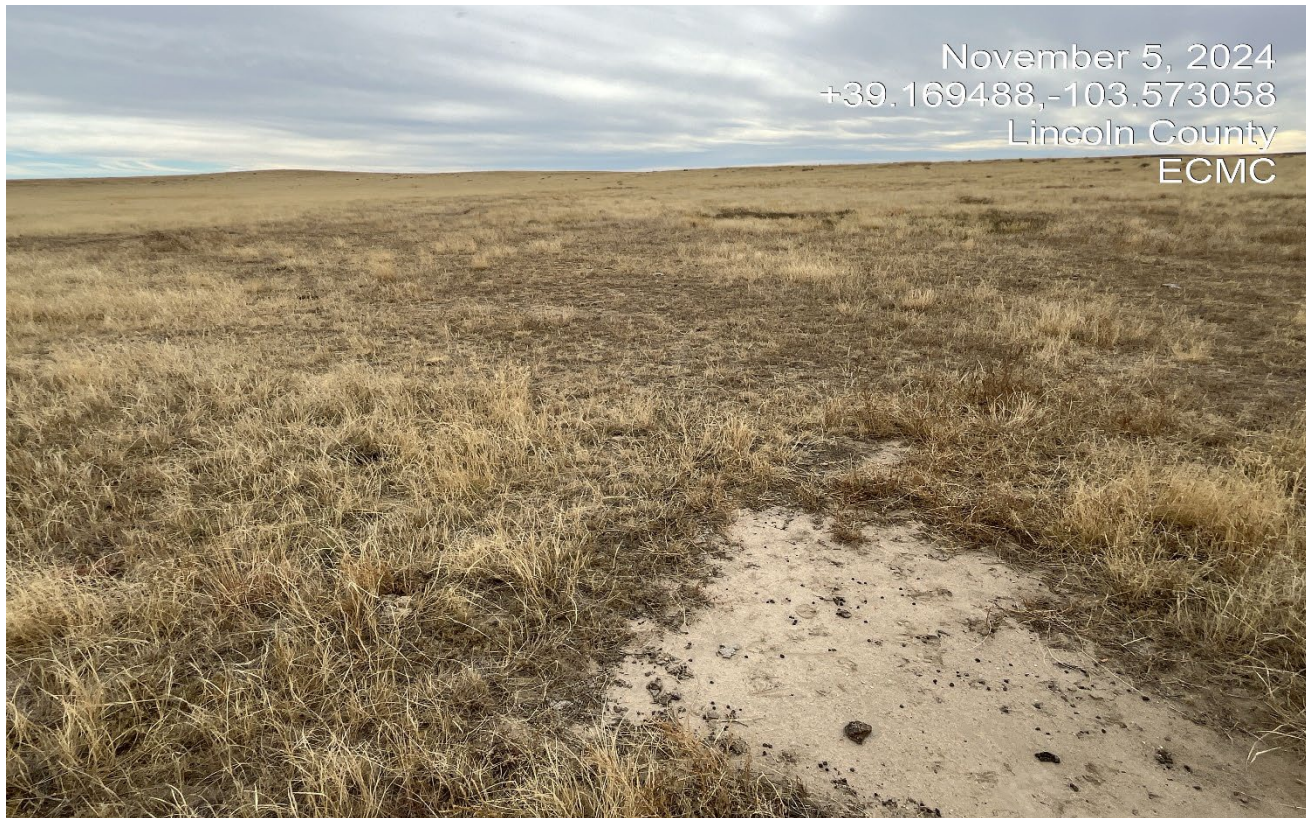
Photo 3. Facing southeast at the location. The south side of the location consists of undesirable weeds (Kochia) and has not yet established sufficient perennial vegetation cover.

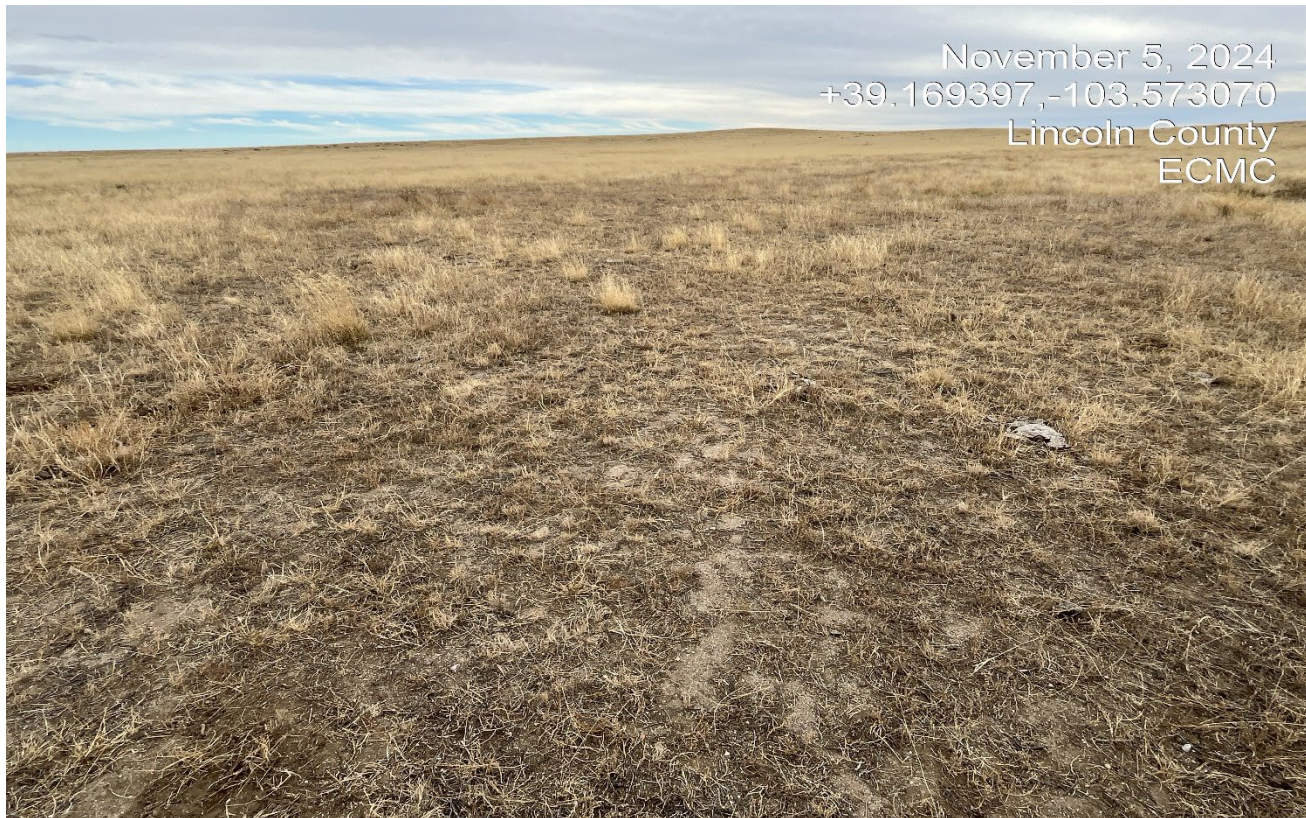
Photo 4. Facing east at the south side of location. The south side of the location consists of undesirable weeds (Kochia) and has not yet established sufficient perennial vegetation cover.

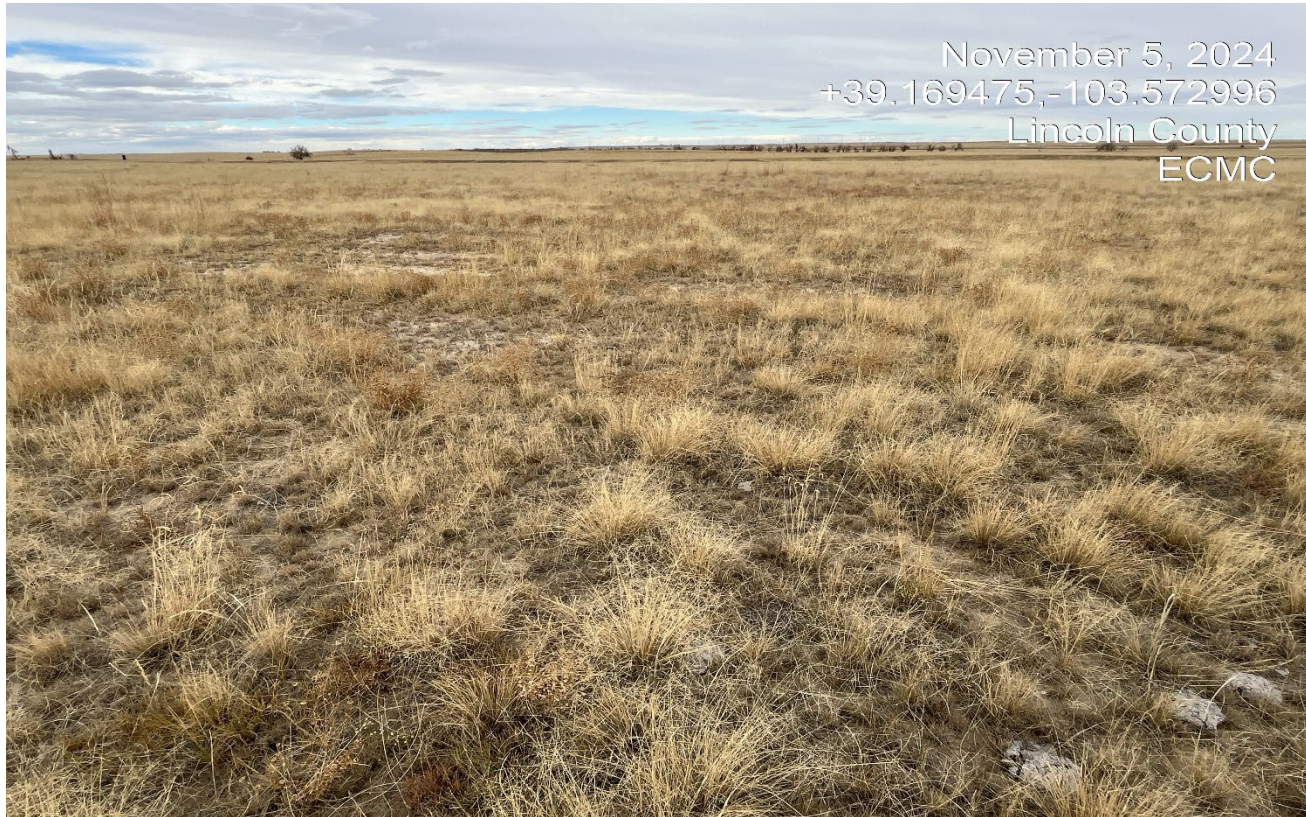
Photo 5. Facing north at the location. Perennial vegetation is progressing at the north side of the location.

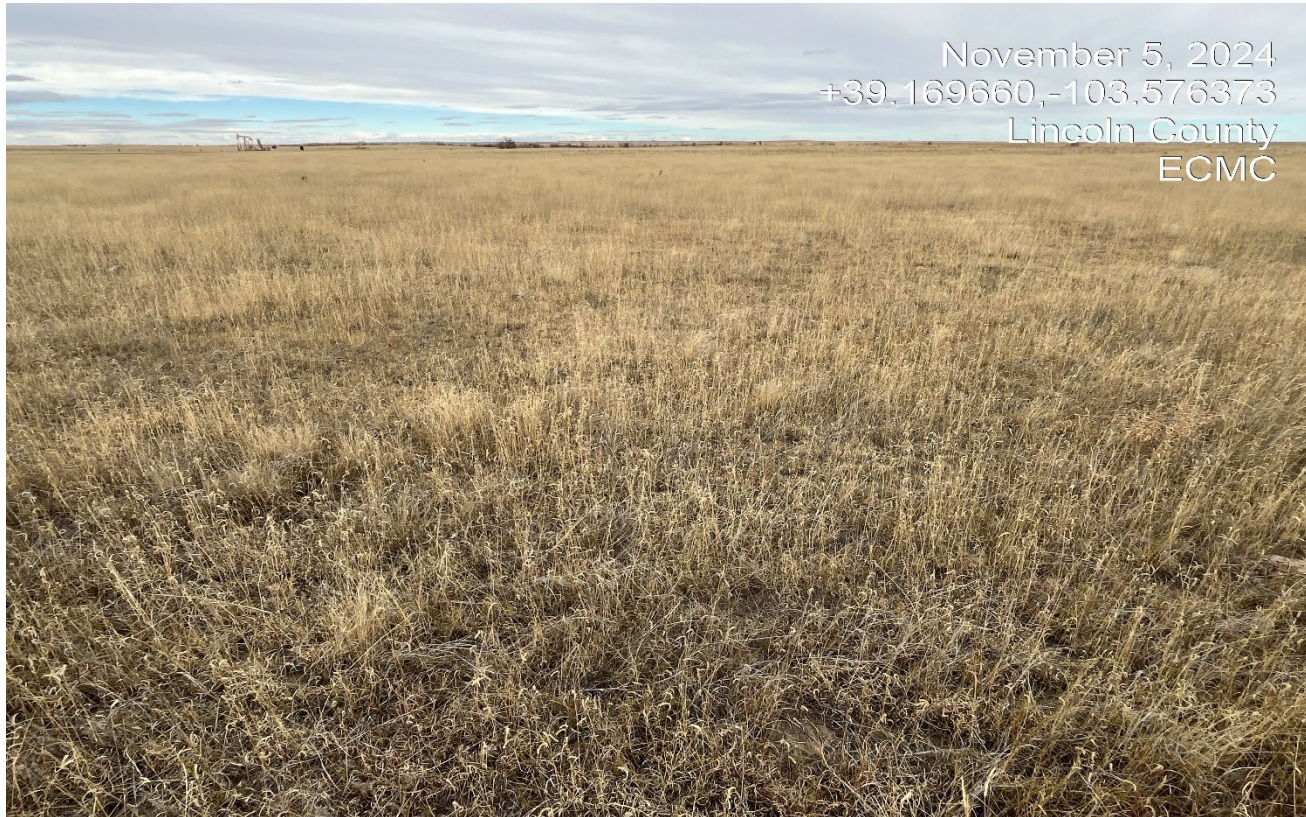
Photo 6. Facing north toward the surrounding undisturbed reference area.
