**Storm Water Management and Erosion control**  
**Location Name: TEP Rocky Mountain LLC CLOUGH RMV 238-29 Pad**  
**Location #: 335323**

**Section/Township/Range: 29 6S94W**

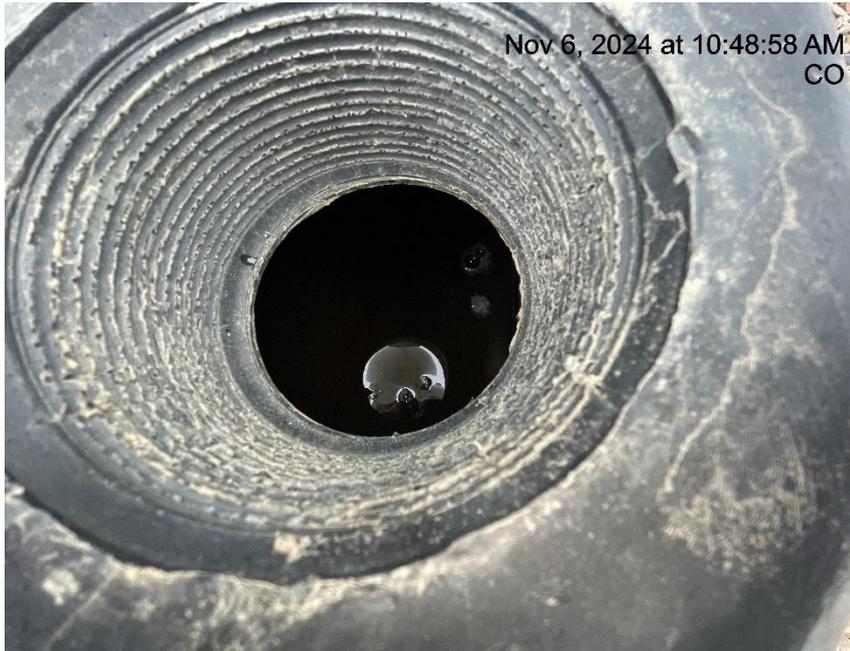
**Photo # 9252 Failure to maintain chemical BMP – Chemical tank containment approximately 3/4<sup>th</sup> full of fluid/BMP insufficient to contain possible spill**
