Interim Reclamation and Stormwater Inspection

Operator: GMT EXPLORATION COMPANY LLC #10243

Location ID: 479191

Inspection Photos
Location Name: Crystal-Ruby/Pad
Location ID: 479191

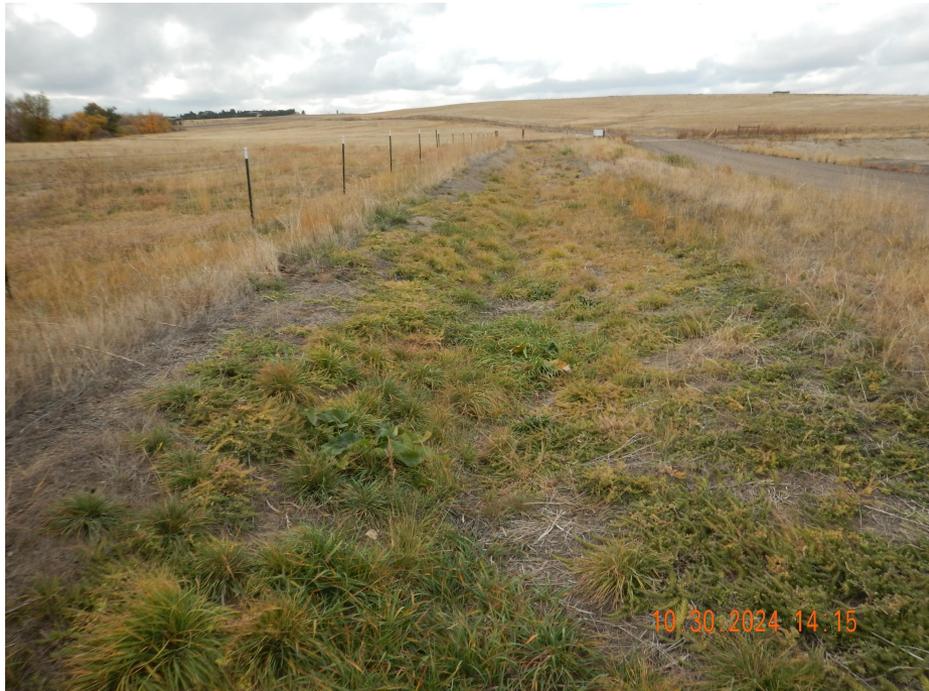
Photo 1. Photo taken along the southeastern perimeter of location, facing West. Photo illustrates preliminary weed control- mowing has only been performed along the perimeter fence line.

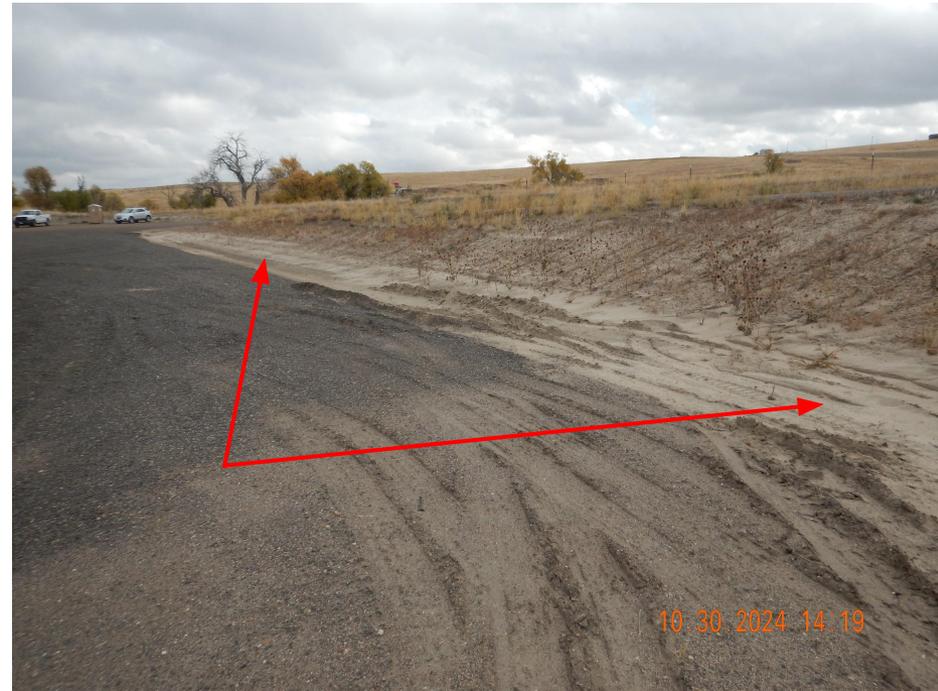
Photo 2. Photo taken along the southwestern perimeter of location, facing Southeast. Photo illustrates ditch BMPs are not properly functioning and have accumulation of sediment.

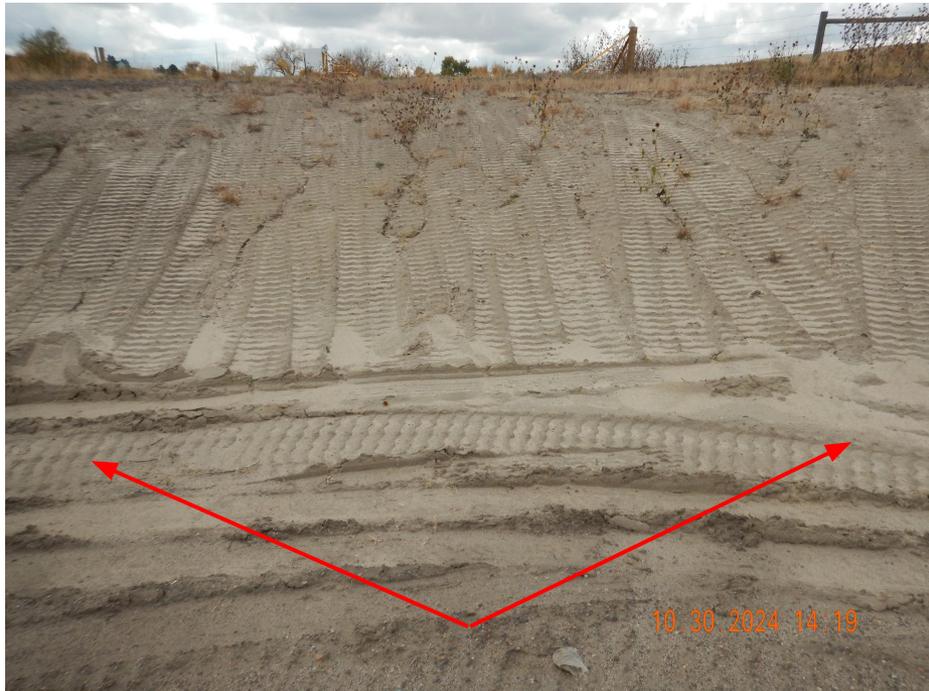
Photo 3. Photo taken along the southwestern perimeter of location, facing West. Photo illustrates repairs have been performed on rill erosion observed on the cut slope.

Ditch BMPs are not properly functioning and have accumulation of sediment.

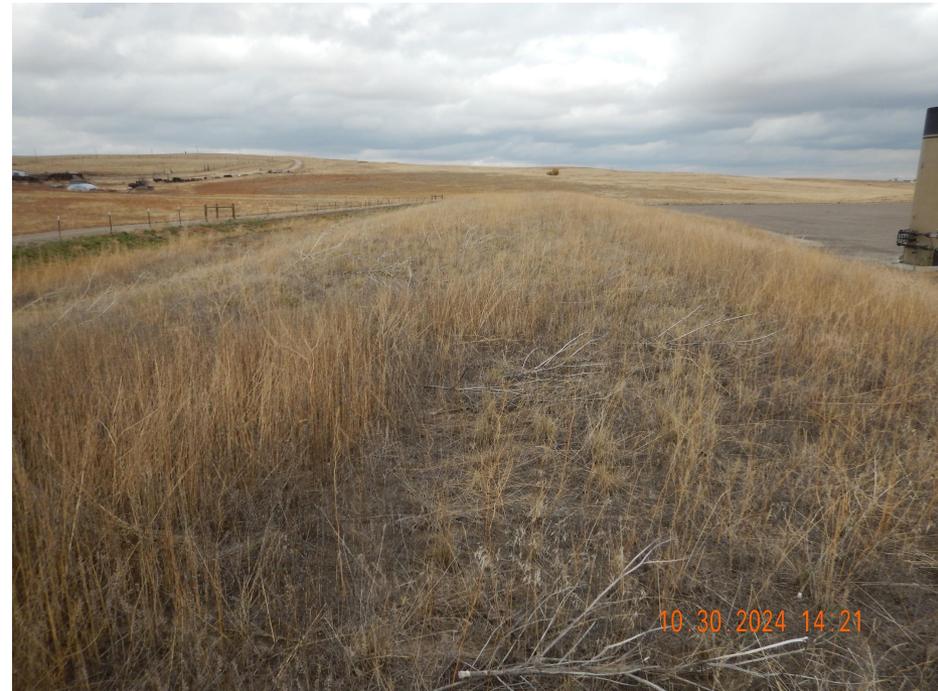
Photo 4. Photo taken from the western topsoil stockpile, facing North. Photo illustrates that weeds do not appear to have been mowed. Reseeding has not been performed but is planned.

Operator did request an extension for reseeding due to environmental conditions.

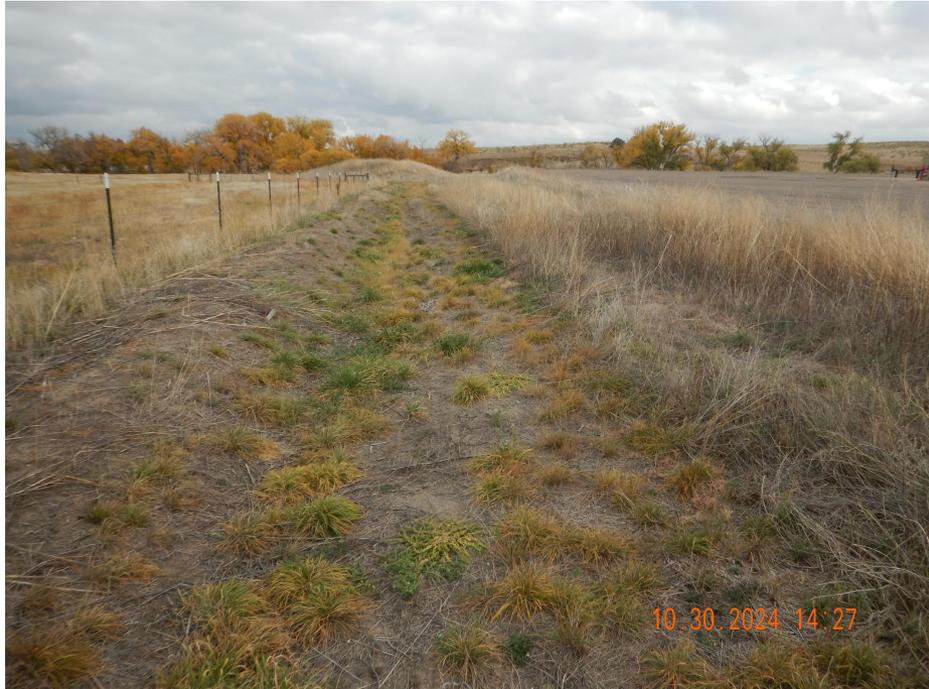
Photo 5. Photo taken along the northwestern perimeter of location, facing East. See comments under Photo 1.

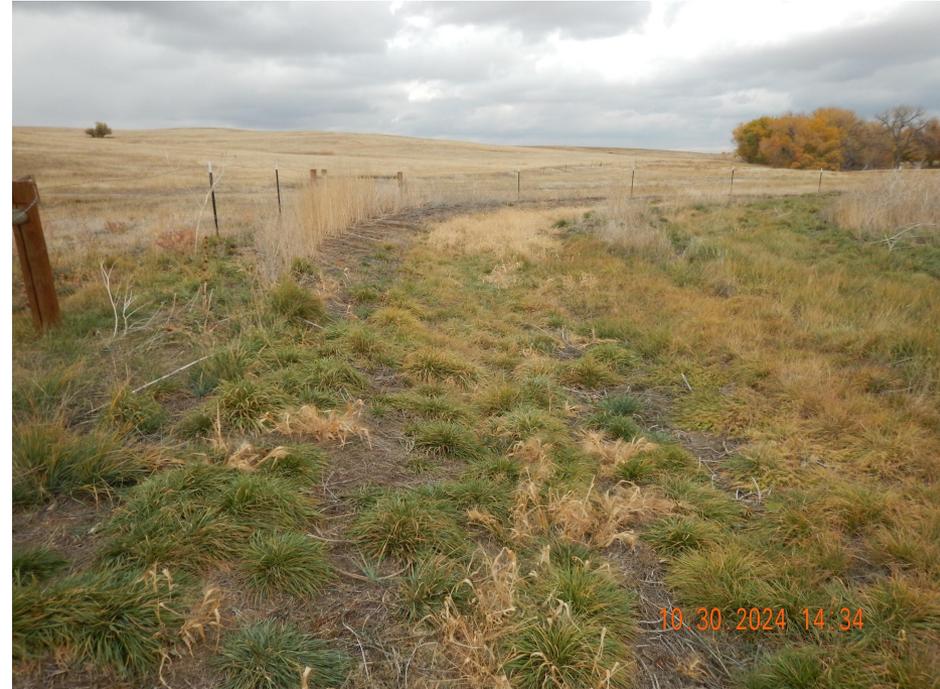
Photo 6. Photo taken along the northern perimeter of location, facing North. See comments under Photo 1.

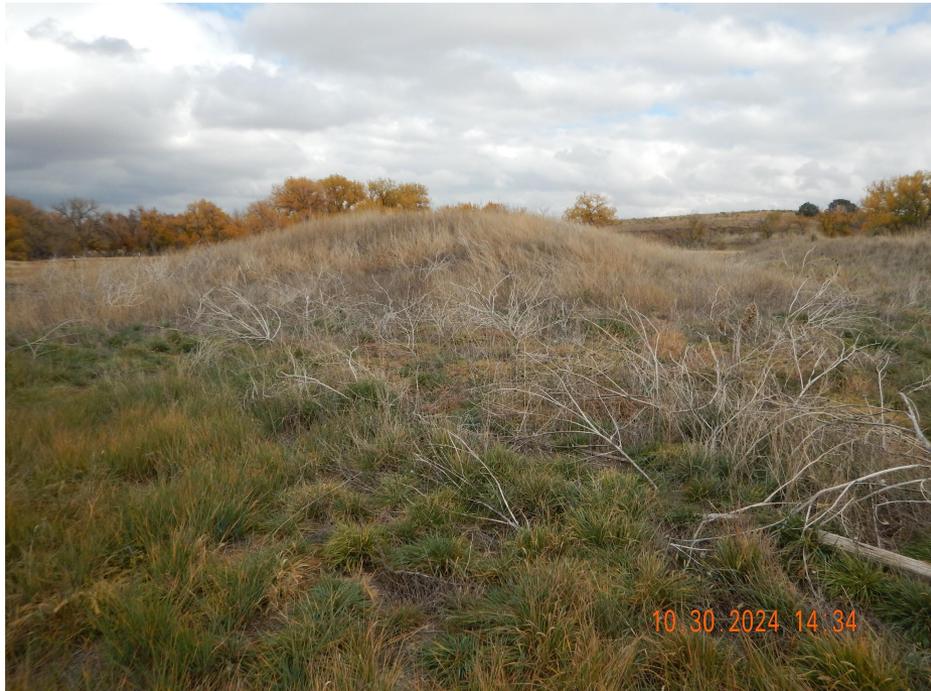
Photo 7. Photo taken from the northern topsoil stockpile, facing East. See comments under Photo 4.

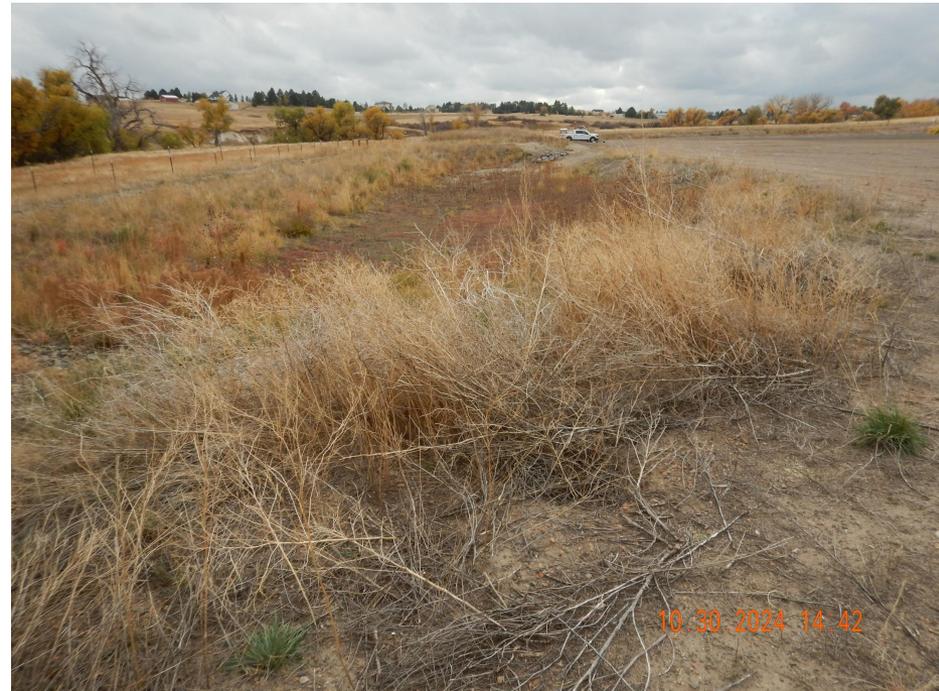
Photo 8. Photo taken along the northeastern perimeter of location, facing South. Photo illustrates weedy, annual vegetation.

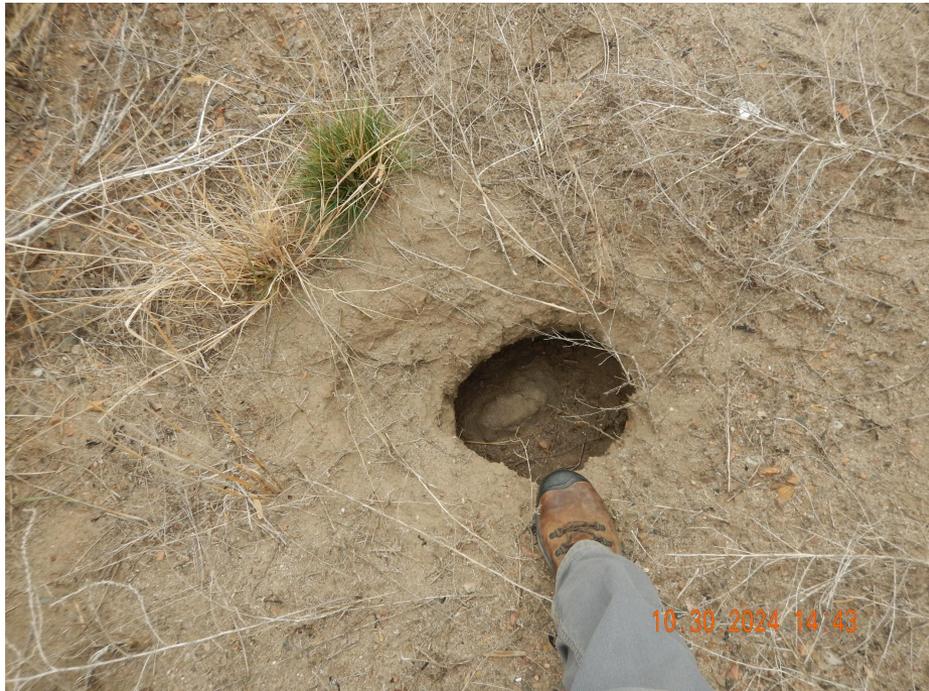
Photo 9. Photo taken along the eastern well pad. Photo illustrates either subsidence or the sound wall hole was never properly backfilled.

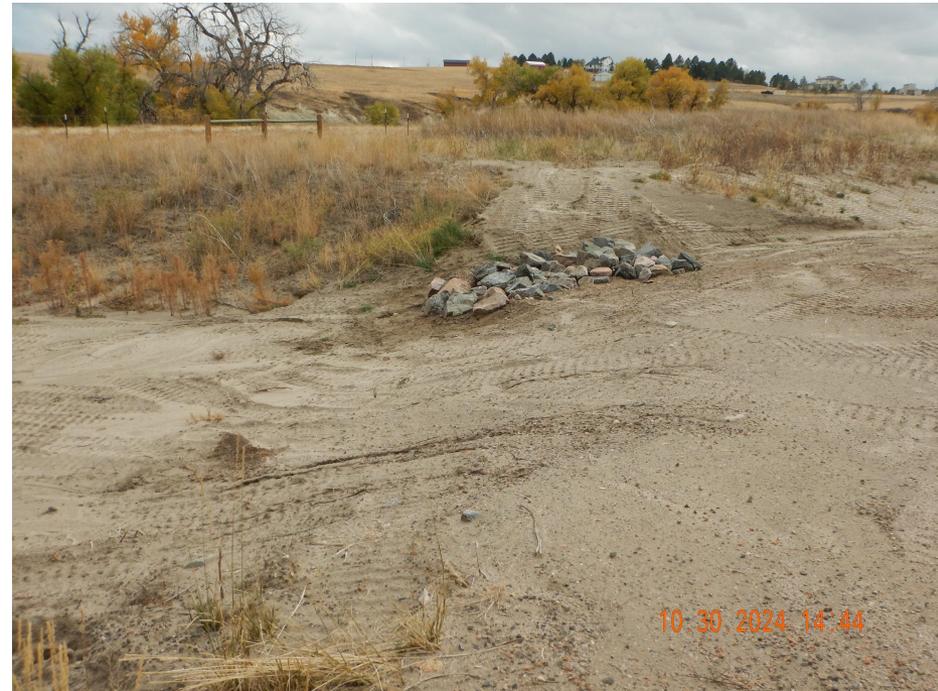
Photo 10. Photo taken of the eastern well pad, facing South. Photo illustrates stormwater repairs have been performed.

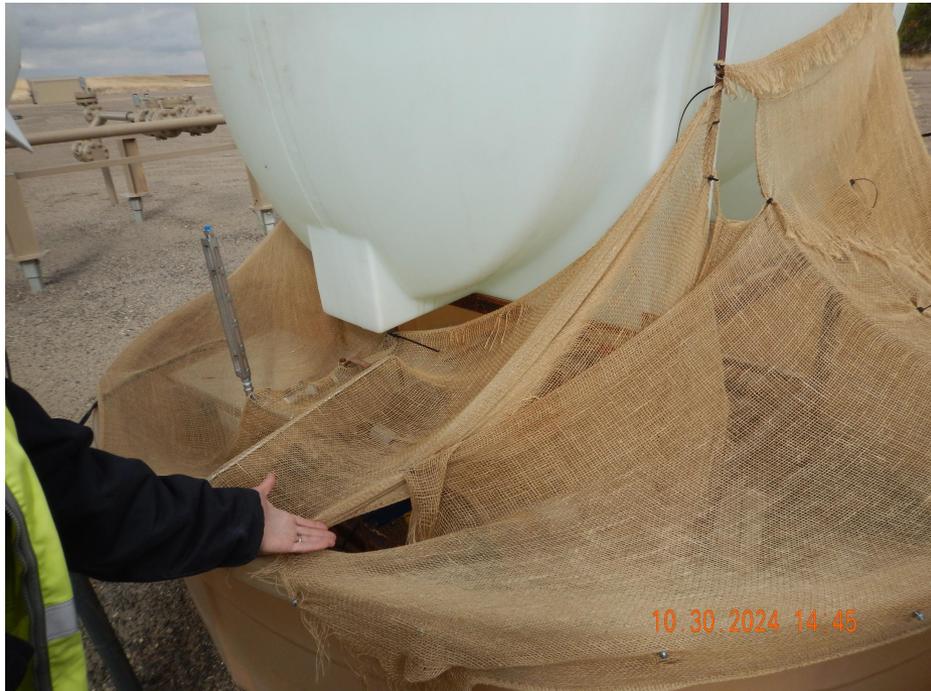
Photo 11. Photo taken from the production facility area. Photo illustrates wildlife netting that has not been properly installed.

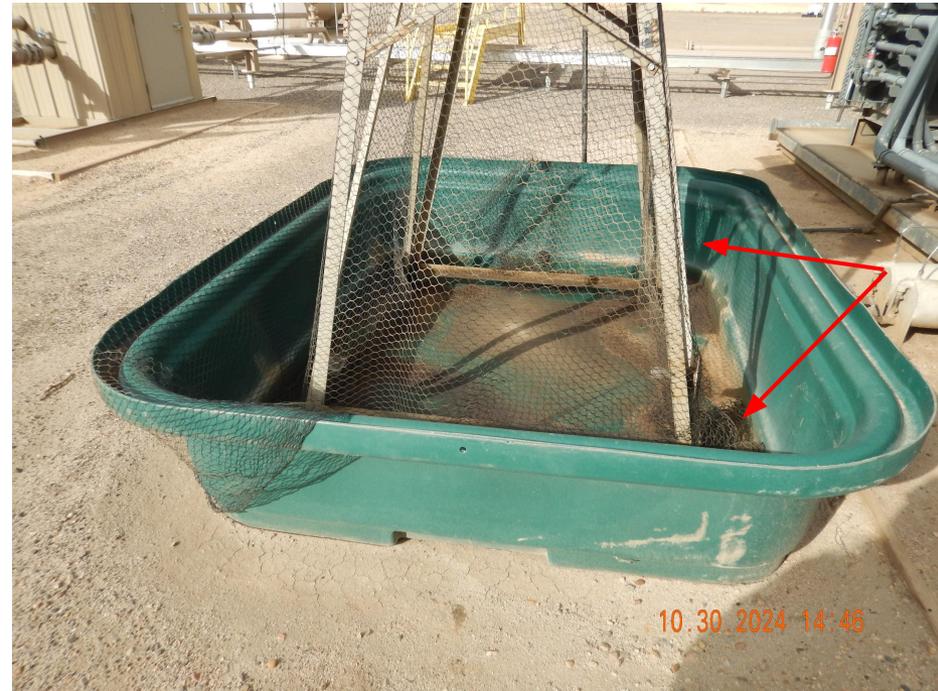
Photo 12. Photo taken from the production facility area. See comments under Photo 11.

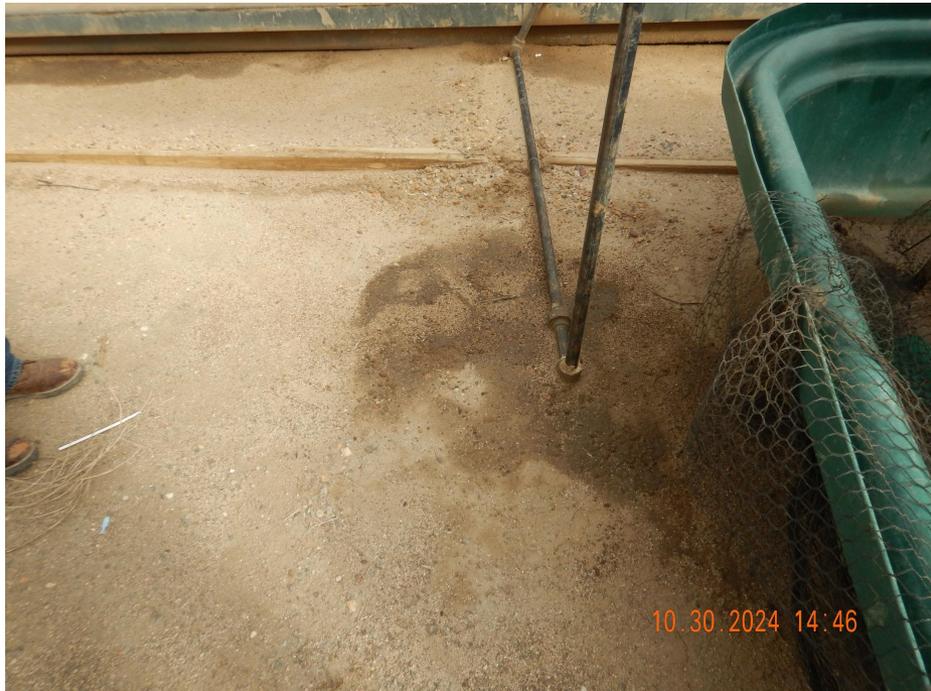
Photo 13. Photo taken from the production facility area. Photo illustrates stained soil.

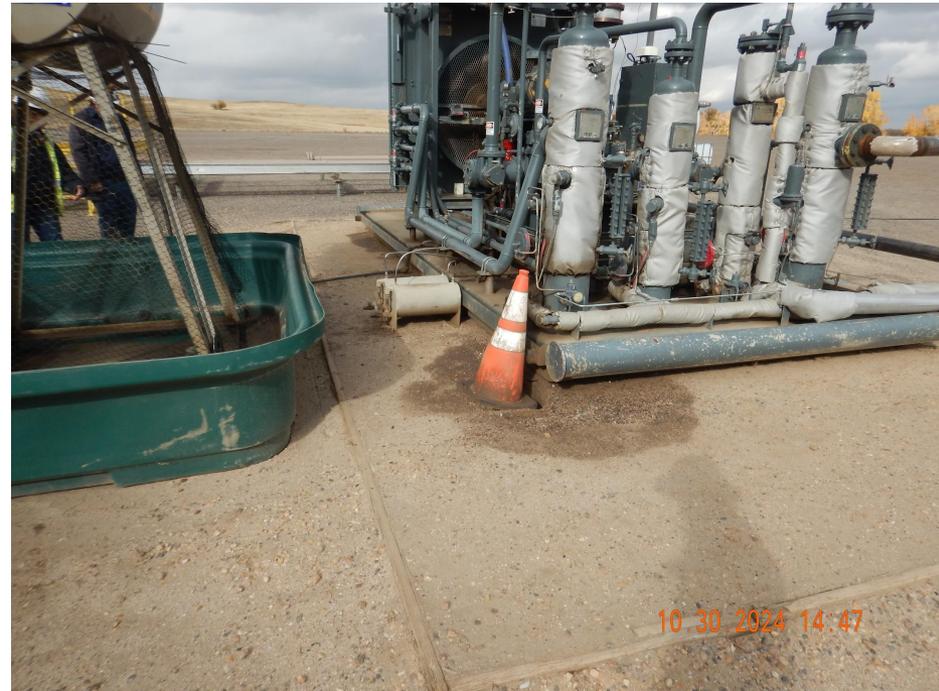
Photo 14. Photo taken from the production facility area. See comments under Photo 13.

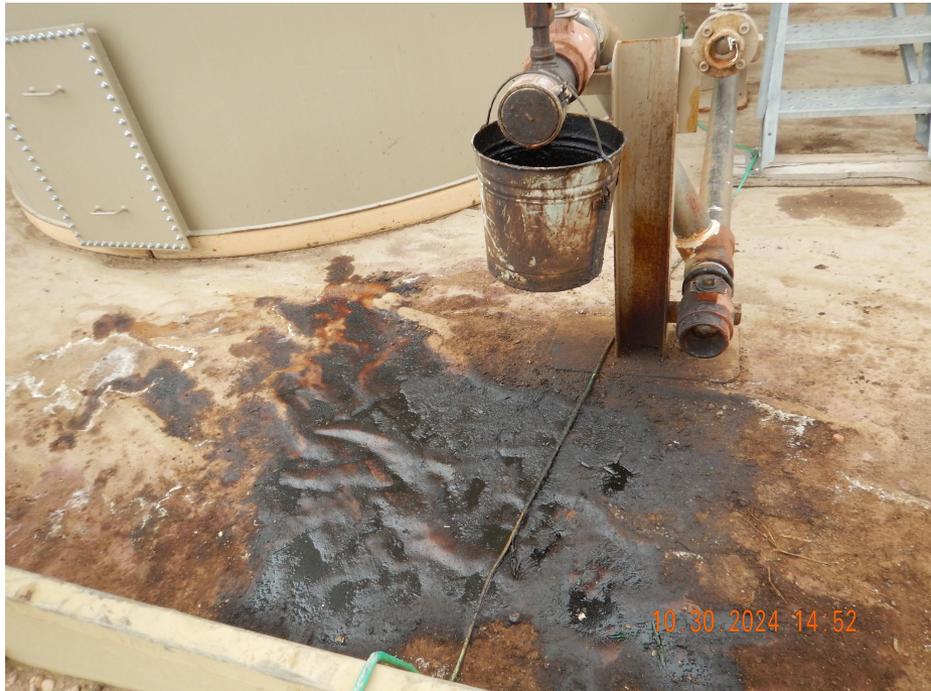
Photo 15. Photo taken from the secondary containment area of the production facility area. Photo illustrates E&P waste that needs to be cleaned up.

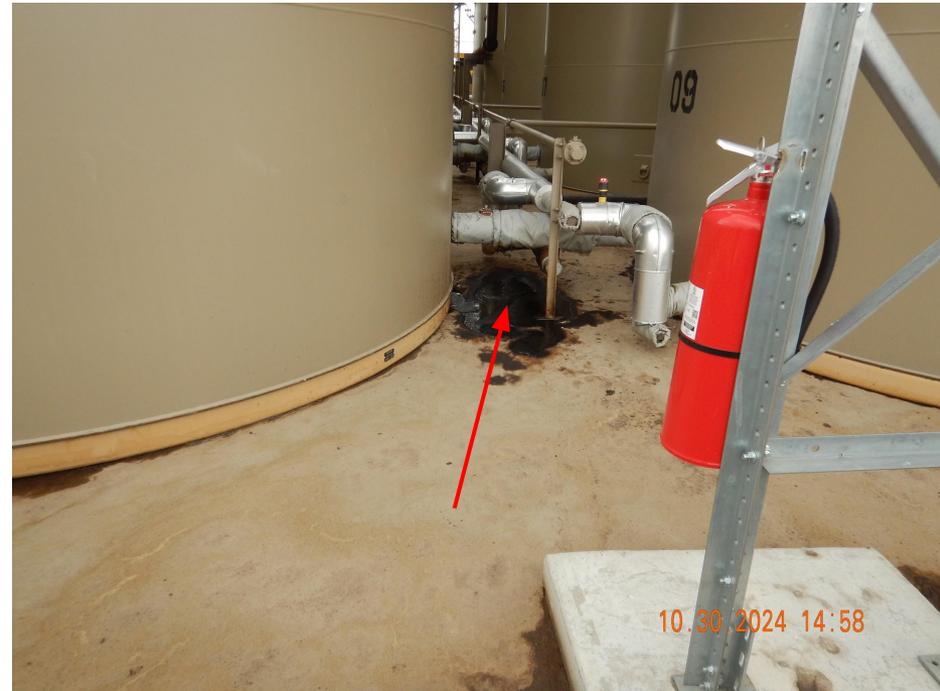
Photo 16. Photo taken from the secondary containment area of the production facility area. See comments under Photo 15.
