Inspection Photos

Location Name: TEP ROCKY MOUNTAIN LLC CLOUGH RMV 3-20 Pad

Location ID: 323886

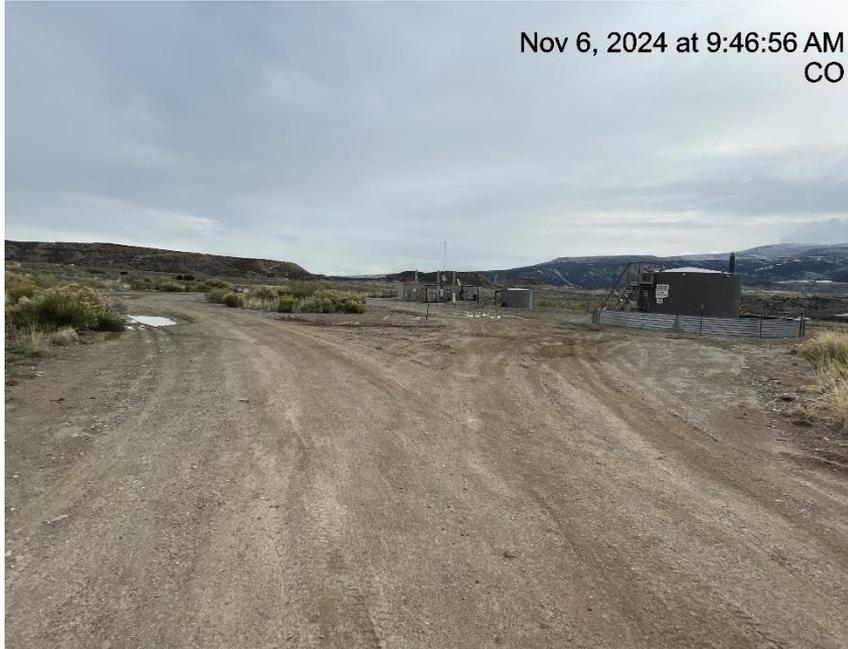
Photo # 9083 From entrance to location

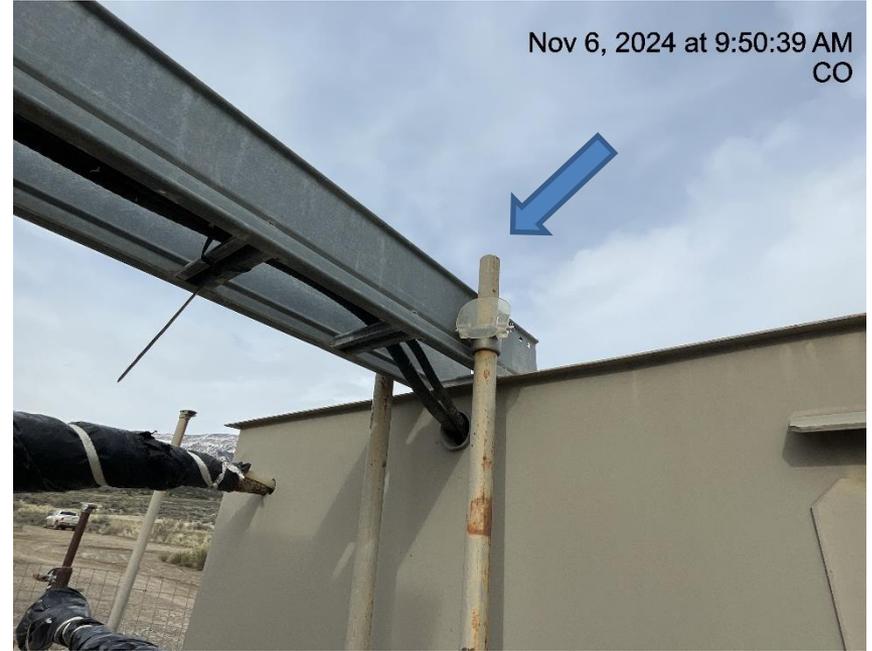
Photo # 9090 PRV vent line does not comply with CECMC pressure safety device rules

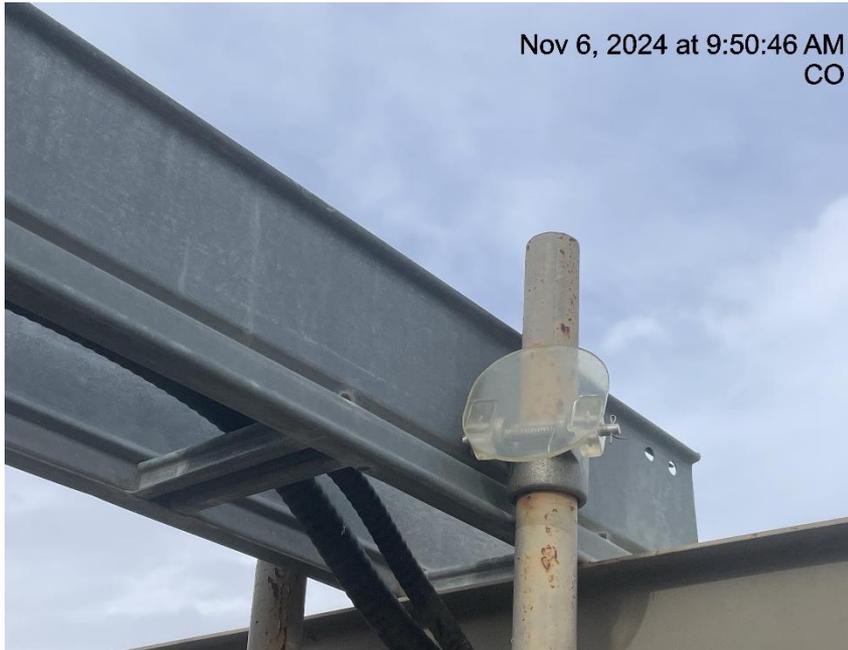
**Photo # 9091 PRV vent line does not comply with CECMC
pressure safety device rules**
