Inspection Photos

Location Name: TEP ROCKY MOUNTAIN LLC FEDERAL WMC 24-17 Pad

Location ID: 480732

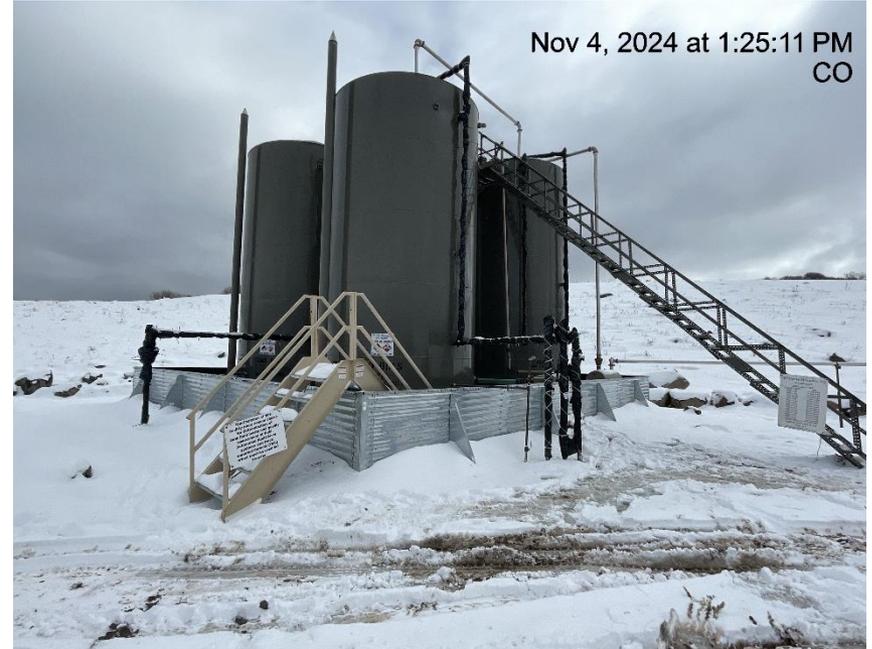
Photo # 8815 Tank battery contains three 500 bbl tanks – FORM 2A submitted by operator only lists 2 tanks/operator is not in compliance with CECMC rules

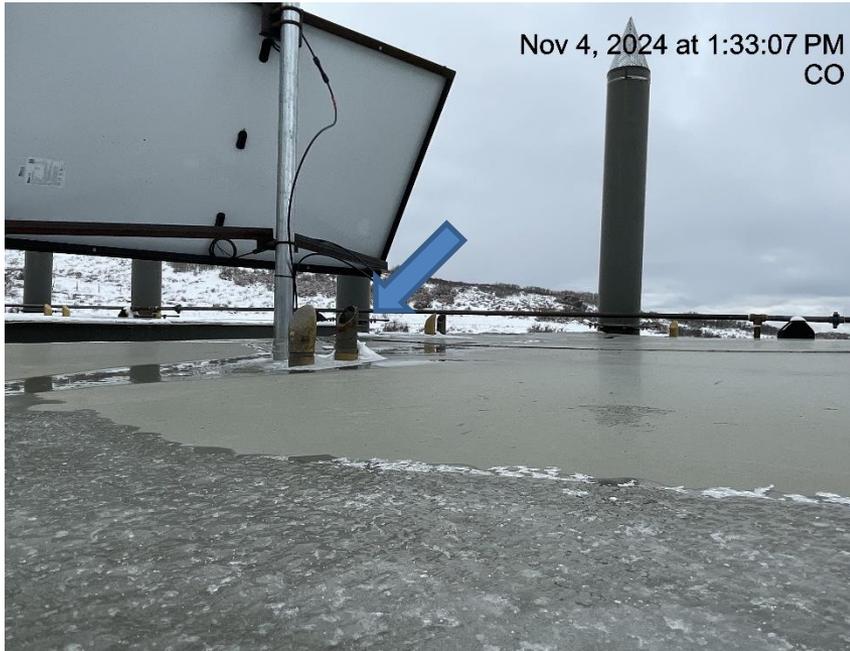
Photo # 8816 PRV vent line does not comply with CECMC pressure safety device rules

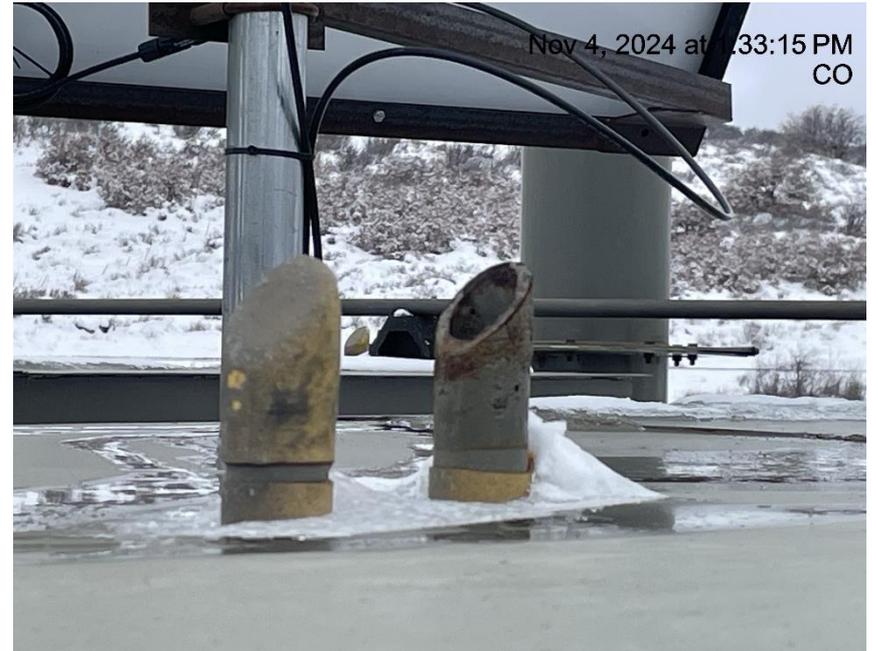
Photo # 8817 PRV vent line does not comply with CECMC pressure safety device rules

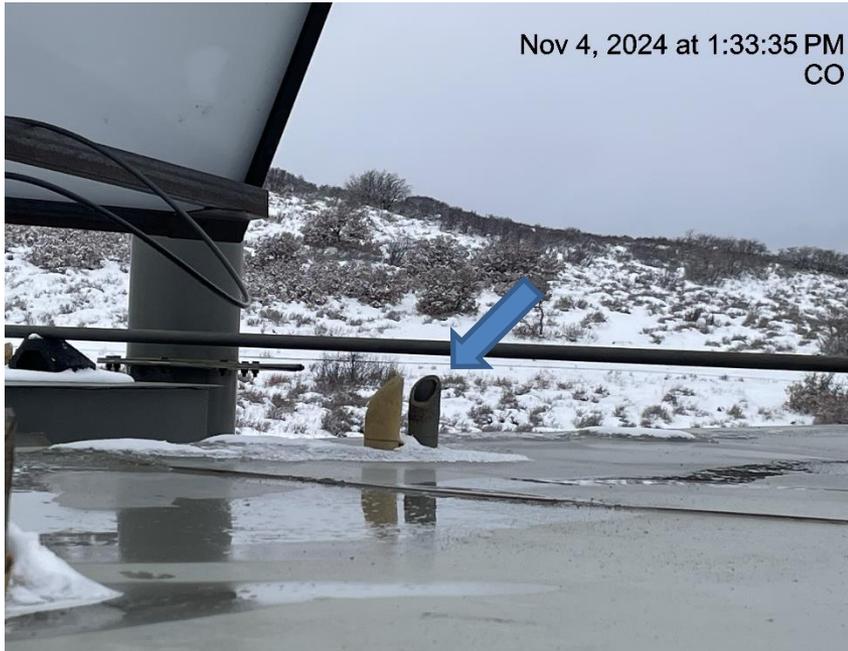
Photo # 8818 PRV vent line does not comply with CECMC pressure safety device rules

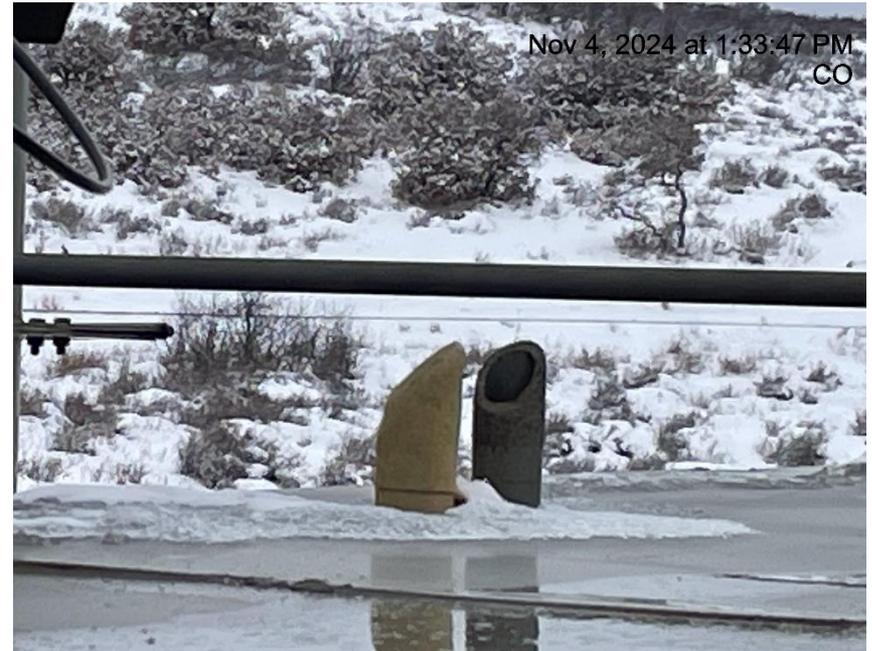
Photo # 8819 PRV vent line does not comply with CECMC pressure safety device rules

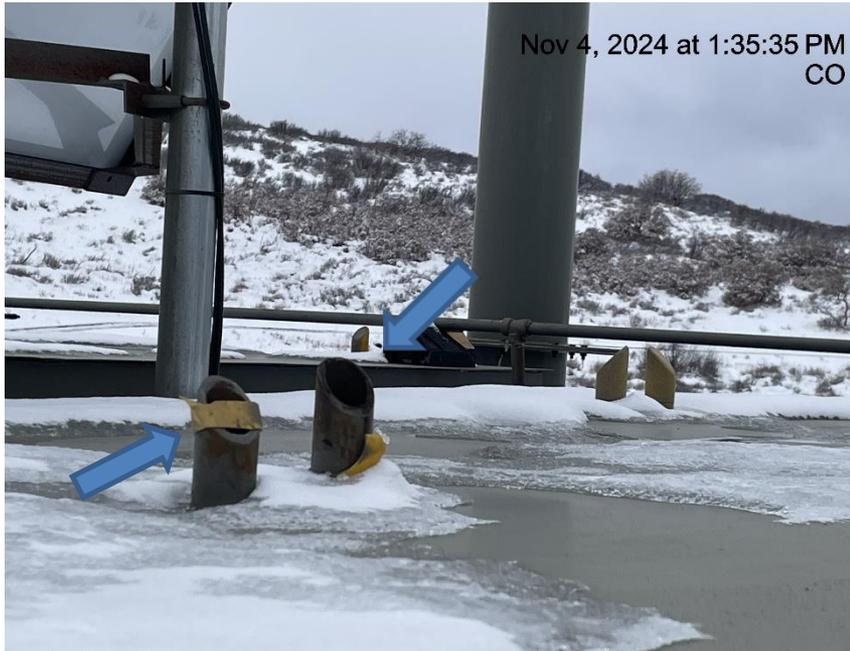
Photo # 8820 PRV vent line & rupture disc vent line do not comply with CECMC pressure safety device rules

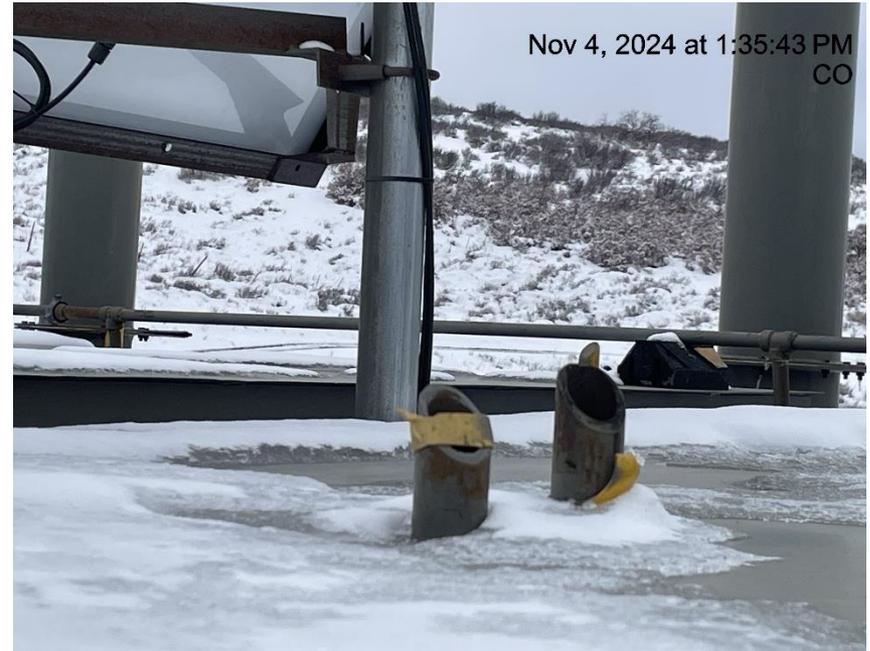
Photo # 8821 PRV vent line & rupture disc vent line do not comply with CECMC pressure safety device rules

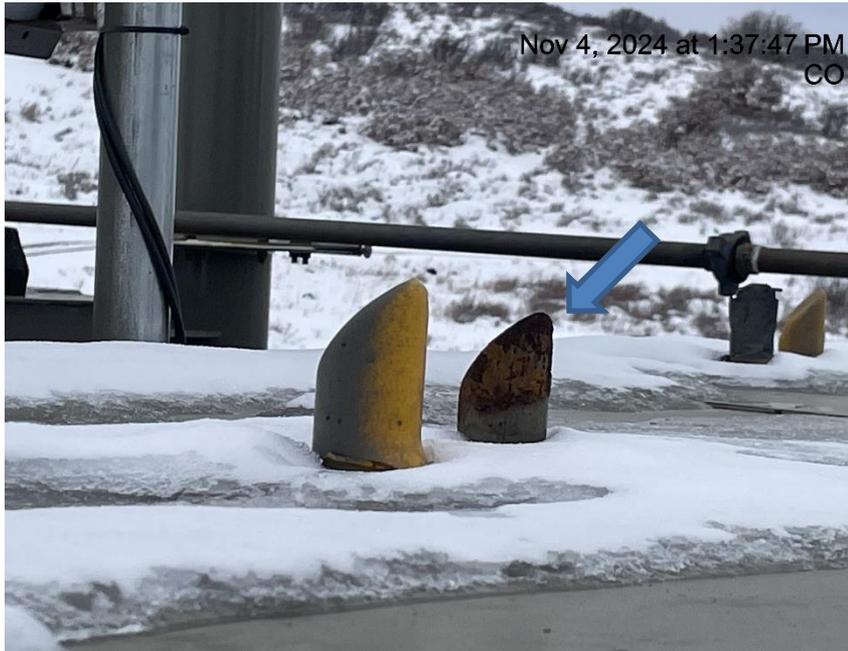
Photo # 8822 PRV vent line does not comply with CECMC pressure safety device rules

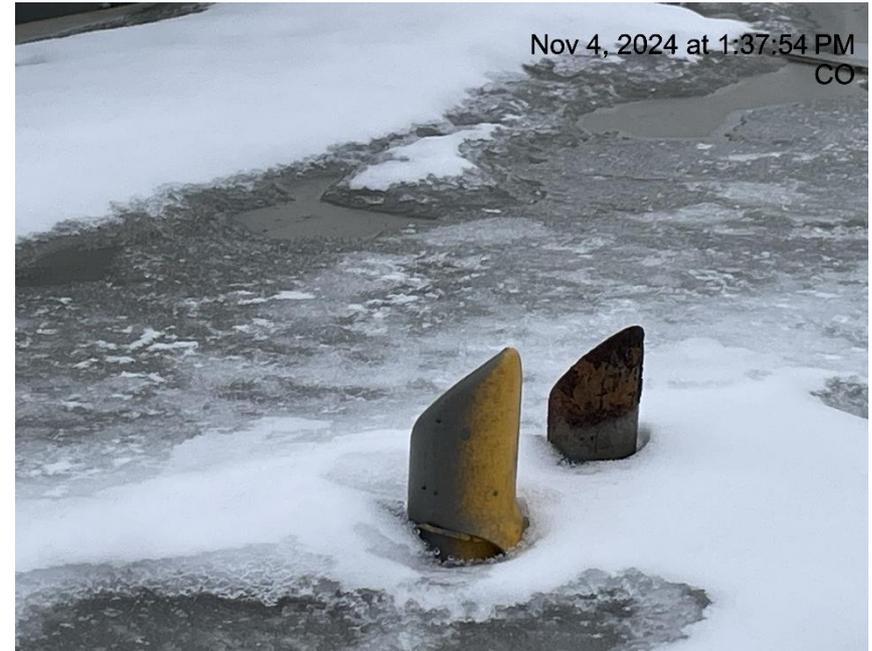
Photo # 8823 PRV vent line does not comply with CECMC pressure safety device rules
