# Inspection Photos

November 12th, 2024

Operator: Simcoe LLC - 10749

Inspection Photos  
Location Name: Gearhart 01-05 2  
Location ID: 307009

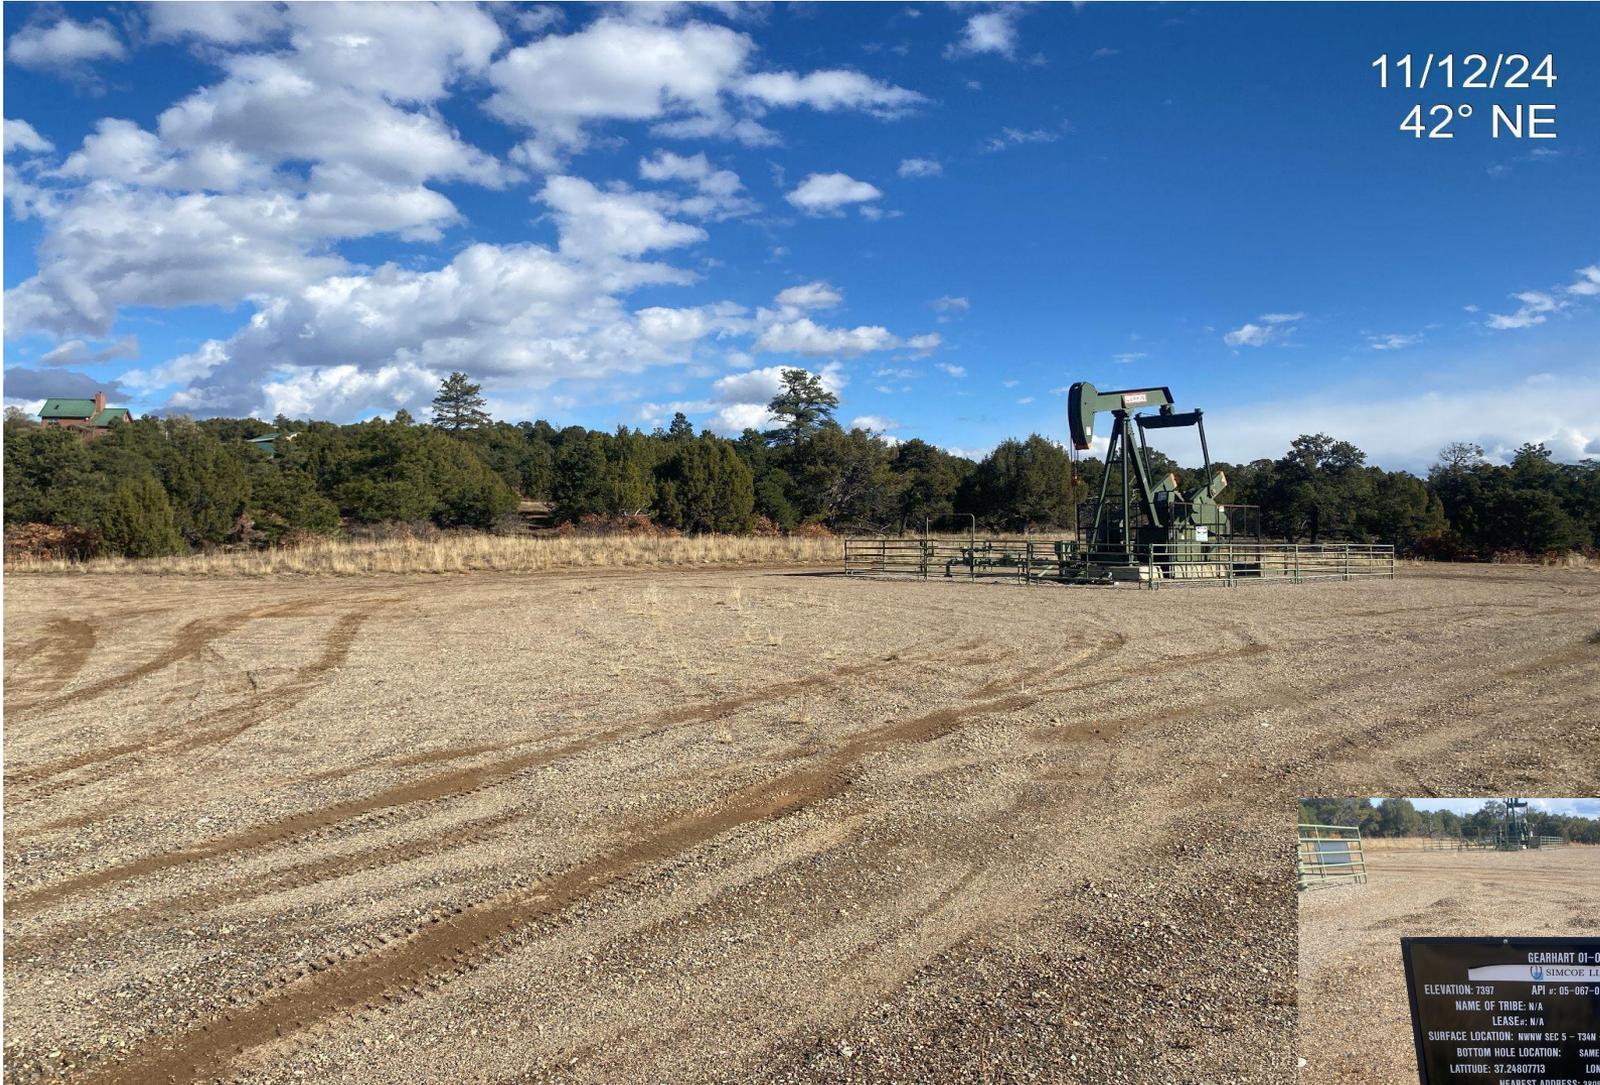
Photo 1. View of well disturbance taken from the access point facing center.

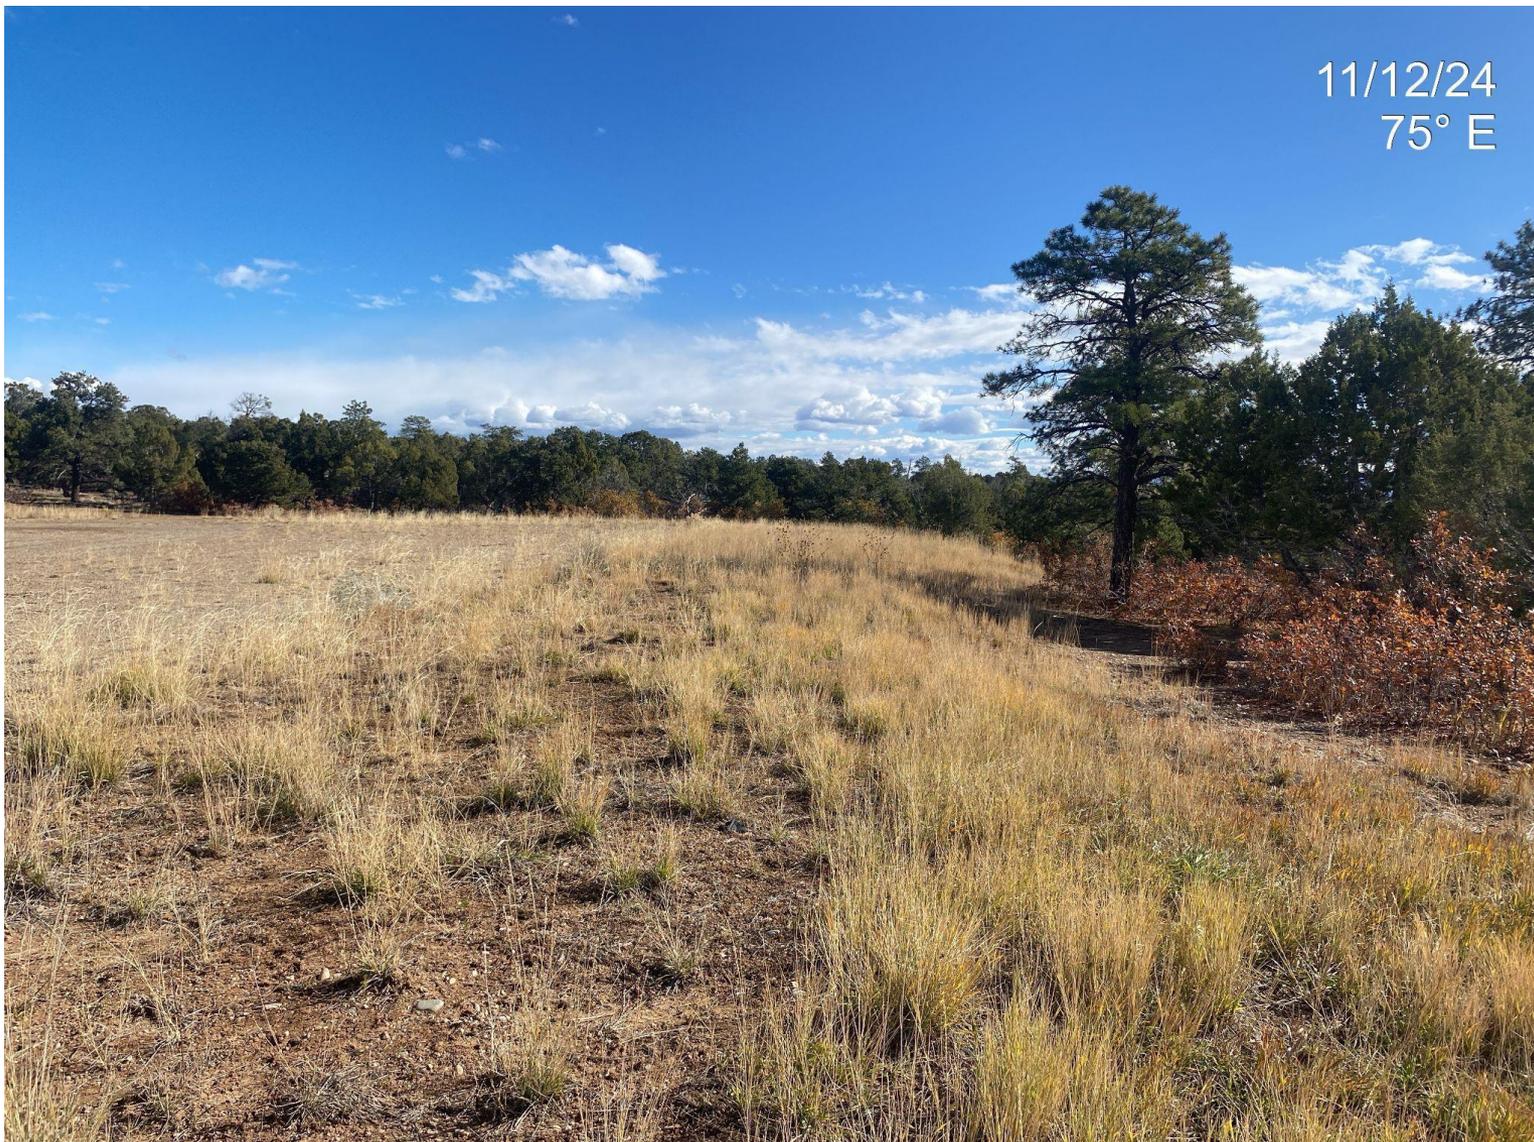
**Photo 2.** Southern reclamation area composed of Sand Dropseed, Smooth Brome and Western Wheatgrass. No erosion observed in the southern portion of the location.

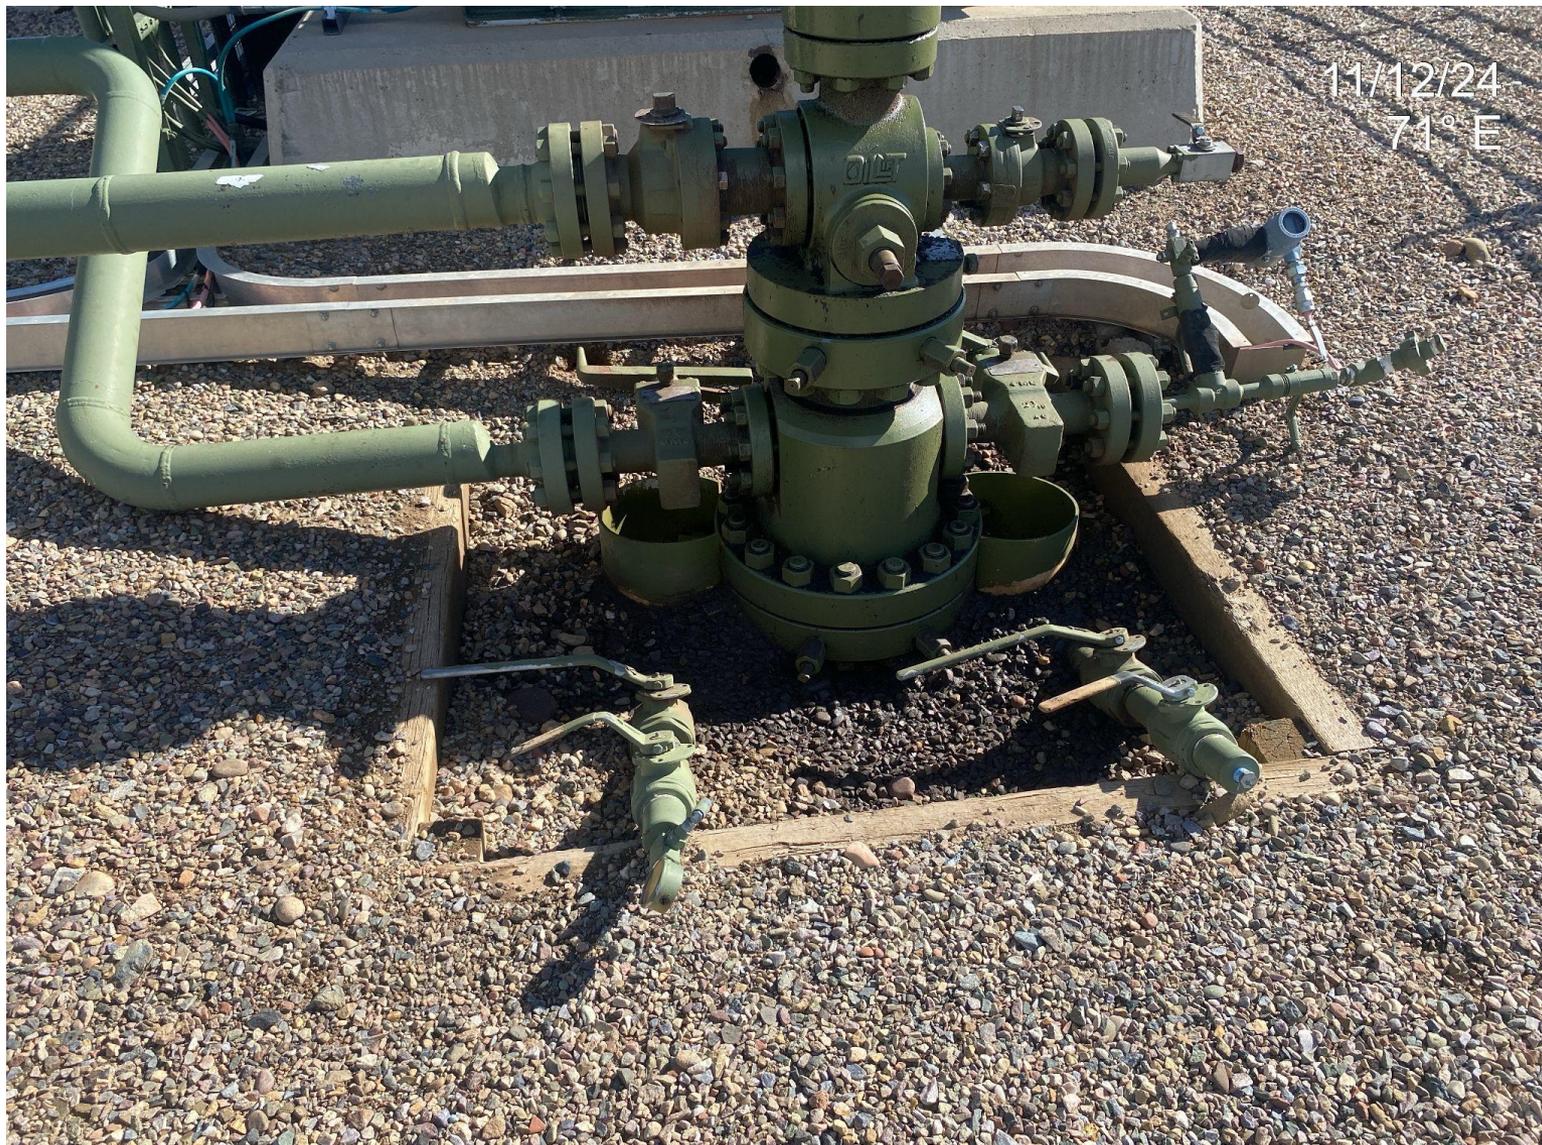
**Photo 3.** Impacted surface material observed at well head.

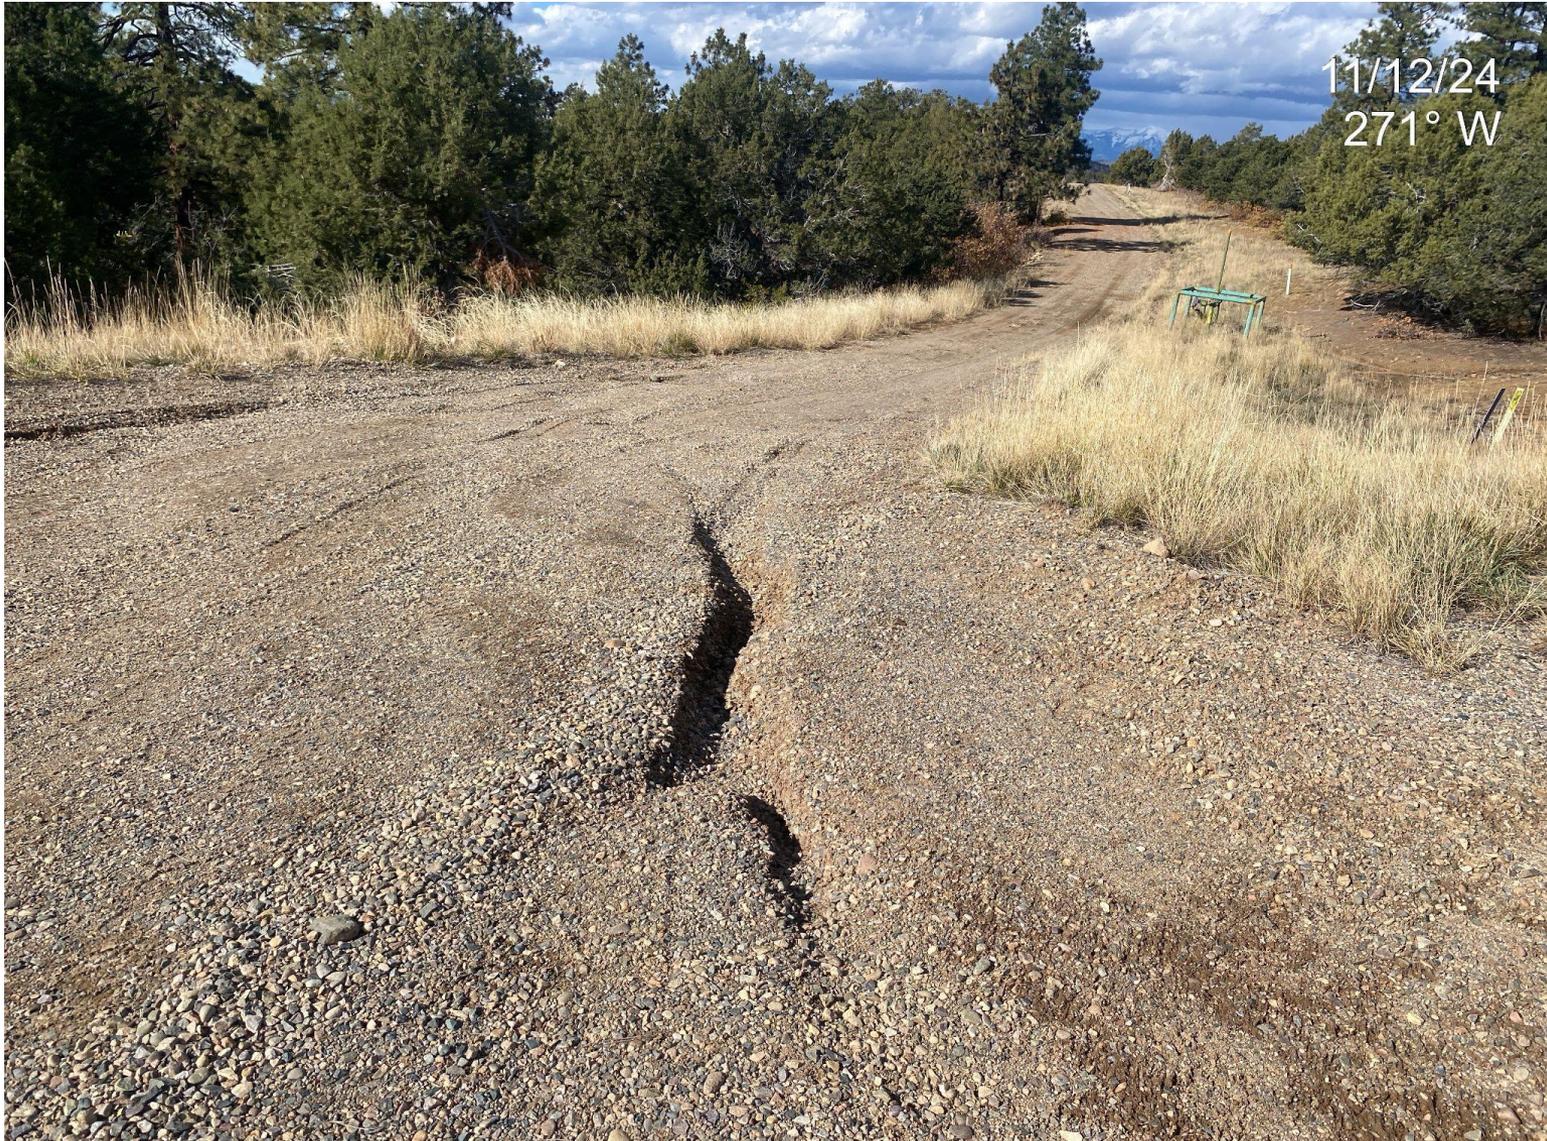
**Photo 4.** Erosion forming at the access point, future maintenance for additional stabilization at access point is advised.

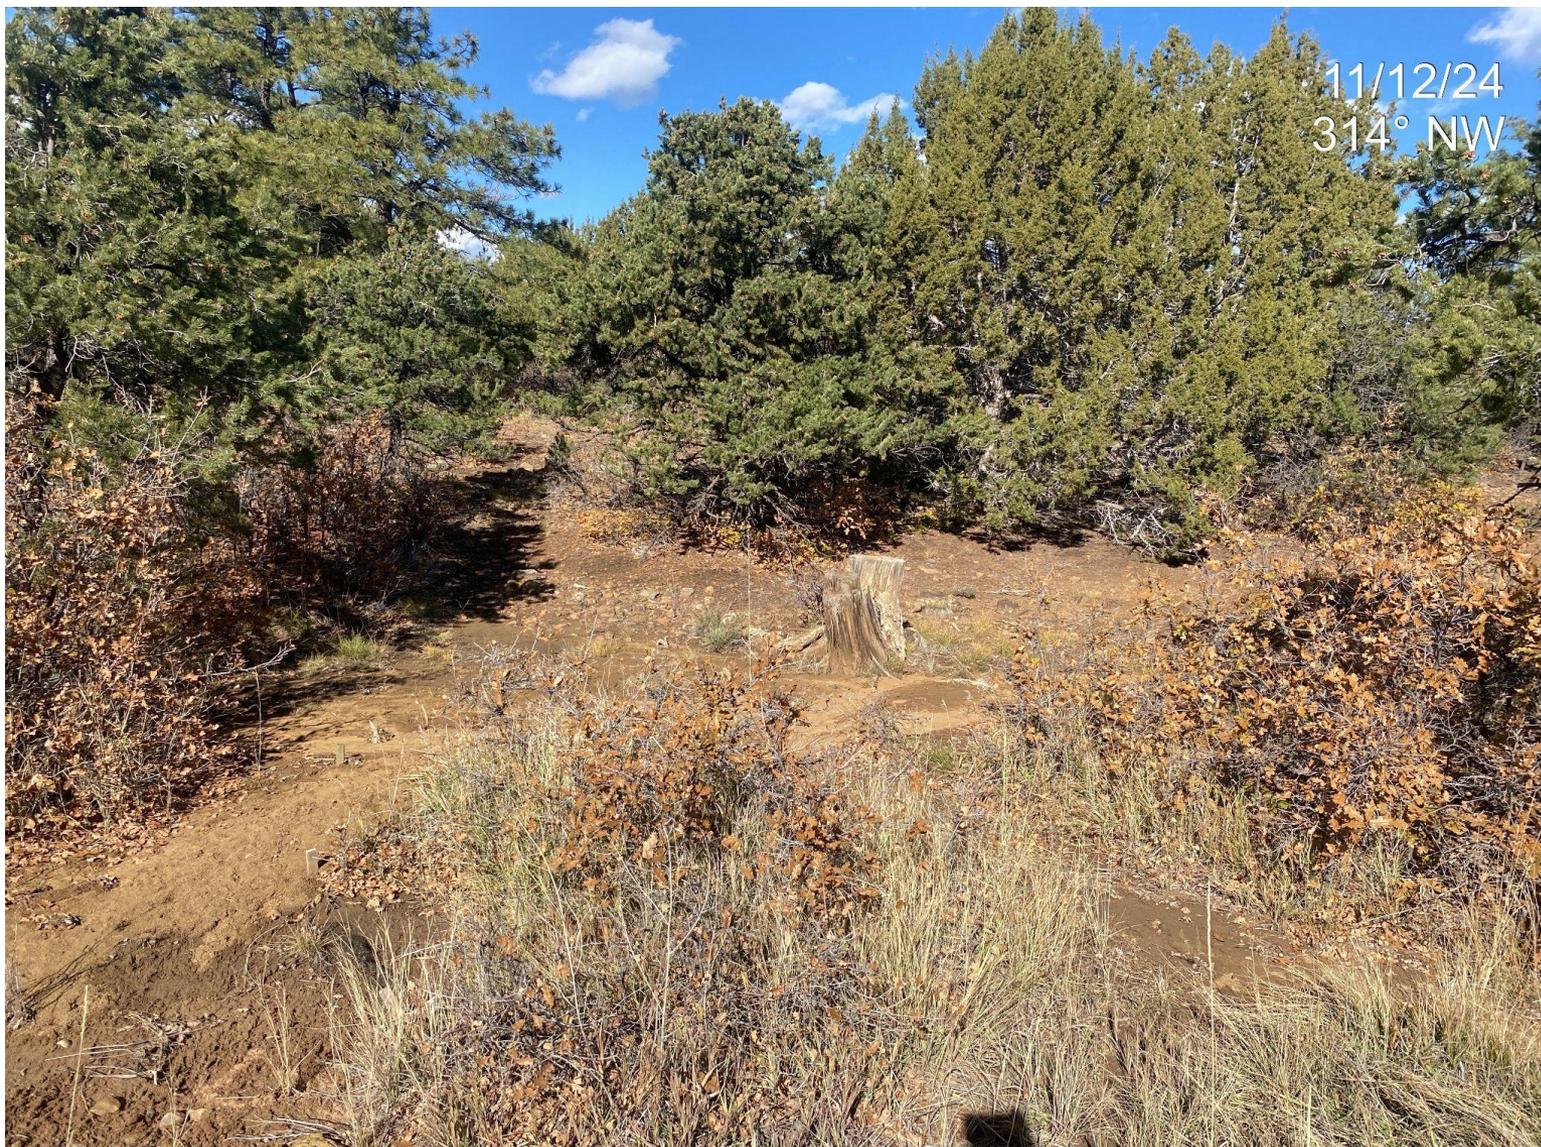
**Photo 5.** Reference area composed of Western Wheatgrass, Gambel Oak and Juniper.
