Inspection Photos

Location Name: TEP Rocky Mountain LLC LANGSTAFF RMV 12-16 Pad

Location # 335188

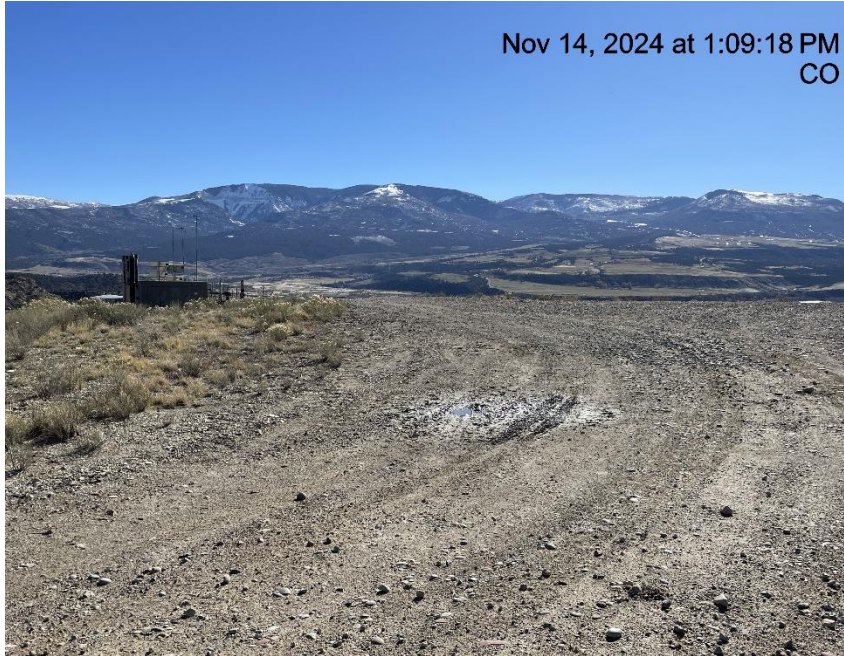
Photo # 88 From entrance to location

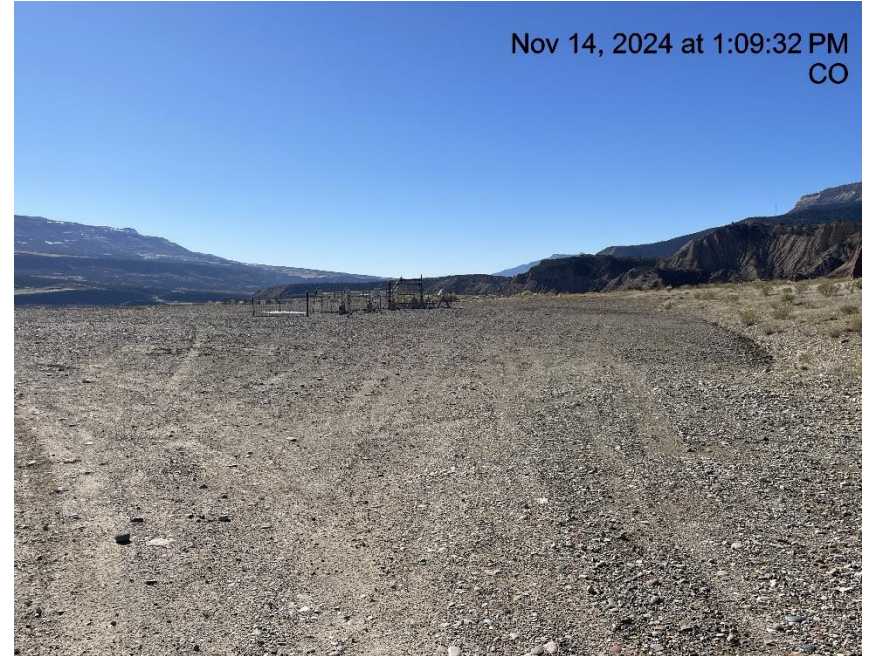
Photo # 89 From entrance to location

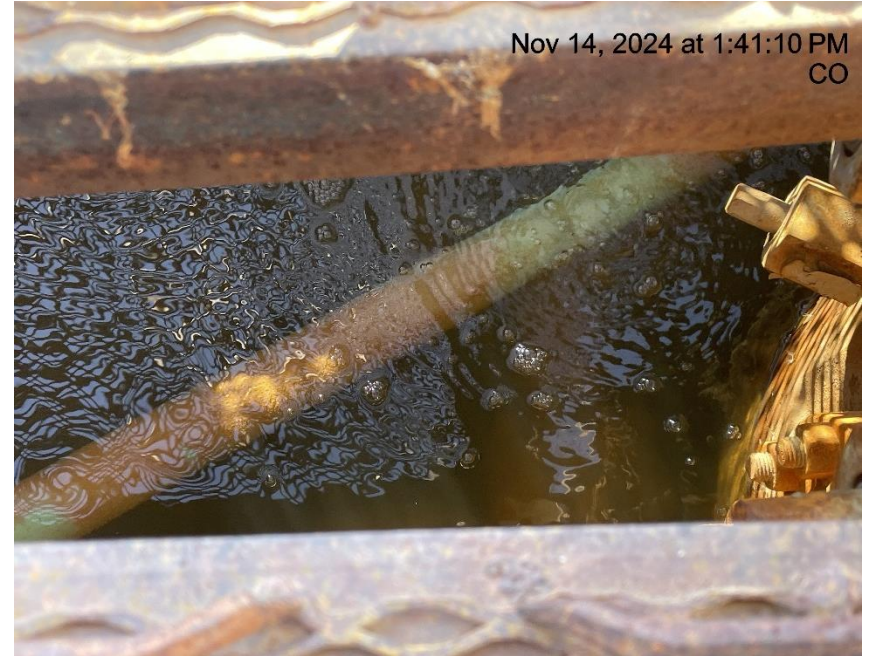
Photo # 95 Mechanical Condition - Possible leak on the Langstaff RWF 724-16 wellhead

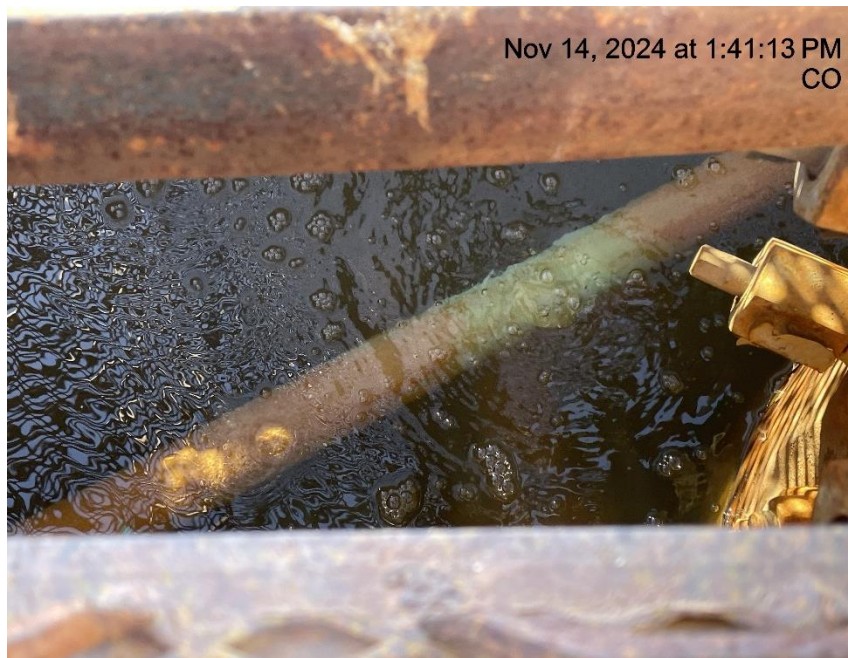
Photo # 96 Mechanical Condition - Possible leak on the Langstaff RWF 724-16 wellhead

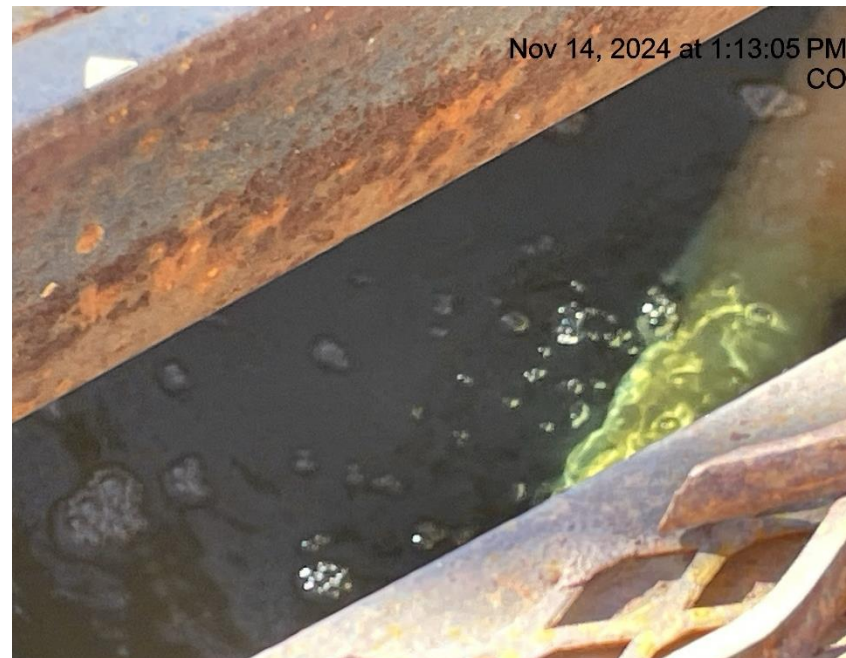
Photo # 97 Mechanical Condition - Possible leak on the Langstaff RWF 724-16 wellhead
