Operator: HPR

Location Name: RSU Anschutz Fed 4-62-2_1 SWNW

Loc ID: 436165

Inspection: 713901038

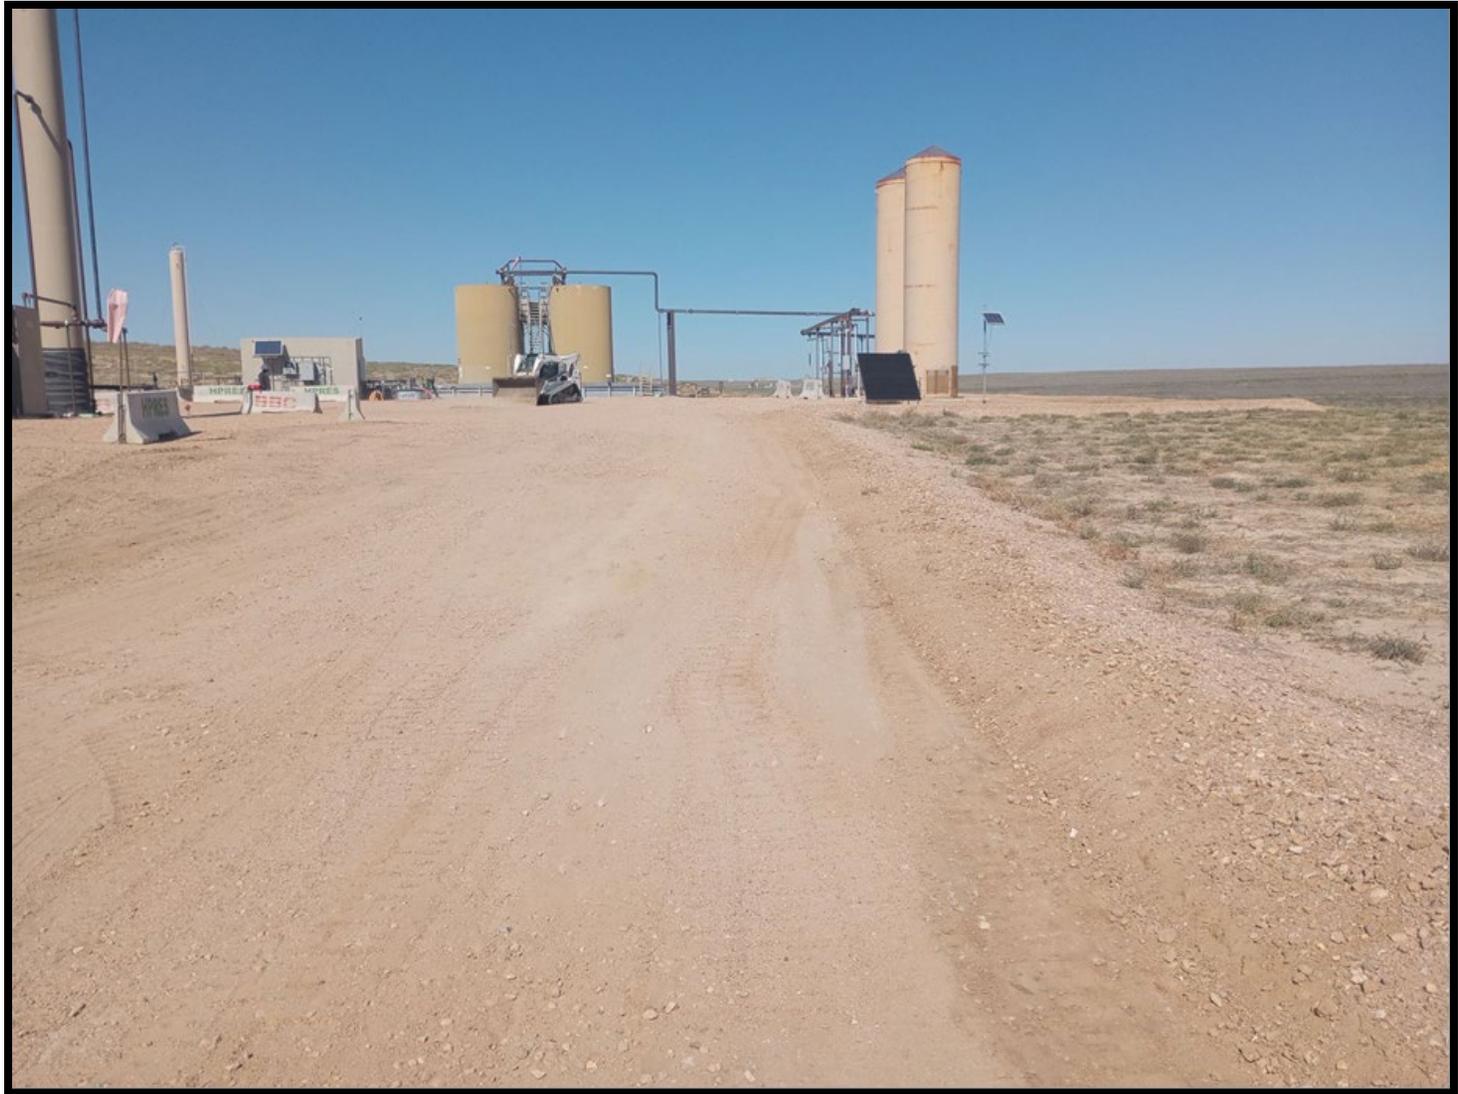
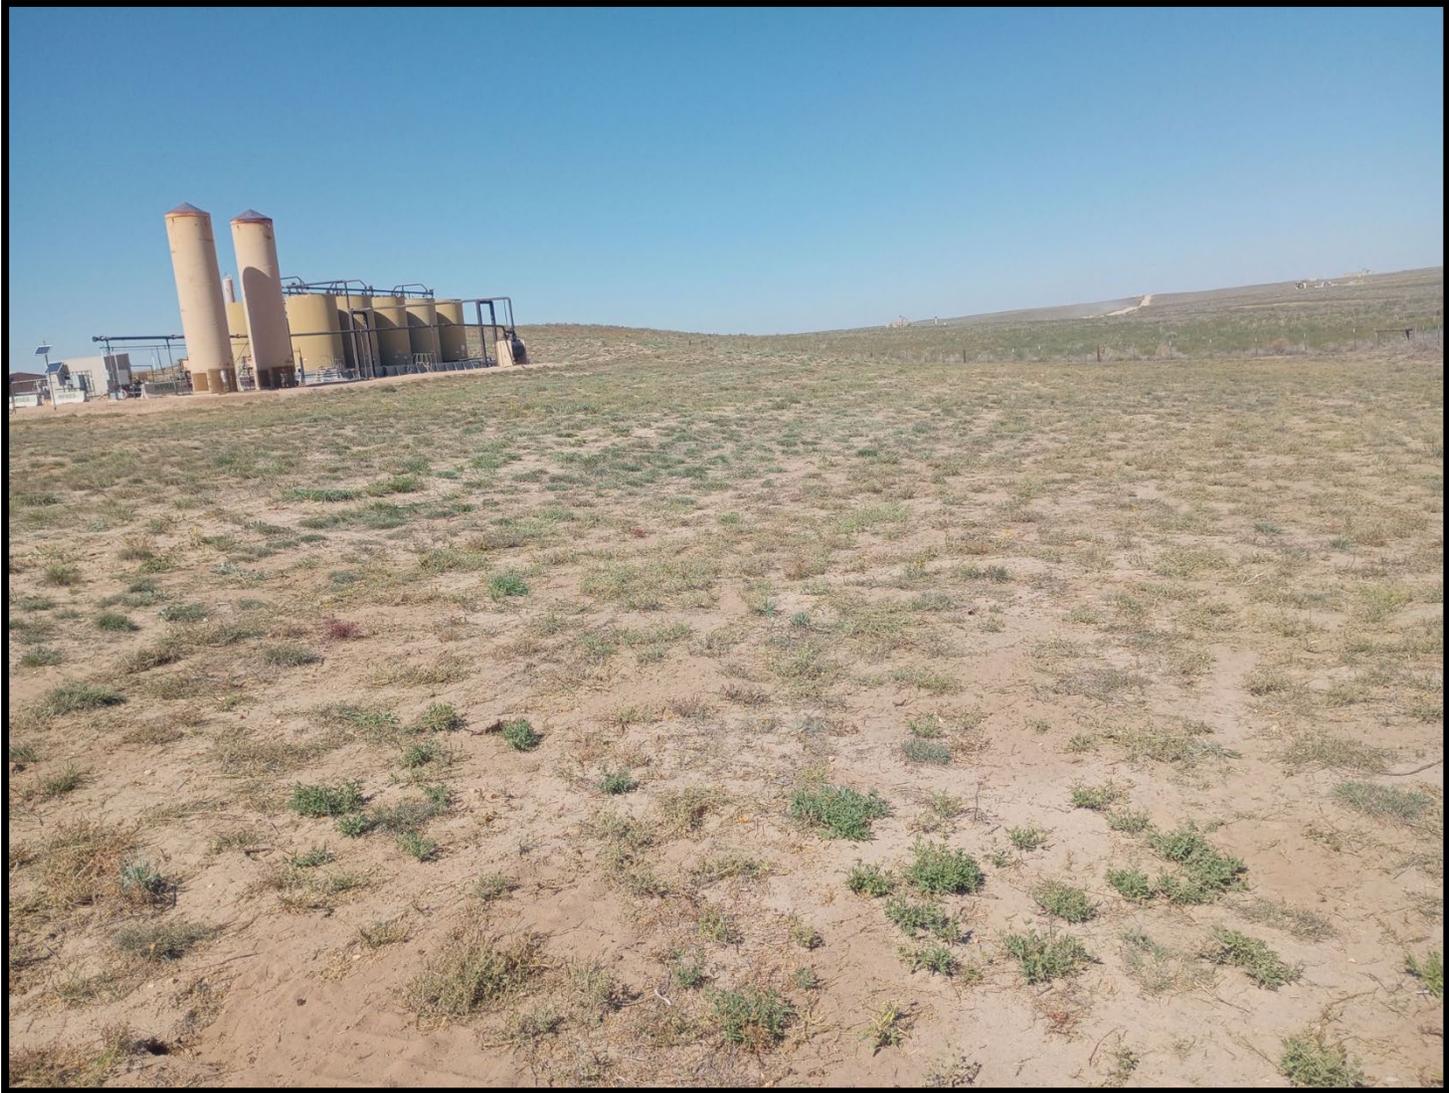
CA: Stained soil observed by diesel tanks on the West side of the pad. Remove stained soil per Rule 912.a.

CA Resolution: Operator removed identified stained soil to comply with the 900 series.

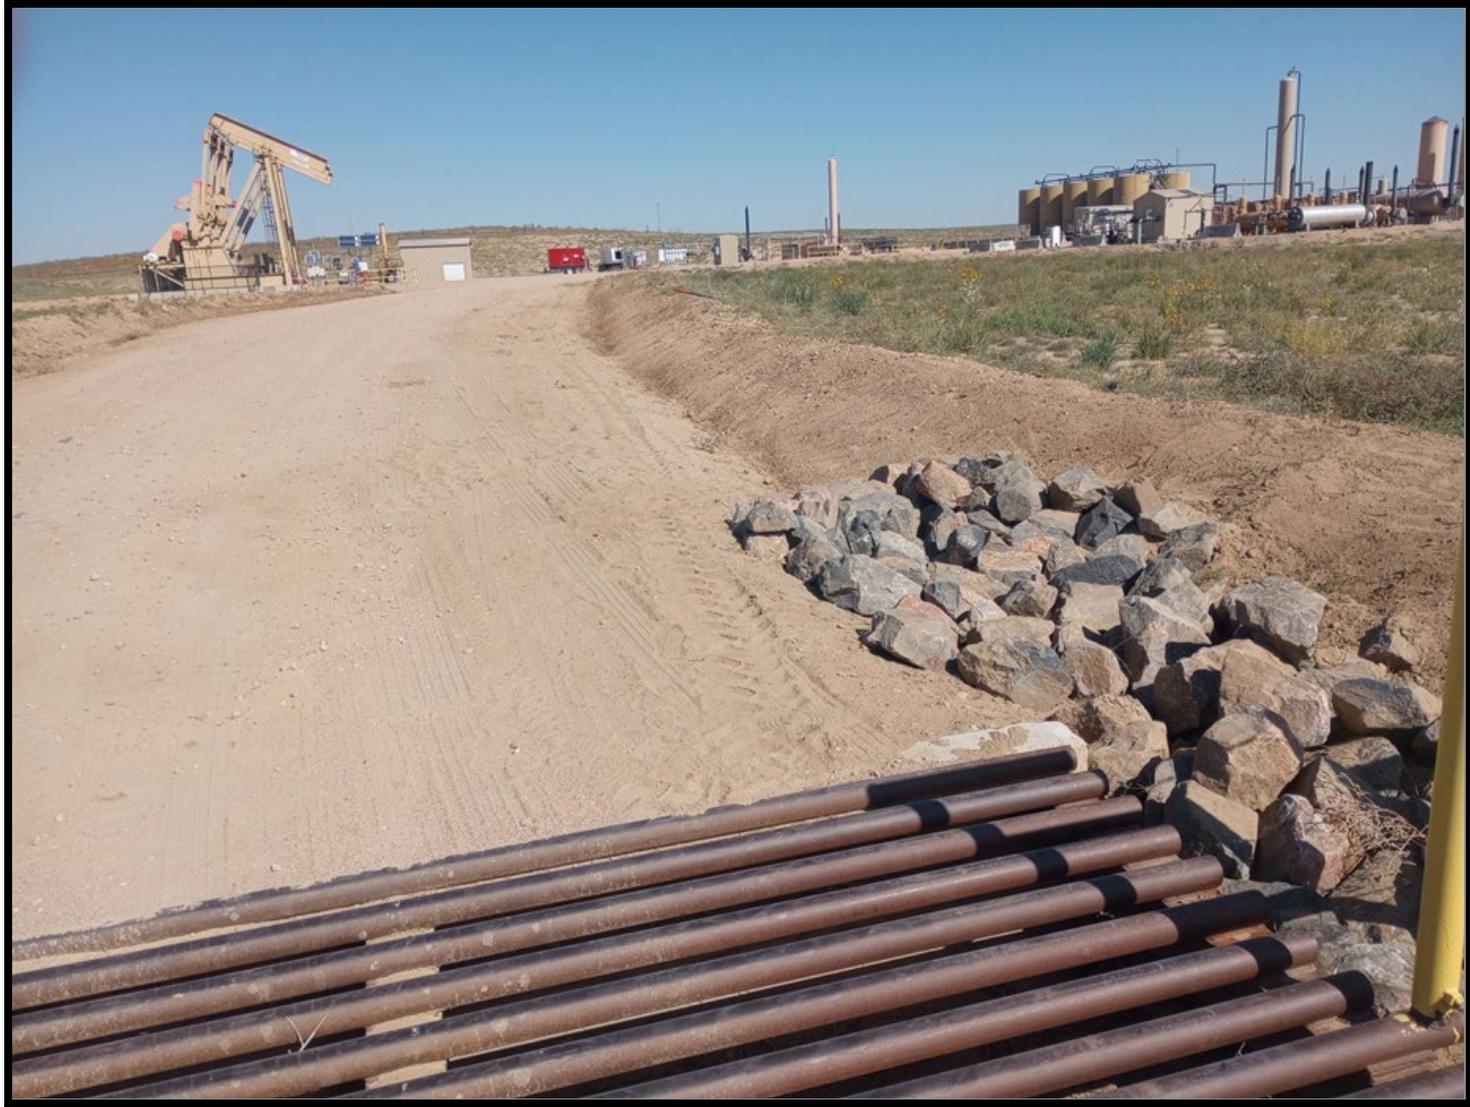
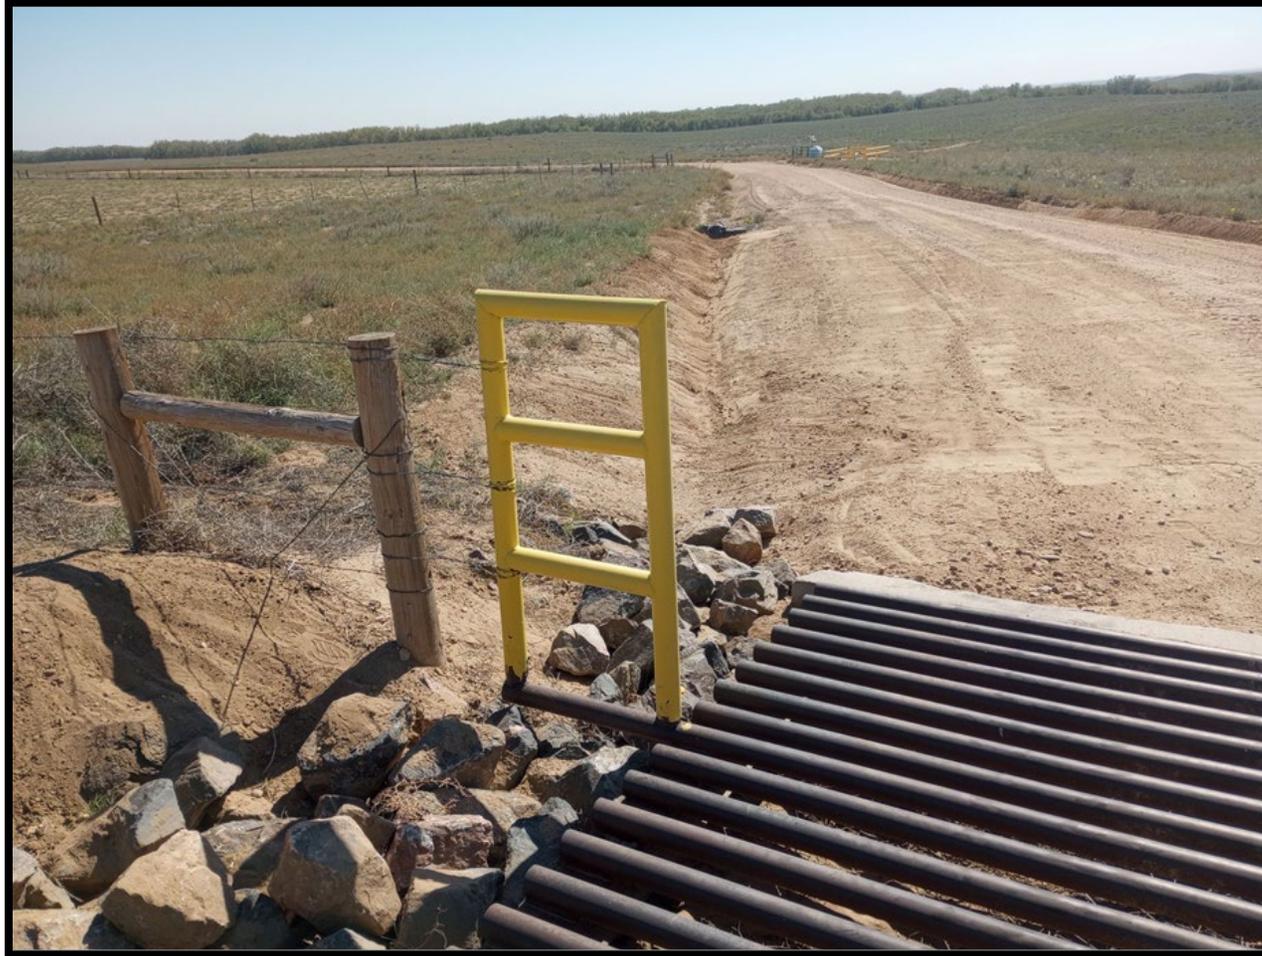
CA: Along the access road and at the entrance cattle guard at the well location the roadside ditch and riprap check dams were full of sediment. Sediment should be removed from access road ditches for BMP's to continue to work properly. Remove sediment accrued in stormwater ditches and riprap per Rule 1002.f.

CA Resolution: Operator has reported riprap and stormwater ditches have been appropriately cleared of sediment to comply with the 1000 series.
