## Inspection Photos

Location Name: TEP Rocky Mountain LLC CLOUGH RMV 25-20 Pad

Location # 335236

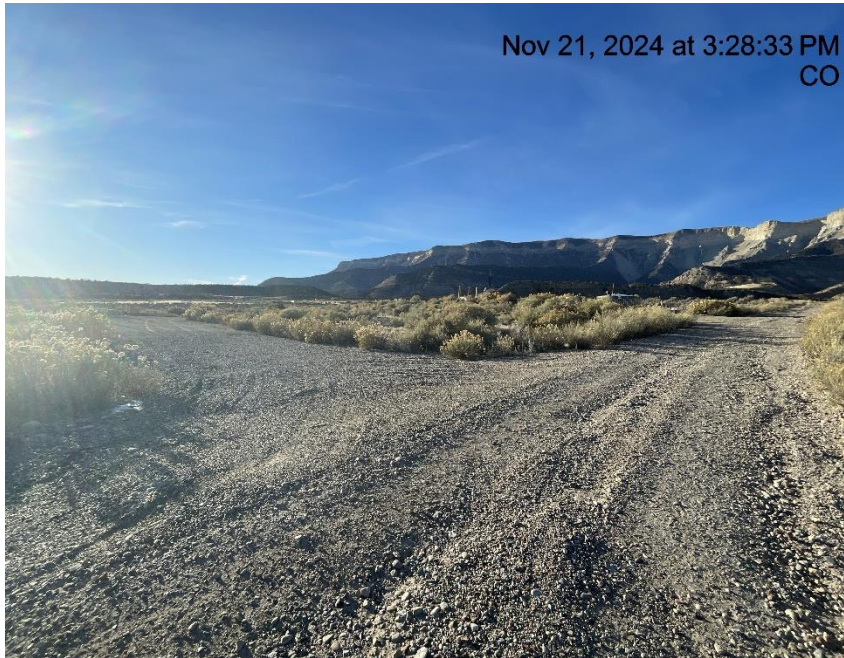
Photo # 950 From entrance to location

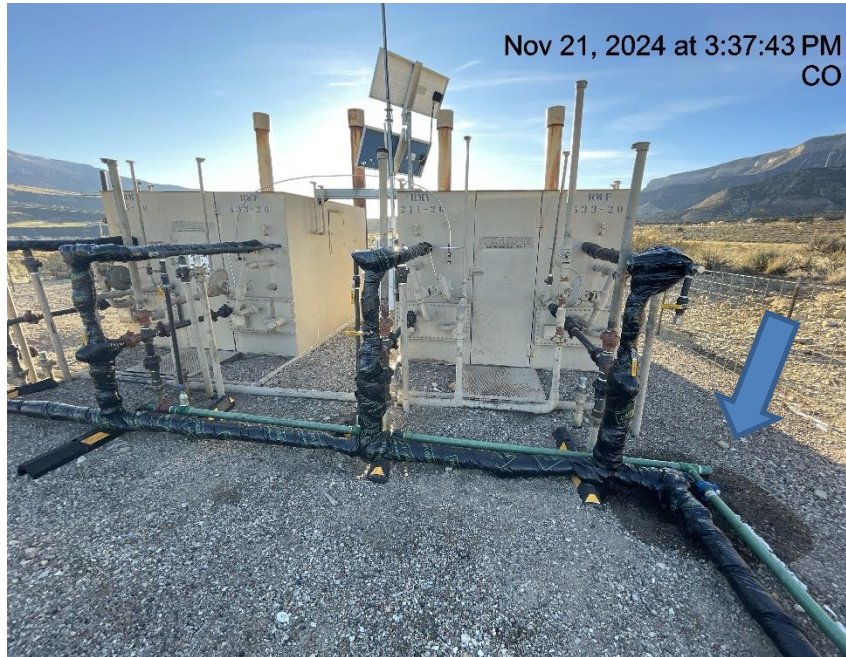
**Photo # 958 Mechanical Condition – possible dump line leak**

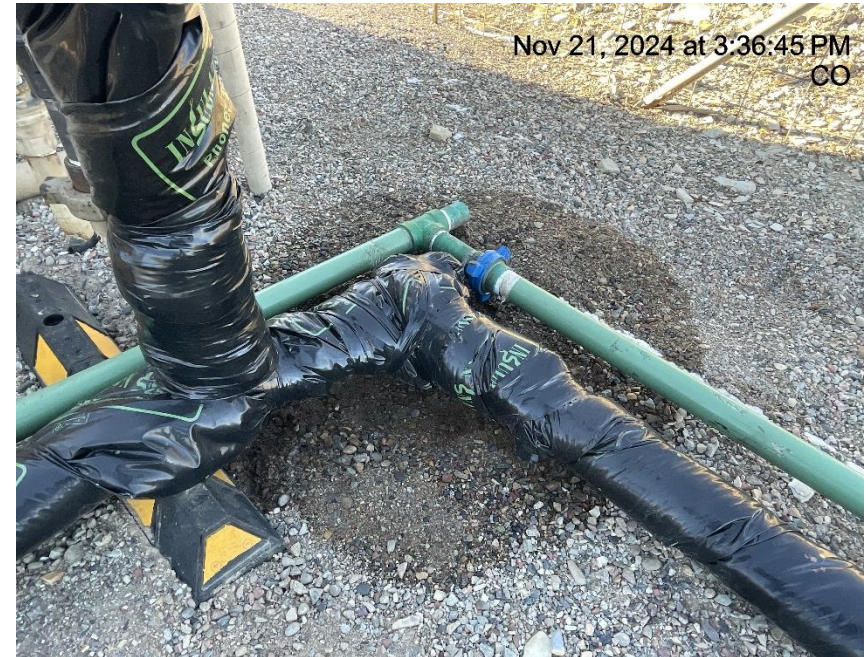
**Photo # 959 Mechanical Condition – possible dump line leak**

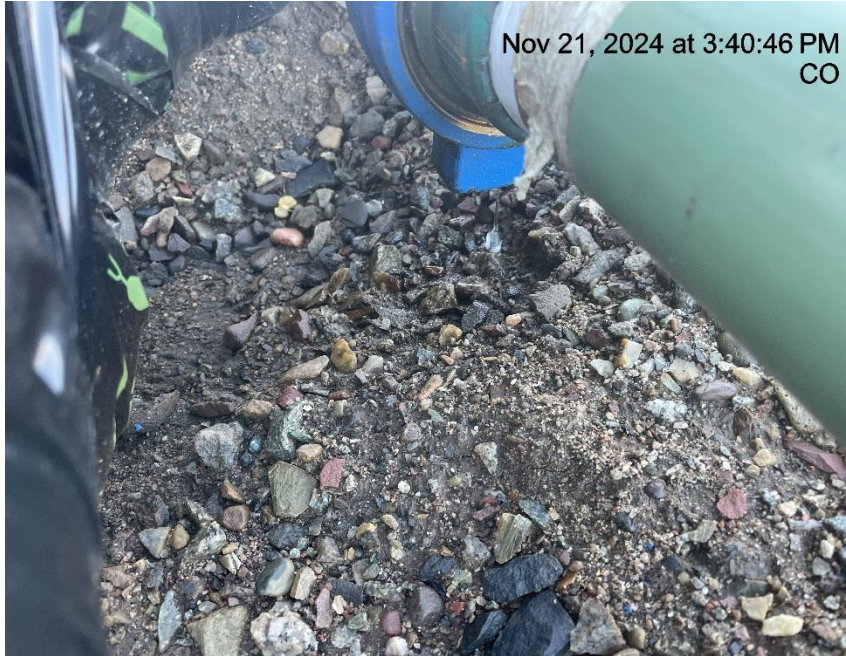
**Photo # 960 Mechanical Condition – possible dump line leak**

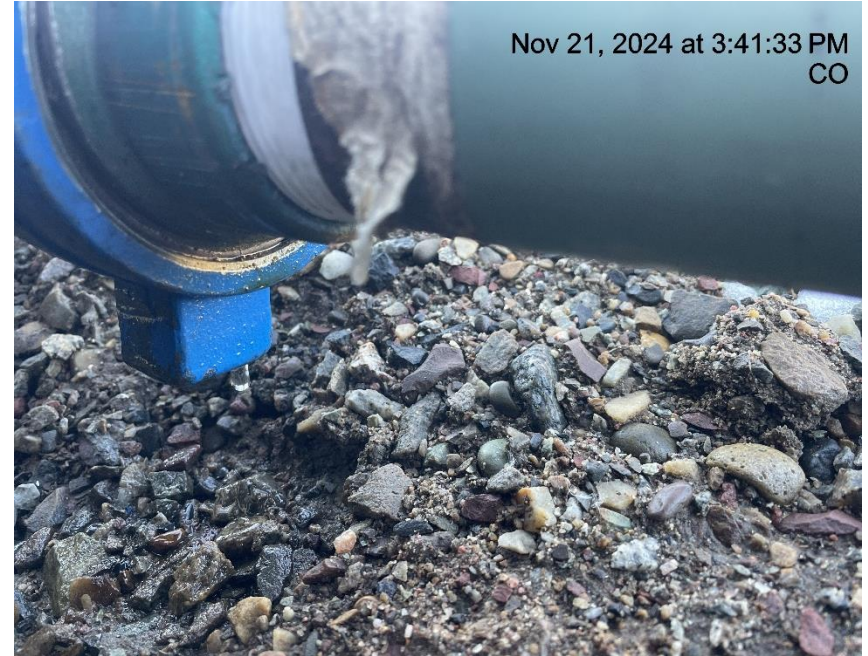
**Photo # 961 Mechanical Condition – possible dump line leak**

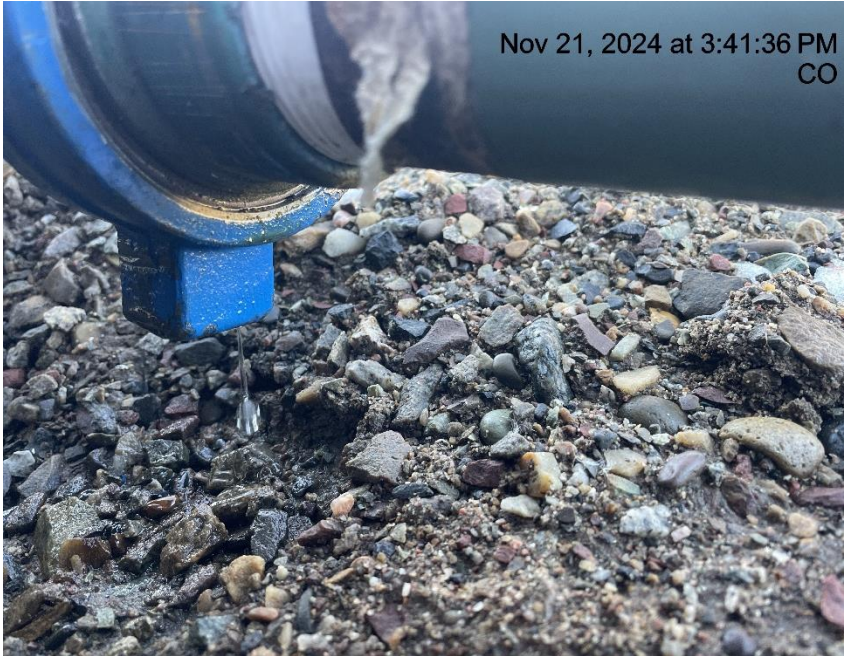
**Photo # 962 Mechanical Condition – possible dump line leak**

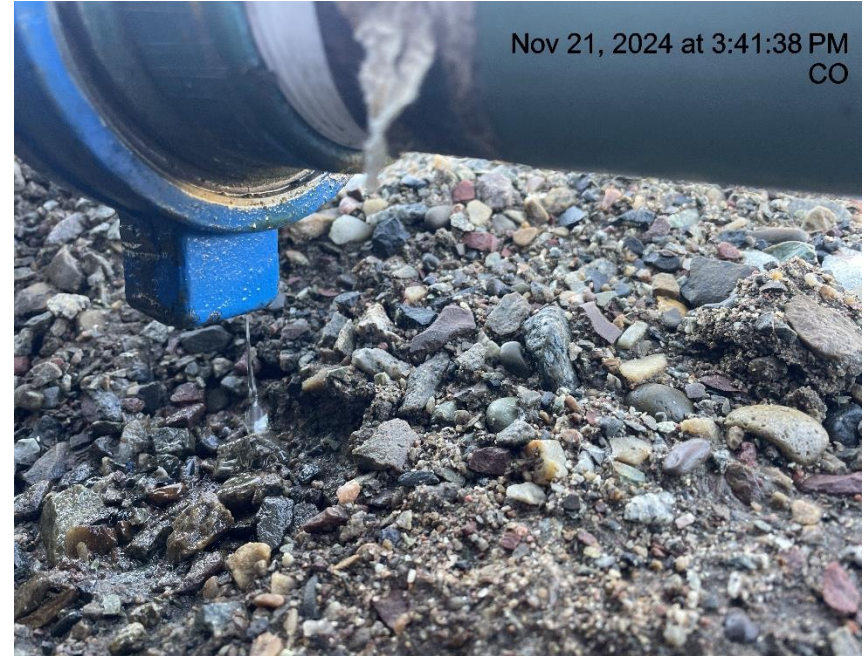
**Photo # 963 Mechanical Condition – possible dump line leak**

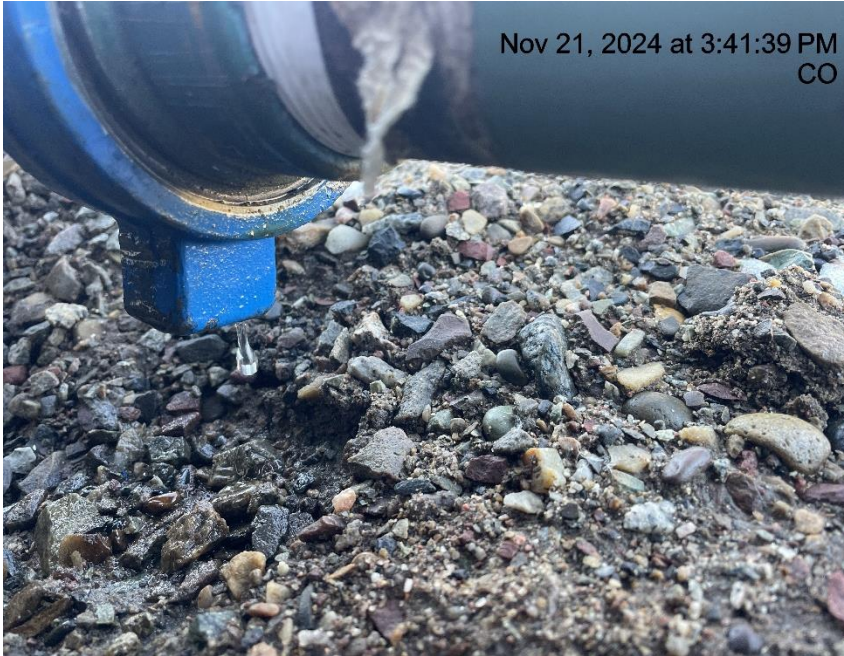
**Photo # 964 Mechanical Condition – possible dump line leak**

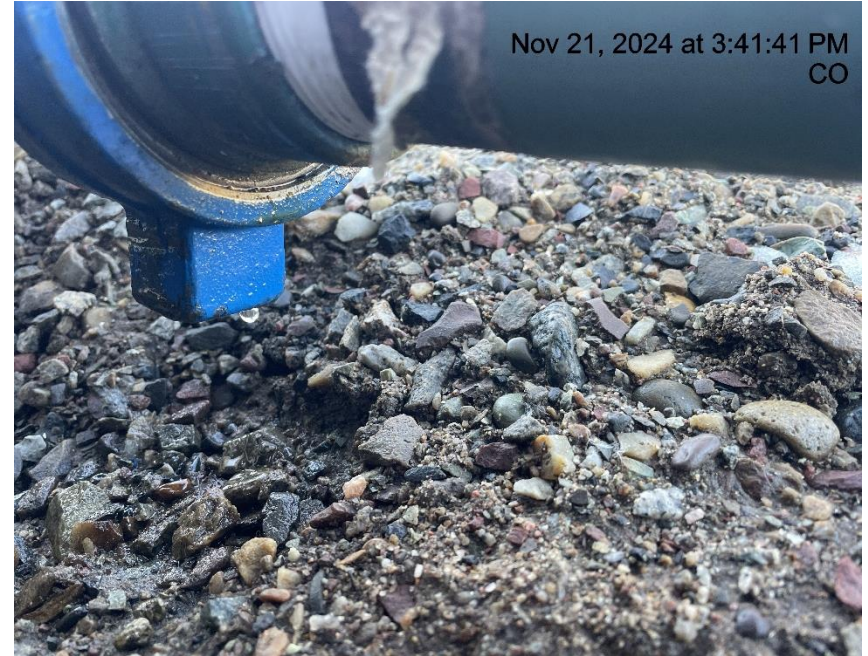
**Photo # 965 Mechanical Condition – possible dump line leak**
