WELL NAME: NEW ELK 36-01, API #: 071-09238, INSP. # 716300290

COLORADO
Energy & Carbon Management
Commission
Department of Natural Resources

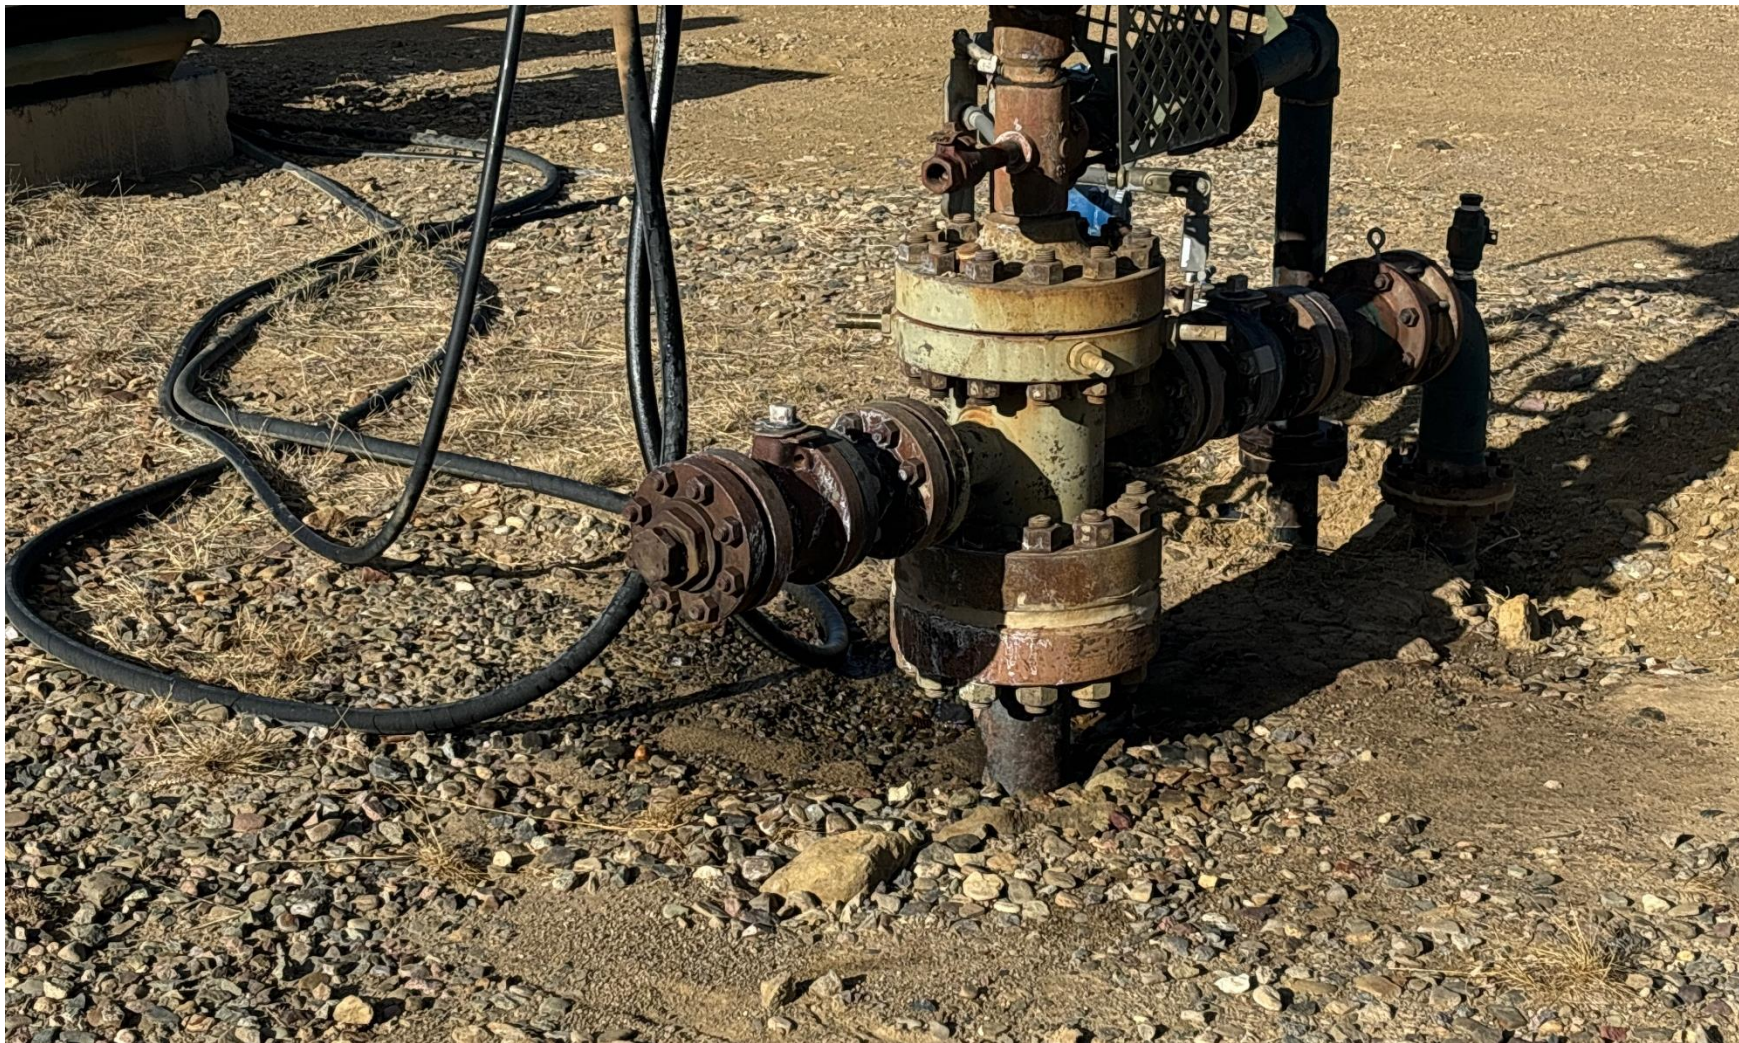
PHOTO 4: AREA OF IMPACTED SOIL AROUND WELLHEAD APPEARS TO BE FROM LEAKING DRIVEHEAD. Conduct maintenance on equipment, cleanup stained material and review self inspection processes. COMPLY WITH RULE 1002,(2).D. CA DATE 12/1/2024.

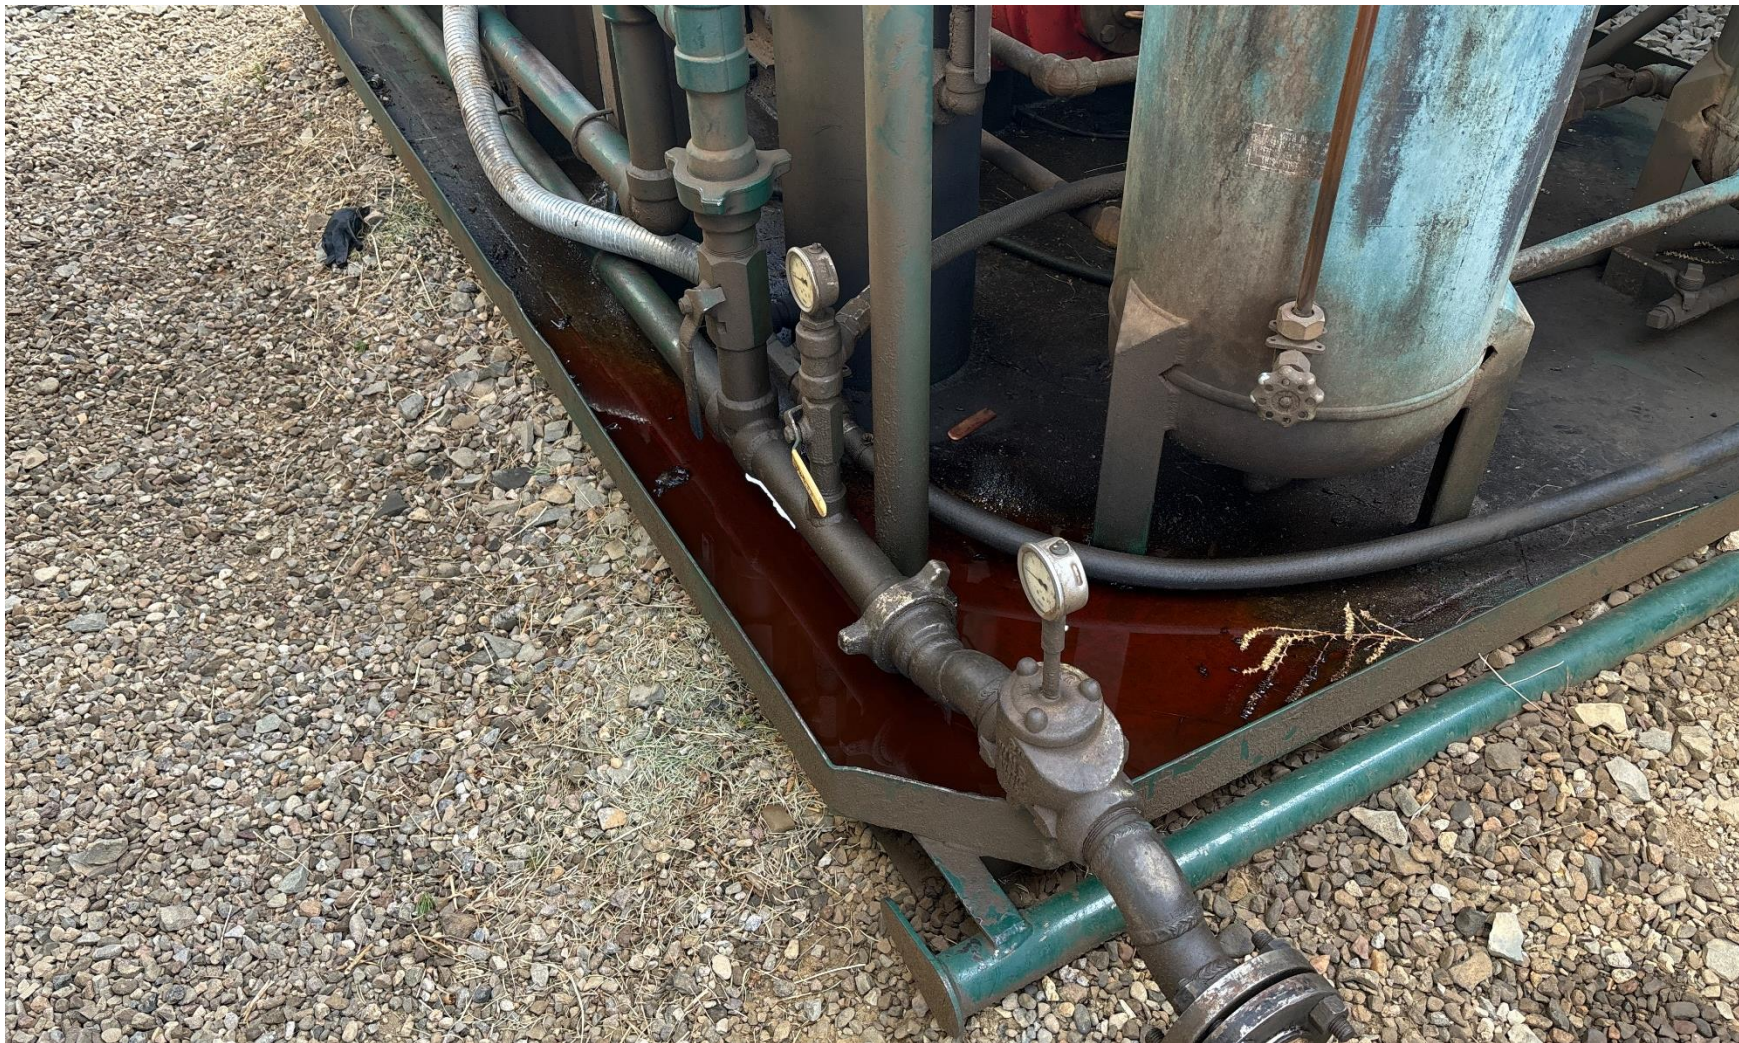
PHOTO 5: OILY WASTE FROM LEAK IN HYDRAULIC MOTOR HAS FILLED SKID AND HAS SPILLED OVER CAUSING IMPACT SOIL SURROUNDING SKID. DRAIN OILY WASTE REPAIR ALL LEAKS AND REMOVE OR TREAT IMPACTED SOIL PER RULE 1002..(2).D & 1002.f.(2)B, Comply with general provisions of the oil and gas act for wildlife protection AND SB-181. CA DATE 11/22/2024 TO DRAIN SKID 12/21/2024 DO REPAIR EQUIPMENT AND STOP LEAKS.
