## Inspection Photos

Location: LARAMIE ENERGY LLC Wagon Track Federal/12-6 Pad

Location ID: 312667

Date: 11/21/2024

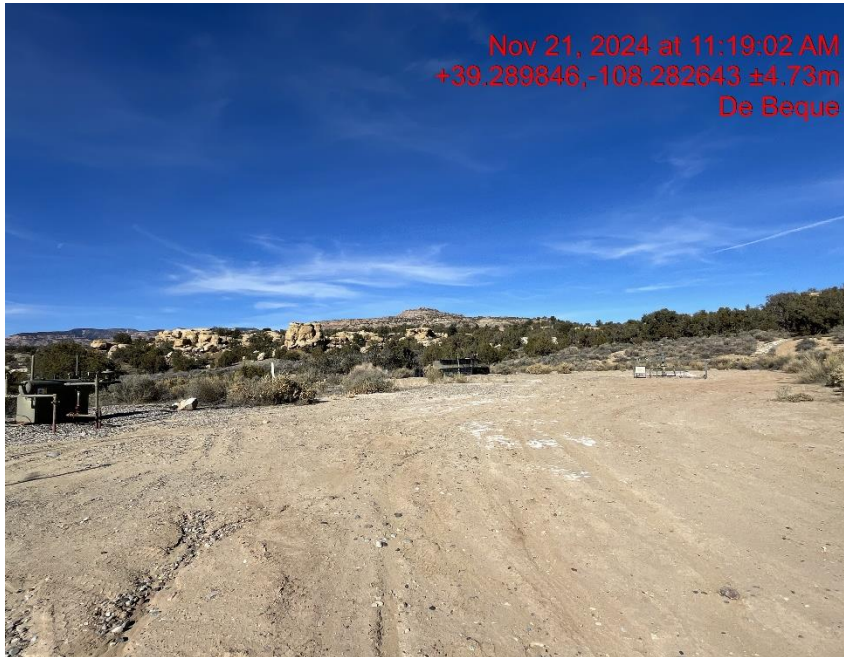
Photo # 9478 Entrance to location

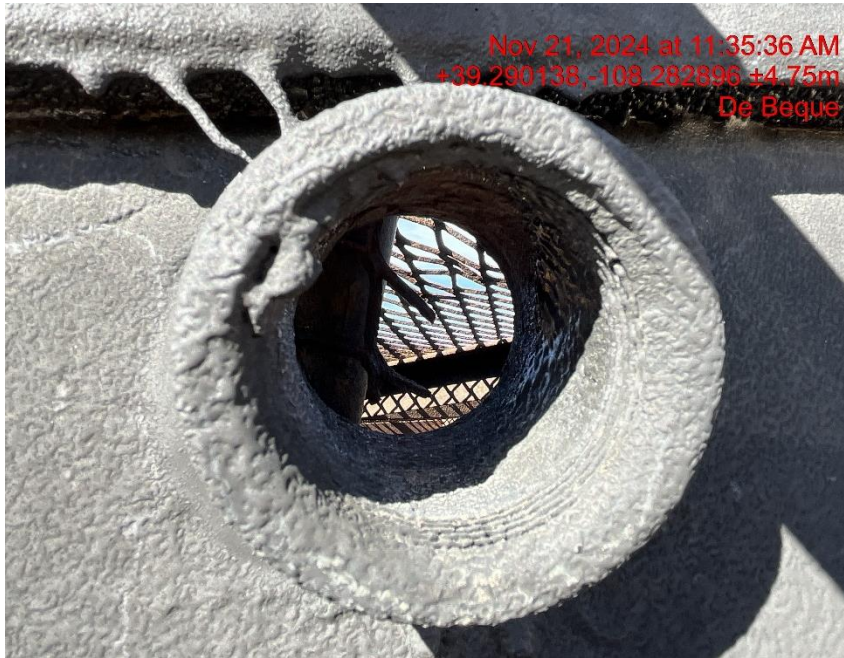
**Photo # 9501 Tank port open to wildlife/wildlife hazard/  
available for entry by wildlife**

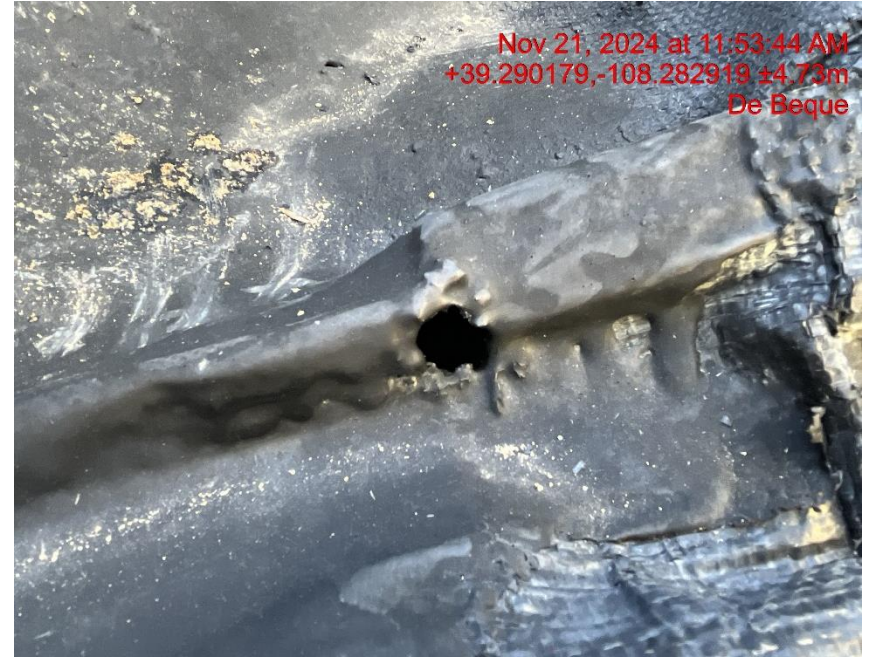
**Photo # 9504 Multiple holes and tears in secondary containment  
liner/liner needs maintenance also the liner is deteriorating and  
lacks integrity**

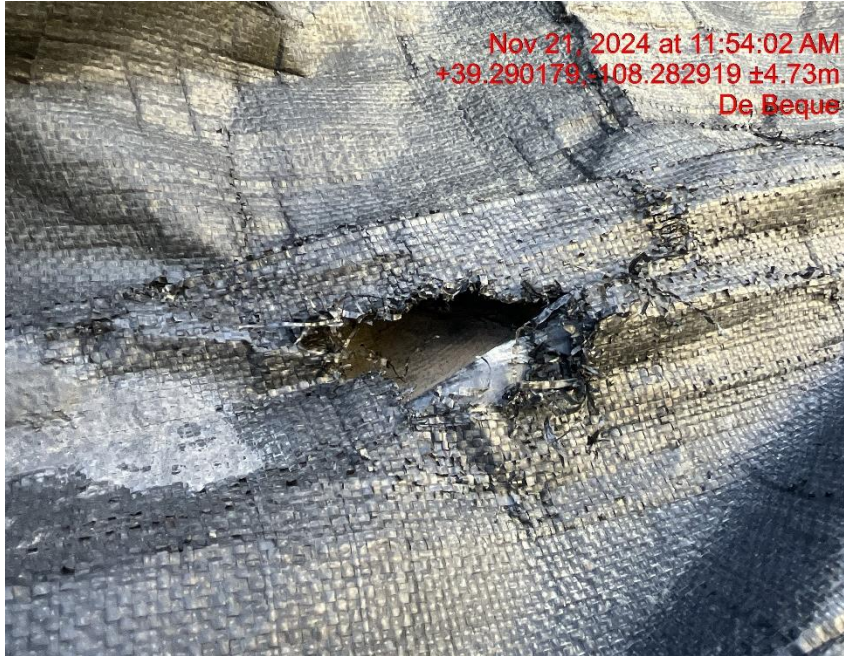
**Photo # 9505 Multiple holes and tears in secondary containment liner/liner needs maintenance also the liner is deteriorating and lacks integrity**

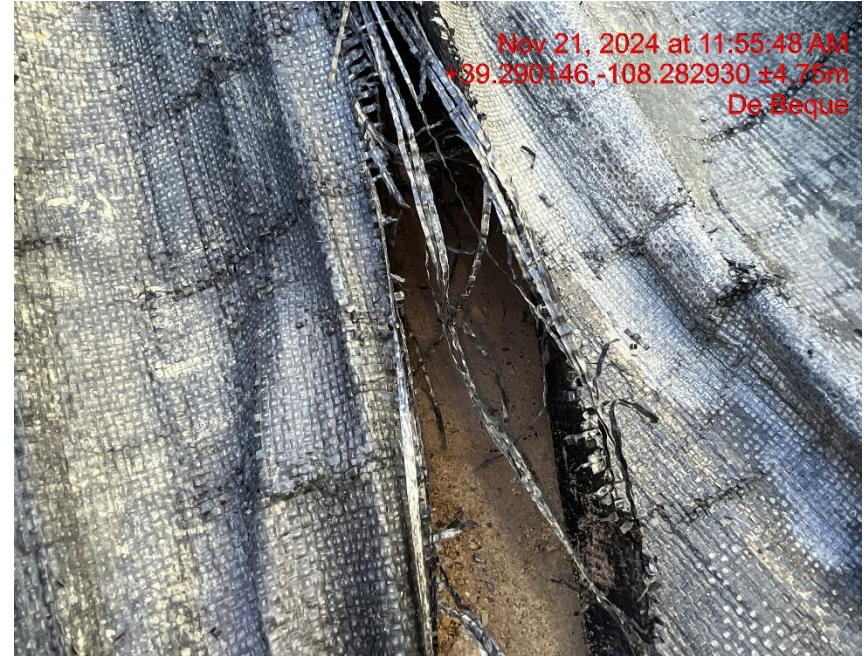
**Photo # 9507 Multiple holes and tears in secondary containment liner/liner needs maintenance also the liner is deteriorating and lacks integrity**

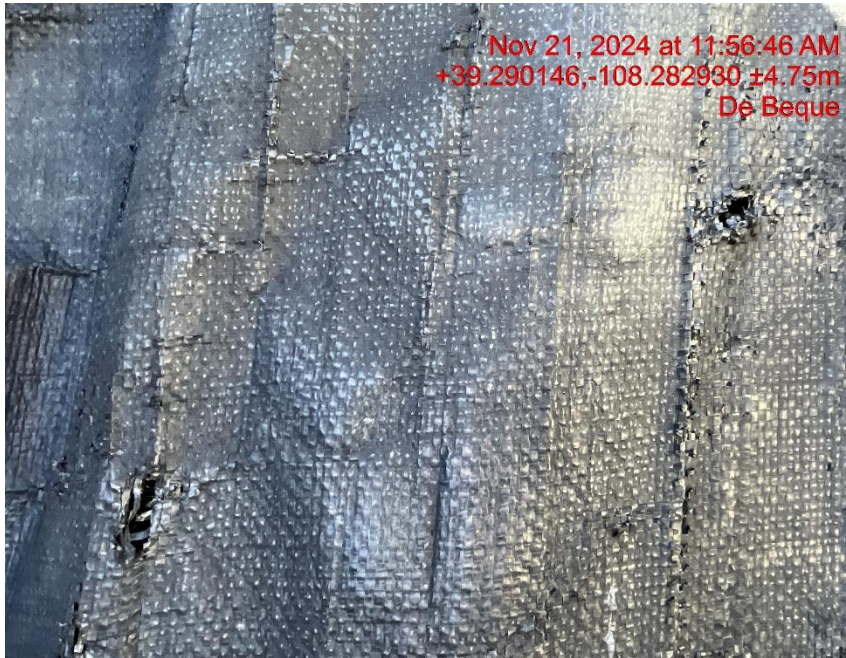
**Photo # 9508 Multiple holes and tears in secondary containment liner/liner needs maintenance also the liner is deteriorating and lacks integrity**

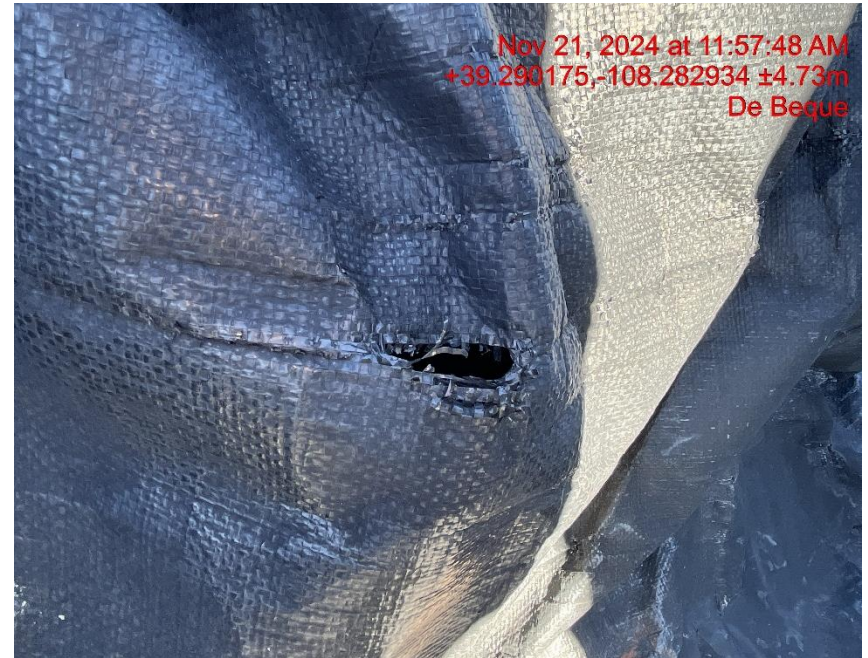
**Photo # 9509 Multiple holes and tears in secondary containment liner/liner needs maintenance also the liner is deteriorating and lacks integrity**

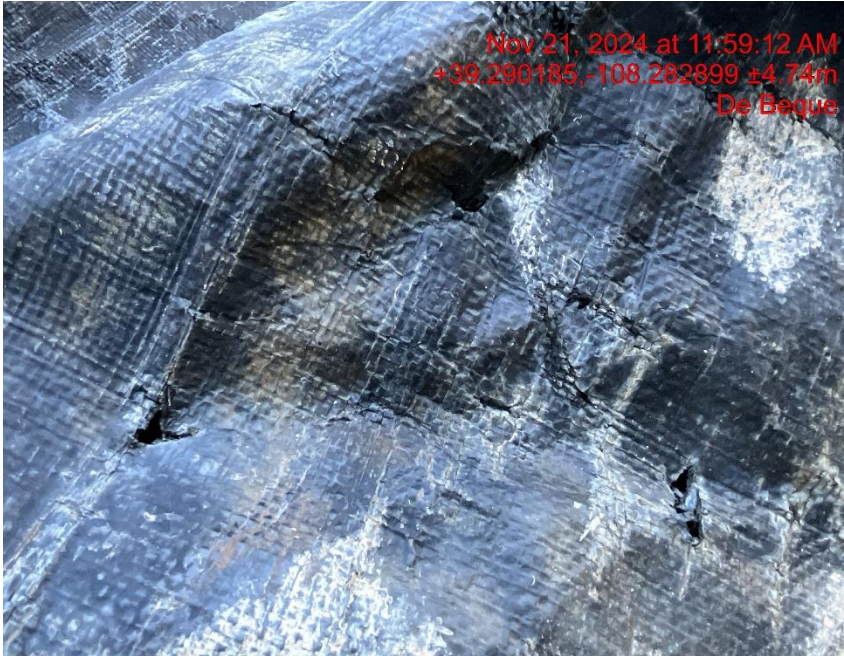
**Photo # 9510 Multiple holes and tears in secondary containment liner/liner needs maintenance also the liner is deteriorating and lacks integrity**

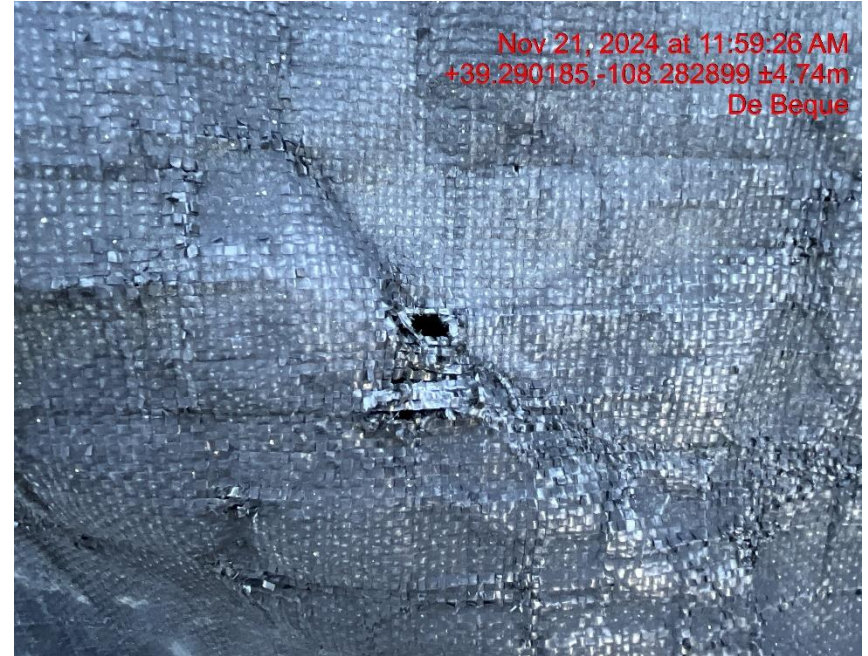
**Photo # 9511 Multiple holes and tears in secondary containment liner/liner needs maintenance also the liner is deteriorating and lacks integrity**

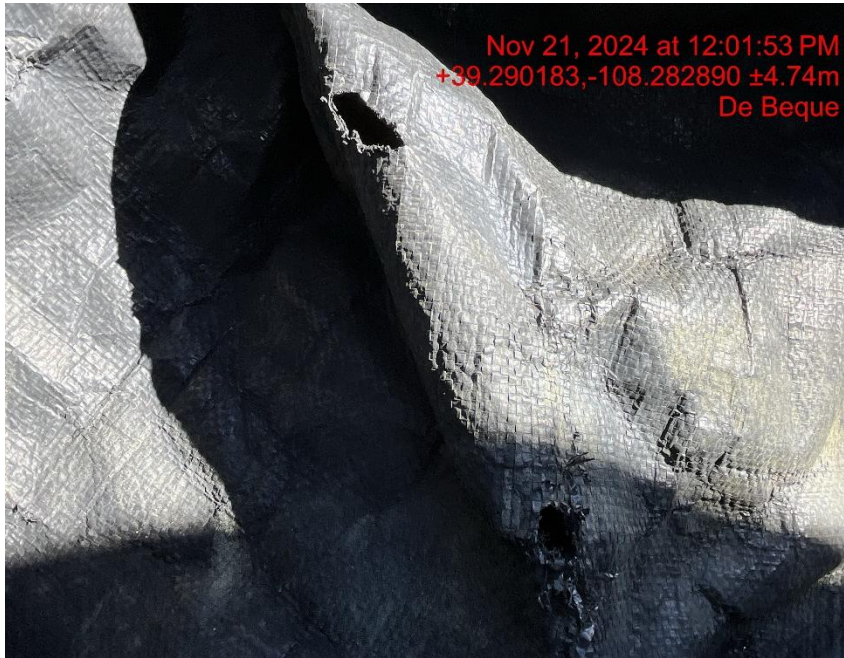
**Photo # 9513 Multiple holes and tears in secondary containment liner/liner needs maintenance also the liner is deteriorating and lacks integrity**

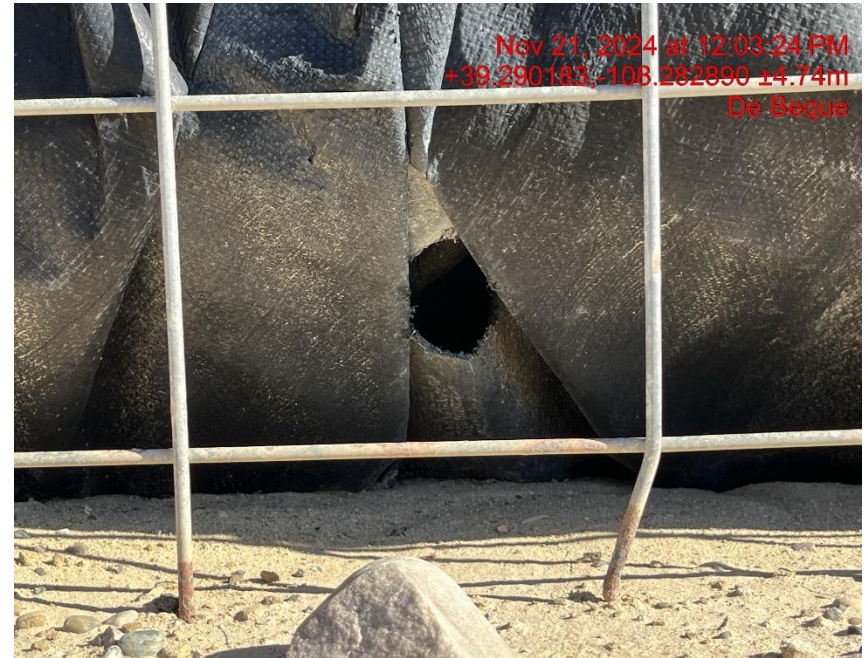
**Photo # 9516 Multiple holes and tears in secondary containment liner/liner needs maintenance also the liner is deteriorating and lacks integrity**

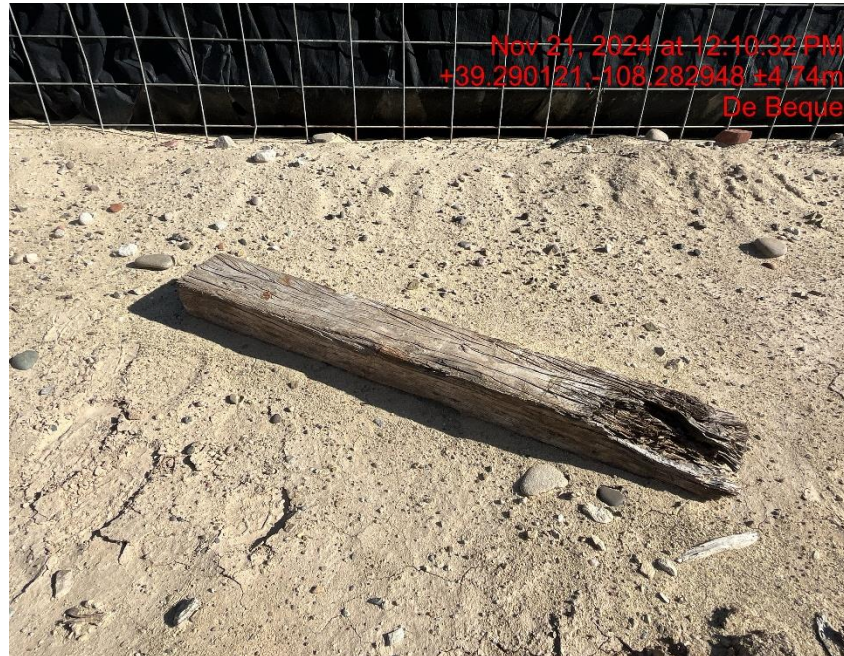
Photo # 9523 Debris
