# Inspection Photos

Loc: 333349

Operator: **OXY USA INC**

Inspection Date: 11/25/2024

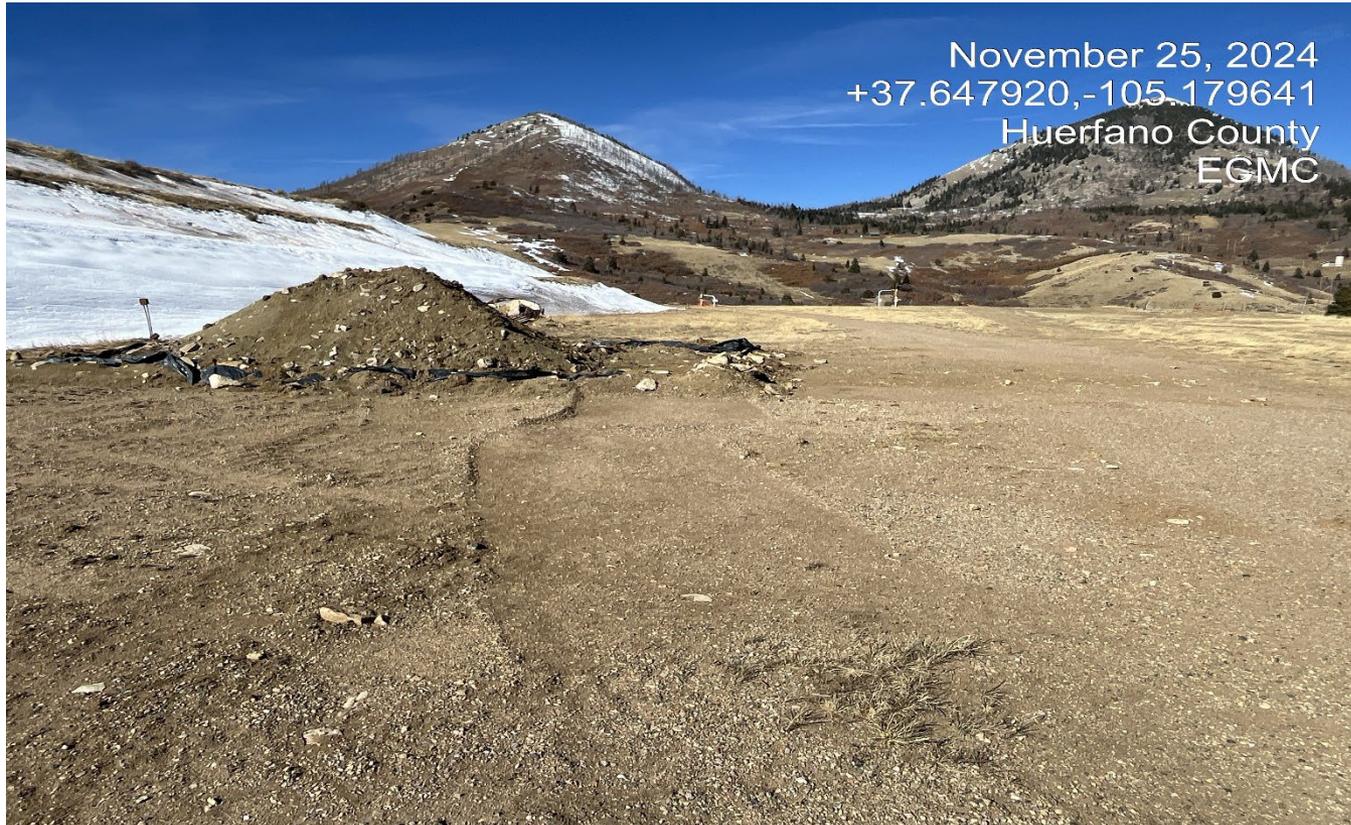
**Photo 1.** Facing northwest toward the location.

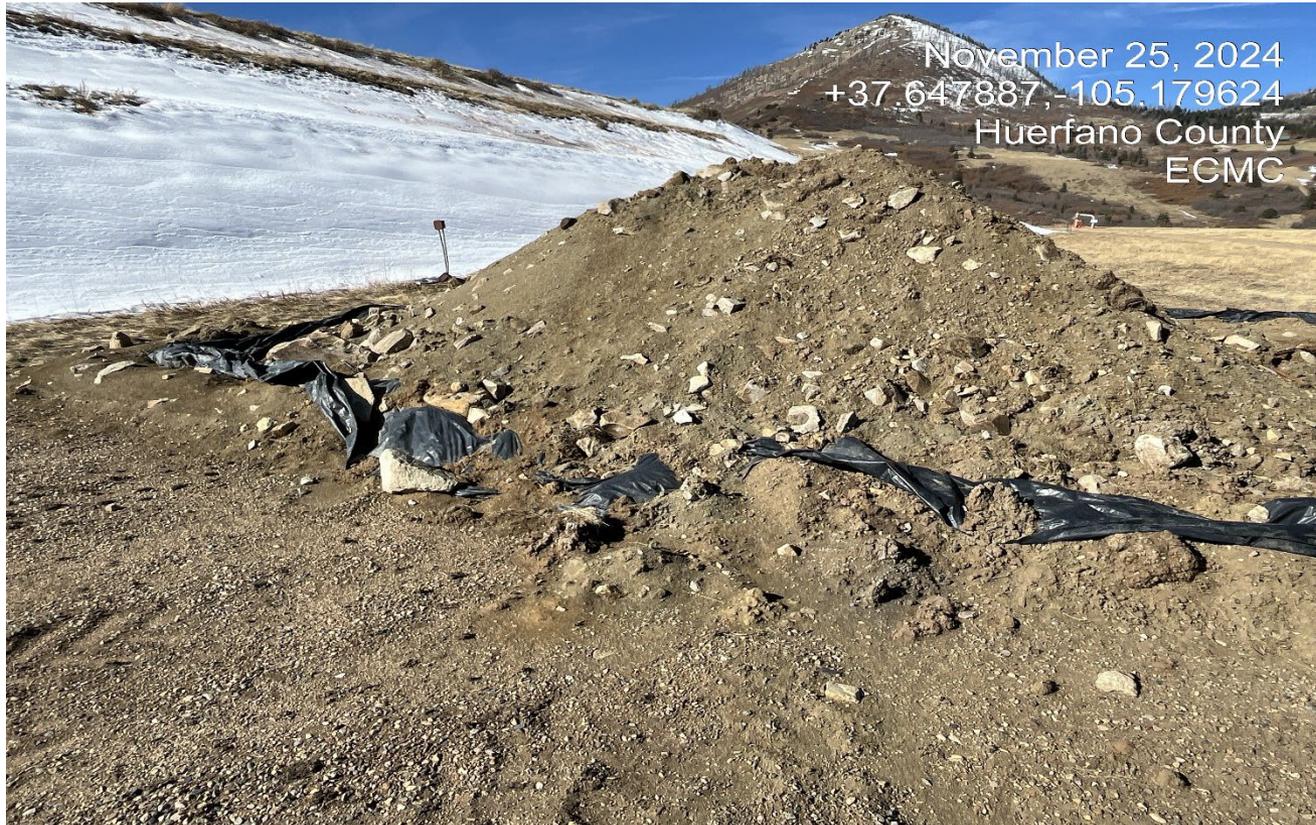
**Photo 2.** There is a material pile stored from the excavated pit. The berm around the pile is inadequate and material has fallen outside of the containment.

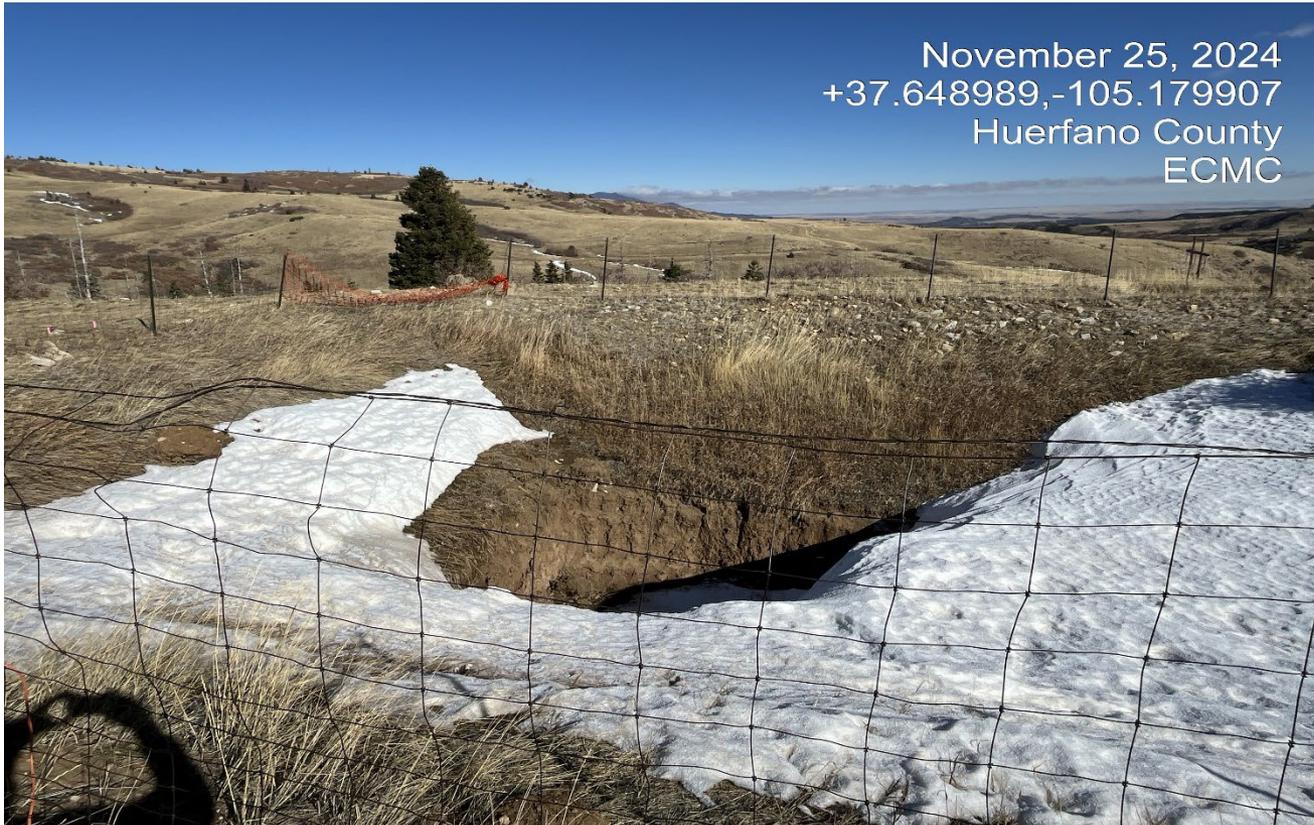
**Photo 3.** Facing toward the nit which has been excavated for remediation.

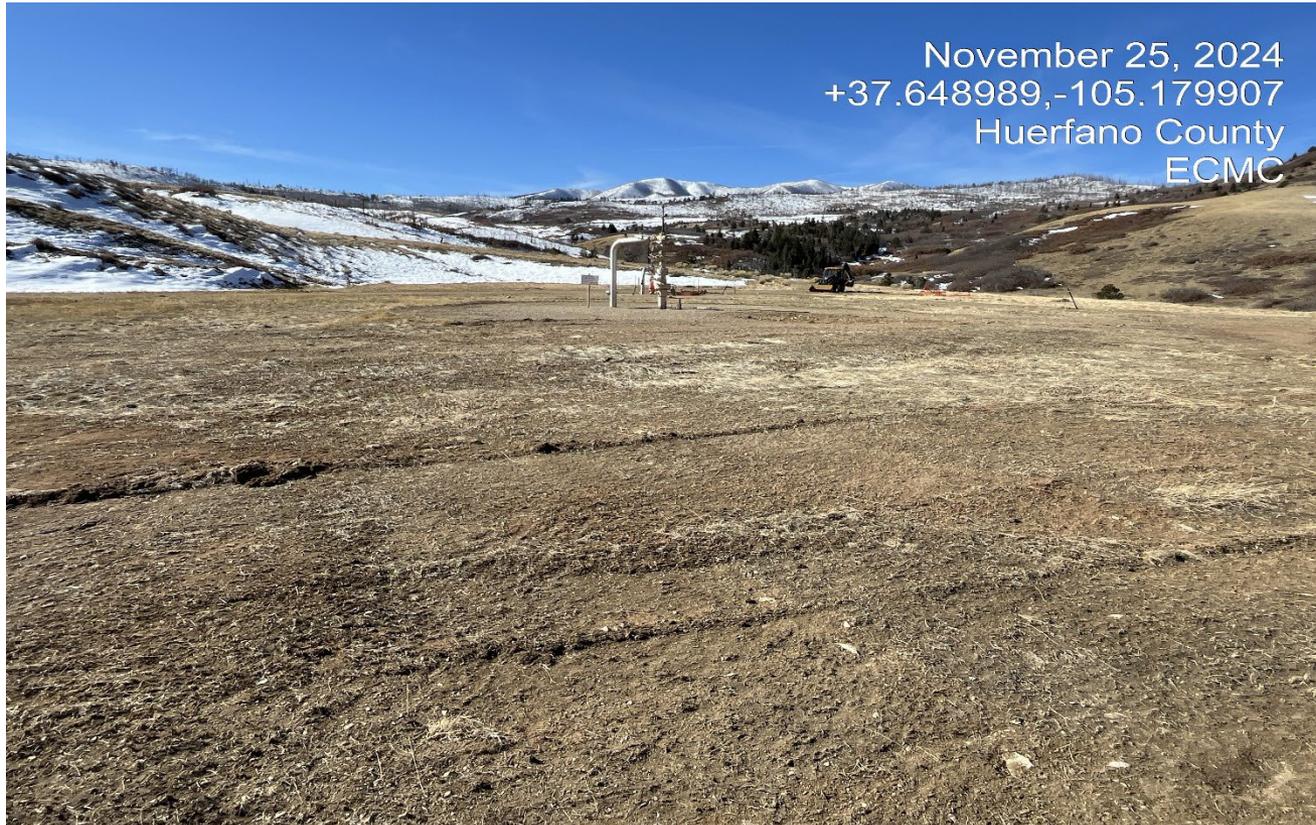
**Photo 4.** Facing northwest toward the wellsite.

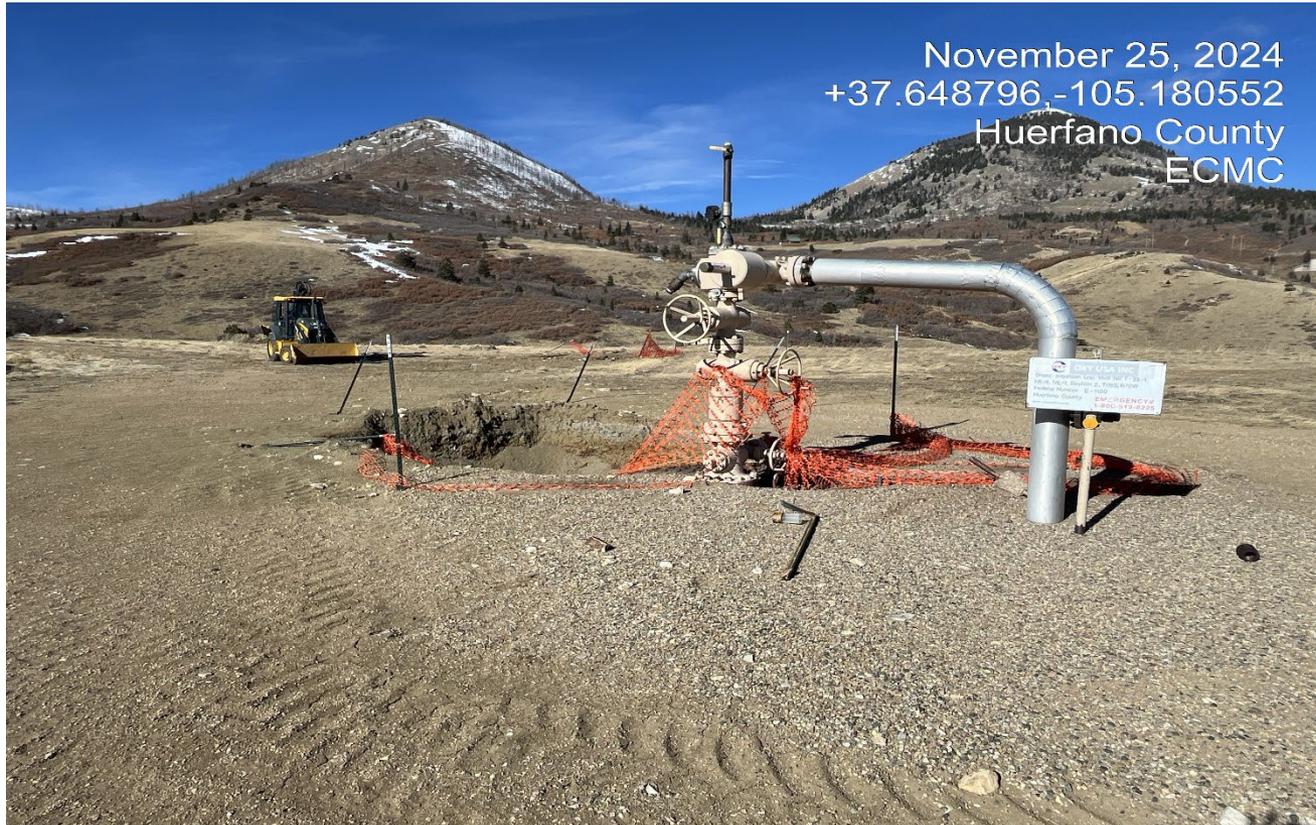
Photo 5. The orange fence is displaced around the excavated area near the well. .
