## Inspection Photos

Location Name: TEP Rocky Mountain LLC LAST DANCE 12-2 Pad

Location # 311612

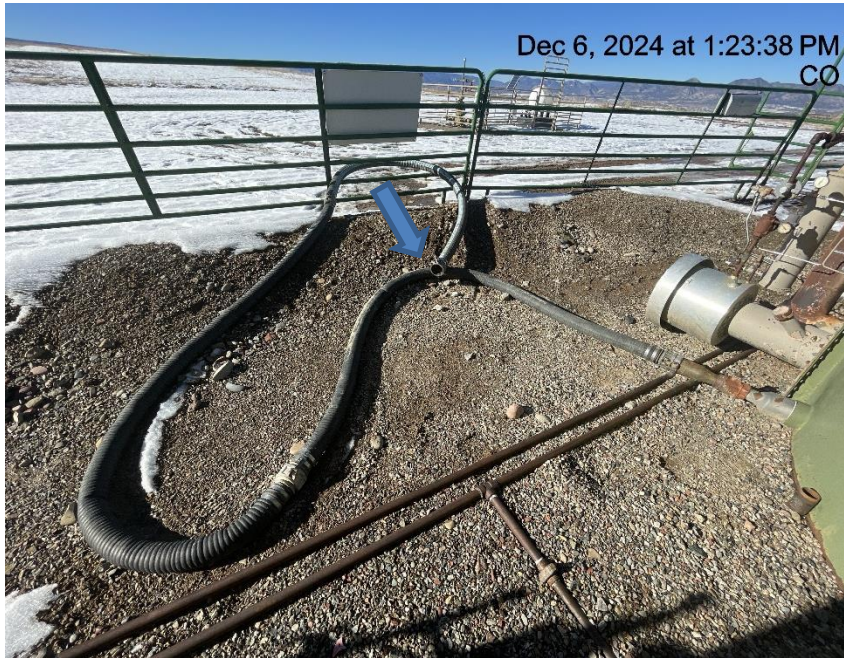
Photo # 2706 Open ended load line

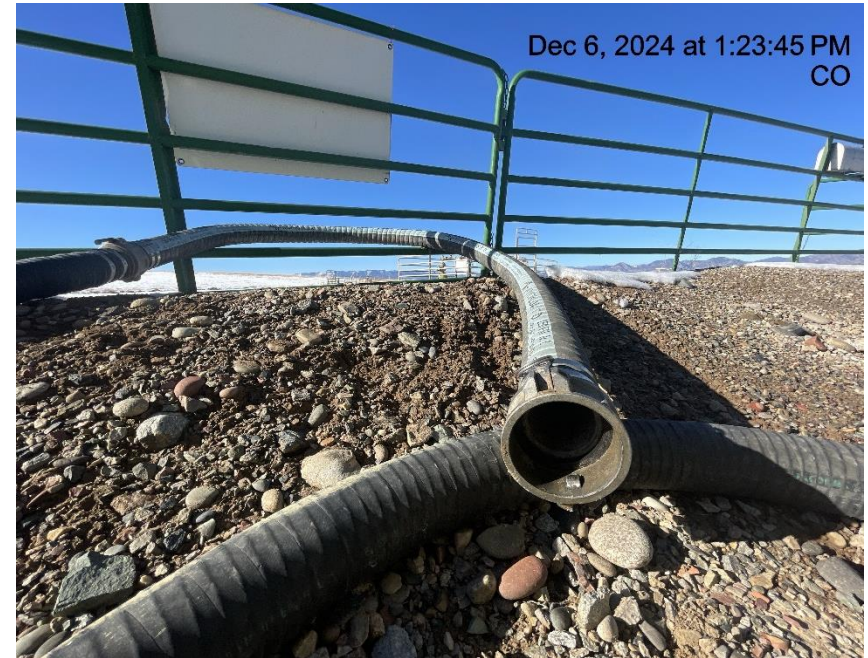
Photo # 2707 Same open ended load line

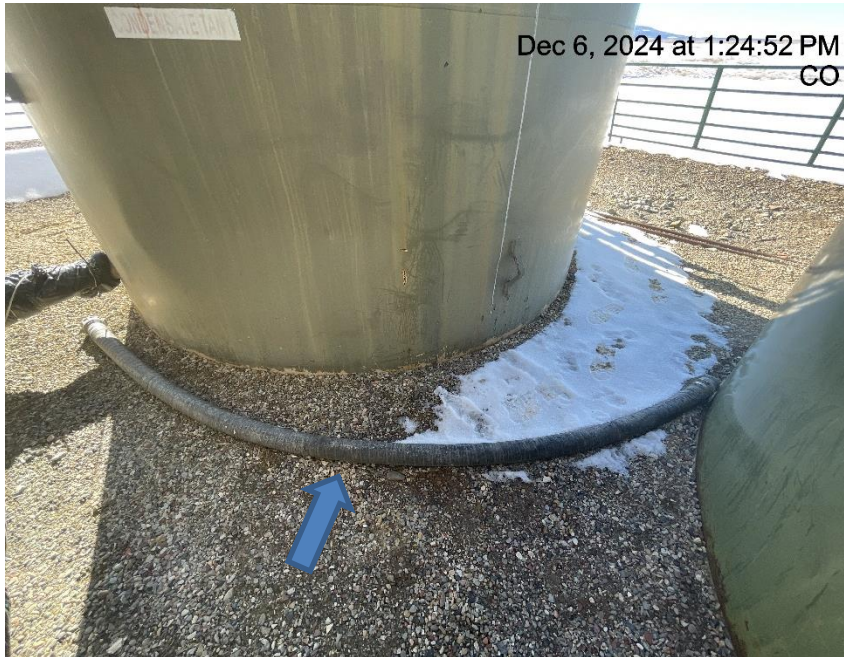
Photo # 2708 Unused hose in secondary containment

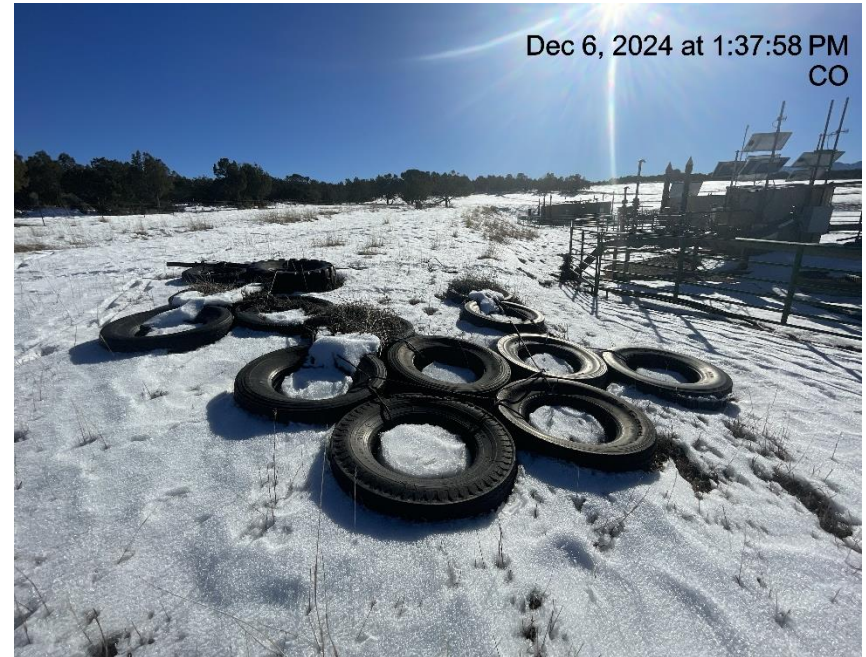
Photo # 2709 Debris

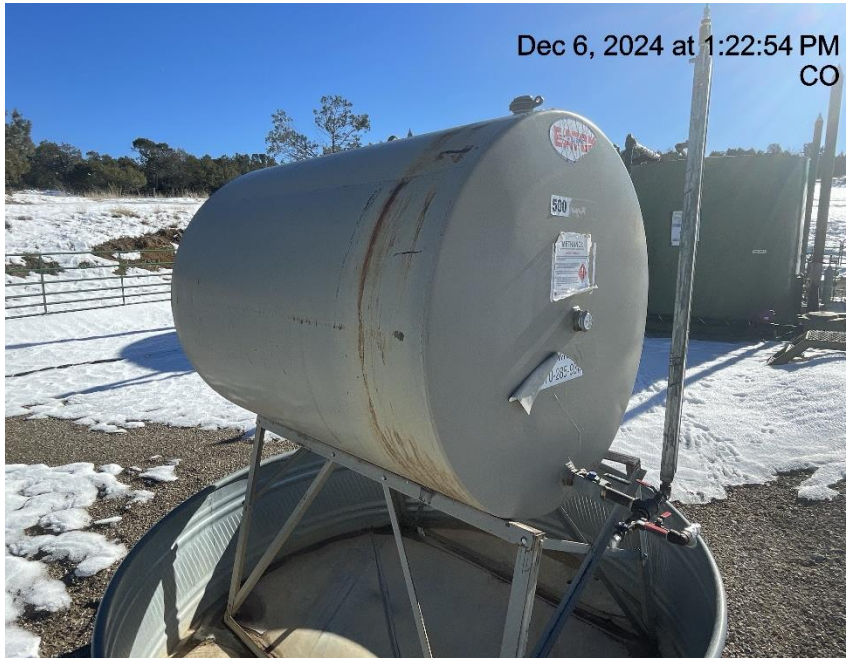
**Photo # 2710 Methanol tank labeling damaged/tank is missing required information**

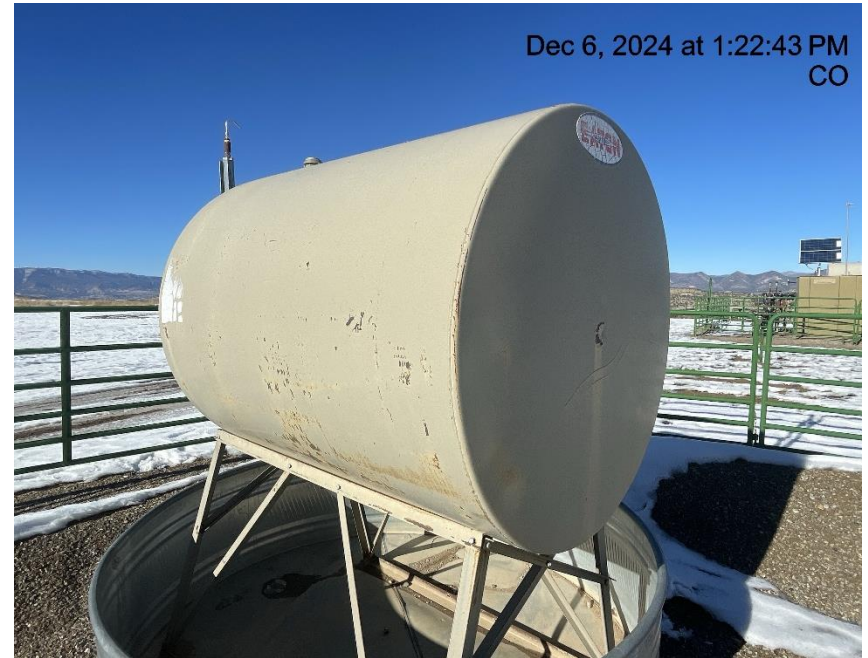
**Photo # 2711 Methanol tank labeling damaged/tank is missing required information**

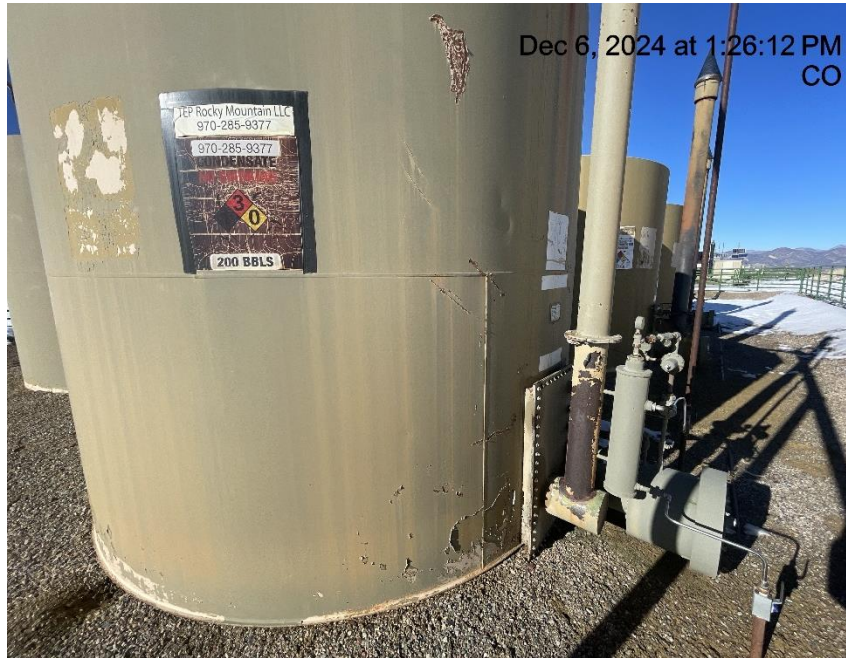
**Photo # 2712 Tank label weathered & starting to become illegible**
