Final Reclamation and Stormwater Inspection

Date: 01/02/2025

Operator: STELBAR OIL CORP INC - 82470

Location ID: 317293

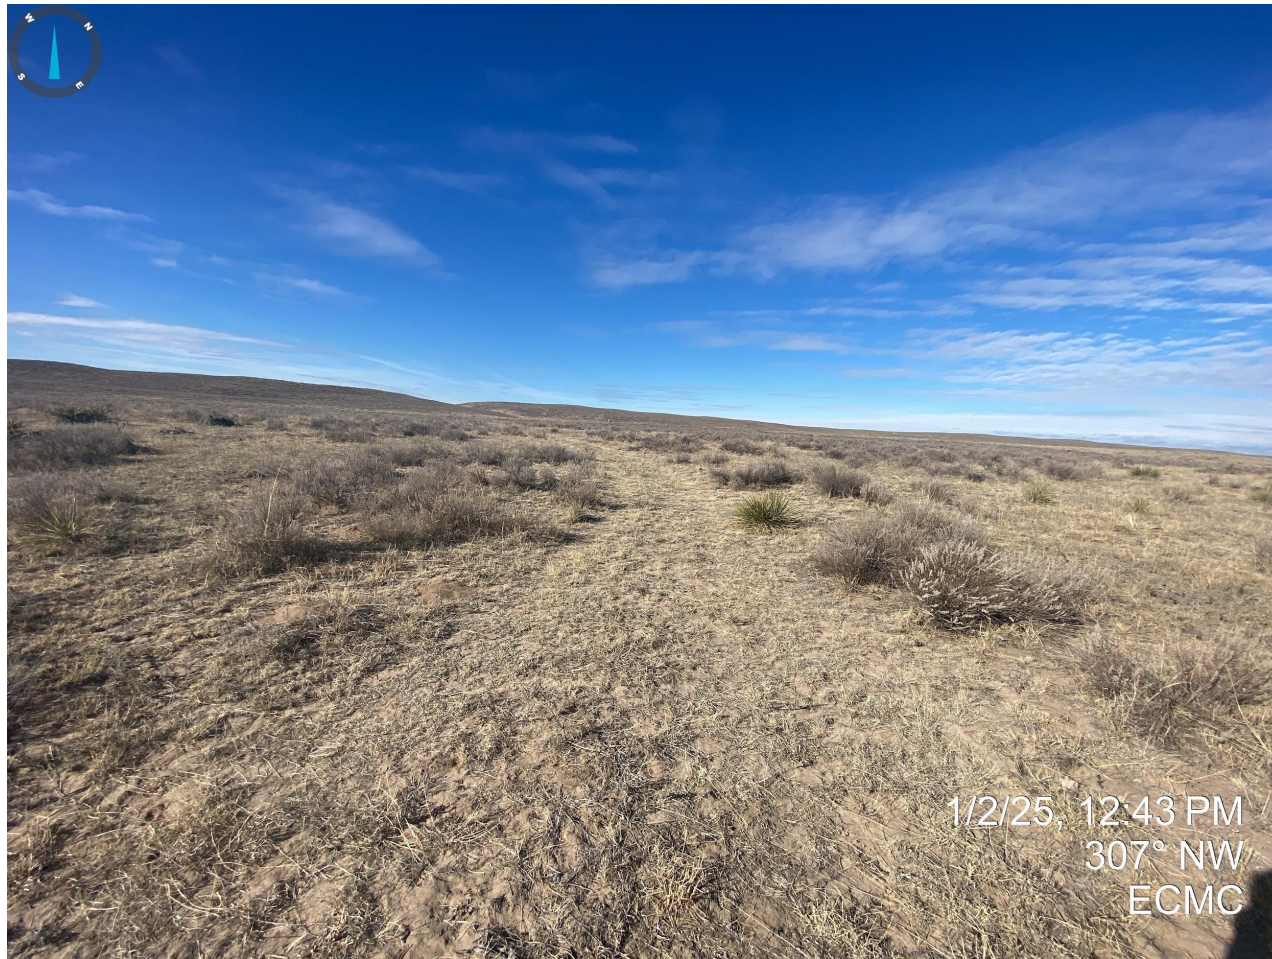
Photo 1. Eastern access road entrance appears to be progressing towards reclamation standards and regulations.

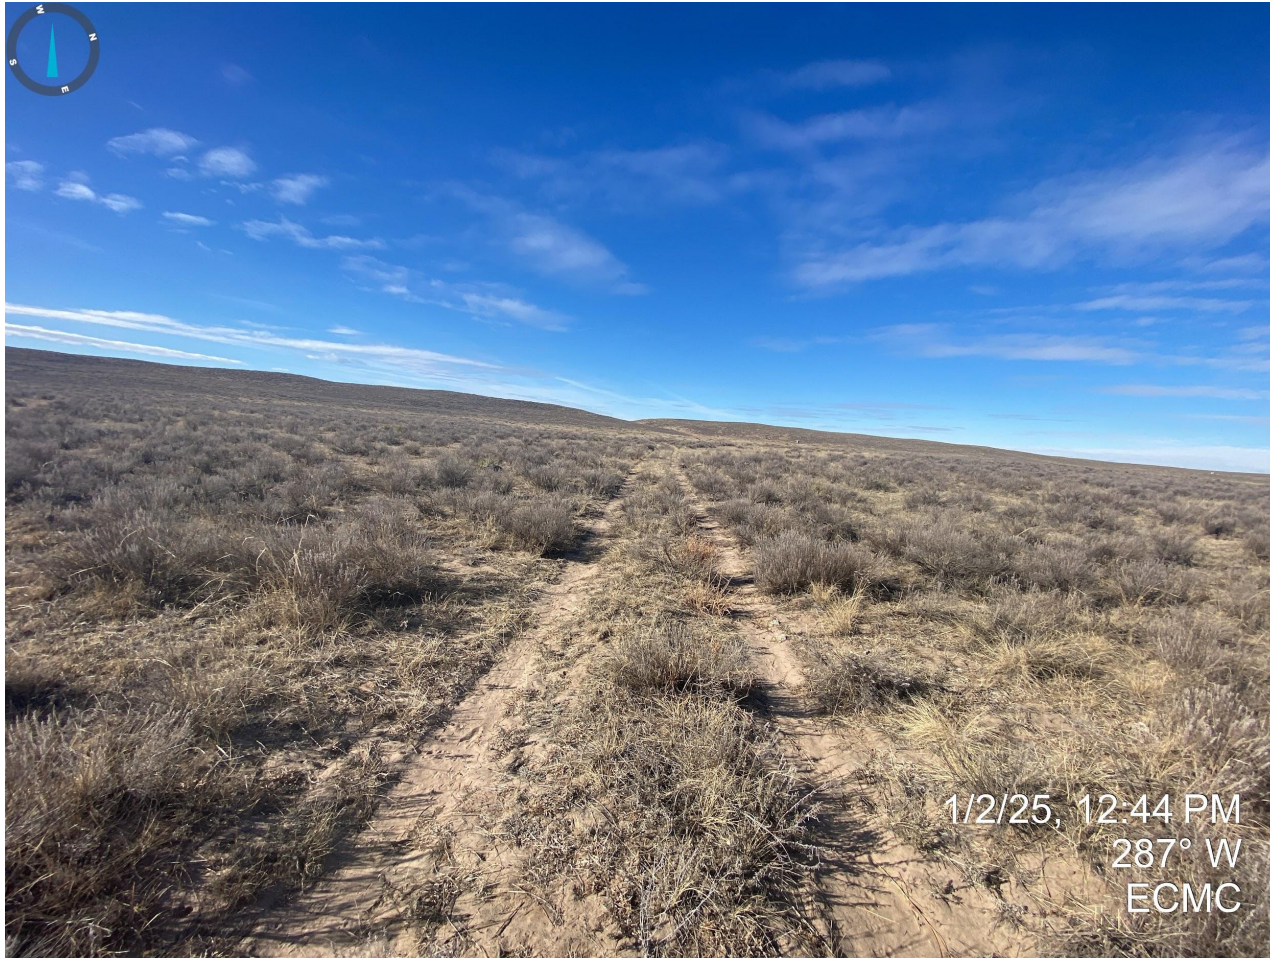
Photo 2. Portions of the access road east of the former location do not appear to have been reclaimed and require additional reclamation activities.

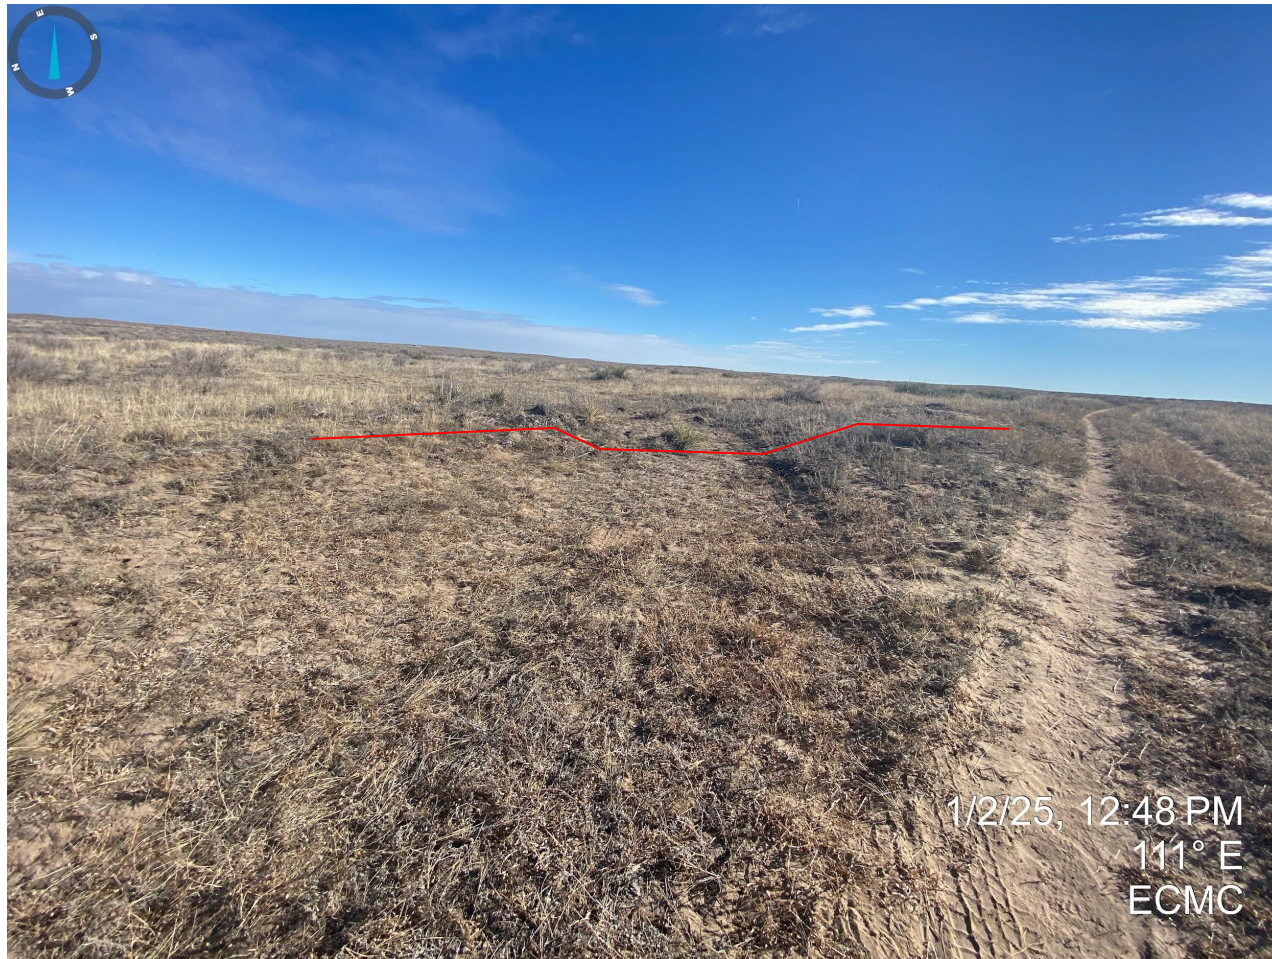
Photo 3. Access road entrance west of the former location requires additional work to contour and grade the road to match the existing grade/topography. Red line approximates current grade of access road.

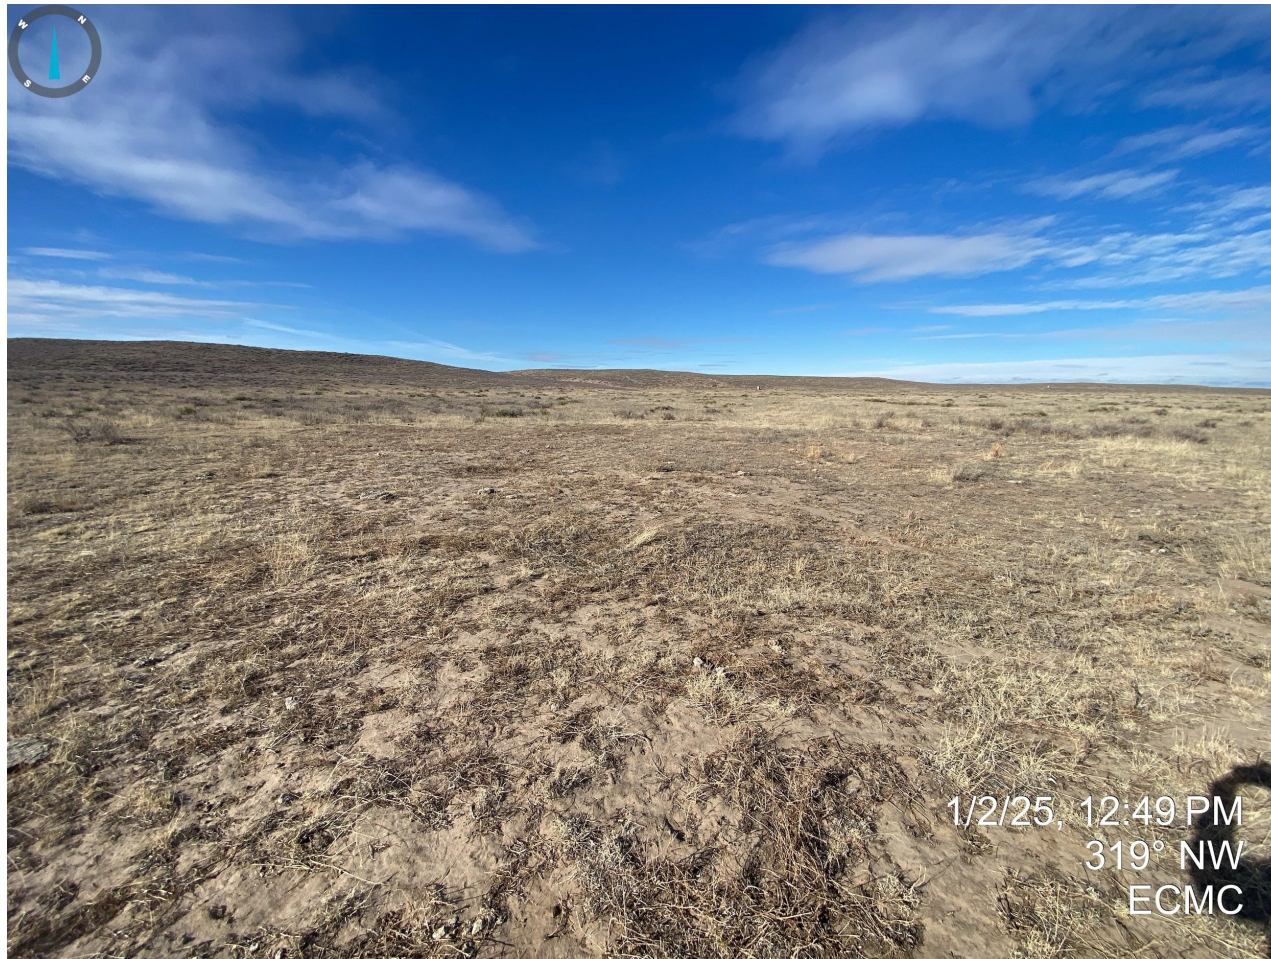
Photo 4. Former meter shed west of the location does not appear to be progressing towards reclamation standards and regulations with evidence of undesirable vegetation and non-uniform vegetation cover.

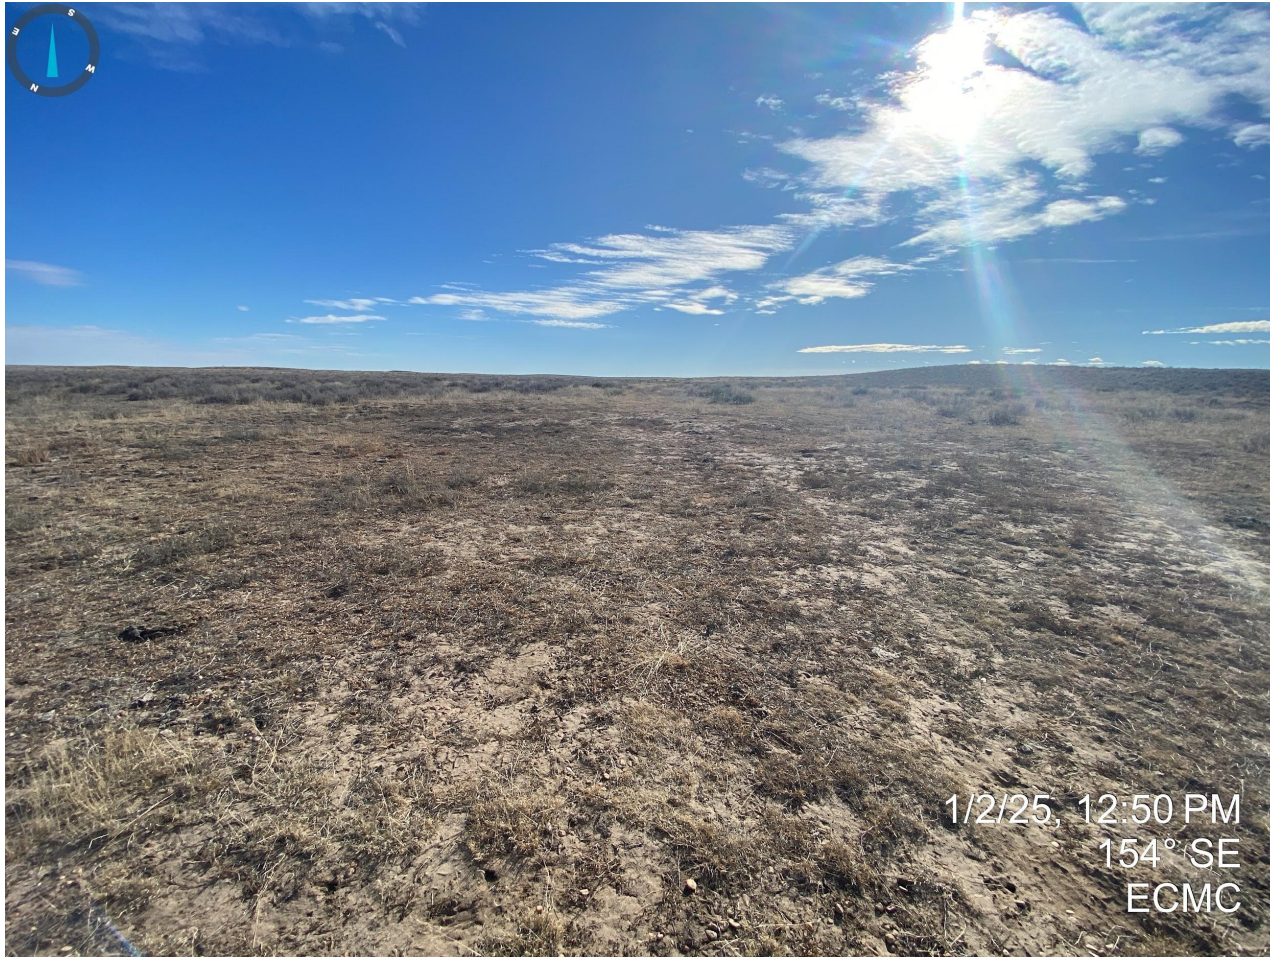
Photo 5. Continued from previous photo, facing southeast. See comments in Photo 4.

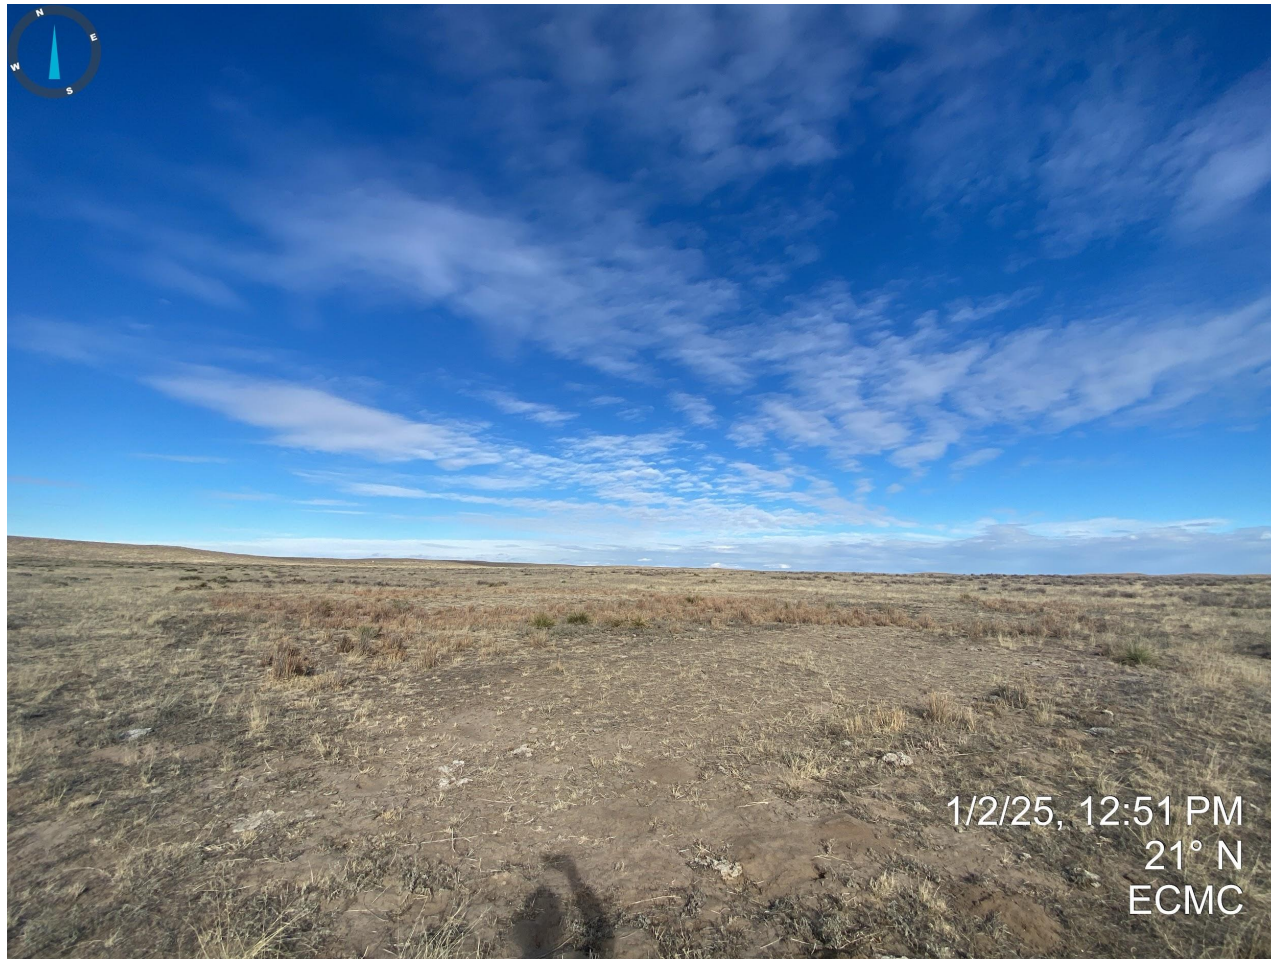
Photo 6. Taken from the southwest corner of the former location, near the separator. The area around the former separator requires additional reclamation activities as evidence of non-uniform vegetation resulting in bare soil was observed.

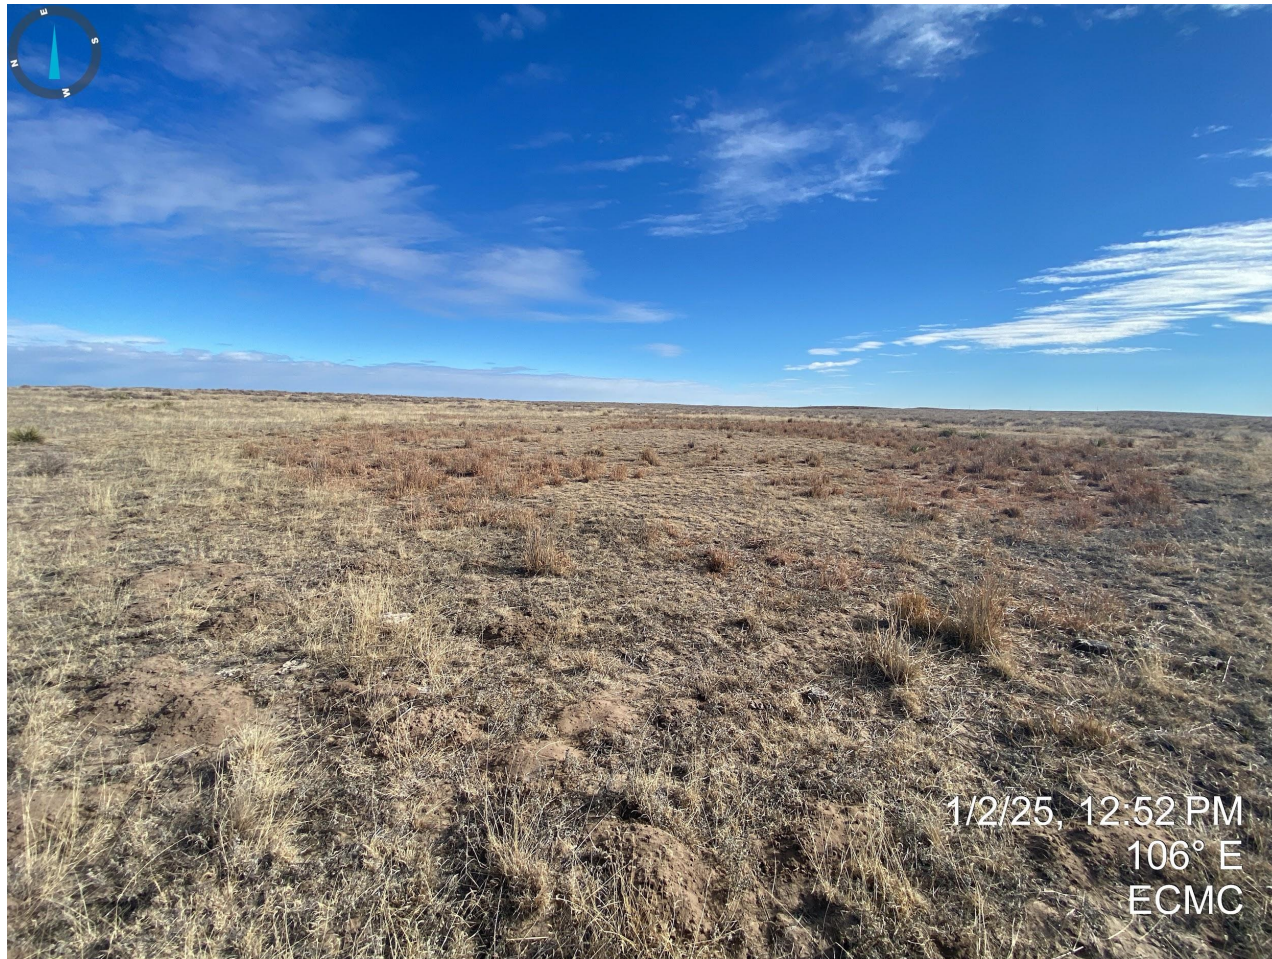
Photo 7. Taken from the northwest corner of the location, facing east. Portions of the reclaimed location appear to be progressing towards reclamation standards.

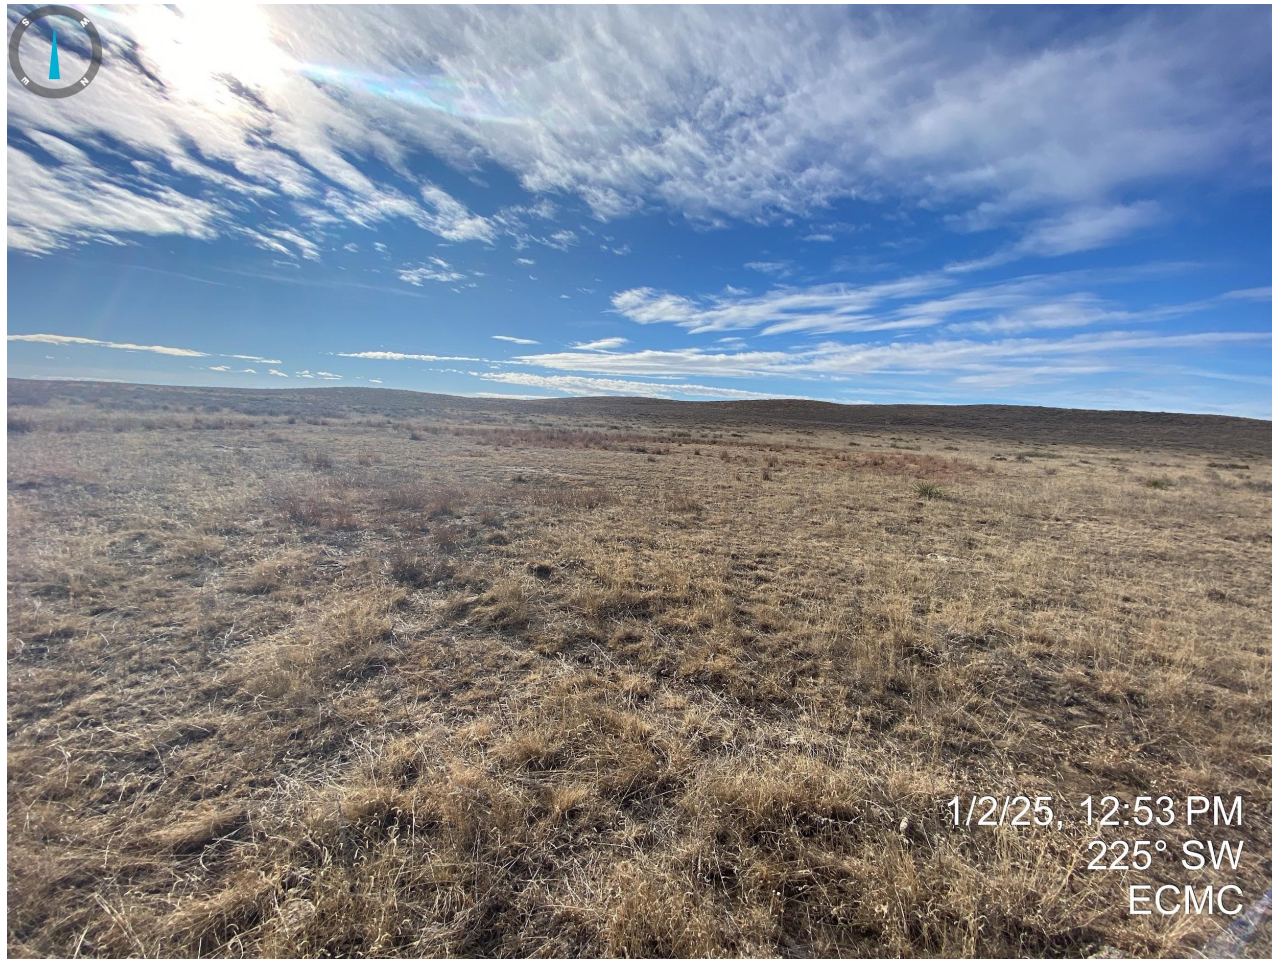
Photo 8. Taken from the northeast corner of the location, facing southwest. Portions of the reclaimed location appear to be progressing towards reclamation standards.

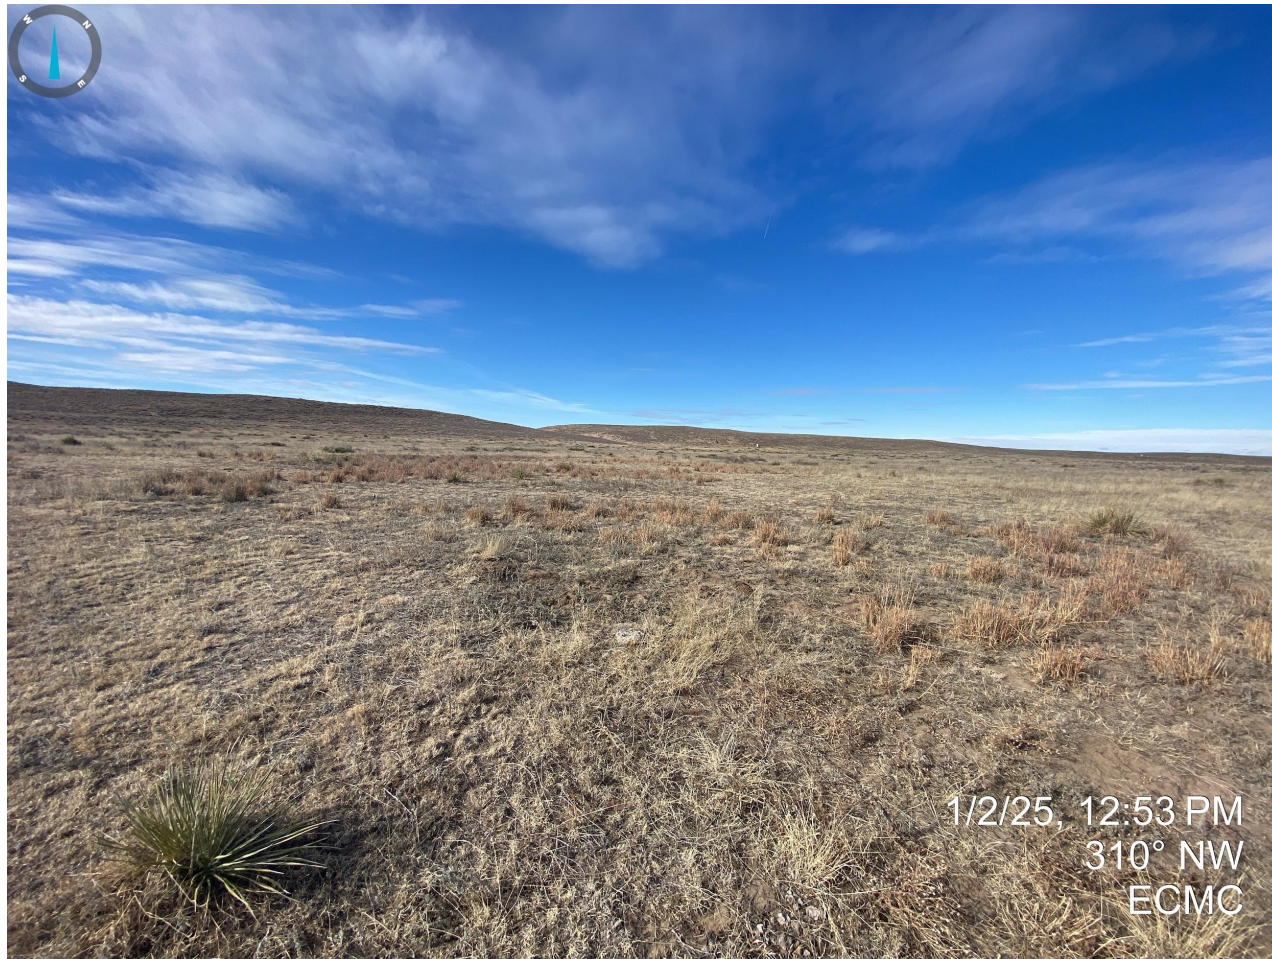
Photo 9. Taken from the southeast corner of the location, facing northwest. Portions of the reclaimed location appear to be progressing towards reclamation standards.
