# Inspection Photos

**Operator:** ANSCHUTZ EXPLORATION CORP -  
3104

**Location ID:** 430927

**Inspection Doc:** 718100144

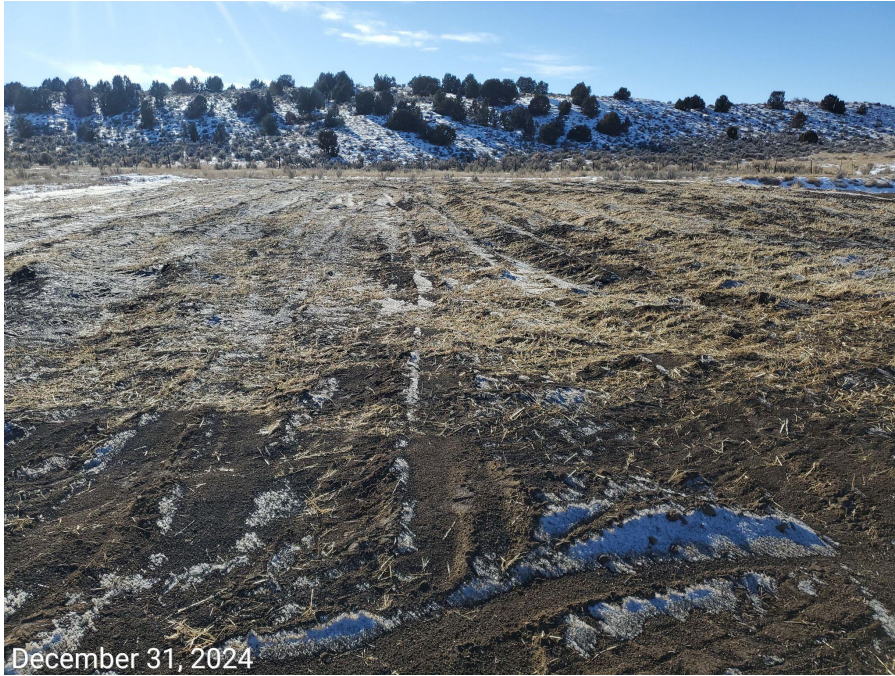
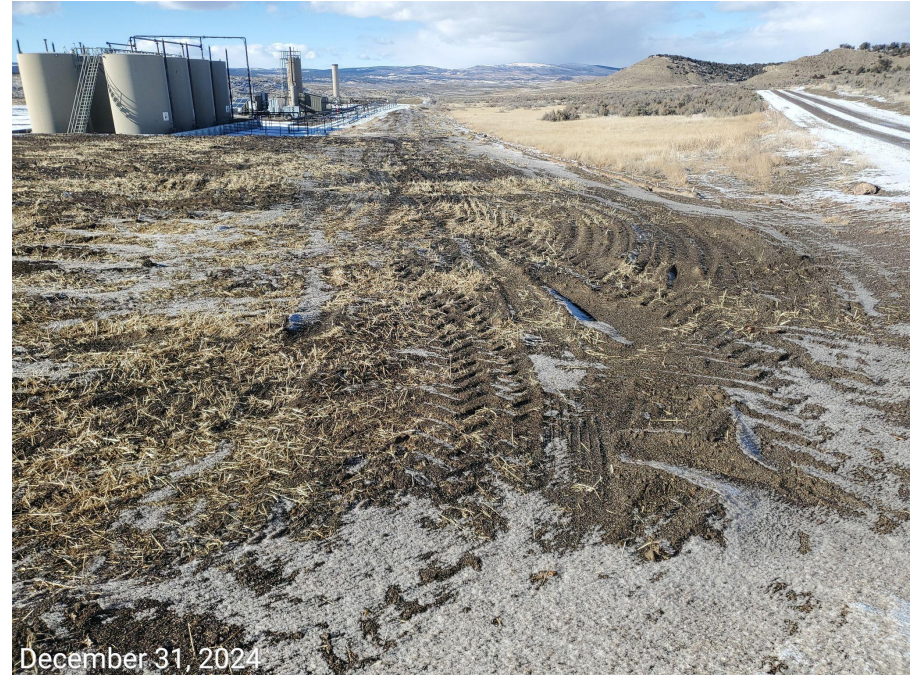
**Photo 1:** Photos taken from the interim areas on the south end of the Location, and from the secondary access road along the northeast end of the Location. Additional reclamation efforts have been performed.

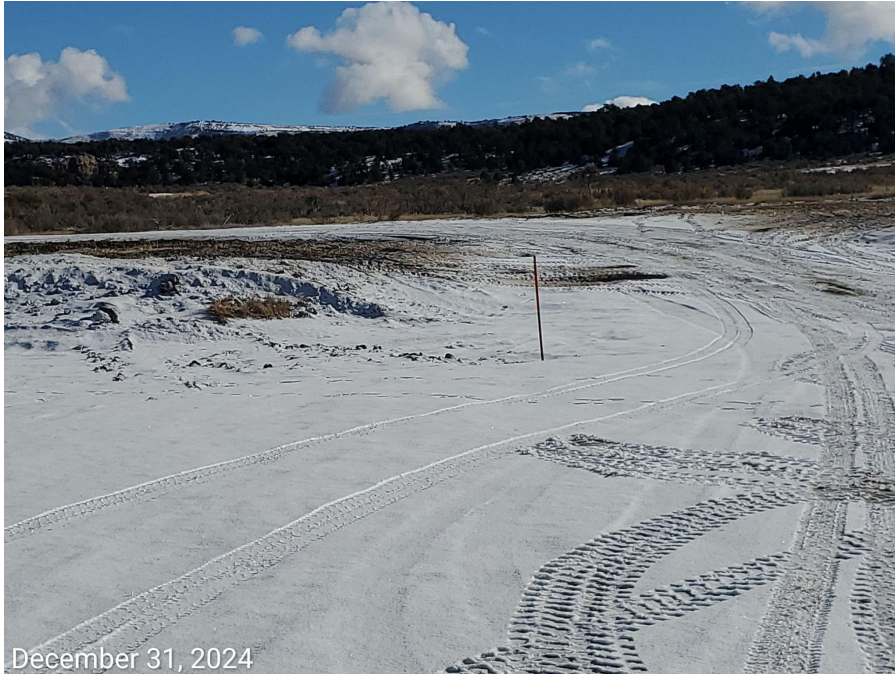
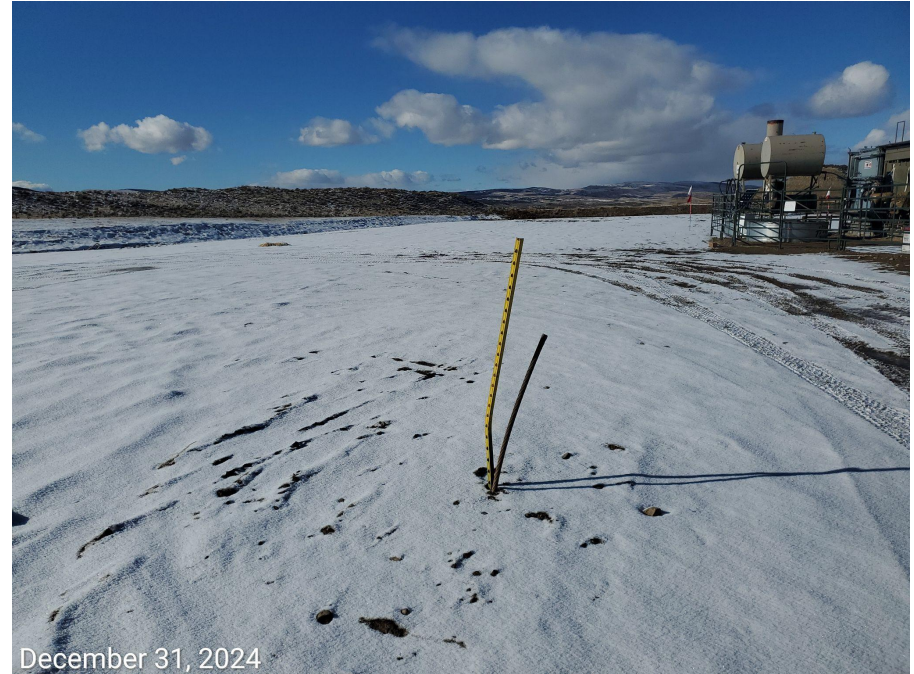
**Photo 2:** Anchors on Location have been marked pursuant to 1003.a requirements.

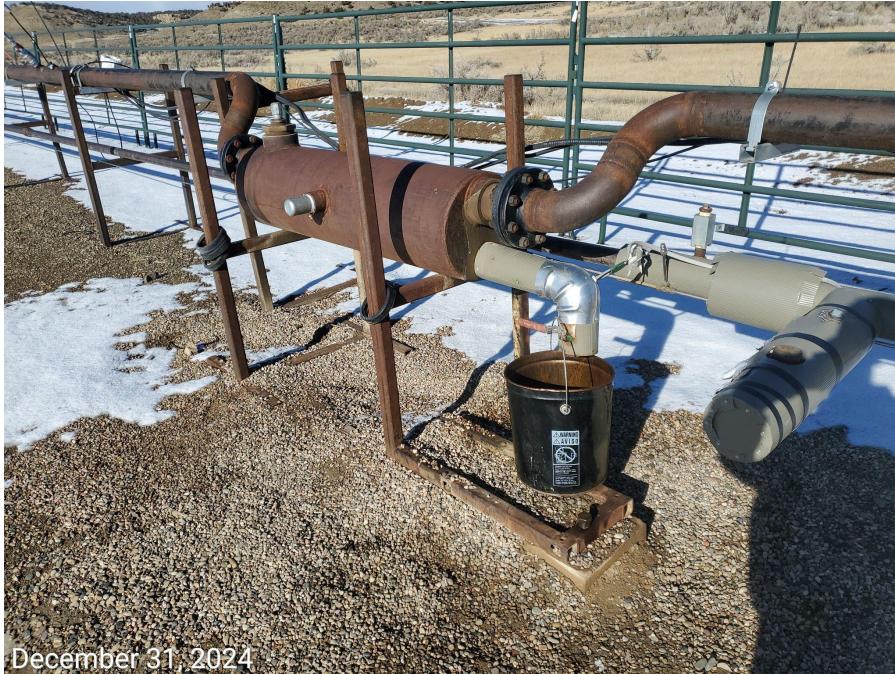
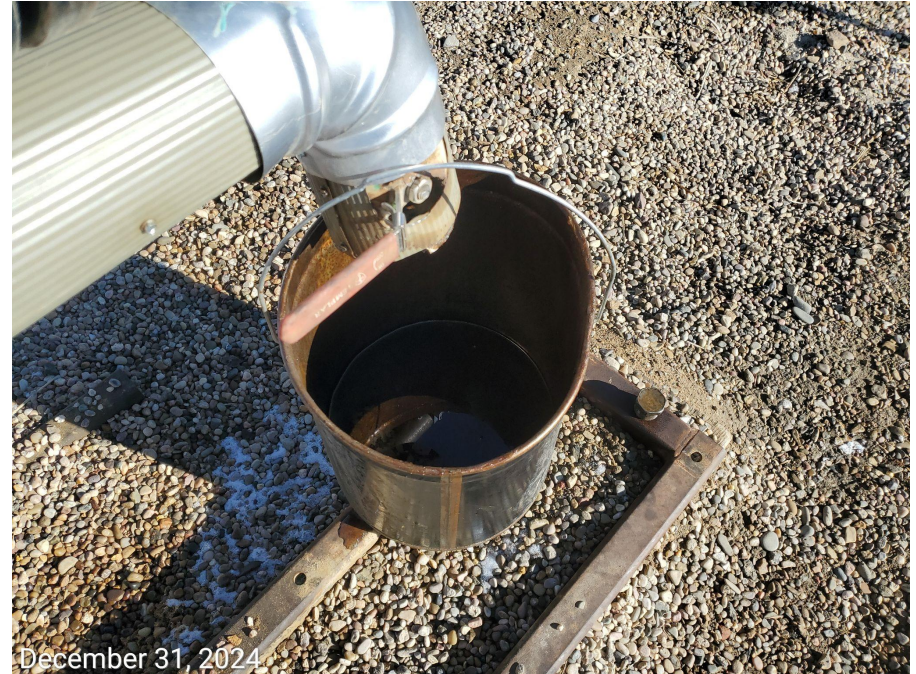
**Photo 3:** Photos taken from equipment on the northeast end of the Location. Spills/leaking from equipment have continued. Operator has precariously placed a bucket beneath equipment to capture fluids; this is not proper management of E&P waste; buckets could easily be knocked over; fluids require removal and proper disposal and equipment maintained pursuant to 608.e requirements.

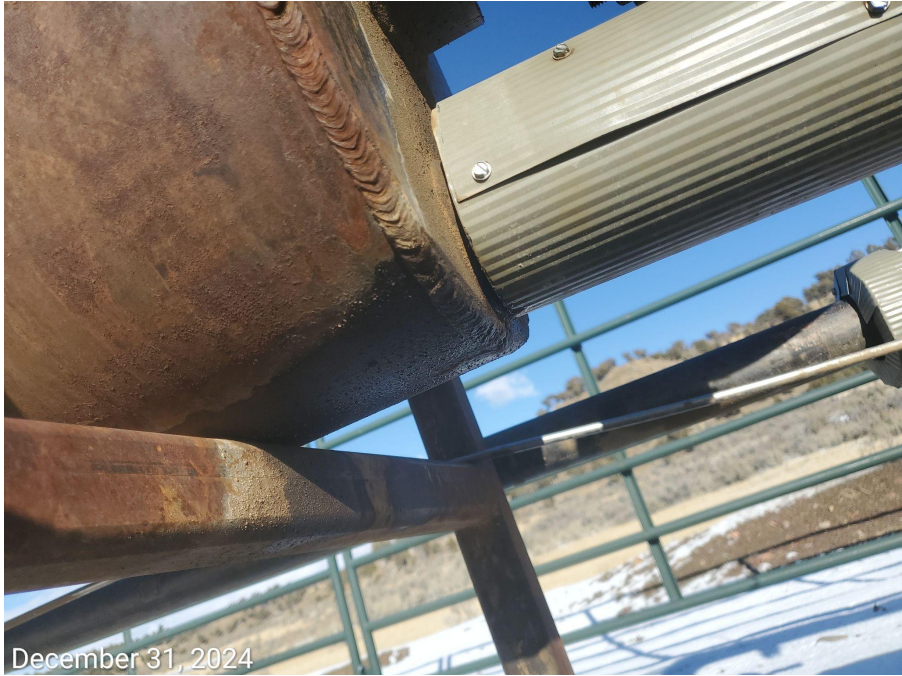
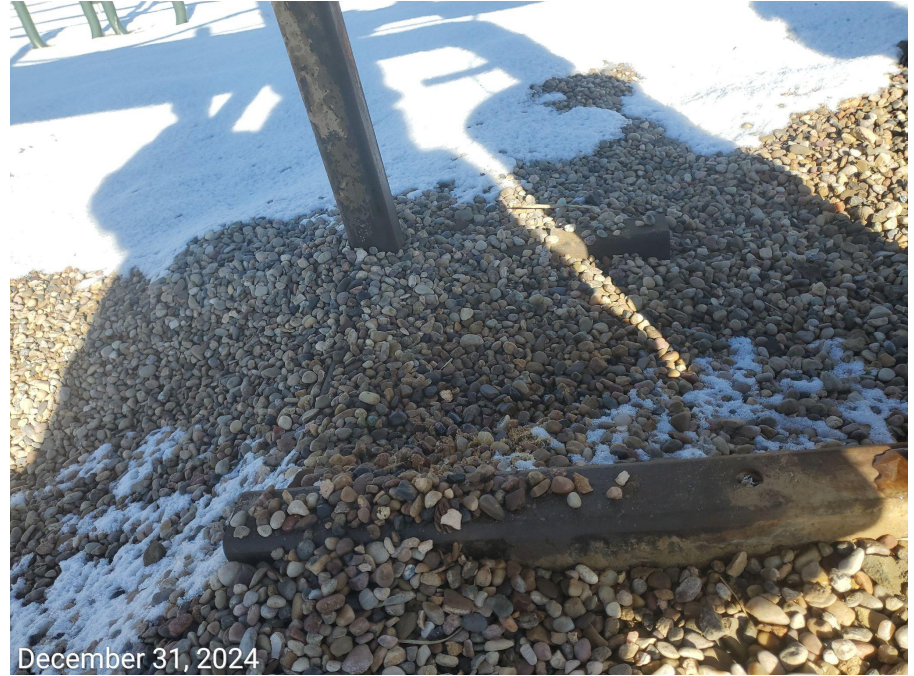
**Photo 4:** Continue from photo 3. Photos show spills/leaks have continued at equipment resulting in spills onto the surface of the Location/Pad.

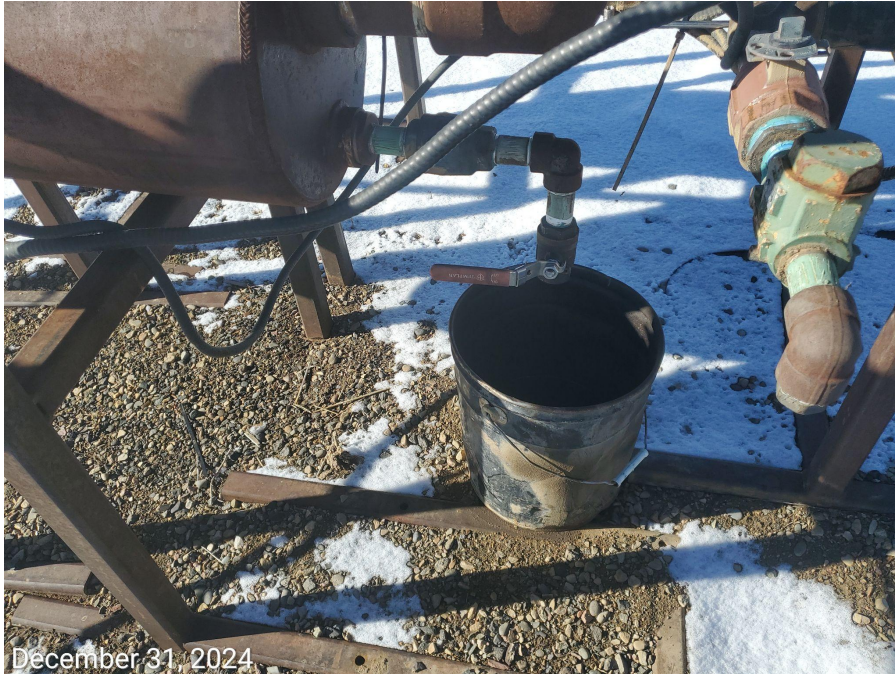
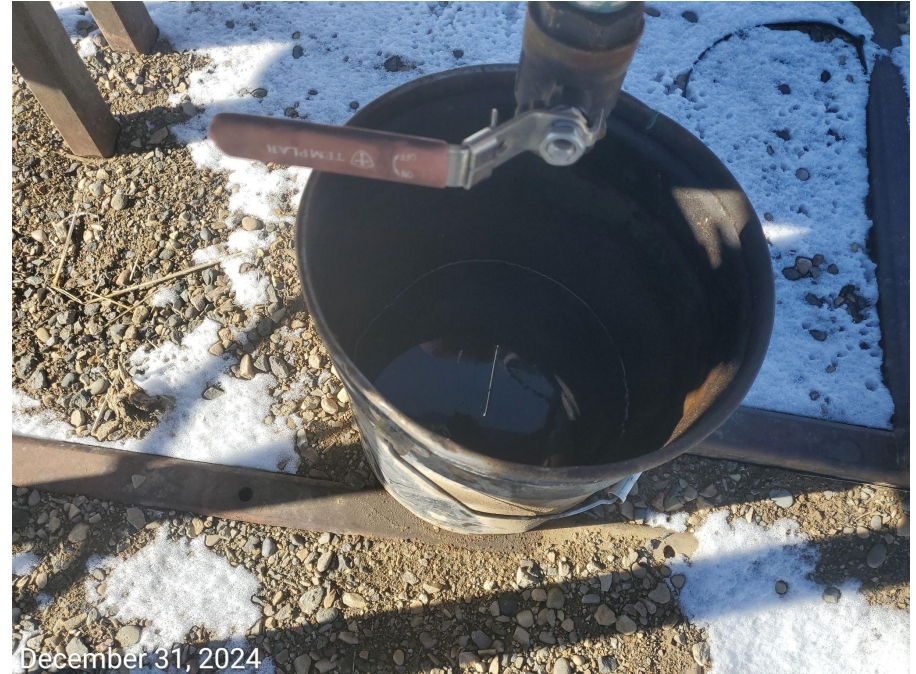
**Photo 5:** Photos taken from equipment on the north end of the Location. Spills/leaking from equipment have continued. Operator has precariously placed a bucket beneath equipment to capture fluids; this is not proper management of E&P waste; buckets could easily be knocked over; fluids require removal and proper disposal and equipment maintained pursuant to 608.e requirements.

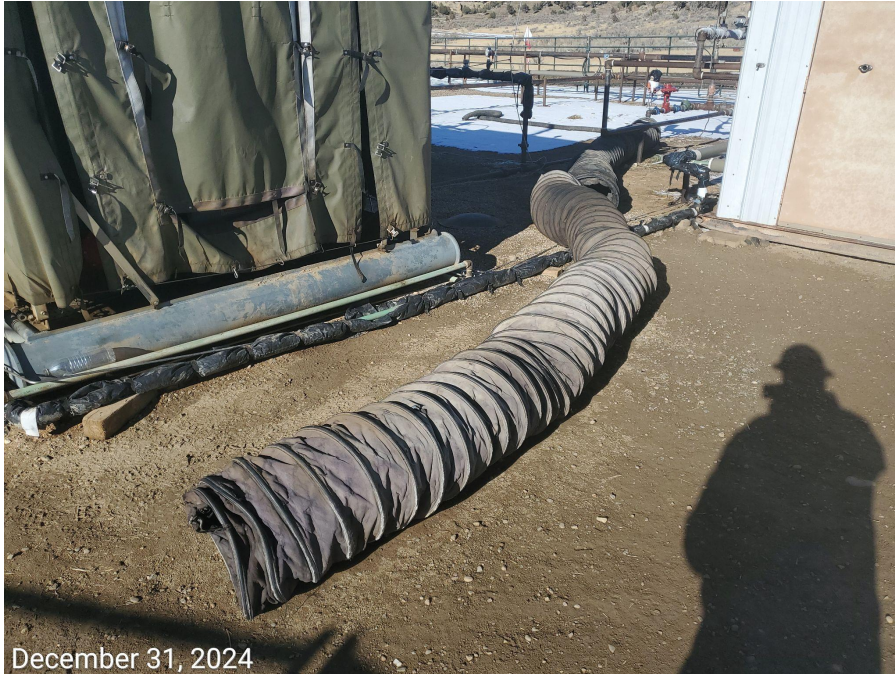
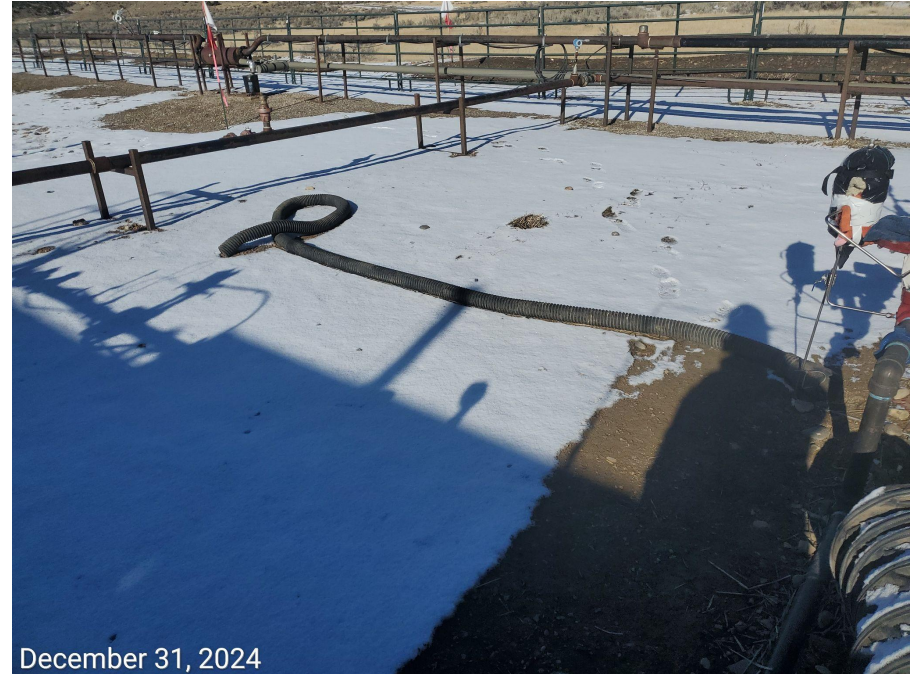
**Photo 6:** Unused equipment stored on Location.

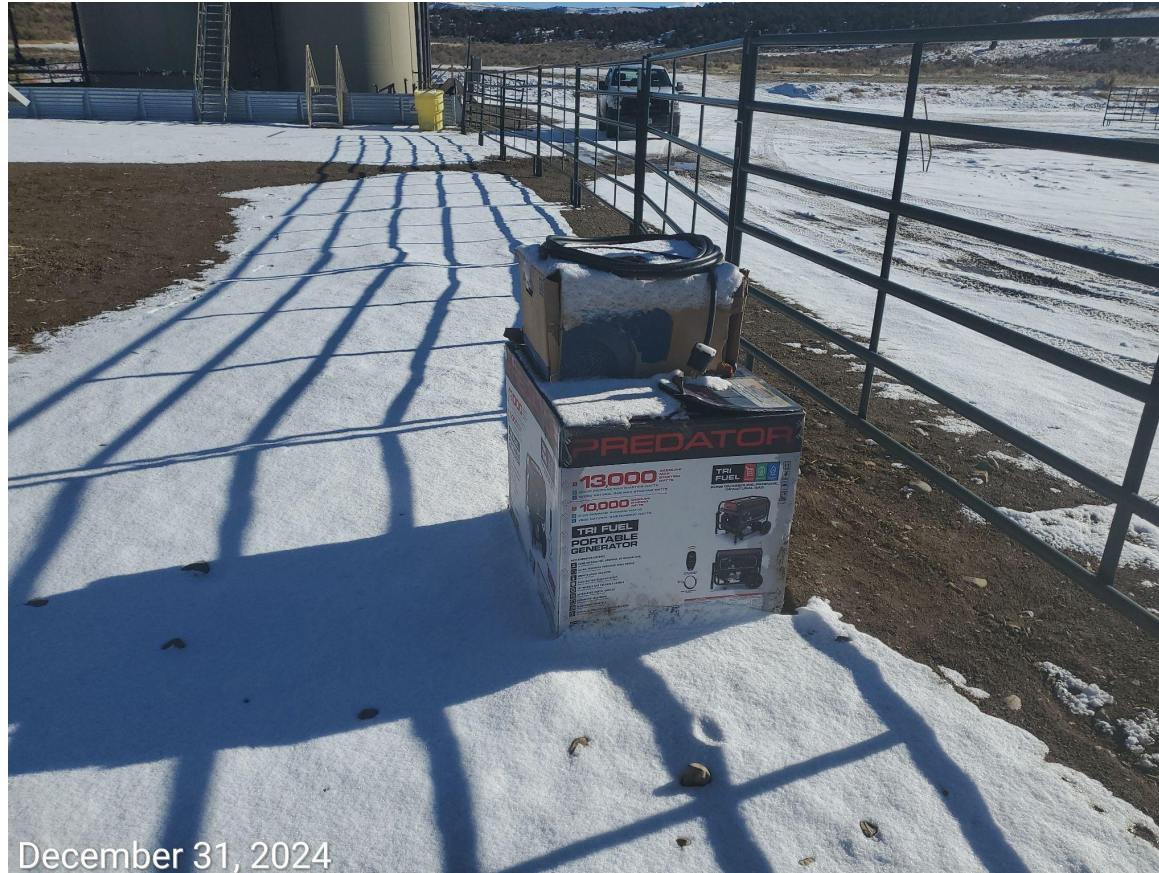
**Photo 7:** Unused equipment stored on Location.
