KT Resources LLC  
Ant Hill Unit 19-44  
Location ID: 316310

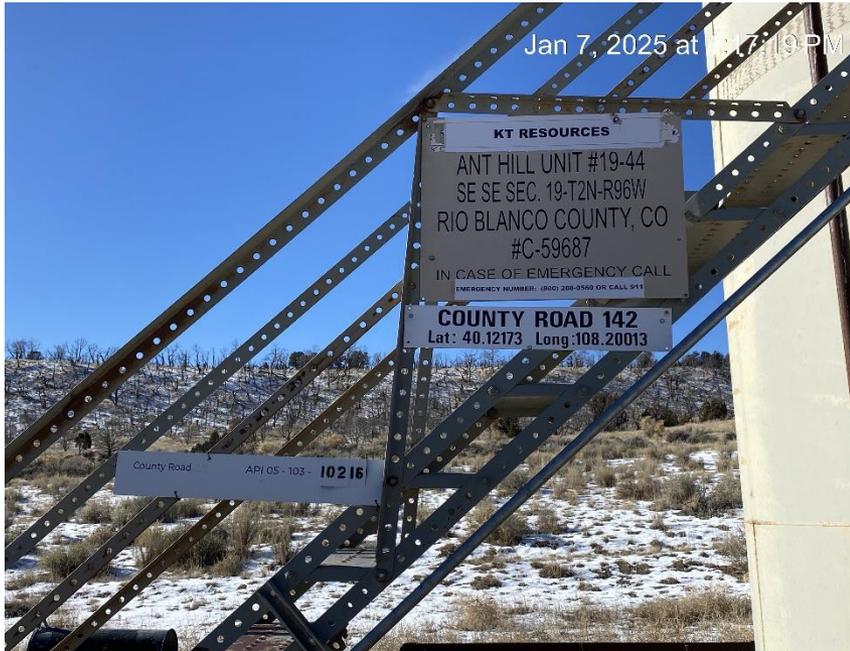
Tank battery signs

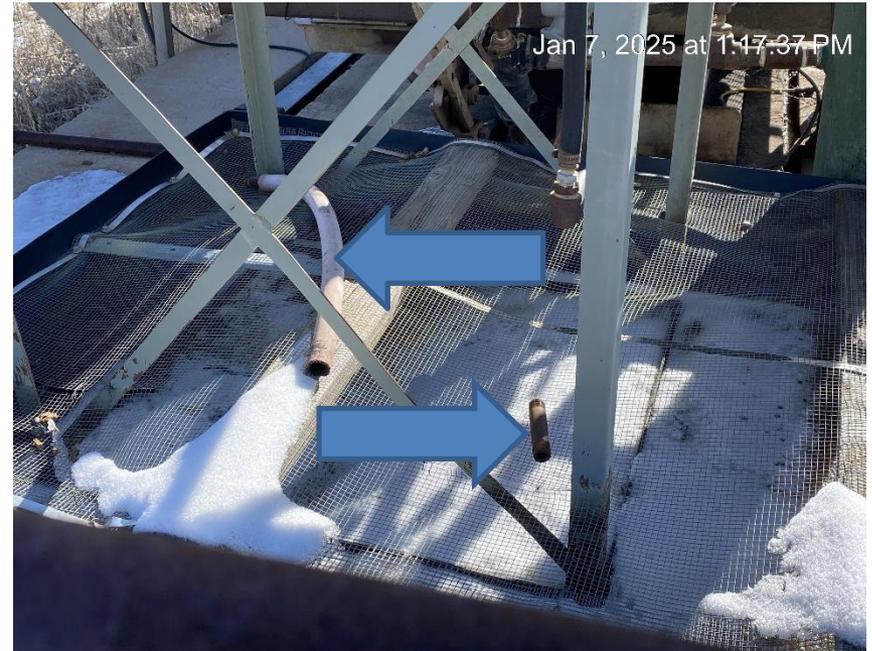
Debris

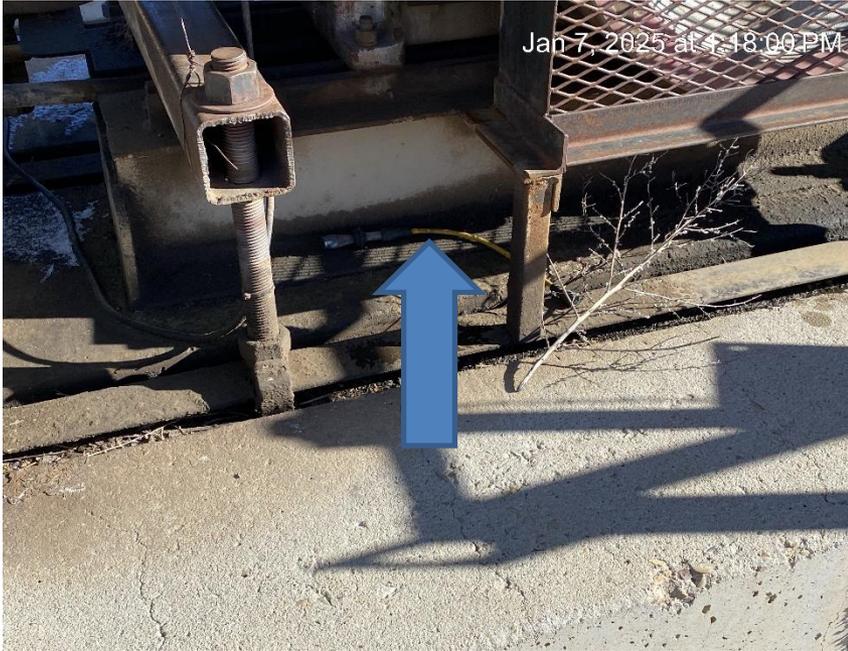
Debris

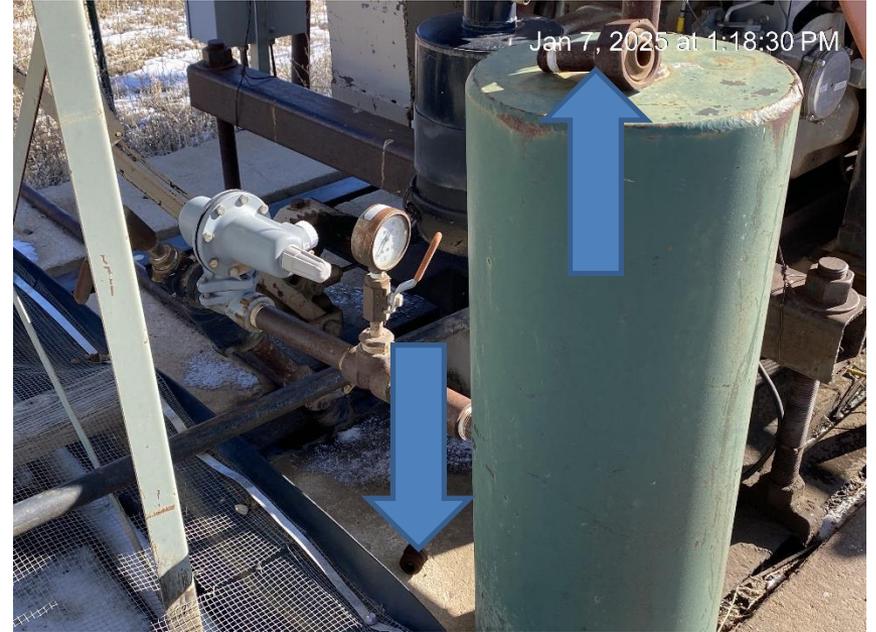
Debris

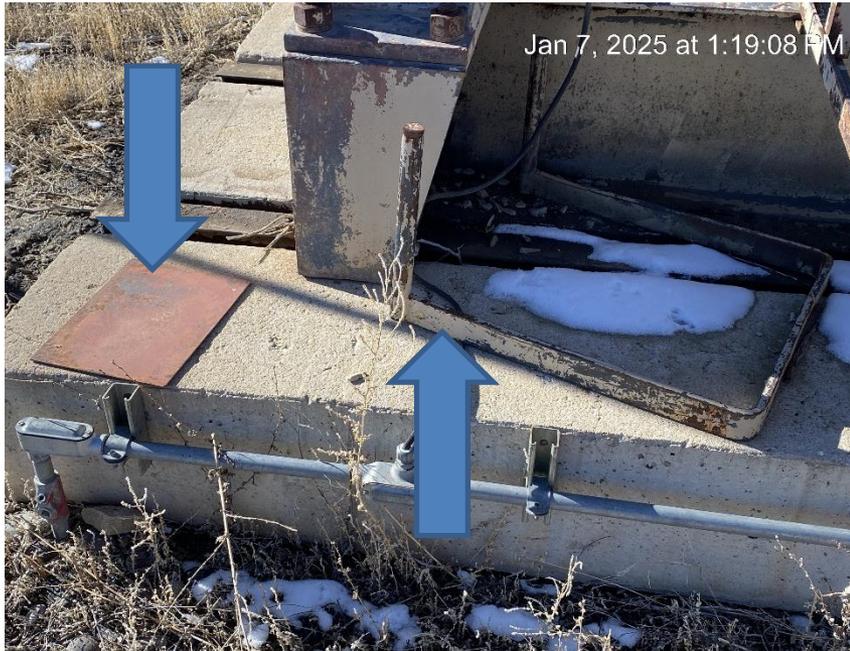
Debris

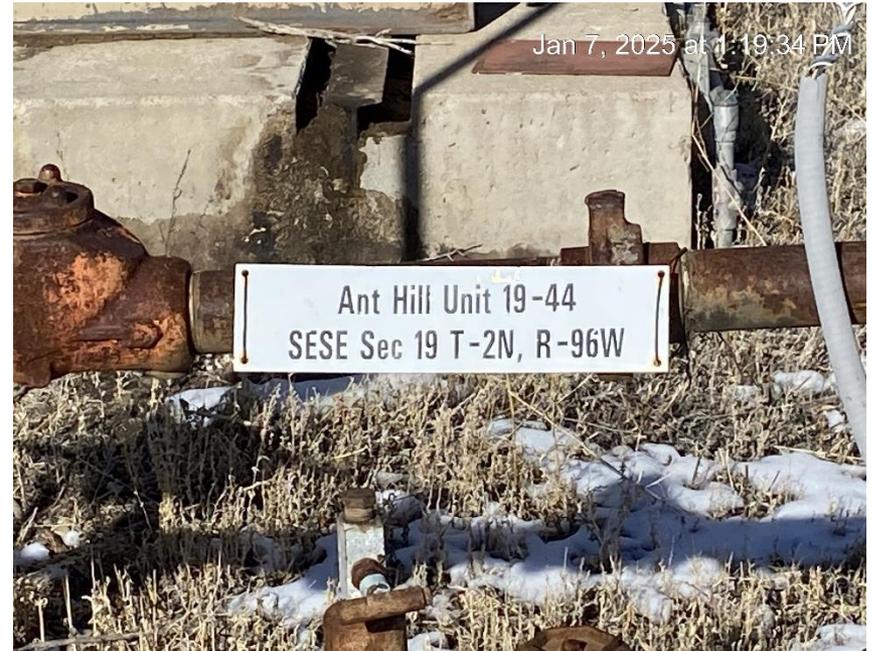
When sign is replaced additional information is required

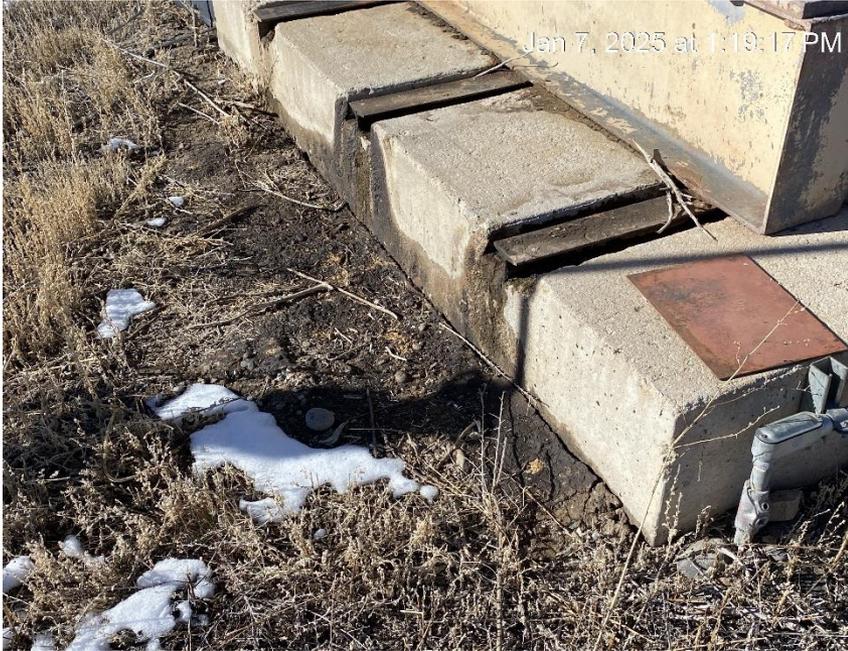
**Equipment leak and staining**

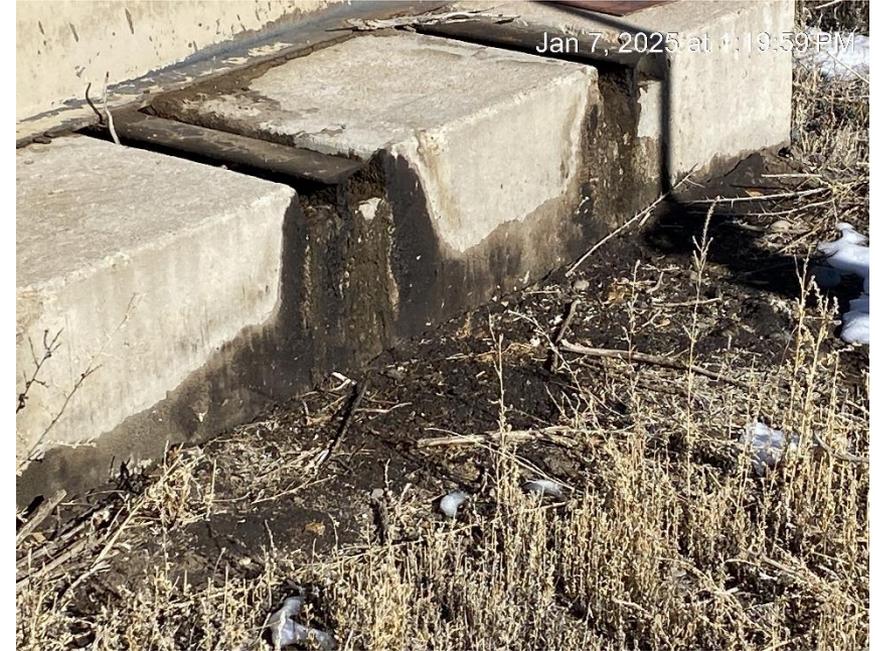
**Equipment leak and staining**

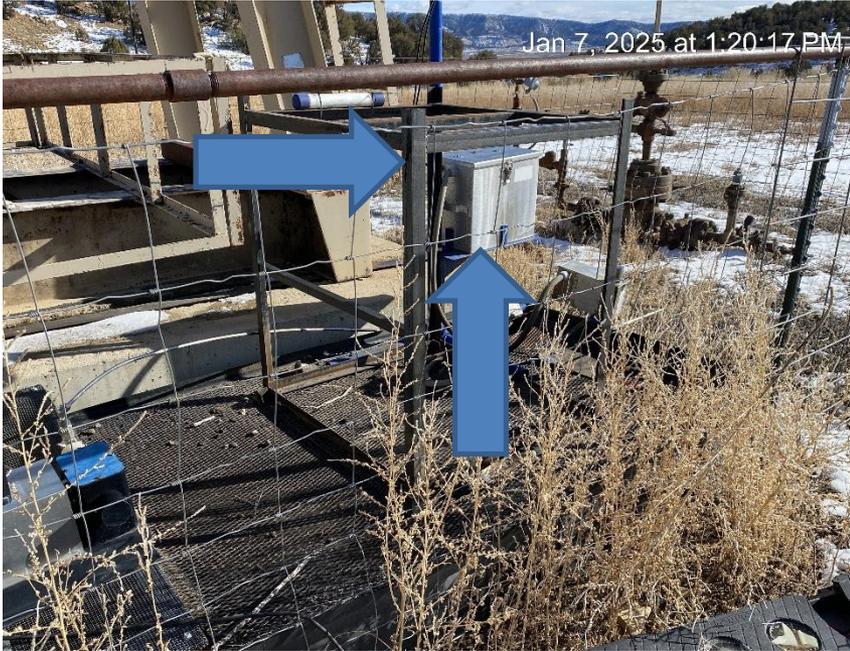
Debris

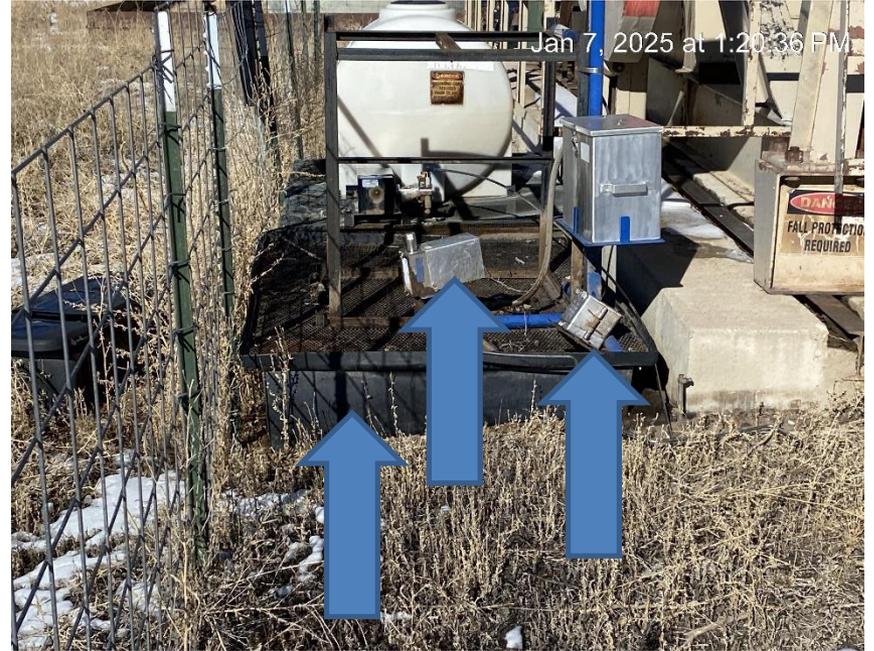
Debris

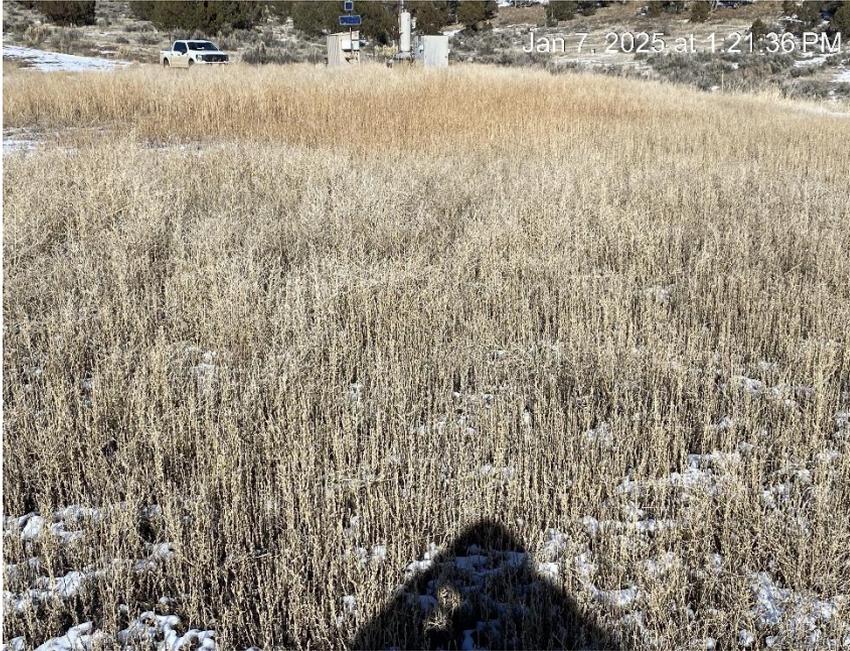
**Weeds**

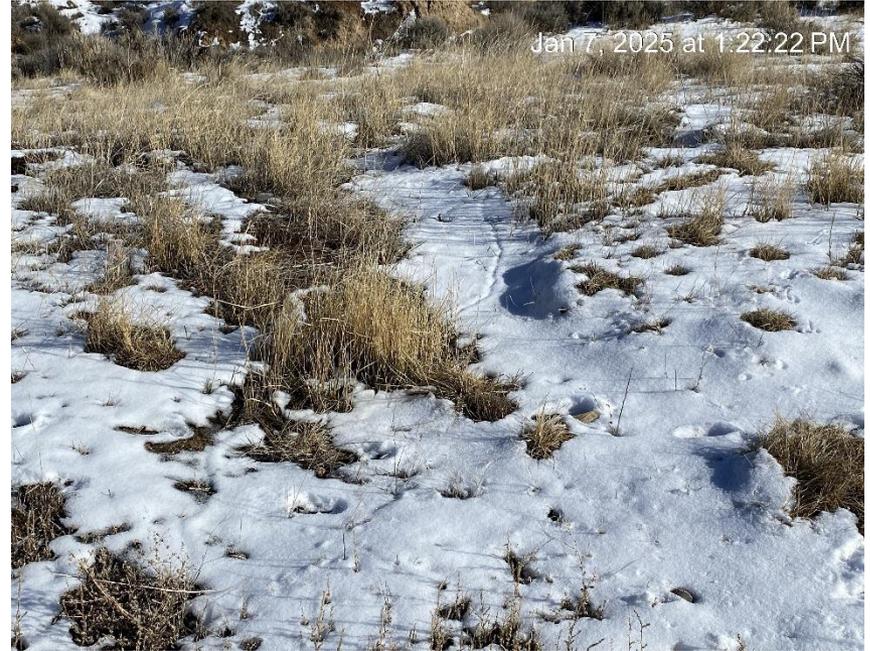
**Erosion and soil migration**

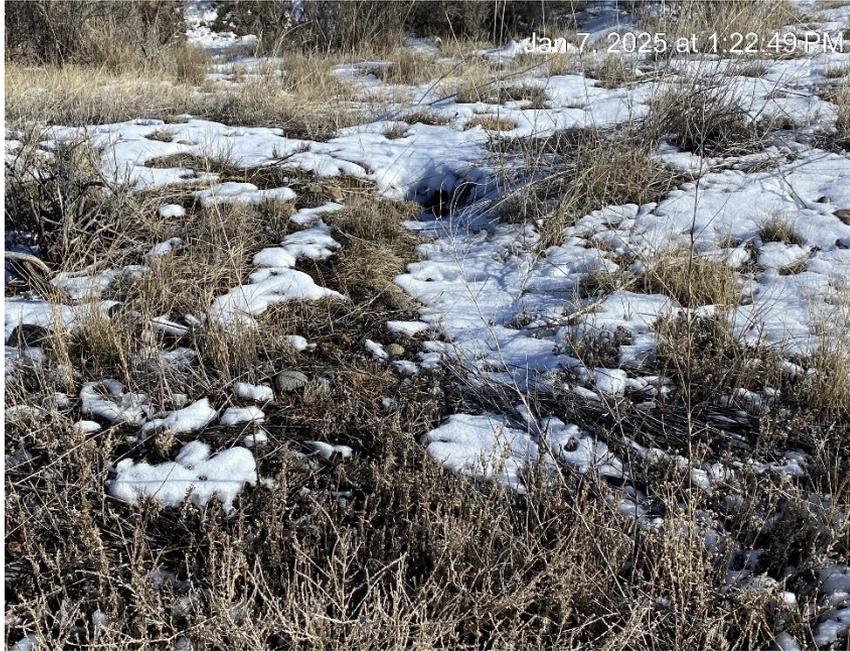
**Erosion and soil migration**

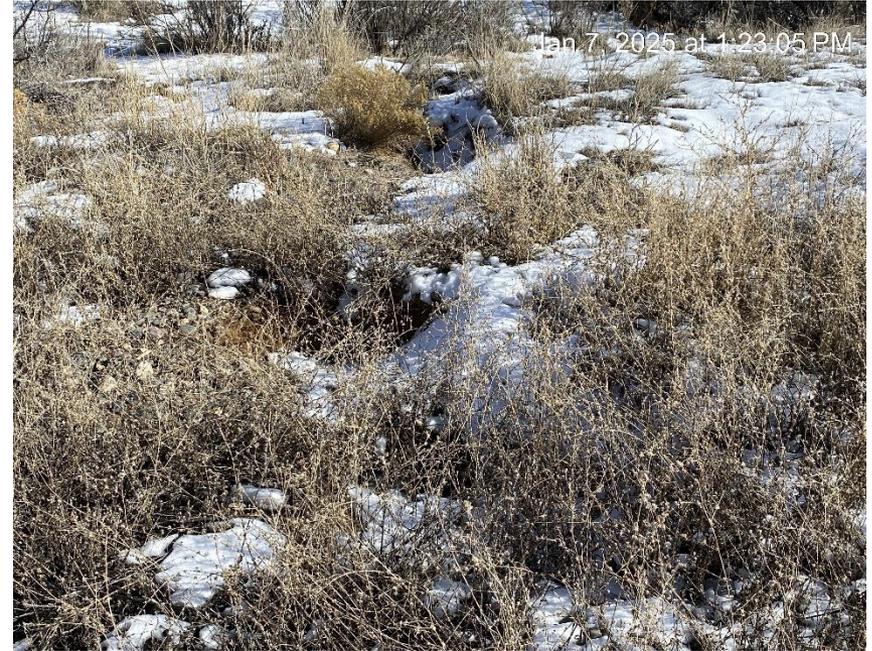
**Erosion and soil migration**

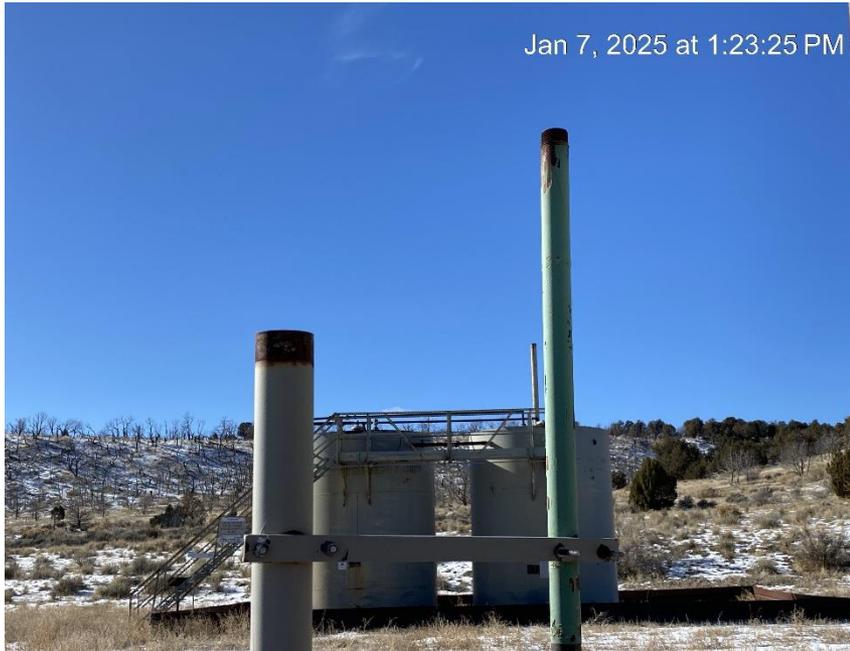
Relief vents missing caps

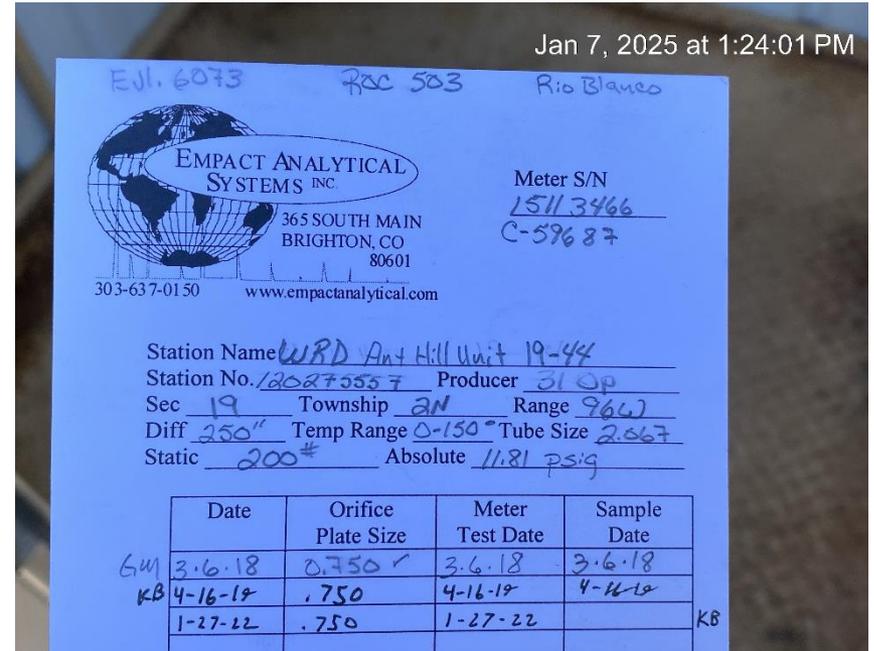
Calibration overdue
