Inspection Photos

Location Name: QB Energy ROSE RANCH 23-4D (A22W) Pad

Location #: 334755

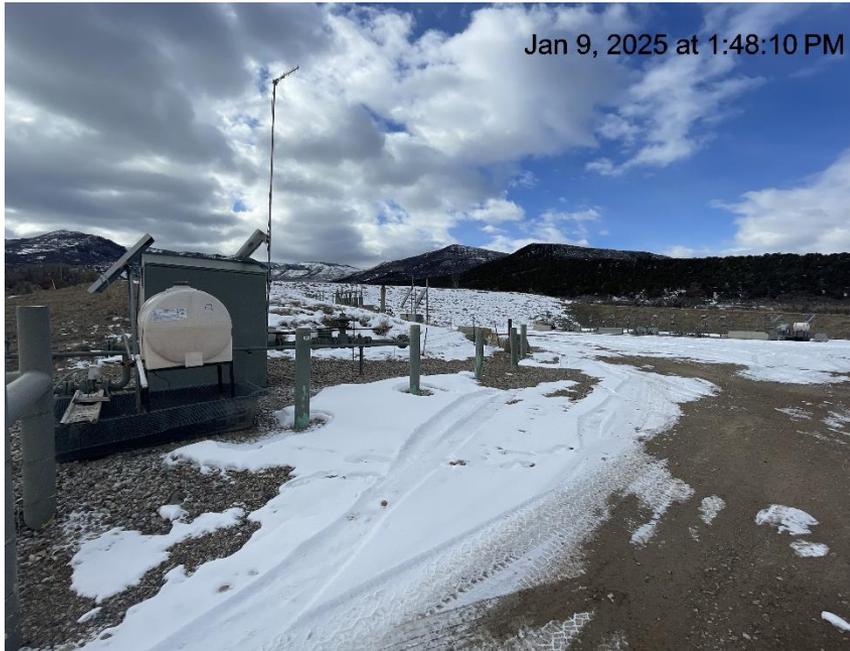
Photo # 7854 From entrance to location

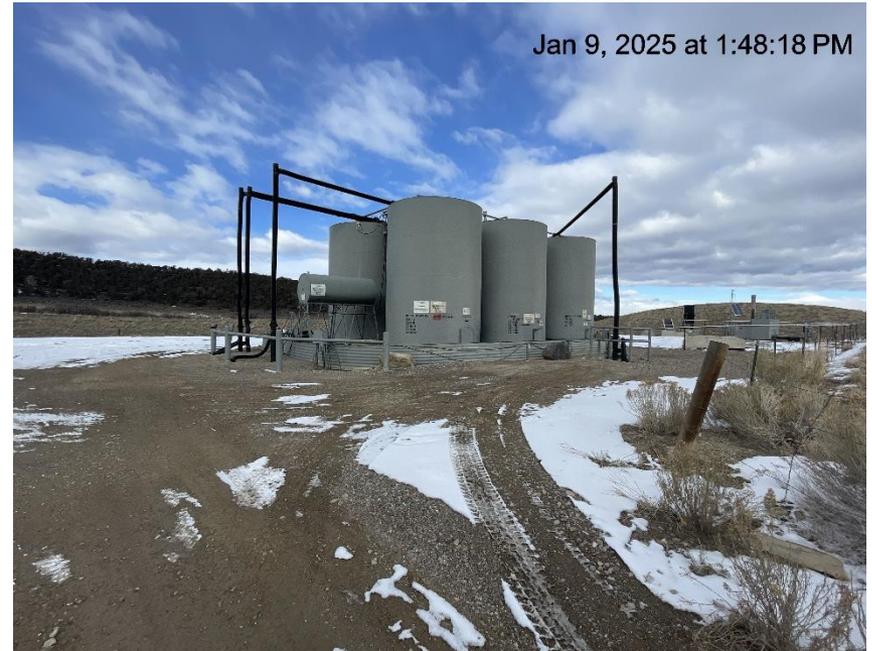
Photo # 7855 From entrance to location

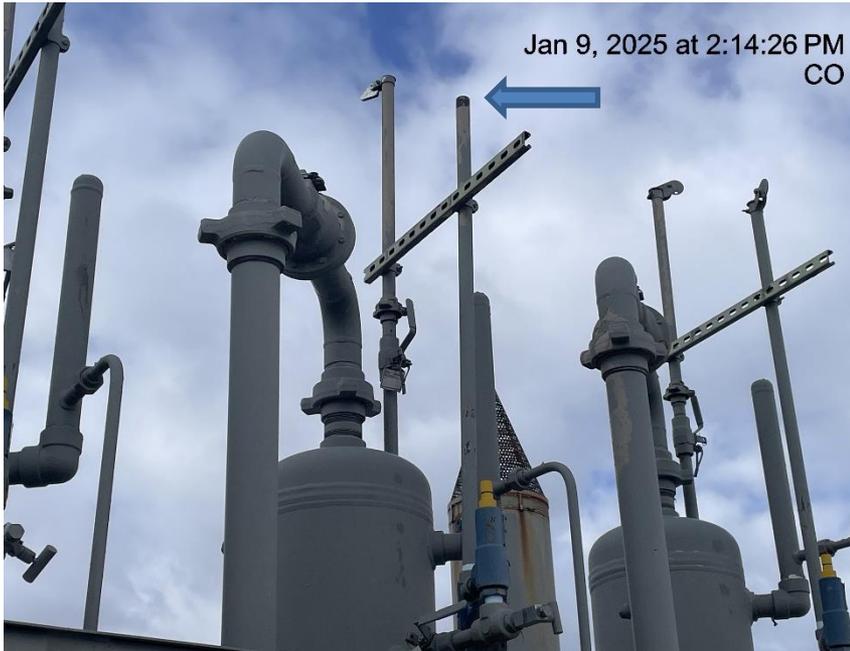
Photo # 7870 PRV vent line does not comply with CECMC pressure safety device rules

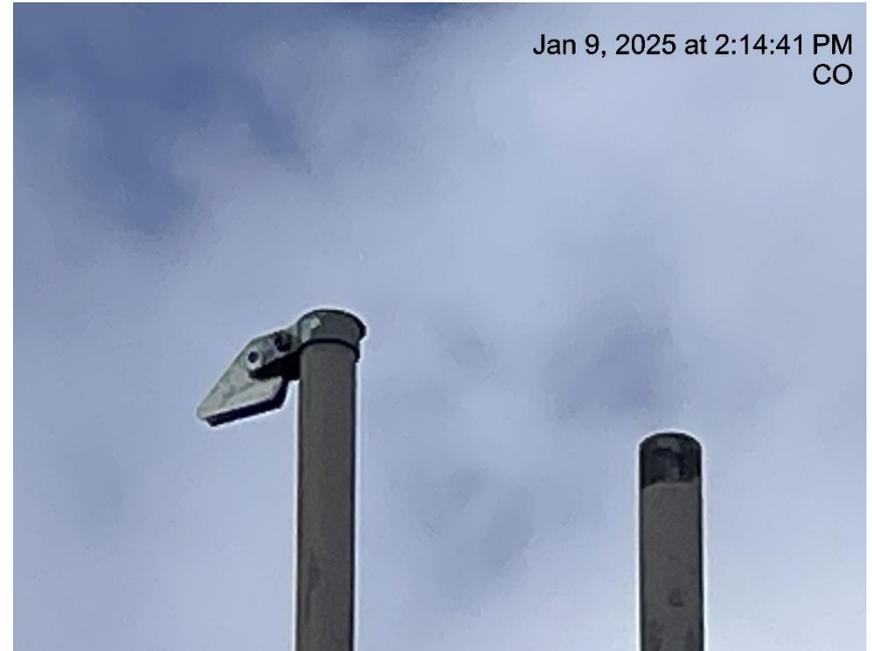
Photo # 7871 PRV vent line does not comply with CECMC pressure safety device rules
