**Inspection Photos**  
**Location Name: QB Energy GMU 23-14 (C26NW) Pad**  
**Location #: 335163**

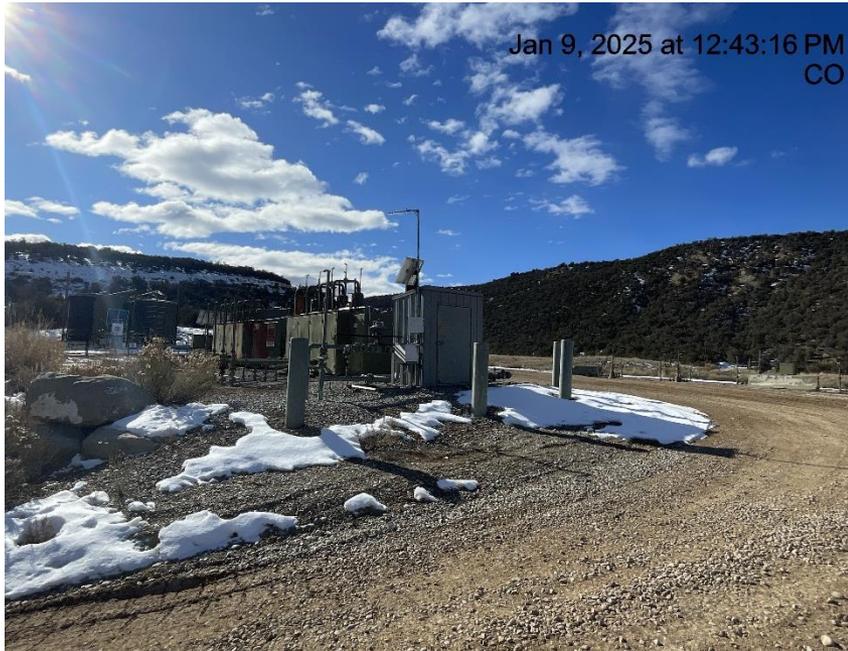
**Photo # 7677 From entrance to location**

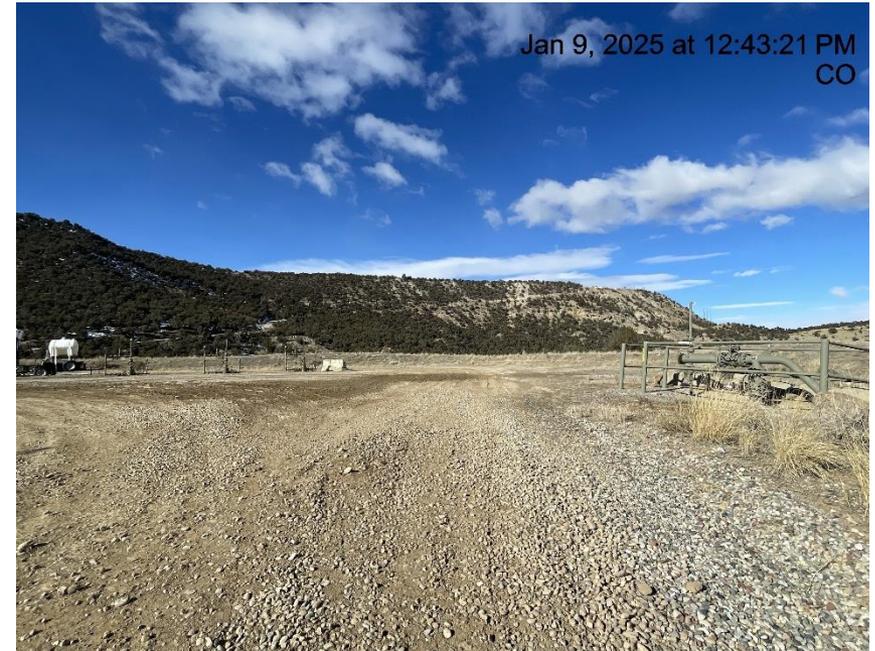
**Photo # 7678 From entrance to location**

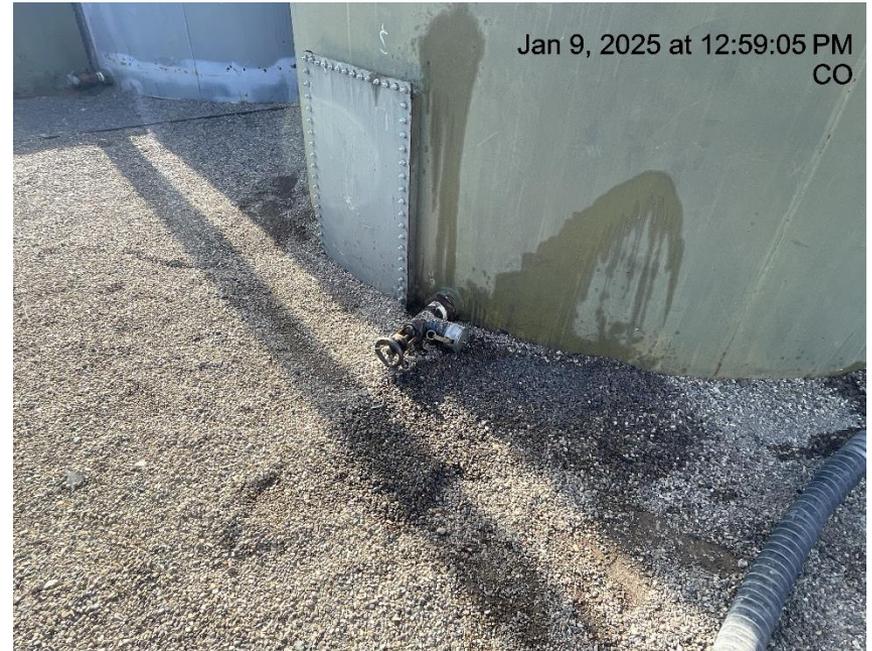
**Photo # 7692 Staining in secondary containment**

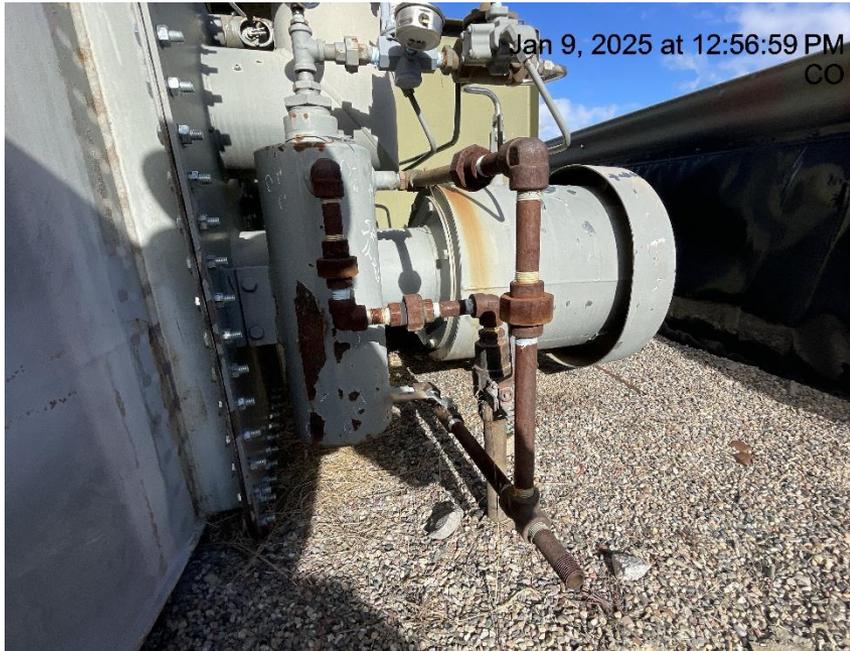
**Photo # 7693 PRV vent line does not comply with CECMC  
pressure safety device rules**
