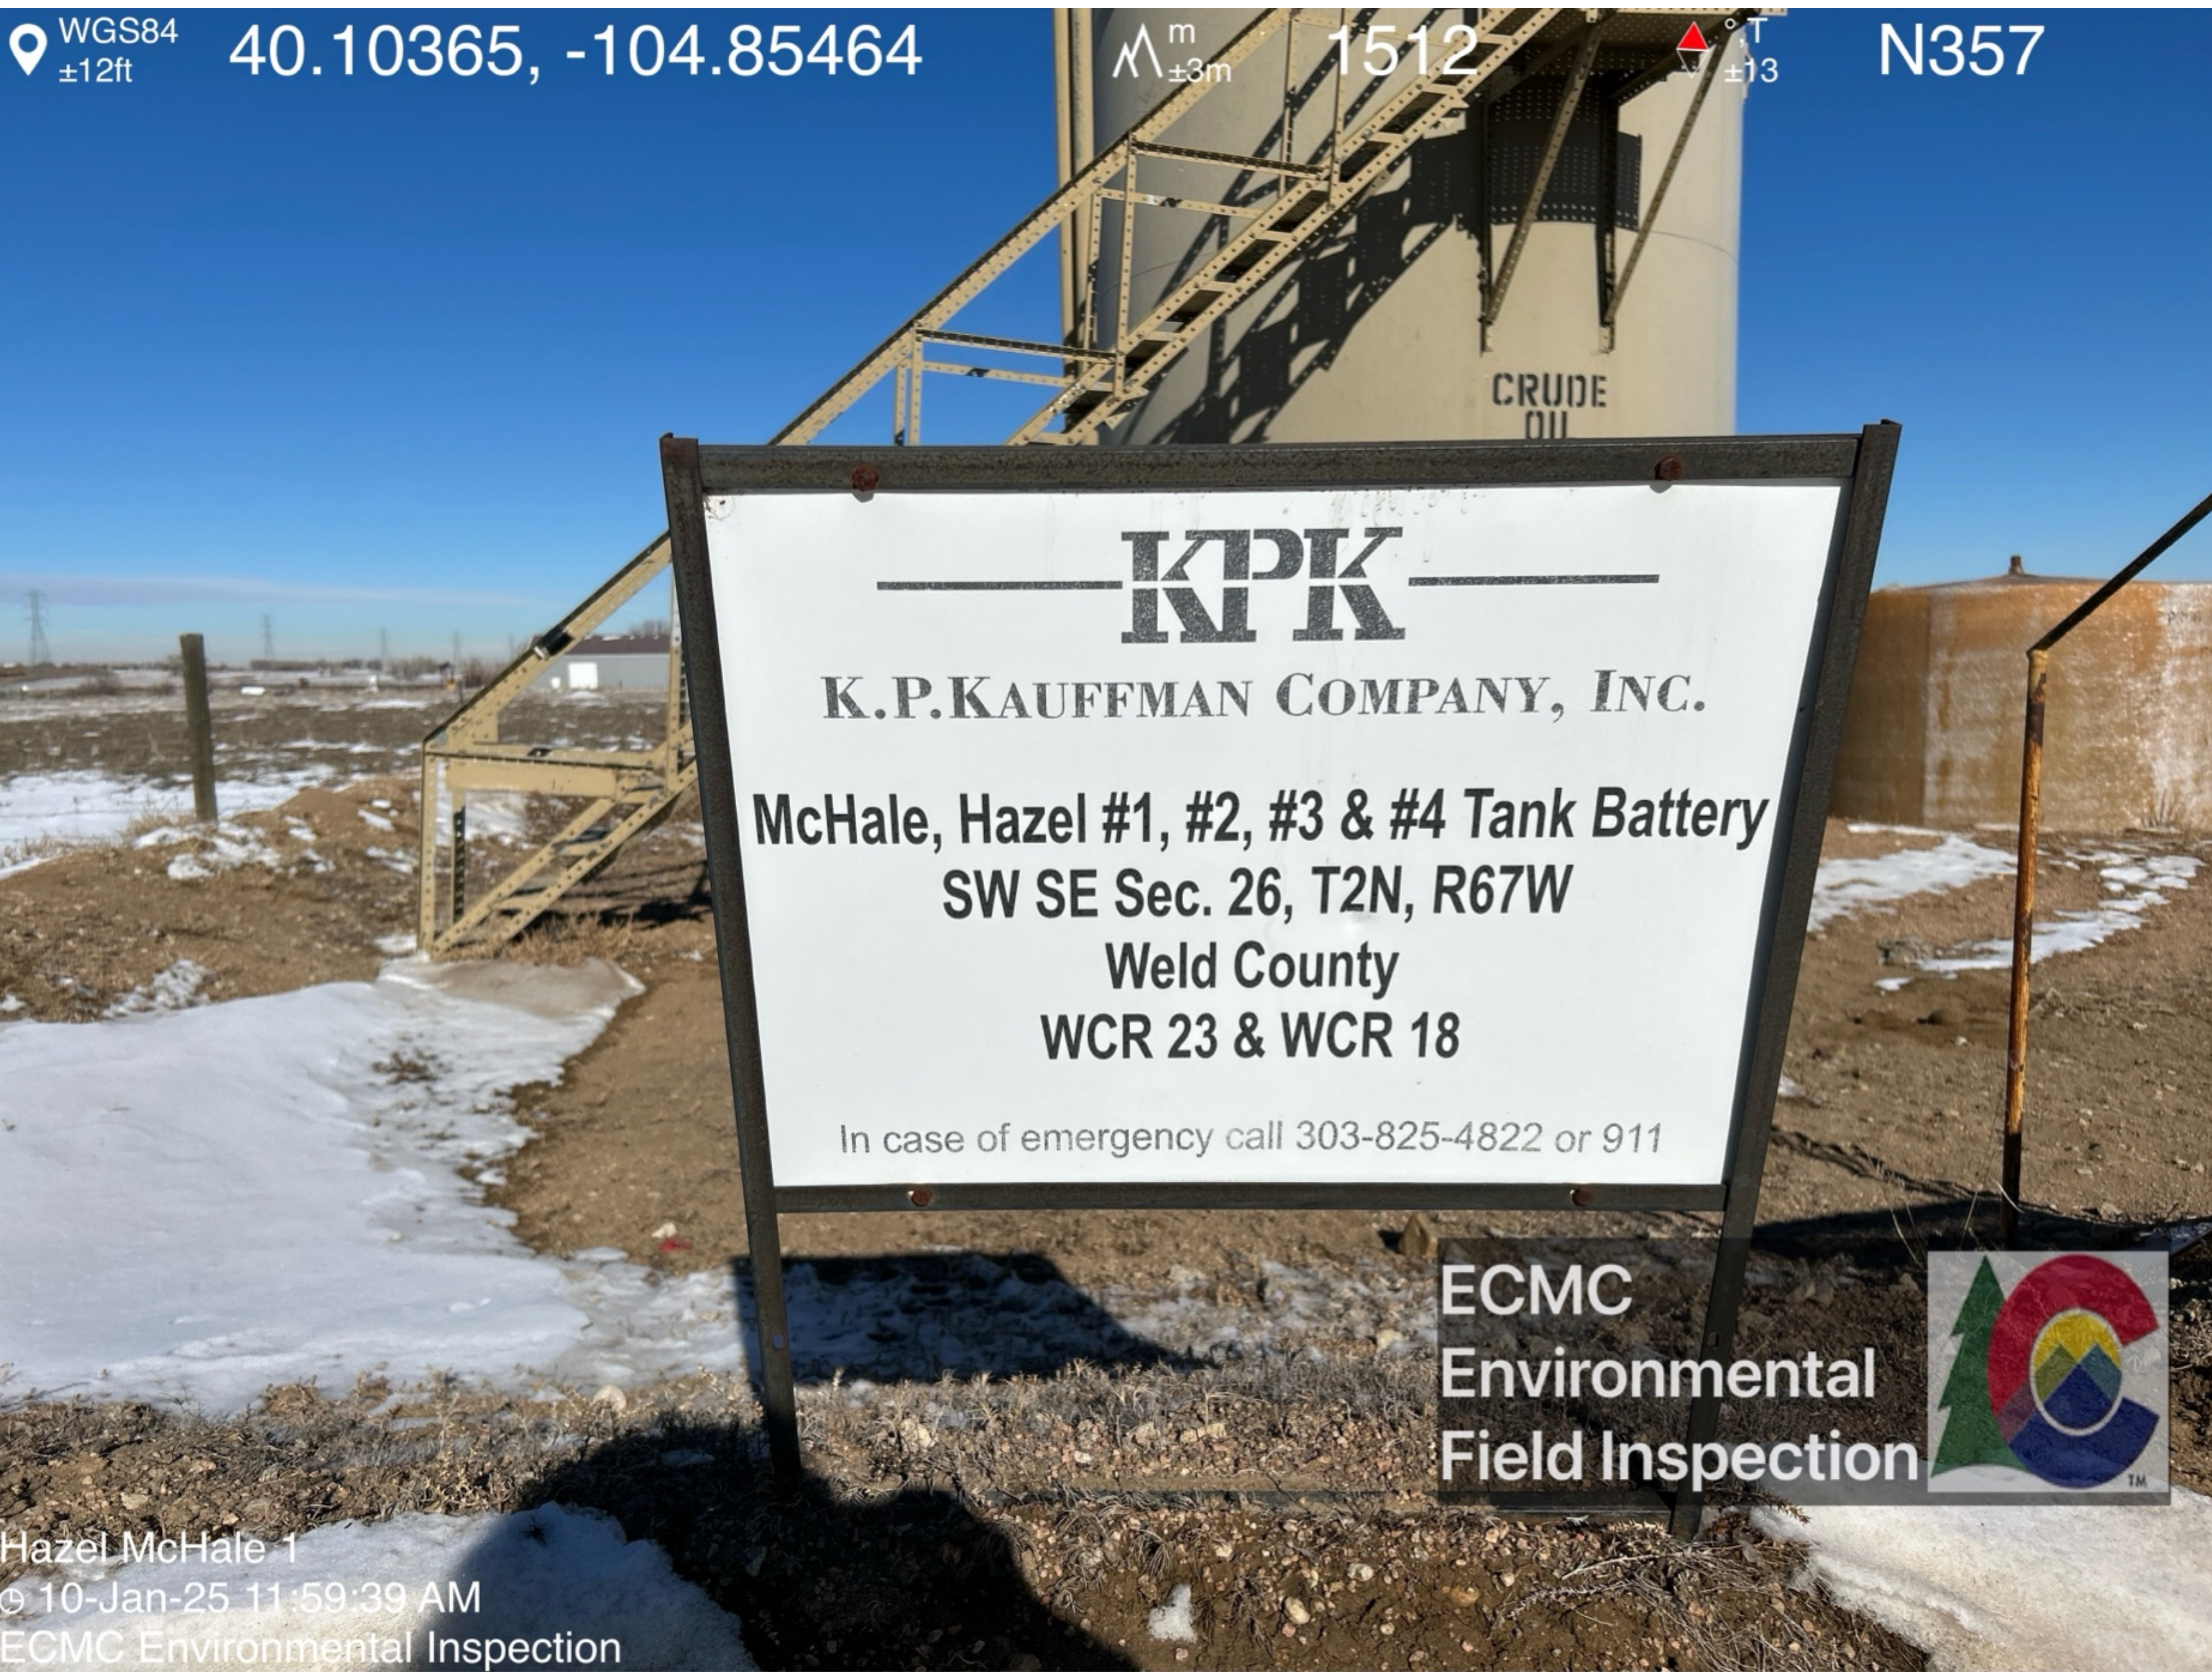
Signage condition is adequate. However, Operator has previously directed ECMC staff to call (303) 833-5670 instead to report emergencies.

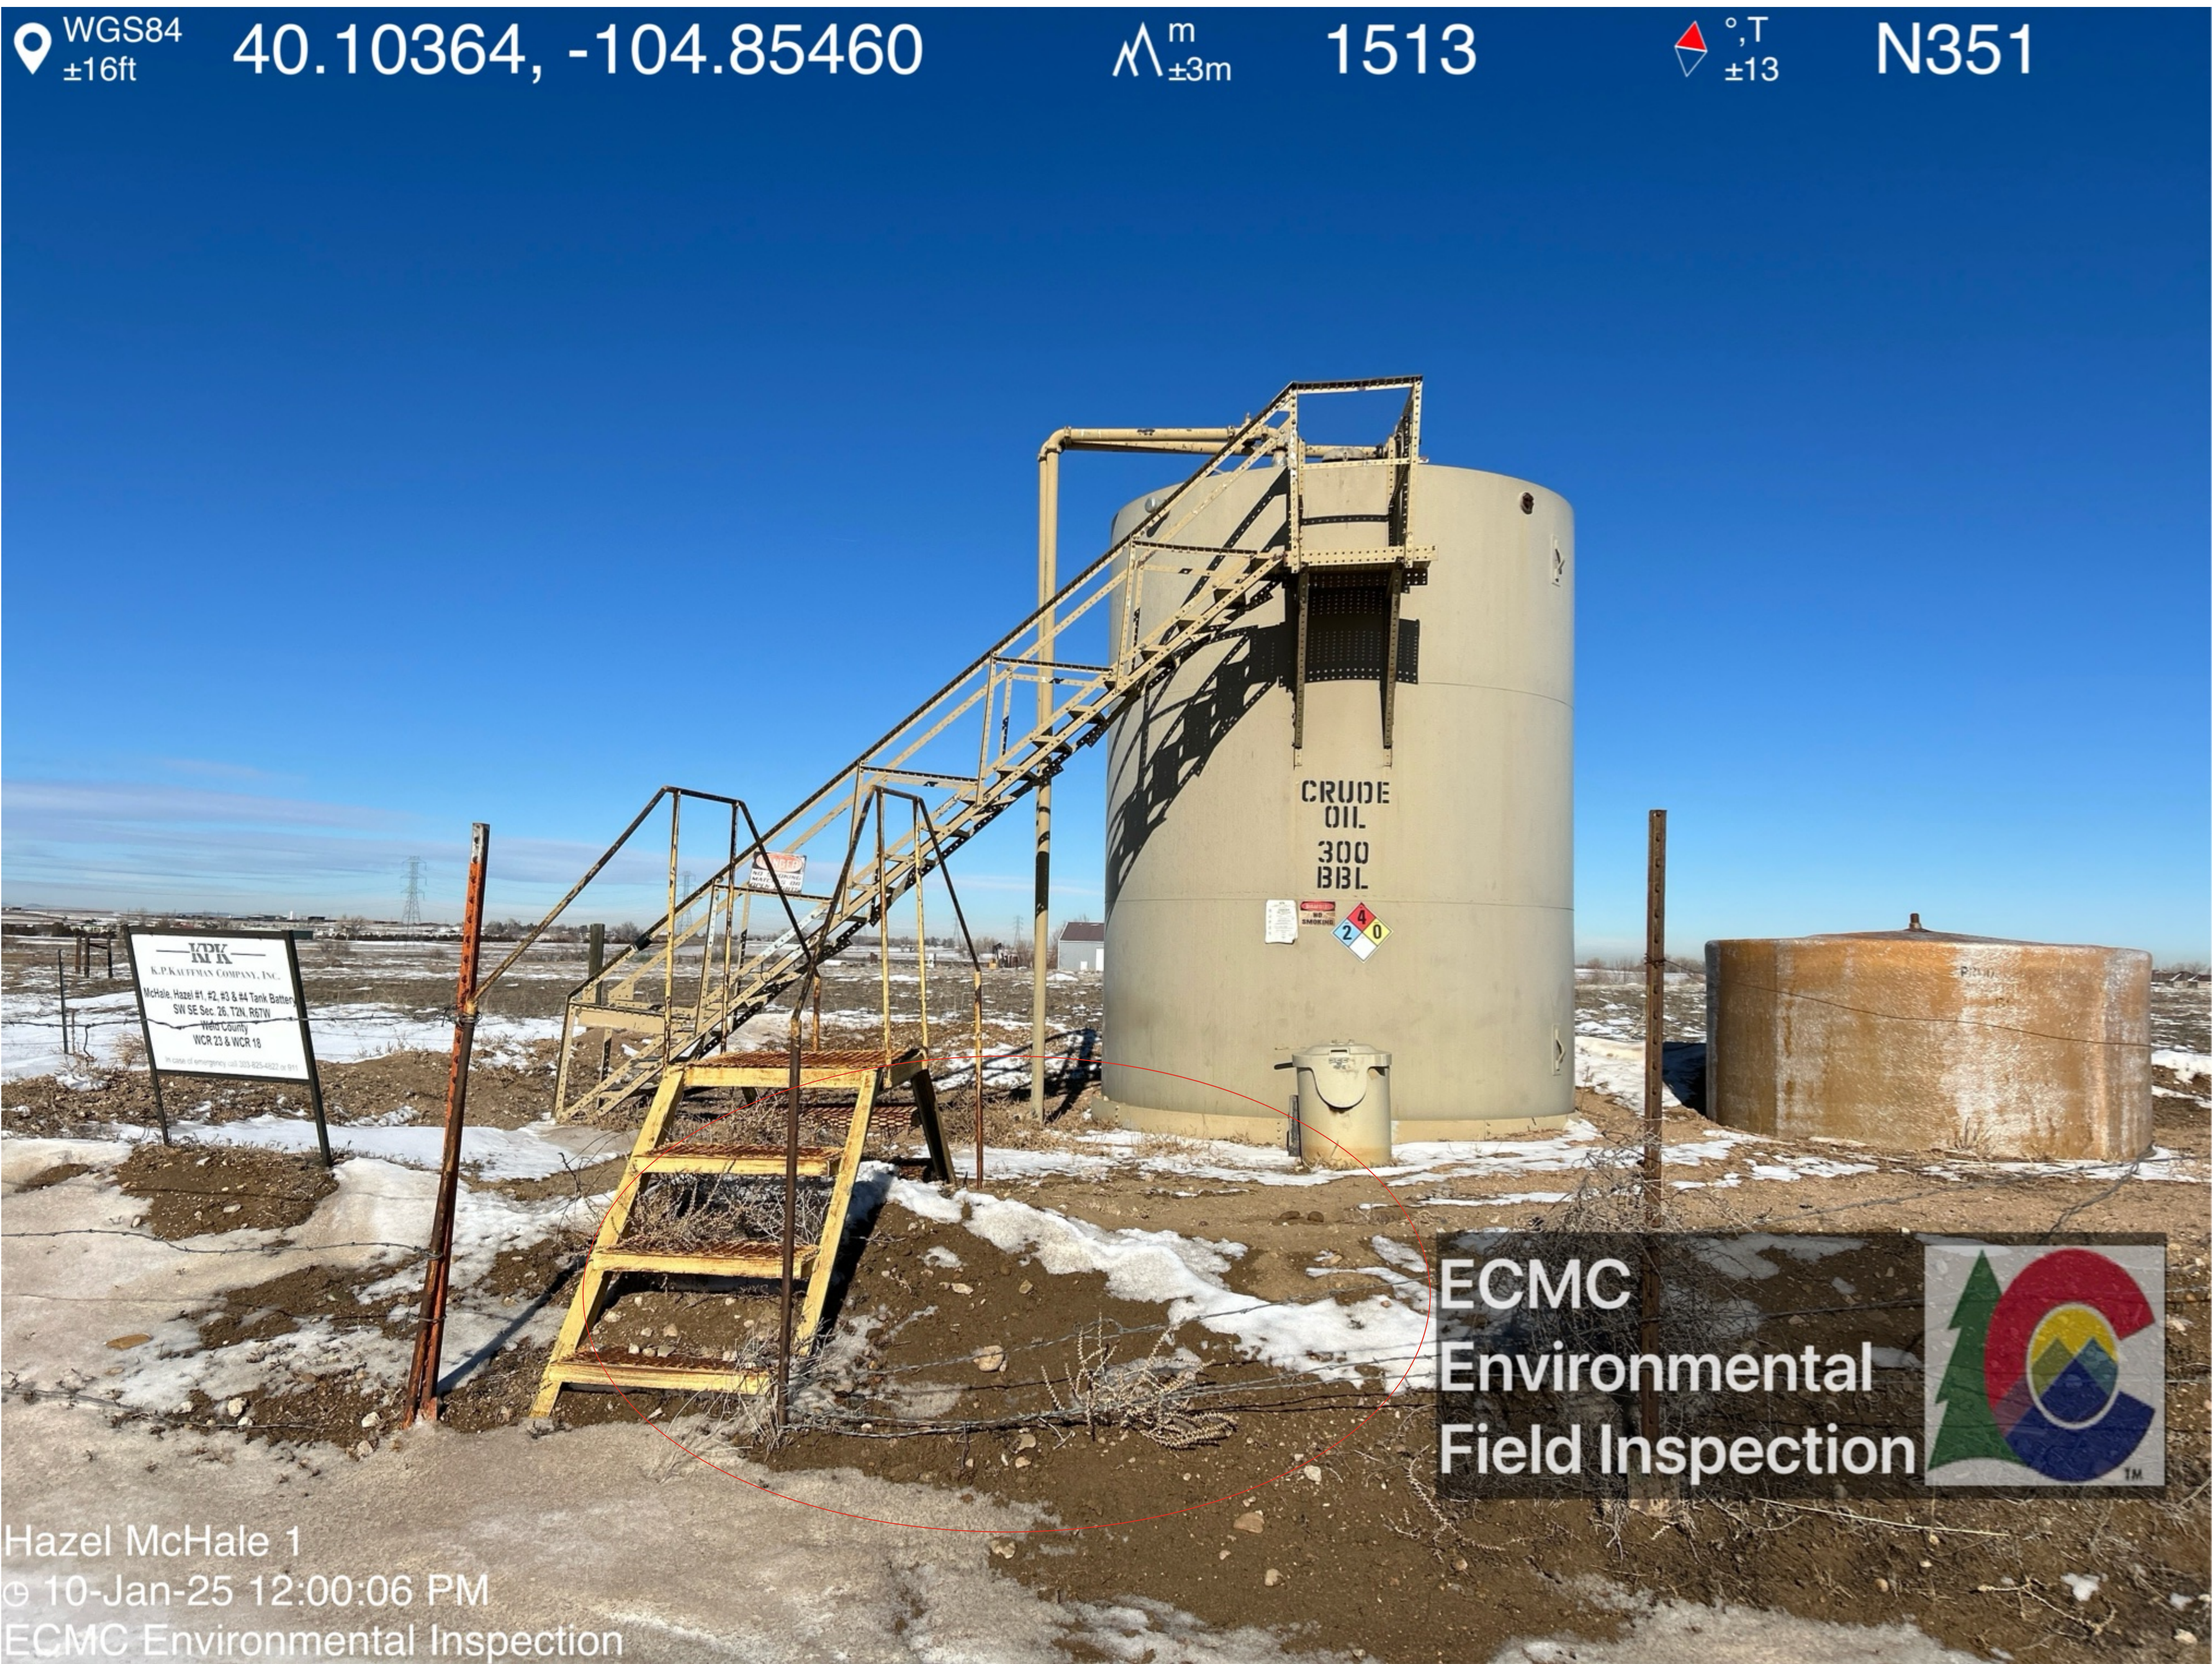
Fencing surrounding tank containment, ancillary equipment, separator, and spill area observed open and in poor condition. Debris observed.

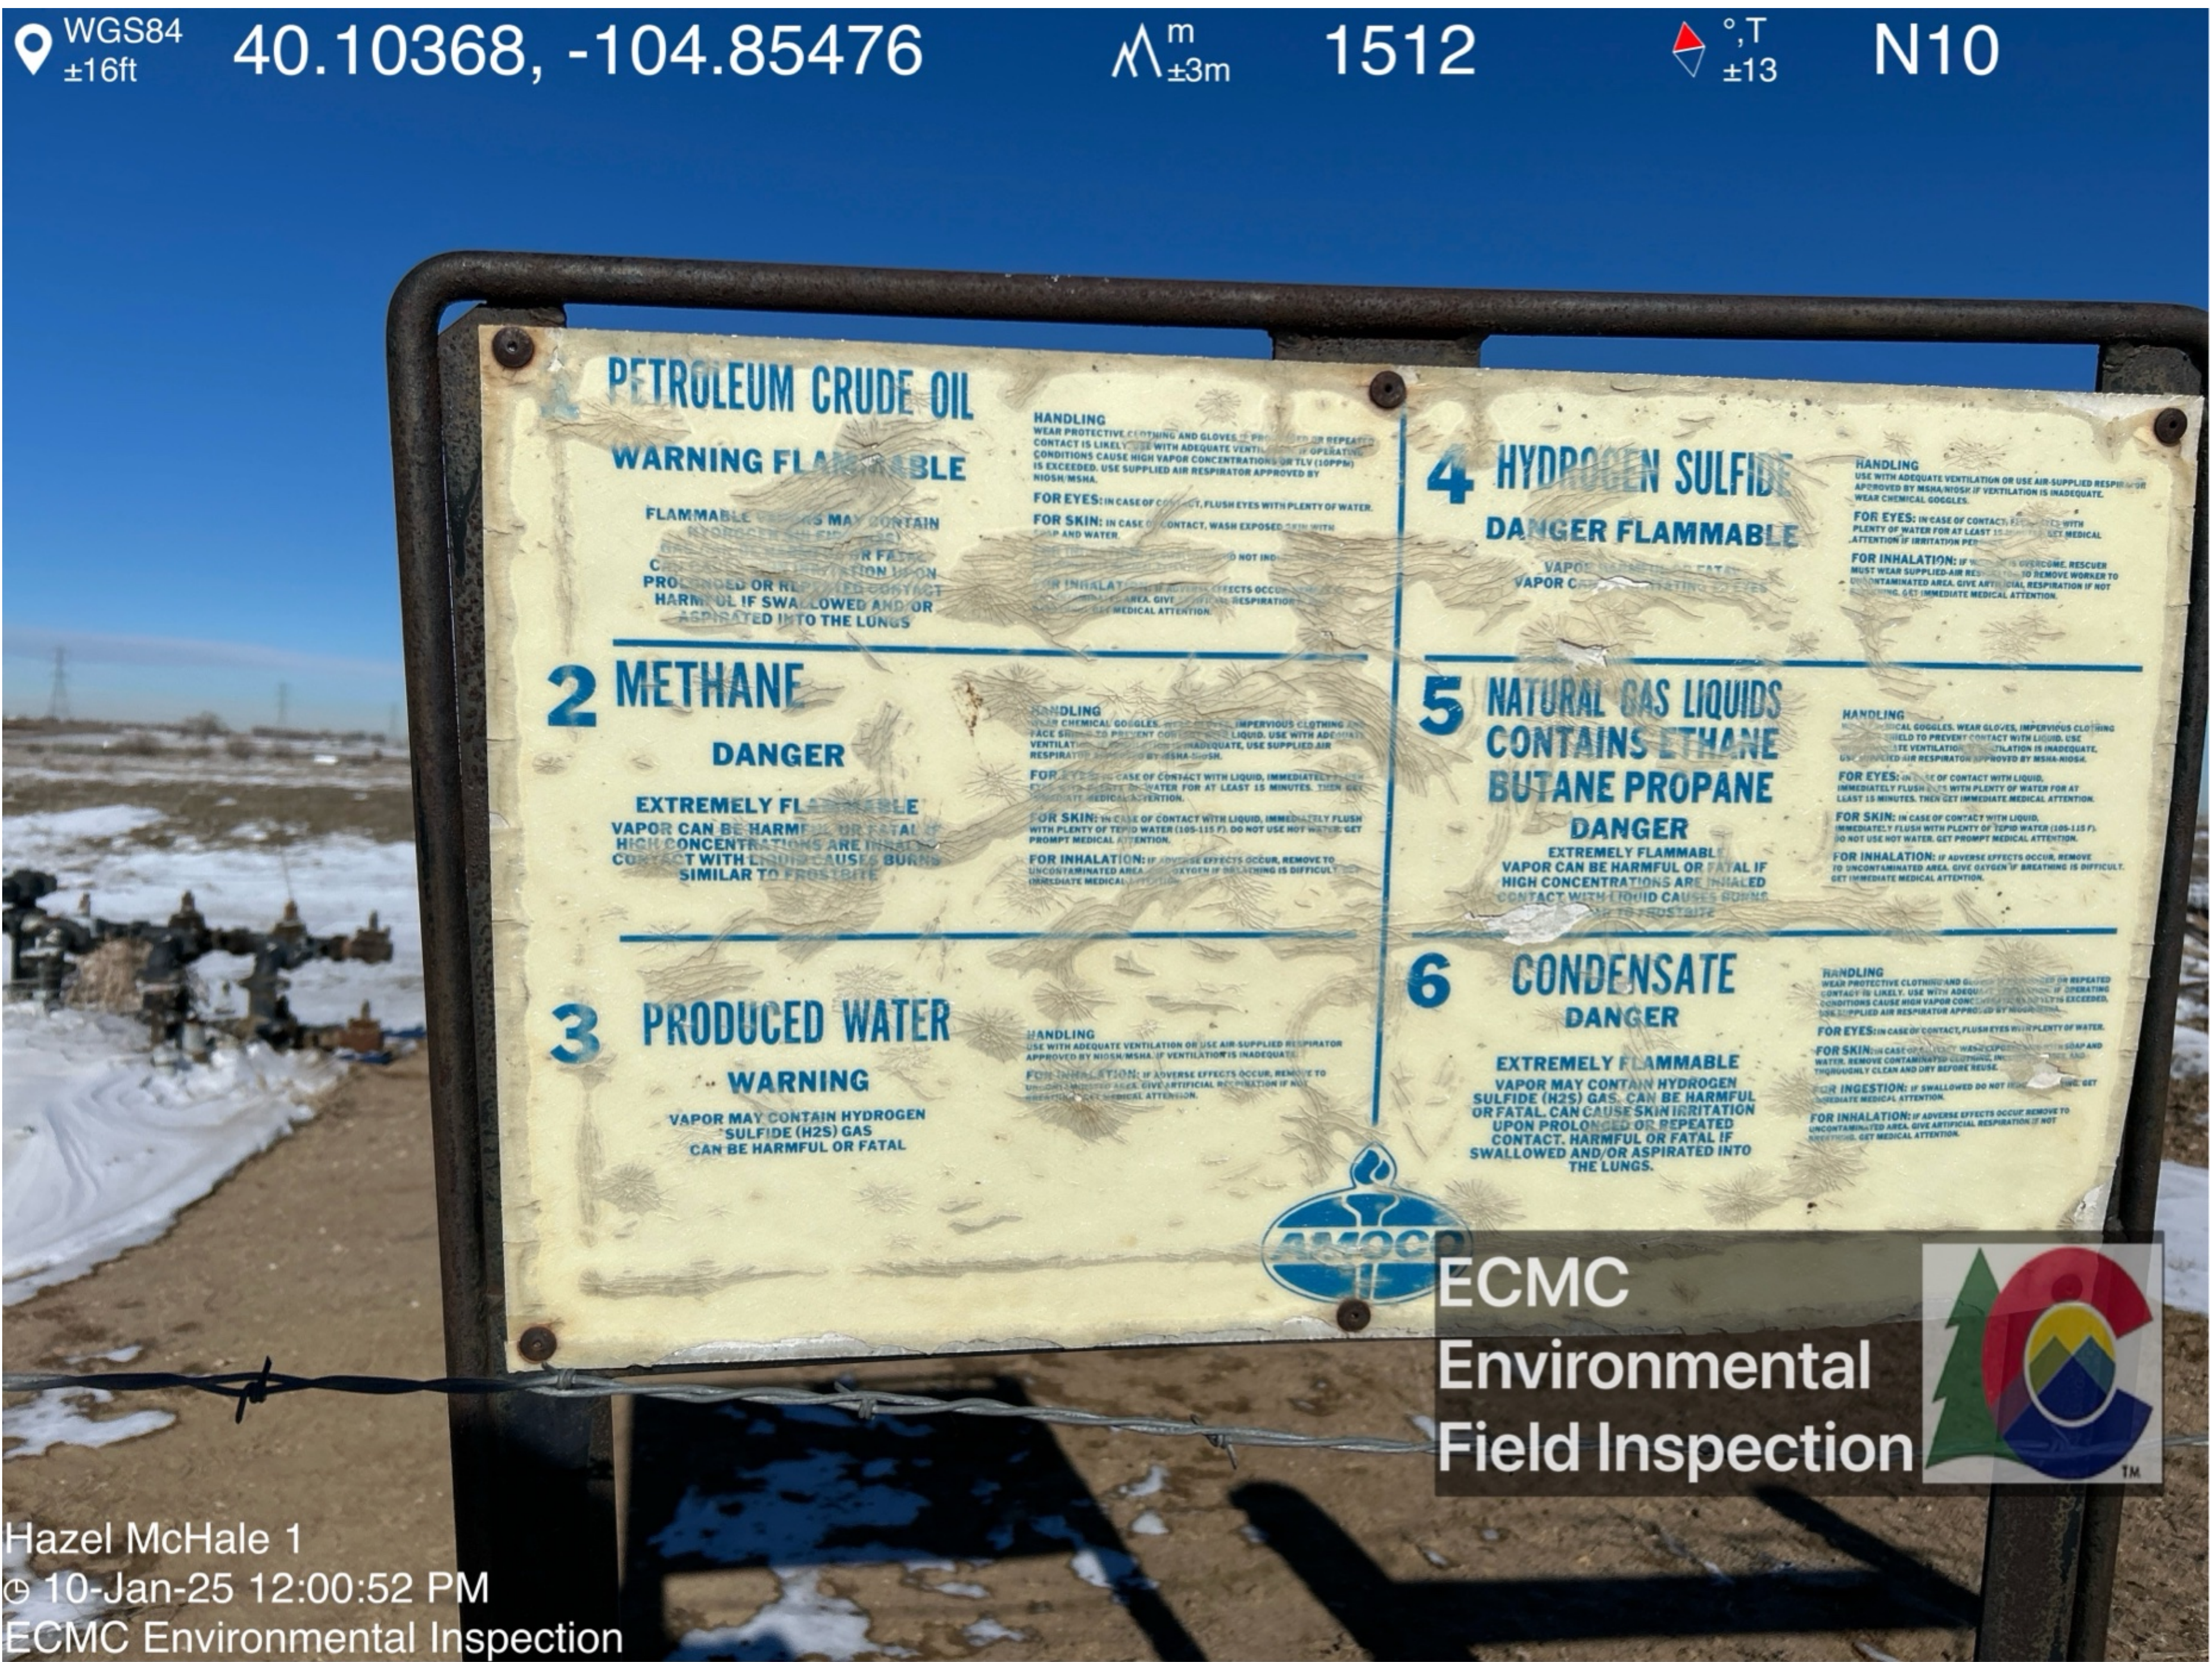
Sign illegible and references a different Operator.

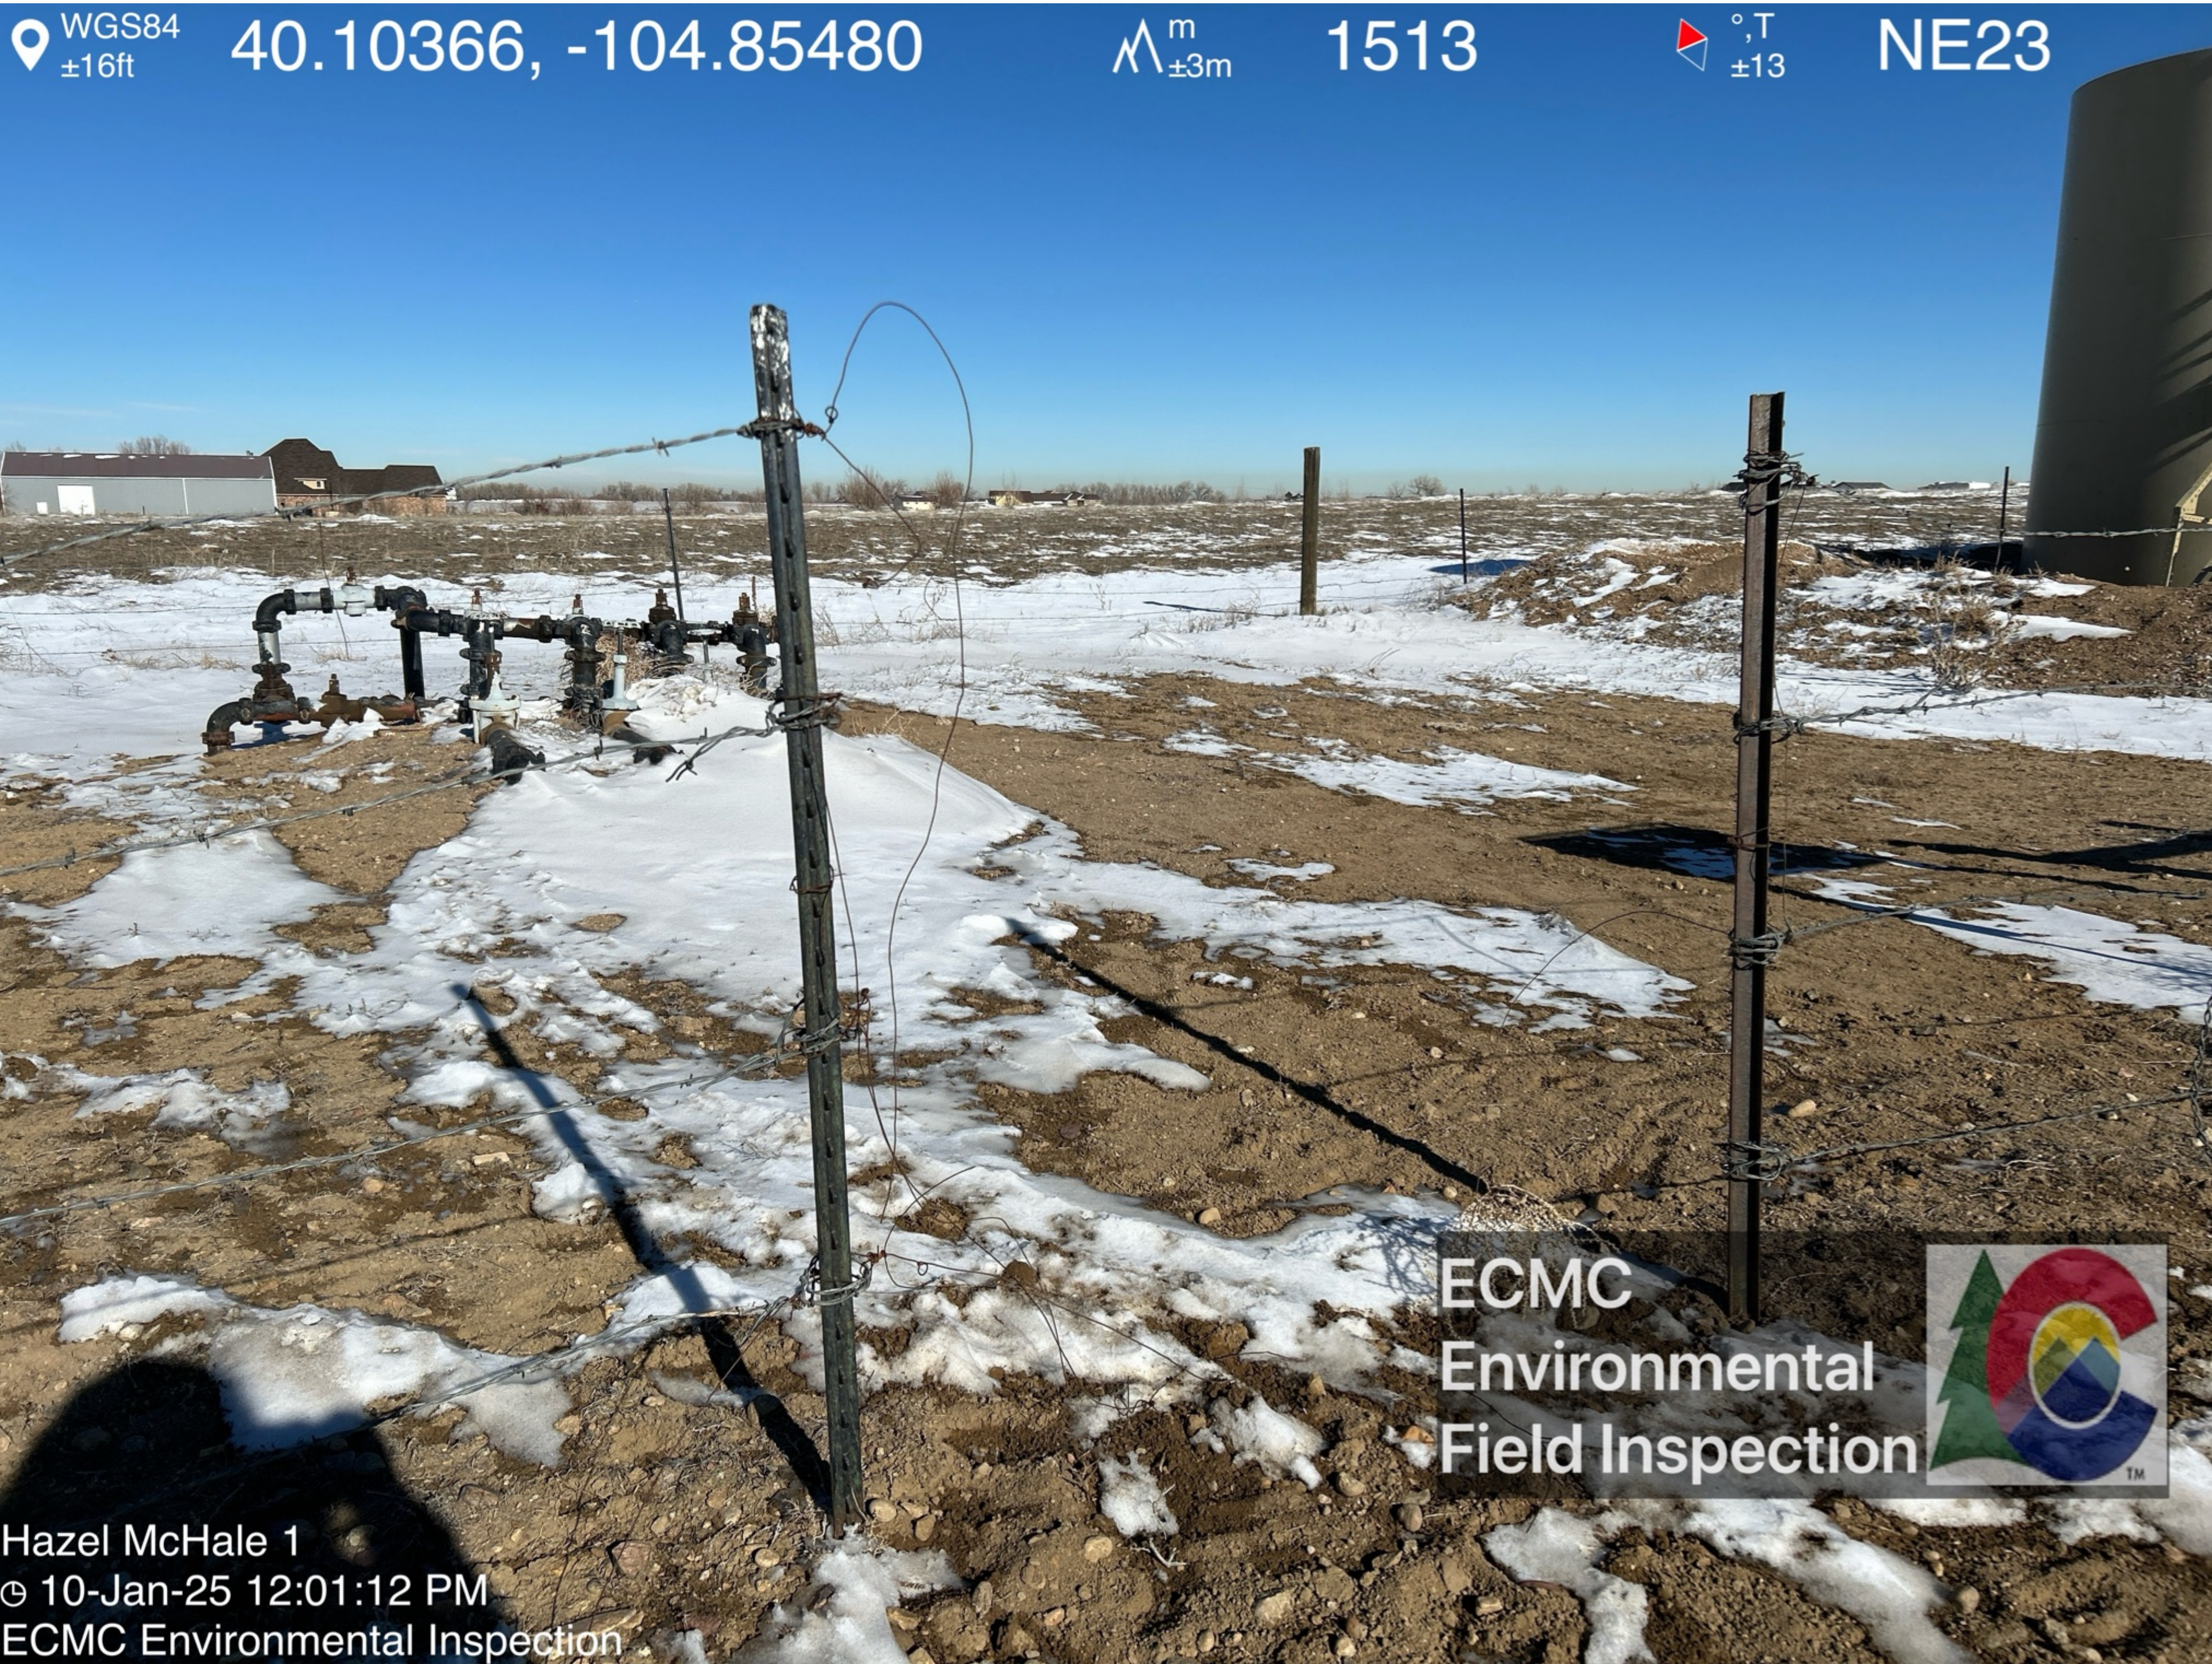
Fencing surrounding tank containment, ancillary equipment, separator, and spill area observed open and in poor condition.

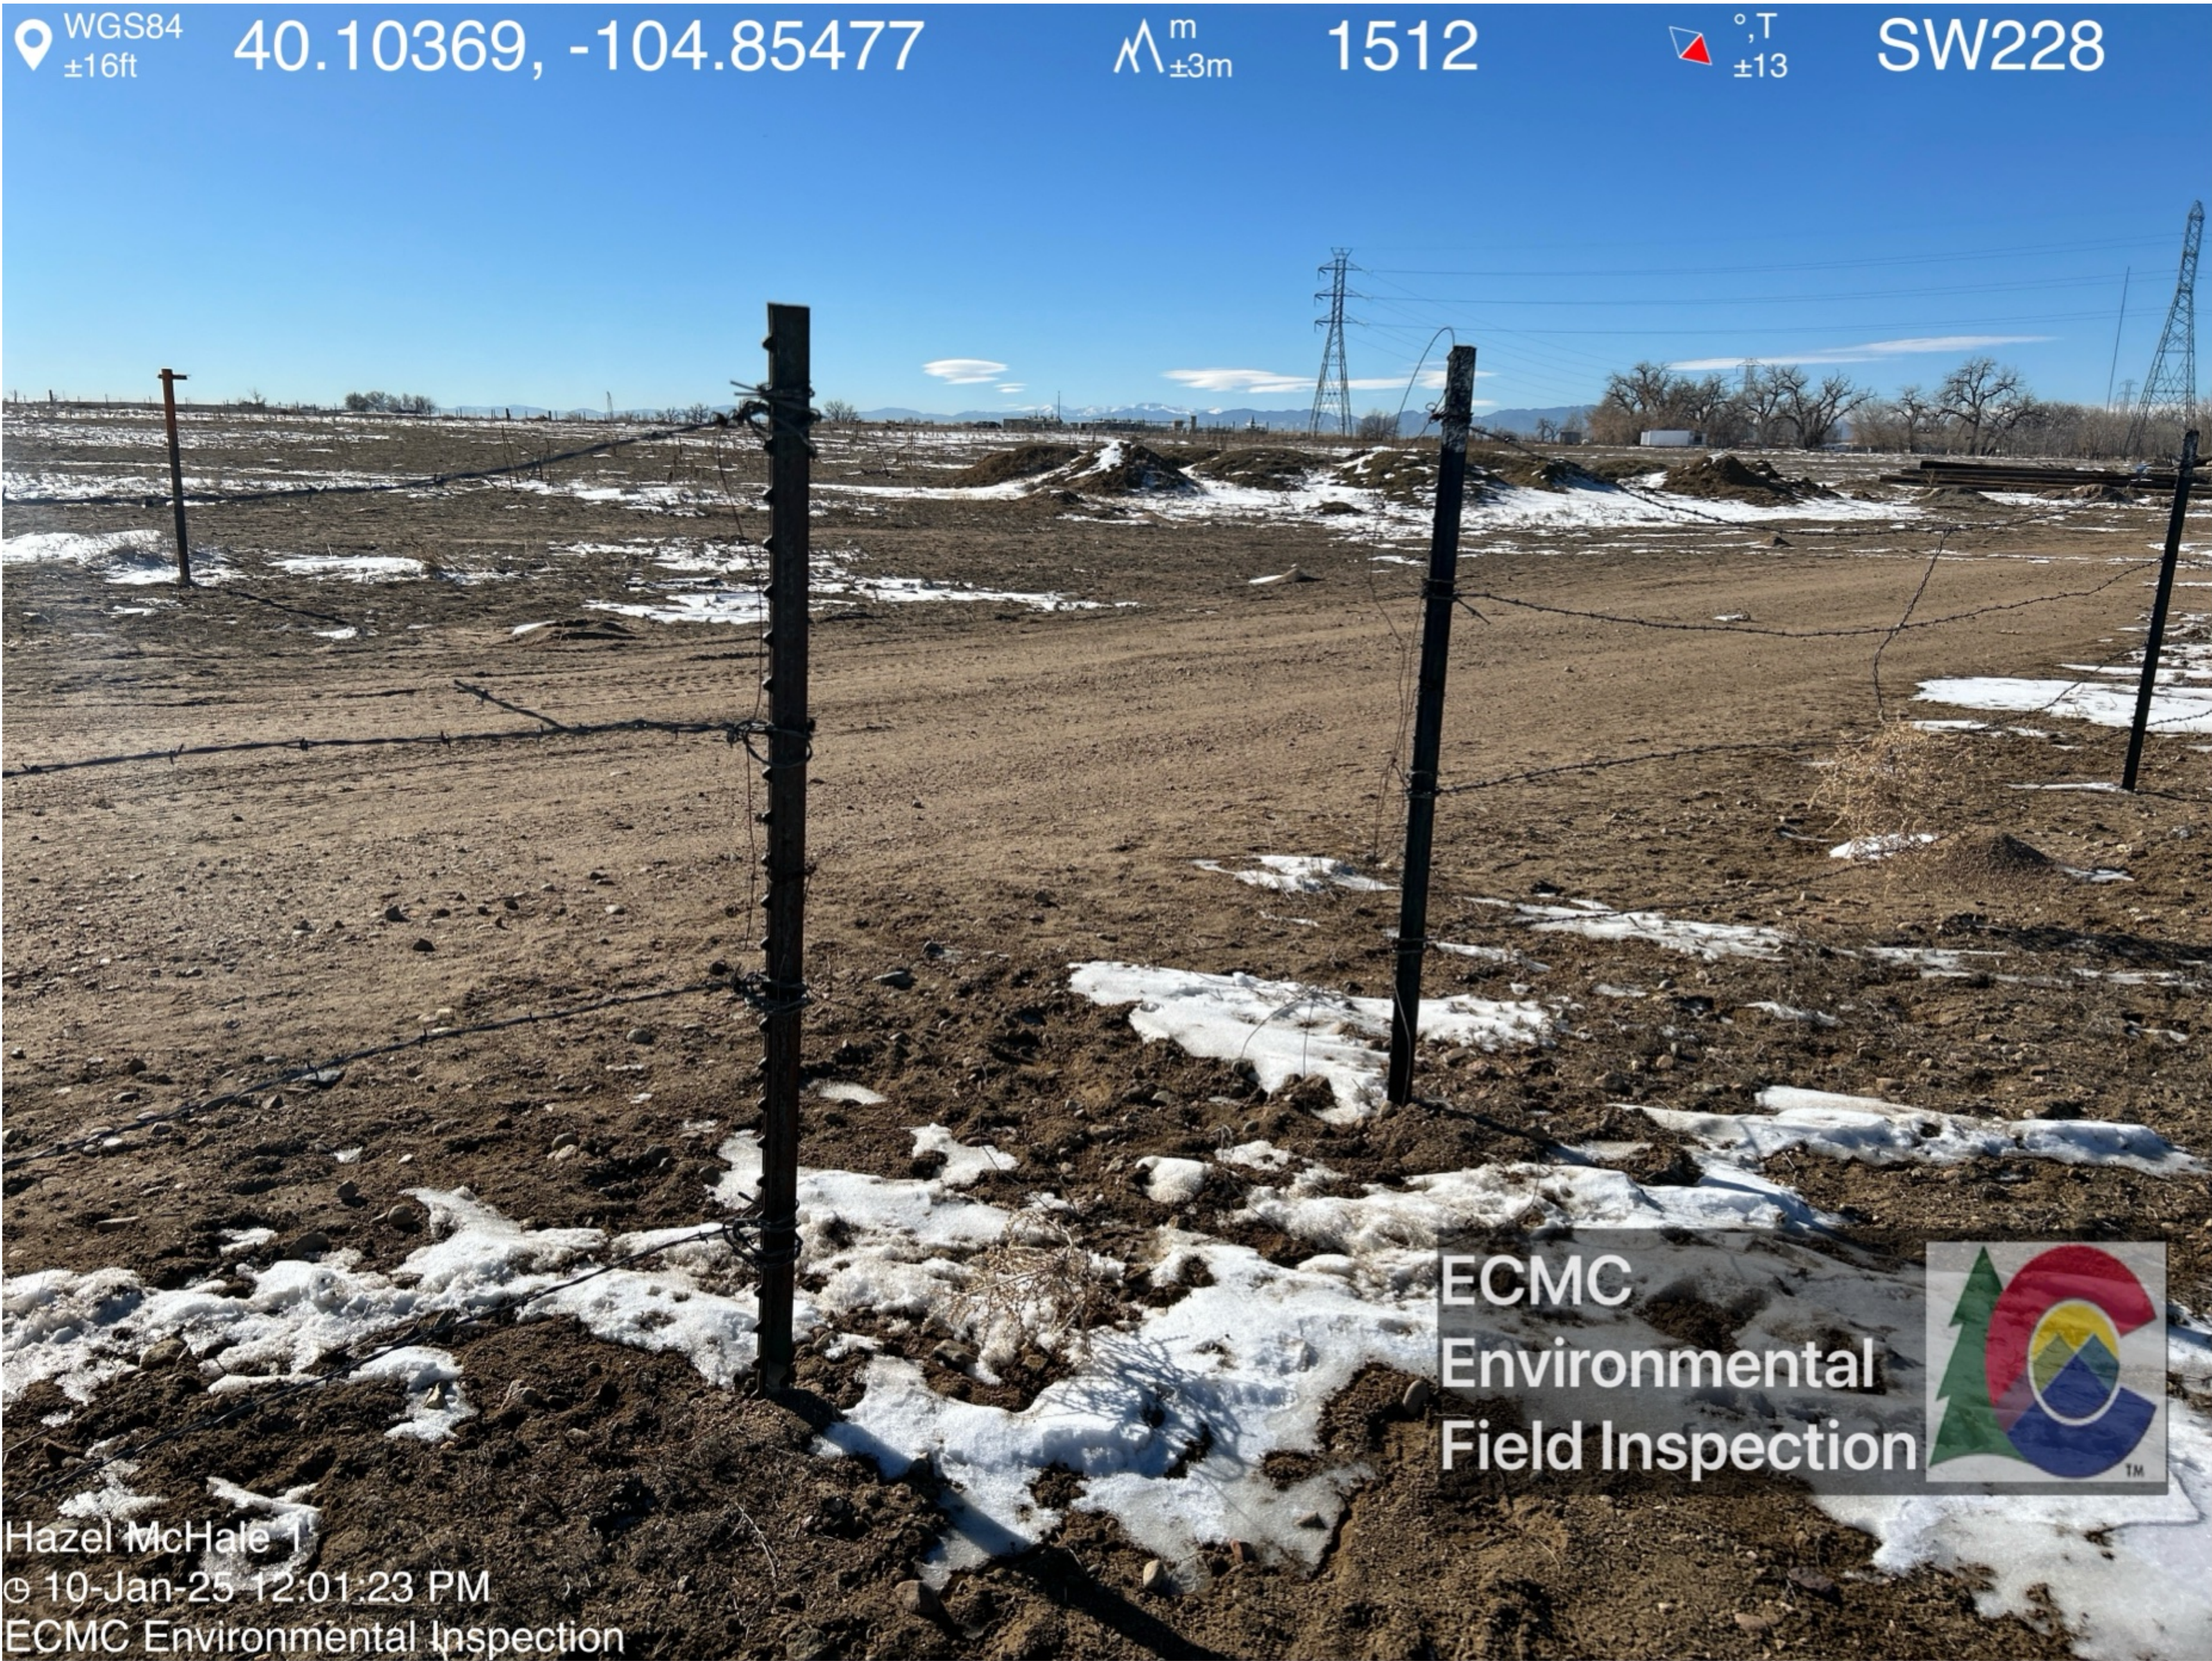
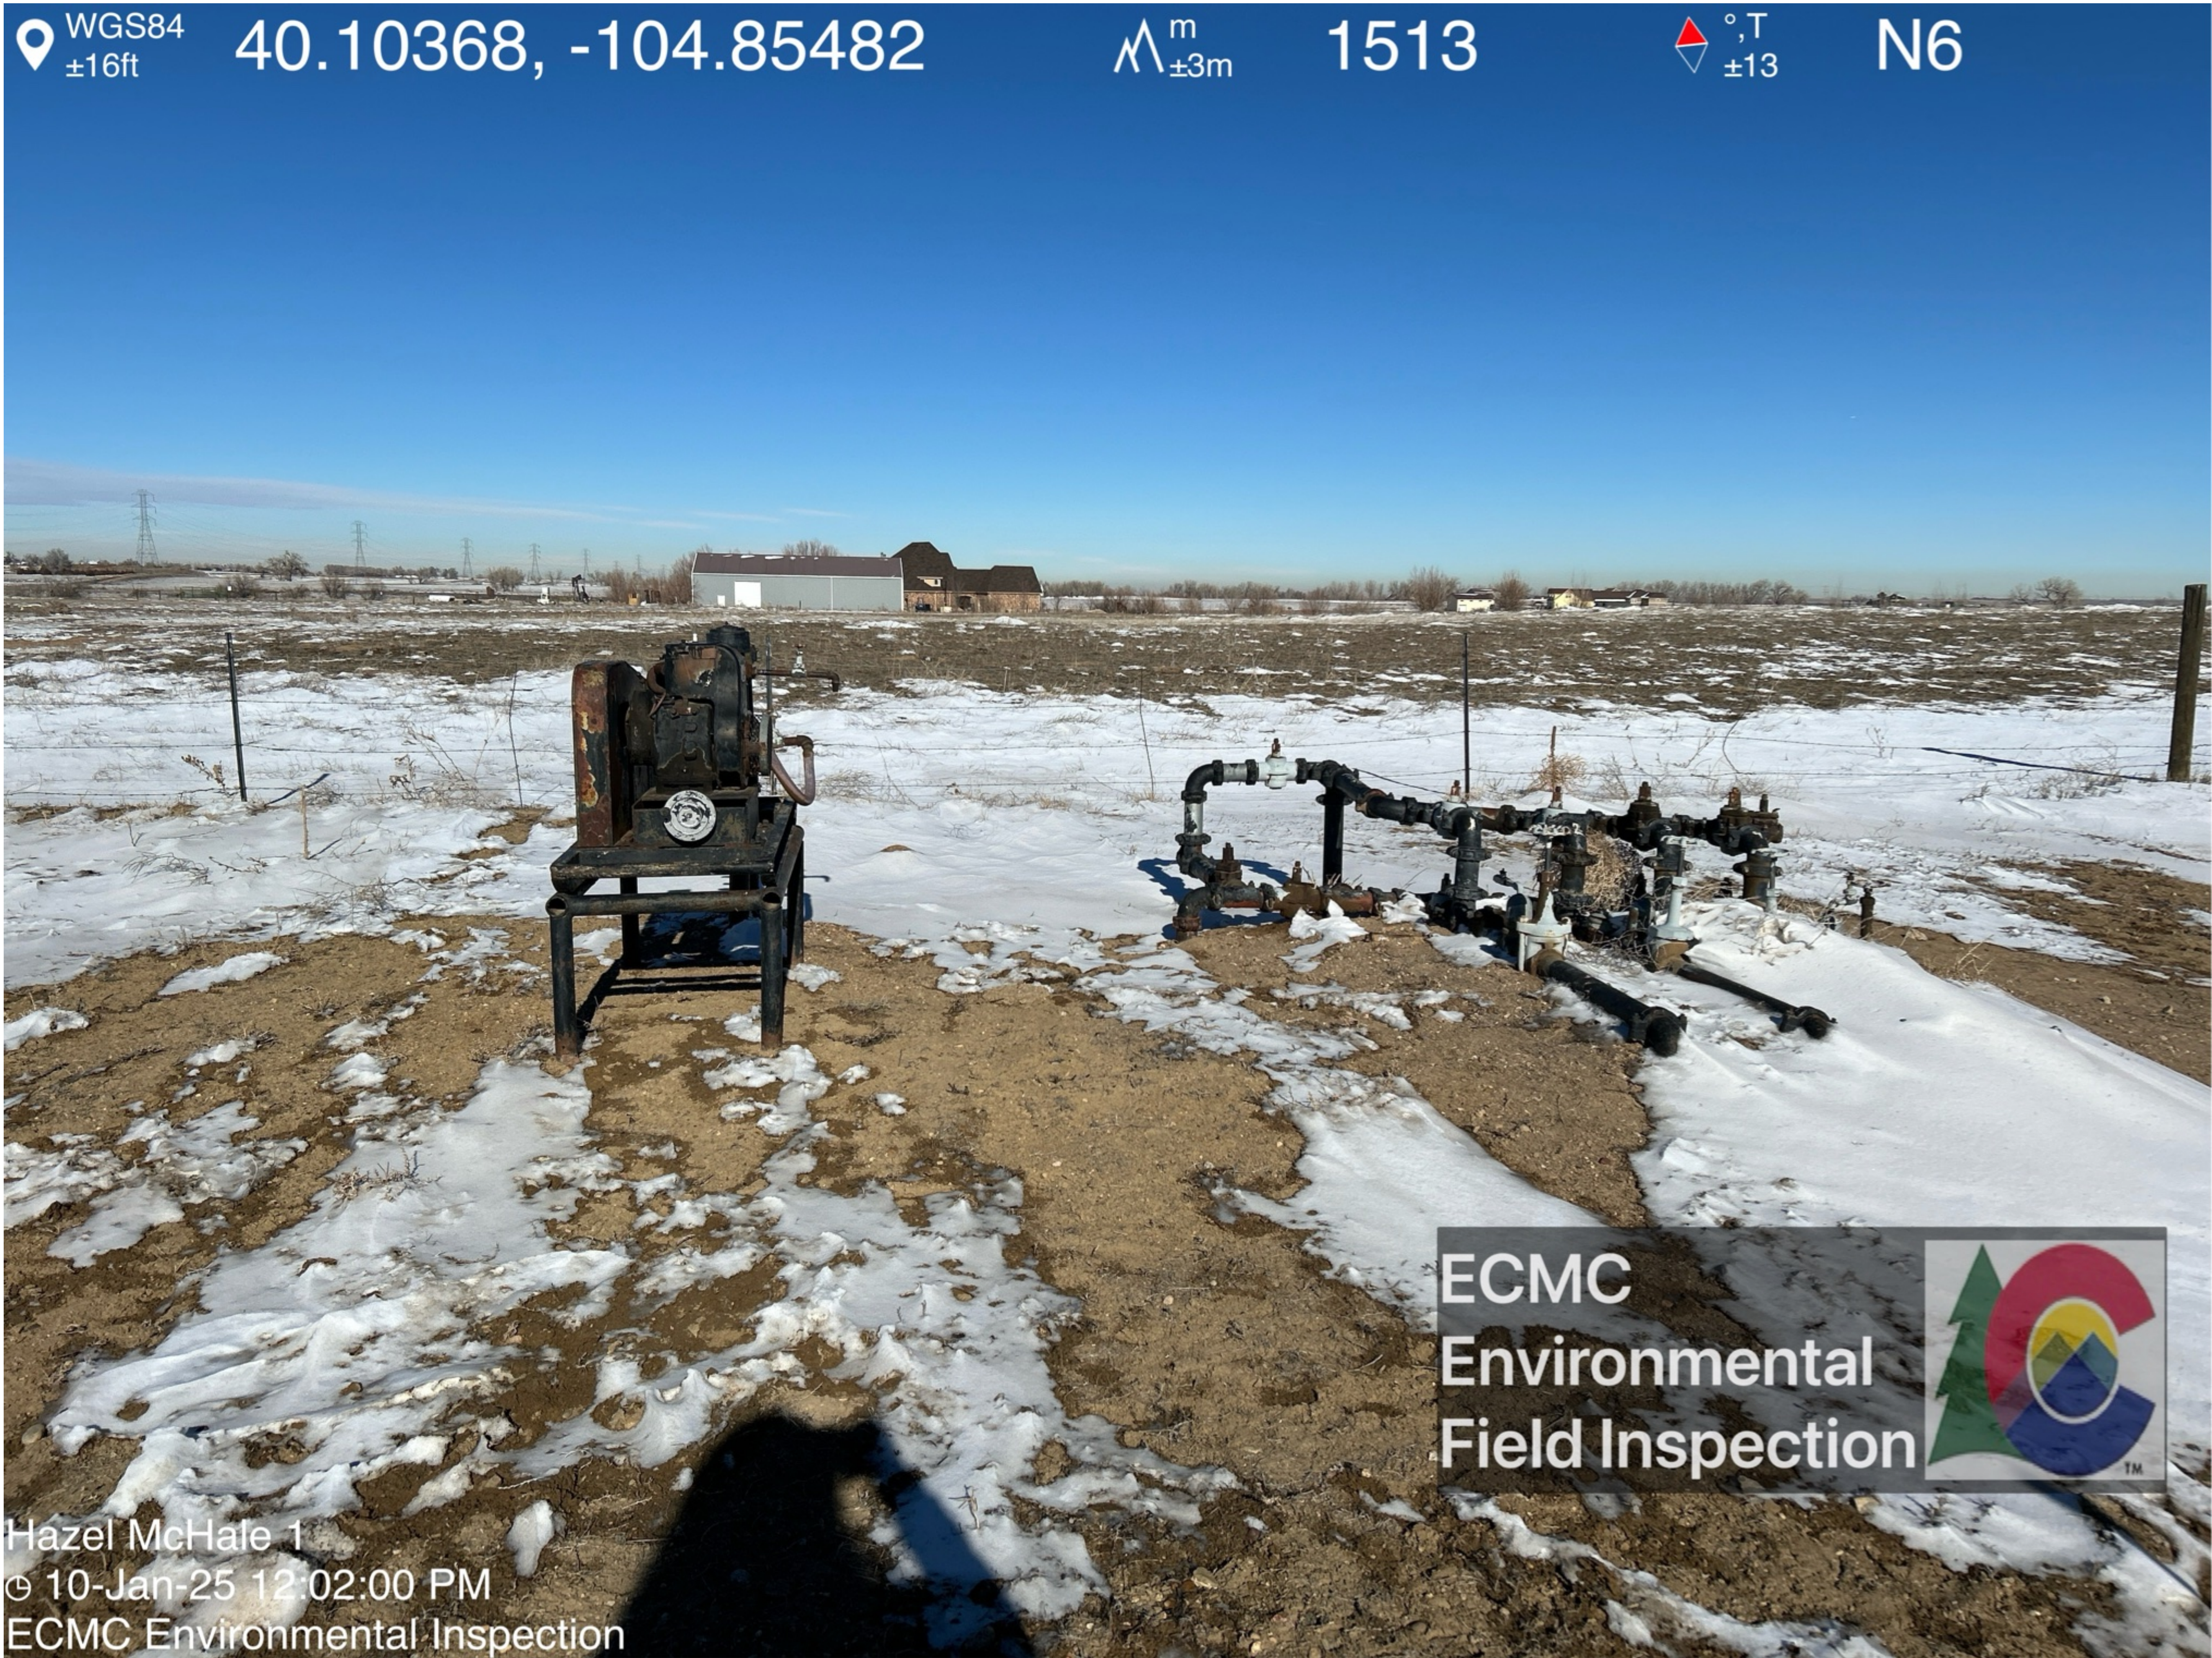
Fencing surrounding tank containment, ancillary equipment, separator, and spill area observed open and in poor condition.
