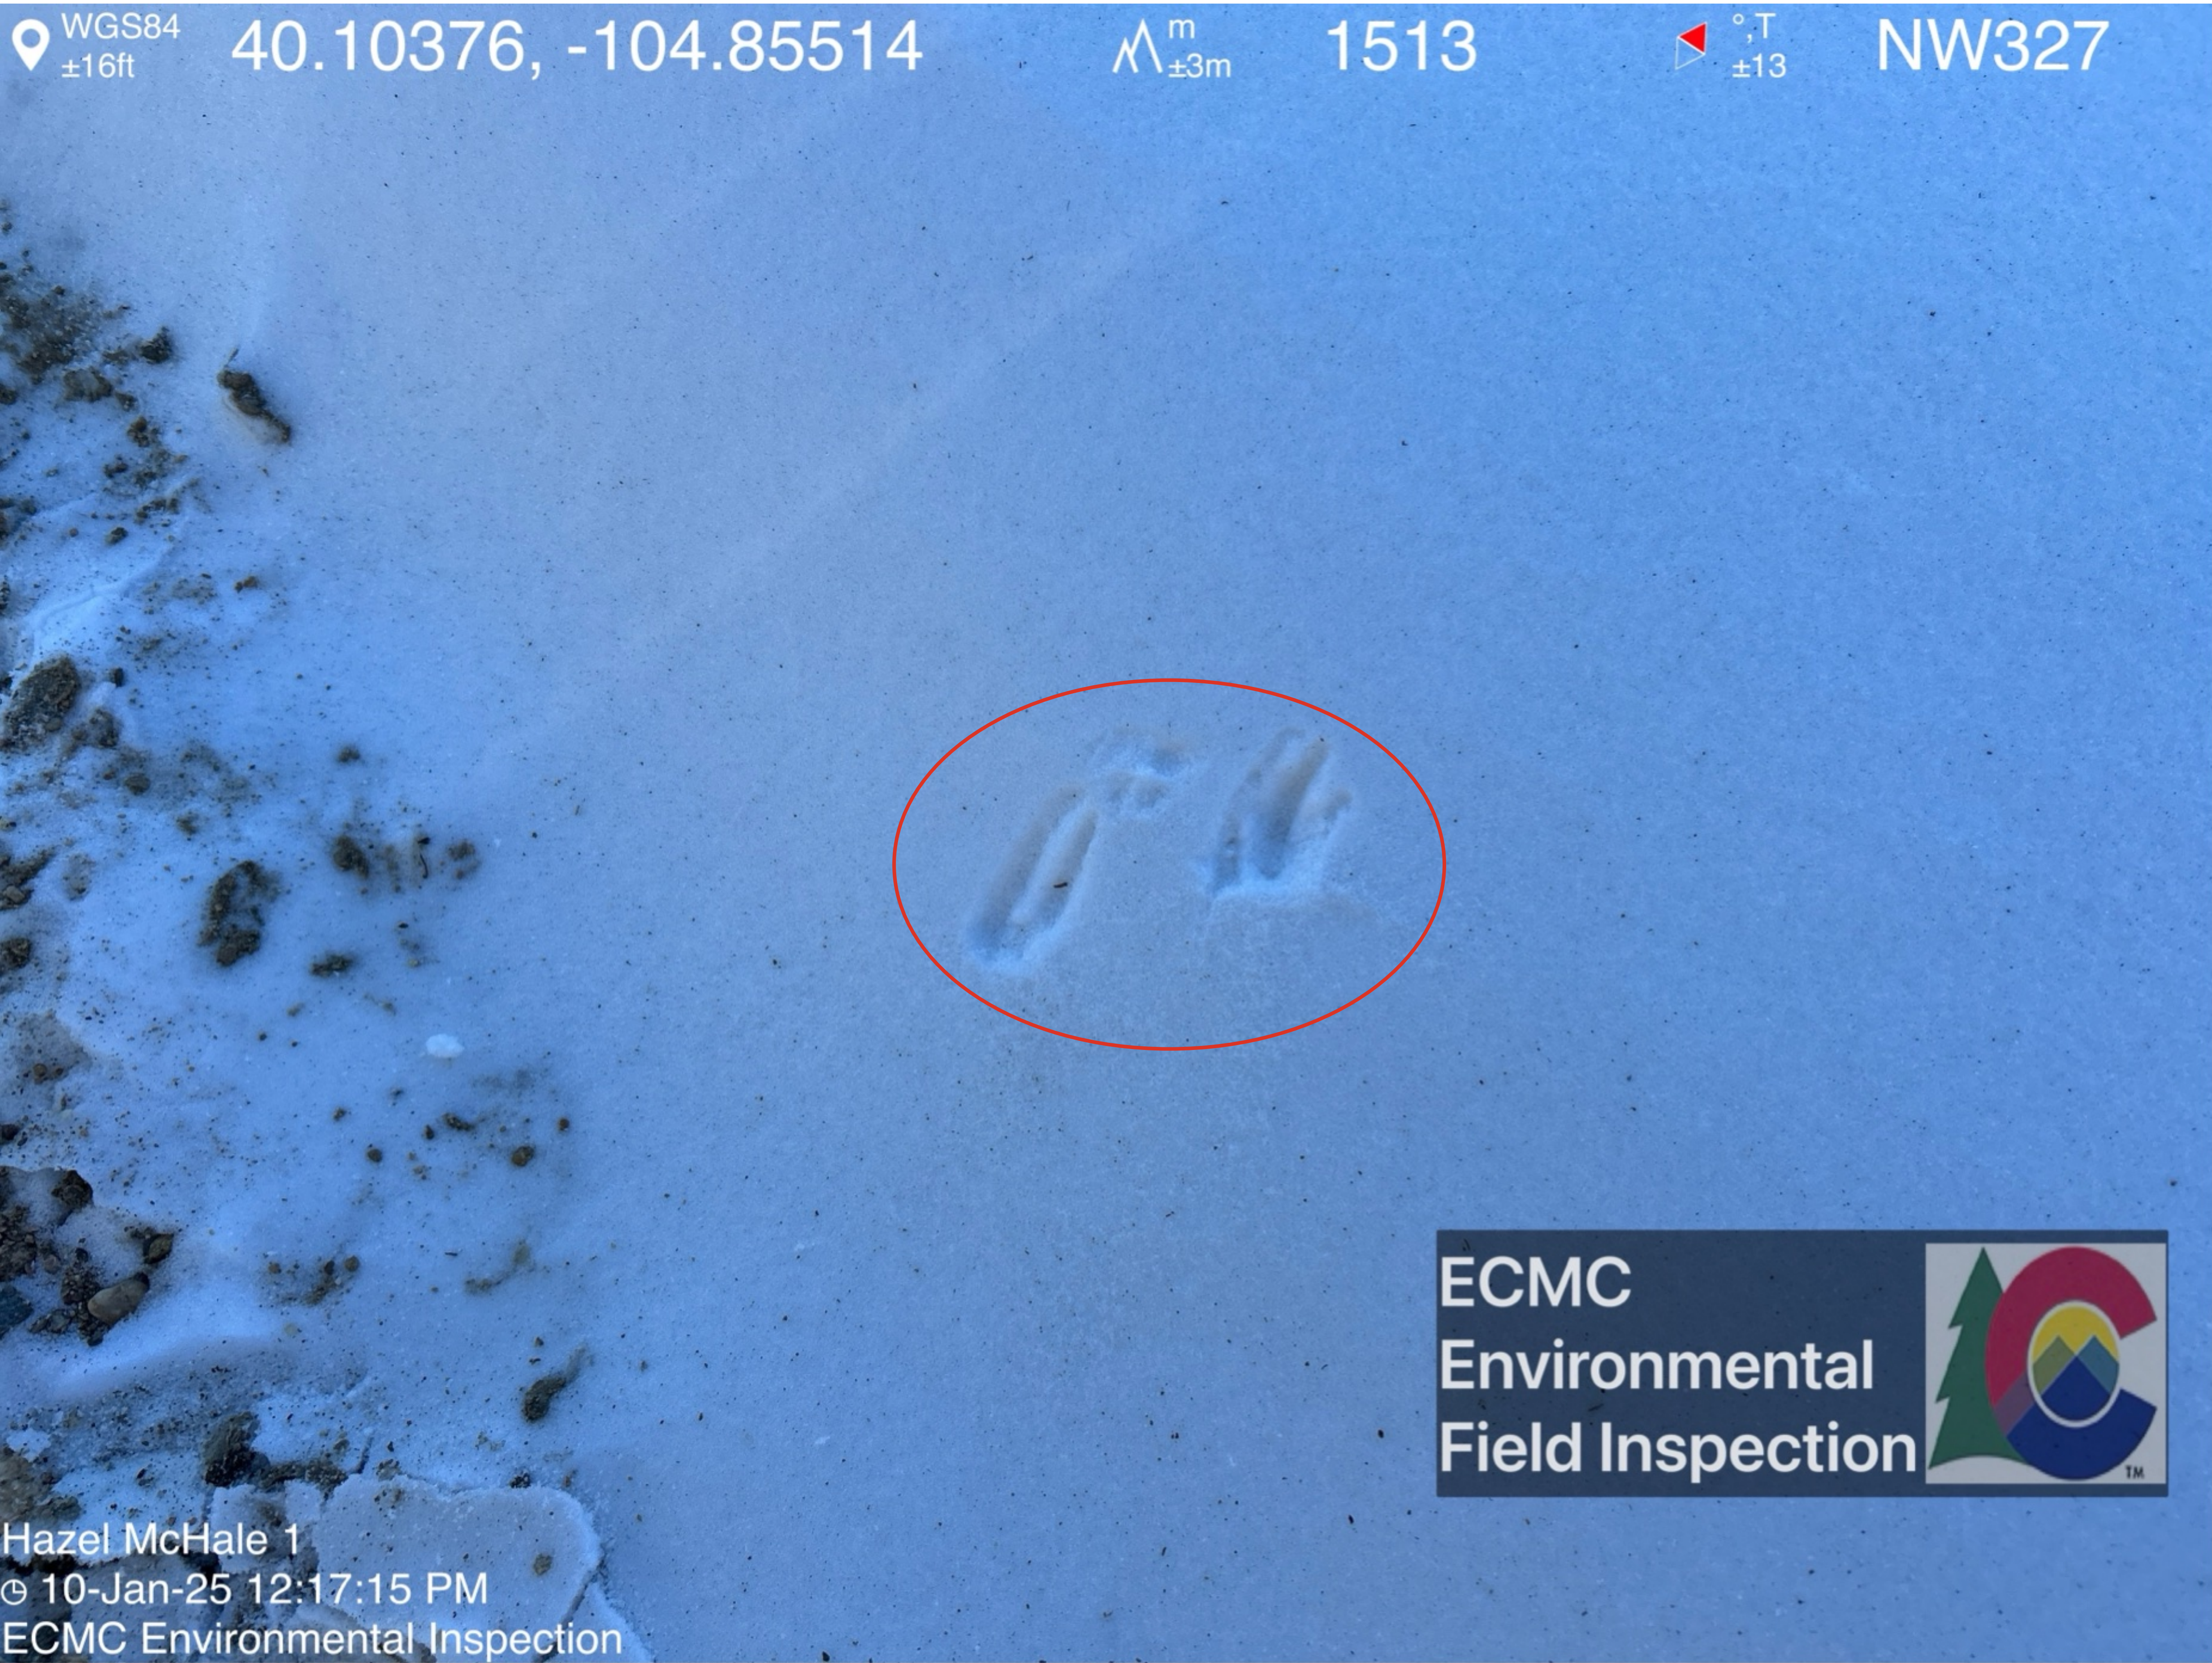
Wildlife tracks observed adjacent to spill location.

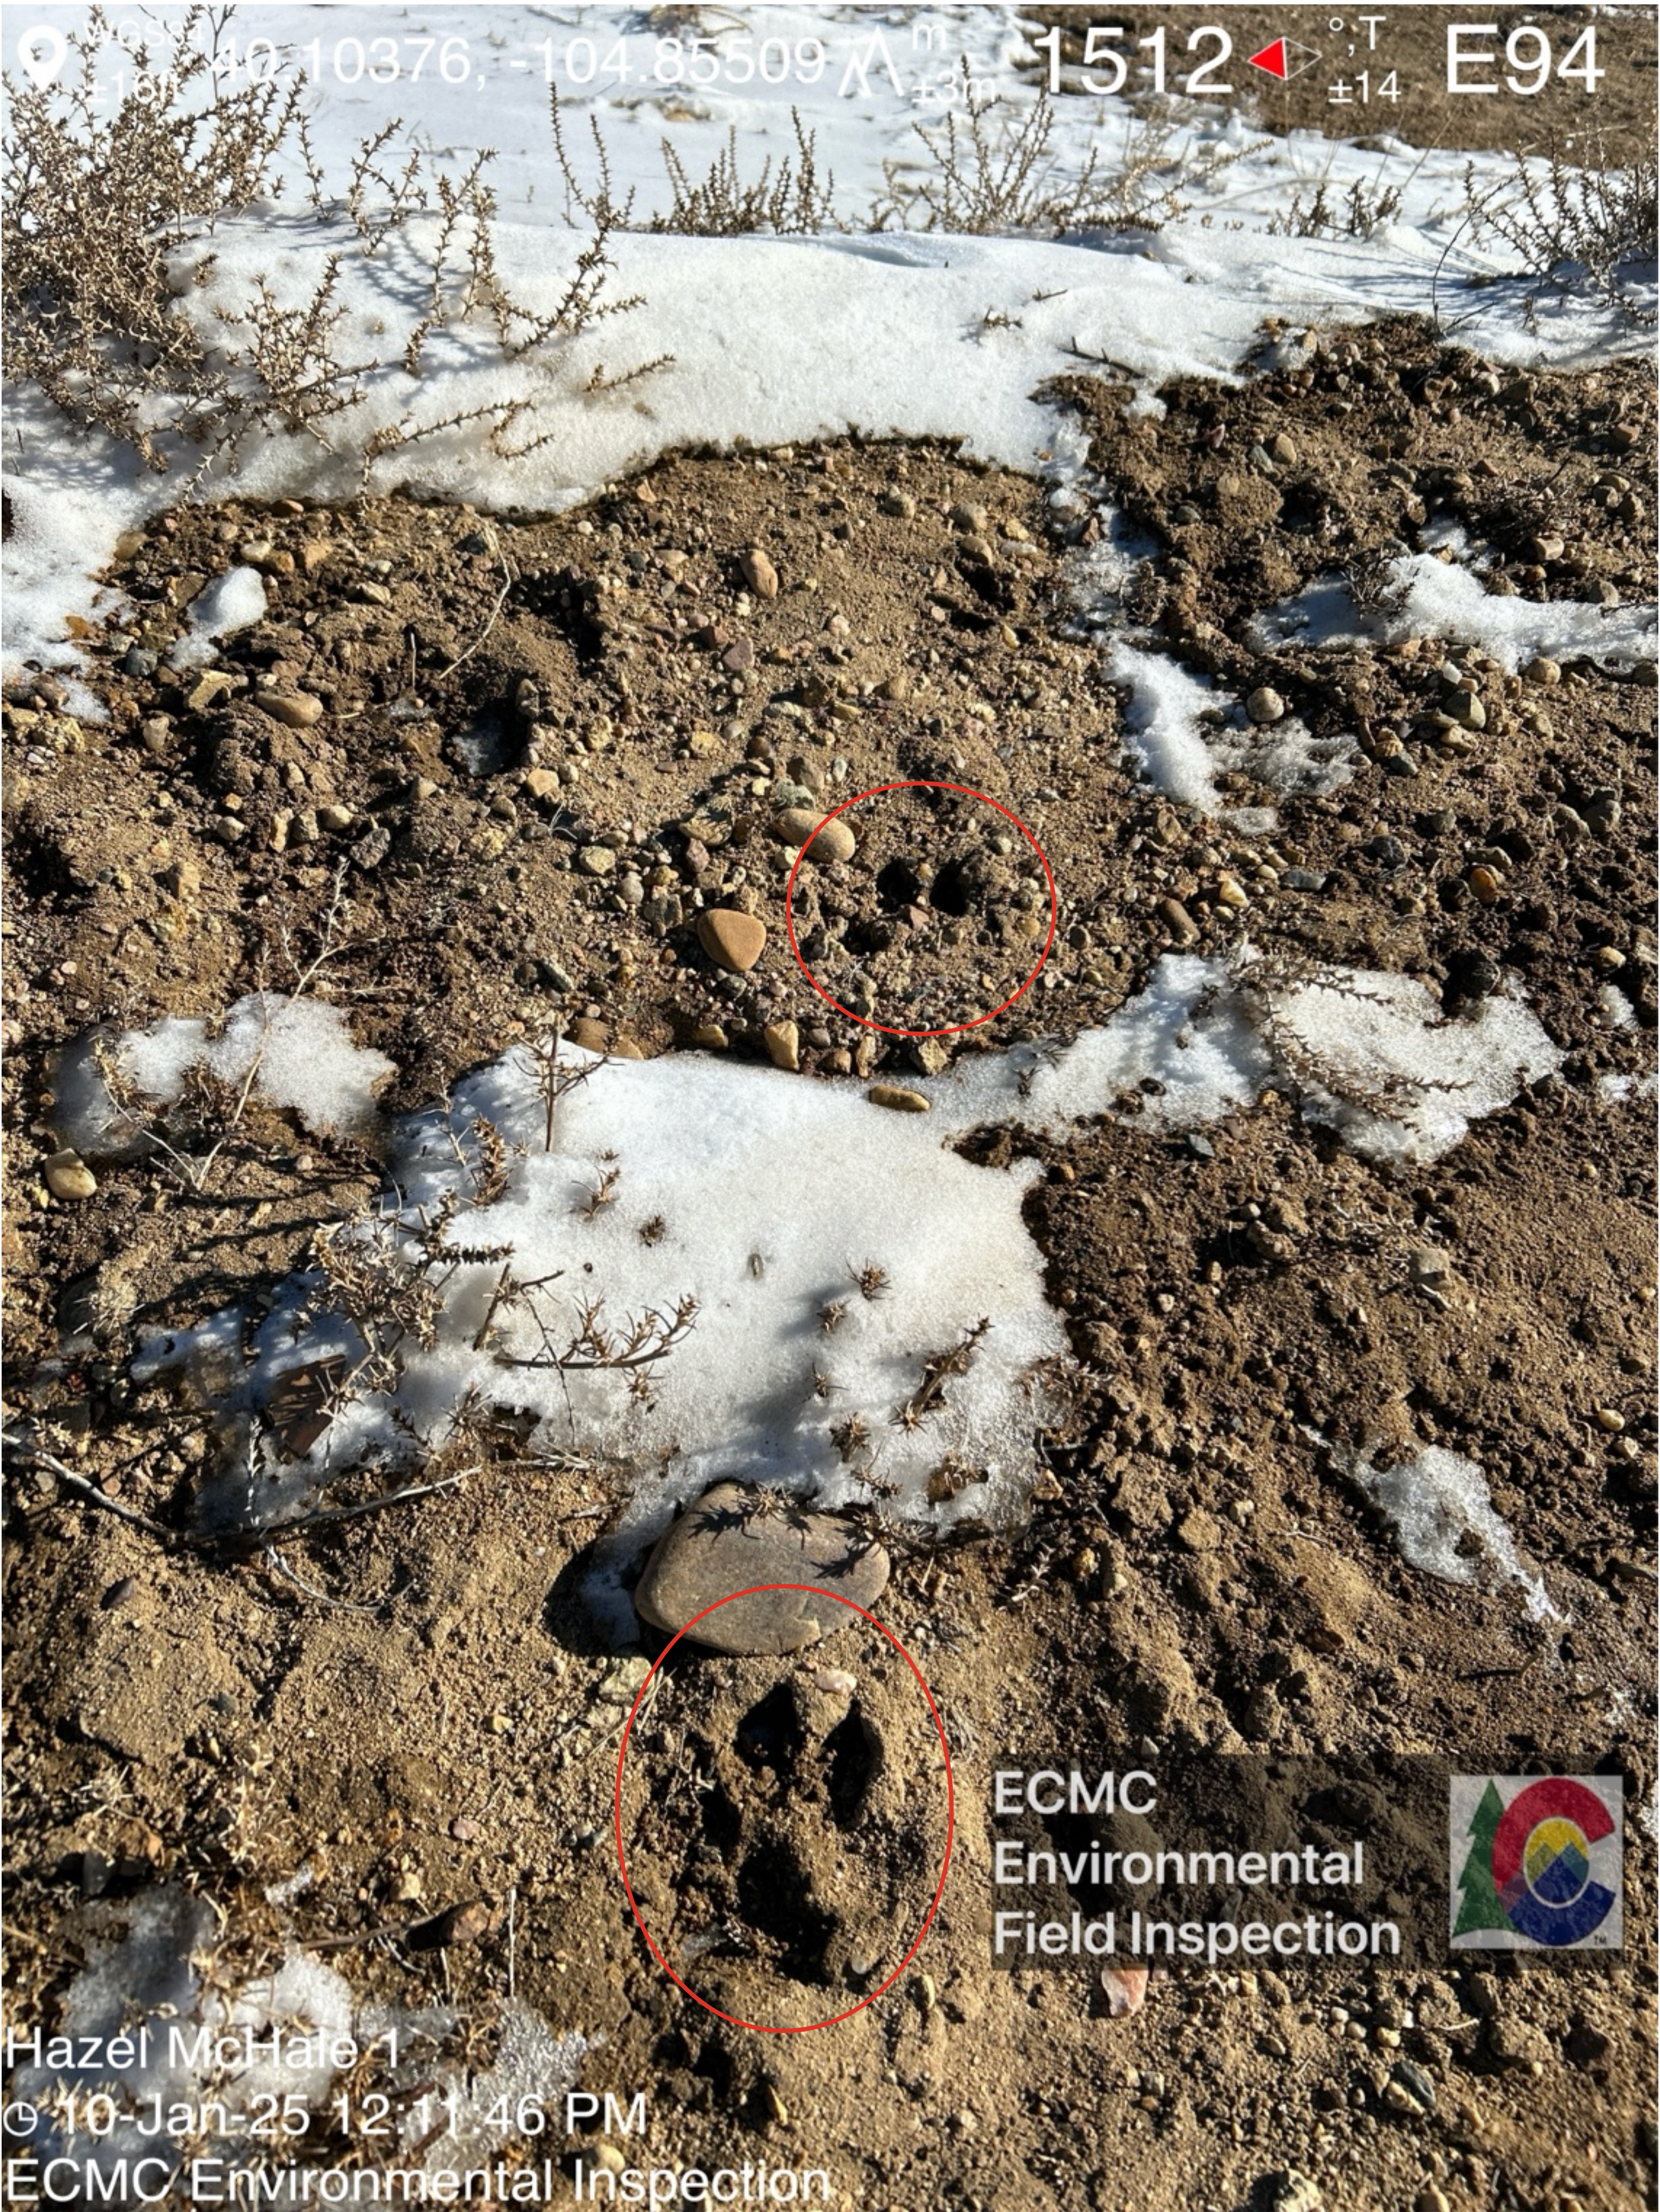
Wildlife tracks observed adjacent to spill location.

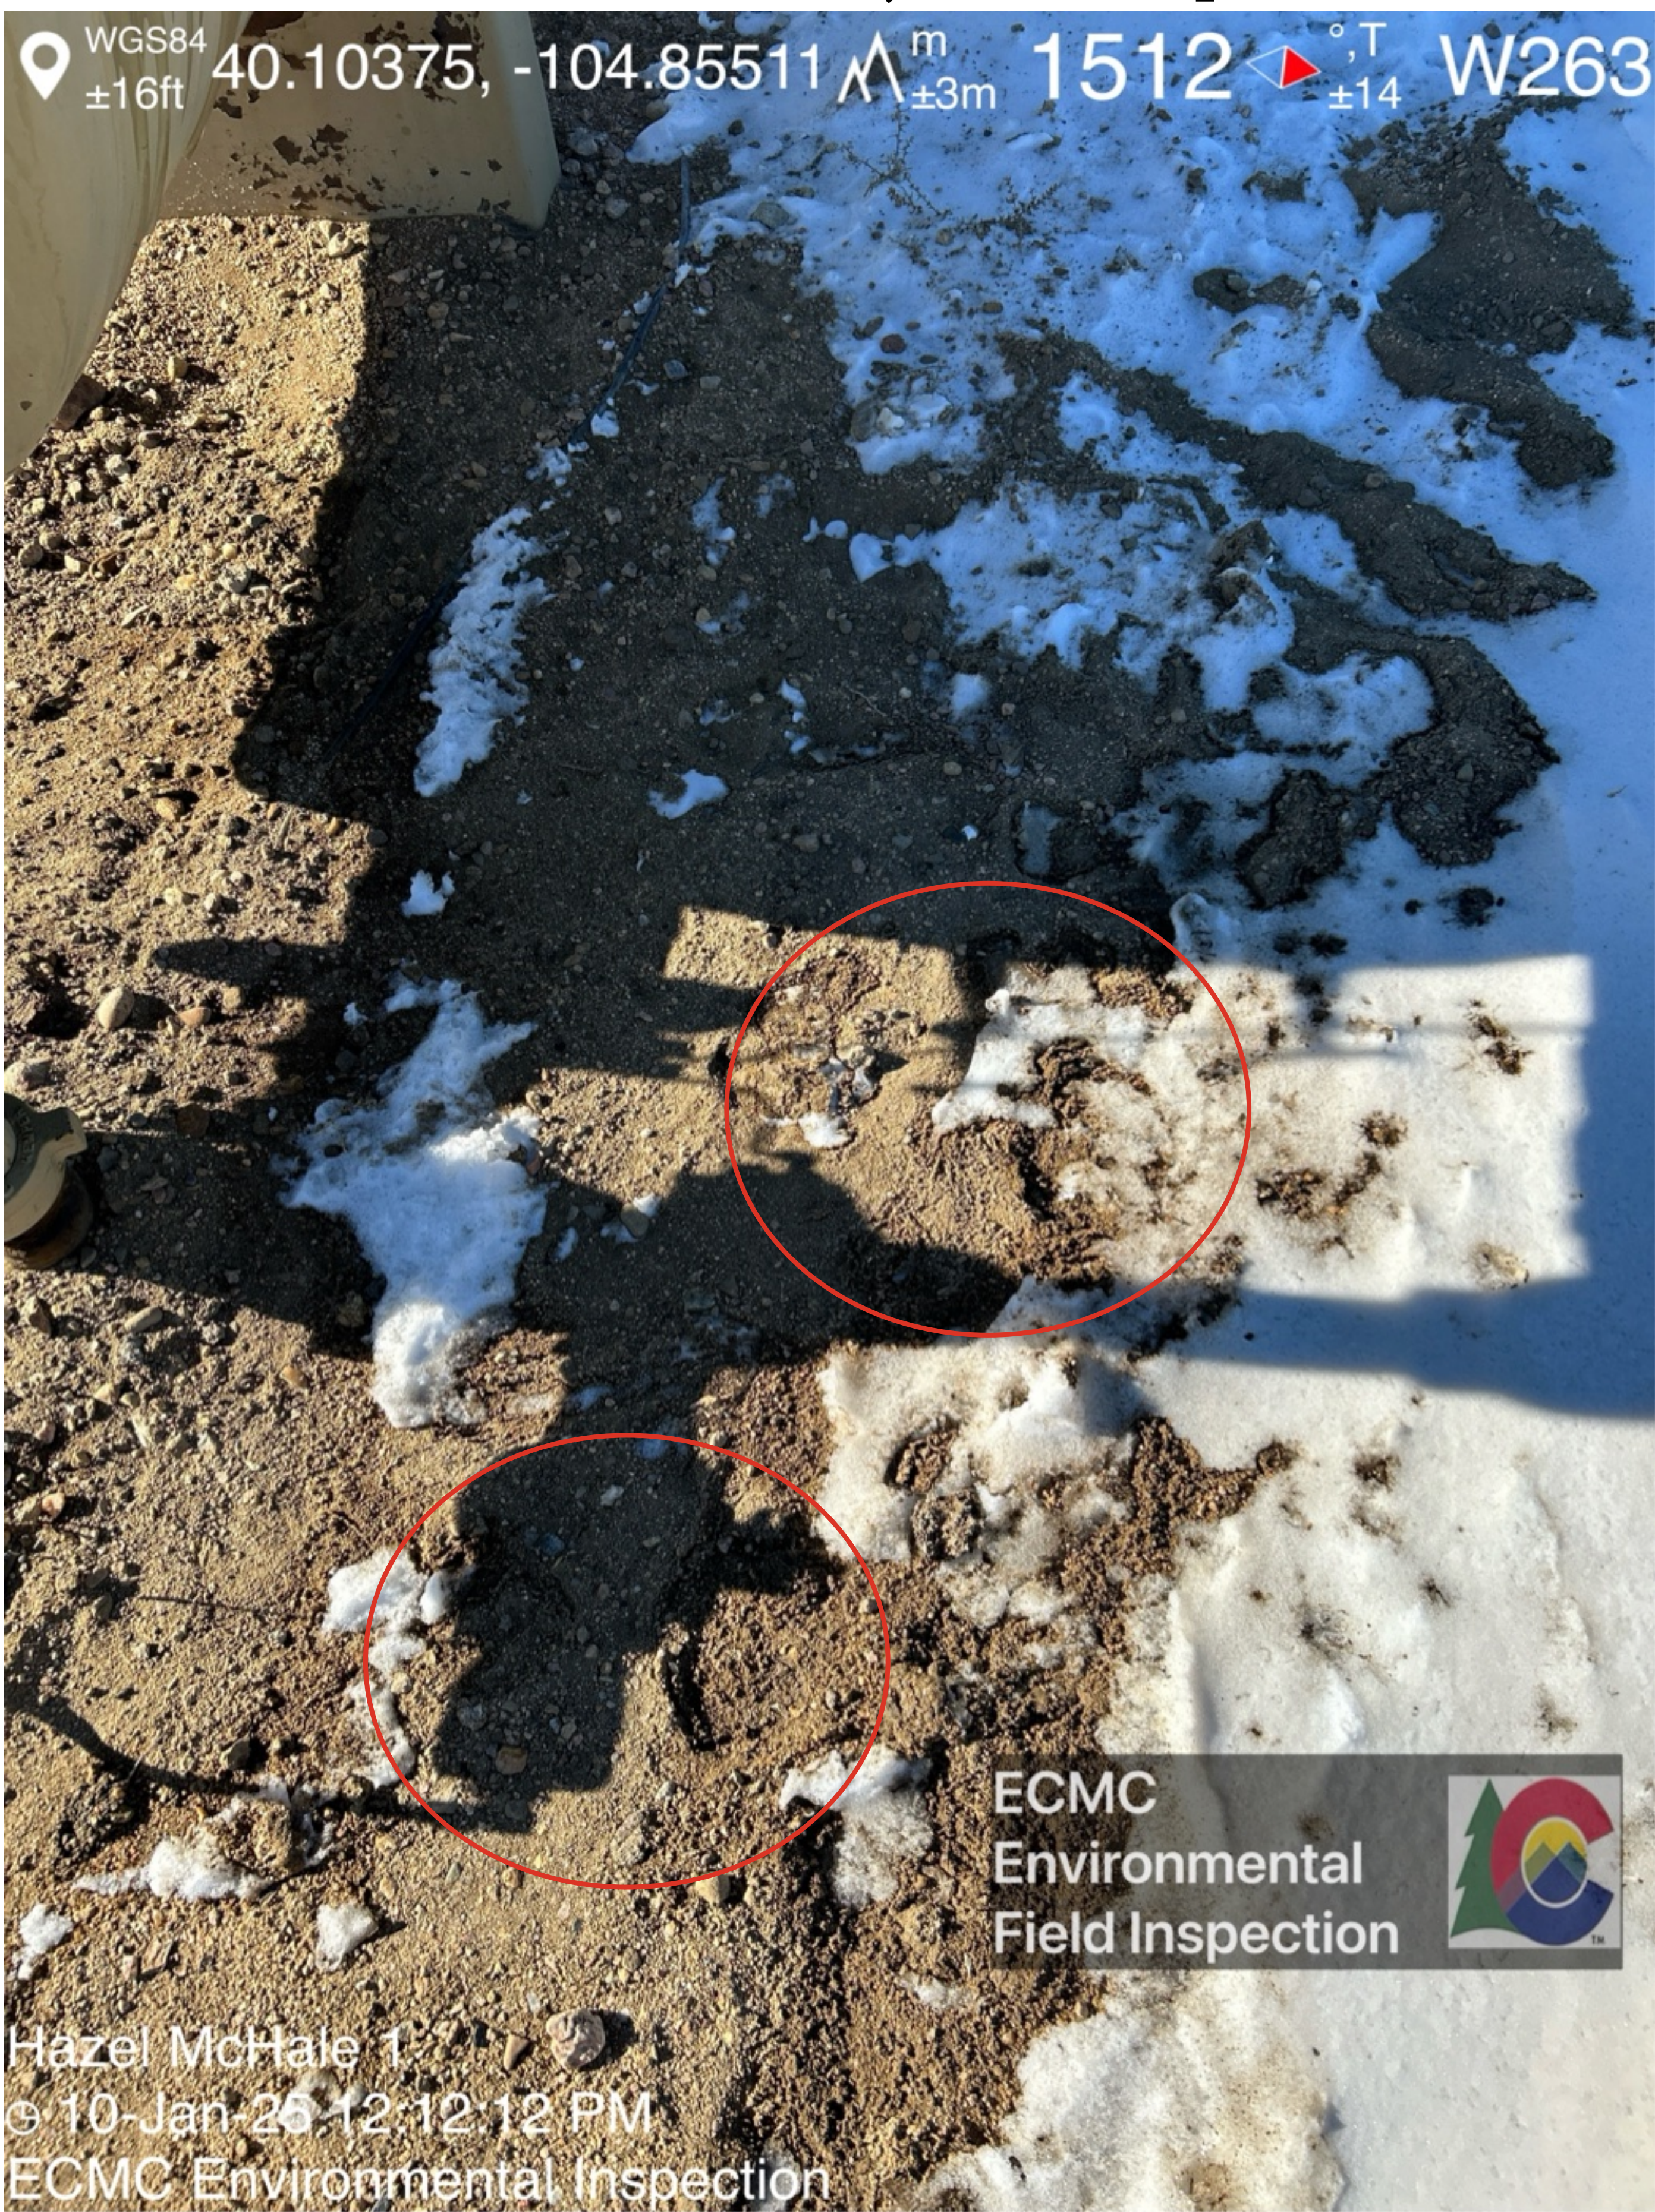
Livestock tracks observed adjacent to spill location.

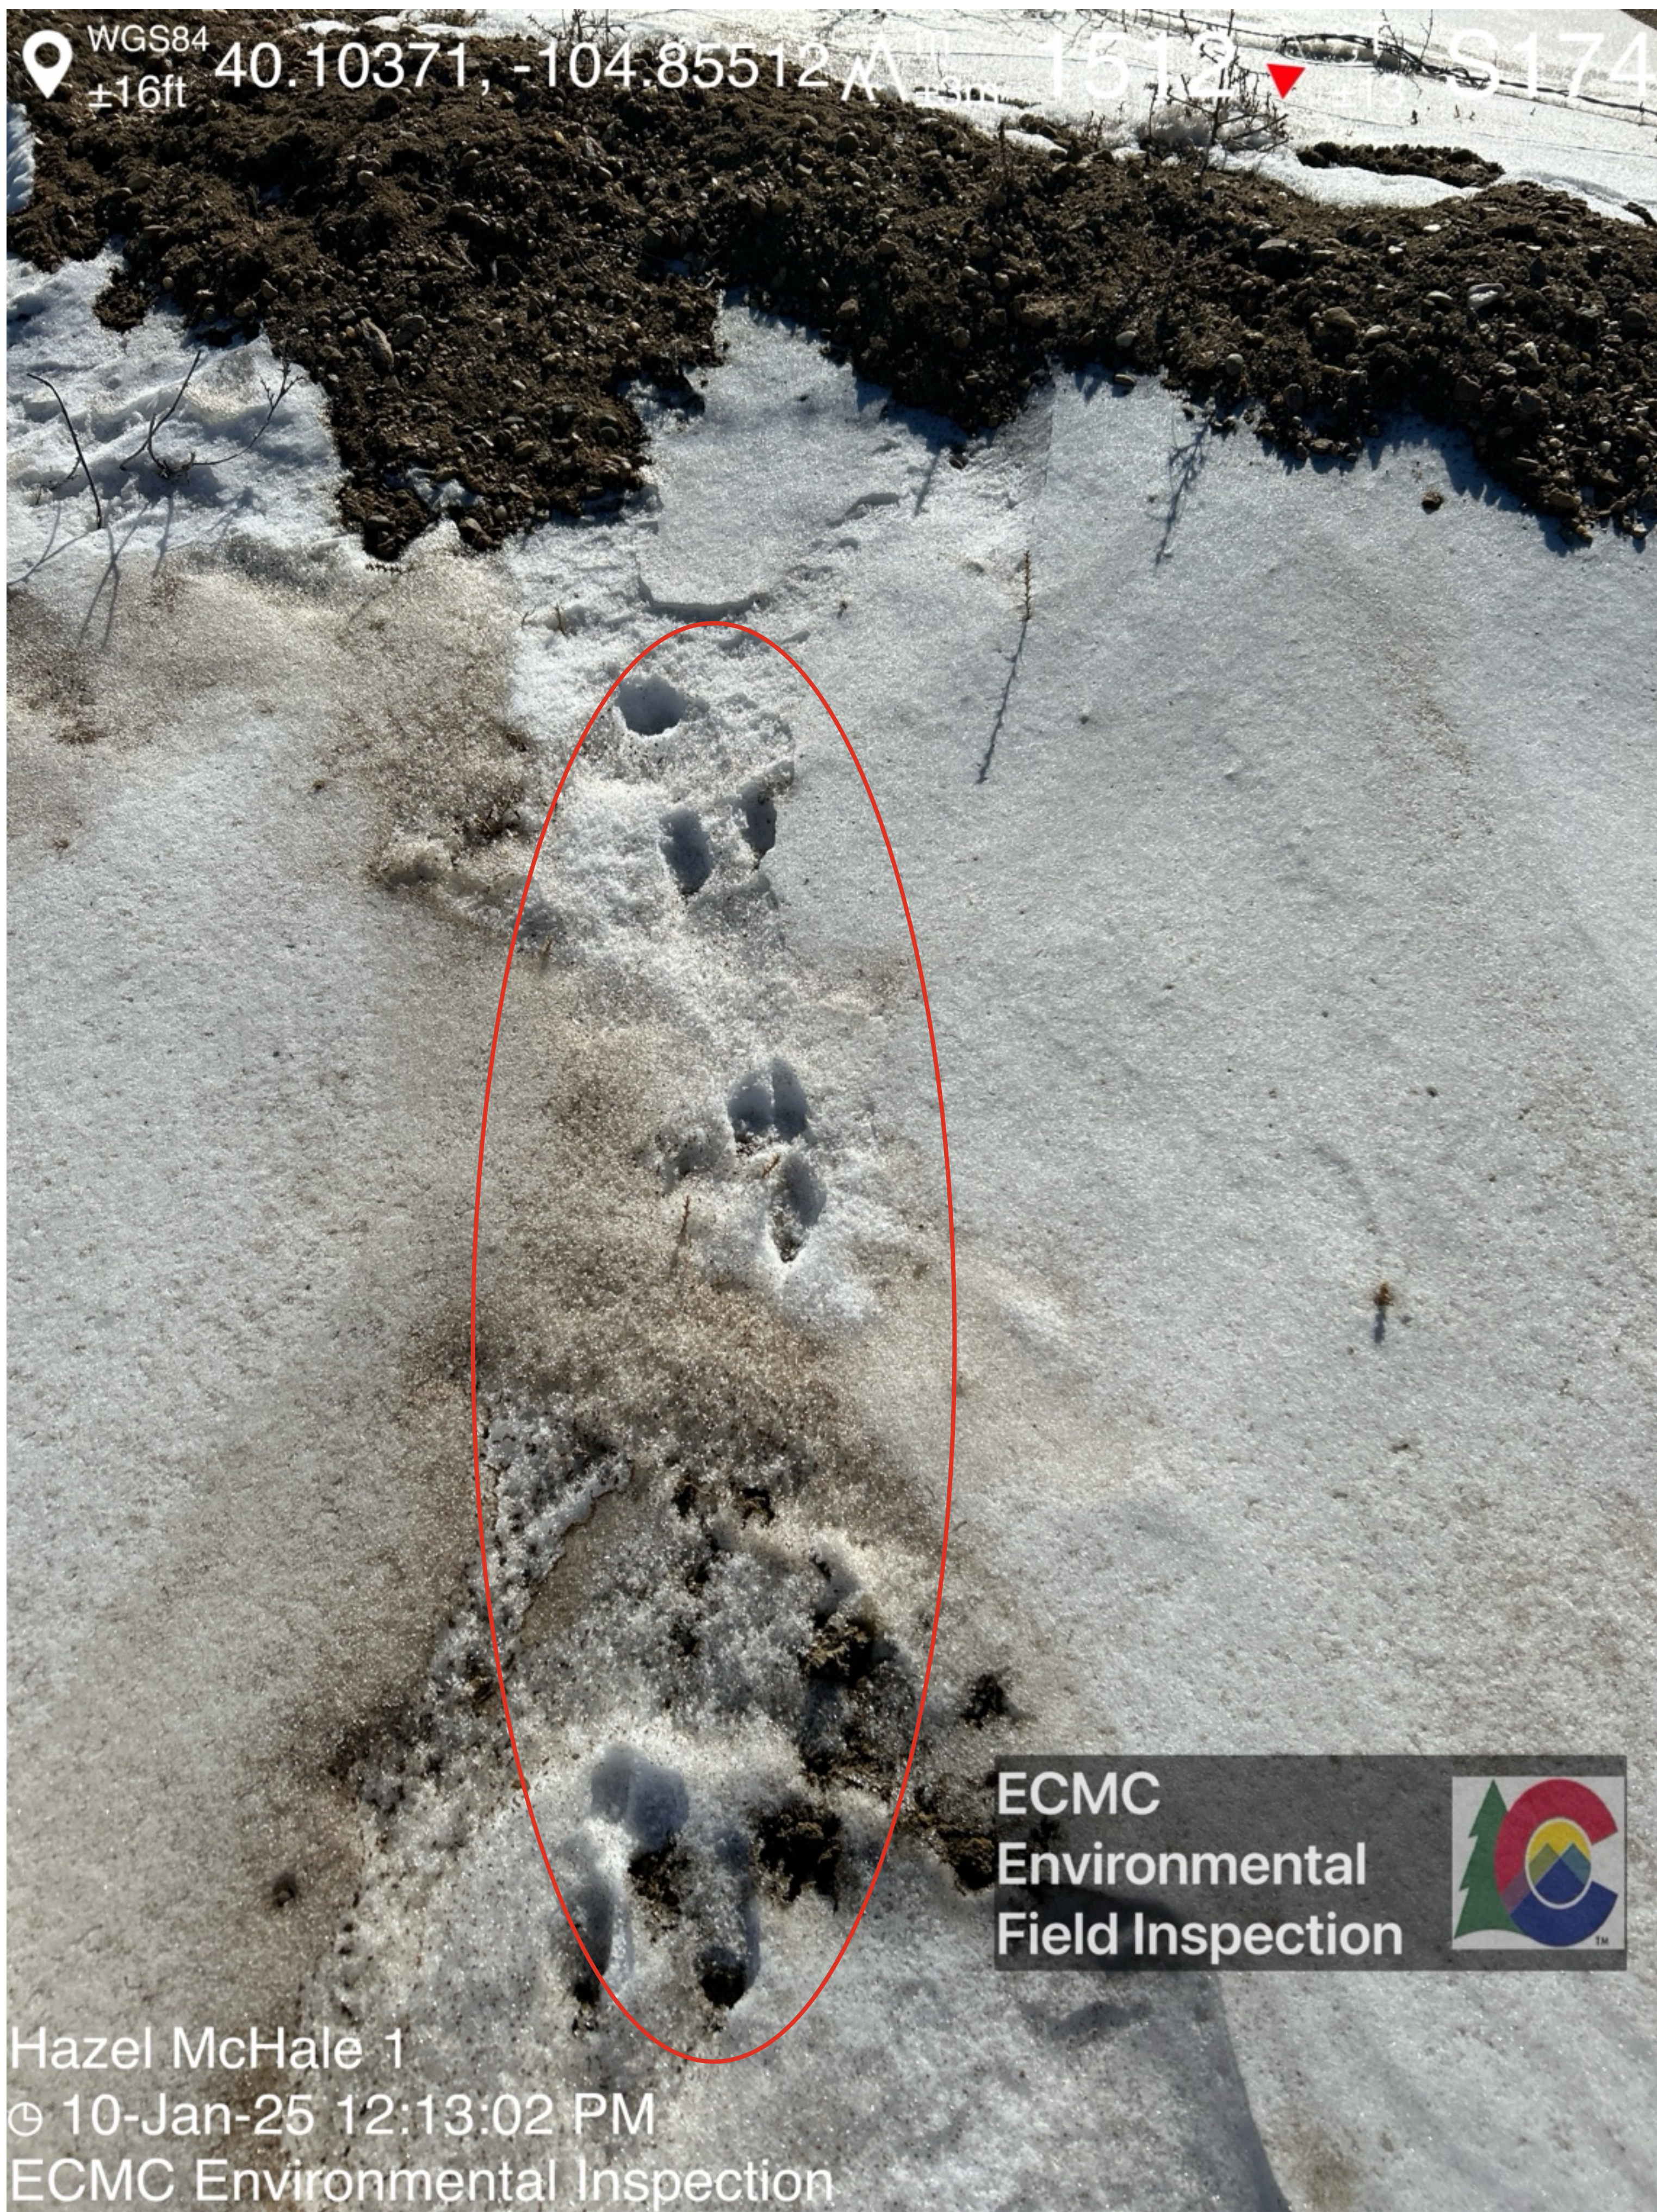
Wildlife tracks observed adjacent to spill location.

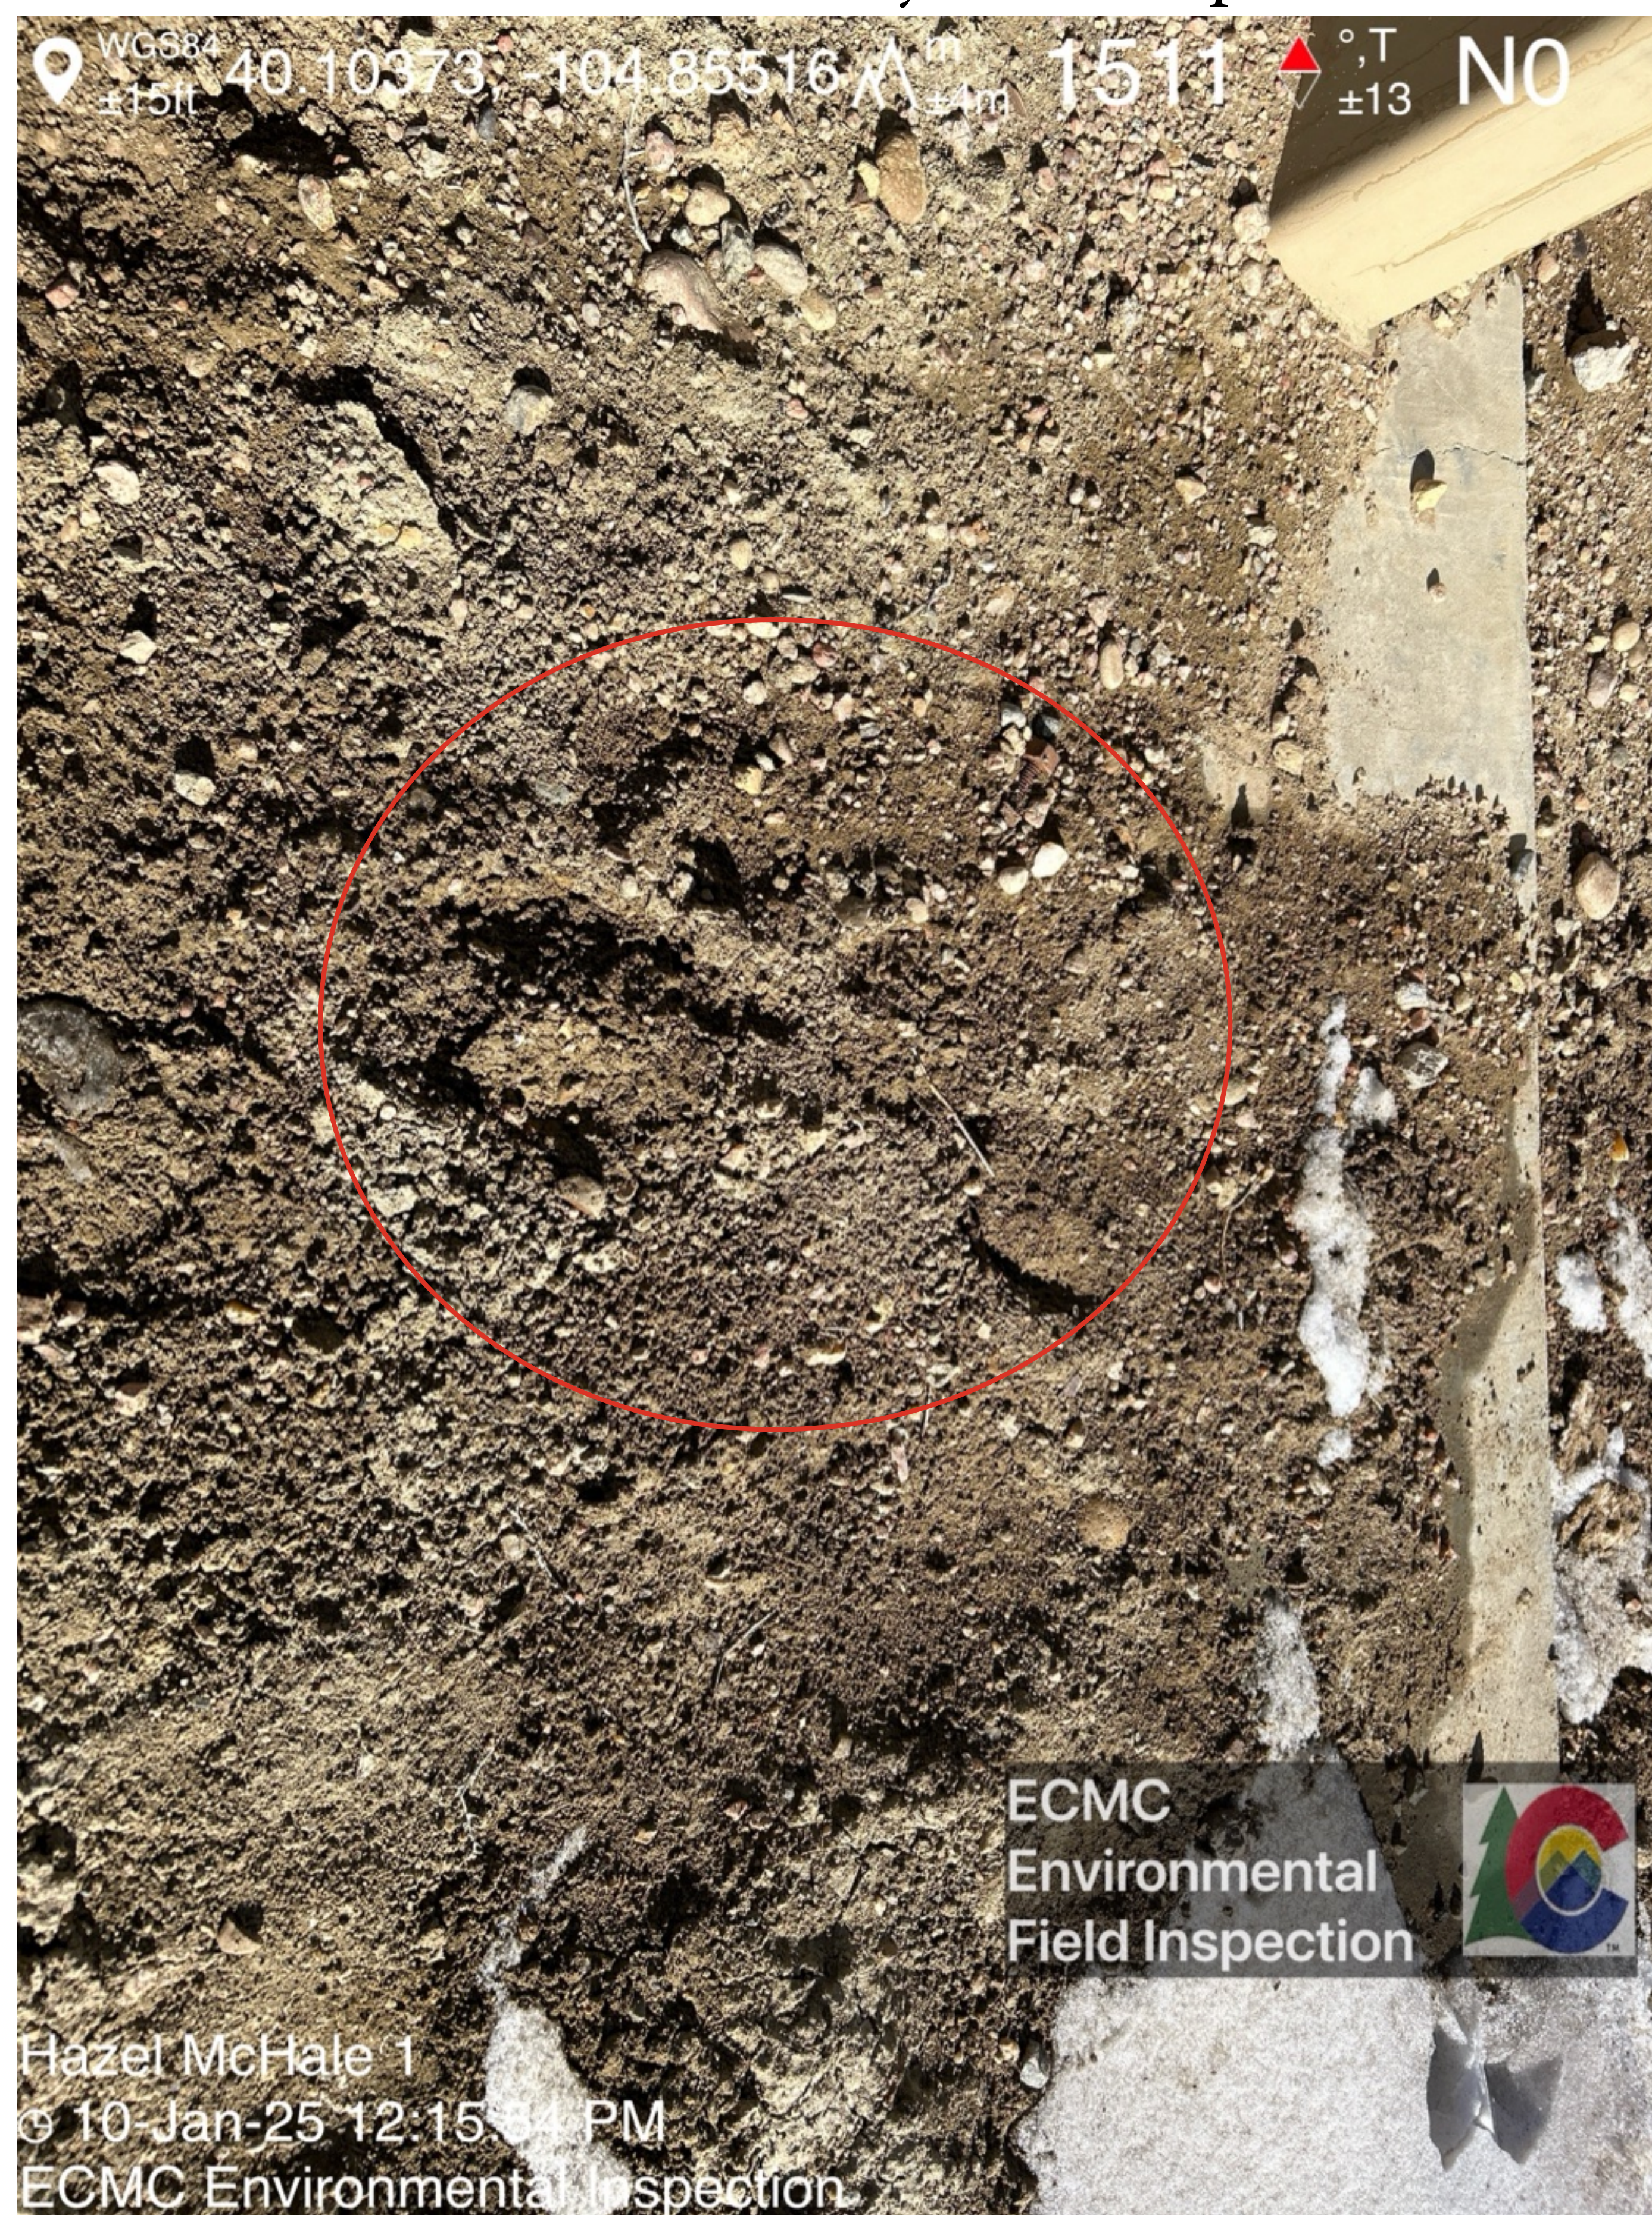
Livestock tracks observed adjacent to spill location.

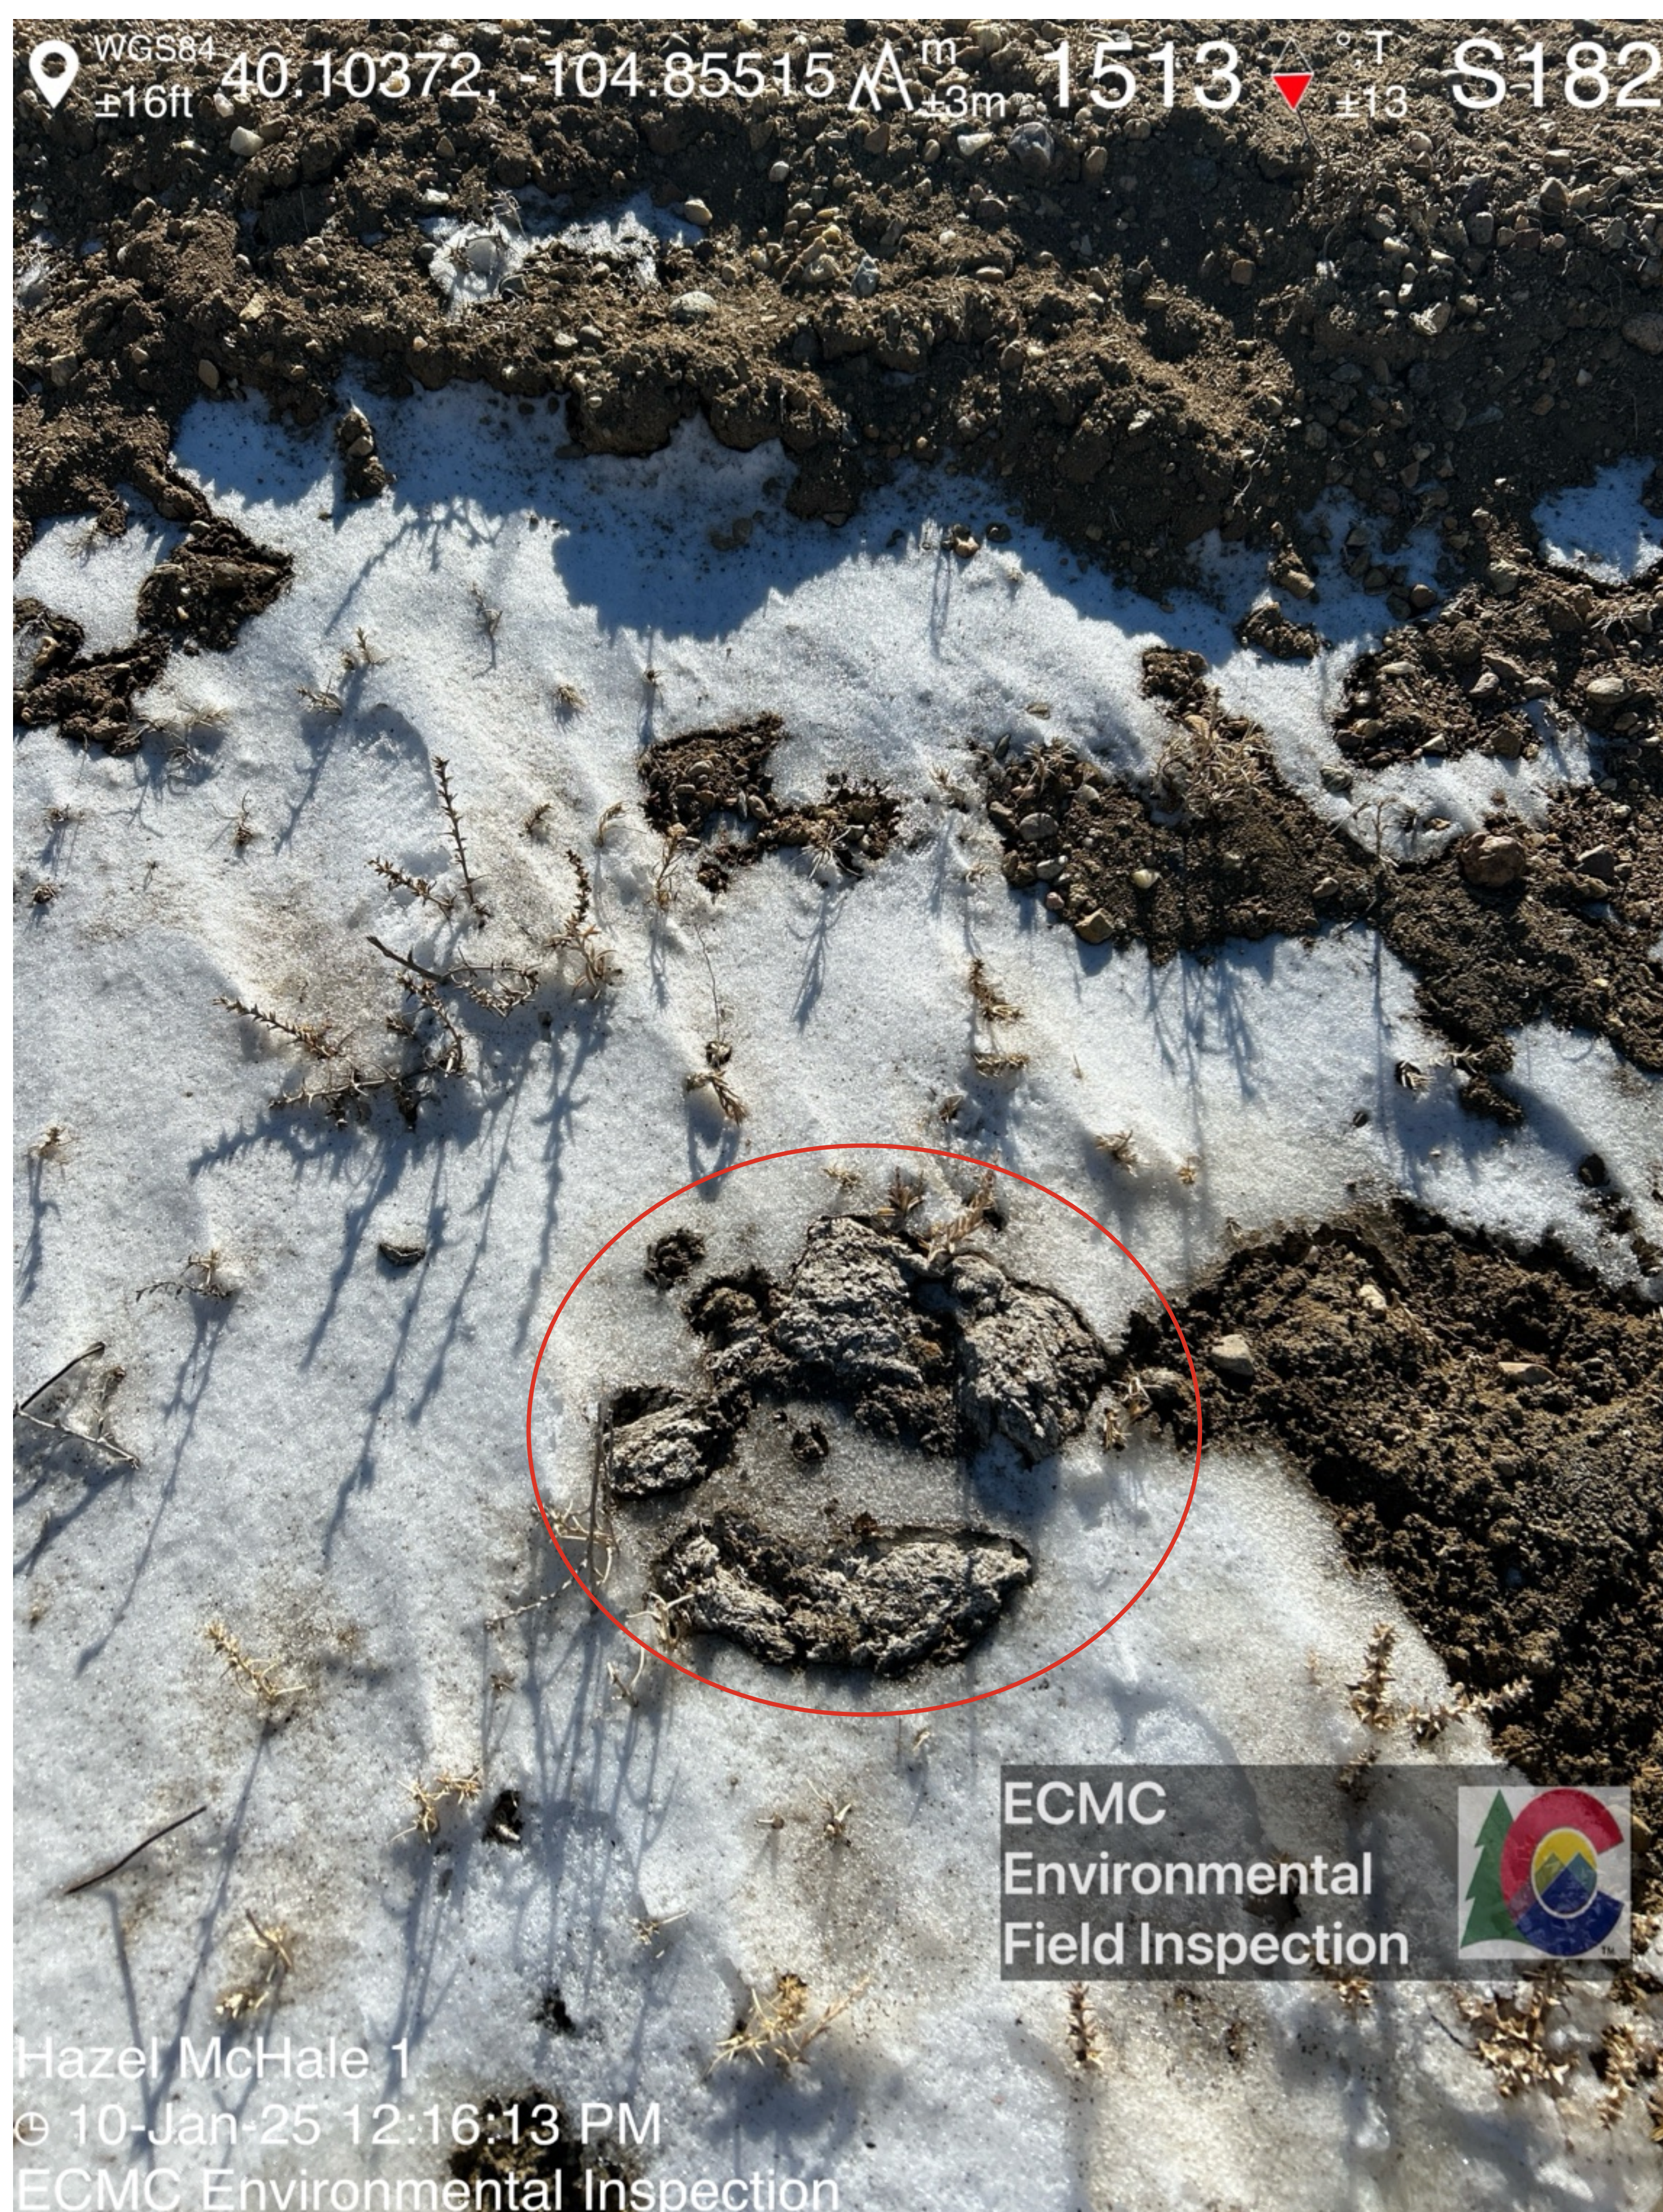
Livestock manure observed adjacent to spill location.
