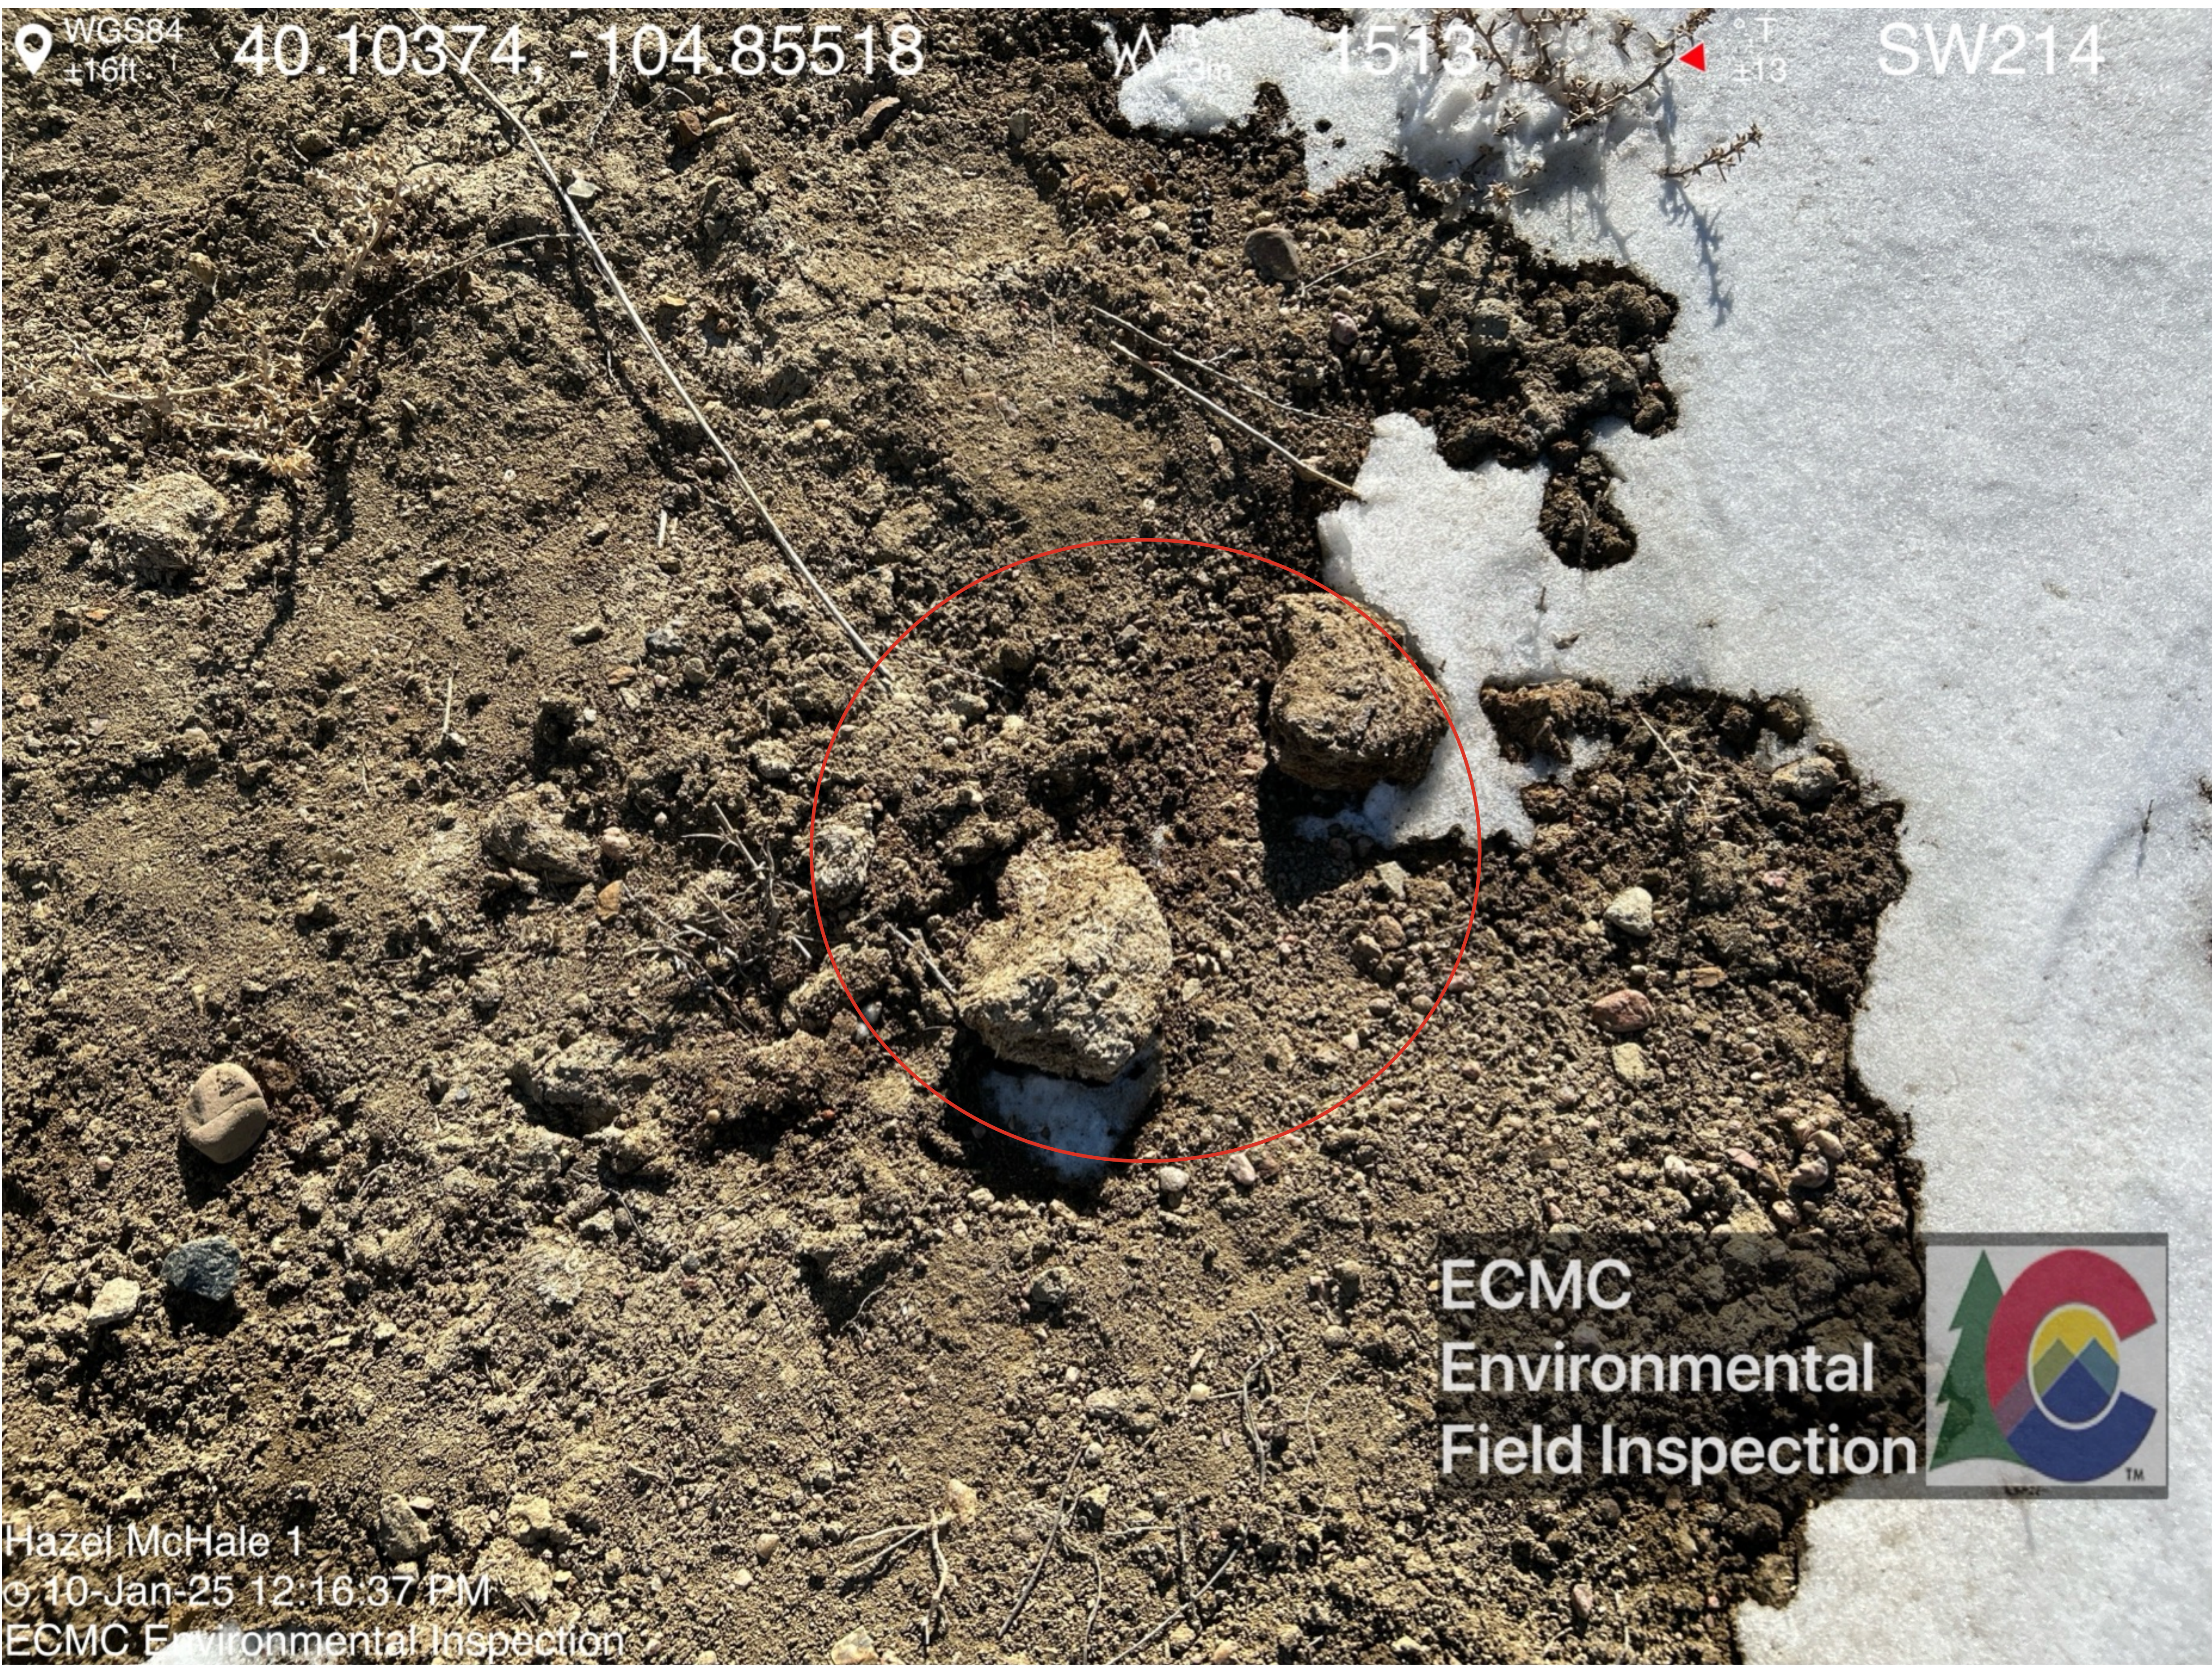
Livestock manure observed adjacent to spill location.

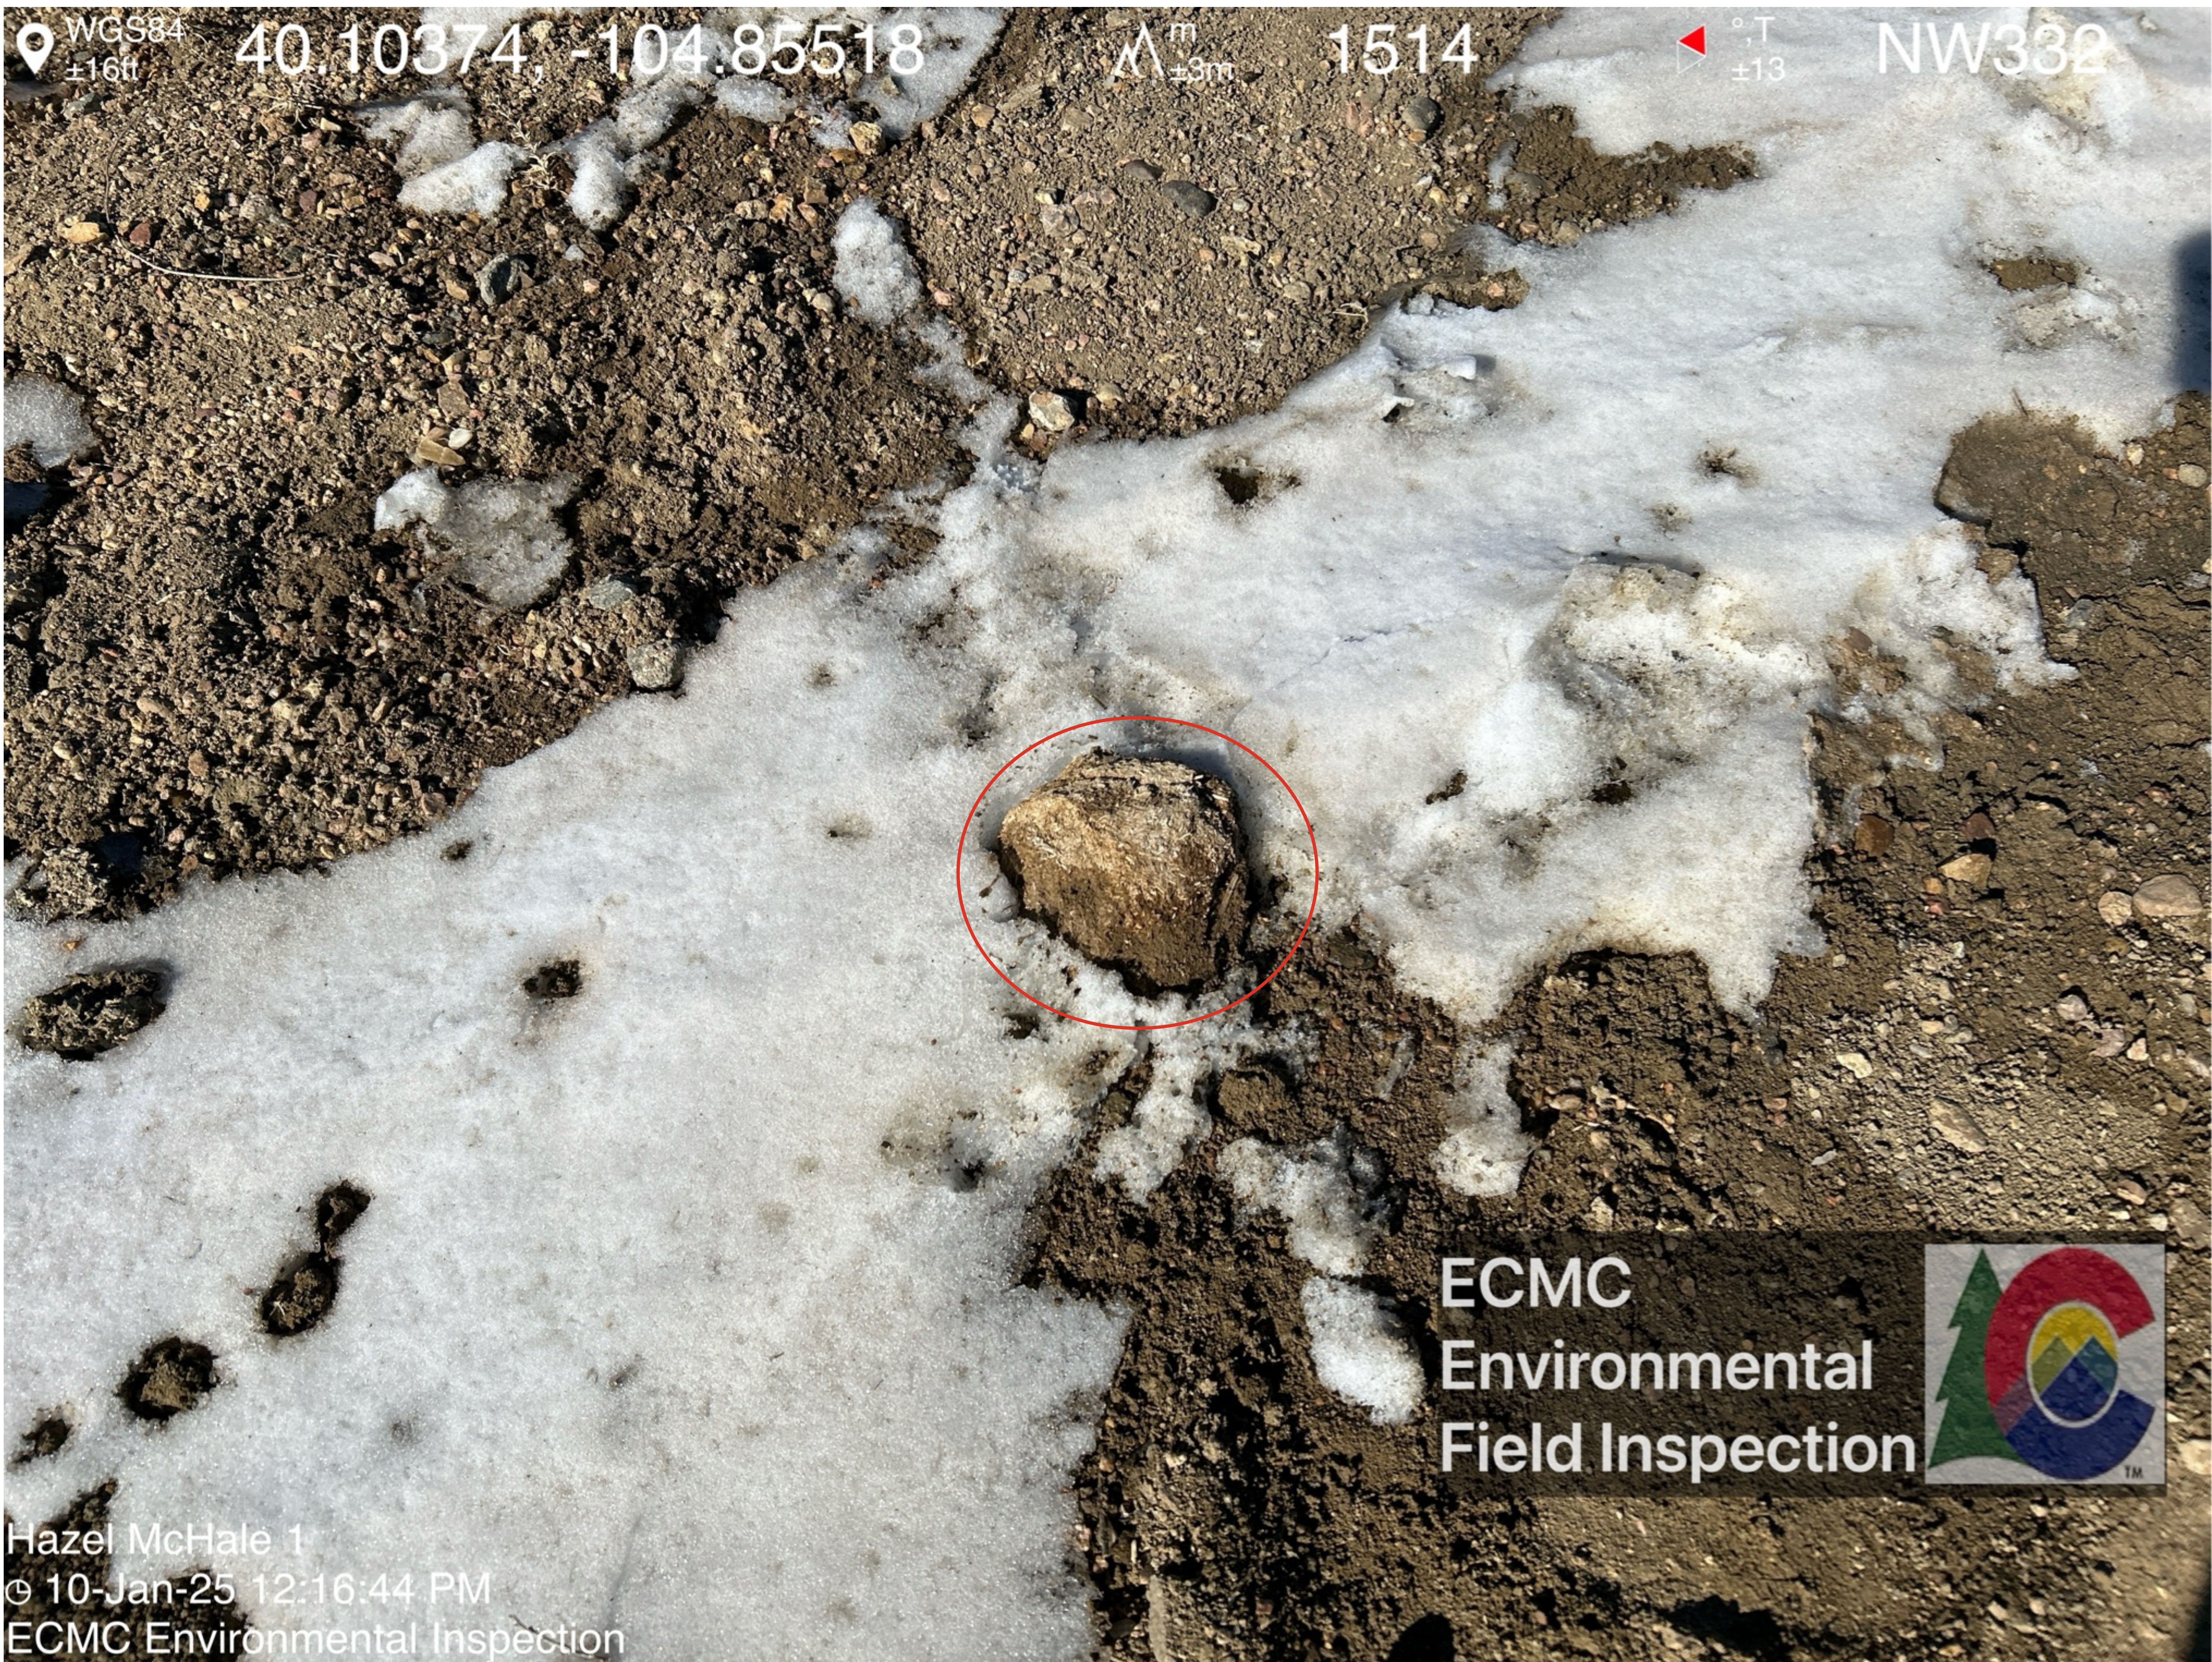
Livestock manure observed adjacent to spill location.

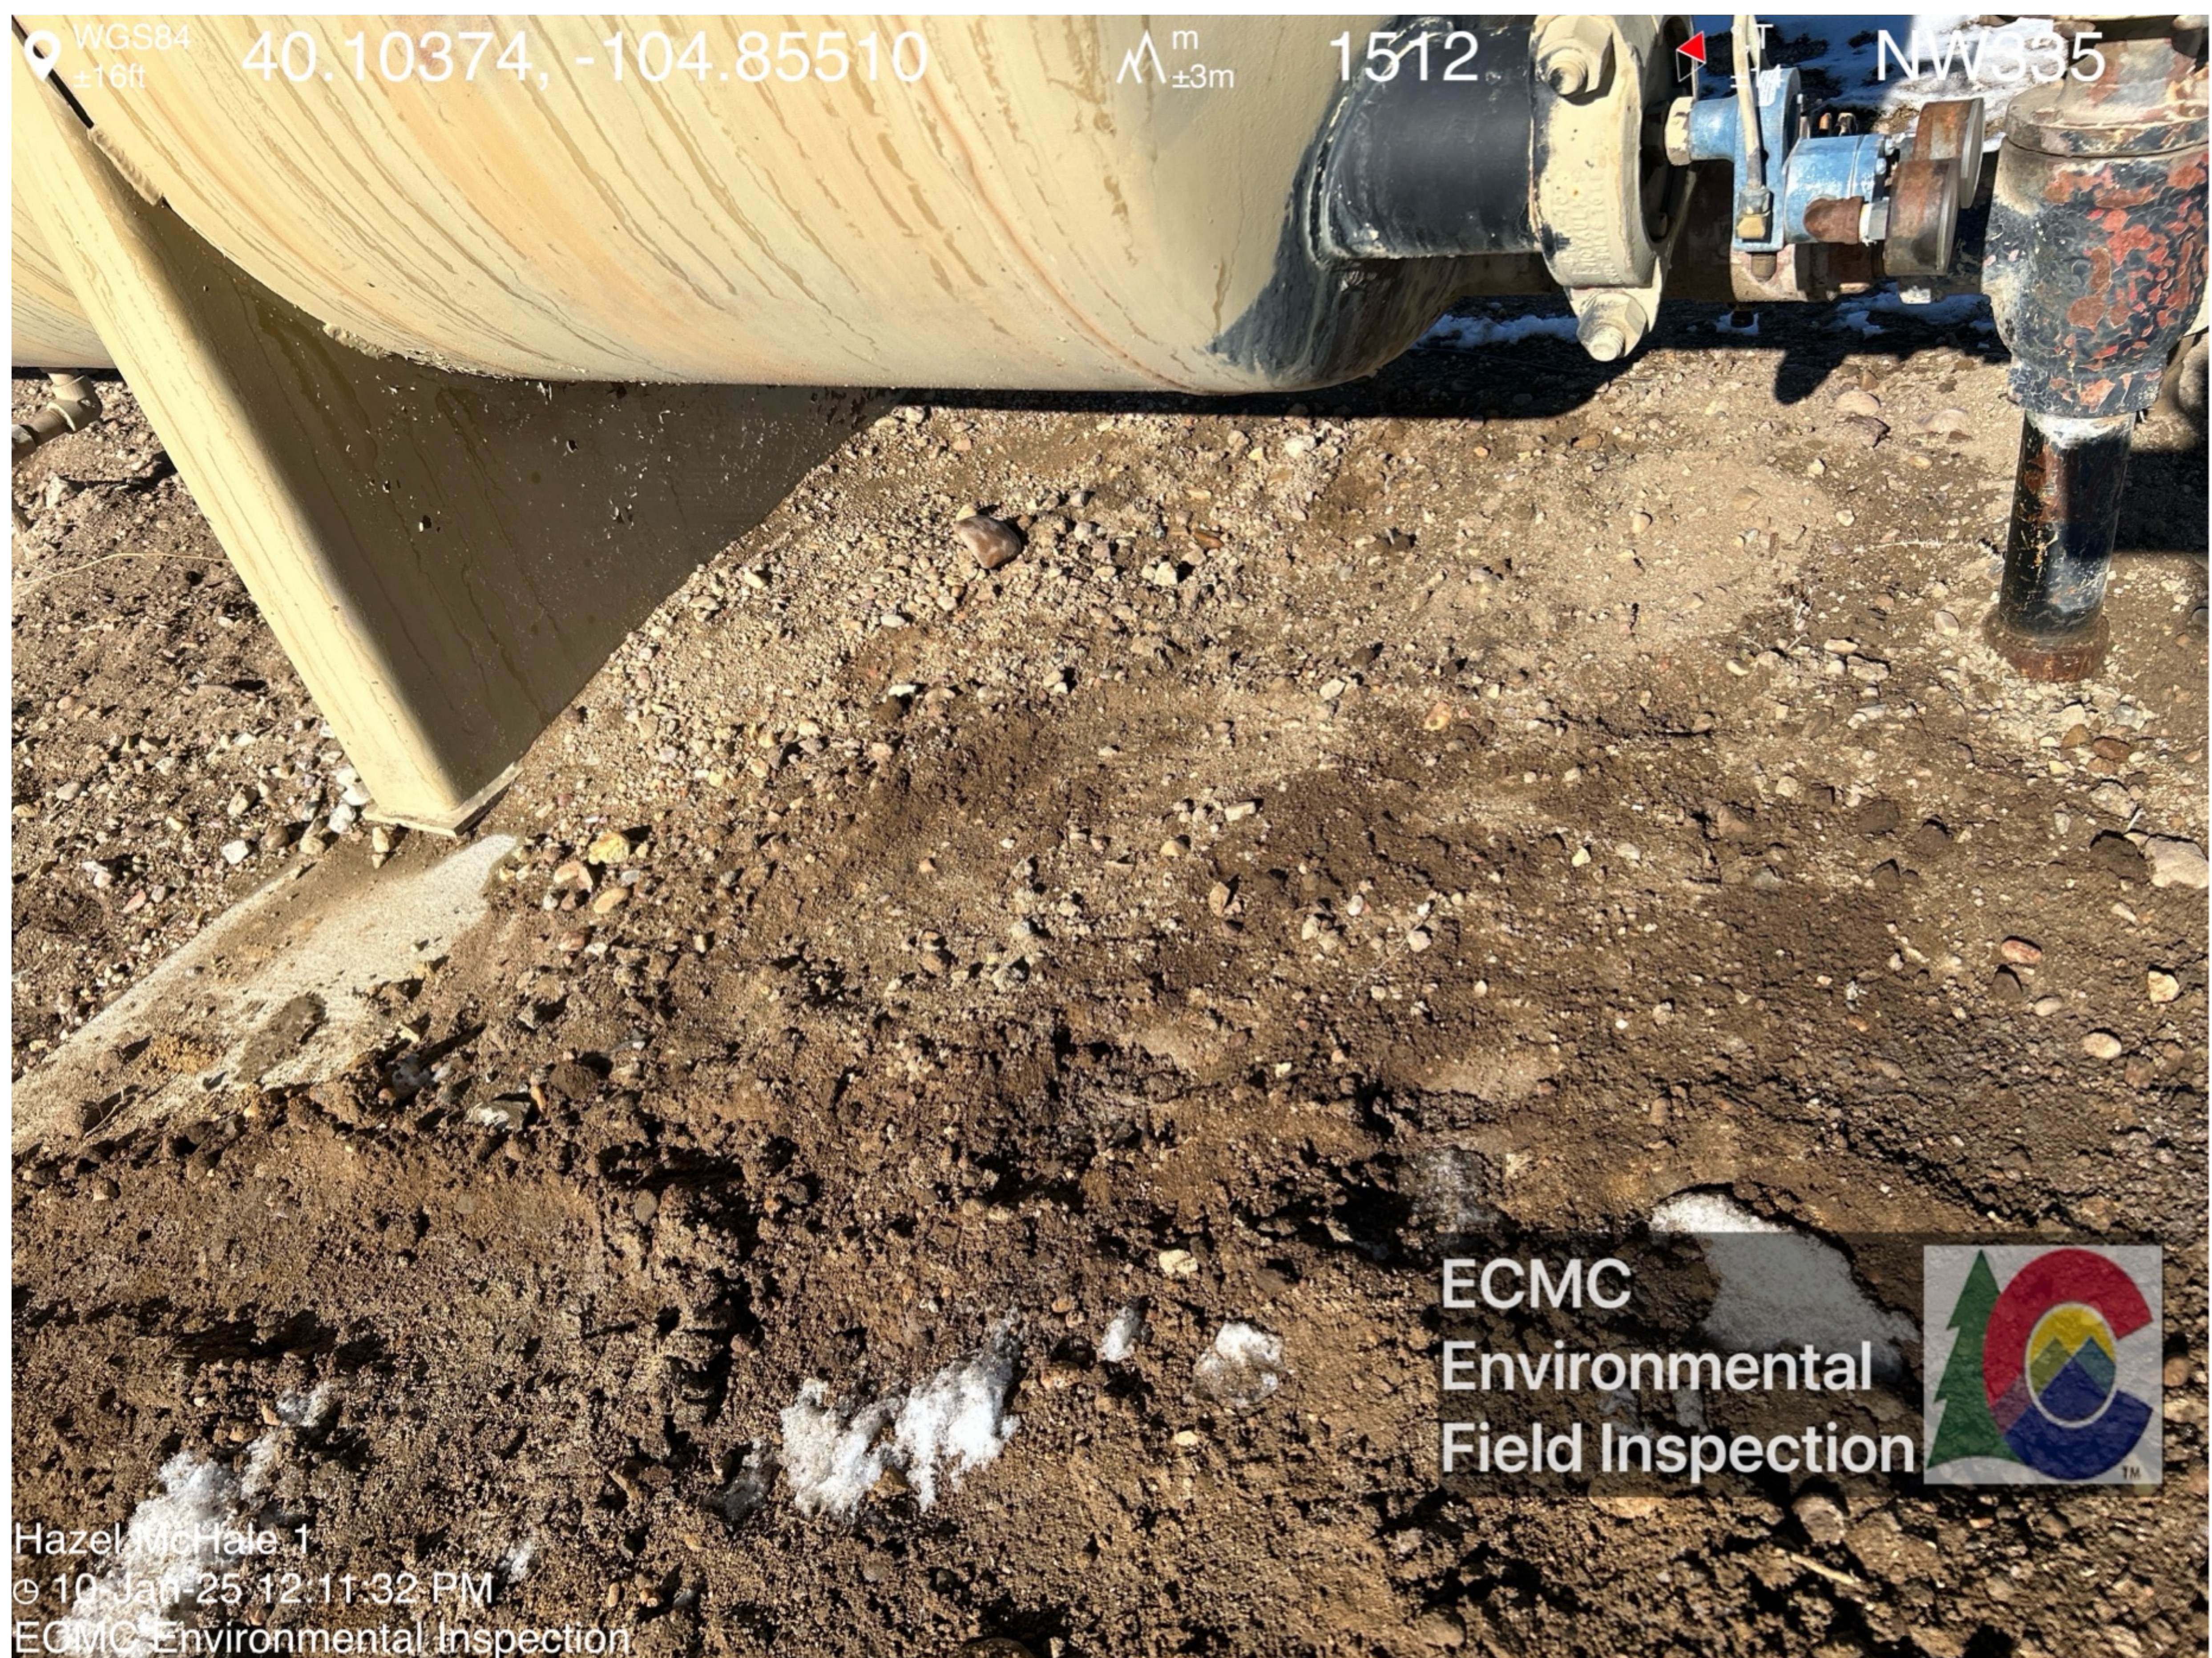
Approximate spill location. Petroleum hydrocarbon odor observed in the vicinity of the separator, increasing in strength when soil was disturbed by walking.

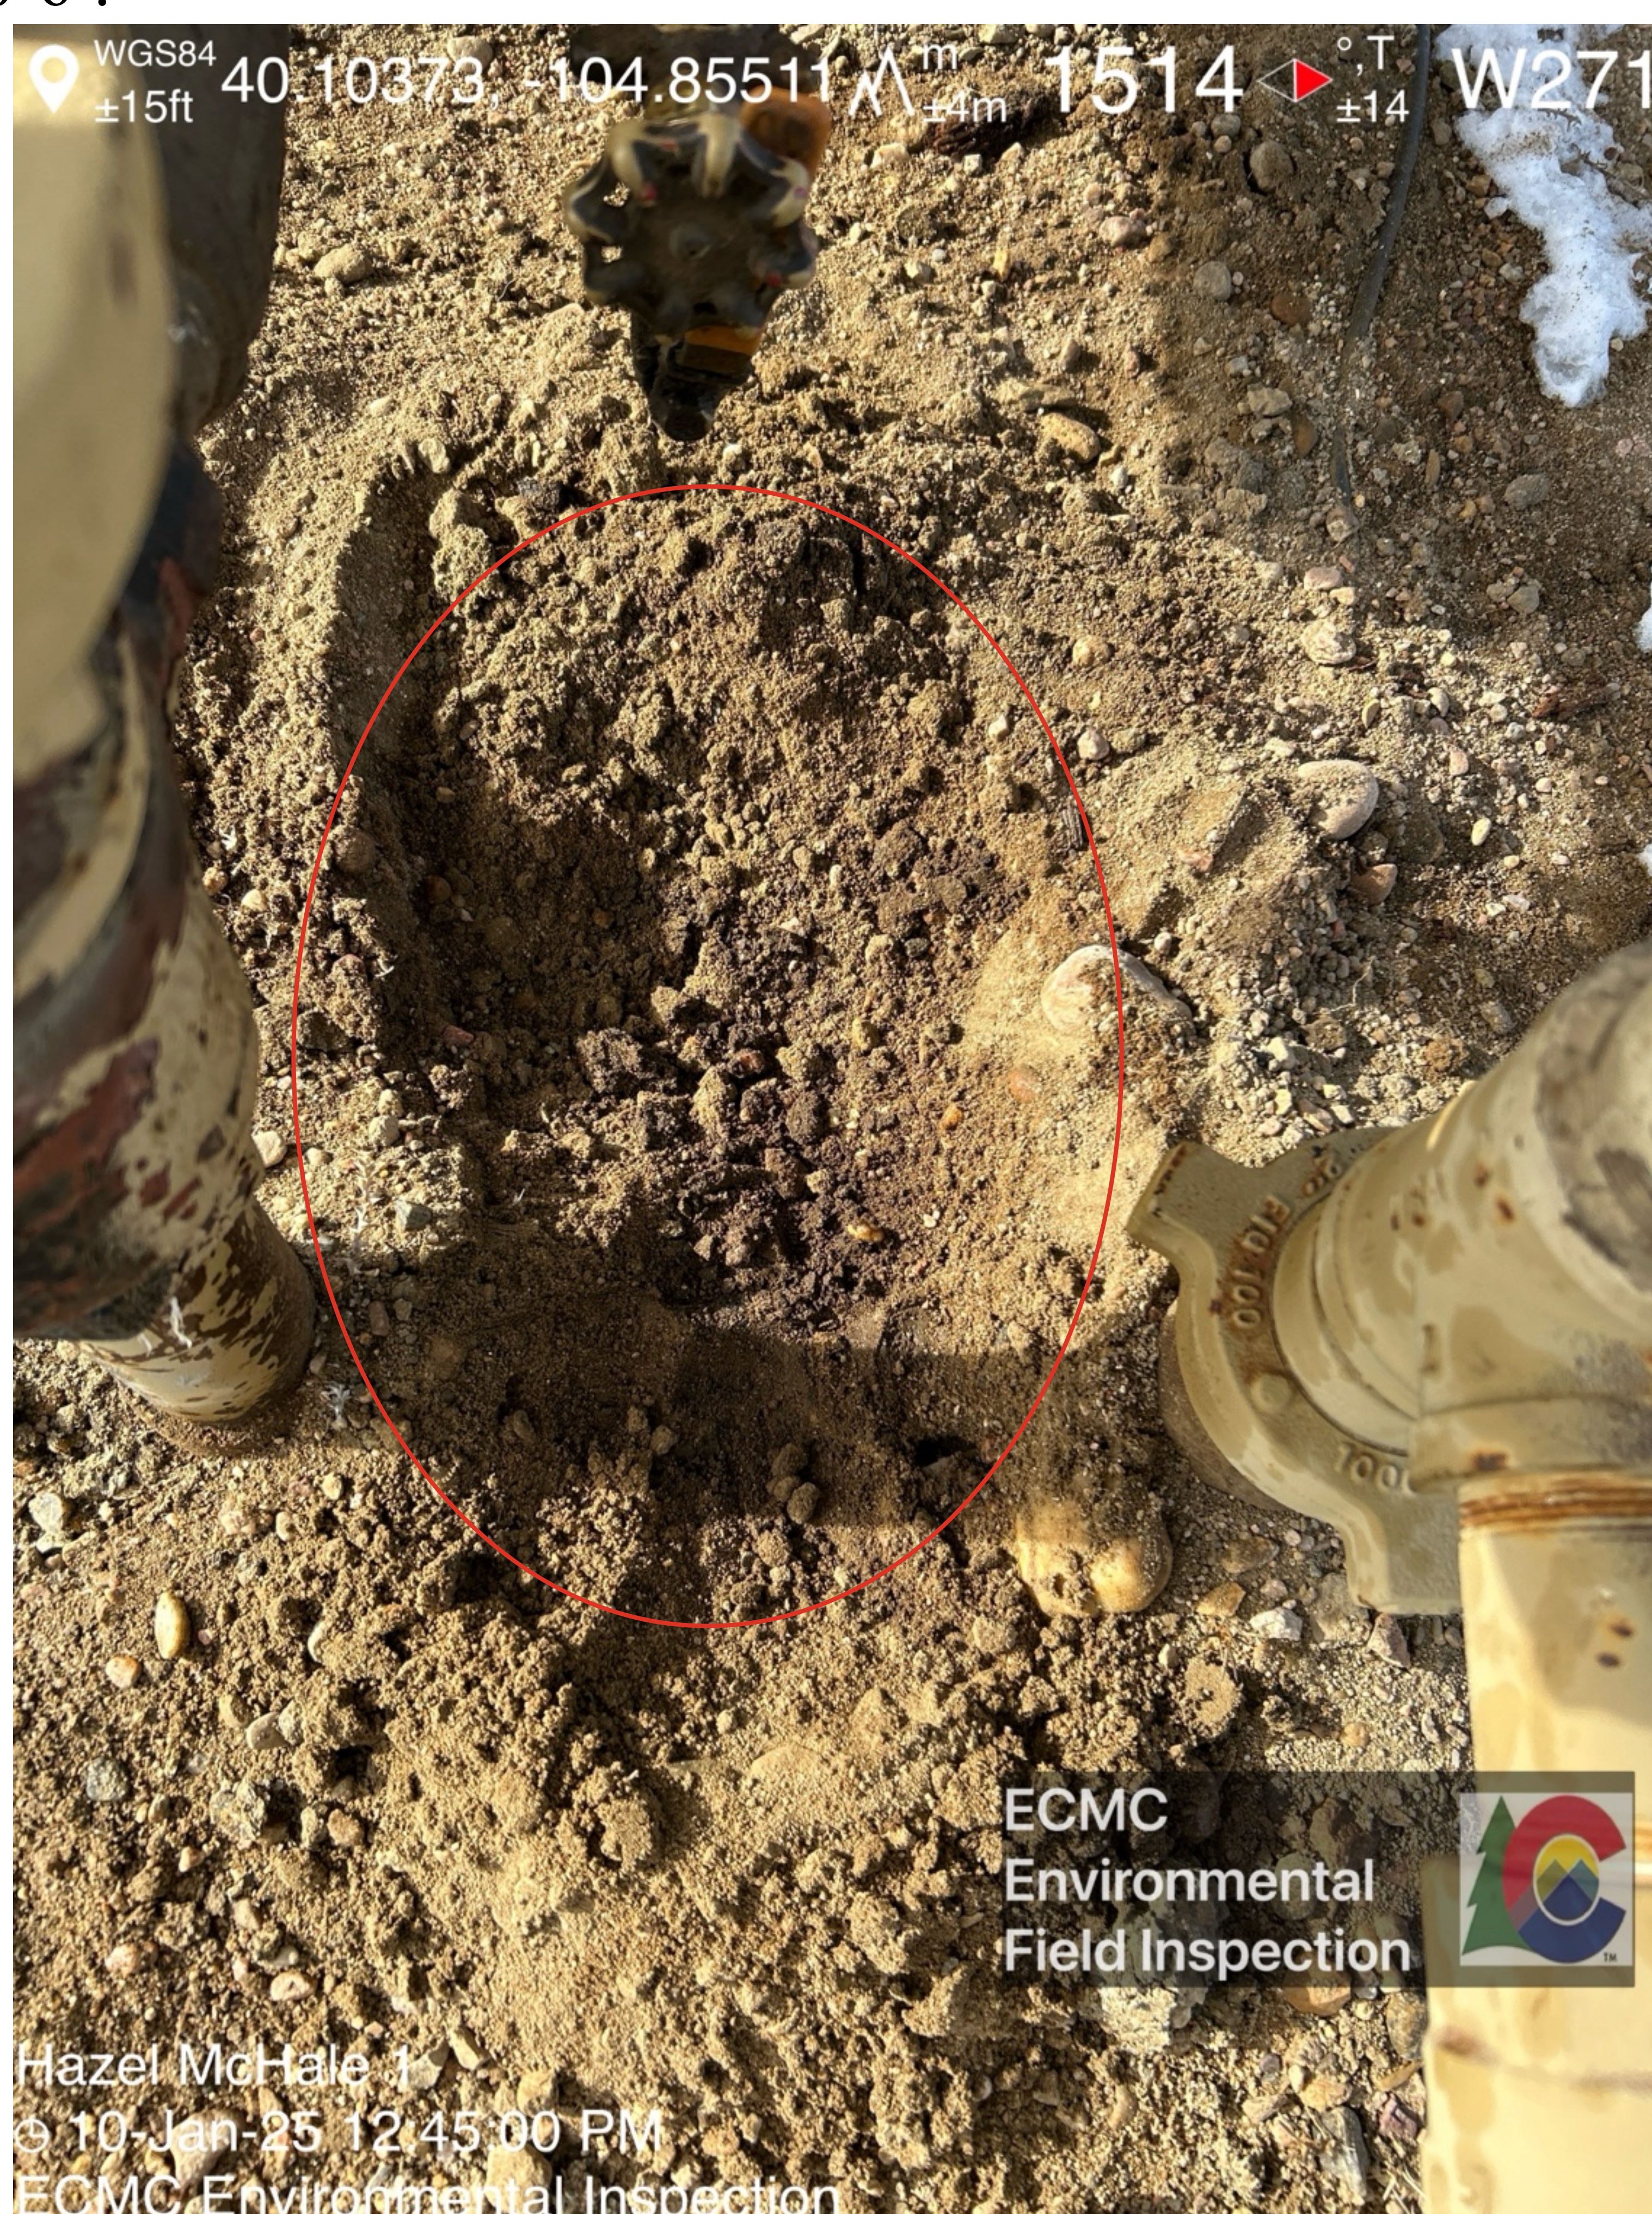
Approximate spill location. Very strong petroleum hydrocarbon odor observed. Petroleum hydrocarbon staining observed under a thin layer of unstained fill material. Soil sample location SS-01@0-6".

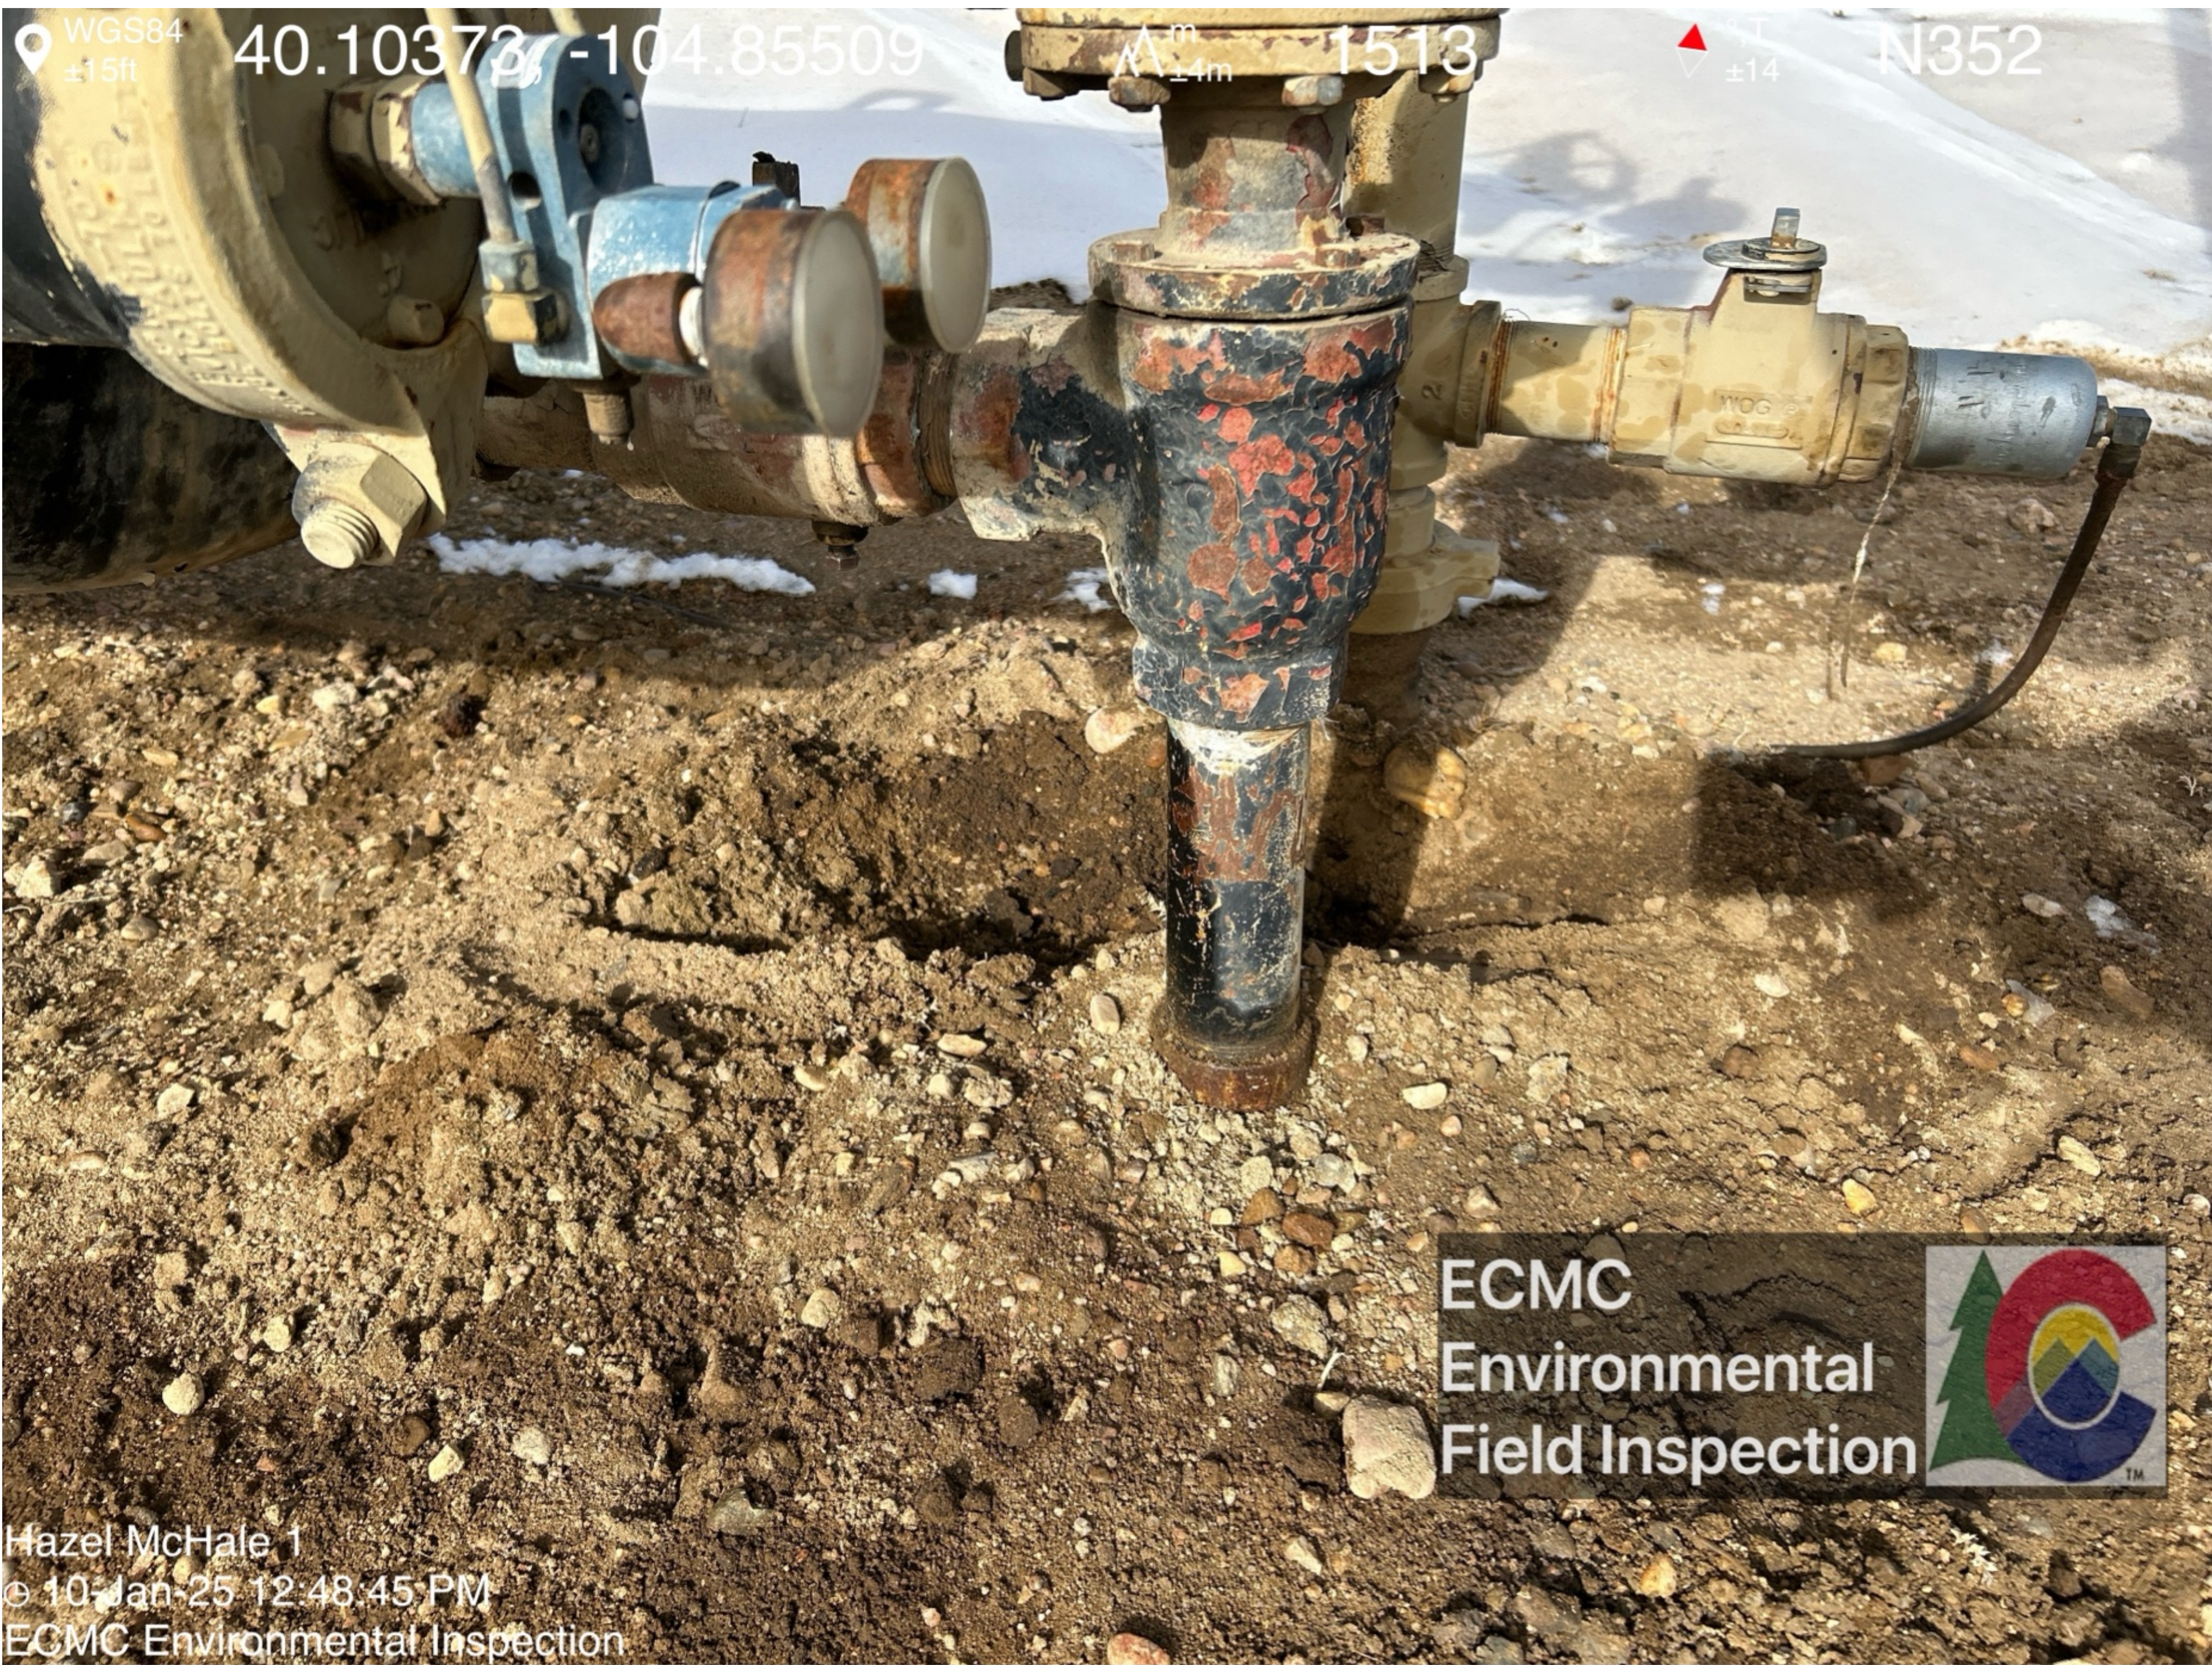
Approximate spill location. Very strong petroleum hydrocarbon odor observed. Petroleum hydrocarbon staining observed under a thin layer of unstained fill material.

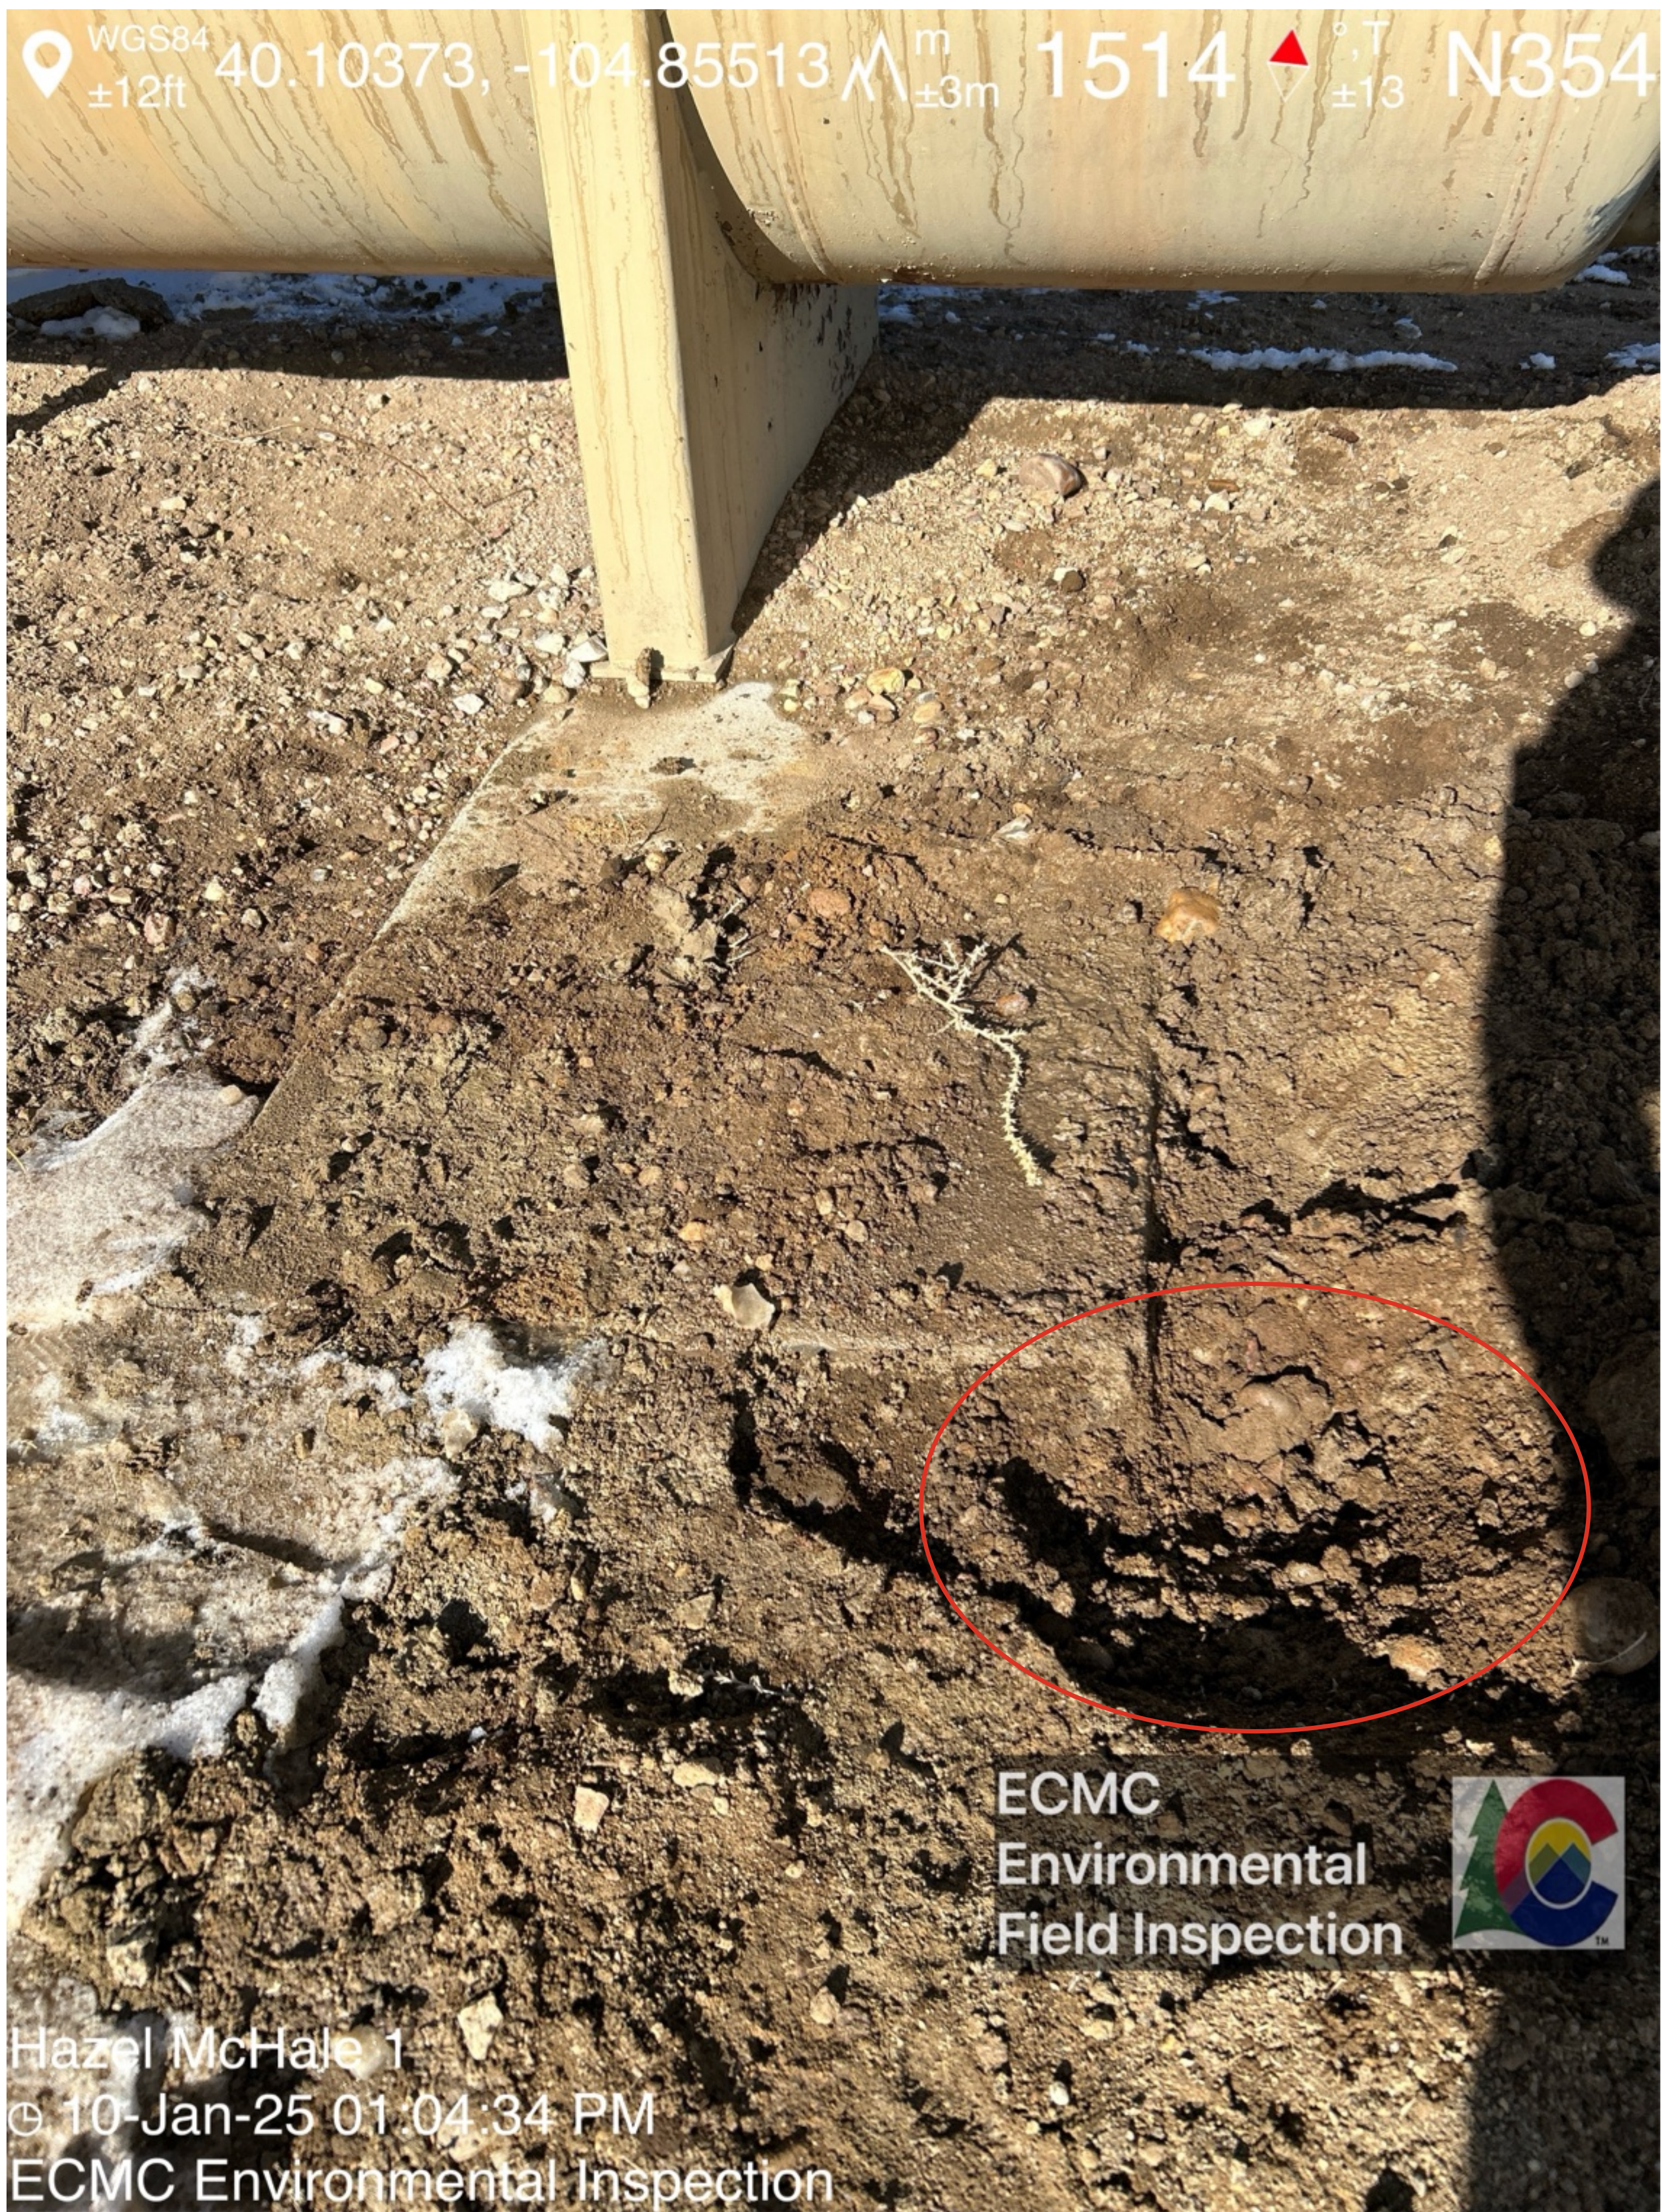
Approximate spill location. Very strong petroleum hydrocarbon odor observed when soil was disturbed. Petroleum hydrocarbon staining observed under a thin layer of unstained fill material. Soil sample location SS-02@0-6".
