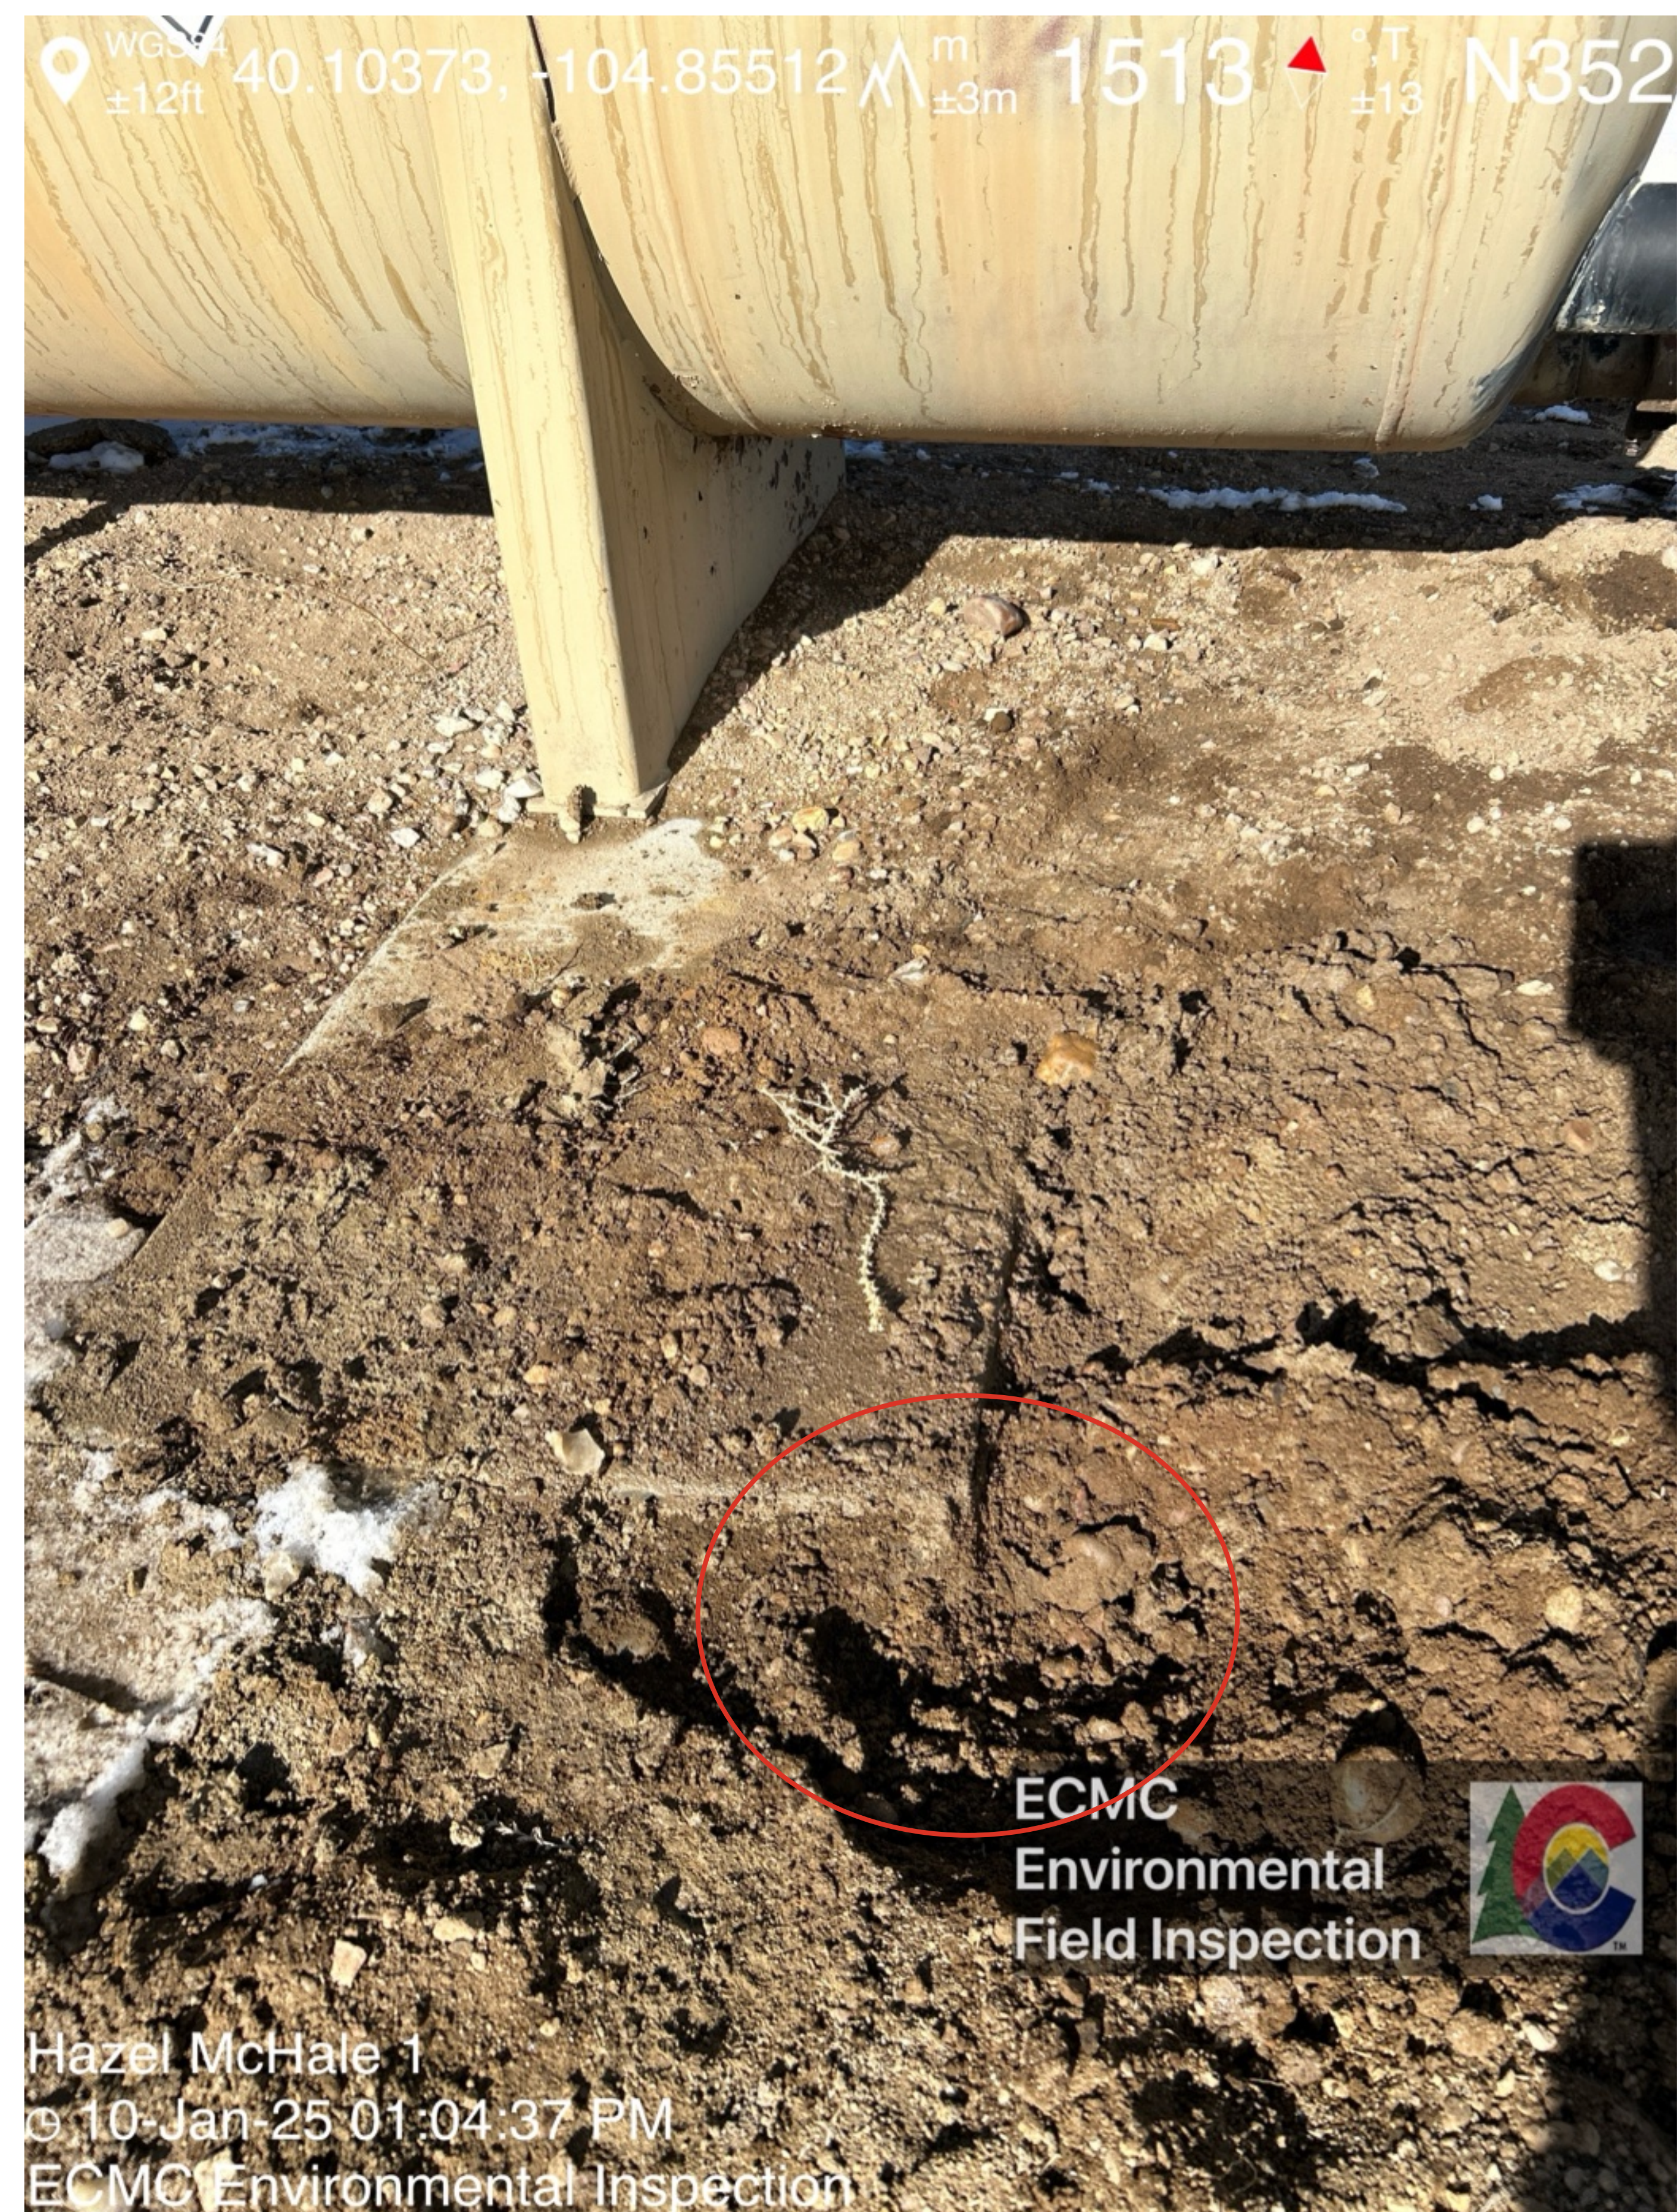
Approximate spill location. Very strong petroleum hydrocarbon odor observed when soil was disturbed. Petroleum hydrocarbon staining observed under a thin layer of unstained fill material. Soil sample location SS-02@0-6".

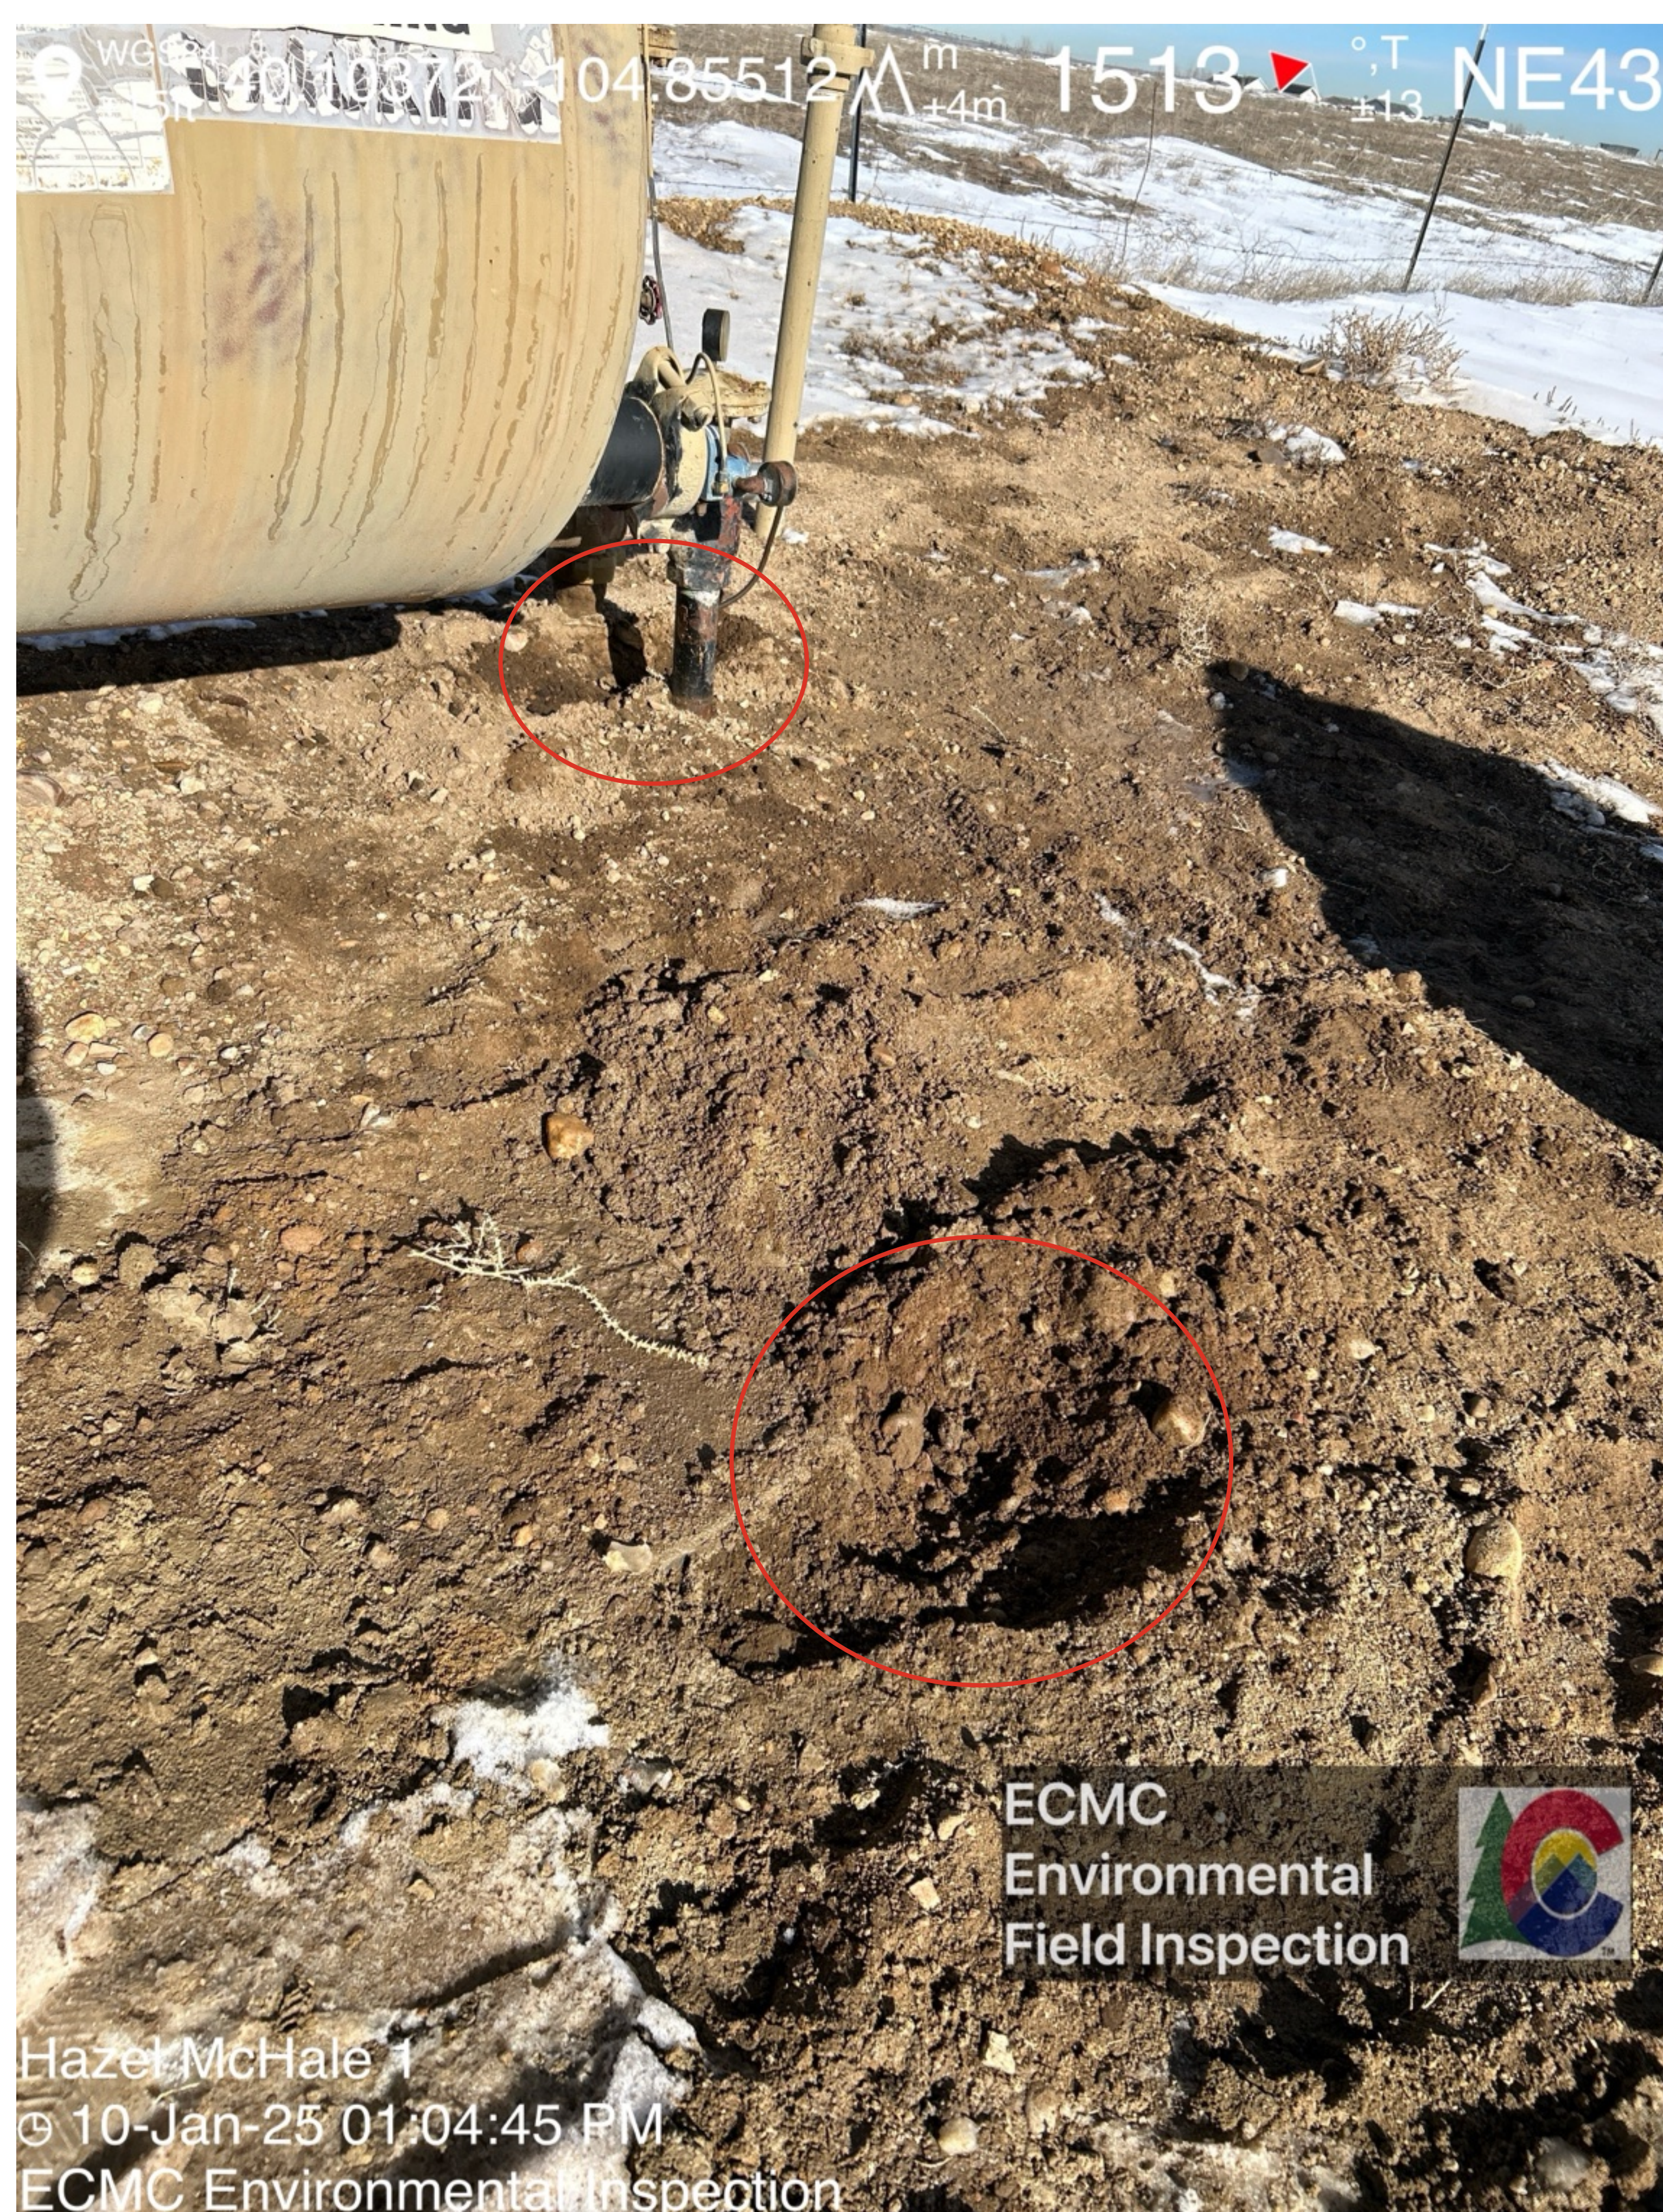
Approximate spill location. Soil sample location SS-02@0-6" visible in foreground and SS-01@0-6" visible in background.

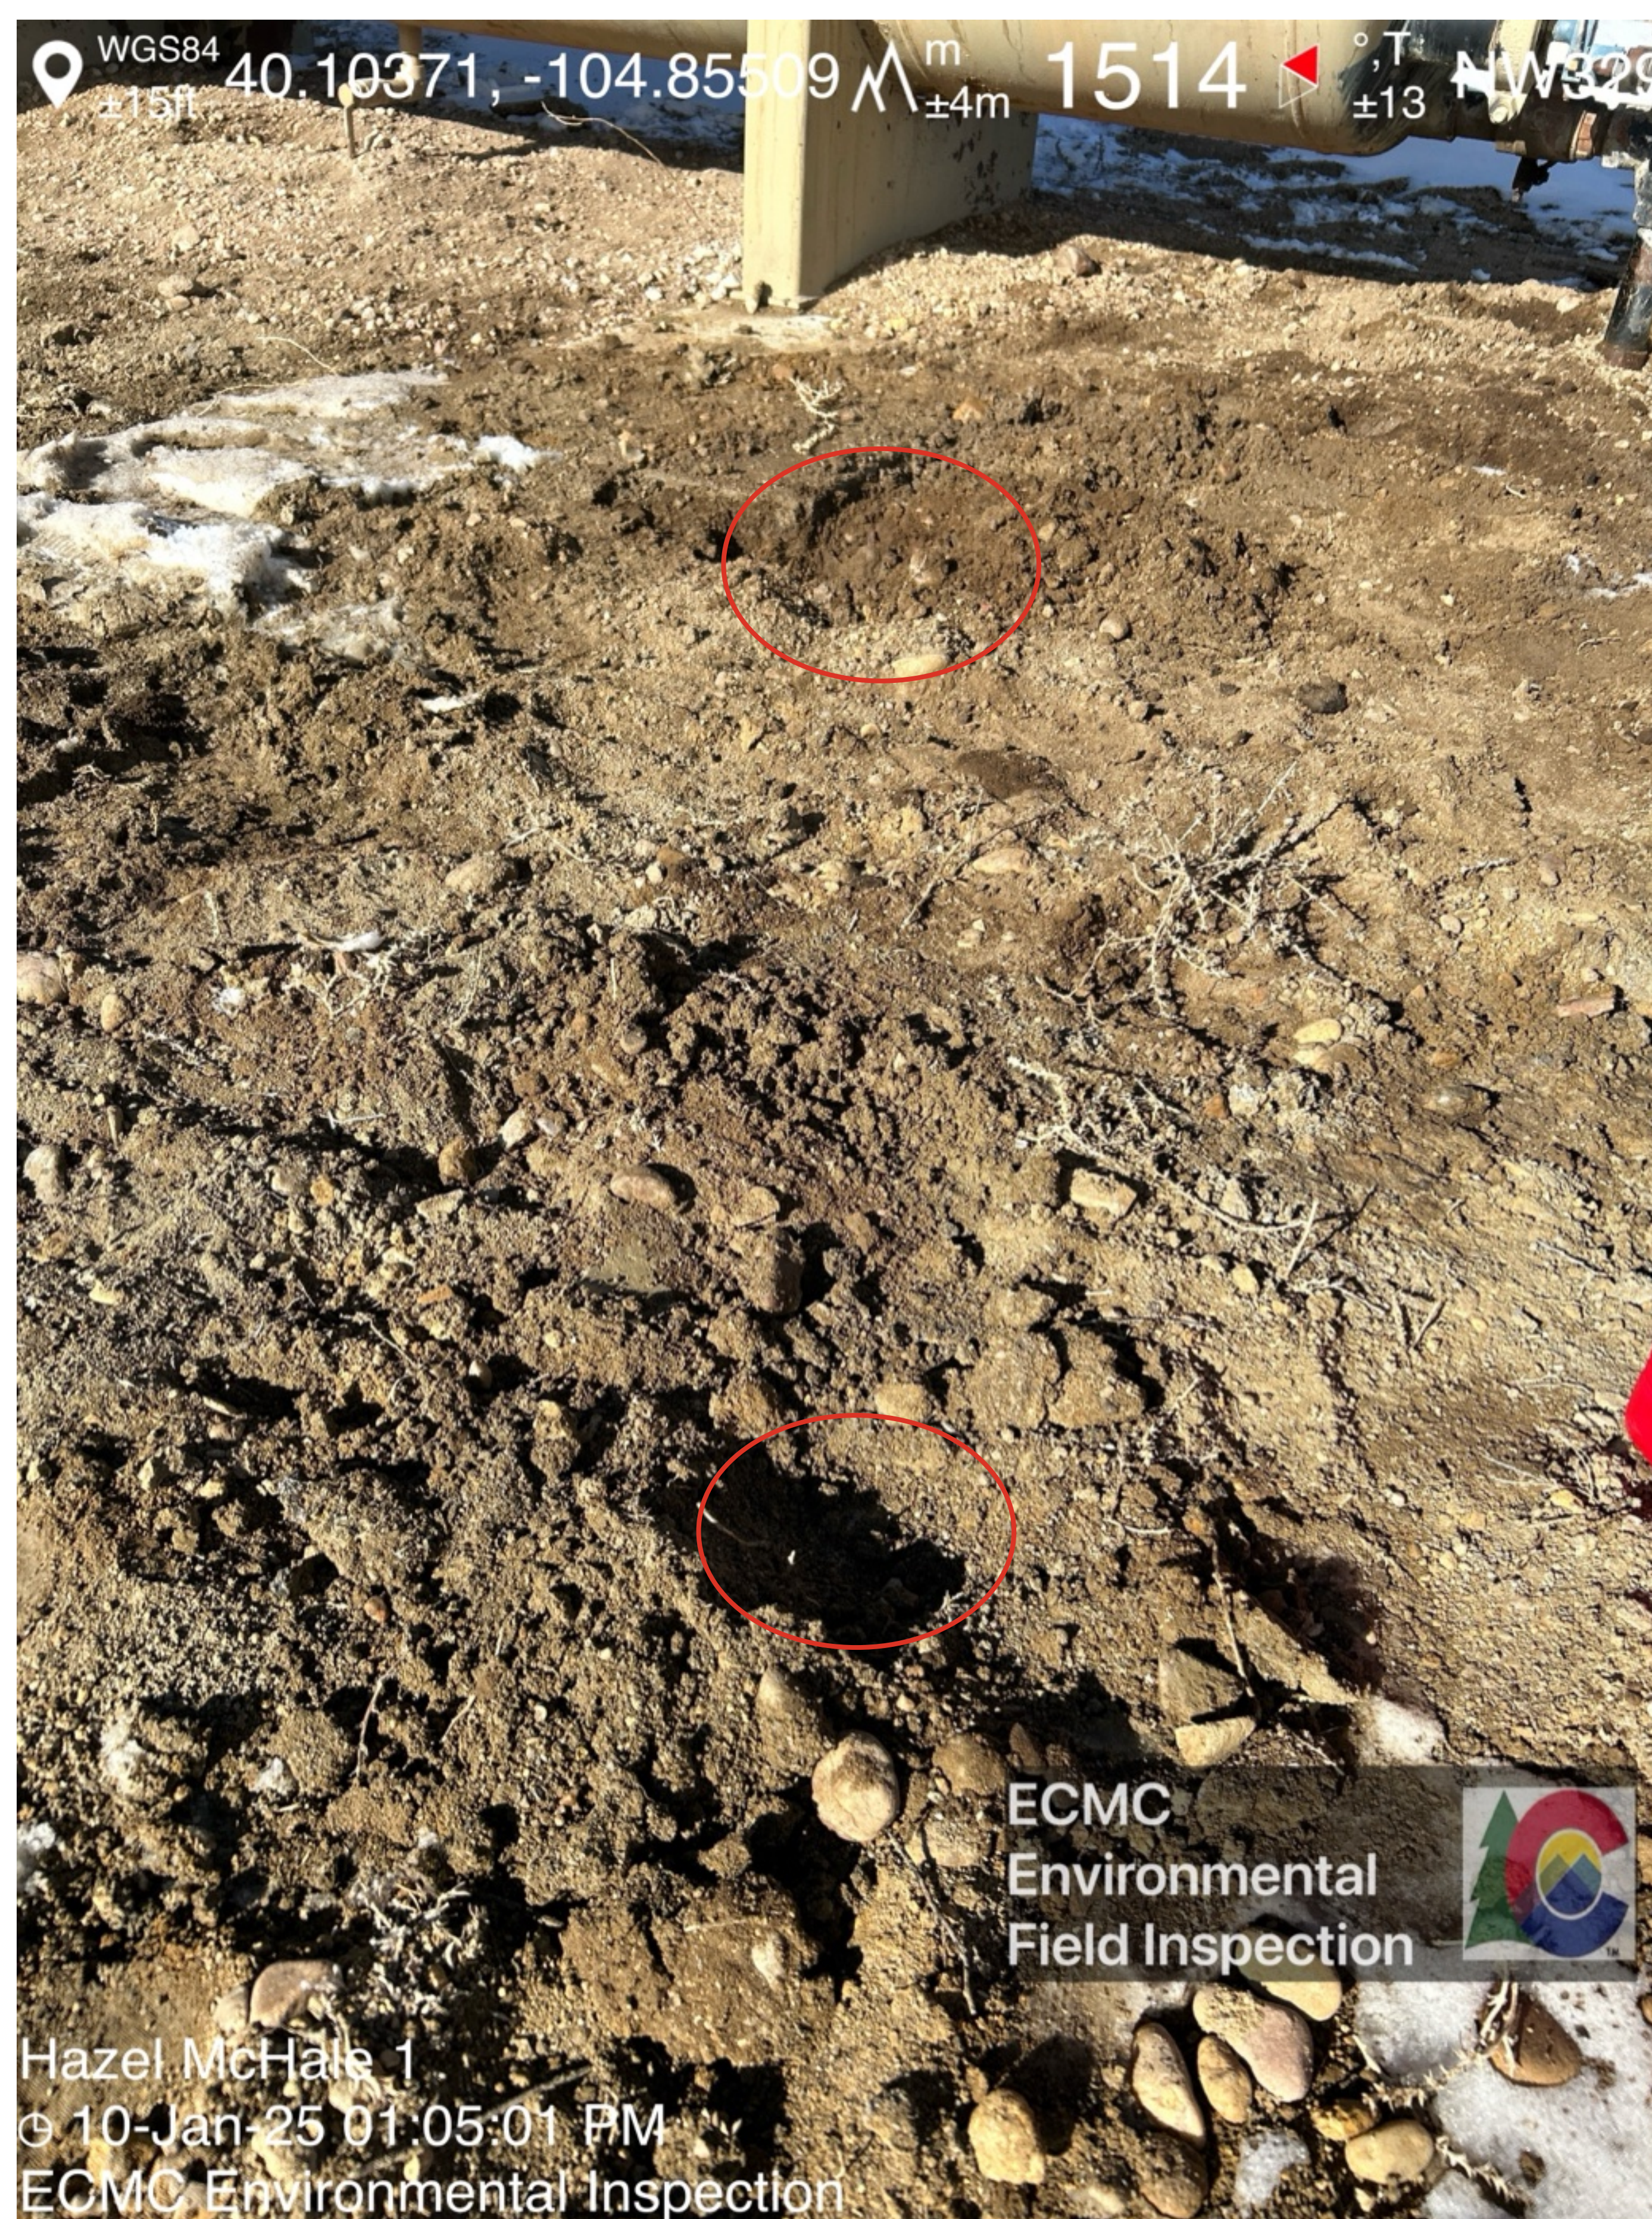
Approximate spill location. Soil sample location SS-03@0-6" visible in foreground and SS-02@0-6" visible in background.

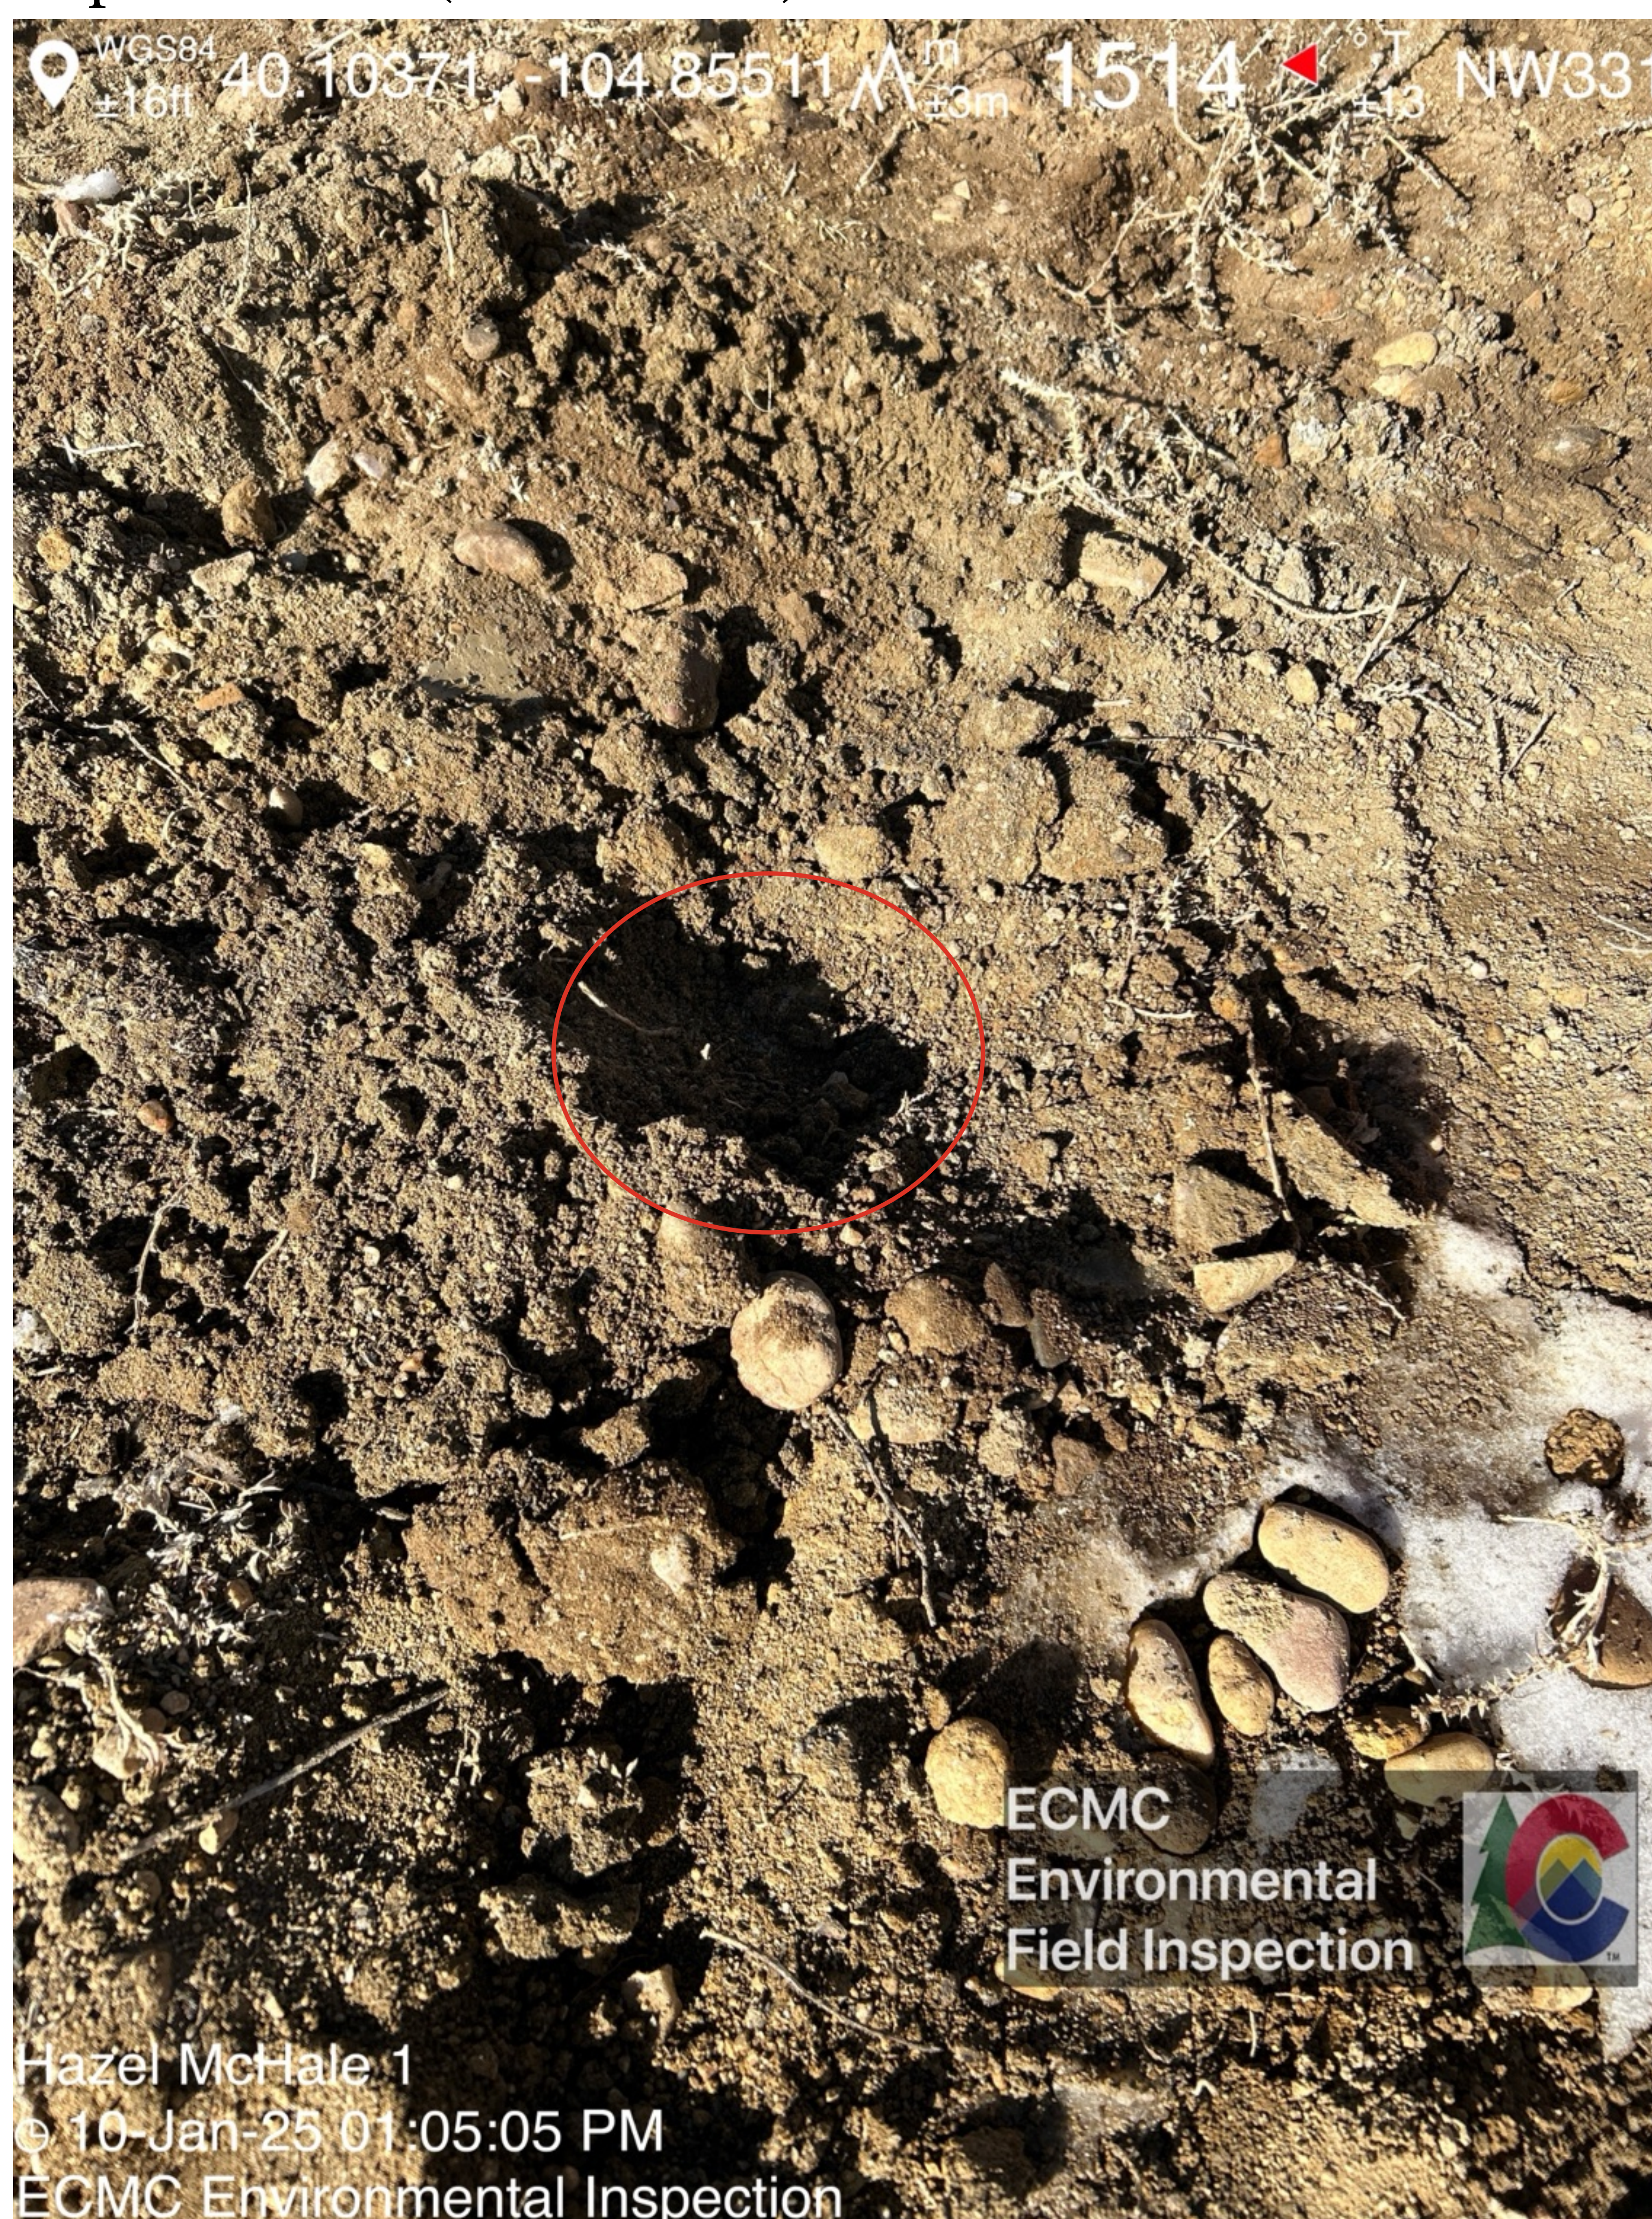
Approximate spill location. Slight petroleum hydrocarbon odor observed when soil was disturbed. Petroleum hydrocarbon staining observed under a thin layer of unstained fill material. Soil sample location (SS-03@0-6").

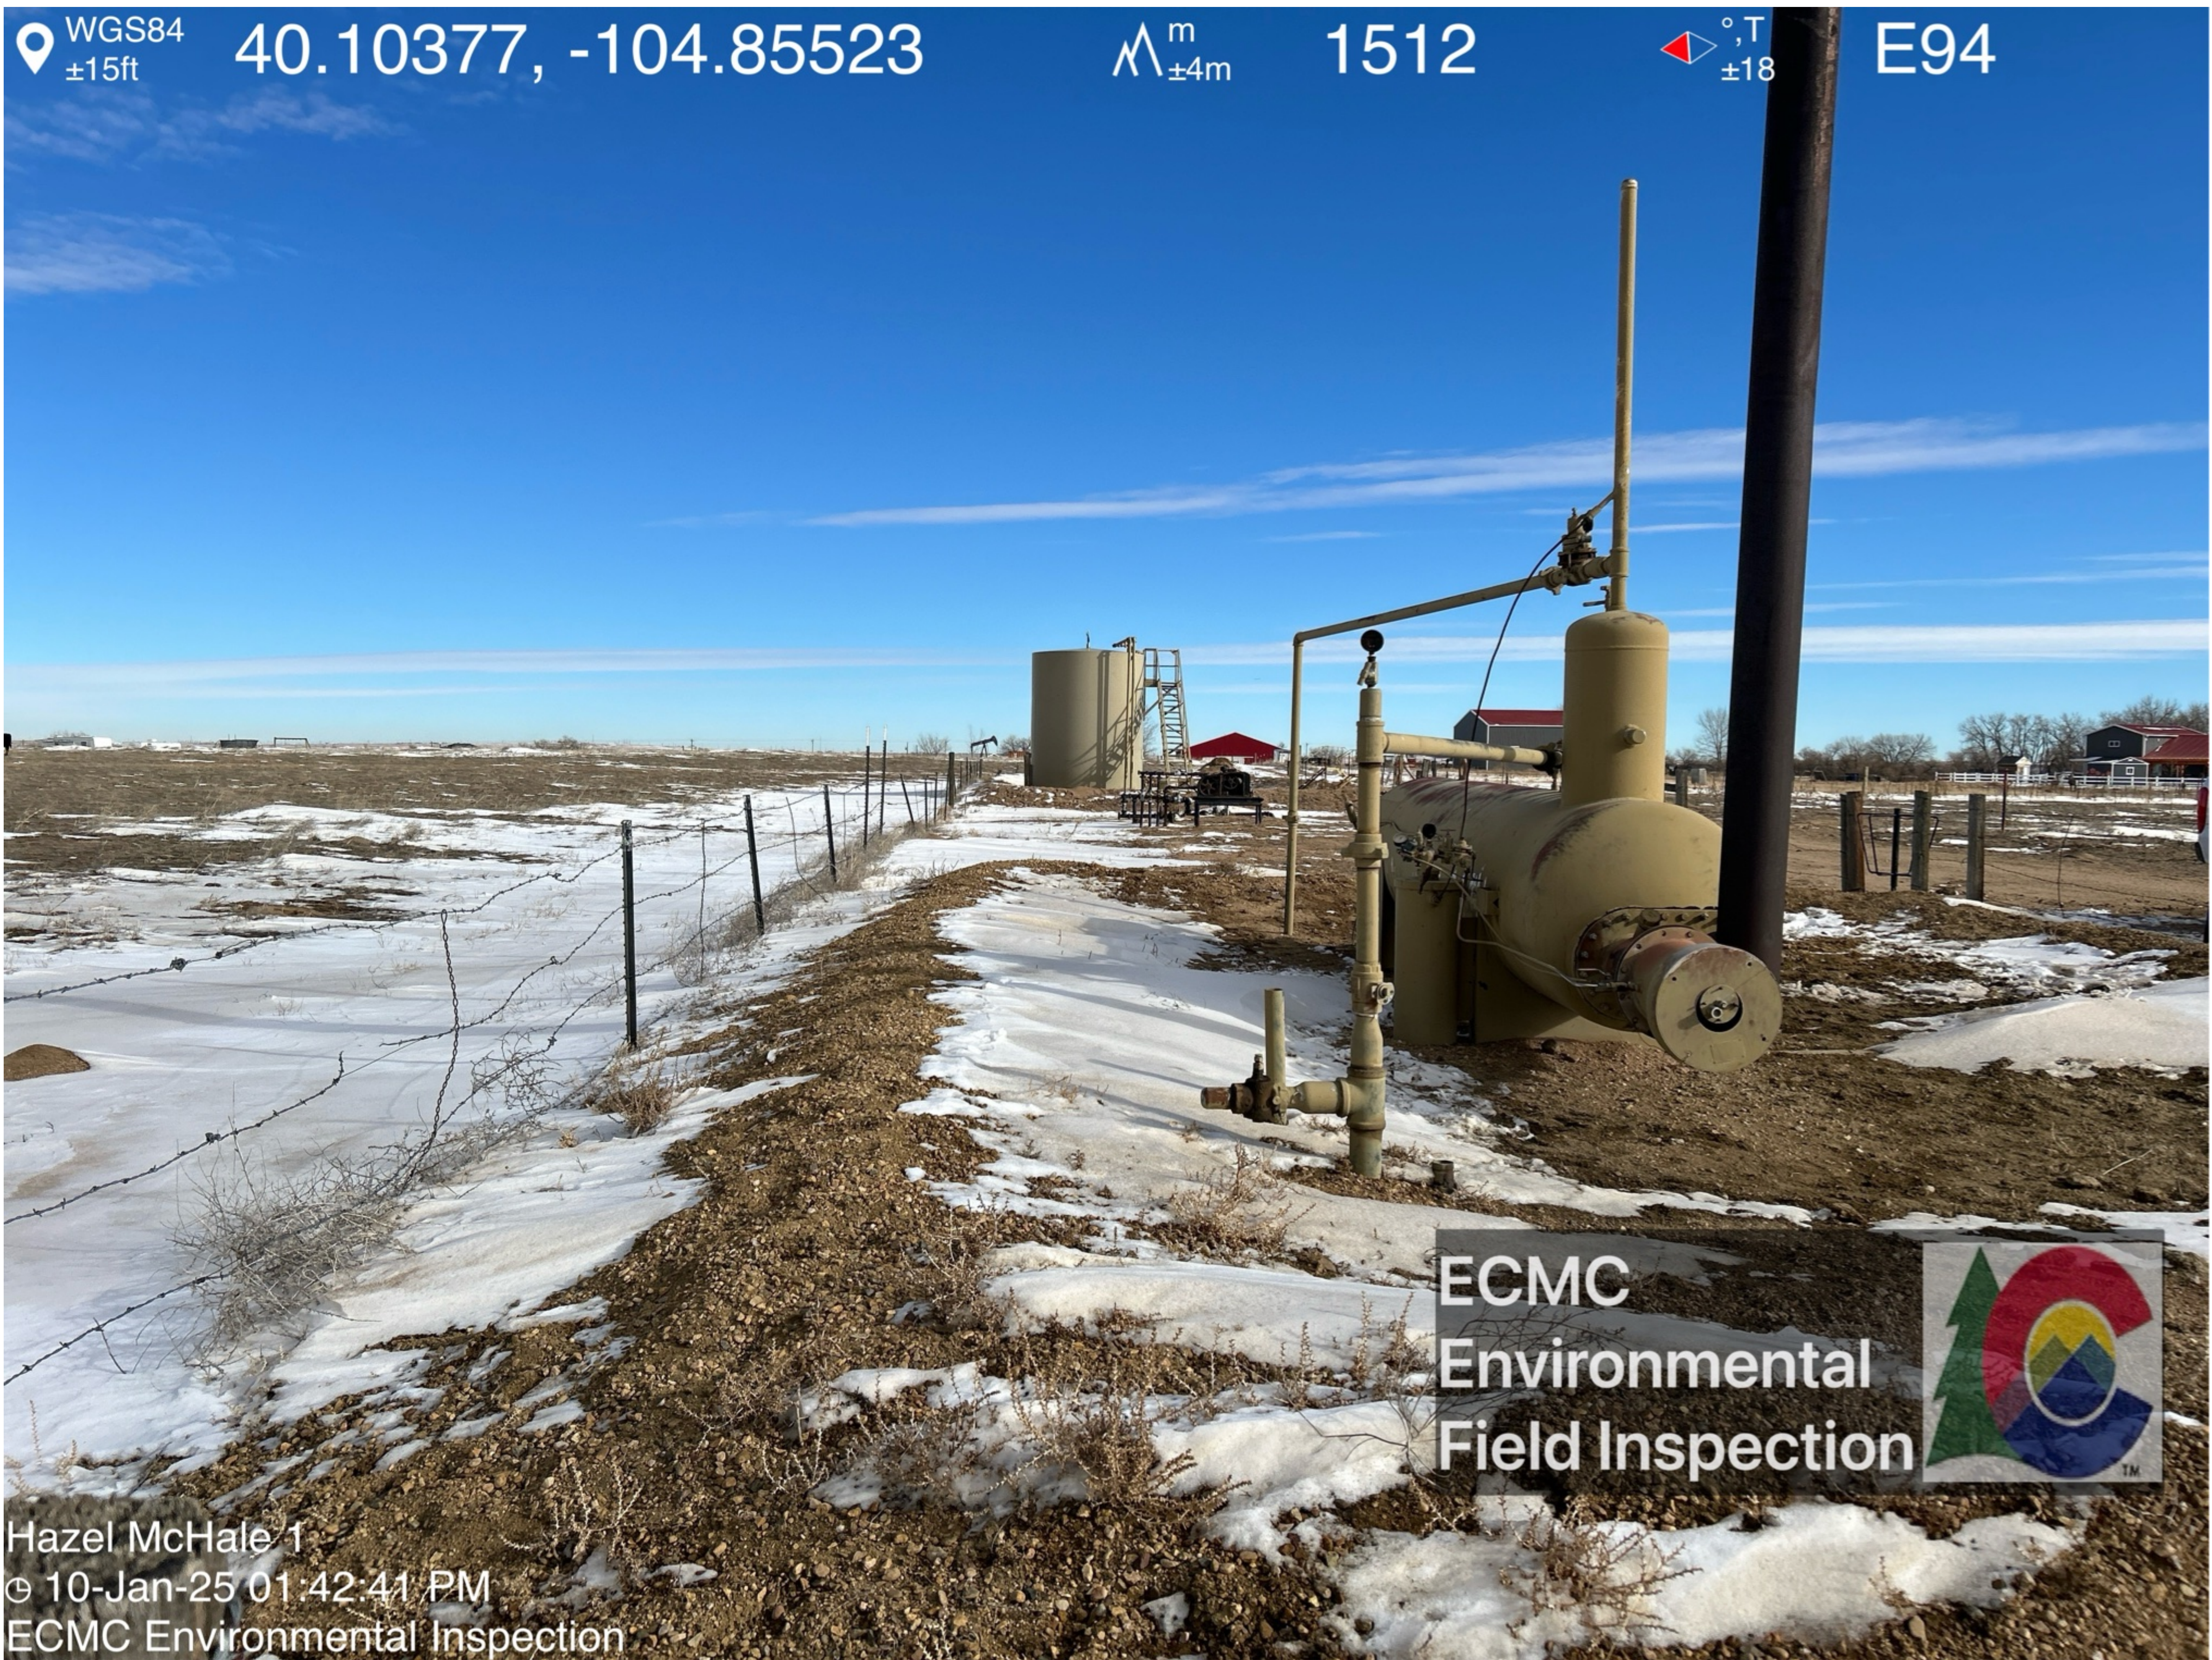
Fencing surrounding tank containment, ancillary equipment, separator, and spill area observed open and in poor condition.

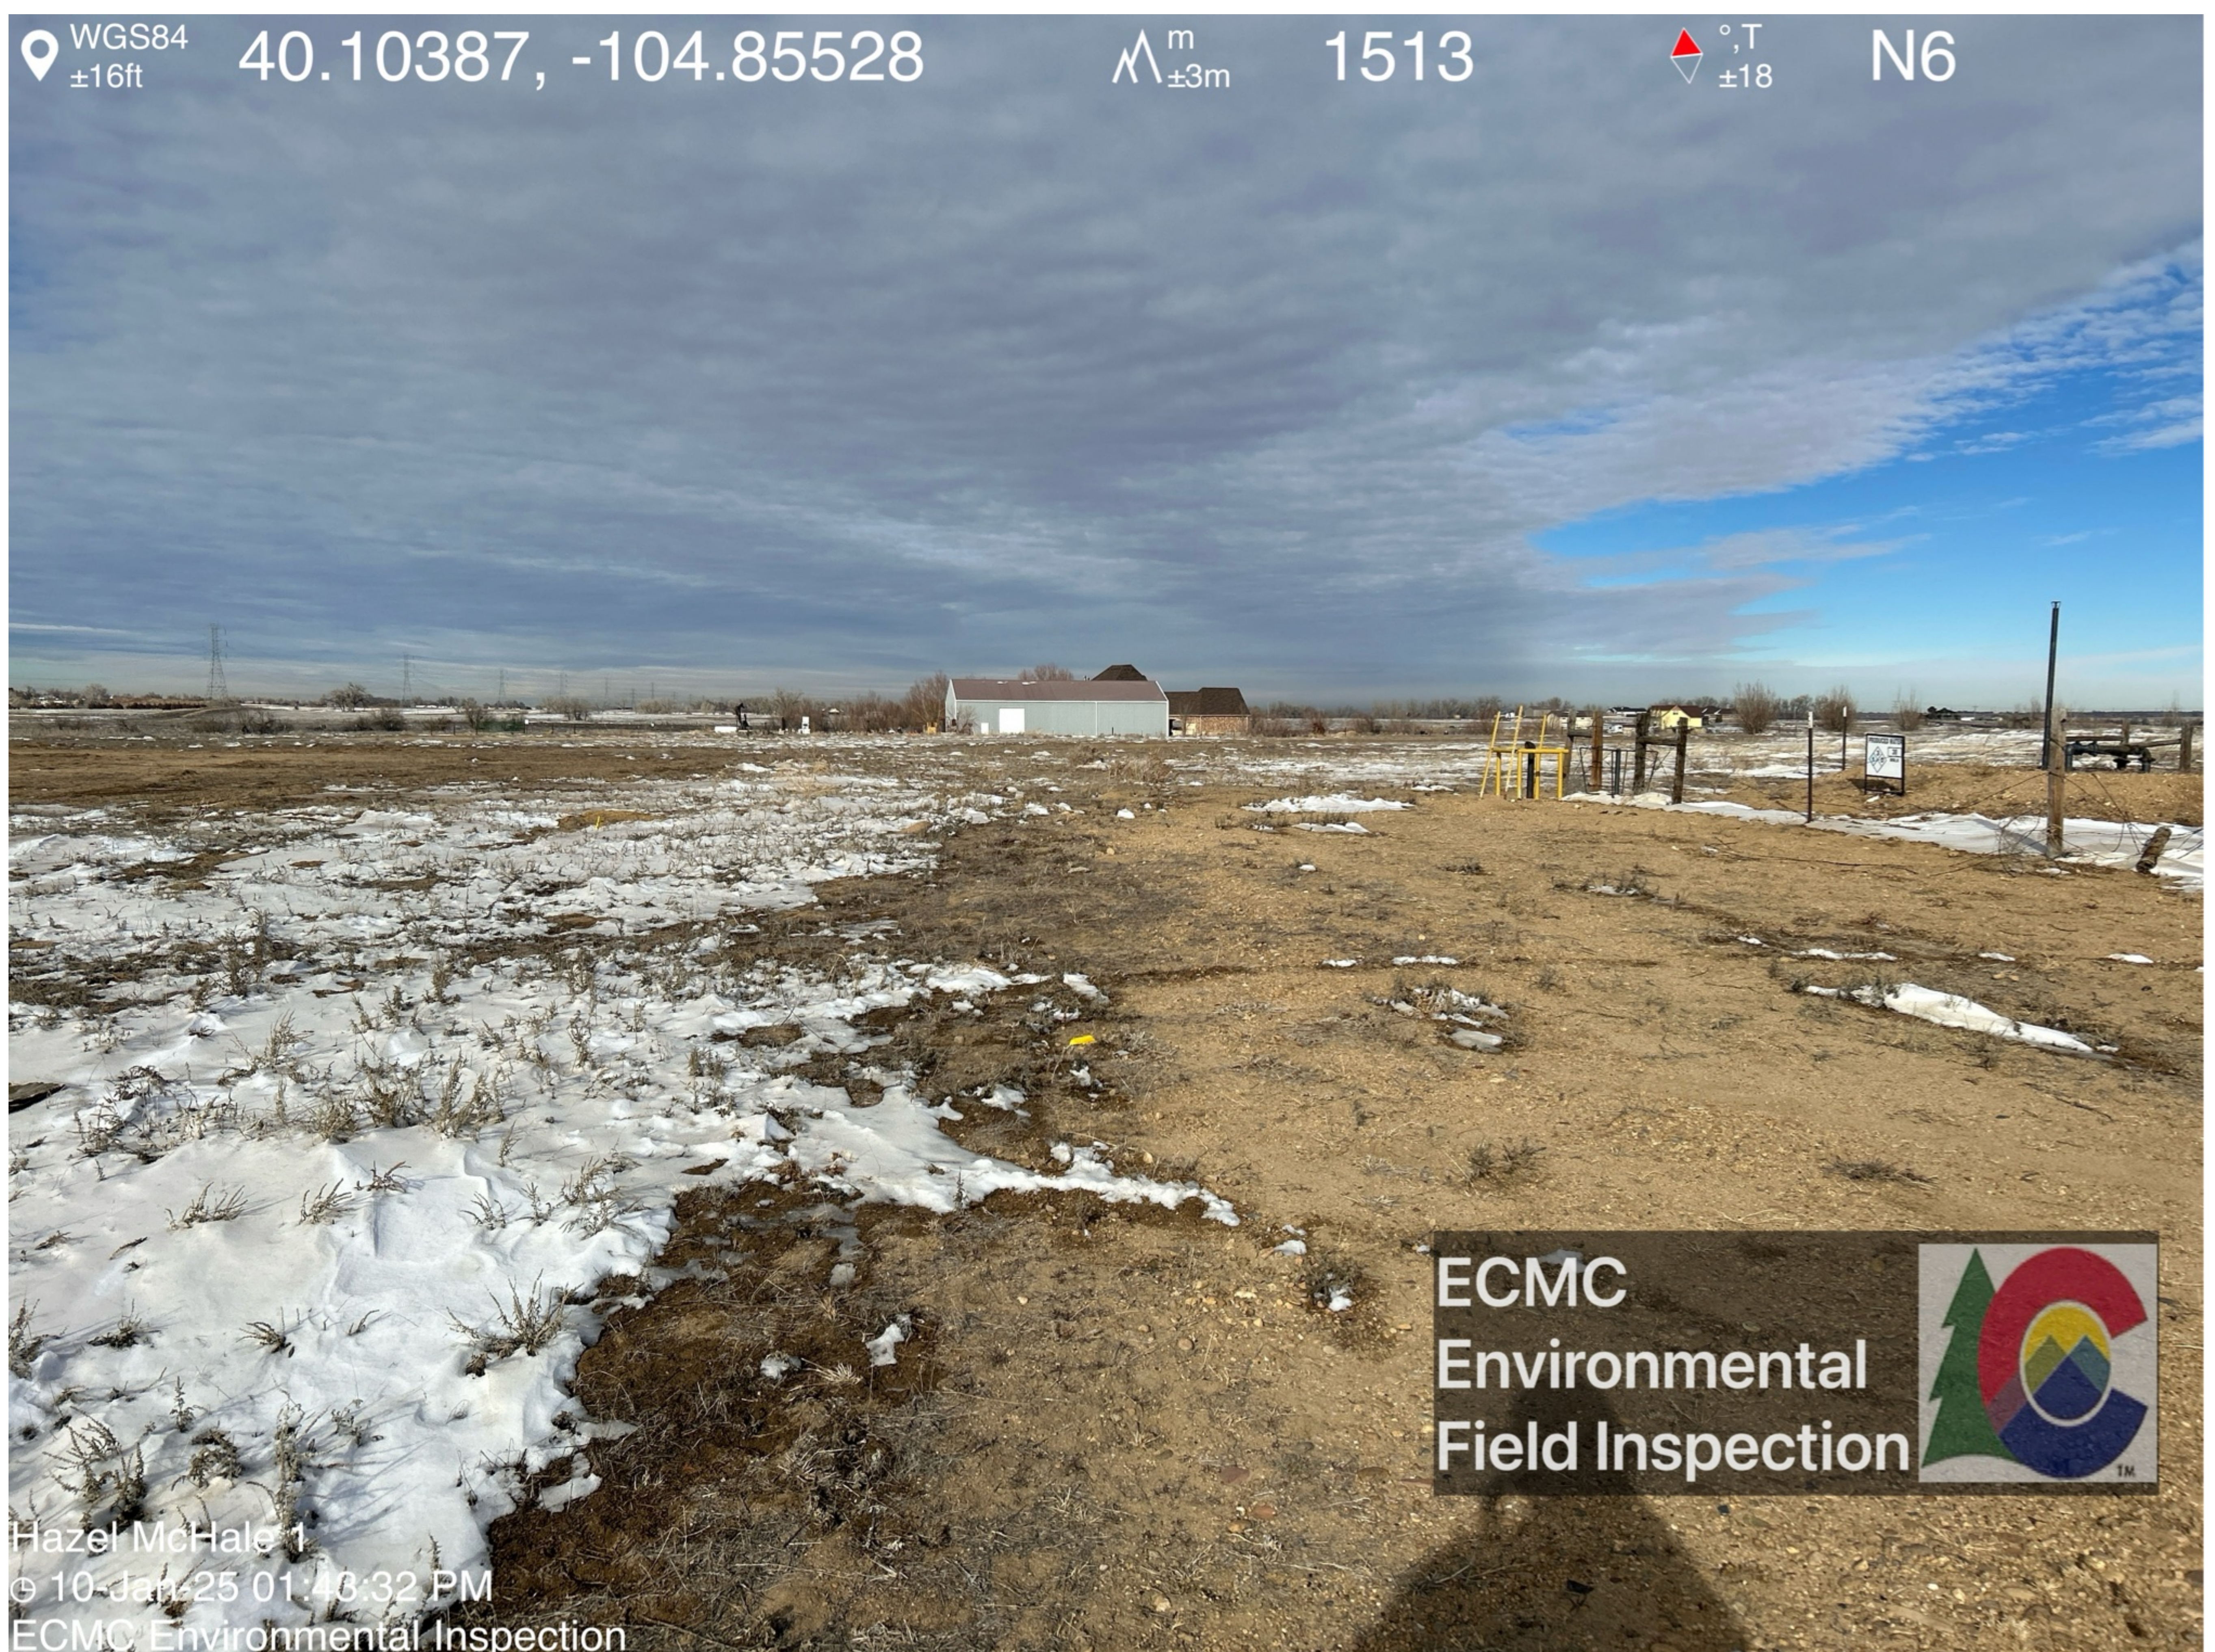
Vegetation was observed present in the surrounding area but absent immediately adjacent to the produced water vault.
