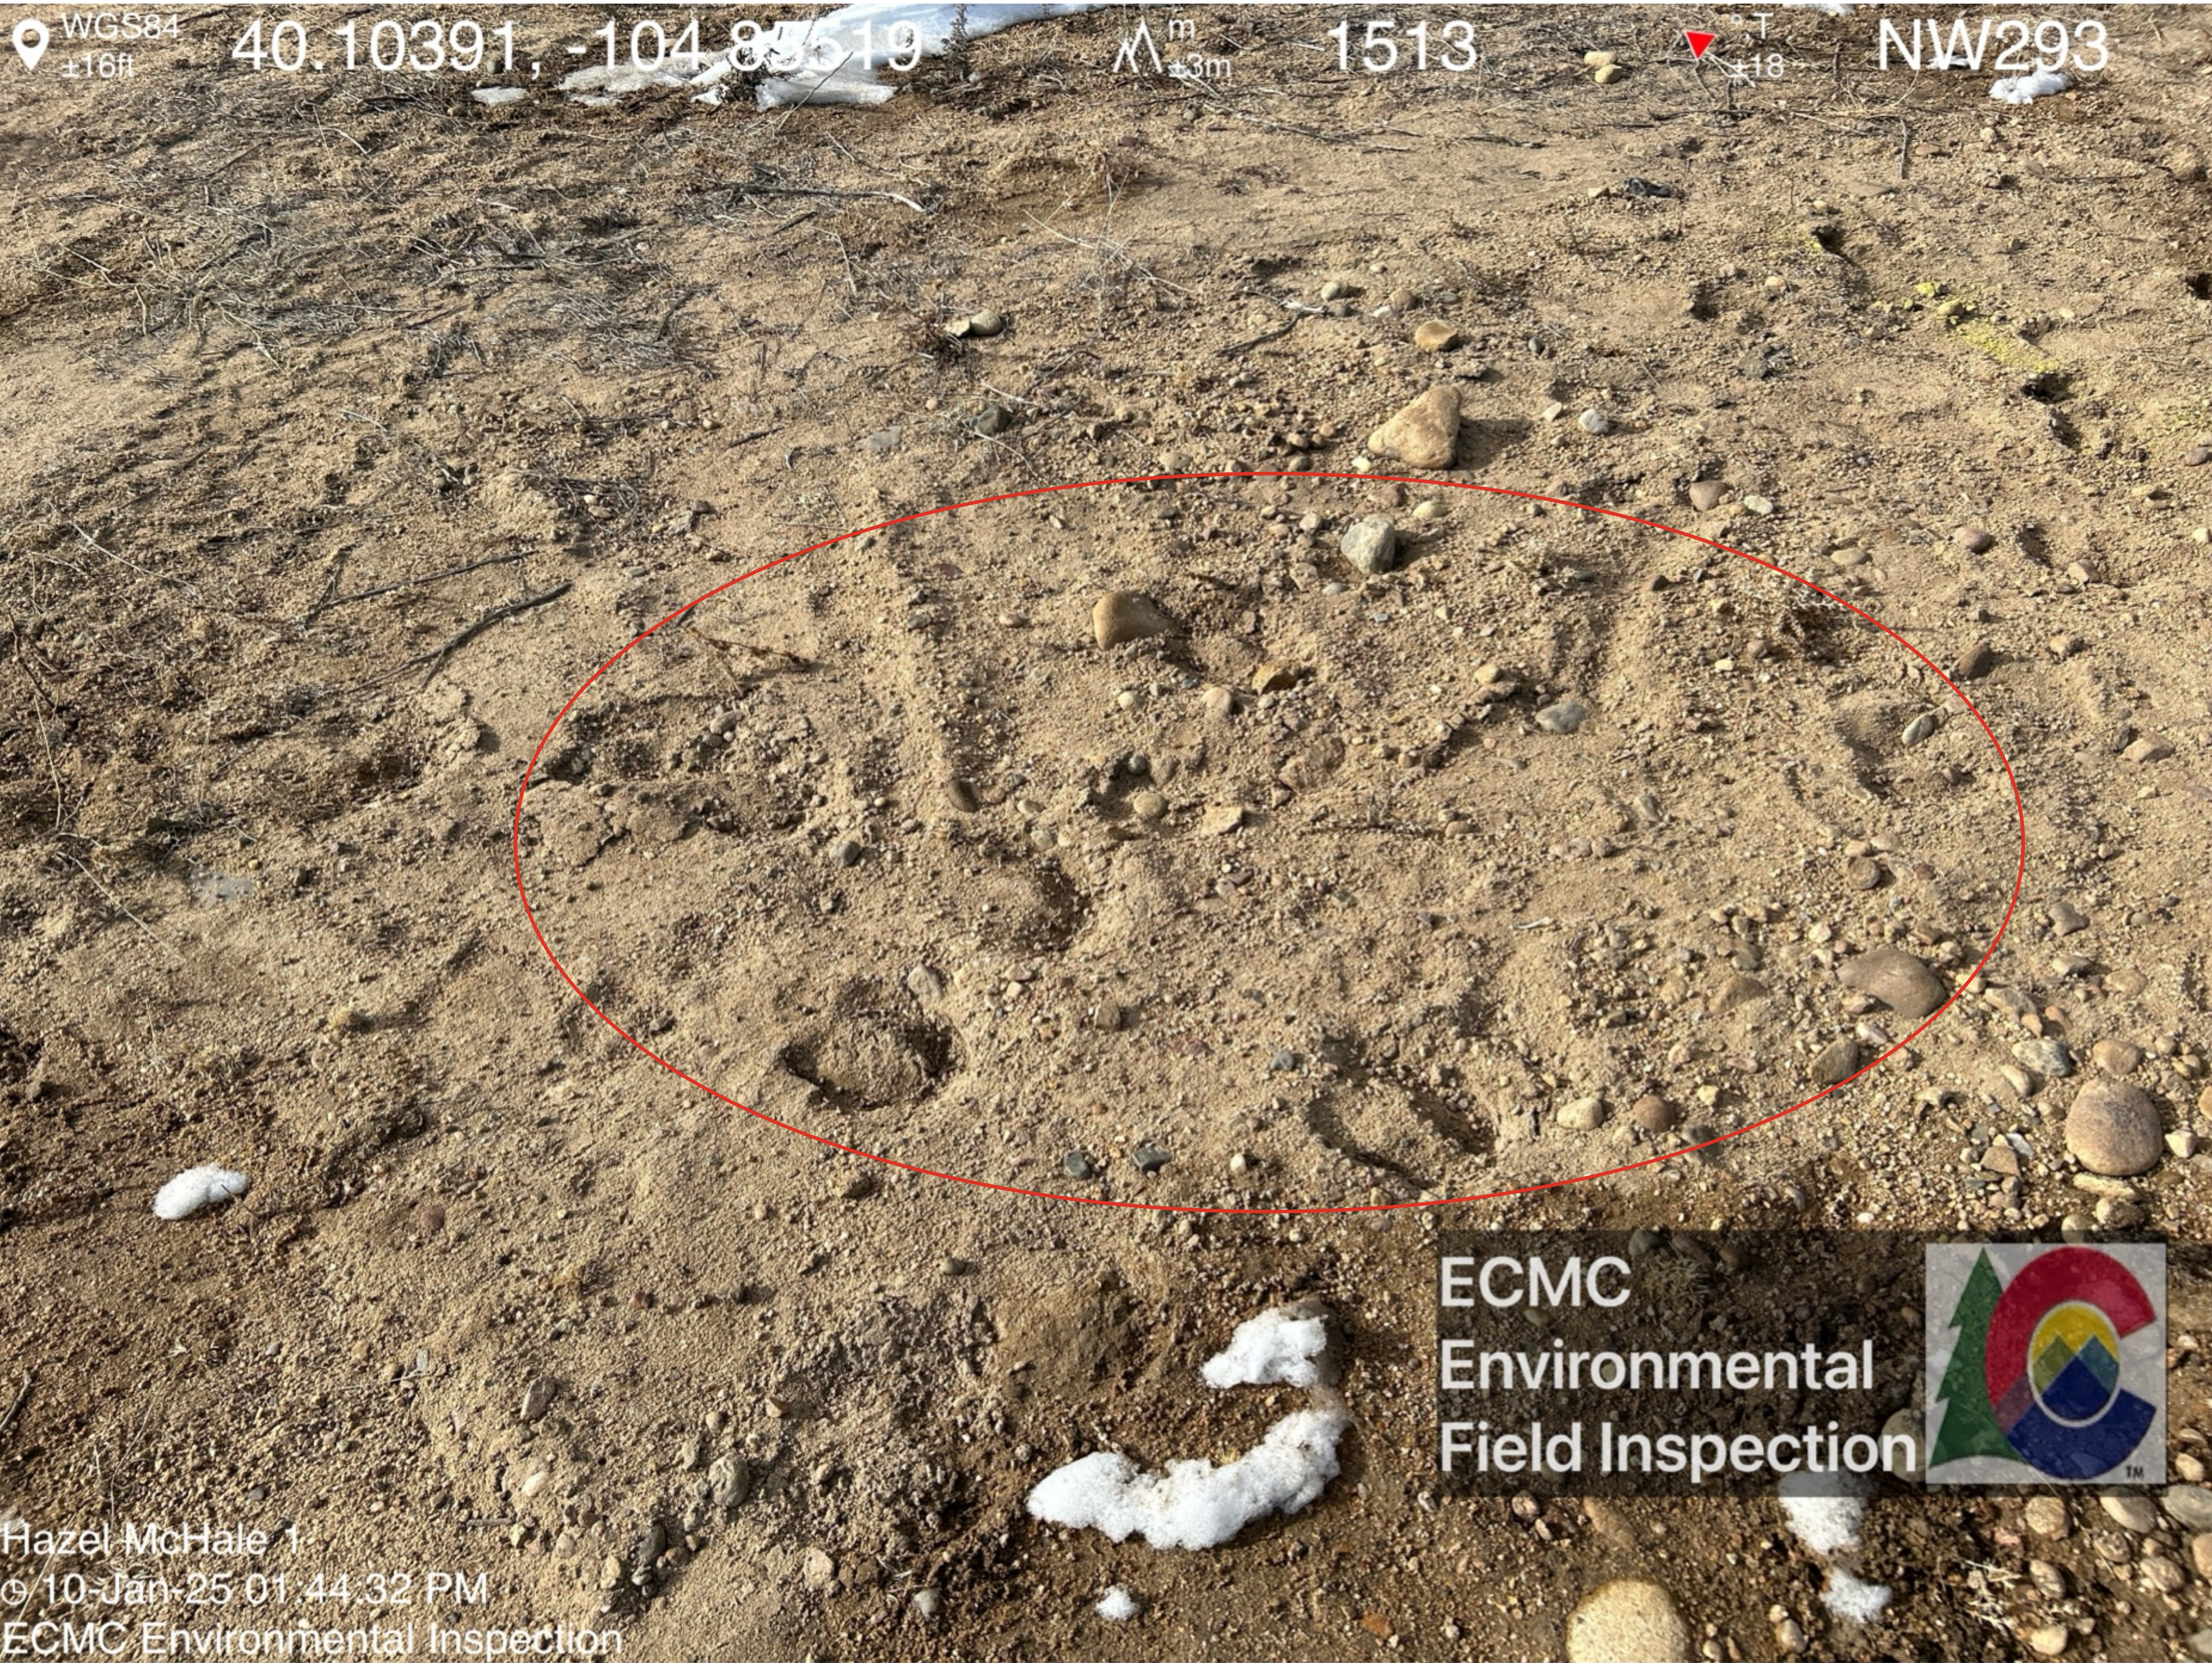
Livestock tracks adjacent to the produced water vault.

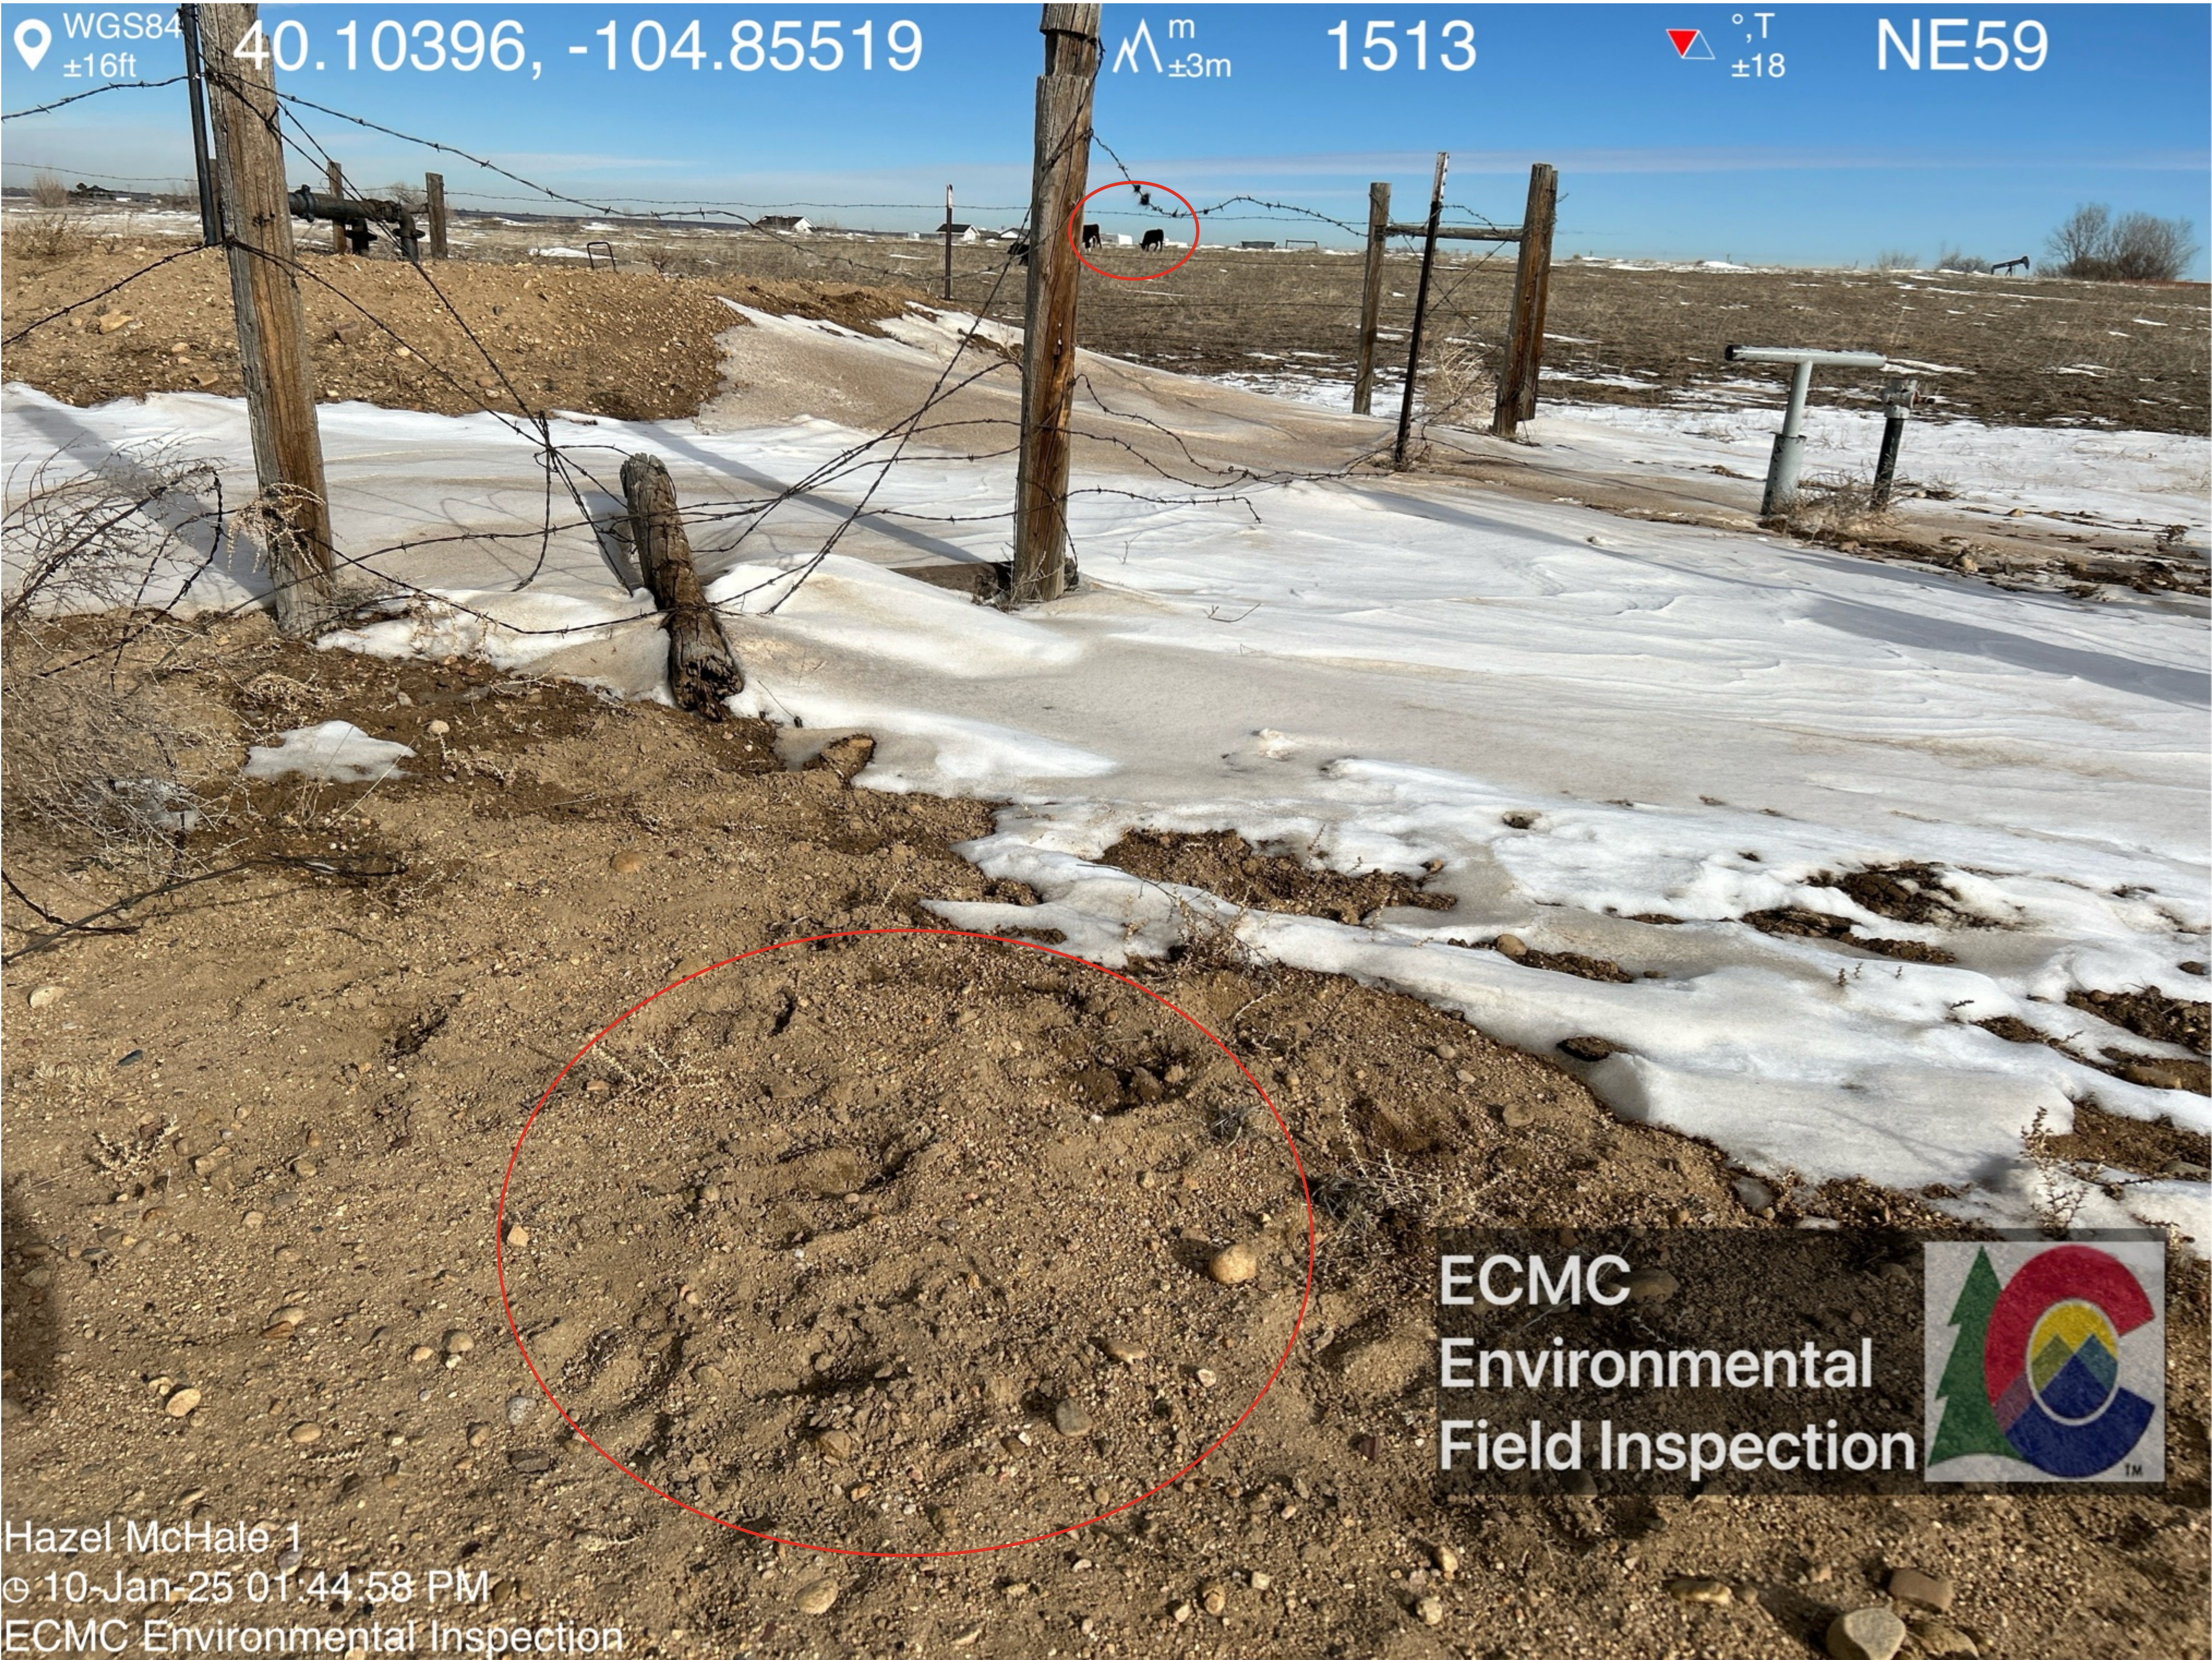
Fencing in poor condition. Livestock tracks adjacent to the produced water vault.

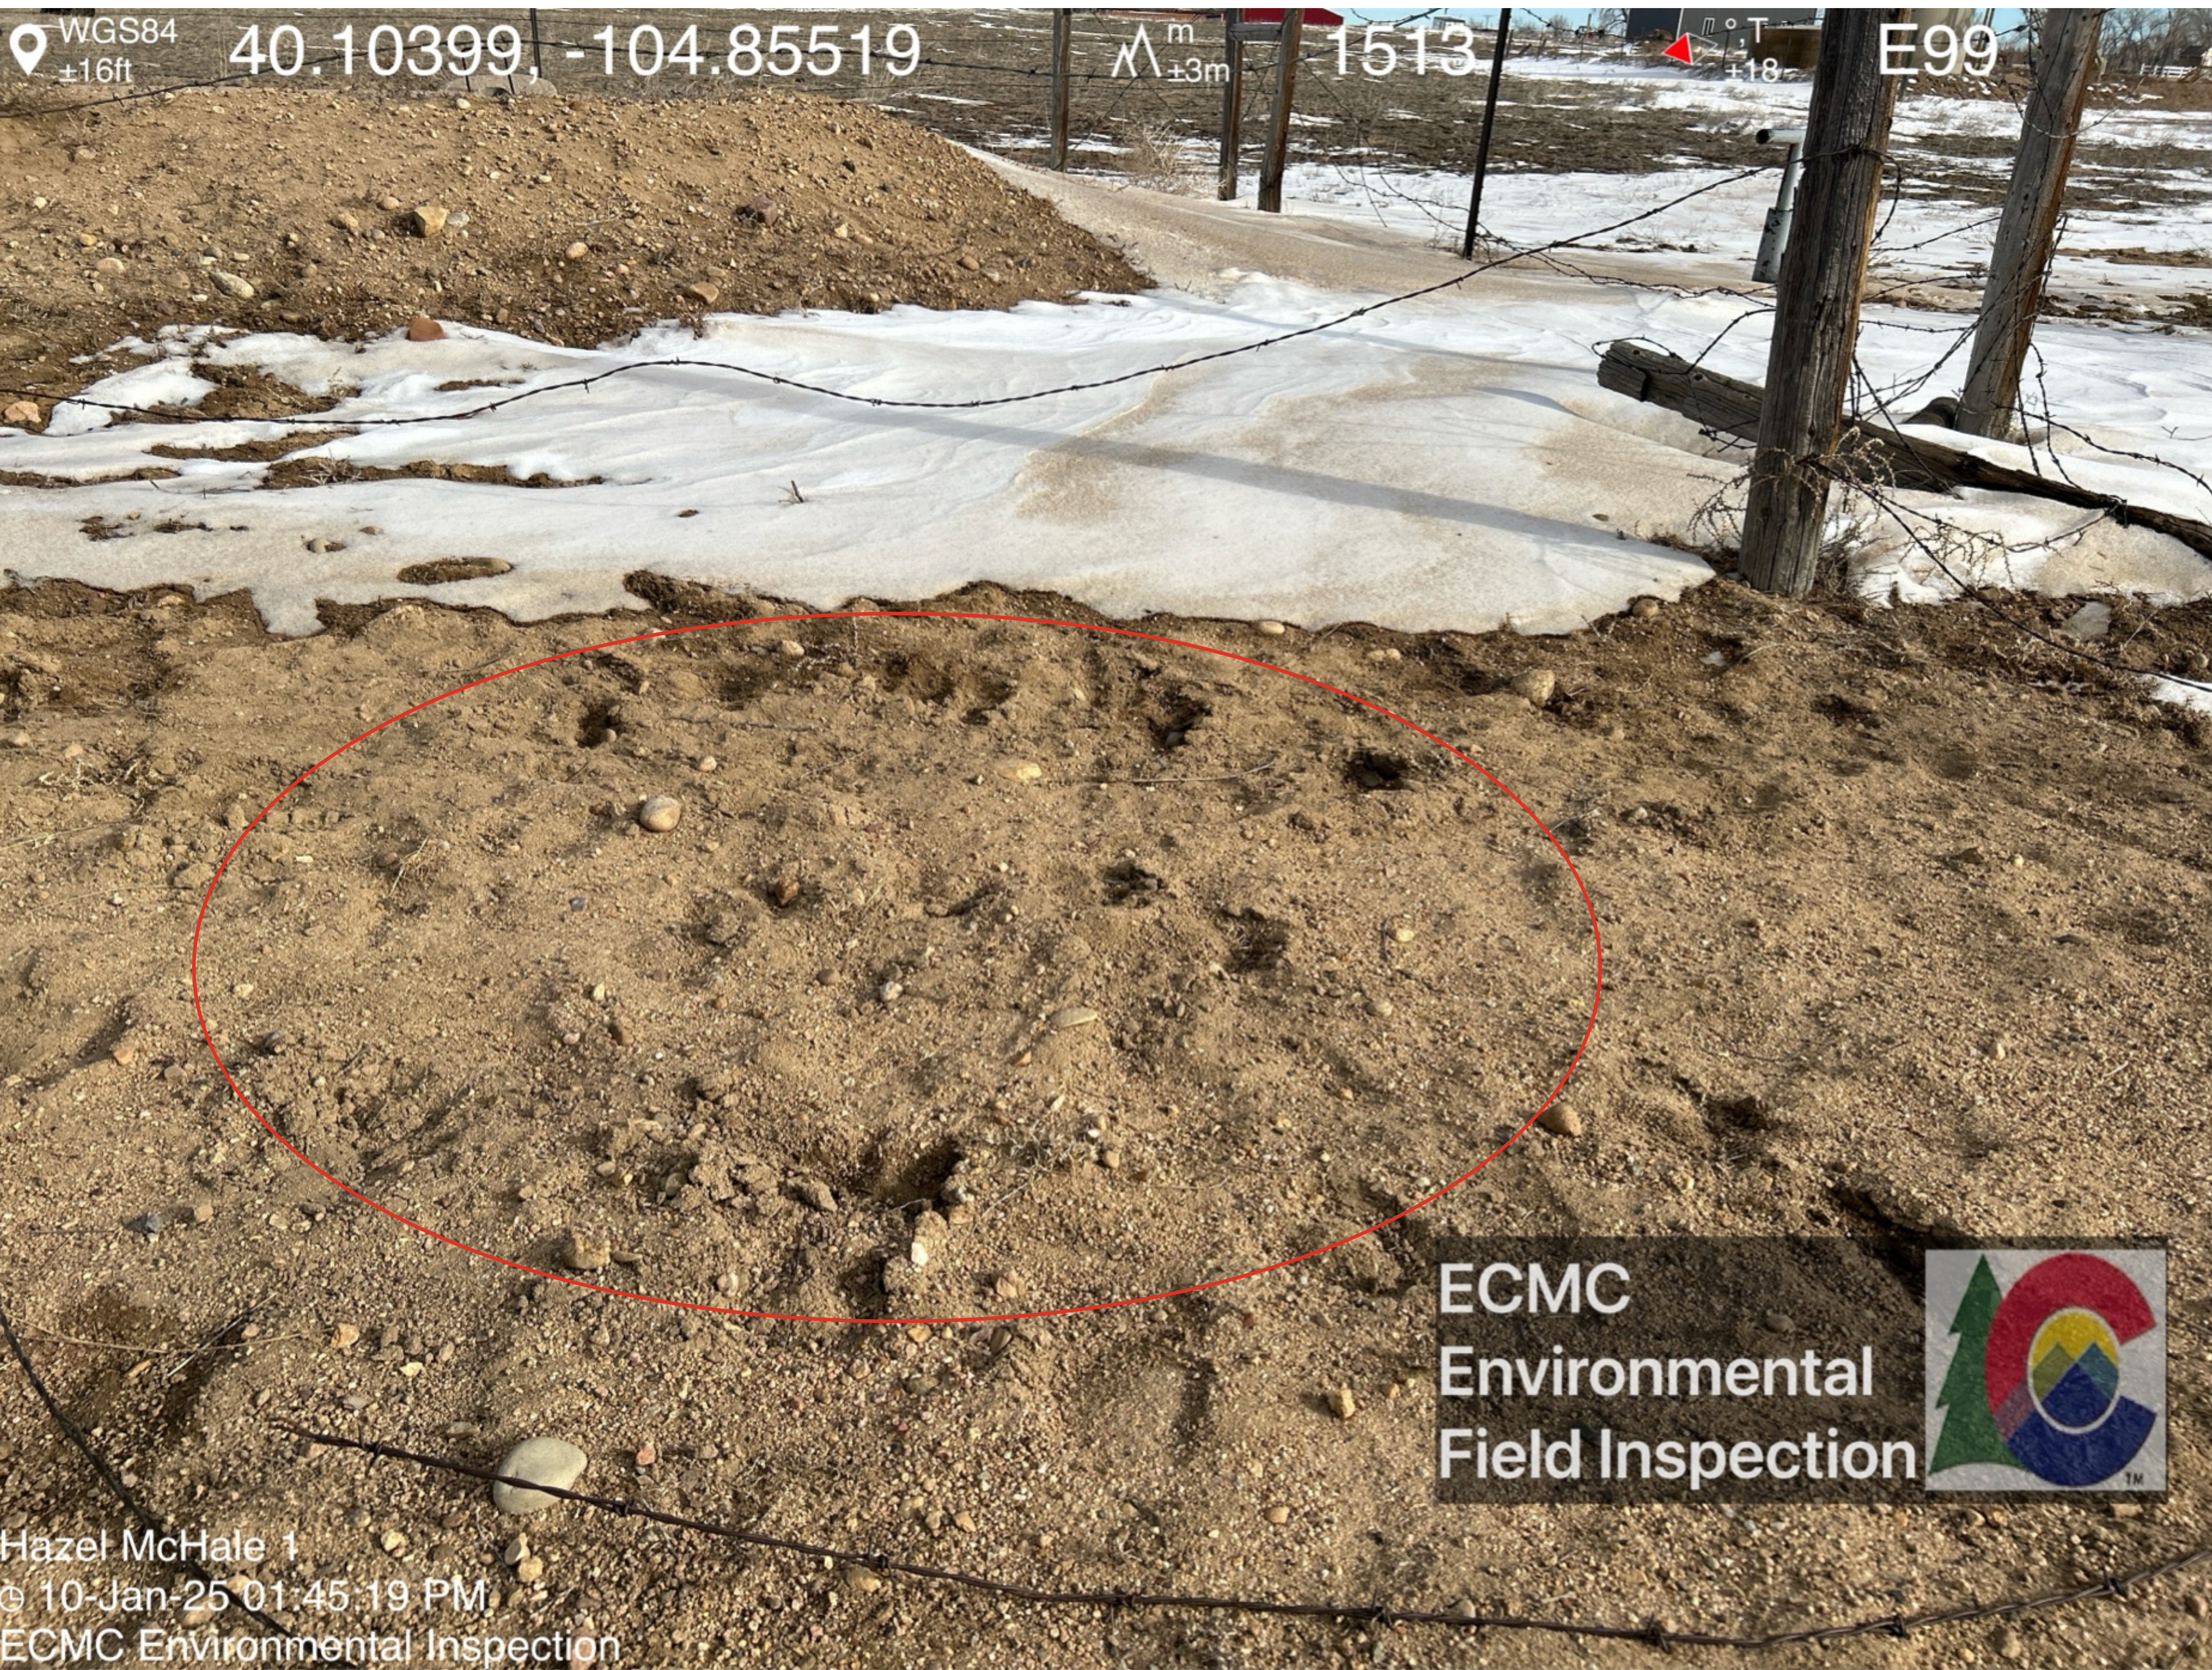
Fencing in poor condition. Livestock tracks adjacent to the produced water vault.

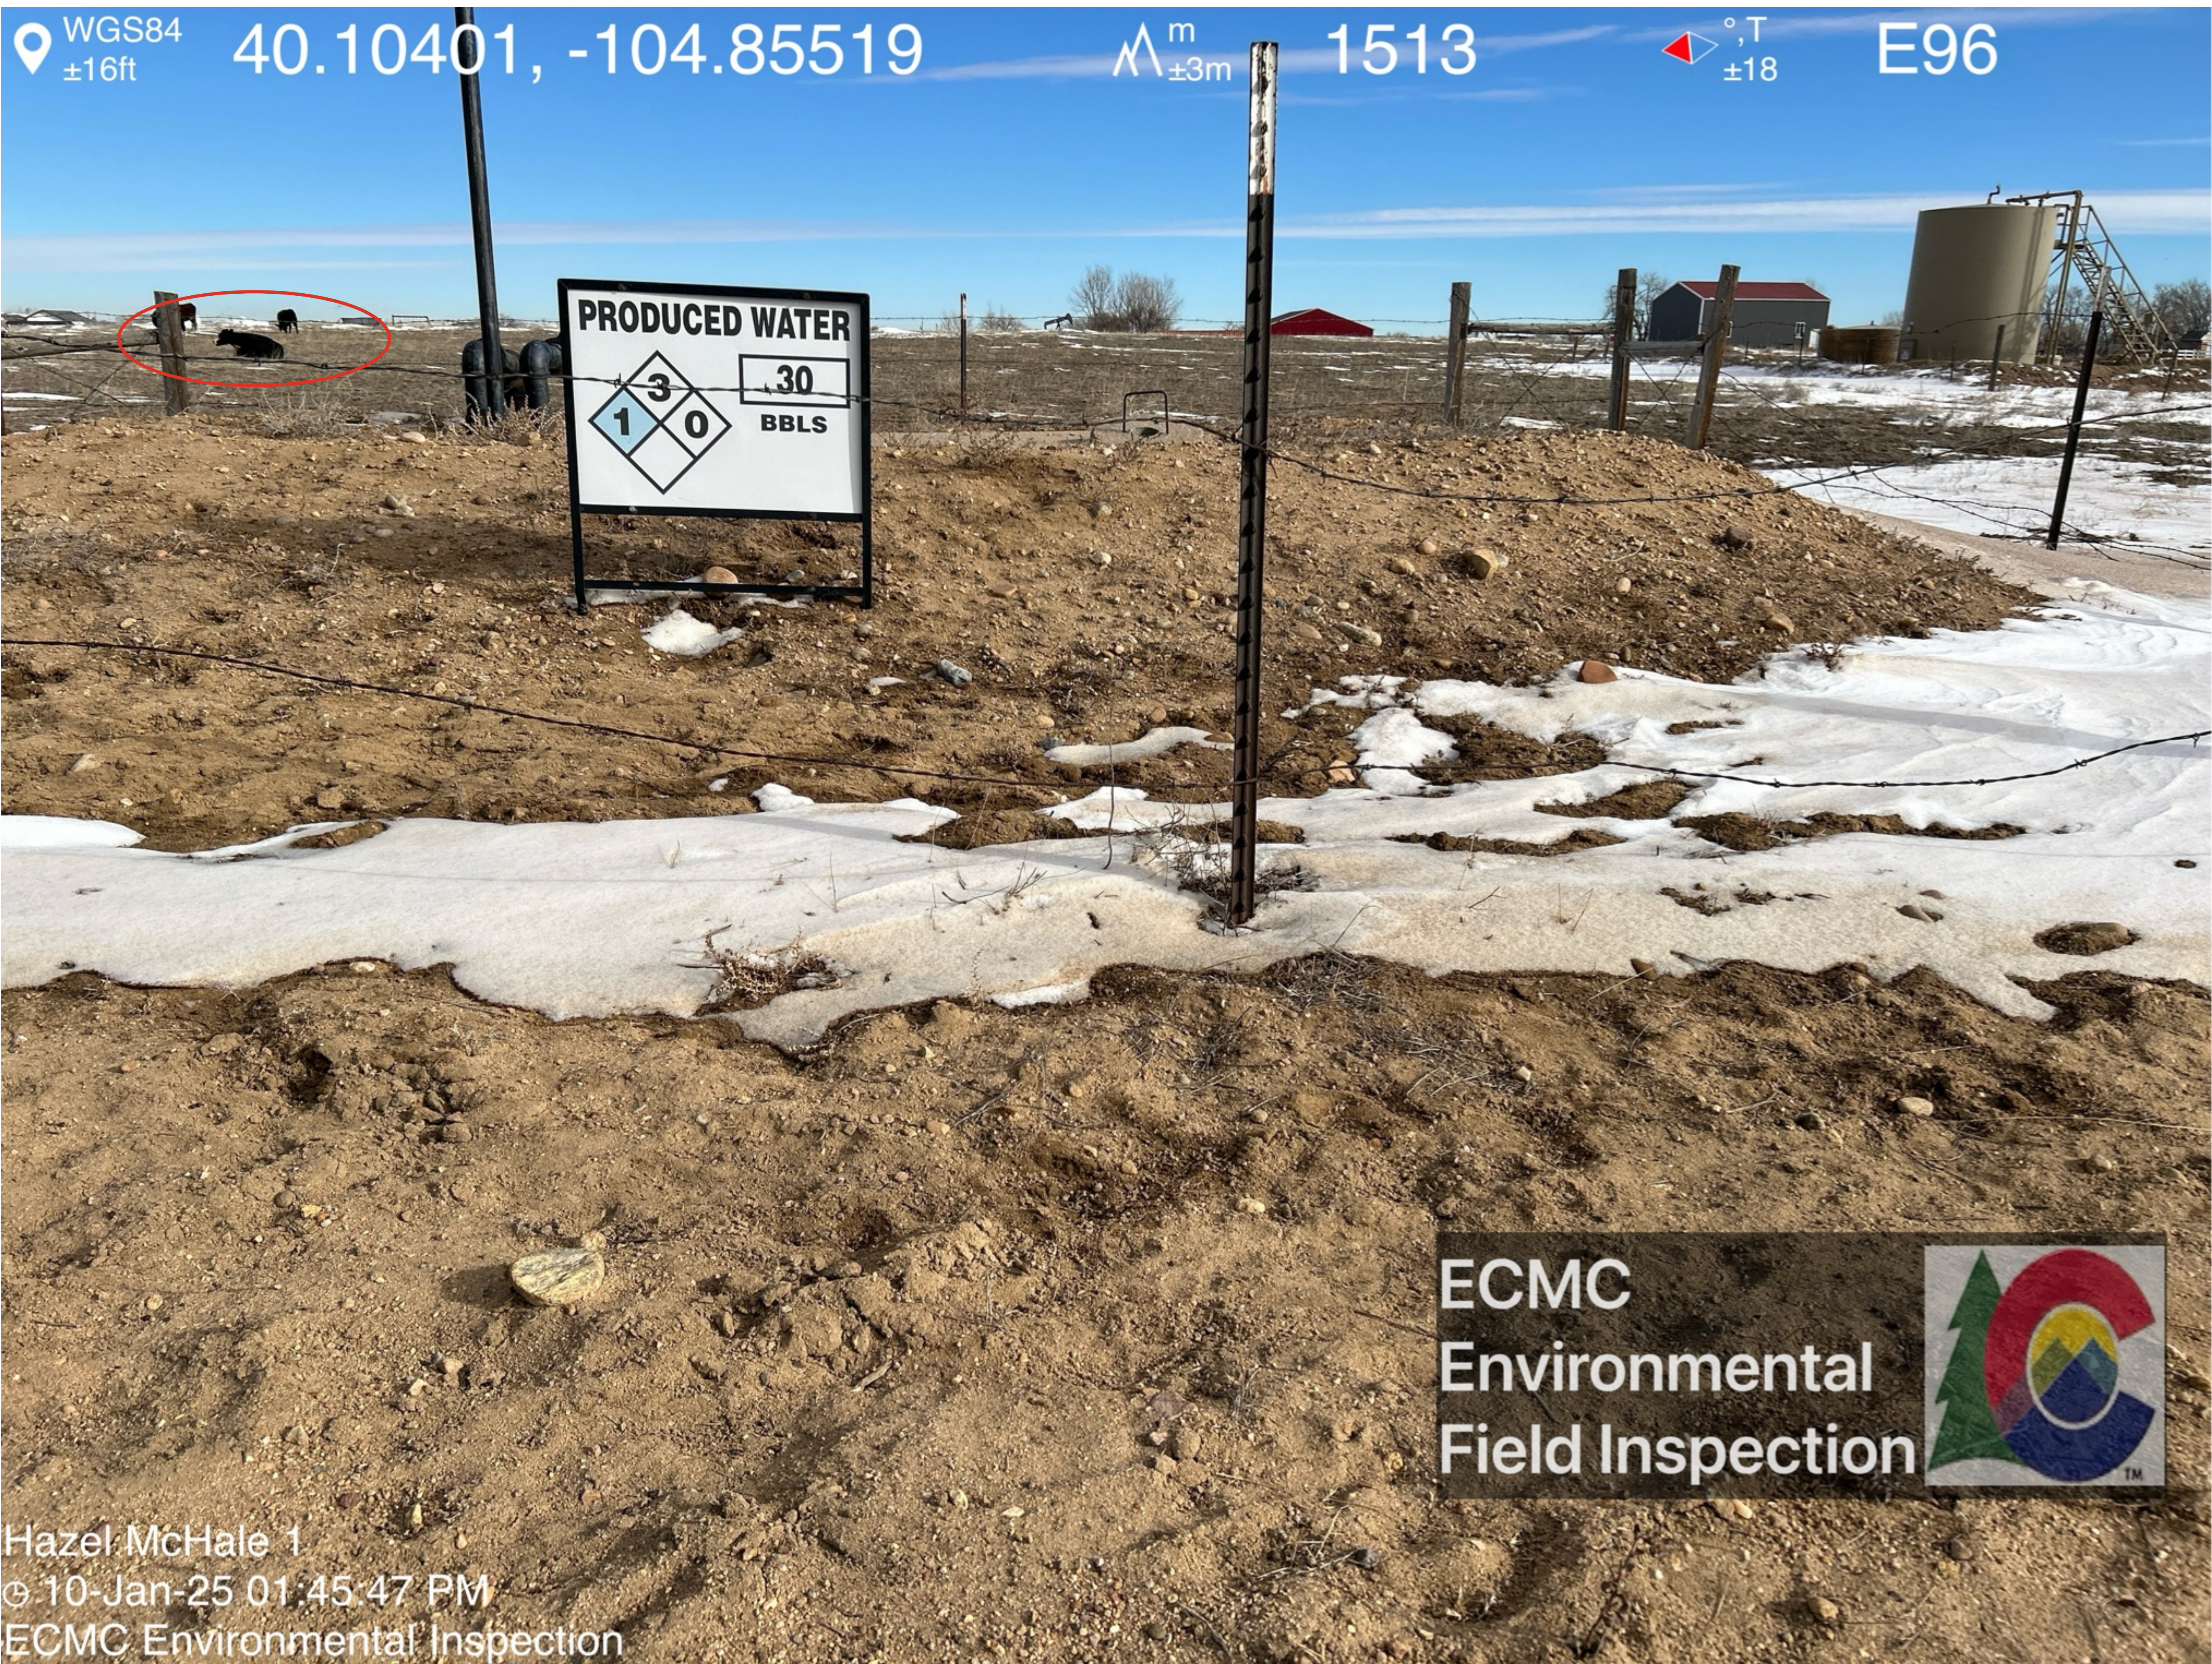
Livestock and livestock tracks adjacent to the produced water vault.

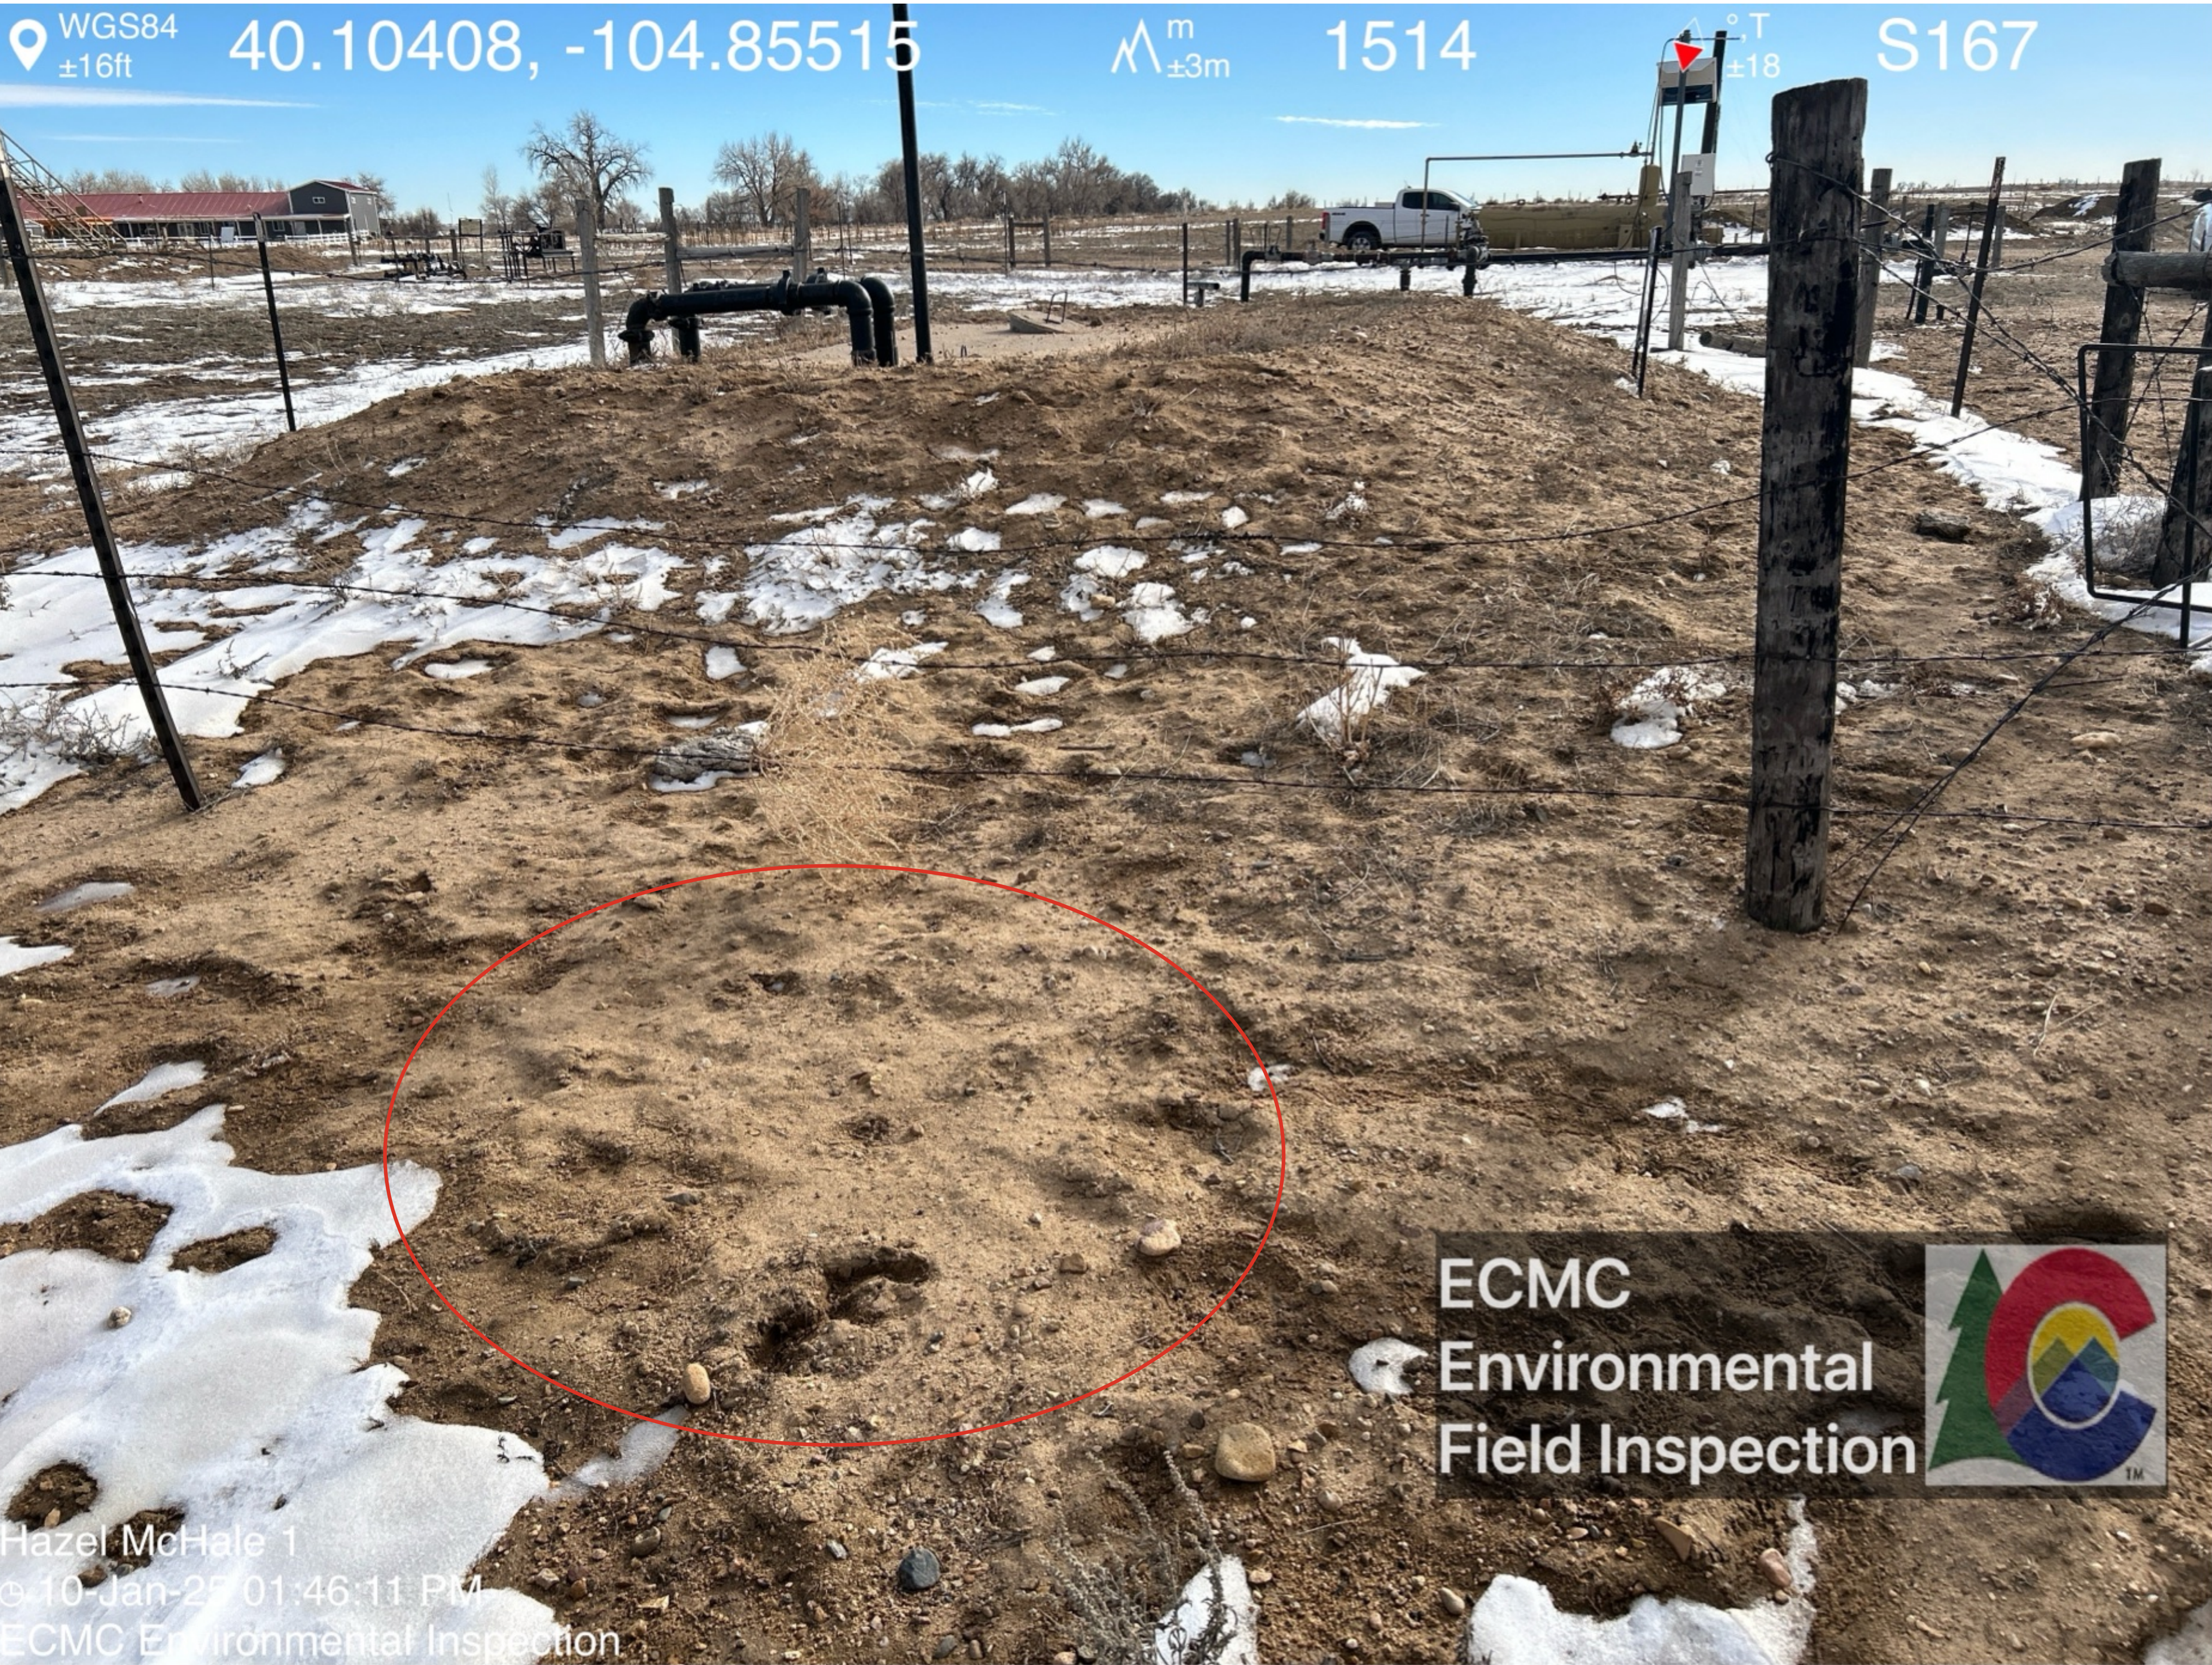
Livestock tracks adjacent to the produced water vault.

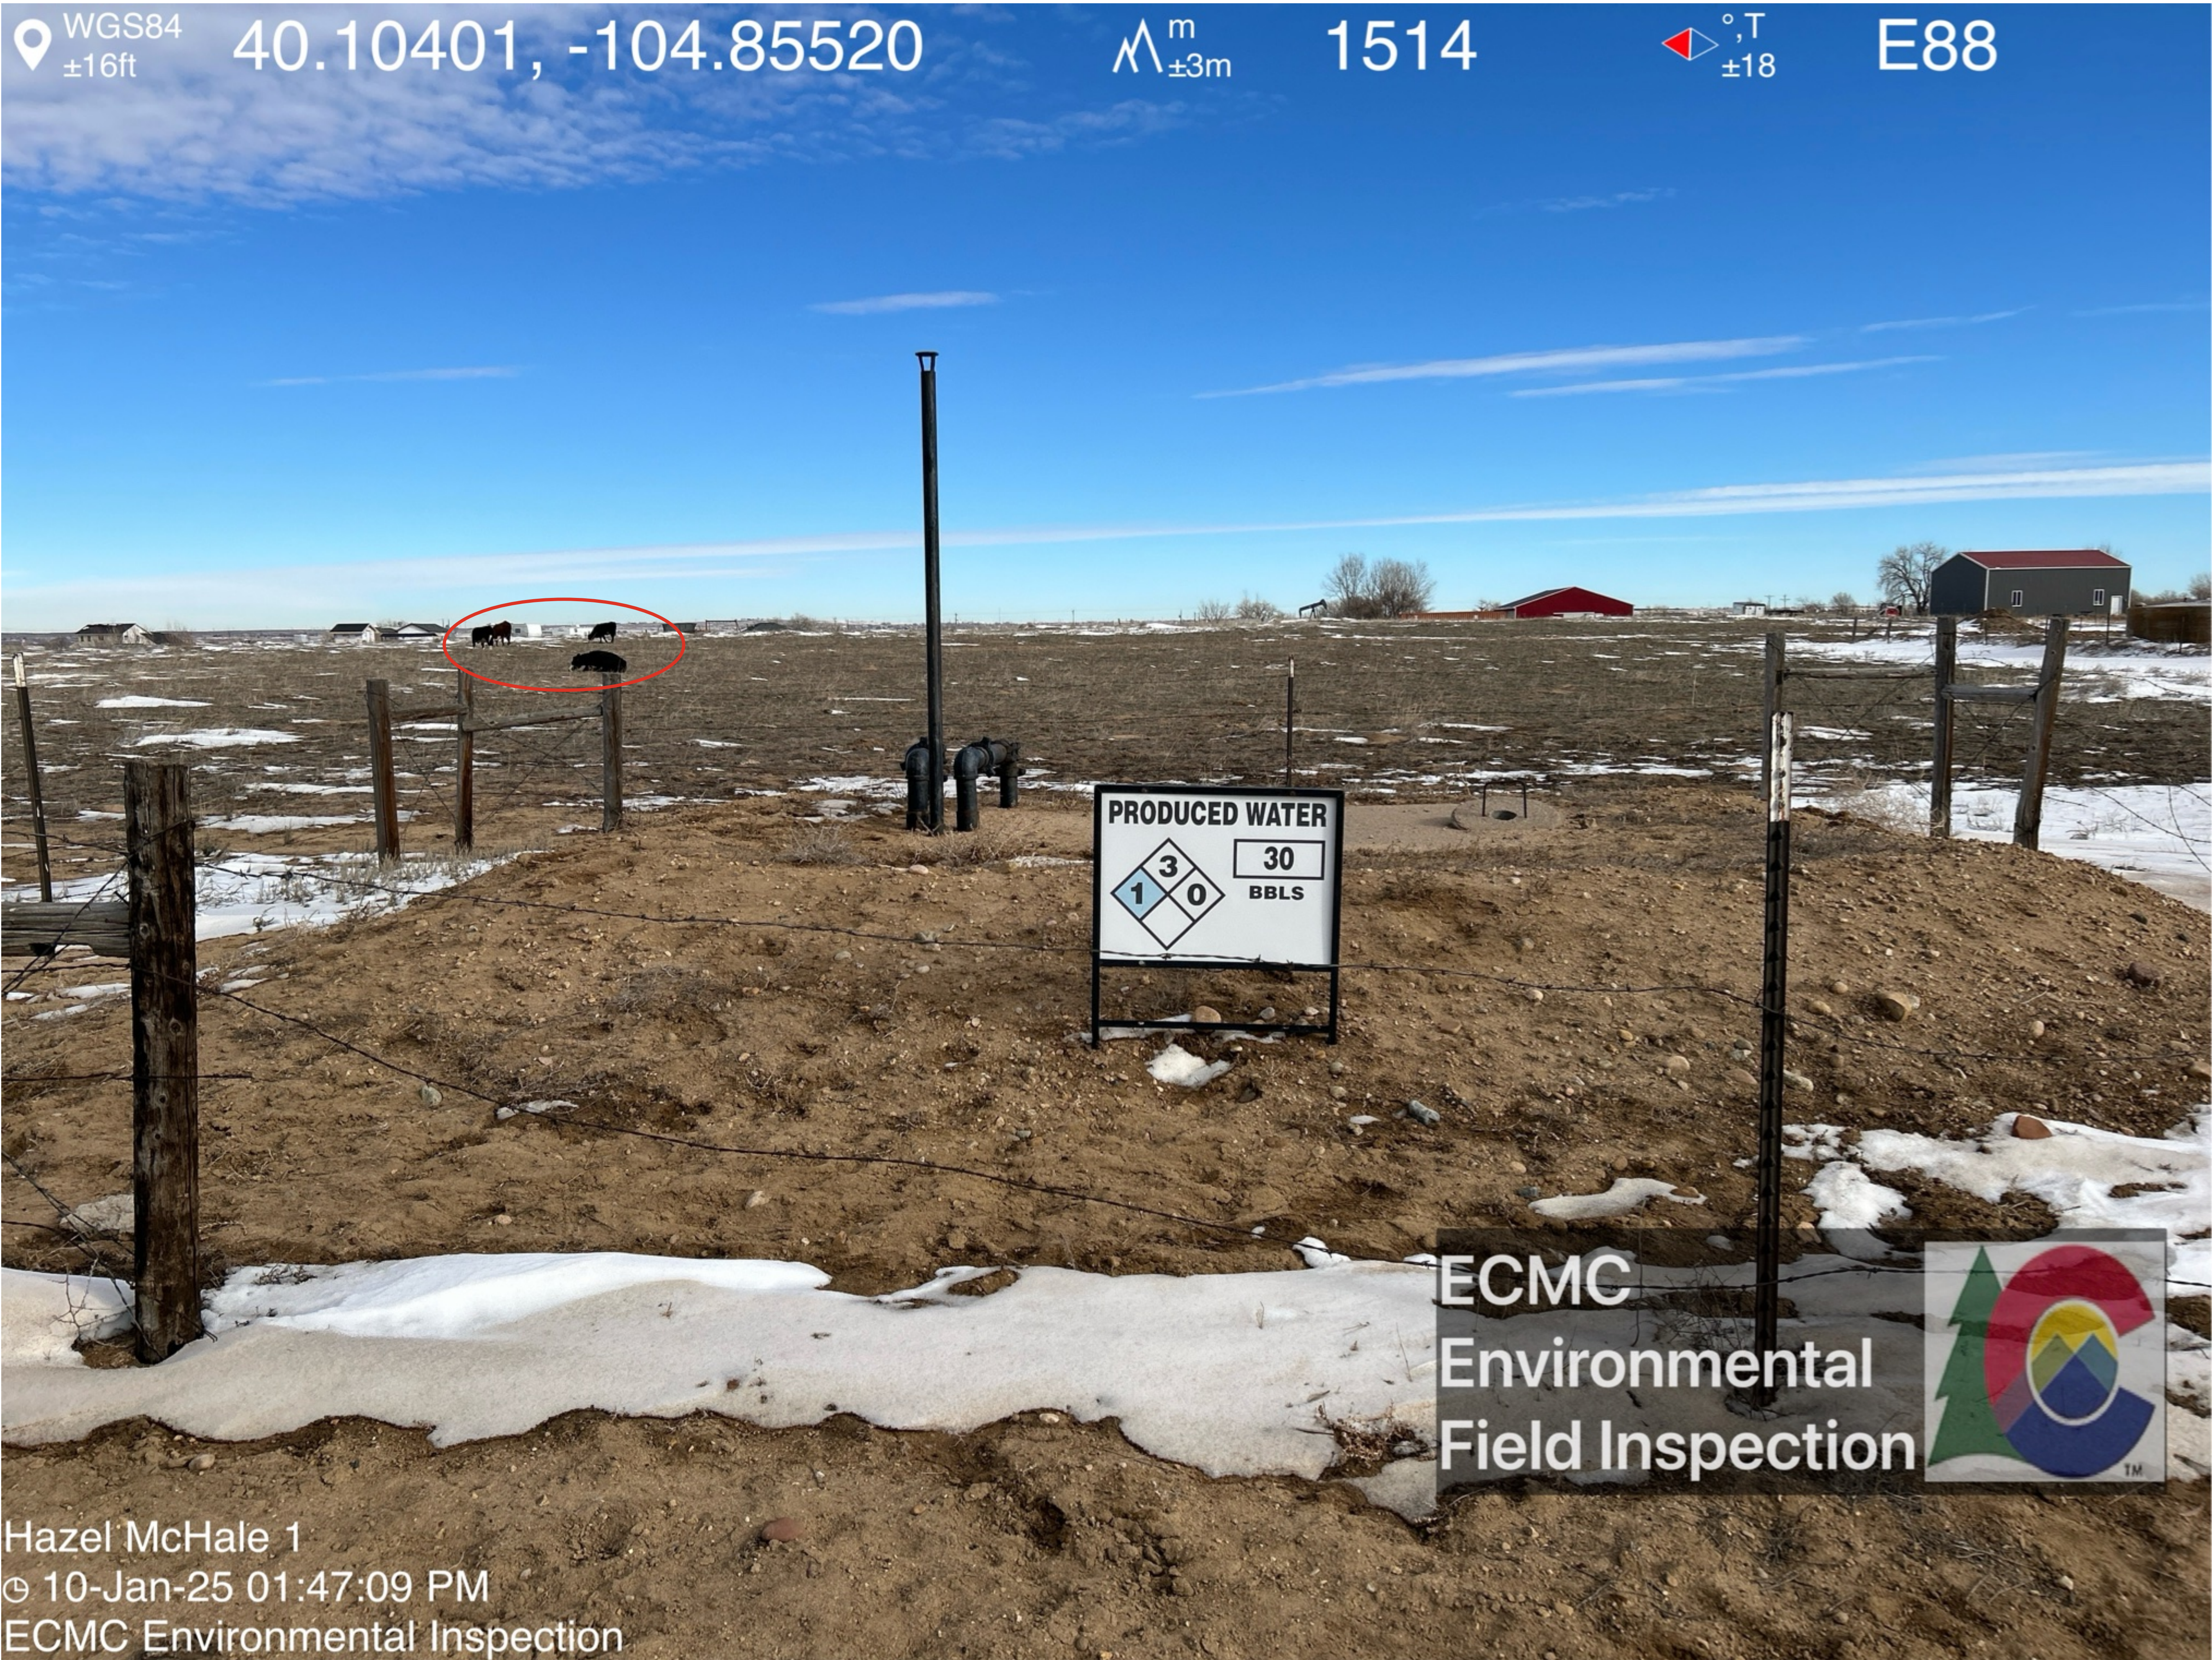
Livestock observed adjacent to location.
