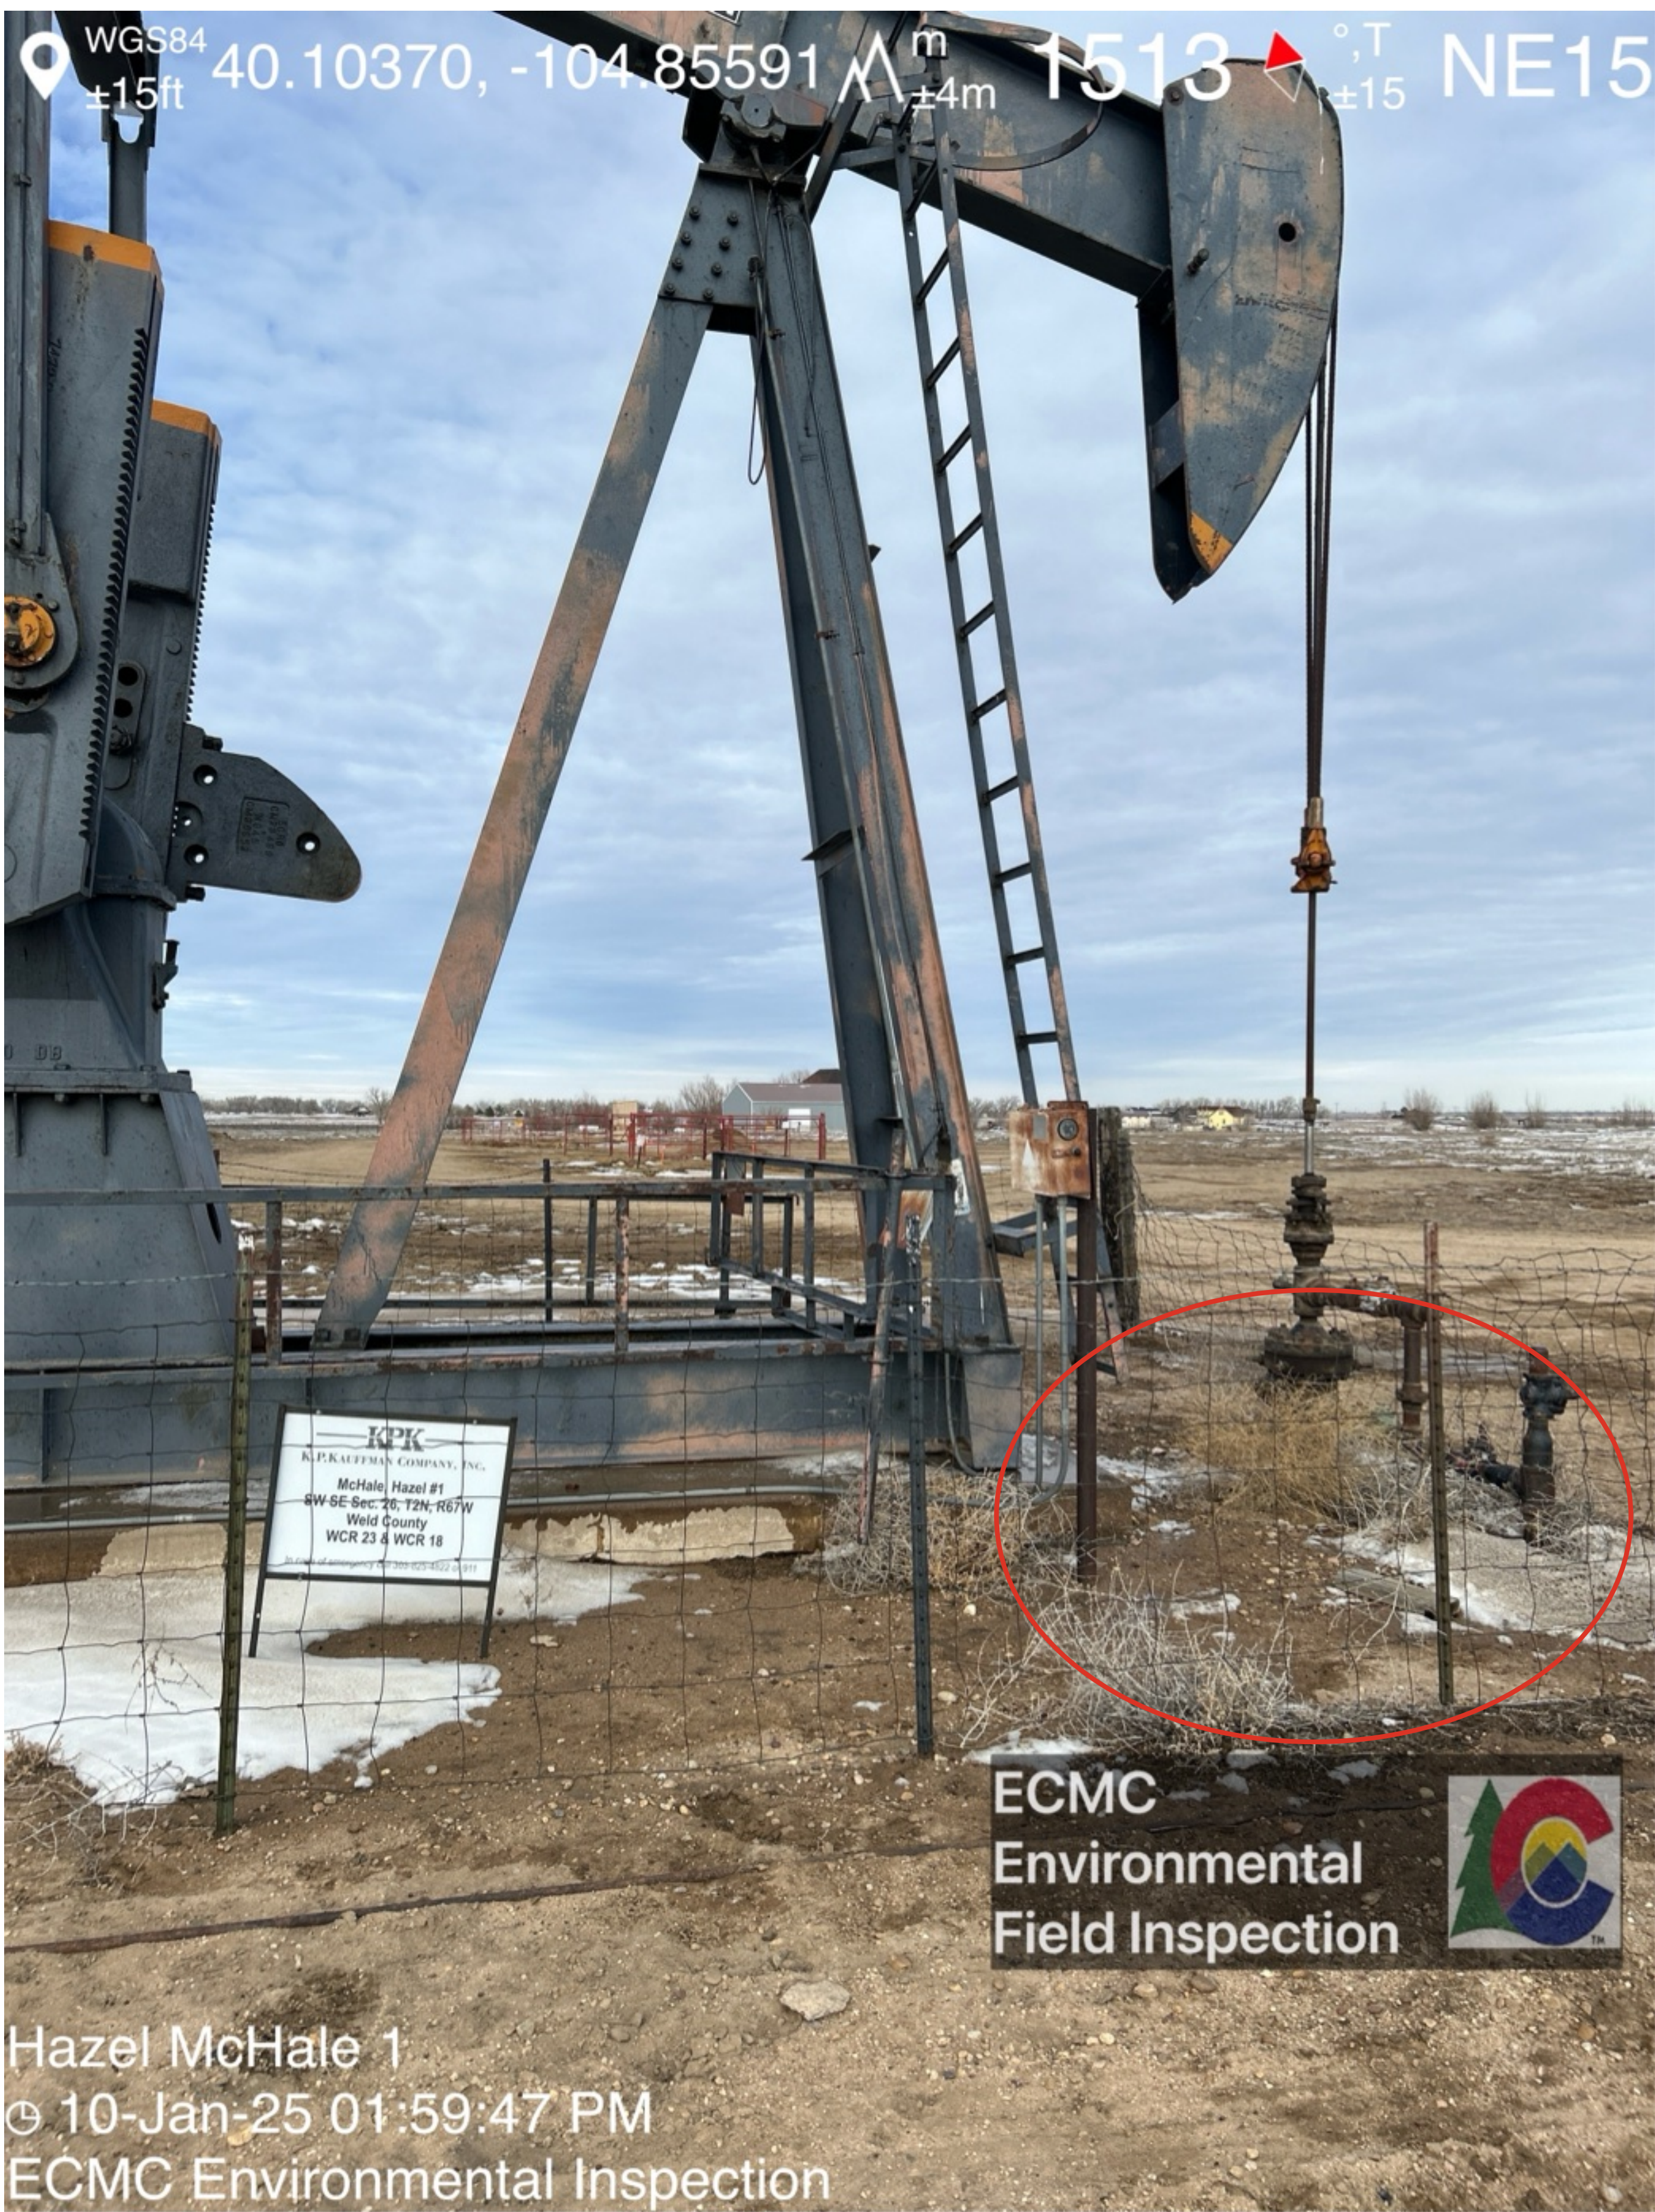
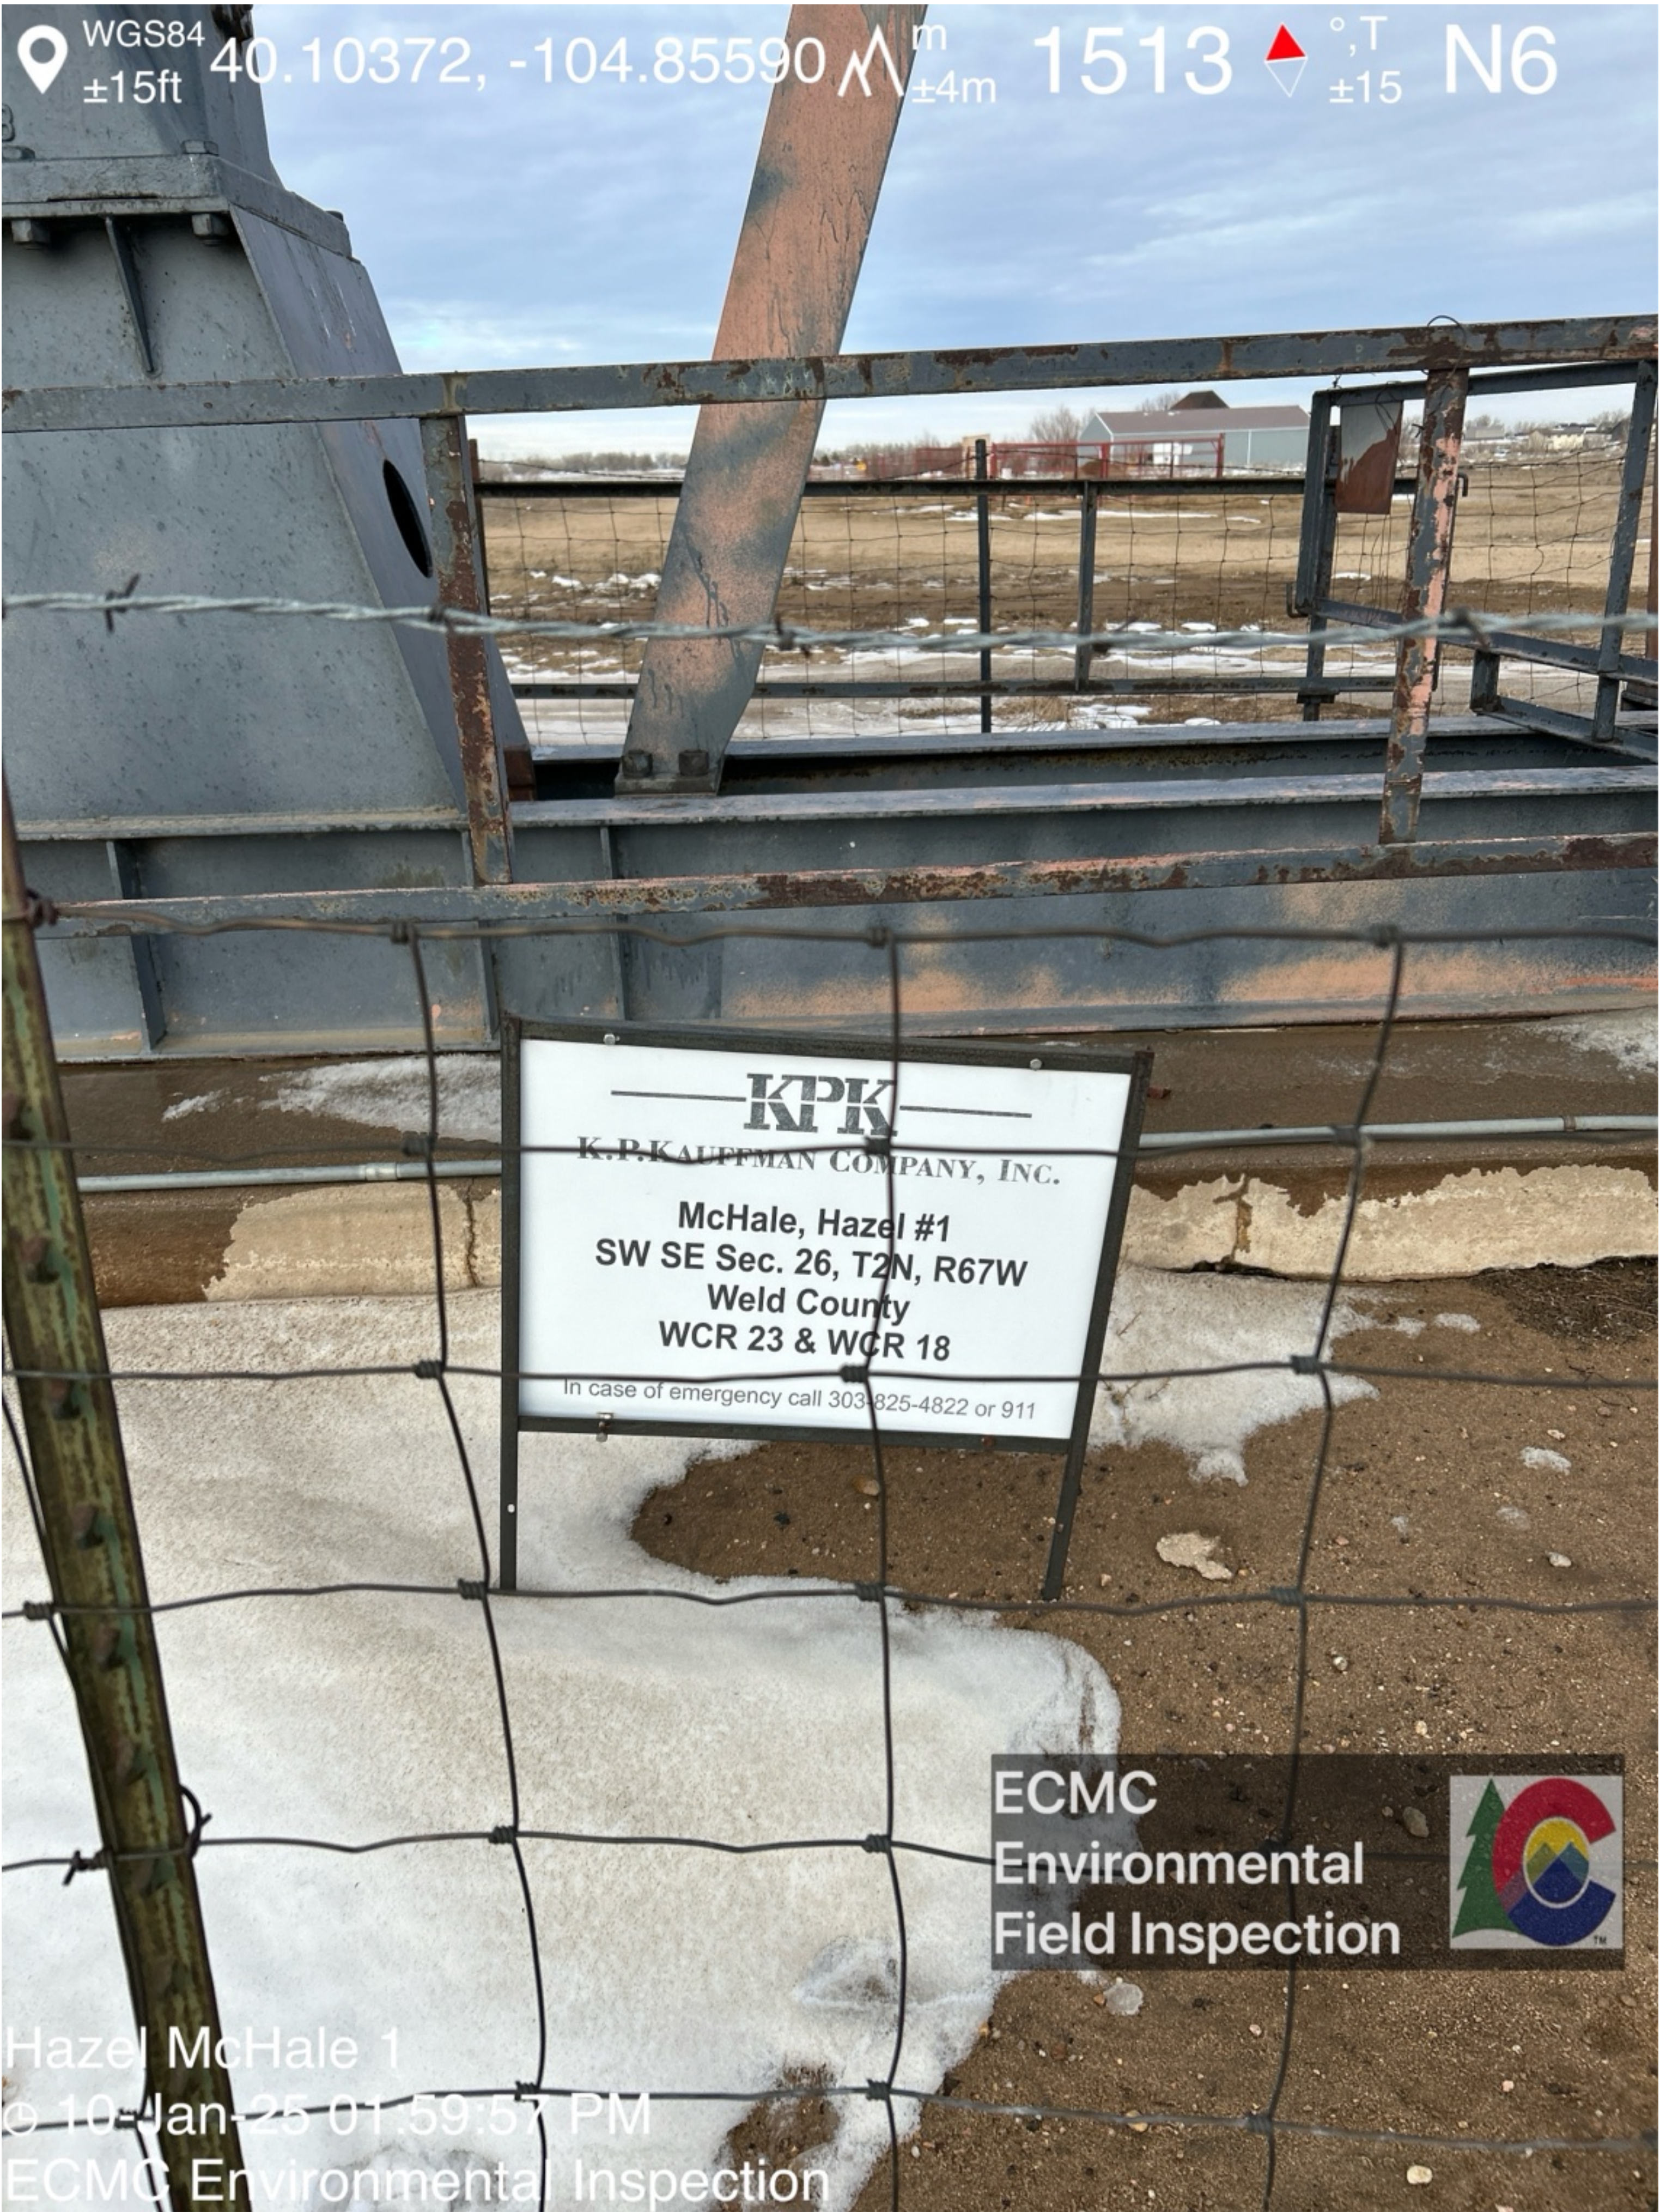
Debris observed within wellhead fencing.

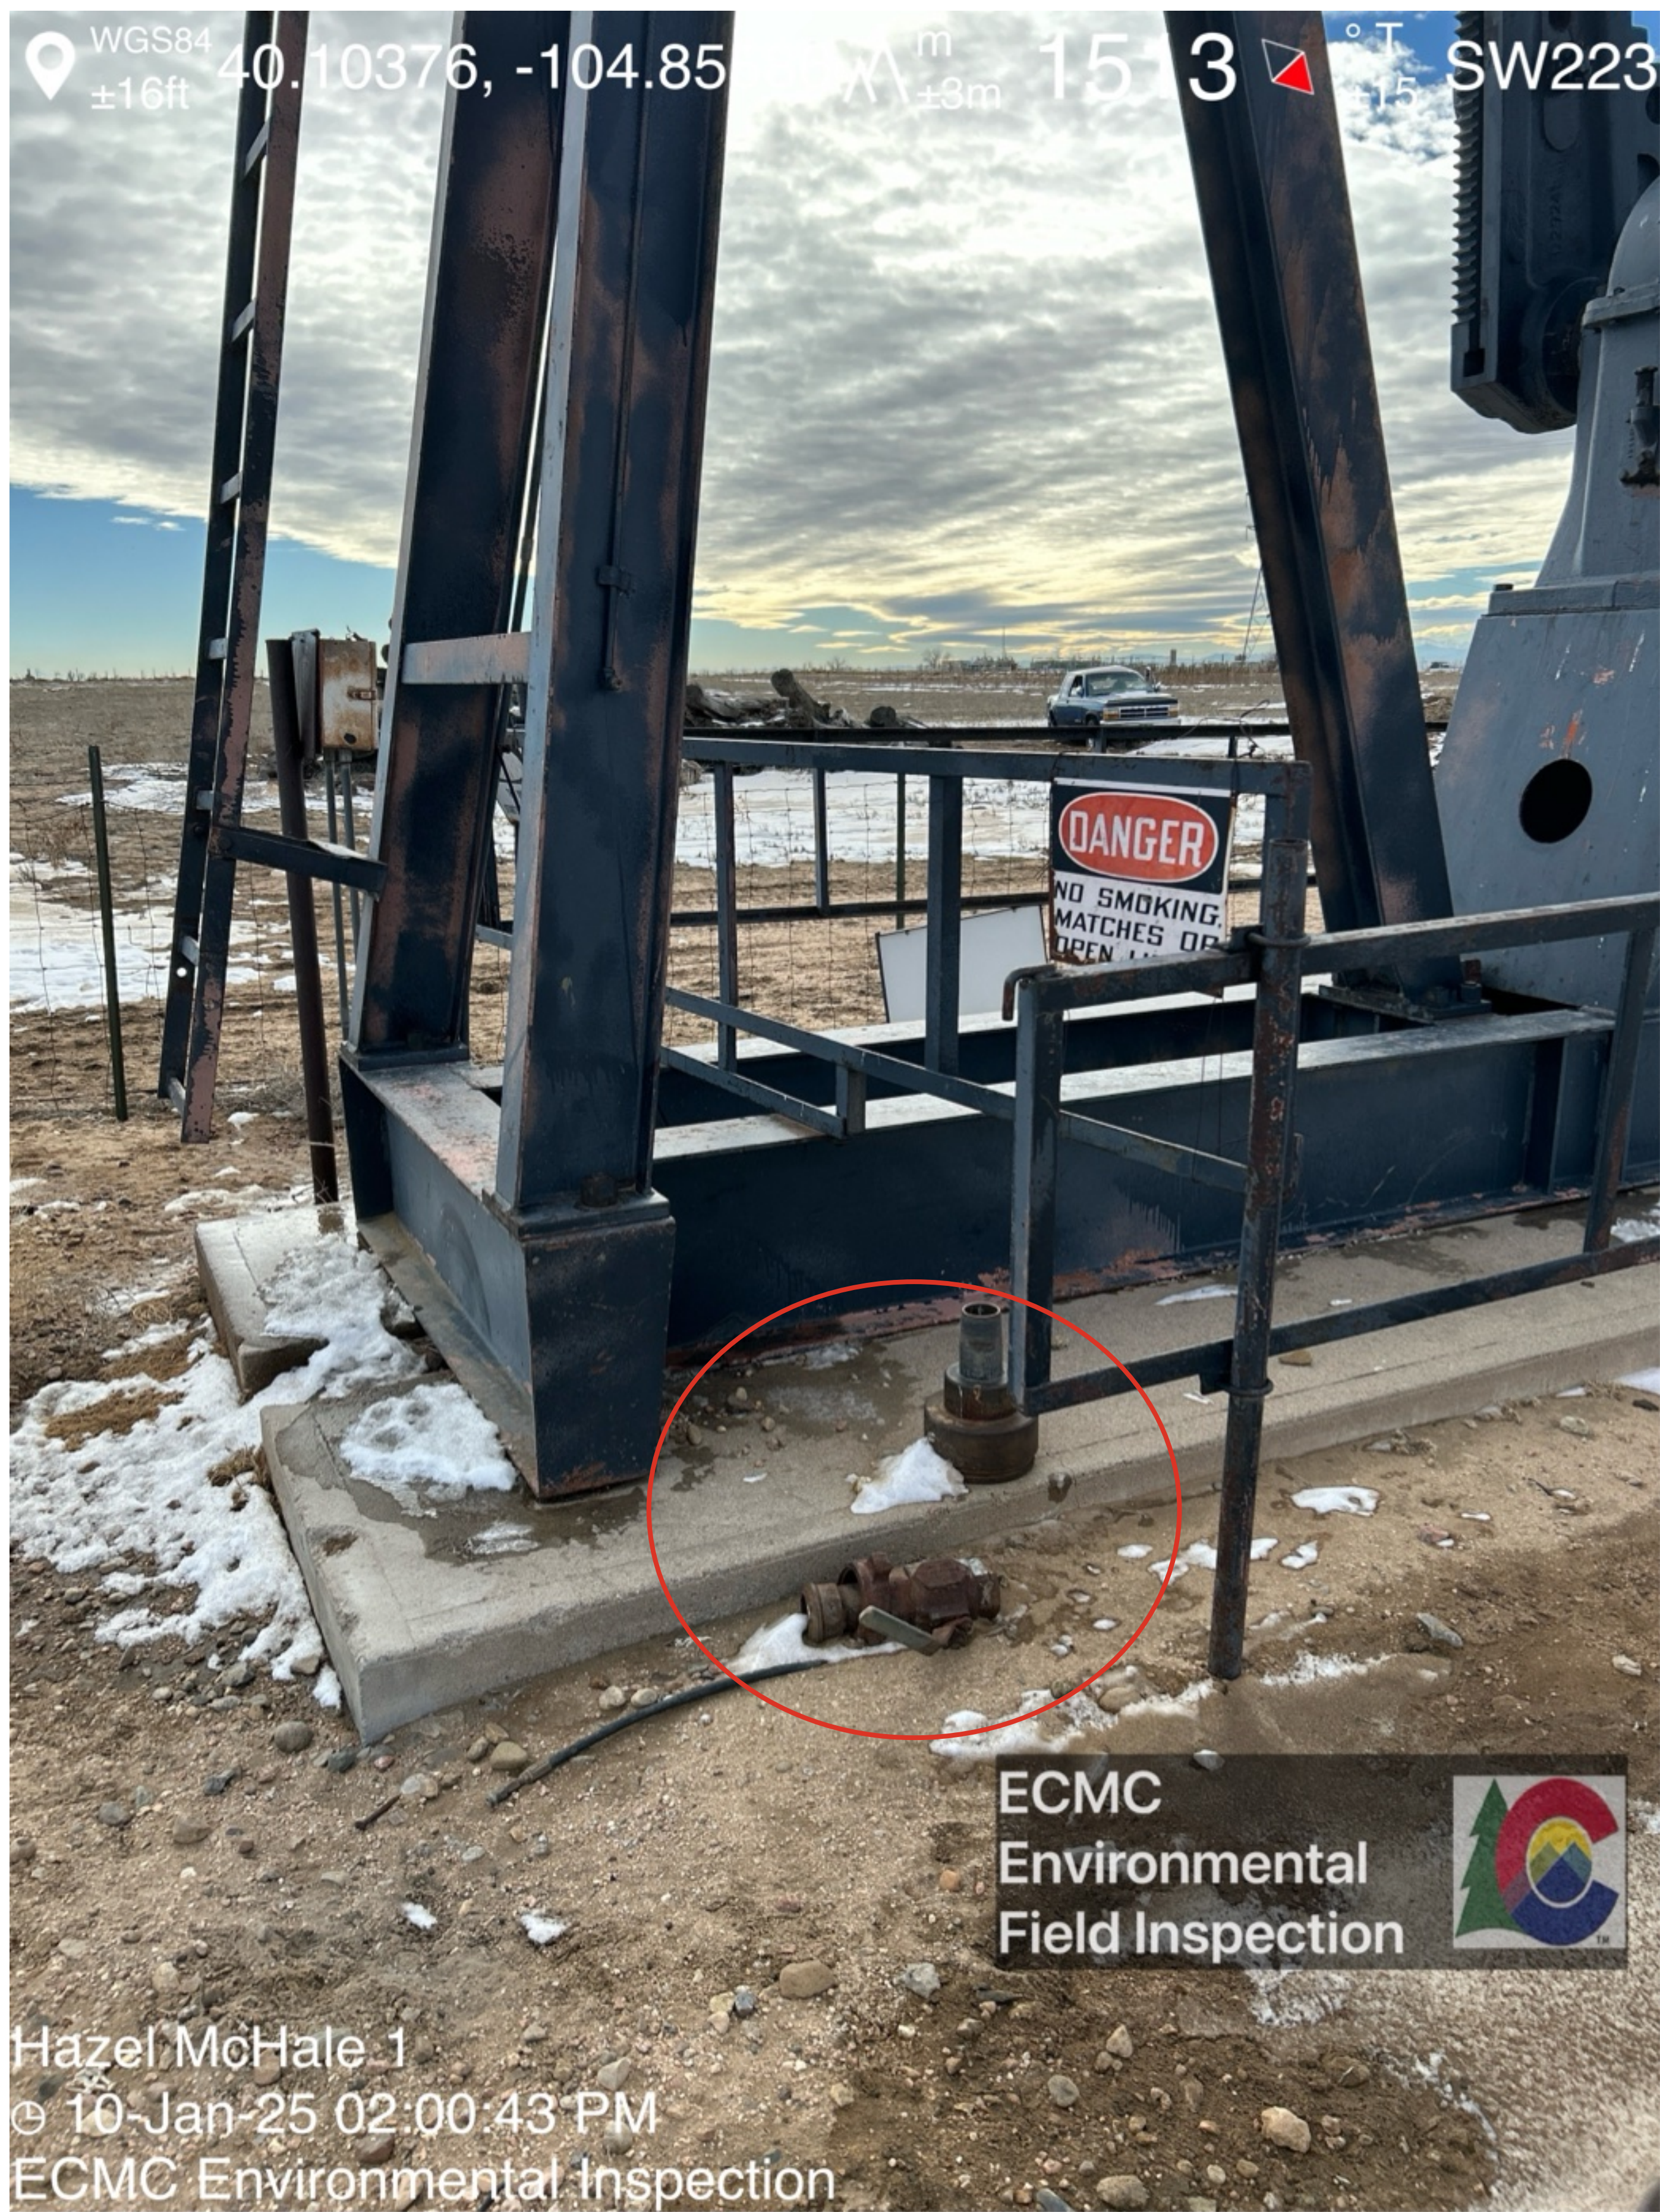
n sed e ipment observed it in ell ead encin .

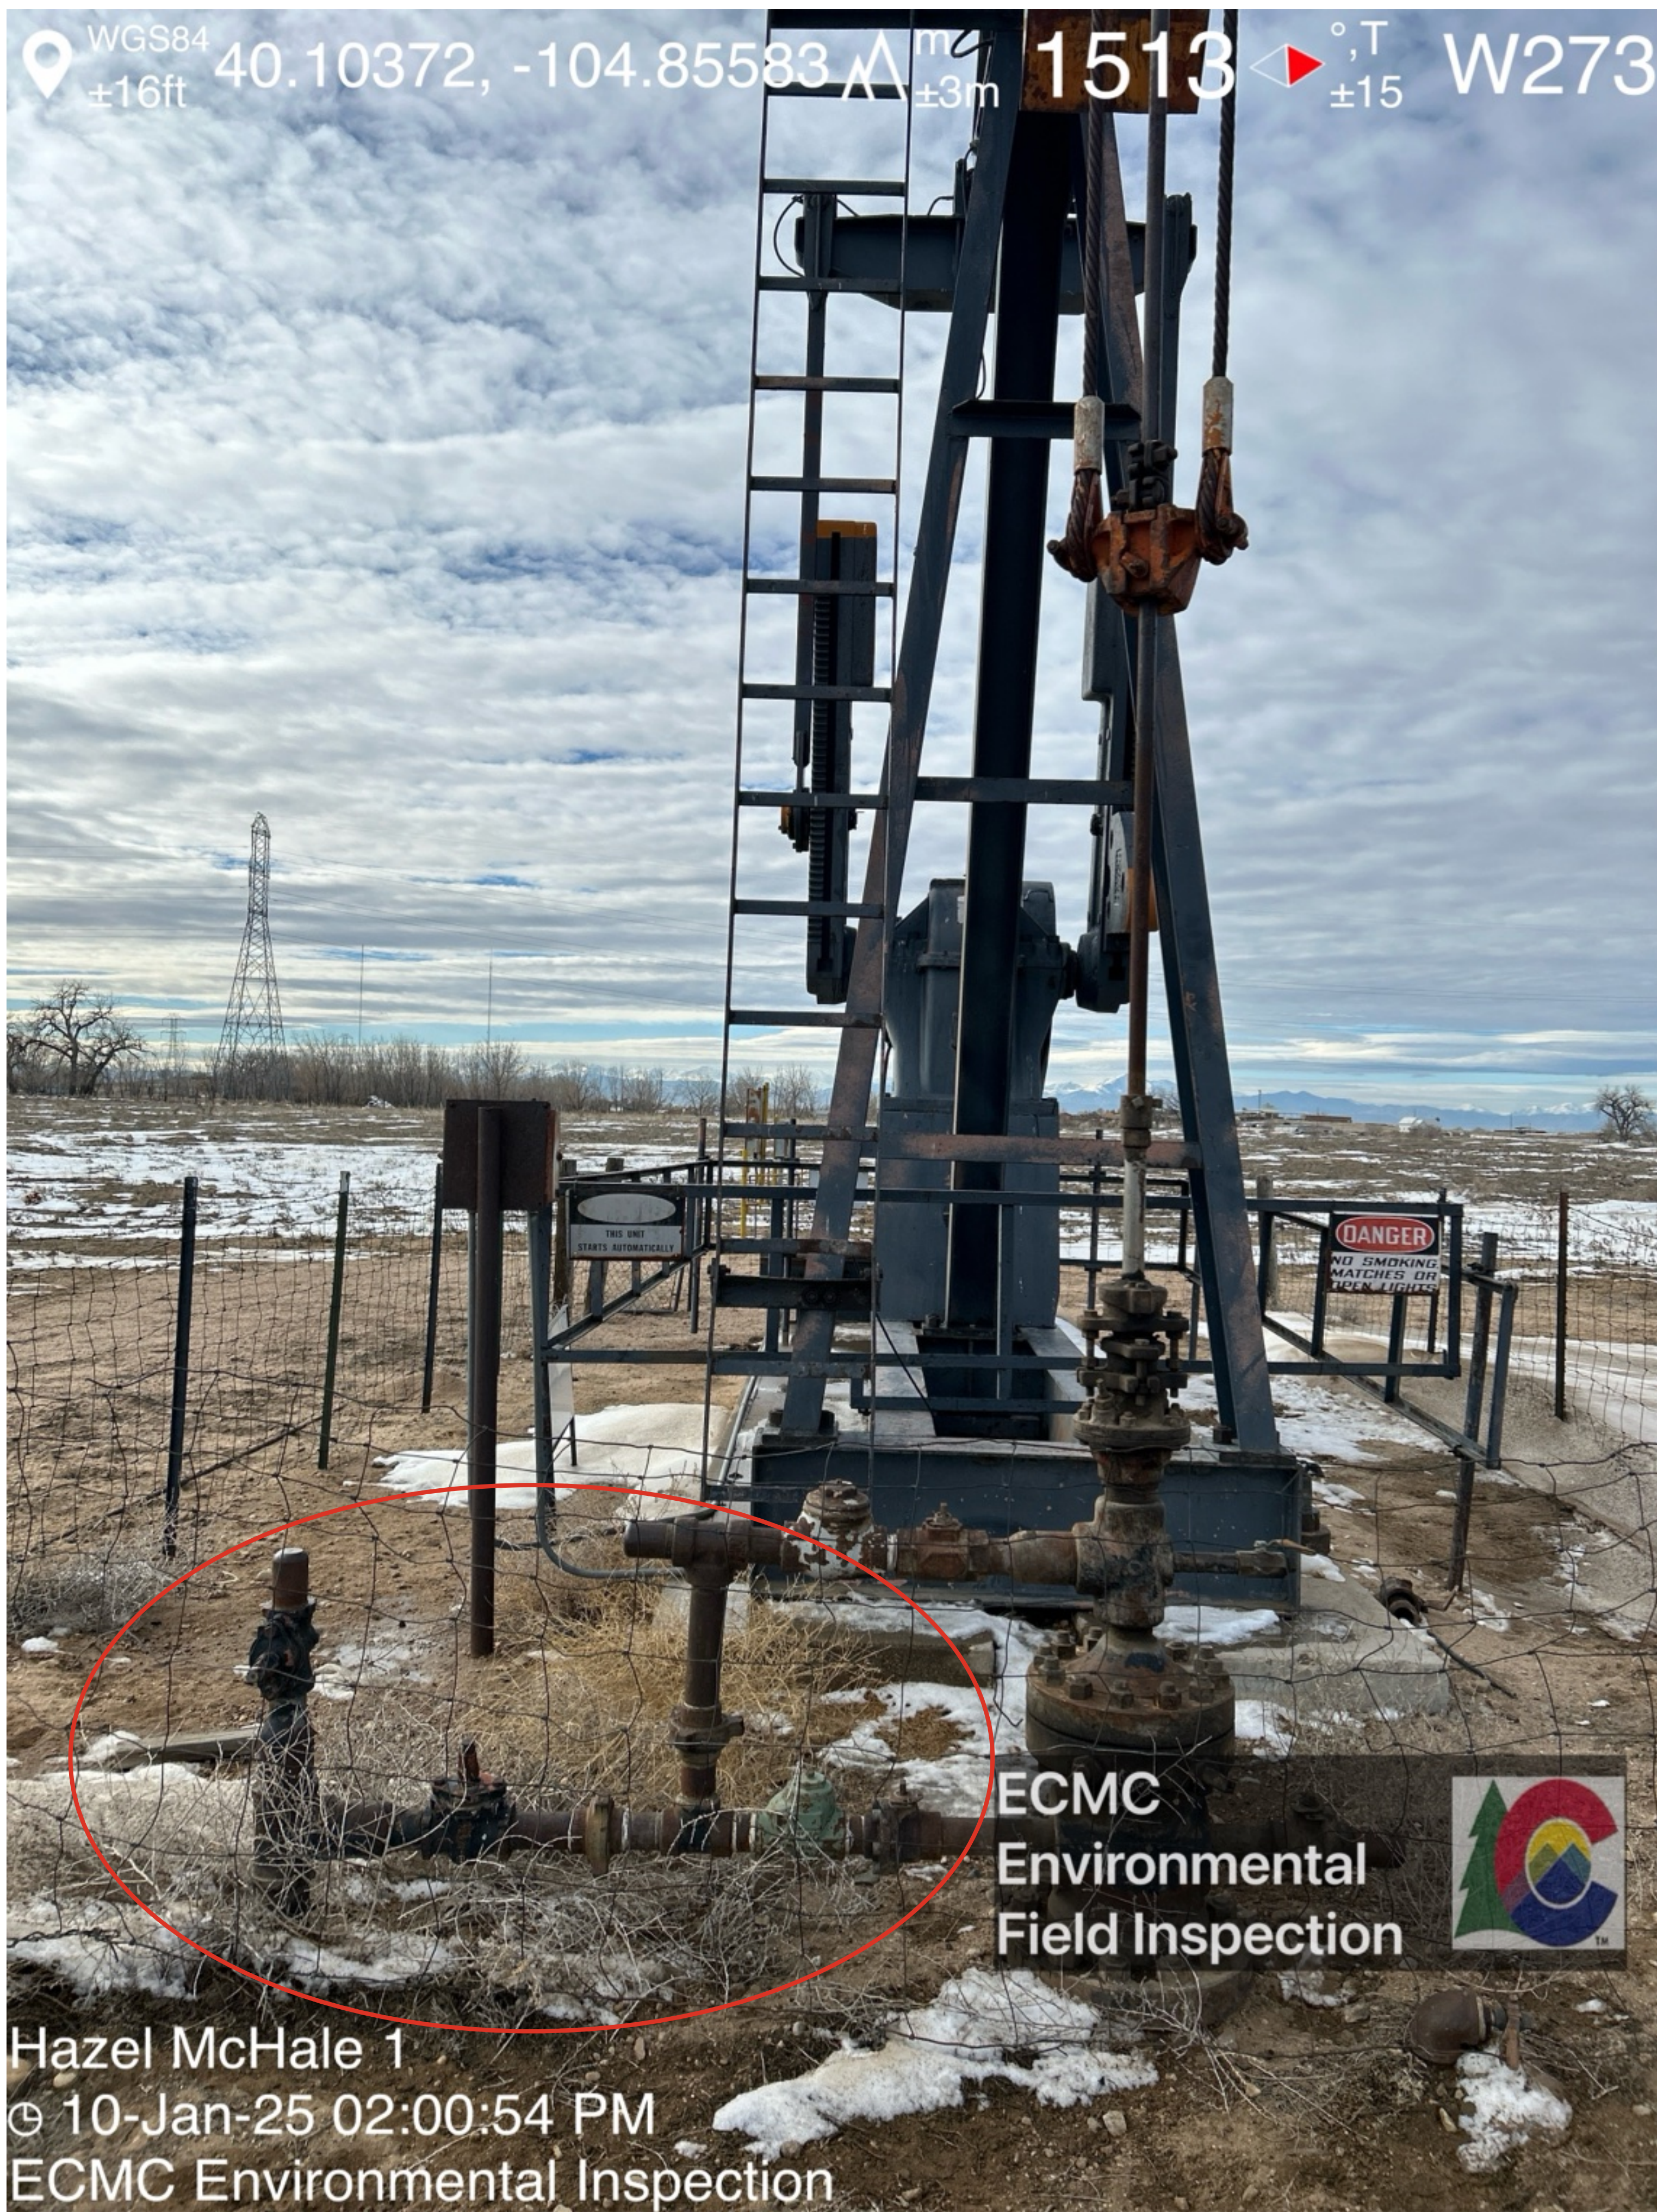
ebri observed it in ell ead encin .
