Inspection Photos

Location: TEP ROCKY MOUNTAIN LLC Lantz/SG 44-23

Location ID: 429938

Date: 01/8/2025

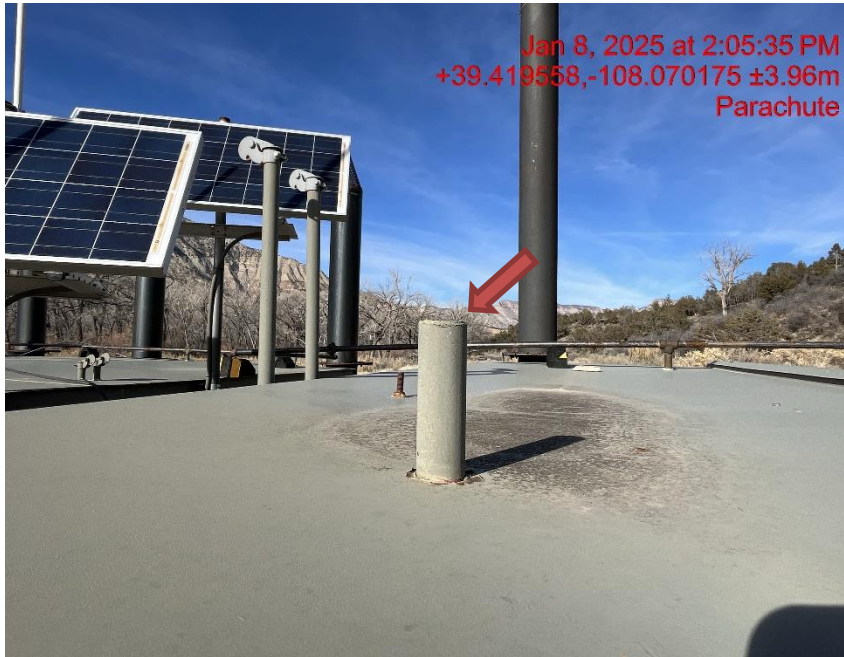
Photo # 2386 PRV vent line does not comply with CECMC pressure safety device rules

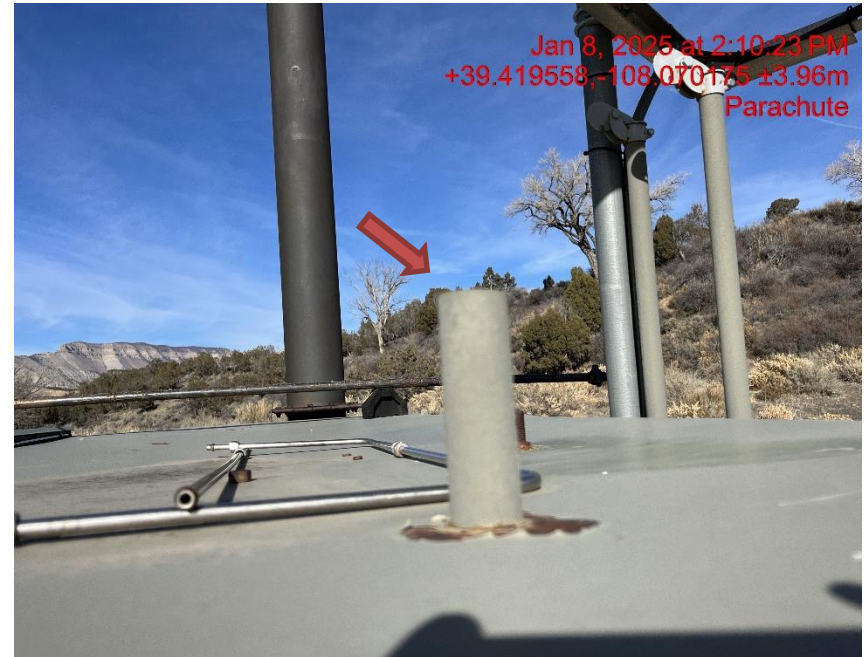
Photo # 2394 PRV vent line does not comply with CECMC pressure safety device rules

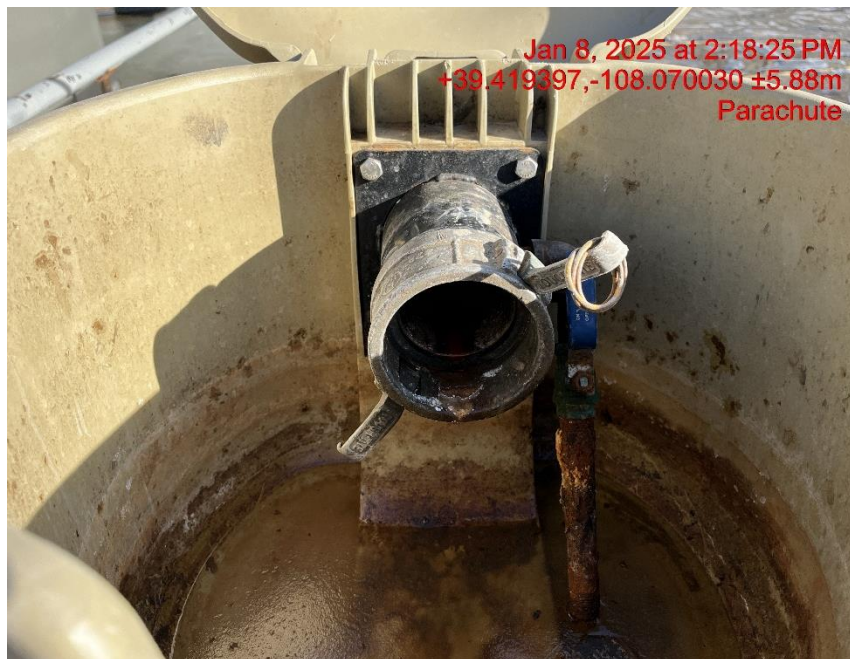
Photo # 2405 Open ended load line

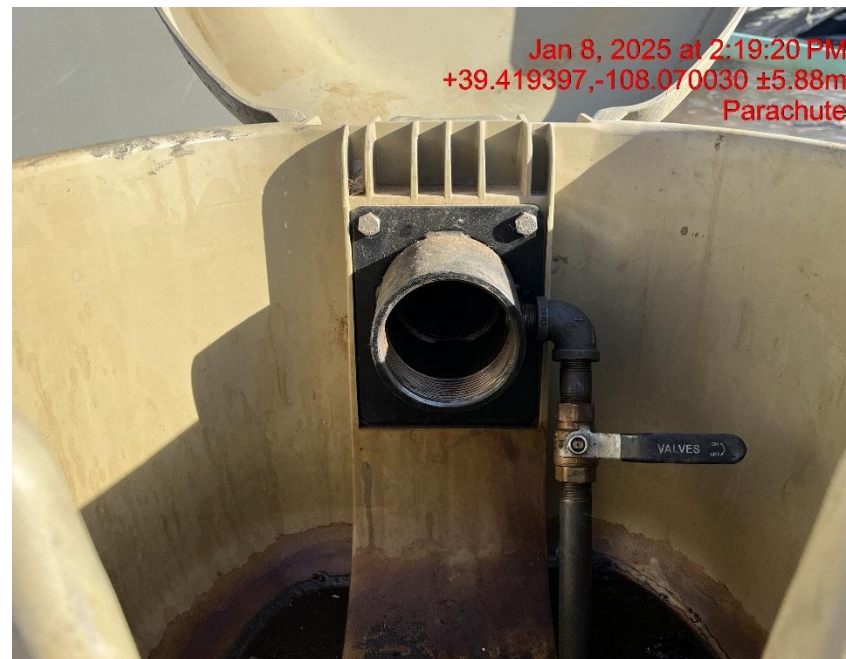
Photo # 2406 Open ended load line

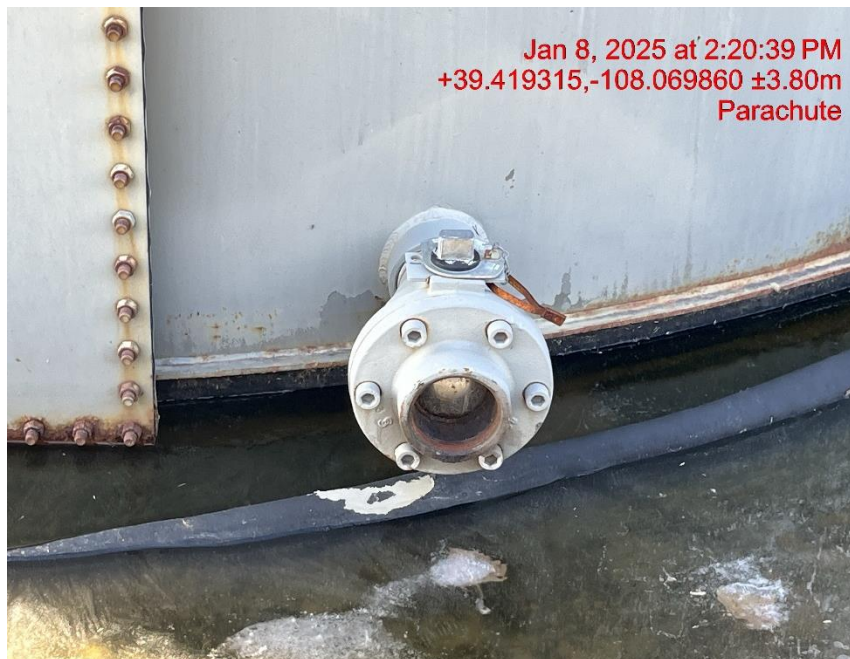
Photo # 2407 Open ended load line

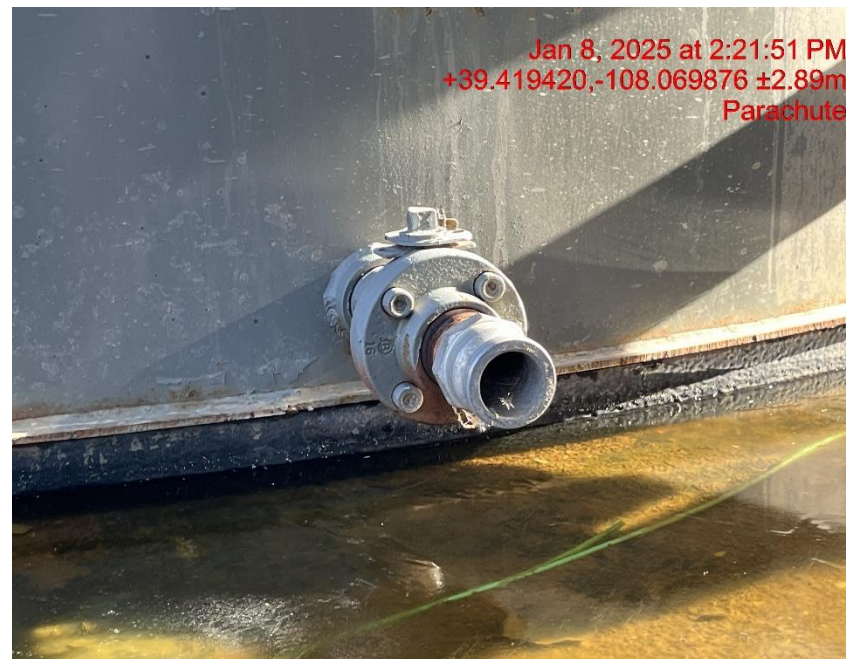
Photo # 2409 Open ended load line

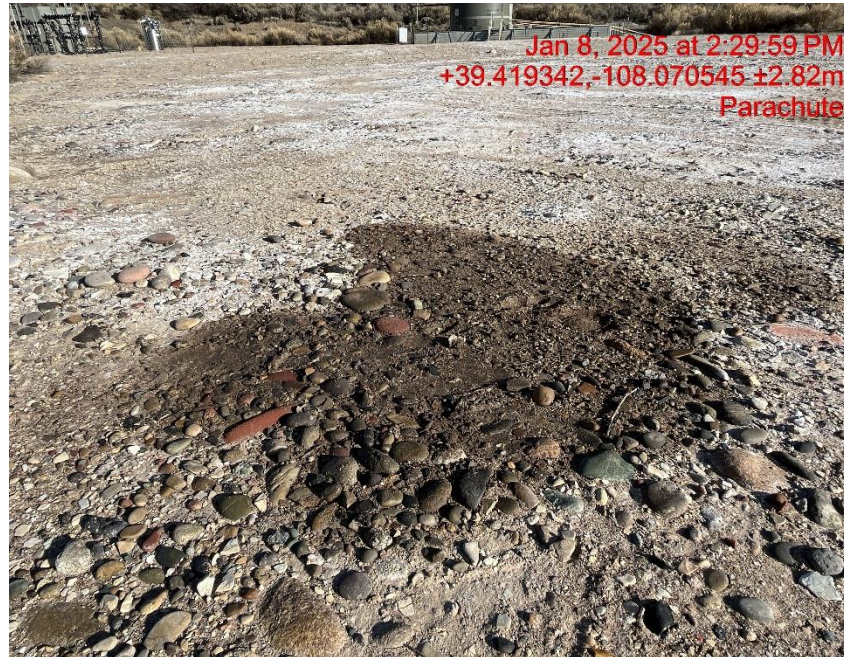
Photo # 2415 Stained soil
