Inspection Photos

Location: Grouse 13-36

Location ID: 307865

API # 05-071-07087

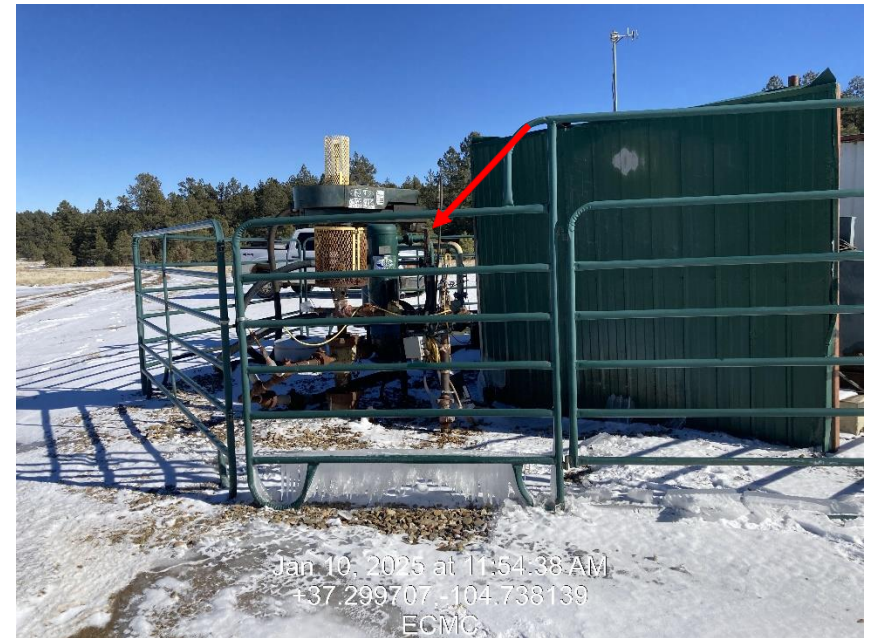
Photo 2 – Wellhead spill source area

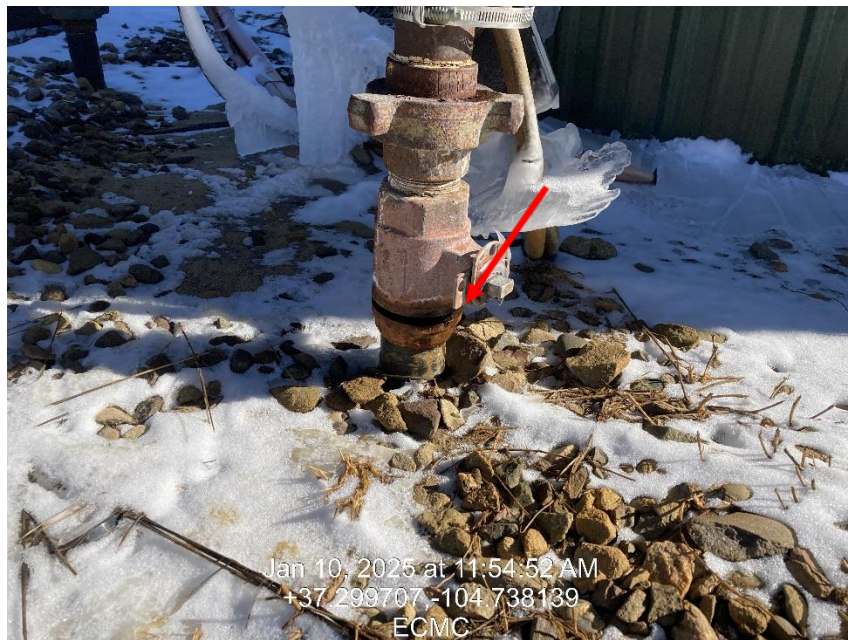
Photo 3 – Leaking valve on gathering line

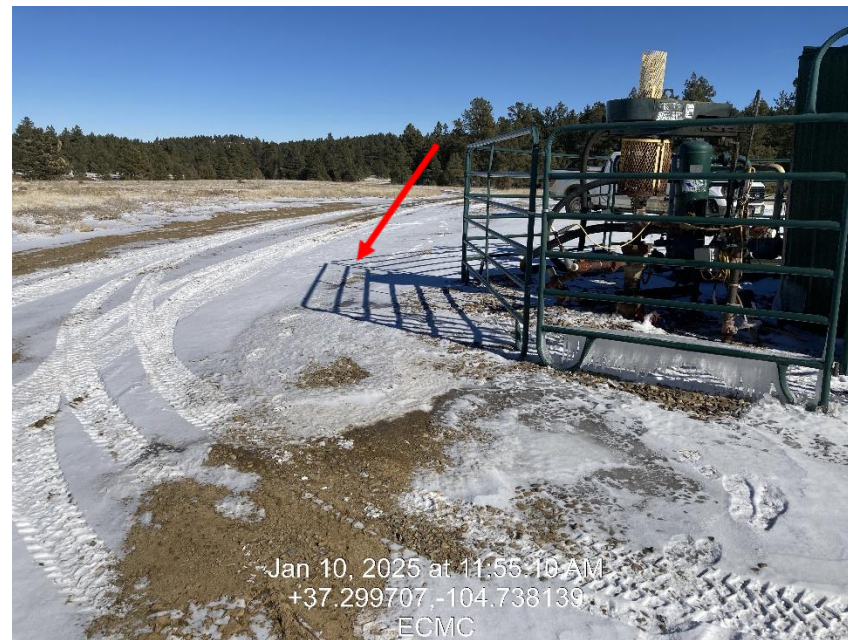
Photo 4 – Spill path looking northeast

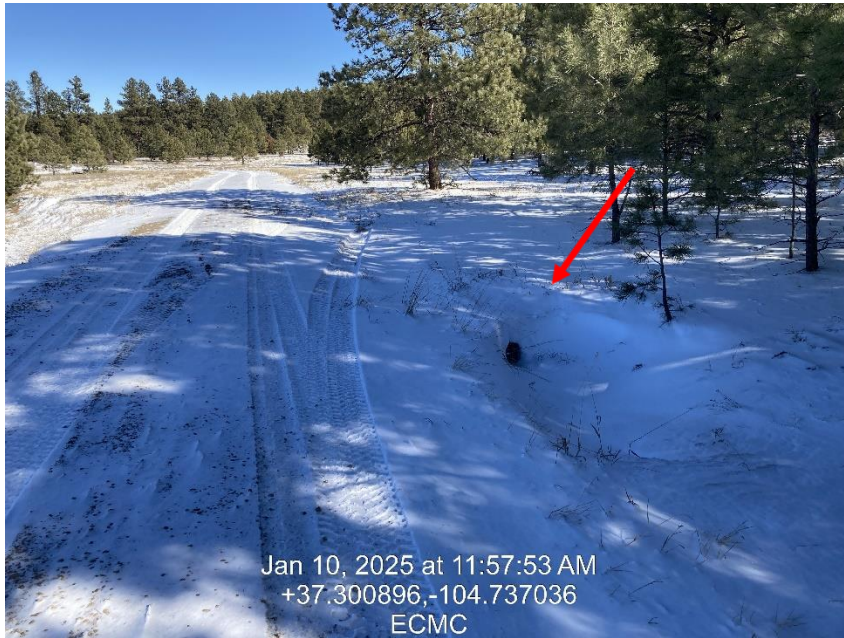
Photo 7 – Culvert in spill path, direction change

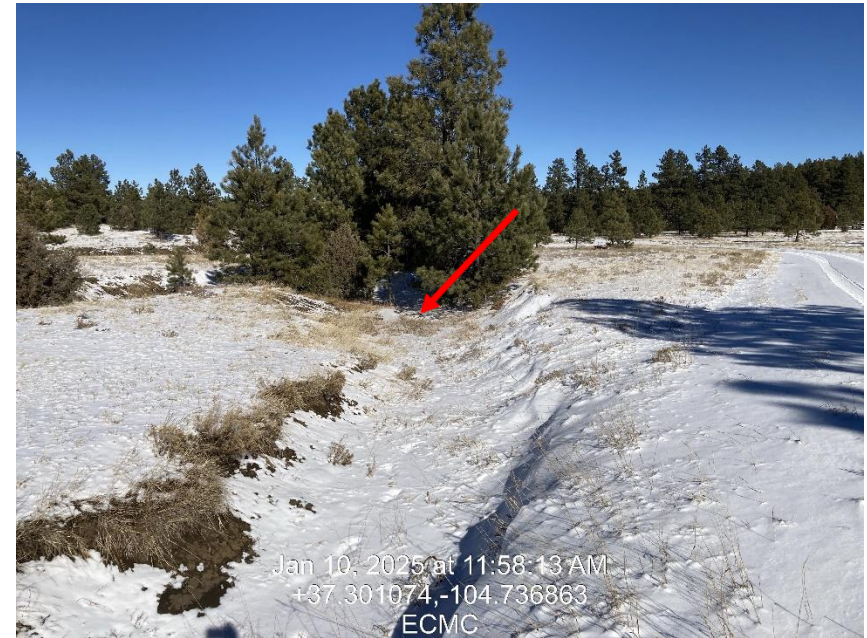
Photo 8 – Spill path, dry gully

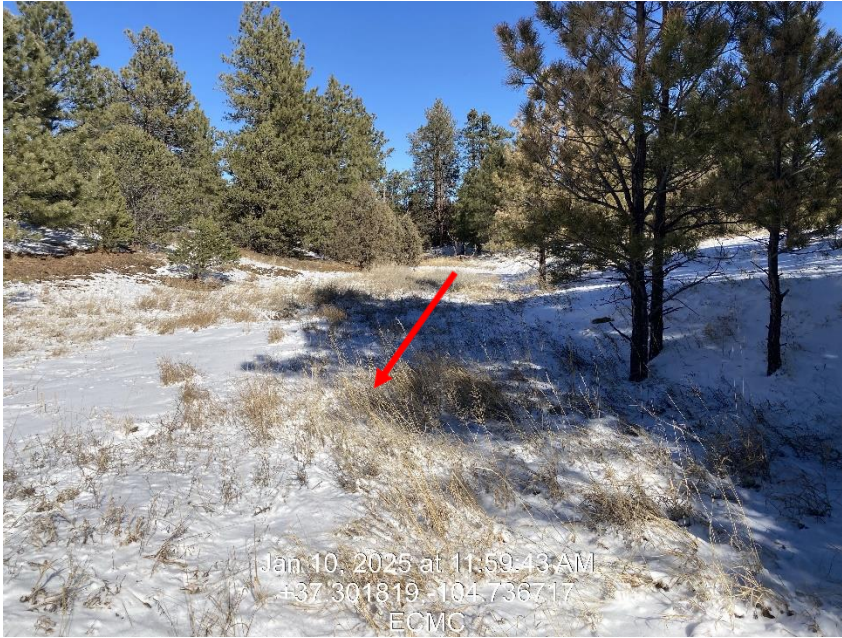
Photo 9 – Spill end, entering main ravine

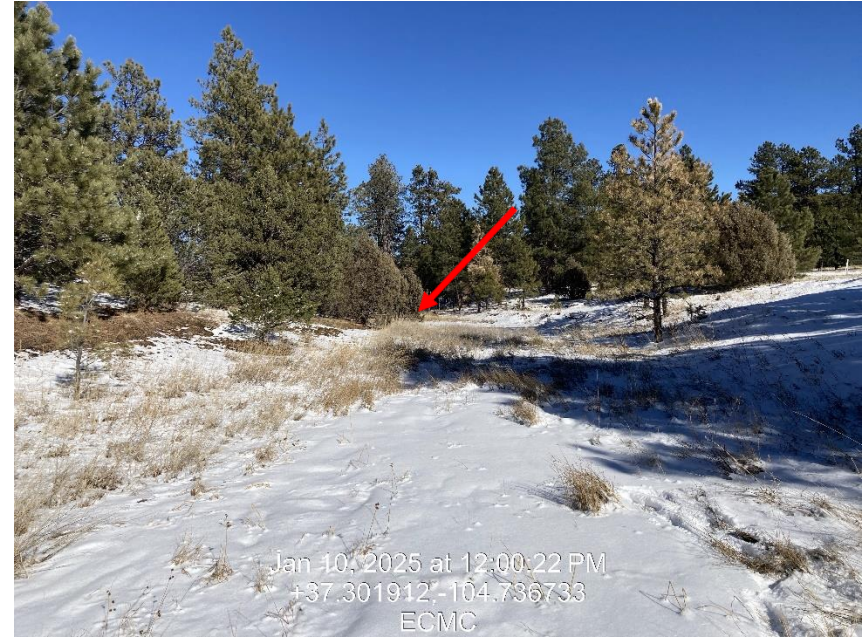
Photo 10 – Main ravine looking northeast, down slope

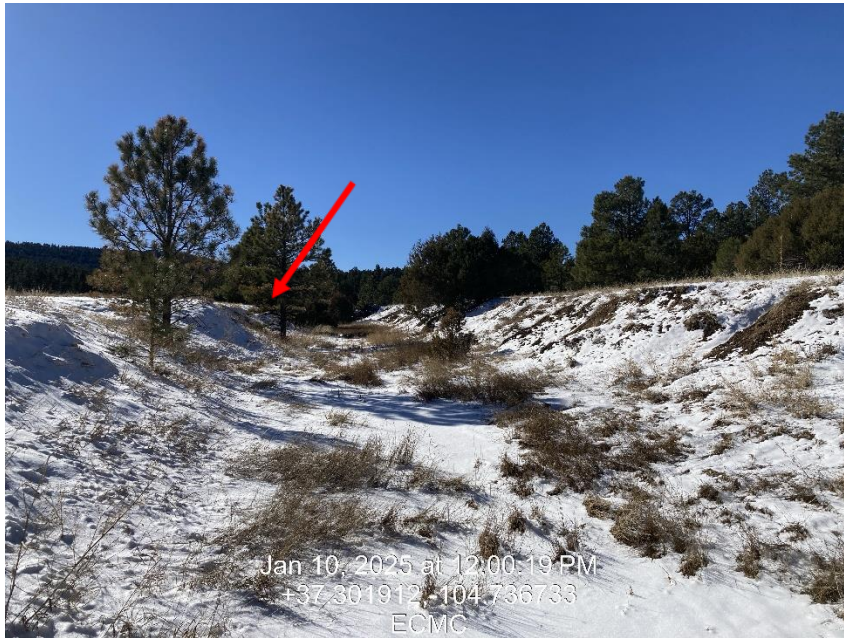
Photo 11 – Main ravine, looking southwest, up slope from spill entry

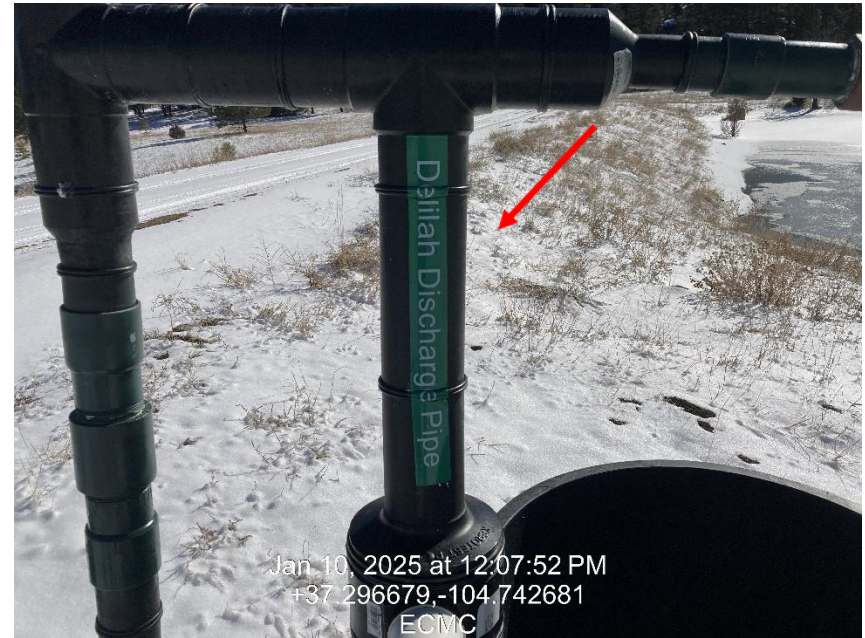
Photo 12 – Delilah 042 A discharge, Permit # COG-900006

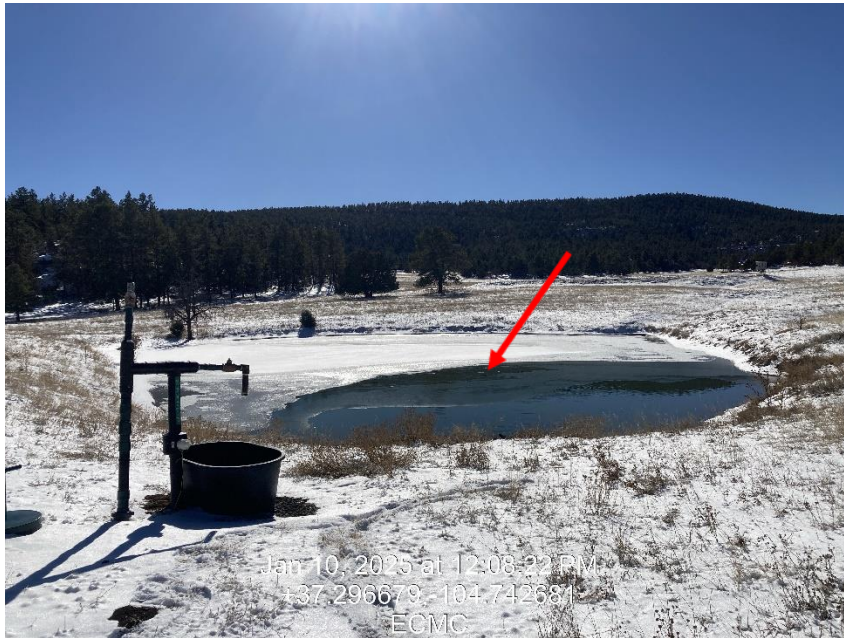
Photo 13 – Delilah 042 A discharge, Permit # COG-900006

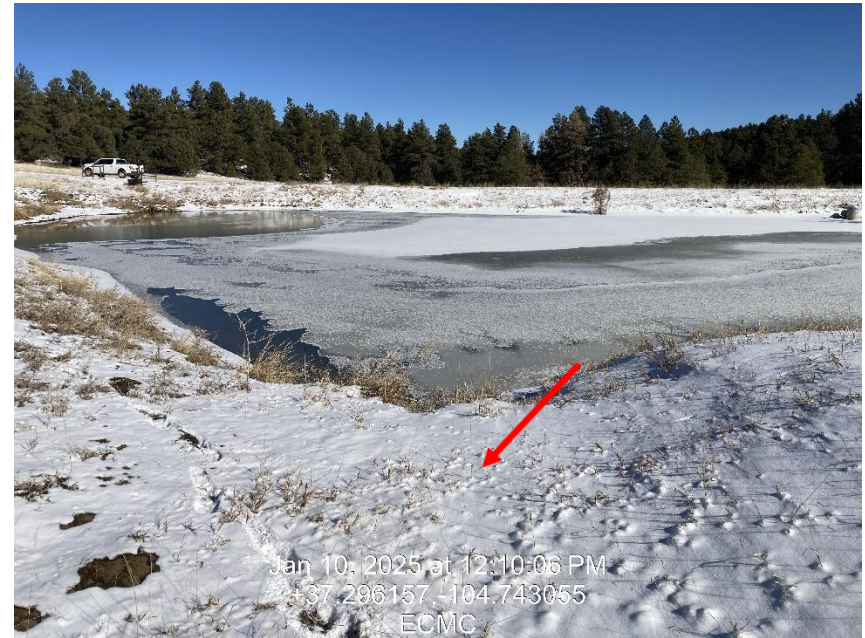
Photo 14 – Looking northeast, ravine up slope from pond

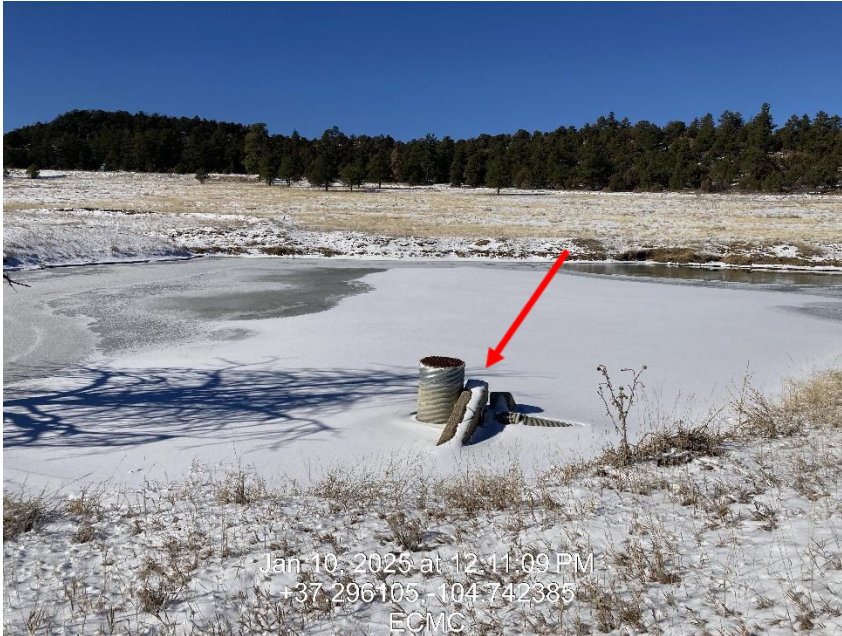
Photo 15 – Delilah 042 A discharge, Pond overflow

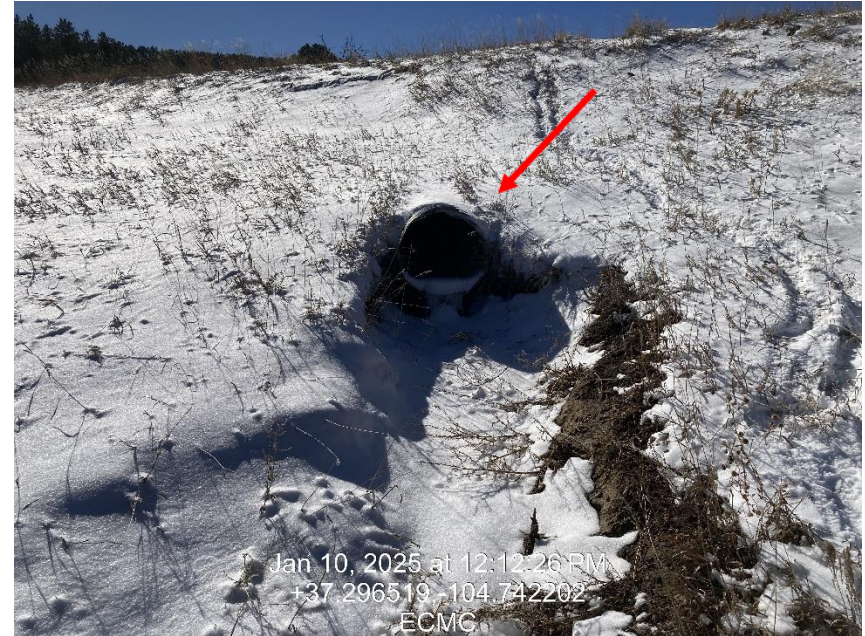
**Photo 16 – Delilah 042 A discharge, Pond overflow
down slope of pond**

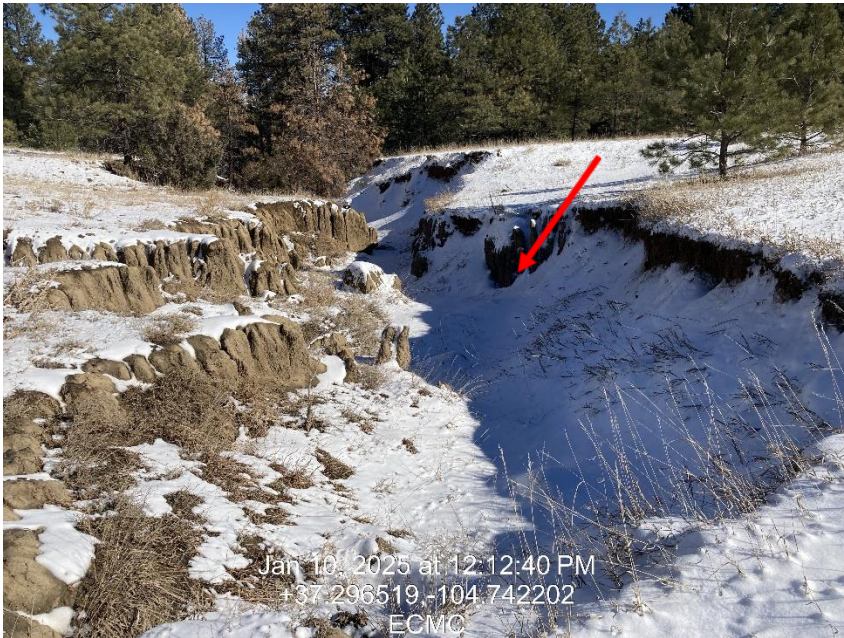
Photo 17 – looking northeast, ravine below Delilah 042 A outfall

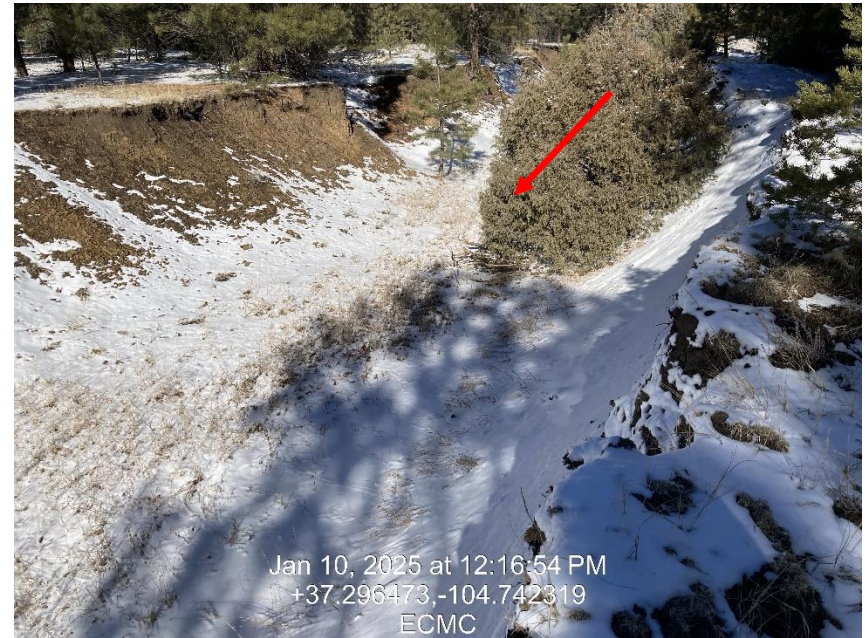
Photo 18 – looking northeast, ravine below Delilah 042 A outfall
