Inspection Photos

Operator: Simcoe LLC - 10749

Location ID: 325965

Inspection Photos
Location Name: Lobato A1
Location ID: 325965

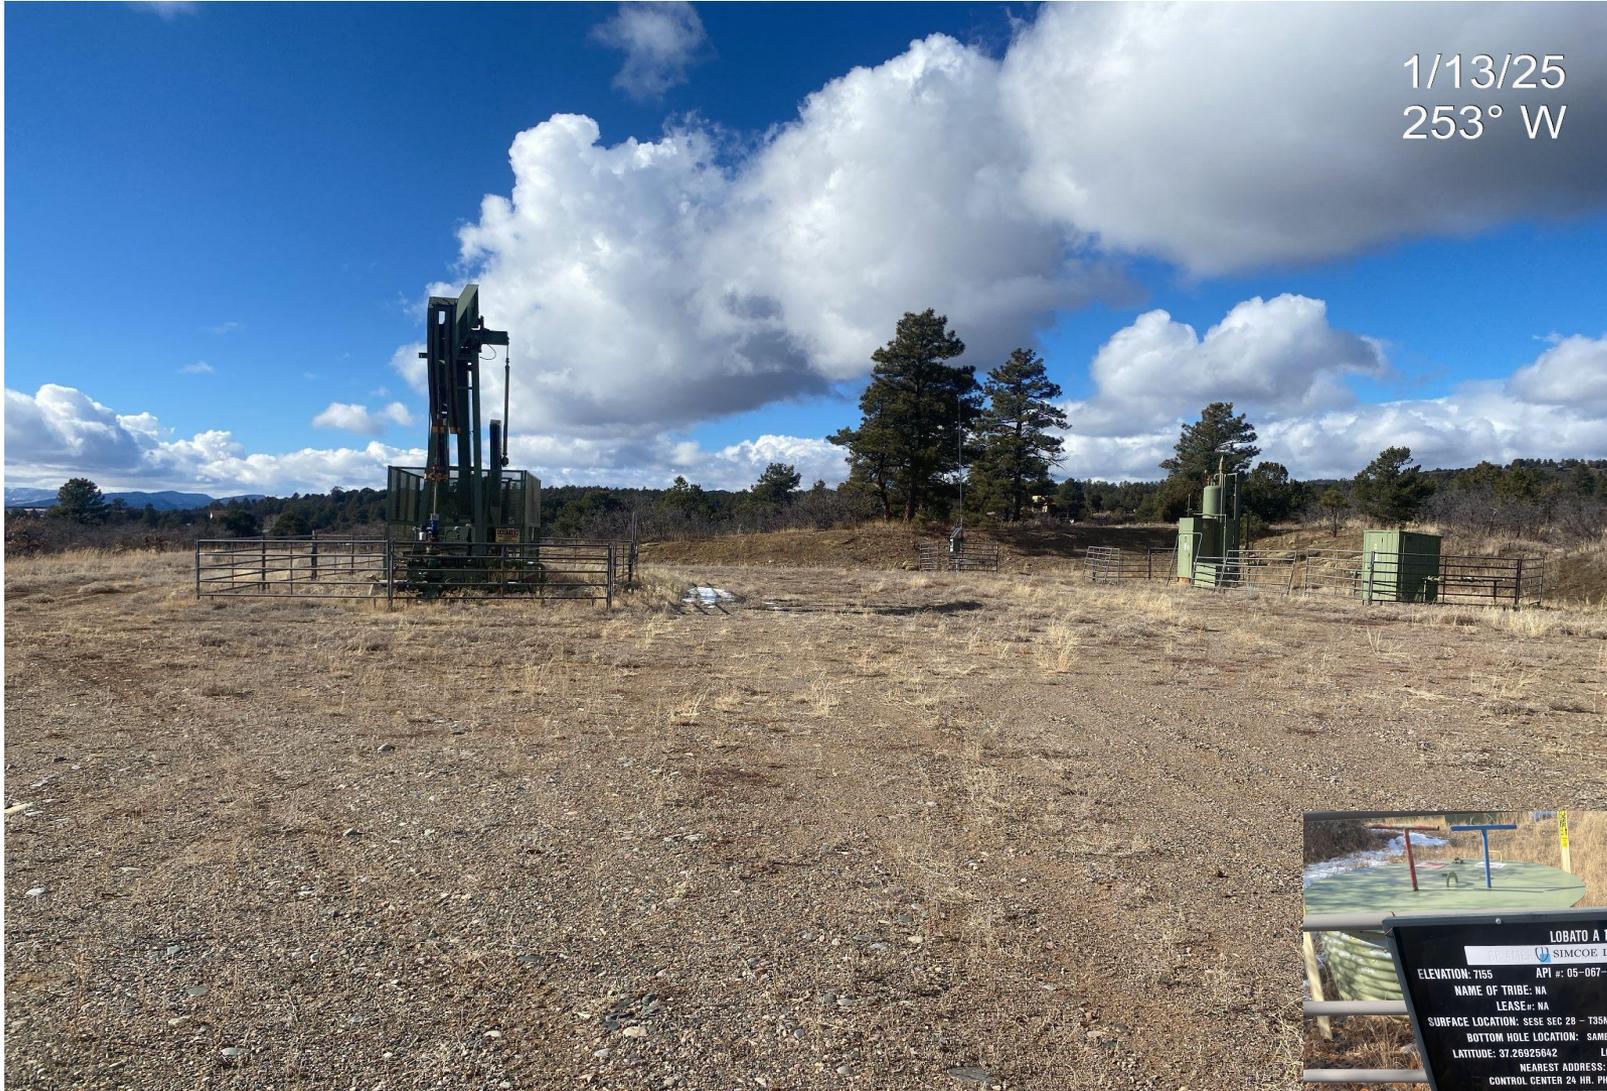
Photo 1. View of well pad taken from the access point facing center.

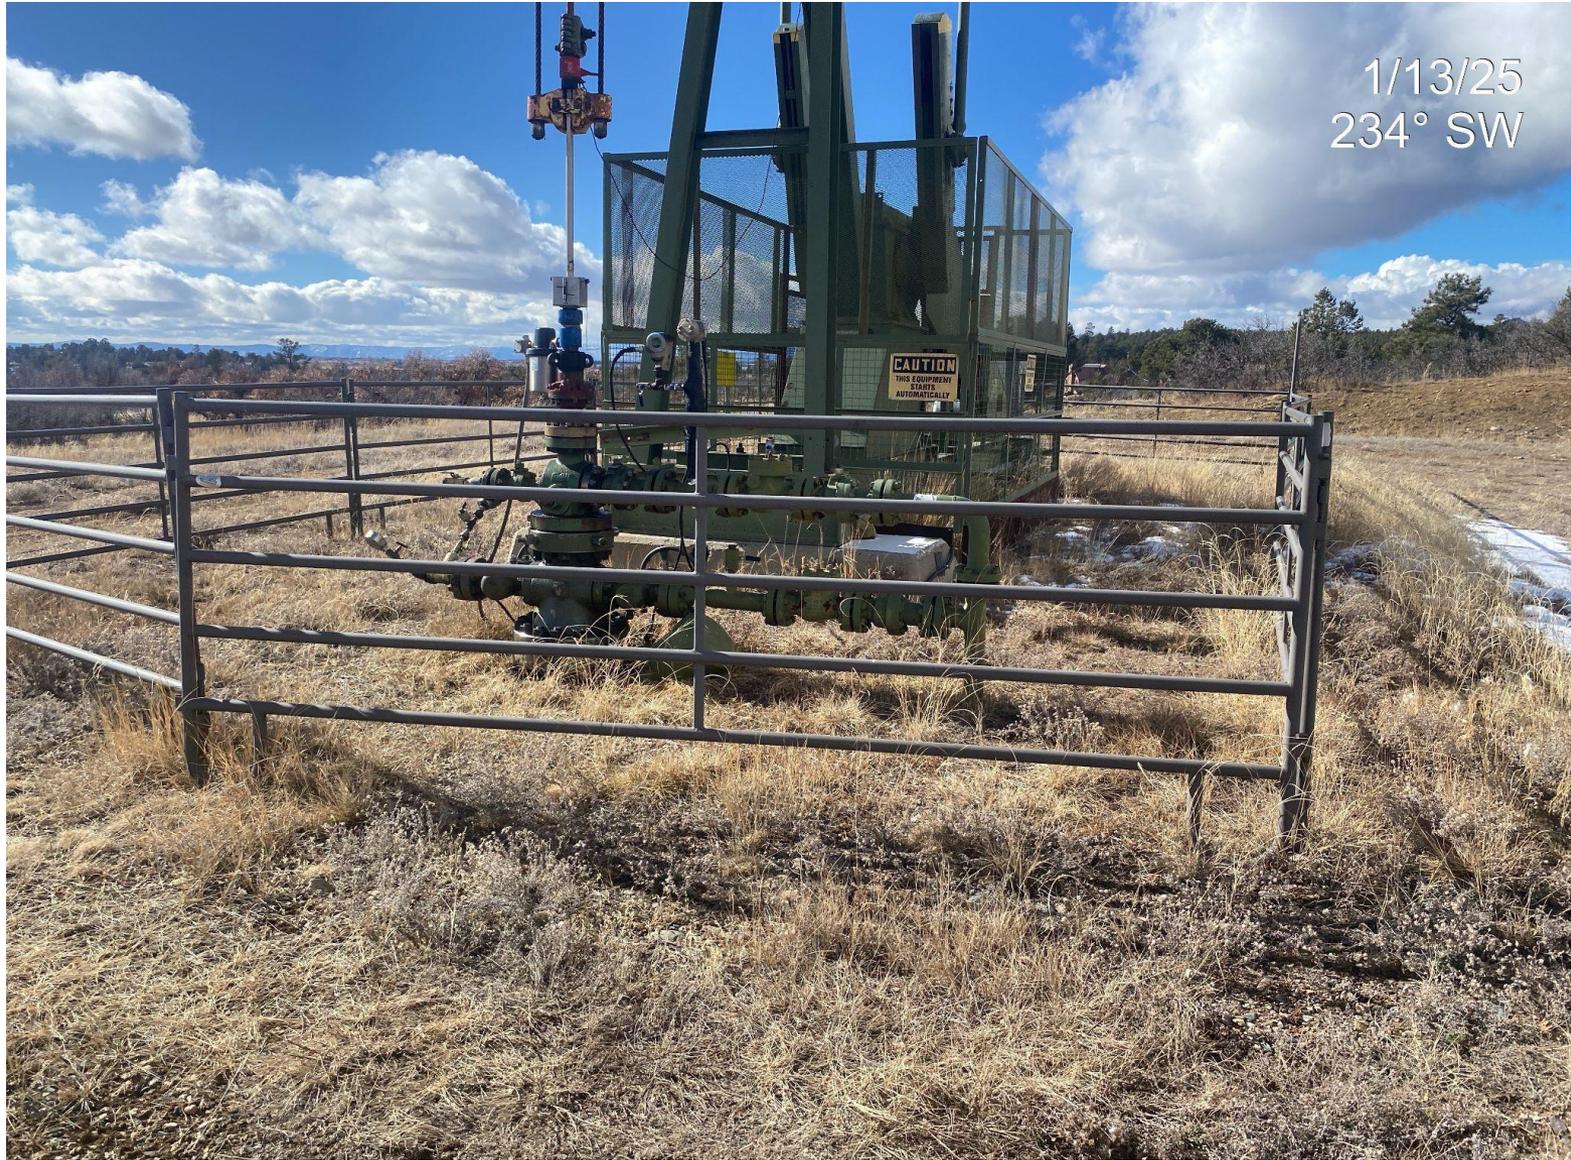
Photo 2. Vegetation encroaching on well head, remove combustible material from active equipment.

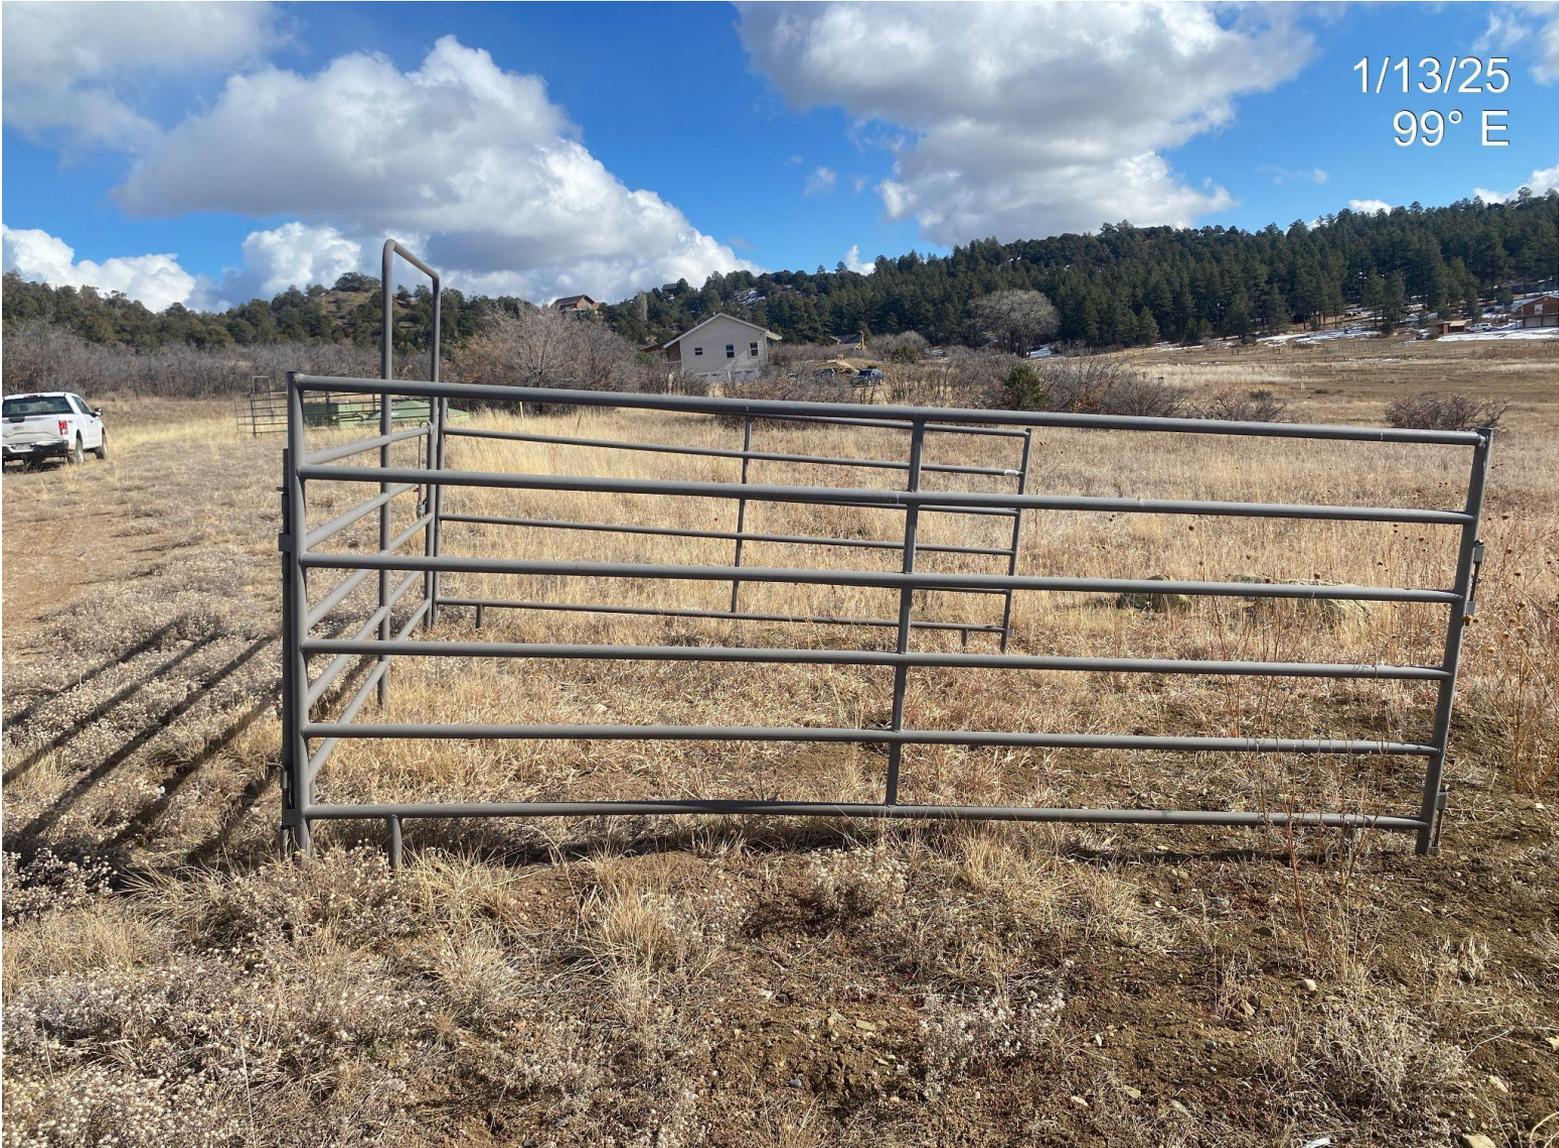
Photo 3. Unused fencing equipment stored in the southern interim reclamation area.

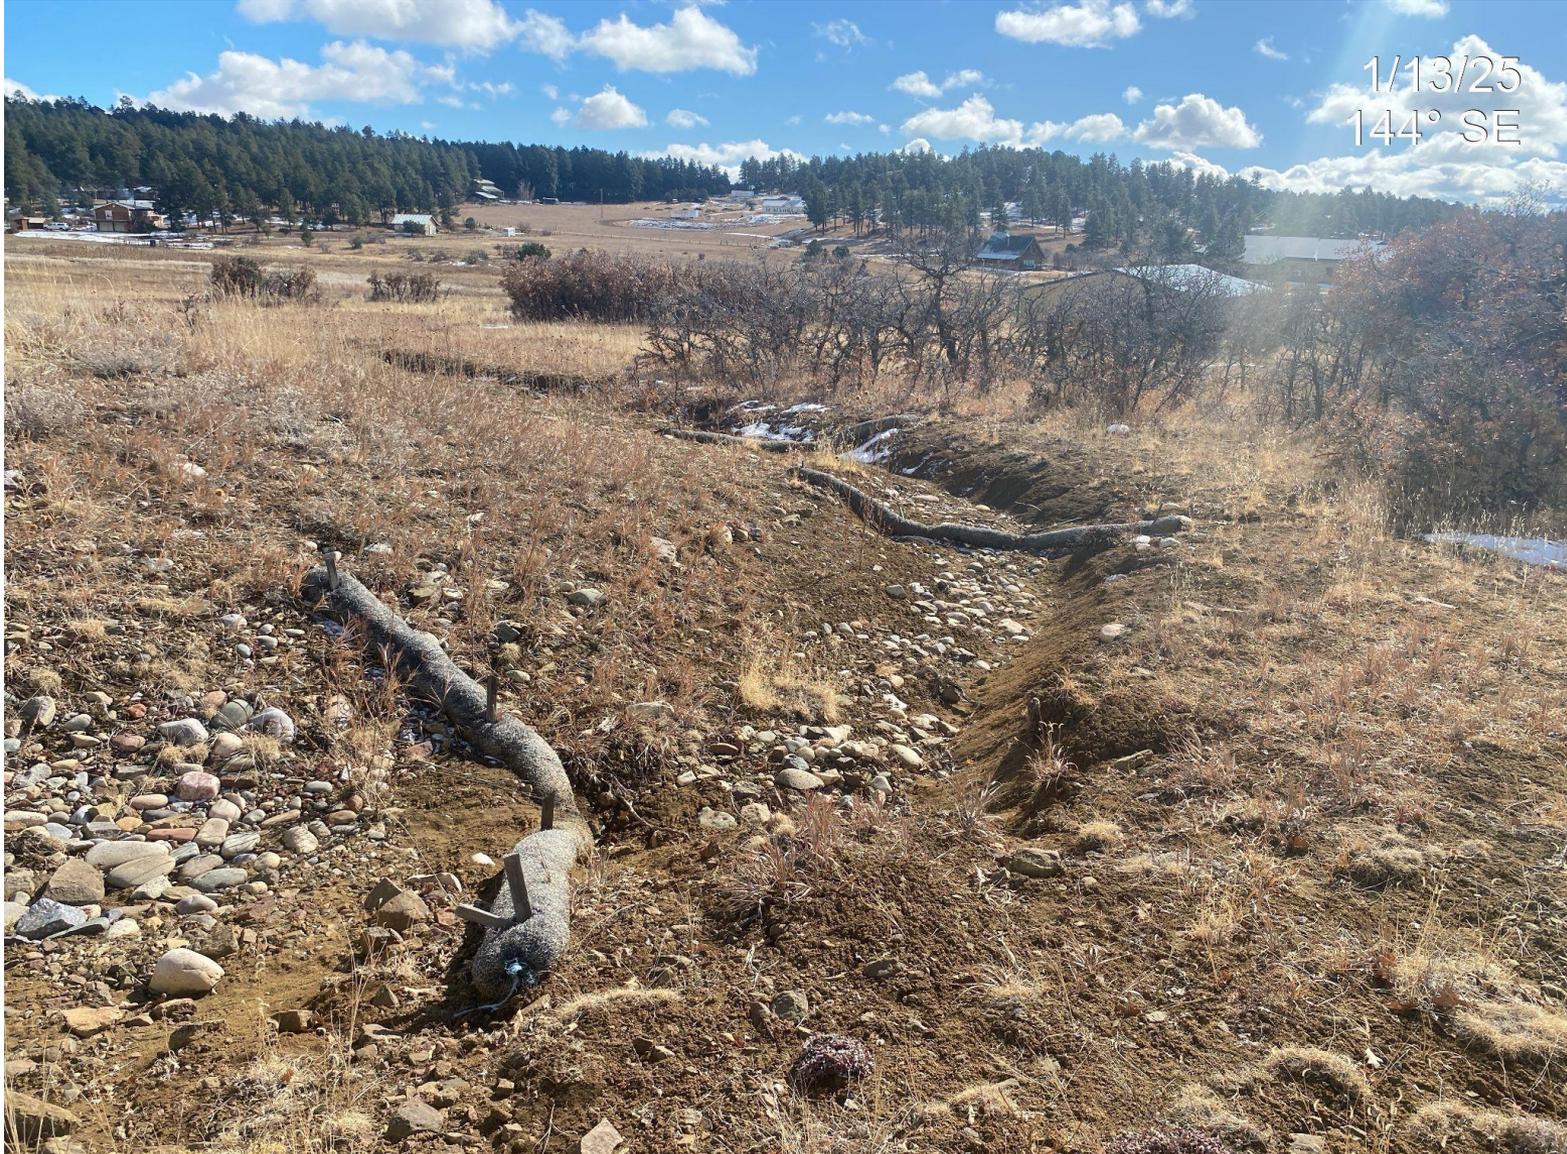
Photo 4. Stormwater BMPs/wattles installed in the southern portion of the location are not longer functioning, erosion persists.

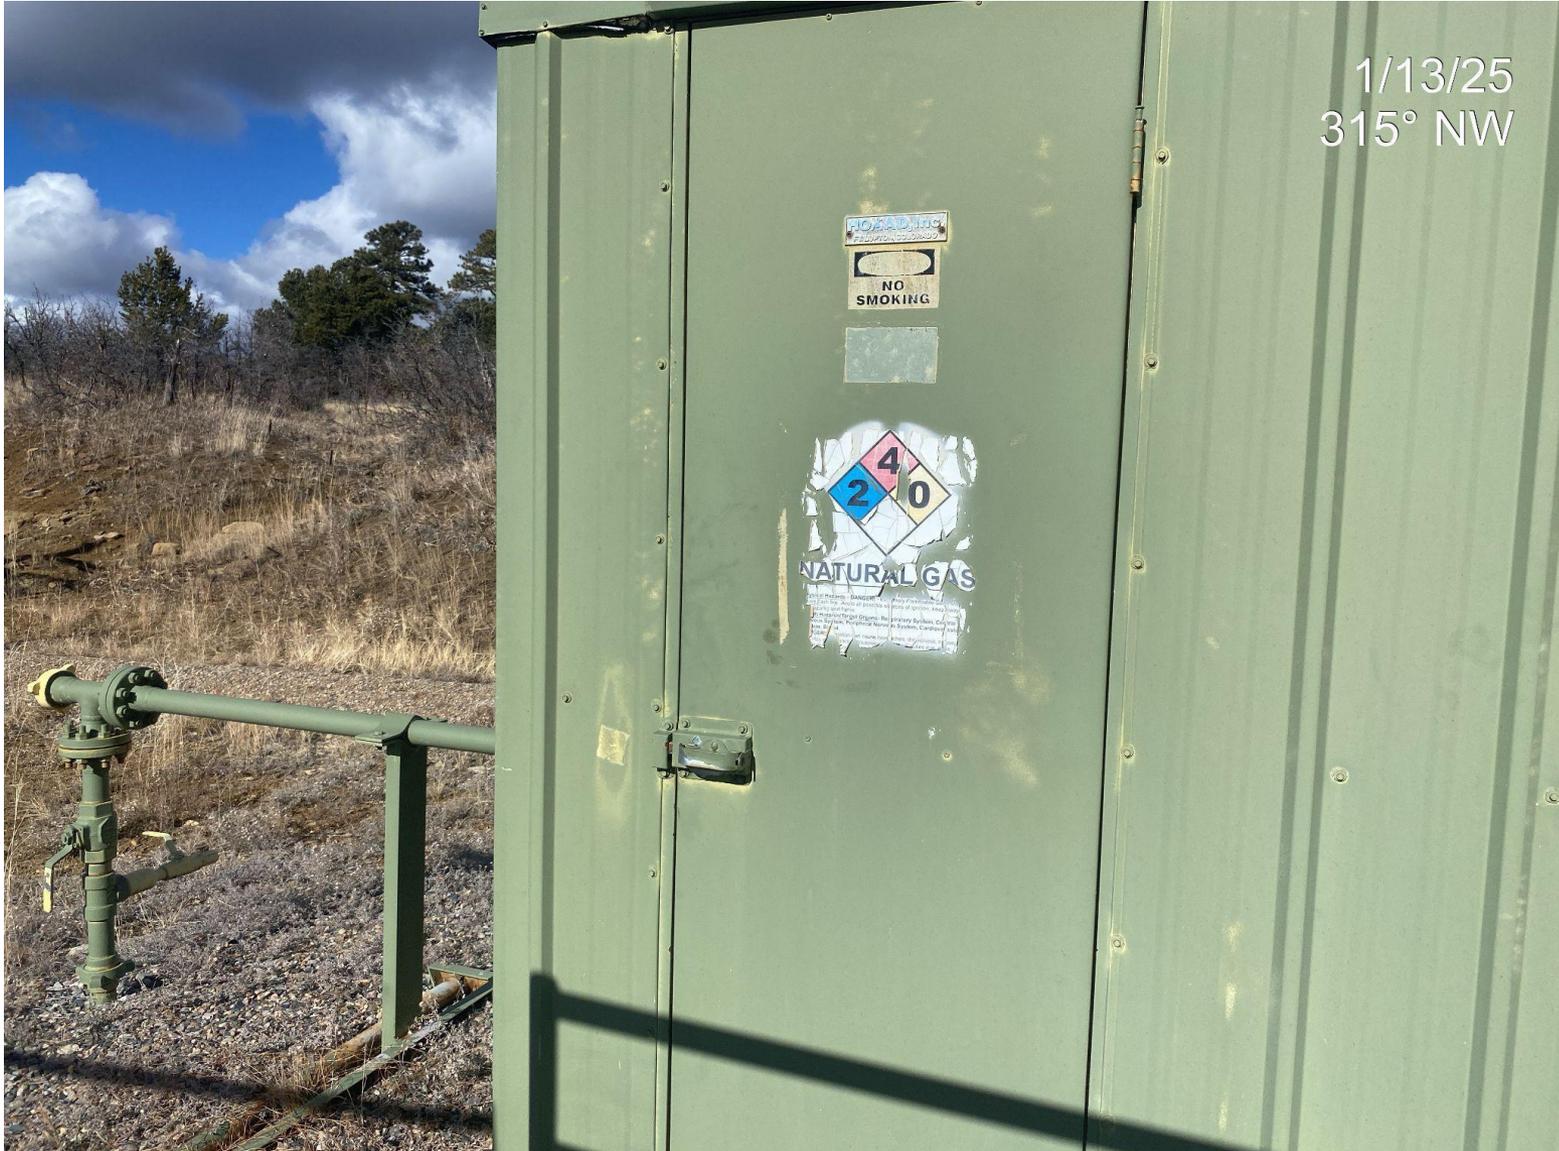
Photo 5. Label at separator is deteriorating, future maintenance is advised.

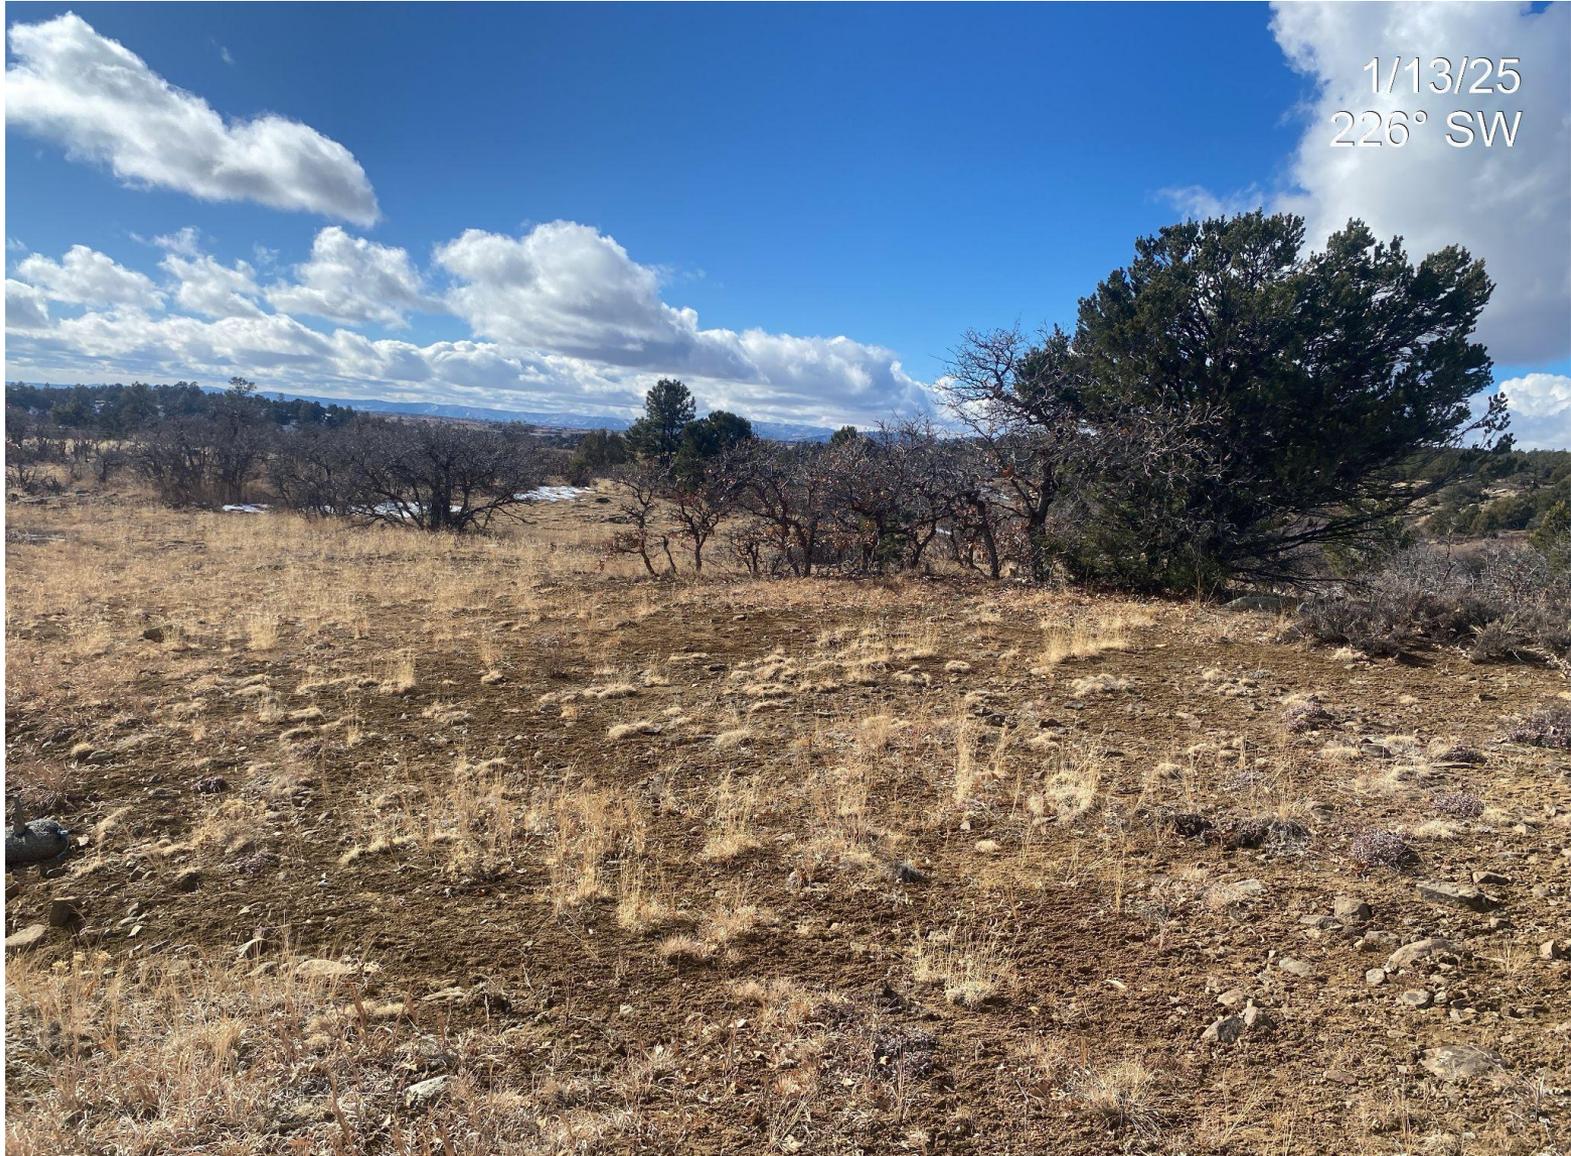
Photo 6. Reference area composed of Smooth Brome, Gambel Oak and Blue Grama.
