**KT Resources LLC  
Fee-62N96W 31SWW  
Location ID: 336391**

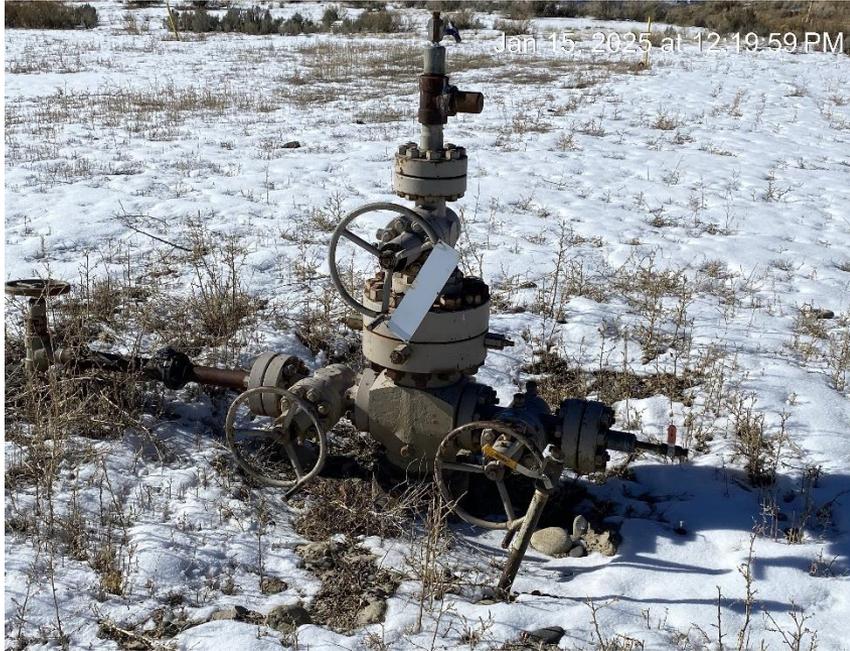
**Displayed well sign**

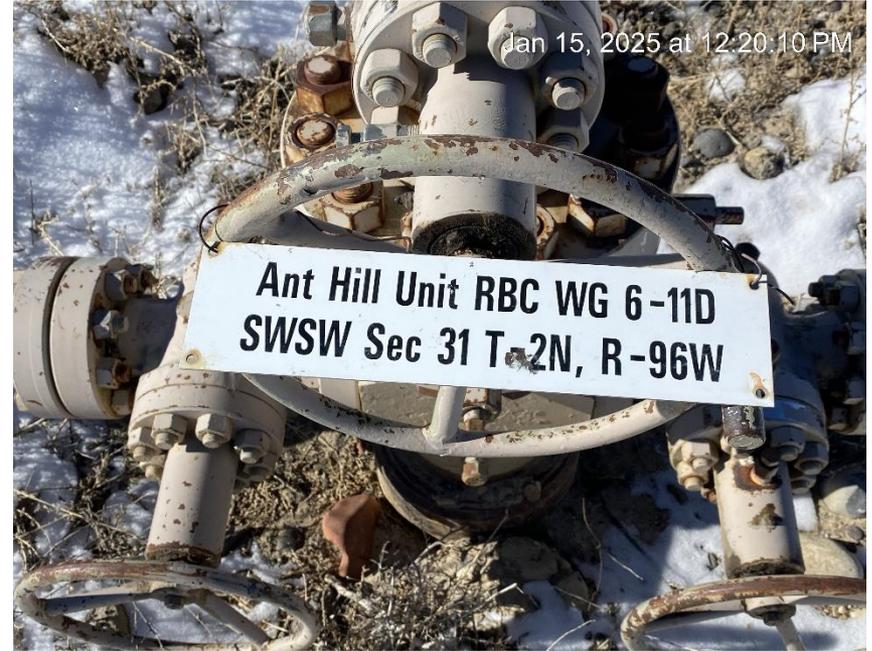
**When replaced additional information is required**

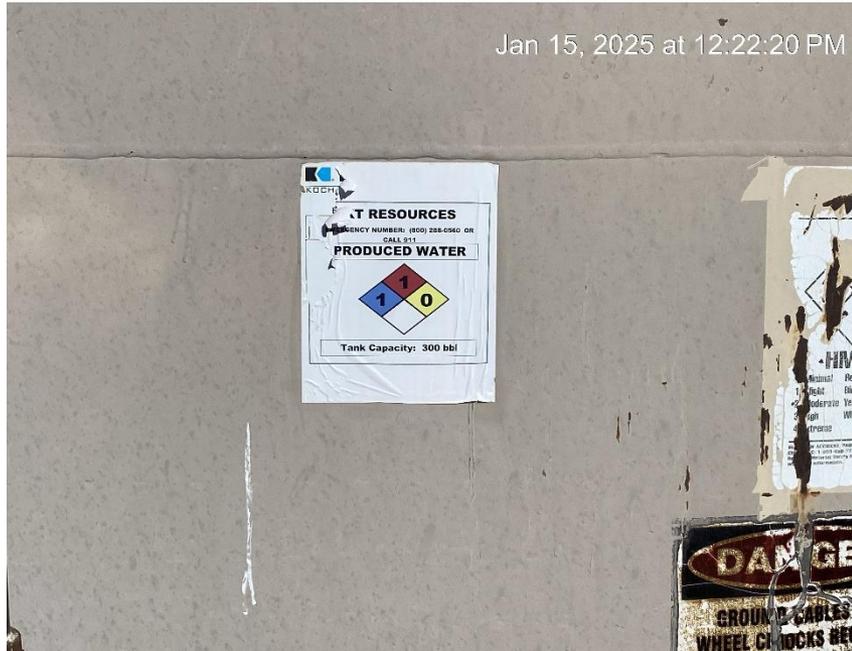
Replace when damaged

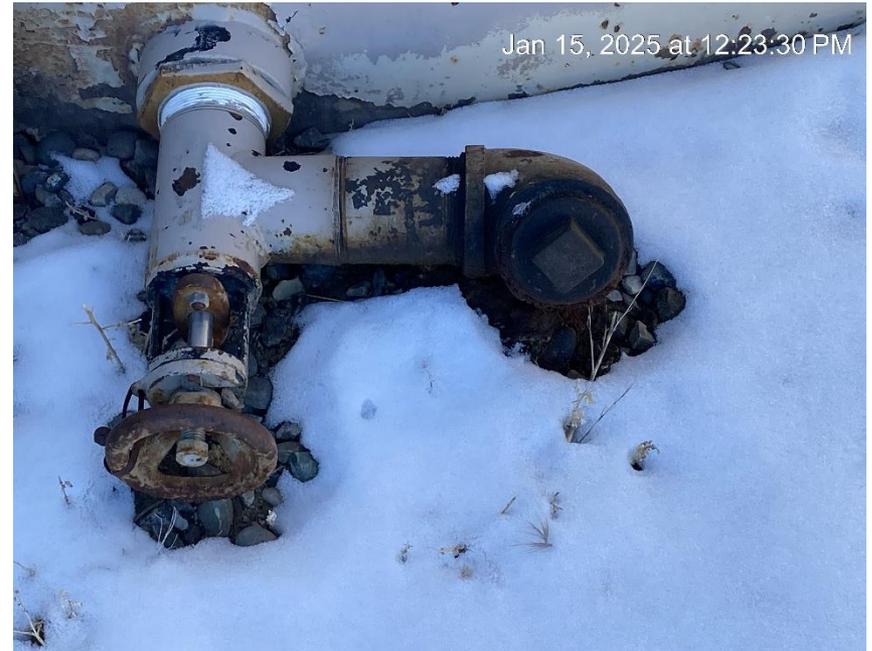
Oily waste from leaking valve

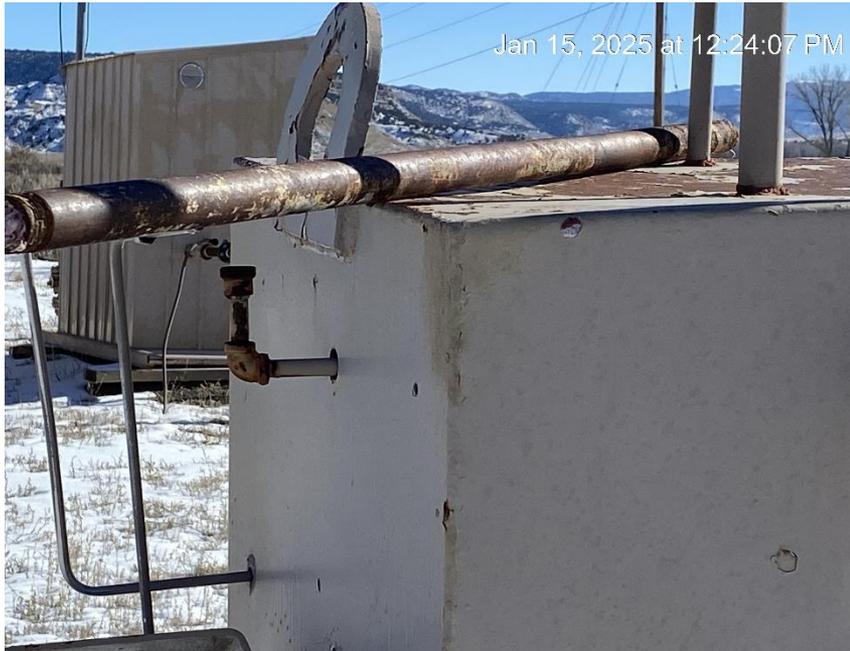
**Debris**

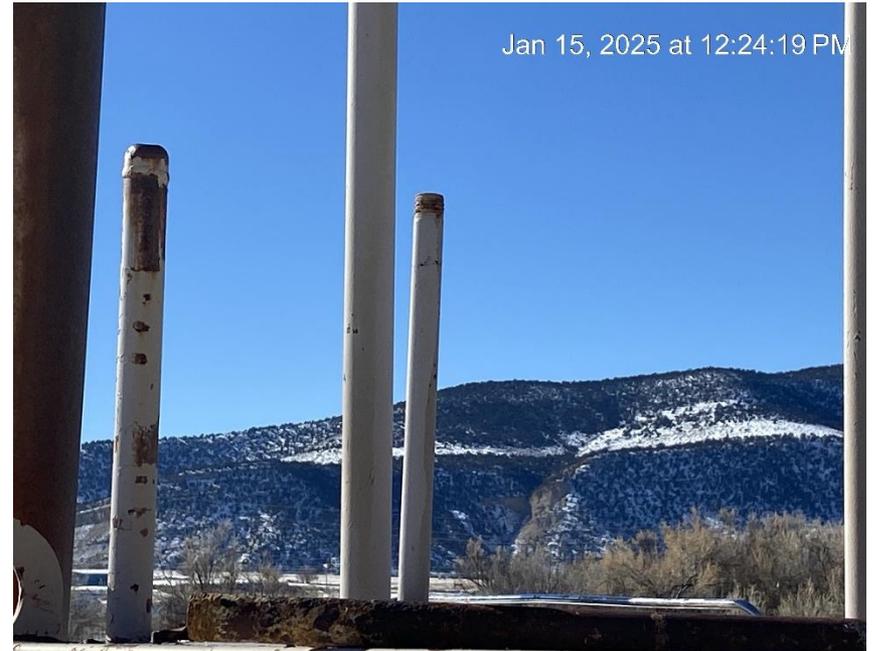
**Vent missing cap**

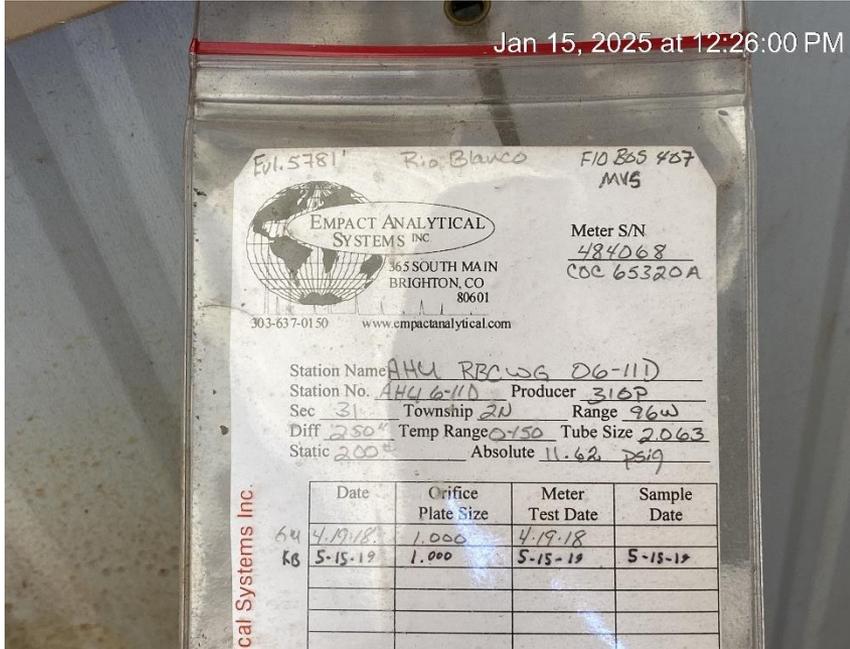
Calibration overdue

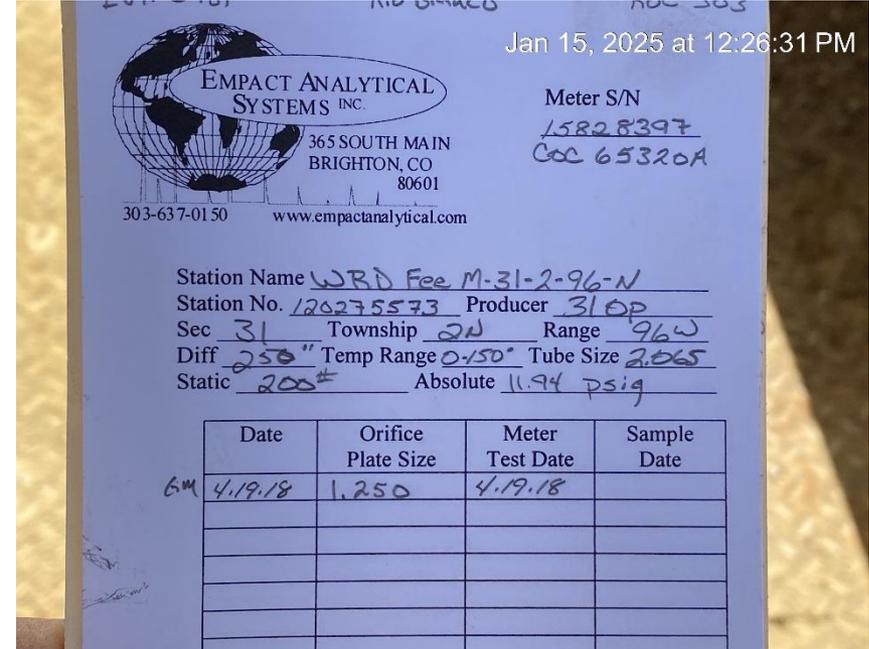
Calibration overdue
