## Inspection Photos

Location Name: TEP ROCKY MOUNTAIN LLC, CHEVRON-66S96W/20NESE

Location ID: 335170

Date: 1/15/2025

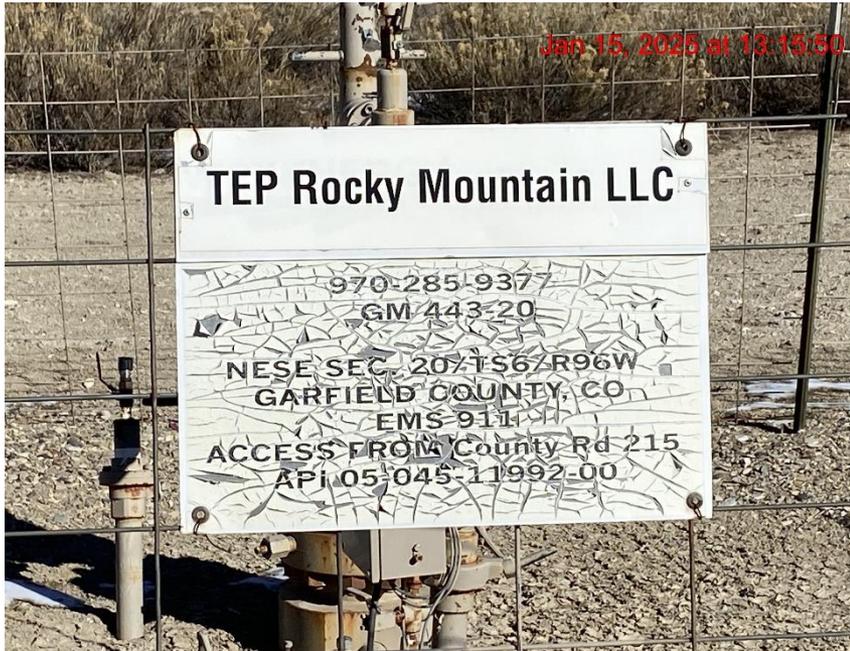
Illegible Wellhead Sign – Photo #05960

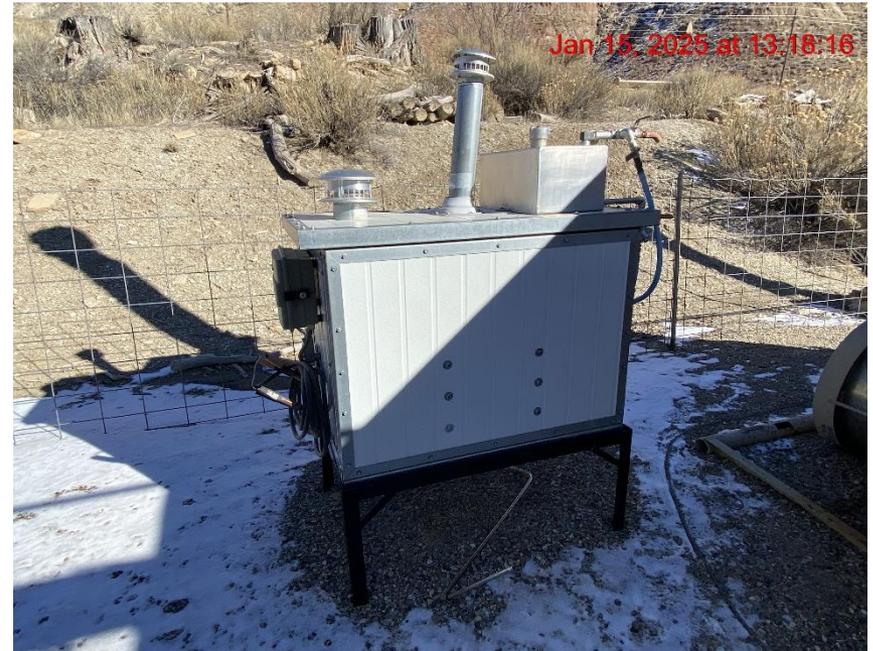
Unused Equipment – Photo #05965

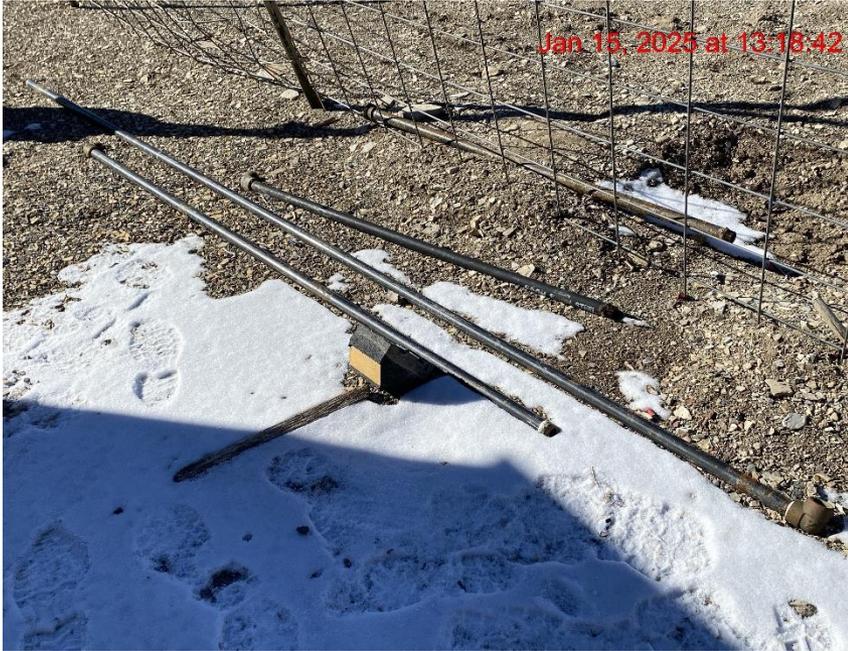
**Stored Supplies – Photo #05967**

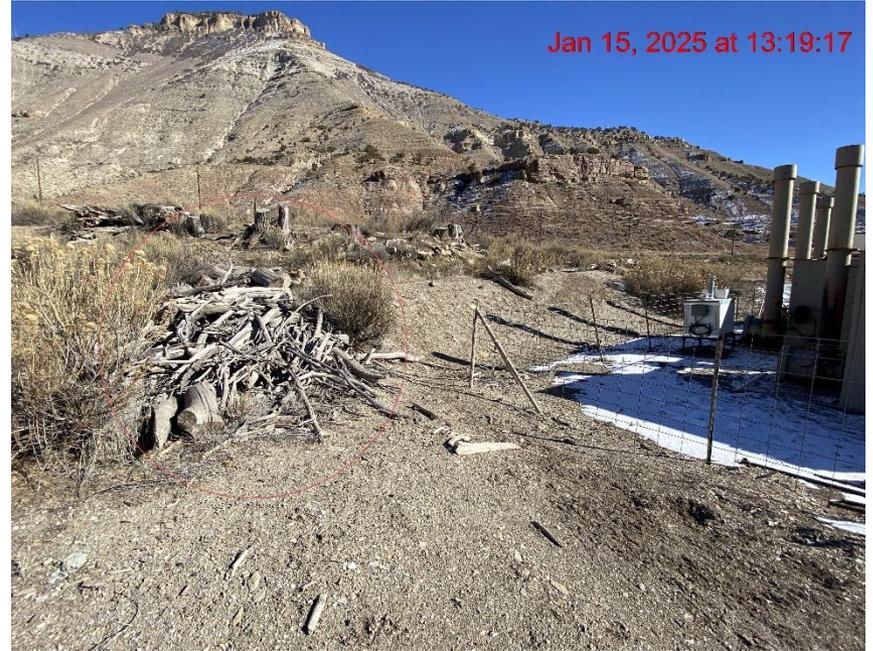
**Debris Pile Near Separators – Photo #05968**

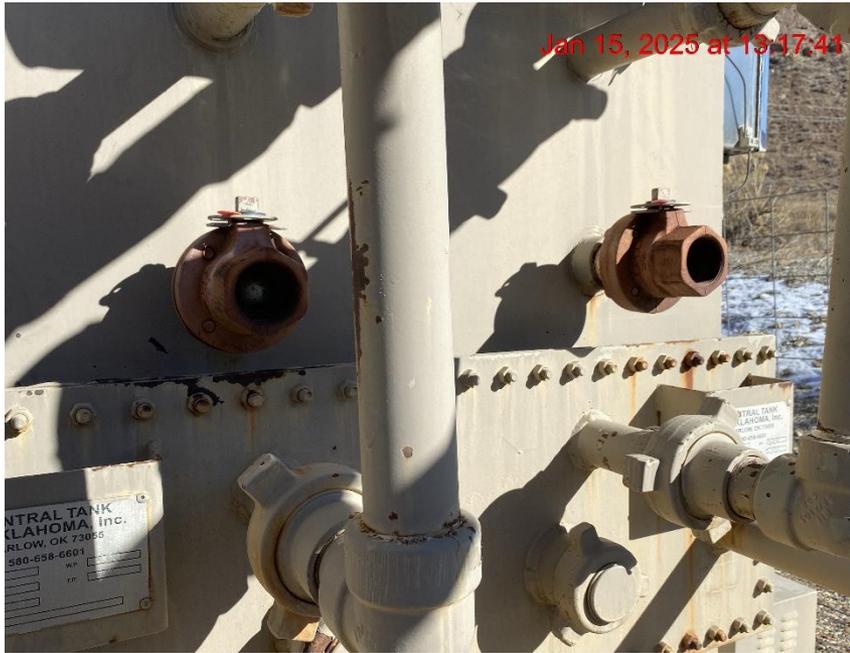
Open-Ended Lines – Photo #05963

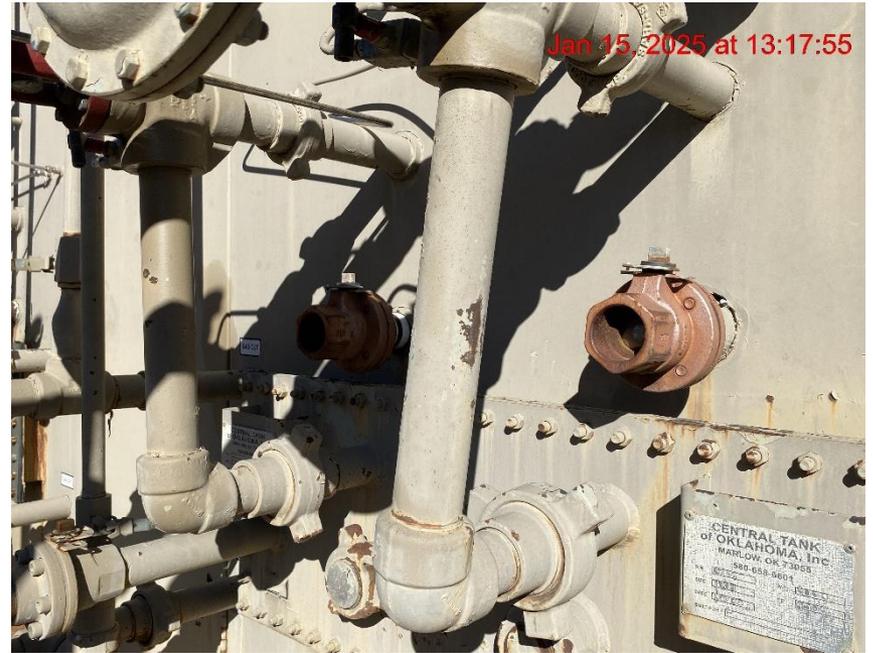
Open-Ended Lines – Photo #05964

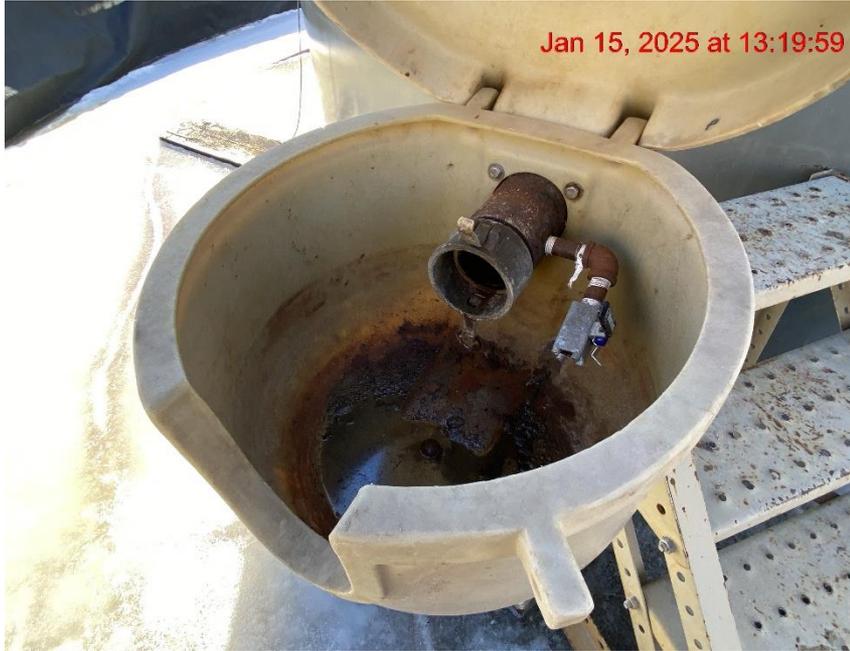
Open-Ended Load Line – Photo #05971

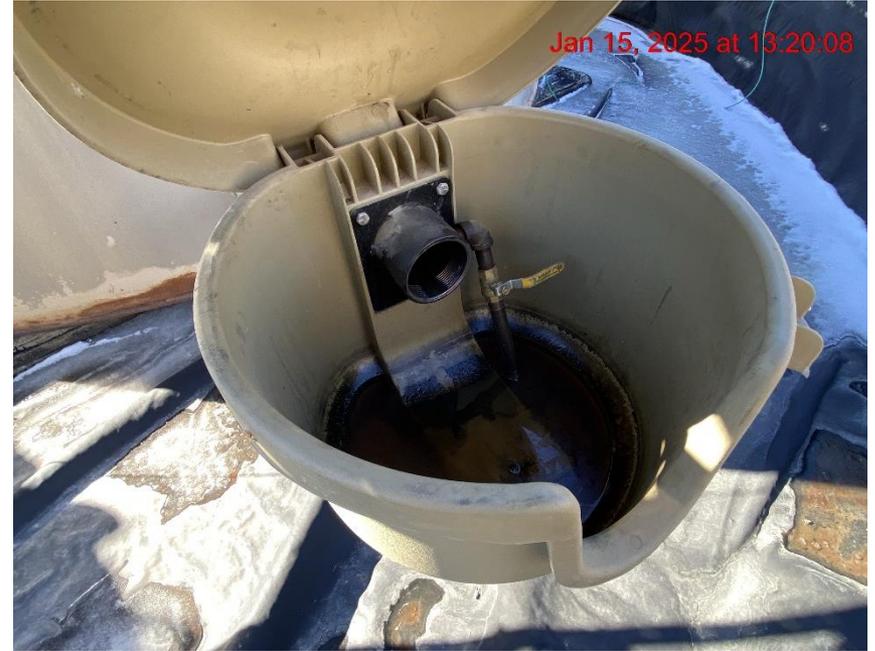
Open-Ended Load Line – Photo #05972

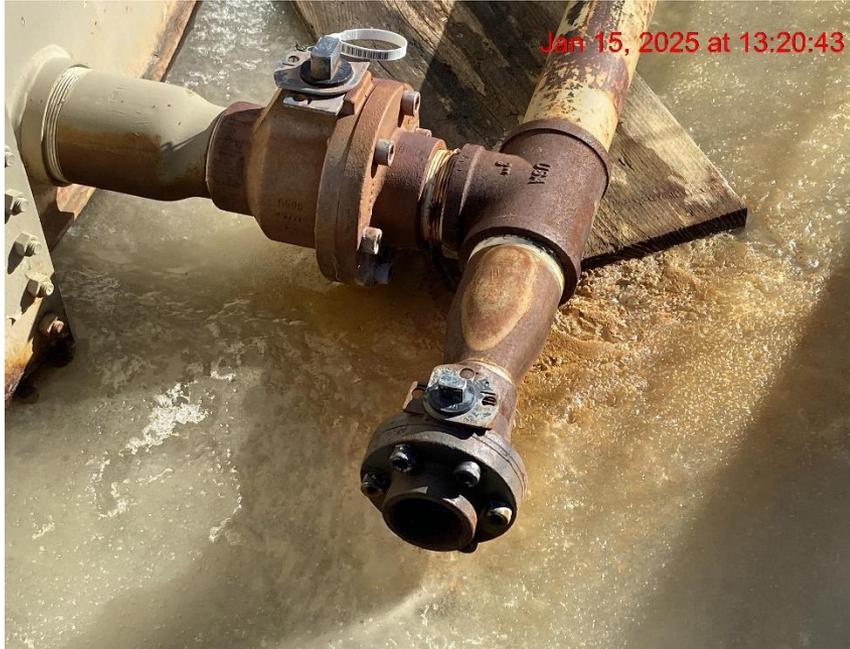
Open-Ended Manifold Line/Oily Waste – Photo #05974

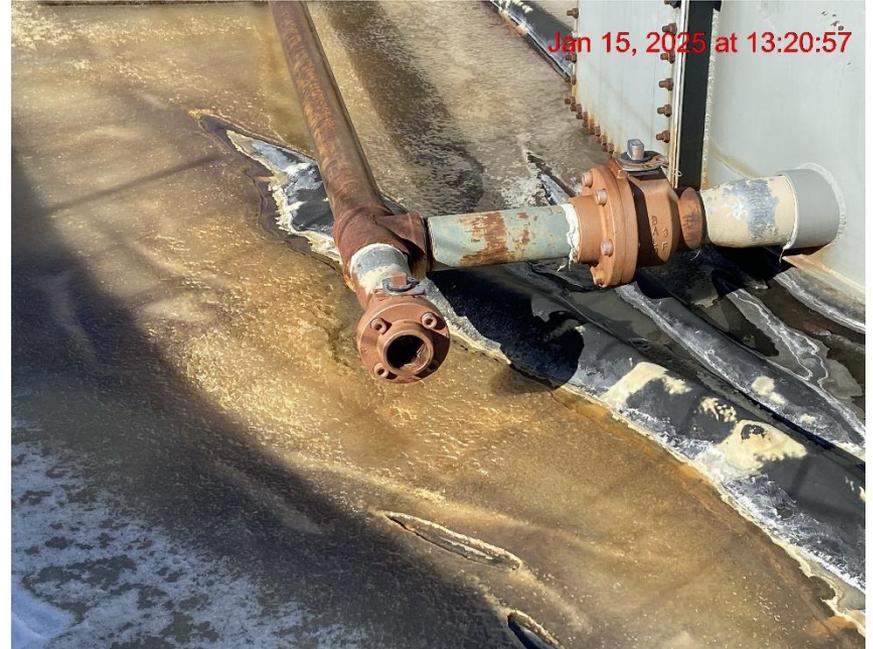
Open-Ended Manifold Line/Oily Waste – Photo #05975
