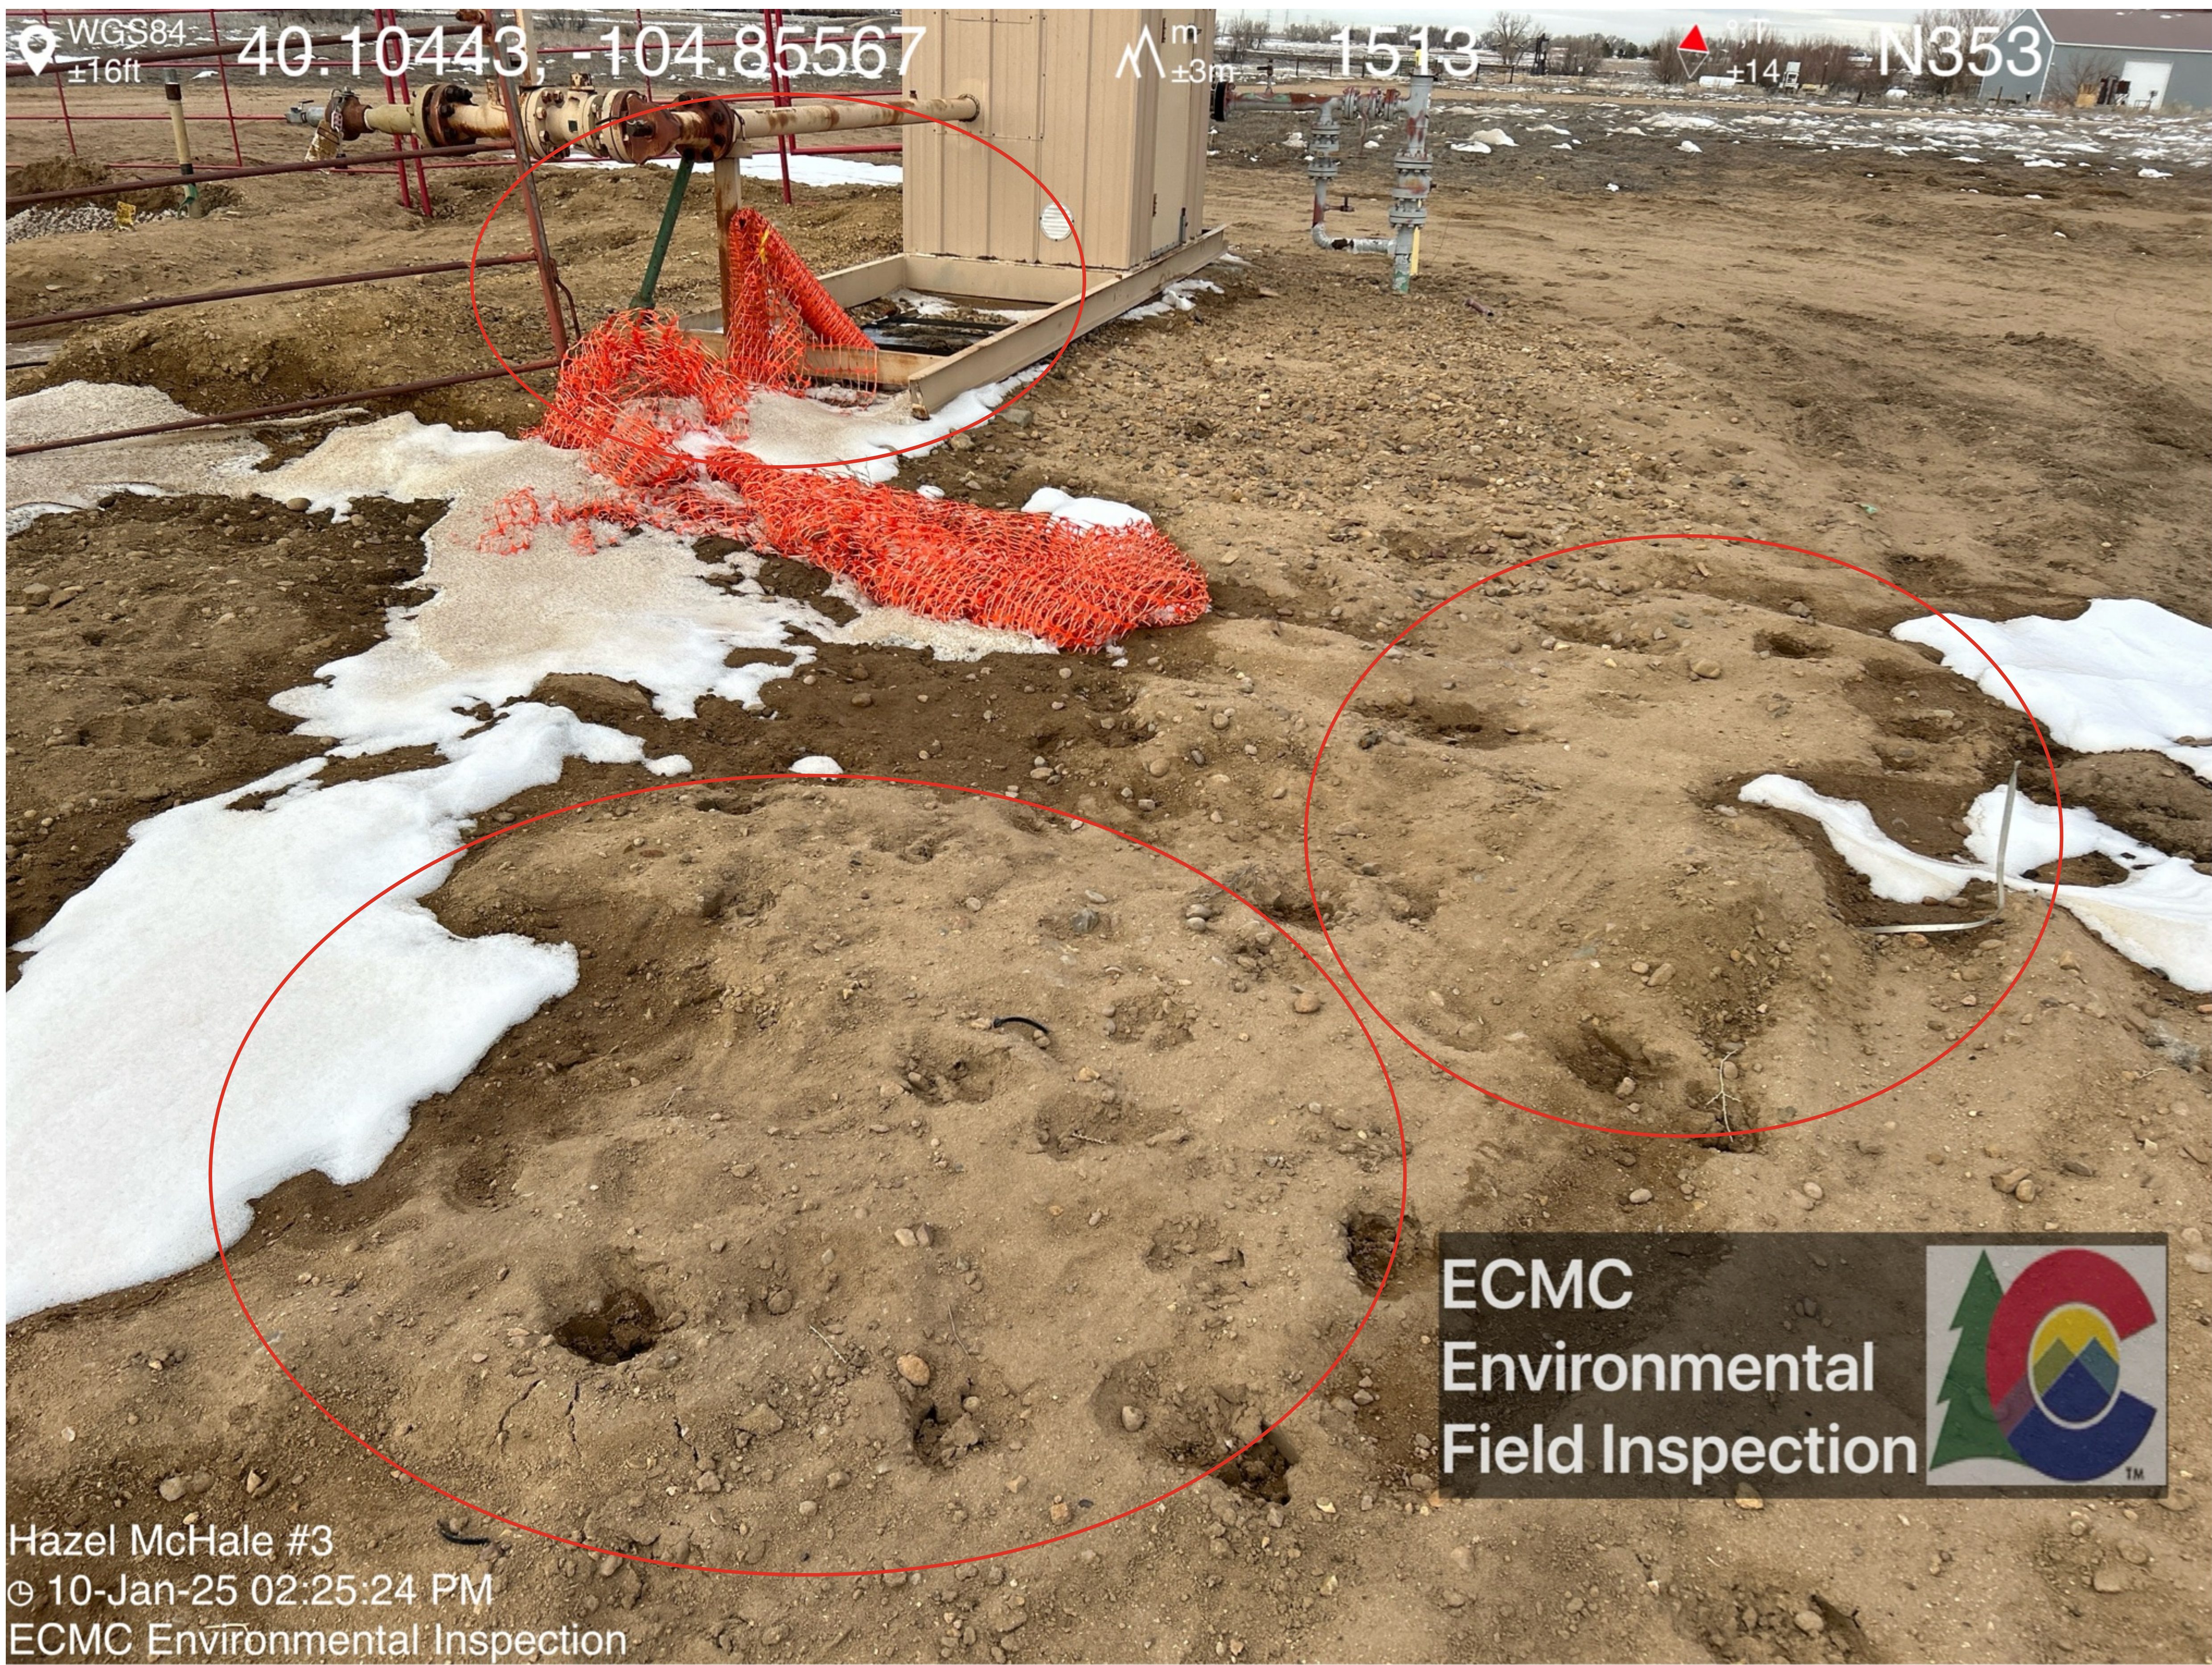
Fencing is present but does not encompass entire excavation. Livestock tracks observed.

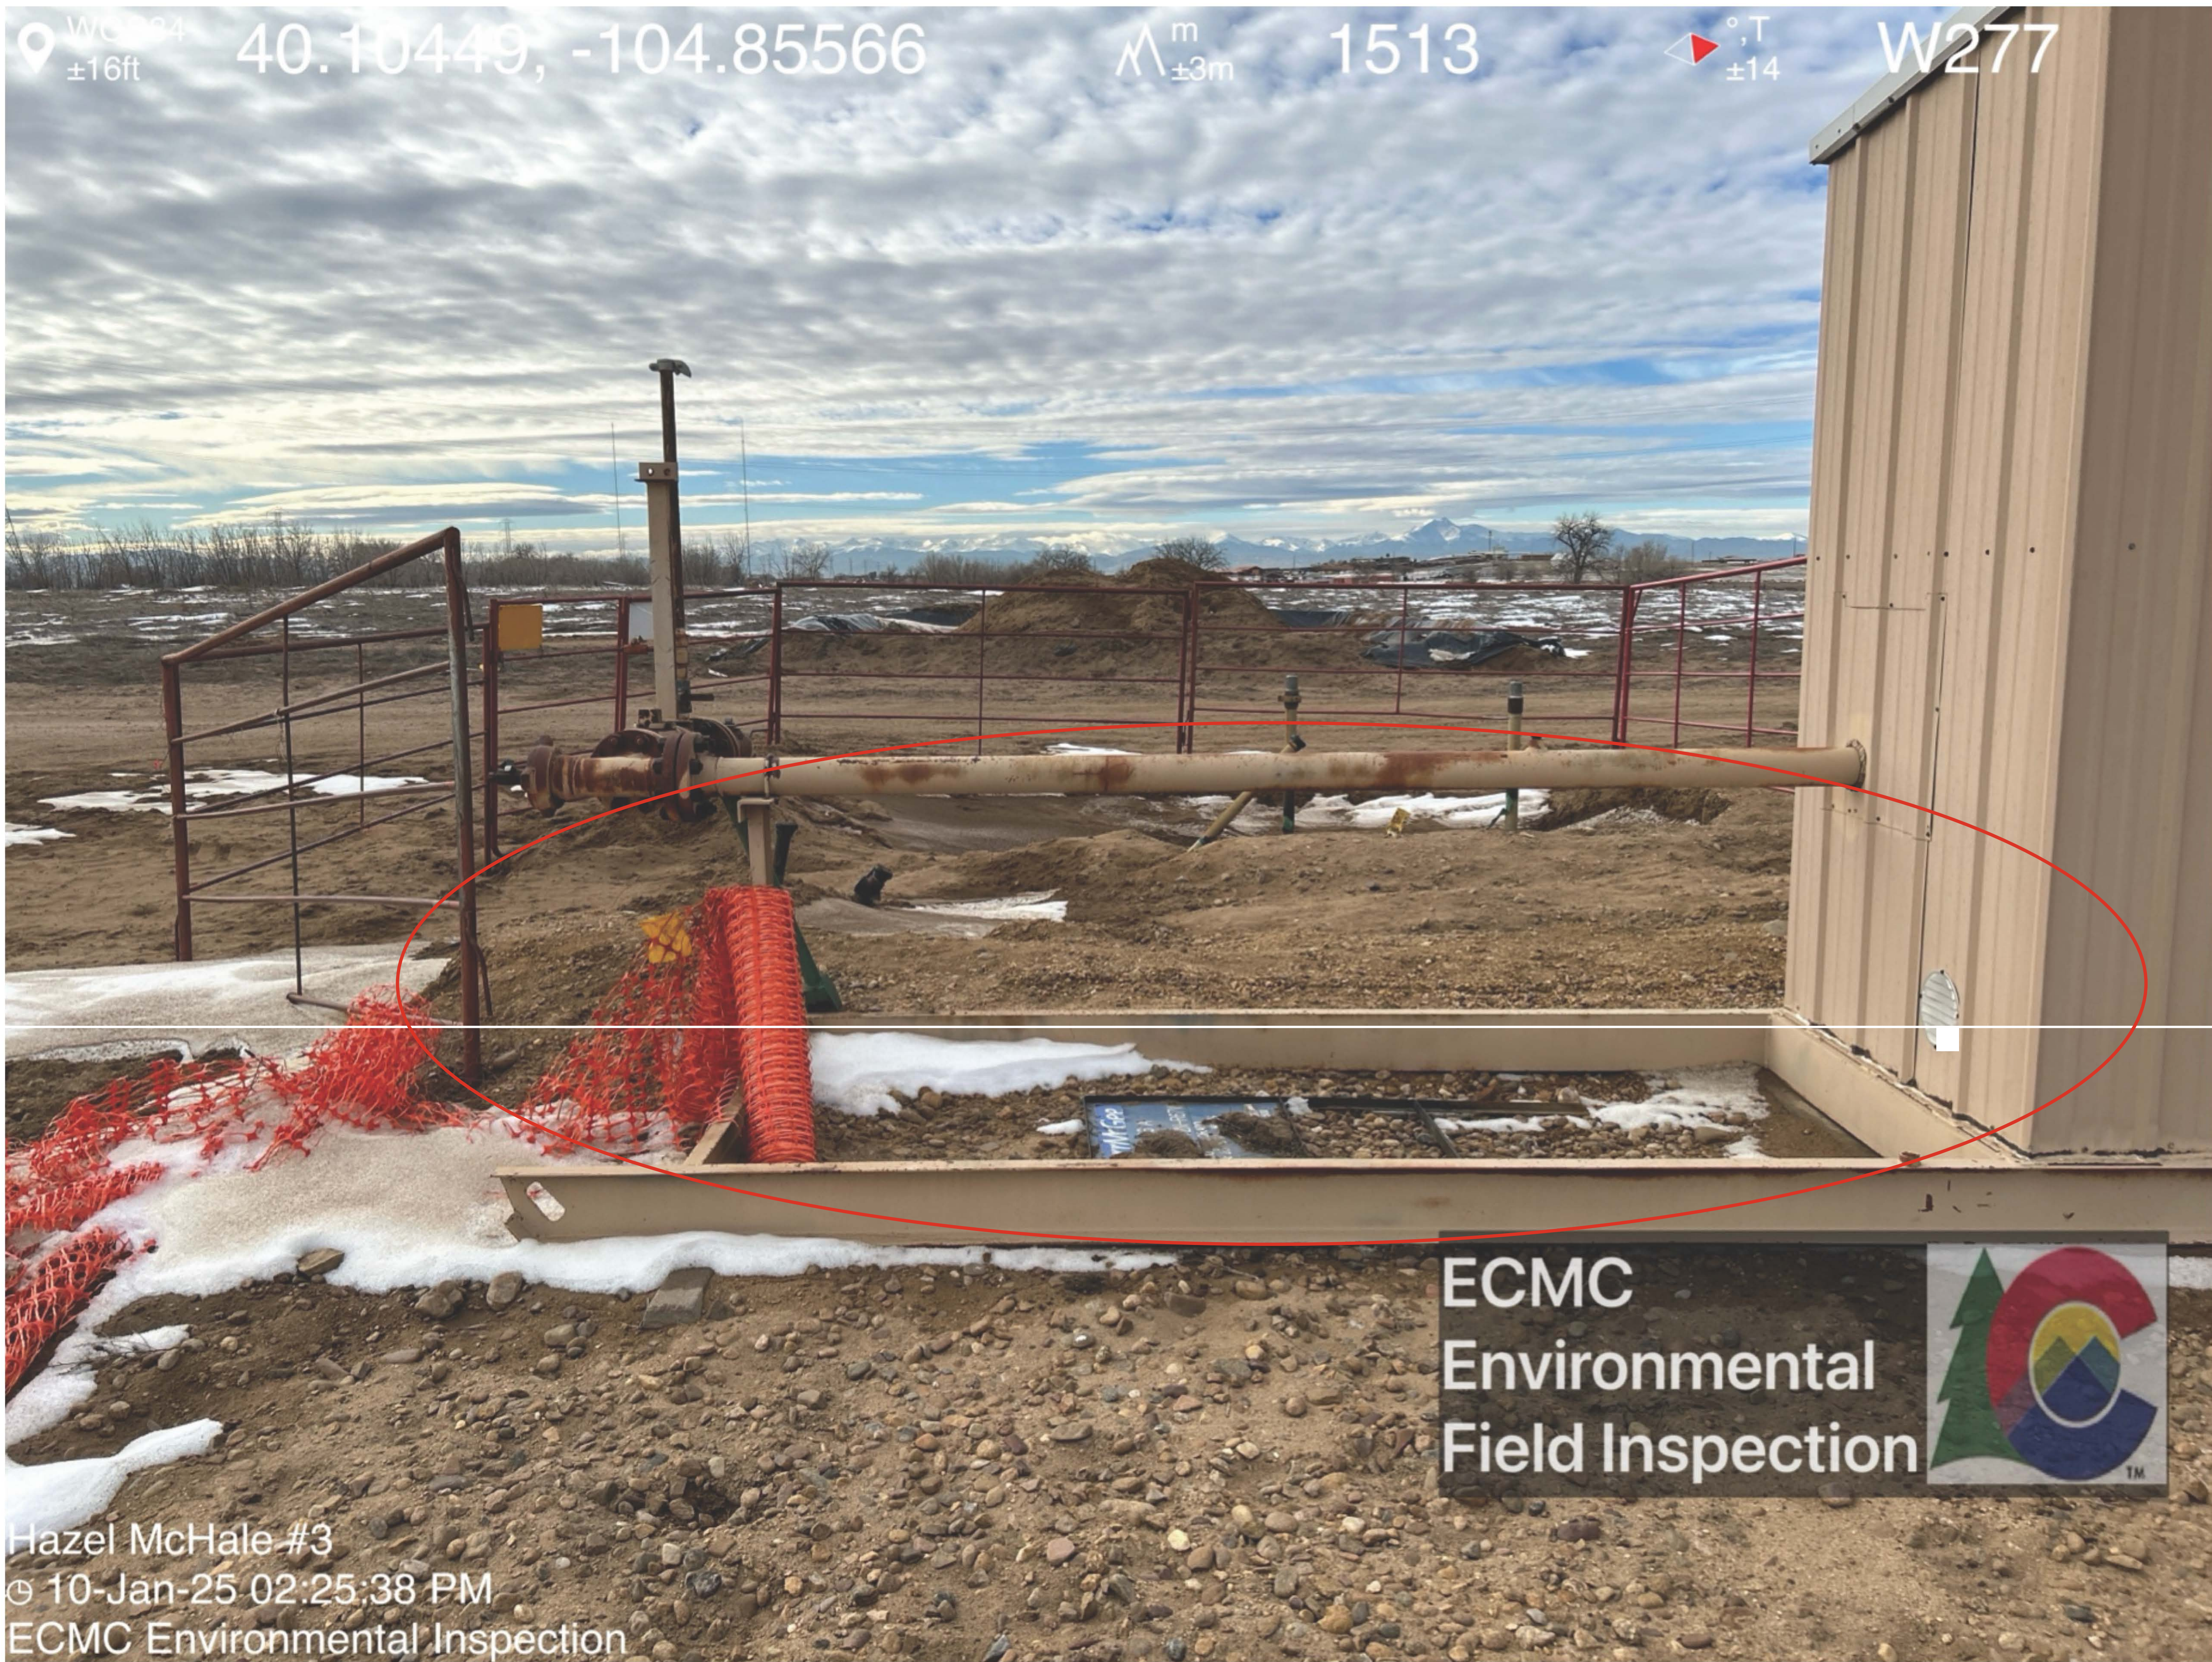
Fencing is present but does not encompass entire excavation.

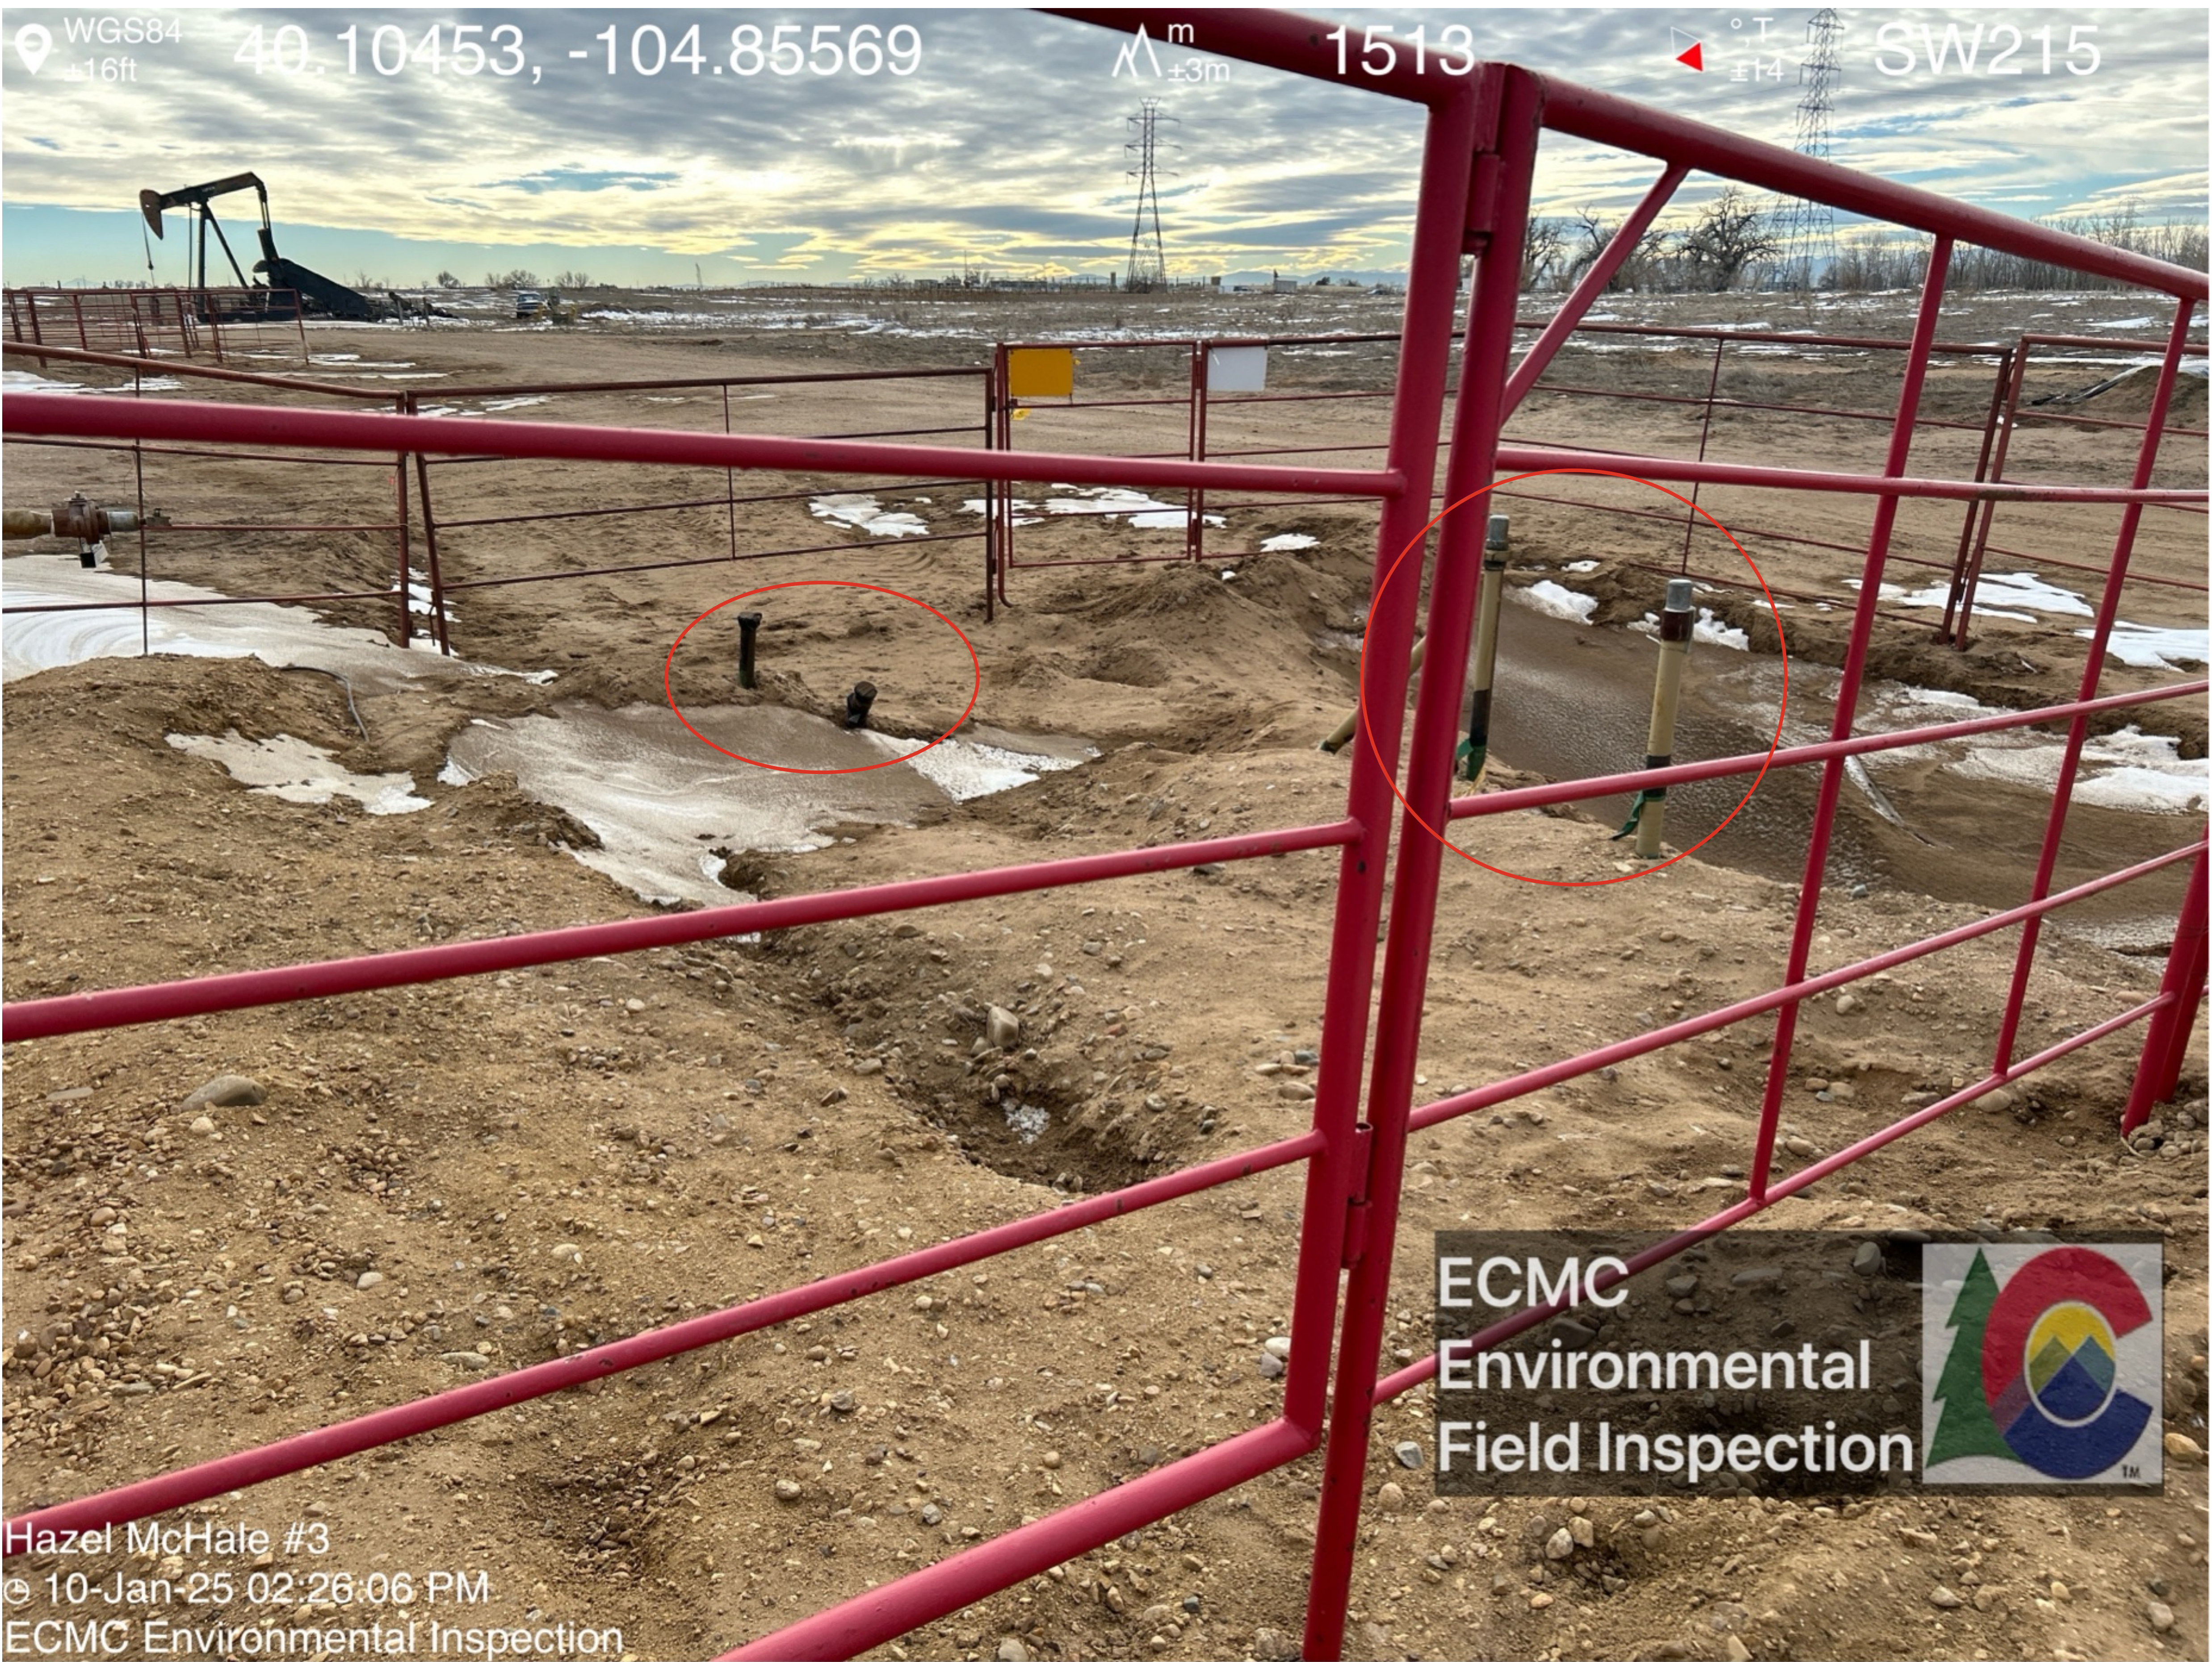
Multiple flowlines/flowline risers exposed within excavation.

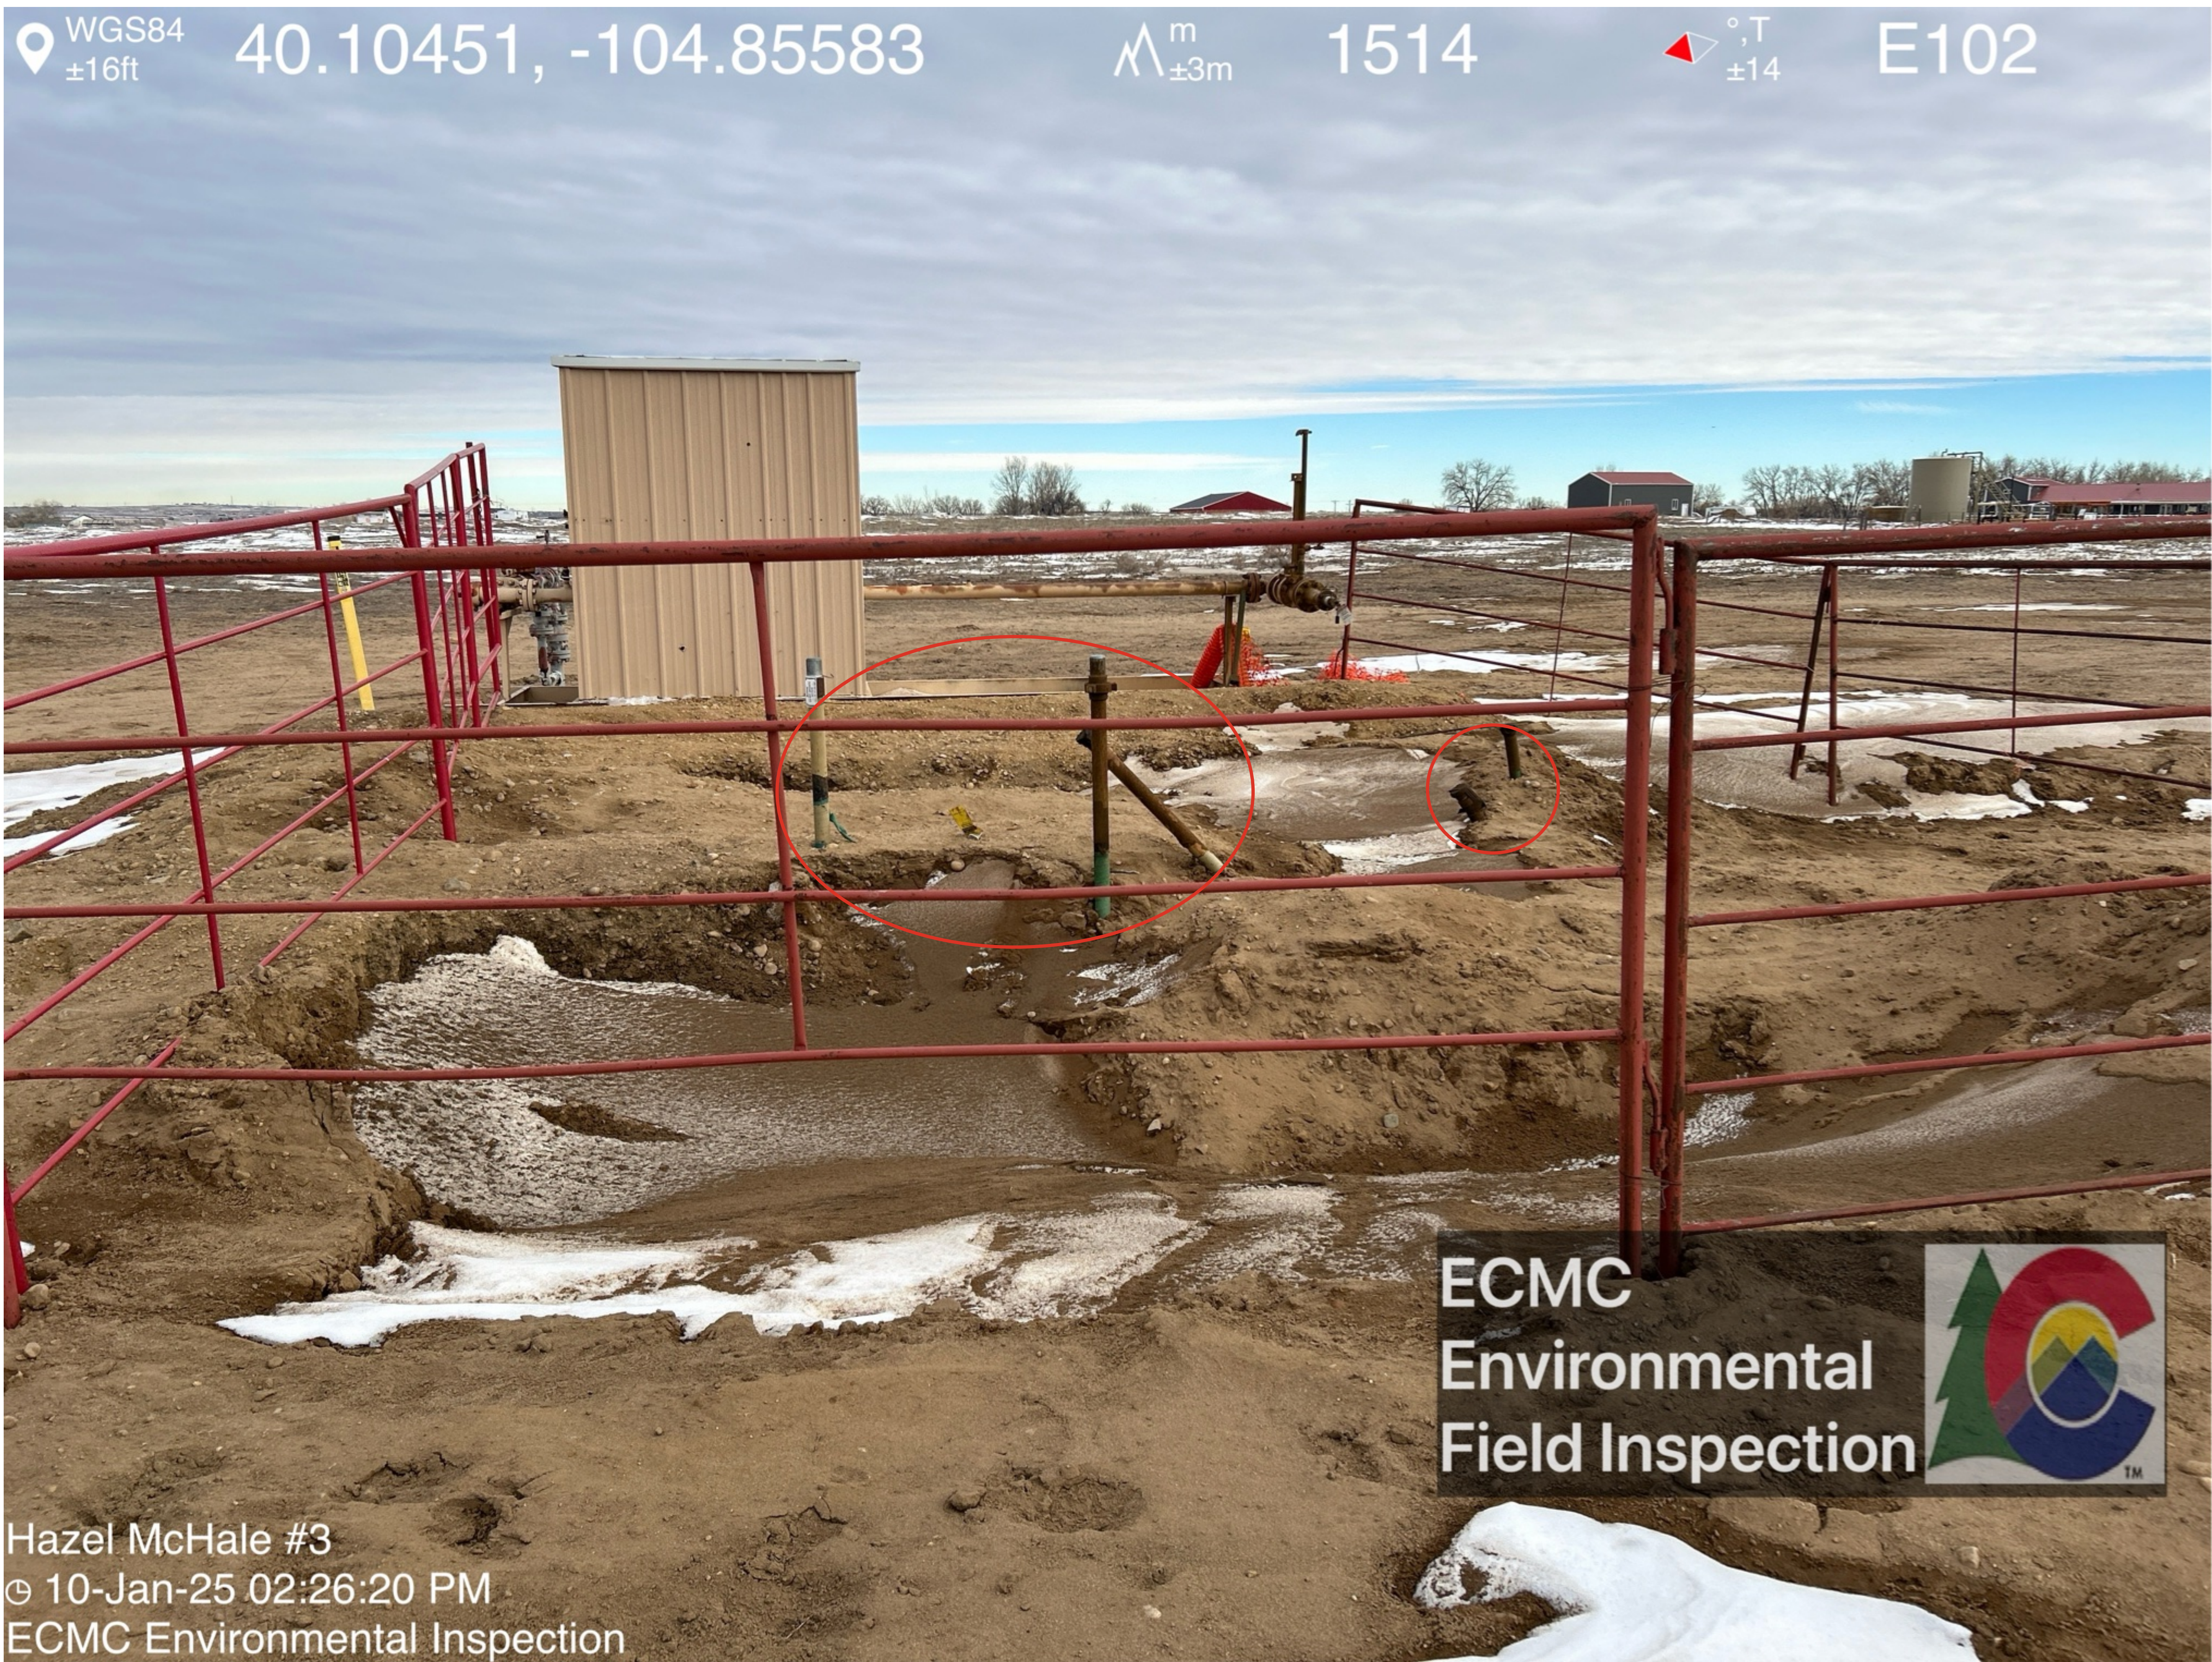
Multiple flowlines/flowline risers exposed within excavation.

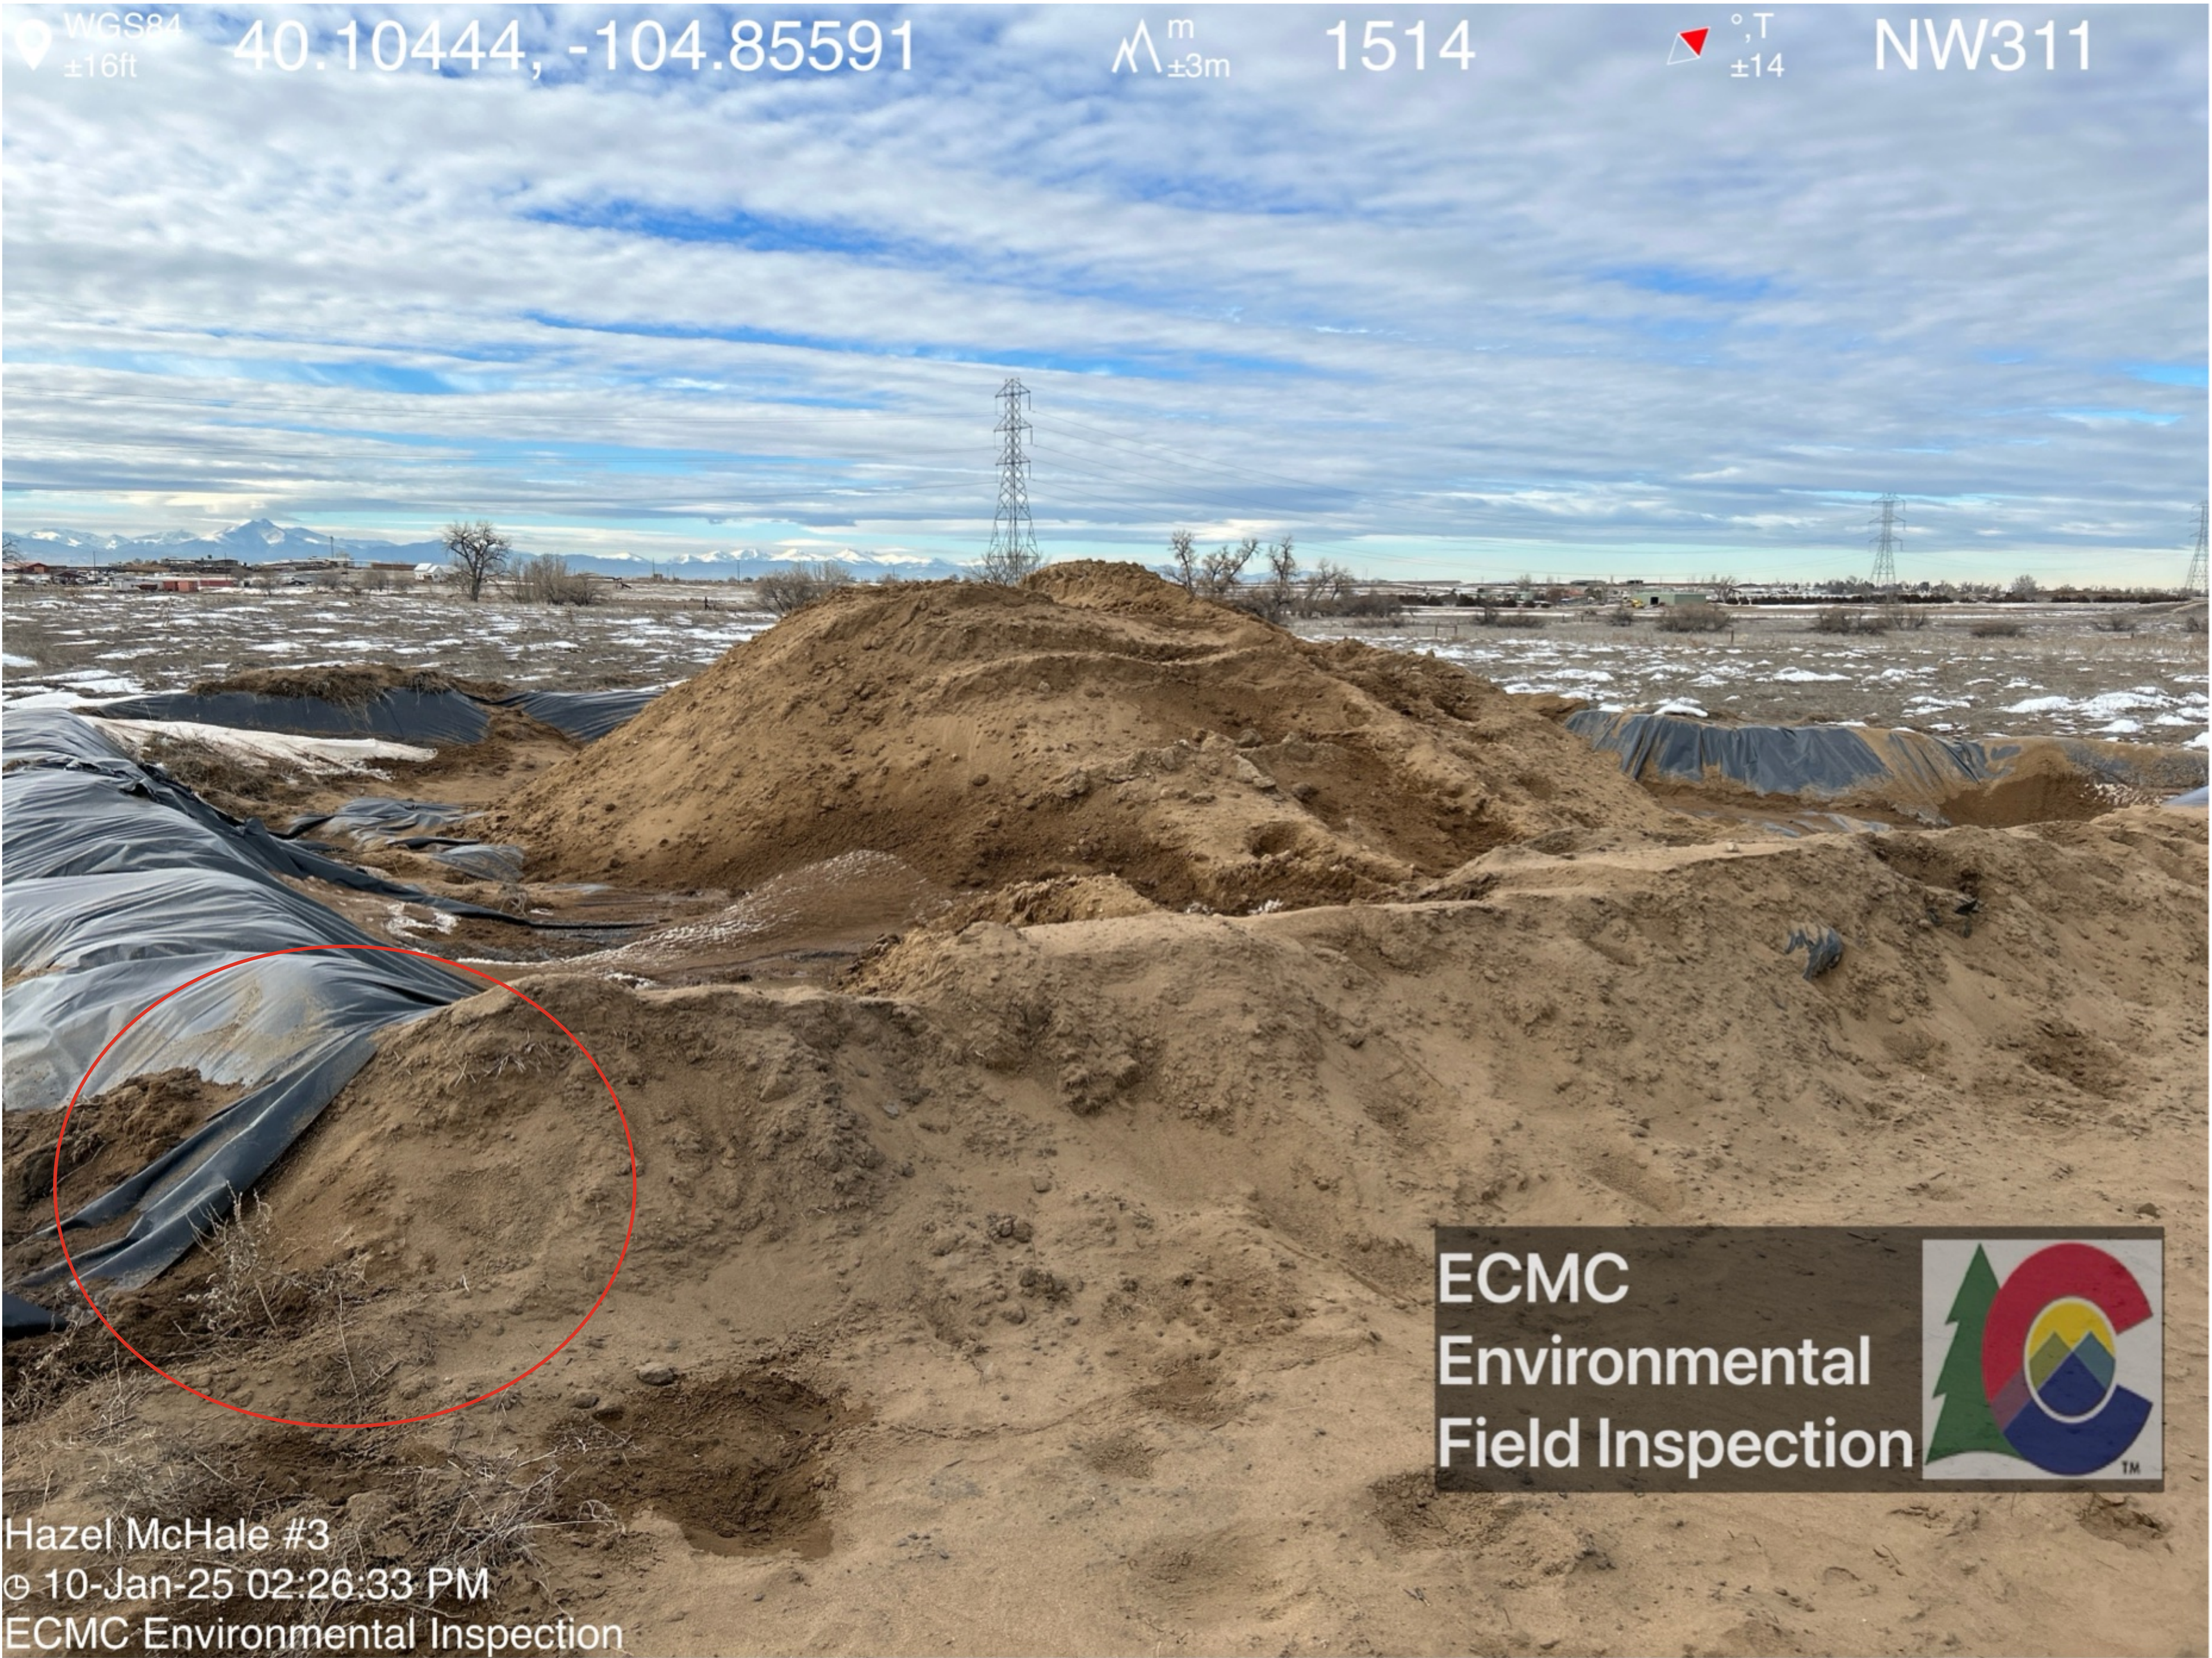
Unlabeled soil stockpiled on location. Liner is discontinuous.

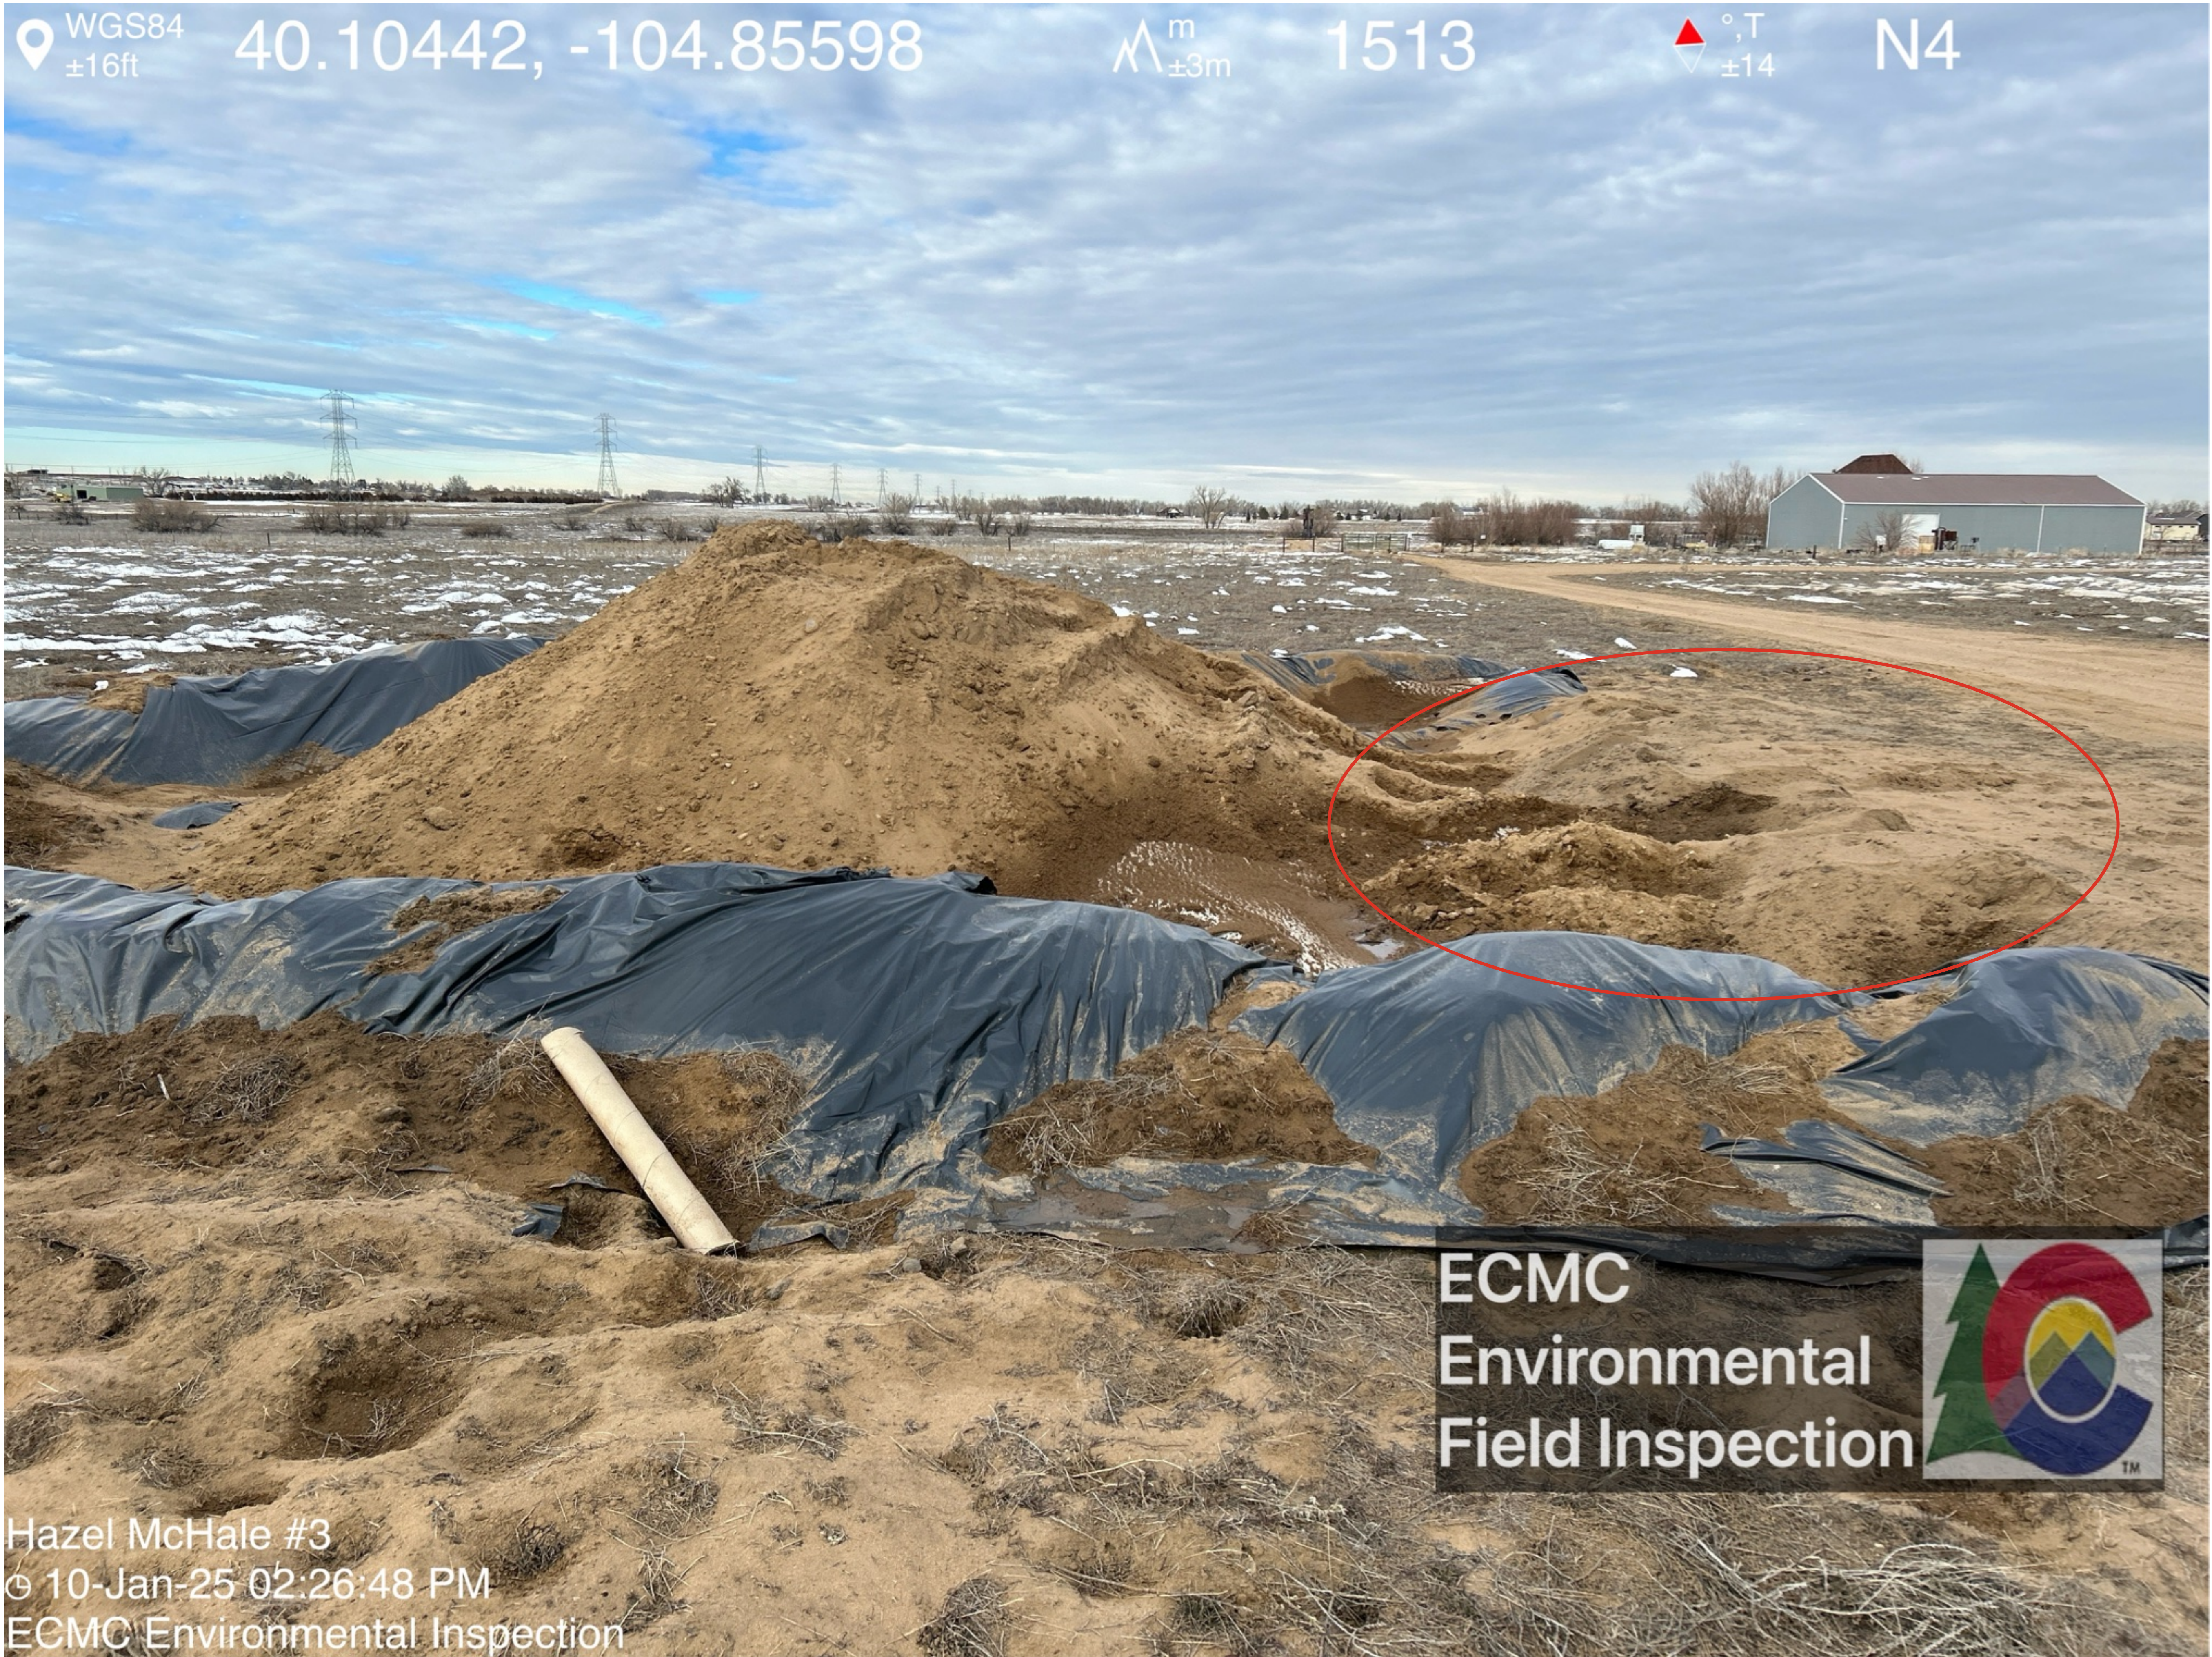
Stockpiled soil appears to have been mixed with berm material.
