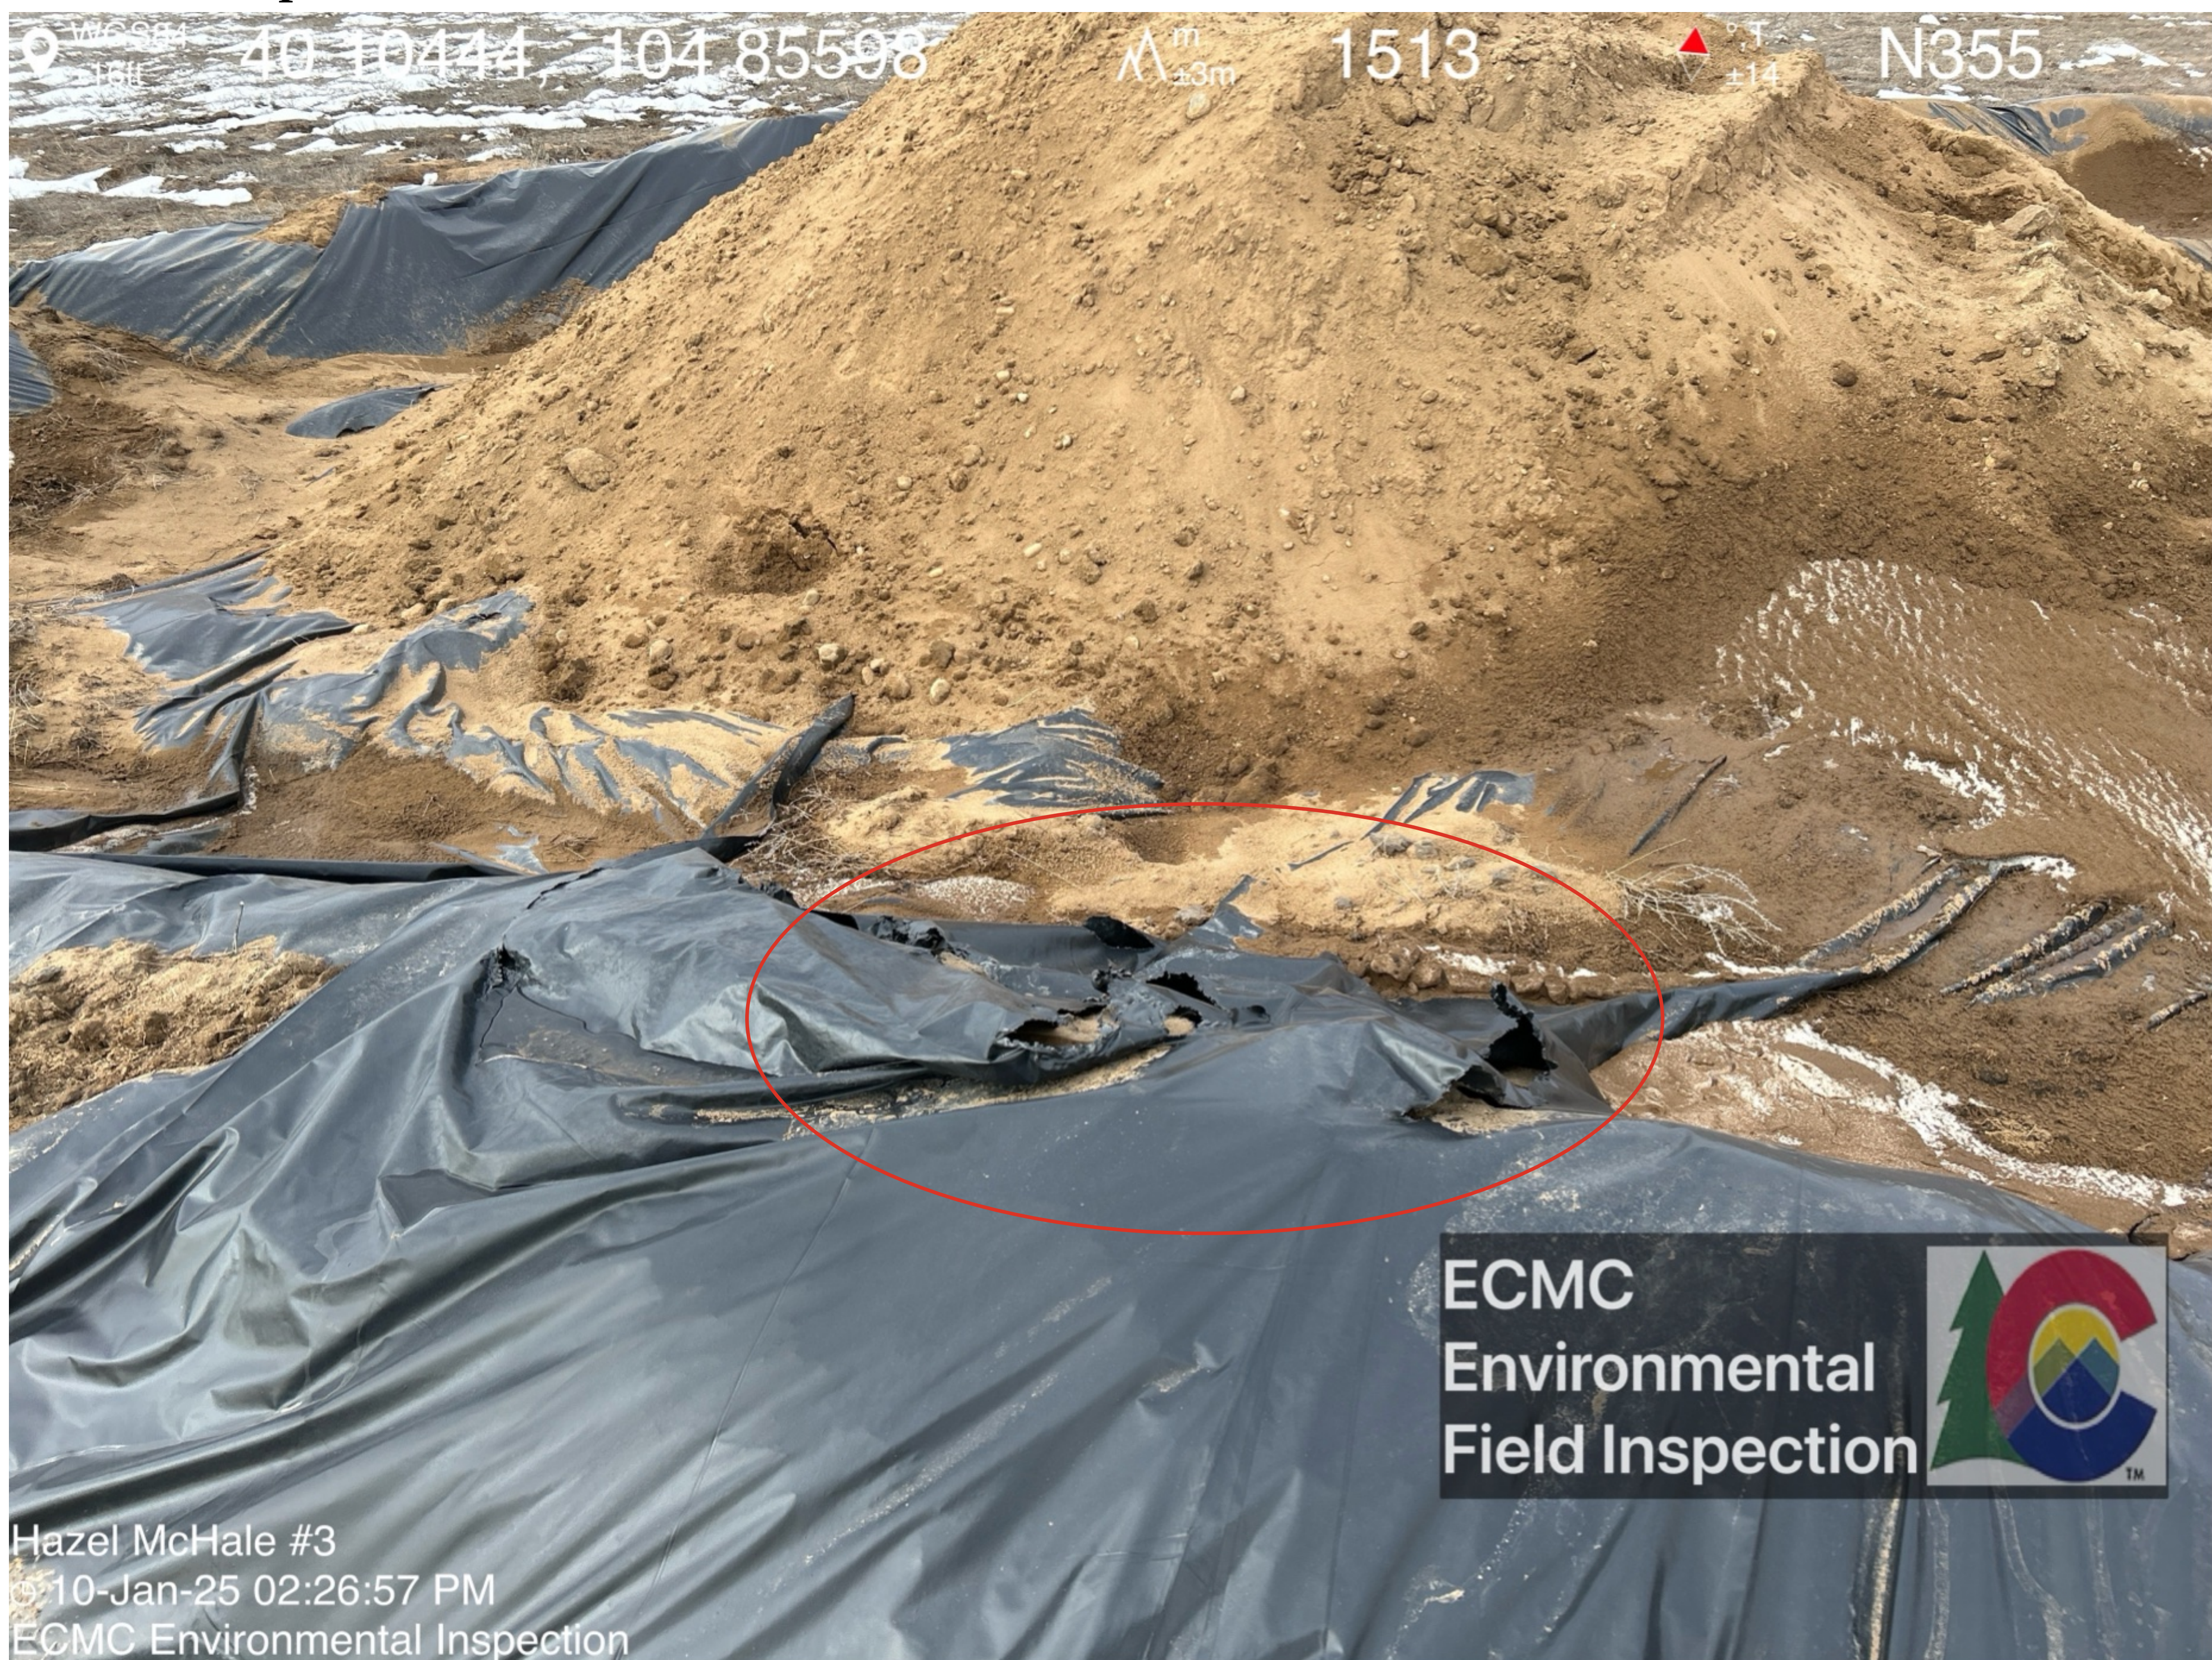
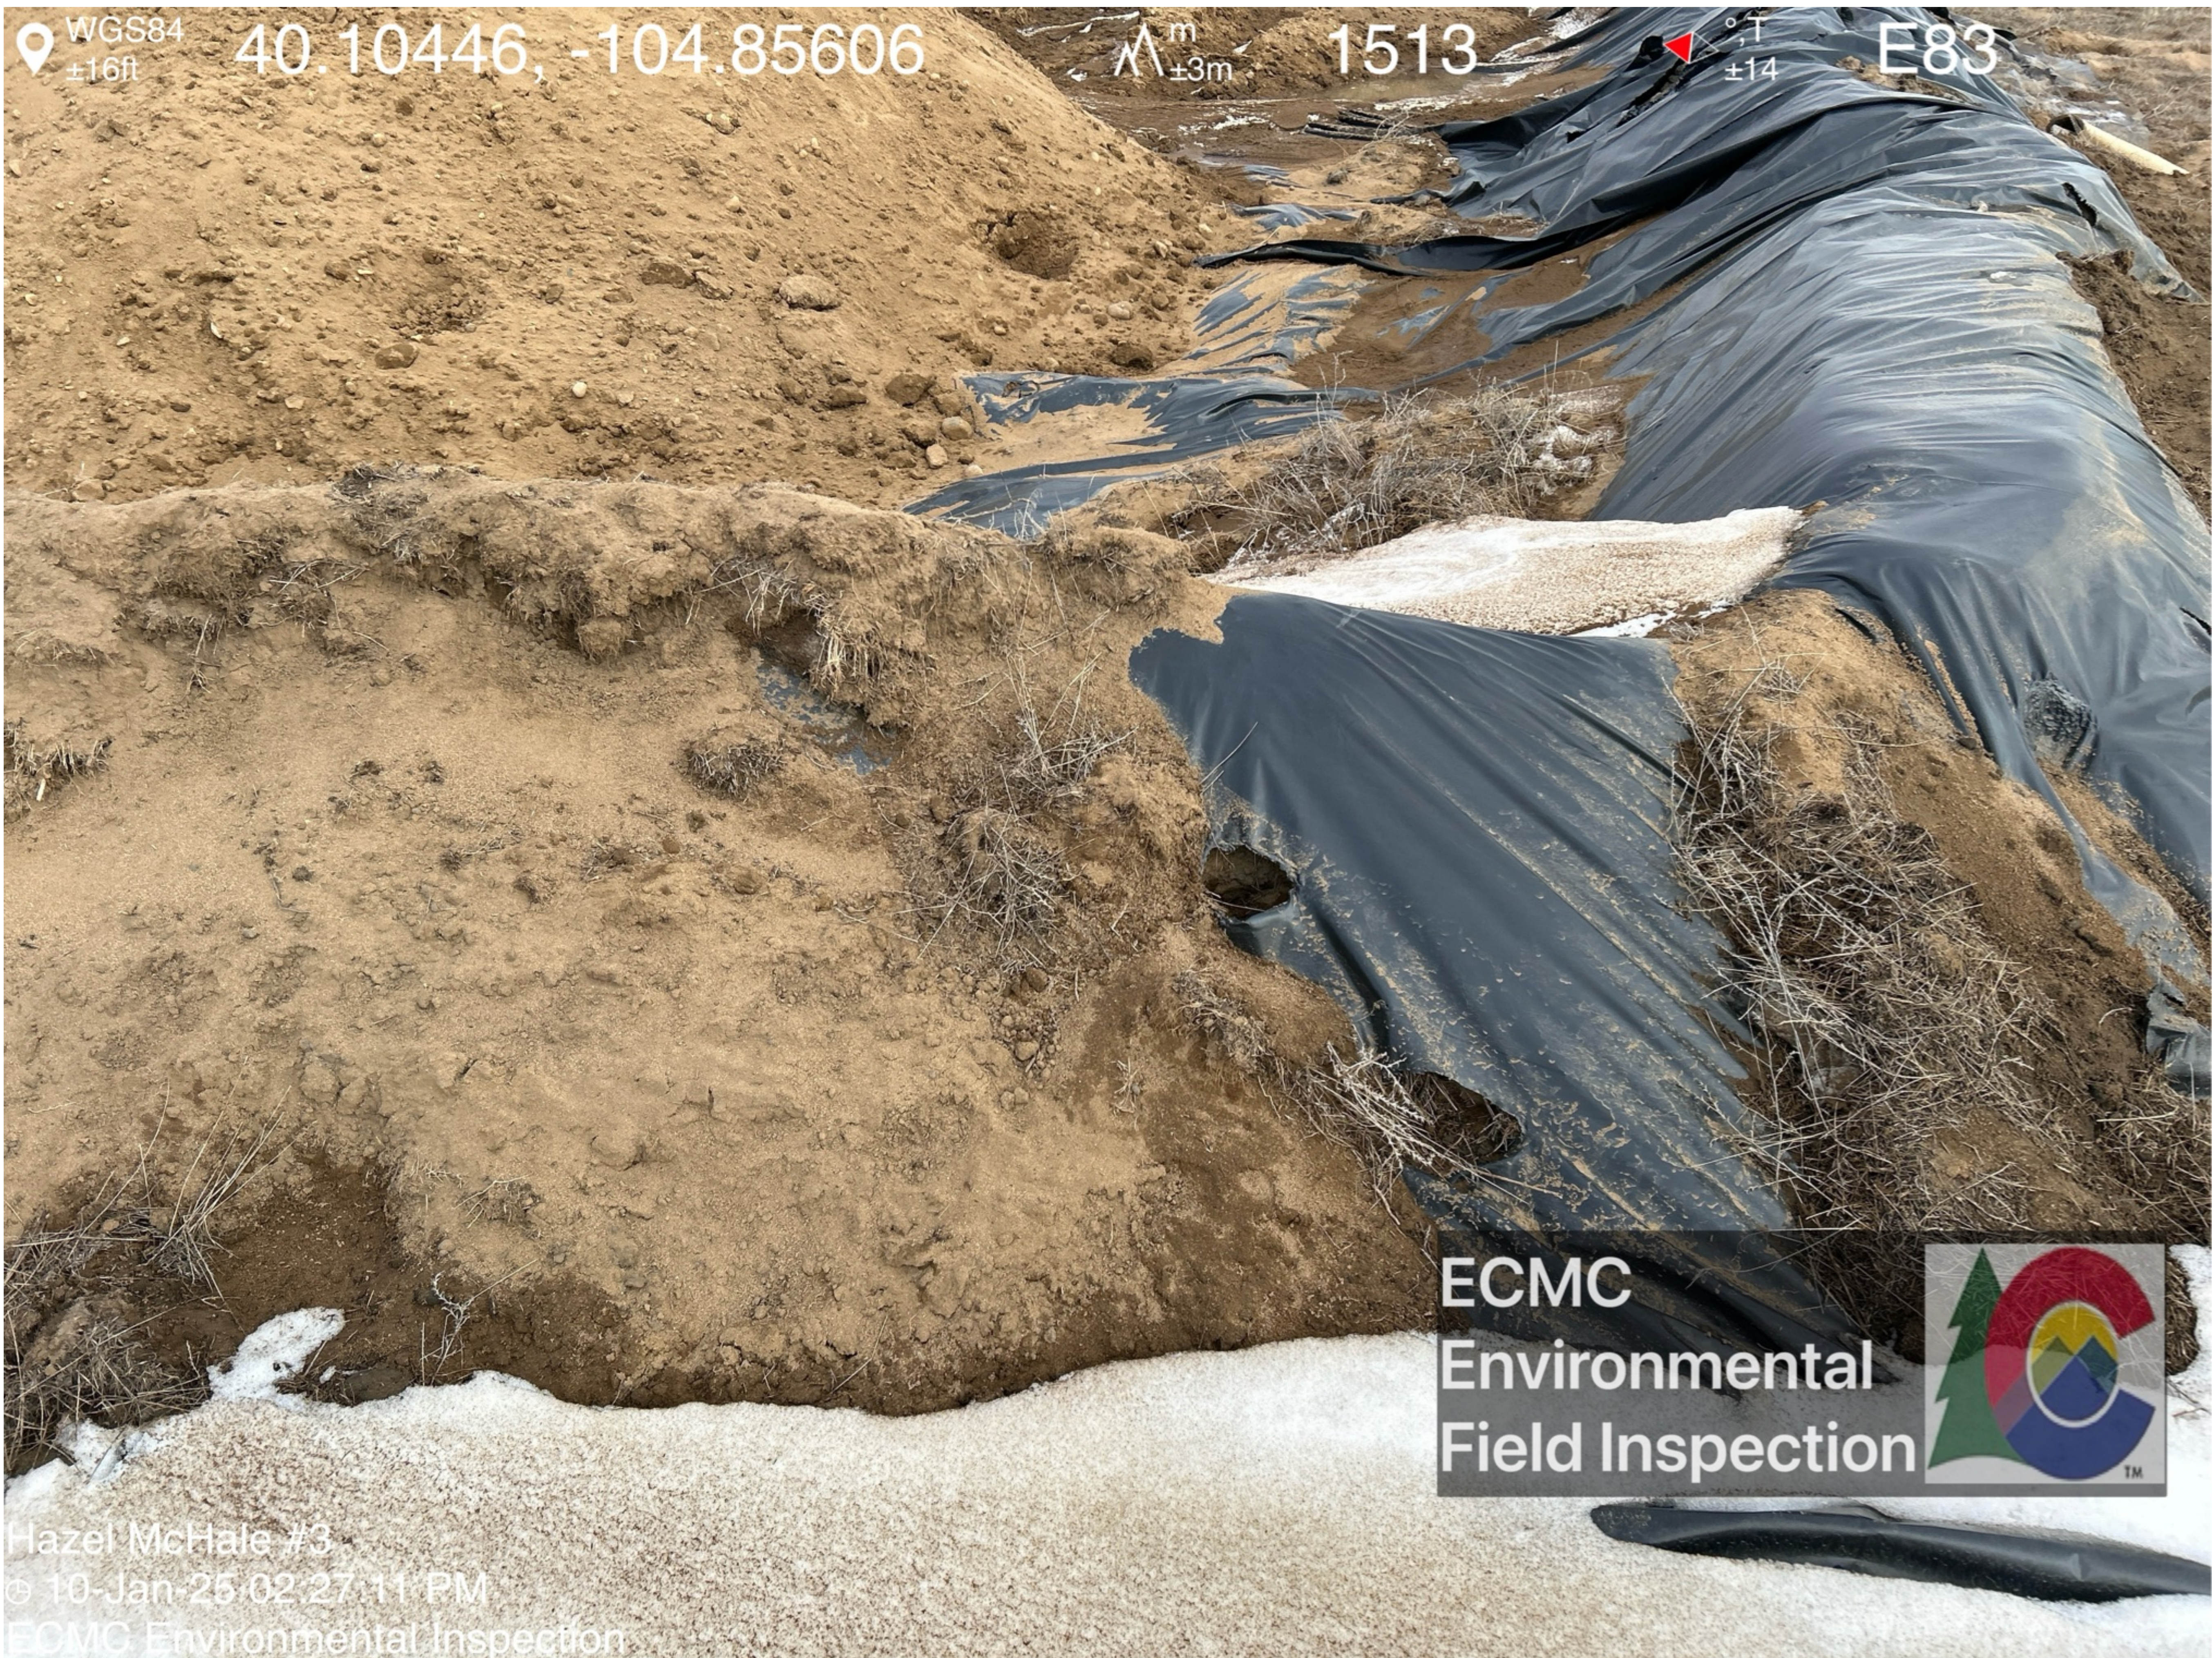
Holes/tears present in liner.

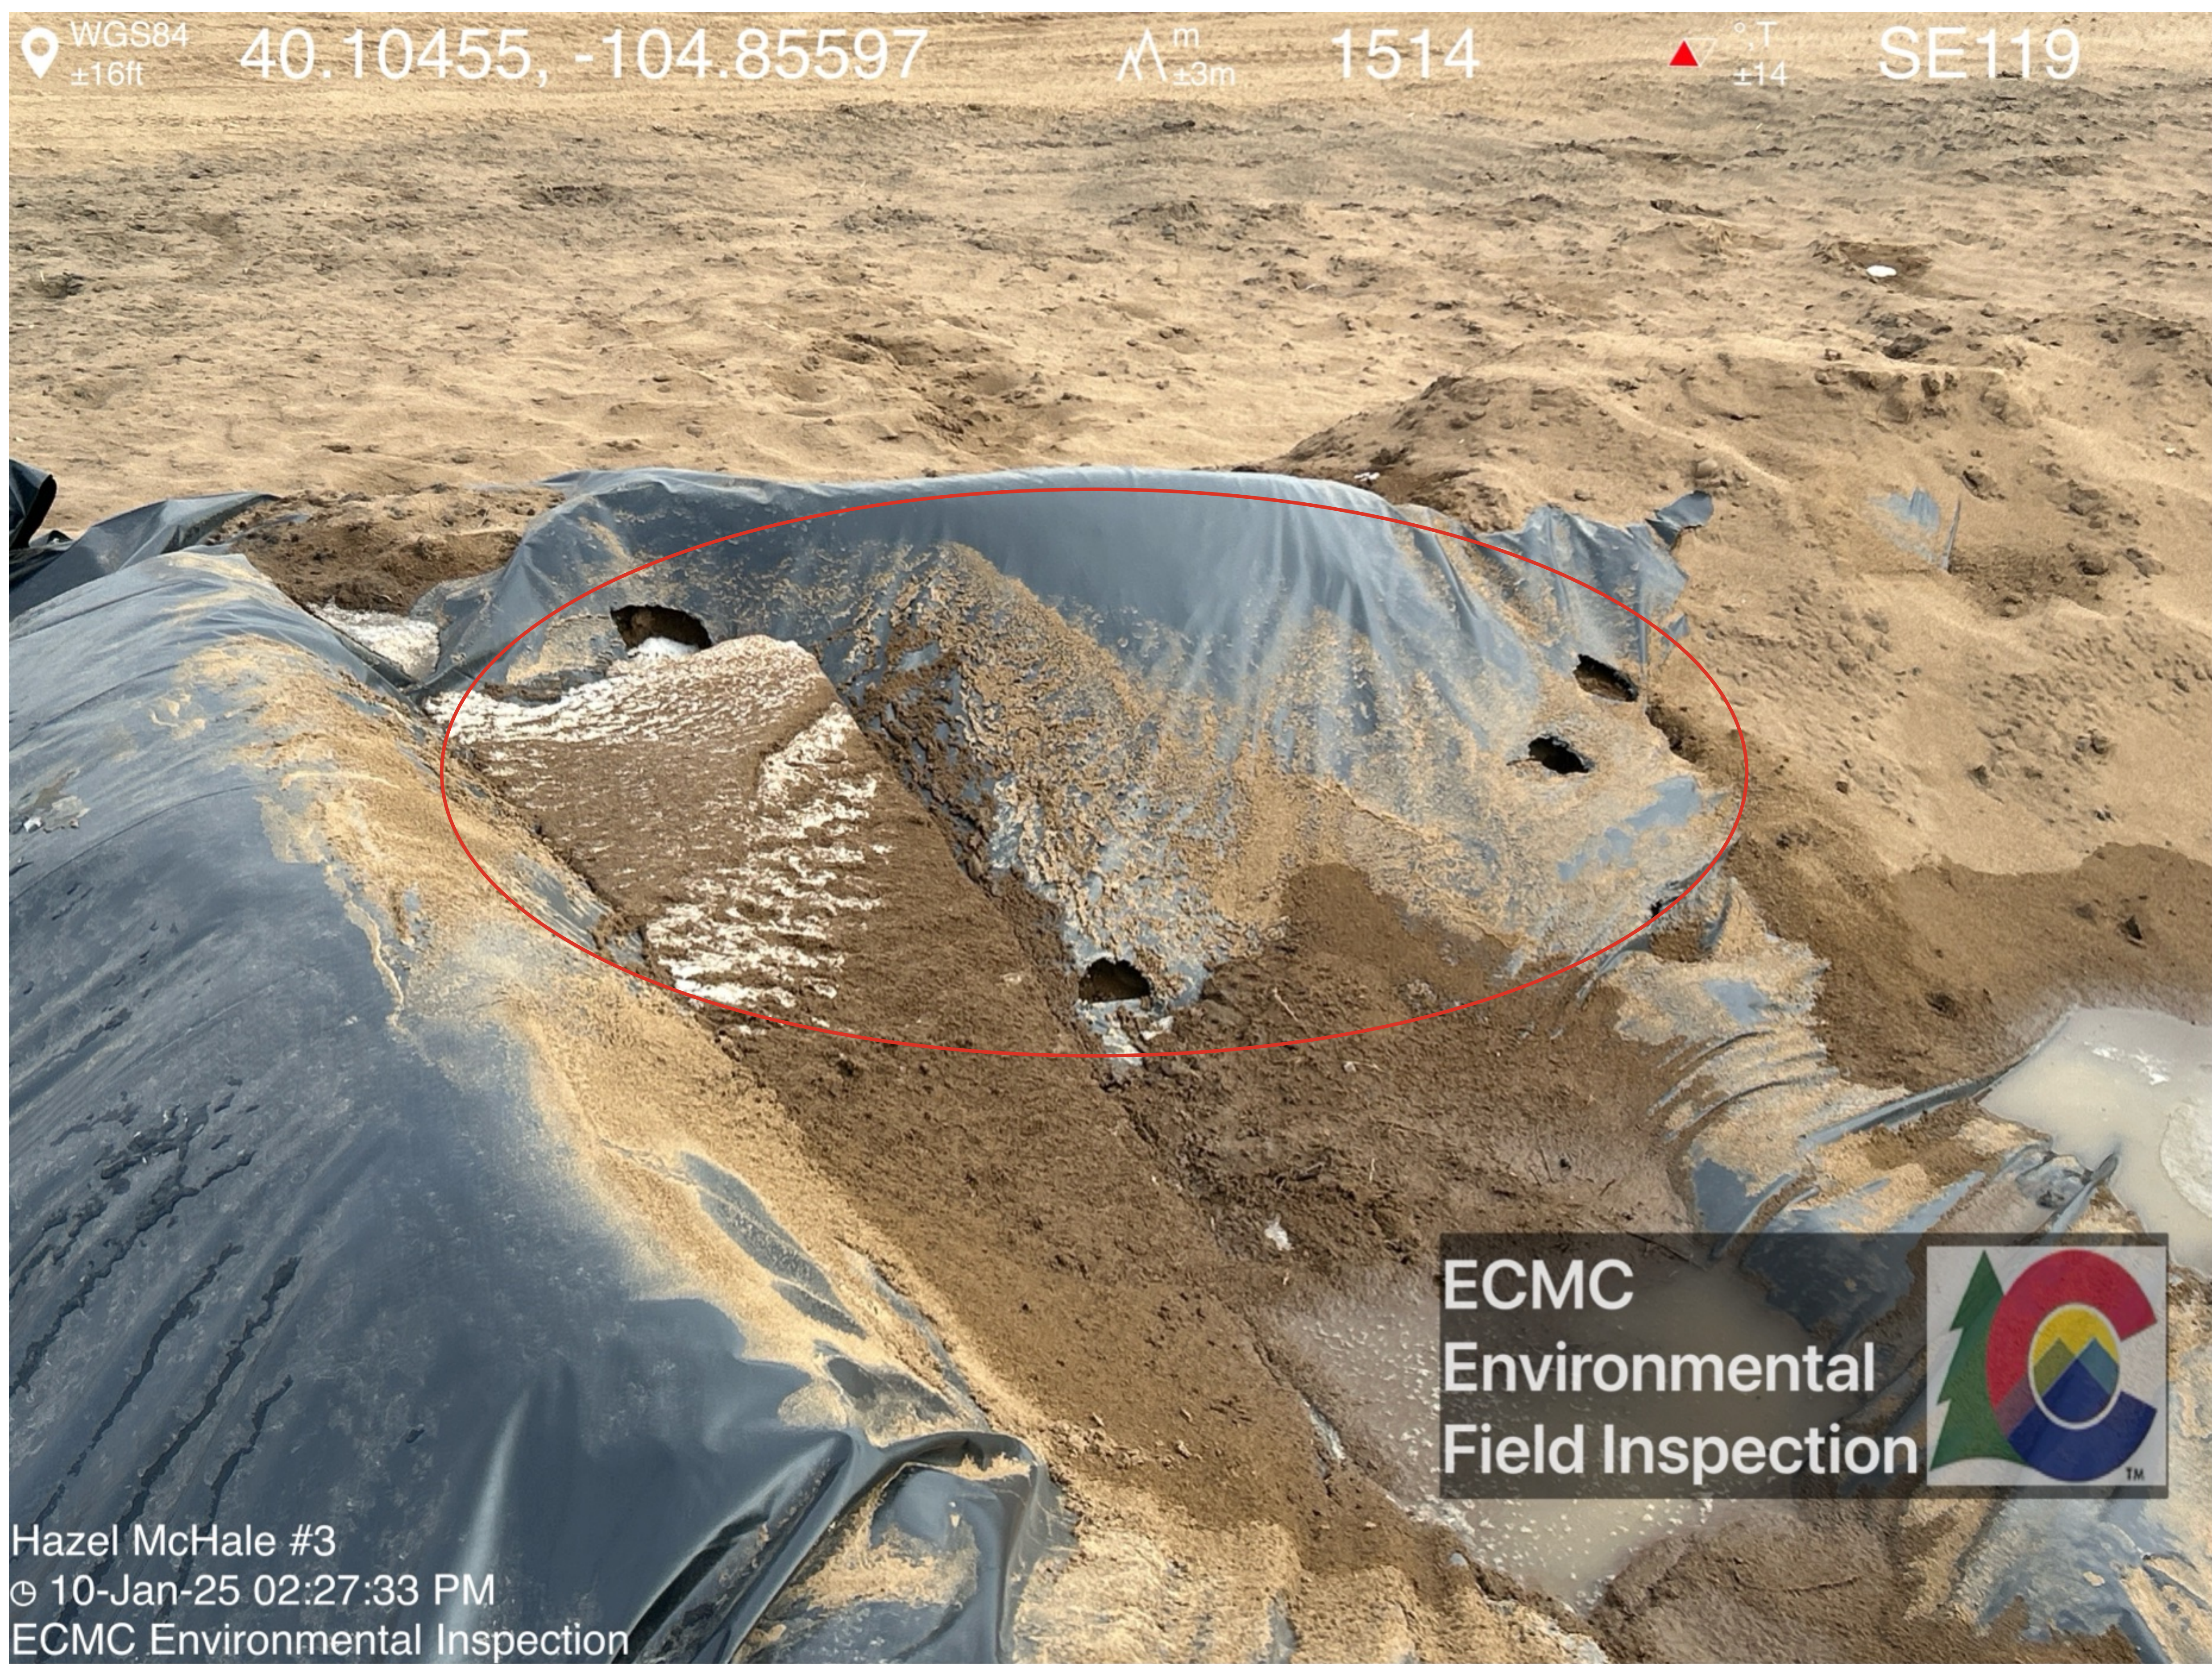
Holes/tears present in liner.

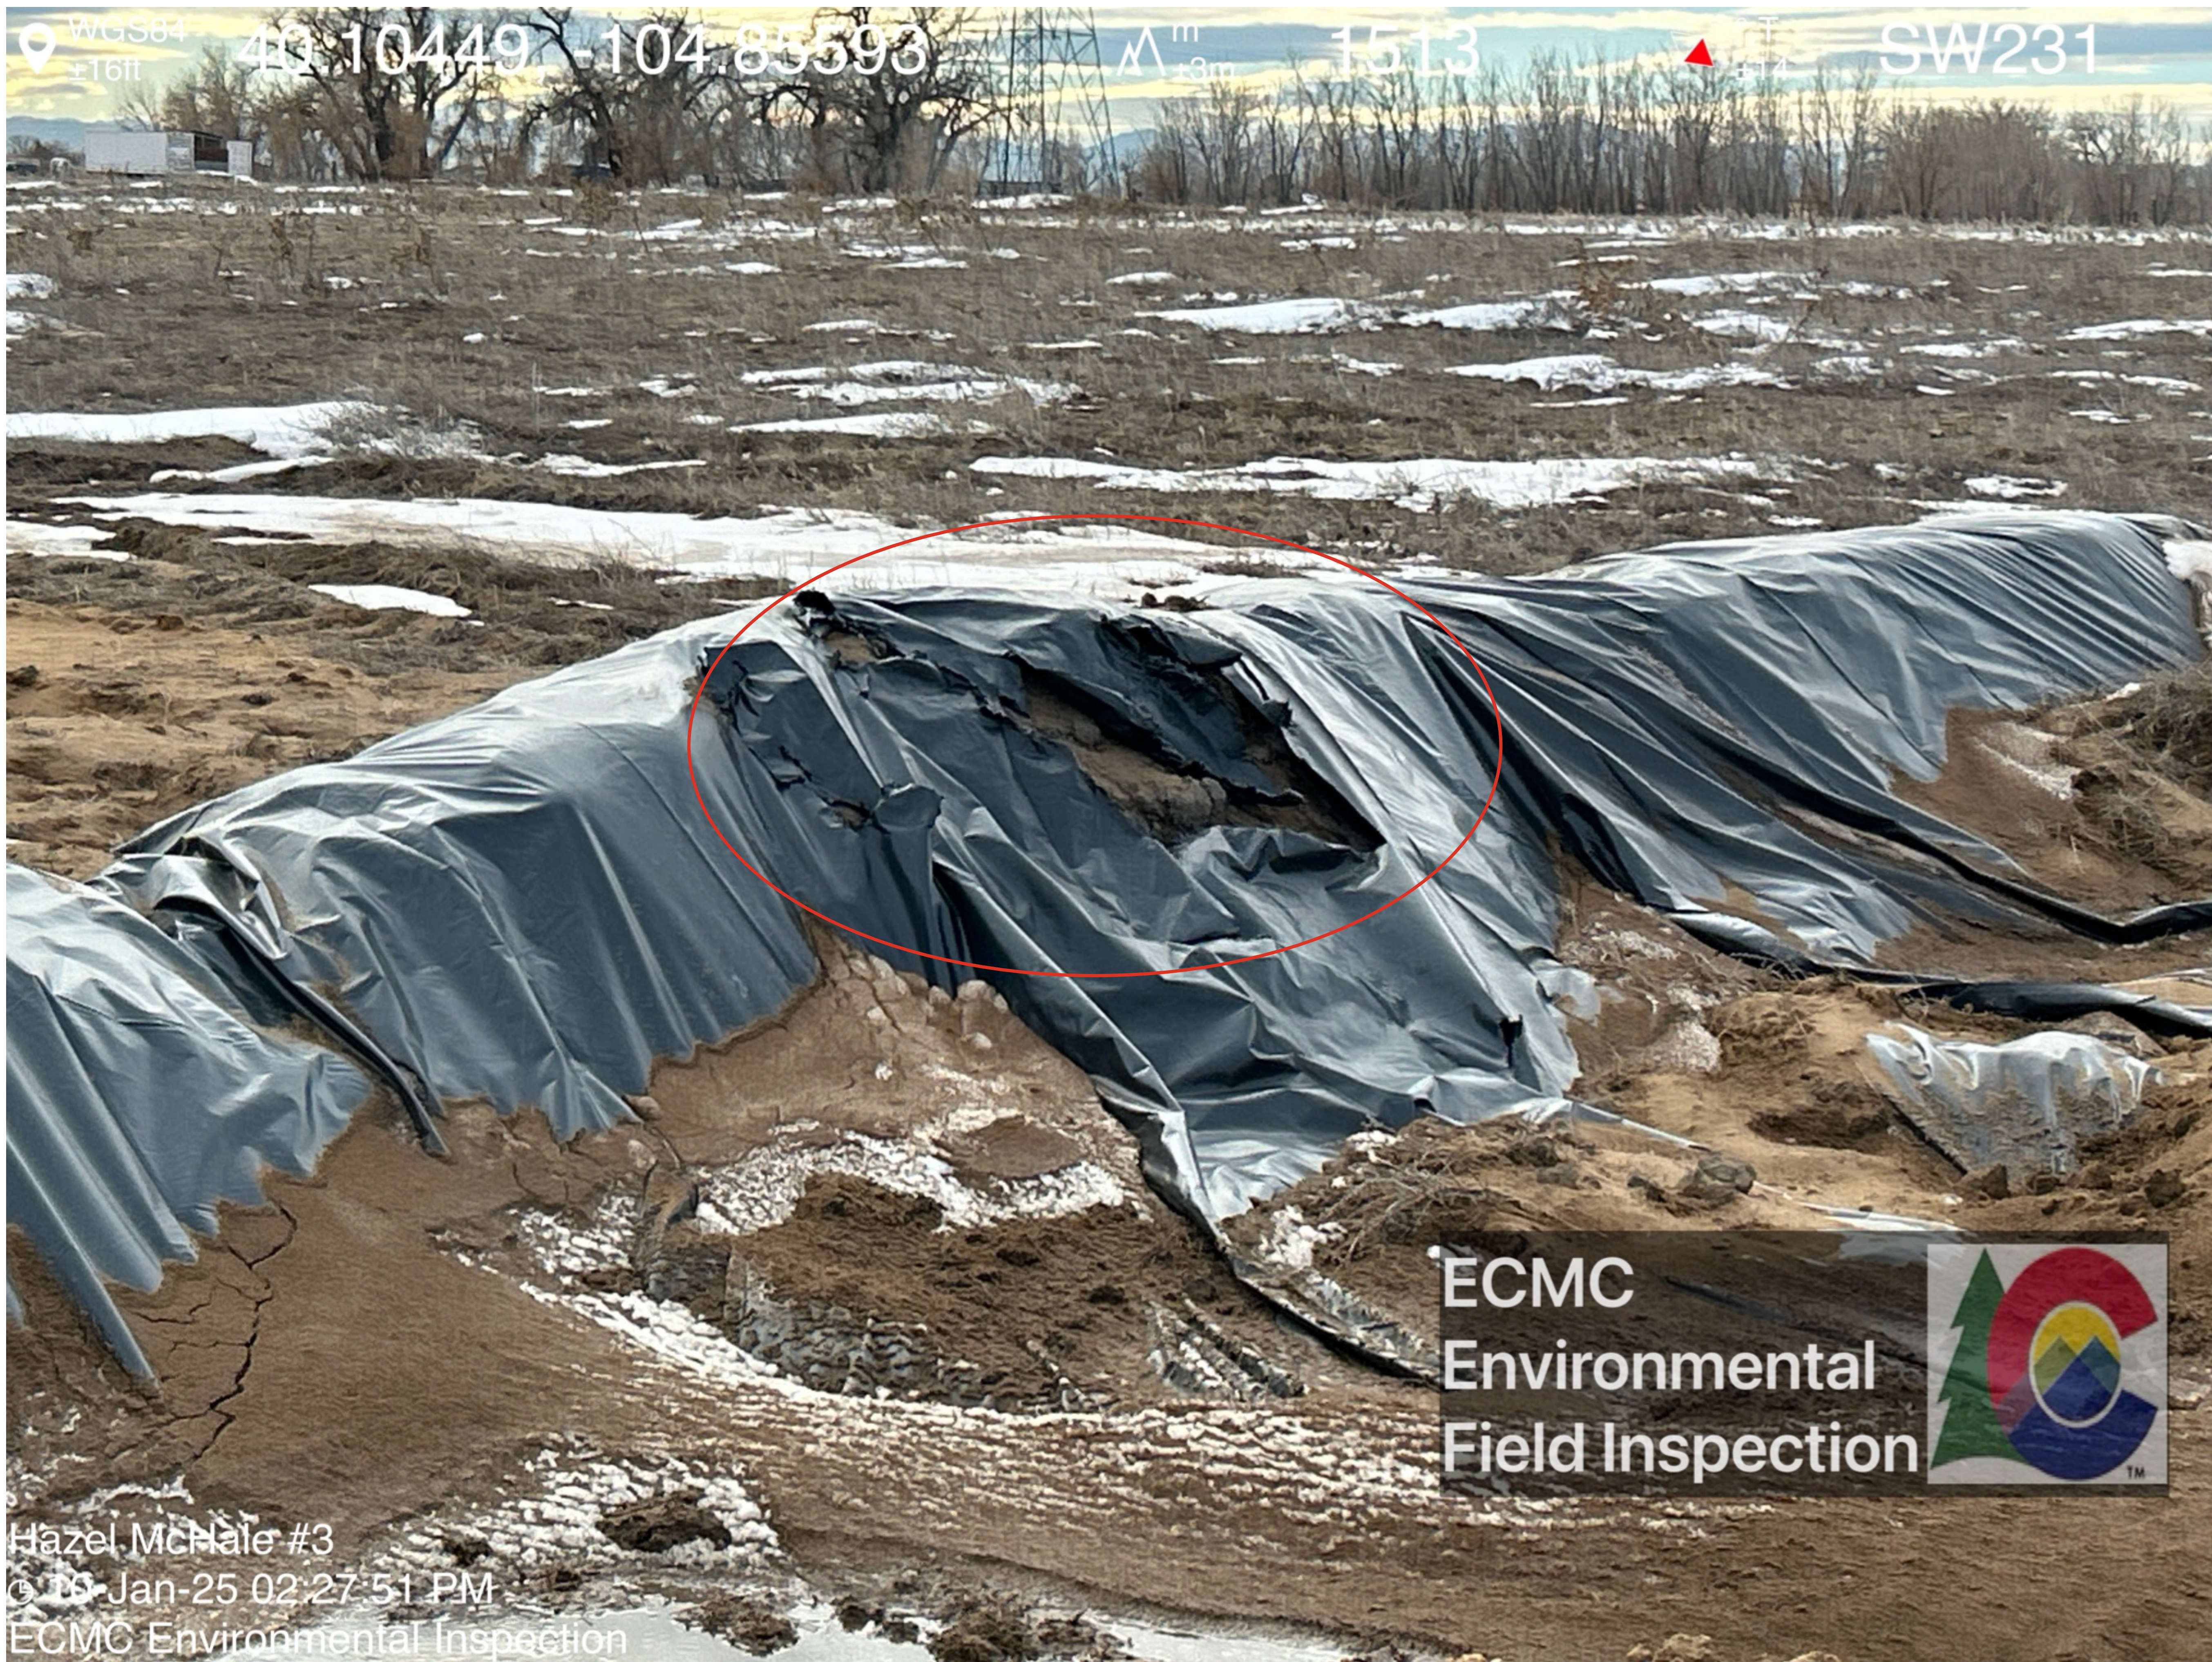
Holes/tears present in liner.

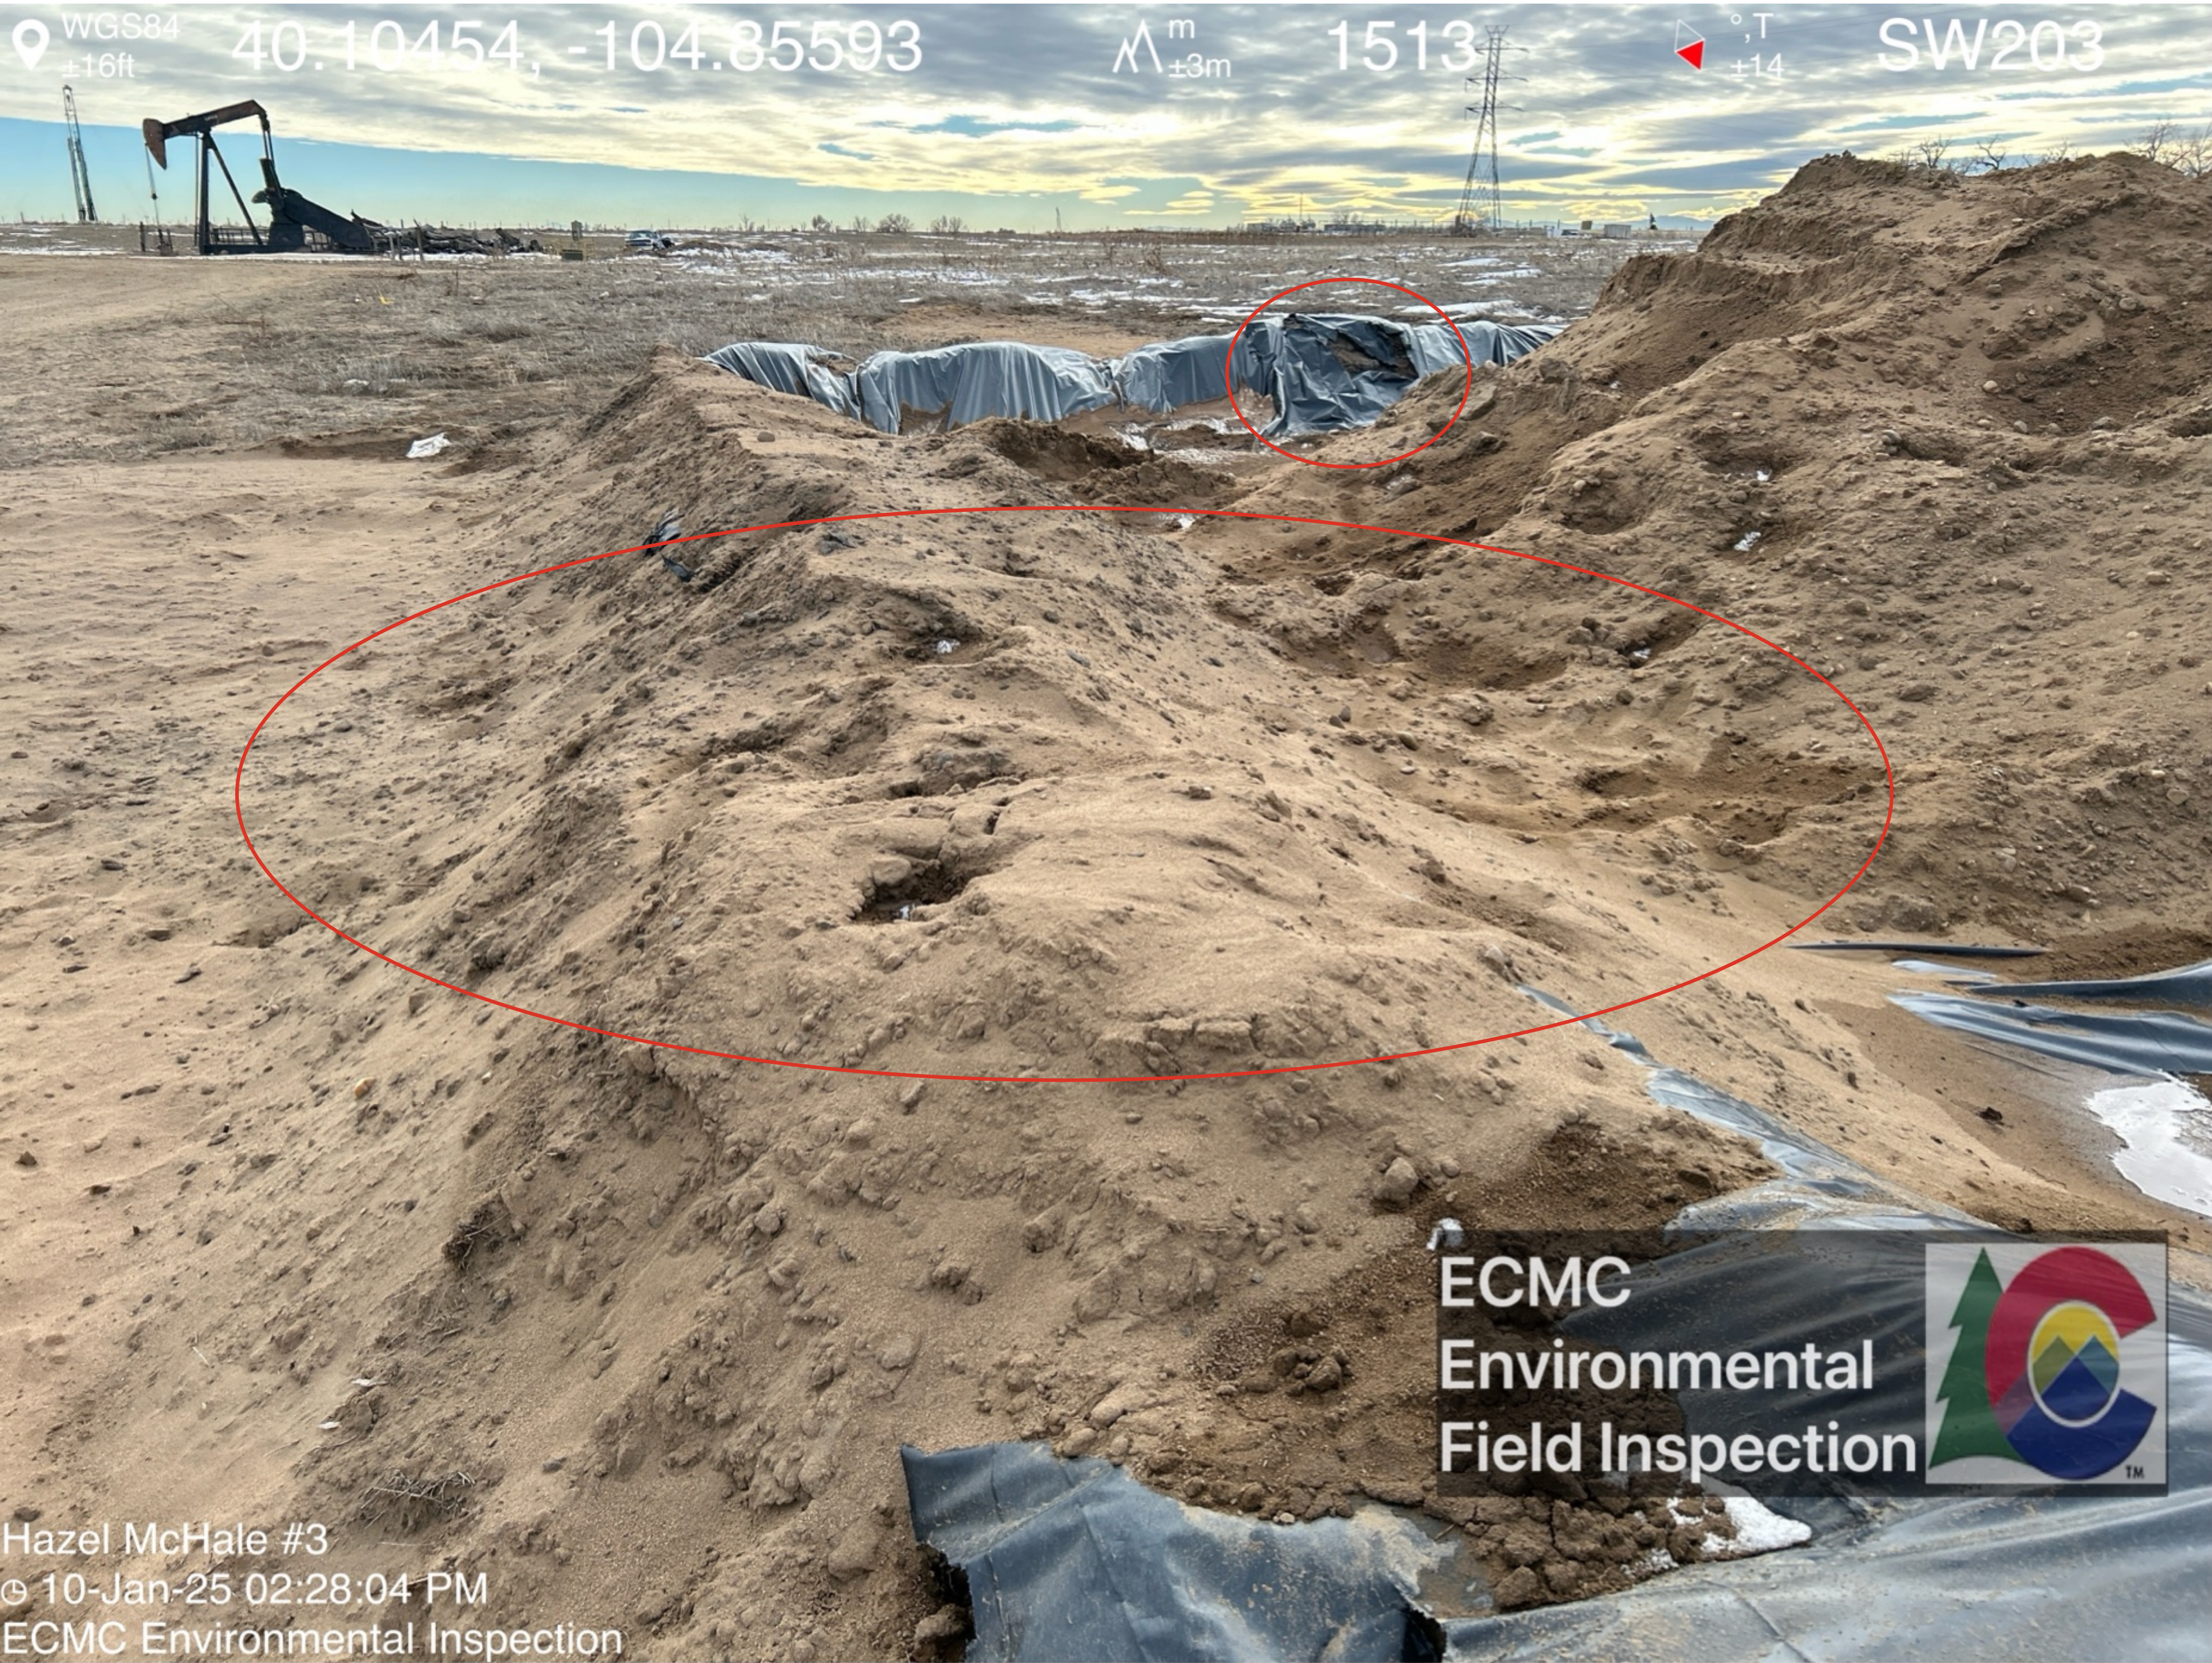
Stockpiled soil appears to have been mixed with berm material. Holes/tears present in liner.

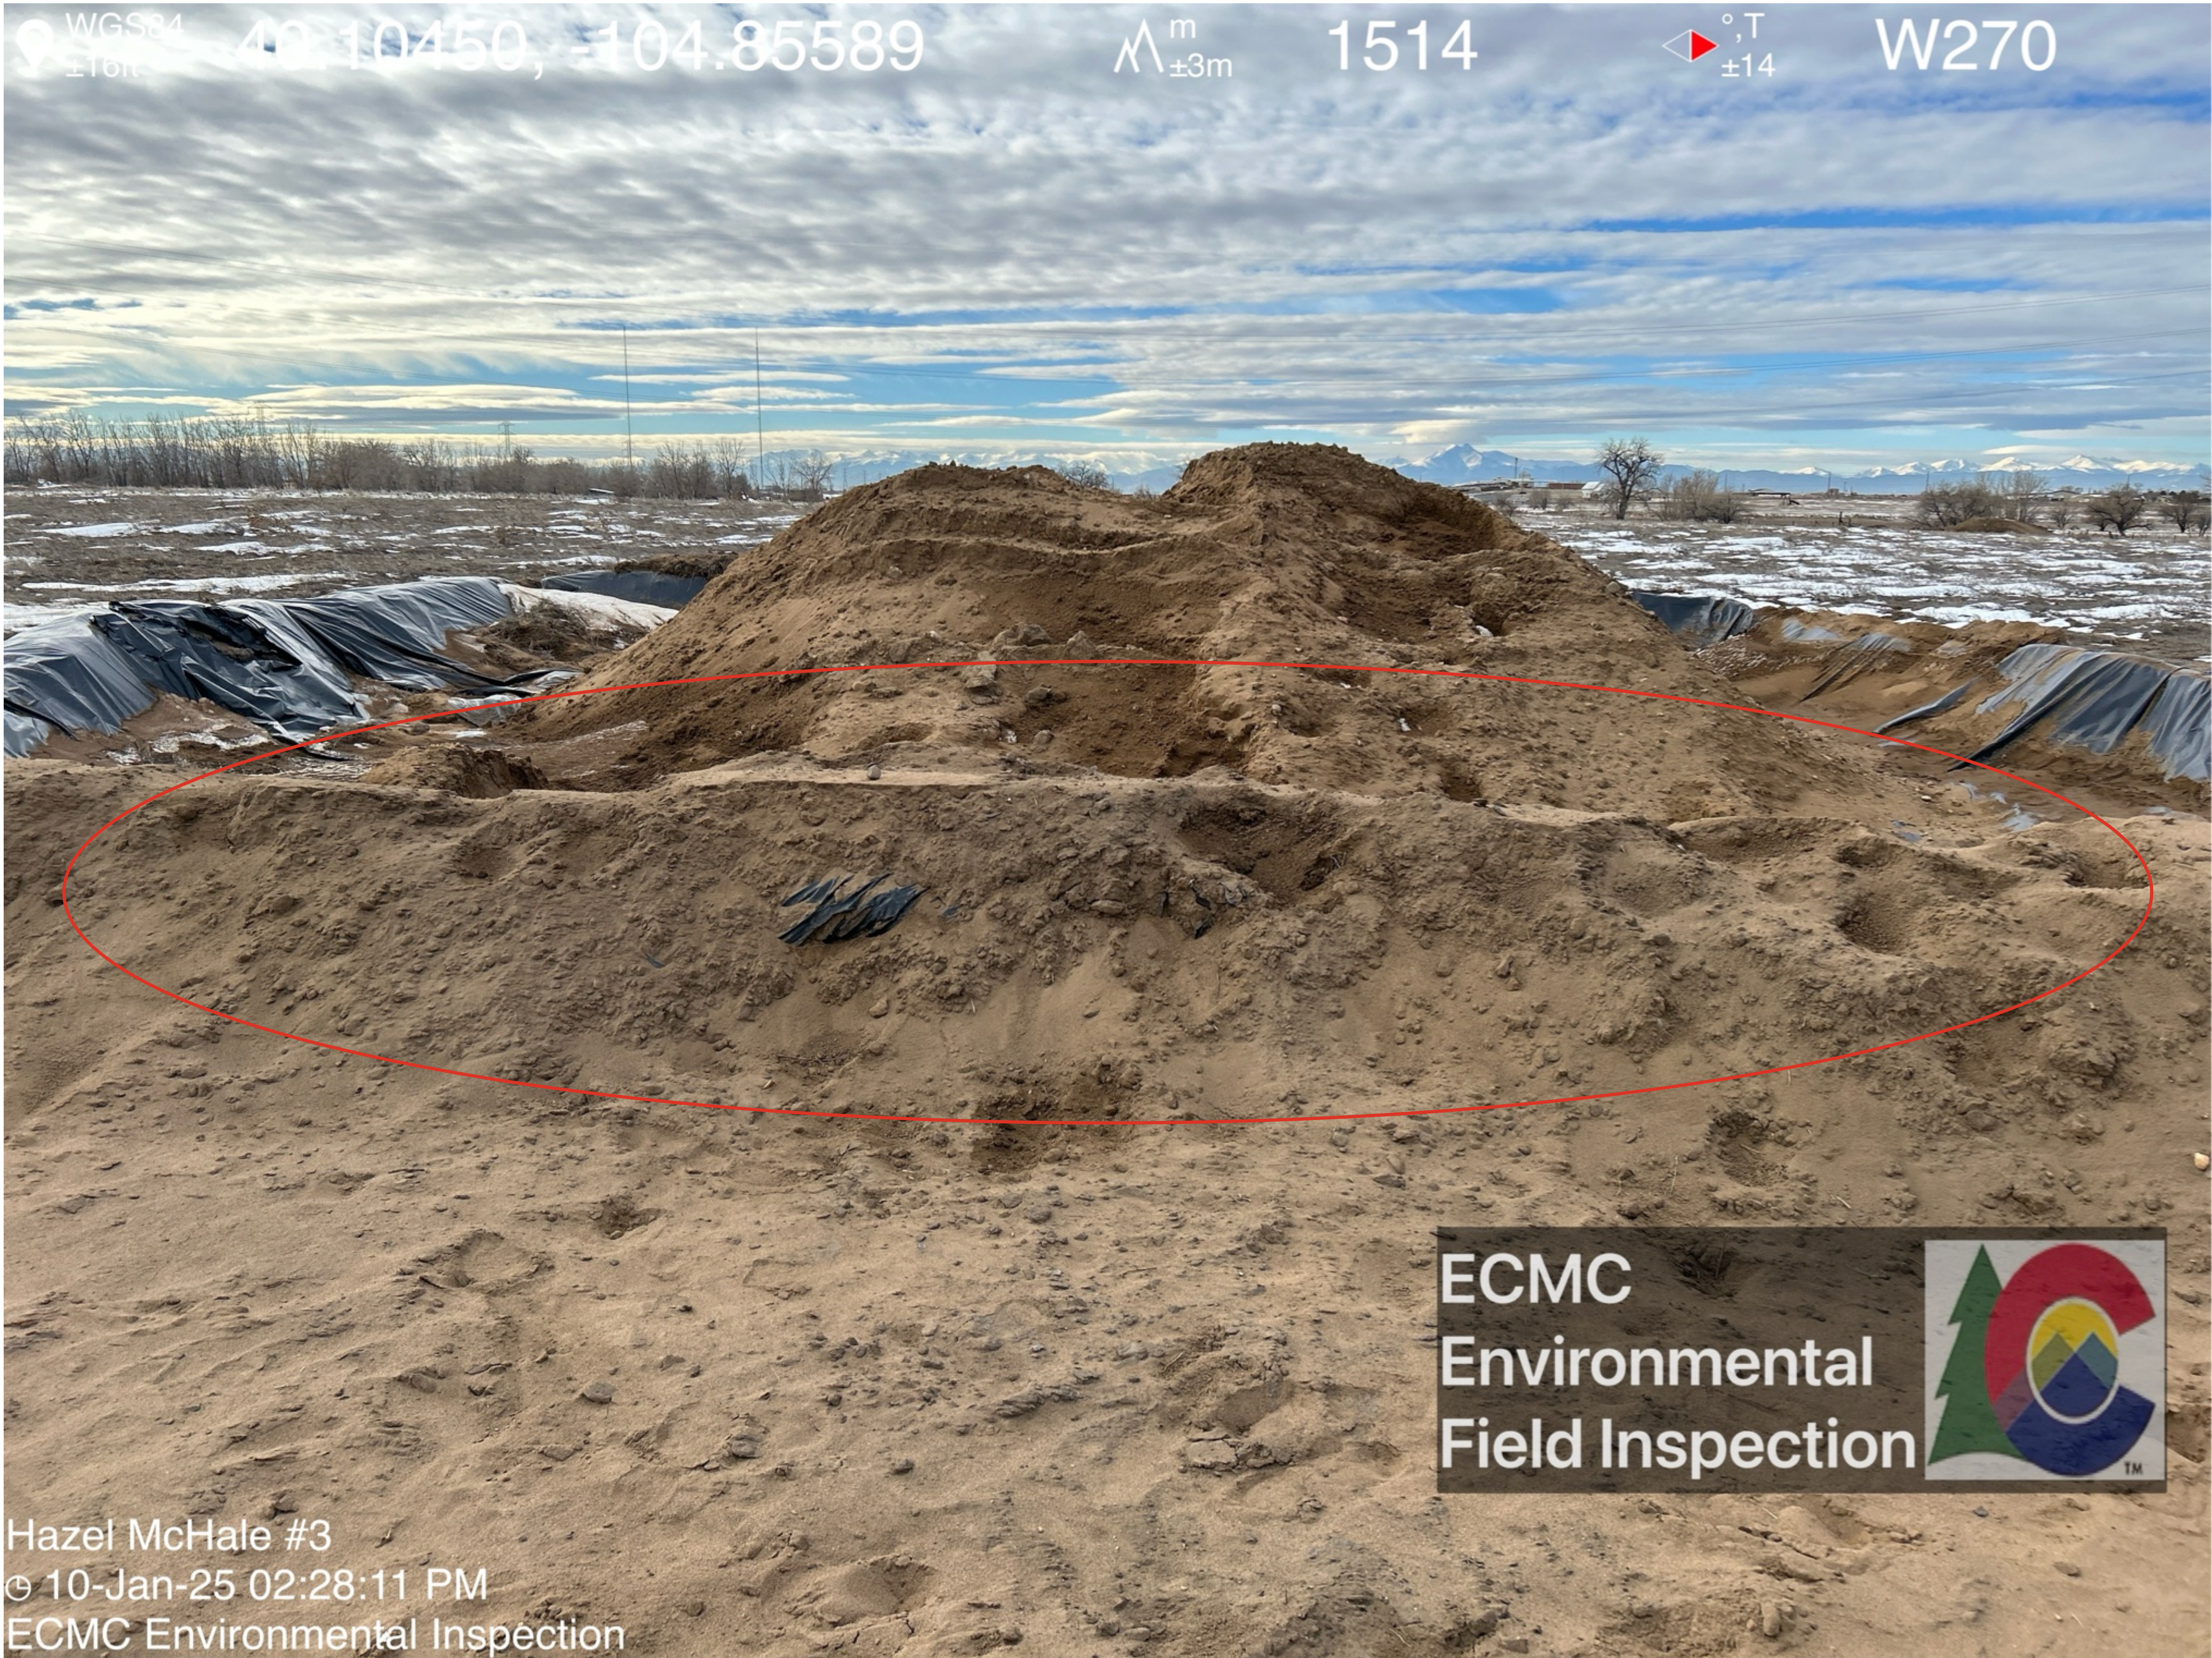
Stockpiled soil appears to have been mixed with berm material.
