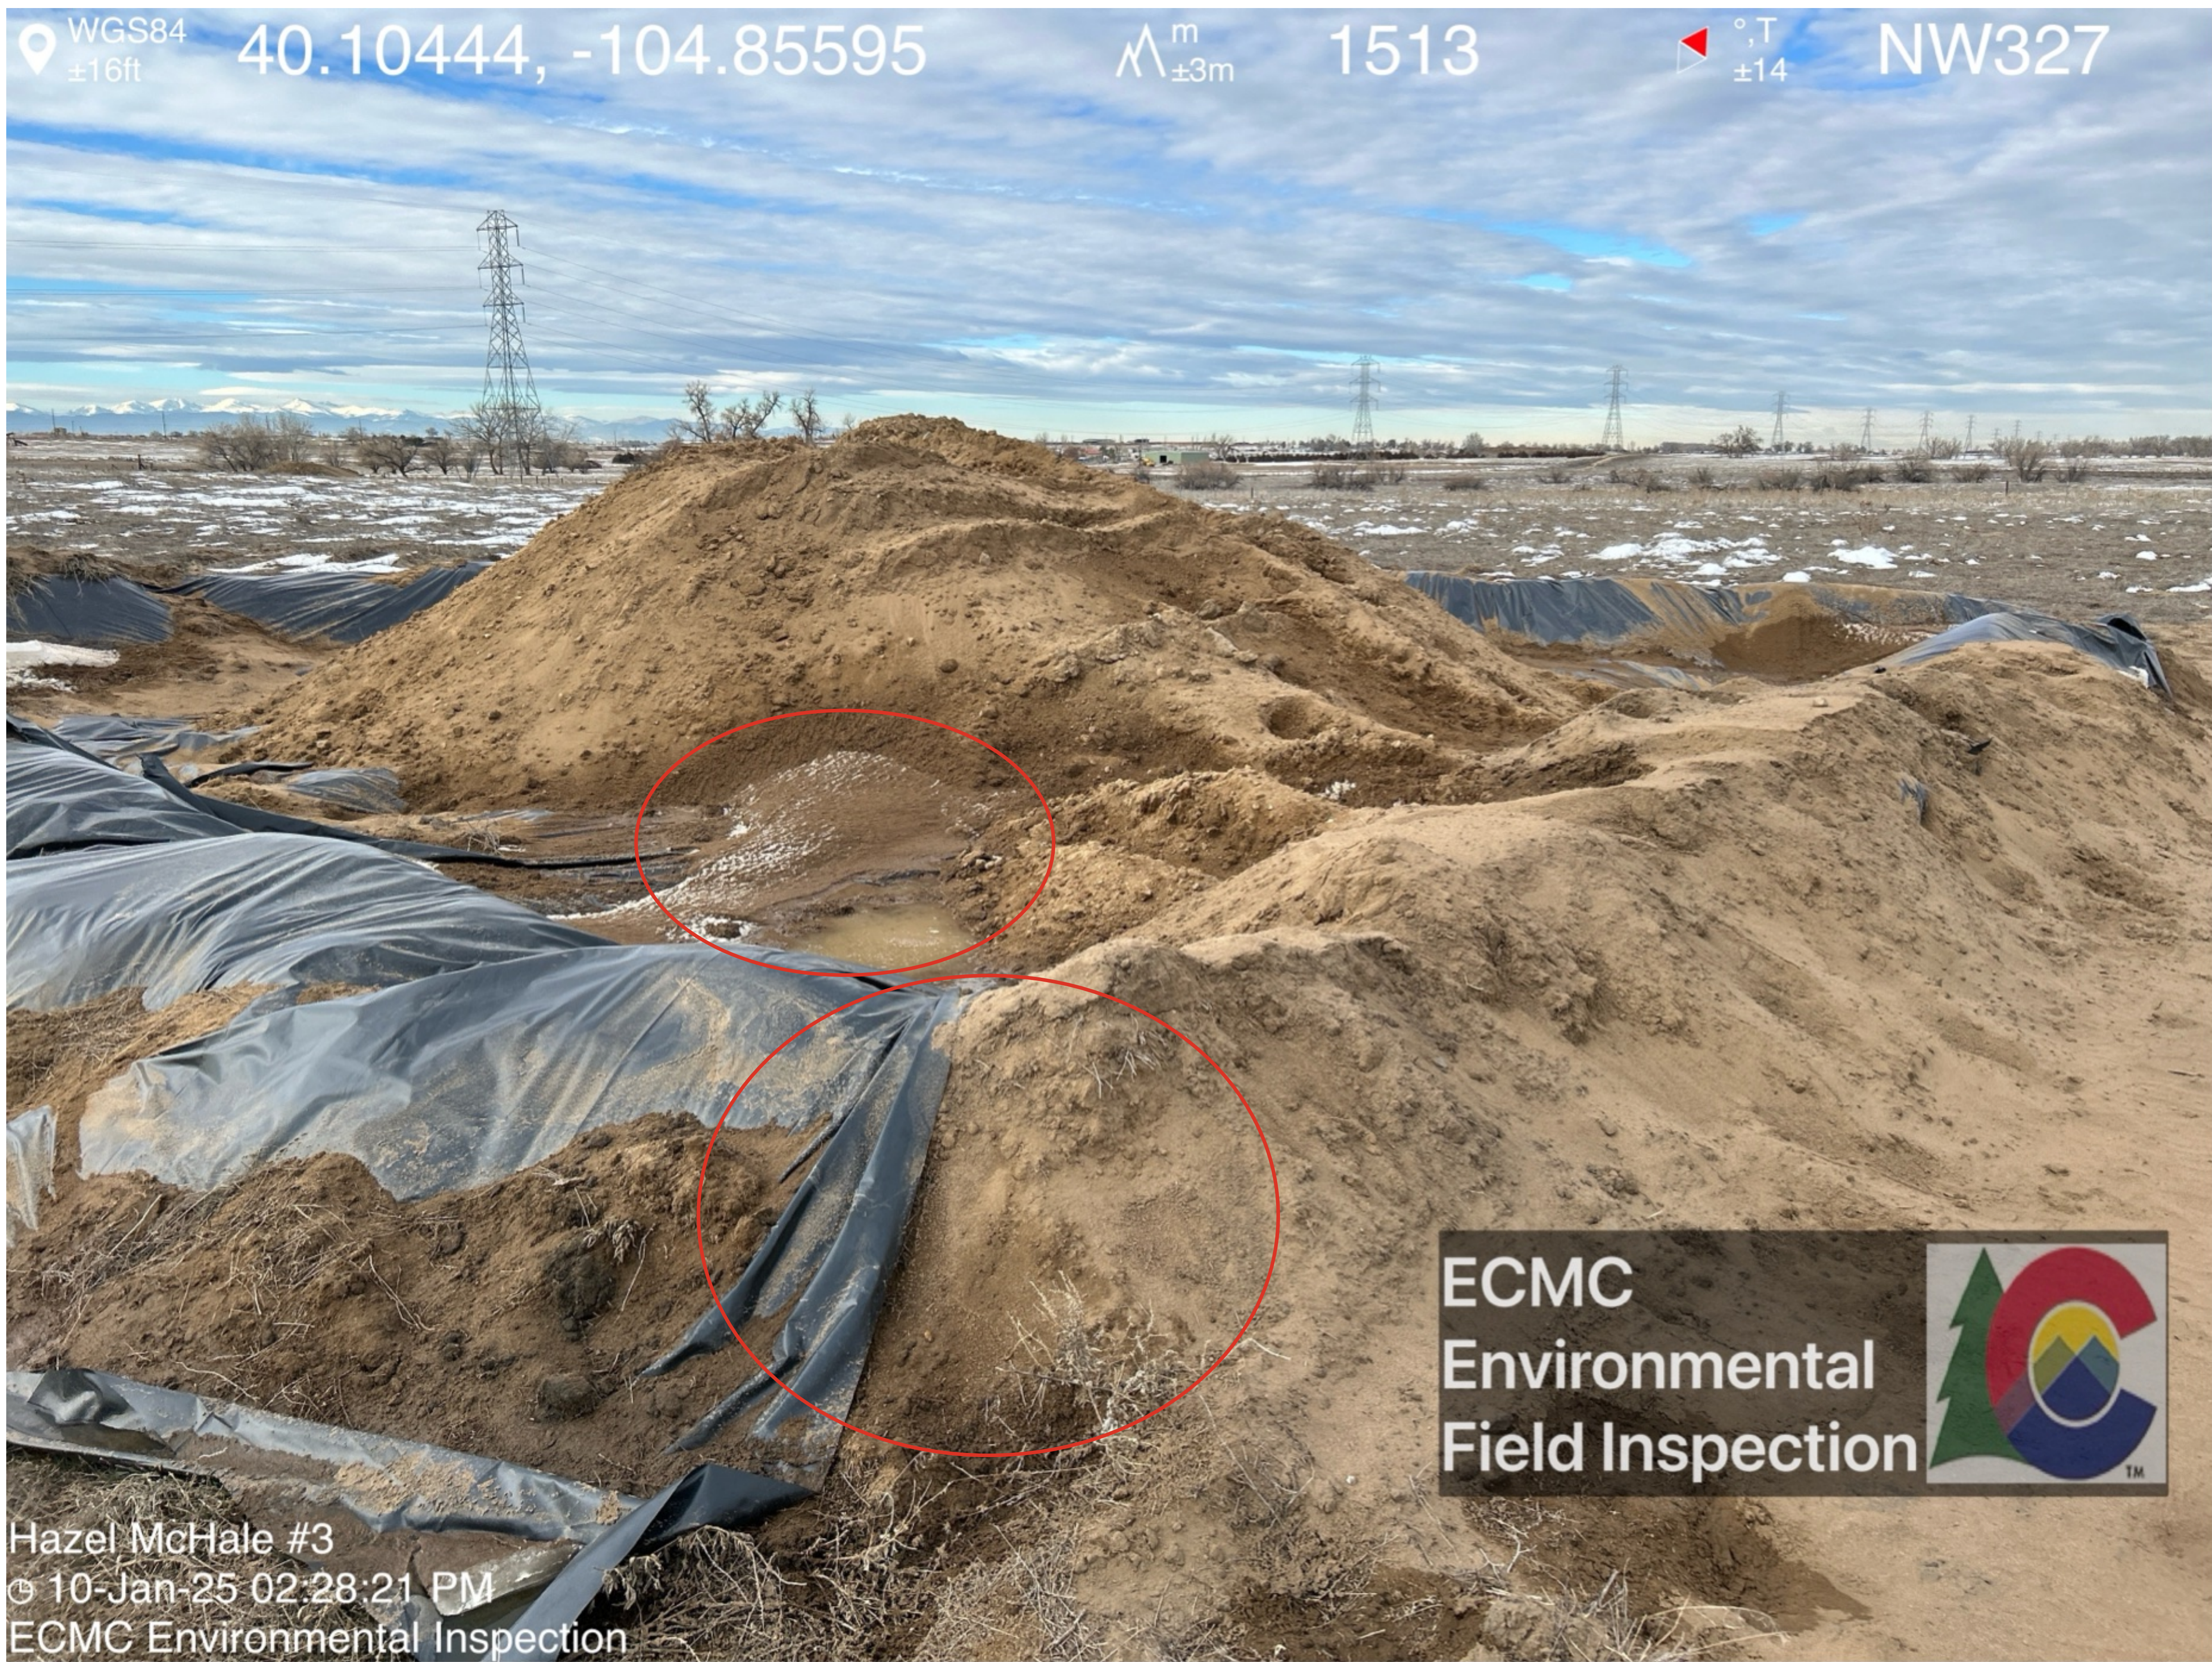
Liner is discontinuous. Snow/water has accumulated.

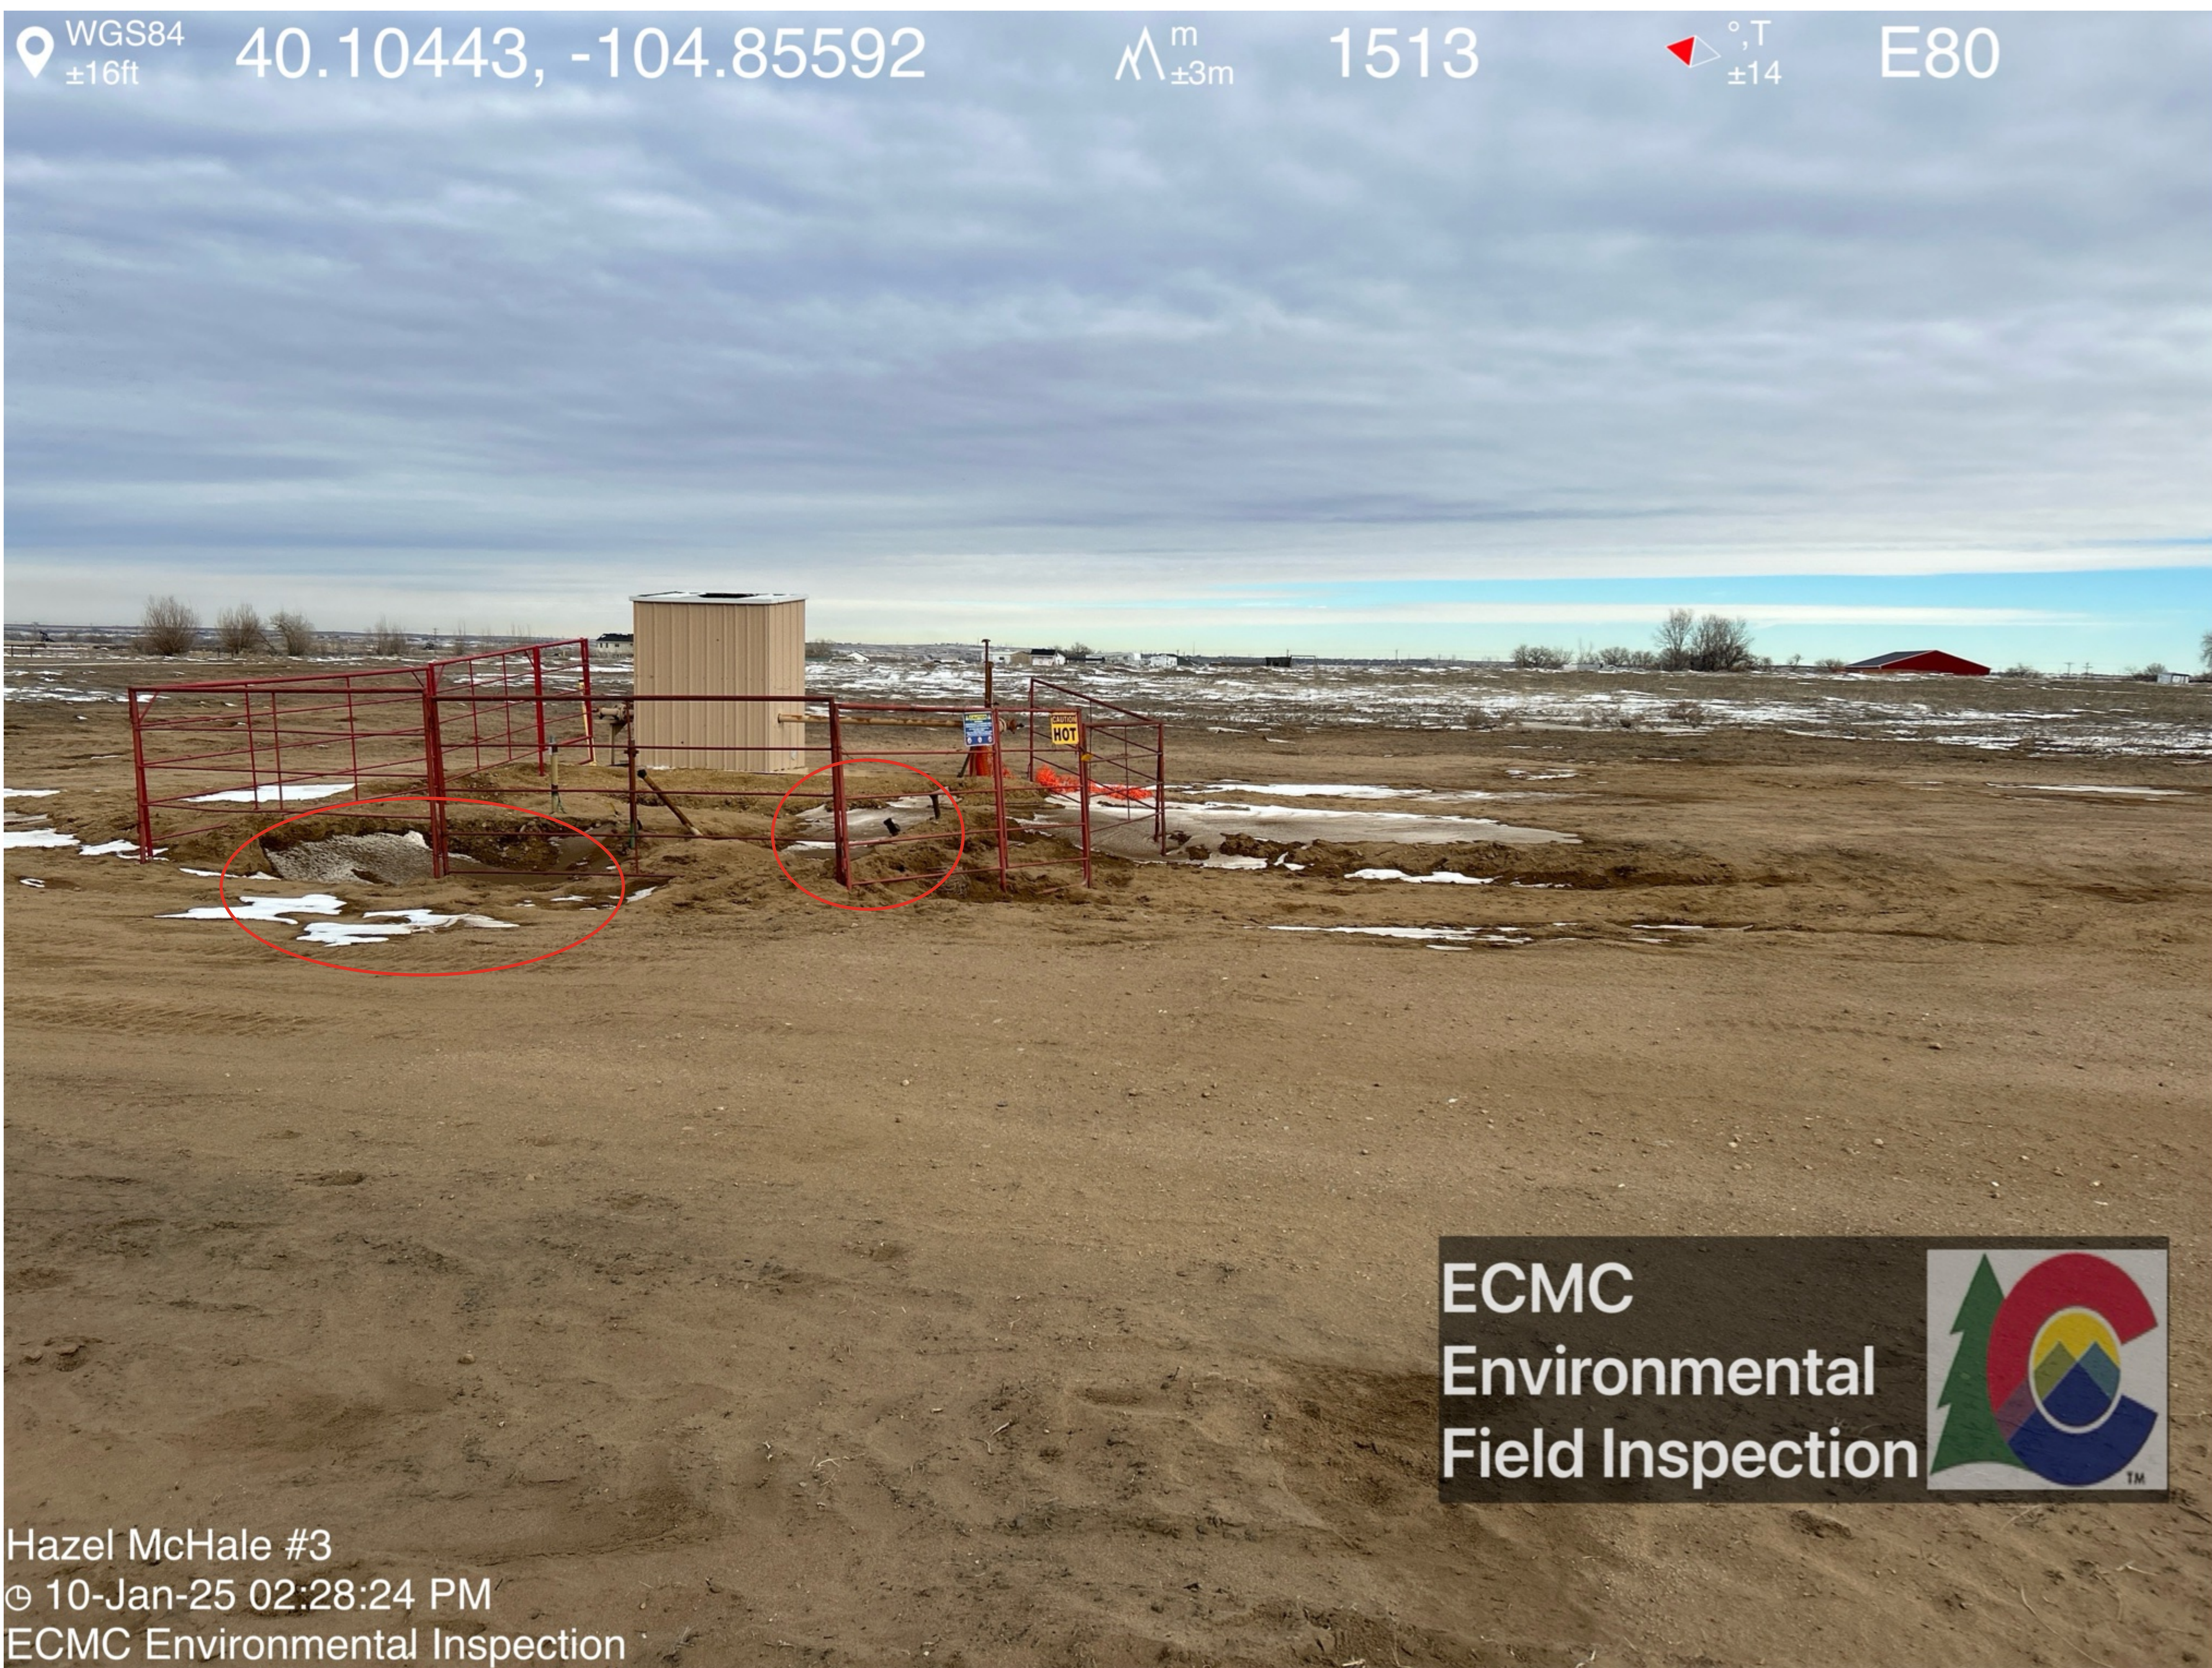
Excavation remains open. Snow has accumulated.

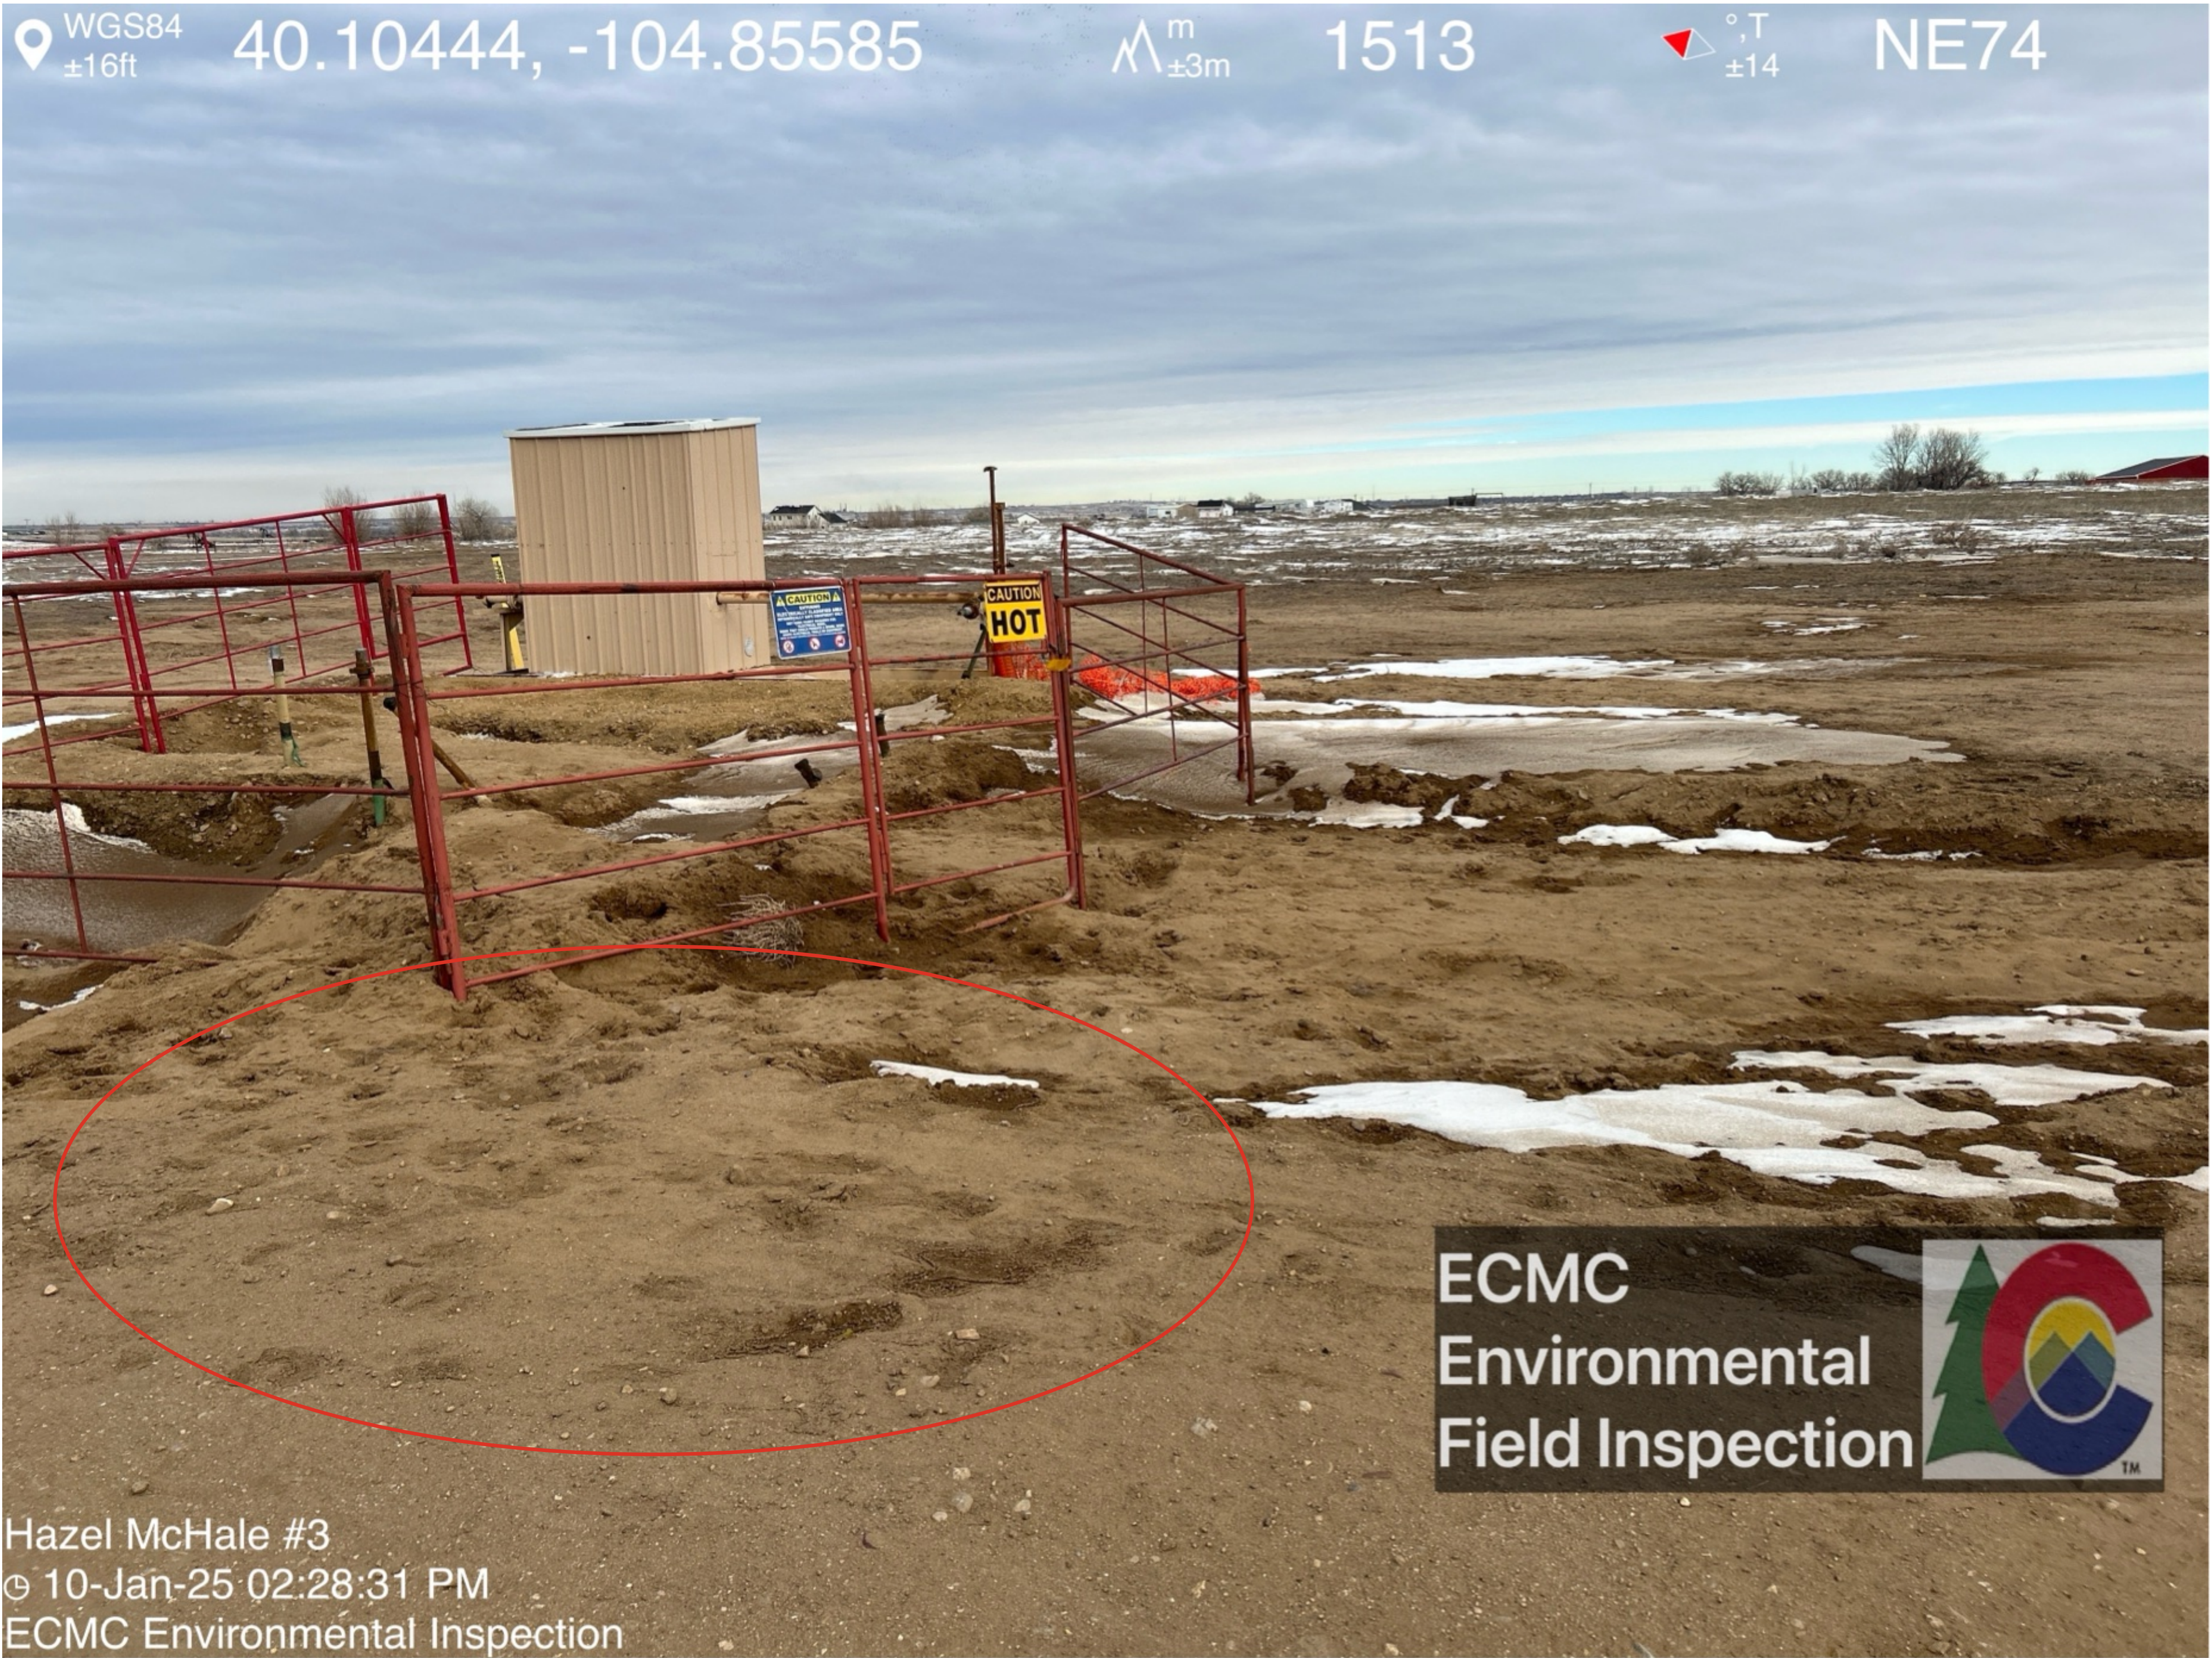
Excavation remains open. Livestock tracks observed.
