Inspection Photos

API: 061-06365

Operator: STRACHAN EXPLORATION INC

Inspection Date: 1/14/2025

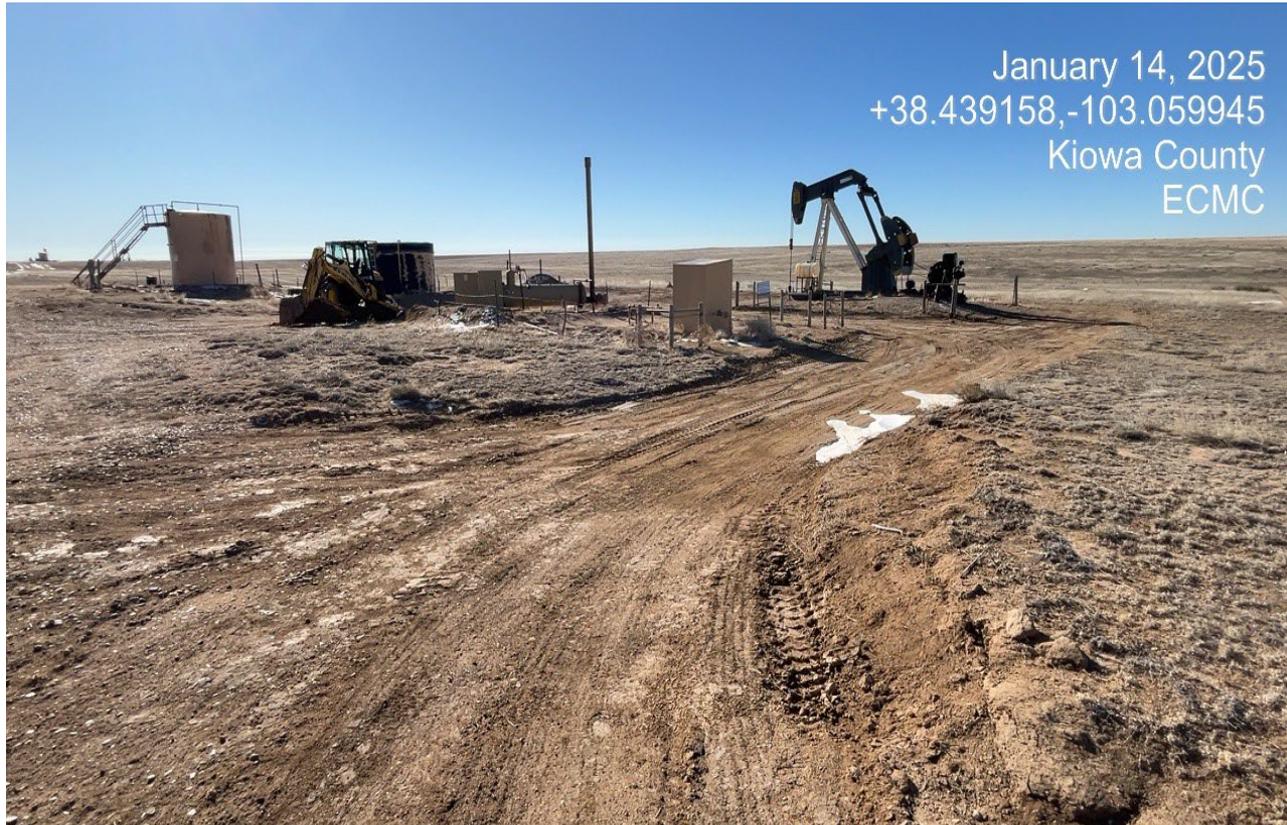
Photo 1. Facing southeast toward by the wellsite. The area along the road where hydrocarbon impacts were observed have been scrapped and removed.

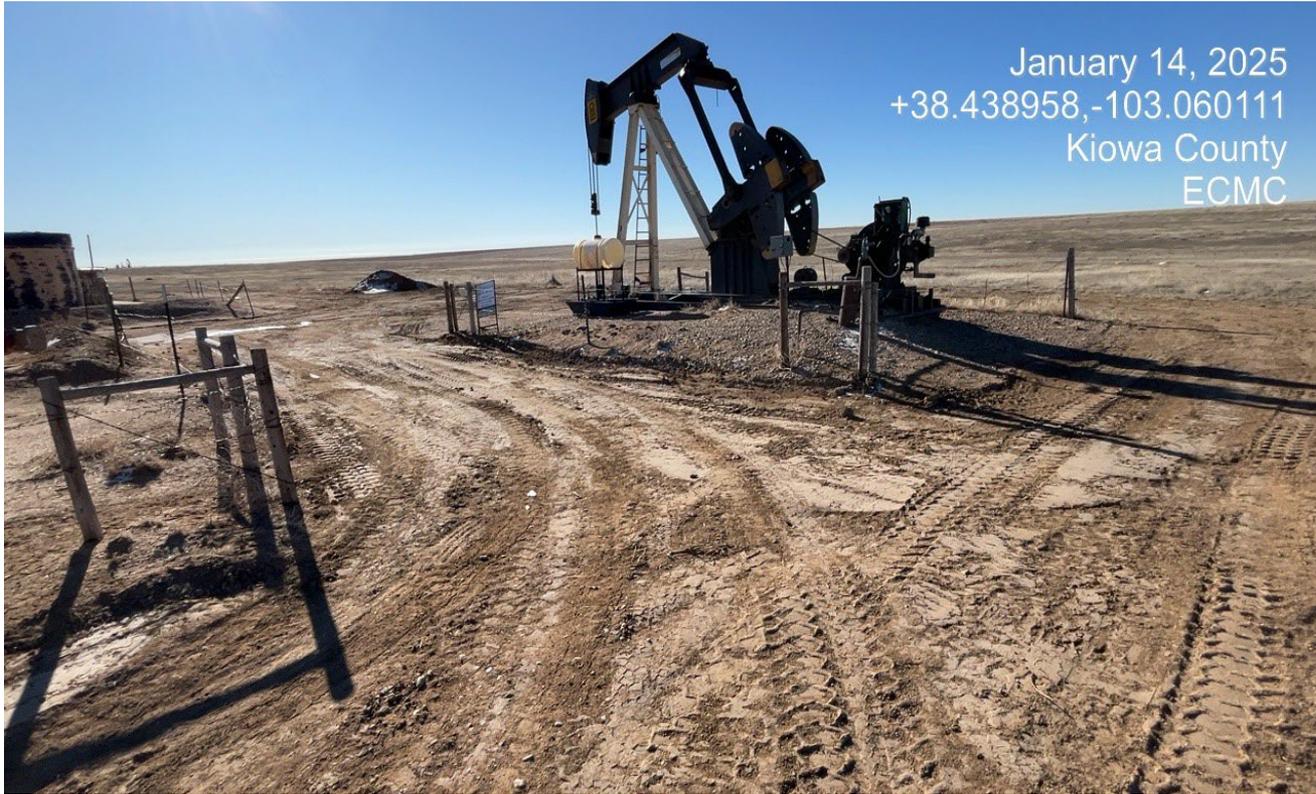
Photo 2. Facing southeast toward the pump jack..

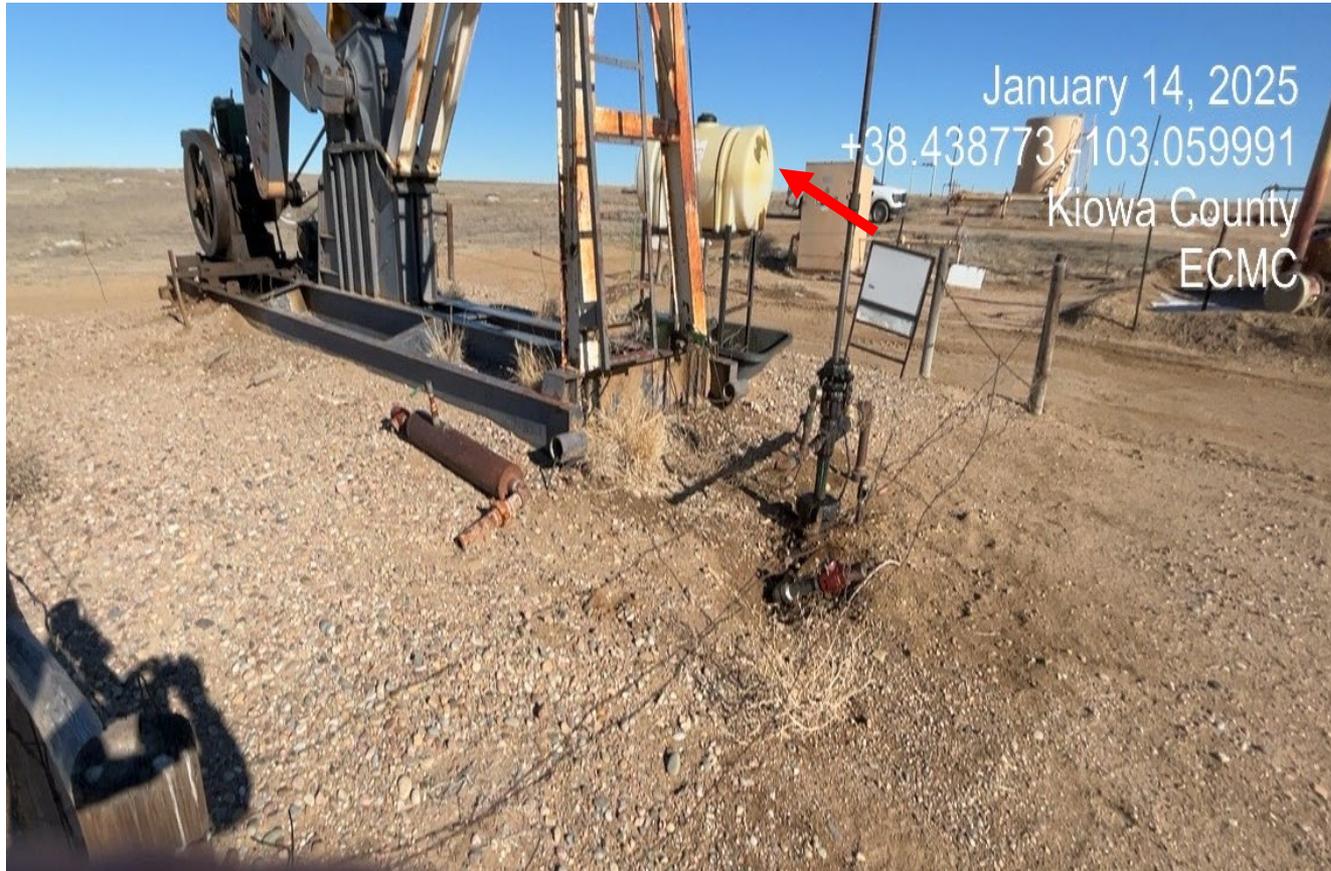
Photo 3. The plastic container at the pumpjack is broke and needs to be removed and disposed. Previous CA was not completed.

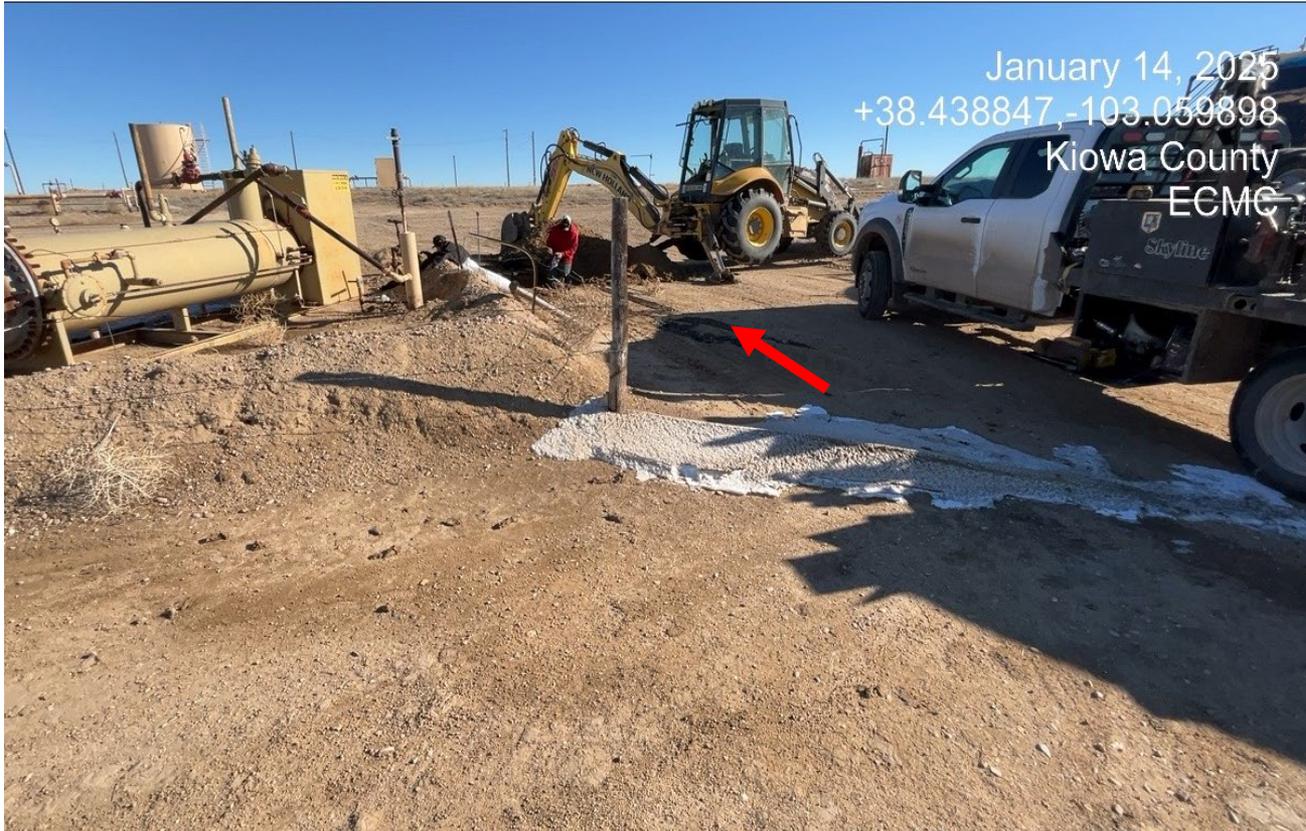
Photo 4. There were workers onsite repairing a leak along the flowline. There were oil stained soils at red arrow that will need to be cleaned up.

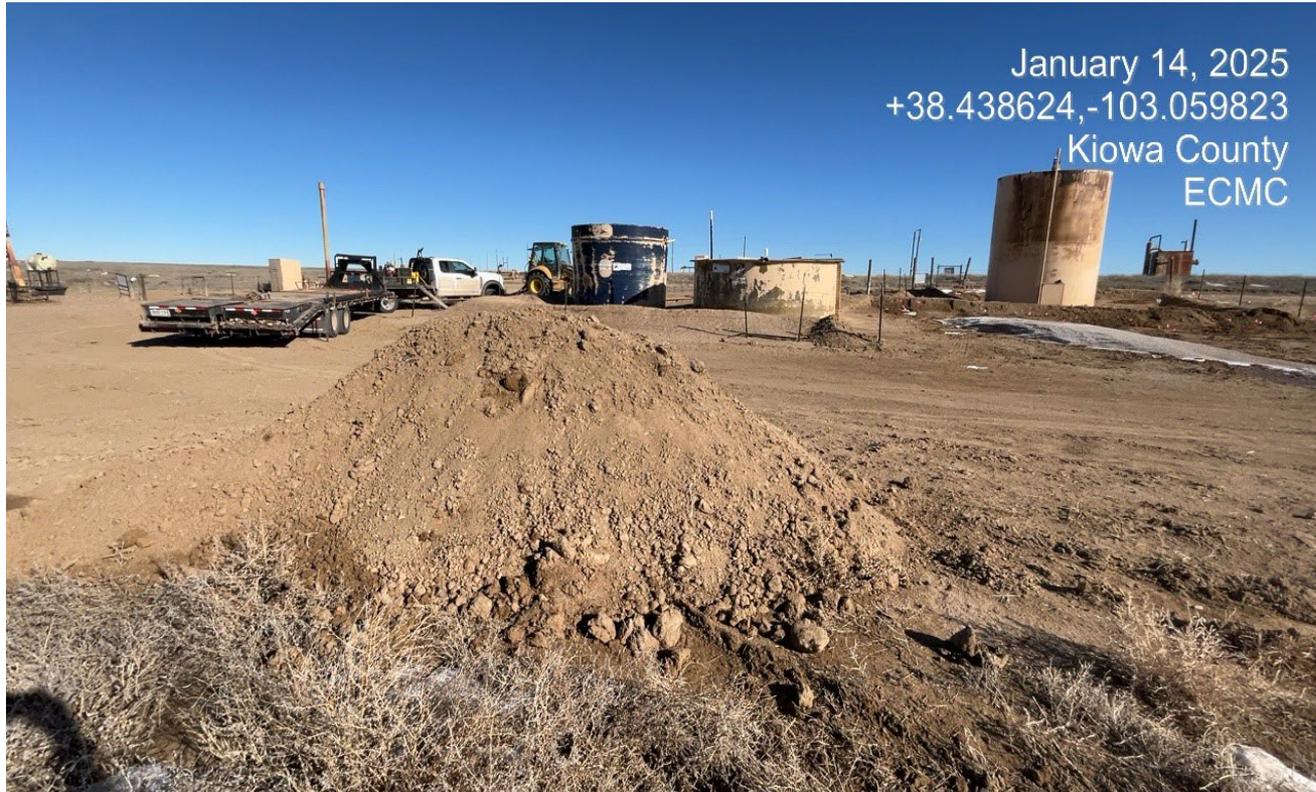
Photo 5. South side of the location facing north. There is a pile of material which has hydrocarbon impacts stored with no liner or containment. This appears to be part of the impacted berm material.

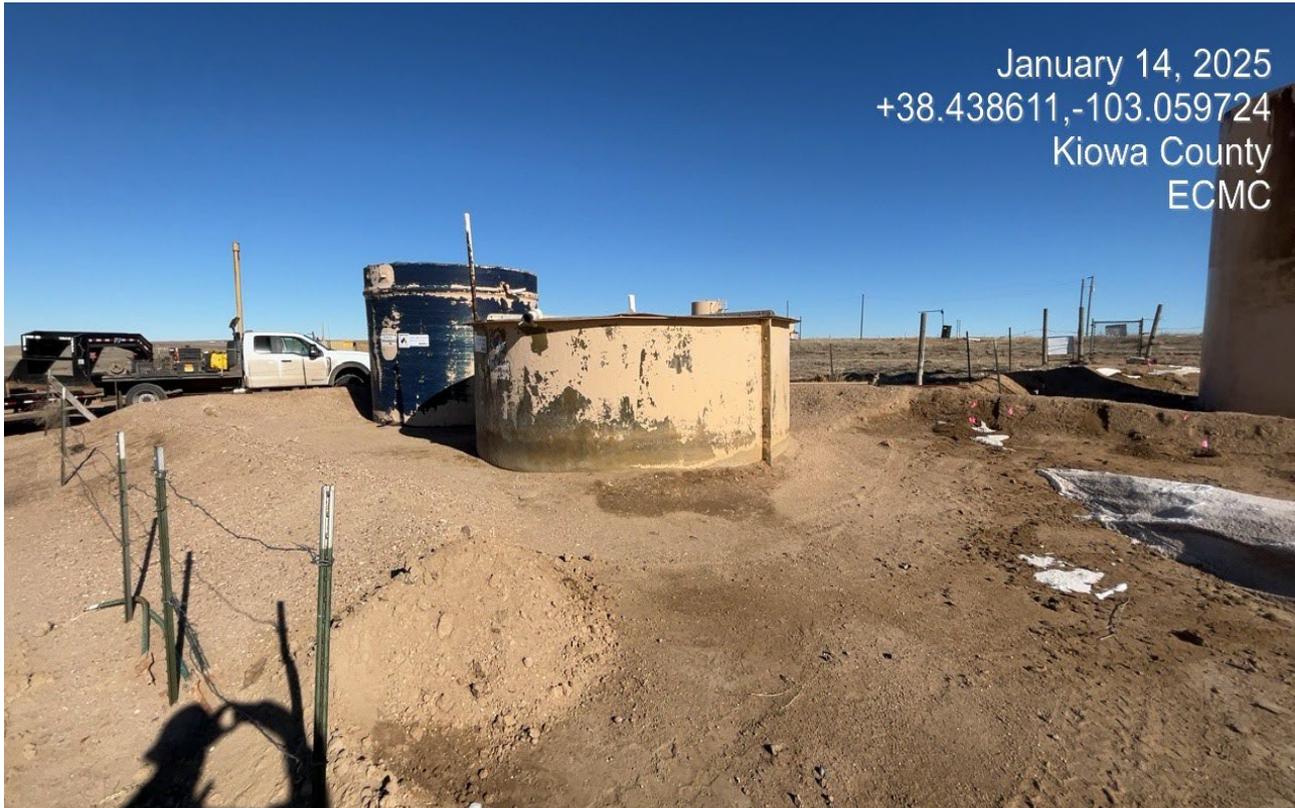
Photo 6. Facing toward the two fiberglass tanks. There is no secondary containment around the tanks which should be empty and not in use without containment.

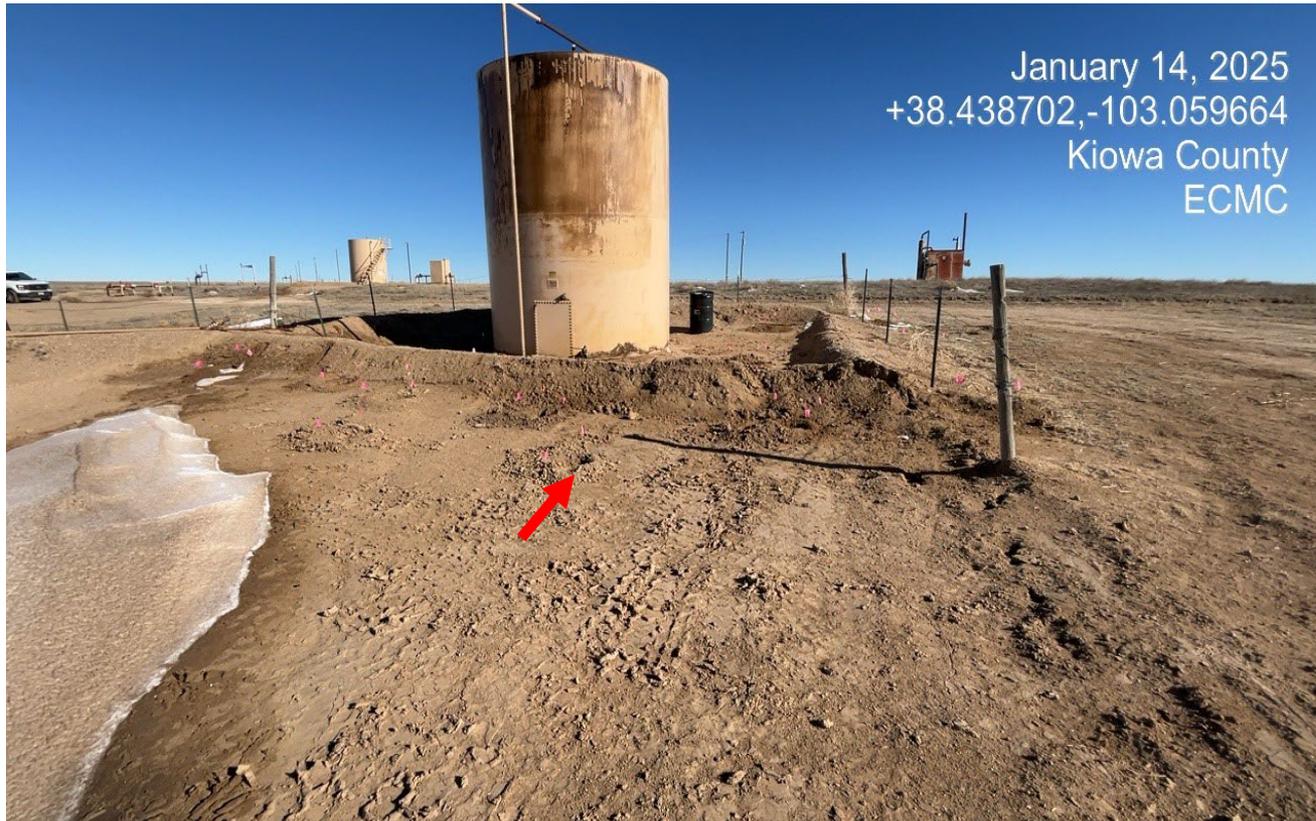
Photo 7. Facing toward the tank where spill had previously occurred. There are sampling bore holes shown at red arrow.

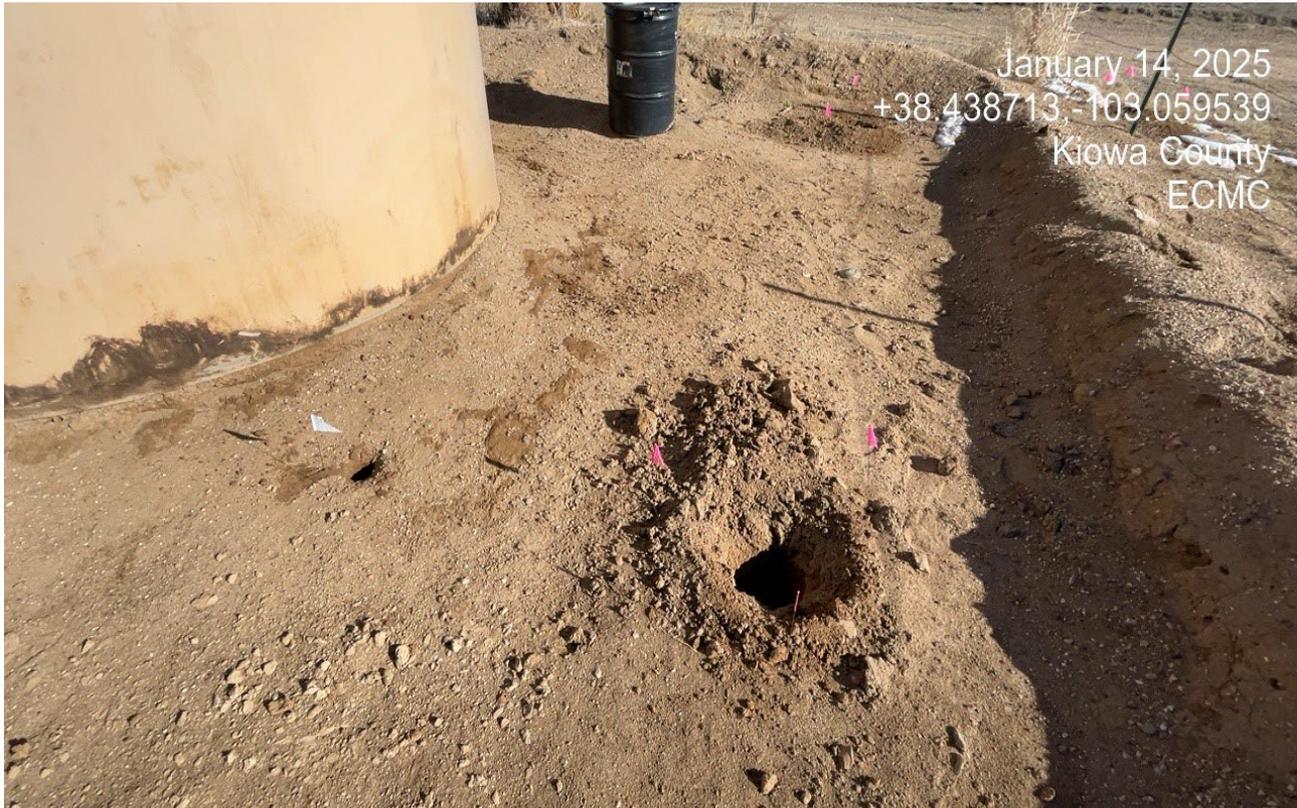
Photo 8. Facing adjacent to the tank. There are still hydrocarbon impacted soils around the entire tank which have not been cleaned up.

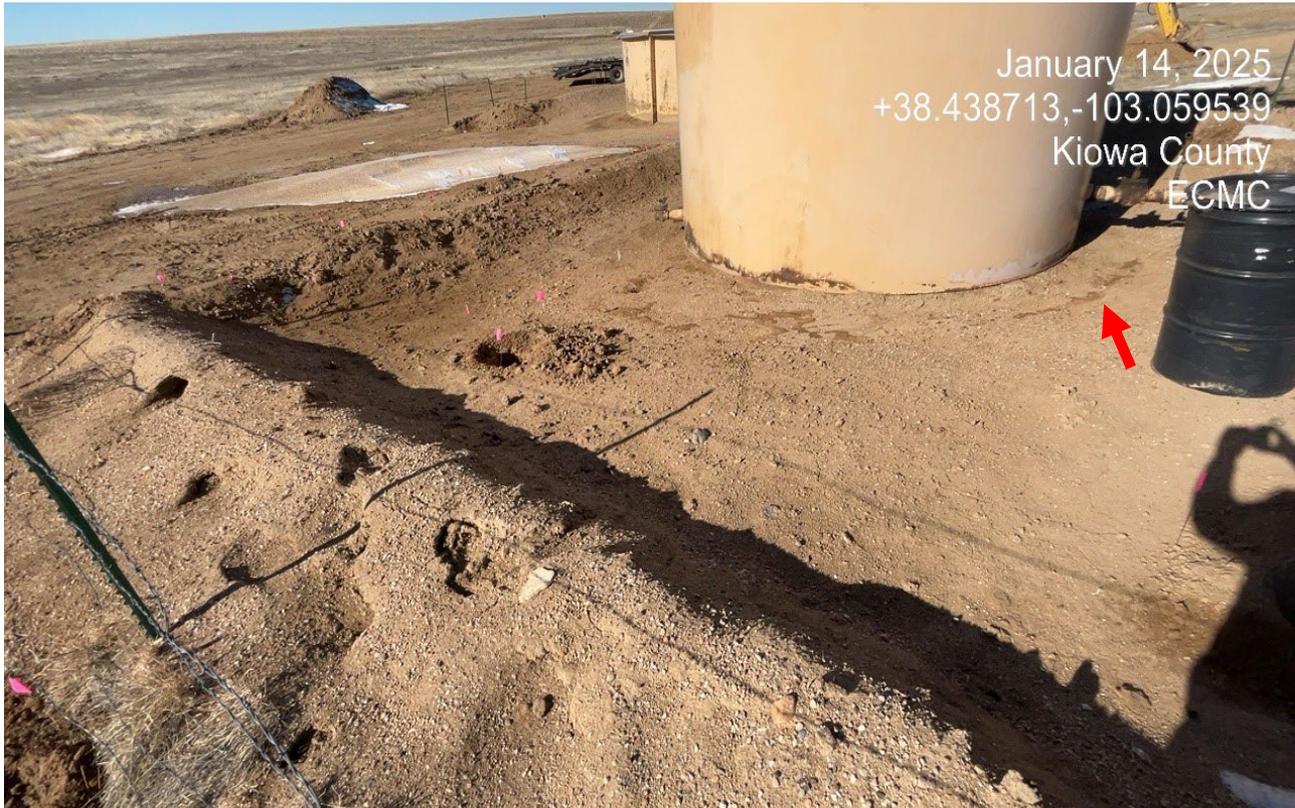
Photo 9. There are still impacted soils around the entire tank where spill had occurred. The tank will need to be removed to excavate and remove all of the impacted soils.

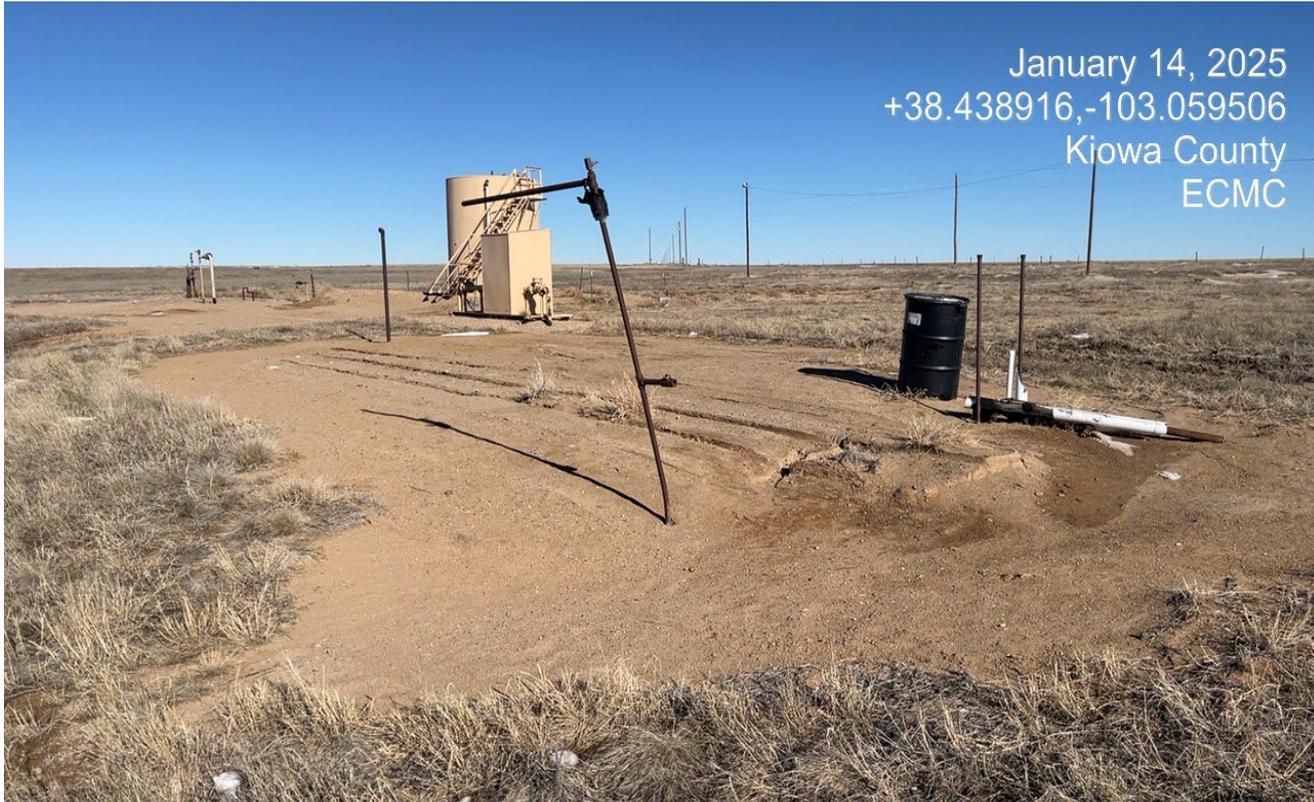
Photo 10. Facing northwest at the location. The two large volume tanks have been removed. The remaining pipes and barrel will also need to be removed. This area will need to be reclaimed.

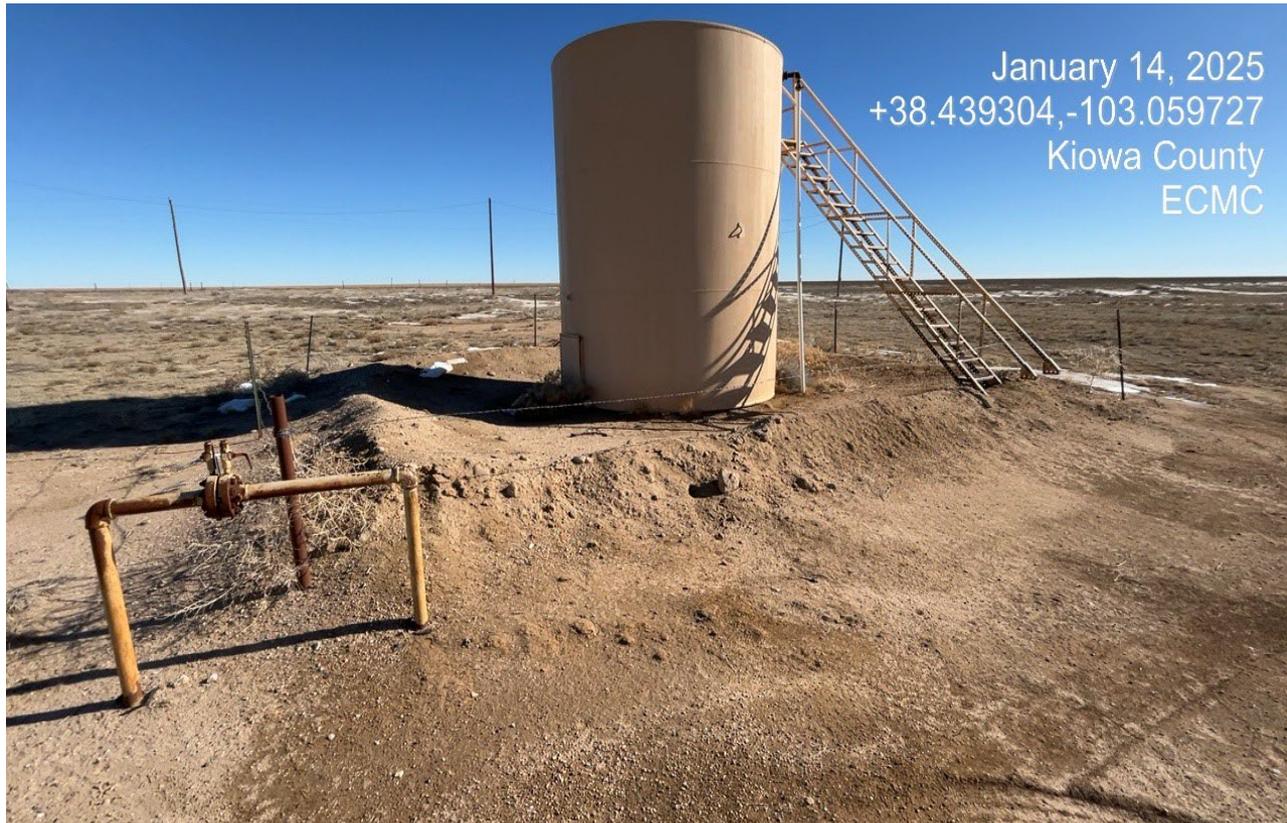
Photo 11. Facing at the north side of the location. The fence around the tank battery is inadequate to prevent livestock entry. The berm around the tank has been rebuilt.

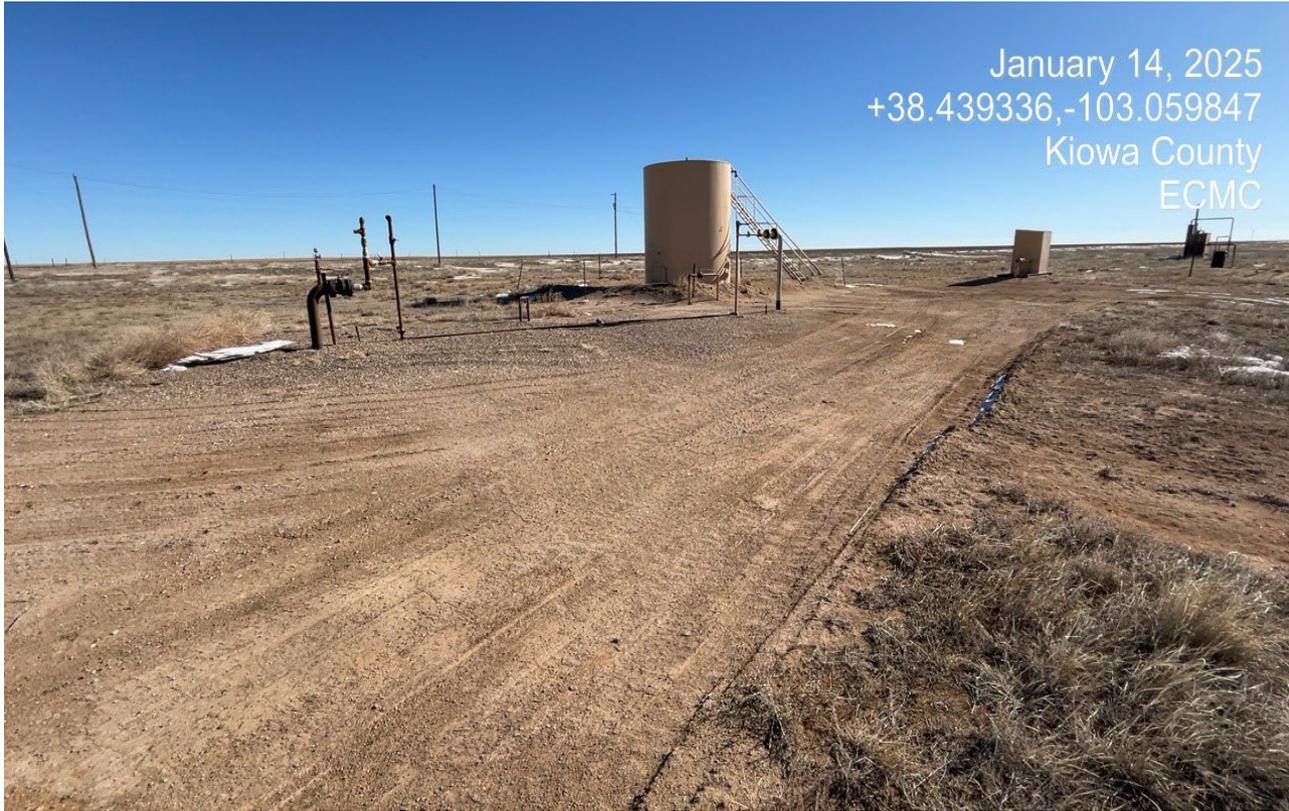
Photo 12. Facing northeast at the north side of the location.
