Hladky O'Gorman 3 Well (API # 05-123-07775)

Hladky-O'Gorman Header  
© 22-Jan-25 10:49:13 AM  
ECMC Environmental Inspection

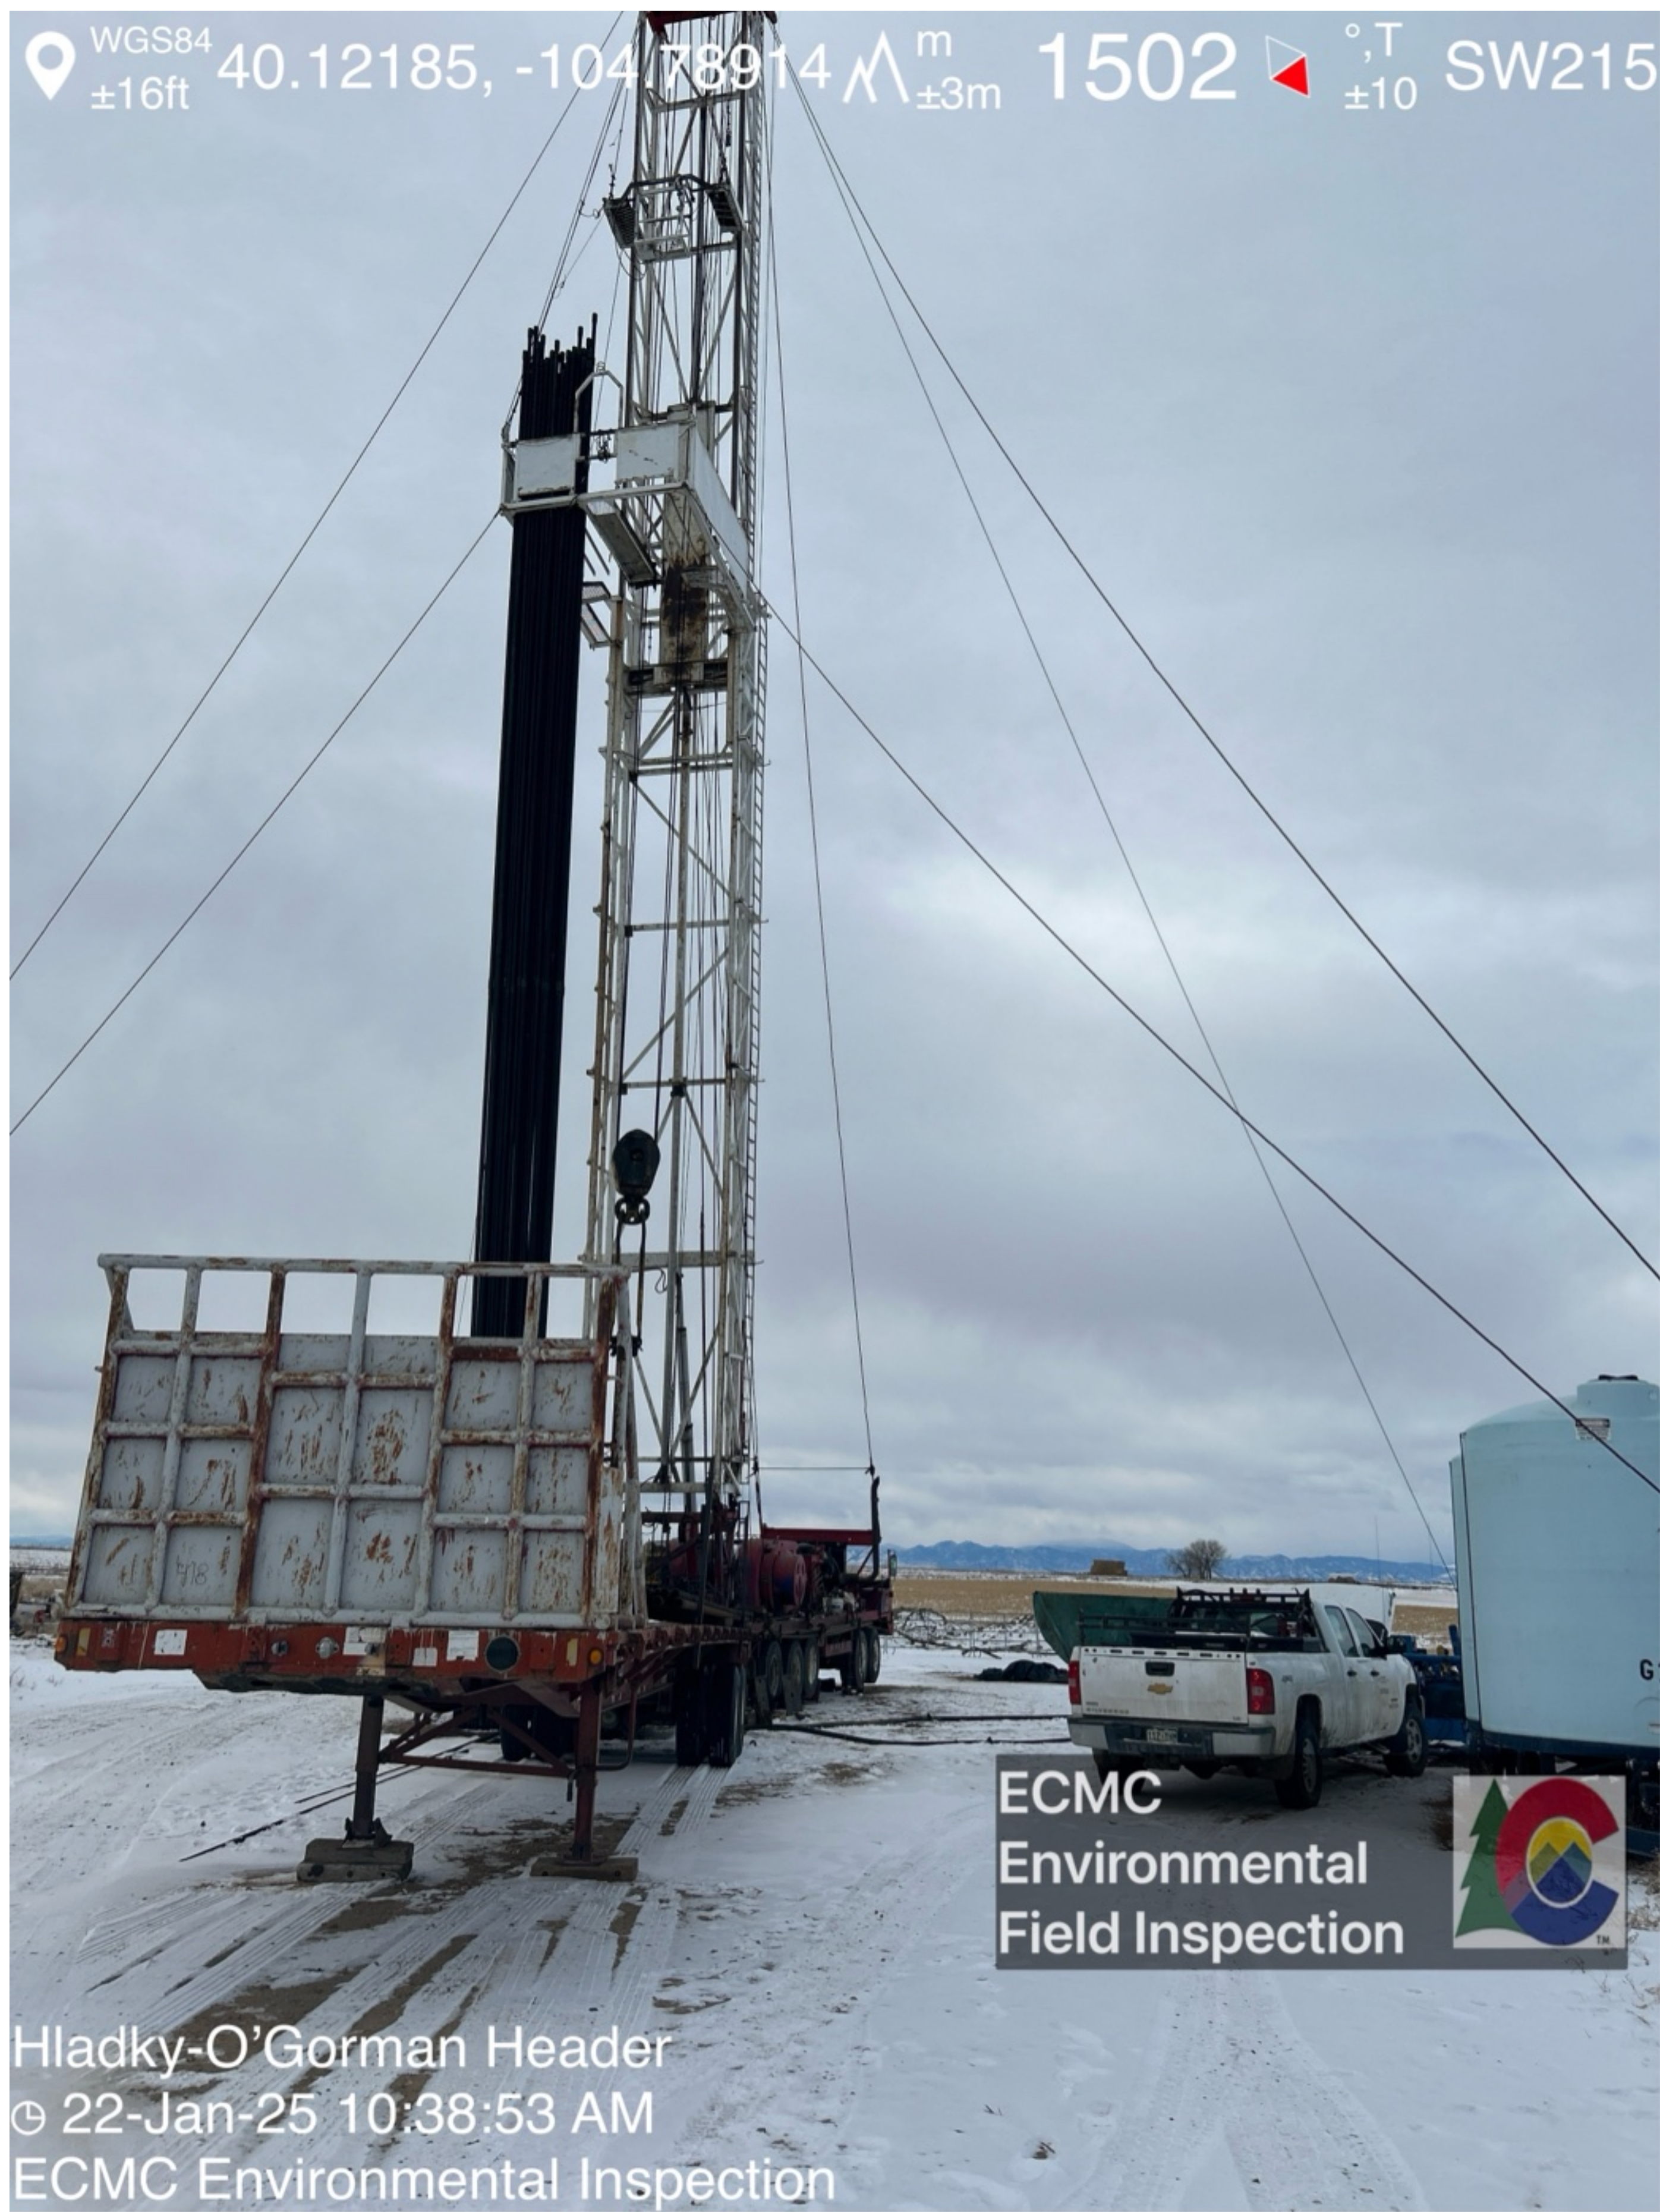
Operator personnel on location for the plugging and abandonment of the Hladky O'Gorman 3 Well (API # 05-123-07775)

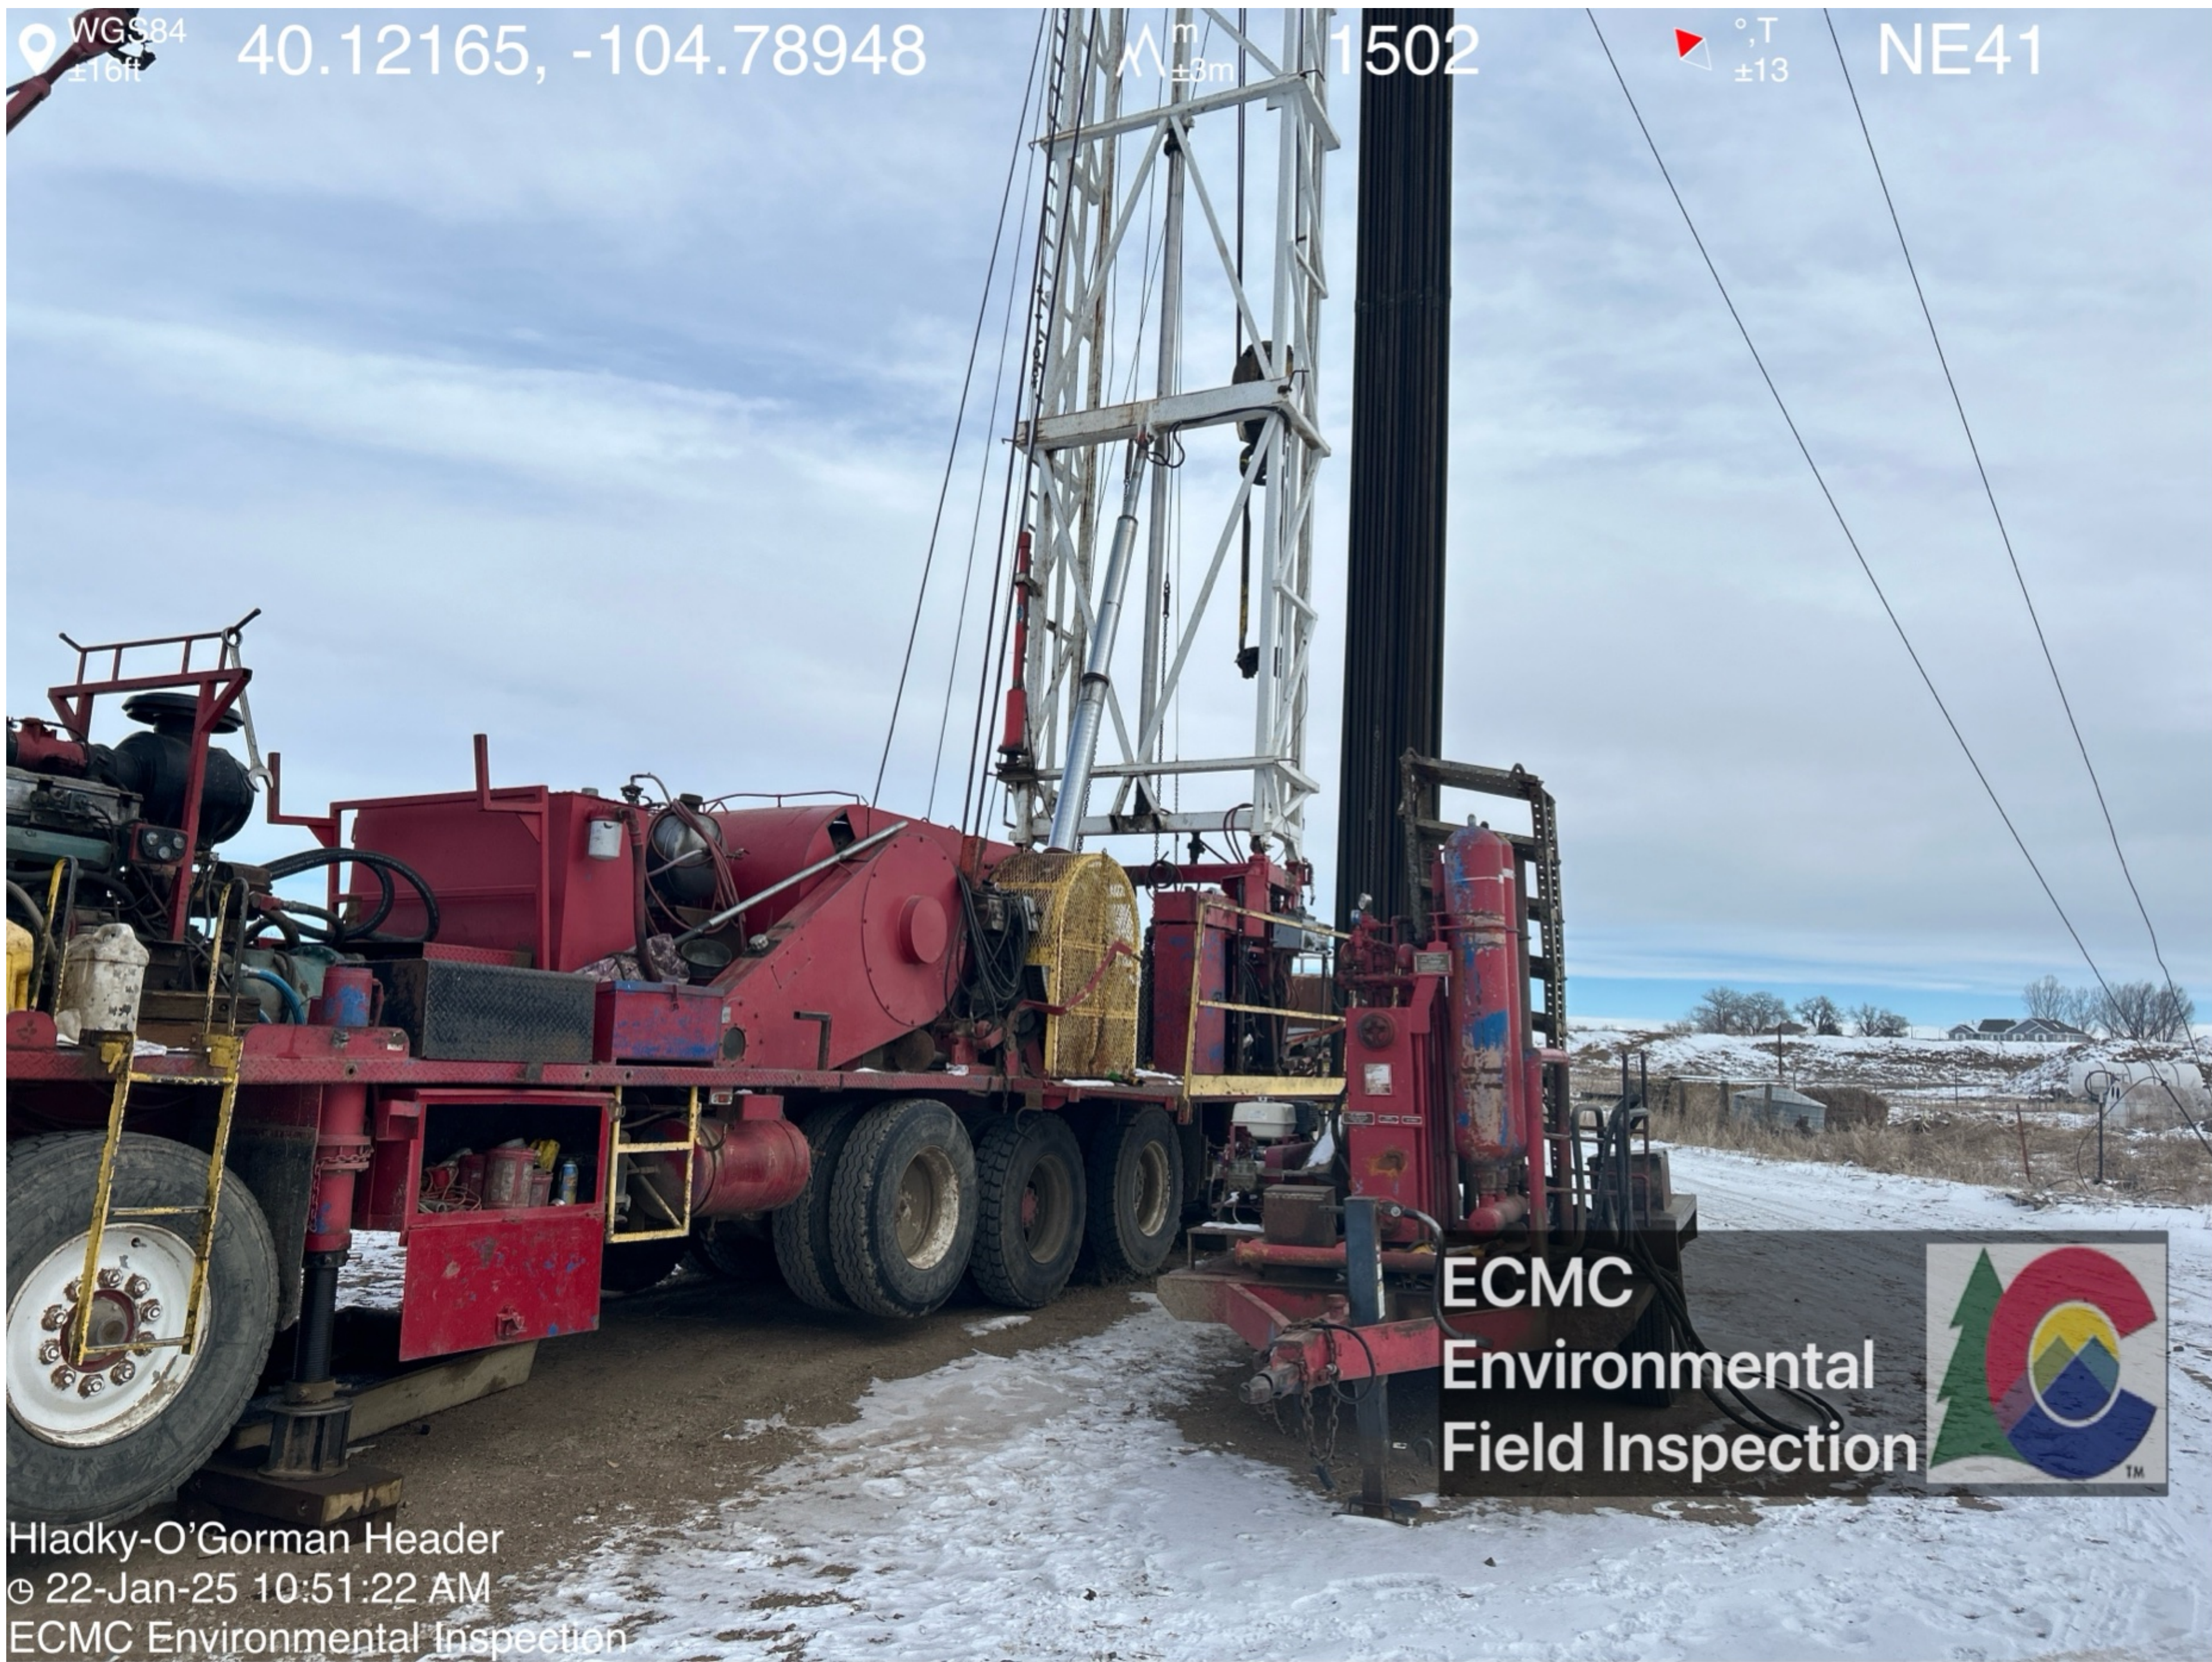
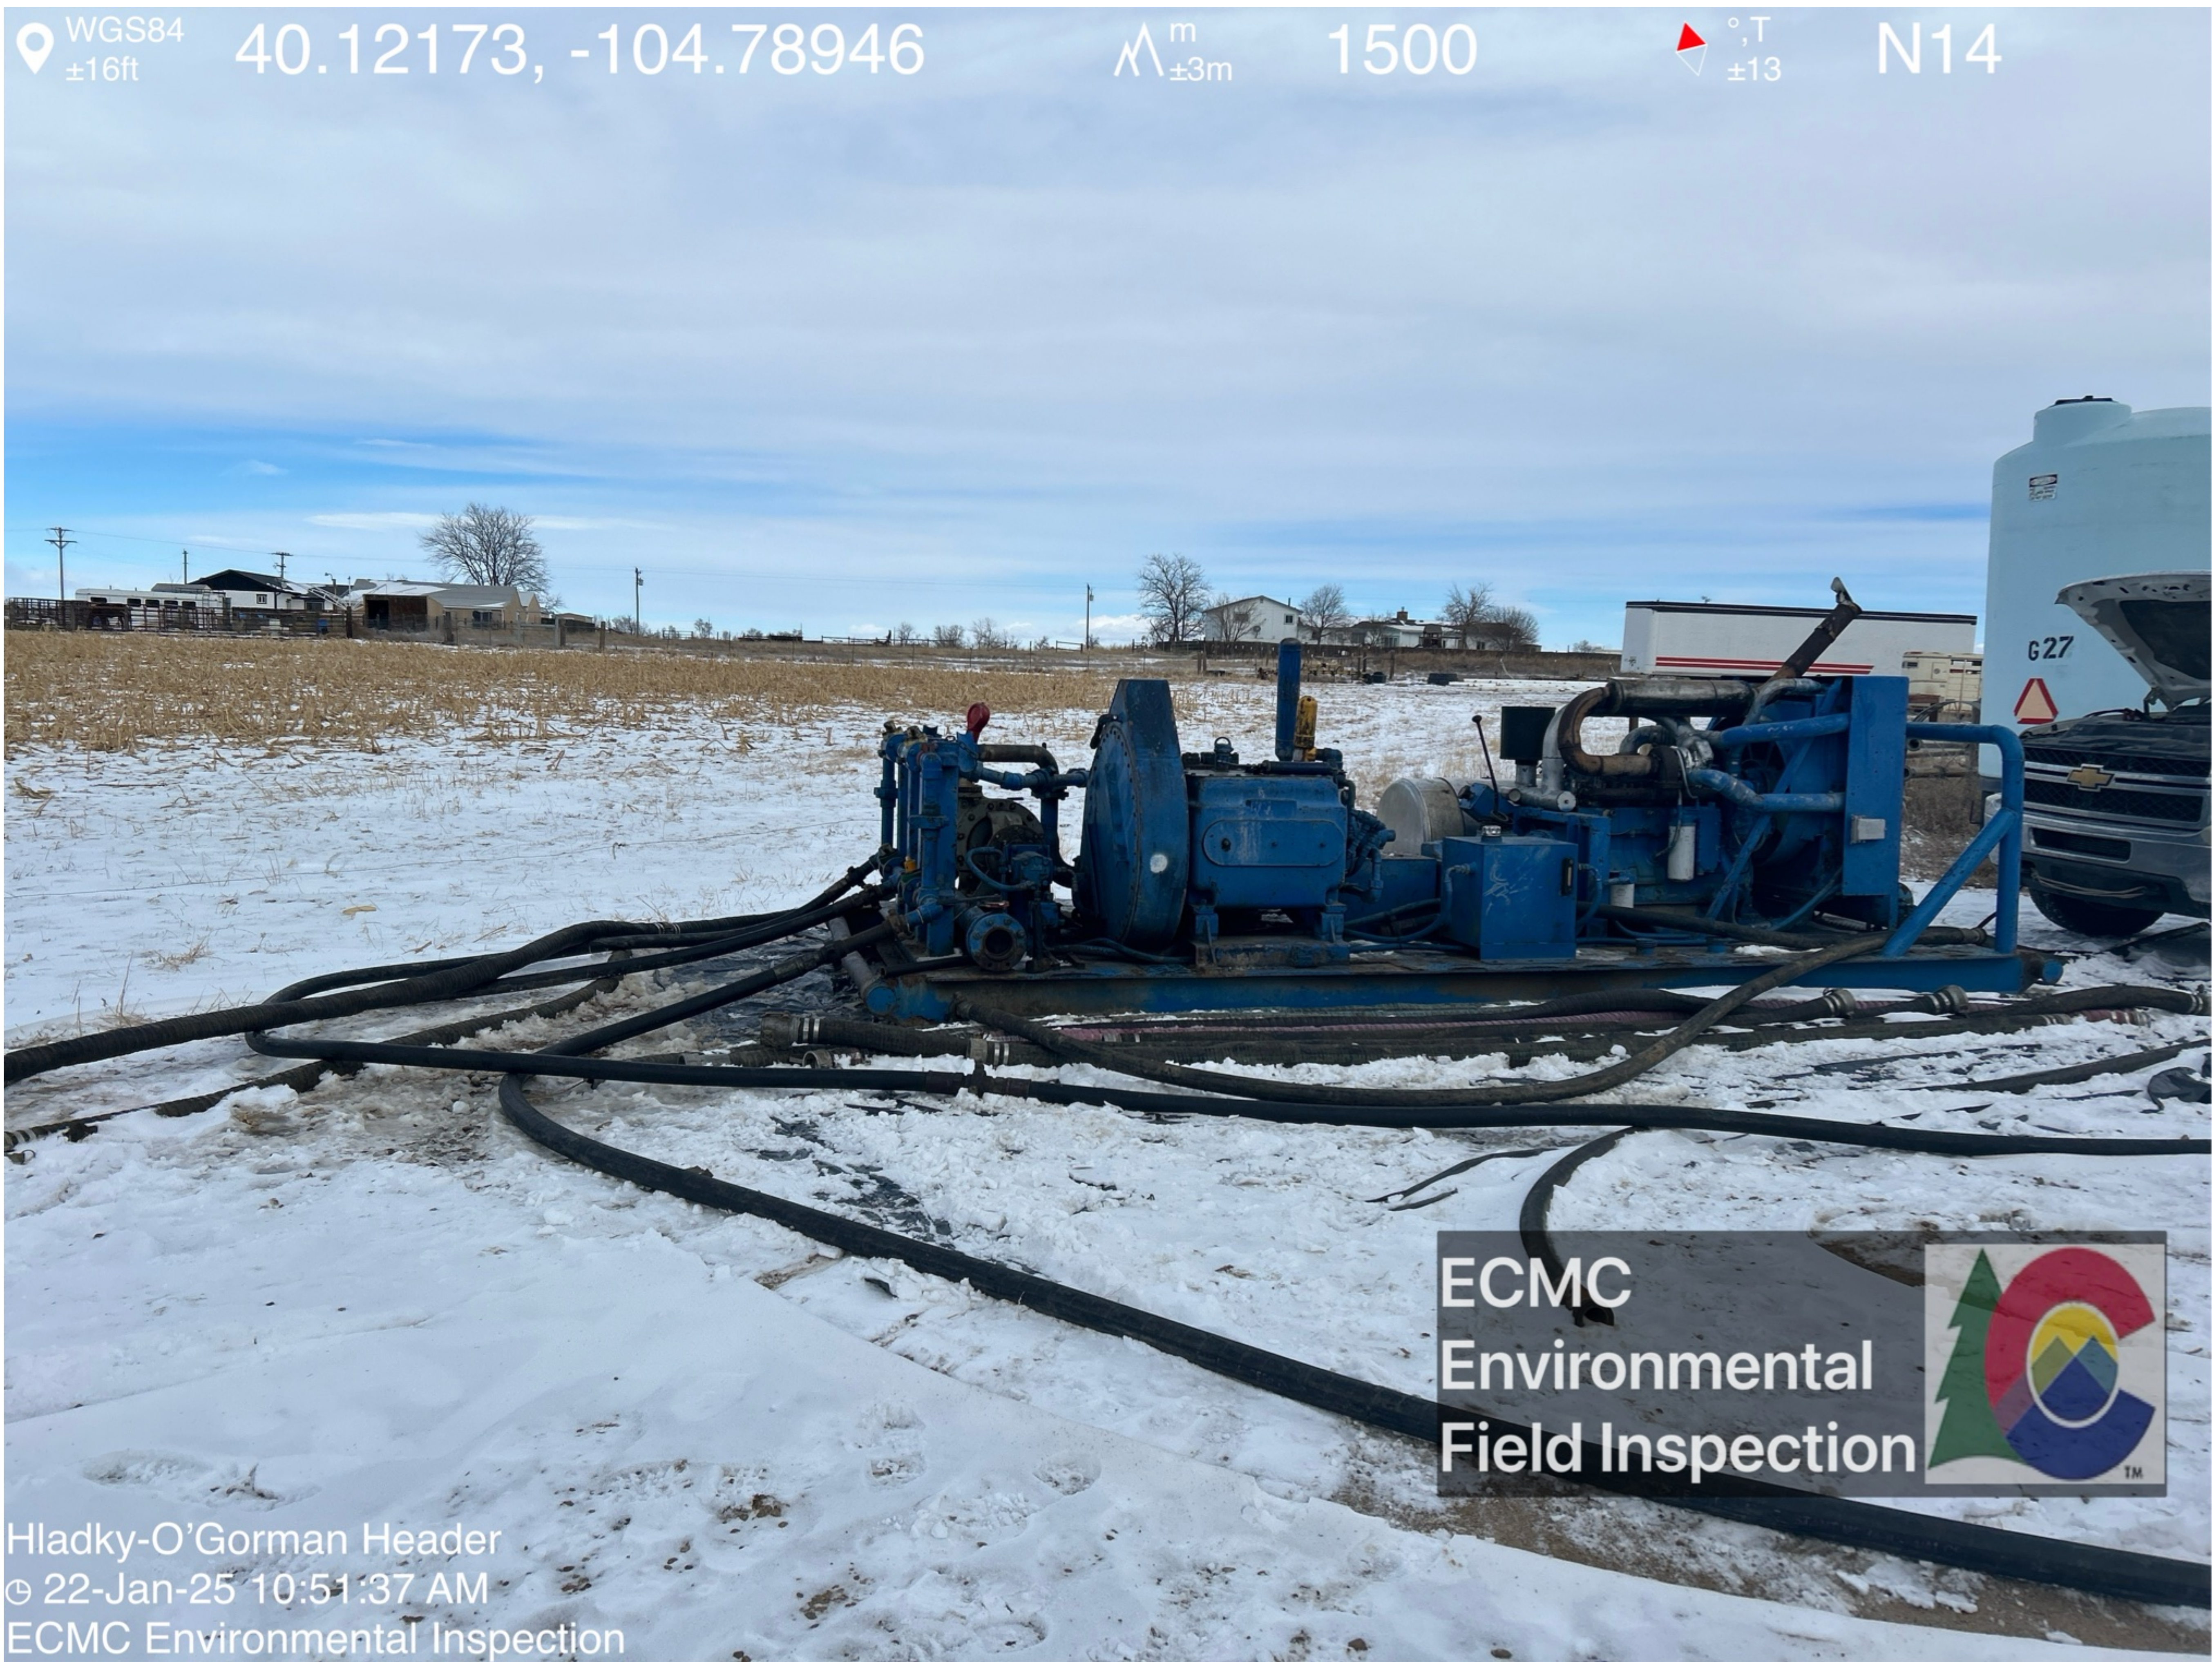
Operator equipment on location for plugging and abandonment activities.

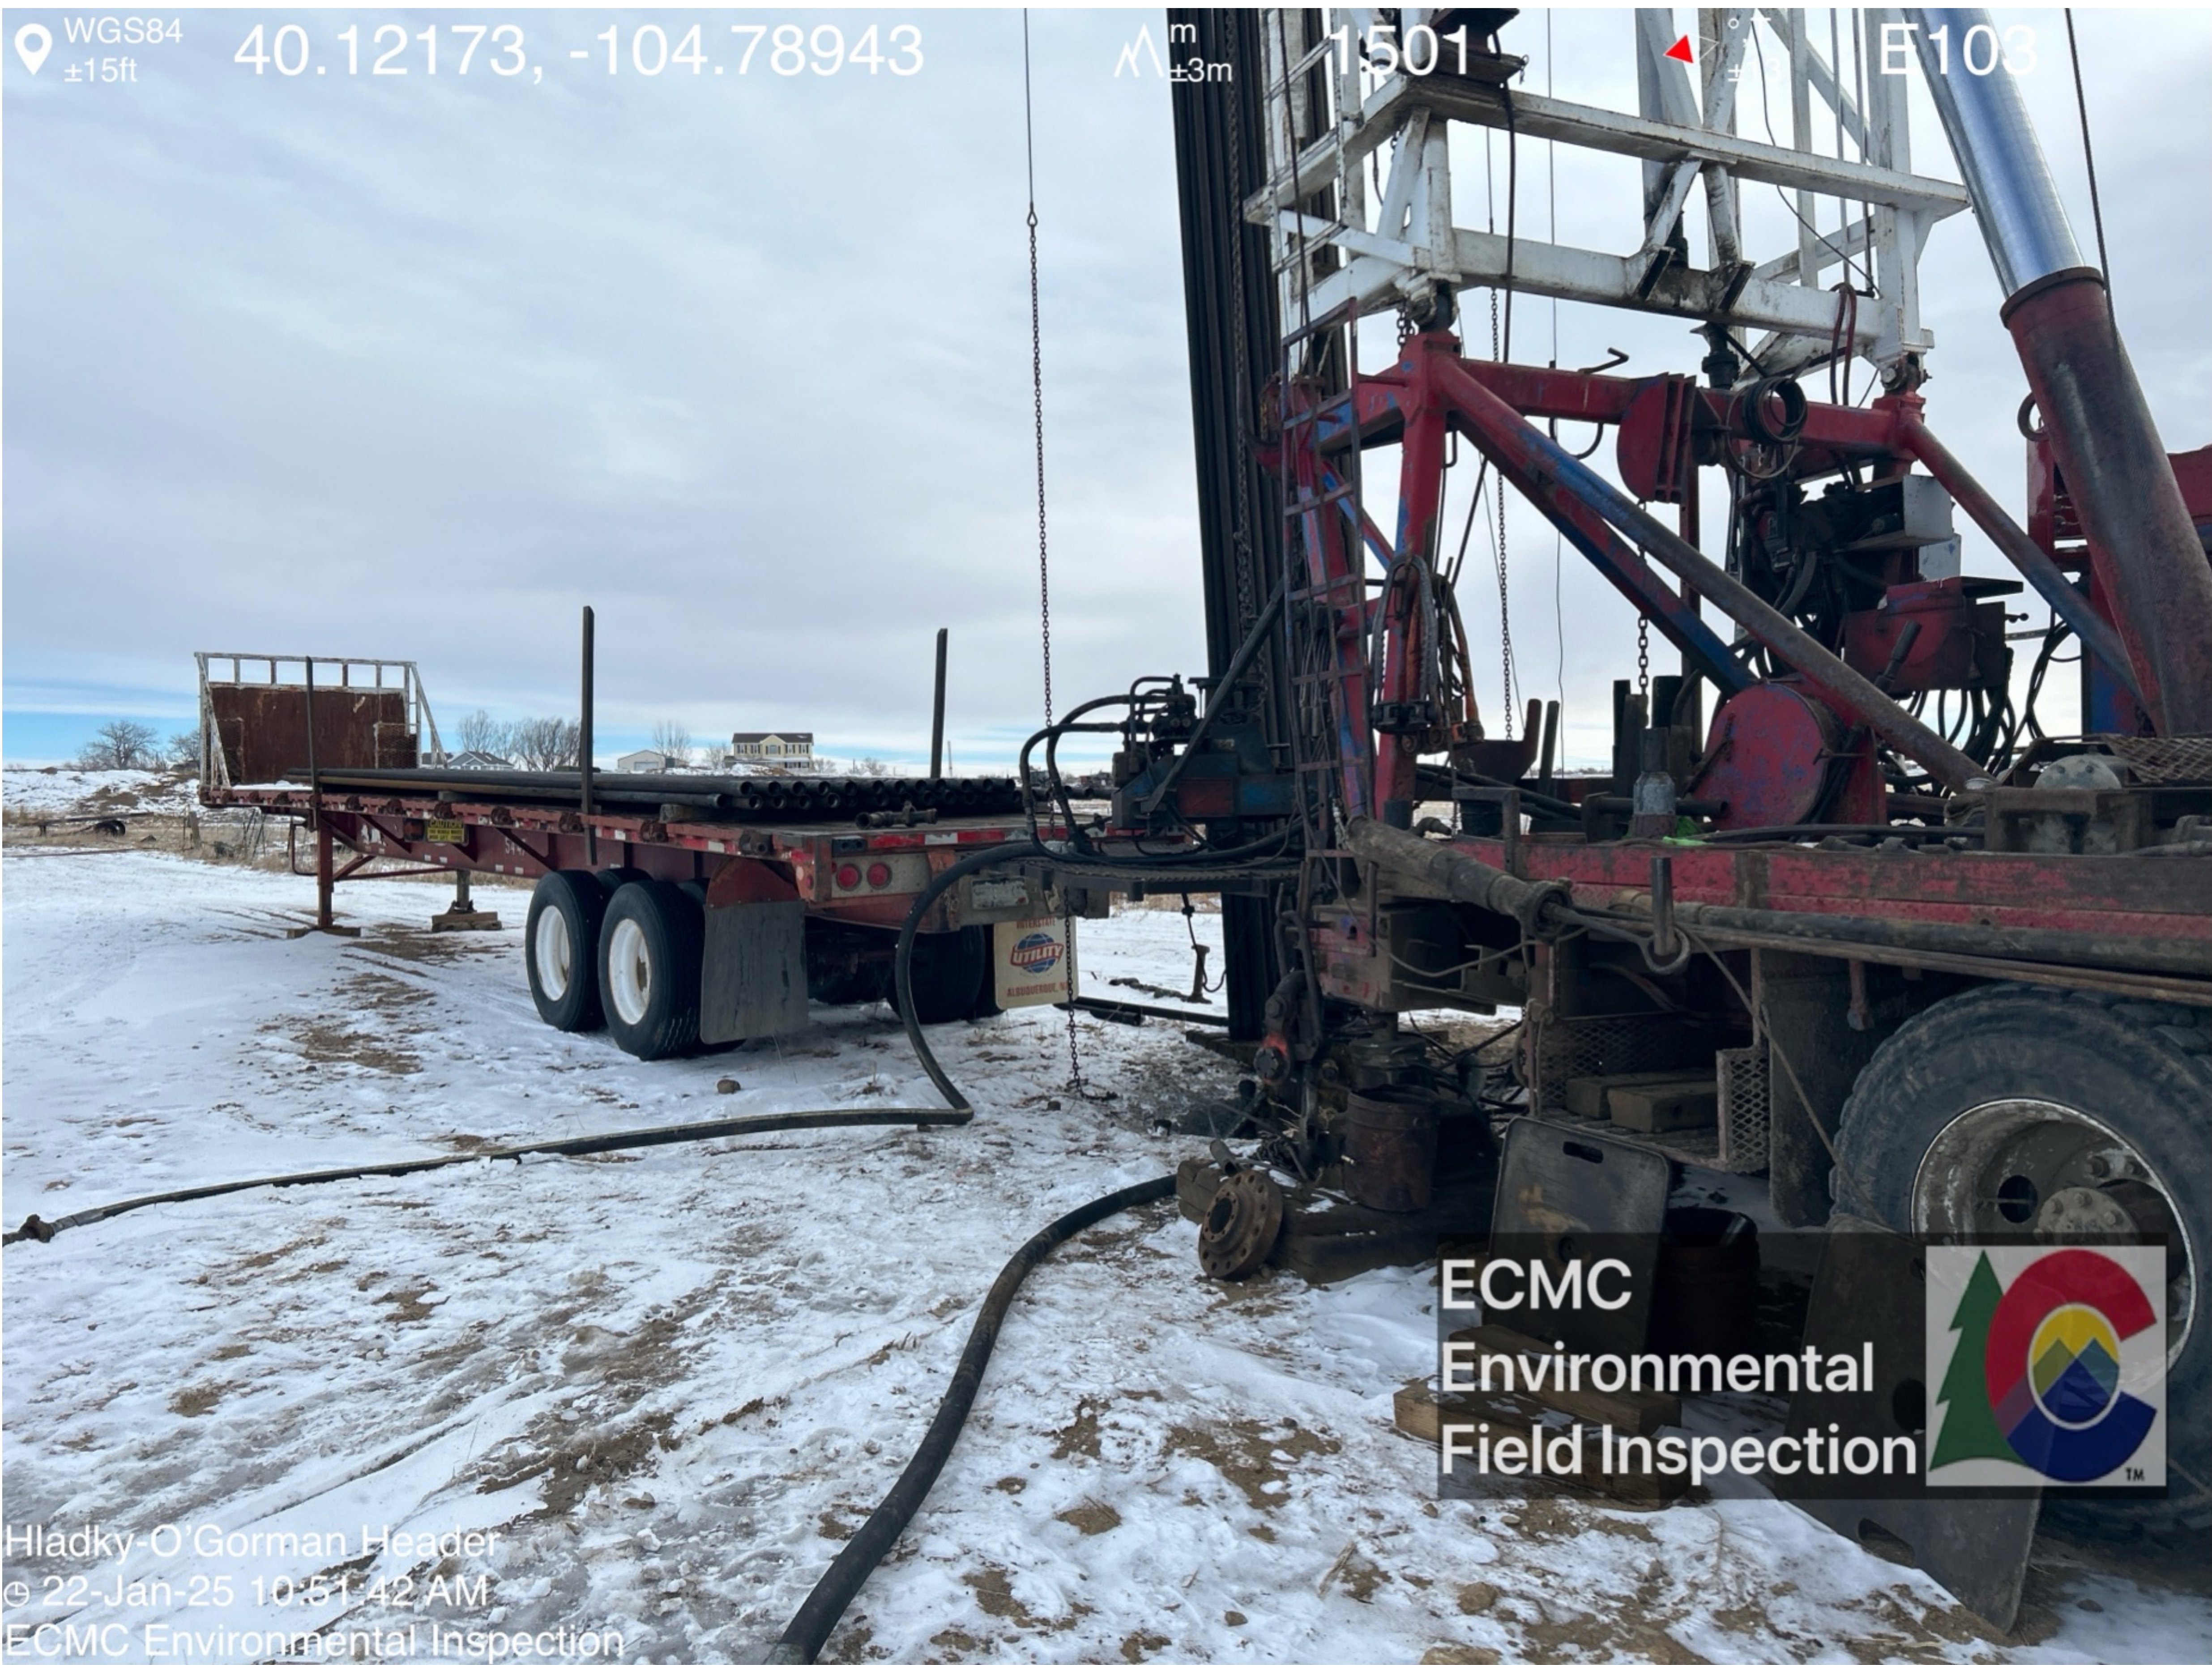
Operator equipment on location for plugging and abandonment activities.

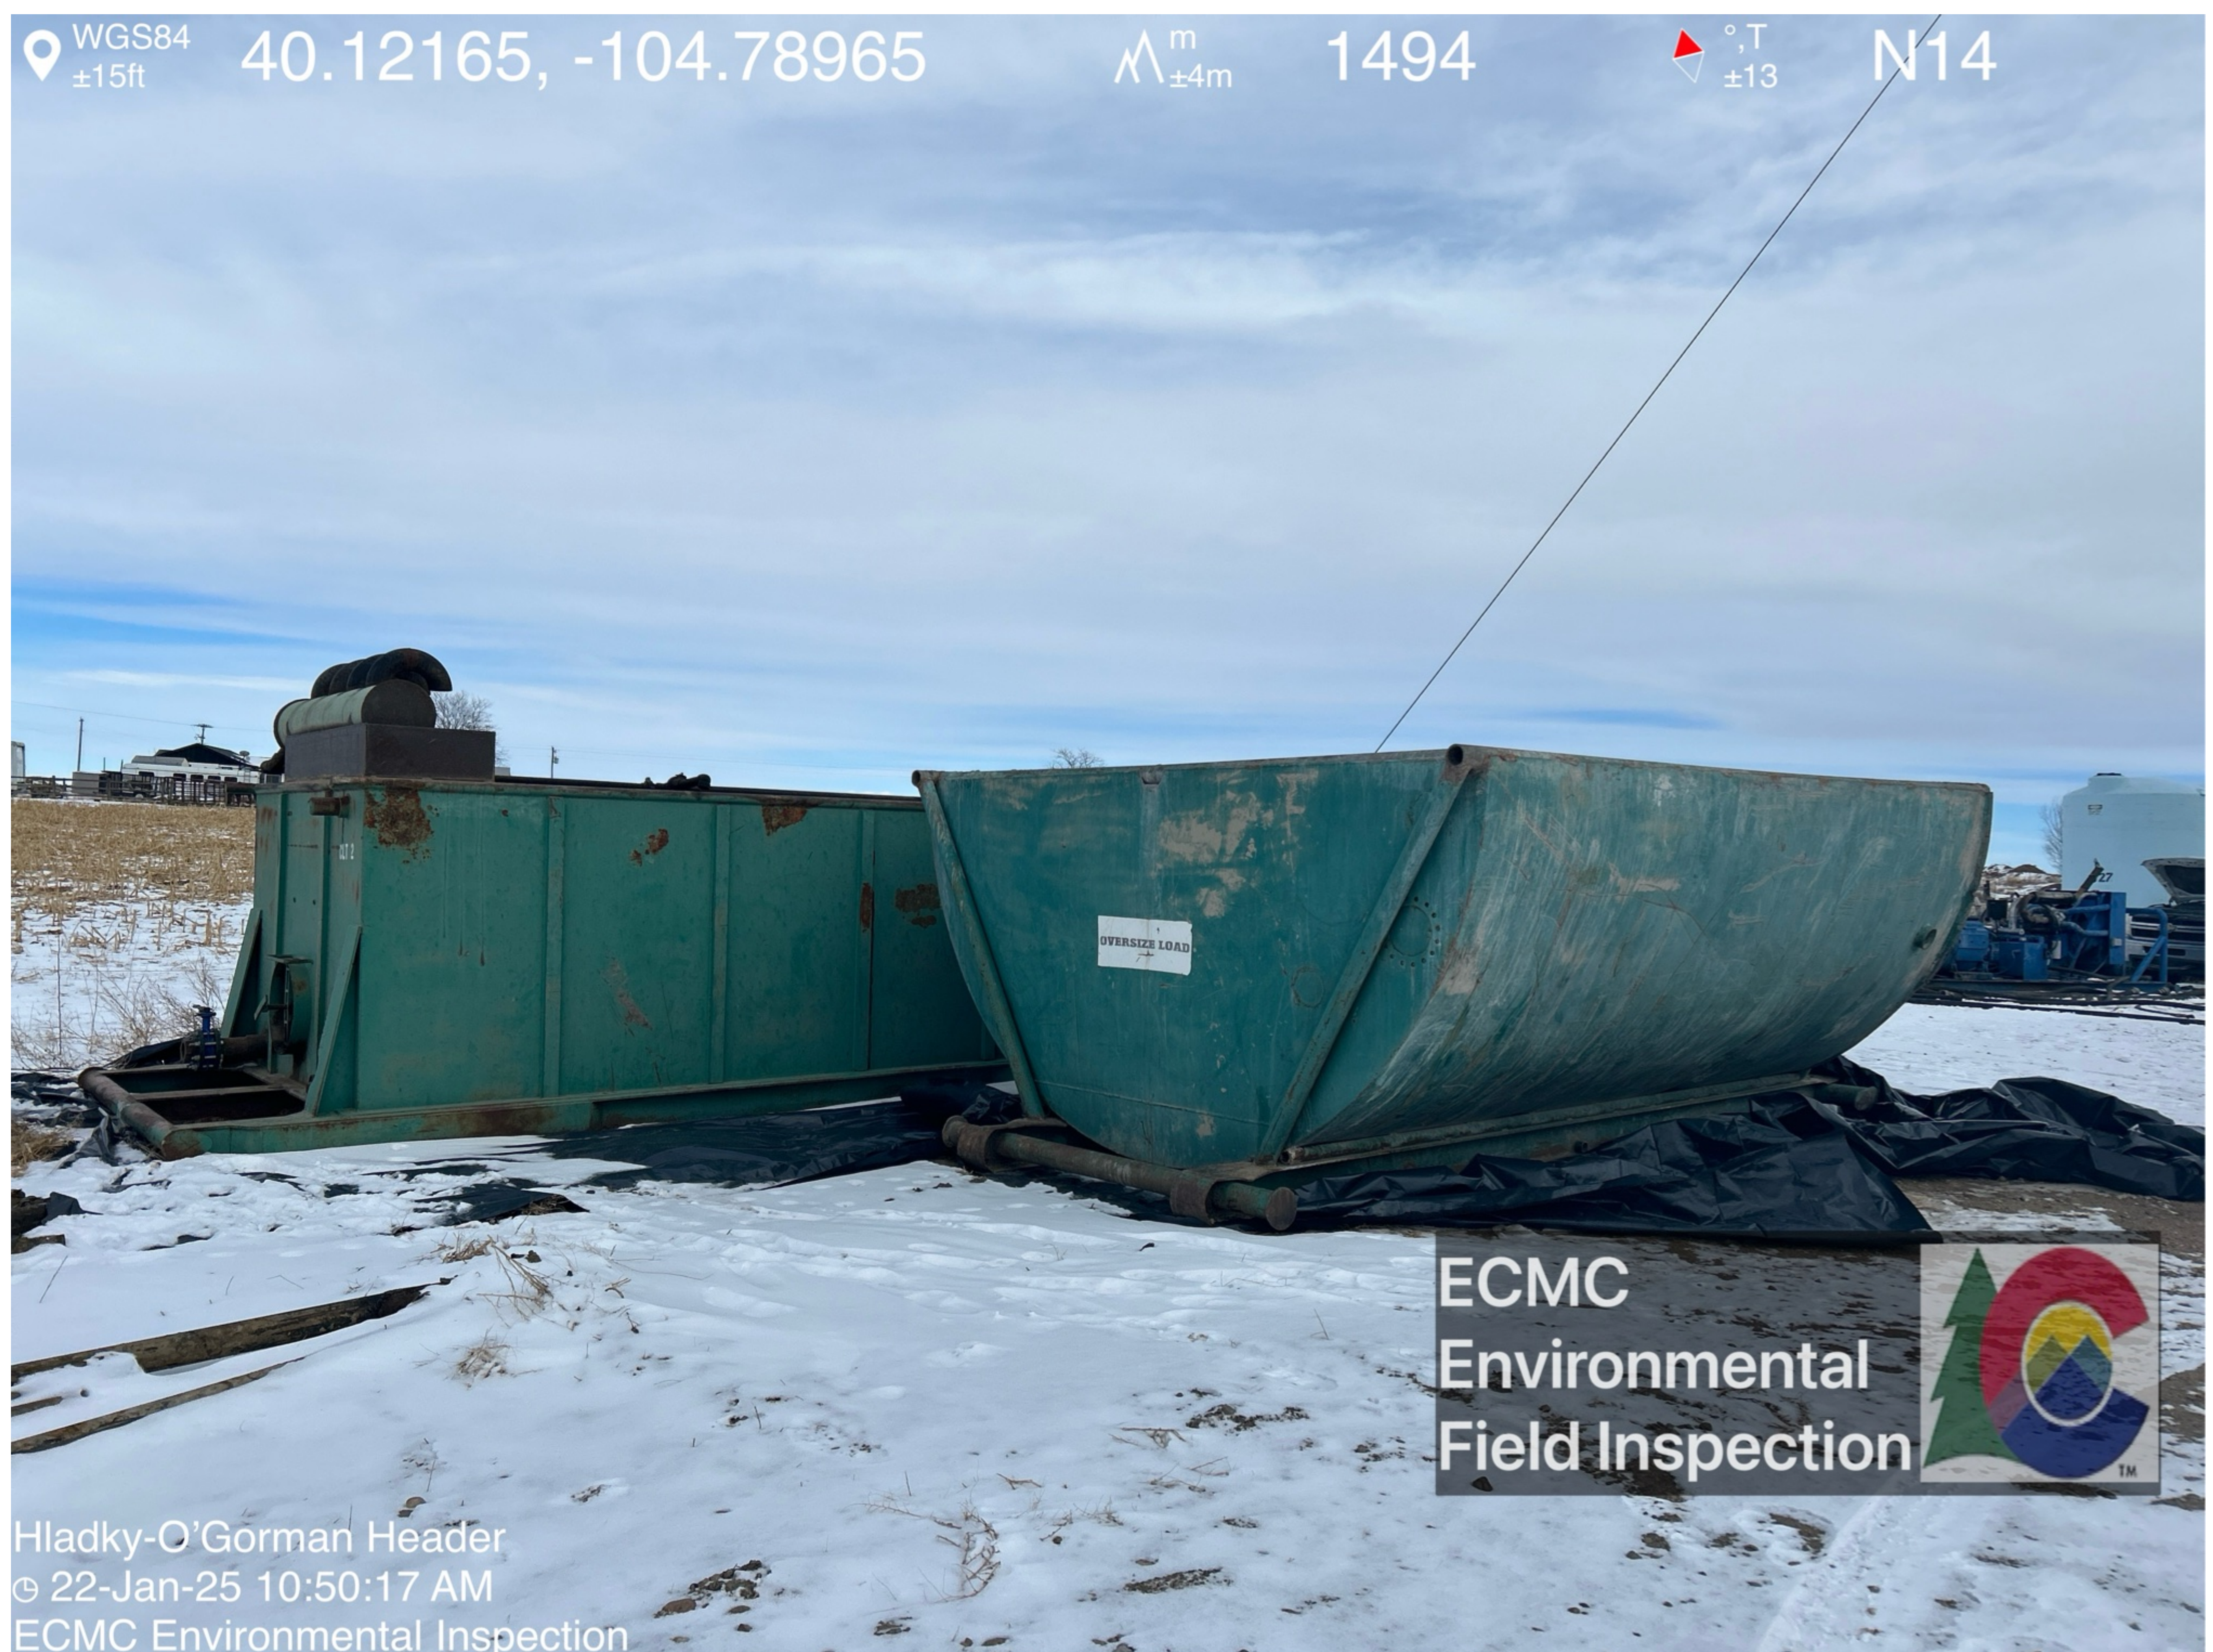
Containers are on site for water and cement for plugging and abandonment activities, per Operator personnel.

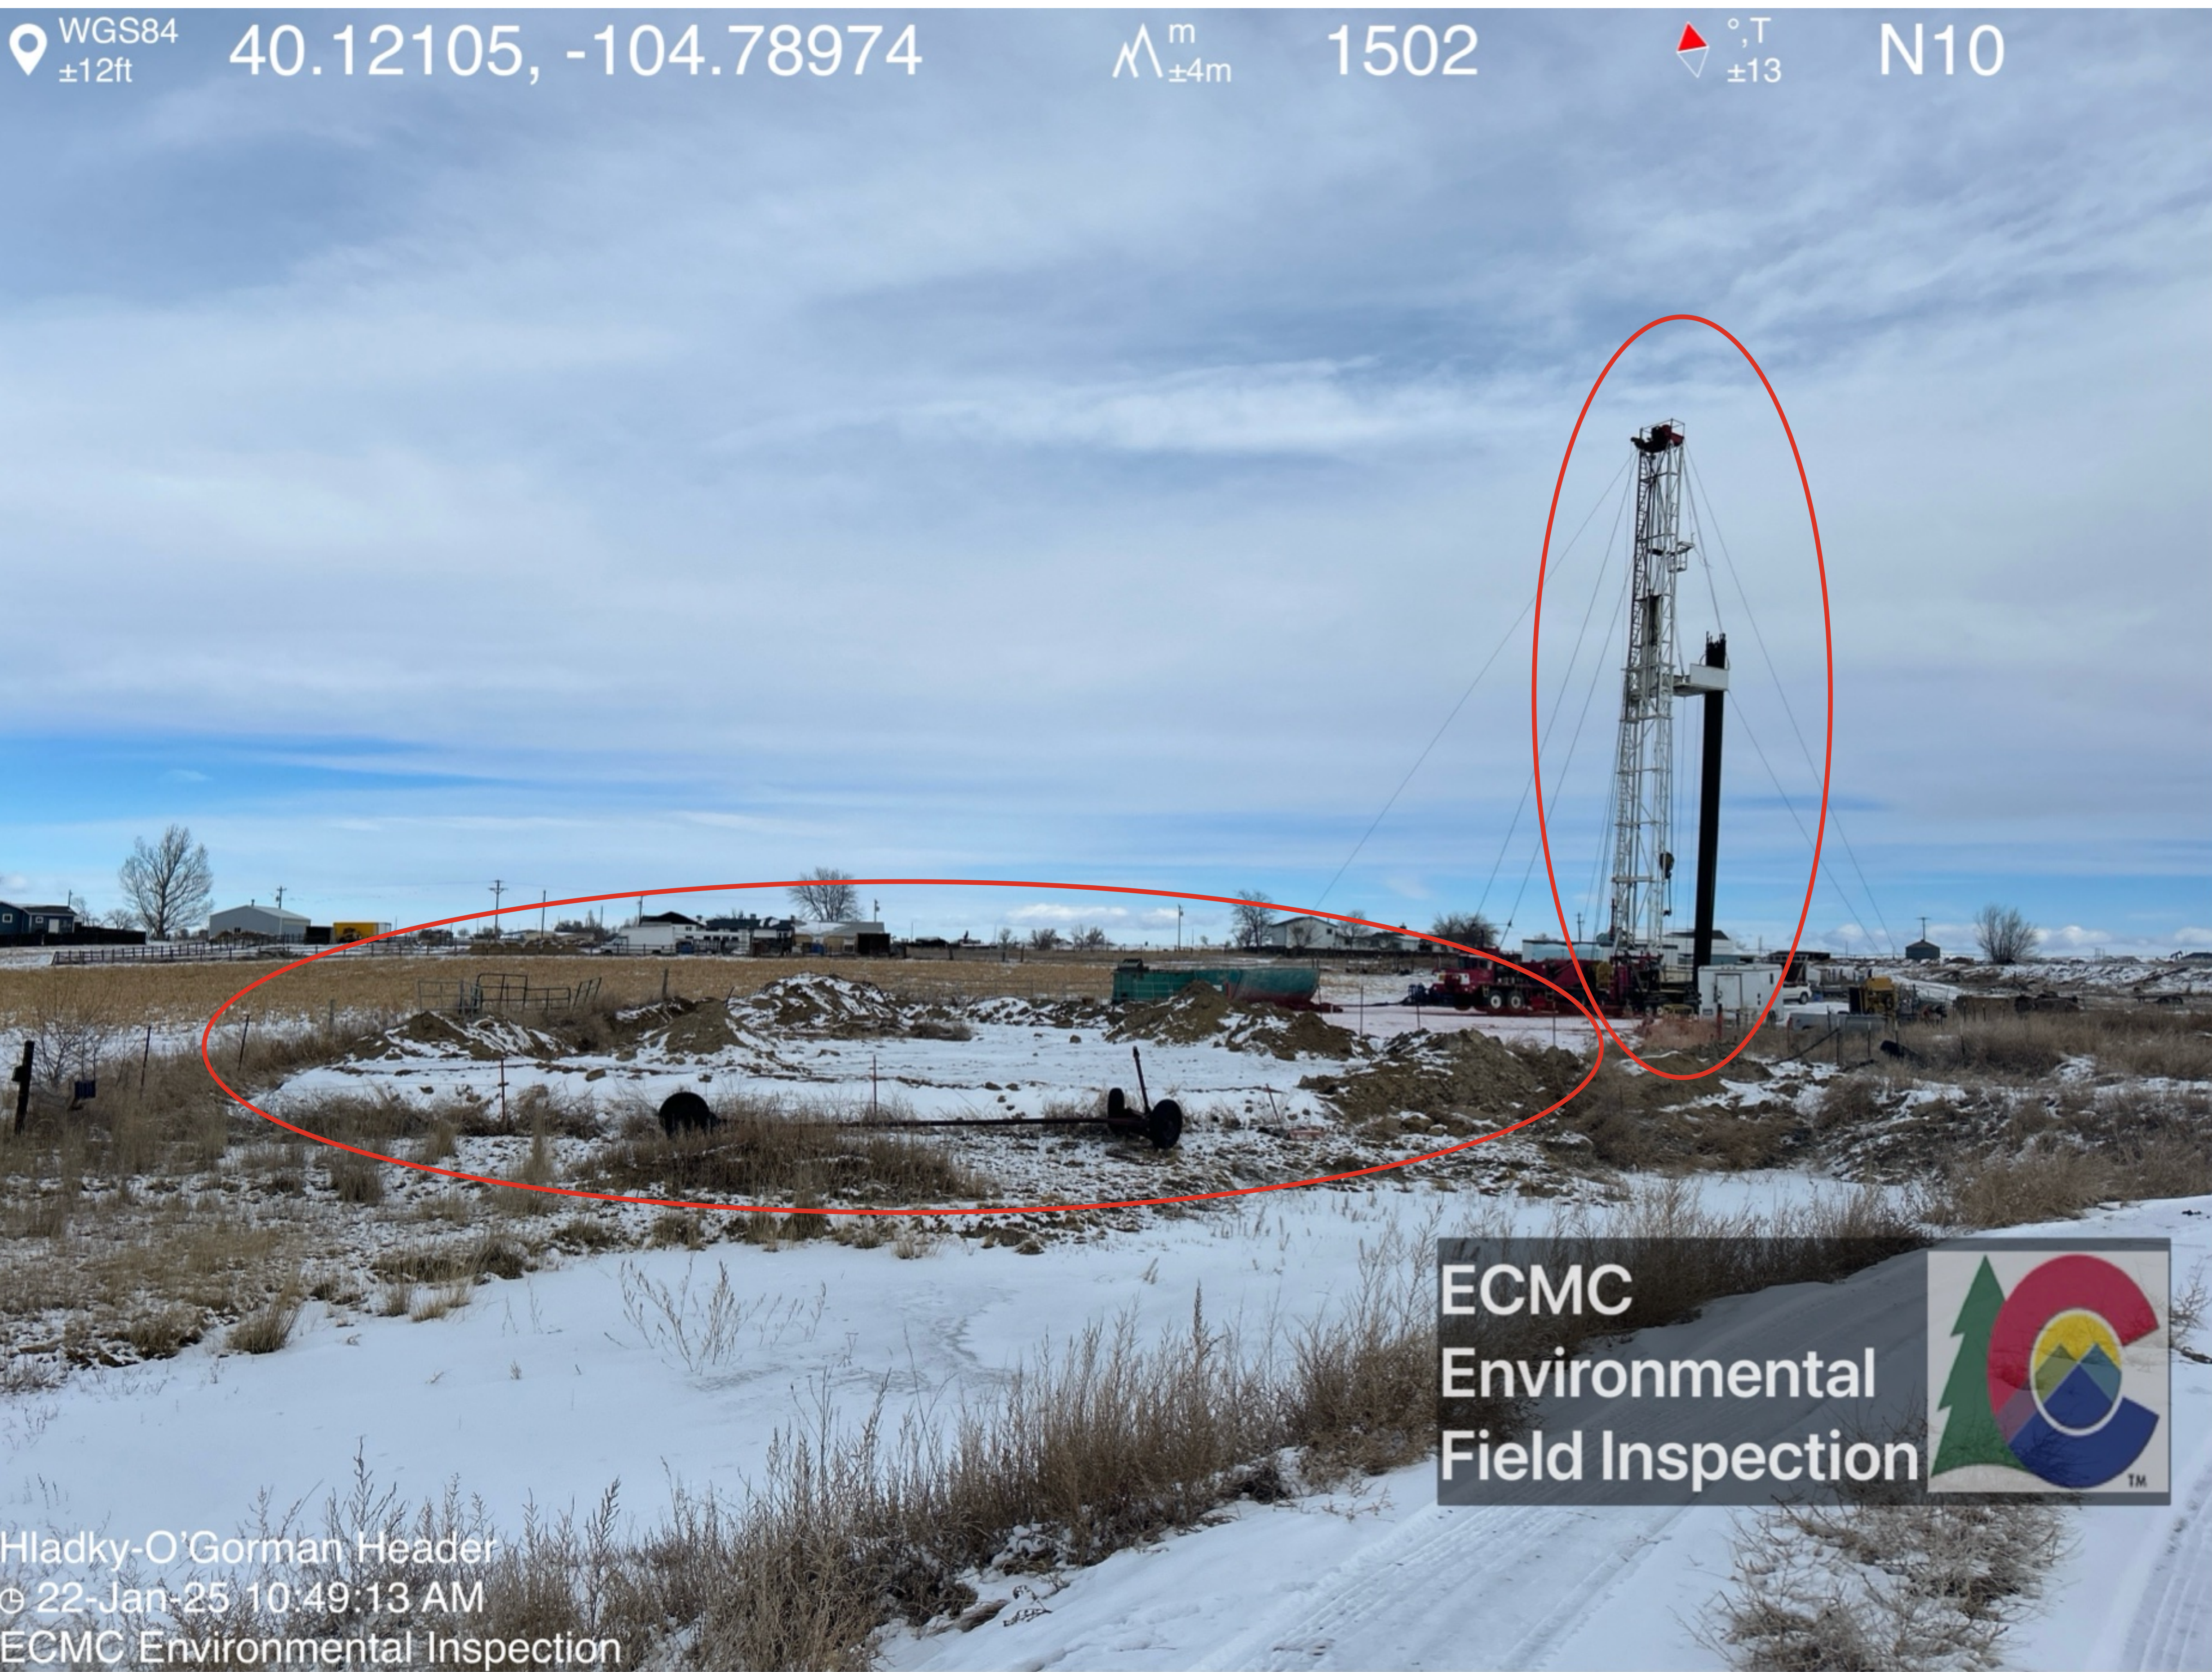
Excavation in foreground; plugging and abandonment rig in background.
