Hladky O'Gorman 3 Well (API # 05-123-07775)

Hladky-O'Gorman Header  
© 22-Jan-25 10:49:13 AM  
ECMC Environmental Inspection

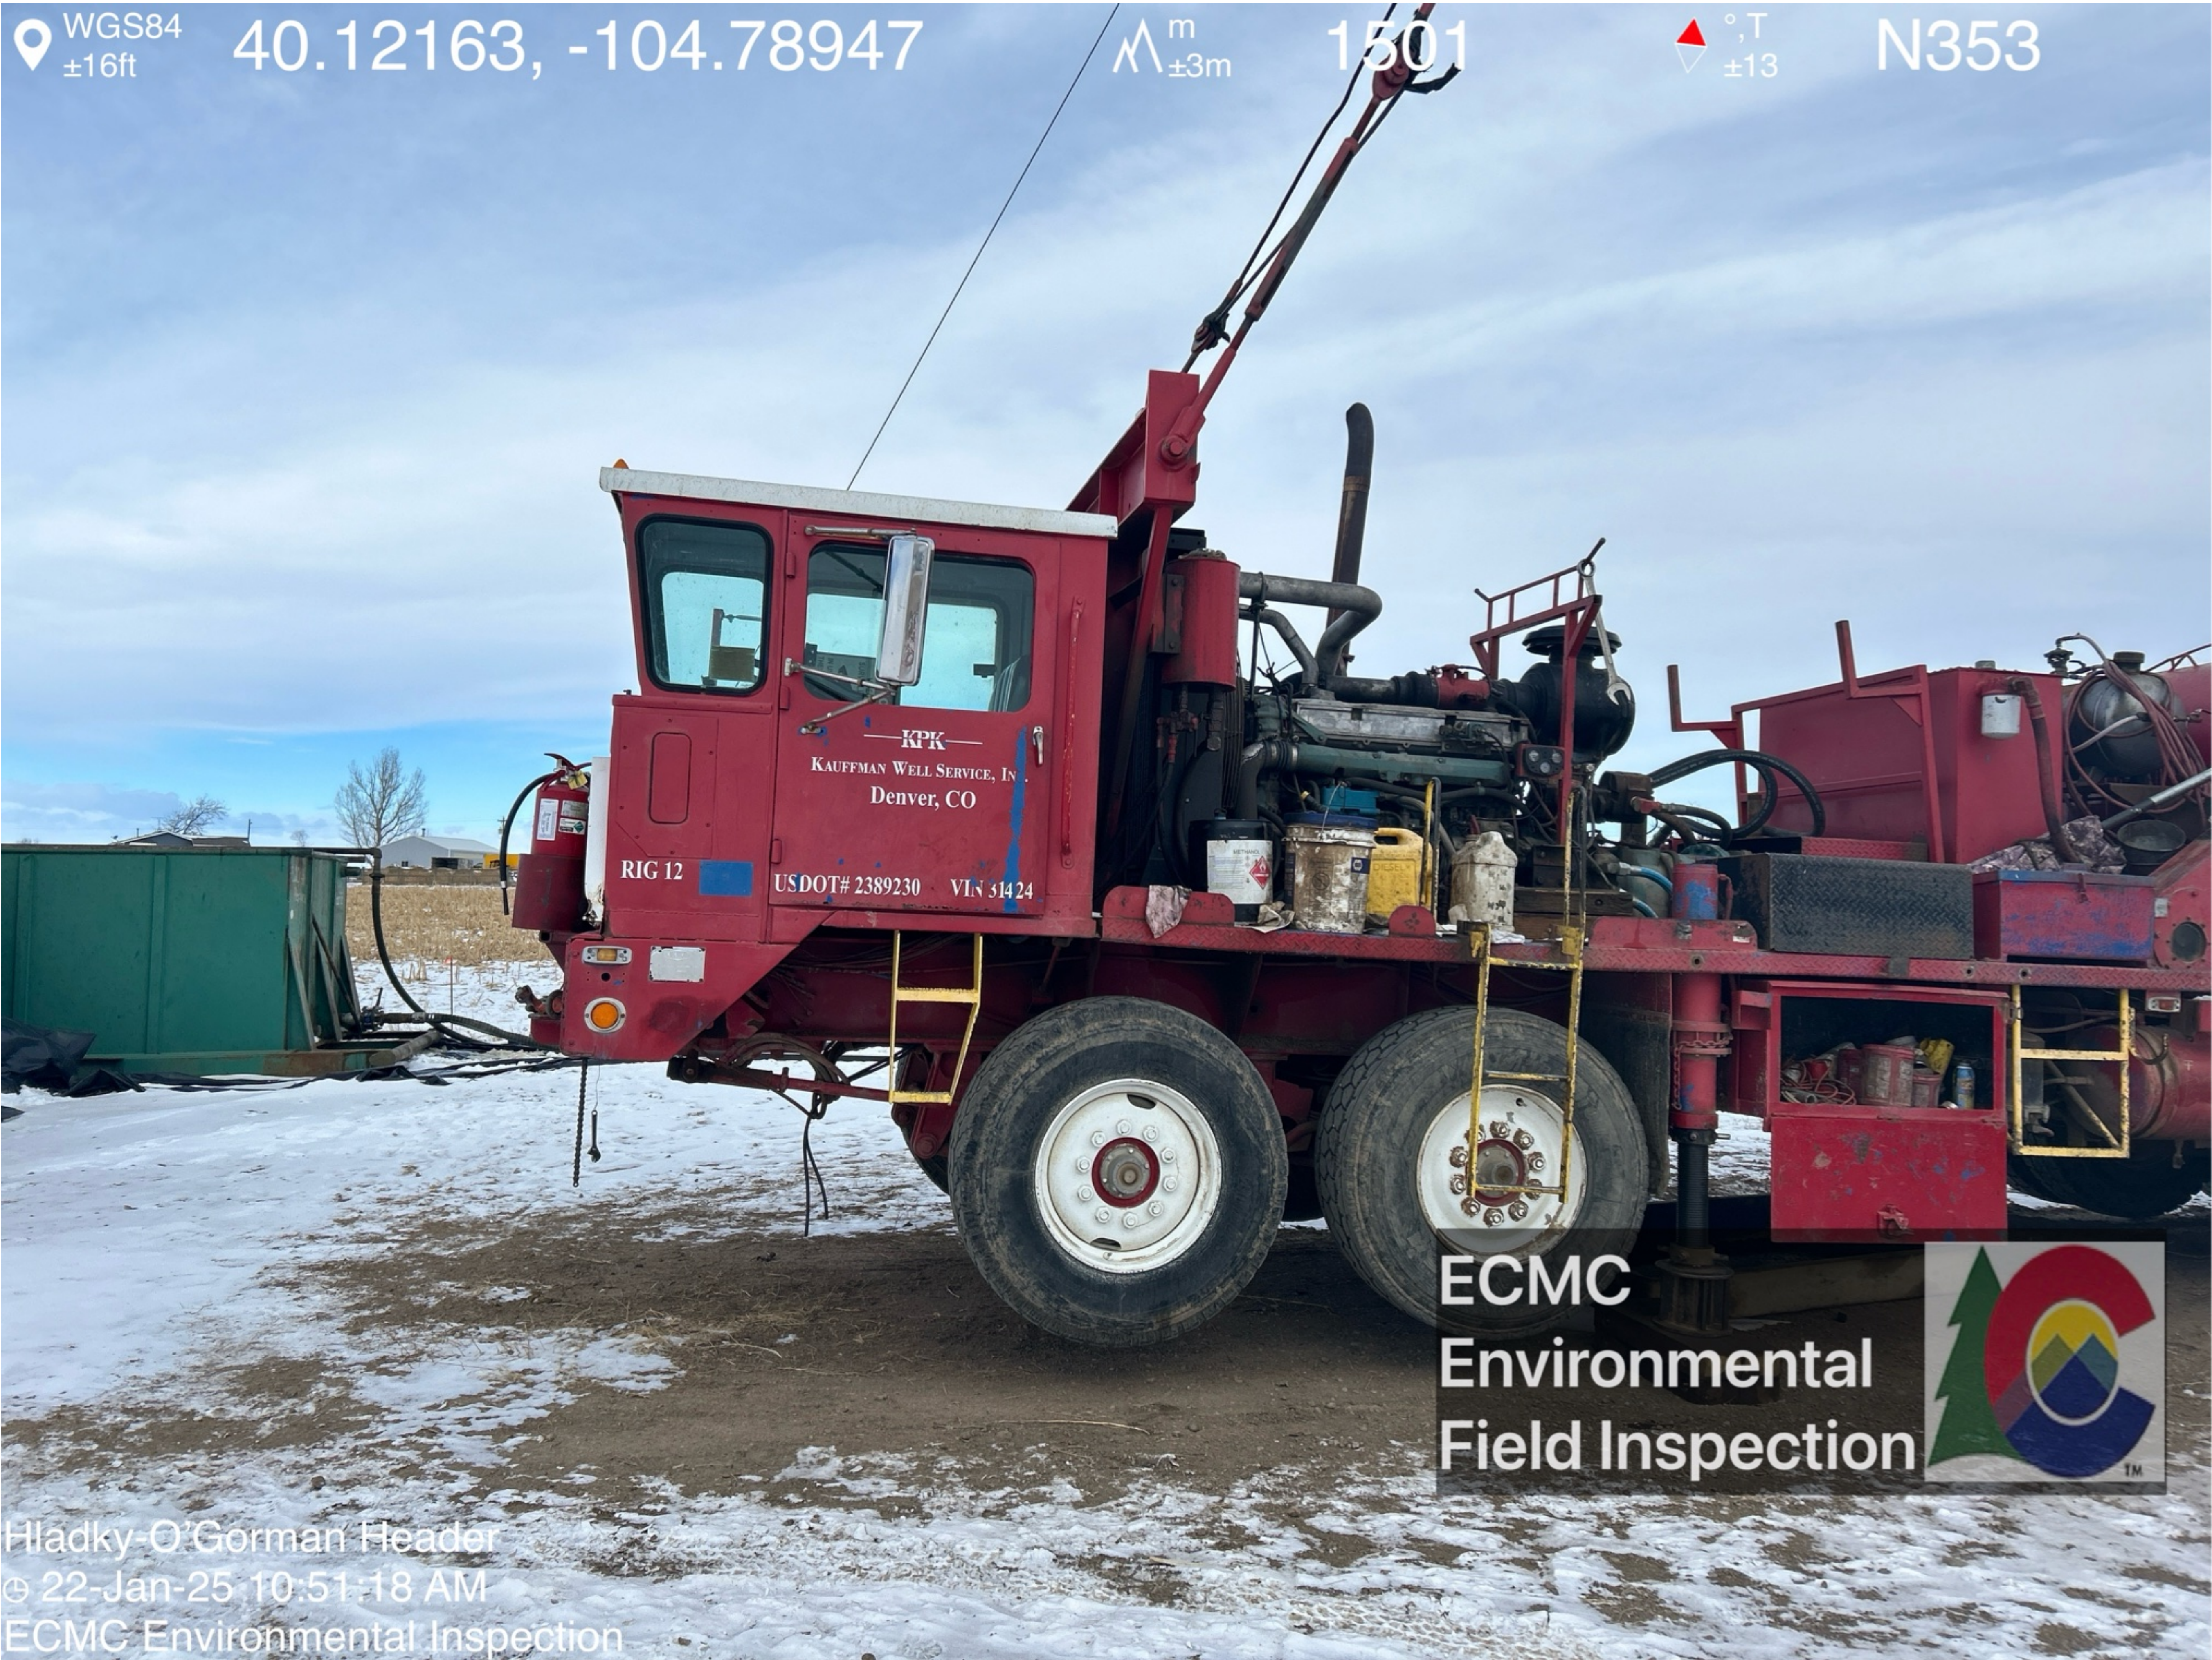
Operator rig on location for plugging and abandonment activities..

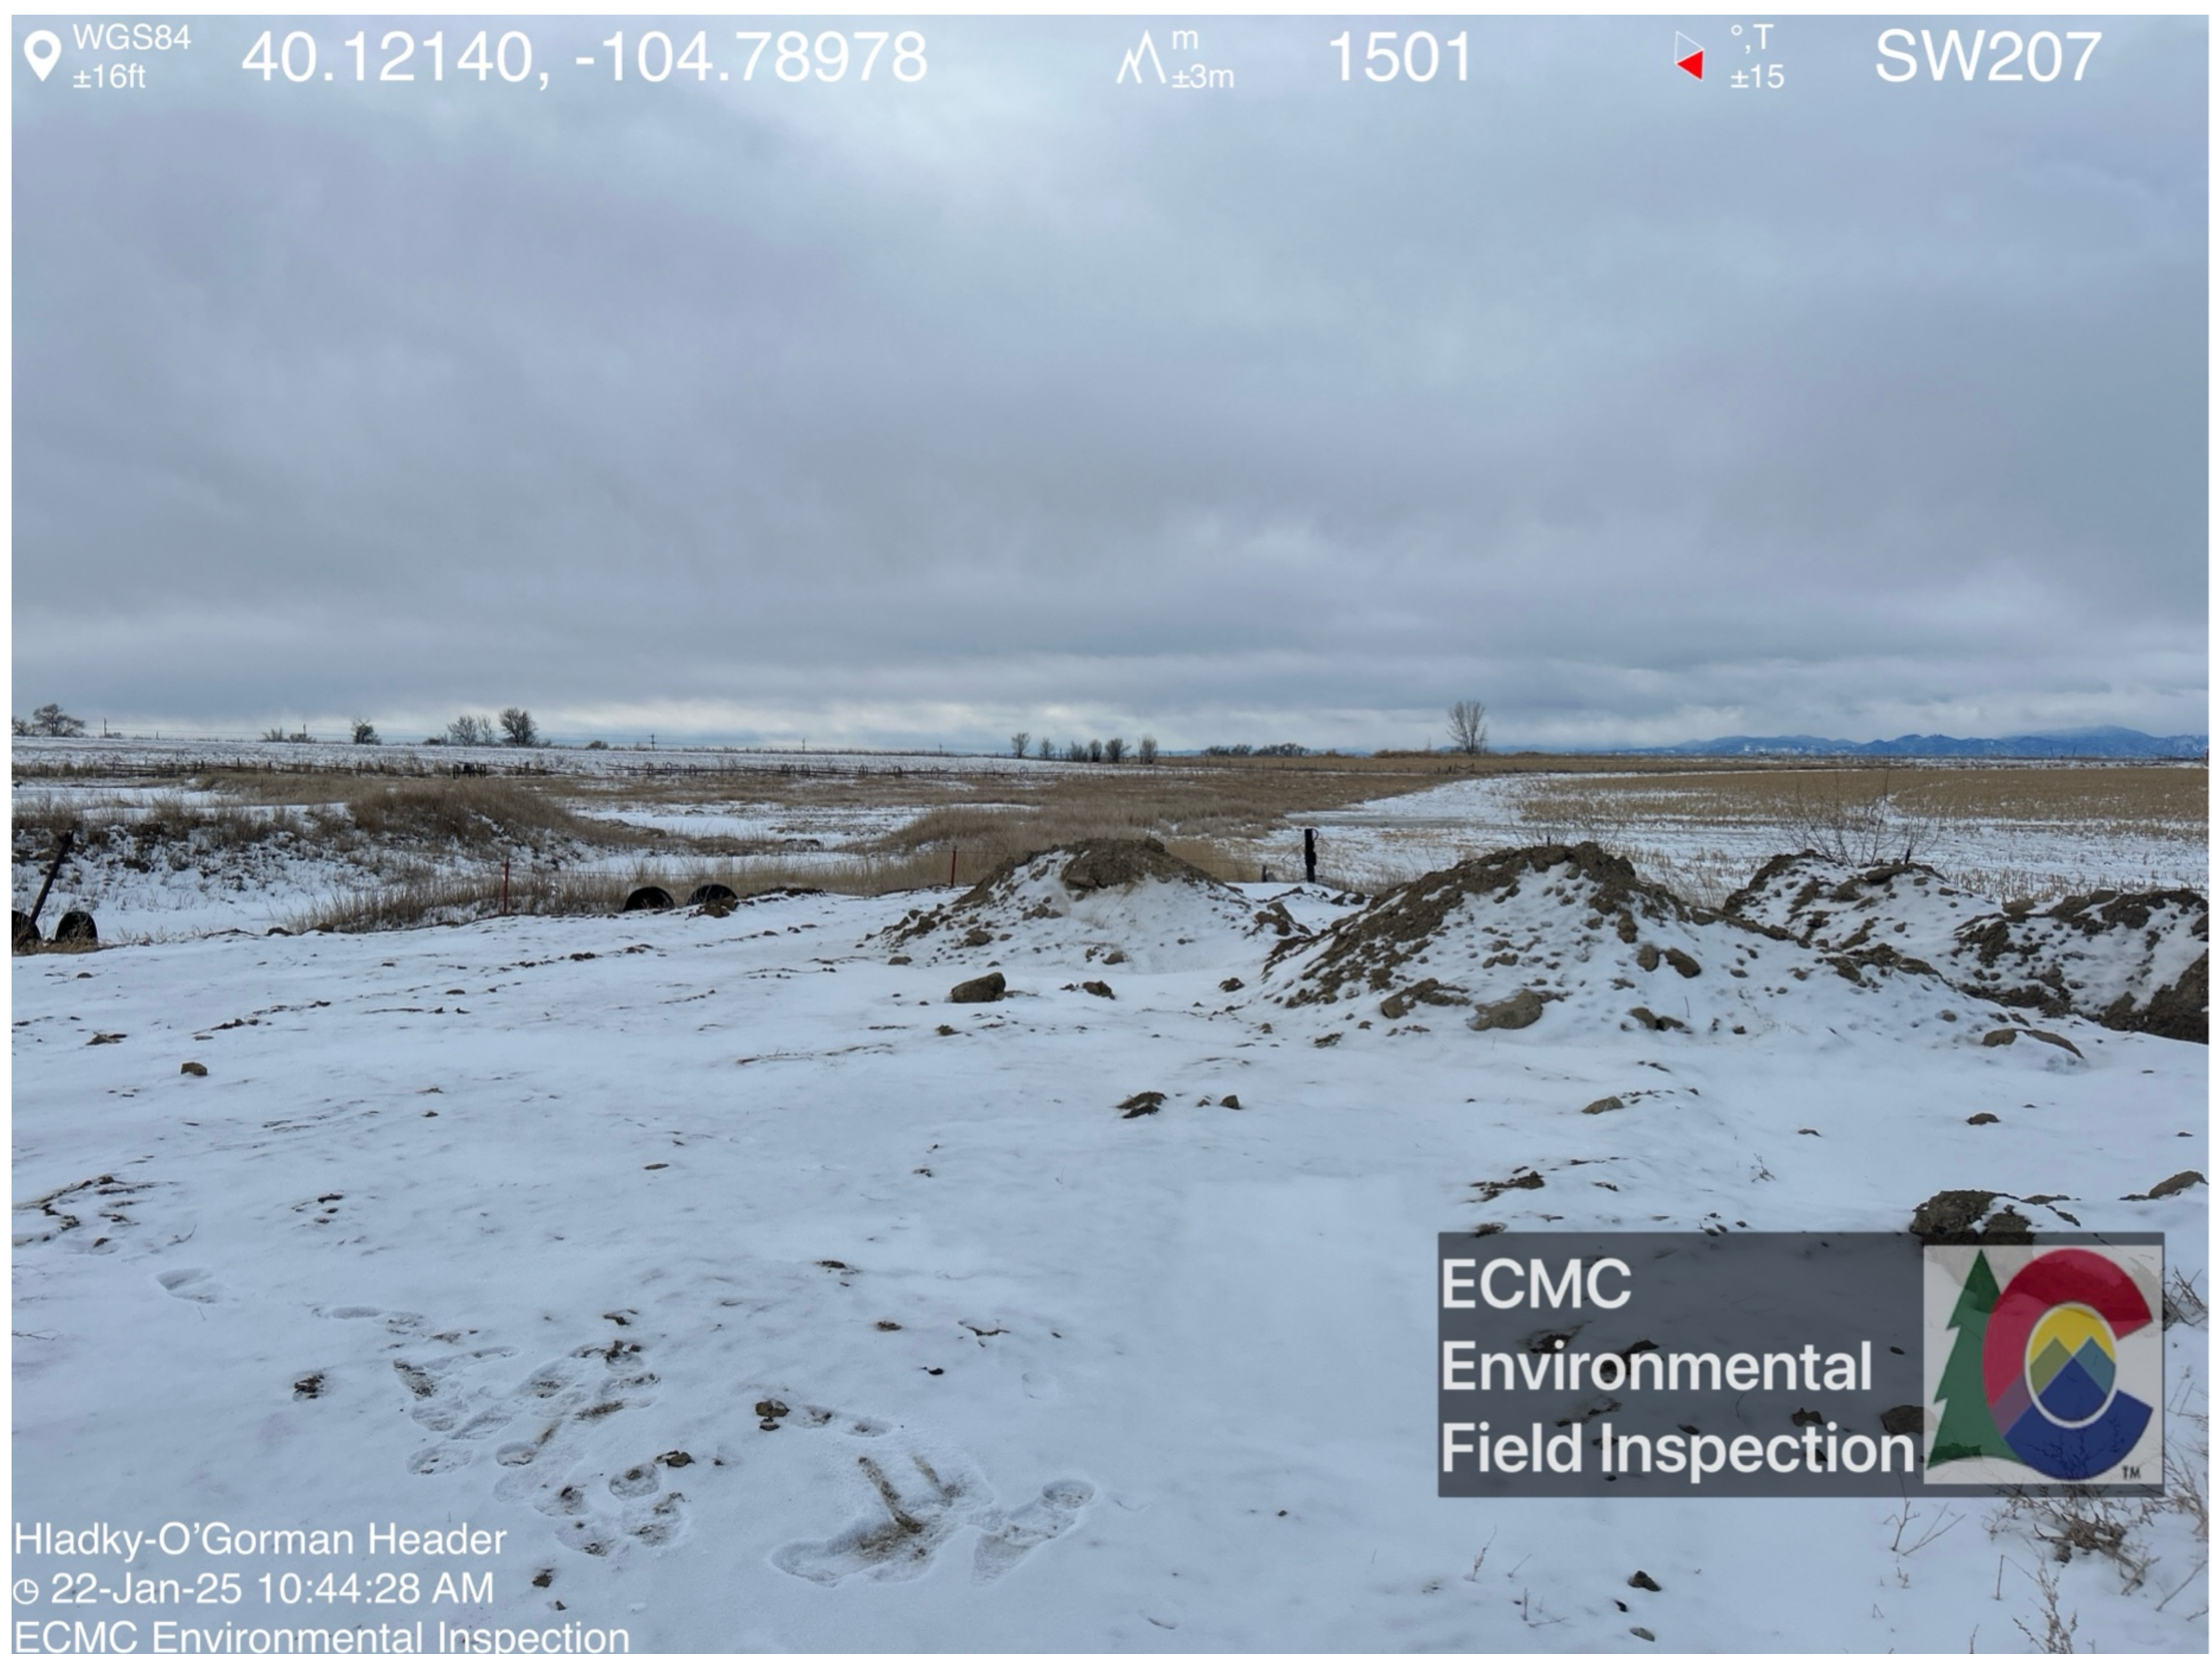
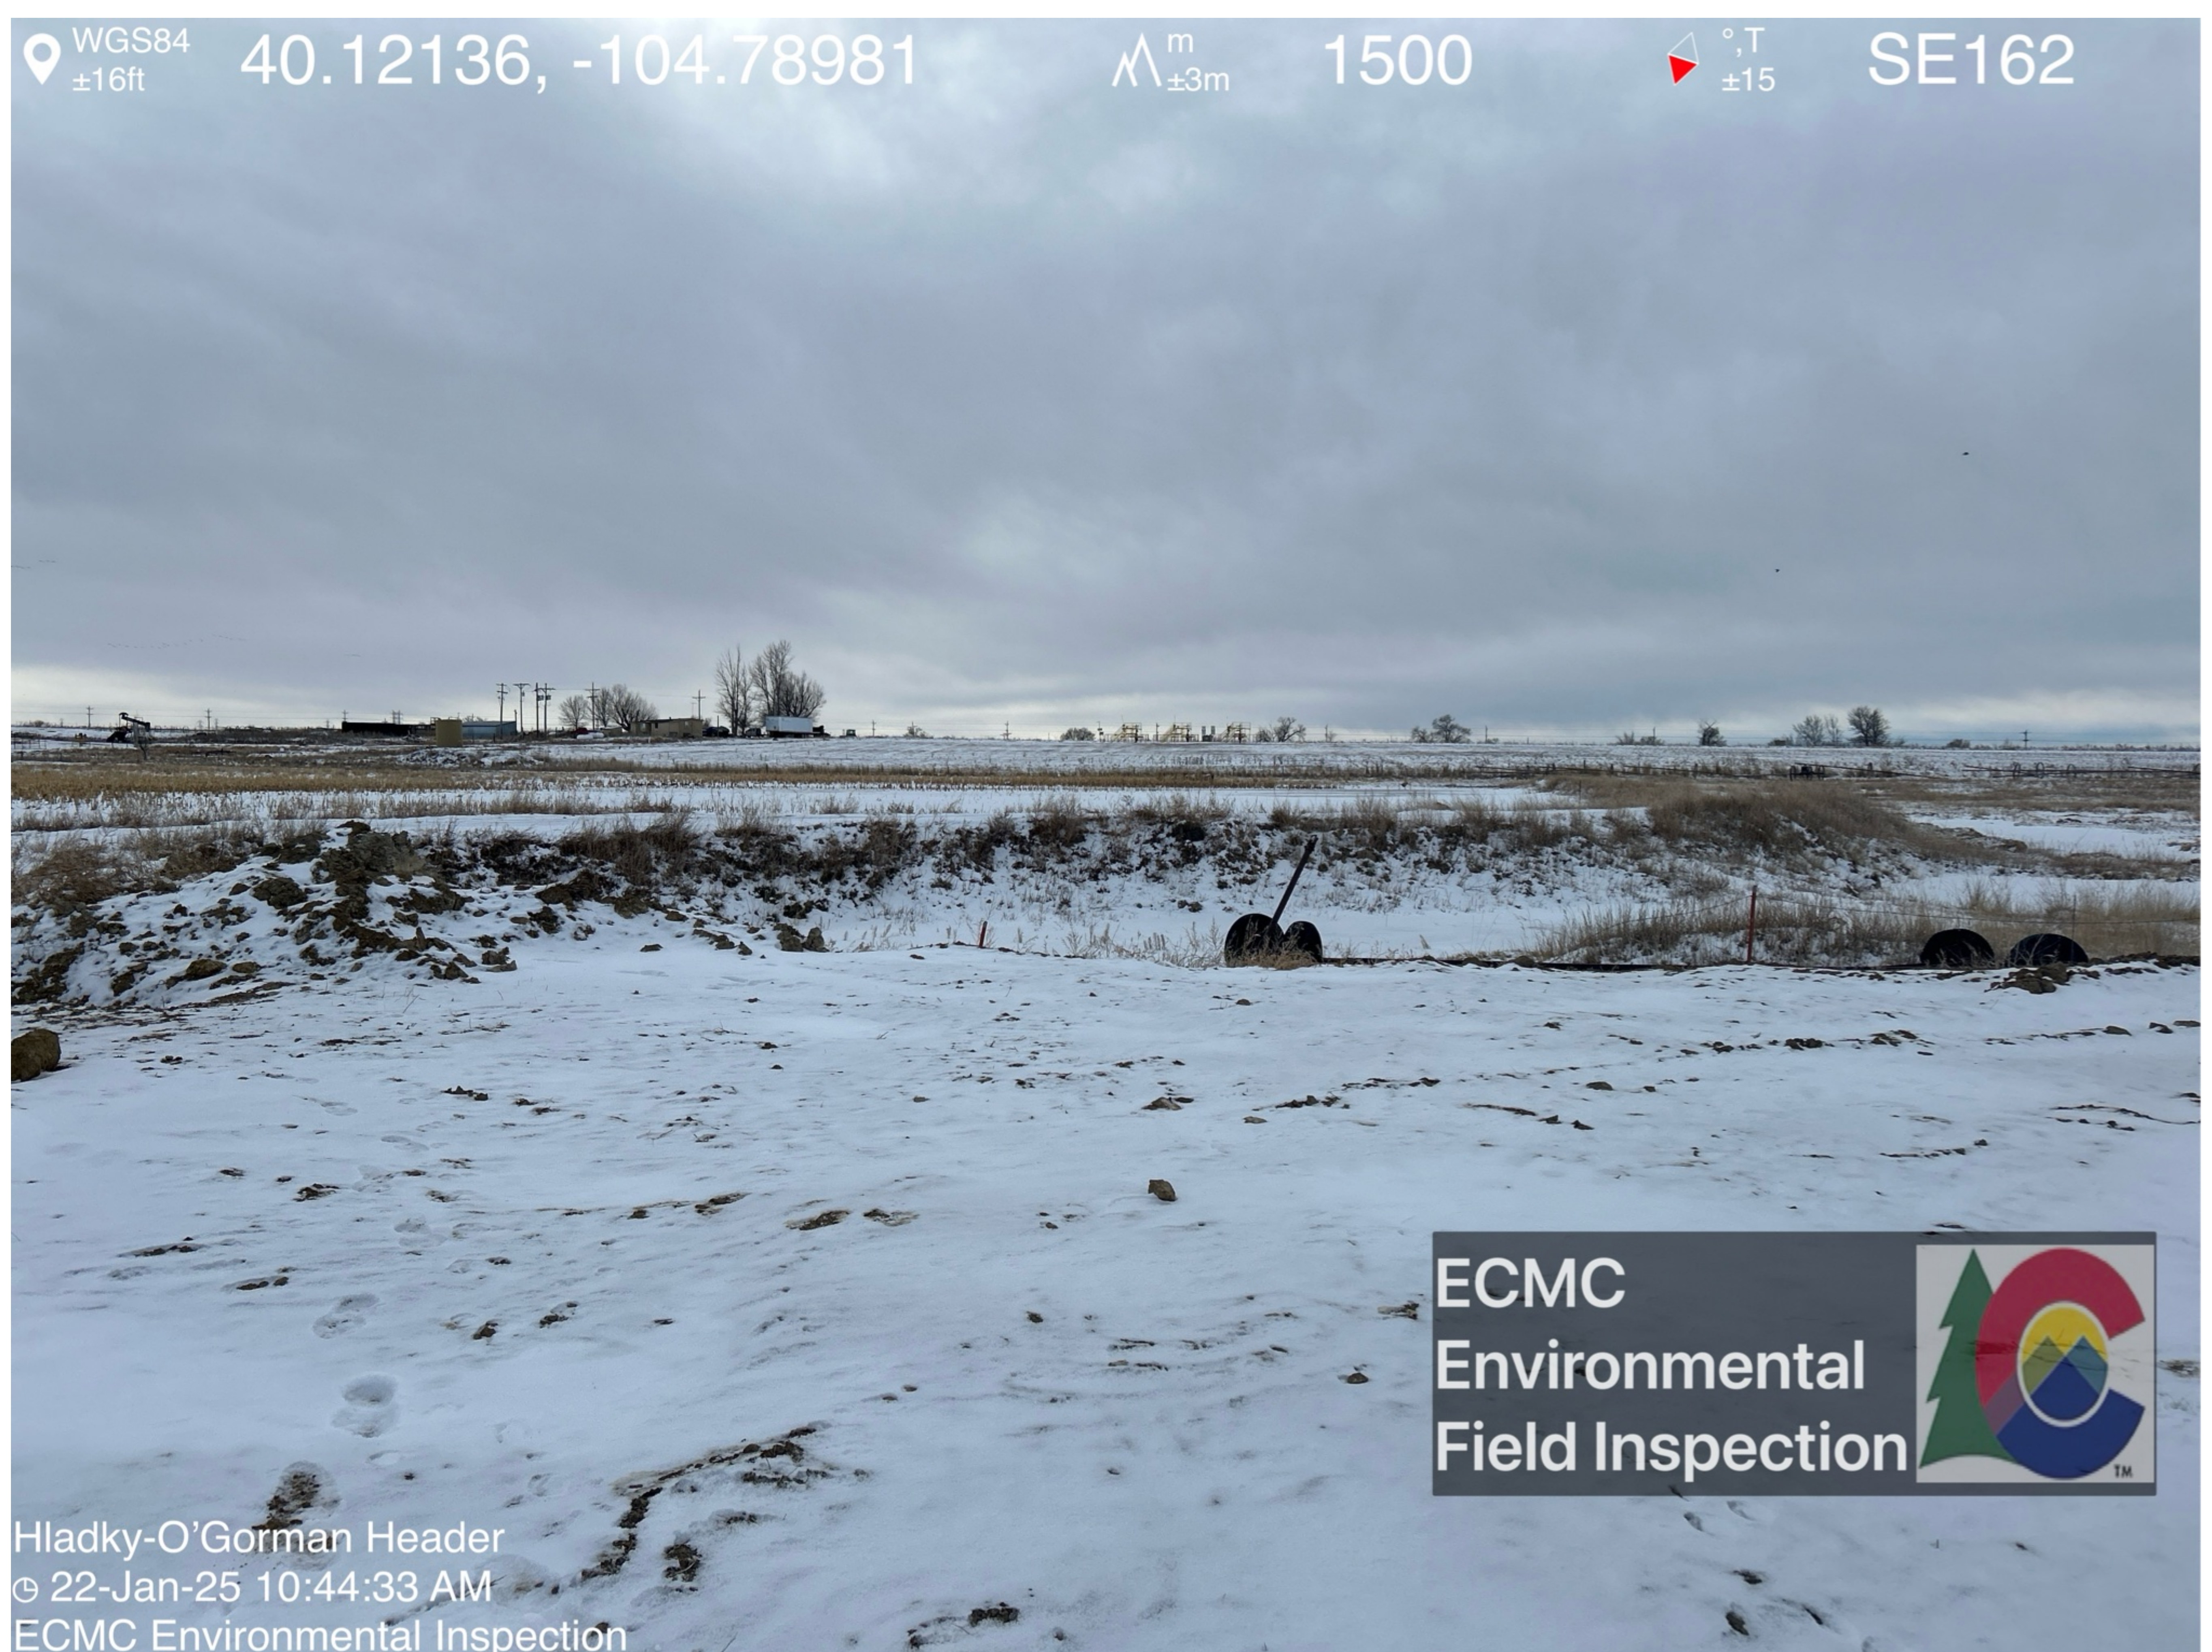
Southern and western portions of the excavation are unsecured. Multiple unmarked soil stockpiles are present on location with no BMPs.

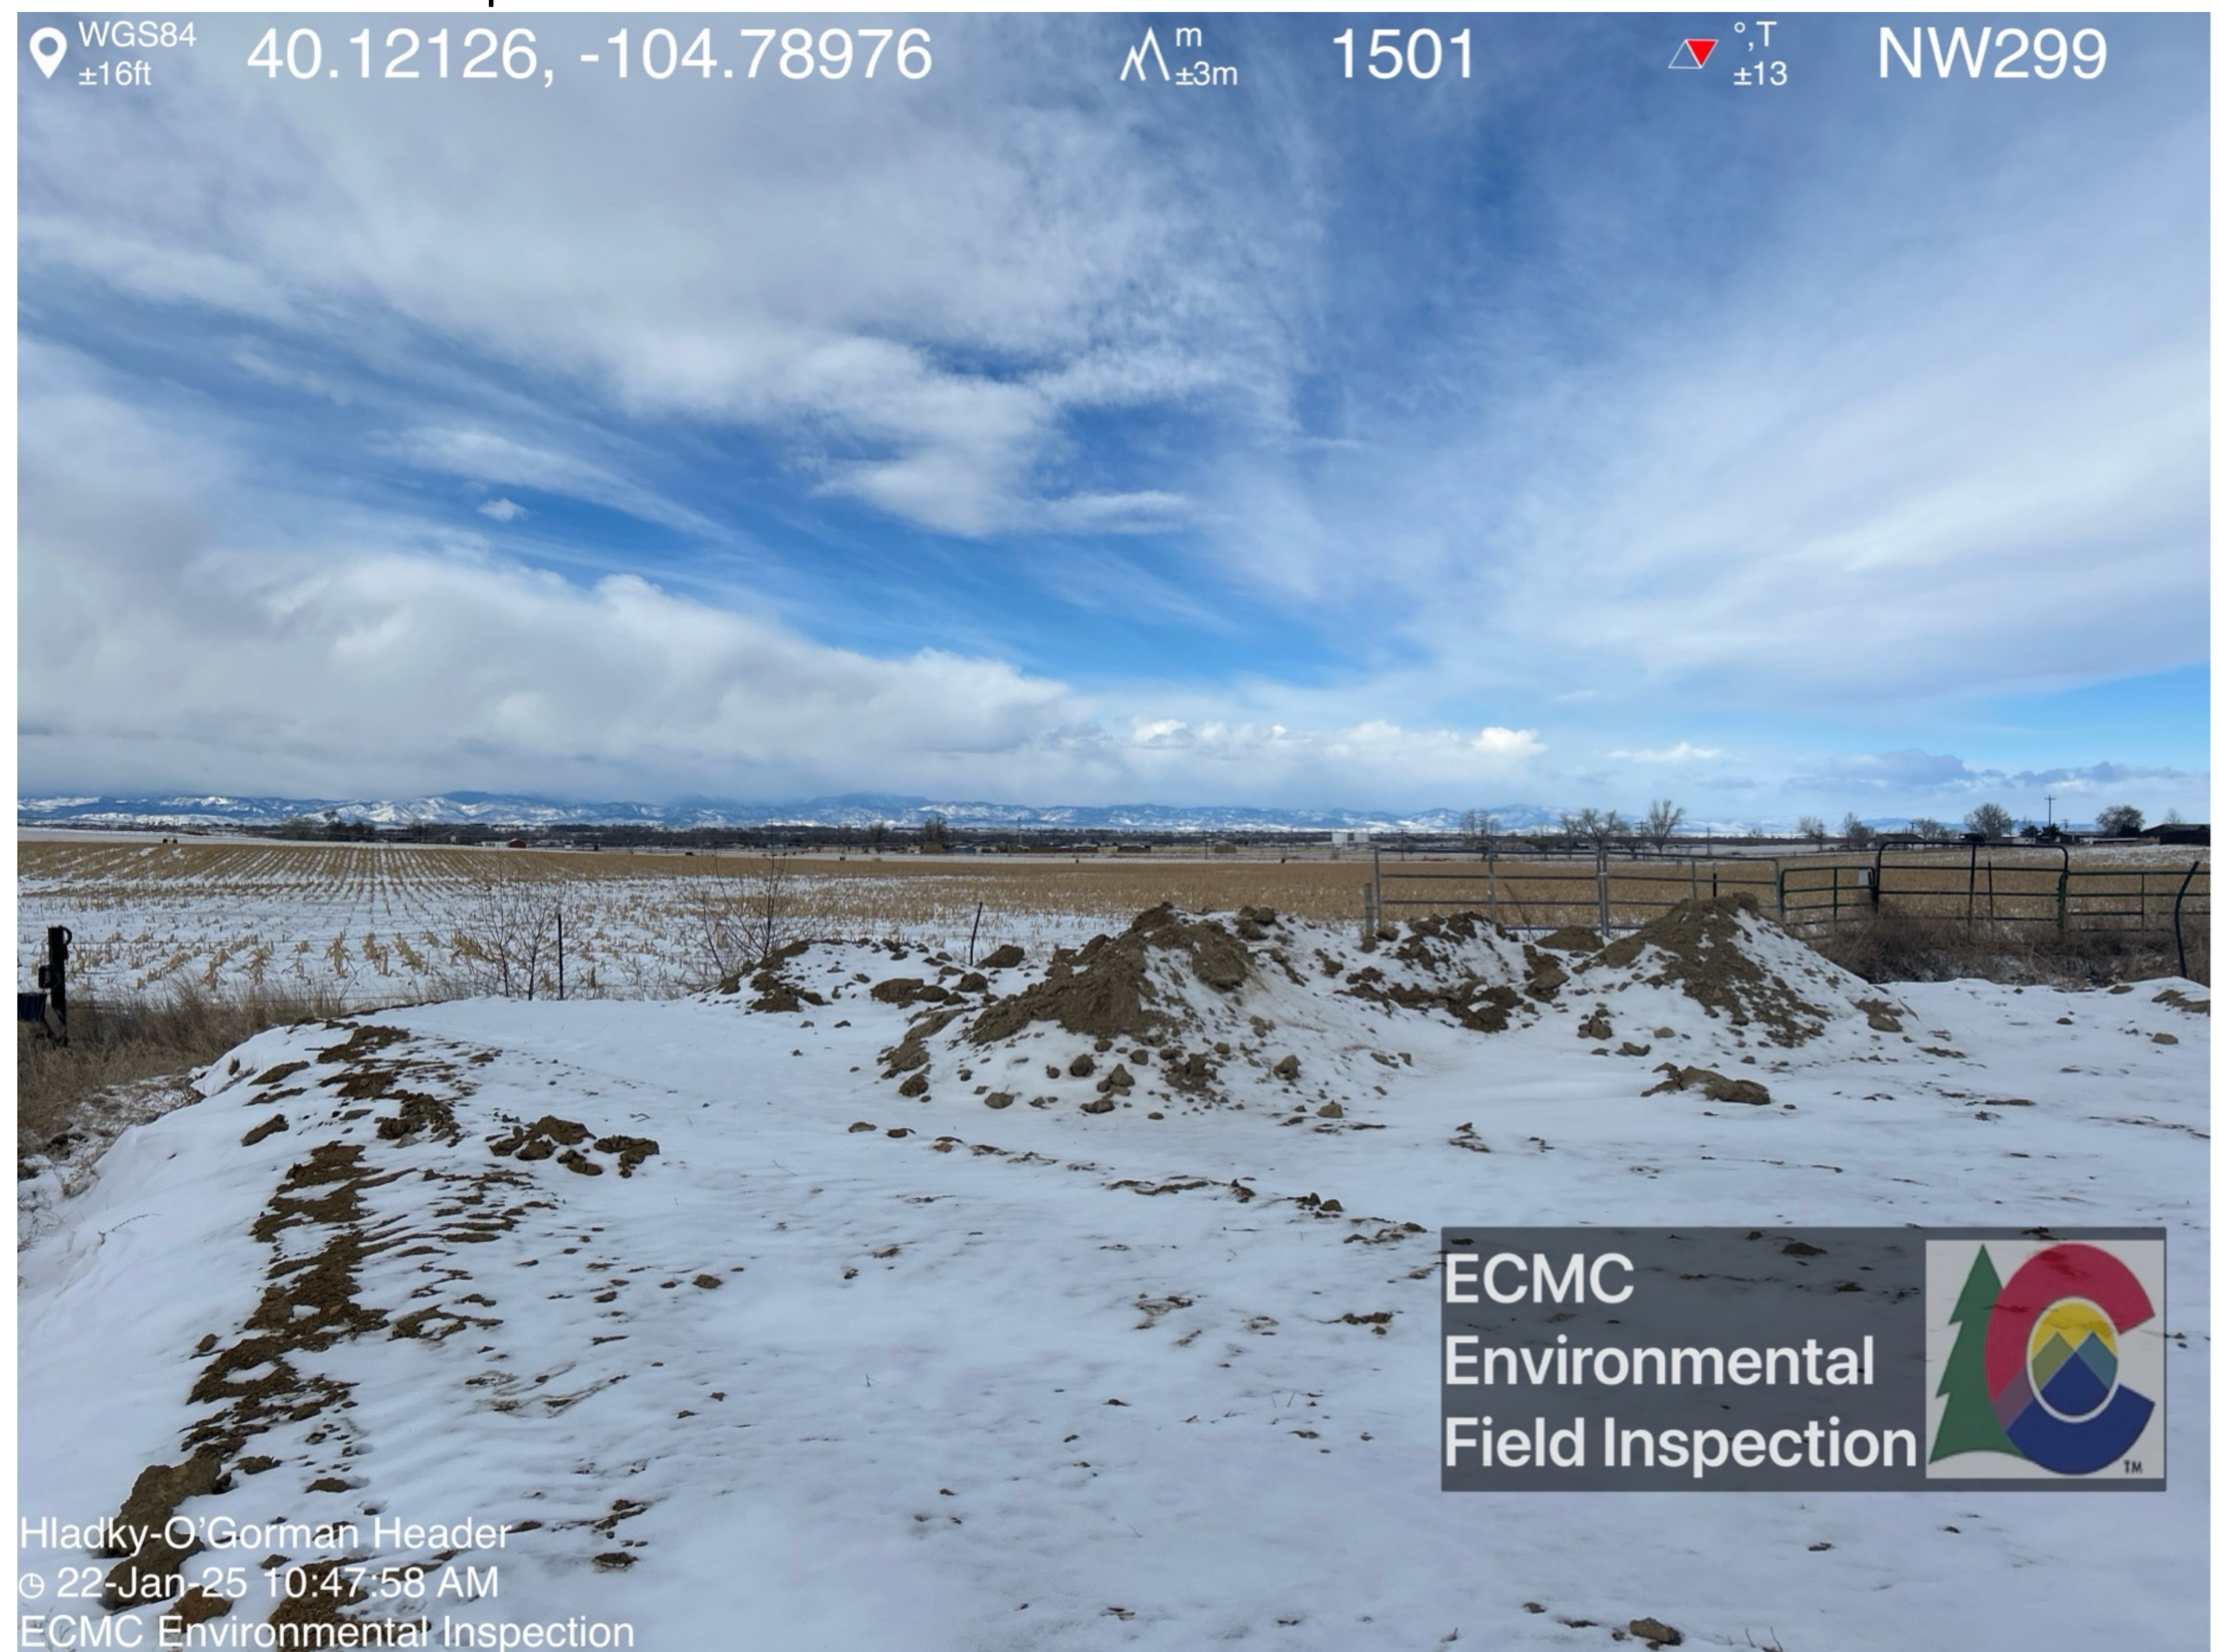
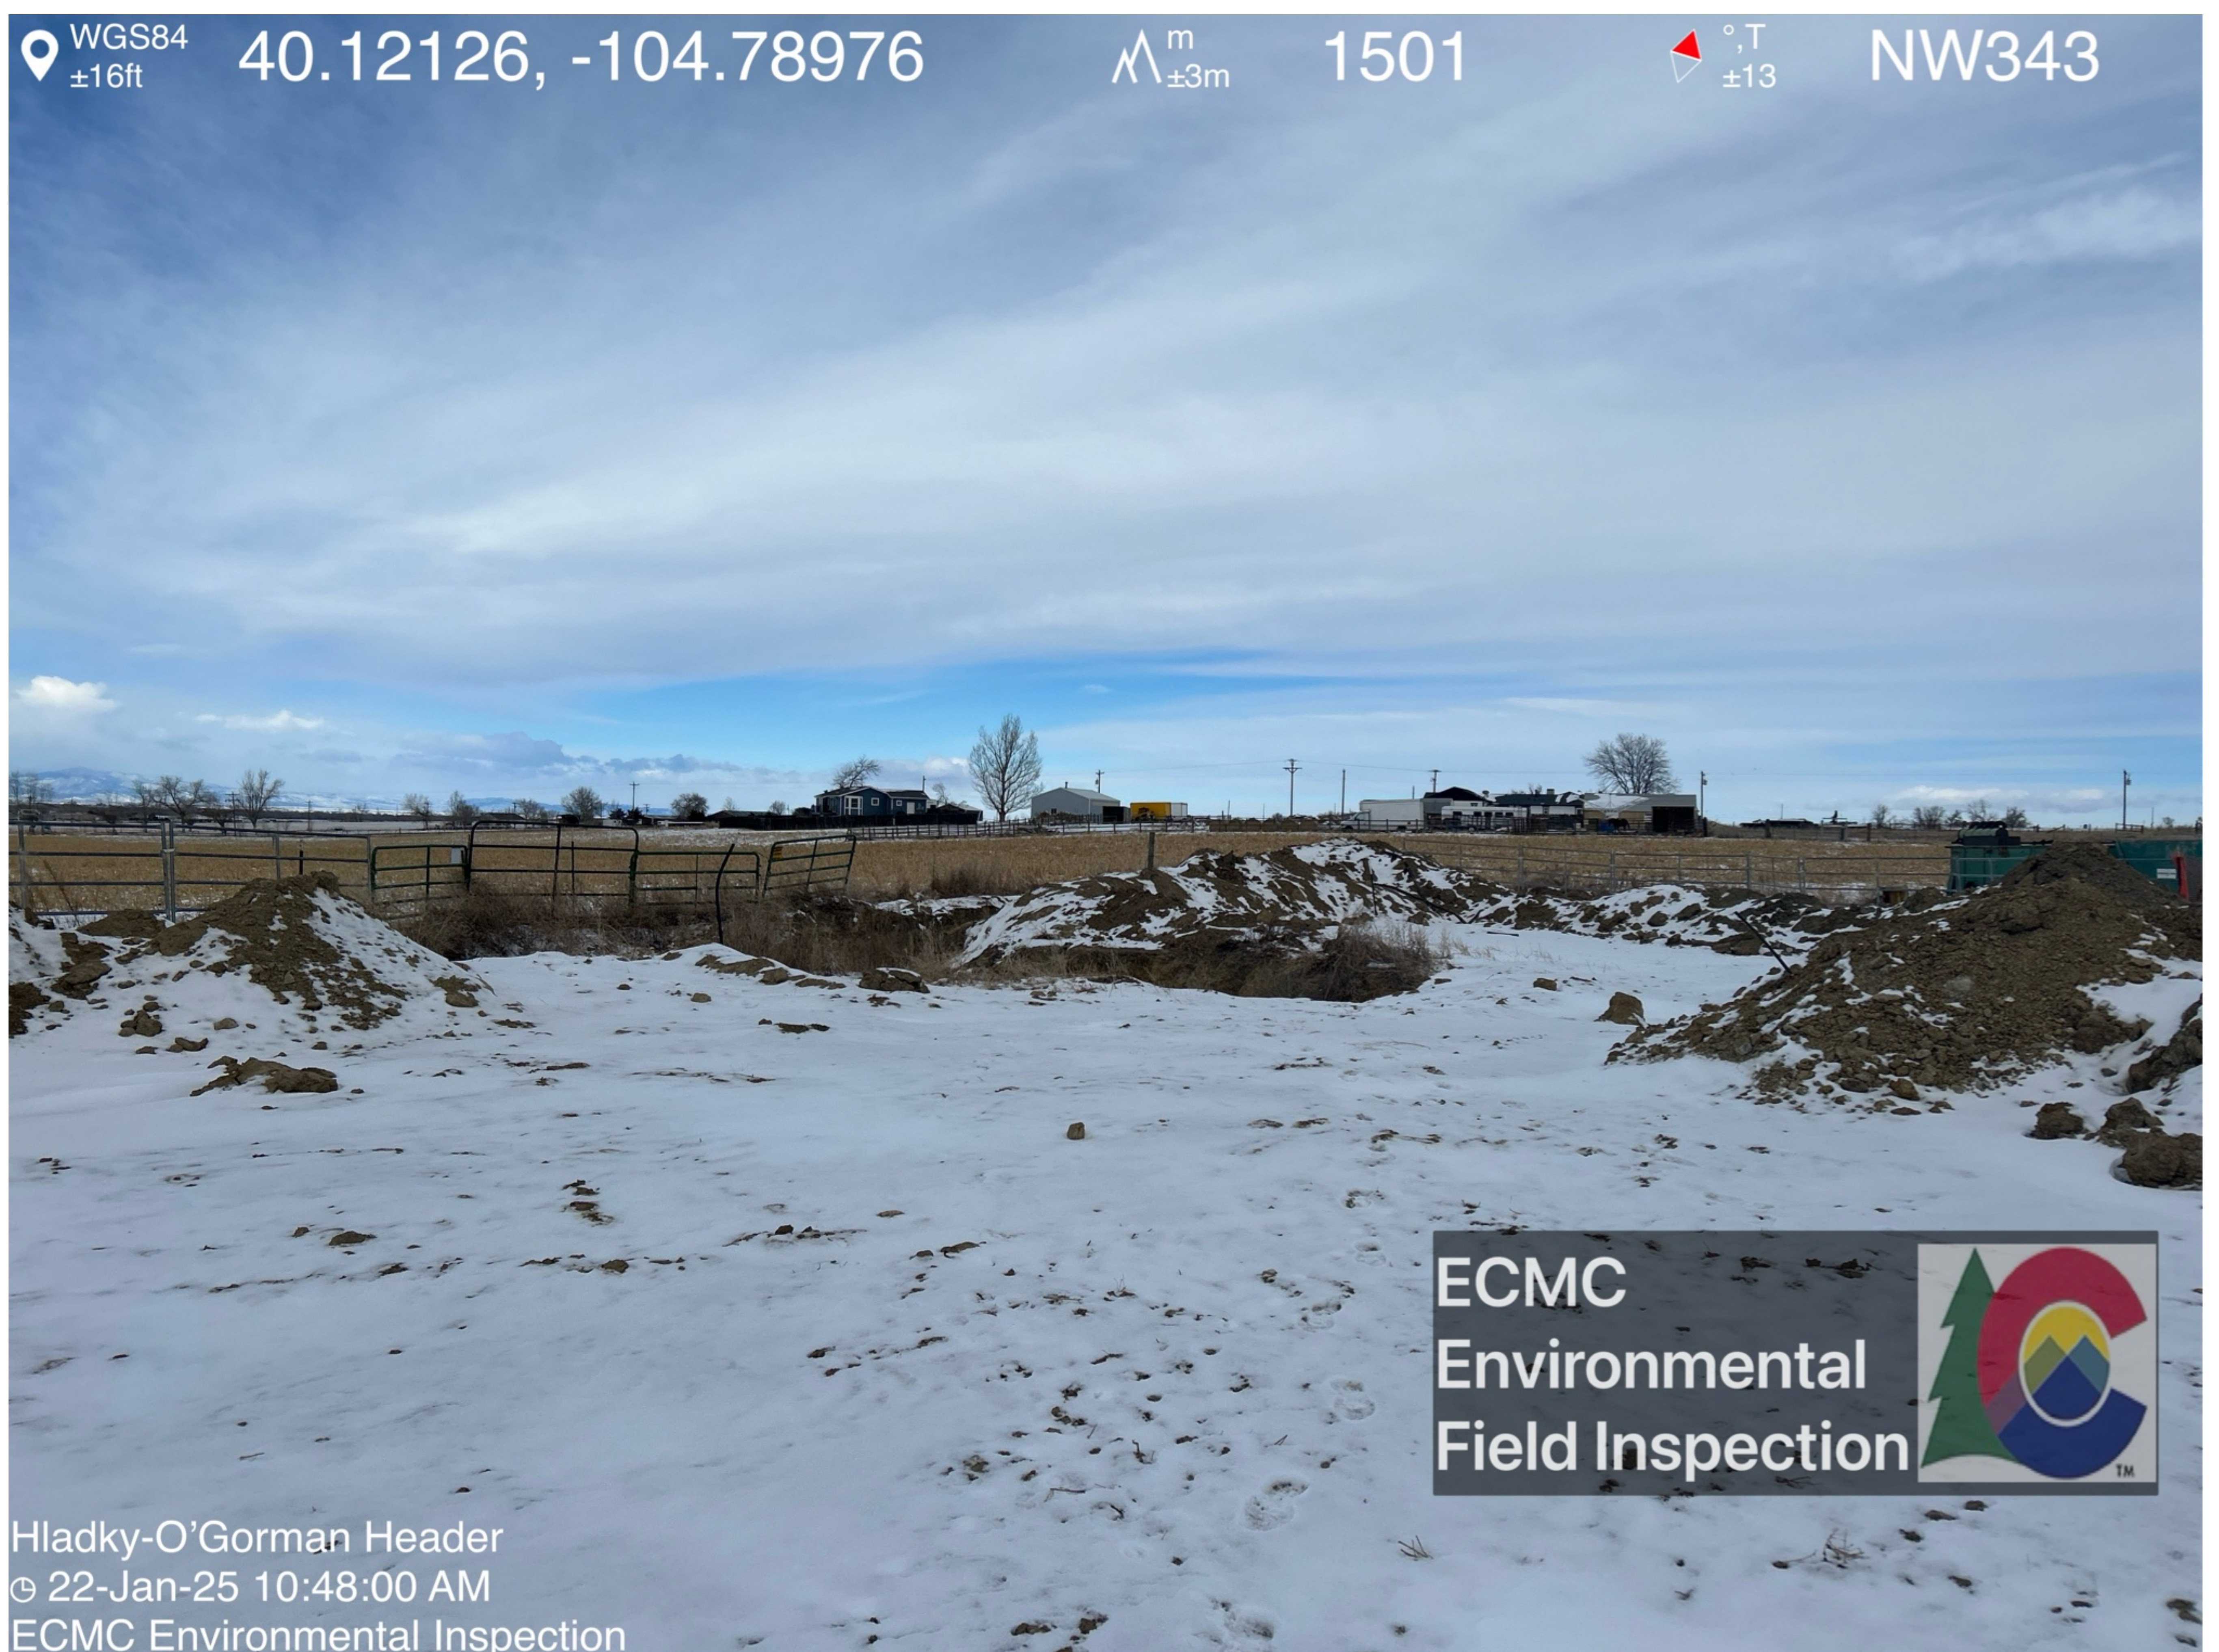
Unmarked soil stockpiled on location with no BMPs.

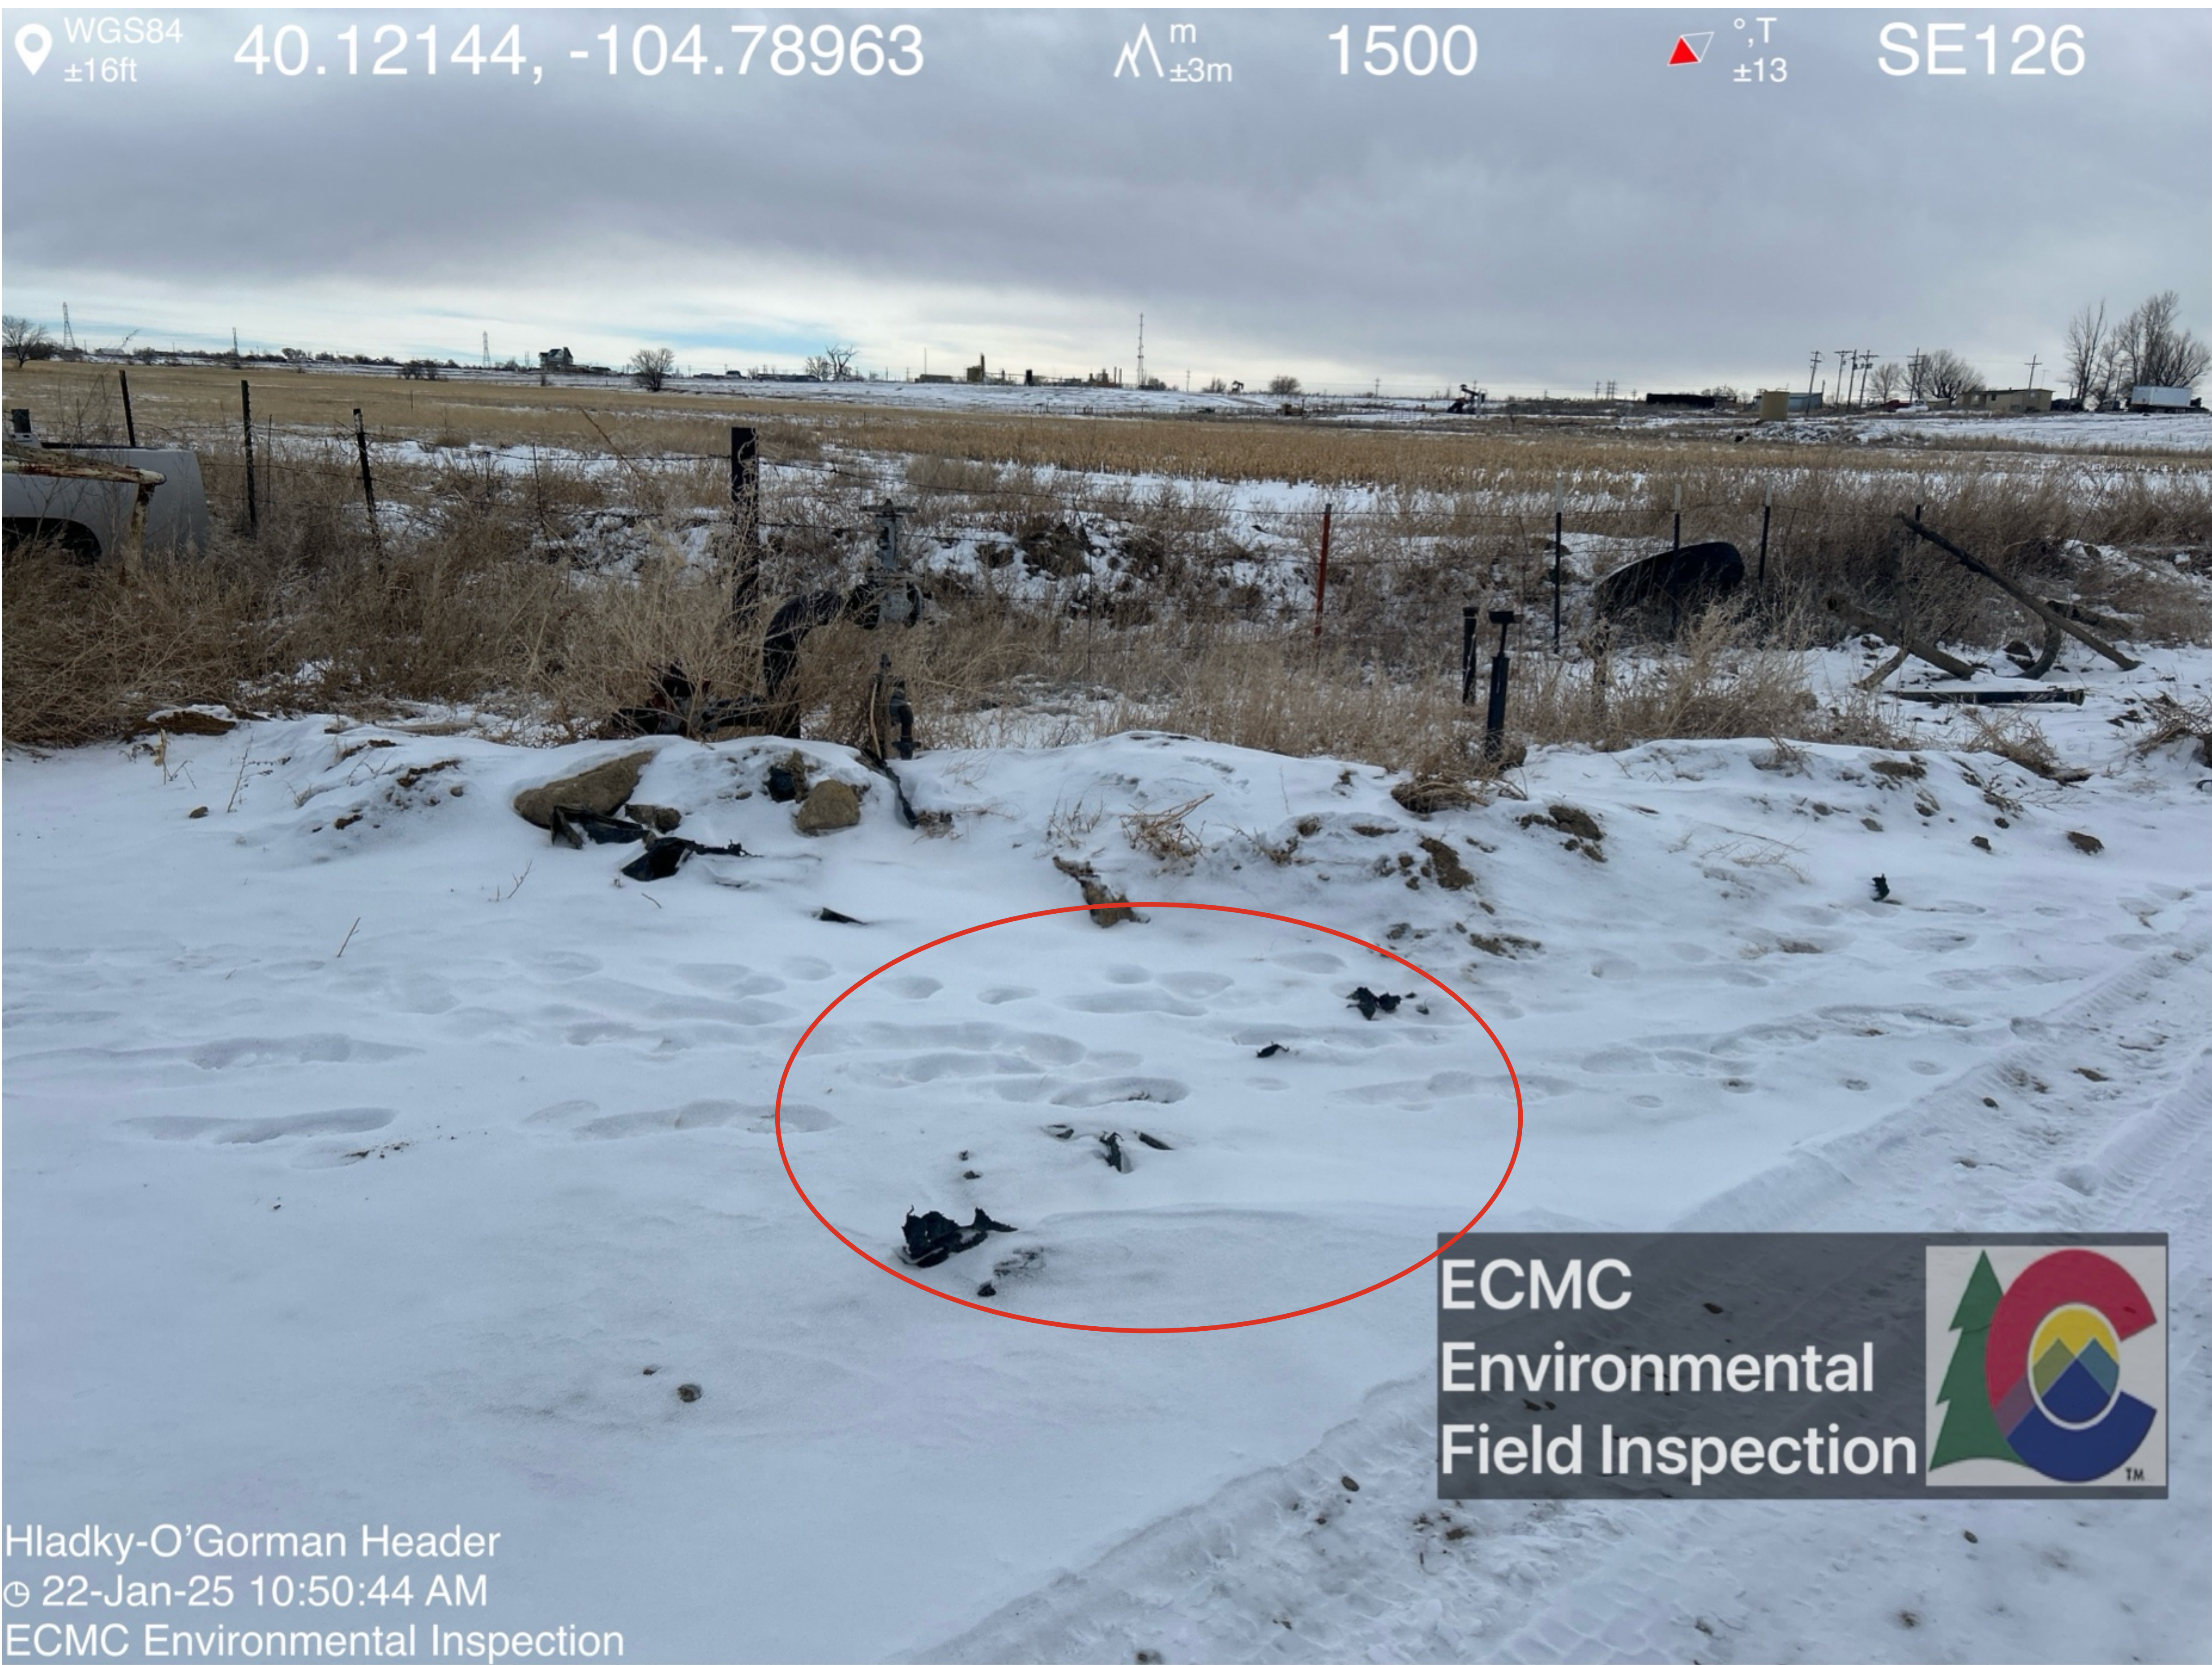
Trash/torn pieces of liner visible on location.
