Hladky O'Gorman 3 Well (API # 05-123-07775)

Hladky-O'Gorman Header  
© 22-Jan-25 10:49:13 AM  
ECMC Environmental Inspection

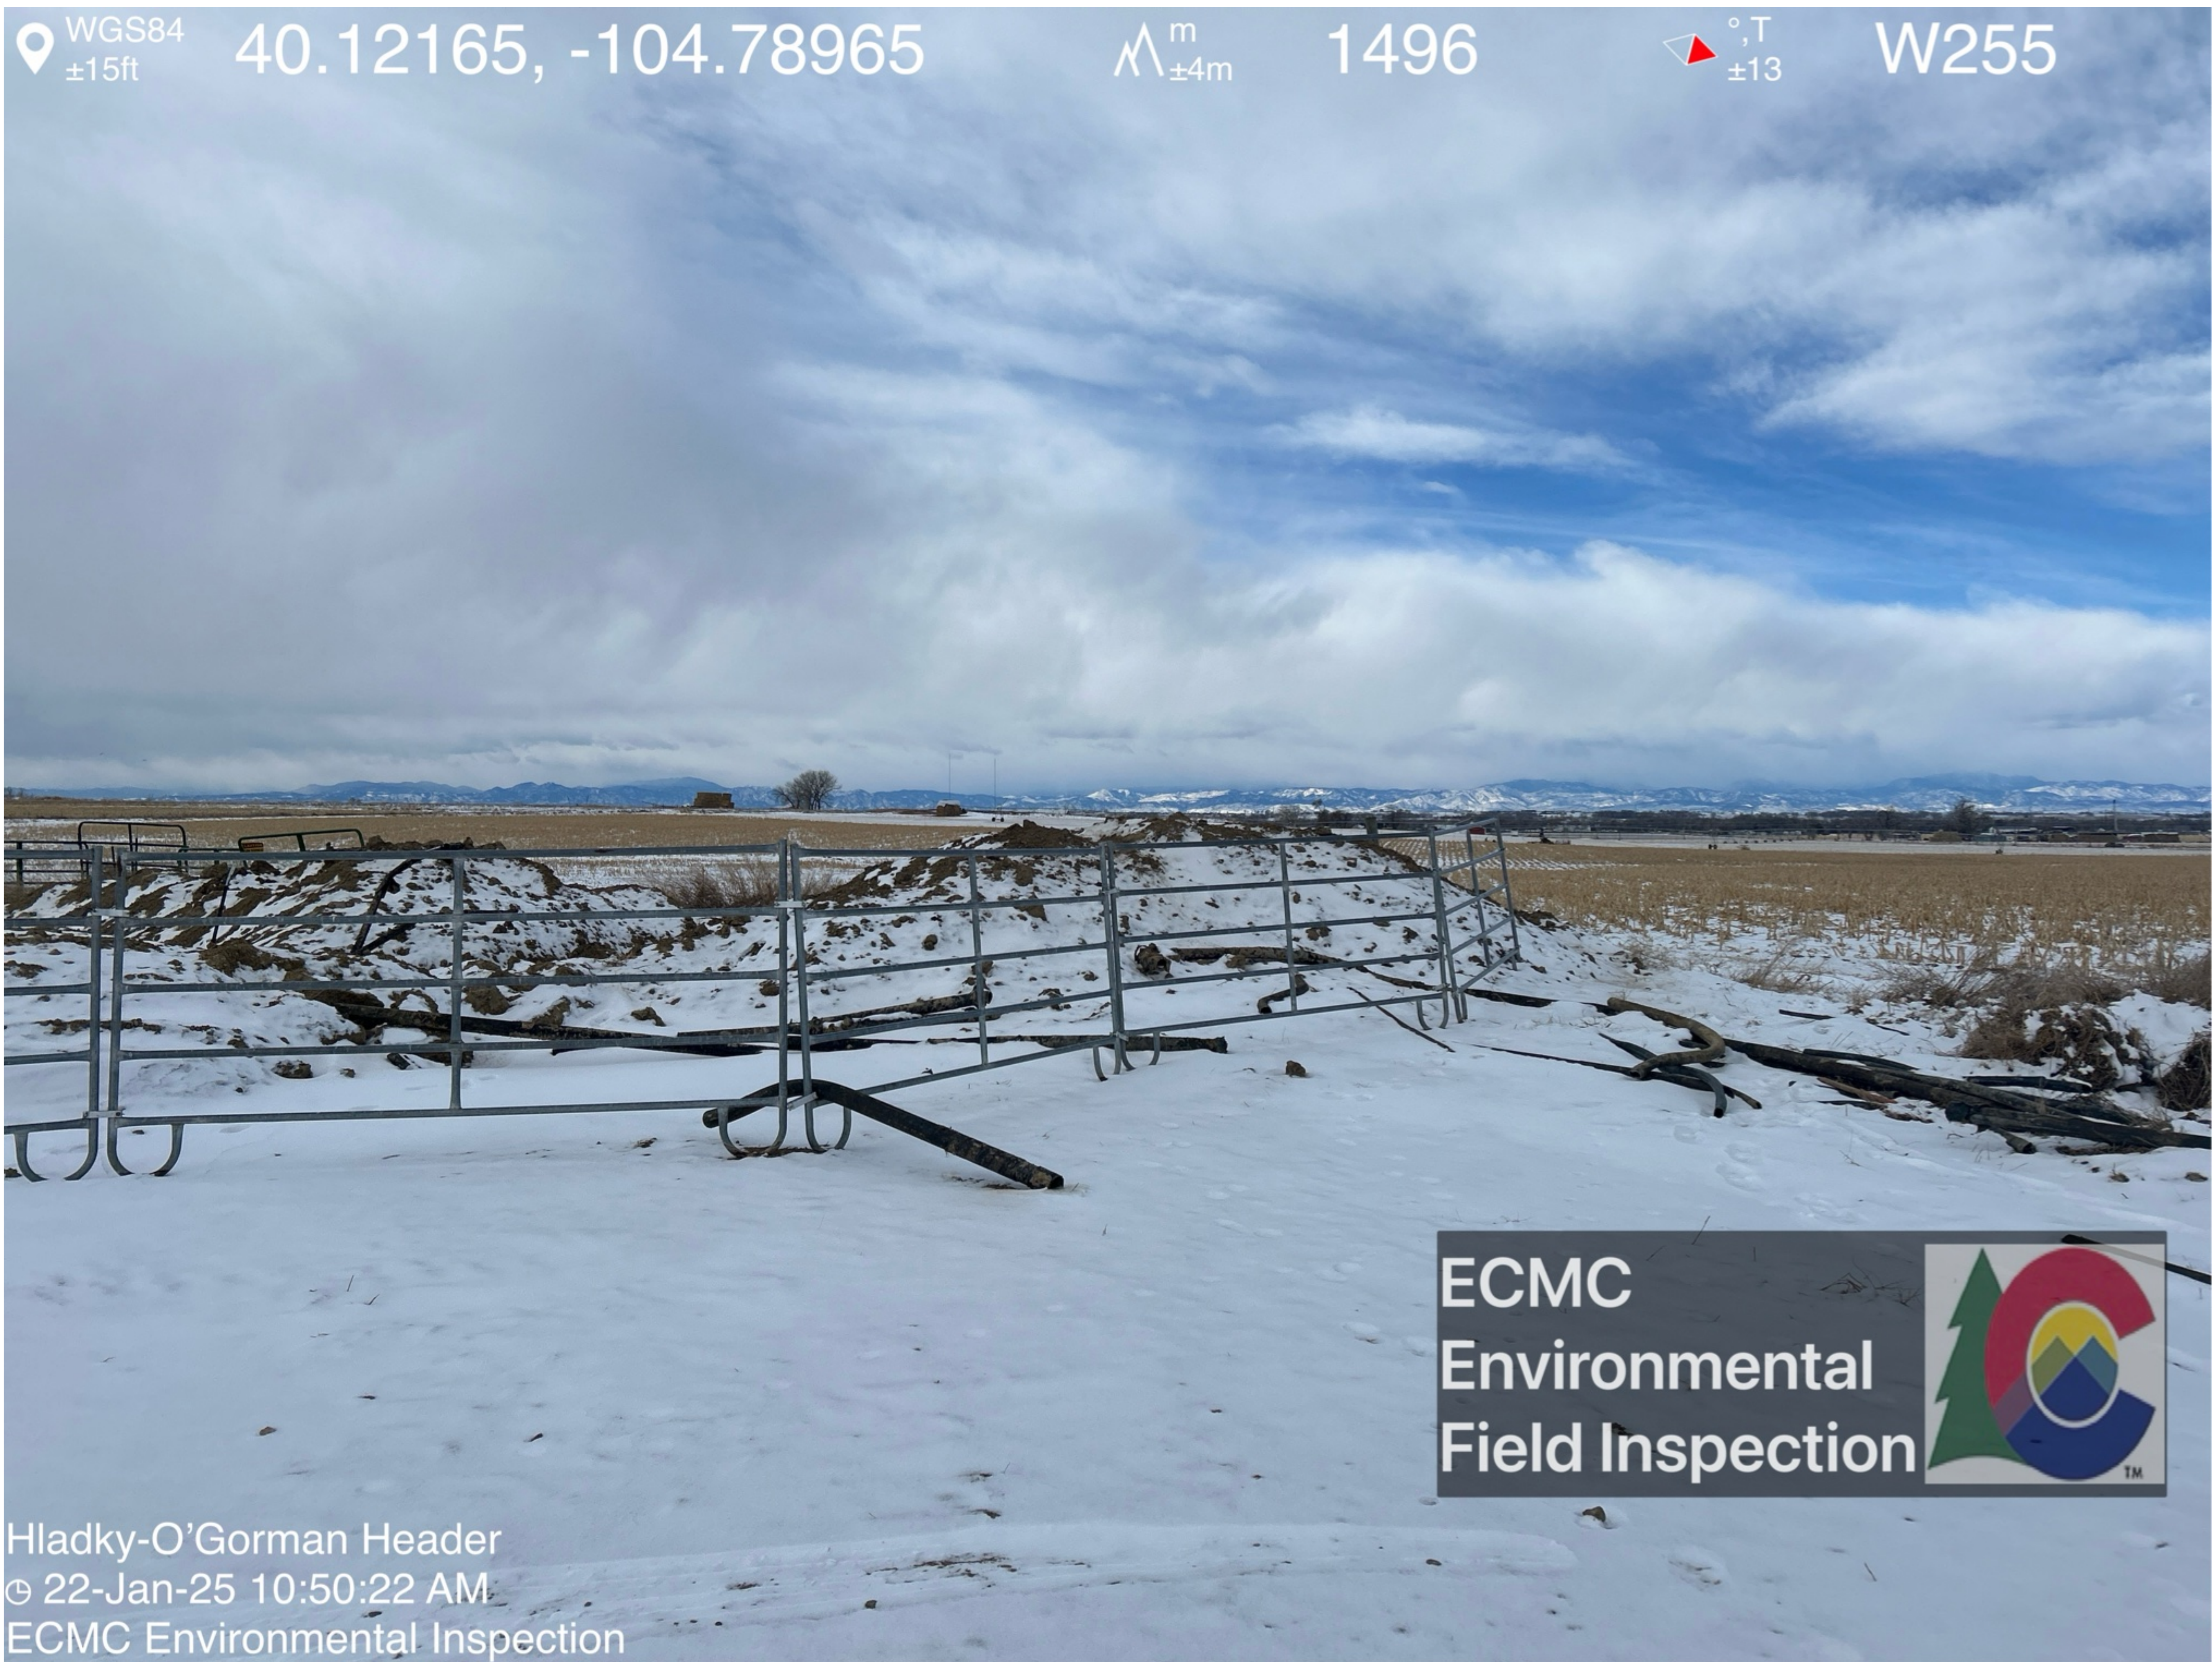
Metal fencing does not fully encompass the perimeter of the excavation area.

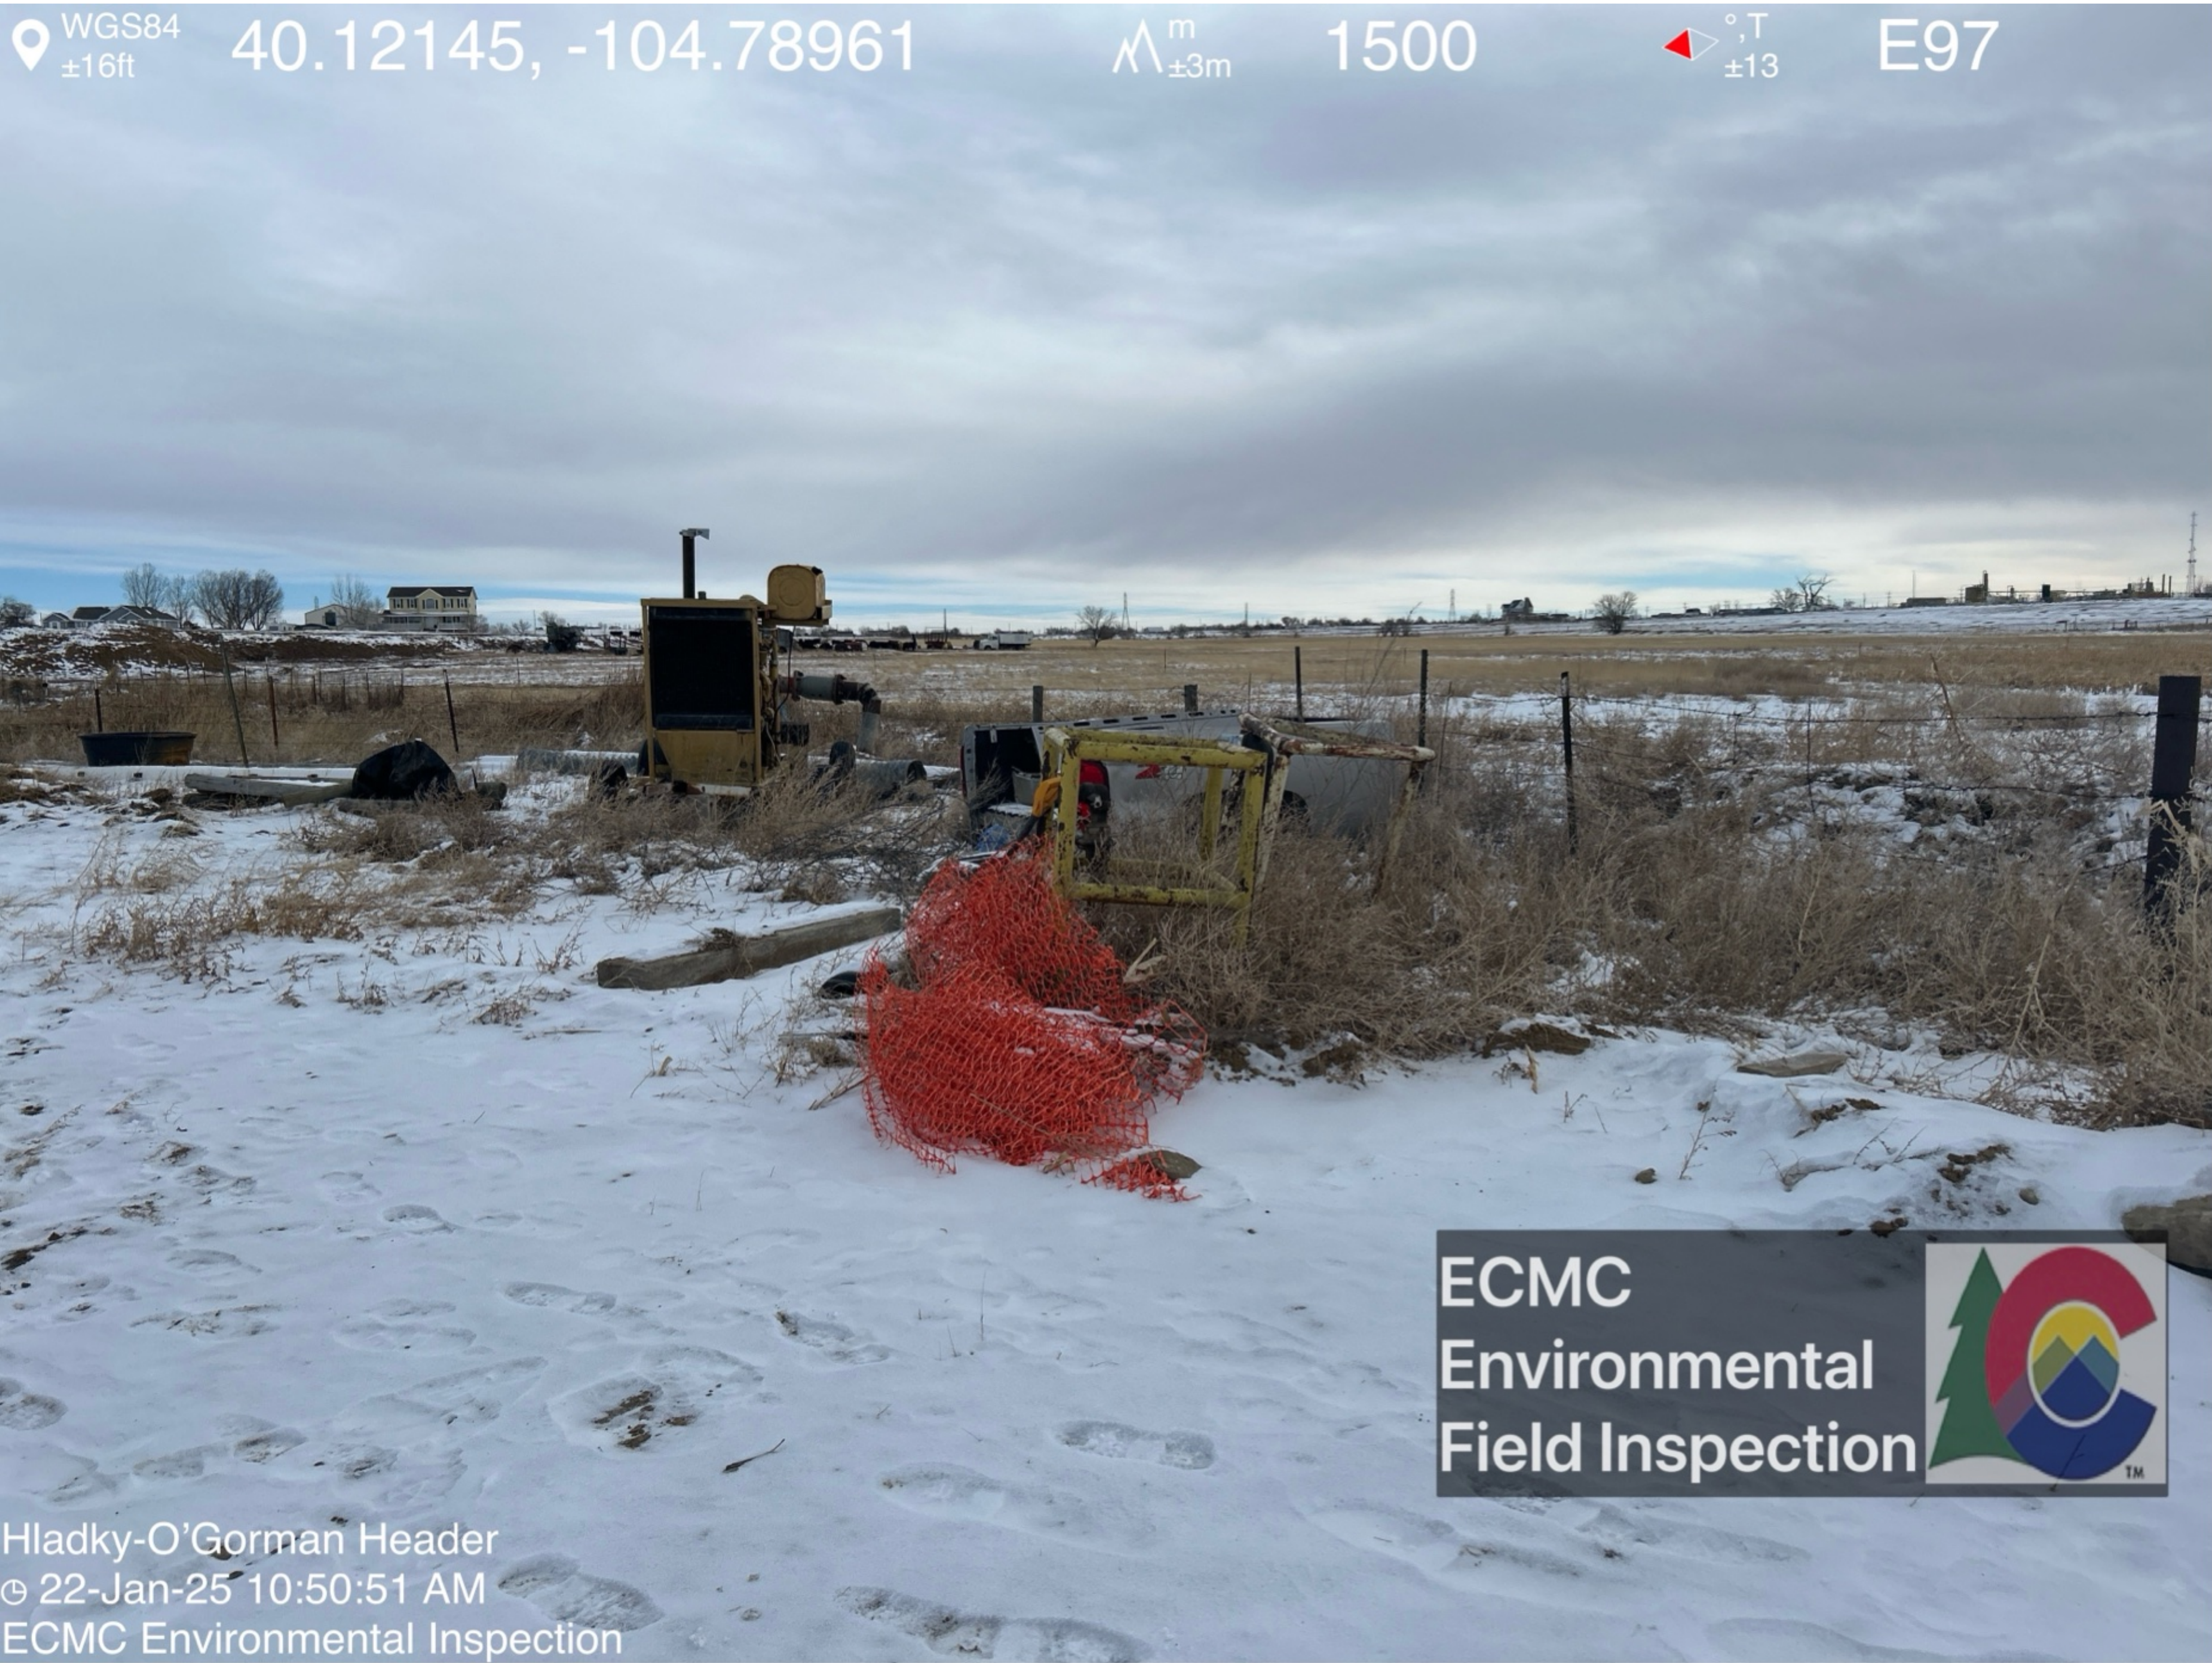
Trash/discarded fencing observed on location.

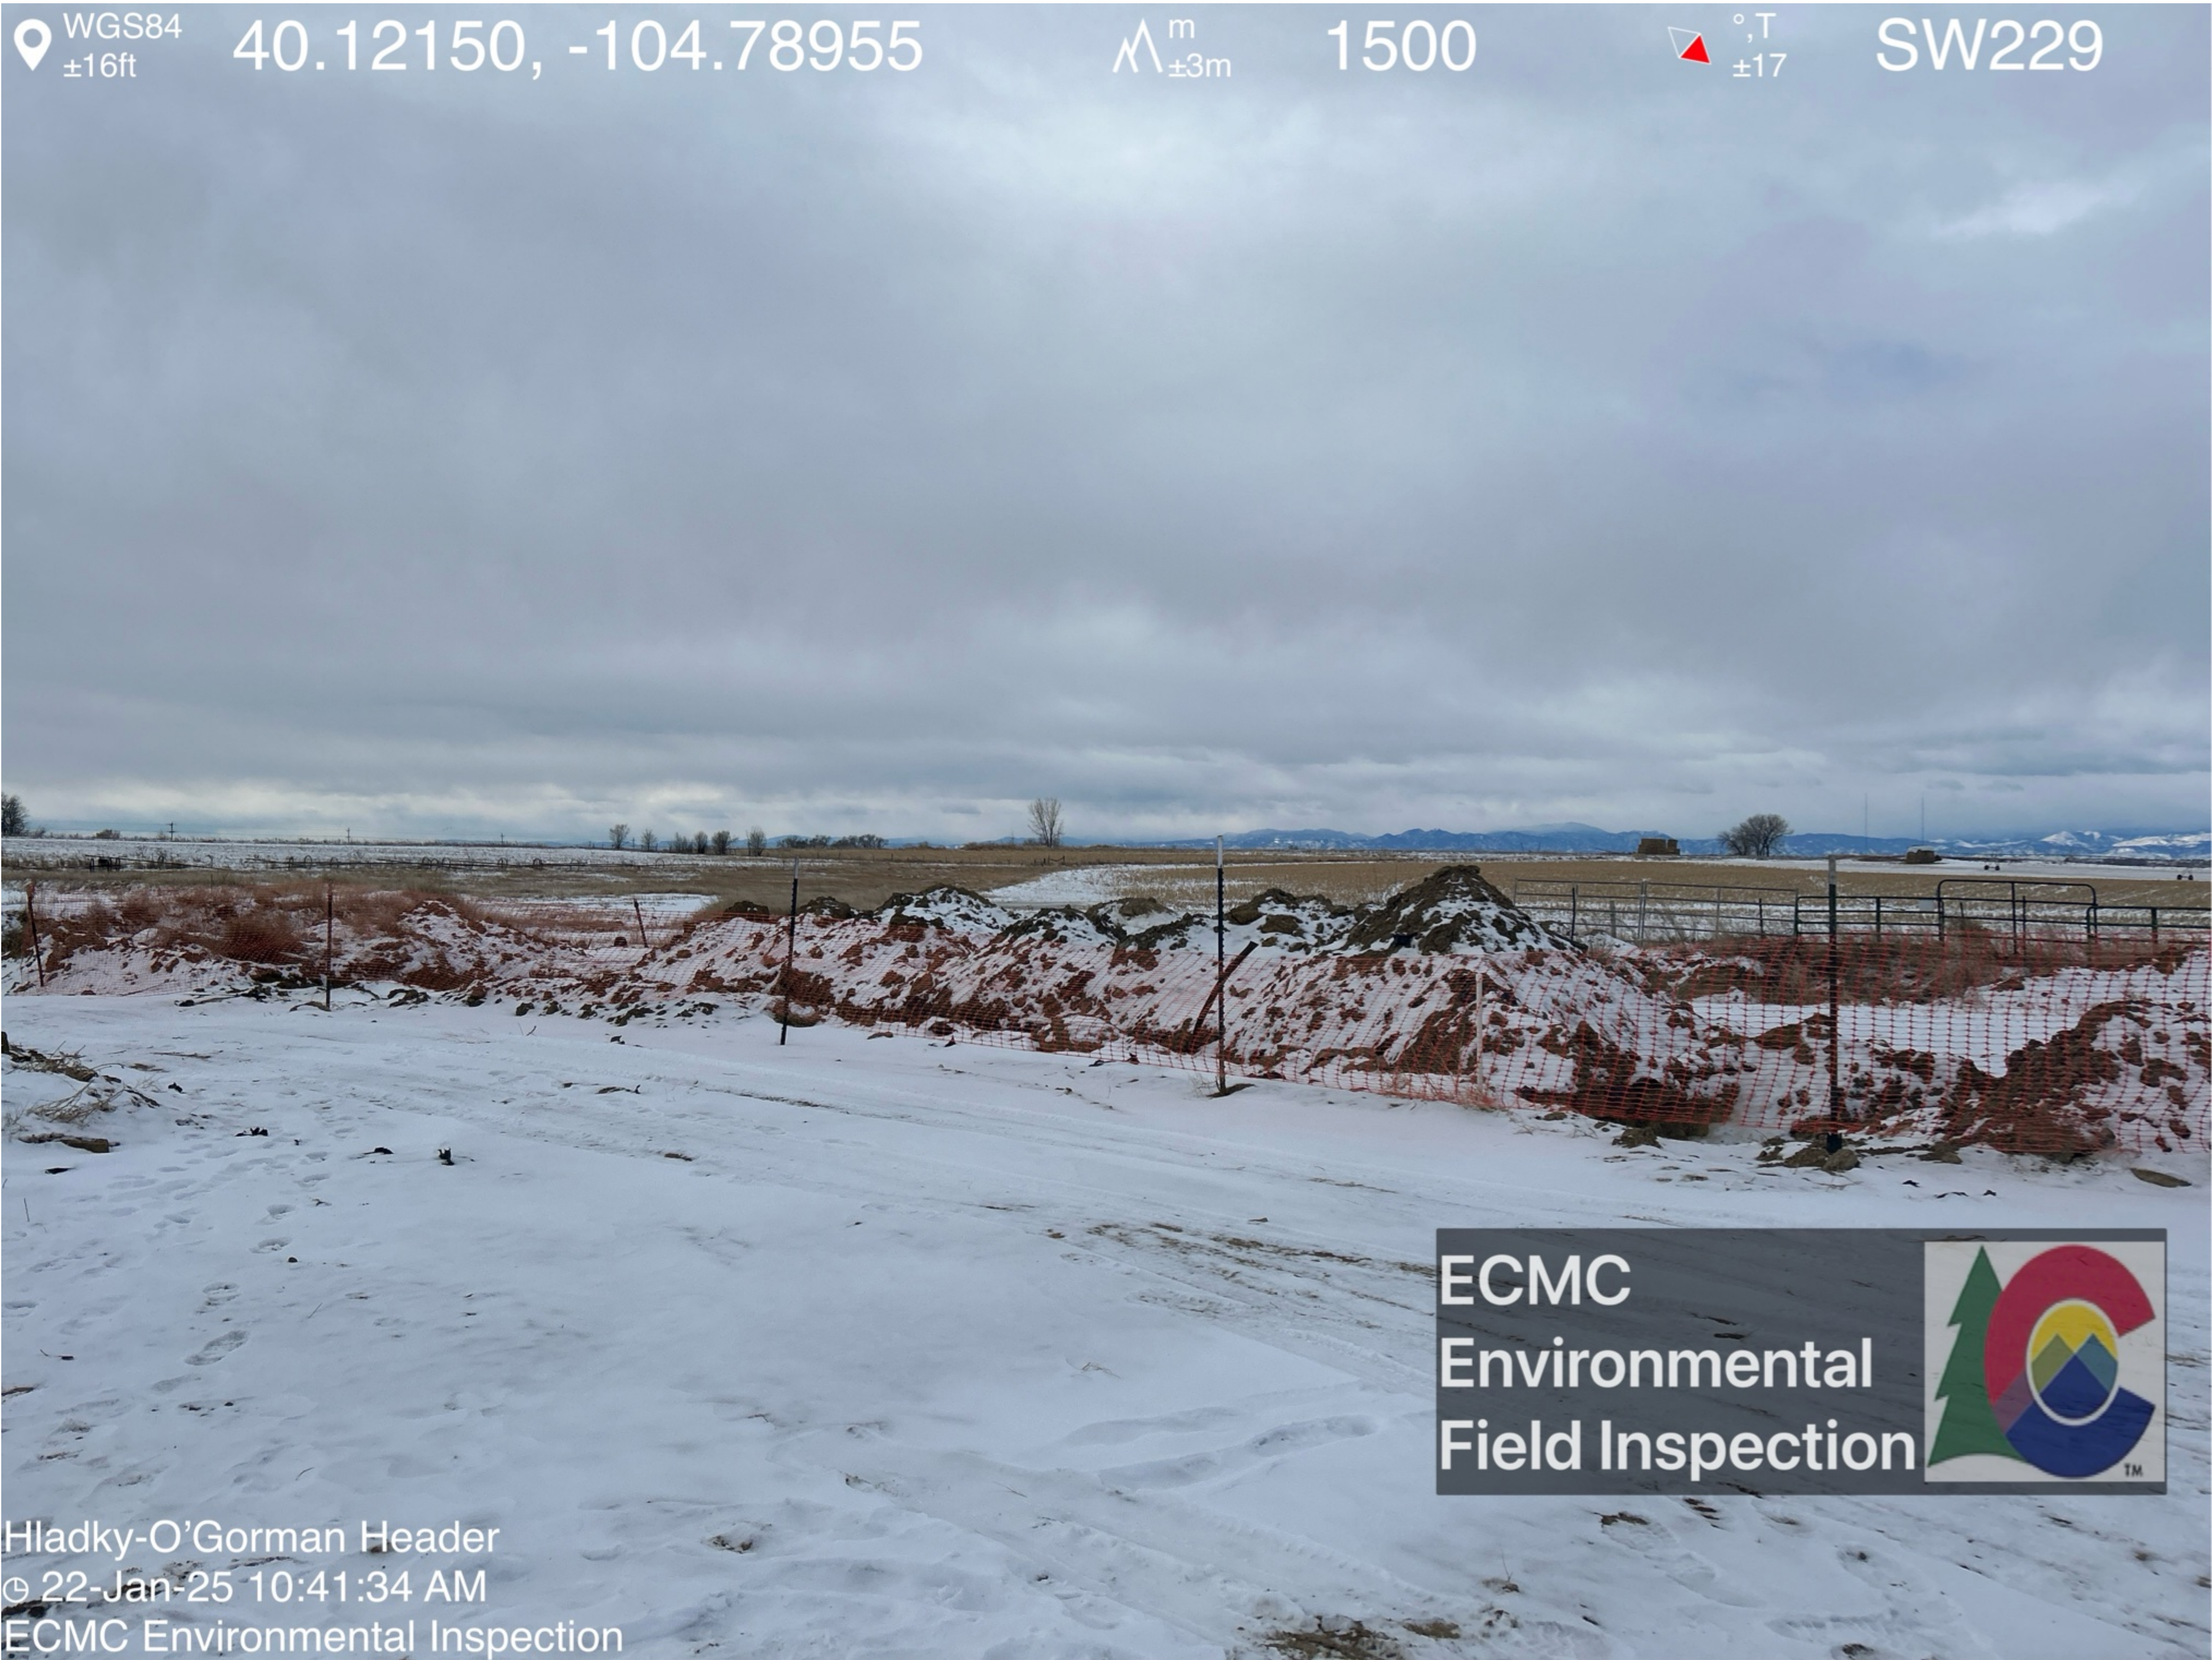
Orange construction fencing partially surrounds the excavation area. Unmarked soil stockpiled on location with no BMPs.

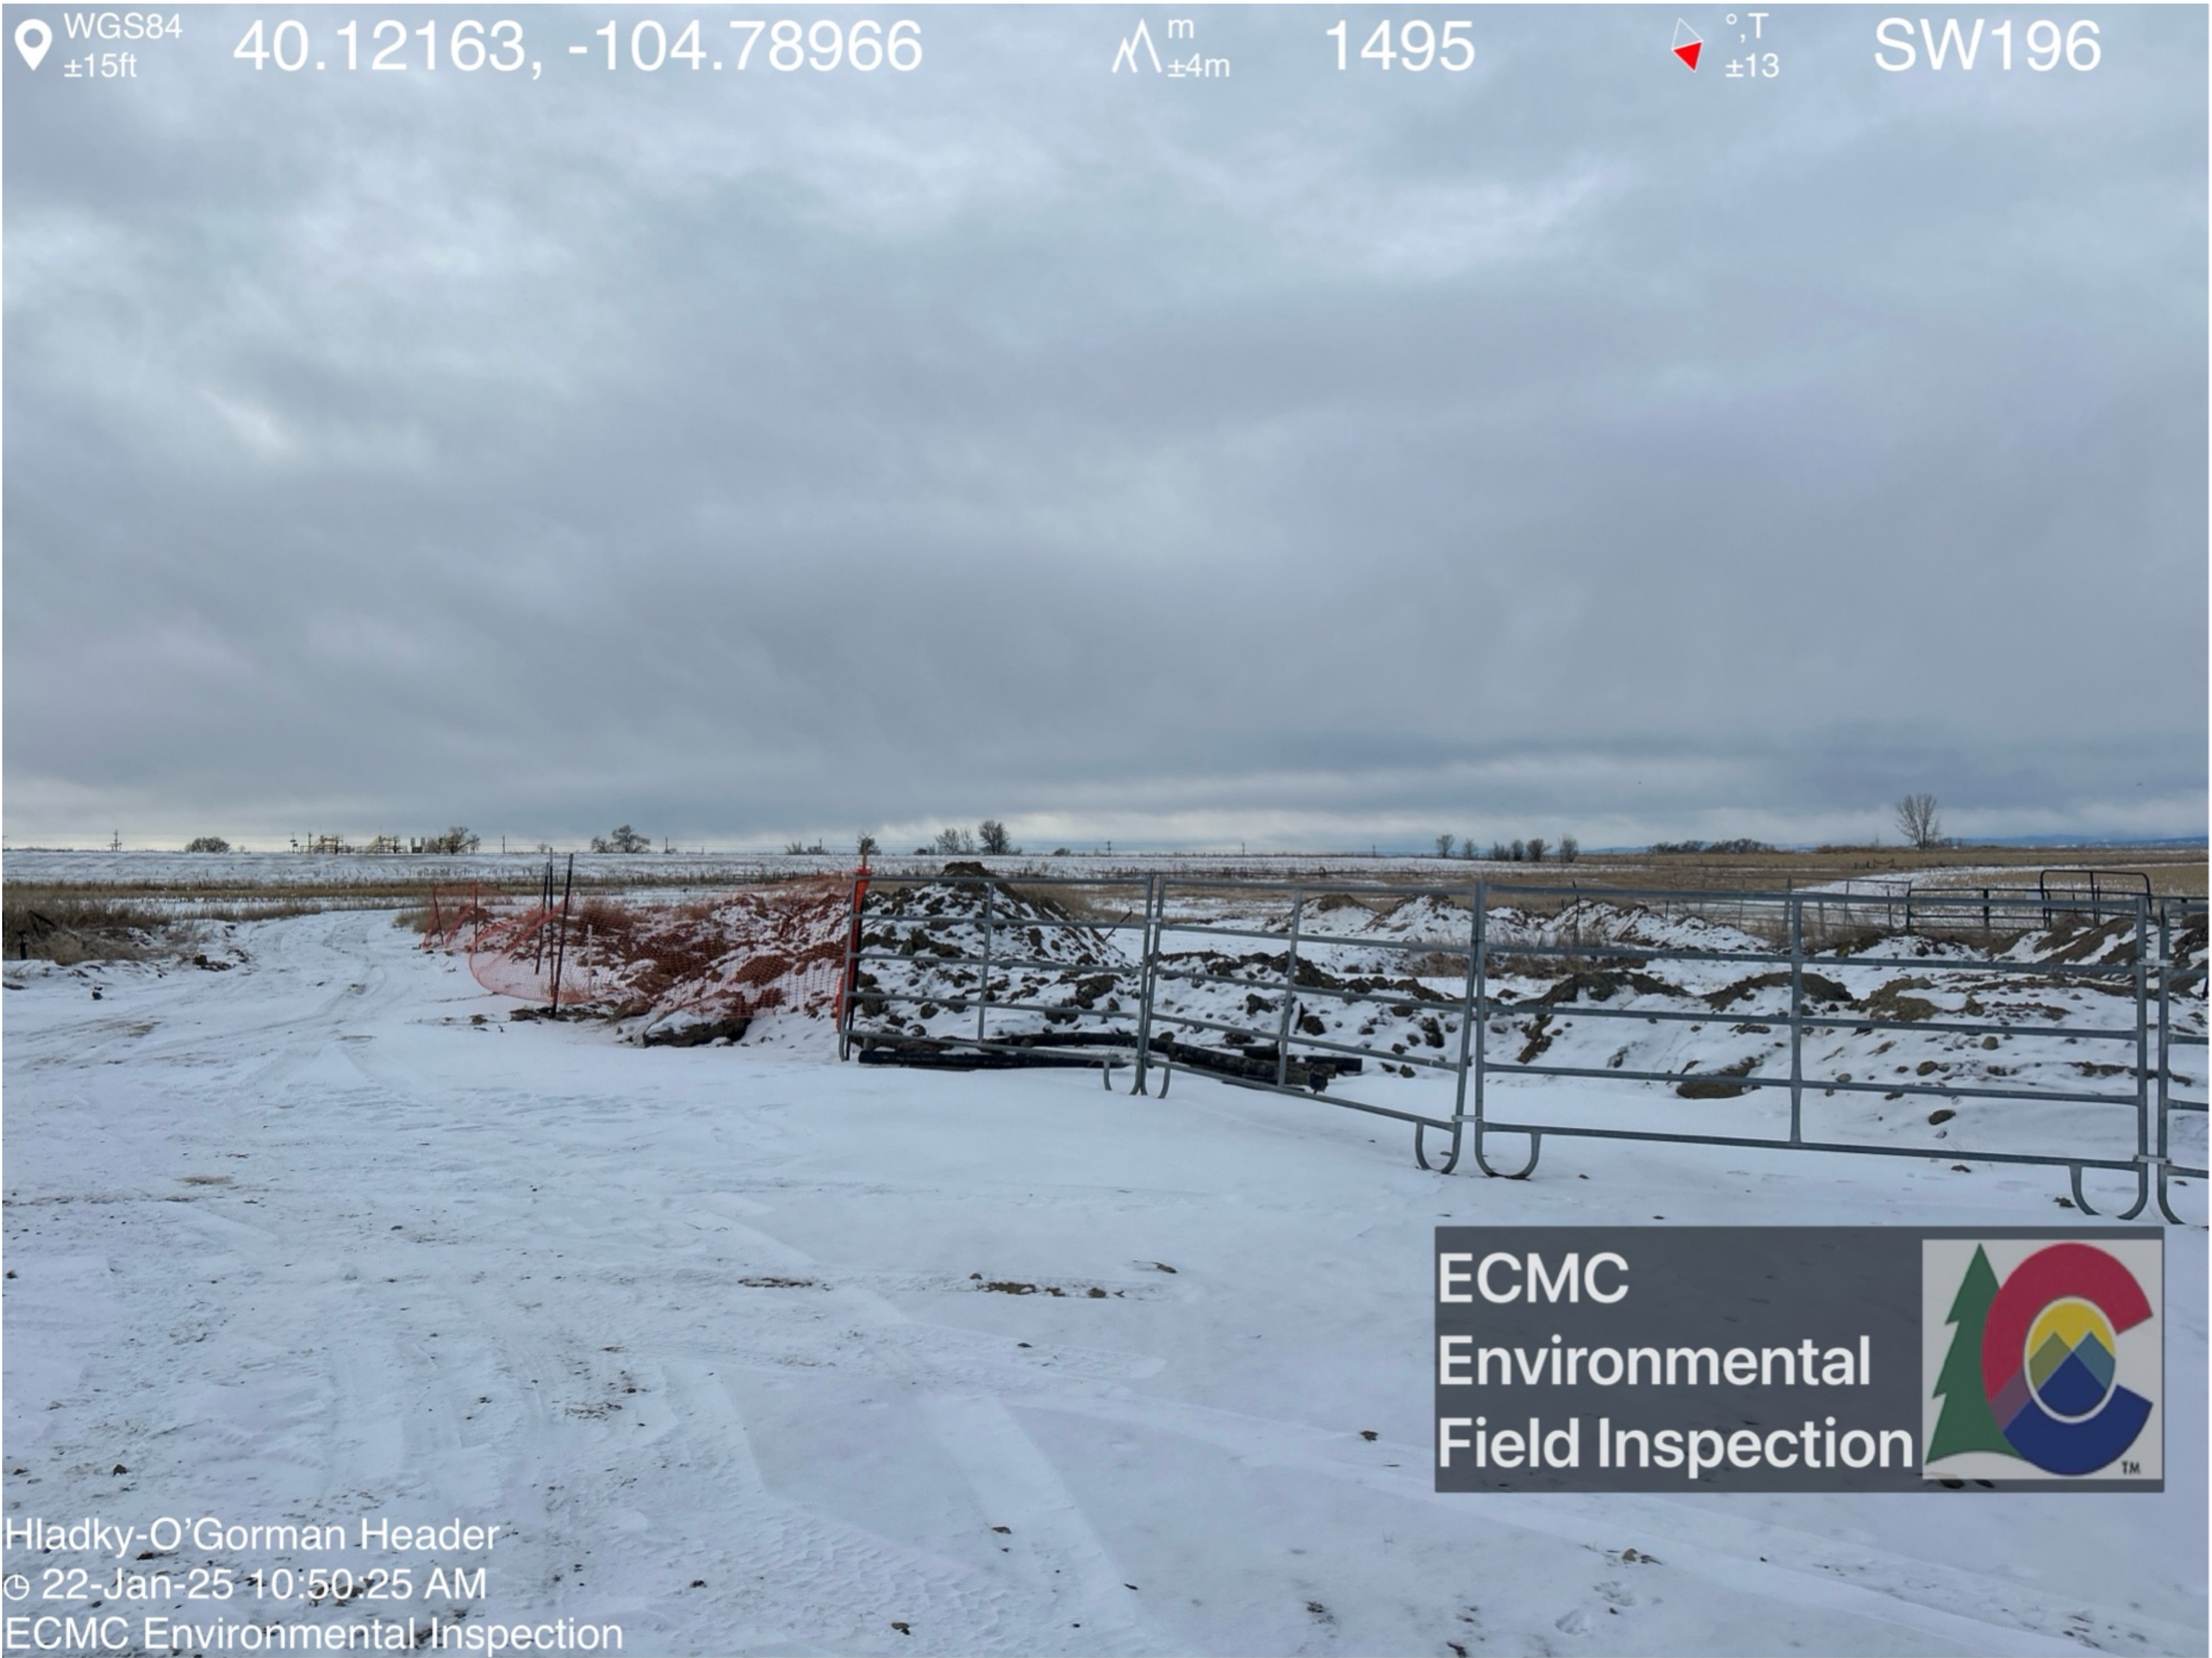
Orange construction fencing and metal fencing surround portions of the excavation area but do not encompass the full perimeter of the excavation.

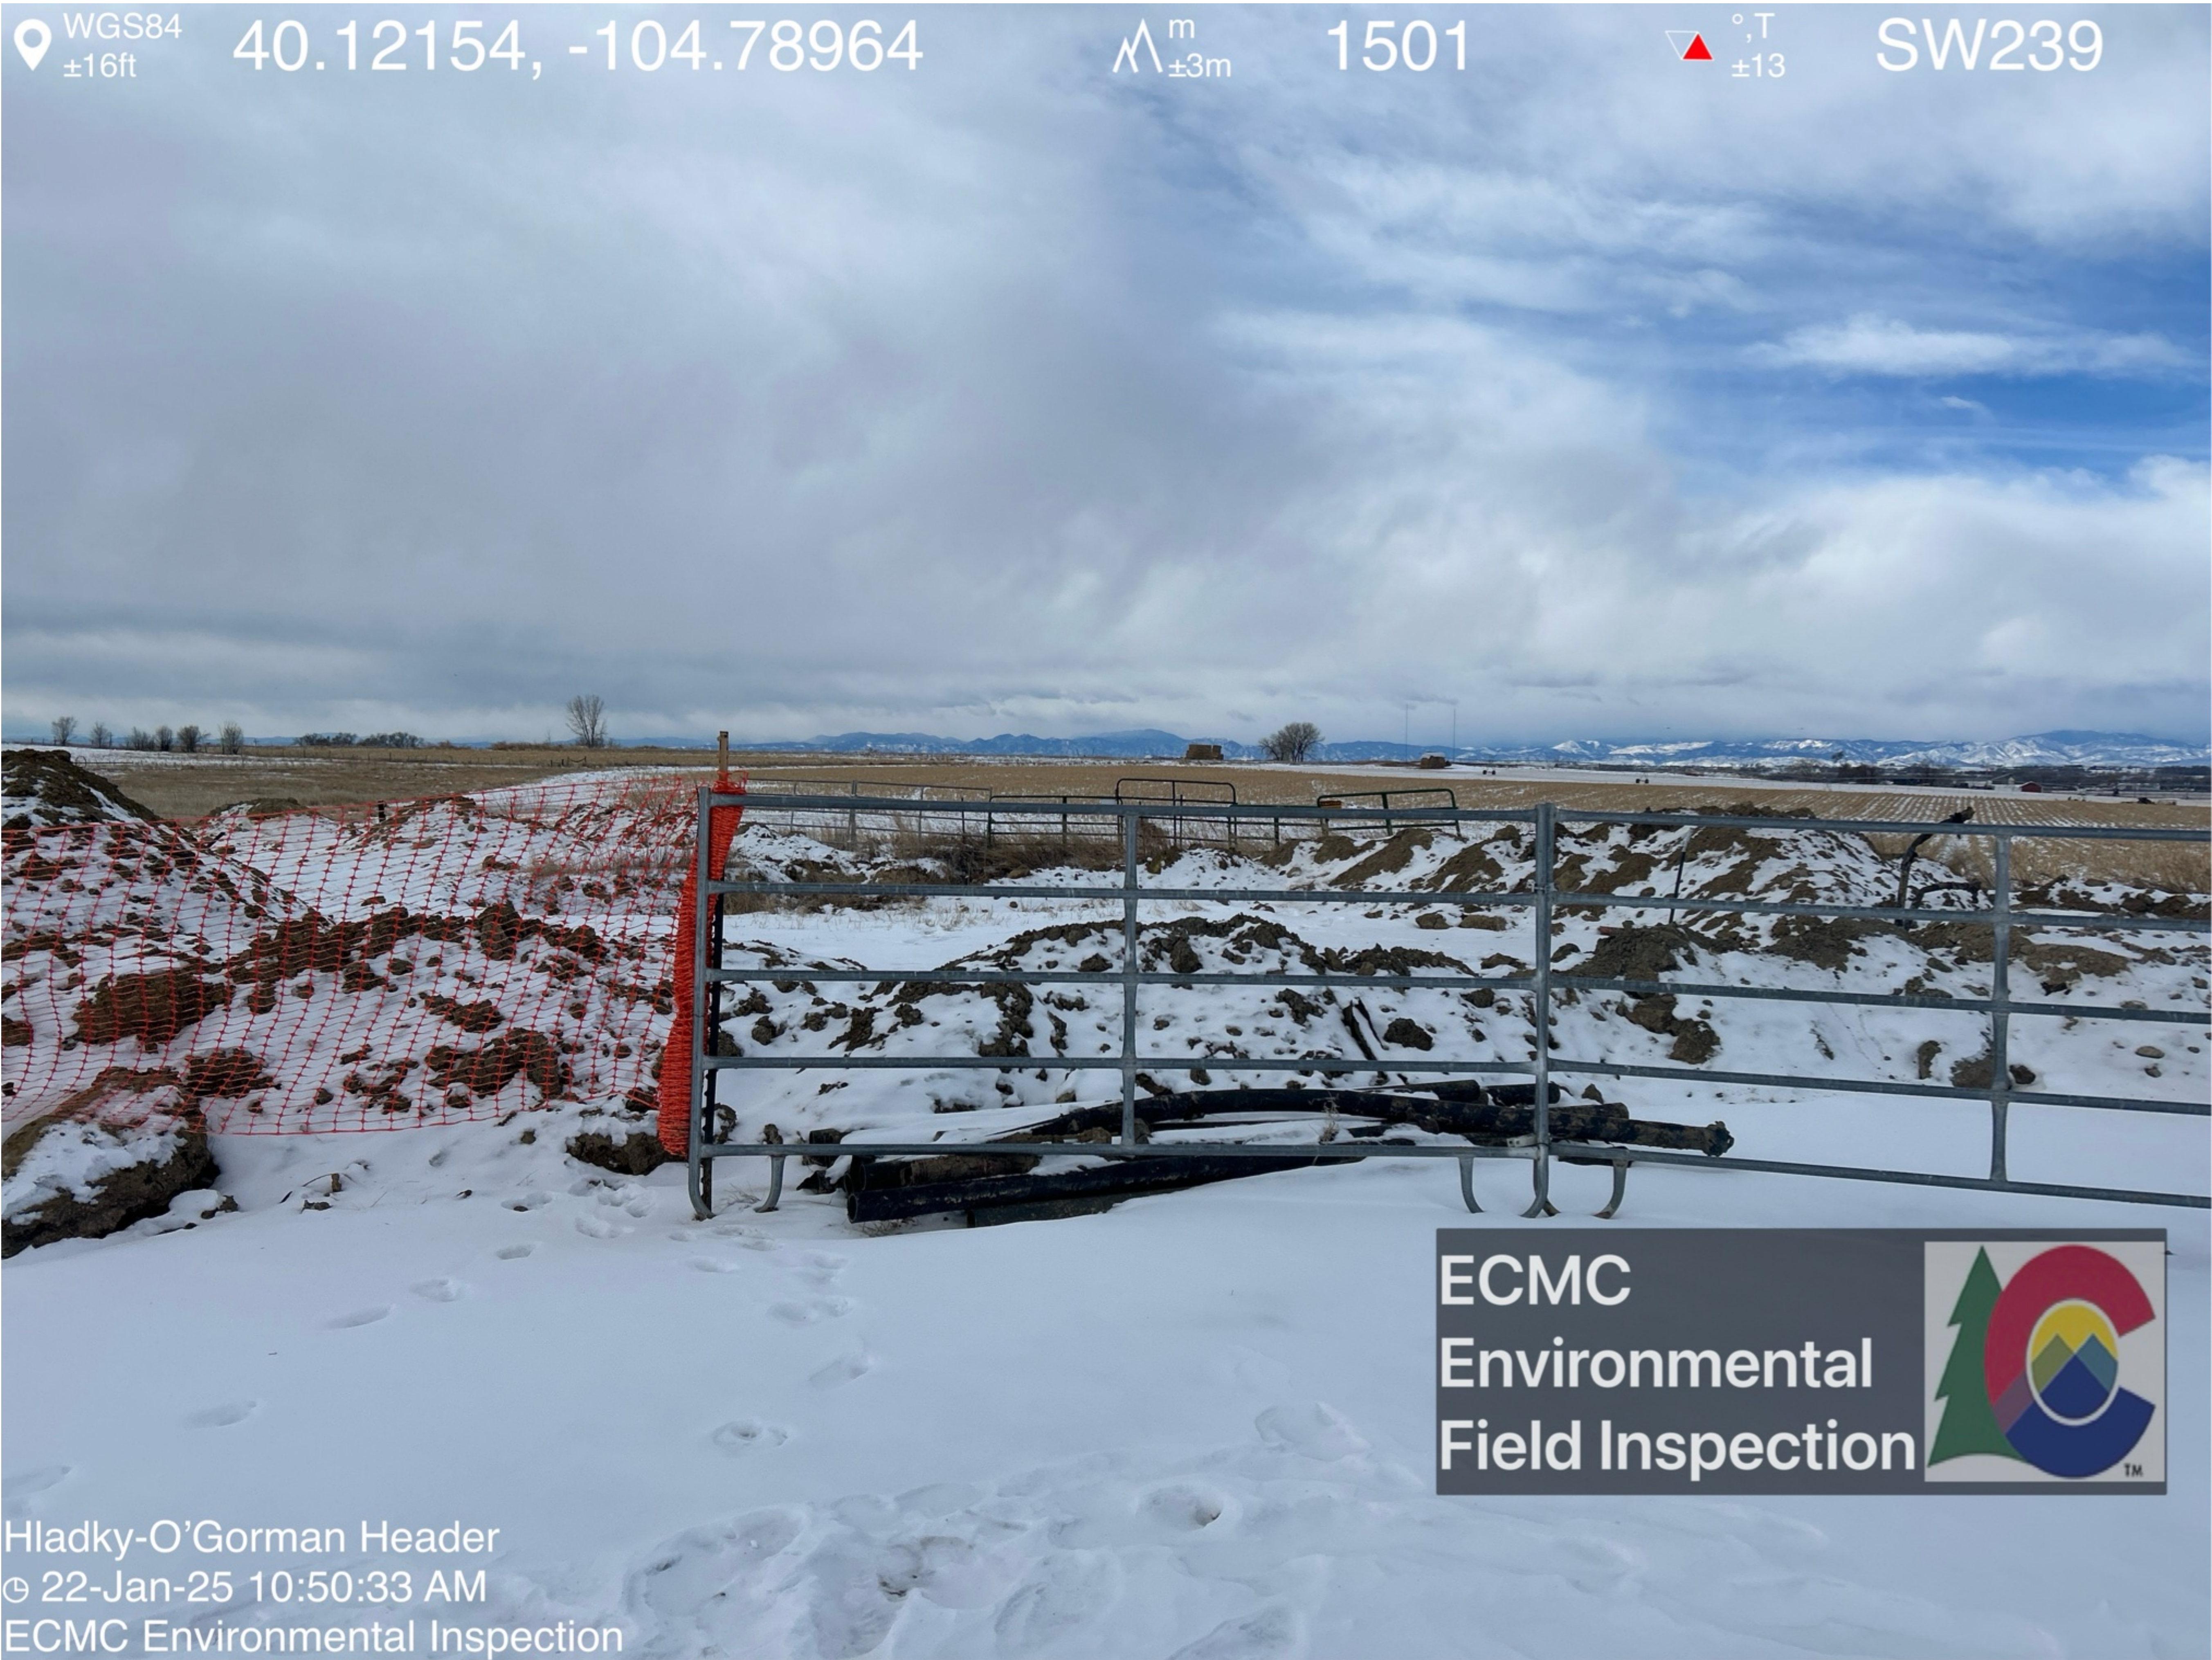
Orange construction fencing and metal fencing partially surround the excavtion.

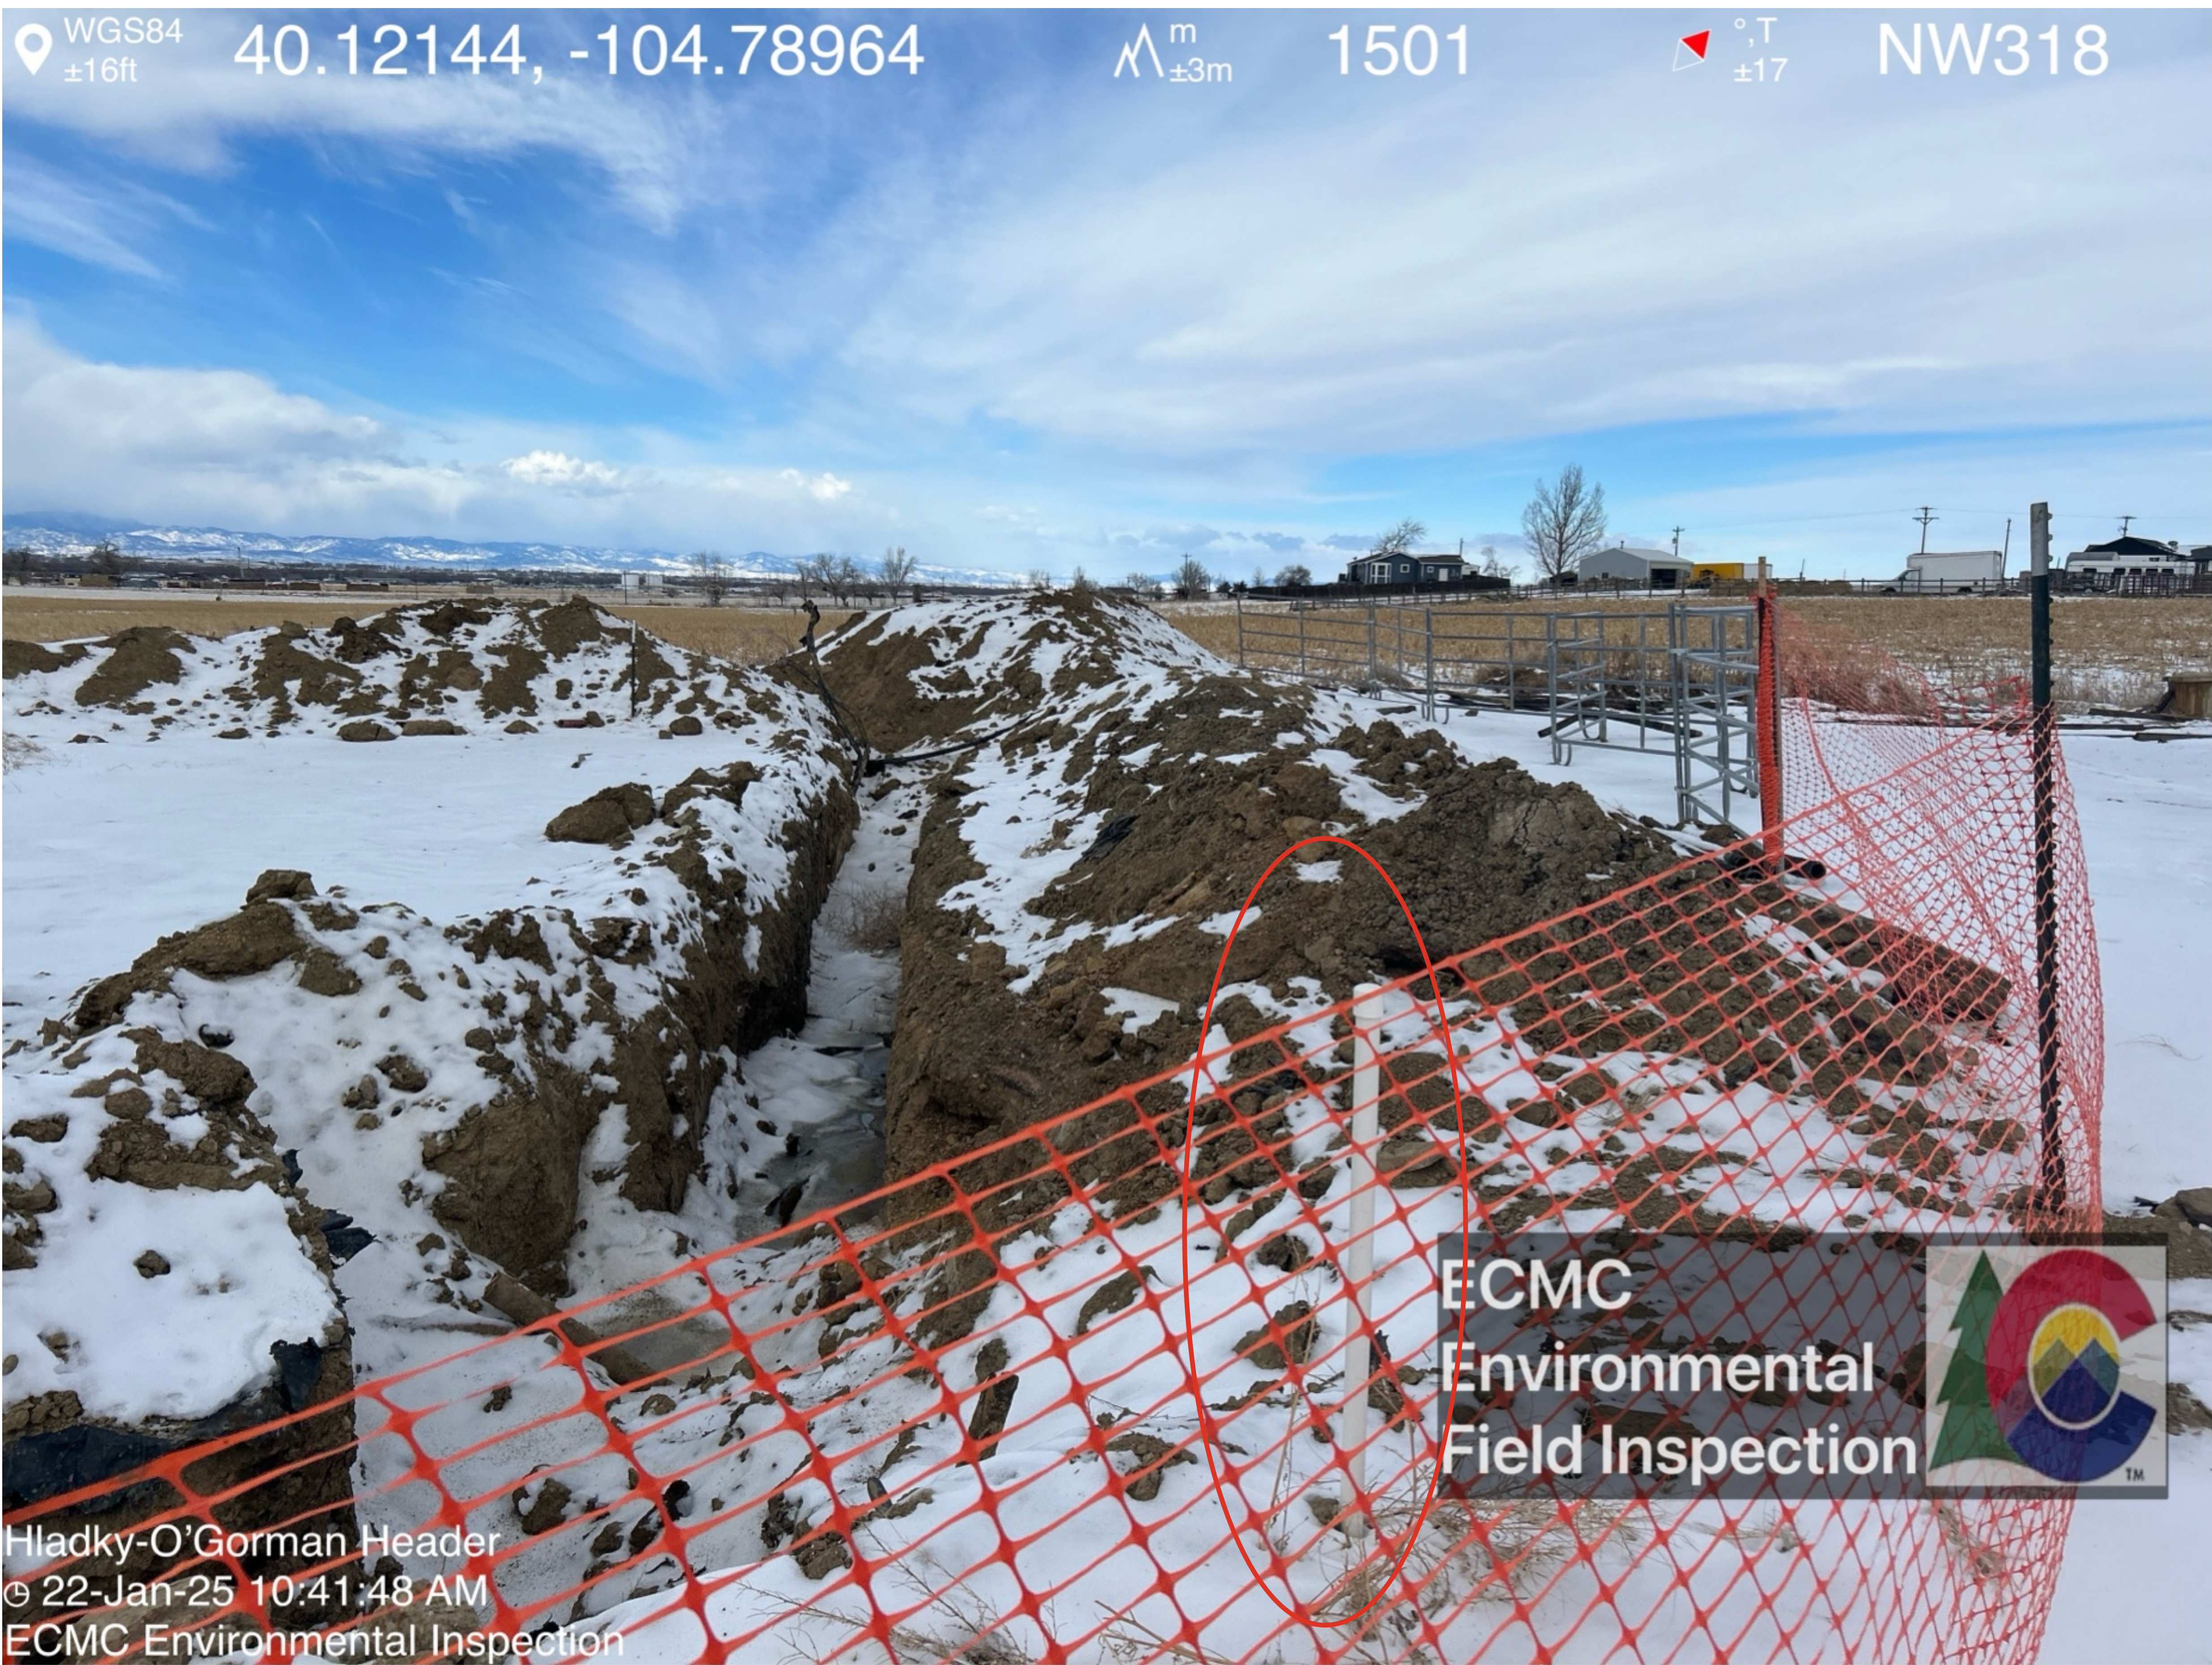
Monitoring well observed within excavation area.
