Hladky O'Gorman 3 Well (API # 05-123-07775)

Hladky-O'Gorman Header  
© 22-Jan-25 10:49:13 AM  
ECMC Environmental Inspection

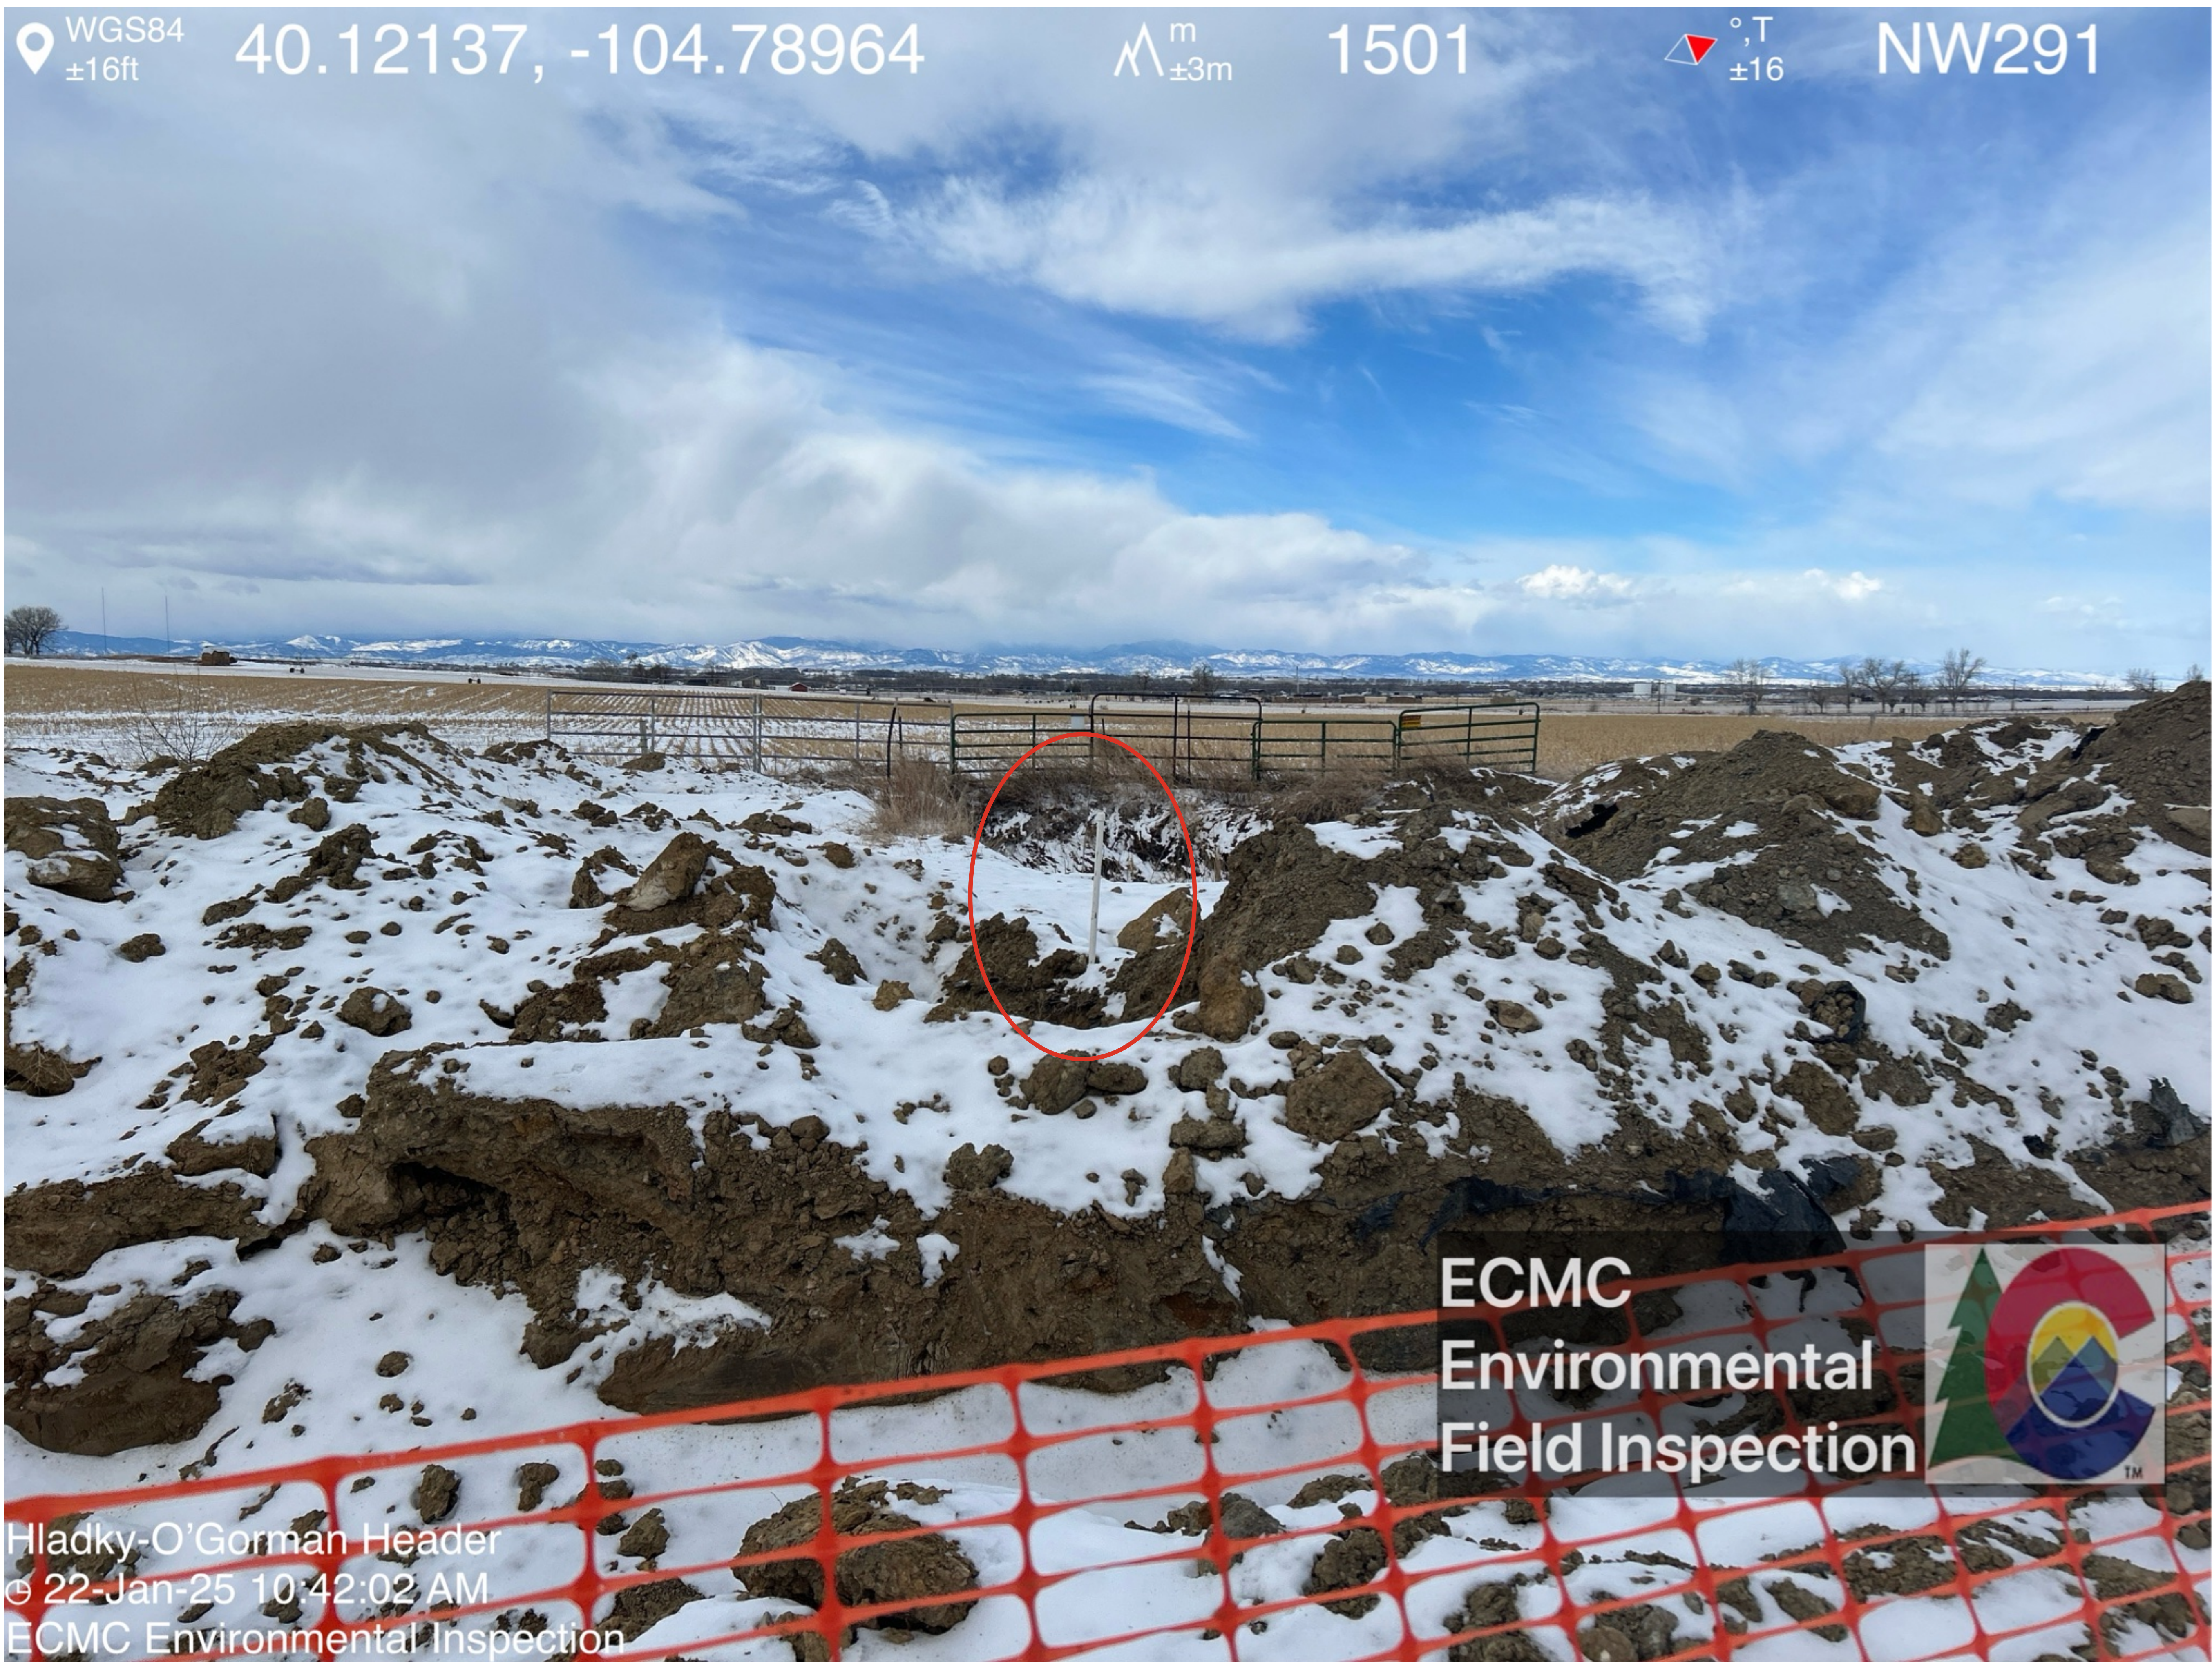
Monitoring well observed within excavation area.

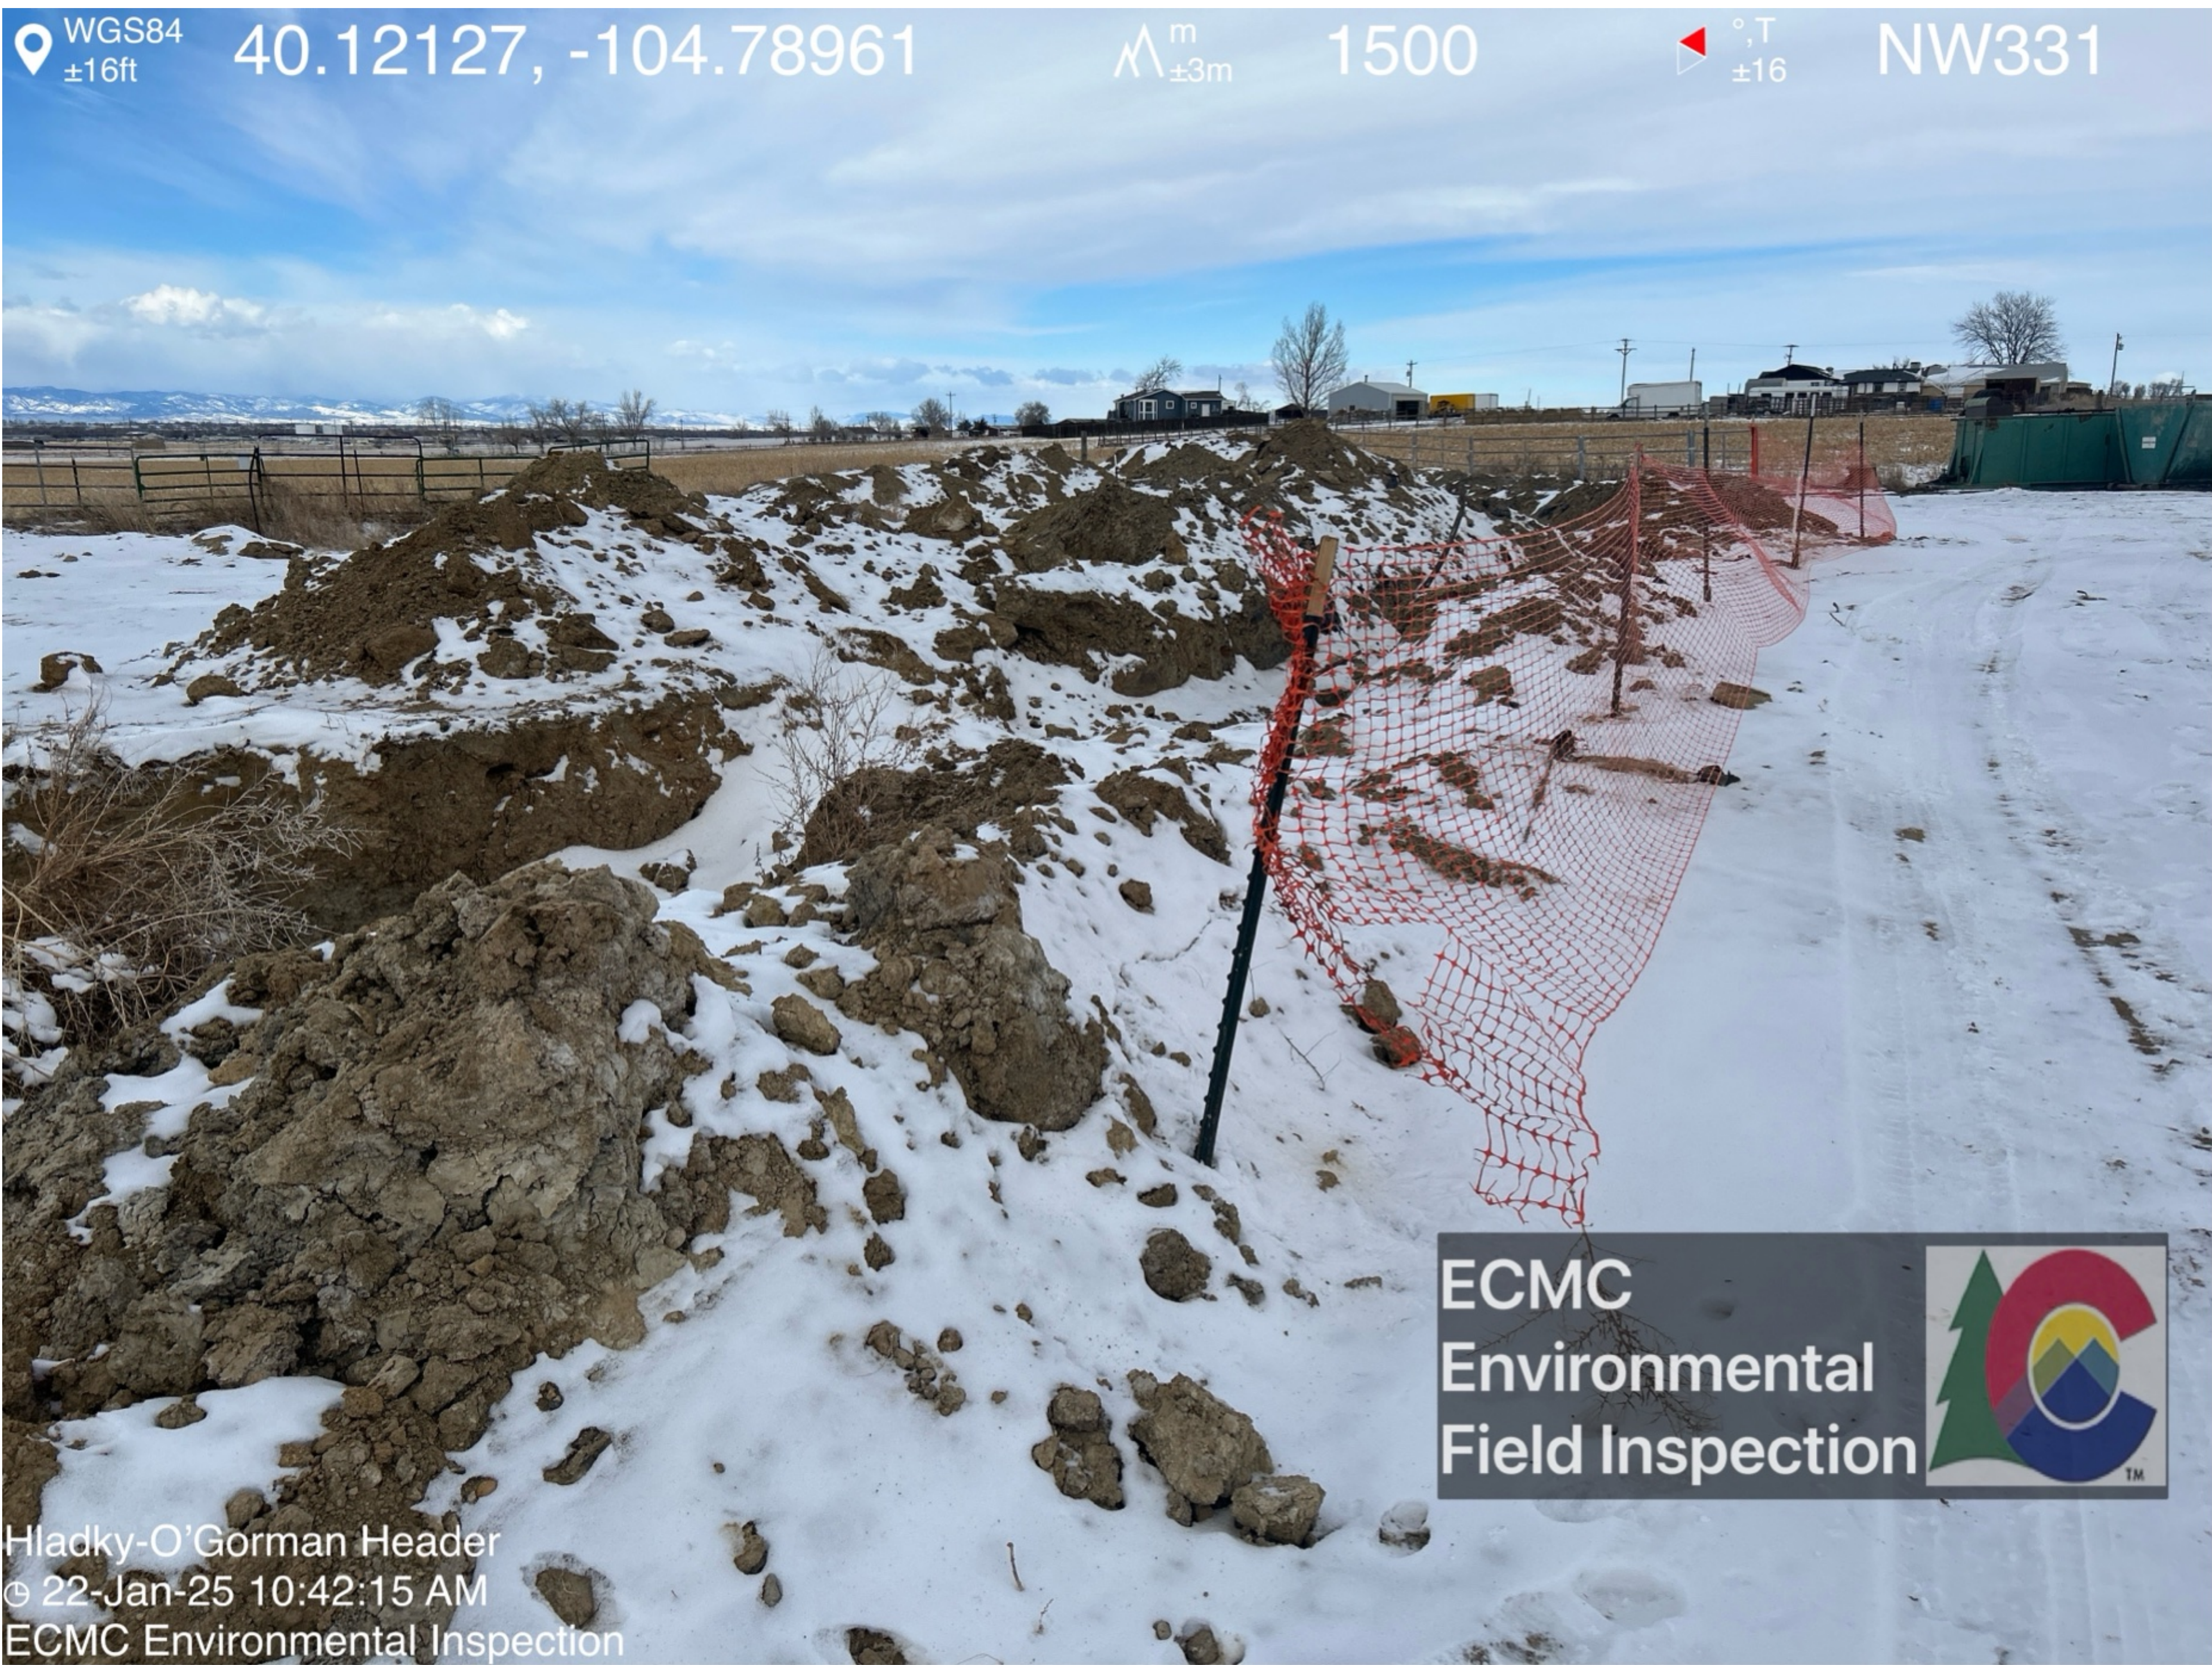
Orange construction fencing did not fully encompass the excavation area and was observed blowing in the wind.

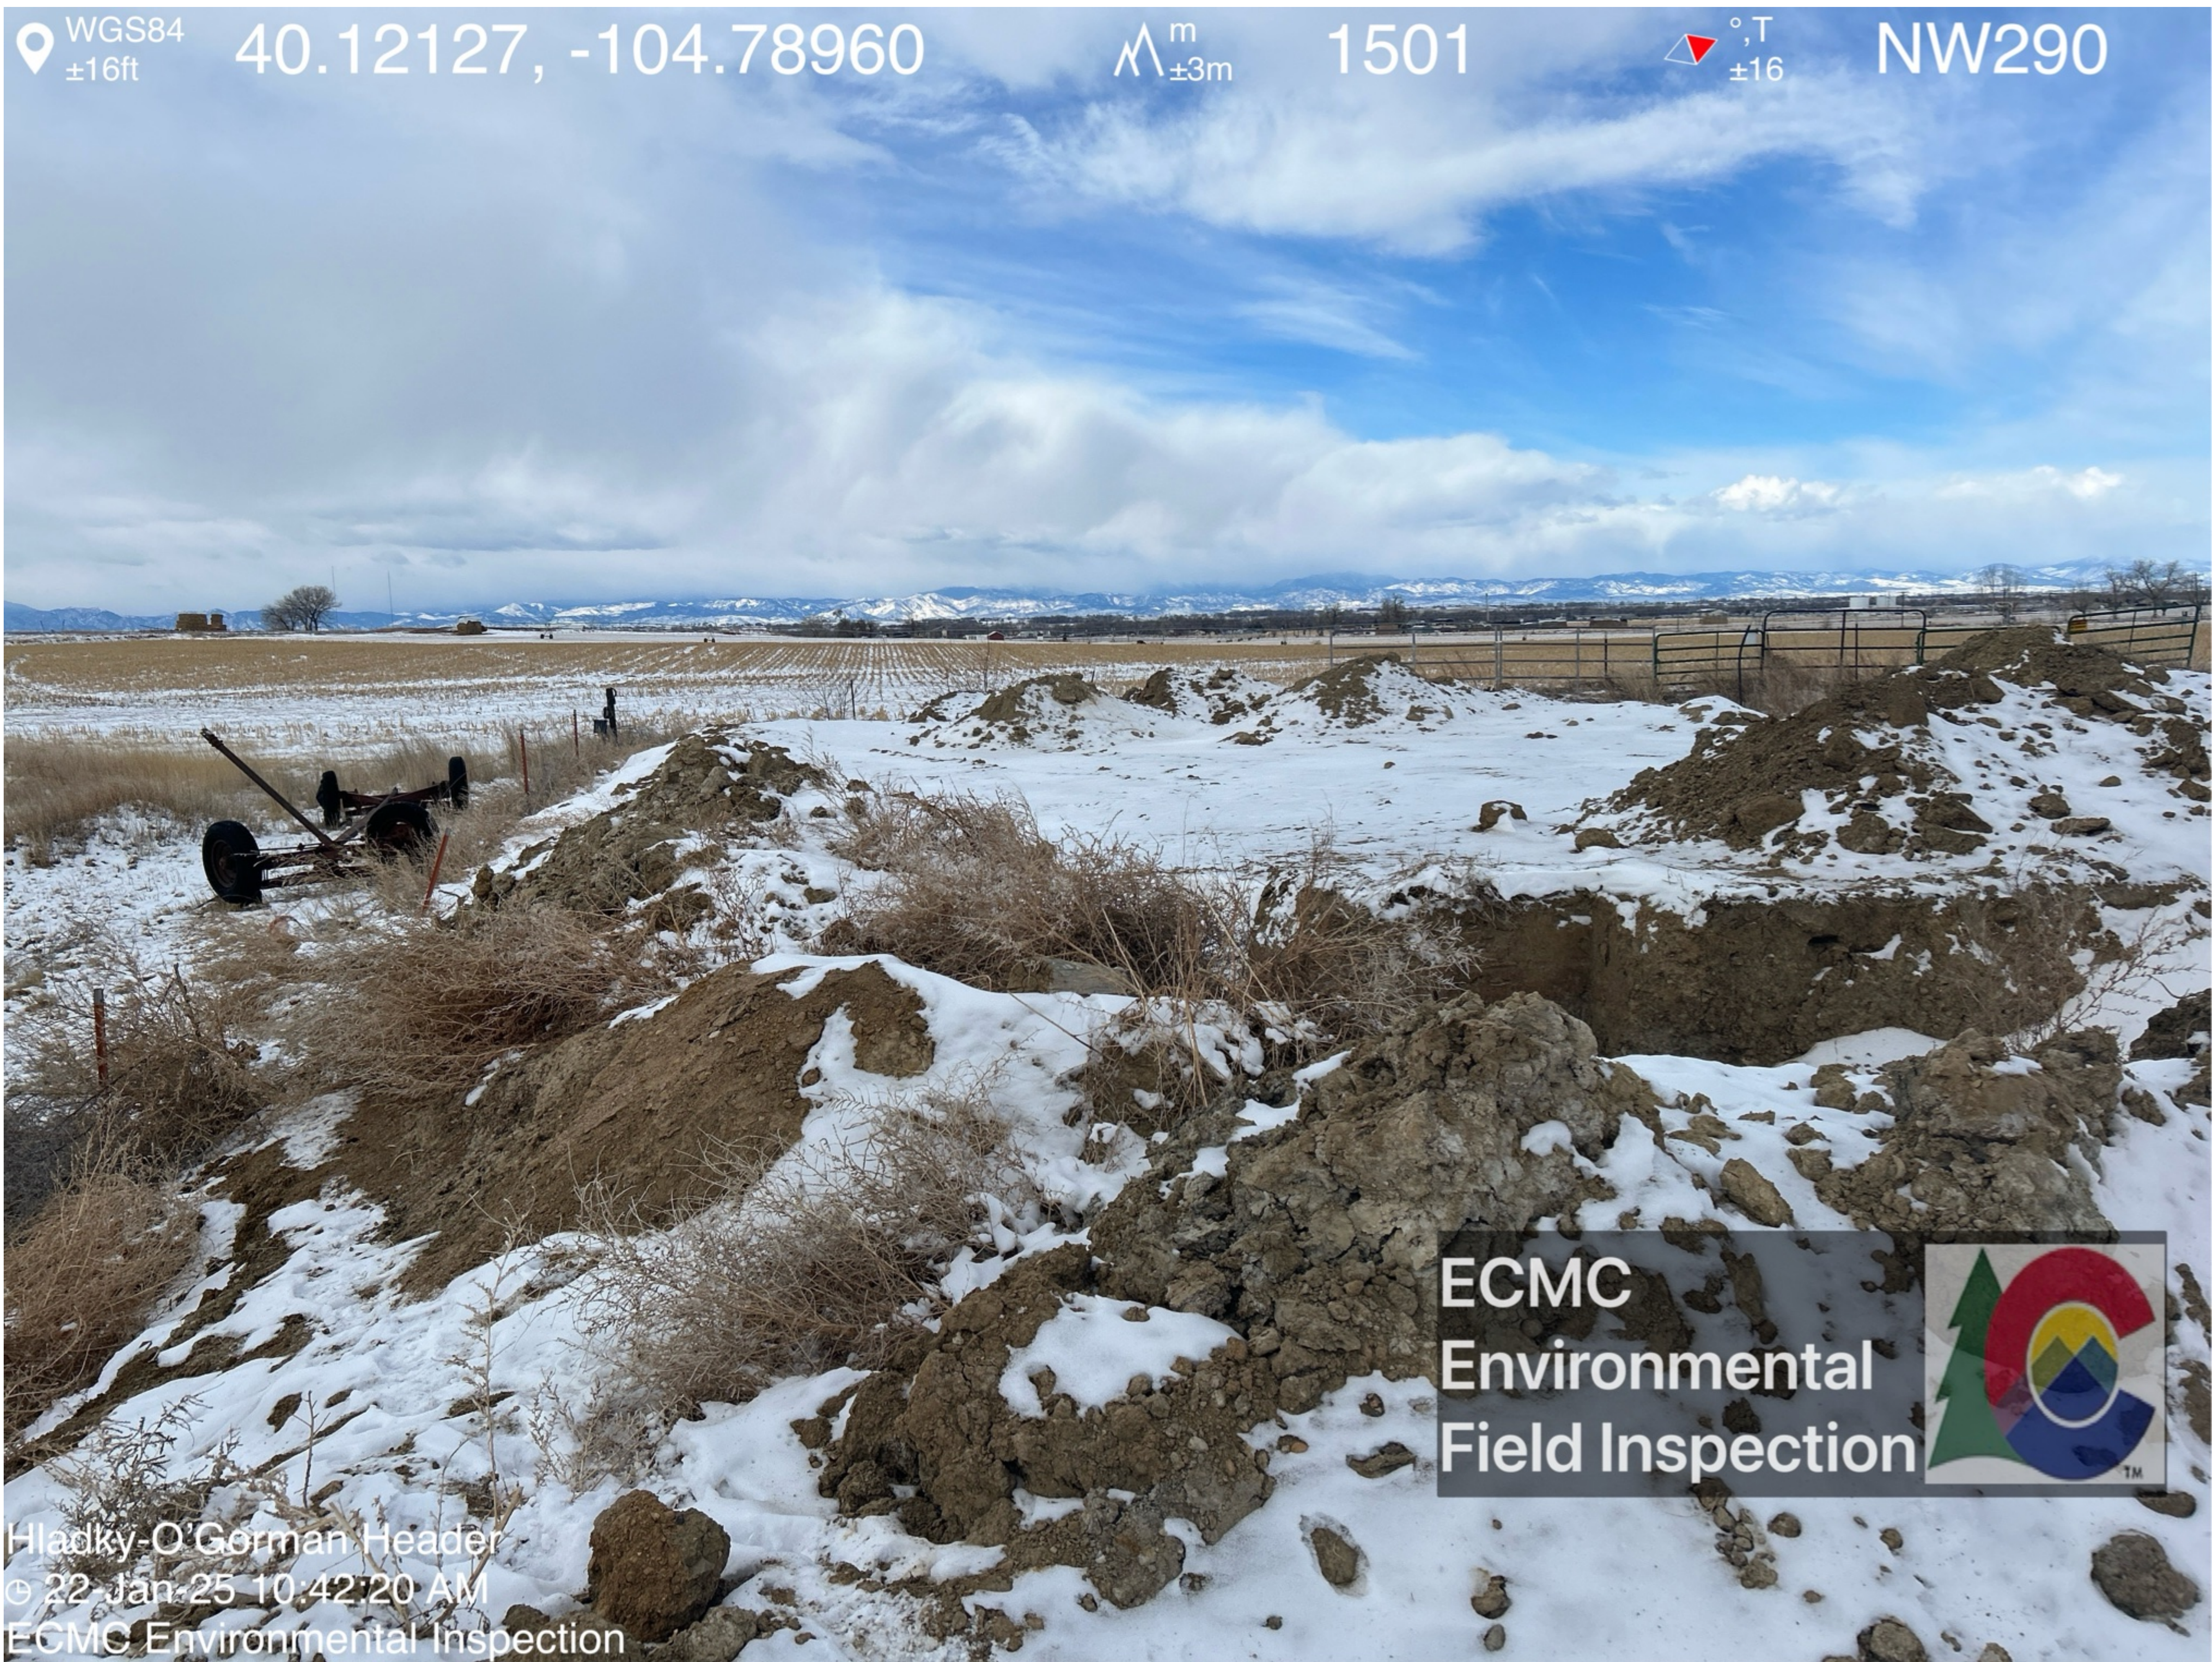
Southern and western portions of the excavation area were not secured.

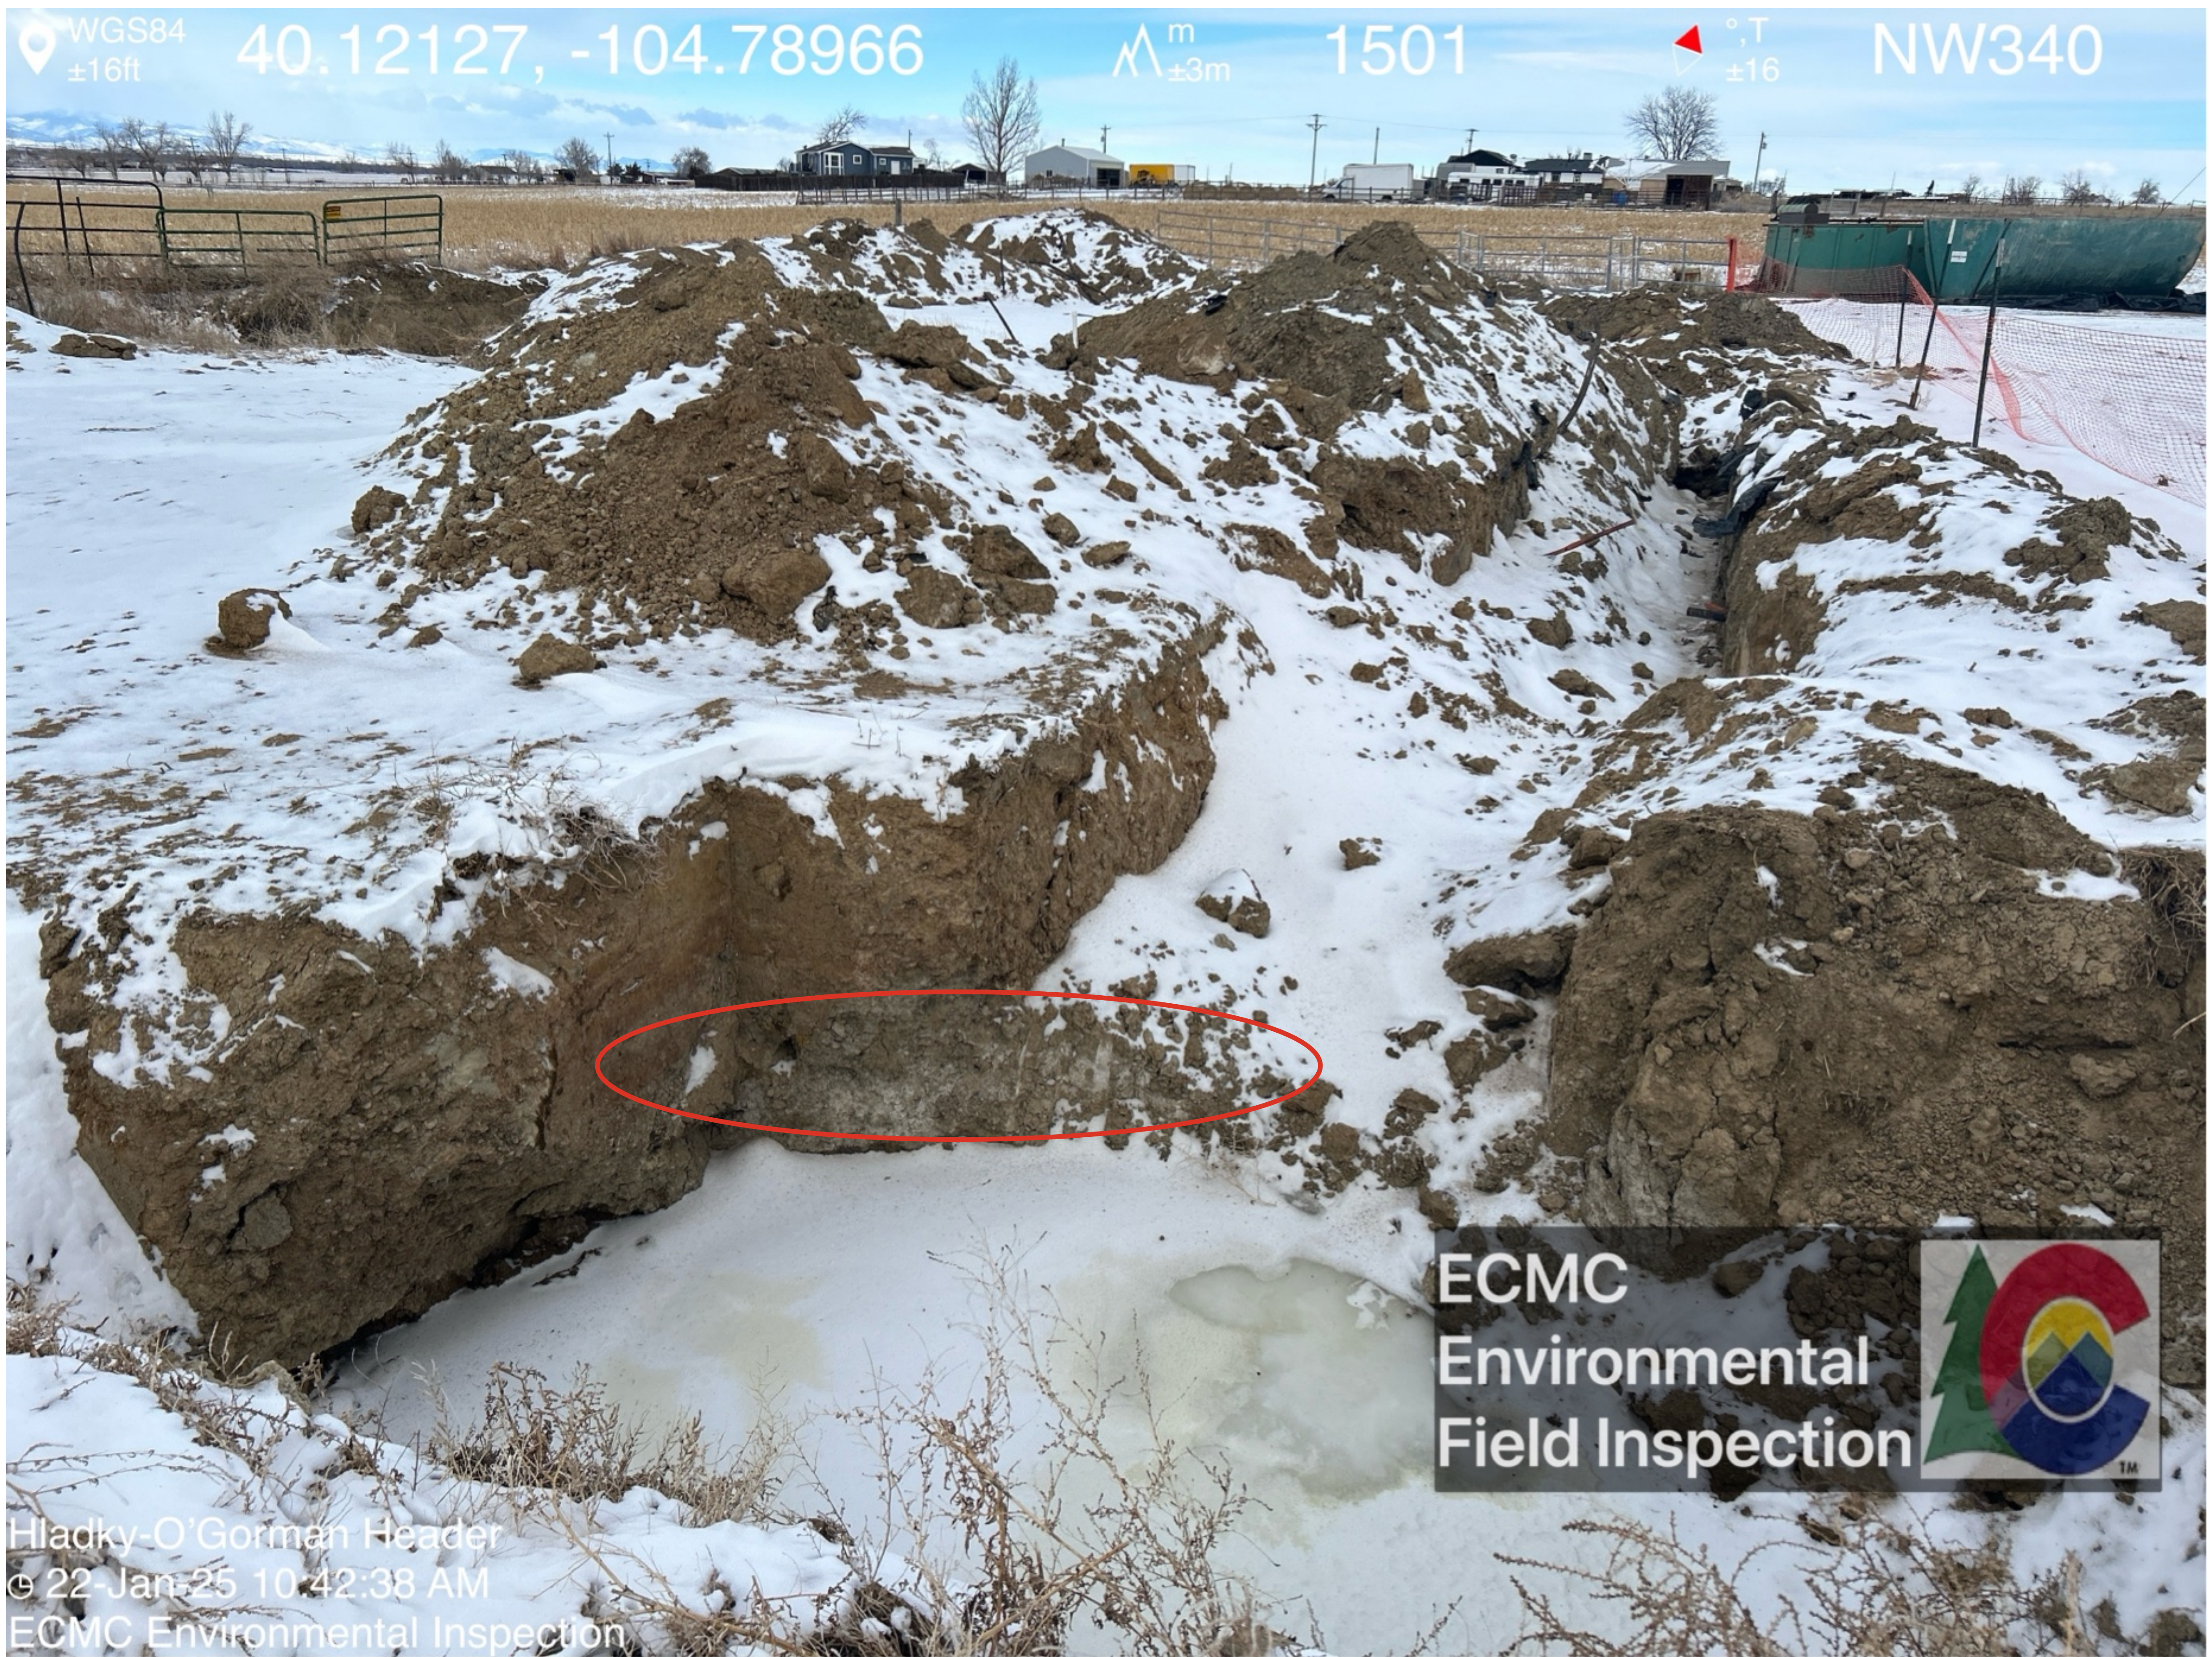
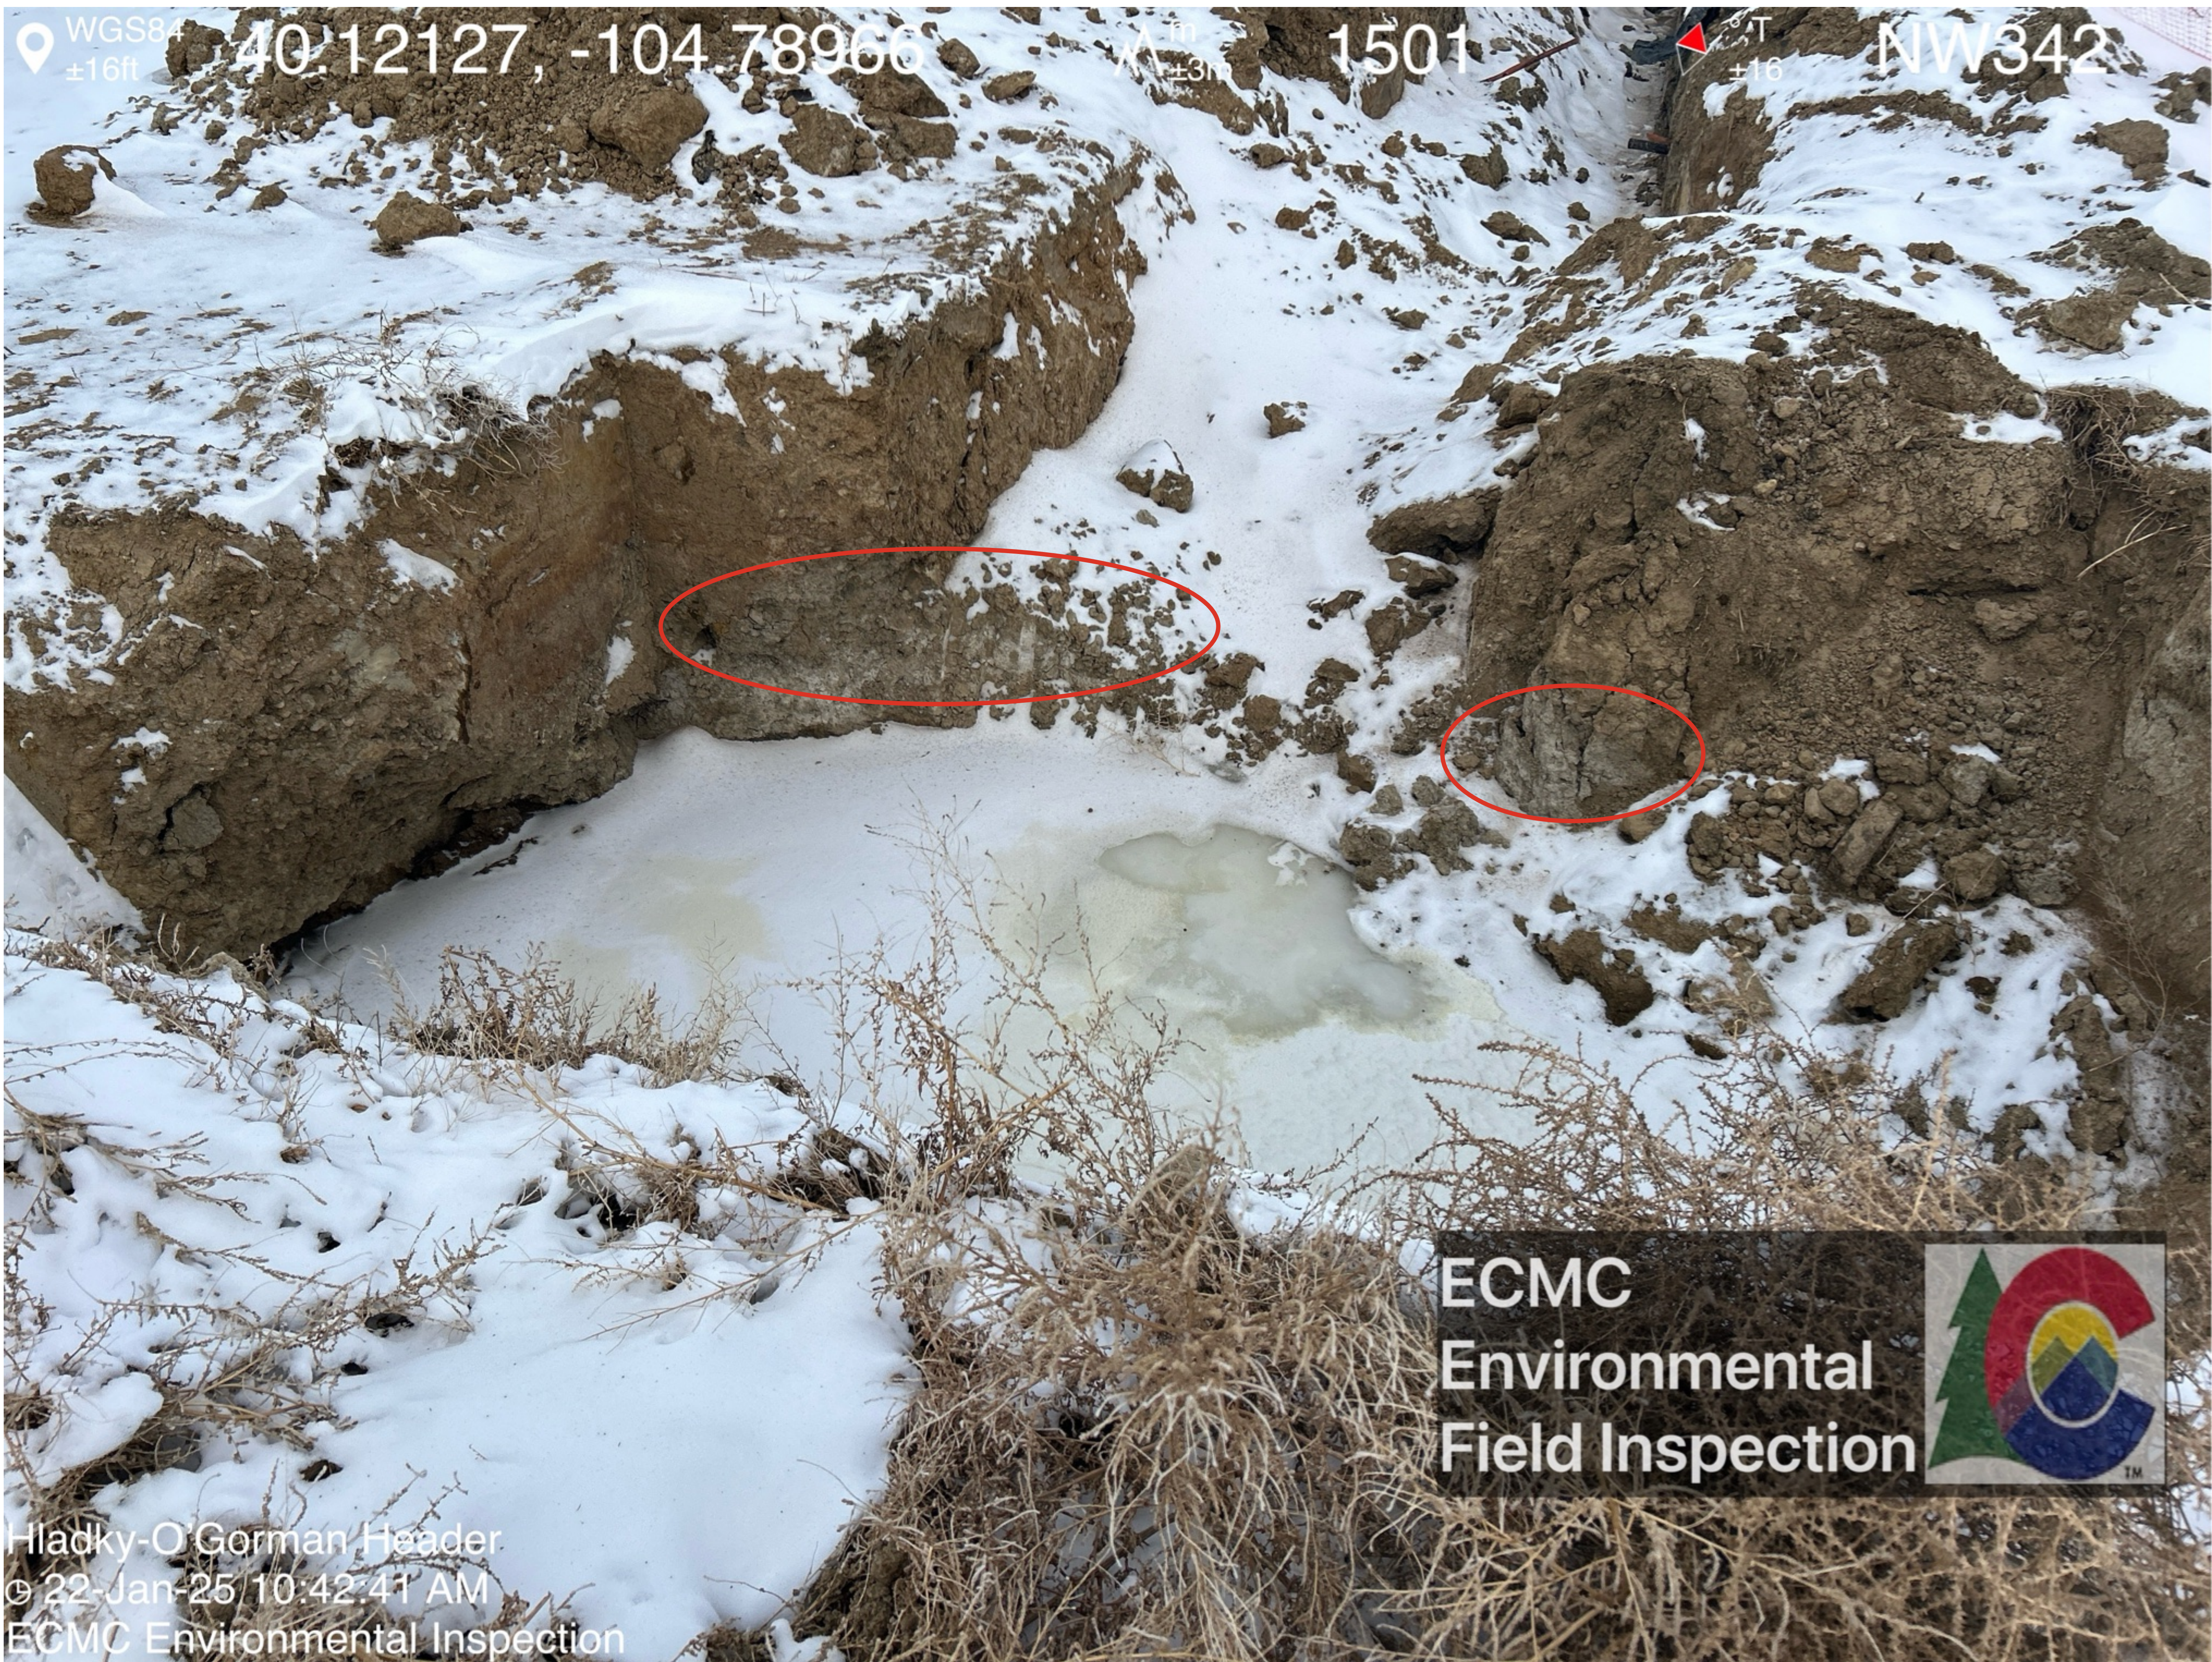
Soil with gray staining was observed in contact with frozen groundwater.

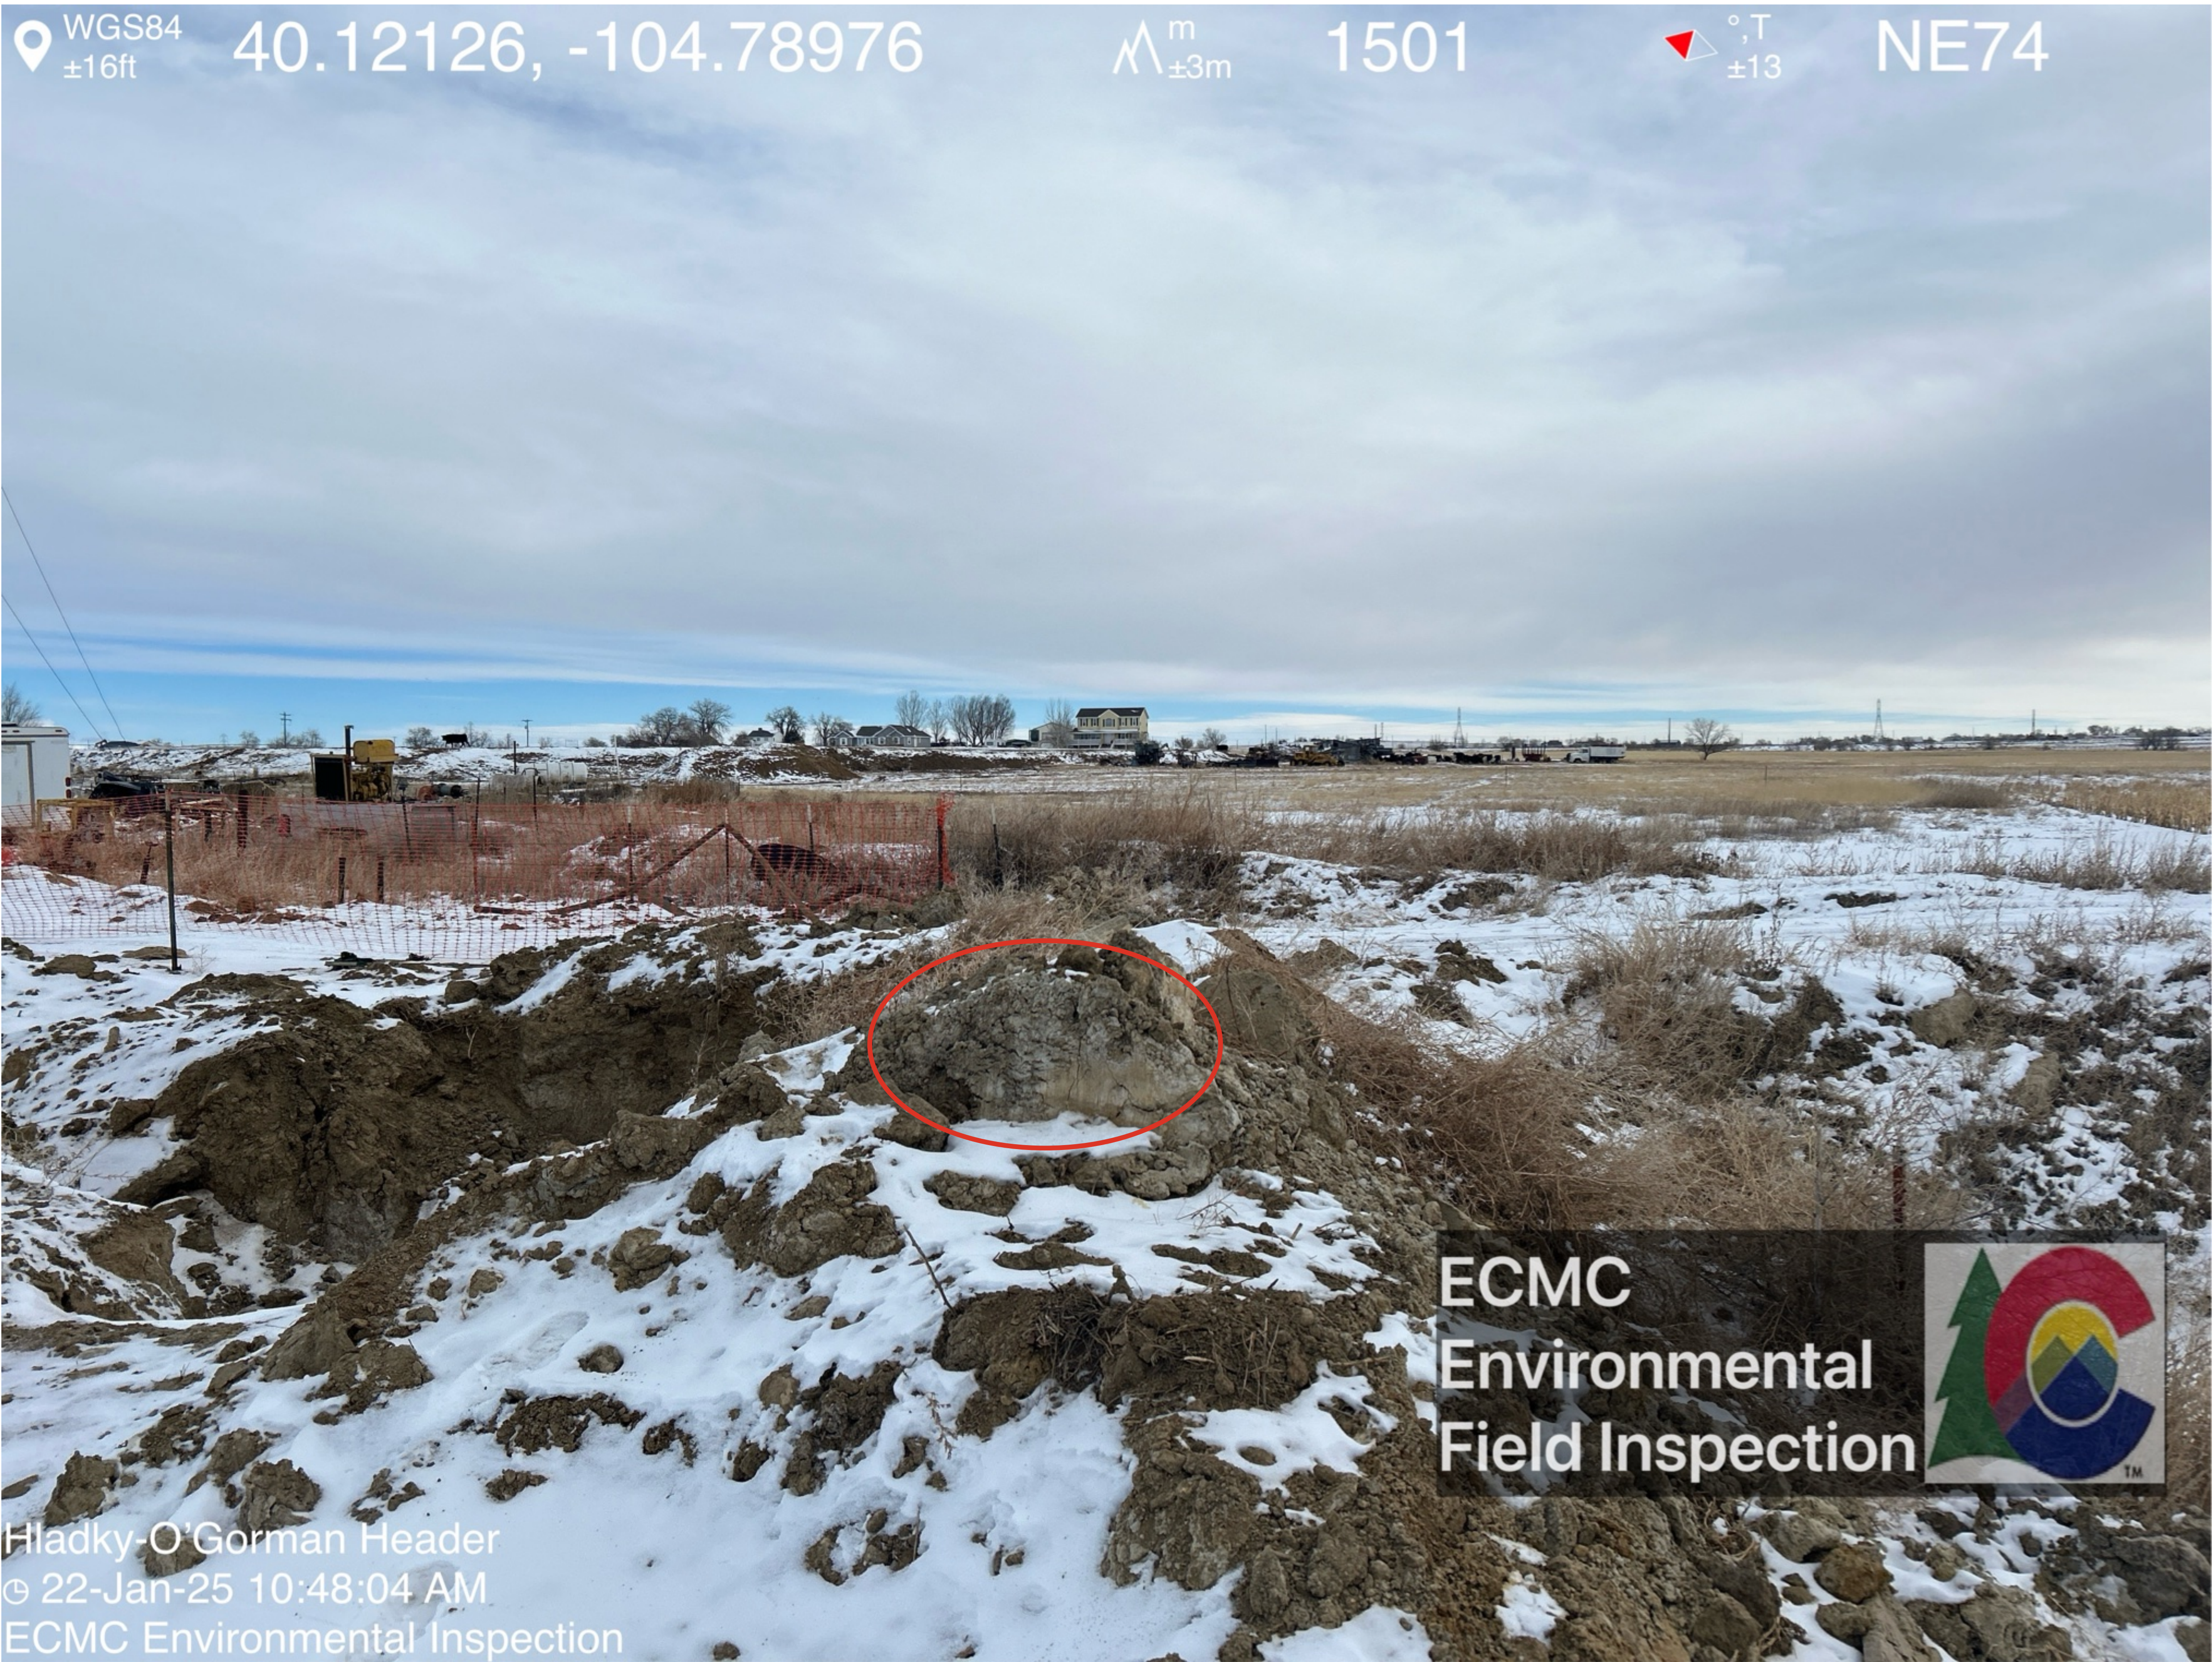
Gray staining observed on stockpiled soil. Weeds have grown on the stockpile and no BMPs are present.
