Hladky O'Gorman 3 Well (API # 05-123-07775)

Hladky-O'Gorman Header  
© 22-Jan-25 10:49:13 AM  
ECMC Environmental Inspection

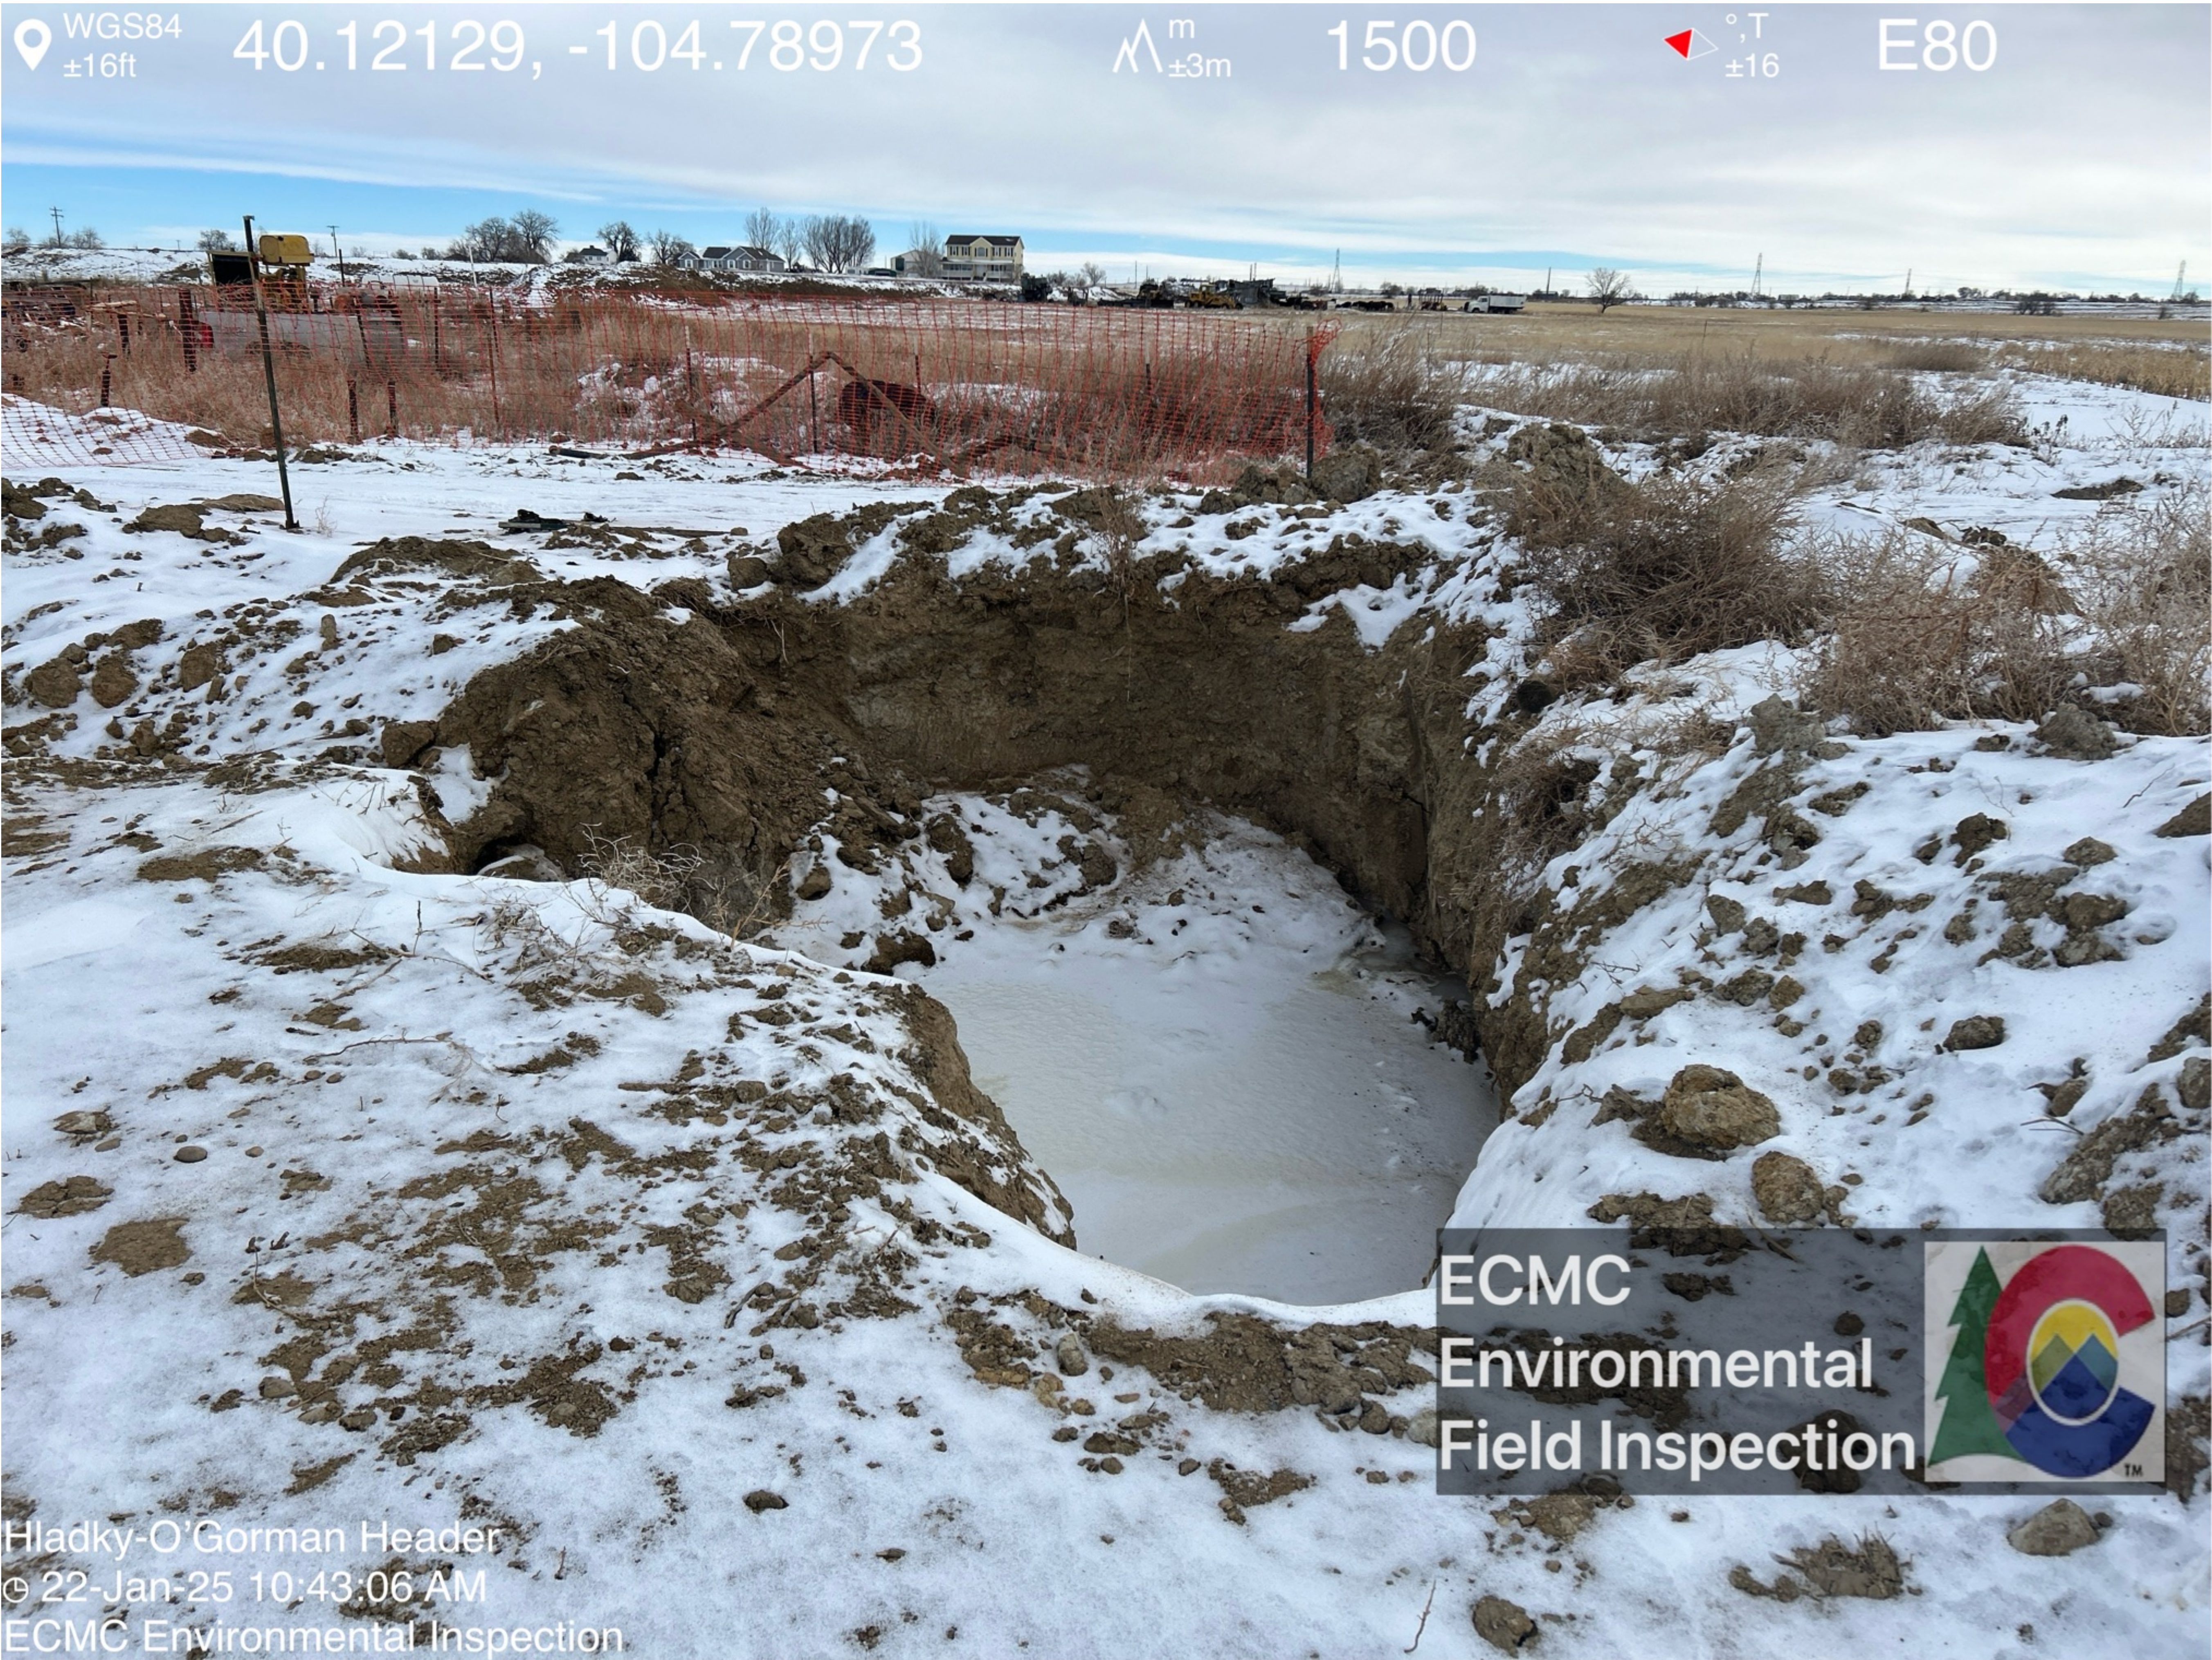
Orange construction fencing does not fully encompass excavation with frozen groundwater.

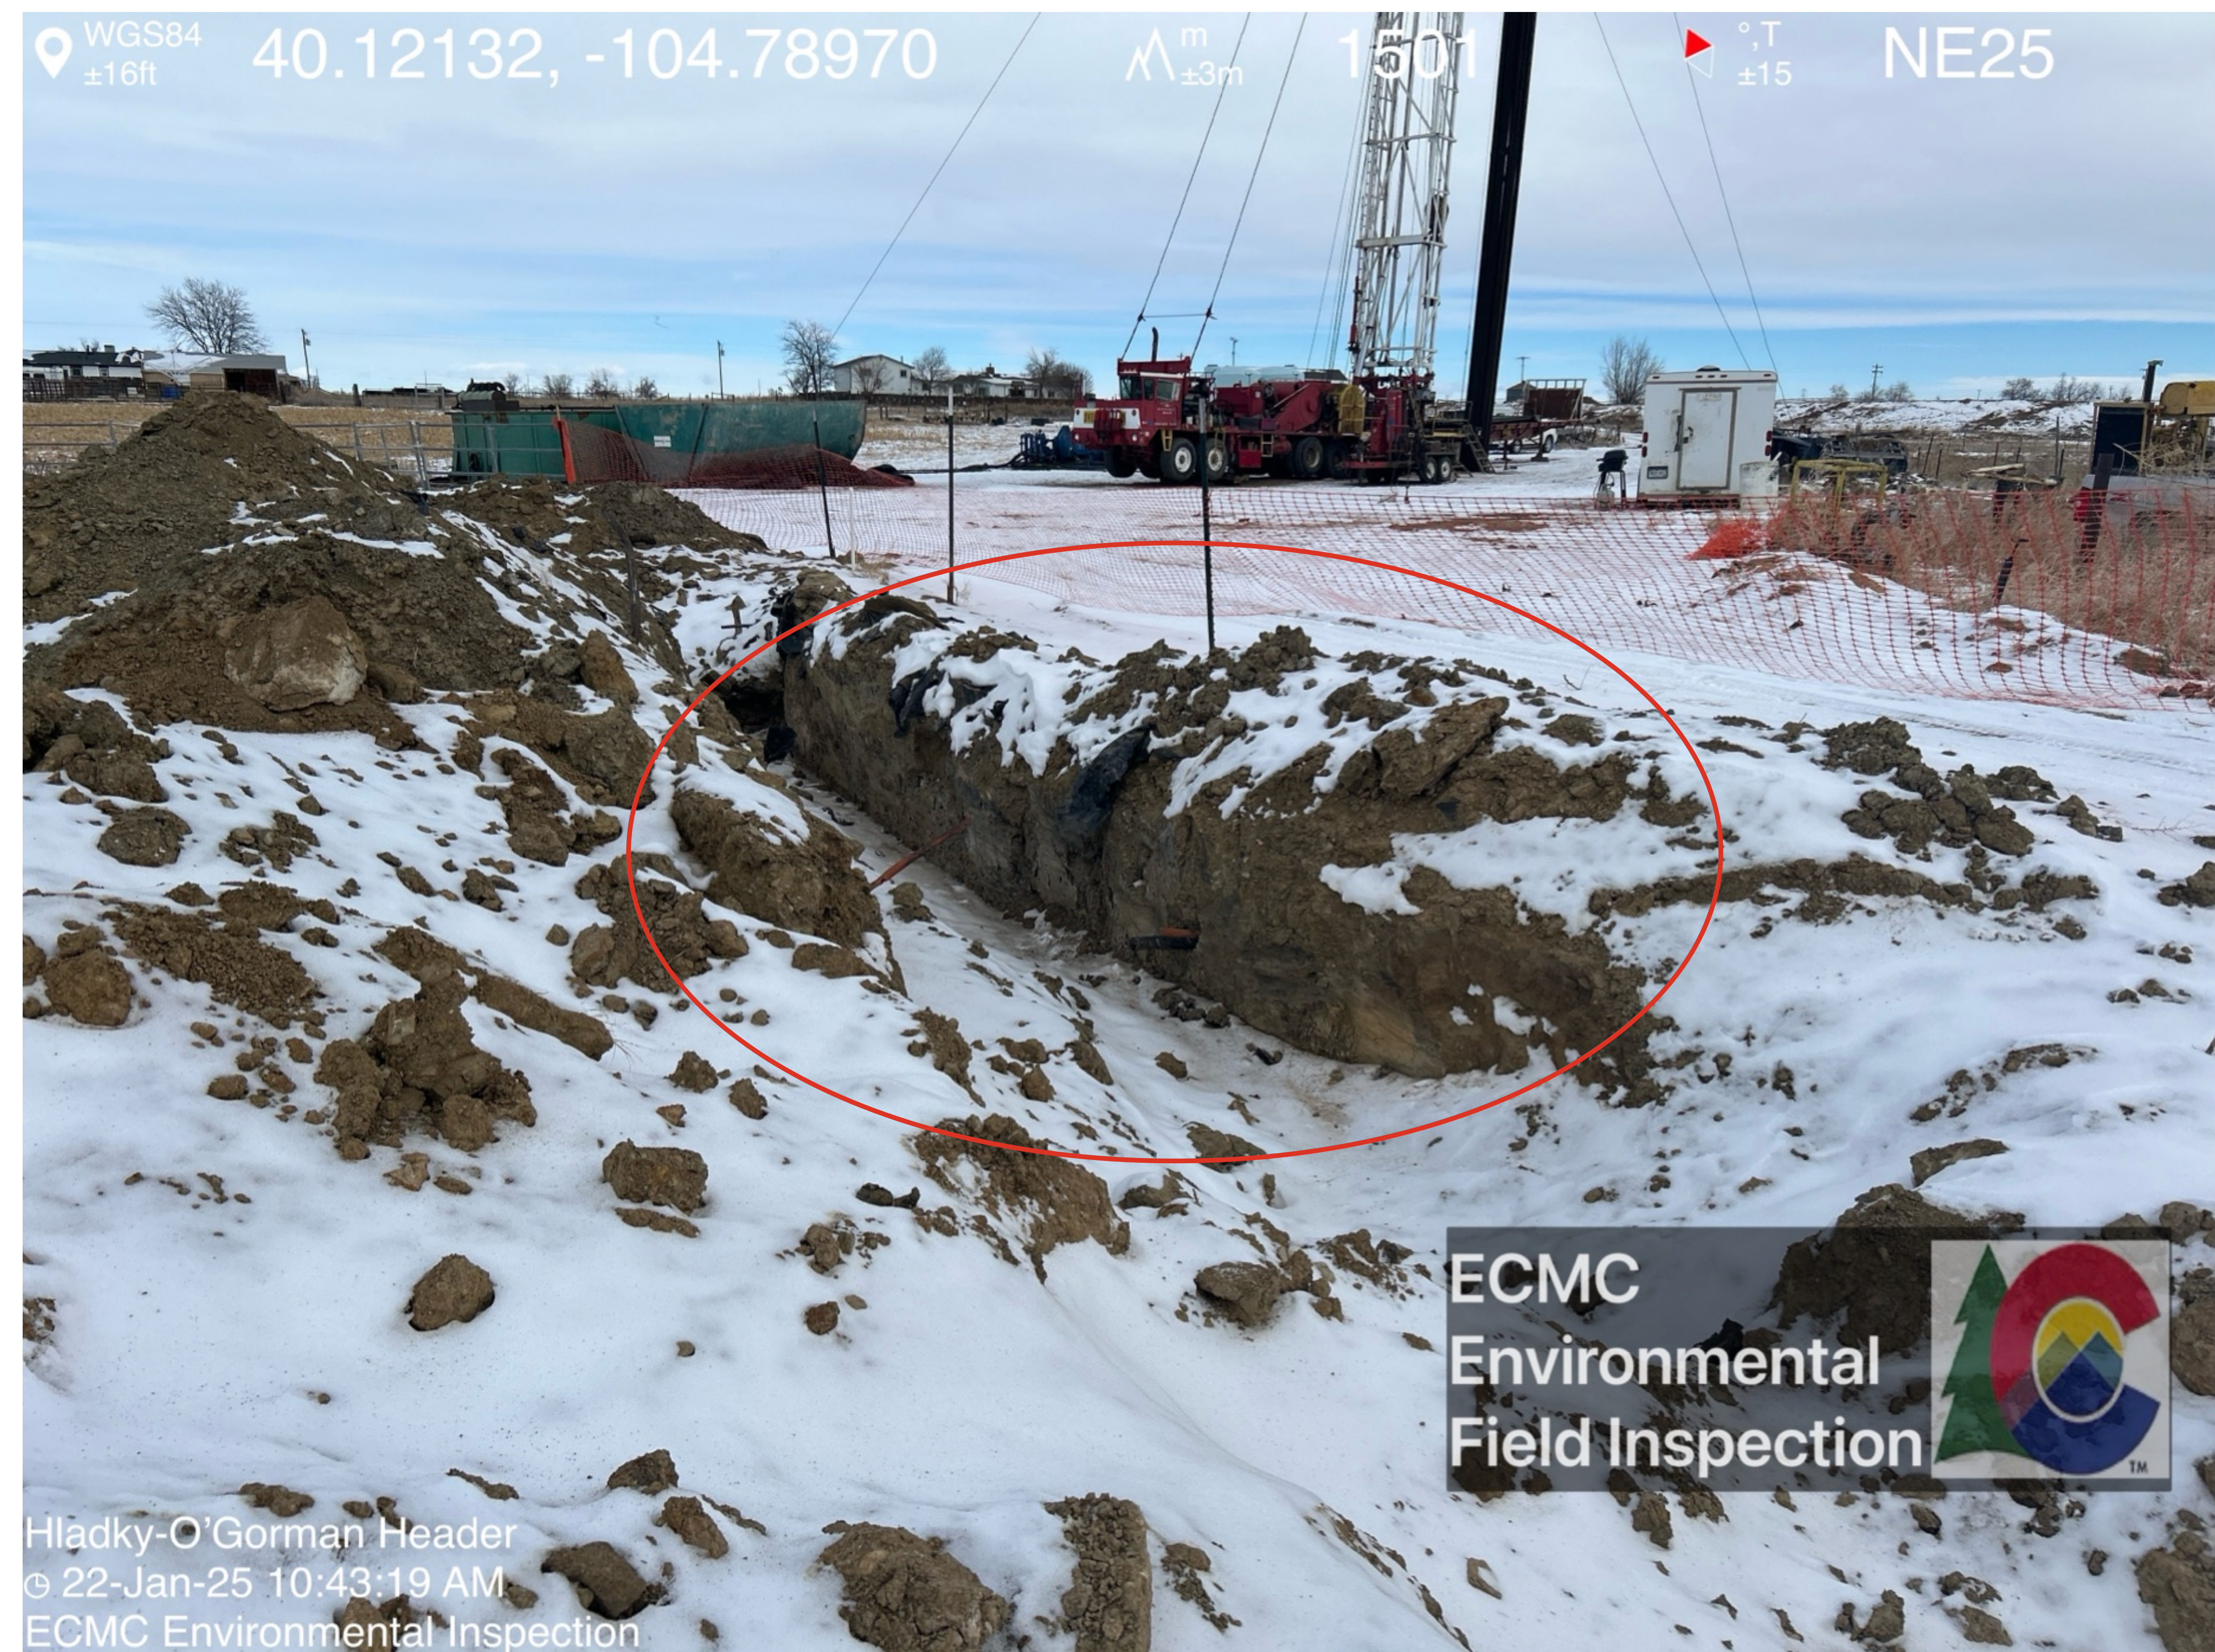
Excavation trenching observed. Gray staining, pieces of a torn liner, and severed pipes/tubes are visible.

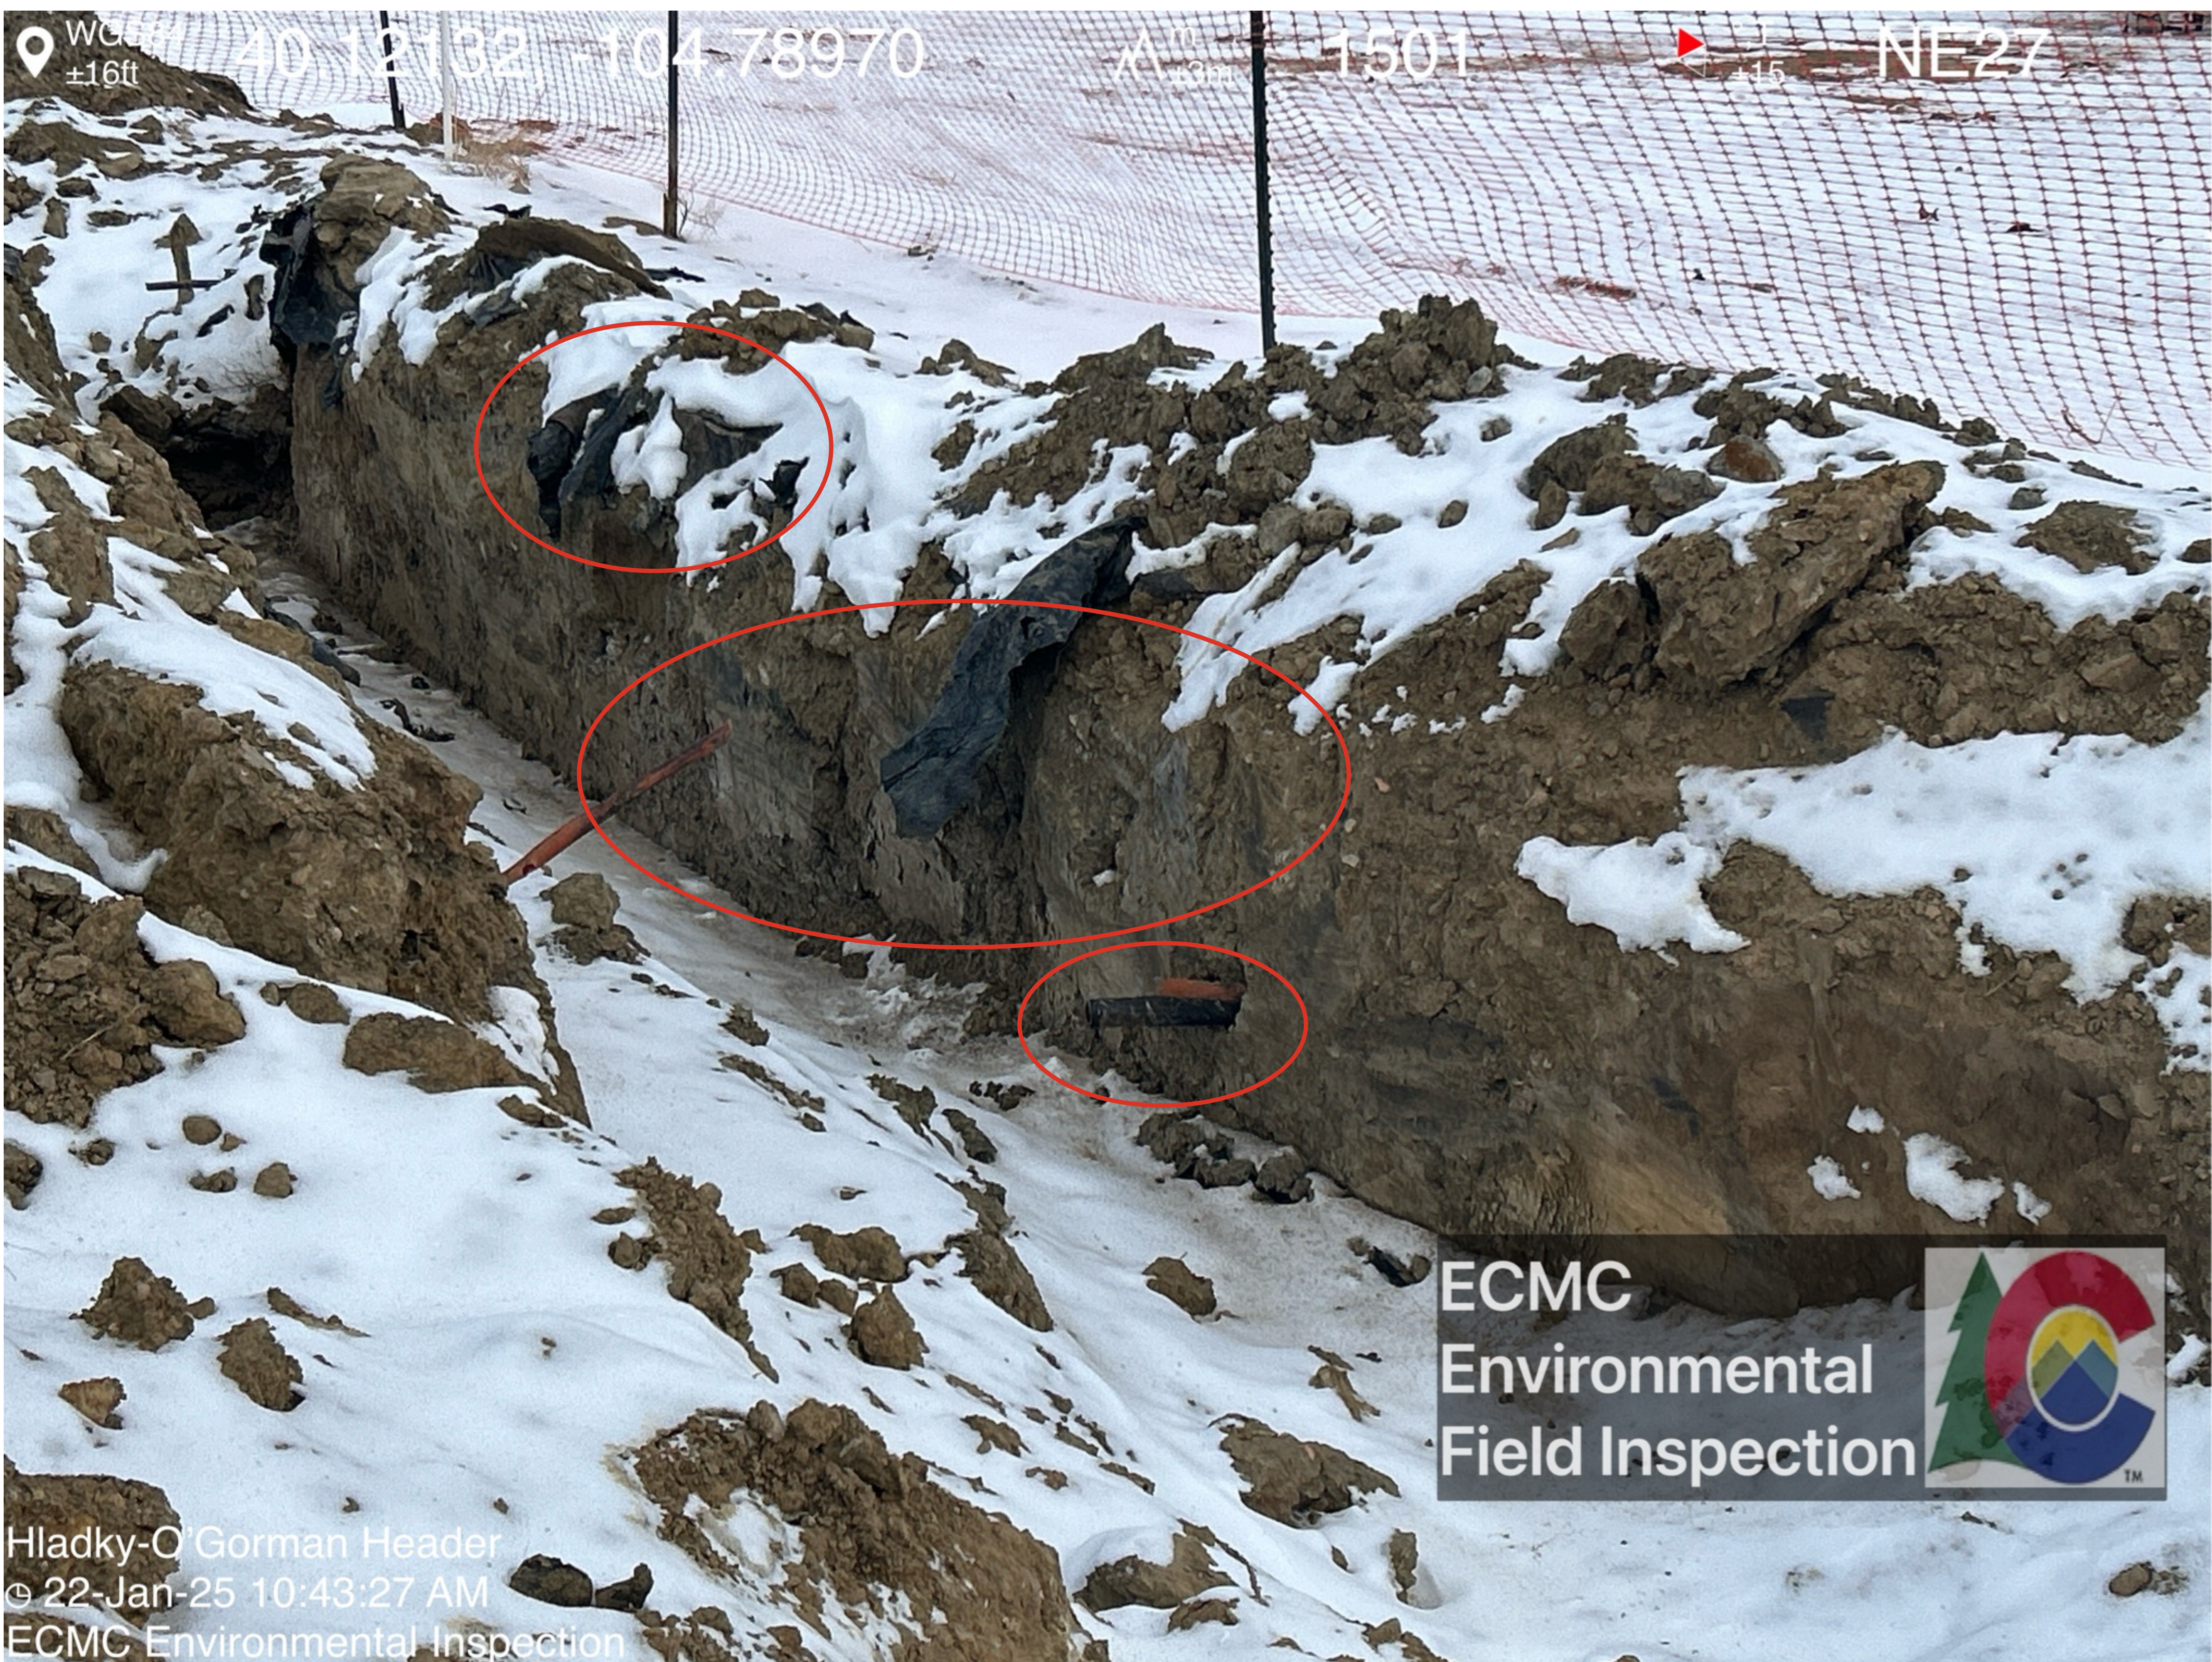
Excavation trenching observed. Gray staining, pieces of a torn liner, and severed pipes/tubes are visible.

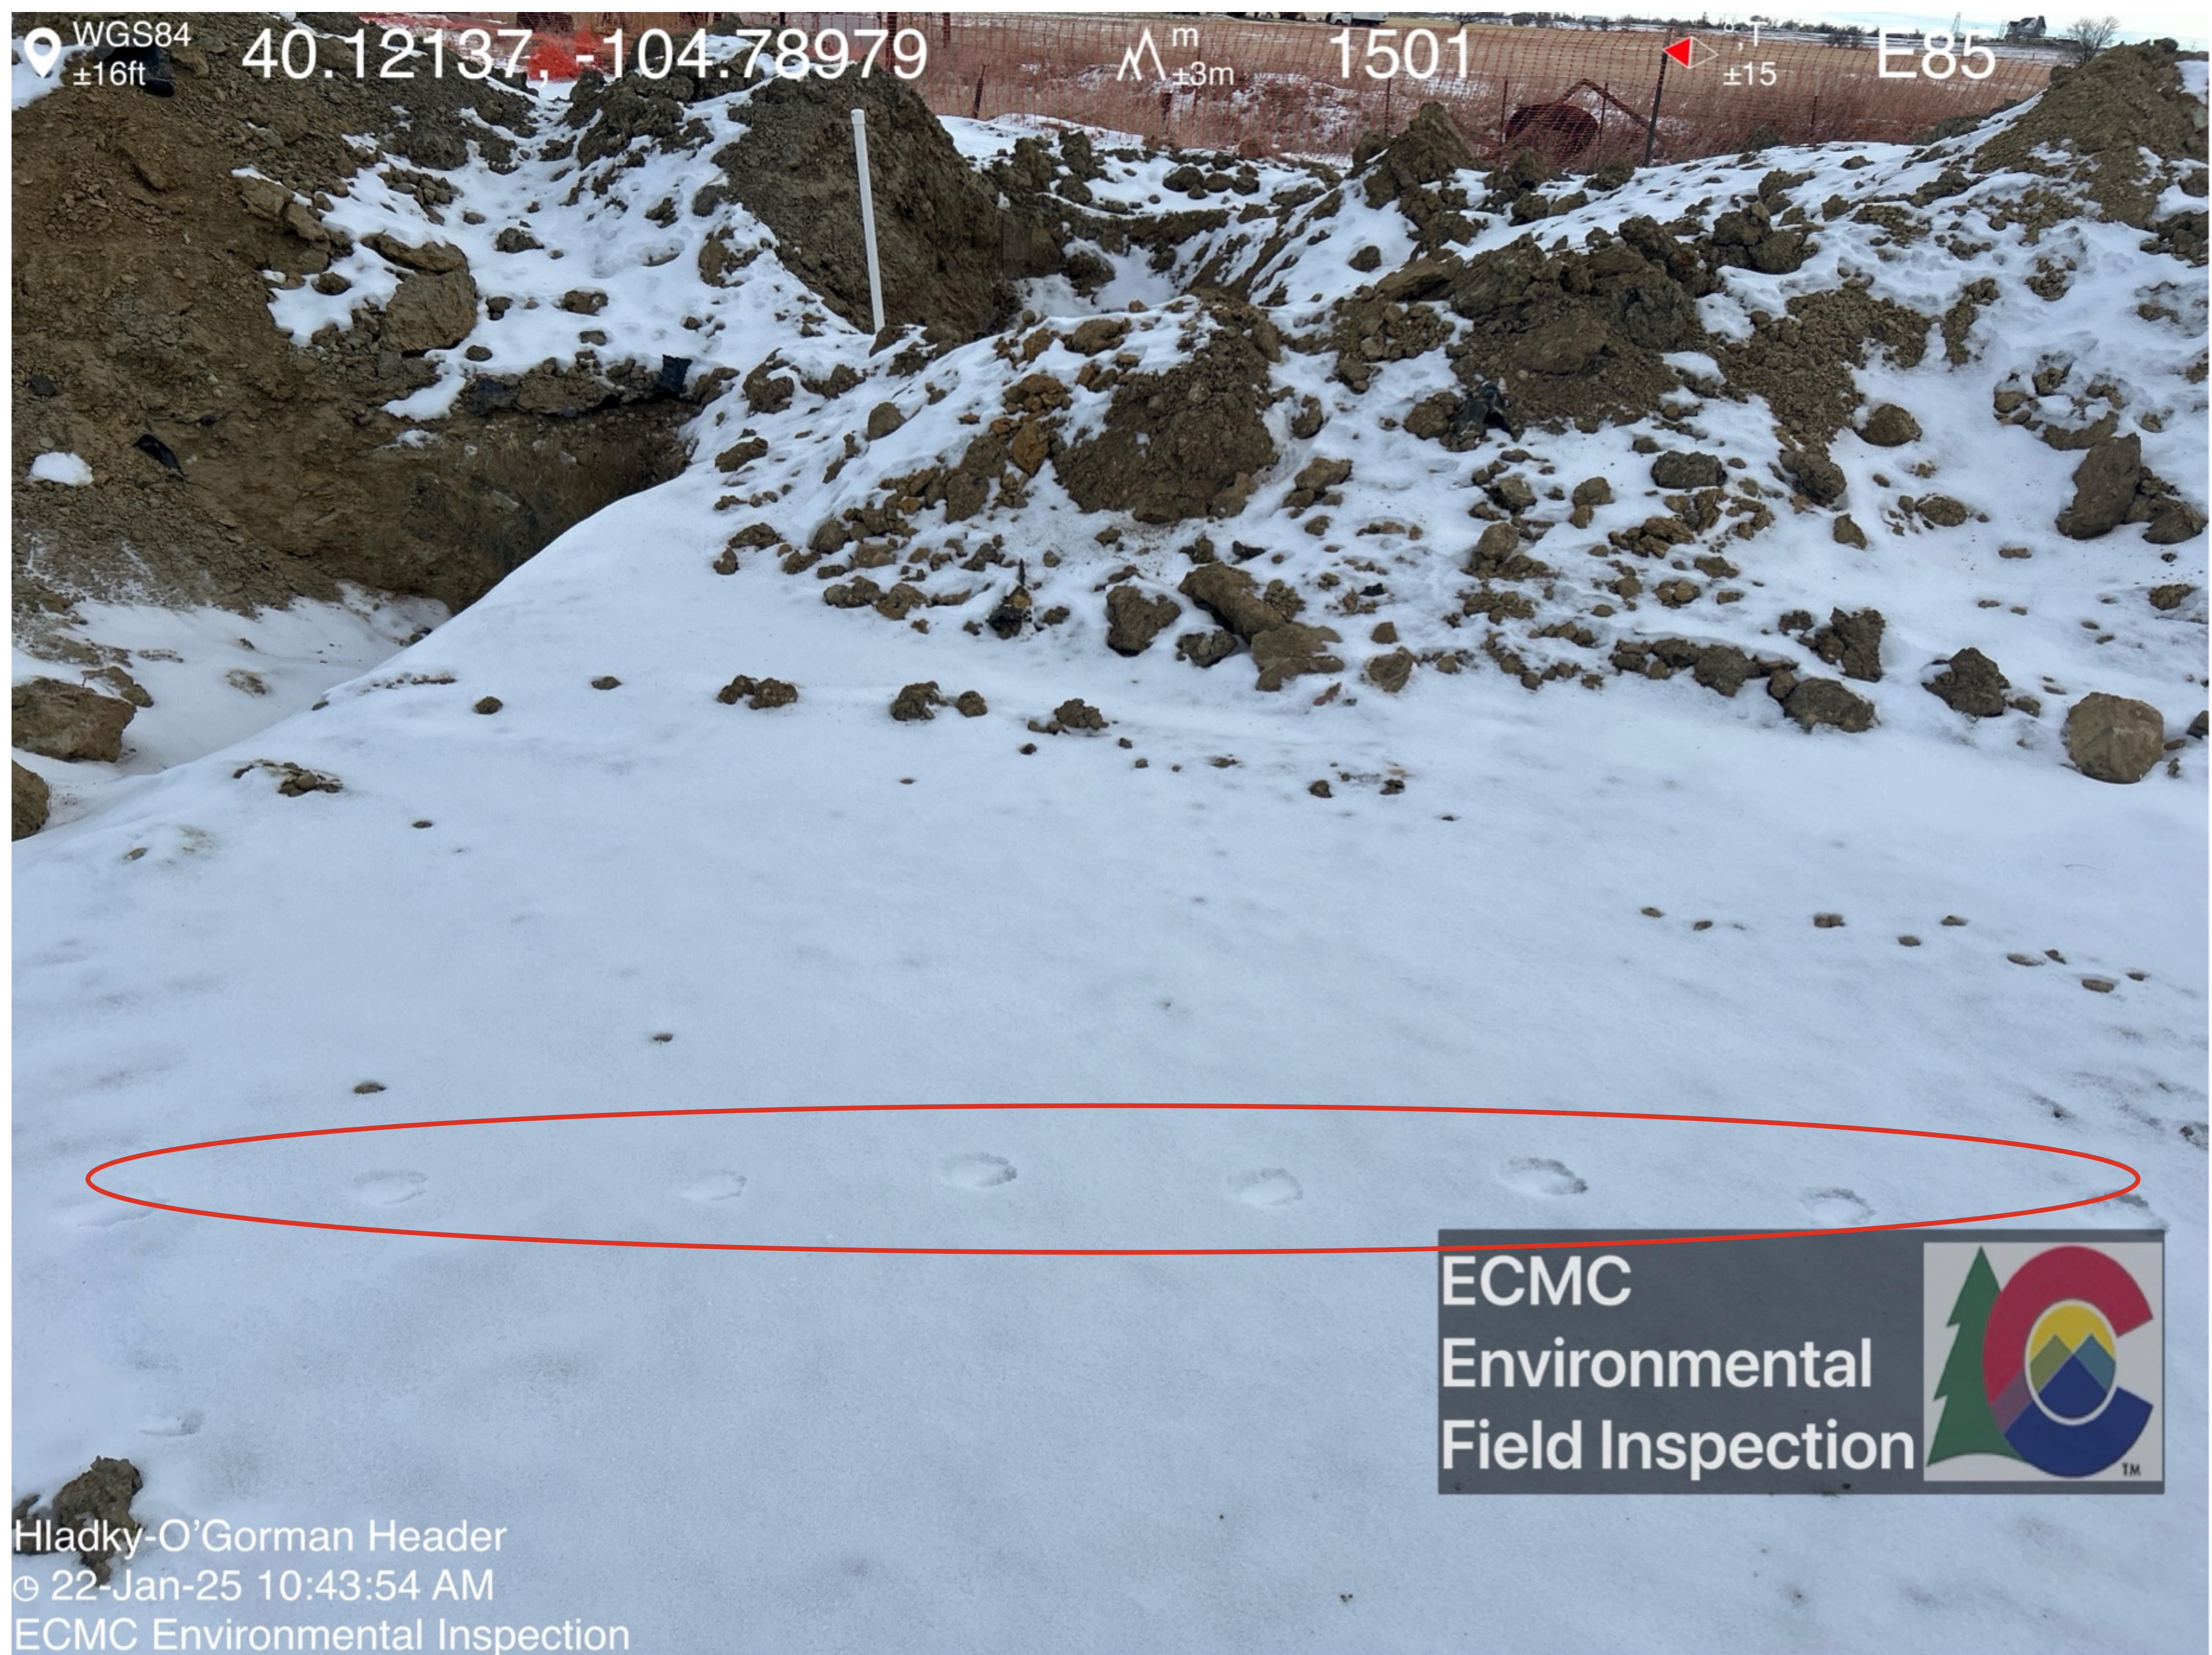
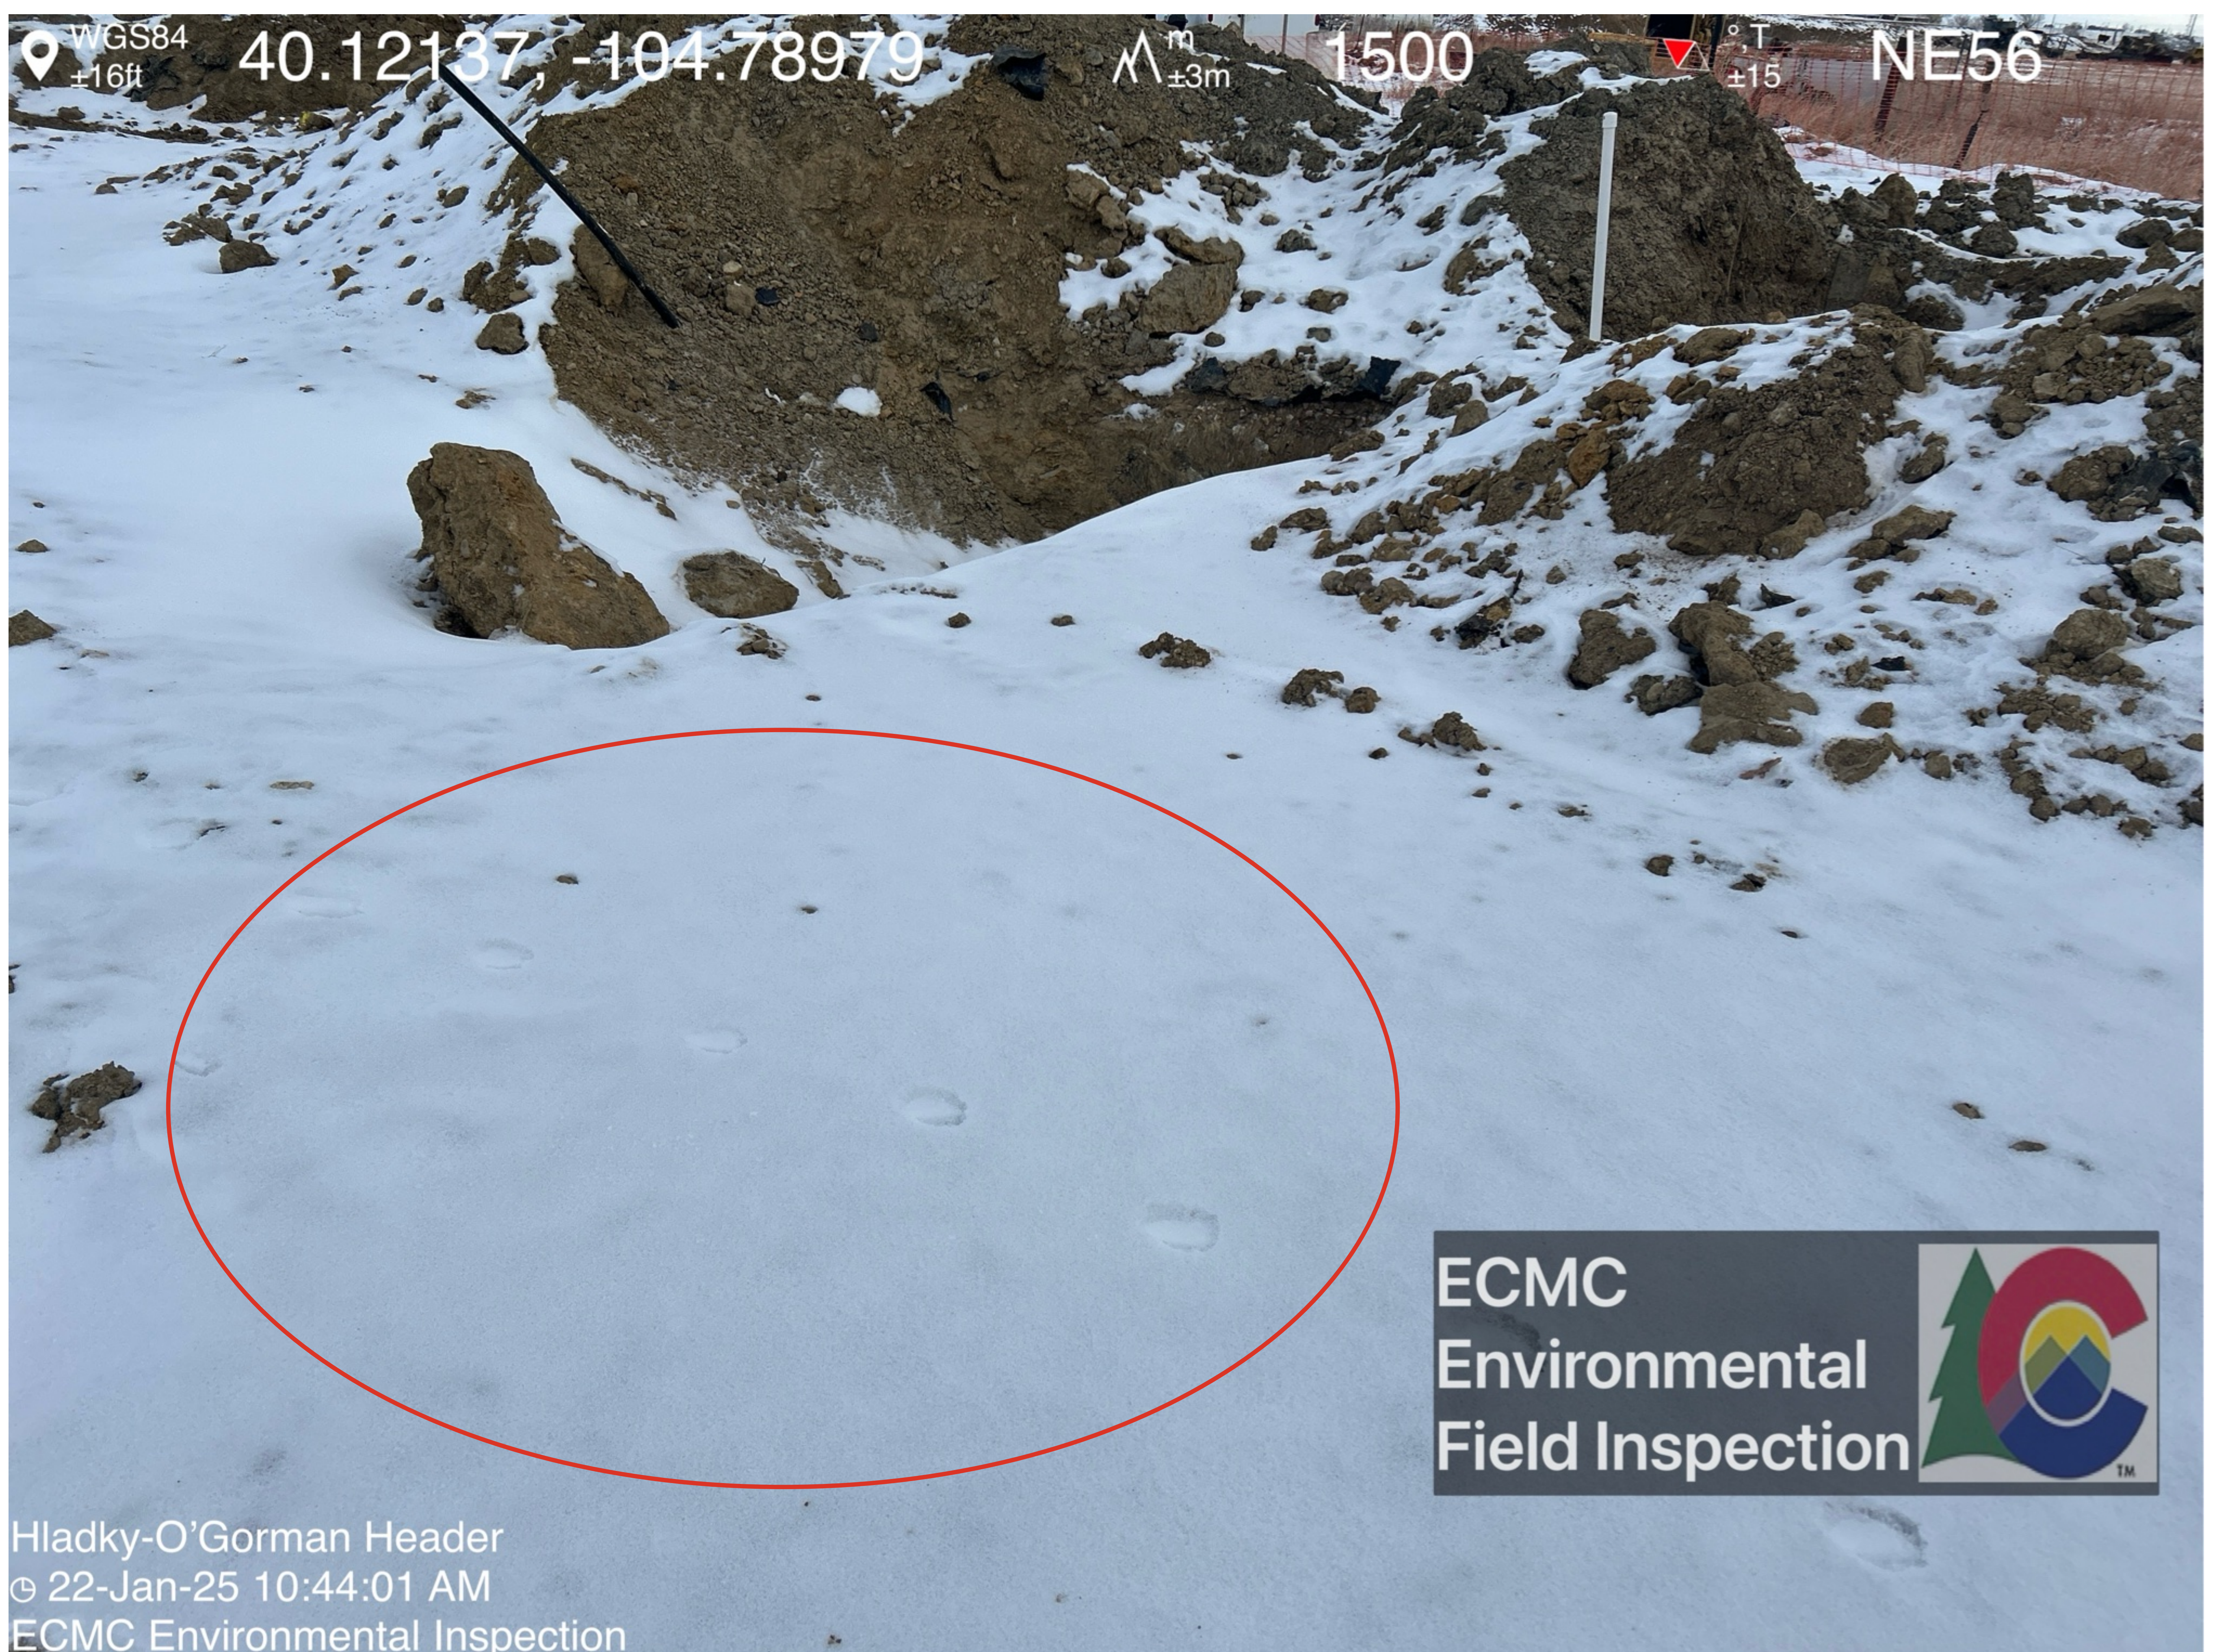
Wildlife tracks were visible throughout the excavation area.

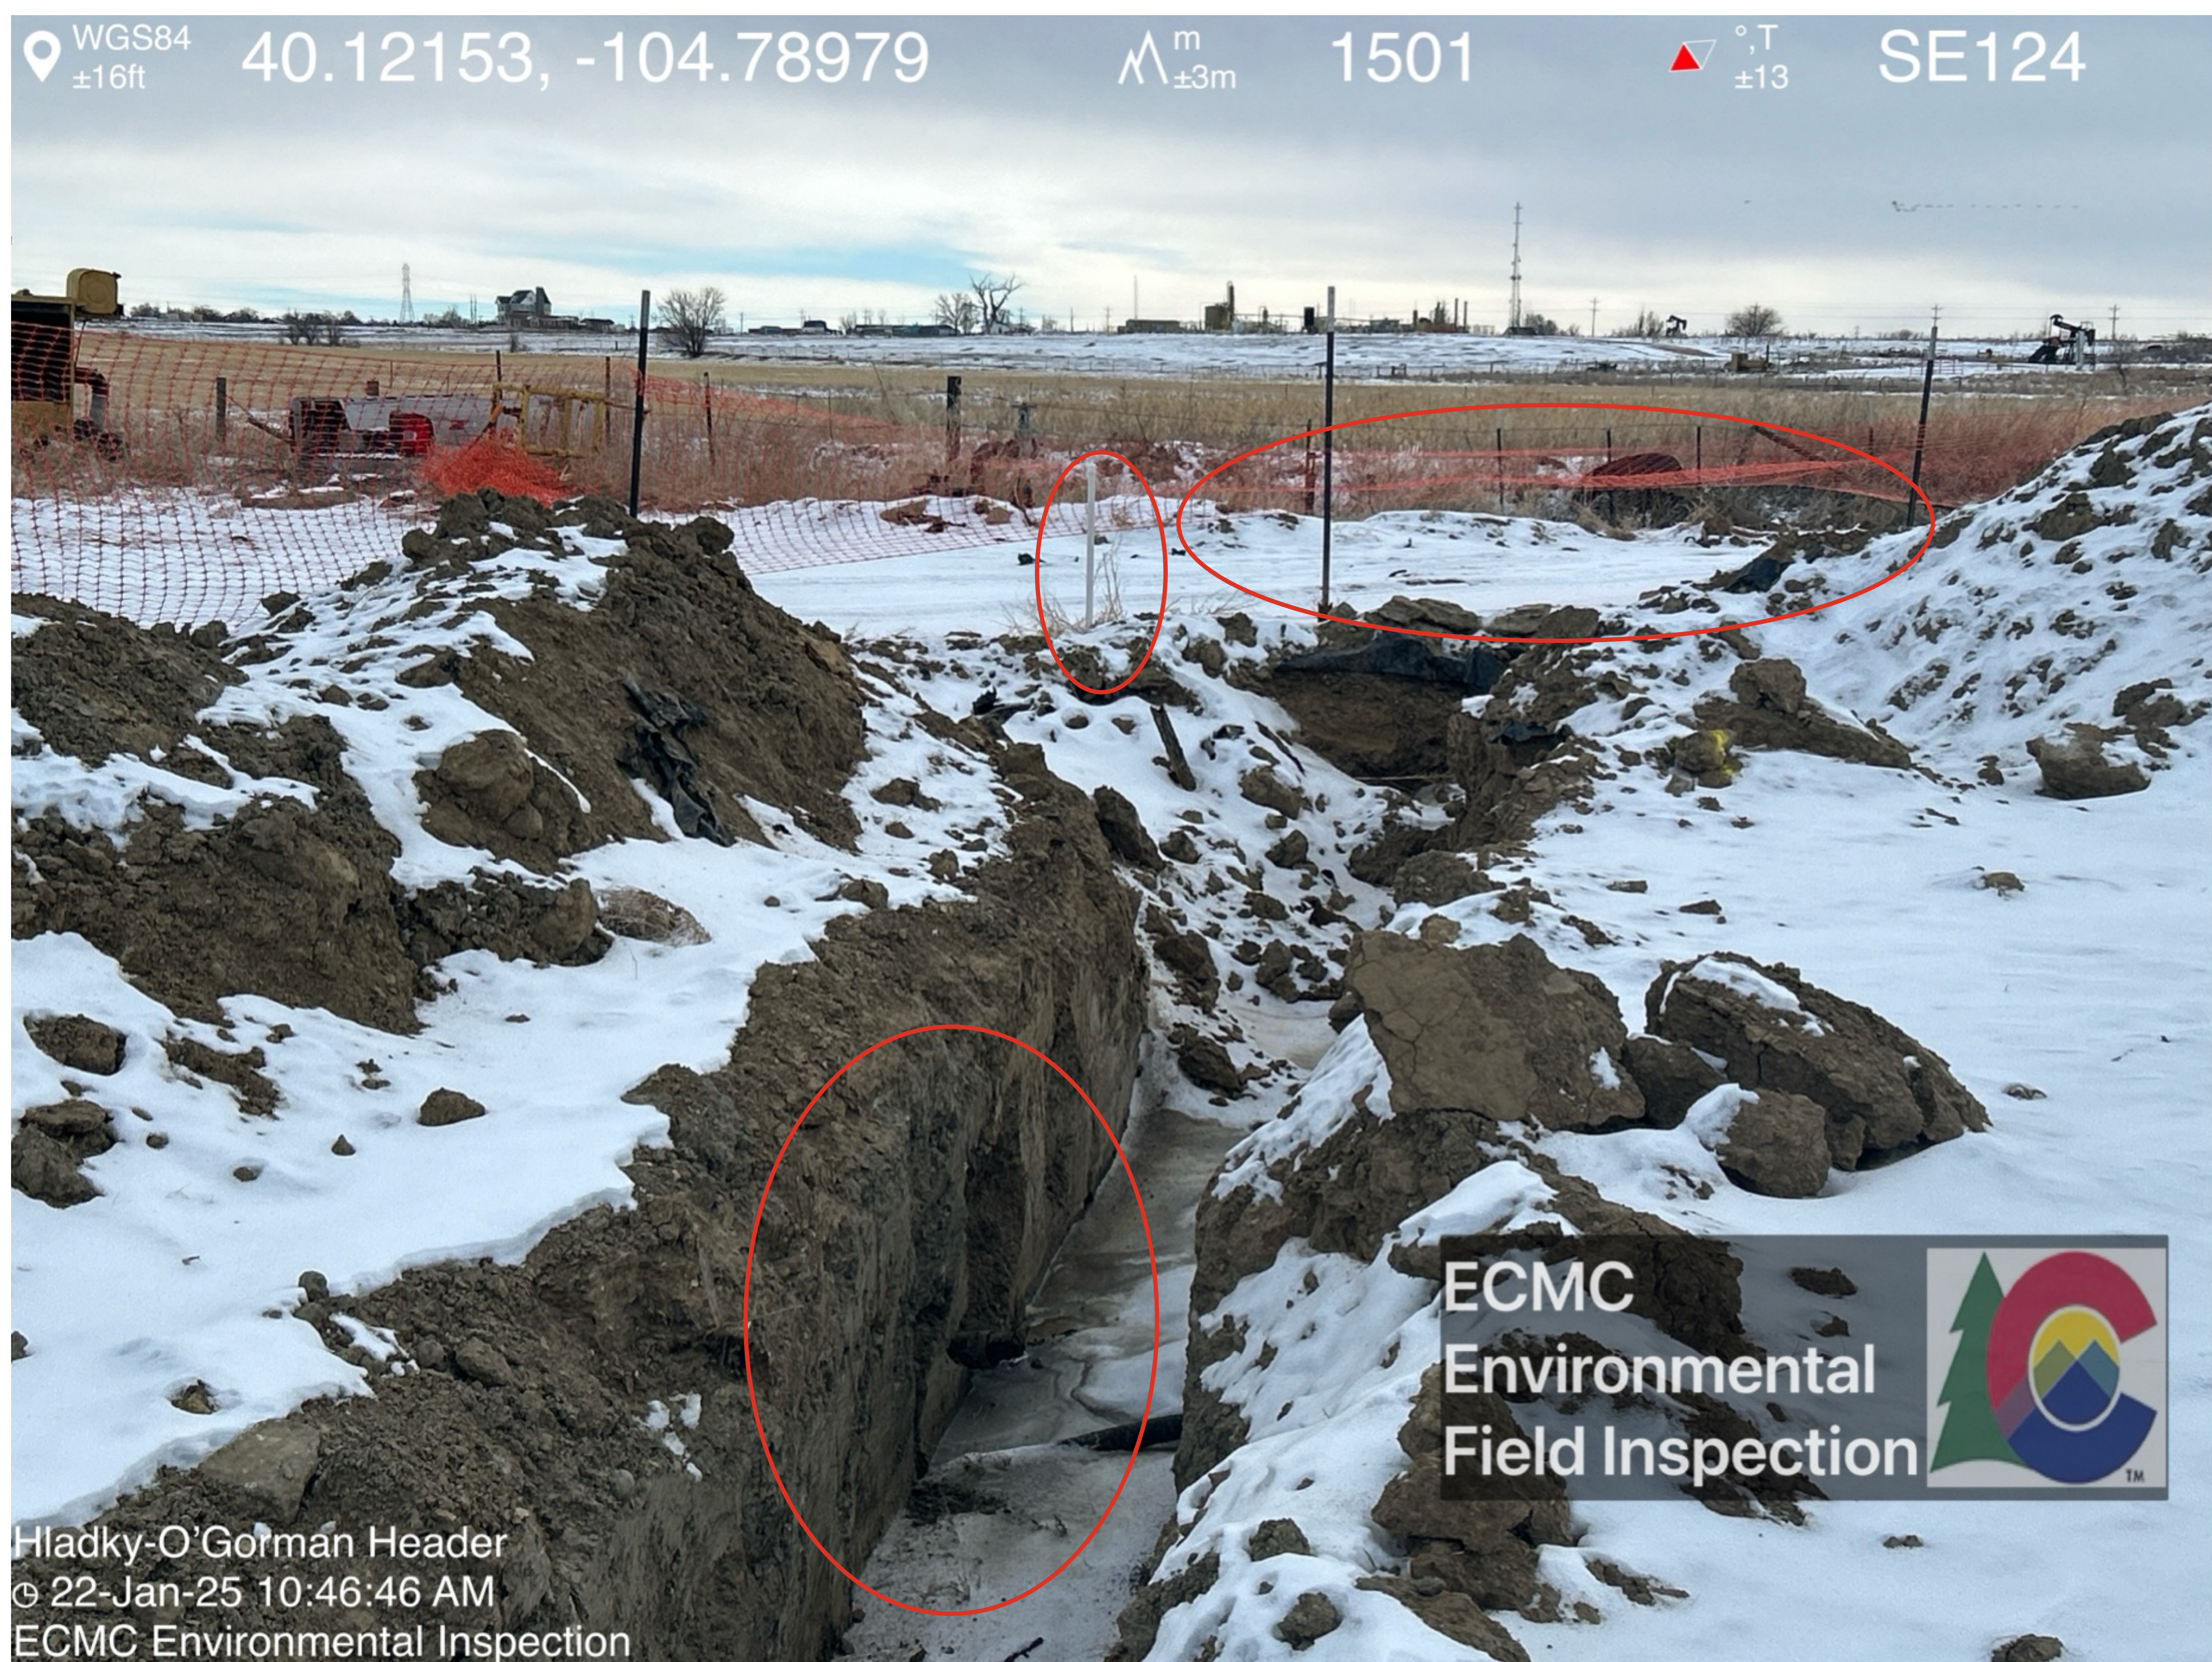
Soil with gray staining in contact with frozen groundwater visible in foreground;  
monitoring well and unsecured orange construction fence visible in background.
