Hladky O'Gorman 3 Well (API # 05-123-07775)

Hladky-O'Gorman Header  
© 22-Jan-25 10:49:13 AM  
ECMC Environmental Inspection

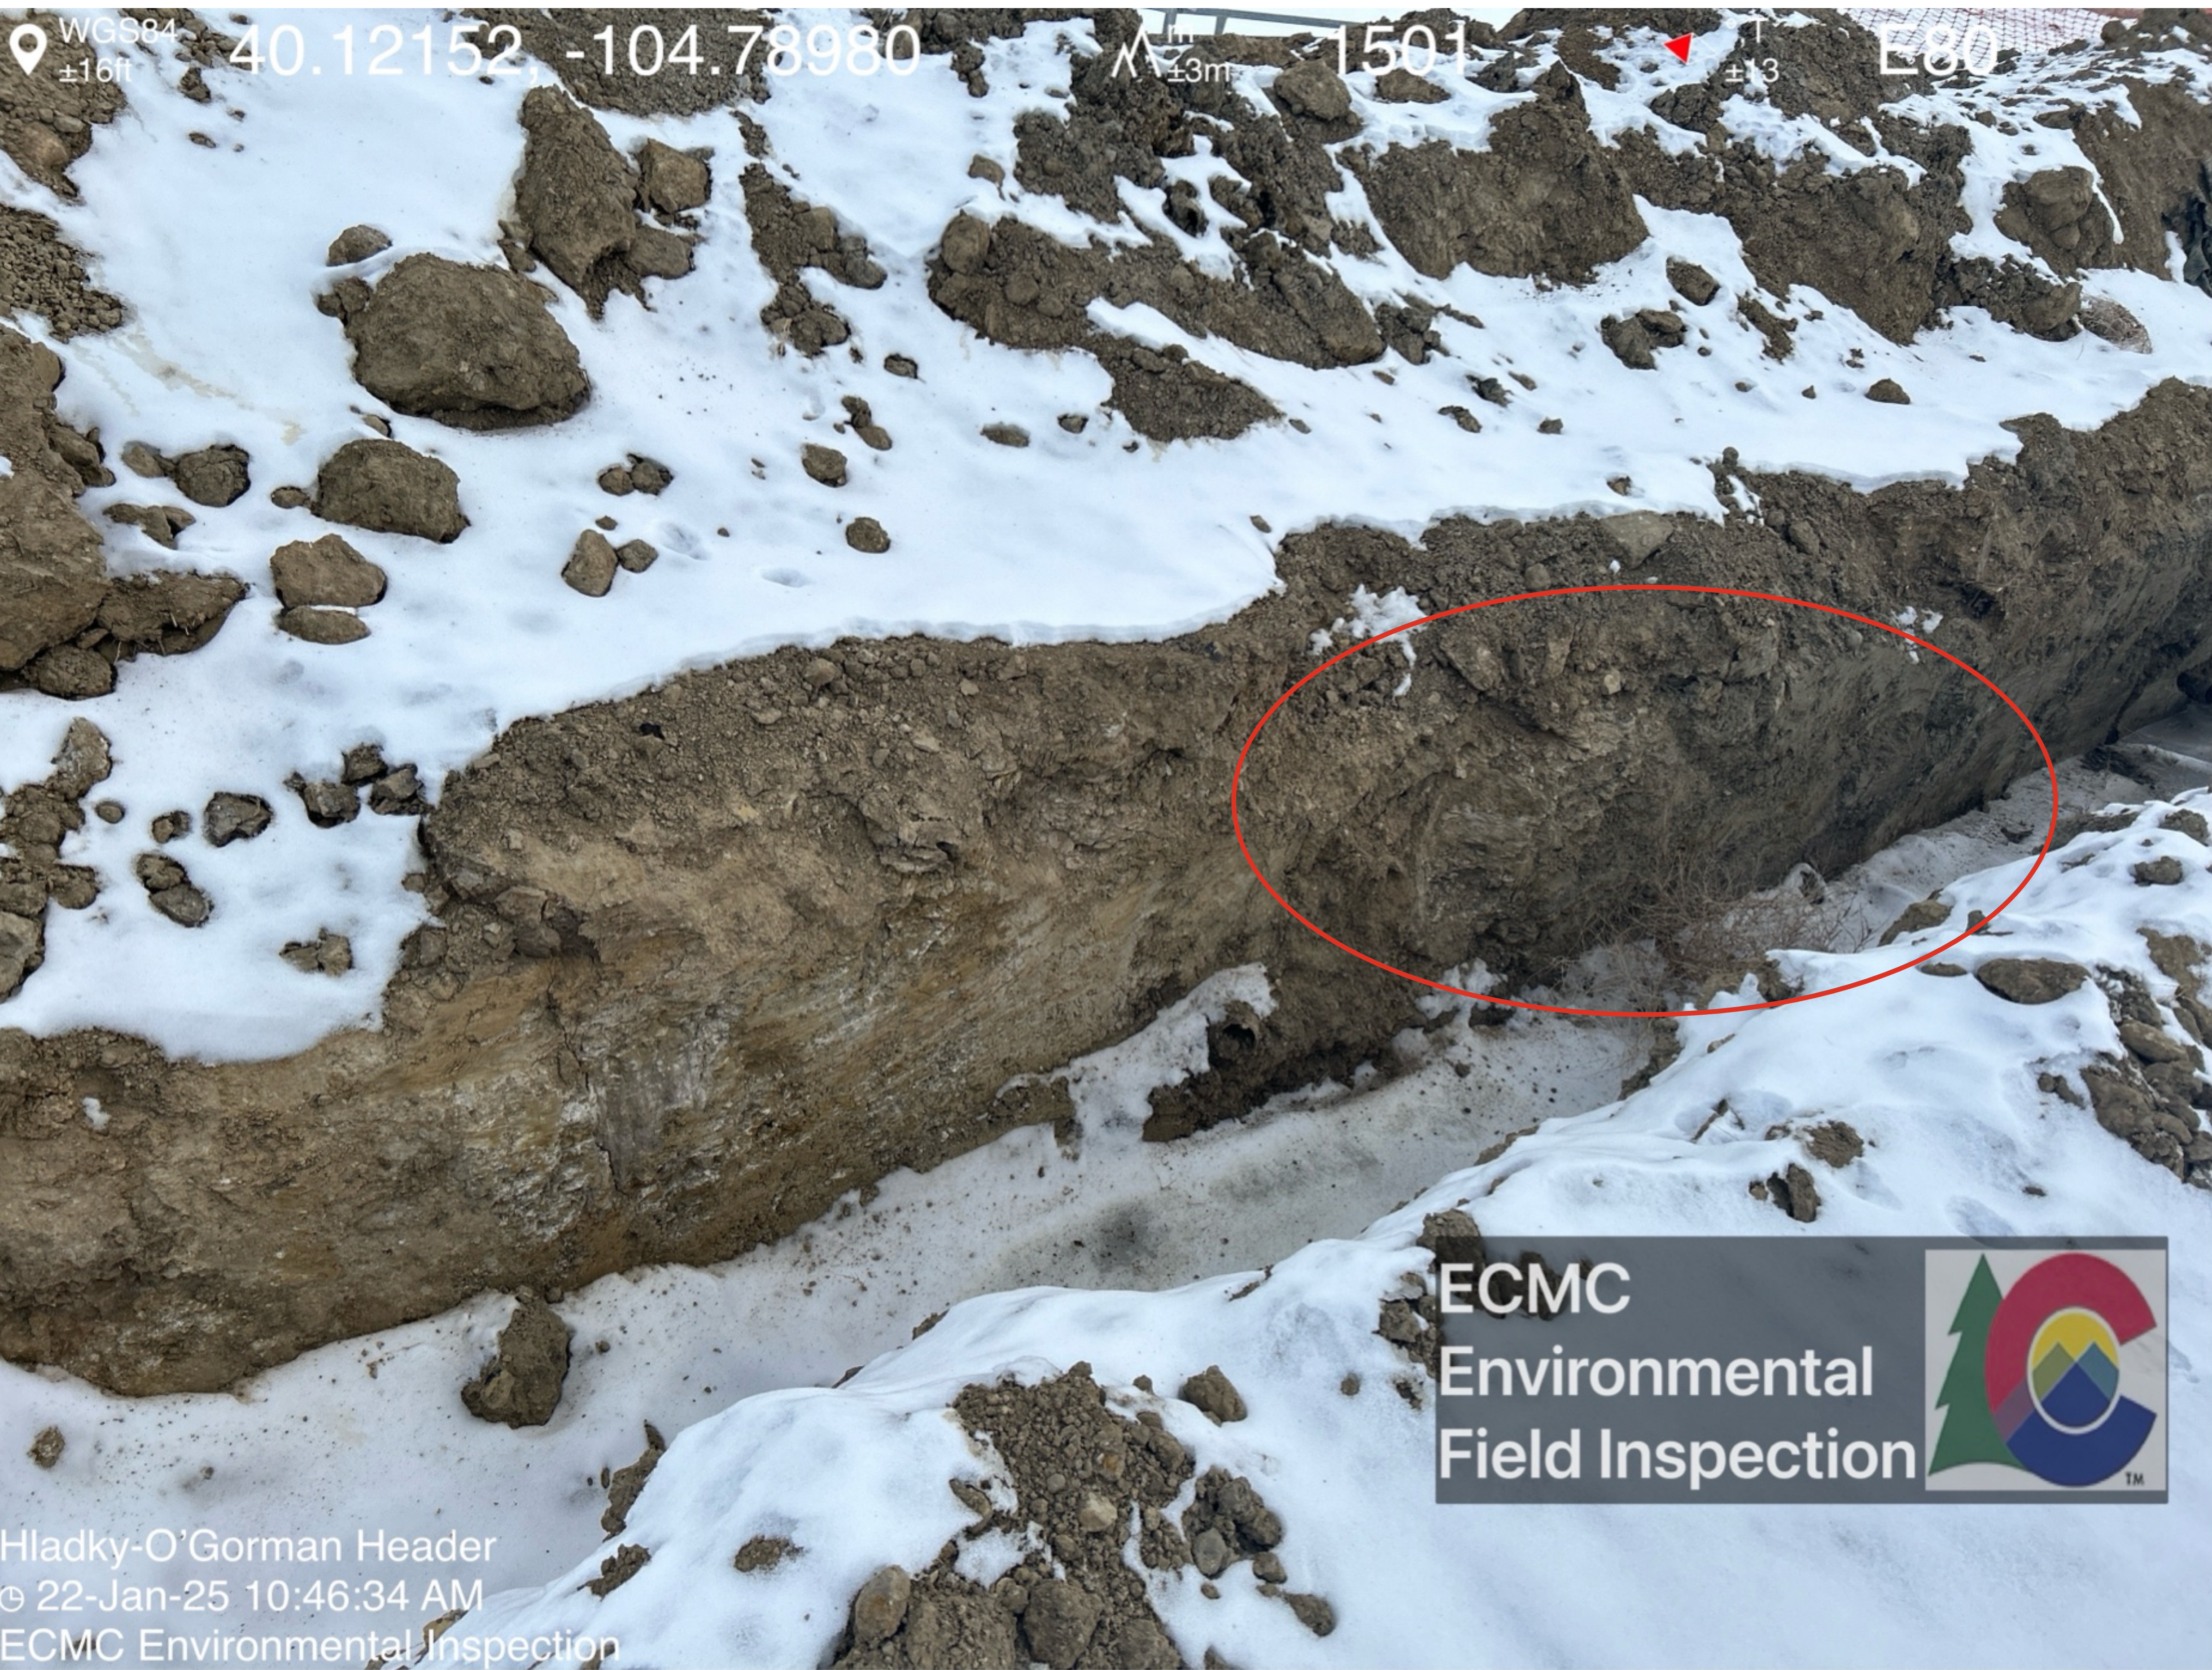
Gray staining visible on sidewalls of trench.

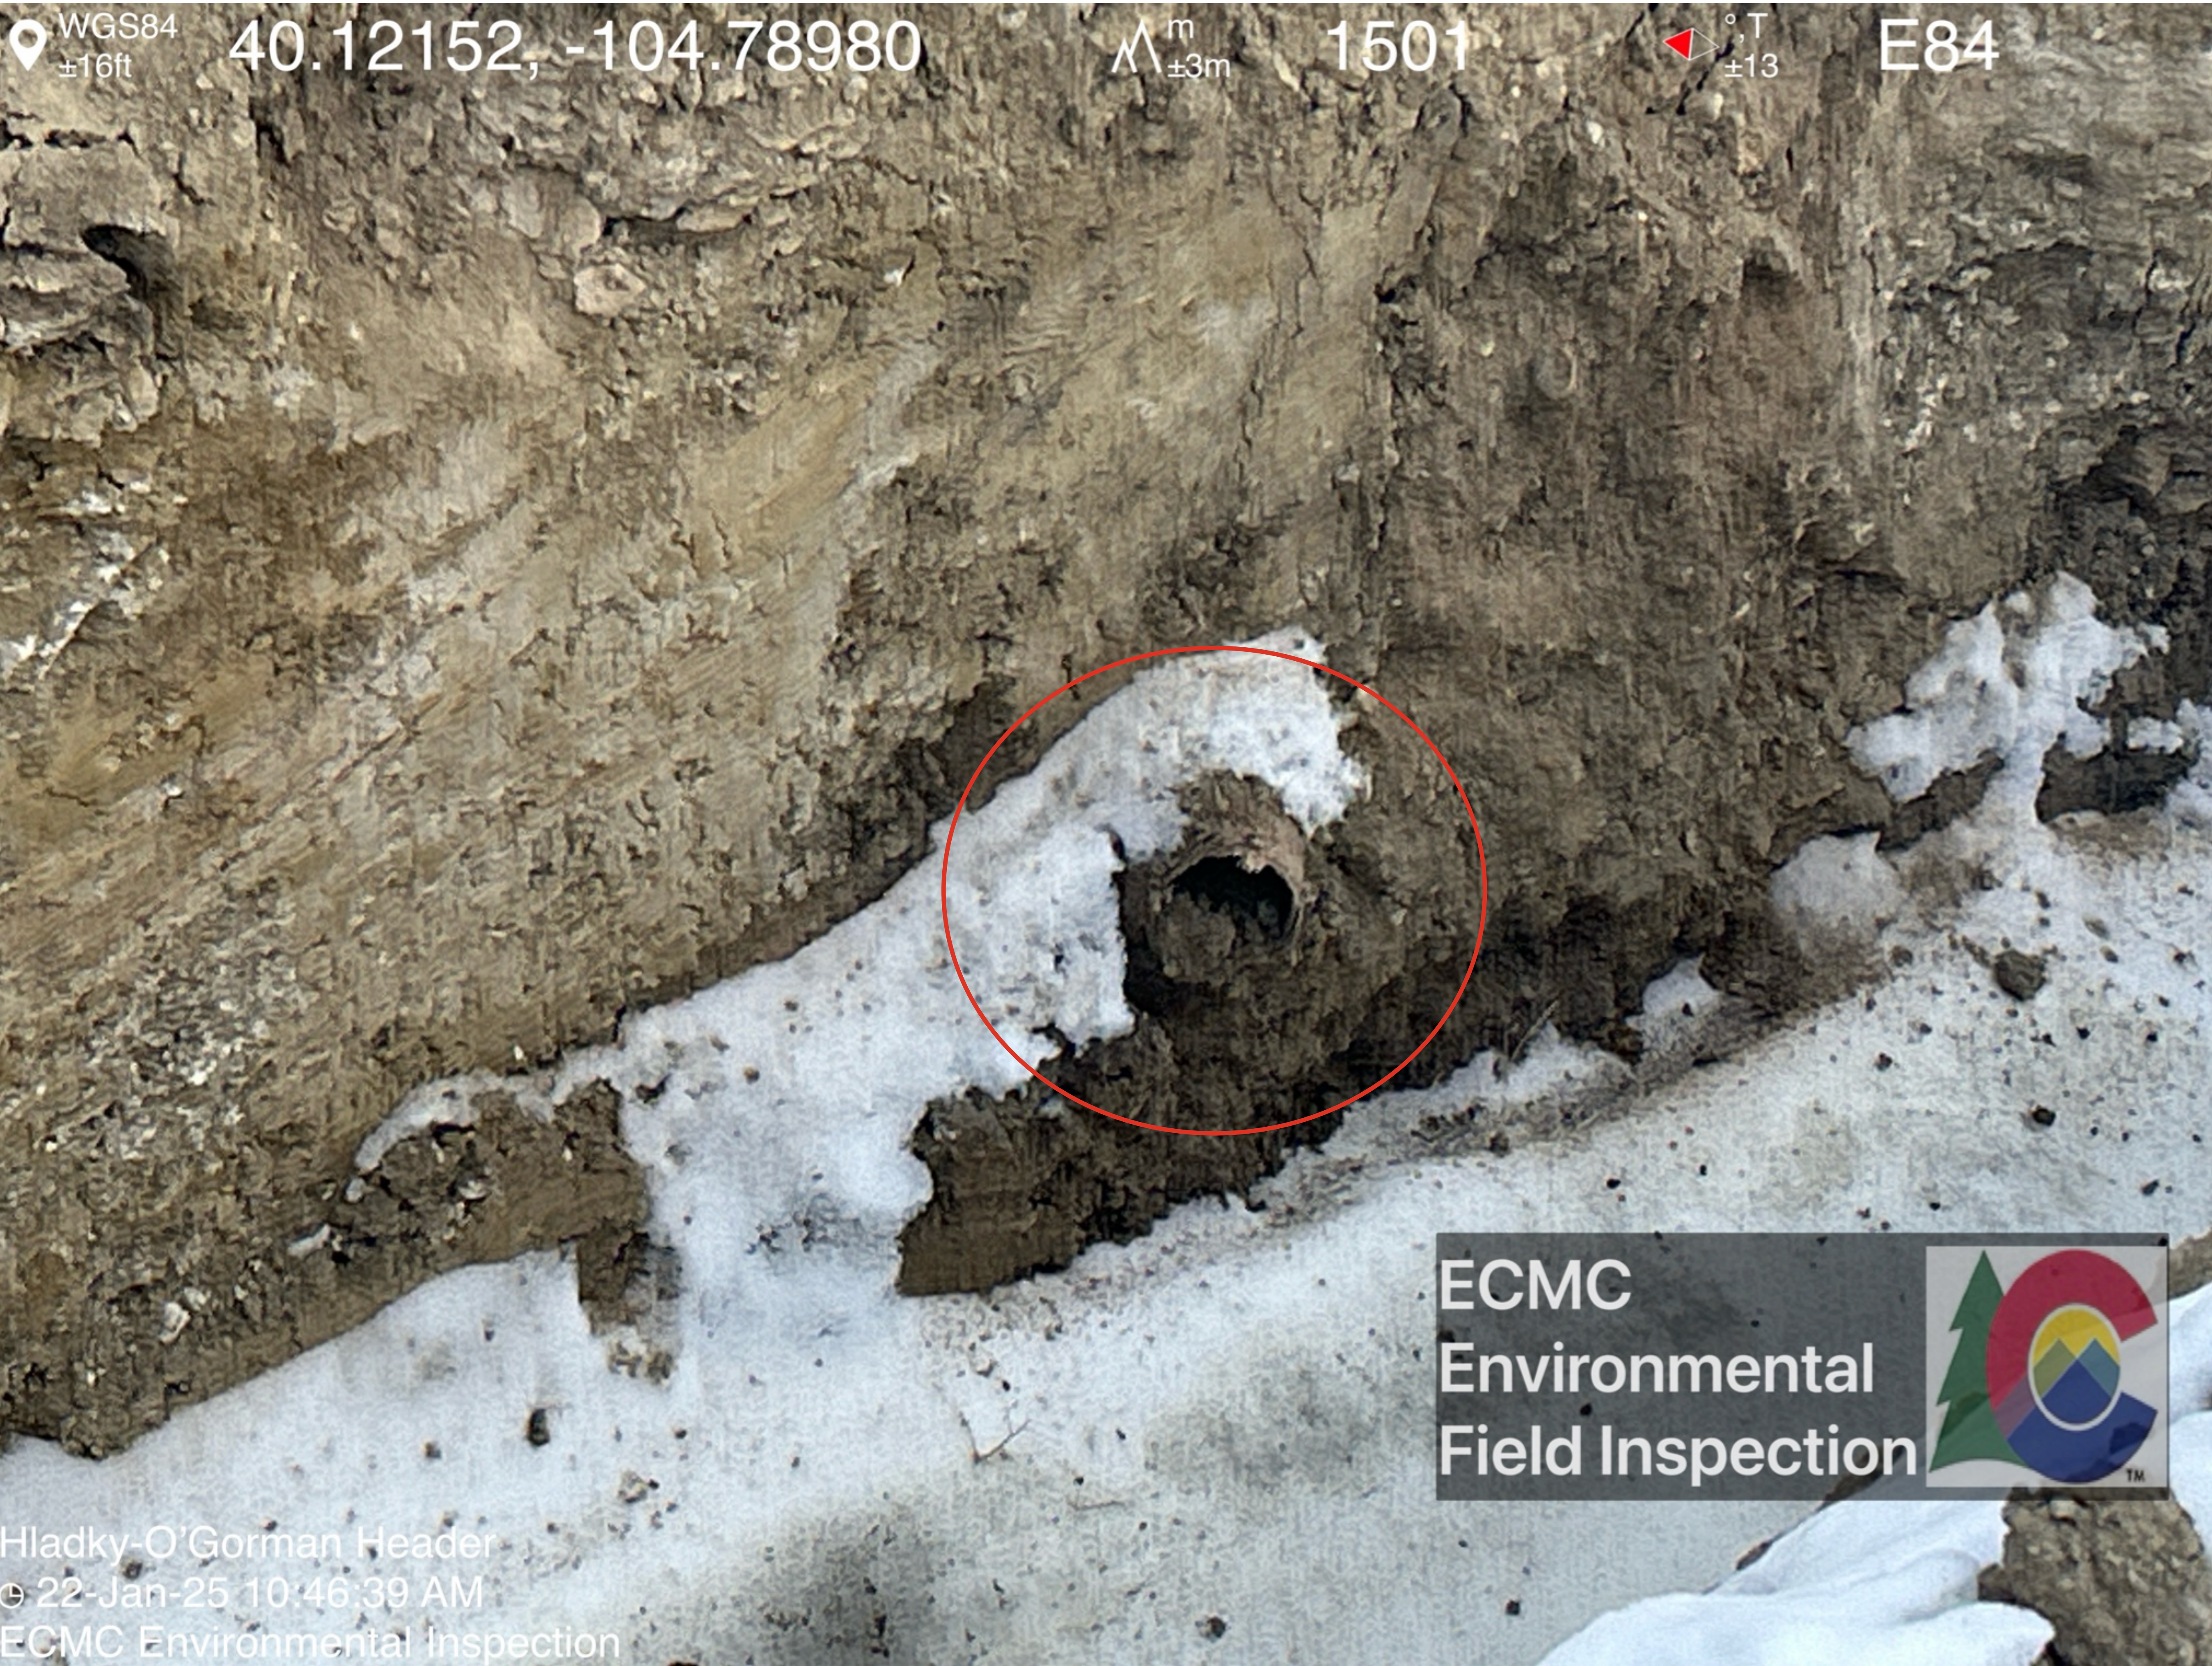
Severed pipe visible within trench.

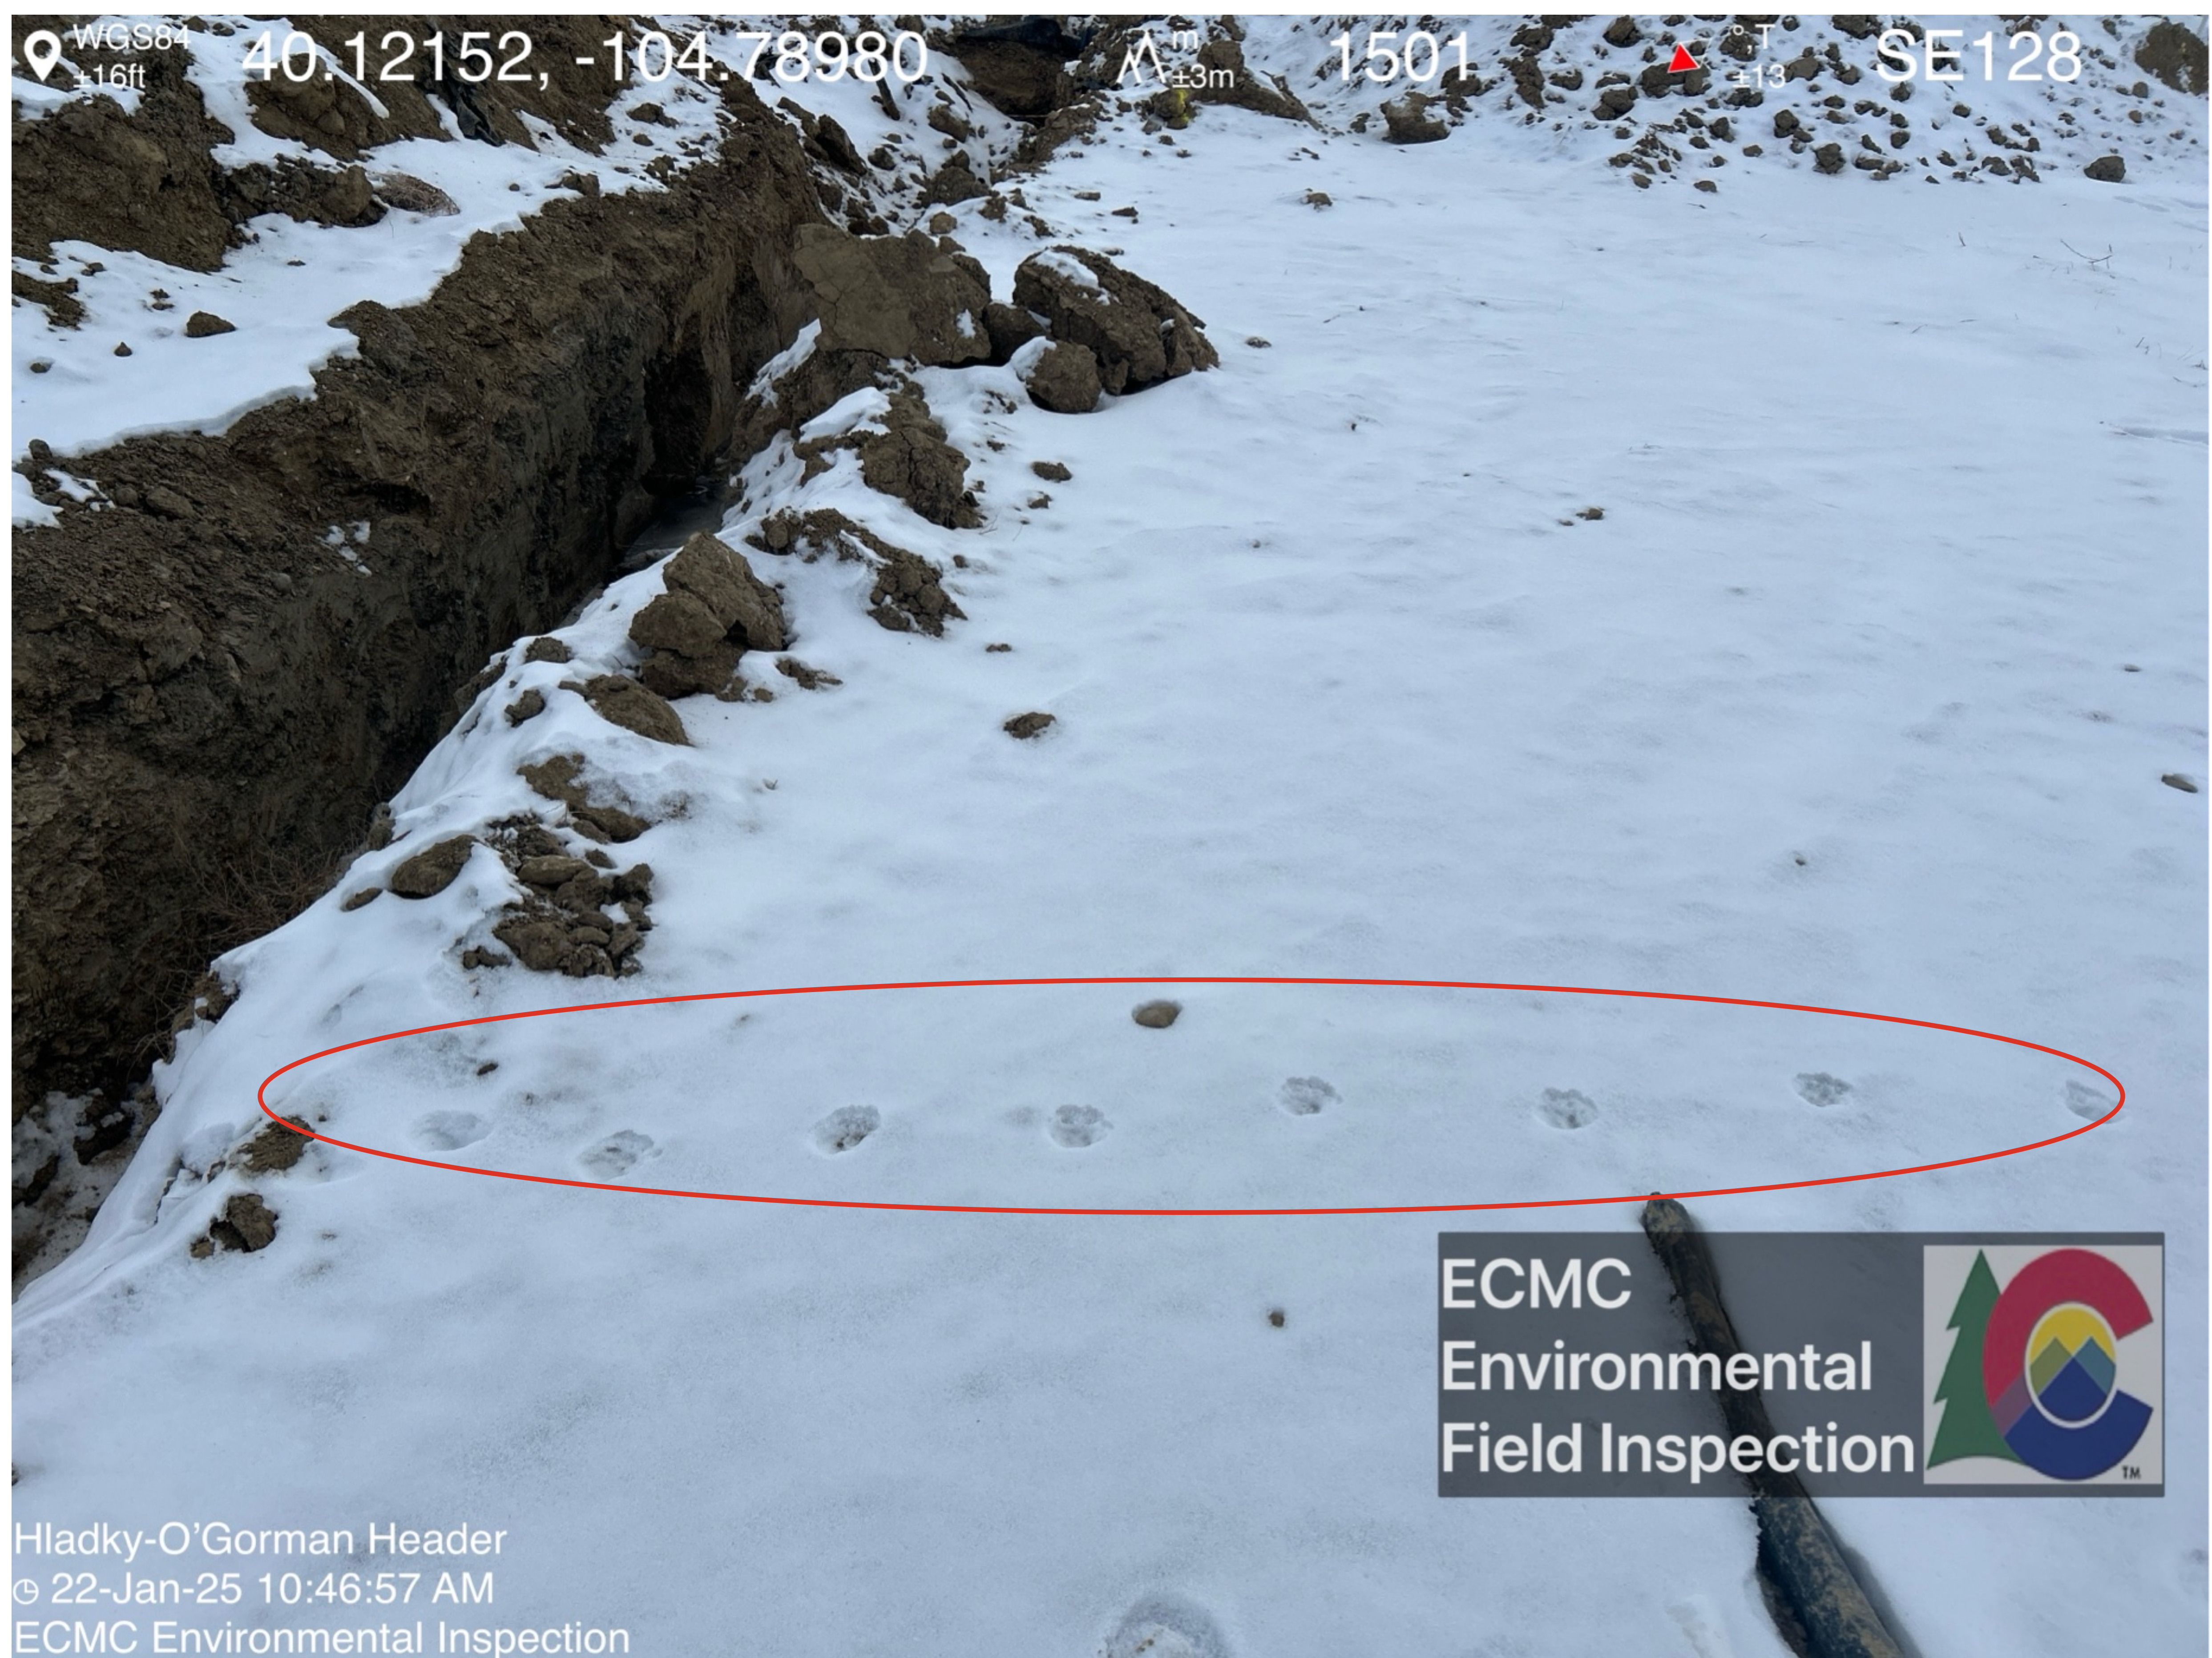
Wildlife tracks visible adjacent to trench.

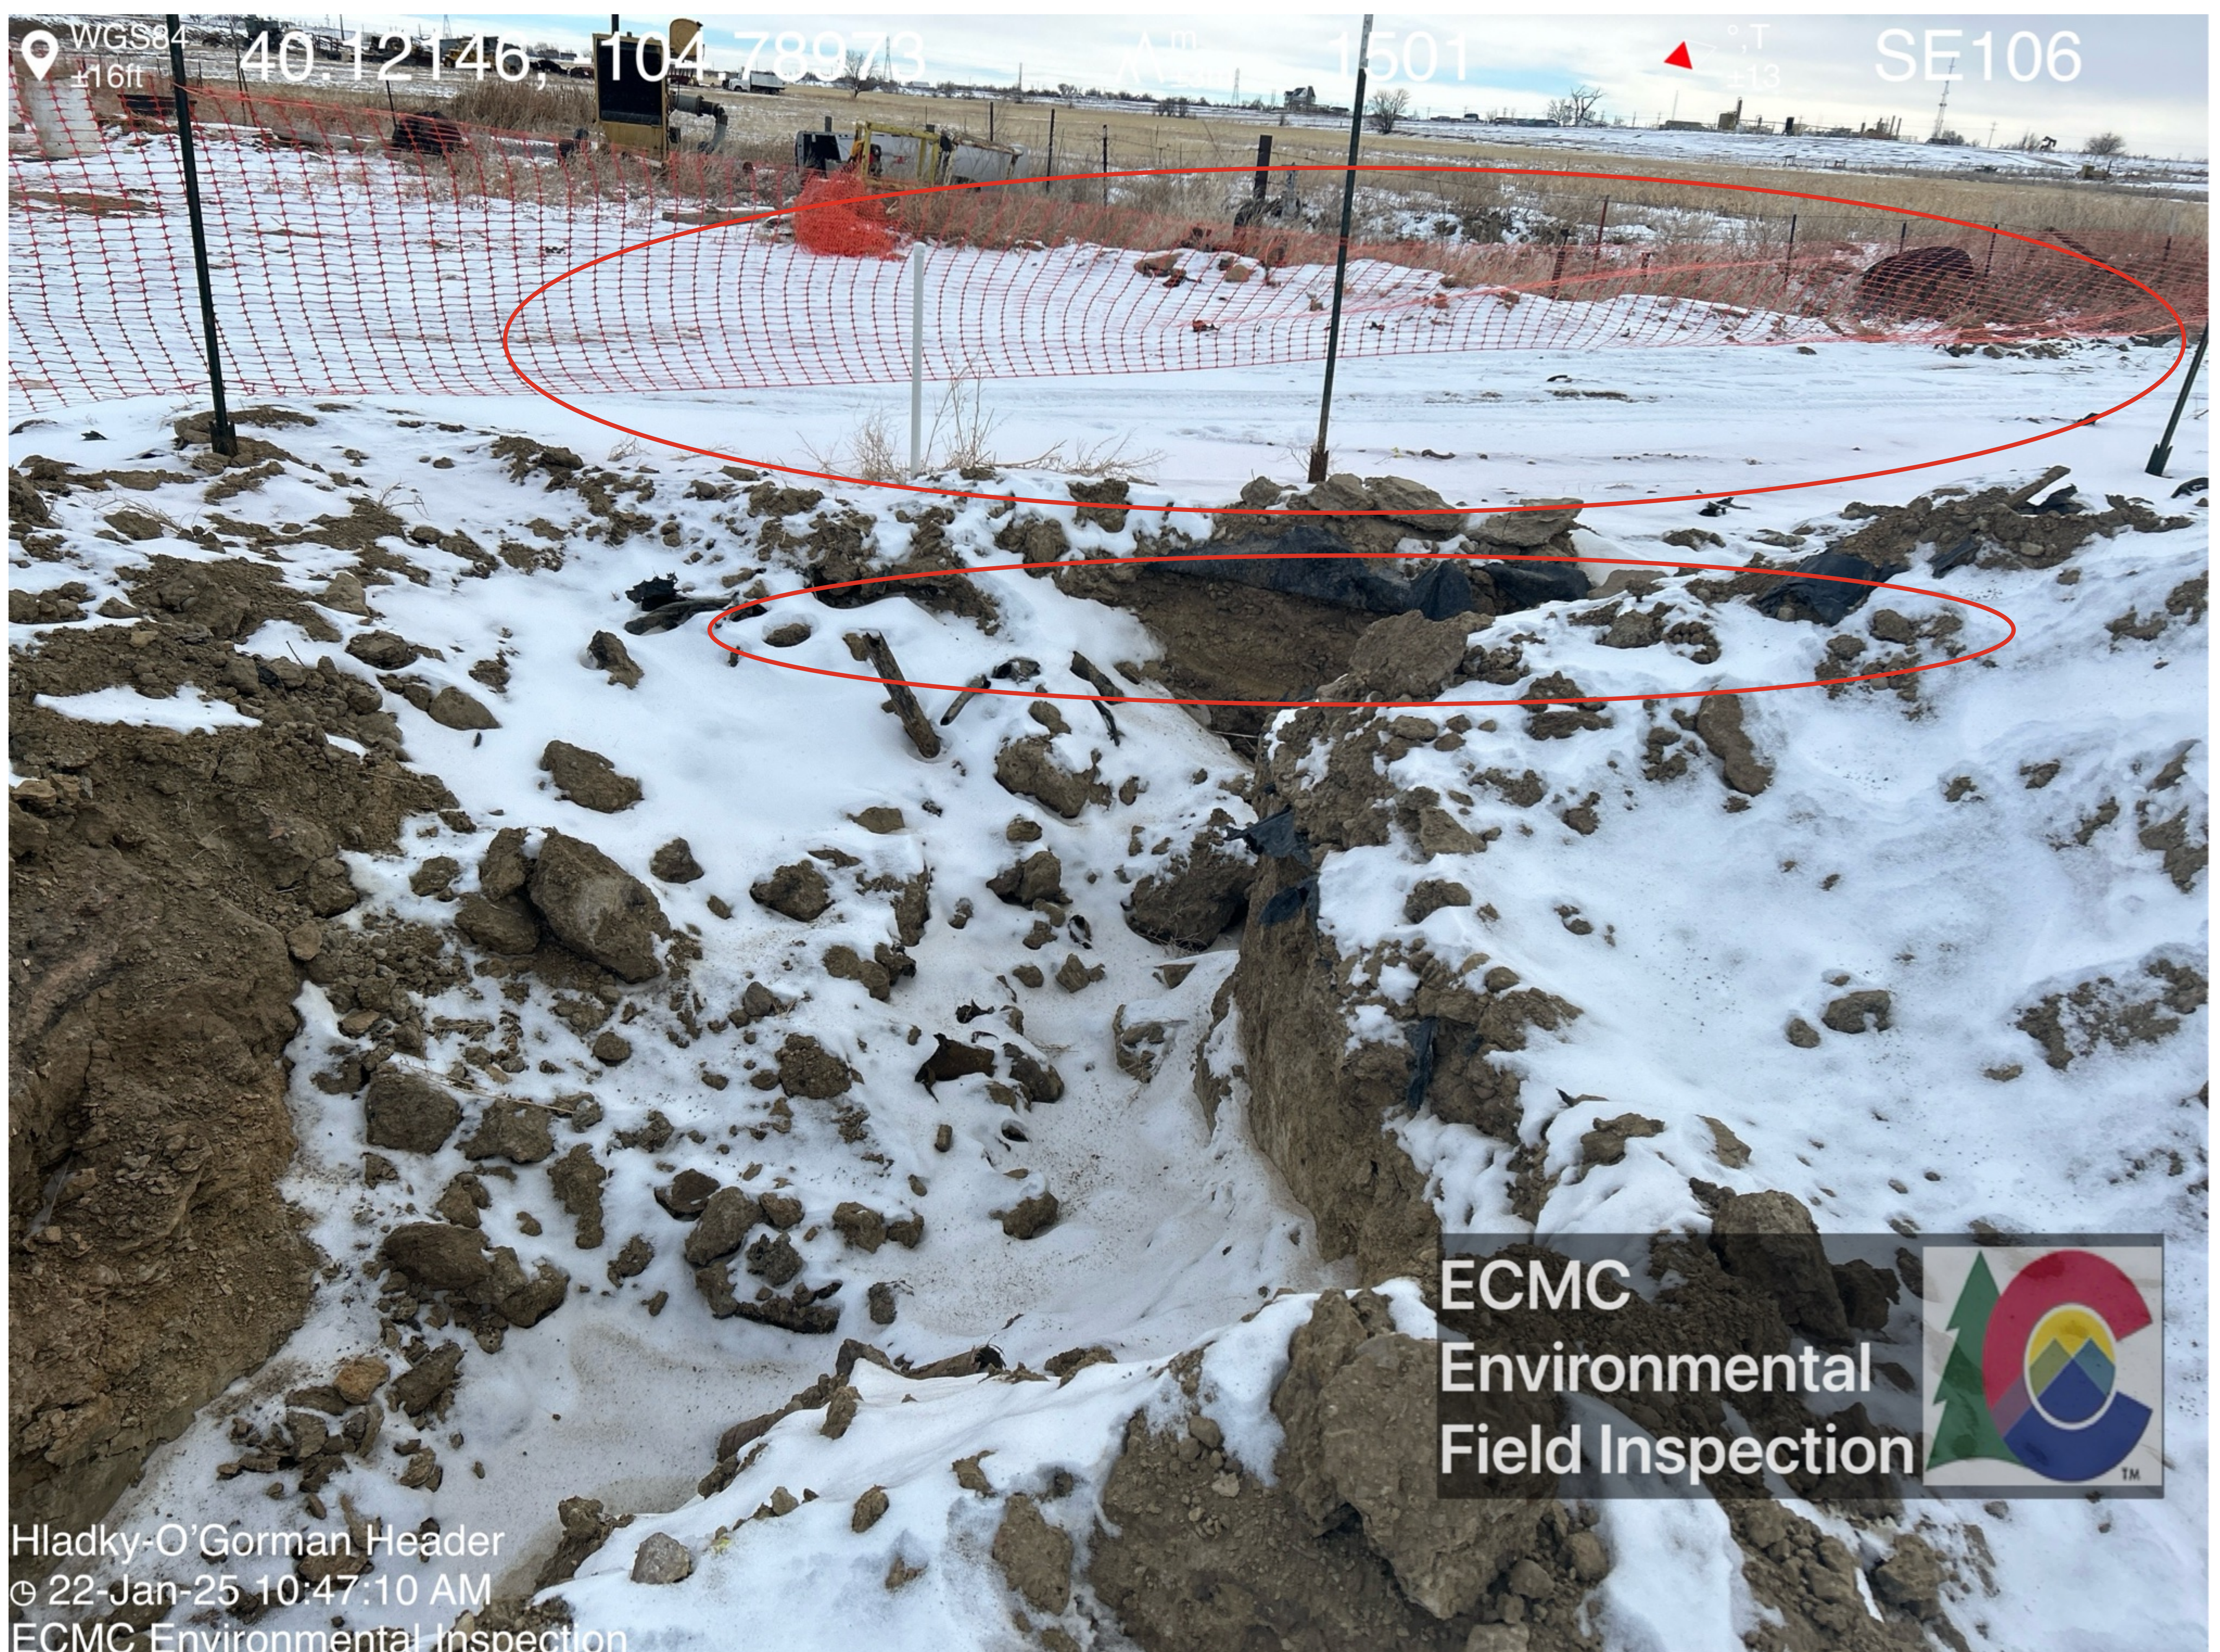
Torn pieces of liner visible within excavation area. Orange construction fencing is visible blowing in wind.

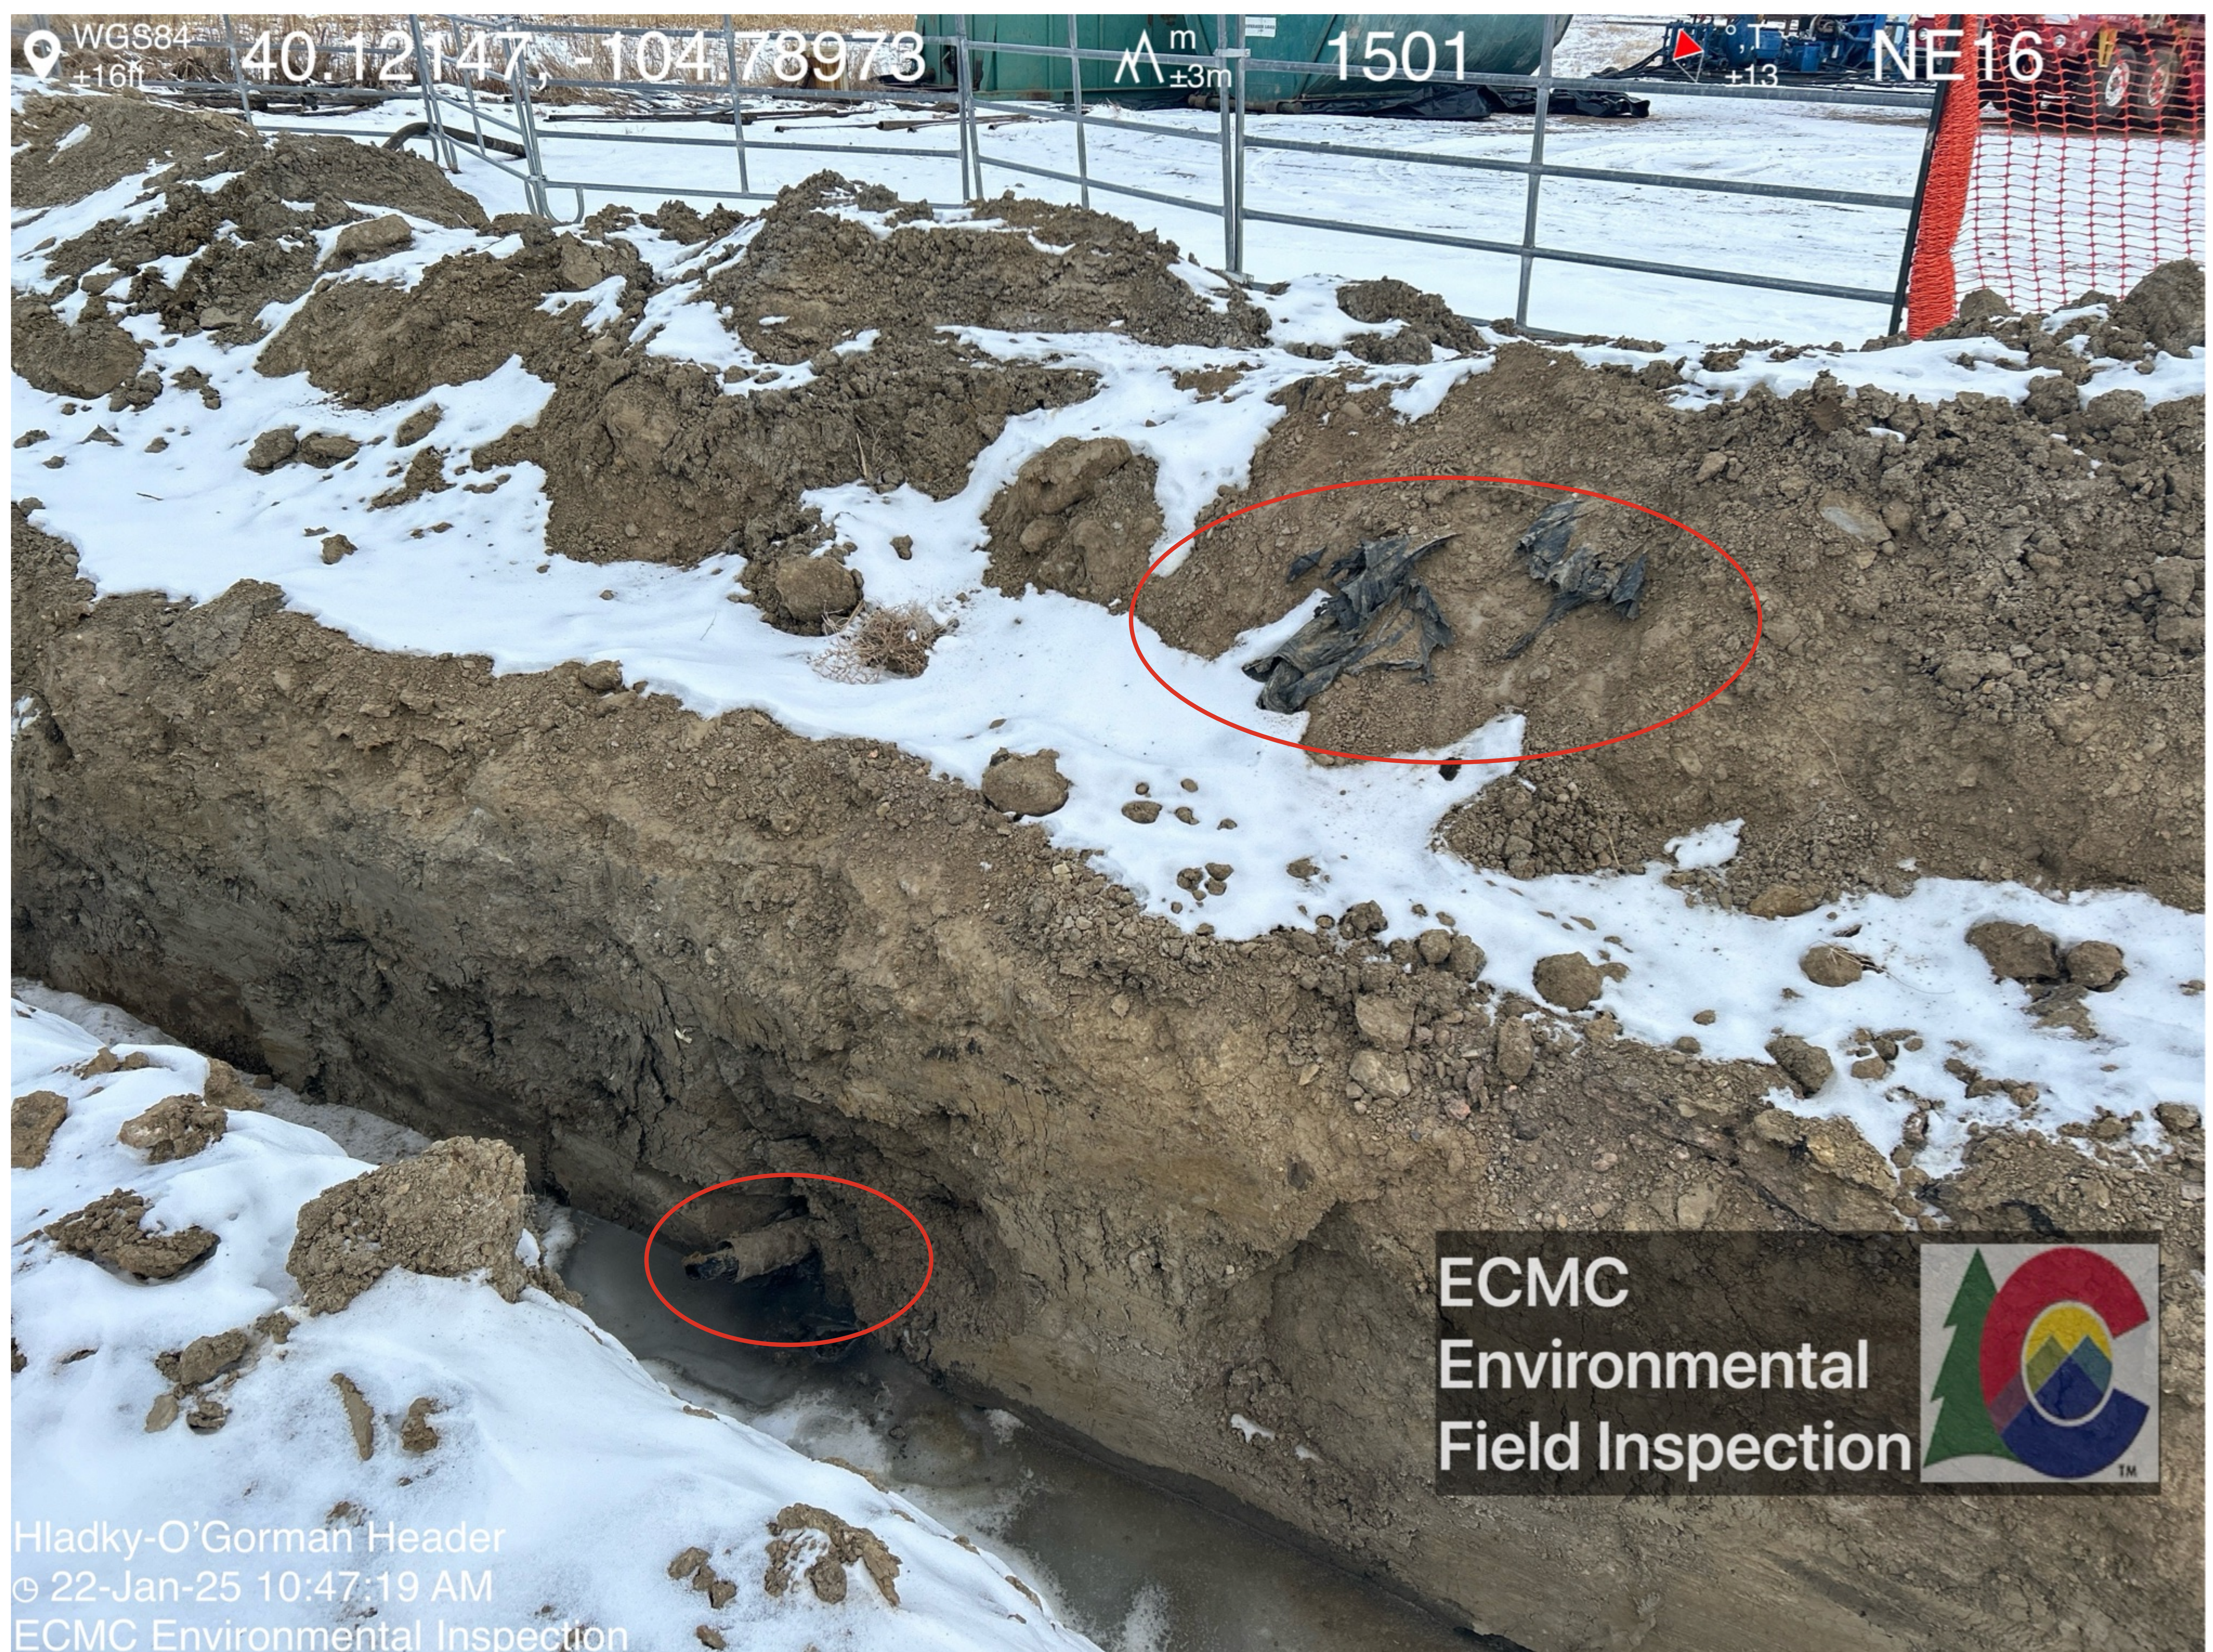
Trench with frozen groundwater, severed pipe, and pieces of torn liner visible.

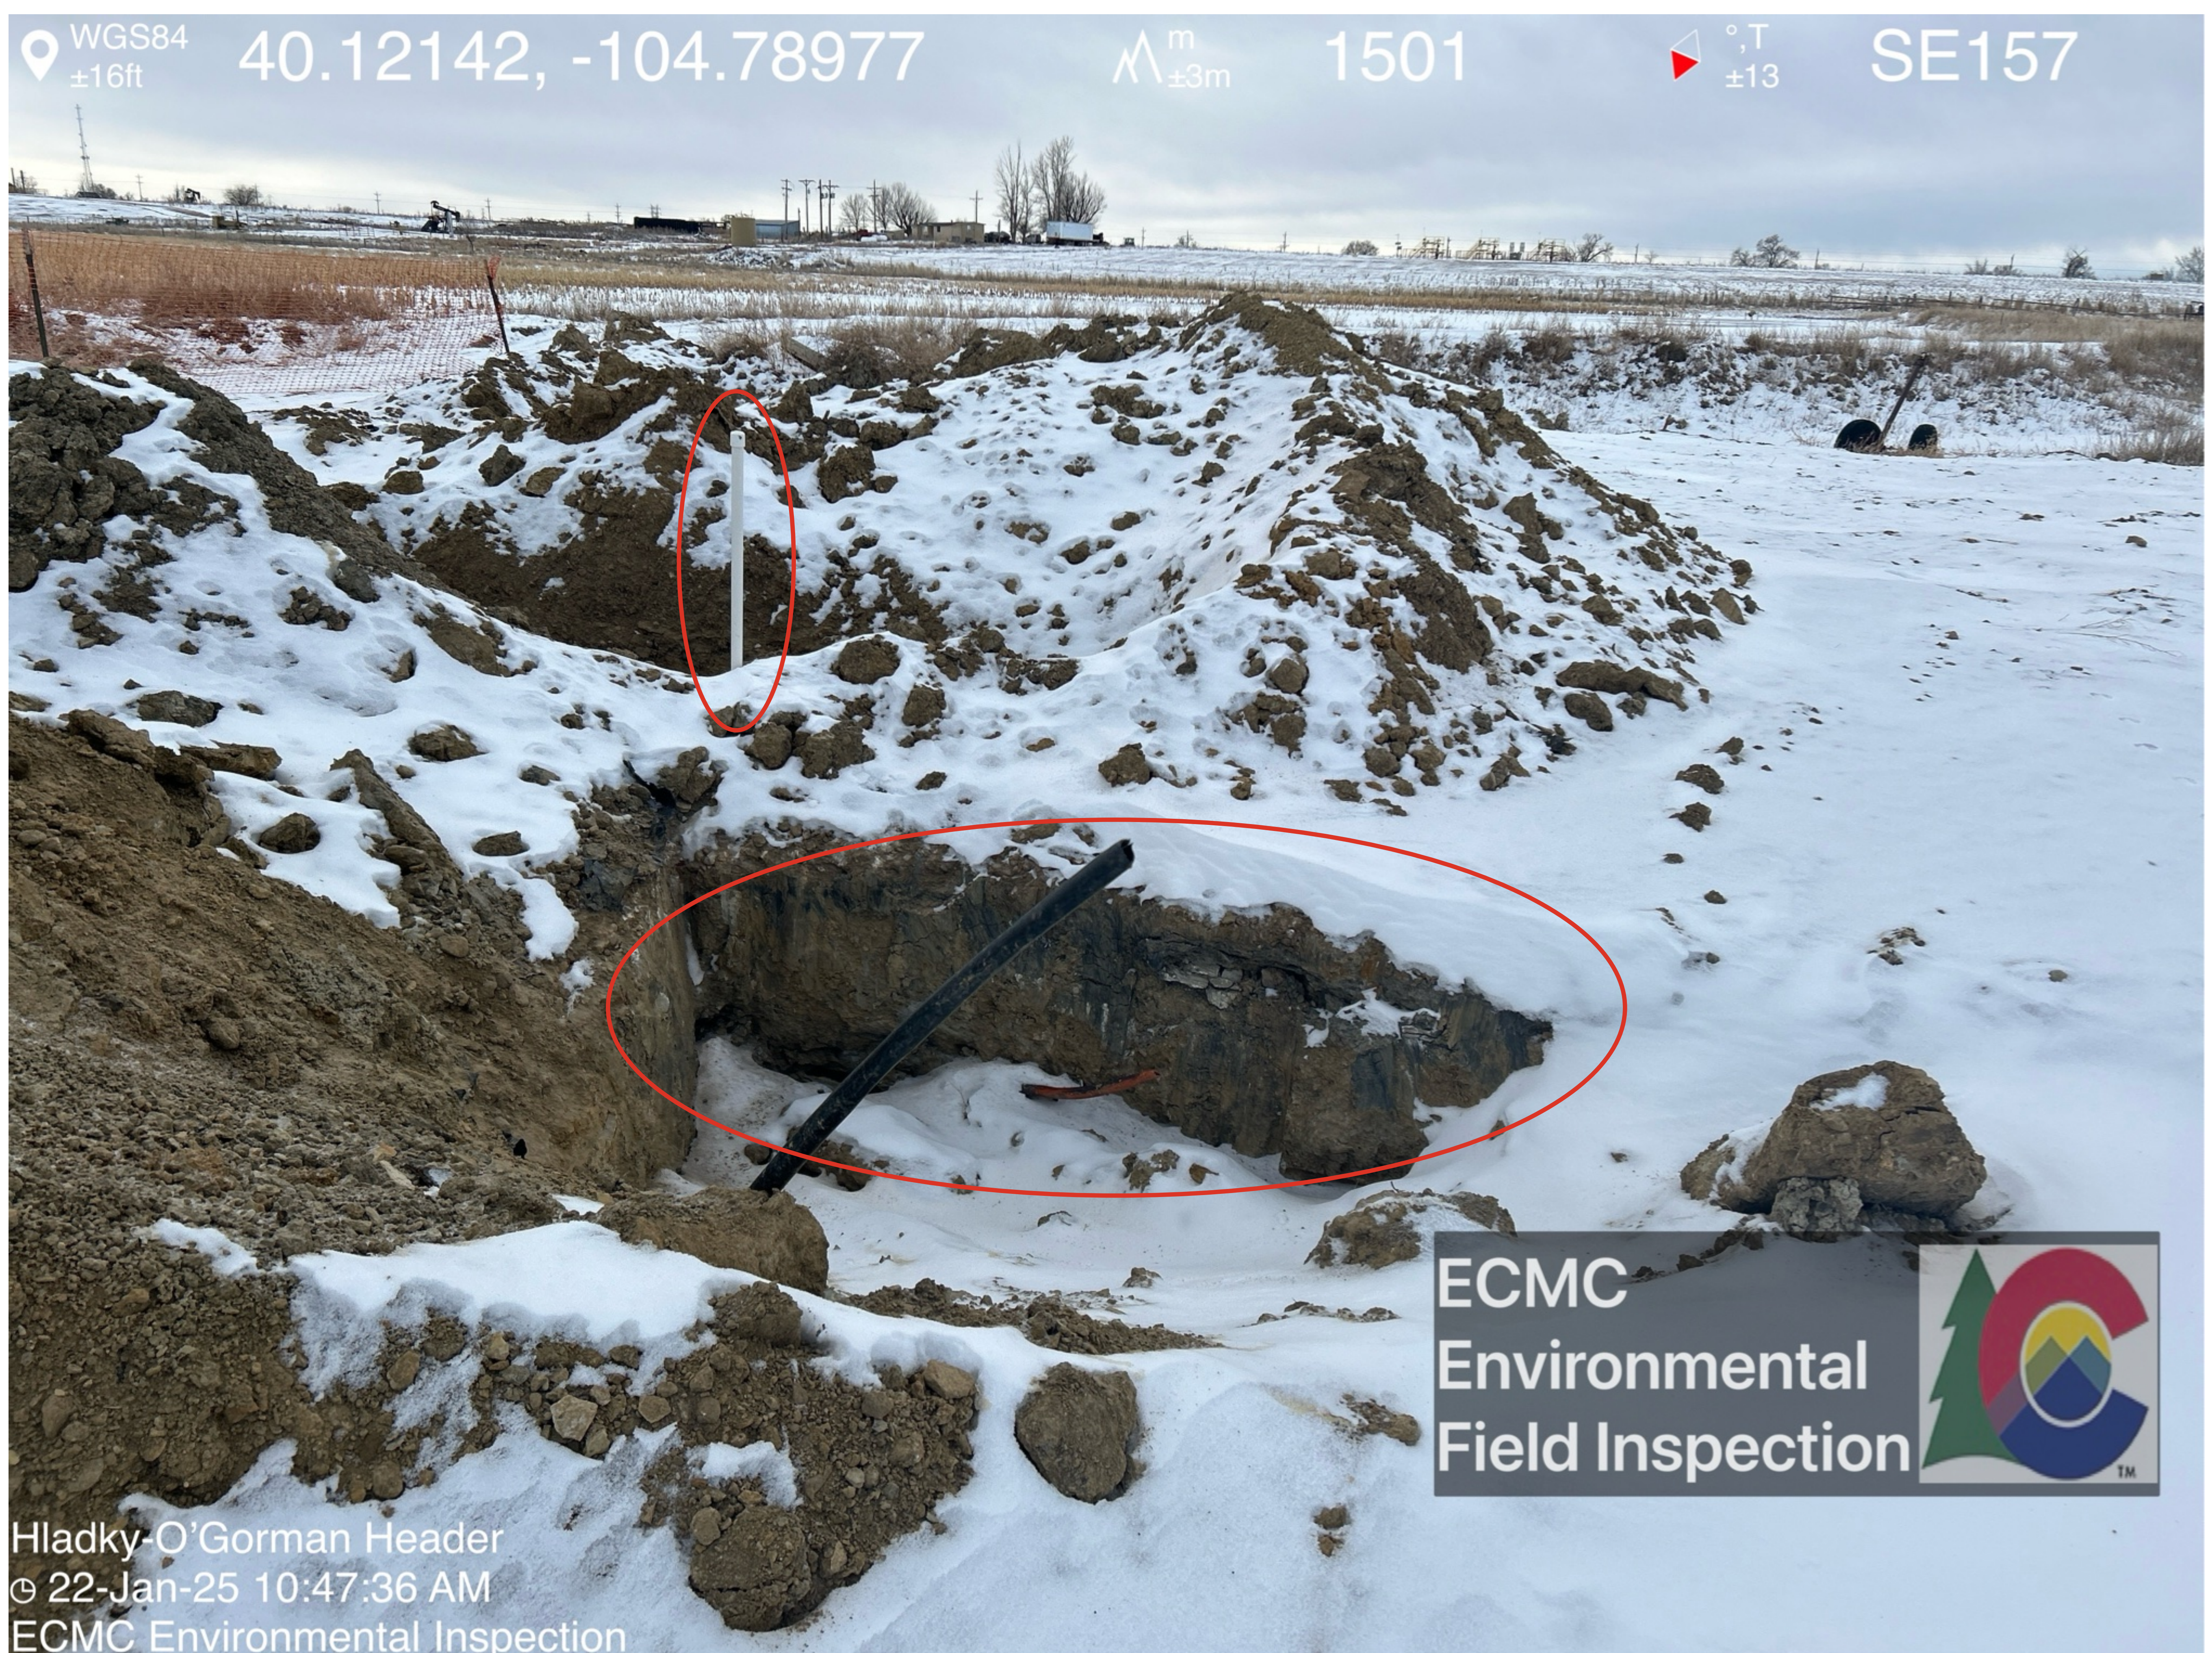
Gray staining visible in-situ. Monitoring well visible. Unmarked soil stockpiled on location with no BMPs.
