Hladky O'Gorman 3 Well (API # 05-123-07775)

Hladky-O'Gorman Header  
© 22-Jan-25 10:49:13 AM  
ECMC Environmental Inspection

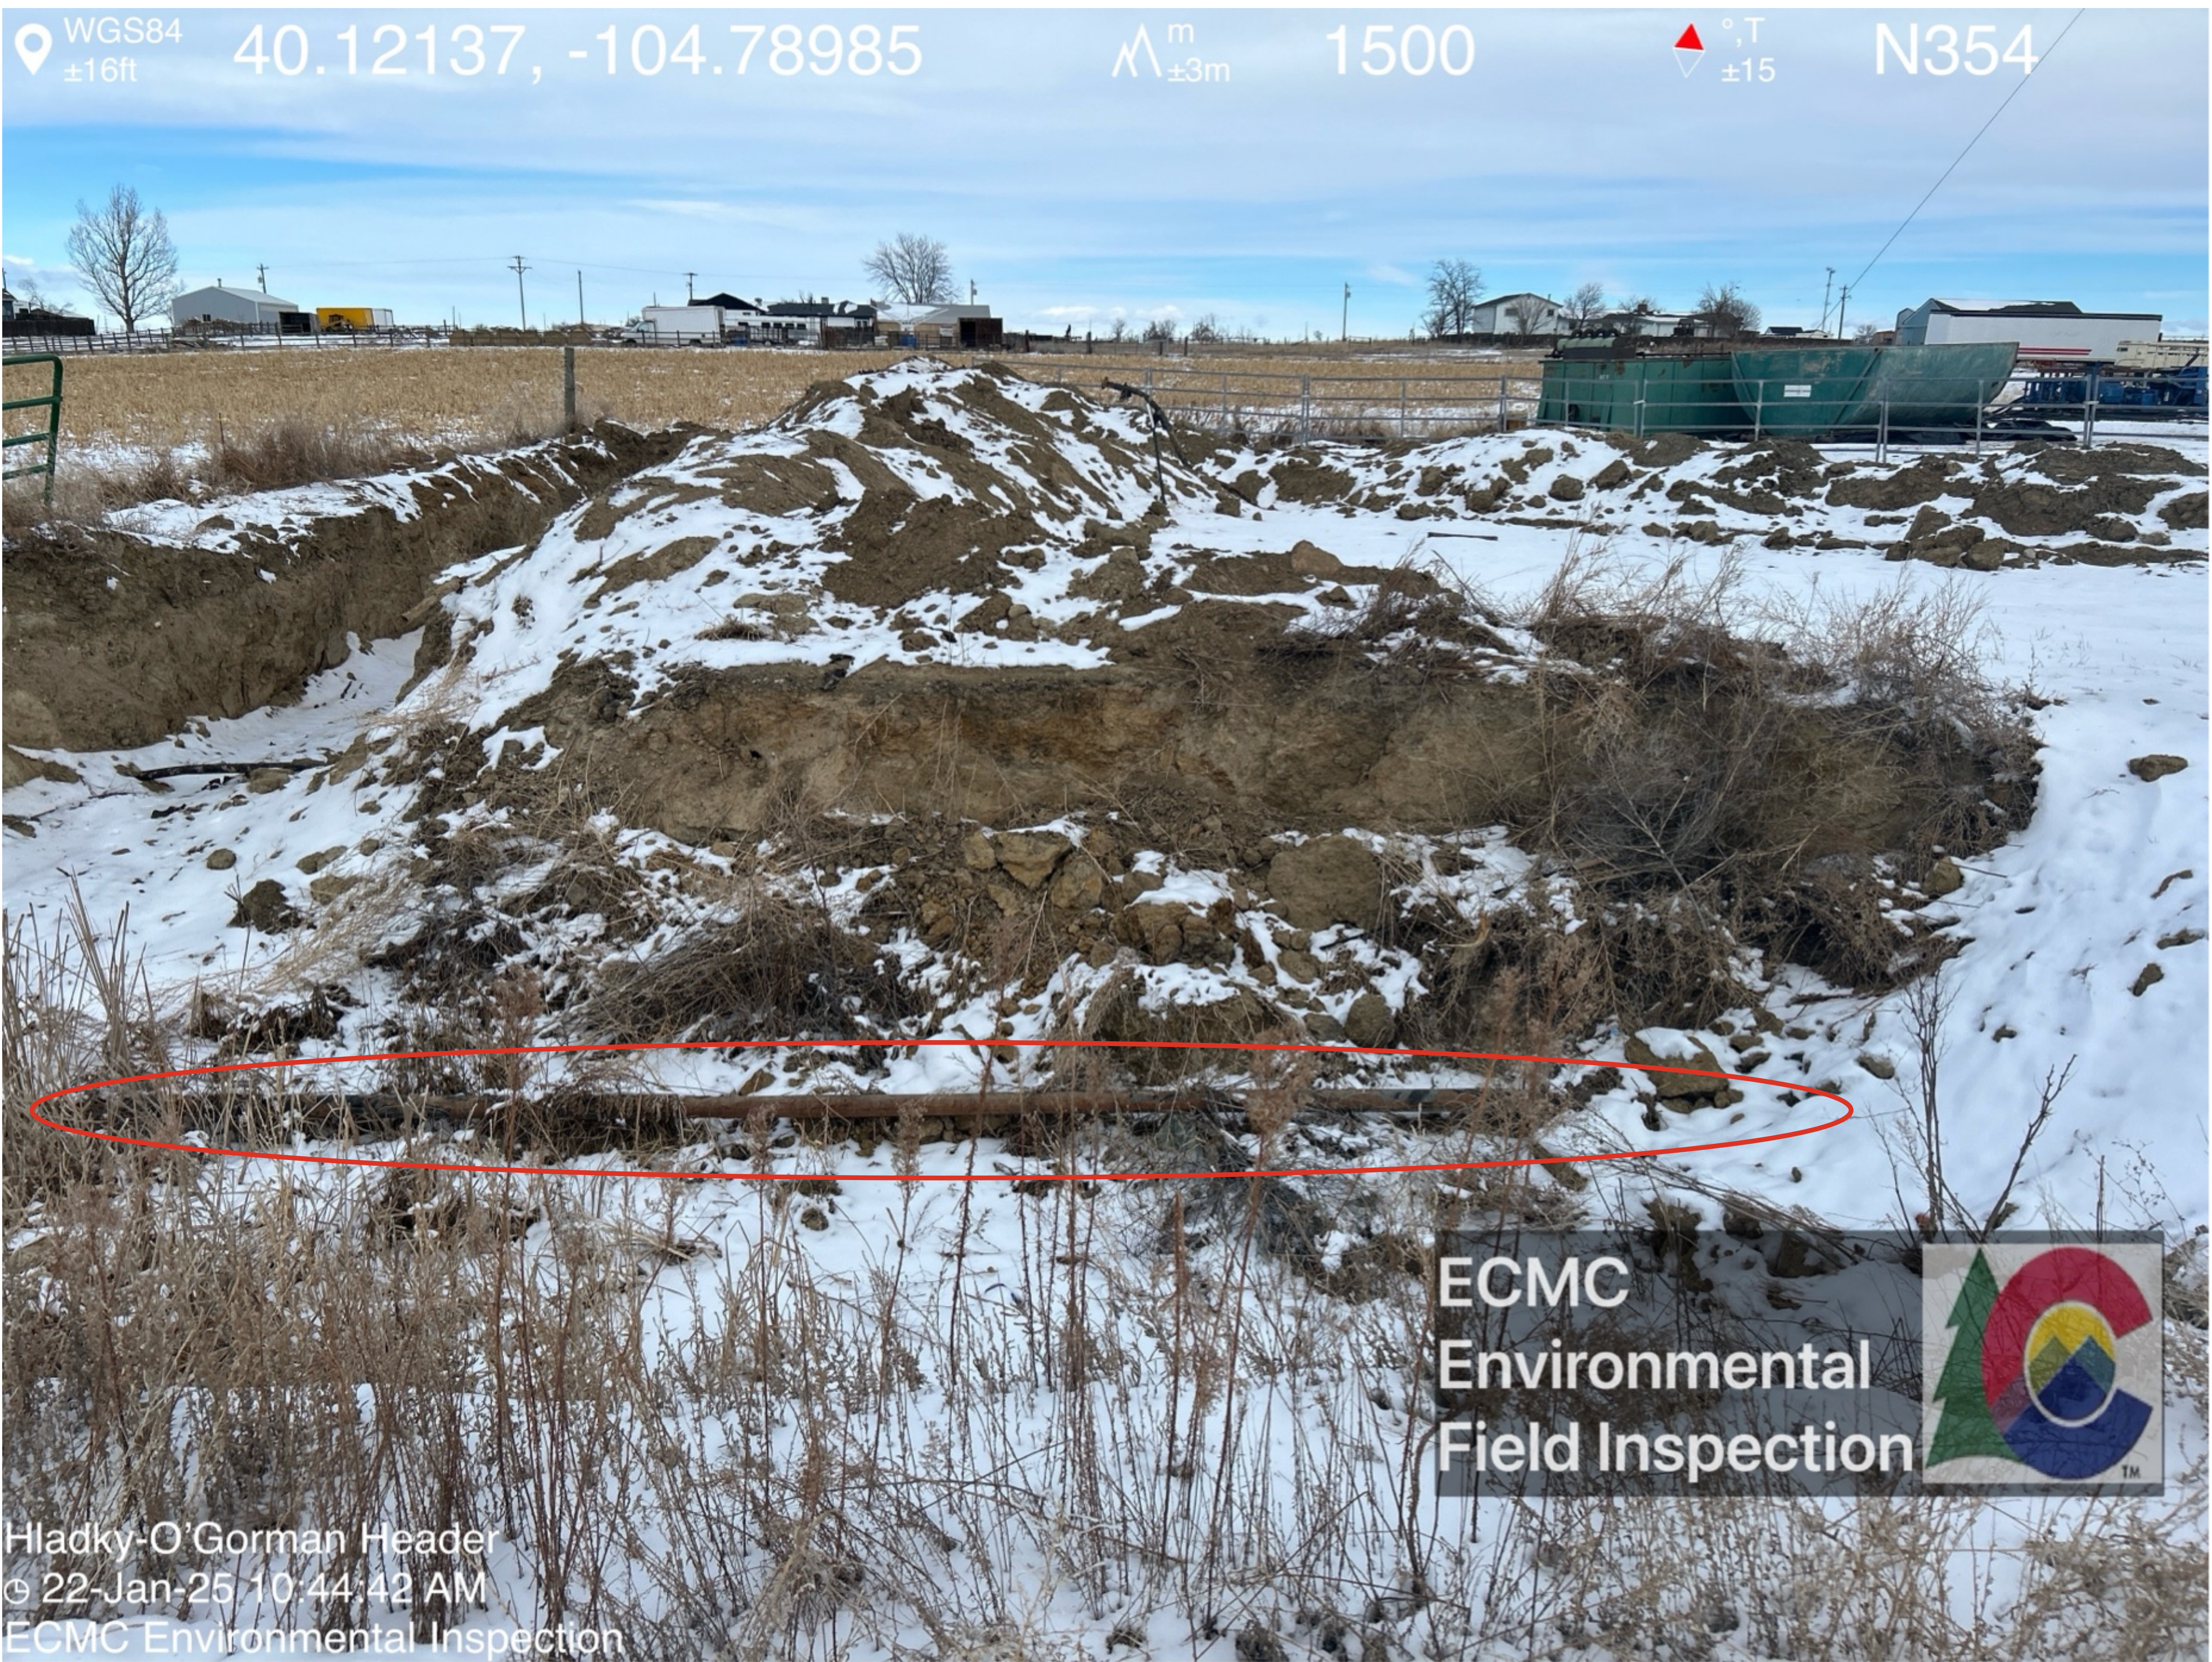
Excavation remains open with weeds visible. Flowline visible within excavation.

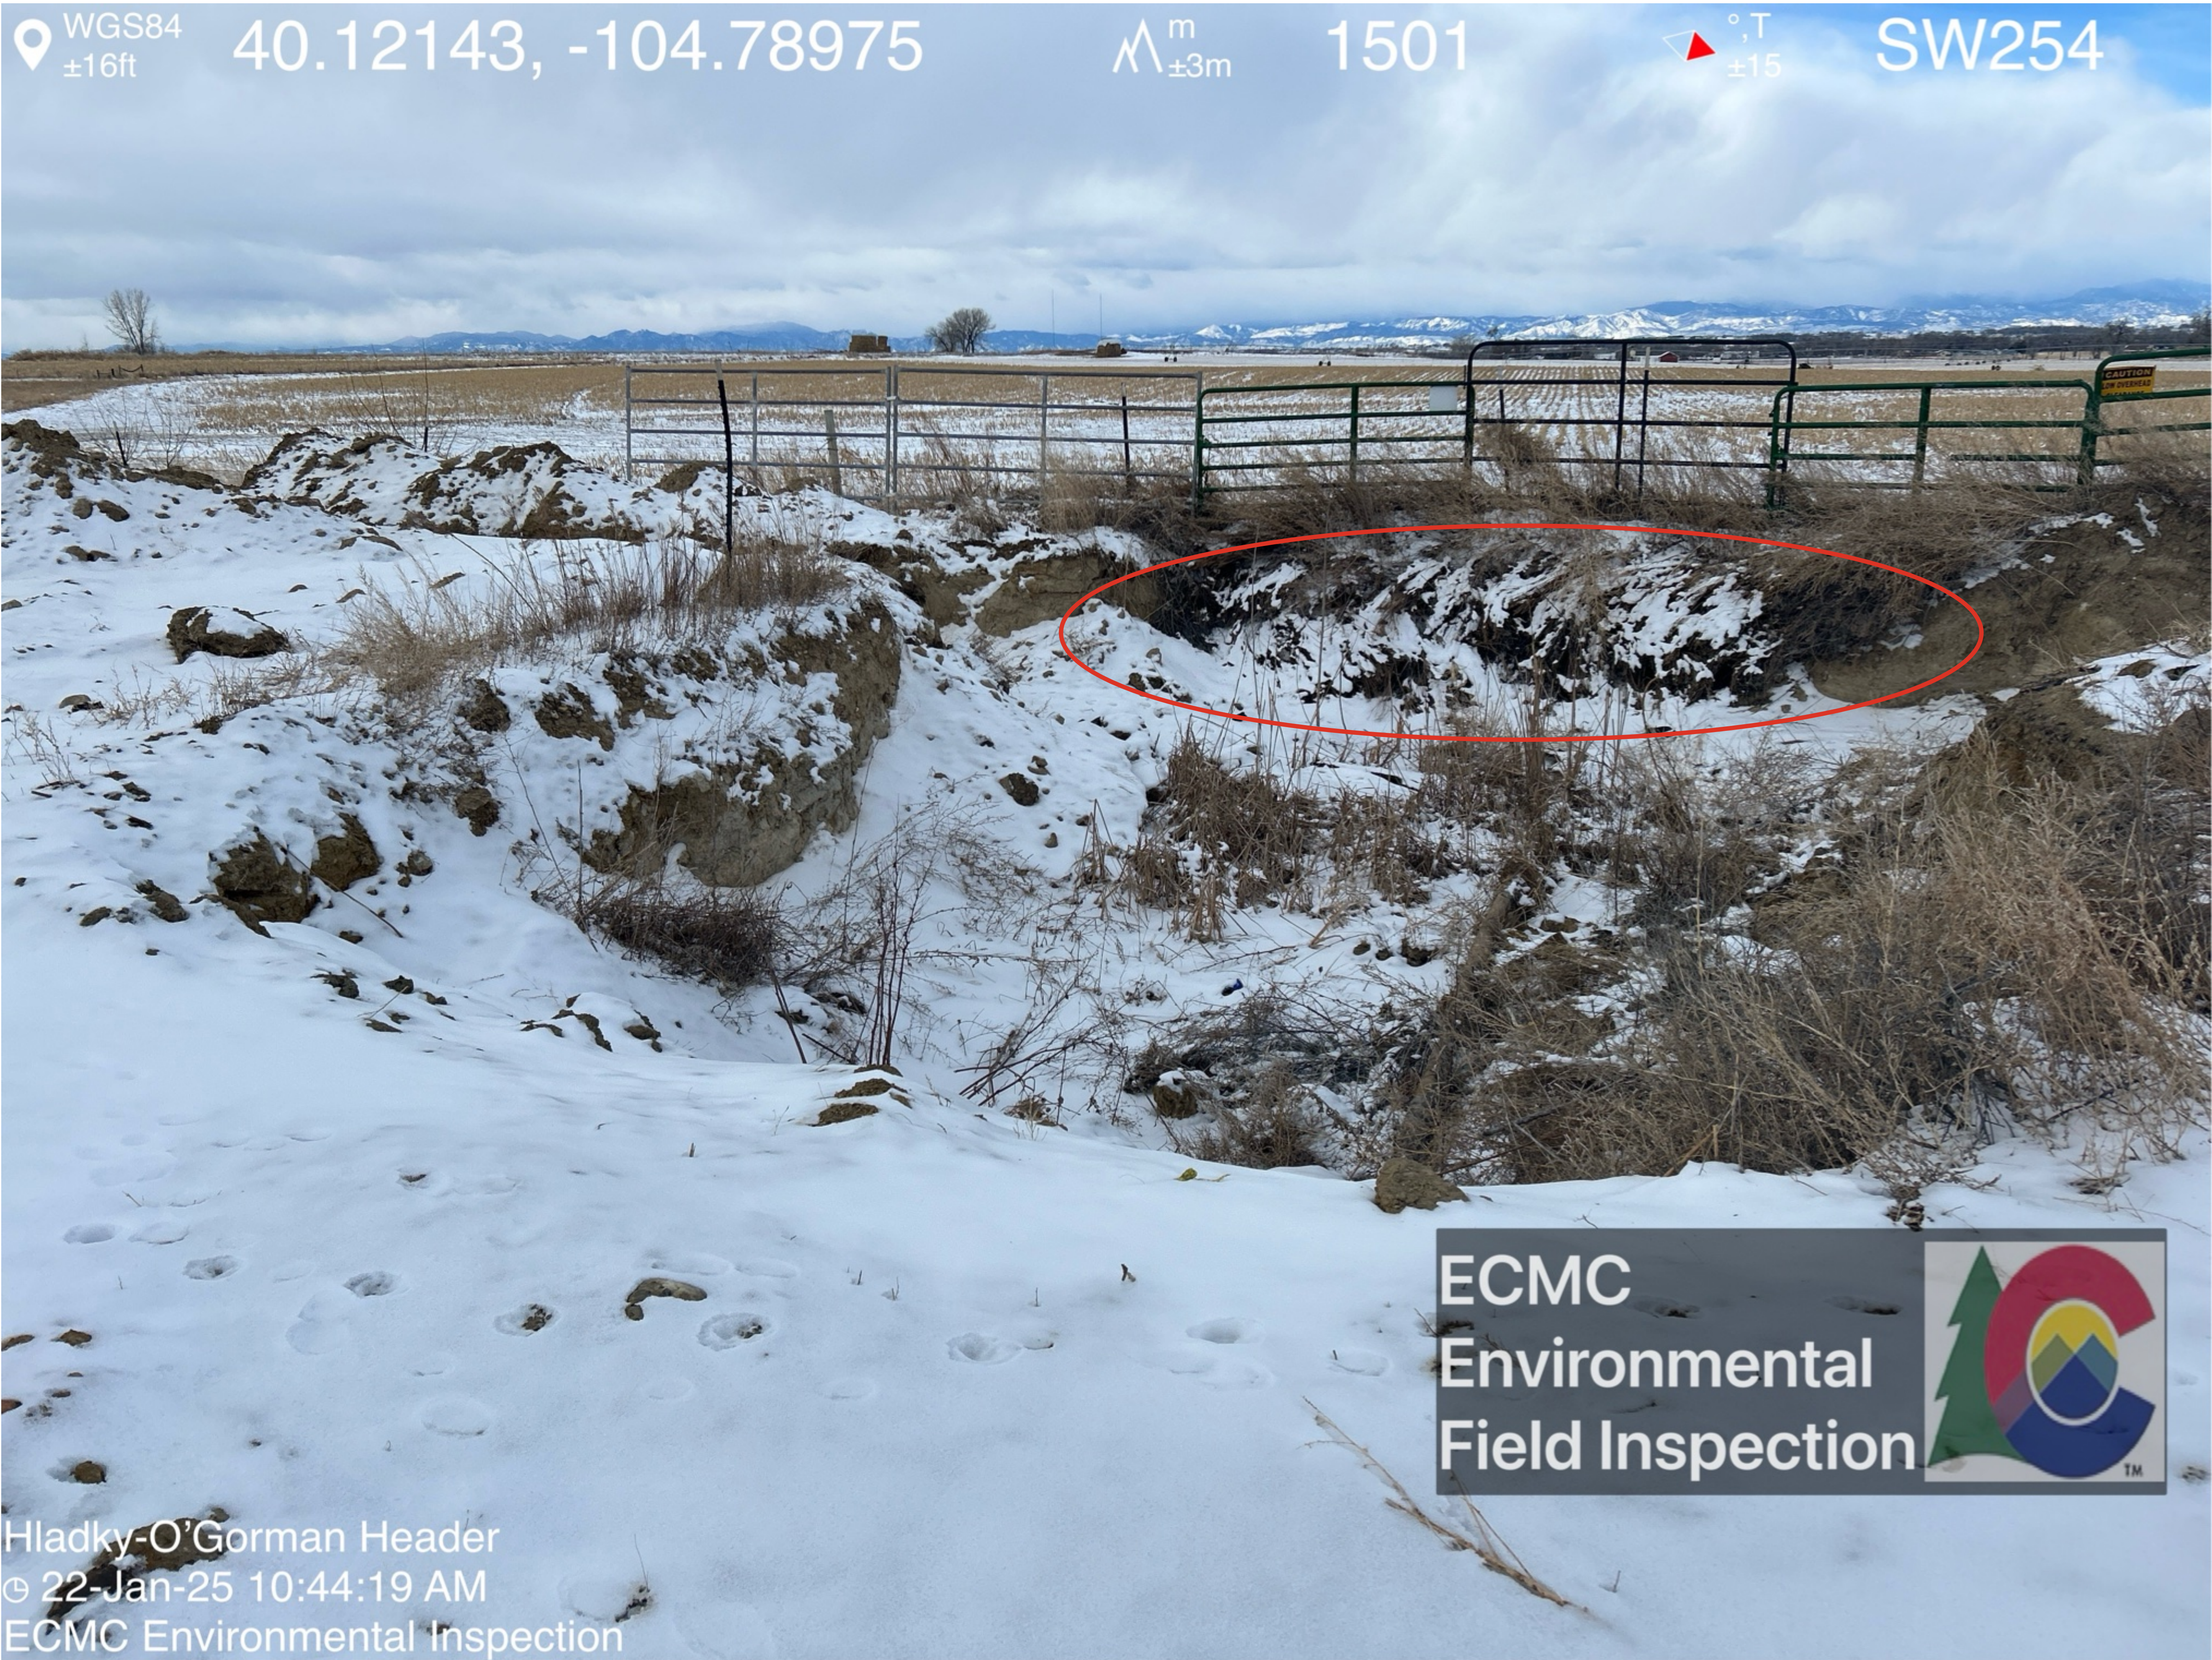
Western sidewall appears to have partially collapsed. Metal fencing is discontinuous and does not fully encompass the excavation.

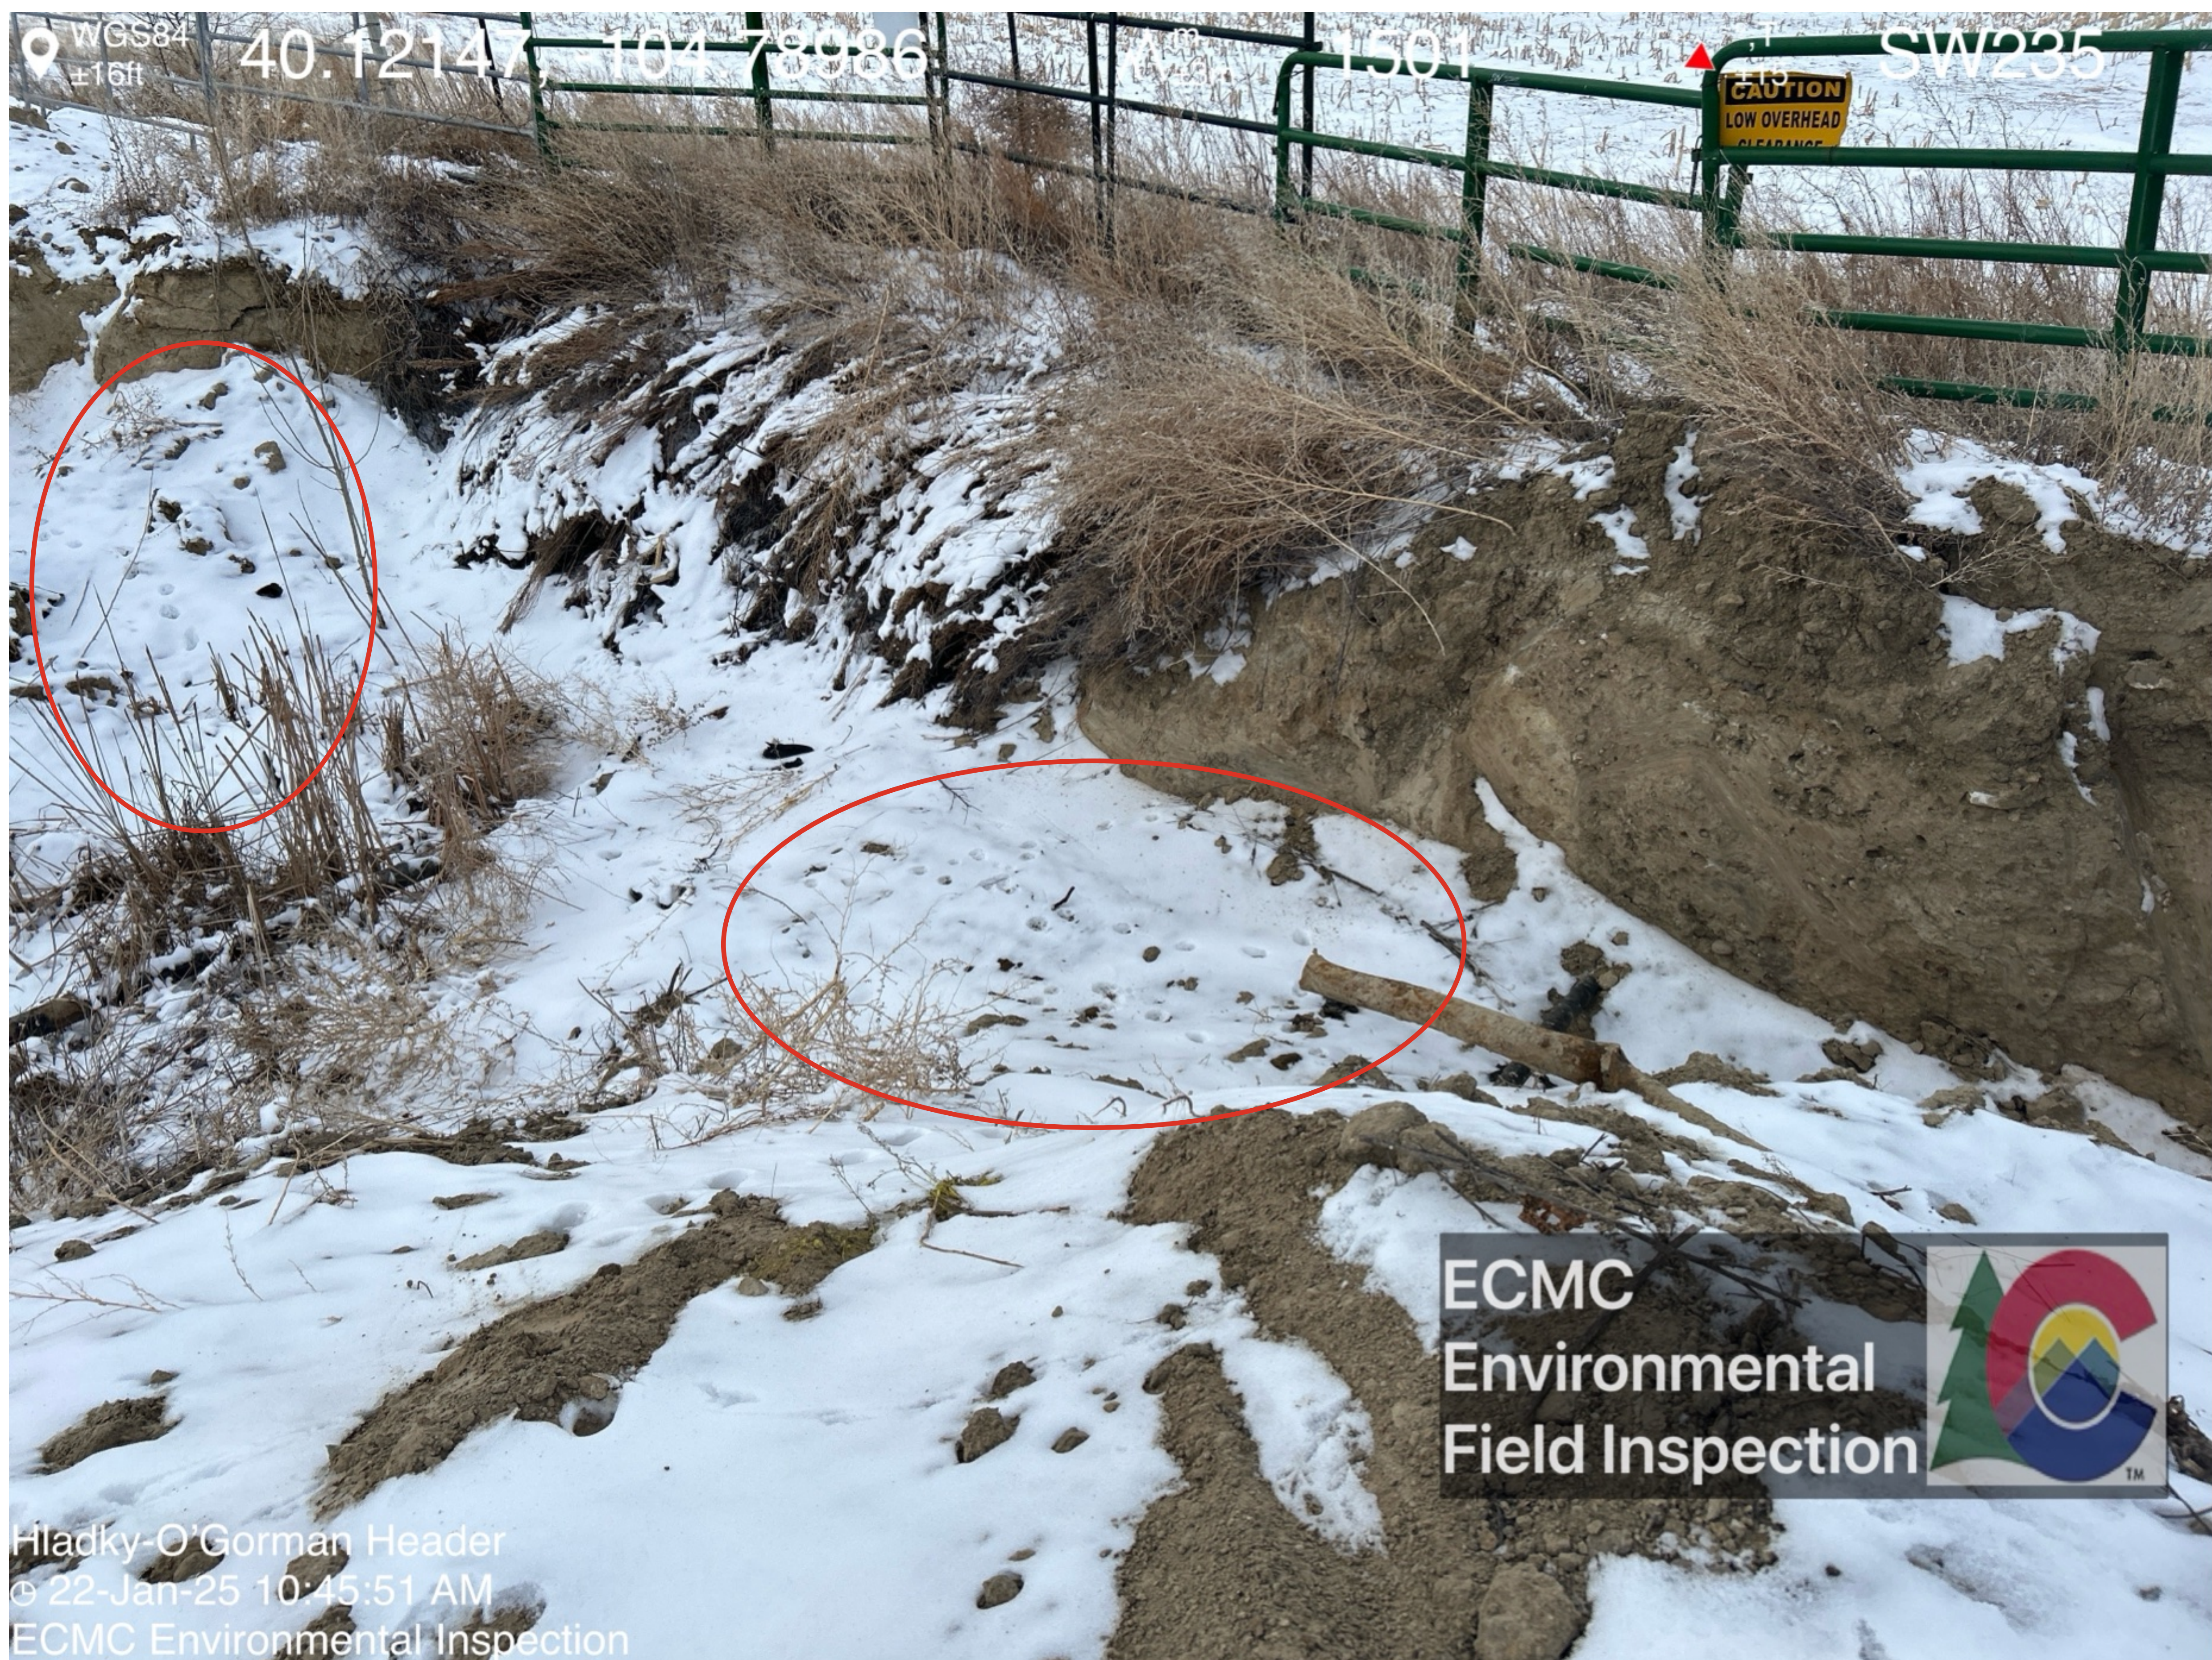
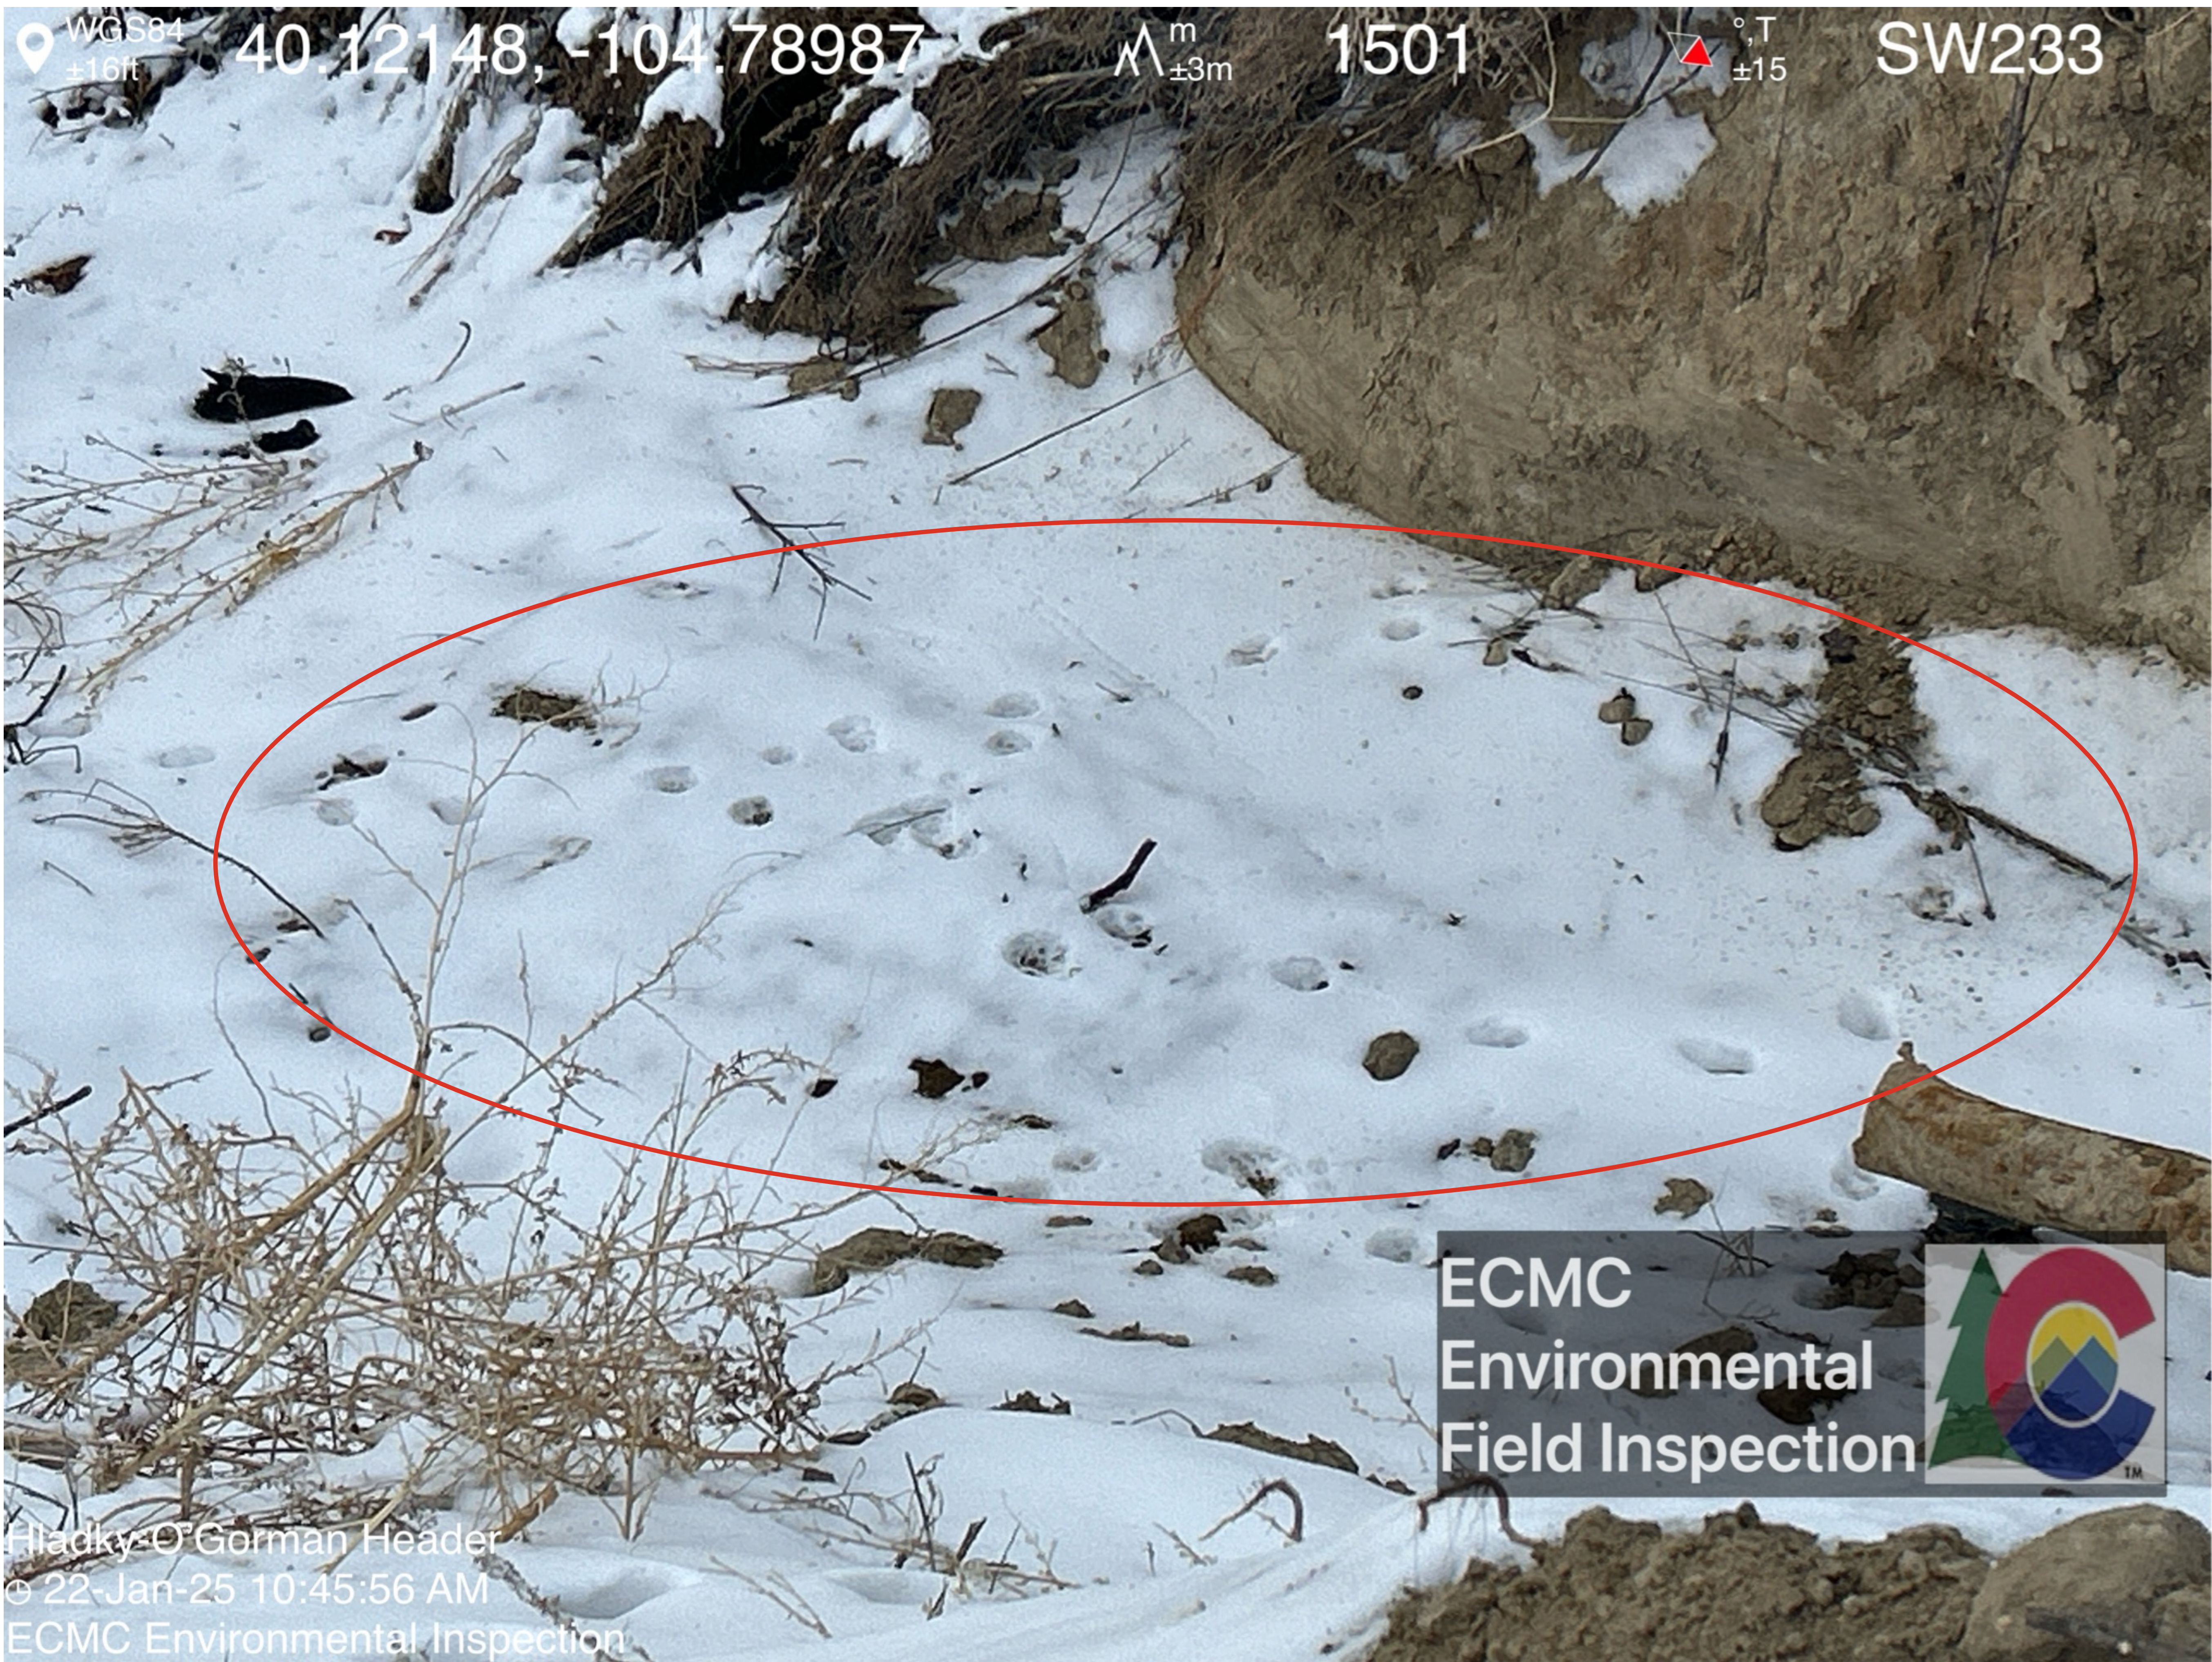
Wildlife tracks were visible within the open excavations.

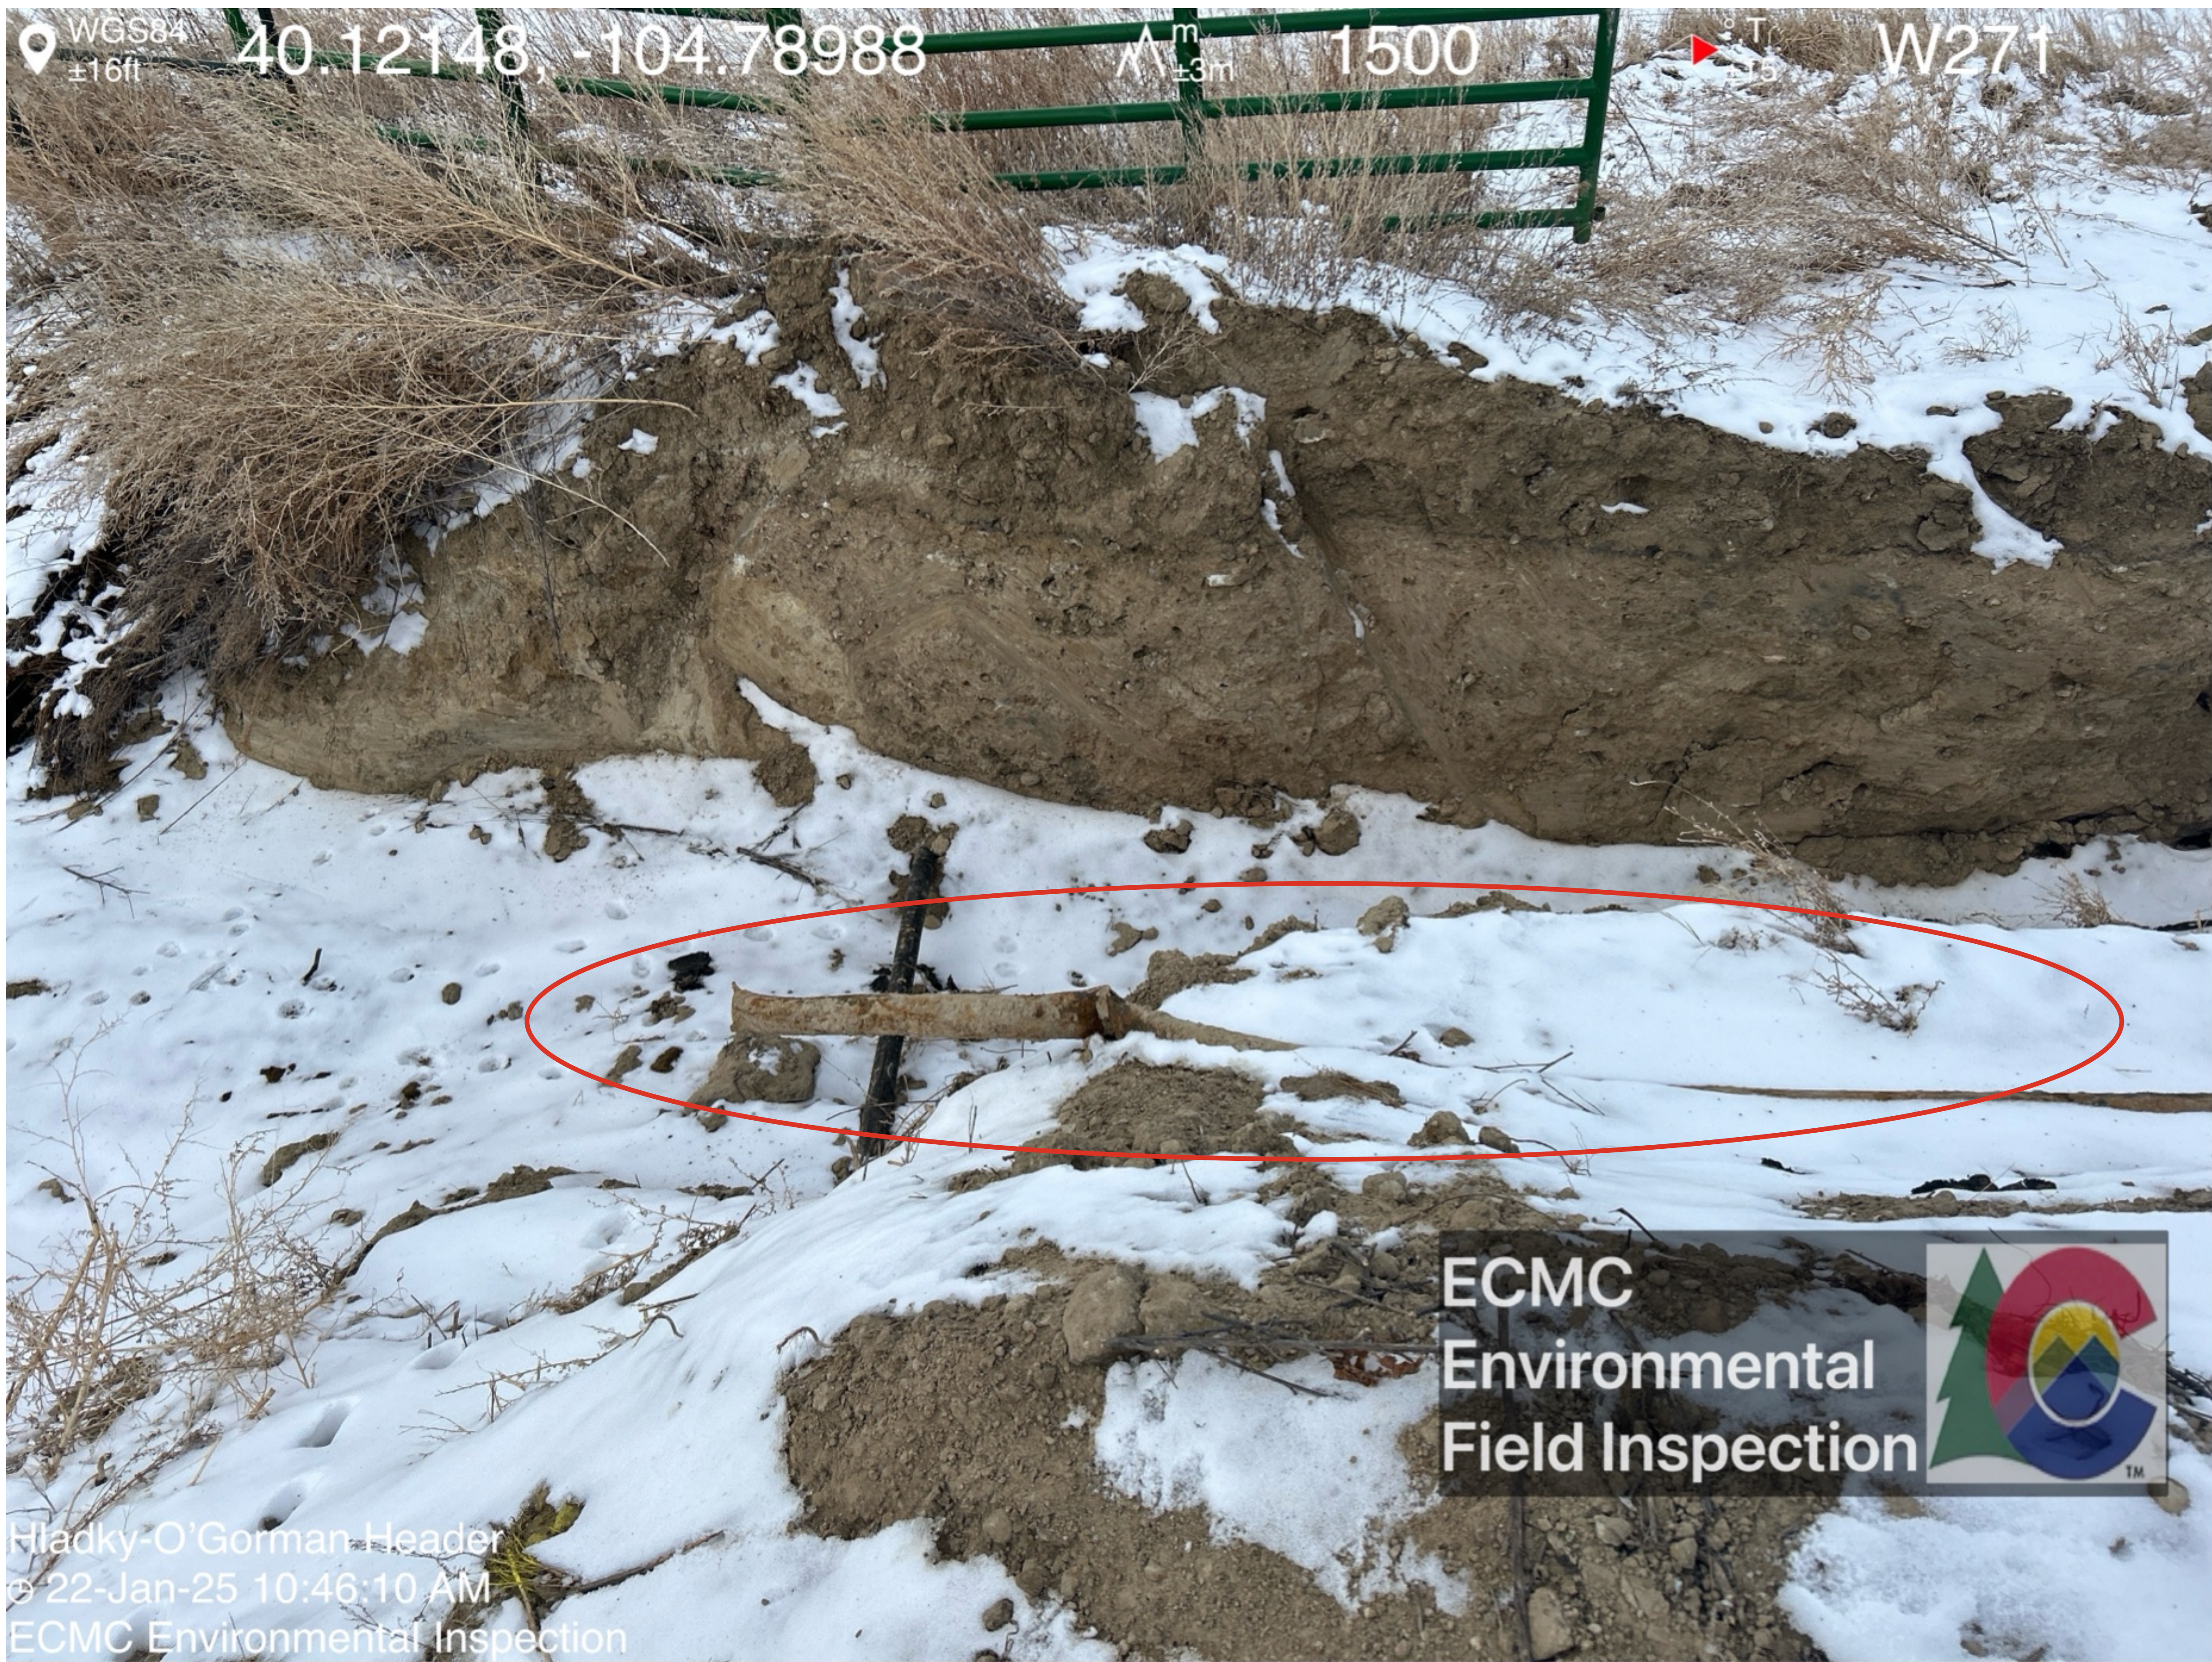
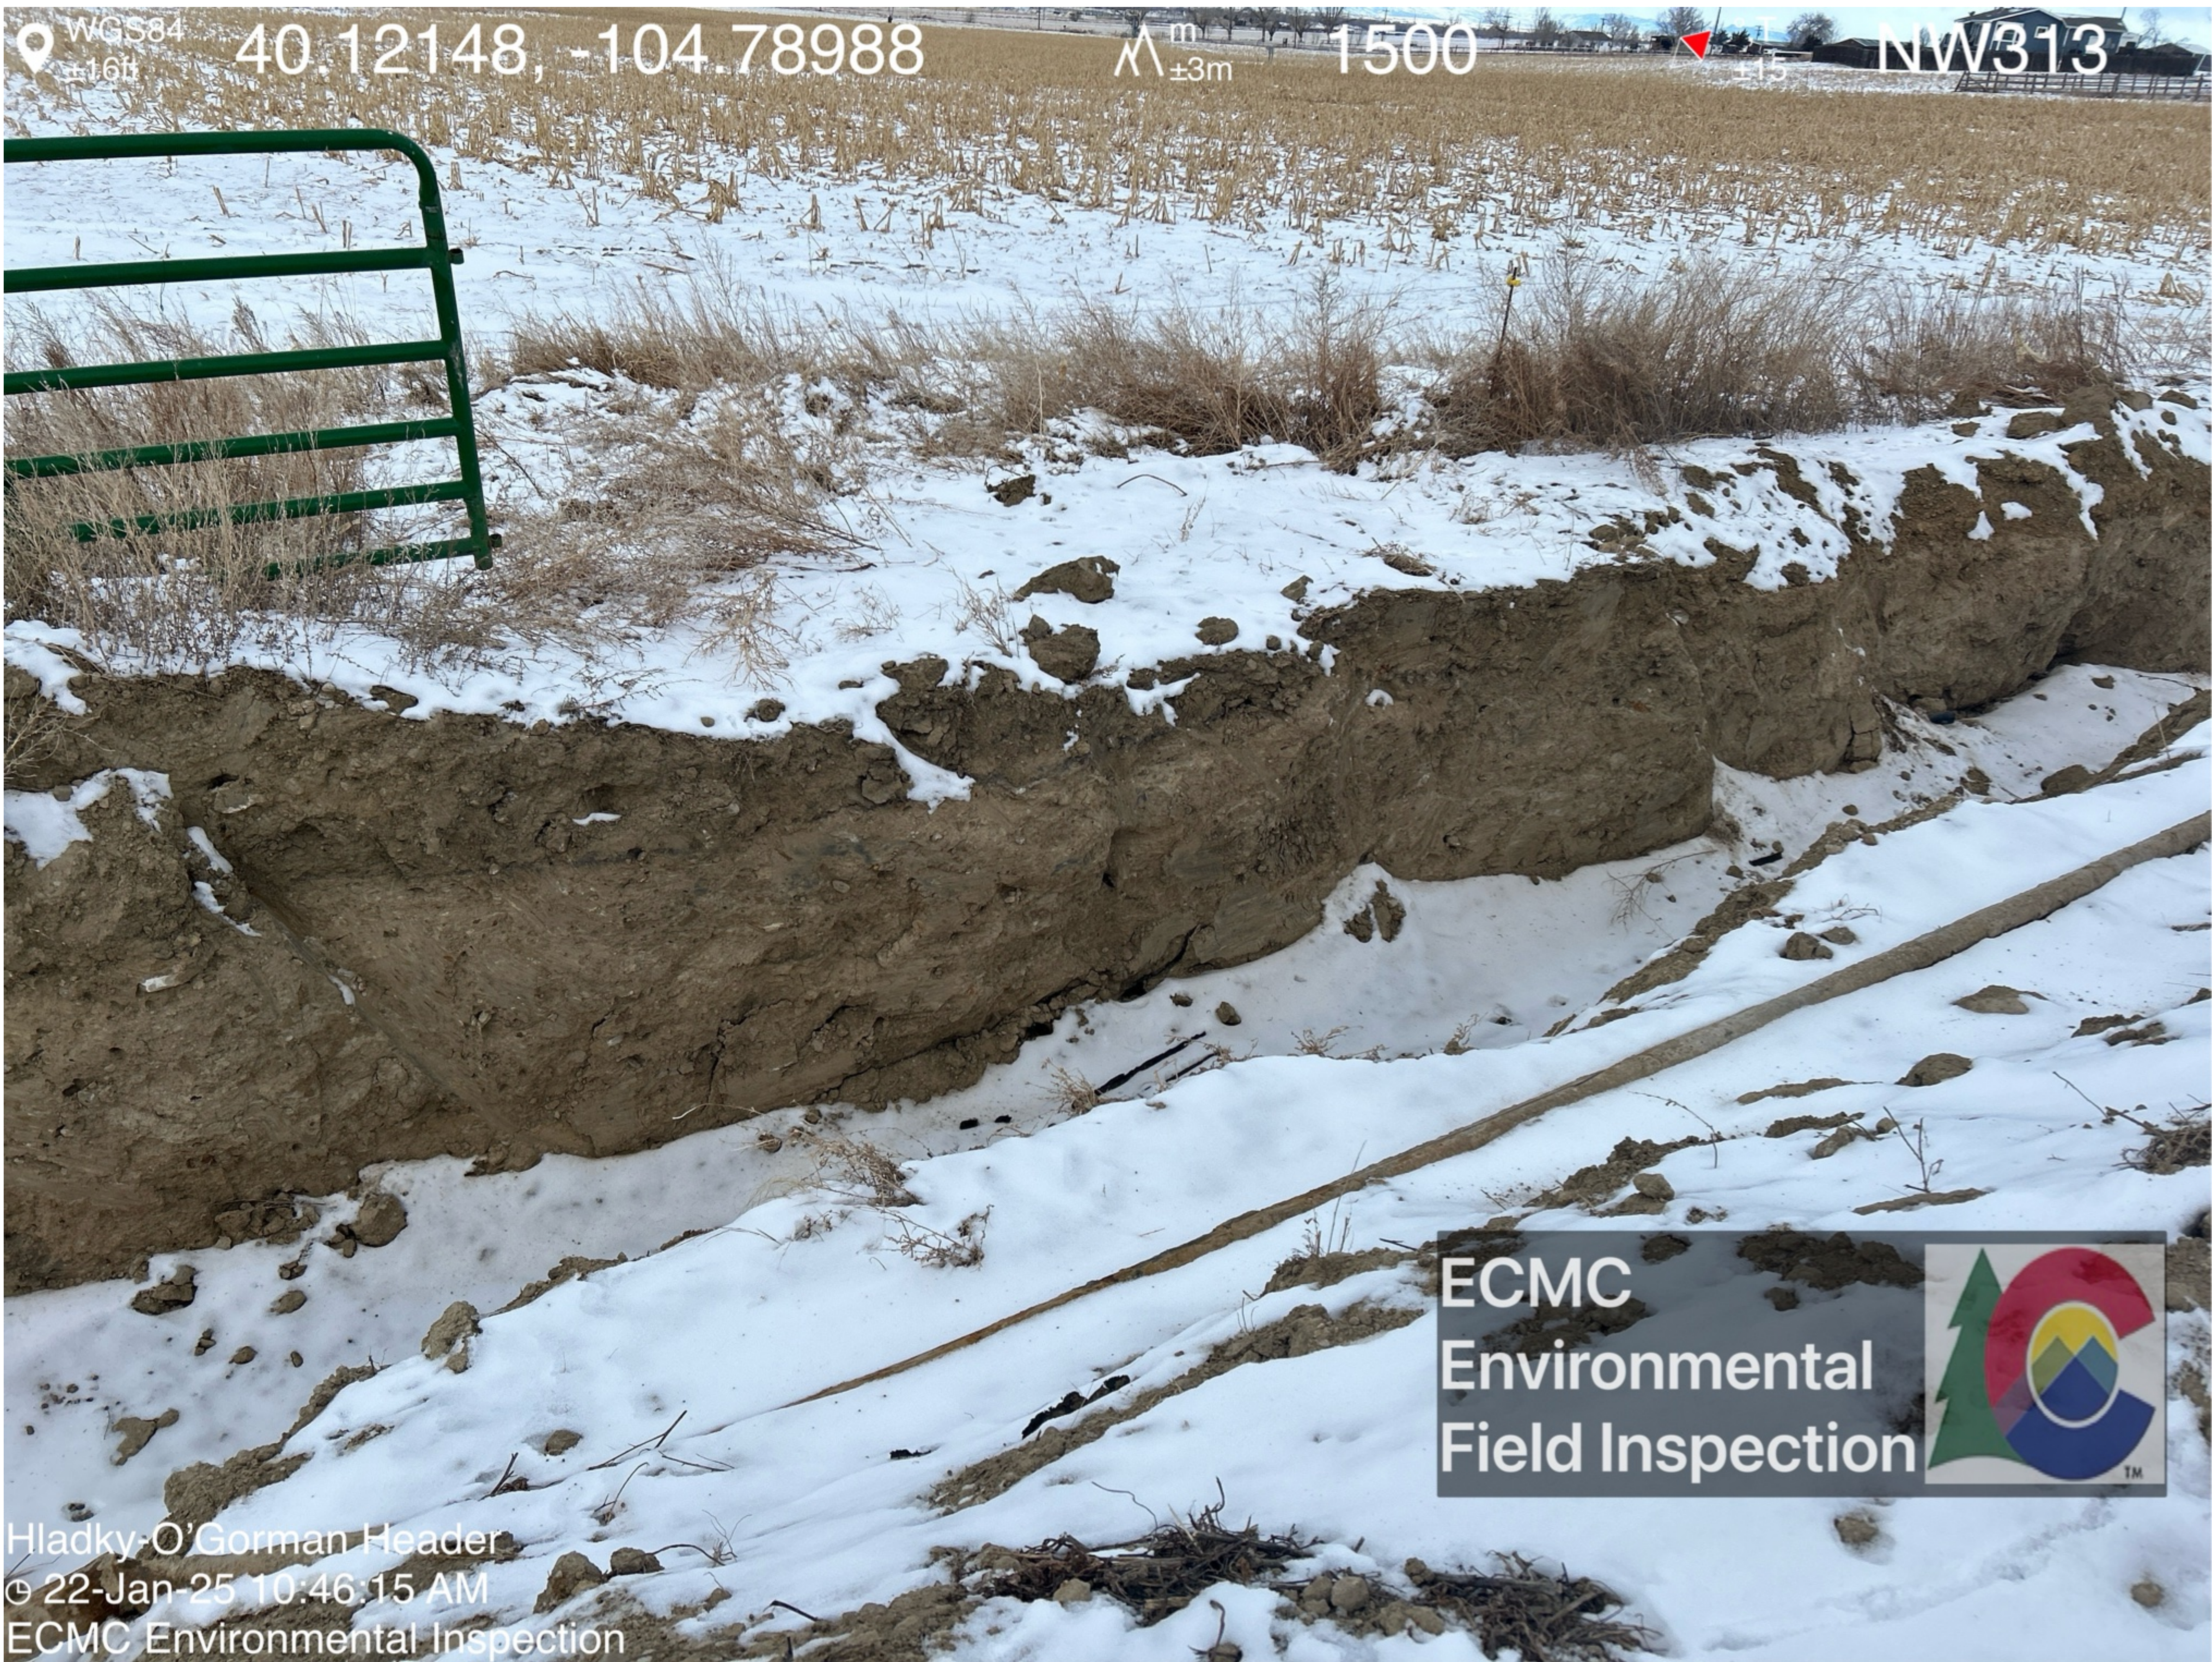
Multiple pipes/lines remain within the excavation.
