Hladky O'Gorman 3 Well (API # 05-123-07775)

Hladky-O'Gorman Header  
© 22-Jan-25 10:49:13 AM  
ECMC Environmental Inspection

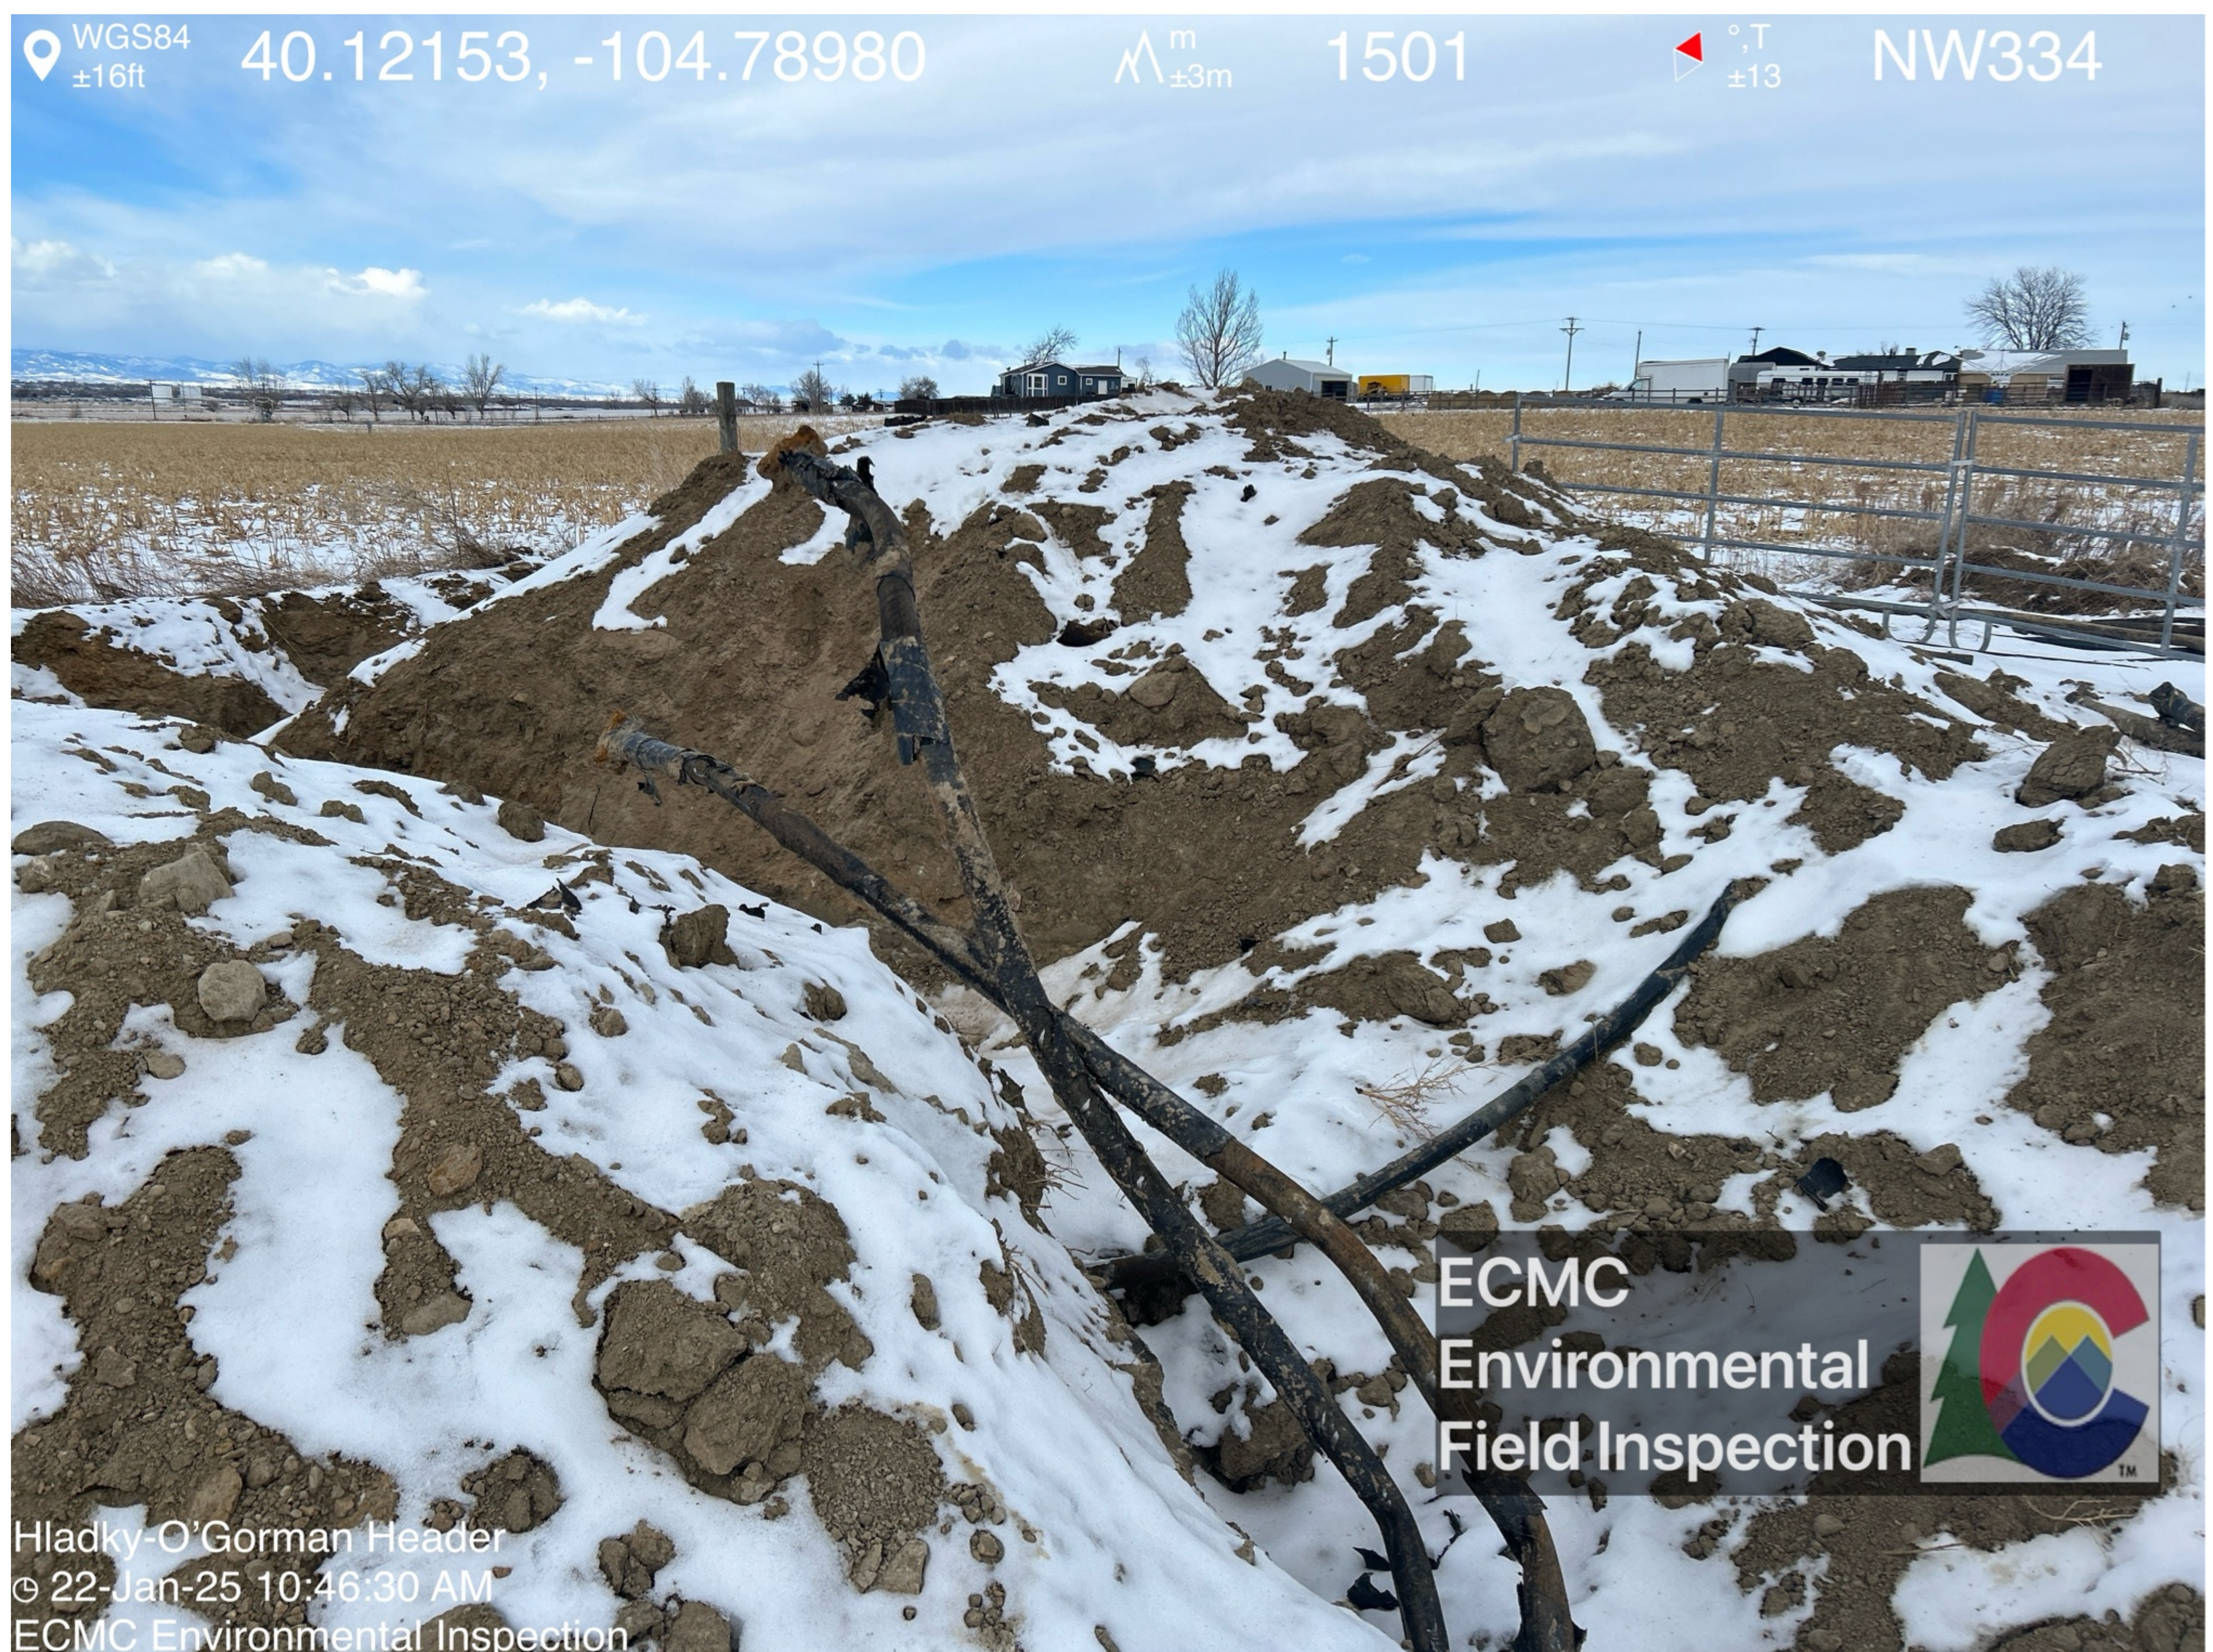
Multiple pipes/lines are present in the unmarked soil stockpiles.

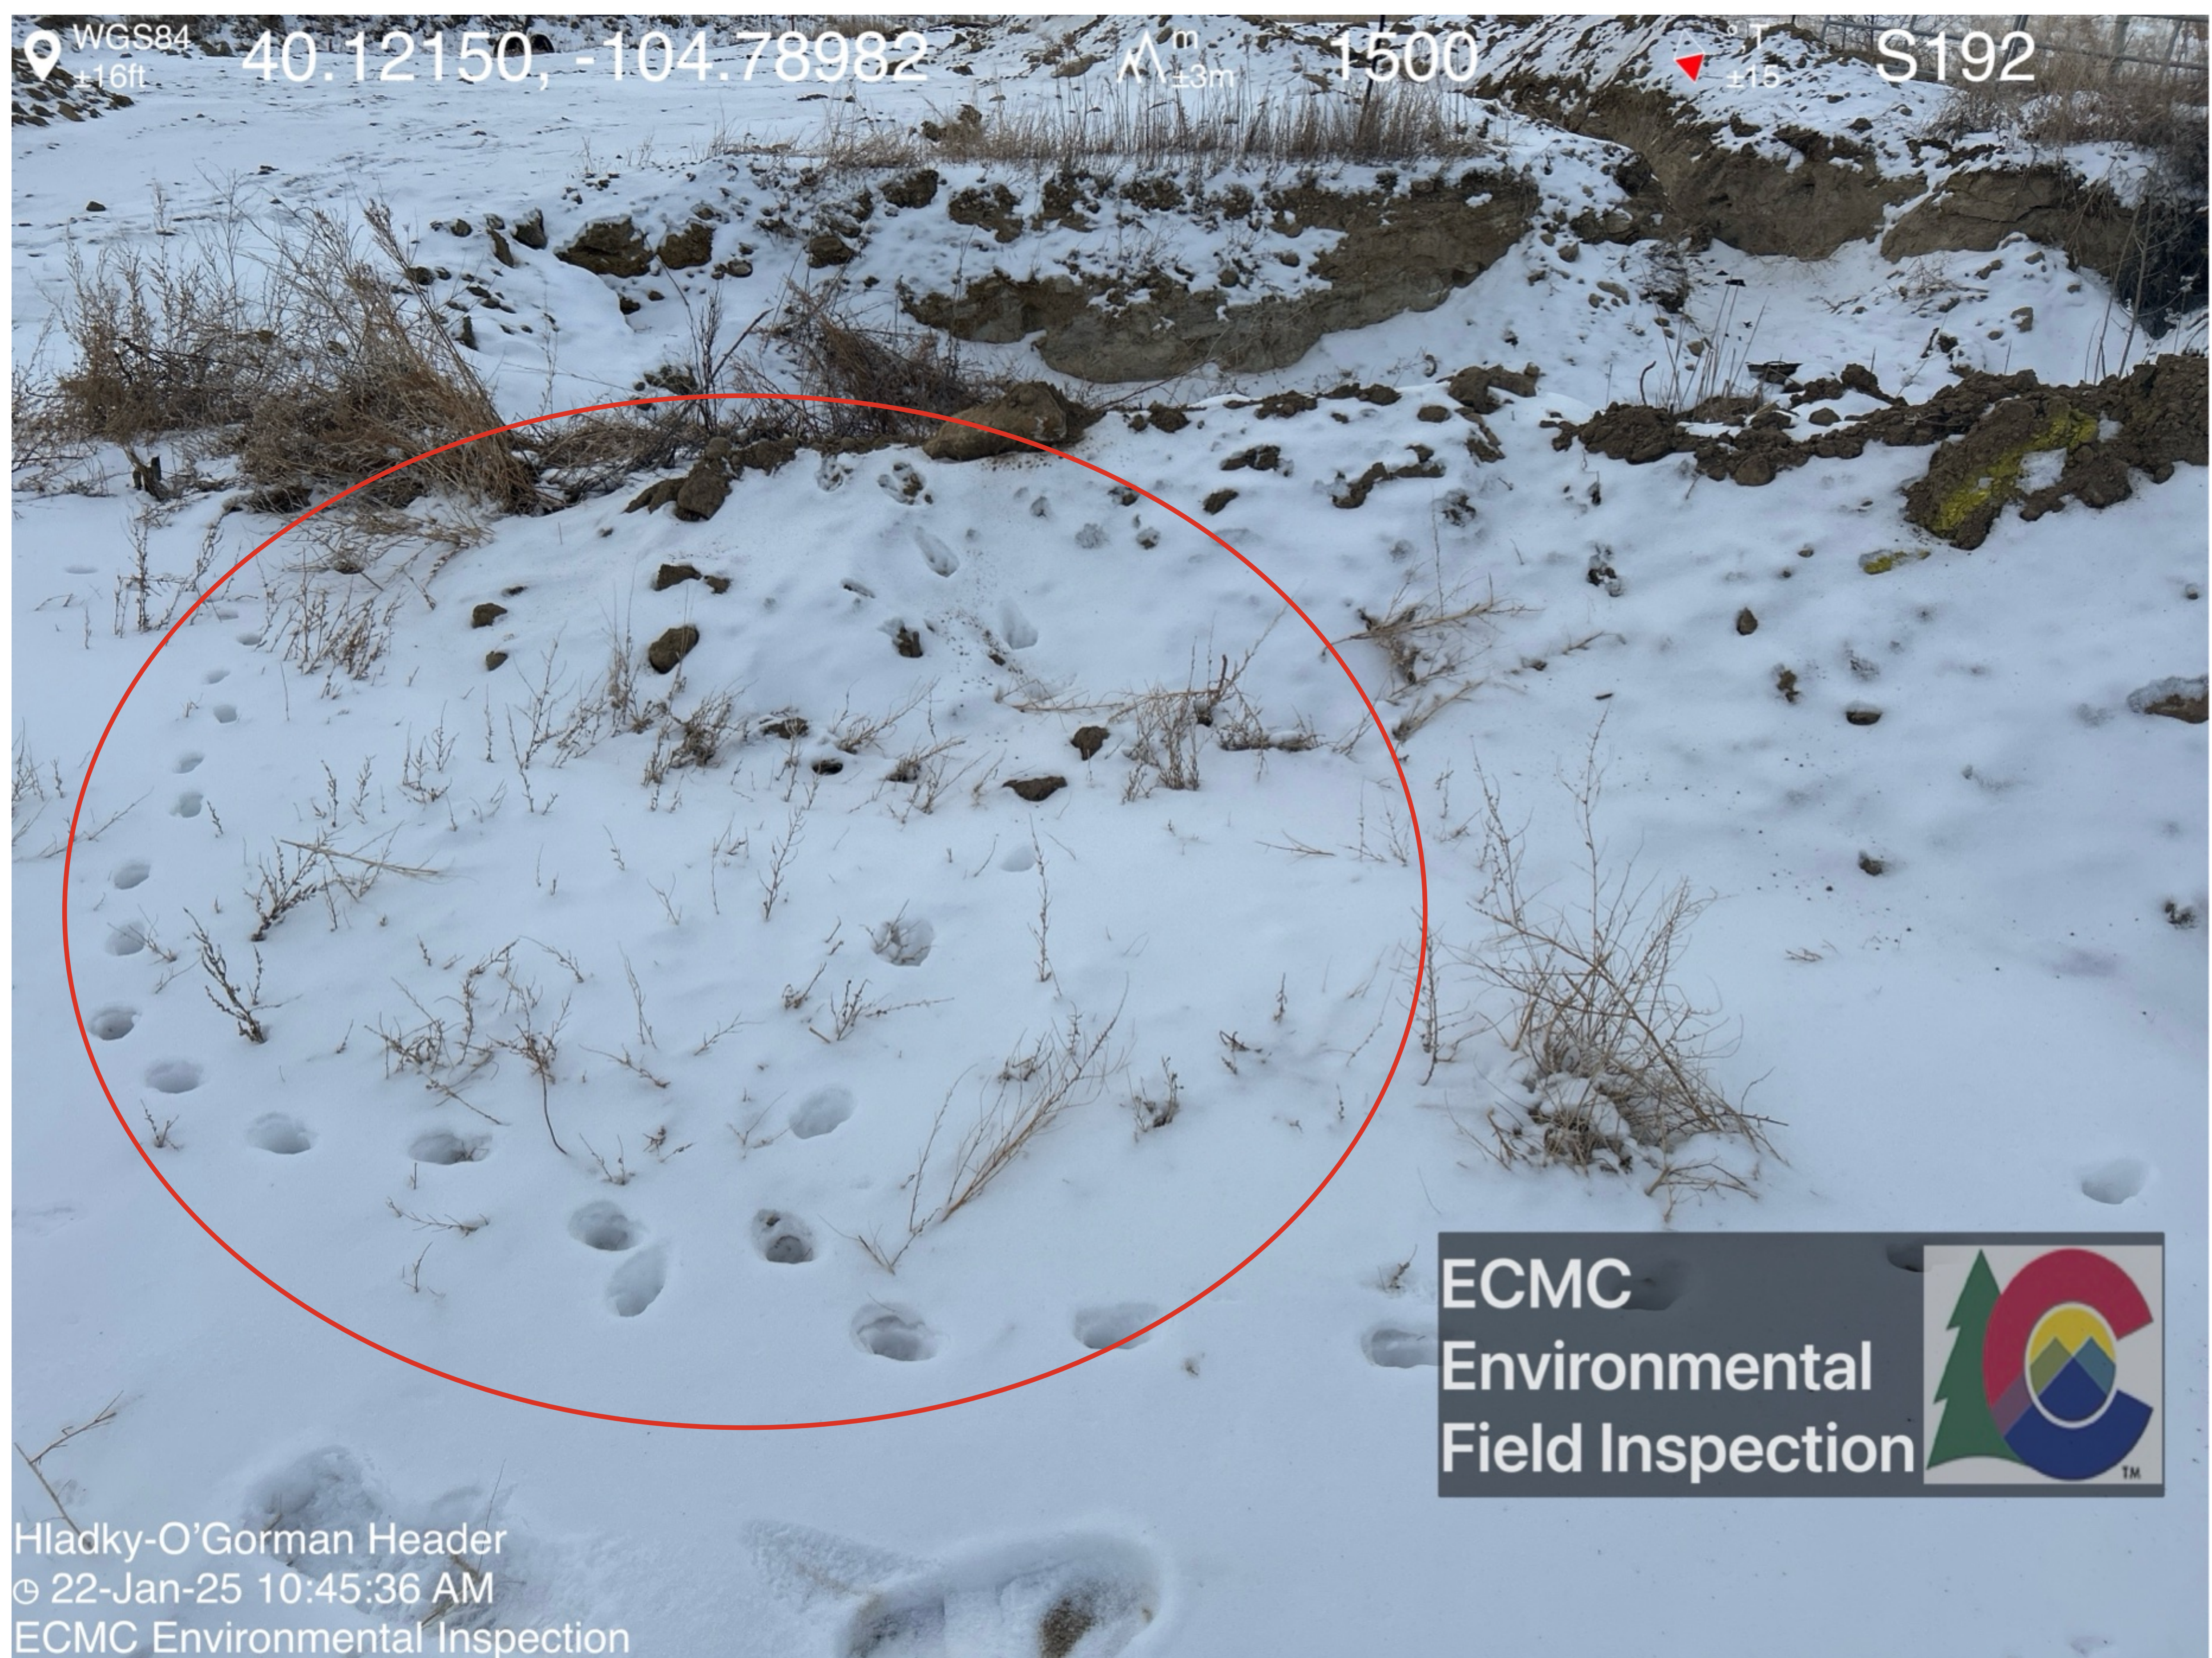
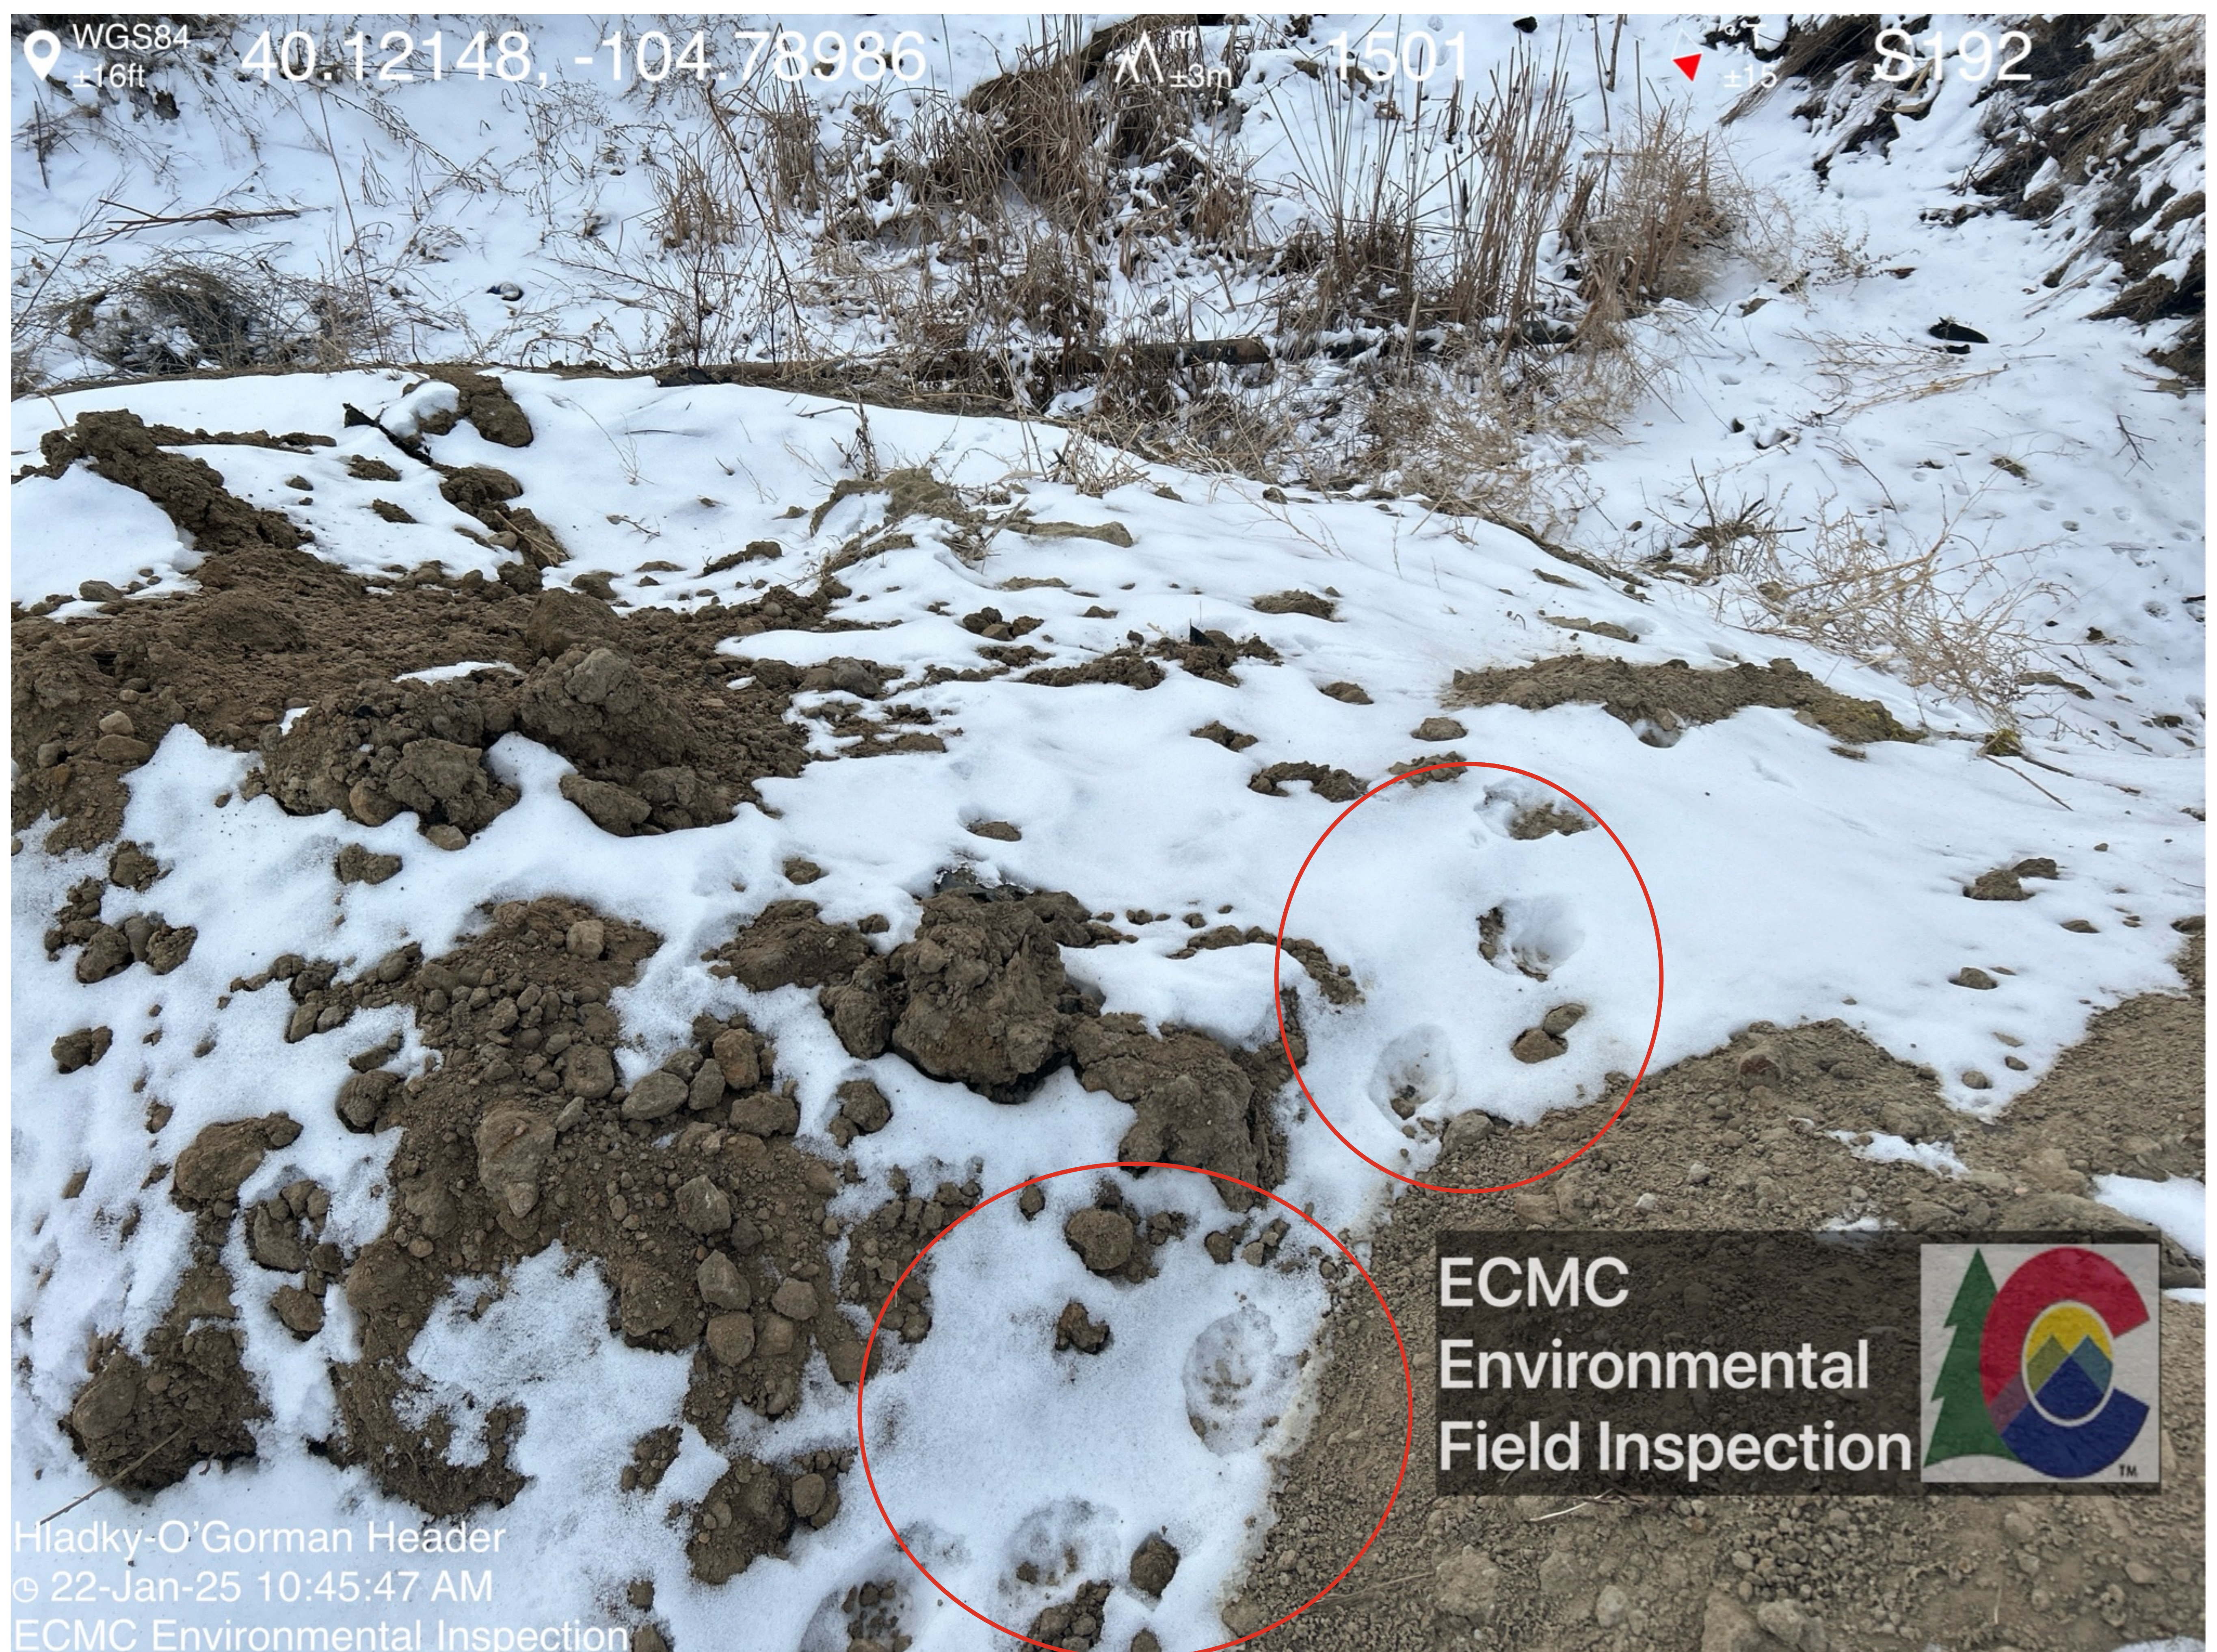
Wildlife tracks were visible throughout the excavation area.

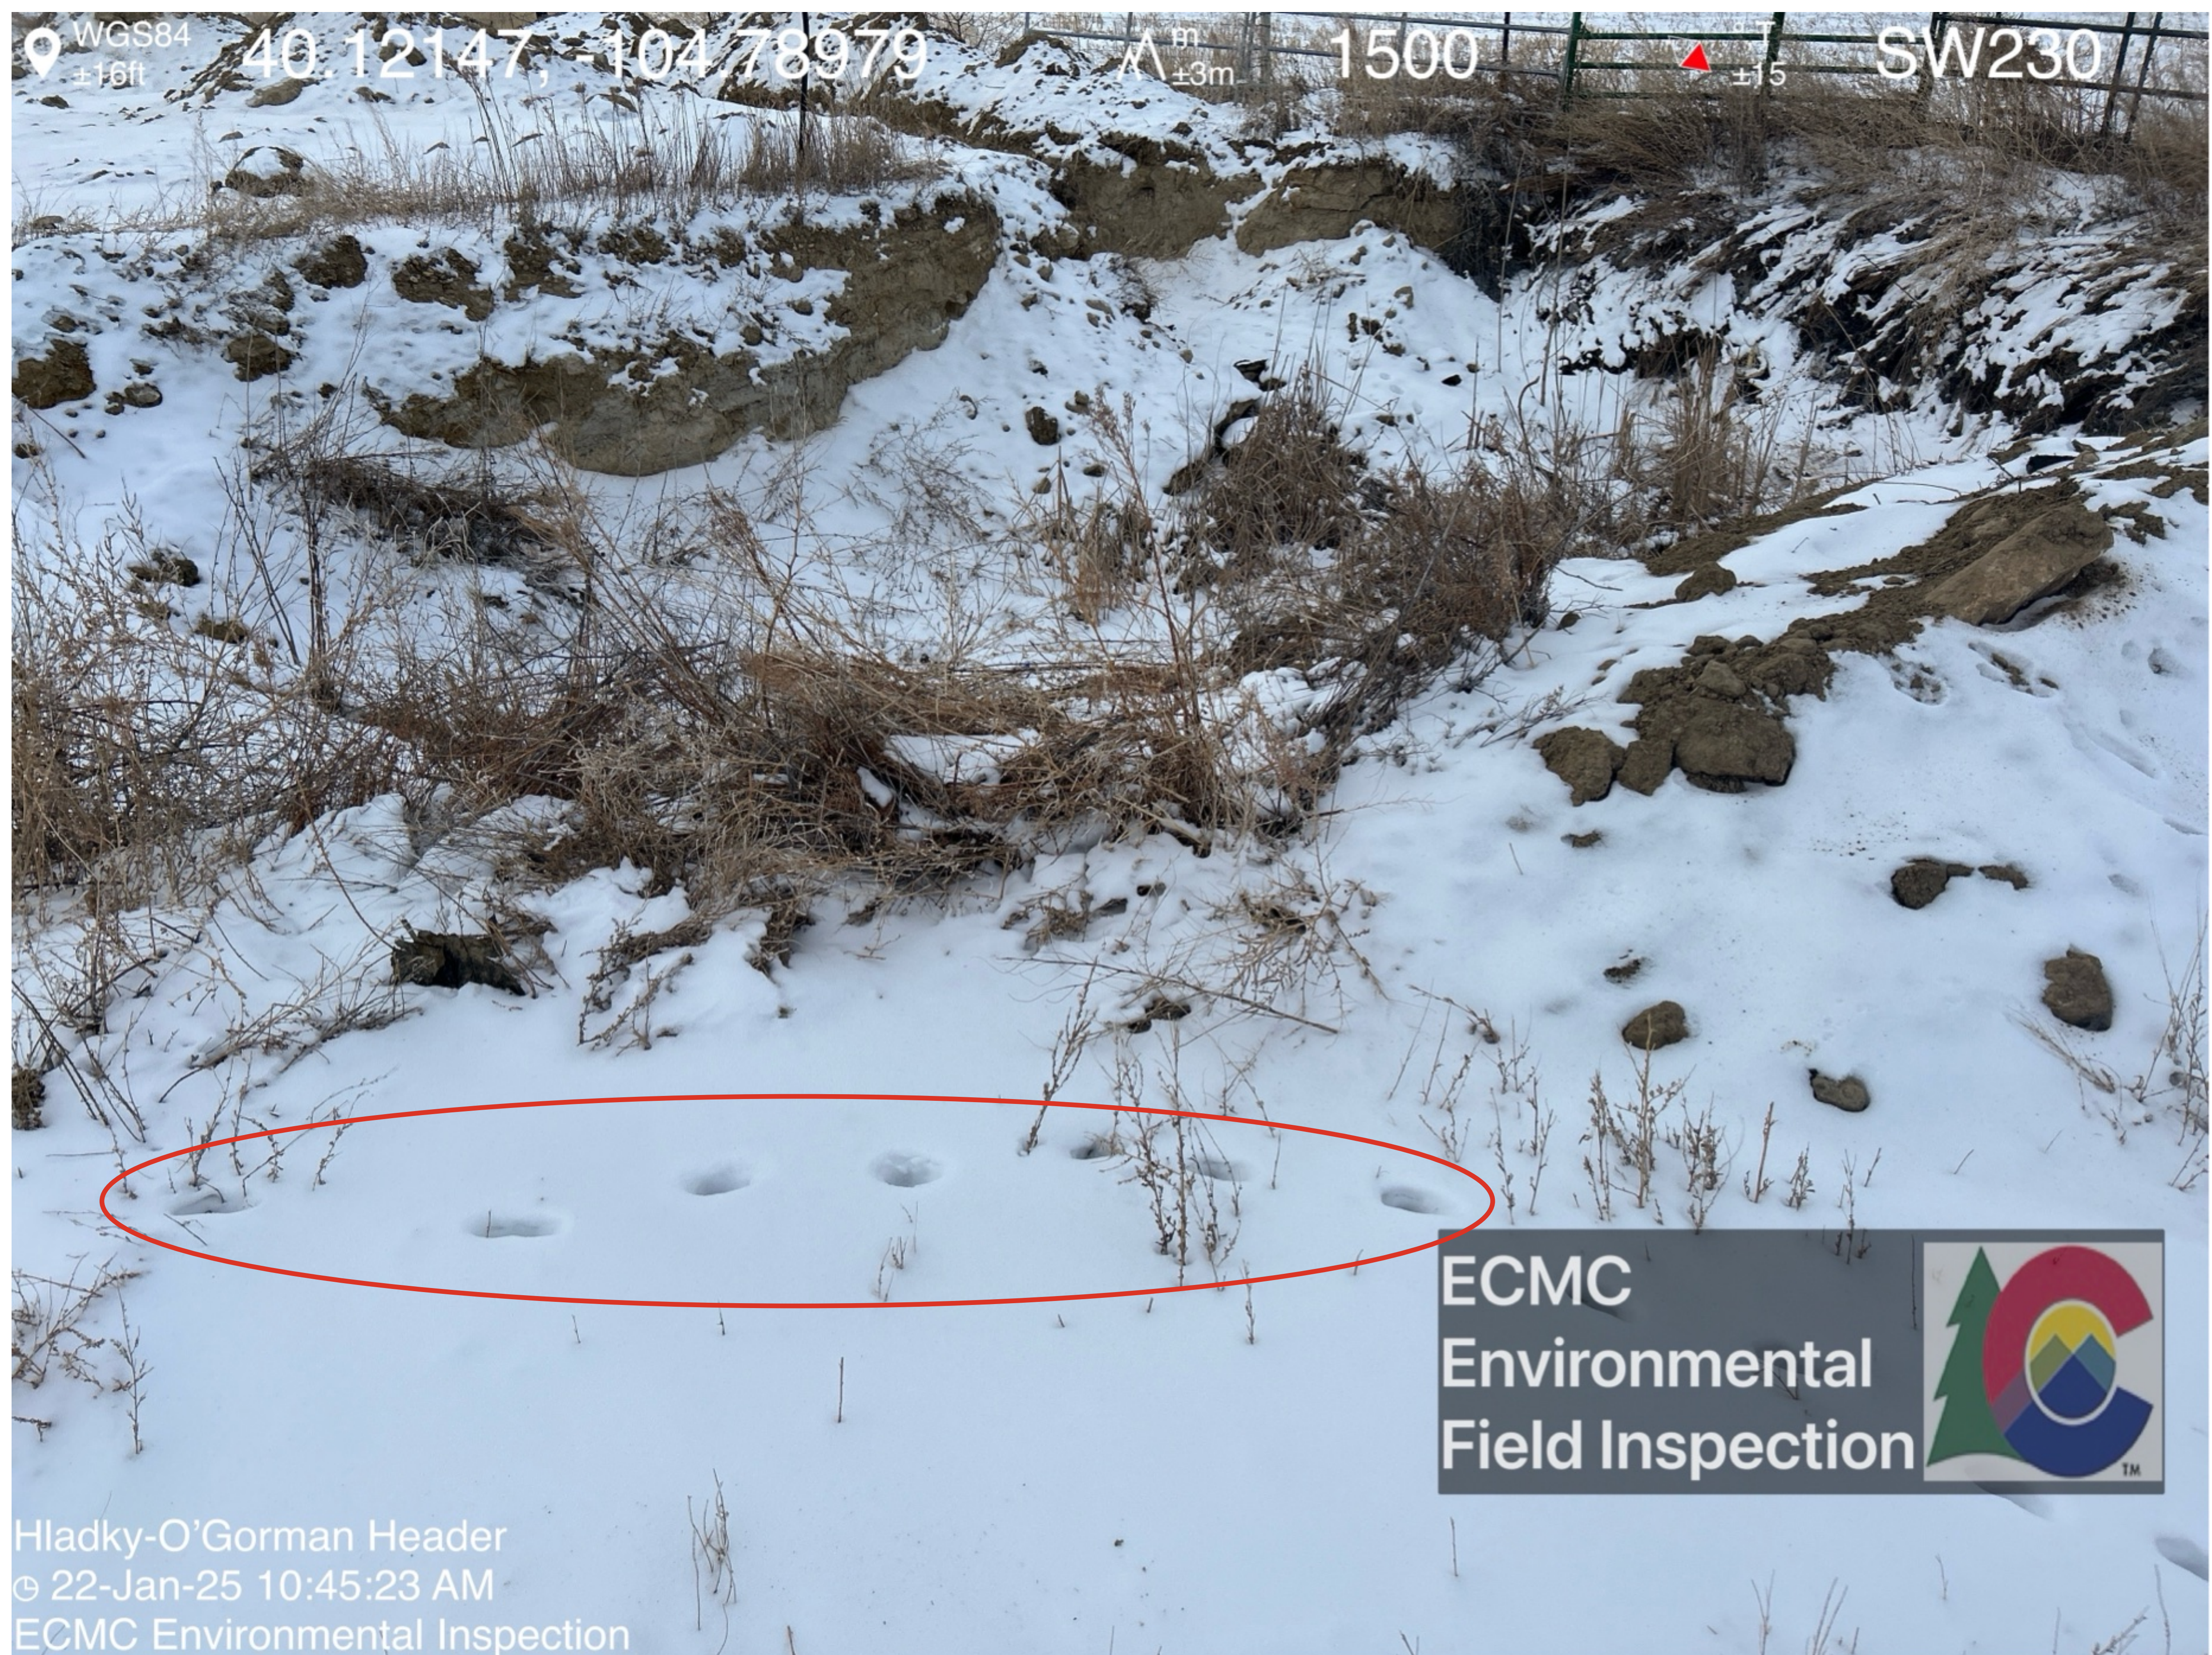
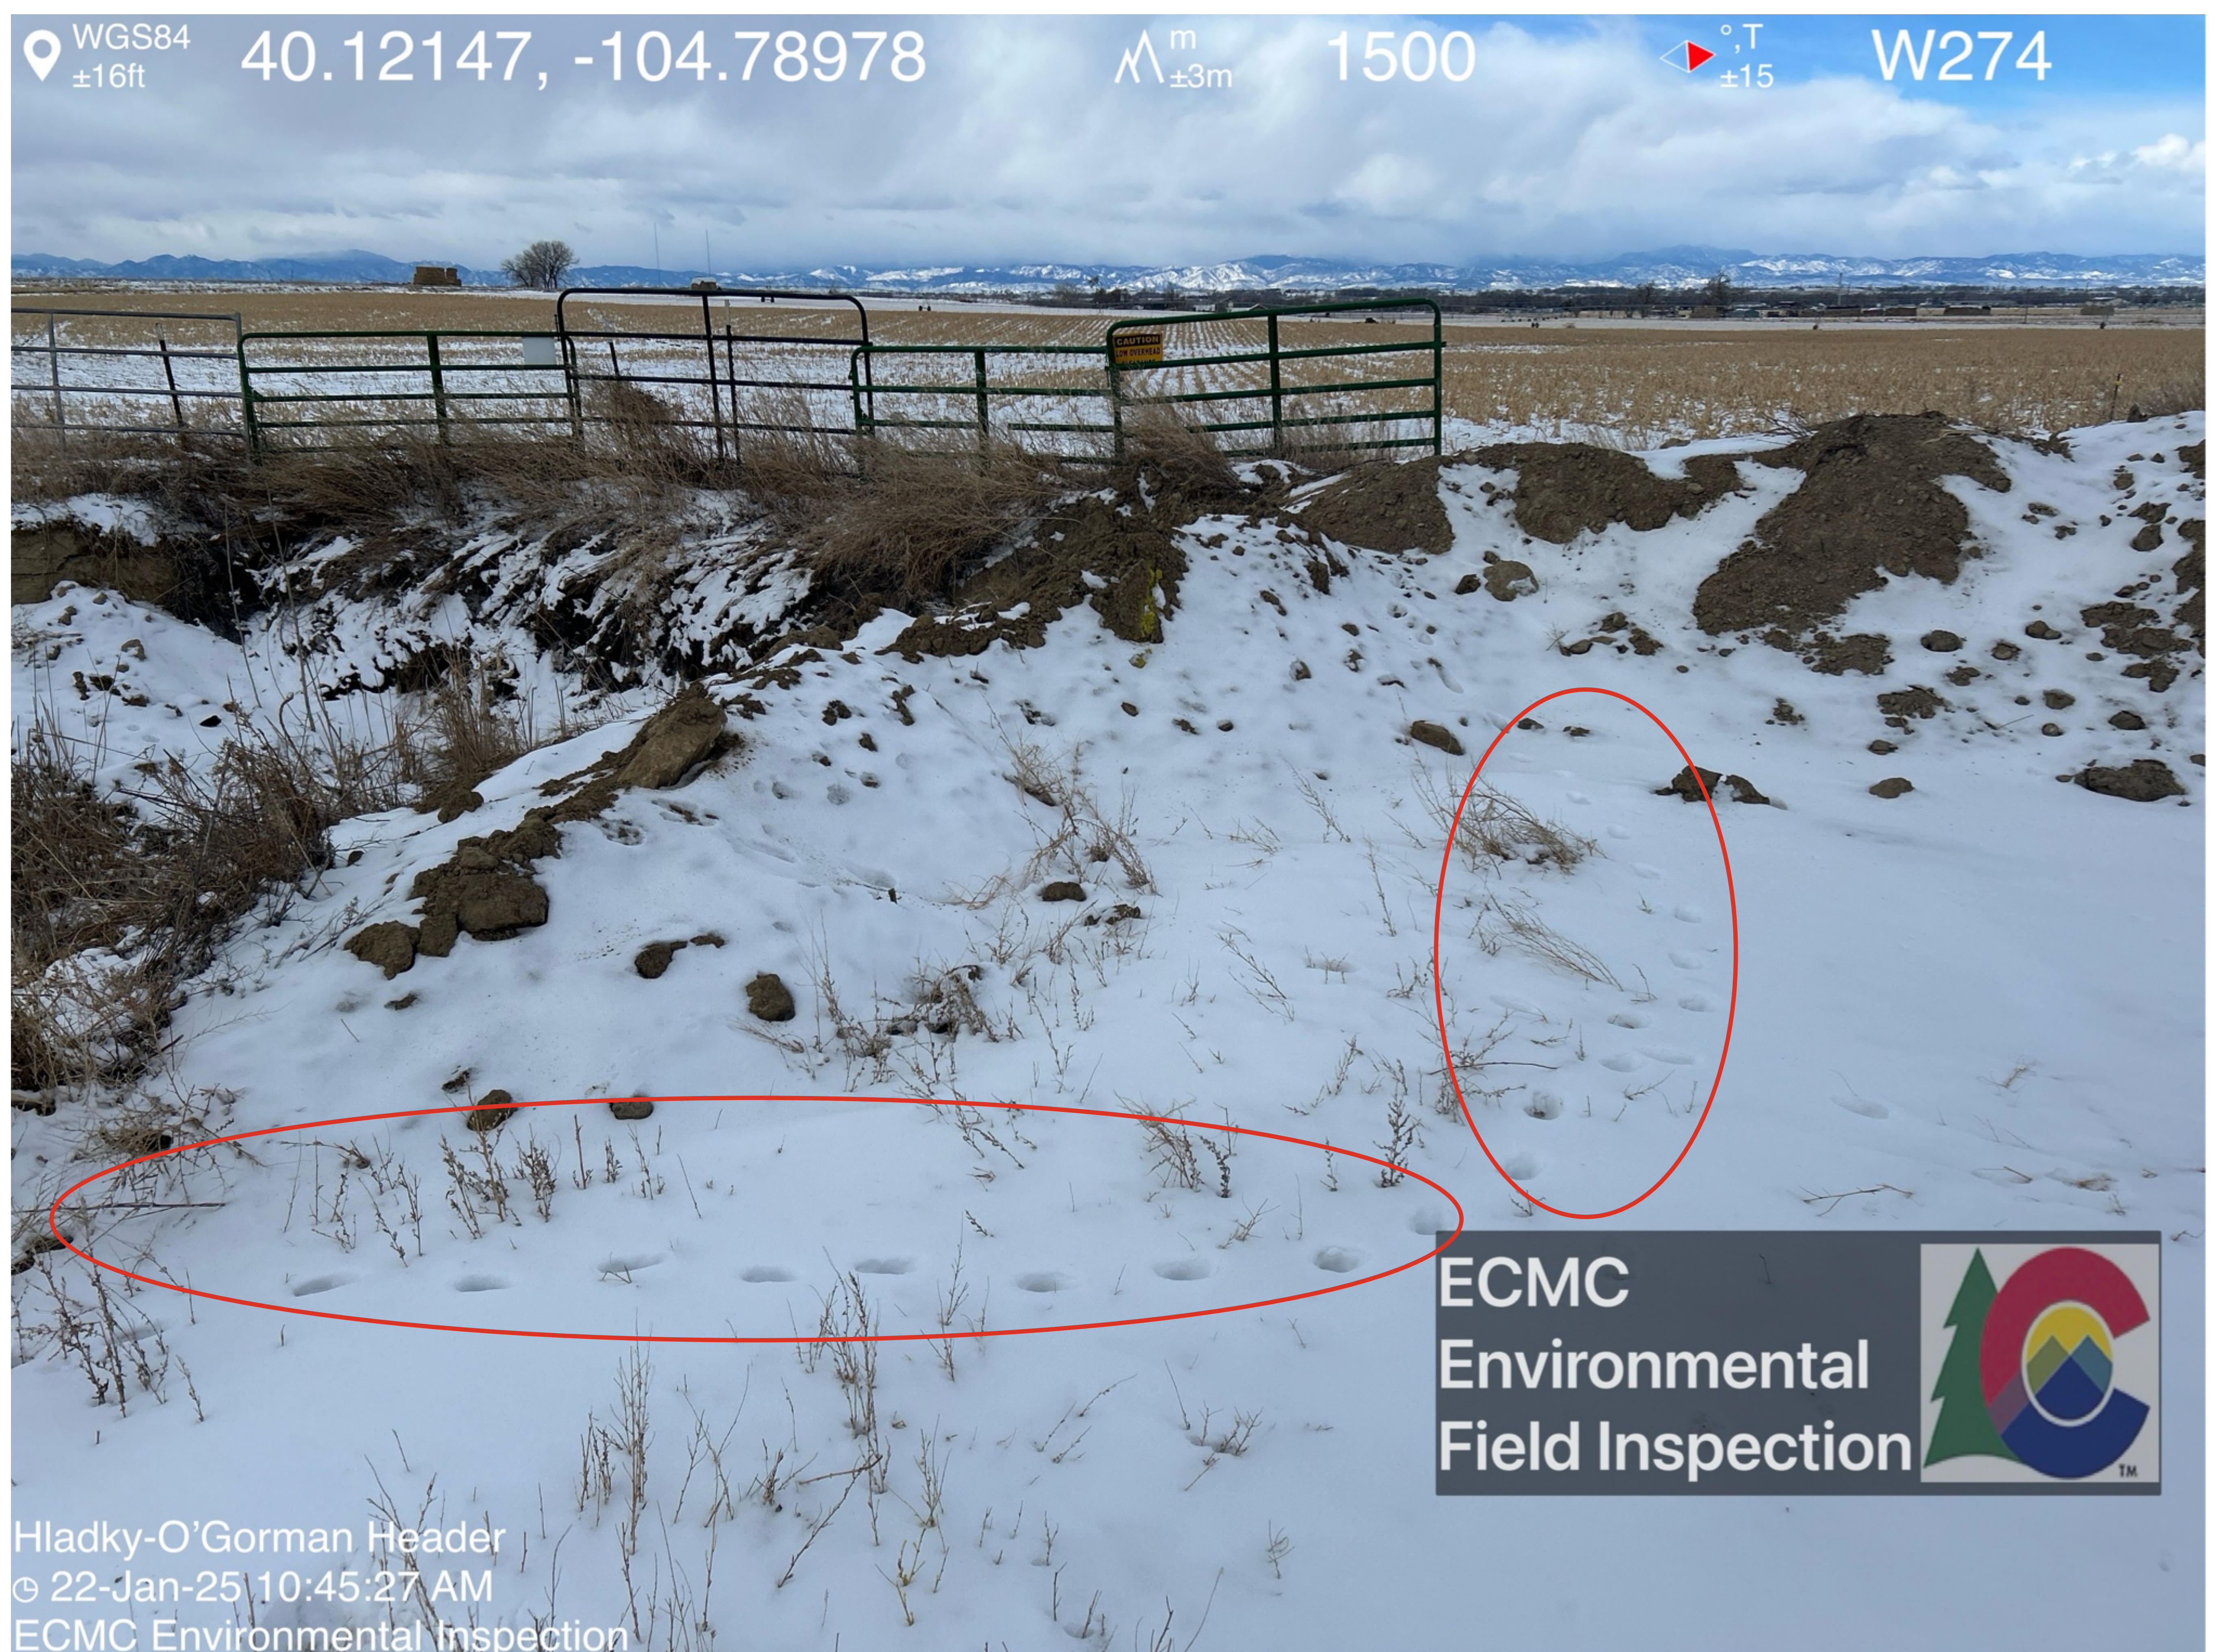
Wildlife tracks were visible throughout the excavation area.
