Inspection Photos

Operator: Hilcorp Energy Company - 10133

Location ID: 326147

Inspection Photos
Location Name: Huber Lobato 1-26
Location ID: 326147

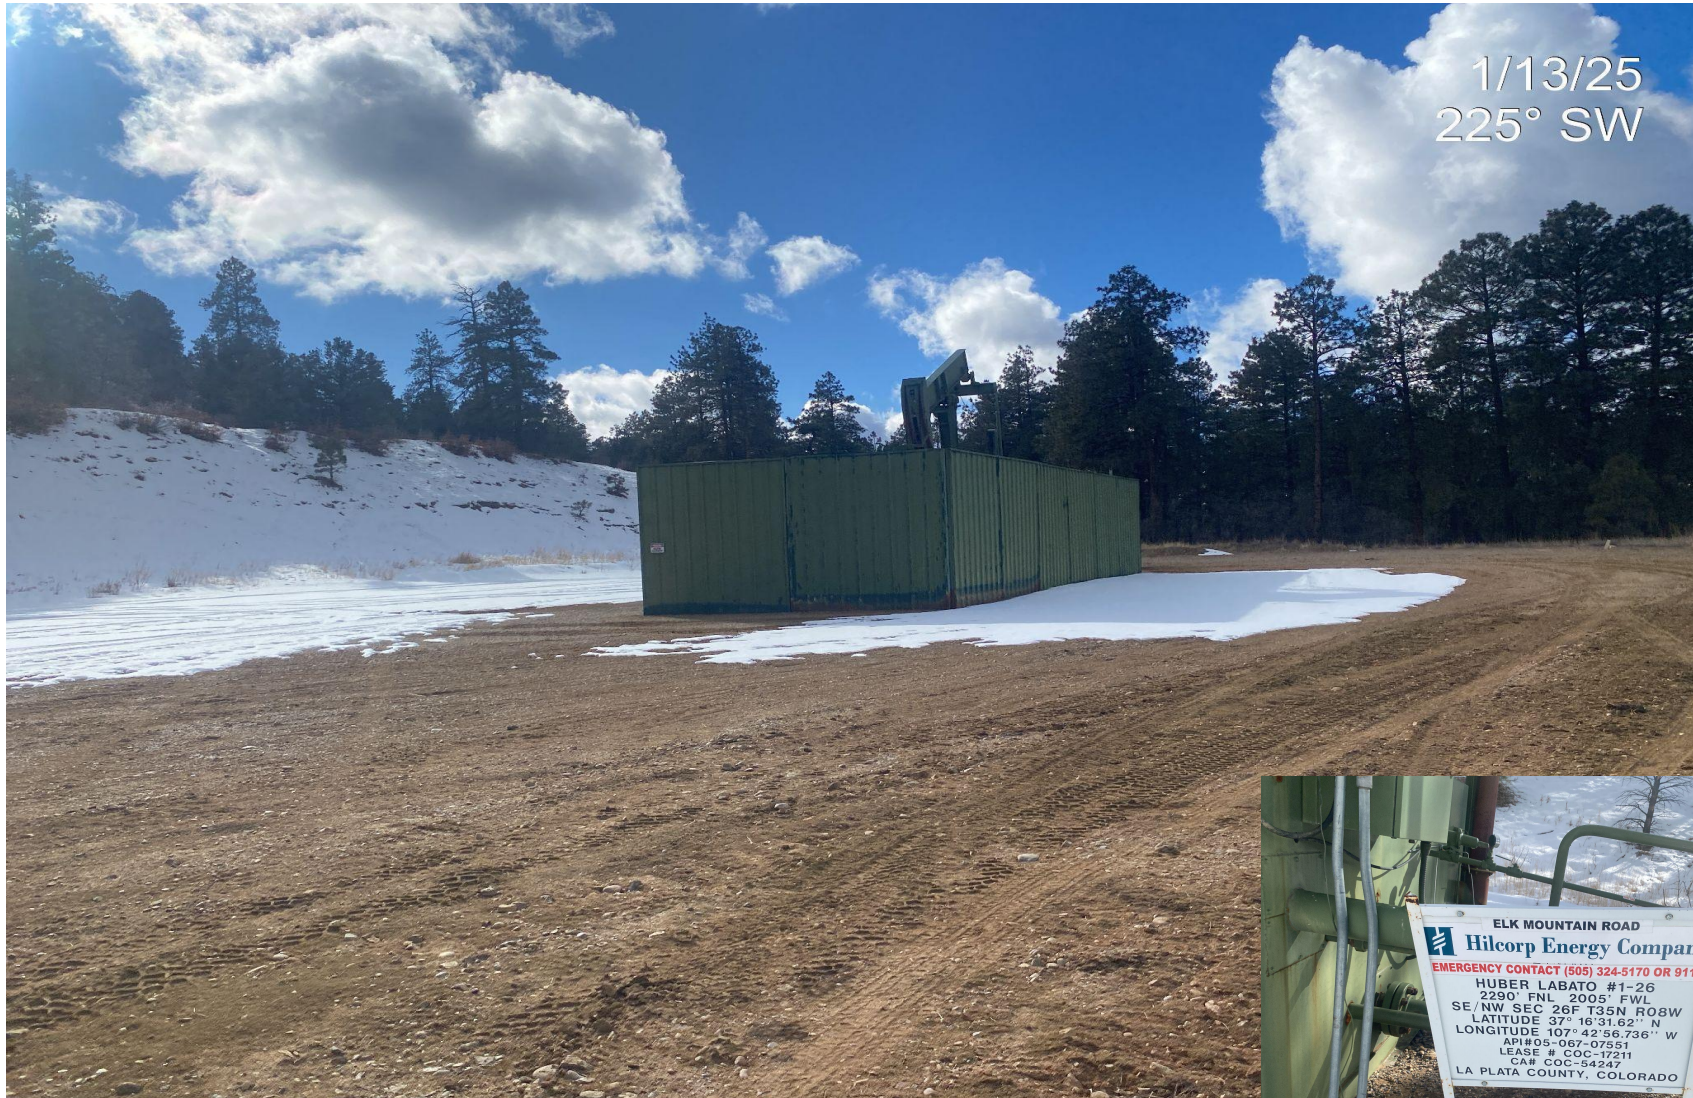
Photo 1. View of well pad taken from the access point facing center.

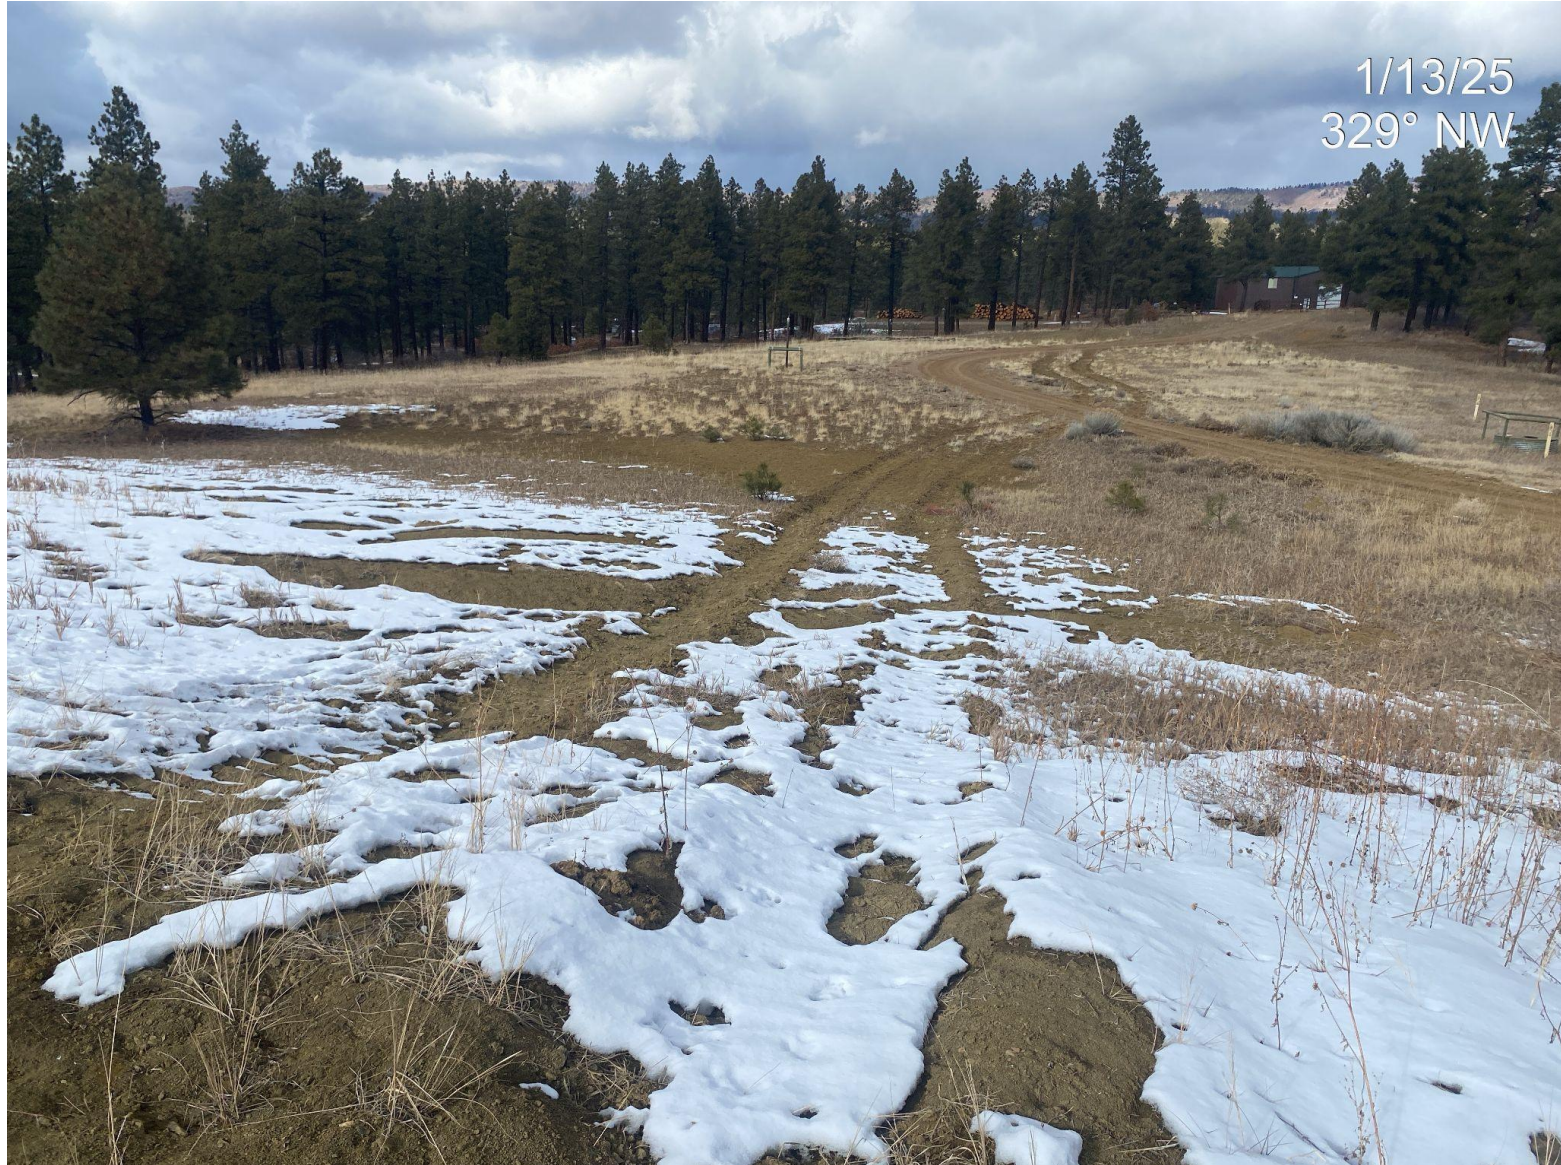
Photo 2. View of large tracks running through the northern interim reclamation area.

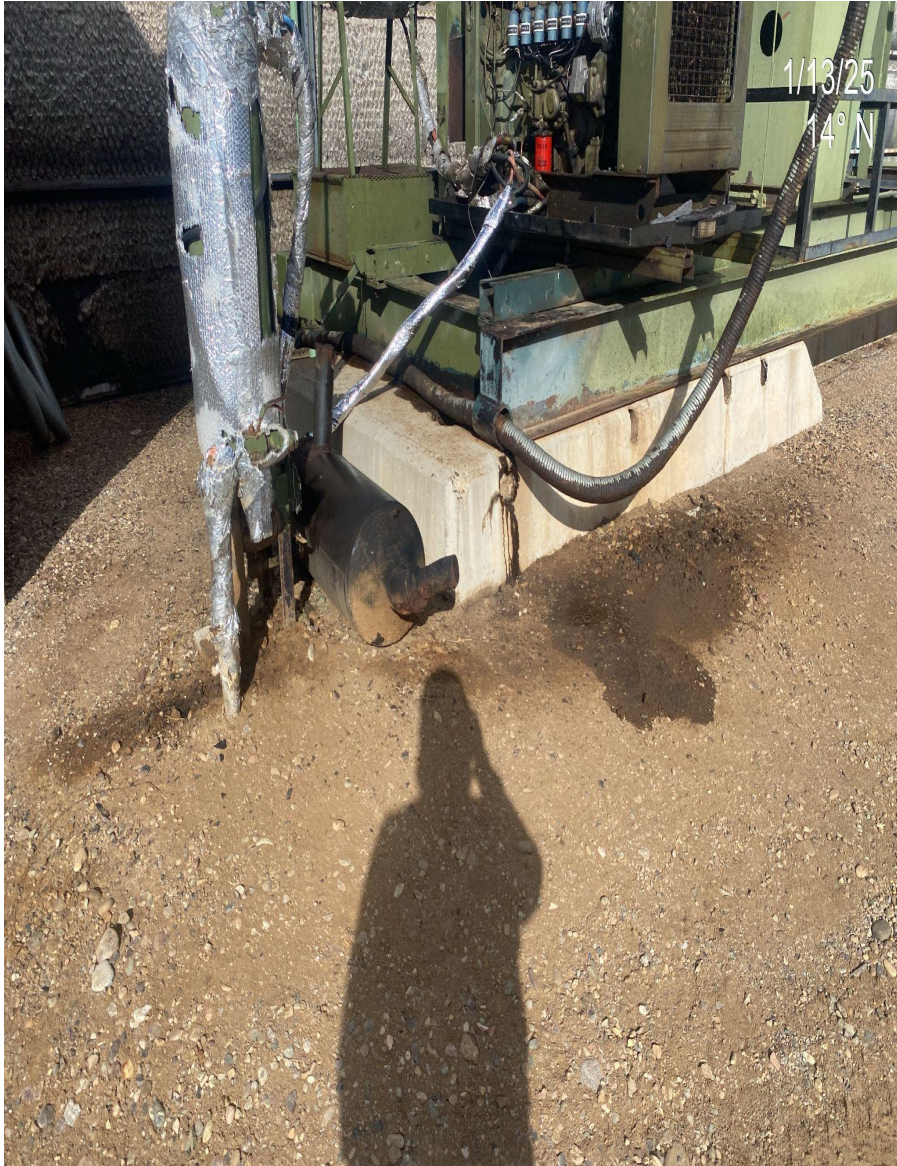
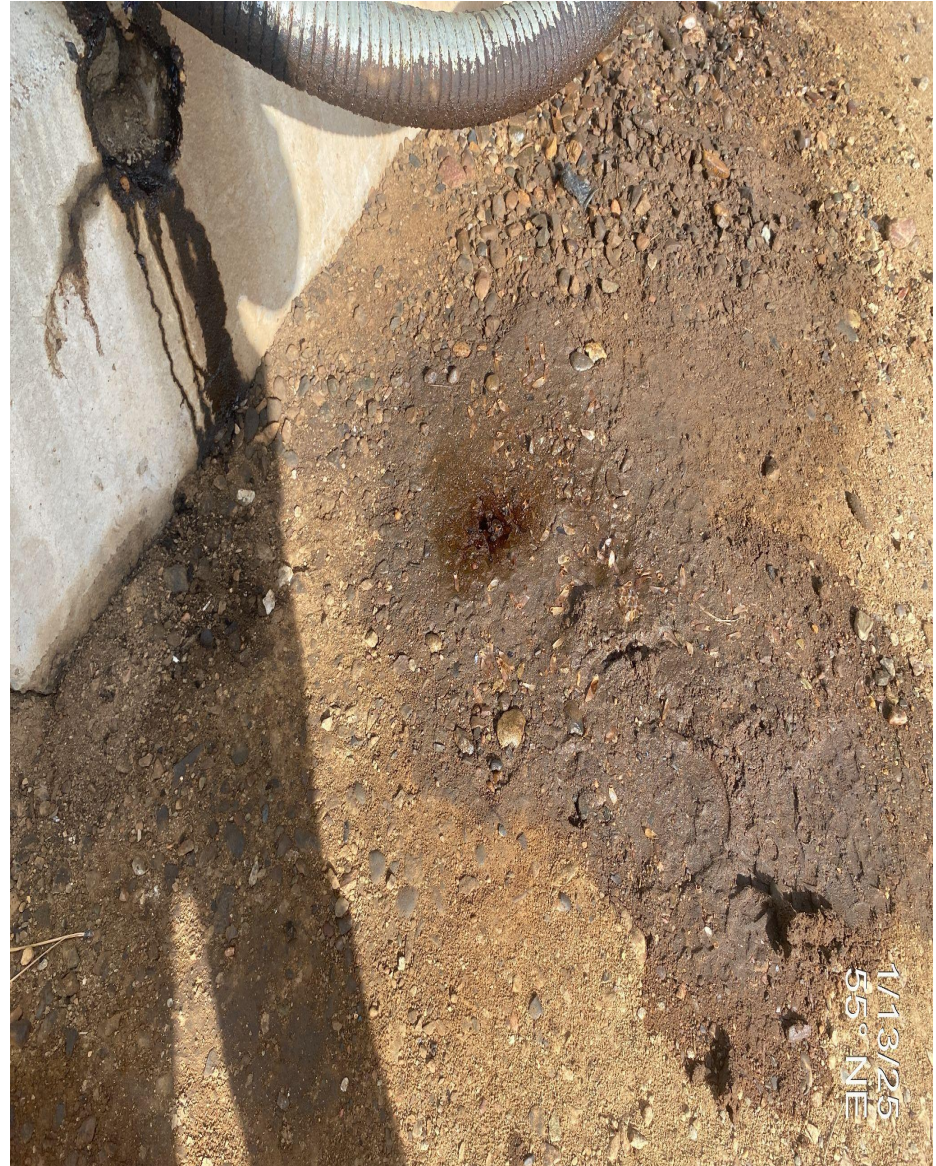
Photo 3. View of stained soils at the pump jack/muffler.

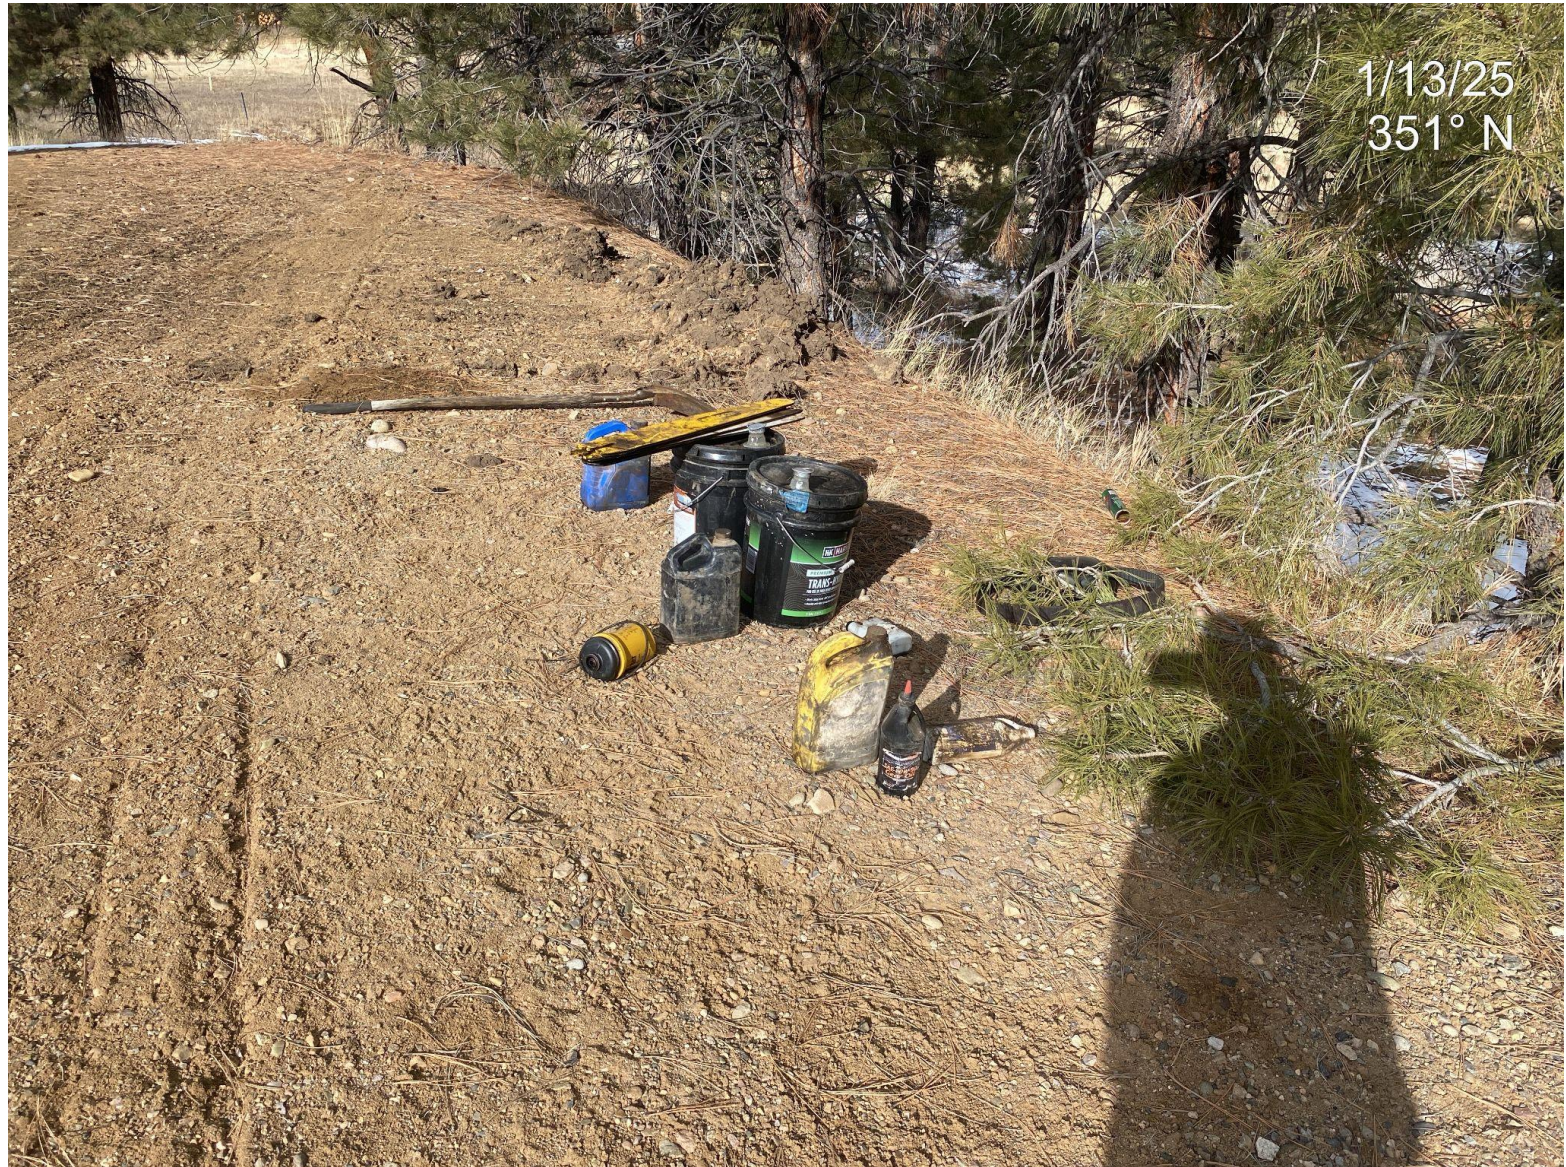
Photo 4. View of trash on the northern edge of the pad.

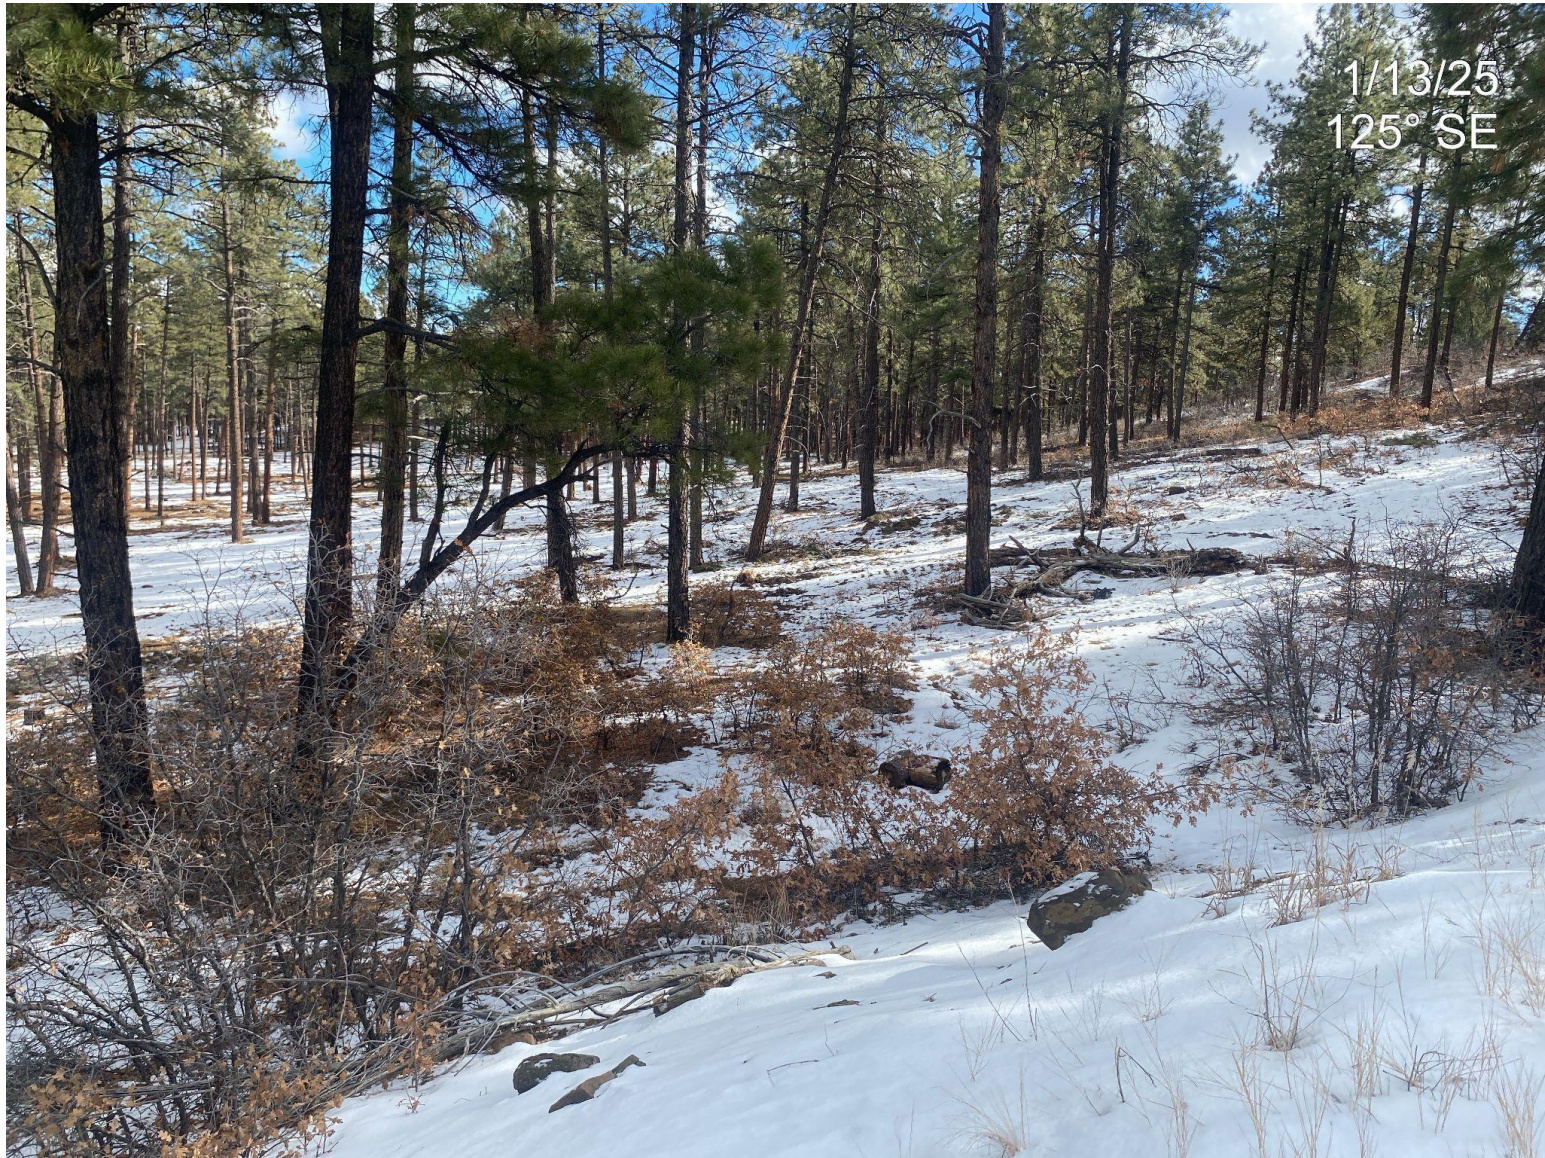
Photo 5. Reference area composed of Pine, Gambel Oak and Smooth Brome.
