Inspection/Audit Photos

Location: VISION ENERGY LLC USA-69S98W/18NESW (USA 1-18 JC)

Location ID: 312548

Date: 01/23/2025

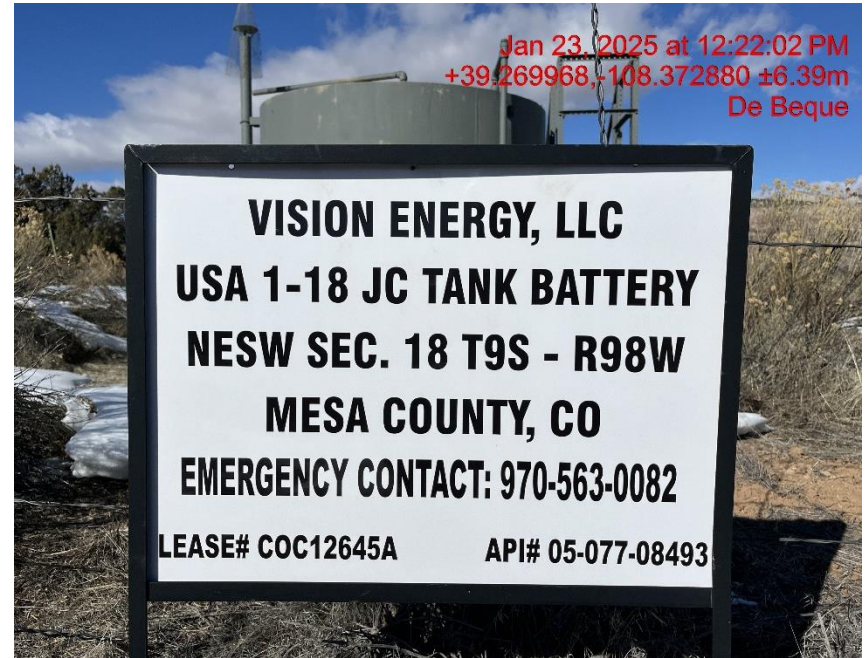
Photo # 3251 Tank battery sign lacks public road used to access location/not in compliance with CECMC rules

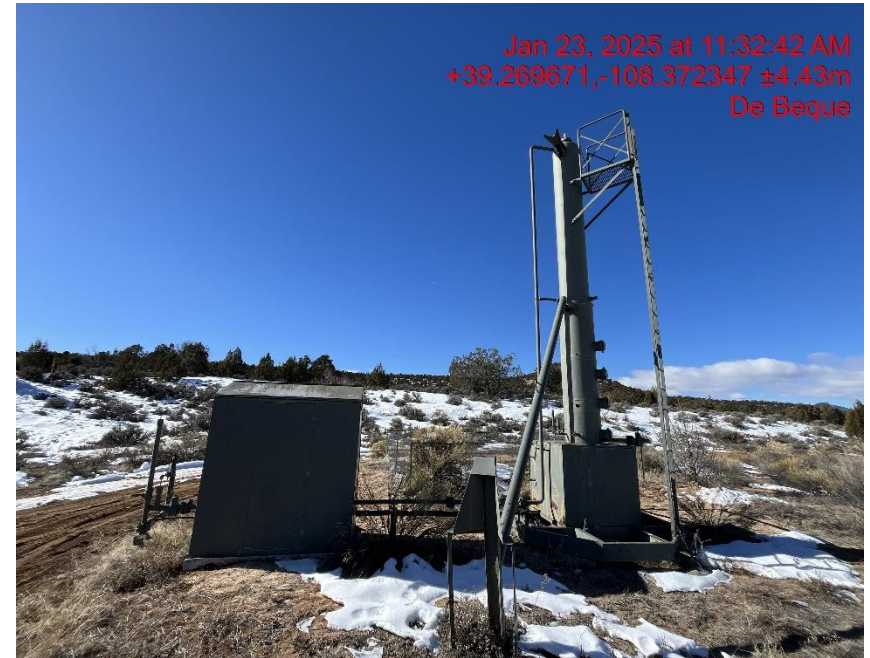
Photo # 3219 Location - Weeds/undesirable plant species near production equipment causing a fire hazard

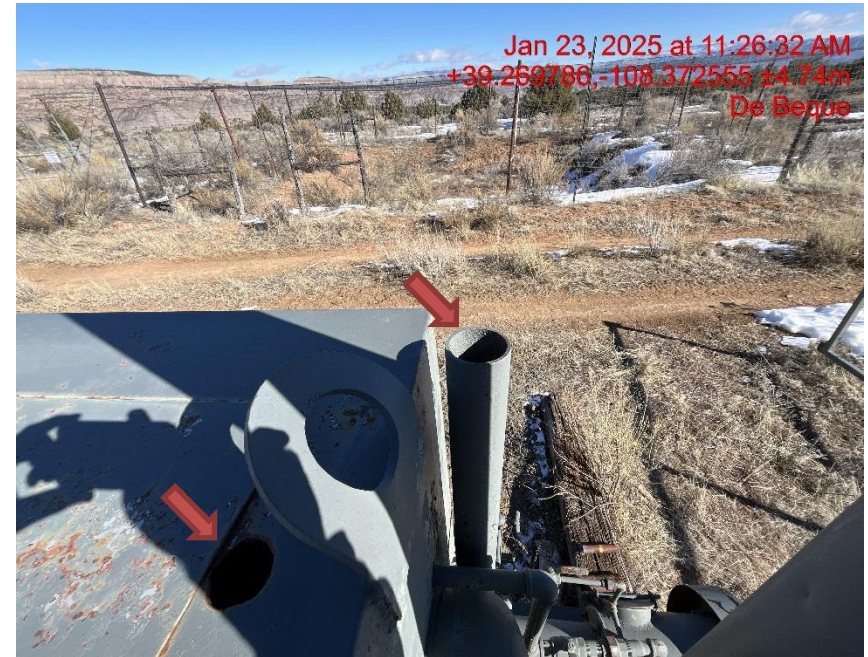
Photo # 3209 Wildlife hazards

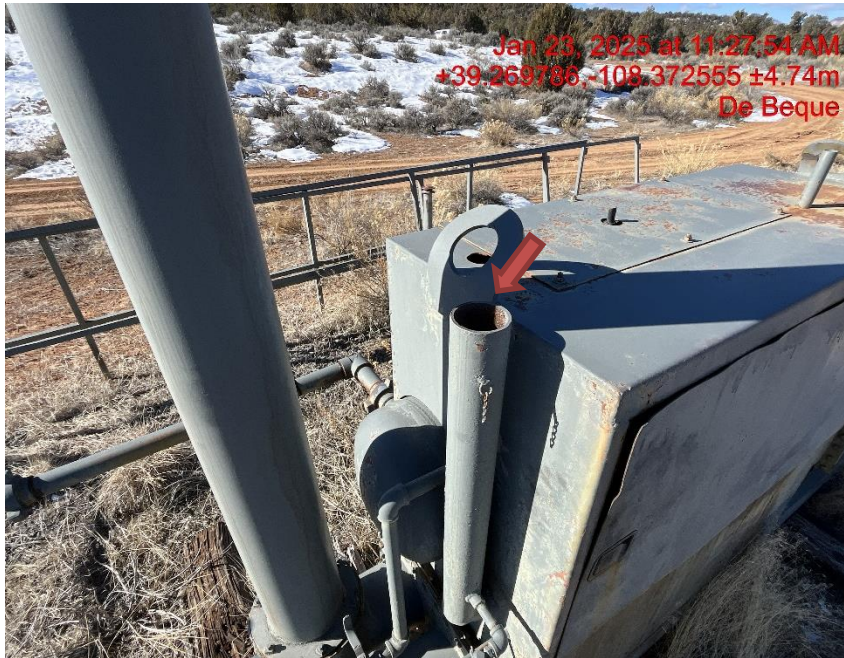
Photo # 3211 Wildlife hazard

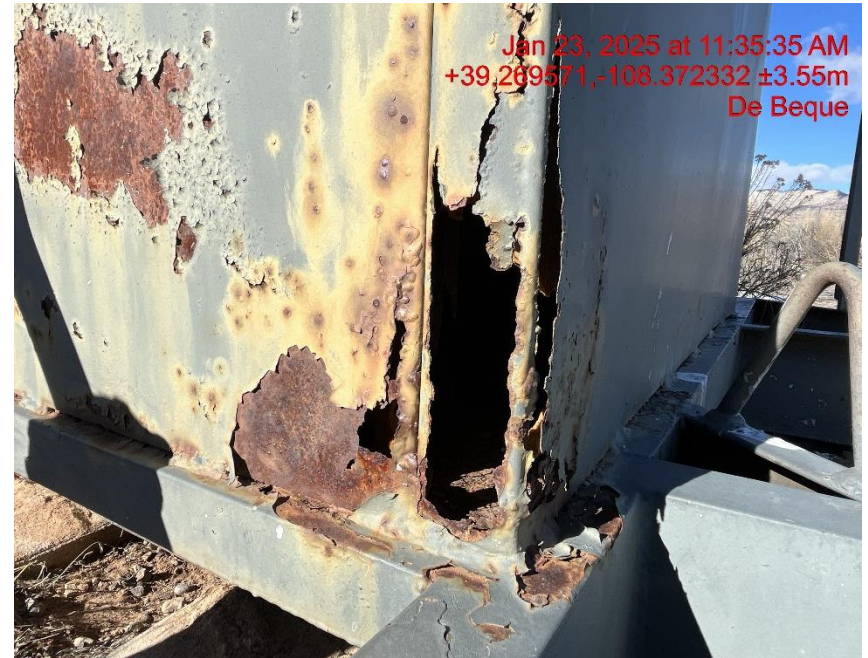
Photo # 3221 Wildlife hazard

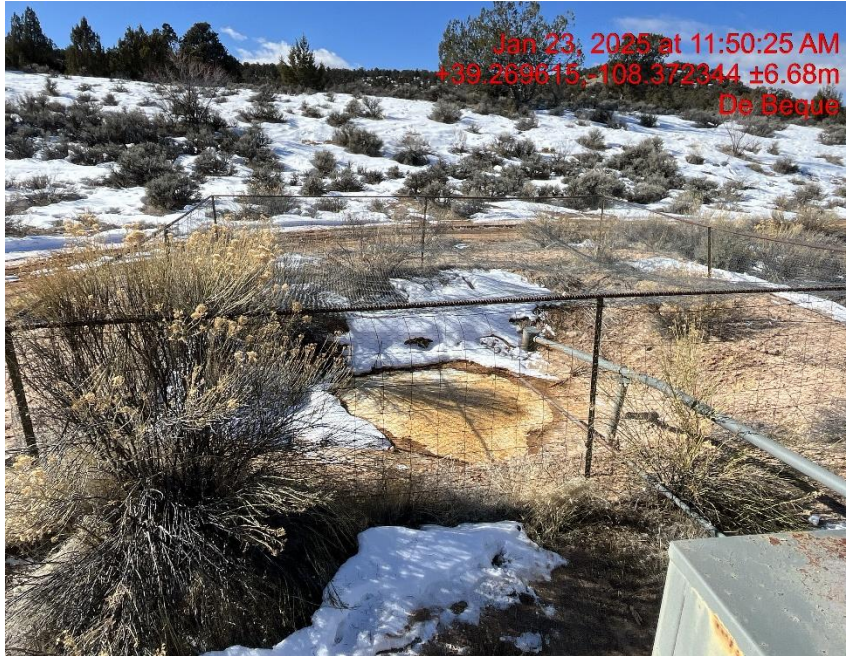
Photo # 3232 Unlined Pit #1 appears to have condensate in it with weeds/undesirable plant species

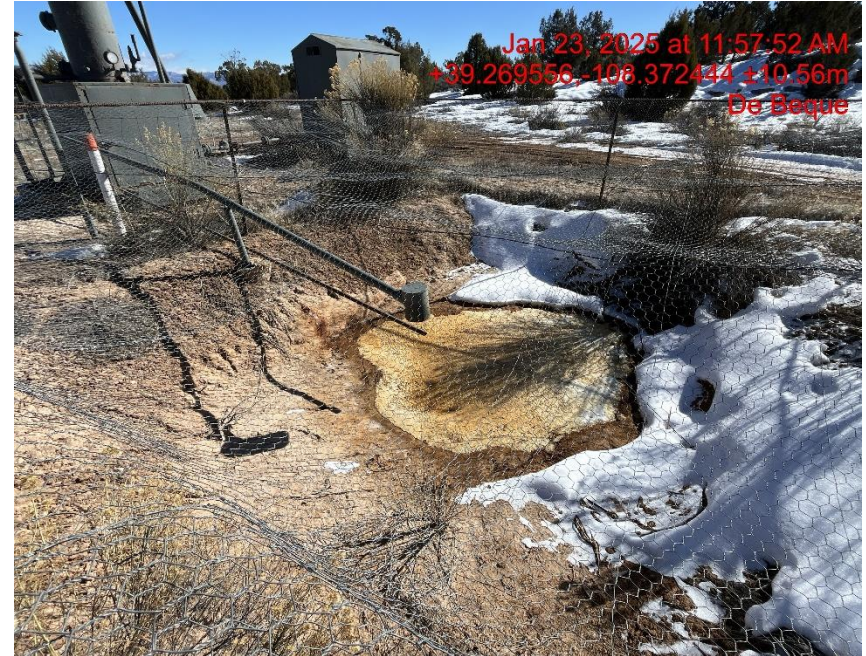
Photo #3237 Unlined Pit #1 appears to have condensate in it with weeds/undesirable plant species

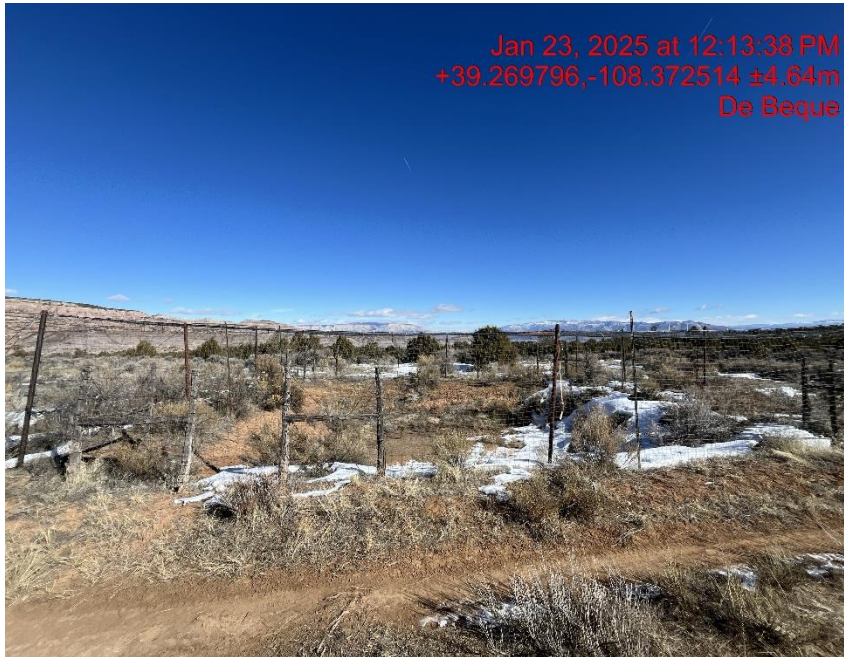
Photo # 3242 Unlined Pit #2 with weeds/undesirable plant species

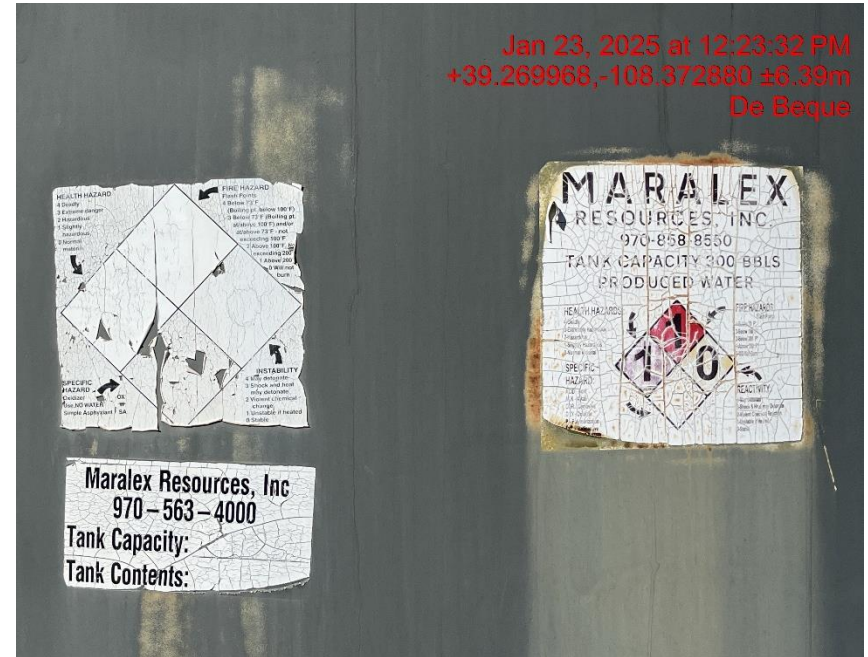
Photo # 3252 Tank labels contain inaccurate info/not in compliance with CECMC rules

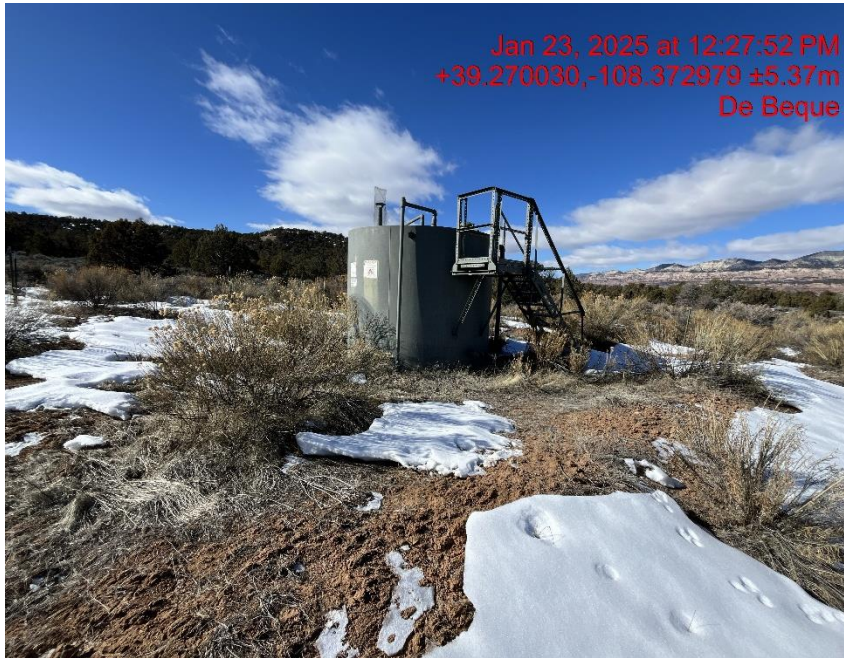
Photo # 3254 Secondary containment is insufficient/does not comply with CECMC rules. Additionally weeds/undesirable plant species inside secondary containment have compromised the containment

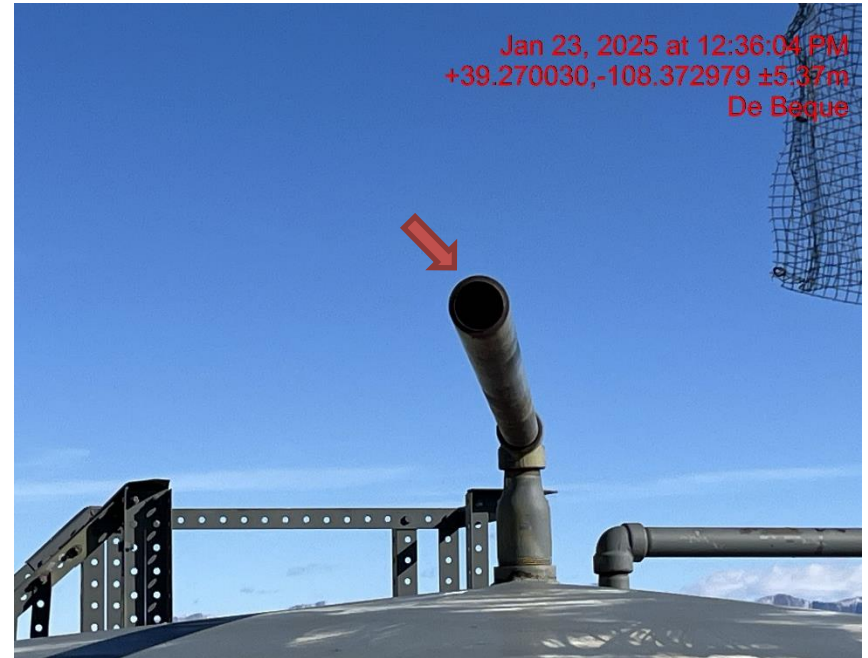
Photo # 3262 Wildlife hazard

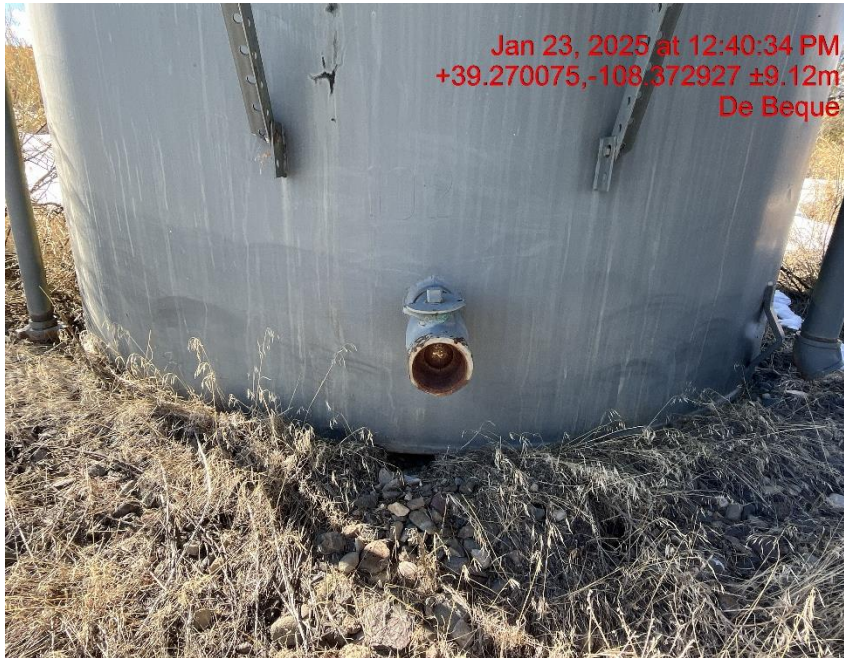
Photo # 3266 Open ended load line

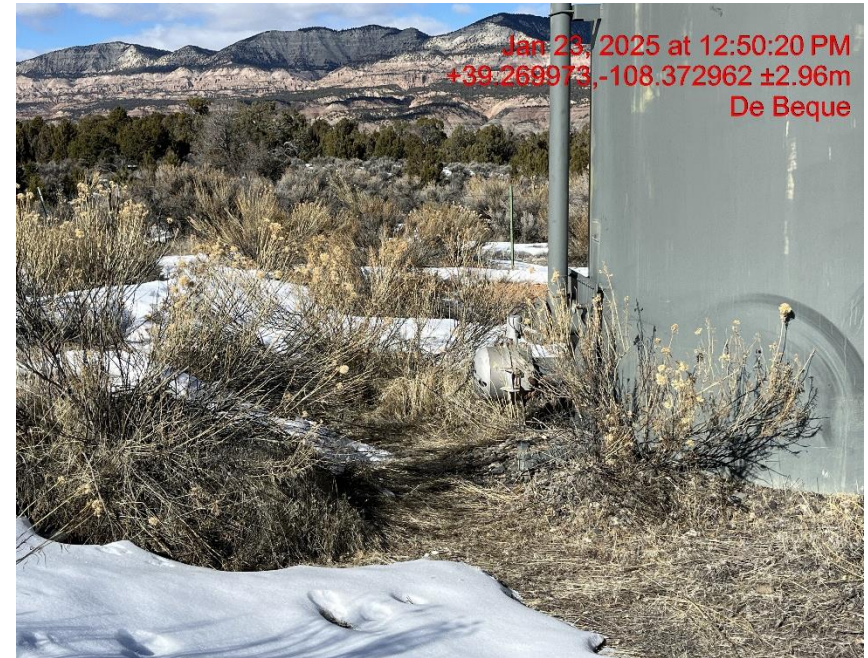
Photo # 3269 Weeds/undesirable plant species near production equipment causing a fire hazard

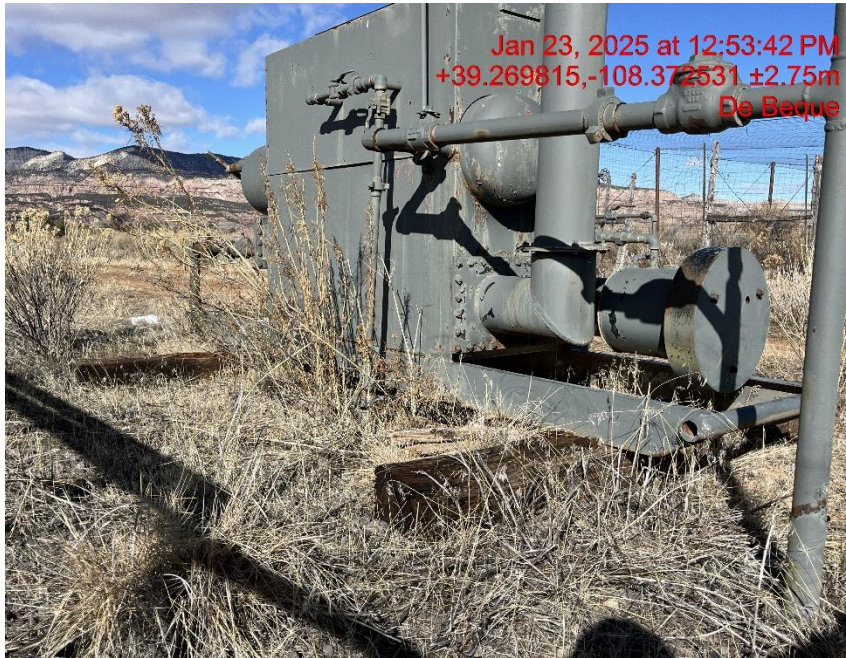
Photo # 3275 Weeds/undesirable plant species near production equipment causing a fire hazard

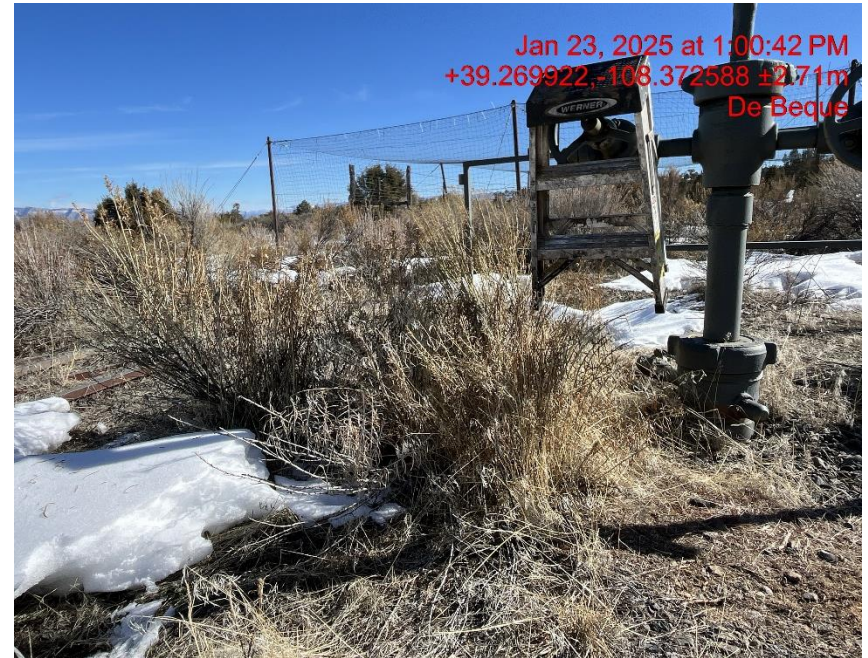
Photo # 3284 Weeds/undesirable plant species near production equipment causing a fire hazard

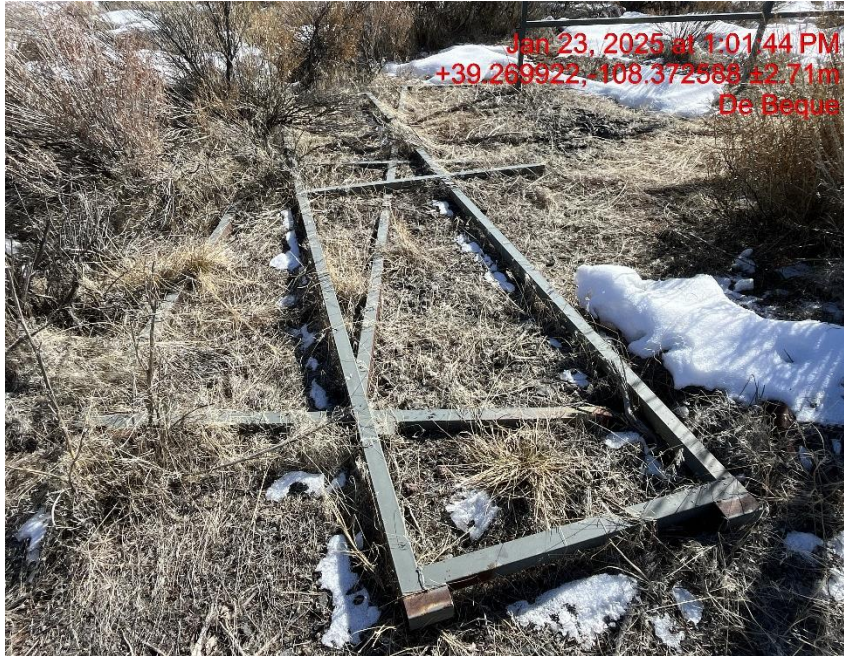
Photo # 3285 Debris

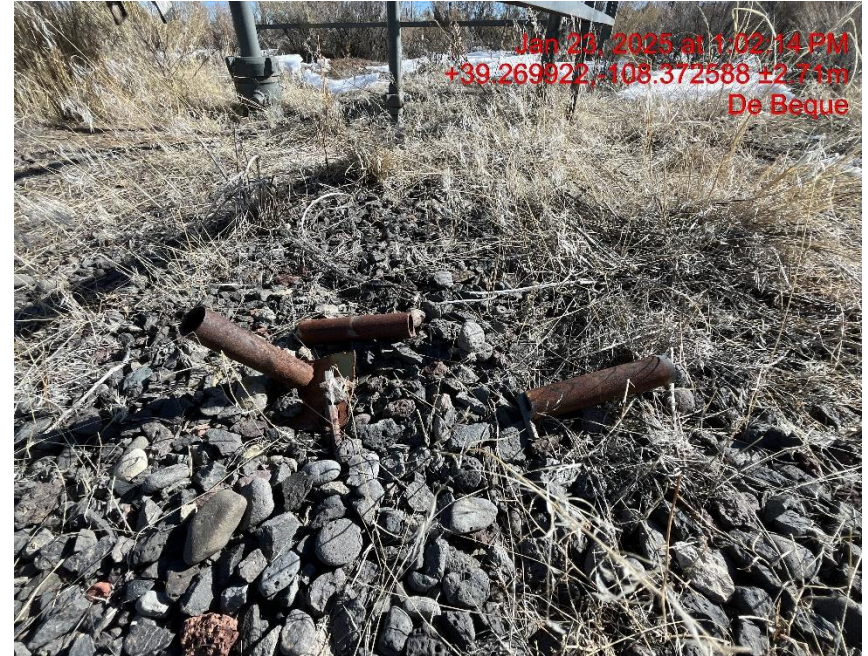
Photo # 3286 Debris

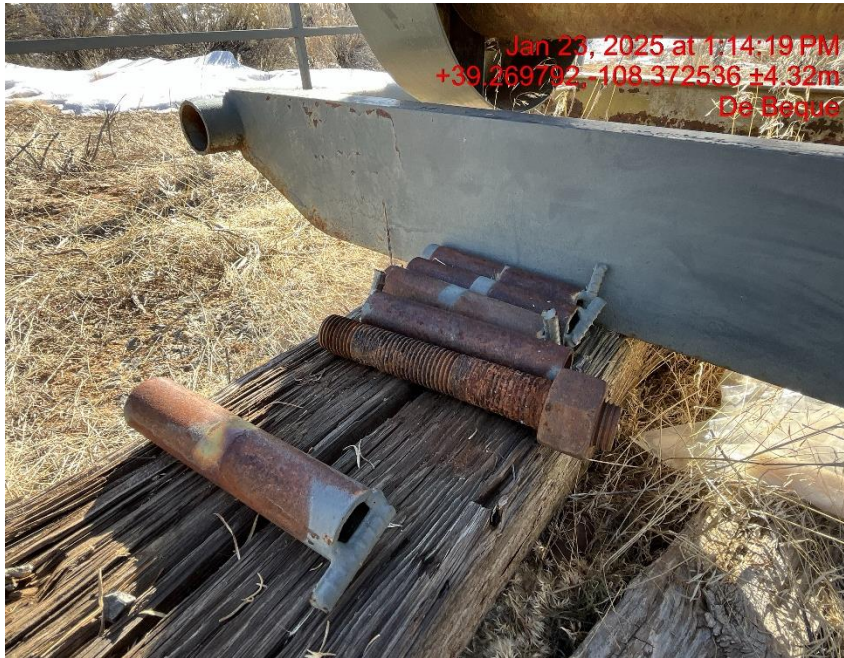
Photo # 3293 Debris

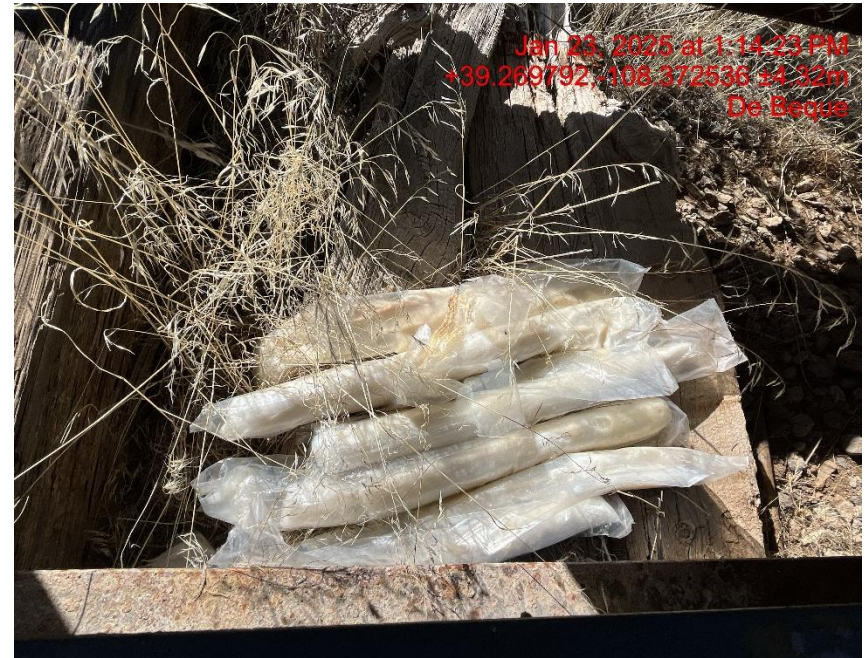
Photo # 3294 Debris
