# SITE-SPECIFIC QUALITY ASSURANCE & QUALITY CONTROL AUDIT

## Final Reclamation Complete Notice – Cropland Drone Imagery

### PERMIT CLOSURE REPORT – CROPLAND

**Location Name** Hirsch Pad/29-C

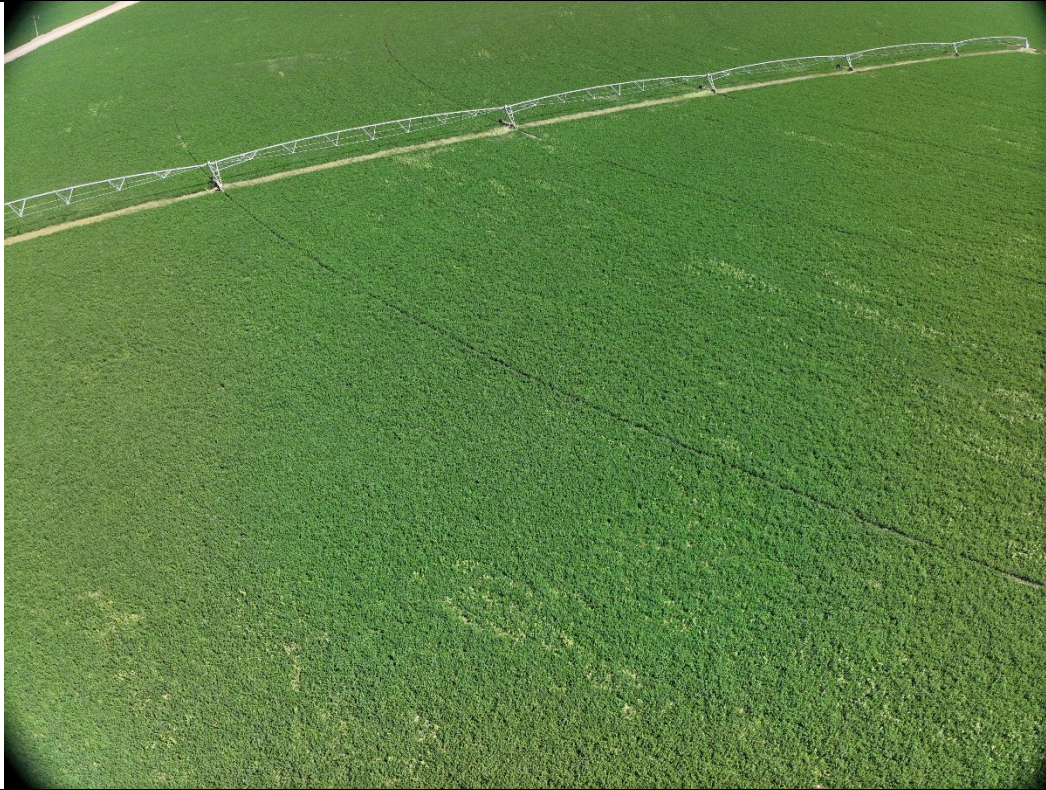
**NORTH** – 40.551130 / -104.800719

**In View** – Well, Access Road, Flowline

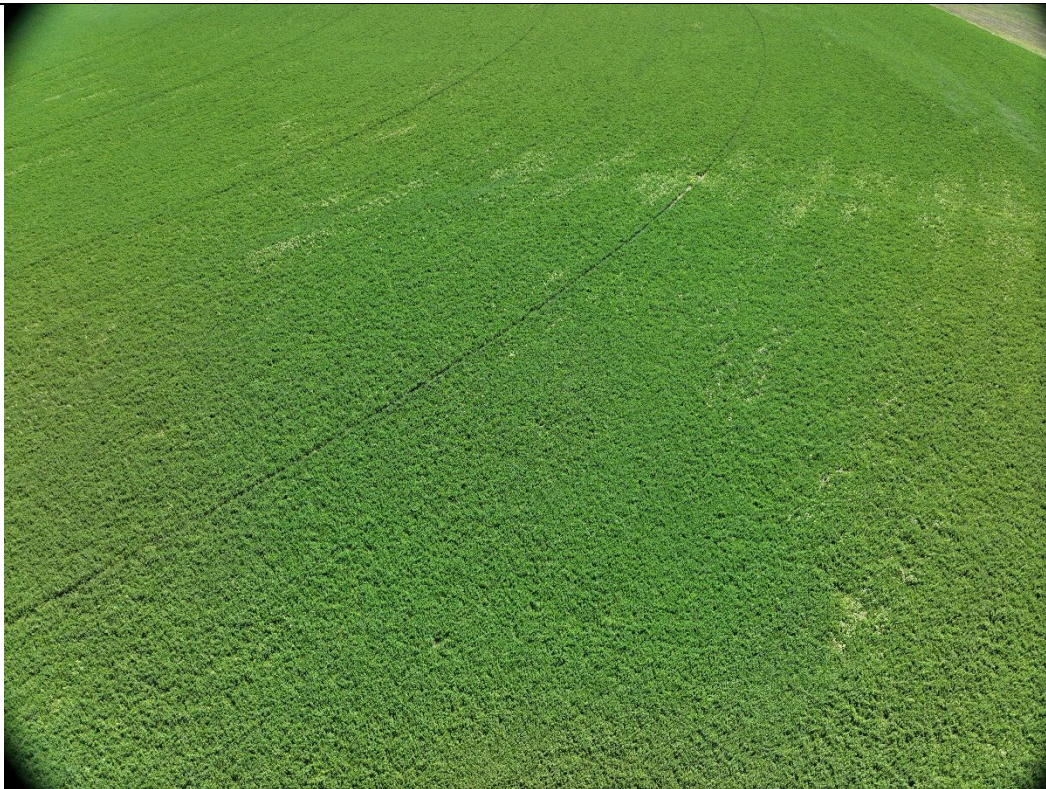
**EAST** – 40.551589 / -104.801349

**In View** – Well, Access Road, Flowline

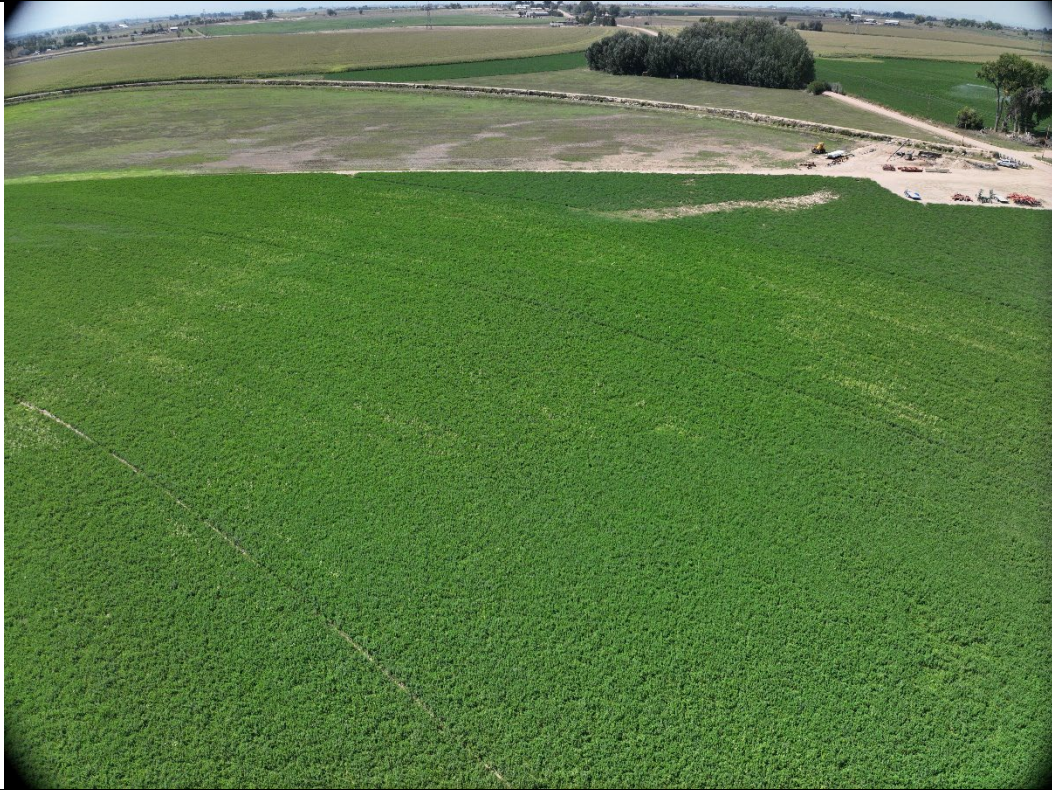
**SOUTH** – 40.552062 / -104.800711

**In View** – Well, Access Road, Flowline

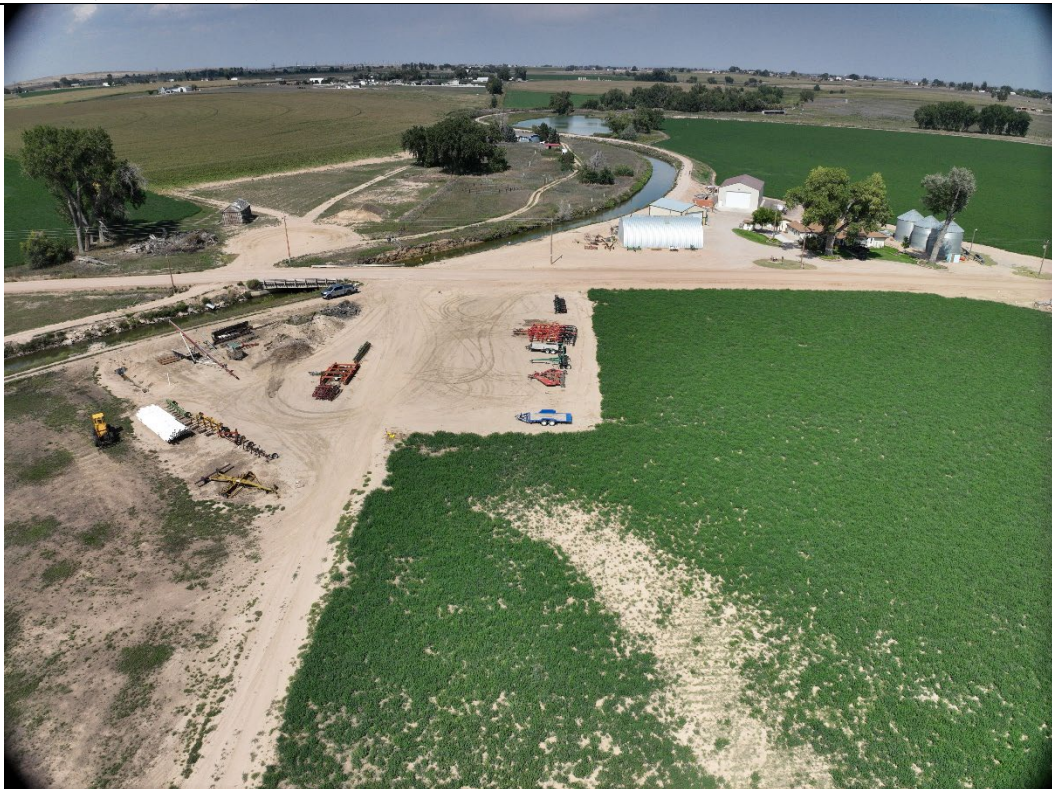
**WEST** – 40.551675 / -104.800206

**In View** – Well, Access Road, Flowline

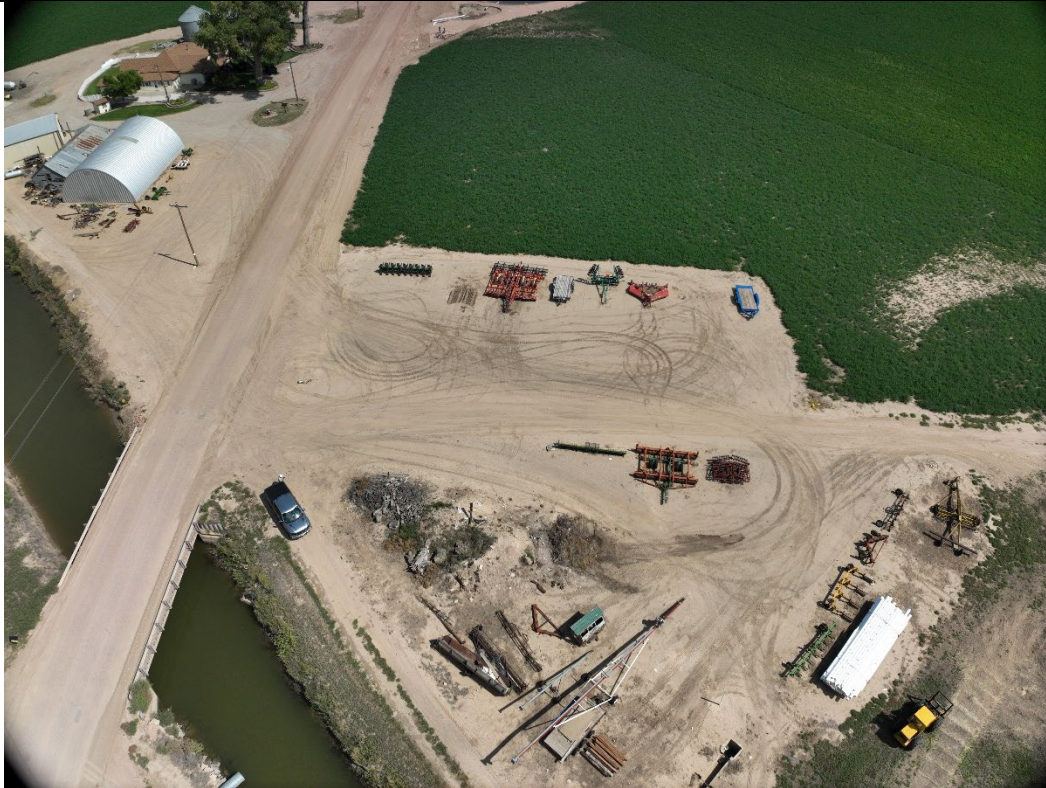
**NORTH** – 40.551806 / -104.802194

**In View** – Tank Battery (Location ID [434021](#)), Flowline

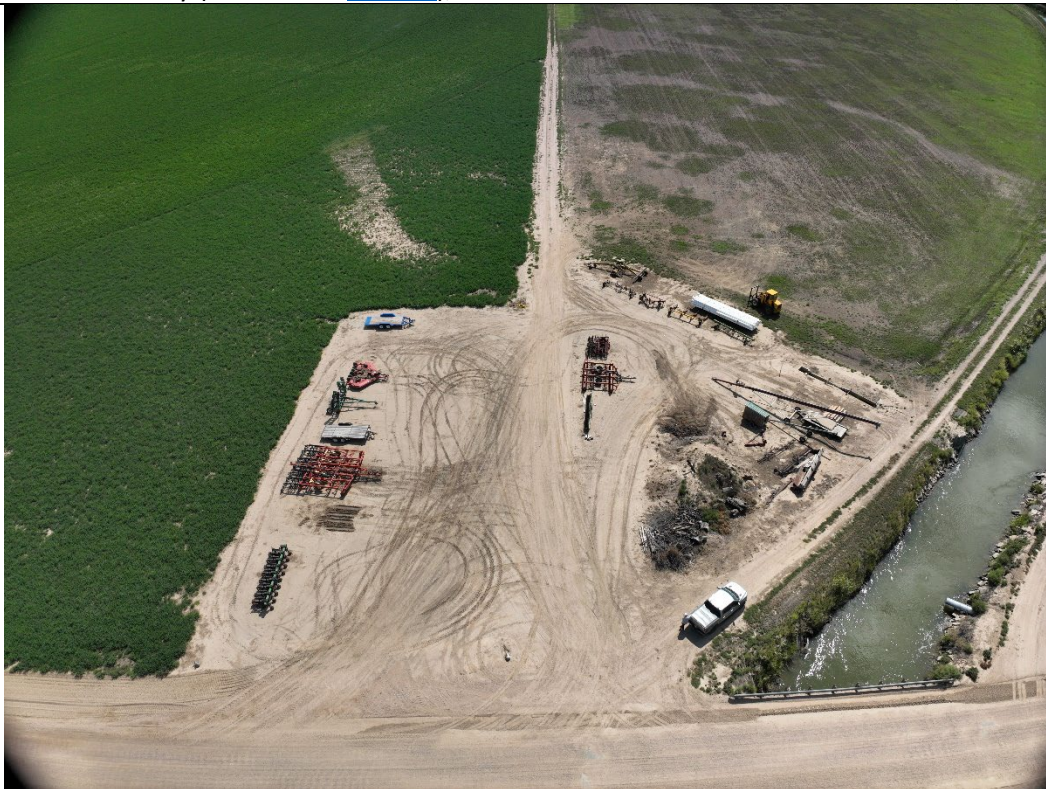
**EAST – 40.552729 / -104.802984**

**In View – Tank Battery (Location ID [434021](#)), Flowline**

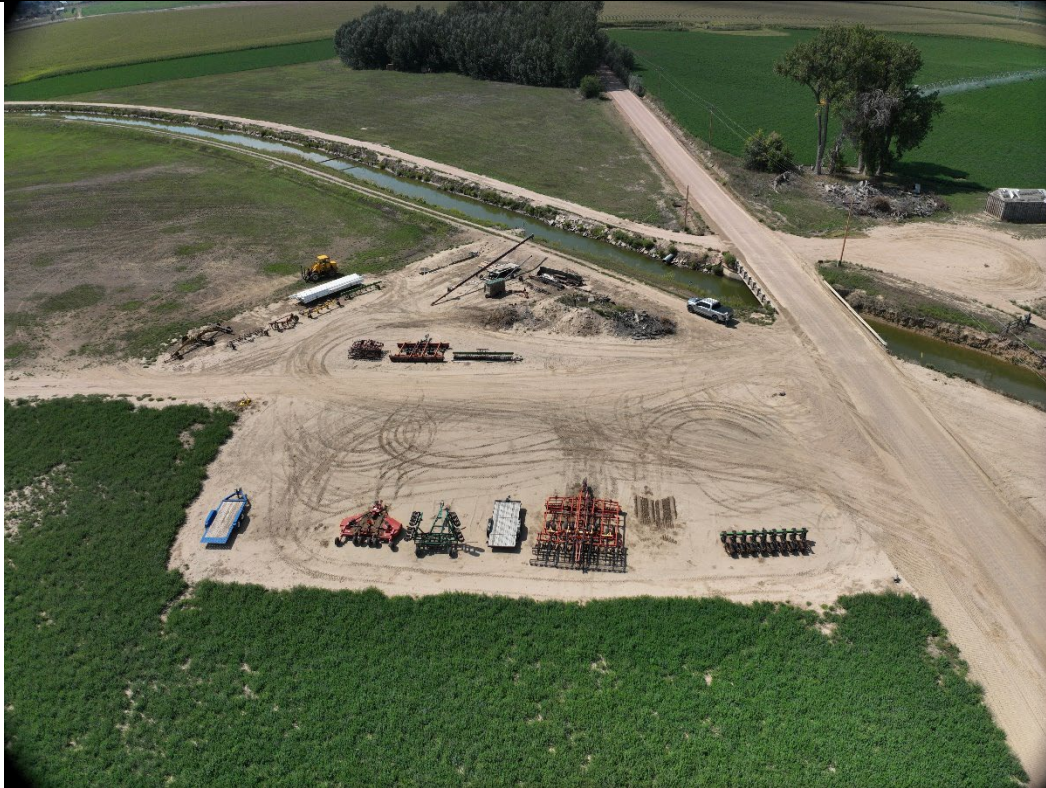
**SOUTH – 40.553236 / -104.802358**

**In View – Tank Battery (Location ID [434021](#)), Flowline**

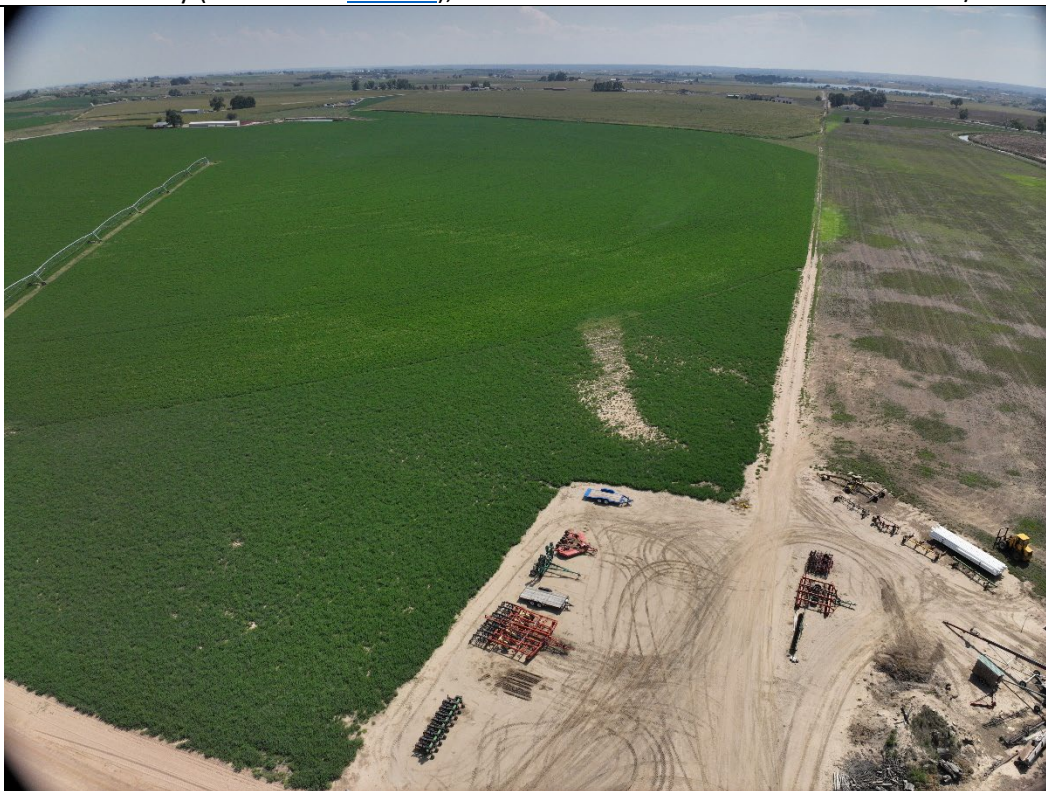
**WEST** – 40.552704 / -104.801619

**In View** – Tank Battery (Location ID [434021](#)), Flowline

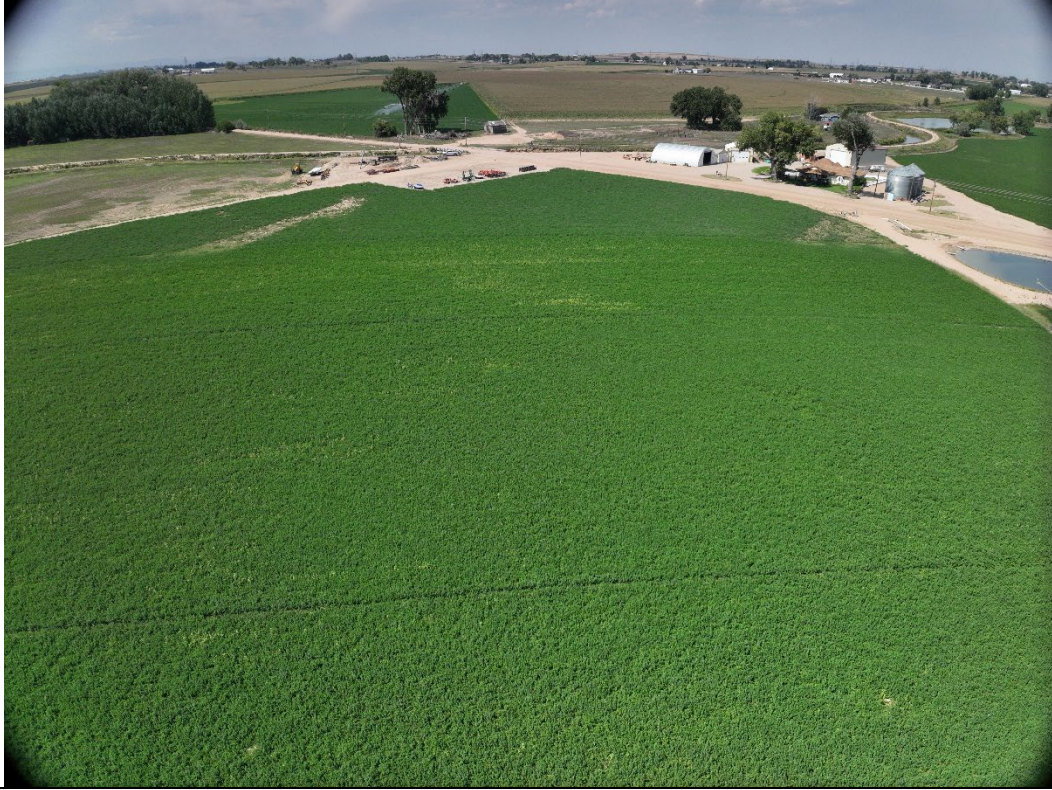
**SOUTHEAST** – 40.553237 / -104.802357

**In View** – Well, Tank Battery (Location ID [434021](#)), Access Road, Flowline

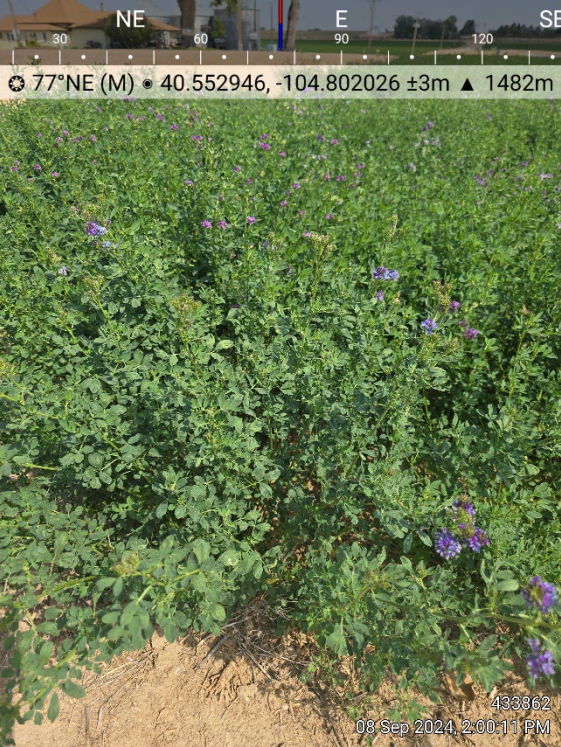
<p>433862 08 Sep 2024, 2:00:11 PM</p>

Handheld photos taken from the access road to the north looking Location ID [433862](#) wellhead.
