Inspection Photos

Loc: 309327

Operator: EVERGREEN NATURAL
RESOURCES LLC

Inspection Date: 1/24/2025

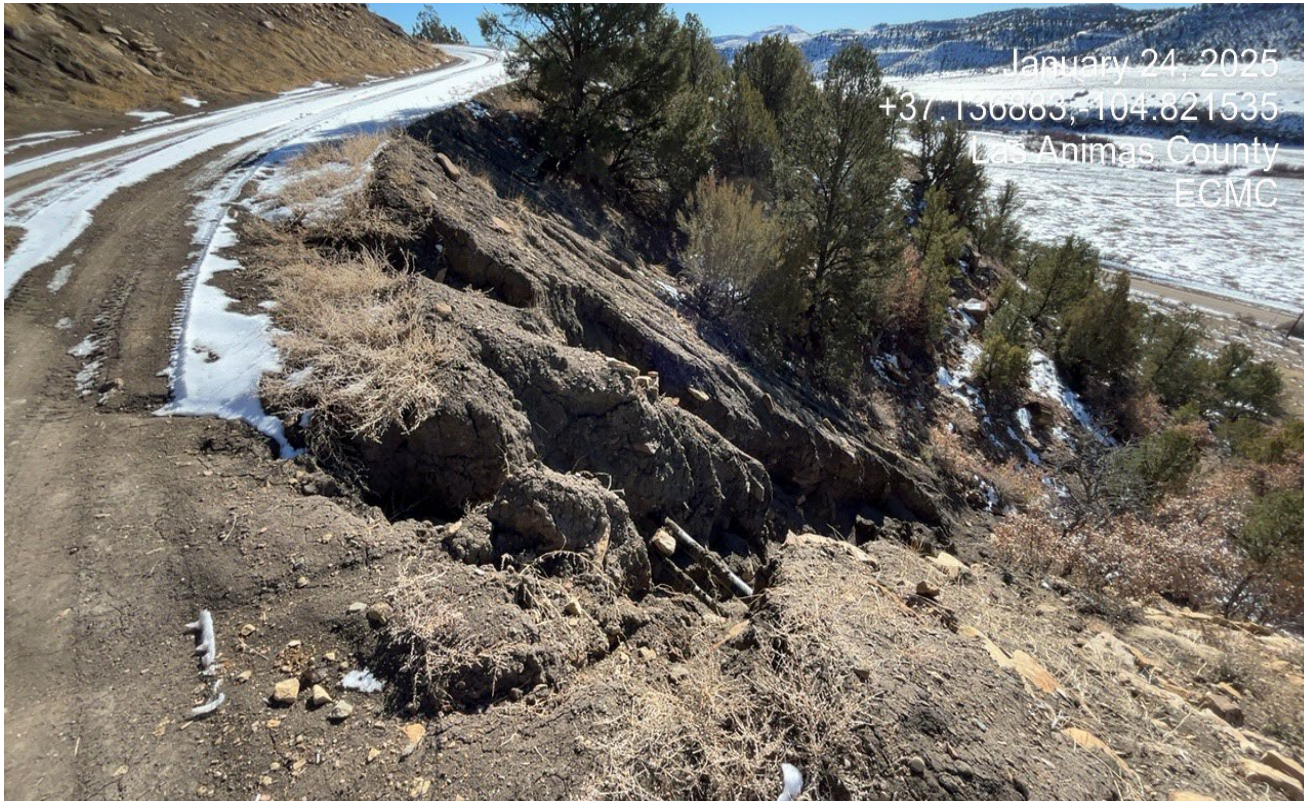
Photo 1. There is erosion occurring along the access road which needs to be repaired and stabilized..

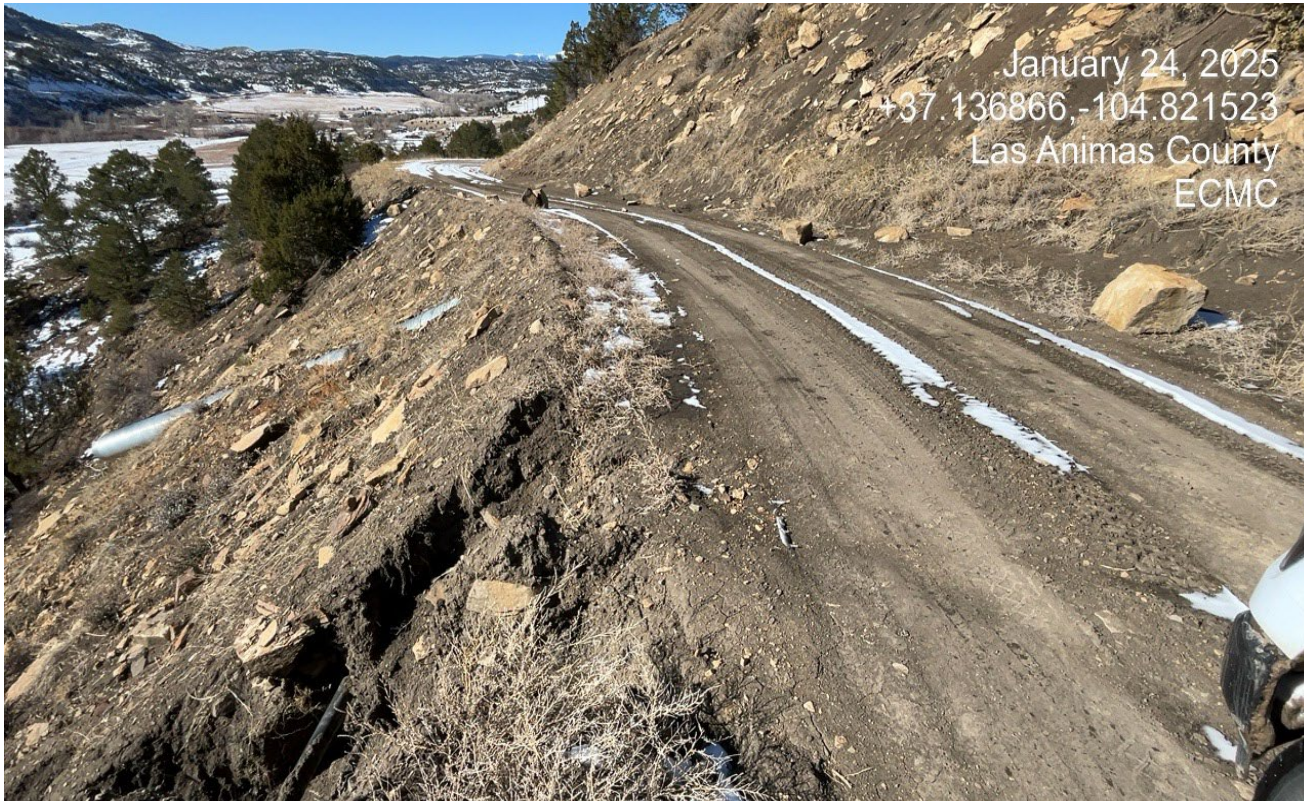
Photo 2. Facing southwest along the access road. The culvert is filled in with sediment at this area.

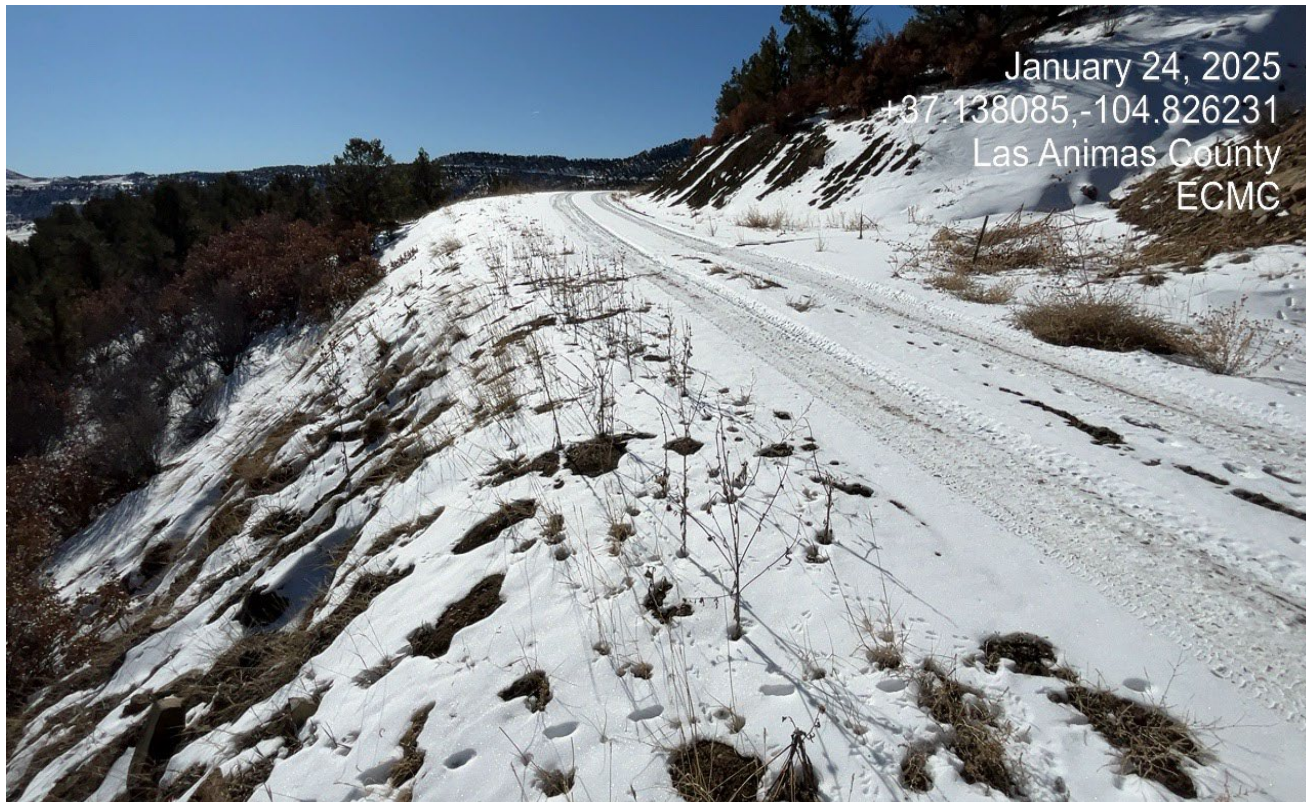
Photo 3. Facing southwest along the access road. It appears the culvert may be filled in and stormwater causing erosion along the road side at this area.

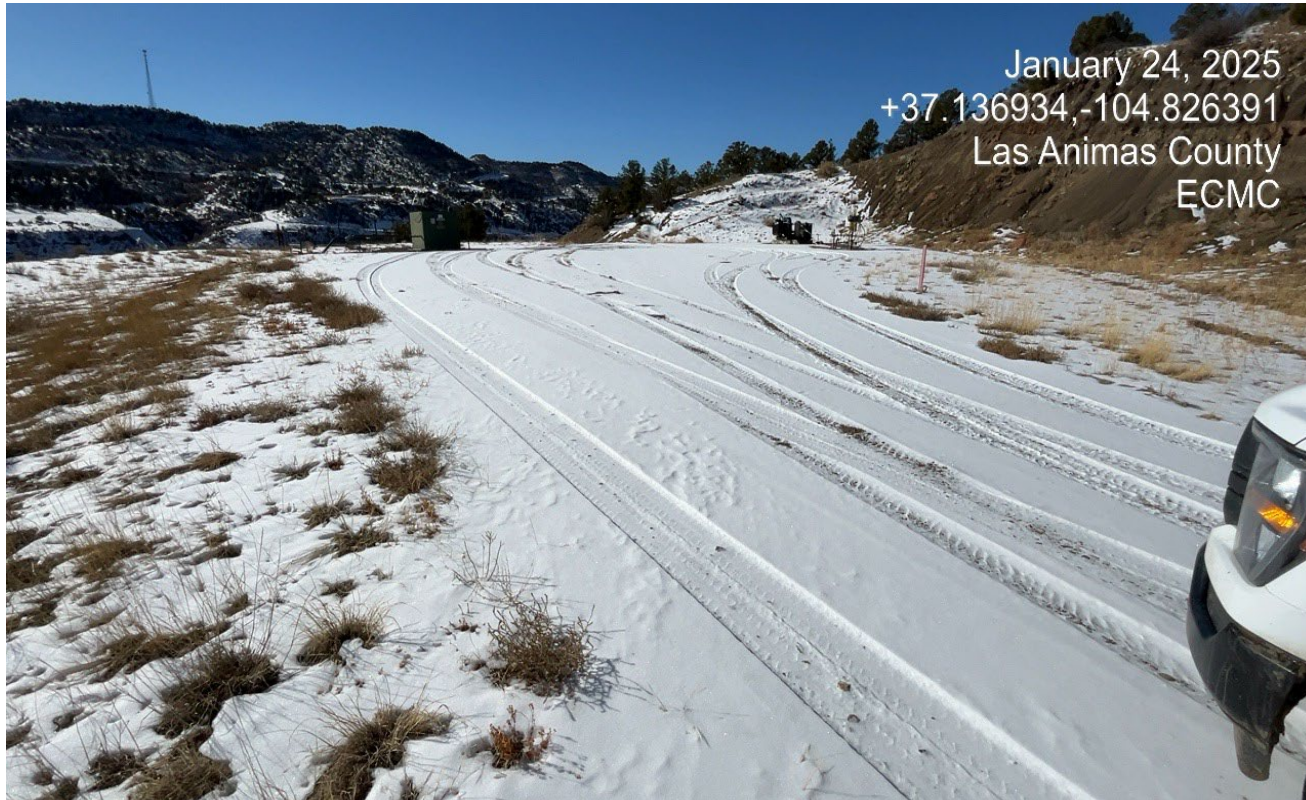
Photo 4. Facing southwest toward the wellsite.

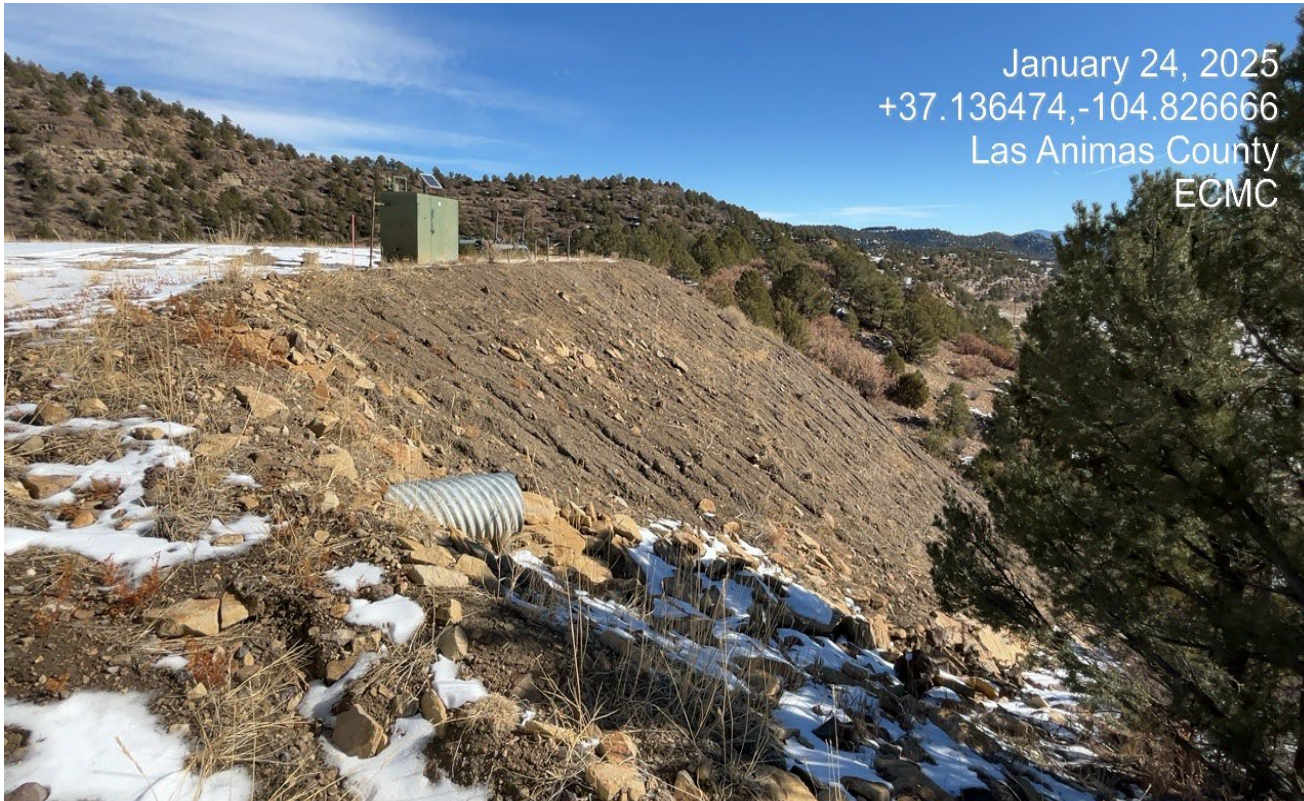
Photo 5. Facing east toward the fill slope. There are signs of erosion along the fill slope.
