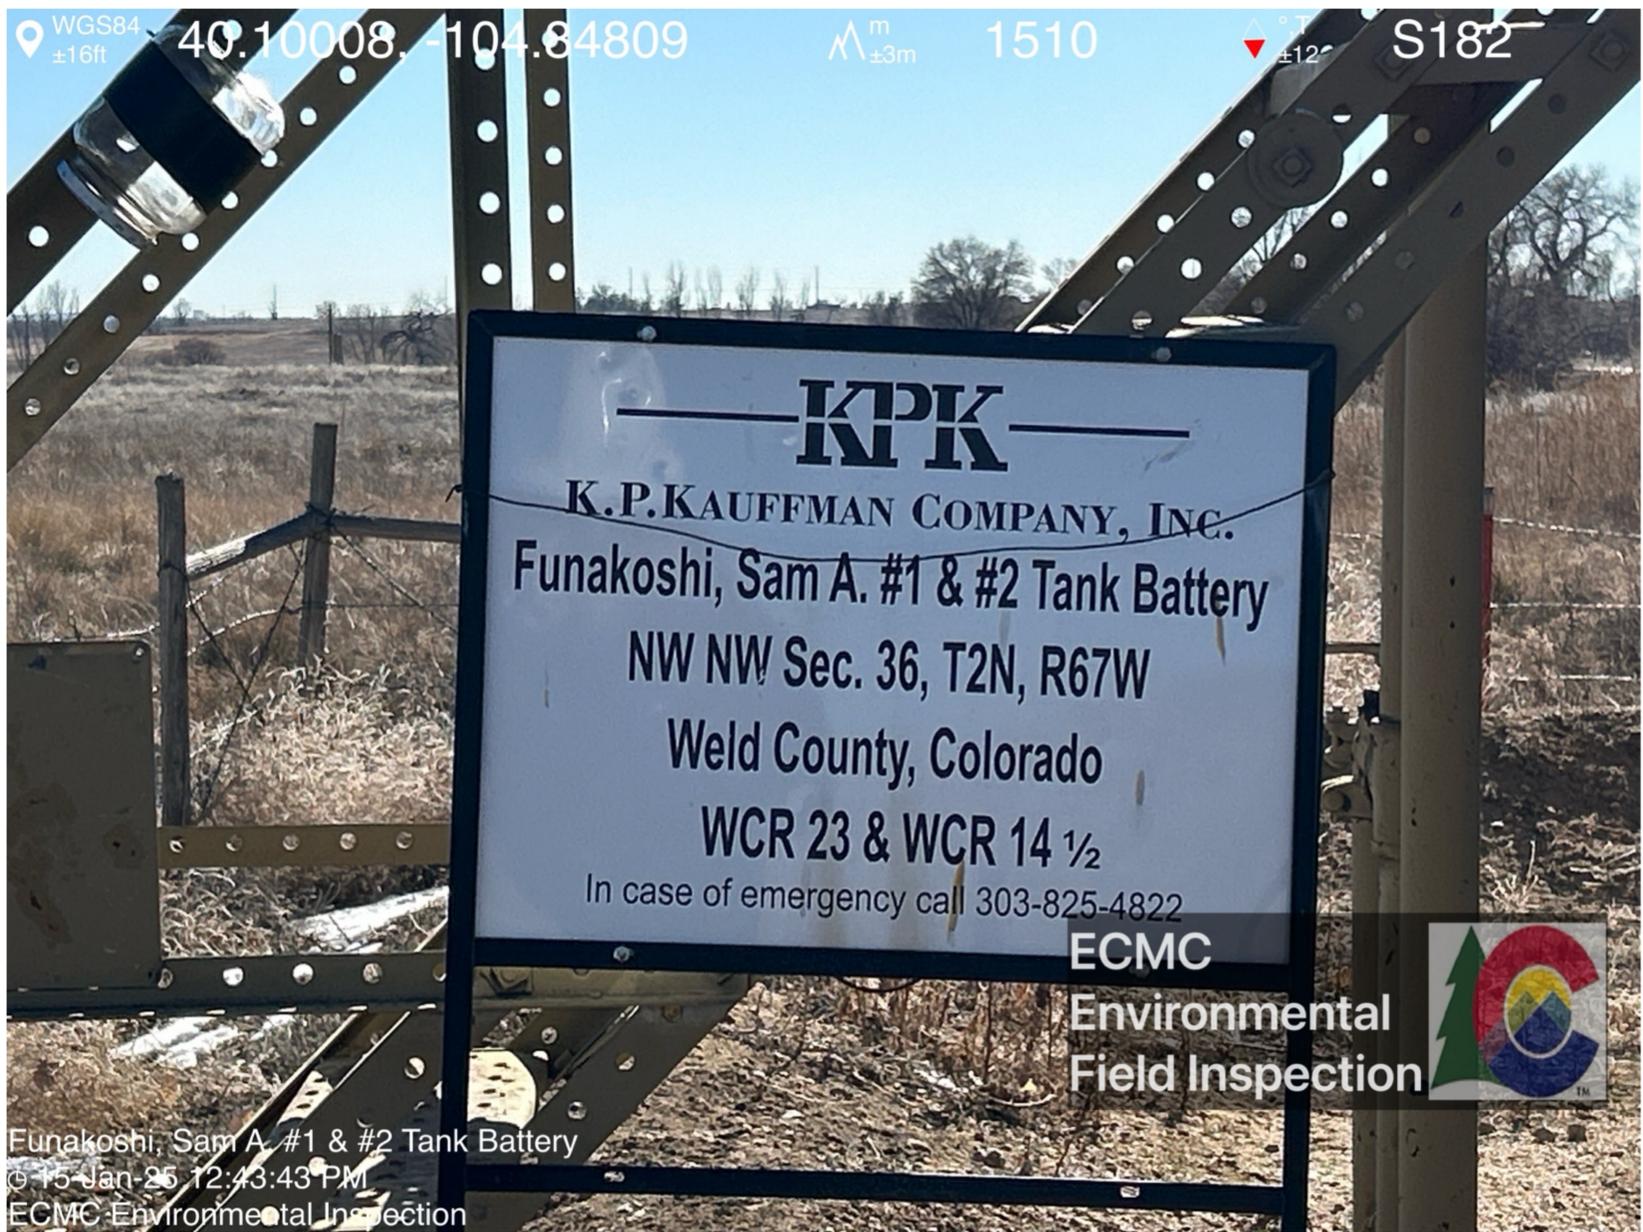
Signage visible at facility.

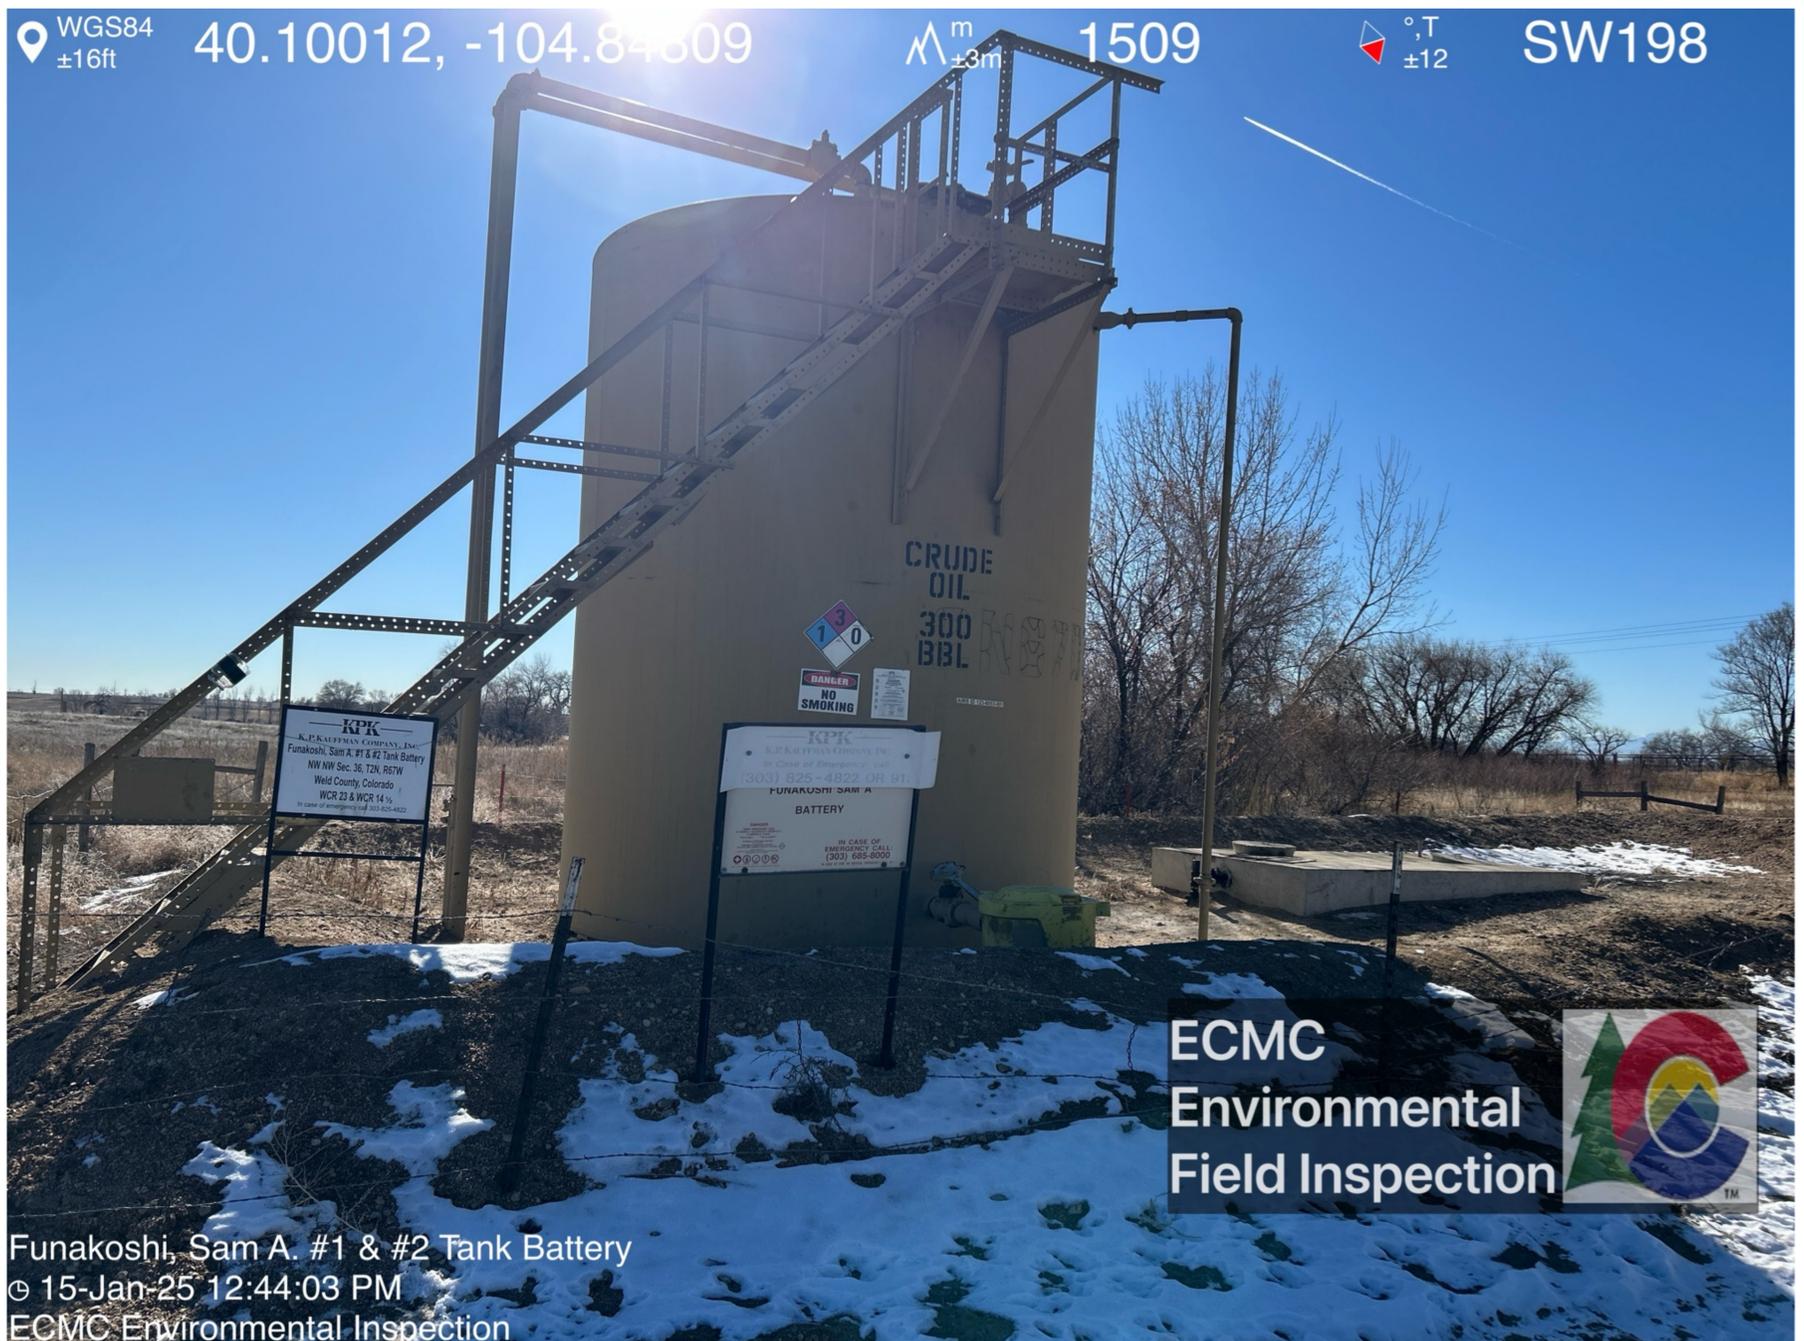
Tank with placard.

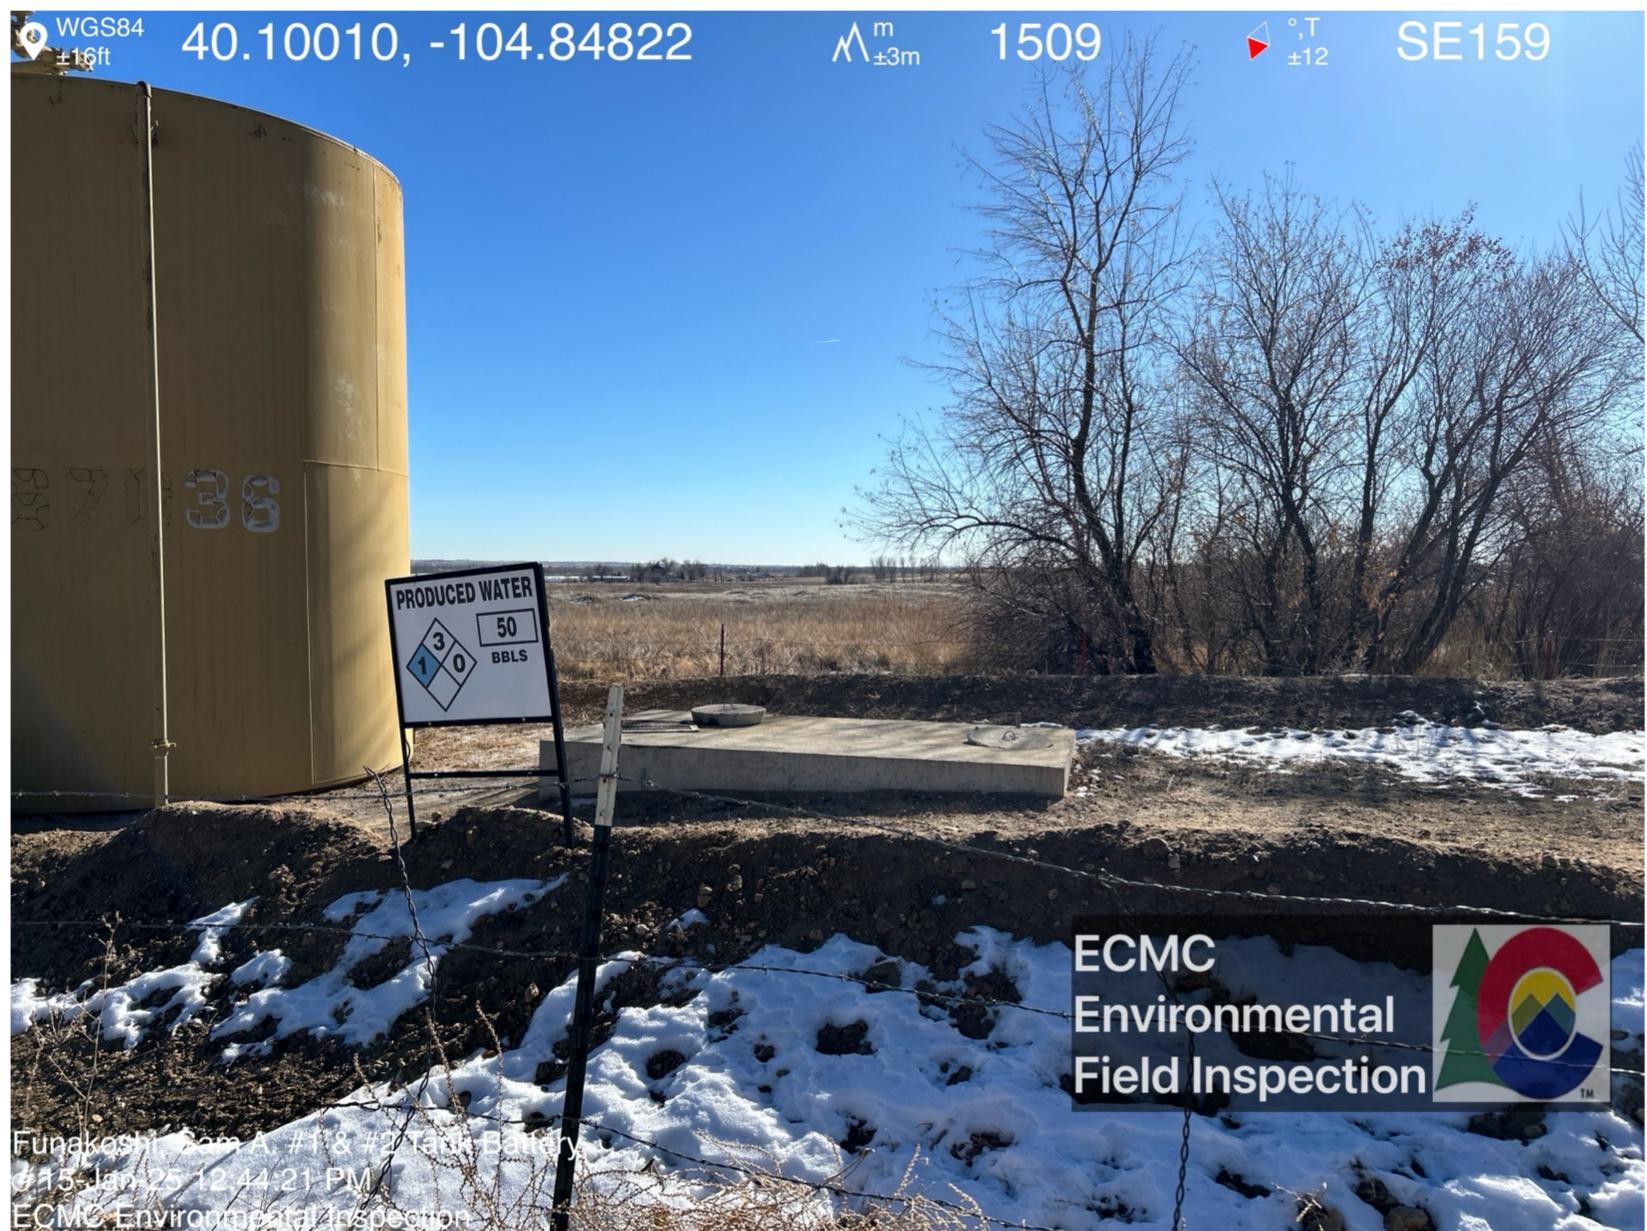
Signage visible at produced water vessel.

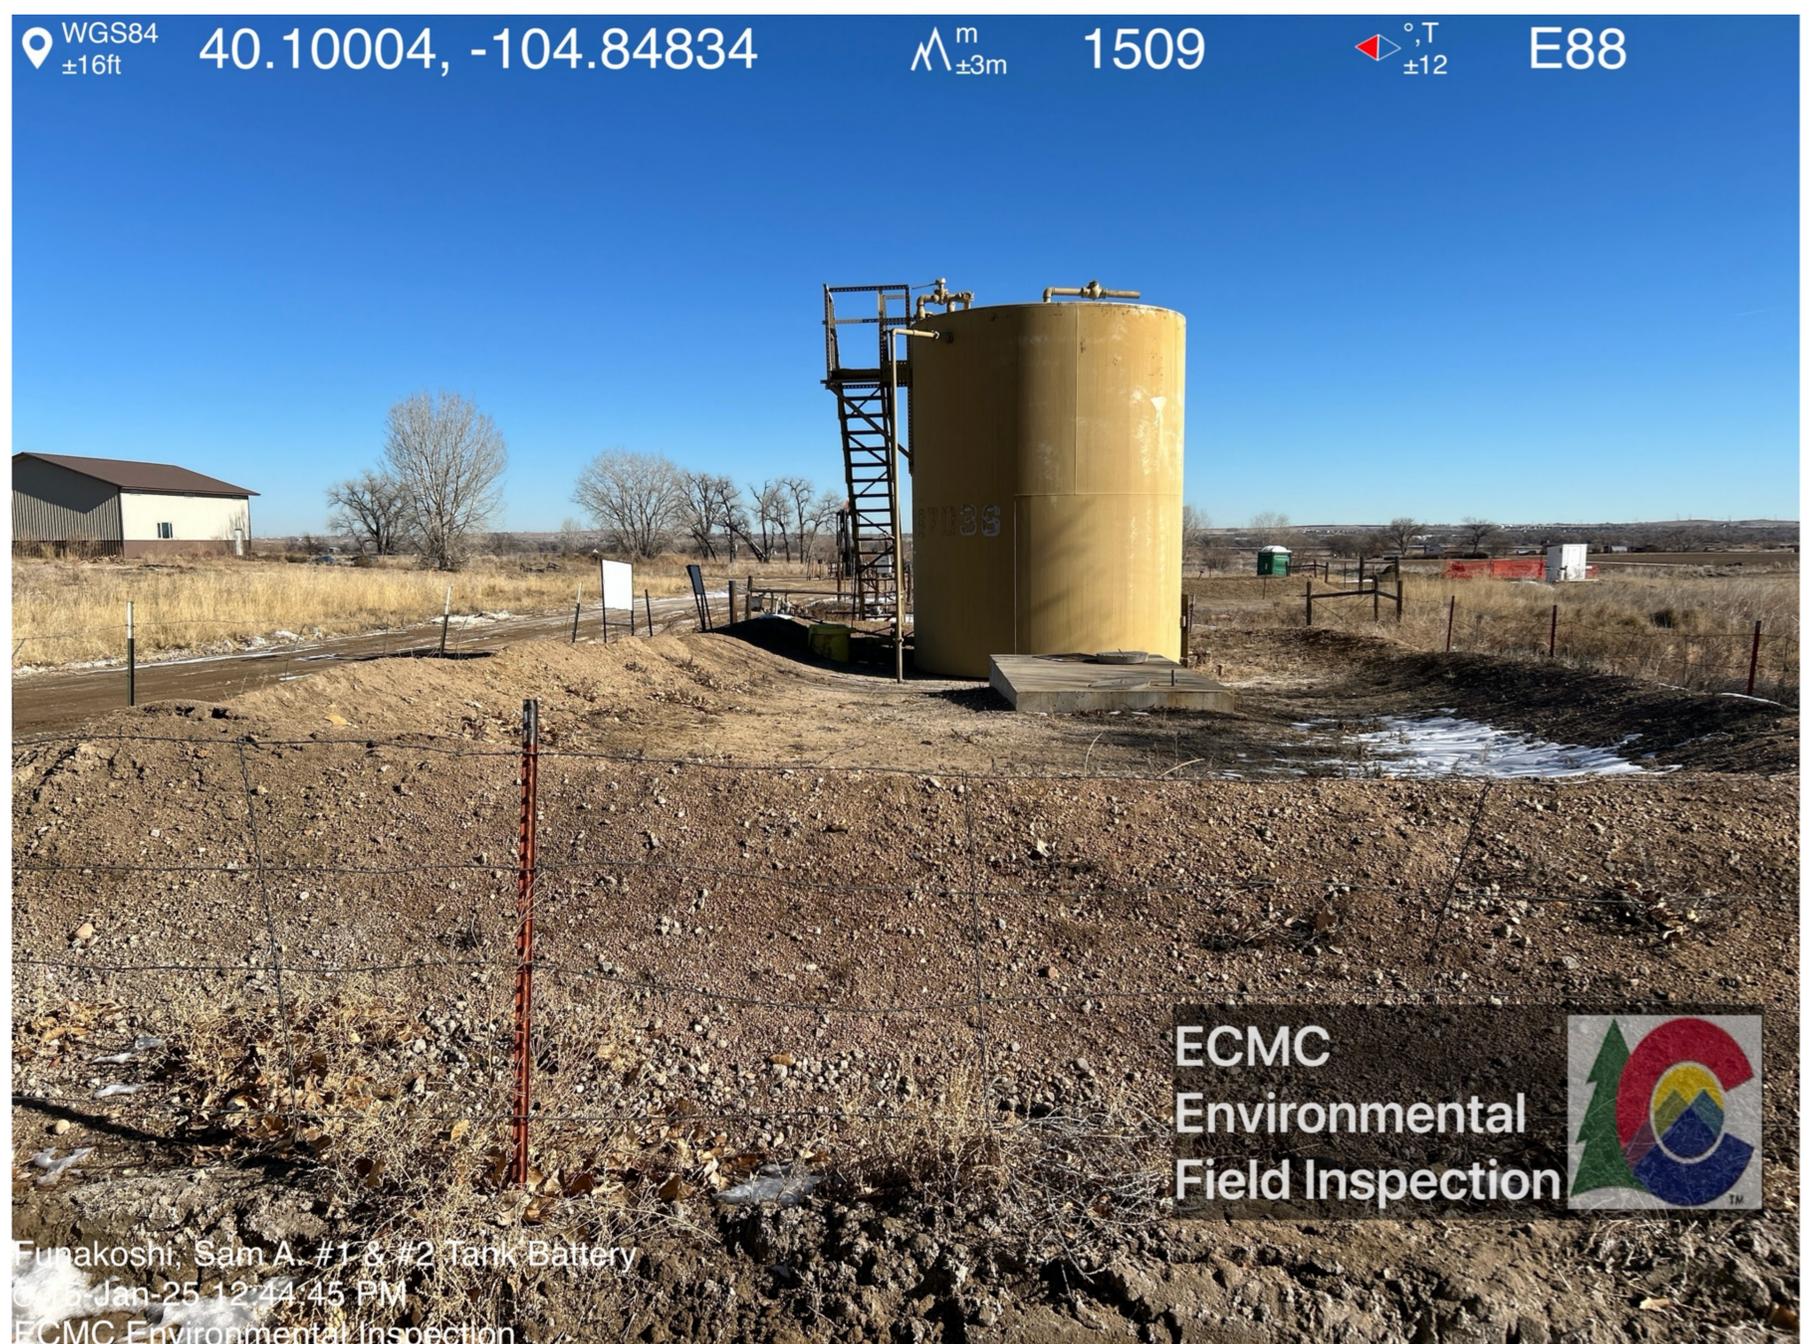
Tank and produced water vessel share containment.

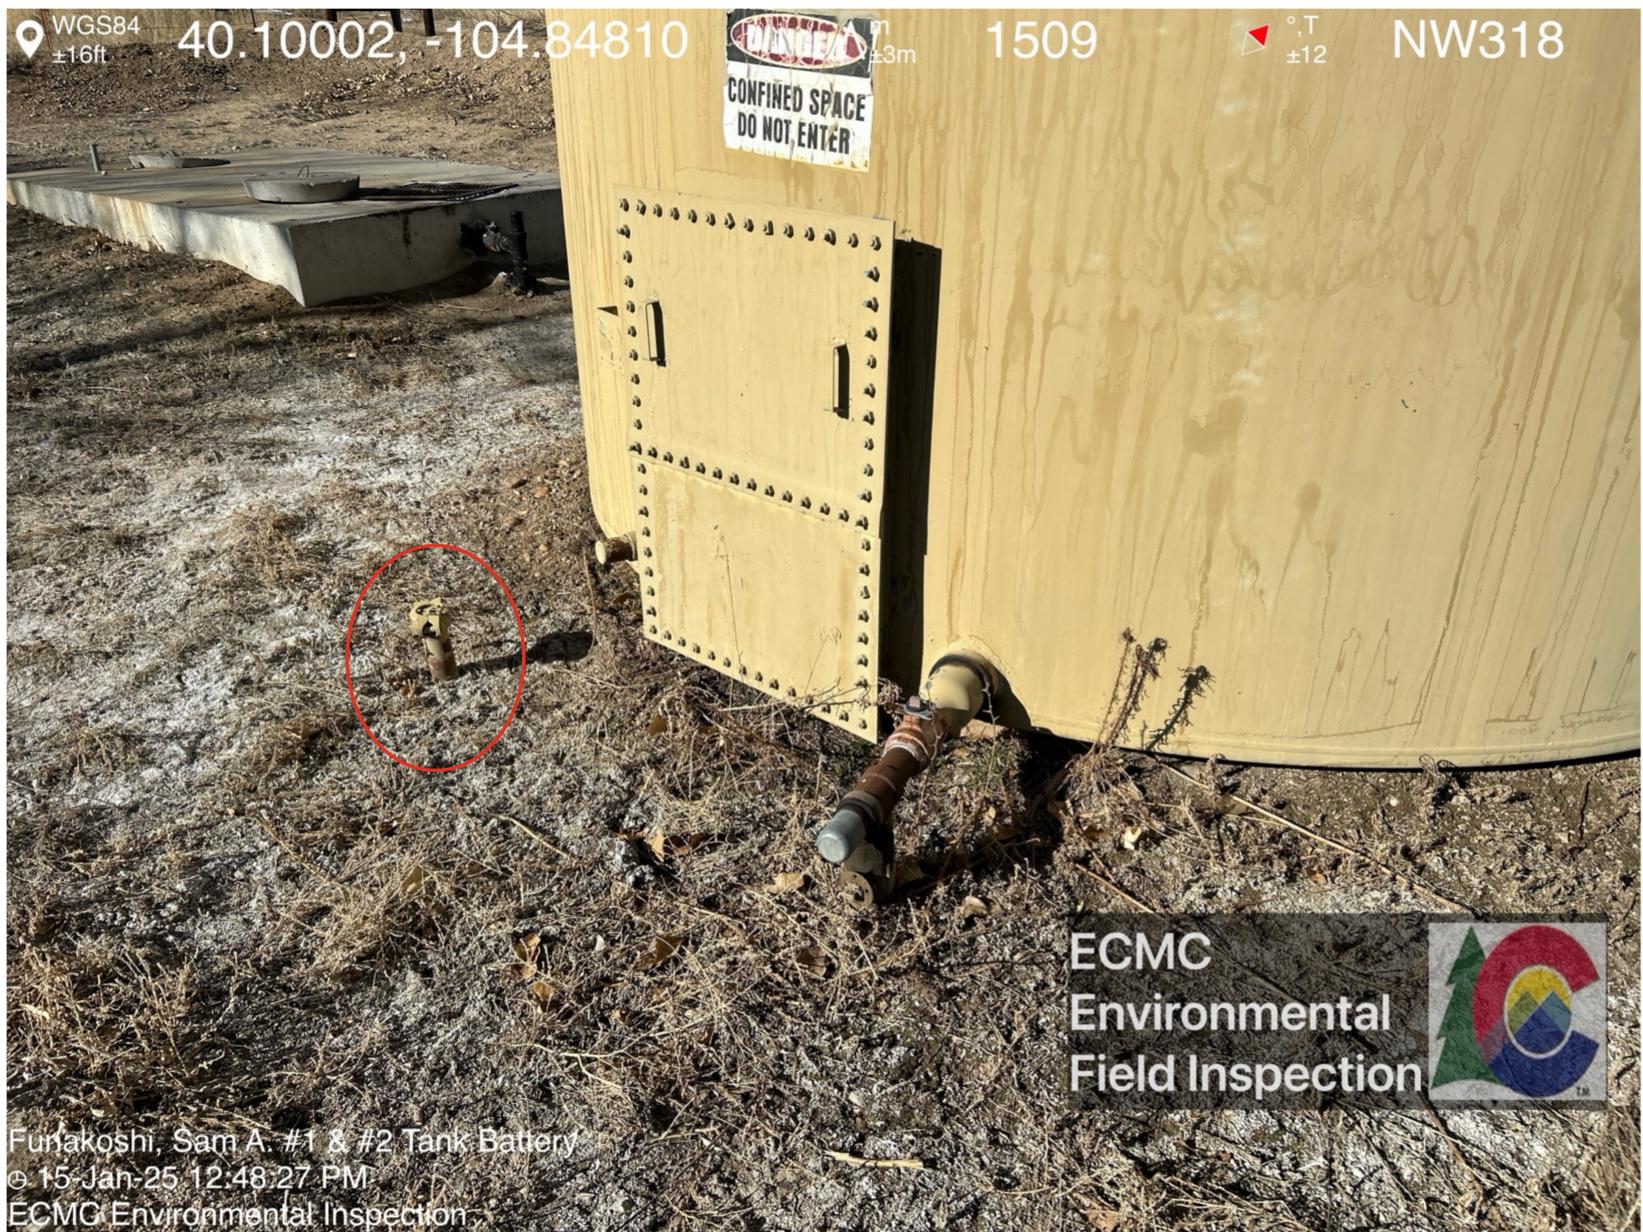
Riser missing OOSLAT.

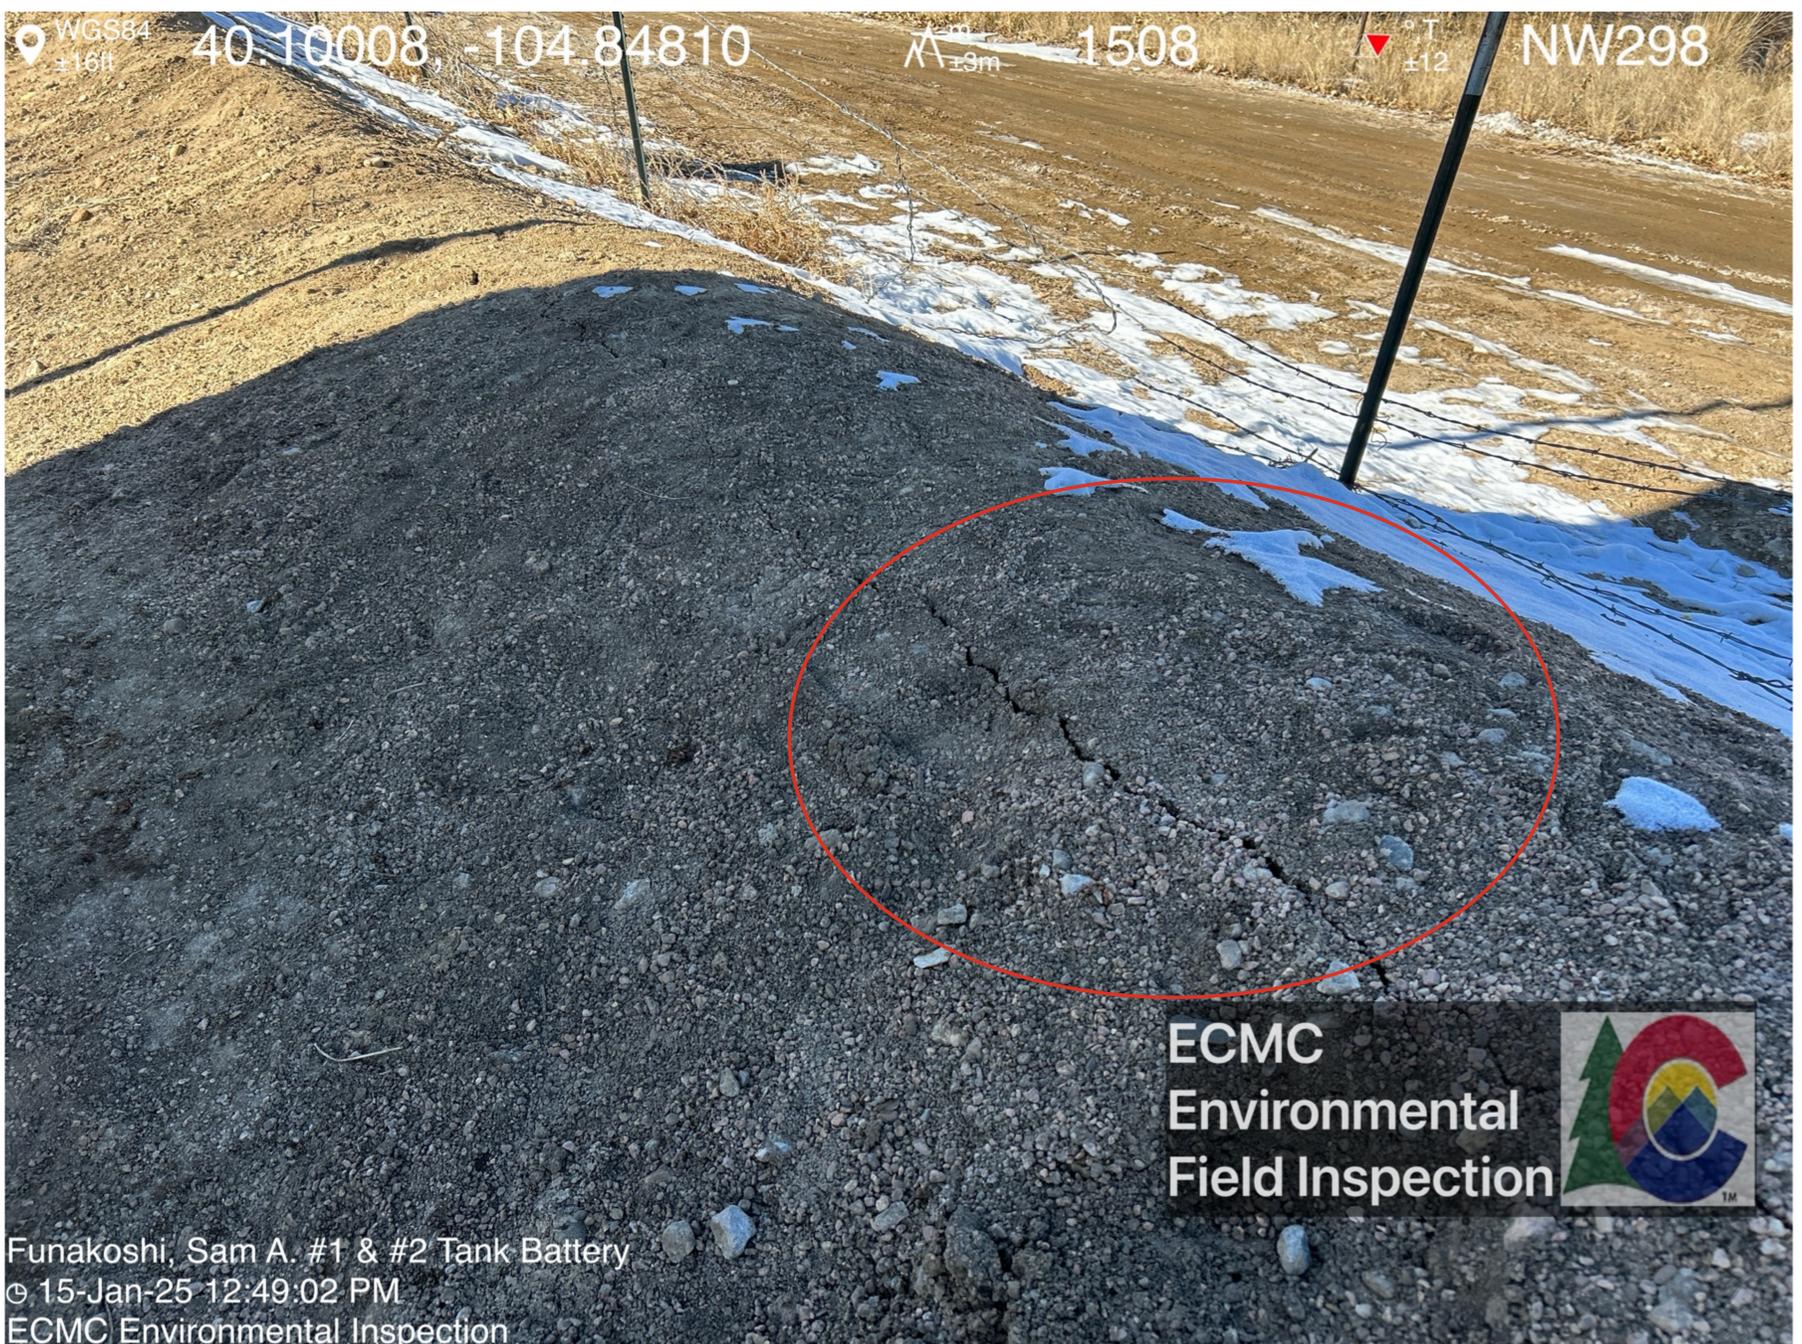
Surface crack observed on the crude oil AST and produced water vessel berm.

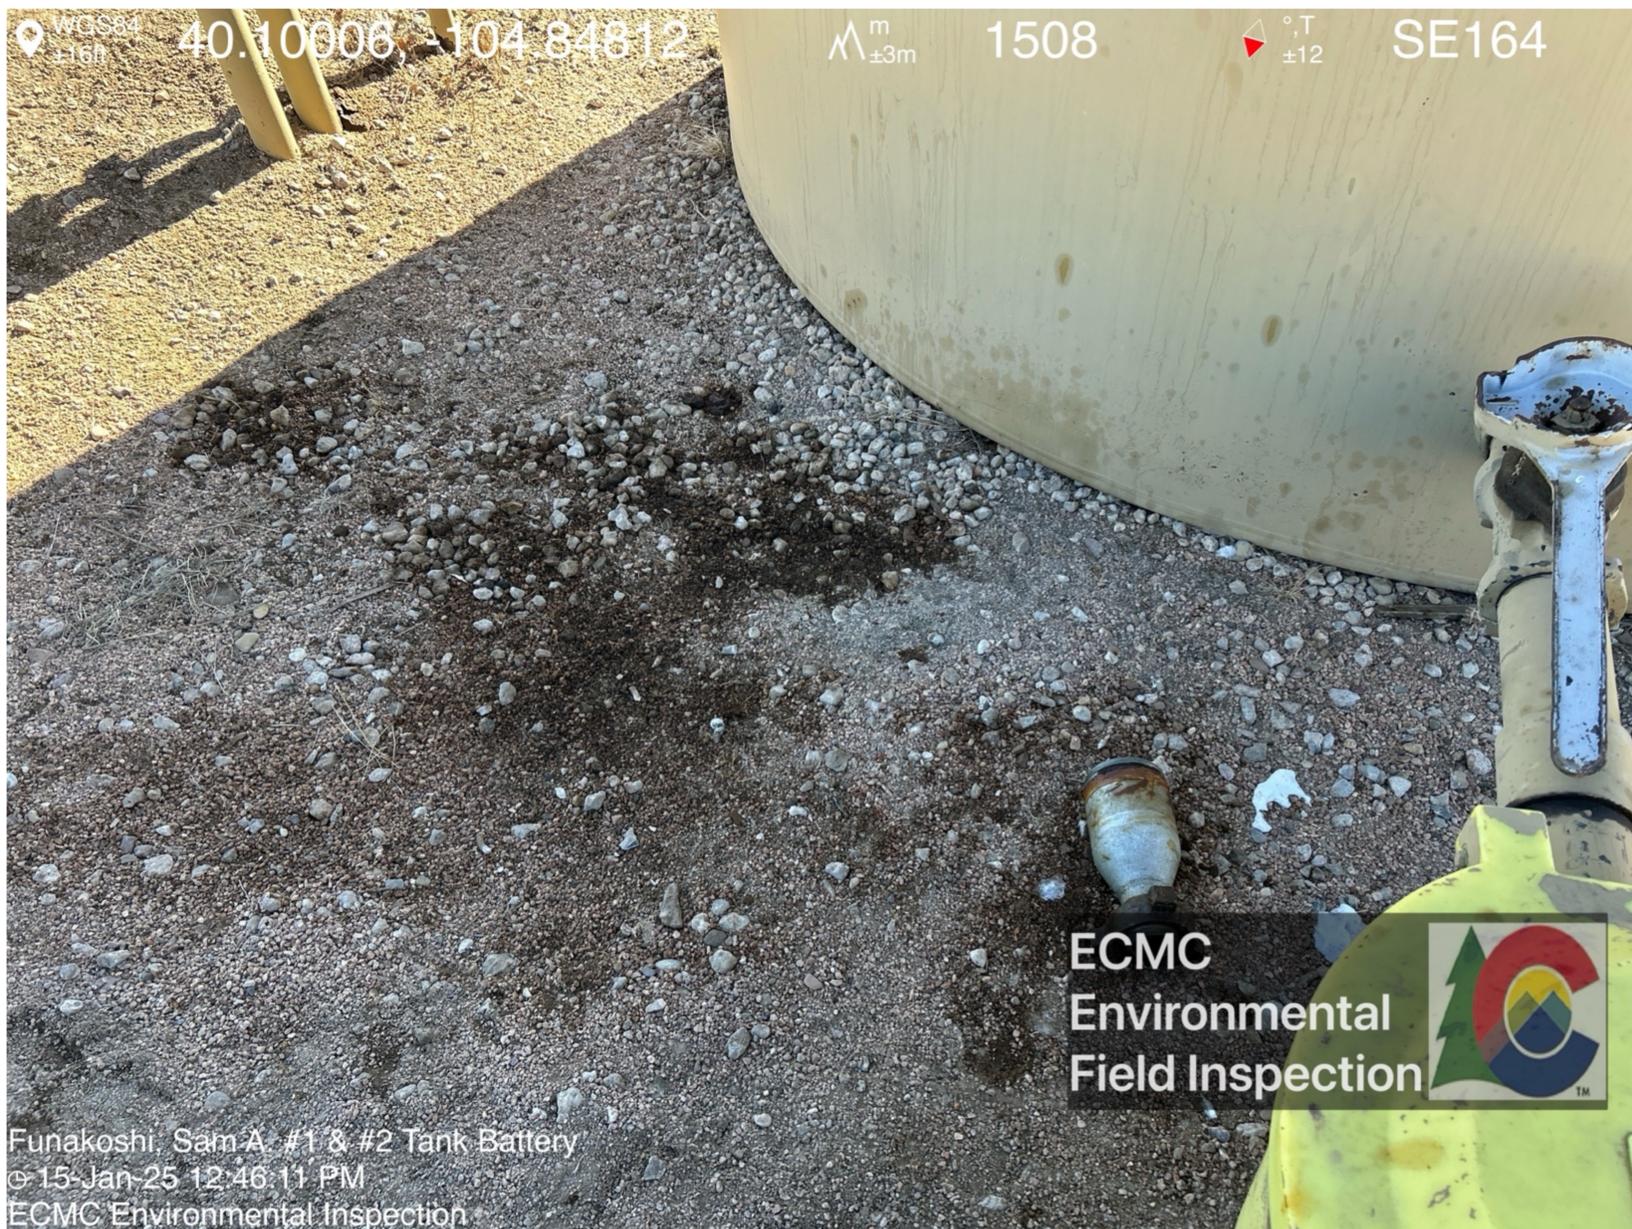
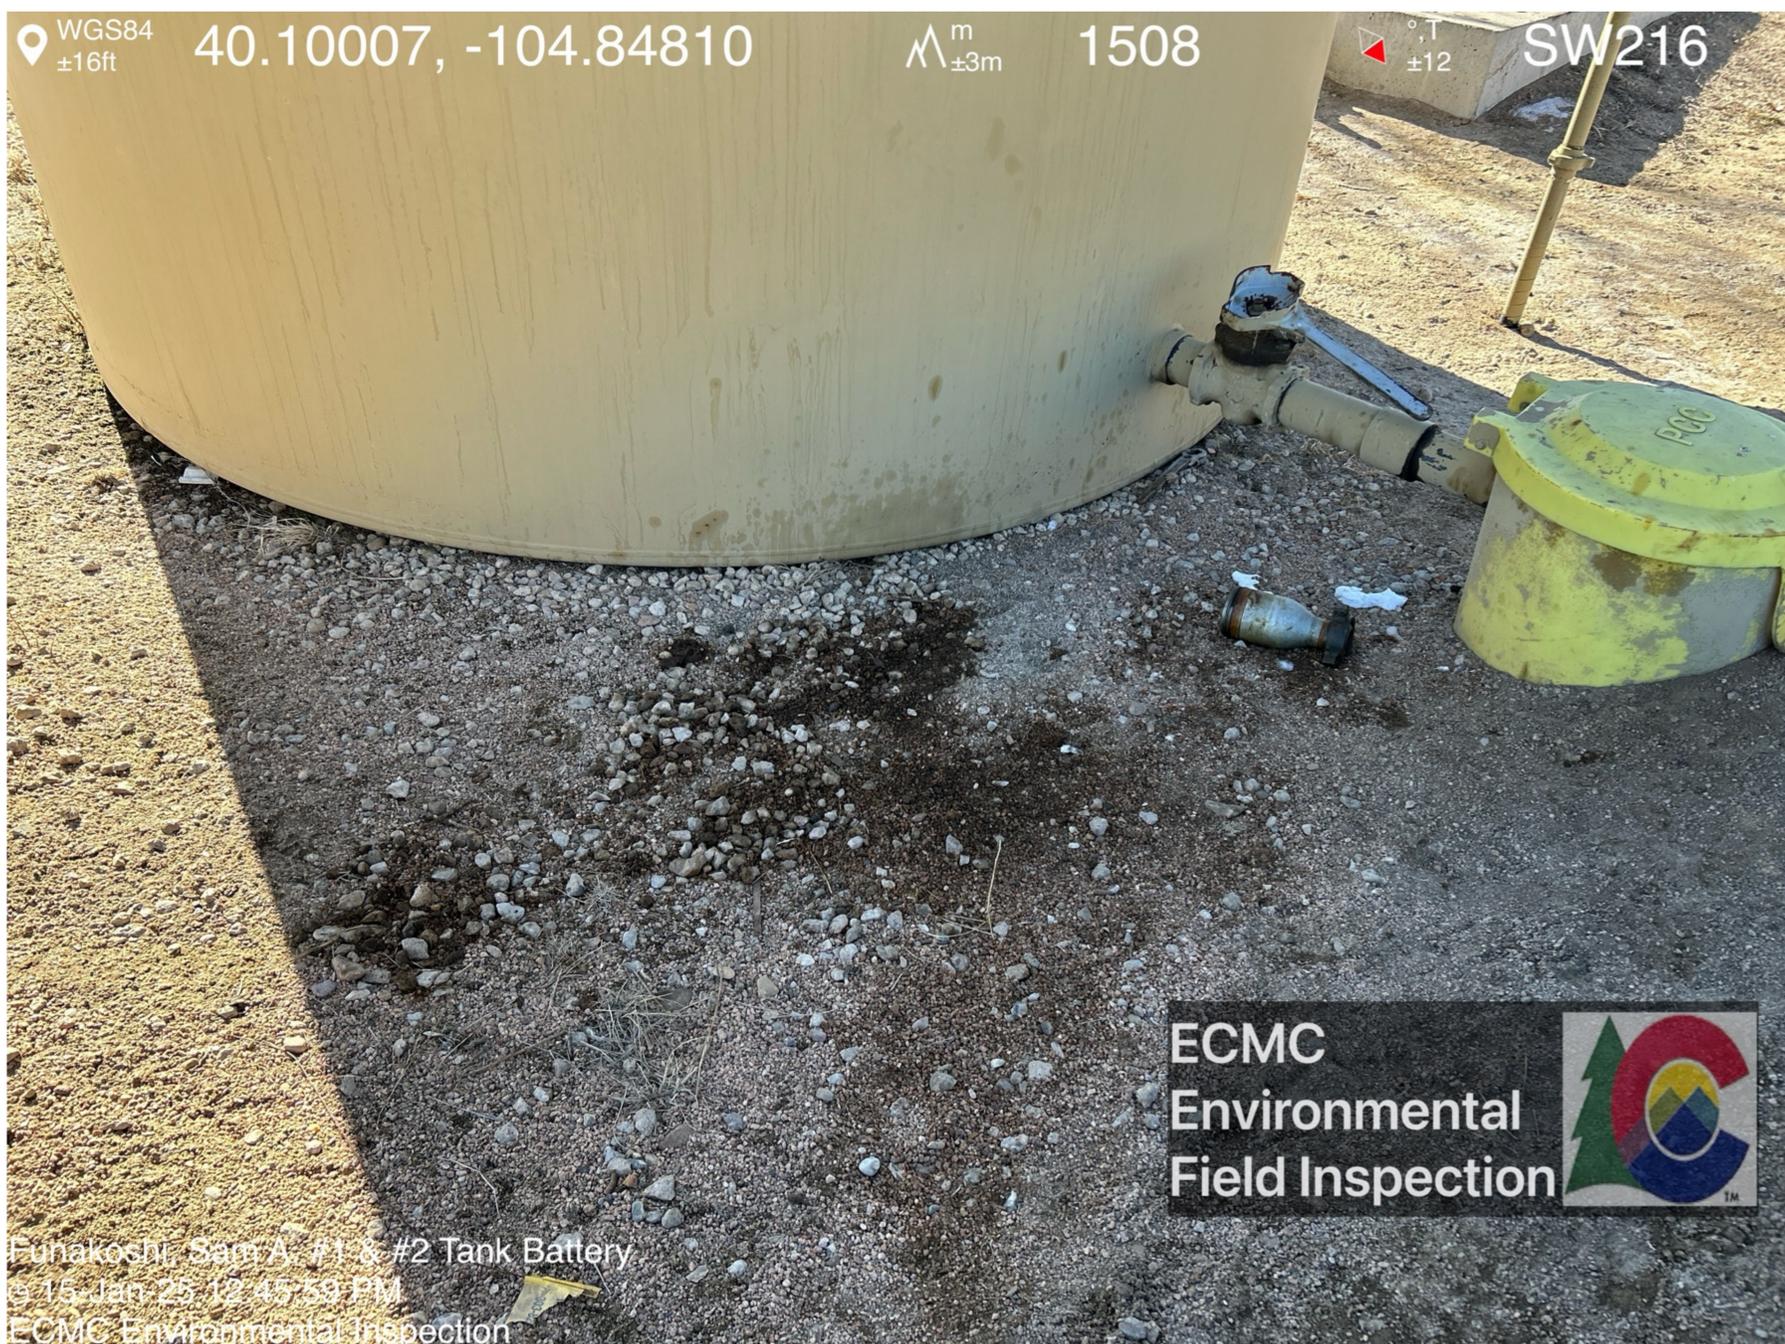
Petroleum hydrocarbon staining visible at crude oil AST valve.  
Very strong petroleum hydrocarbon odor observed in area of stained soil.

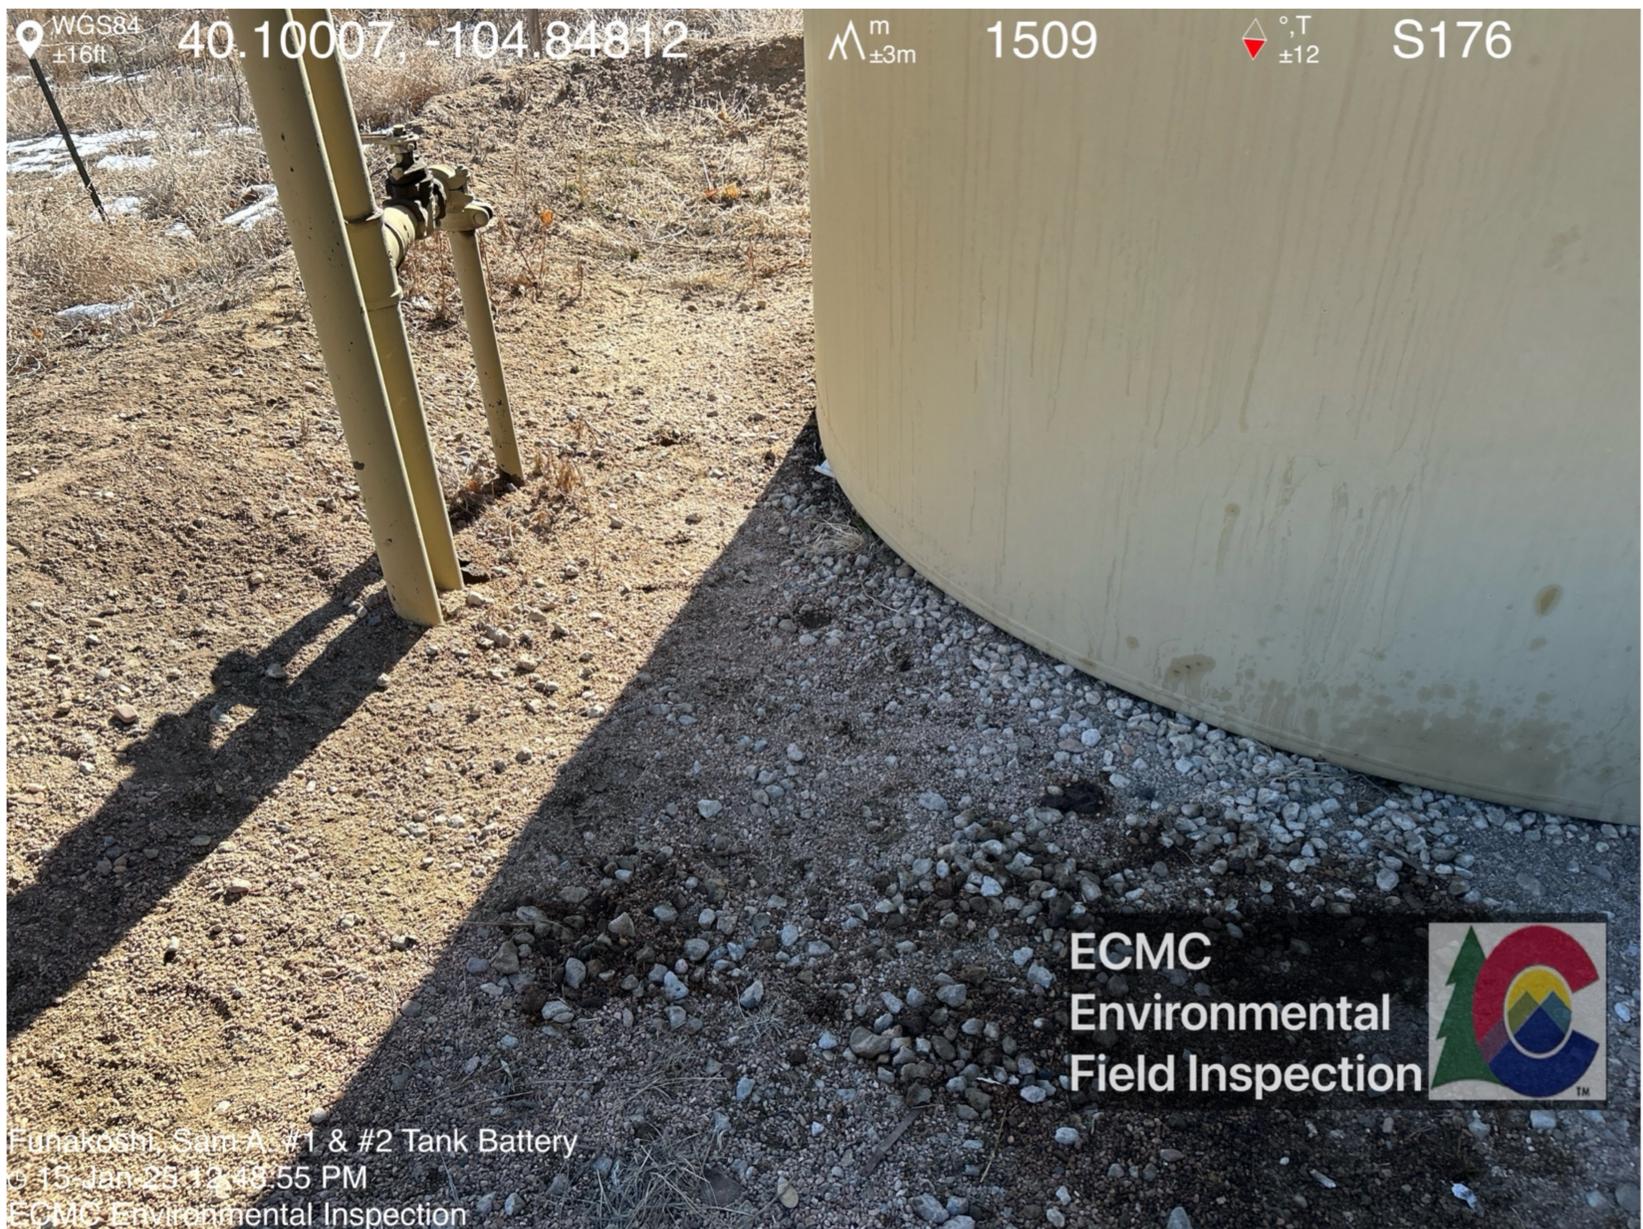
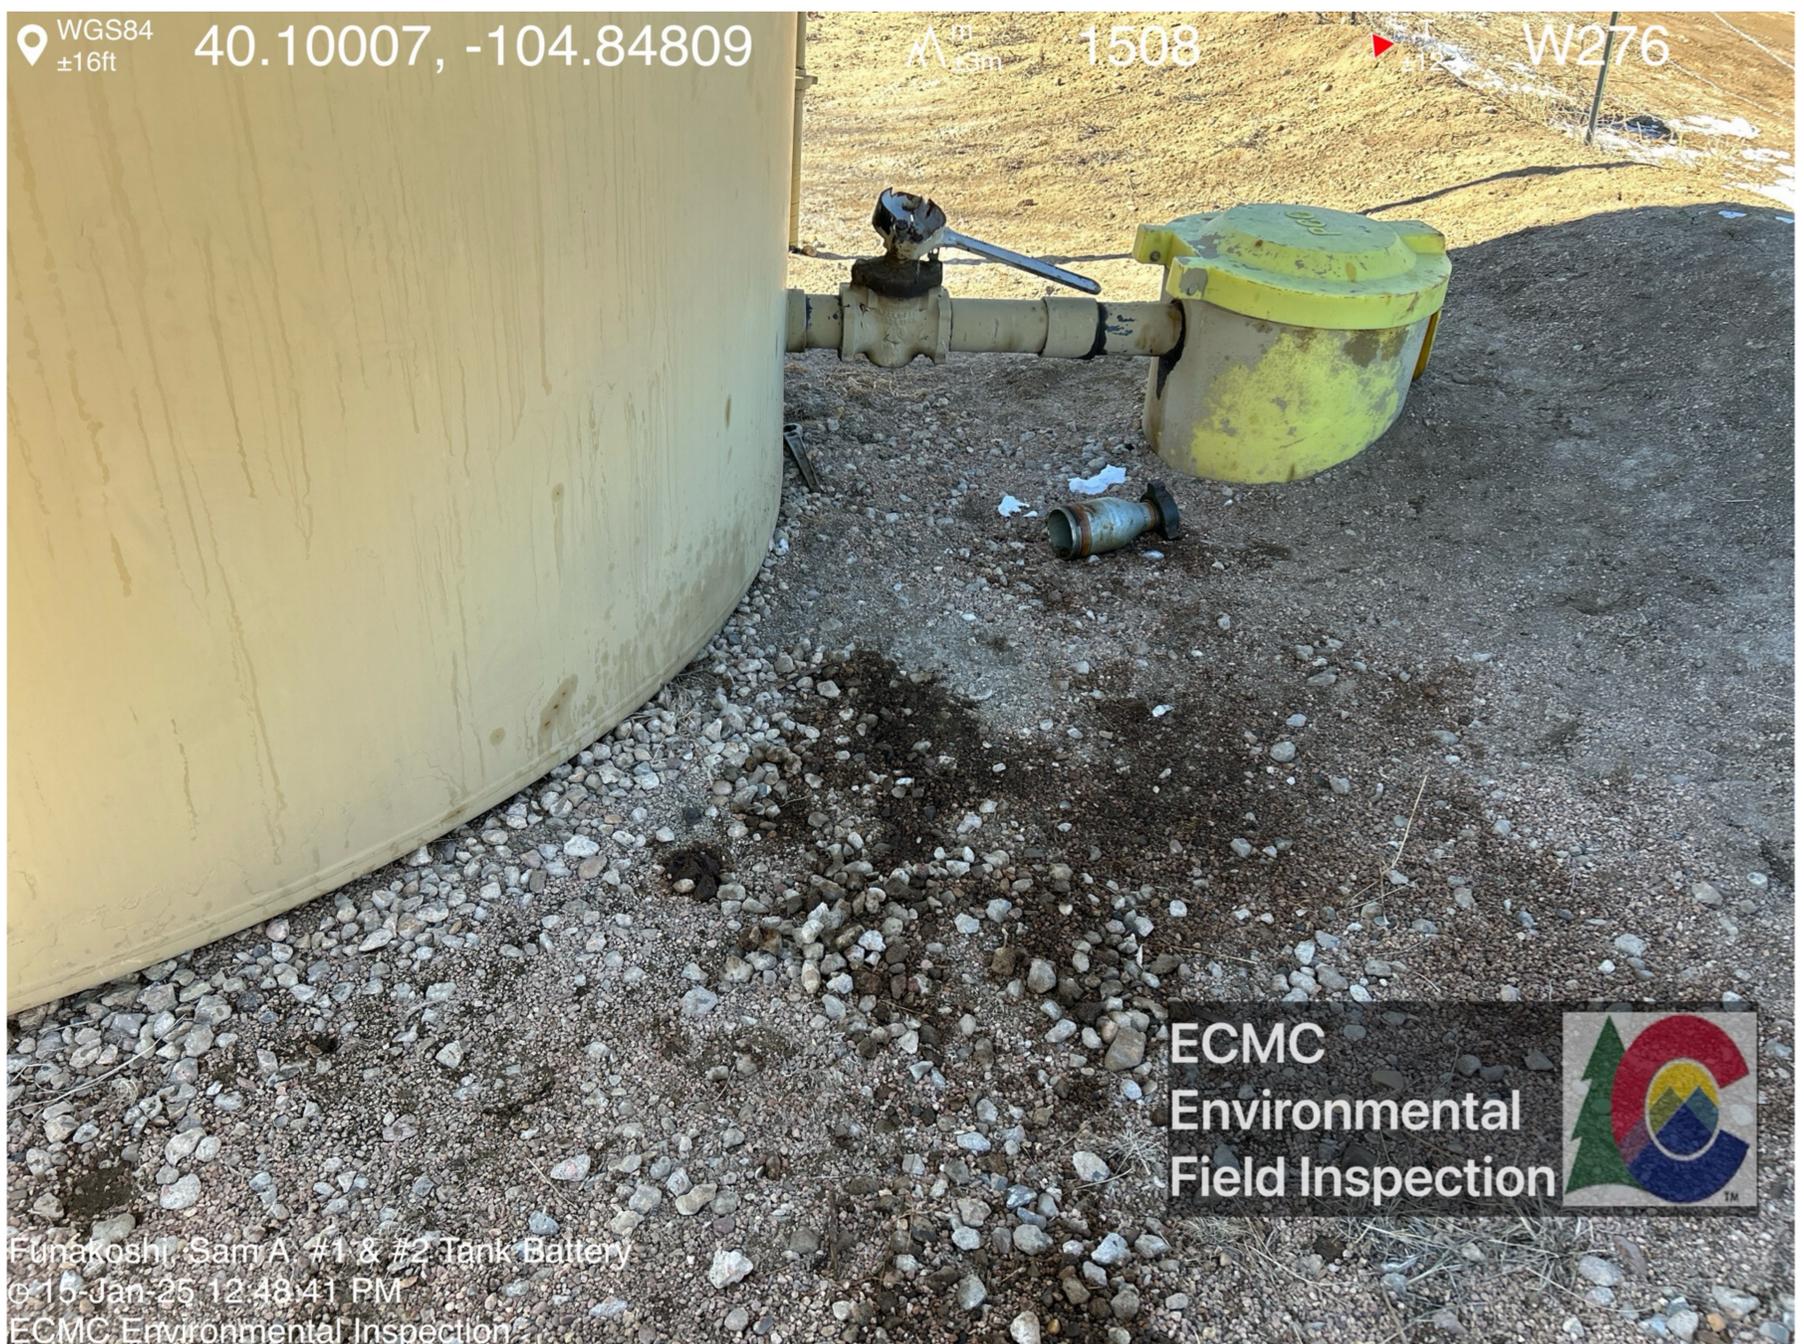
Petroleum hydrocarbon staining visible at crude oil AST valve.  
Very strong petroleum hydrocarbon odor observed in area of stained soil.
