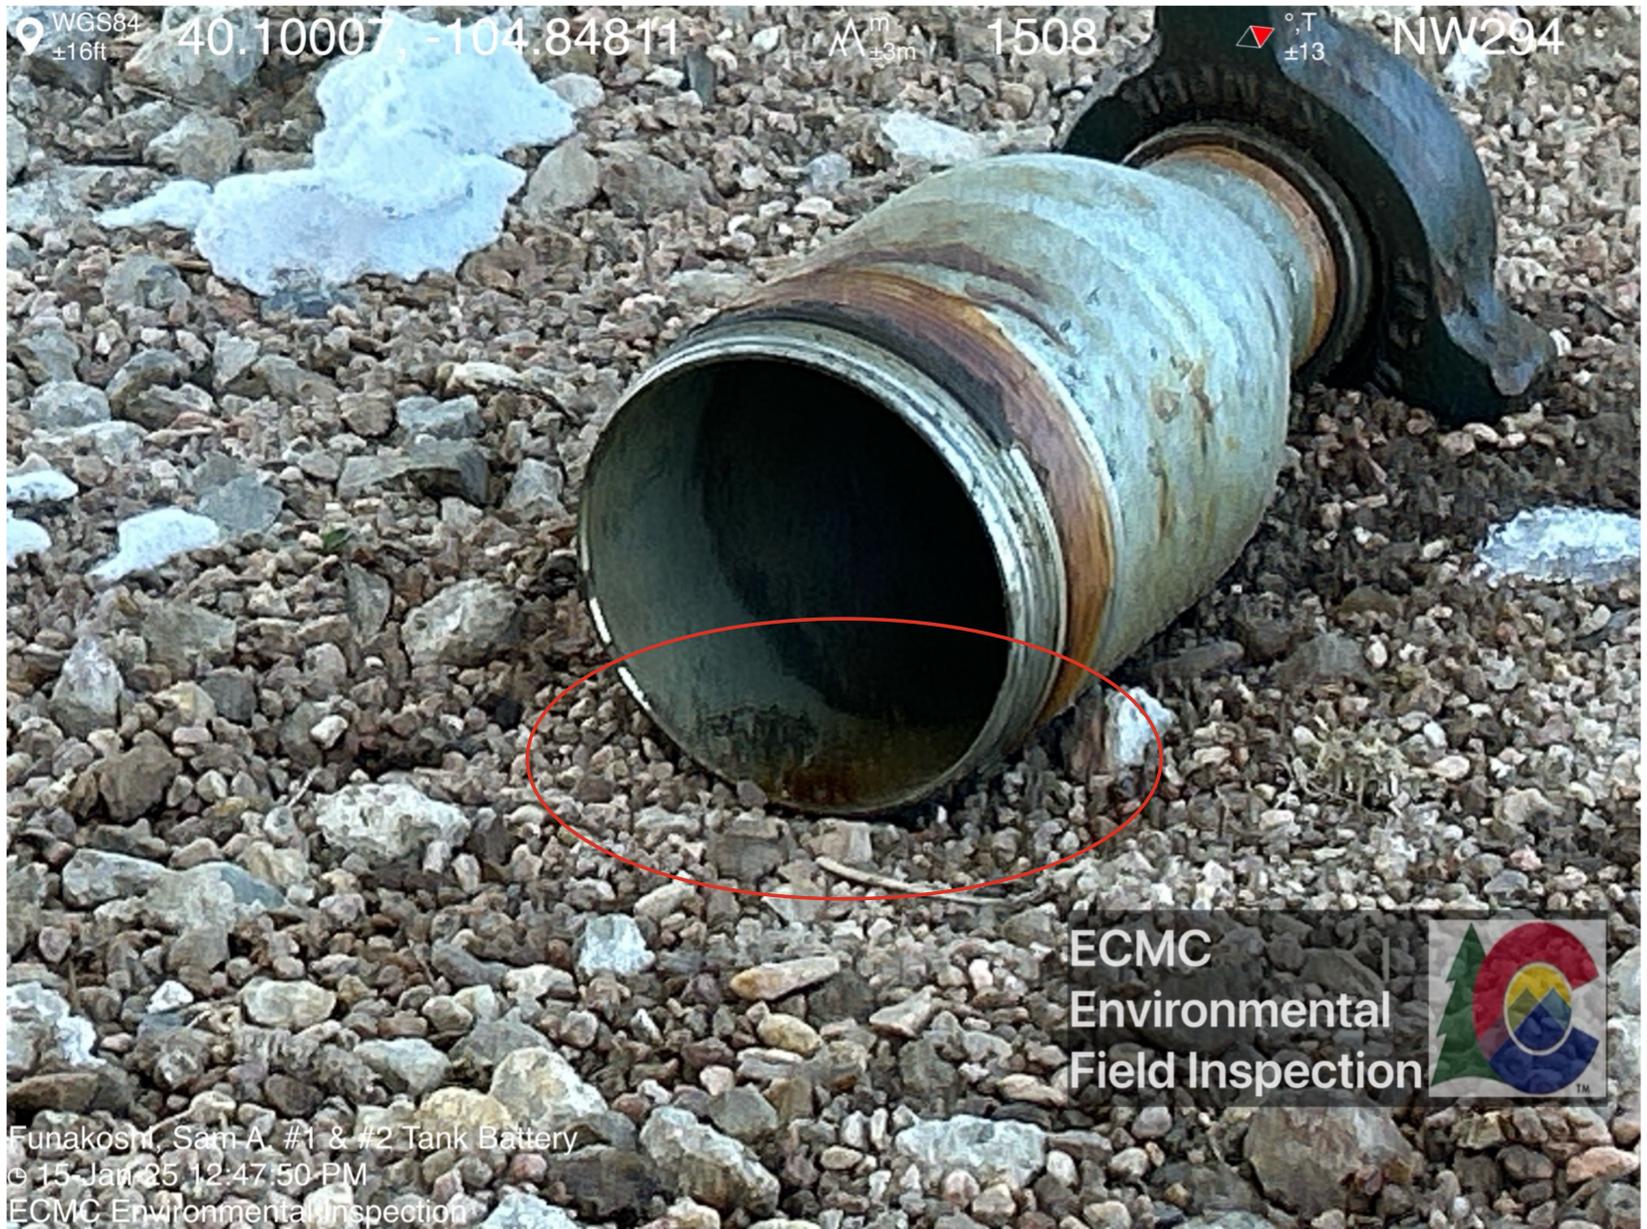
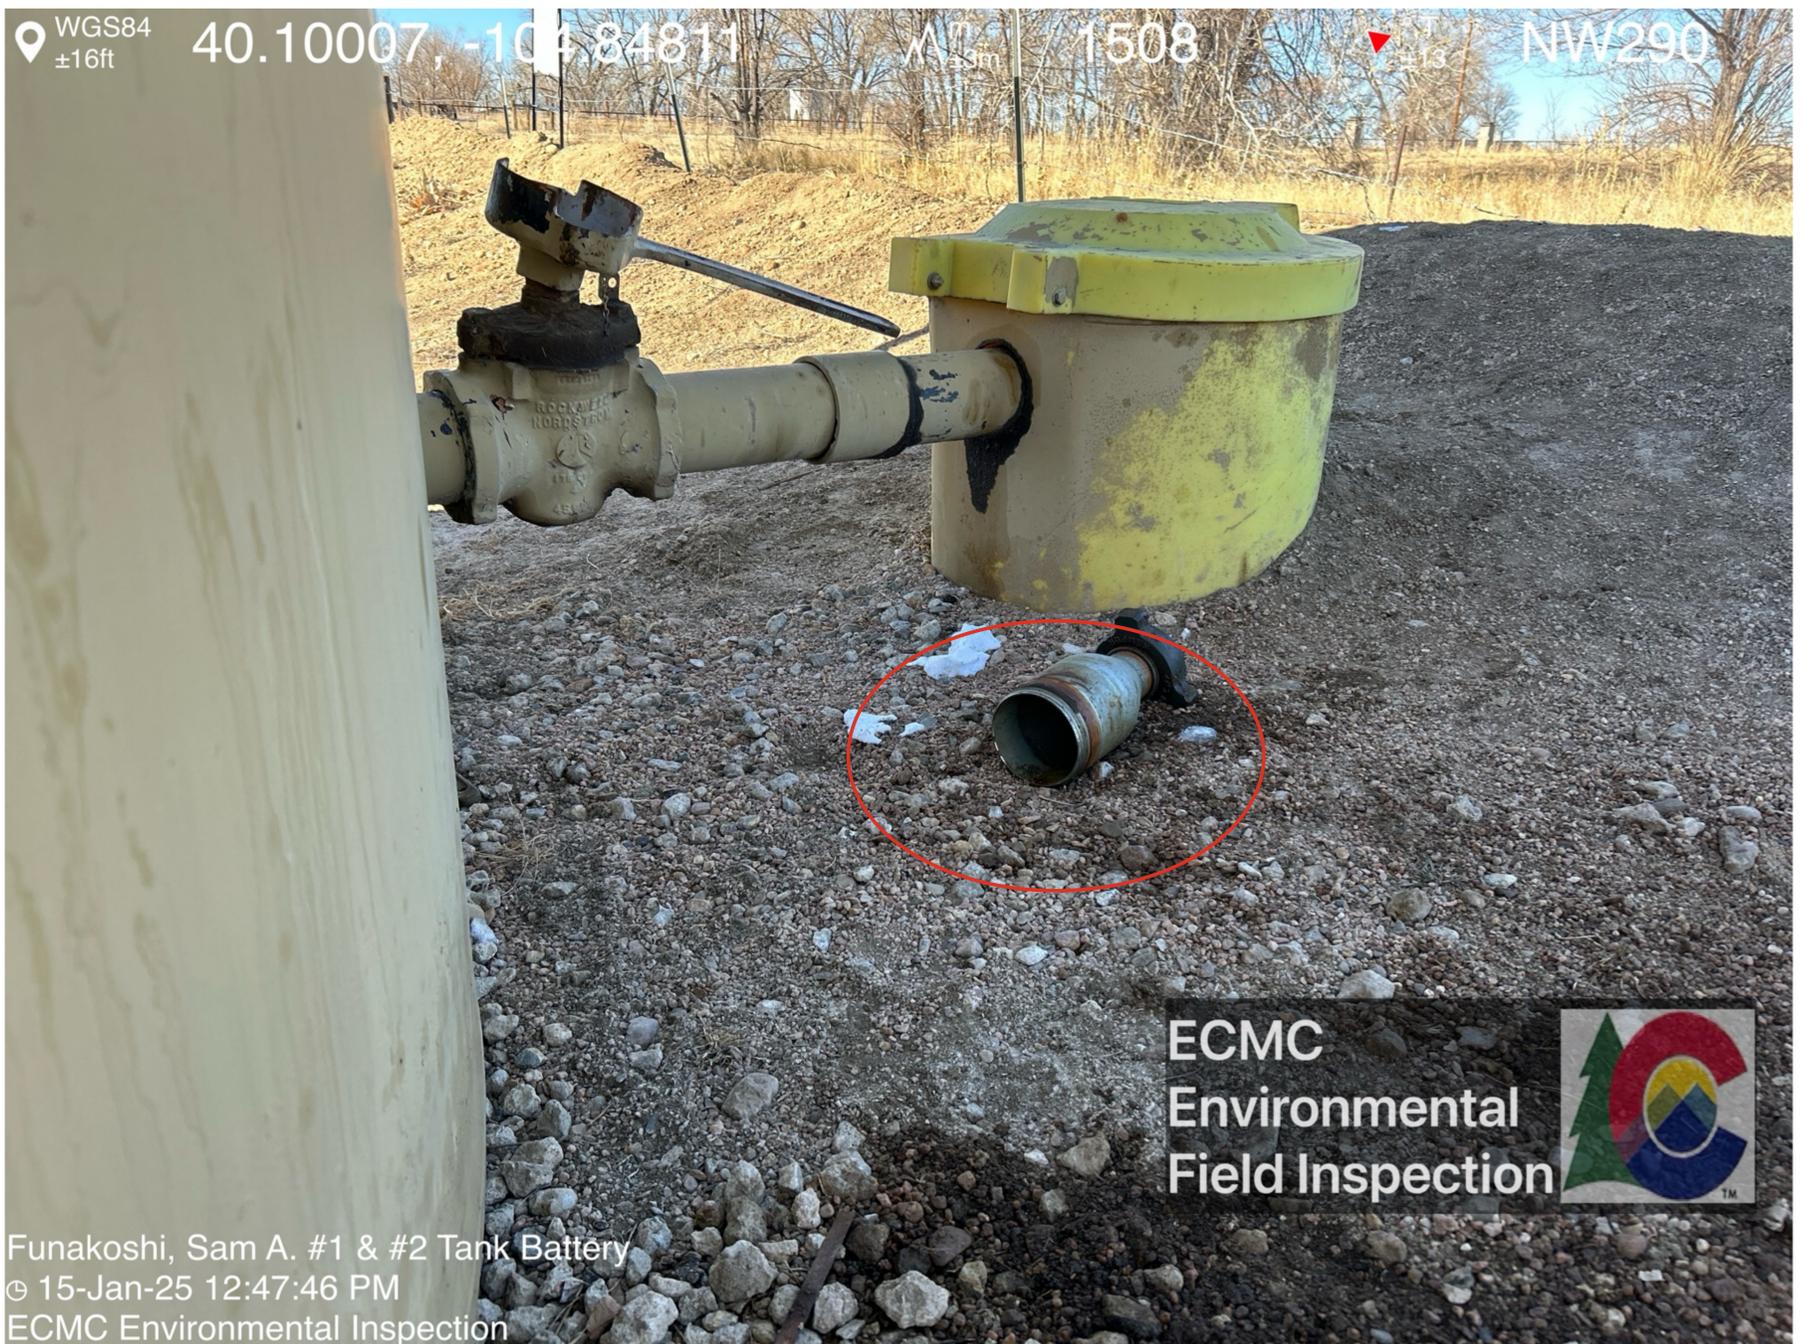
Residual petroleum hydrocarbon fluids are visible in discarded equipment.

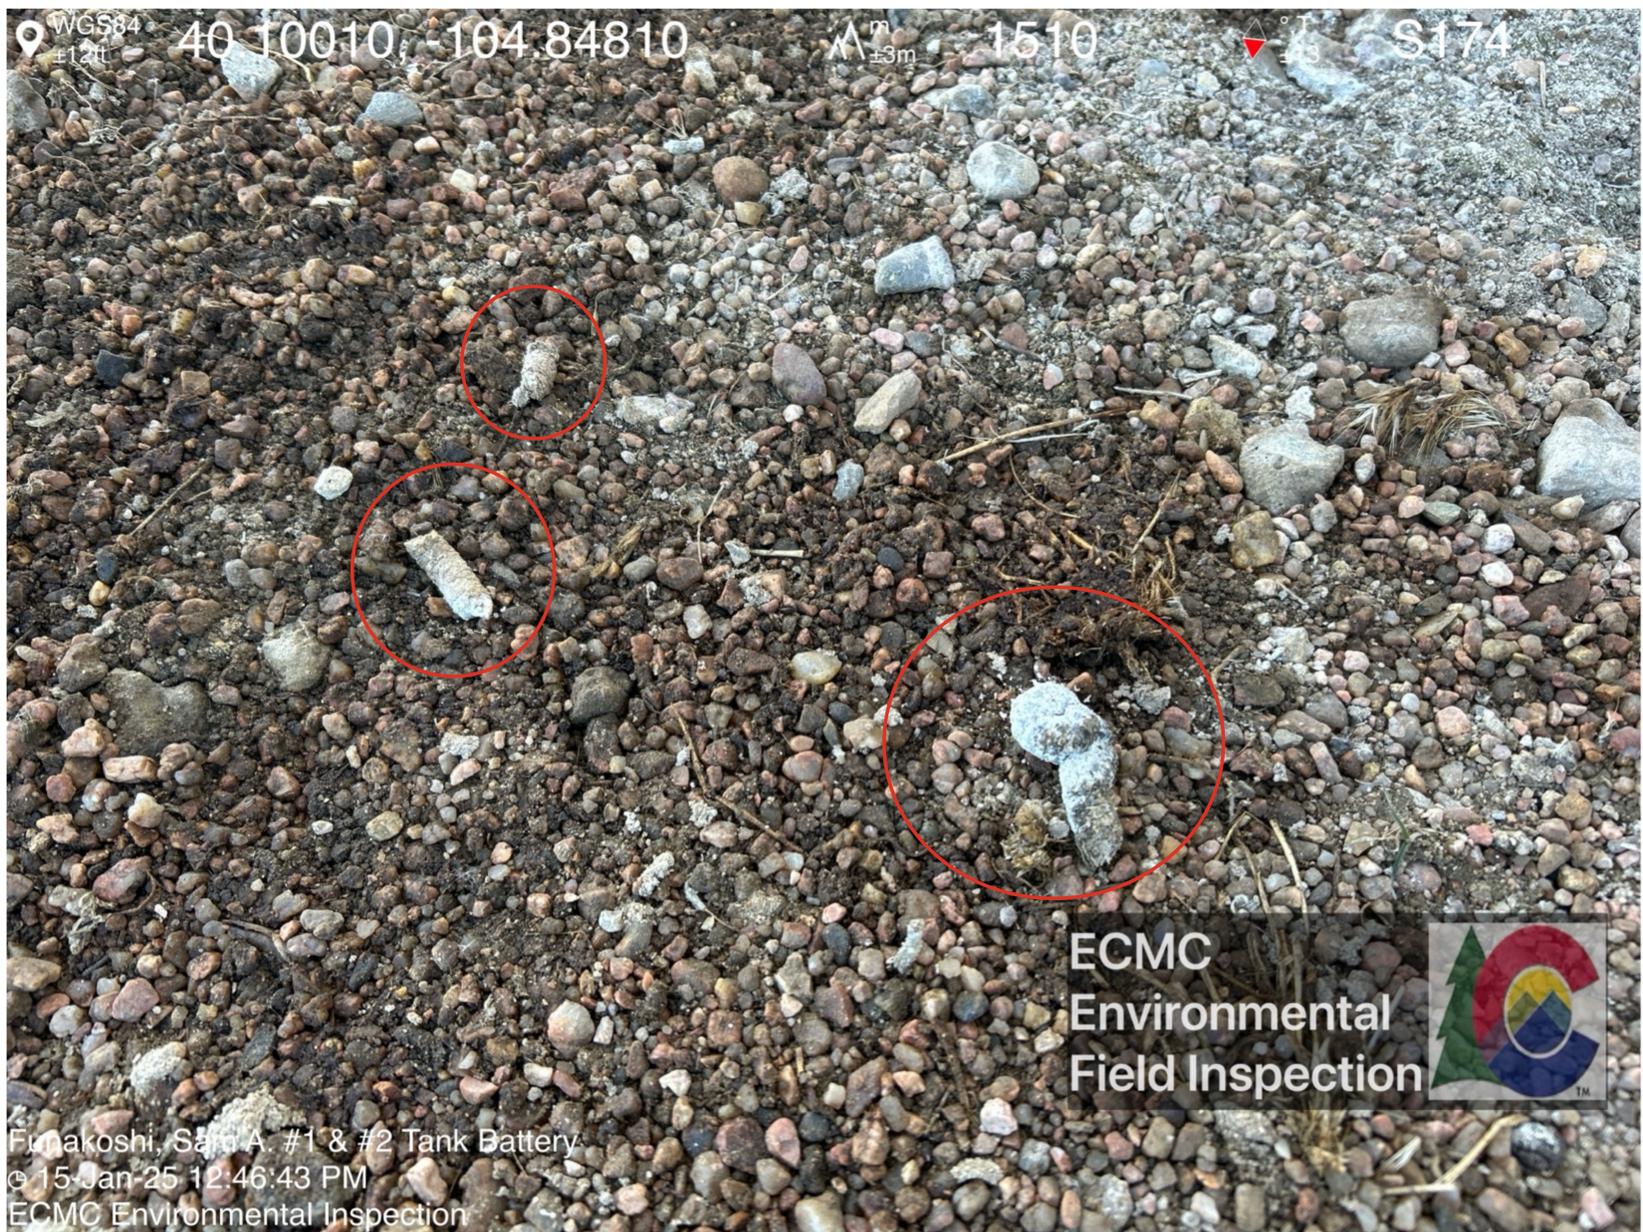
Wildlife scat observed on petroleum hydrocarbon saturated soil.

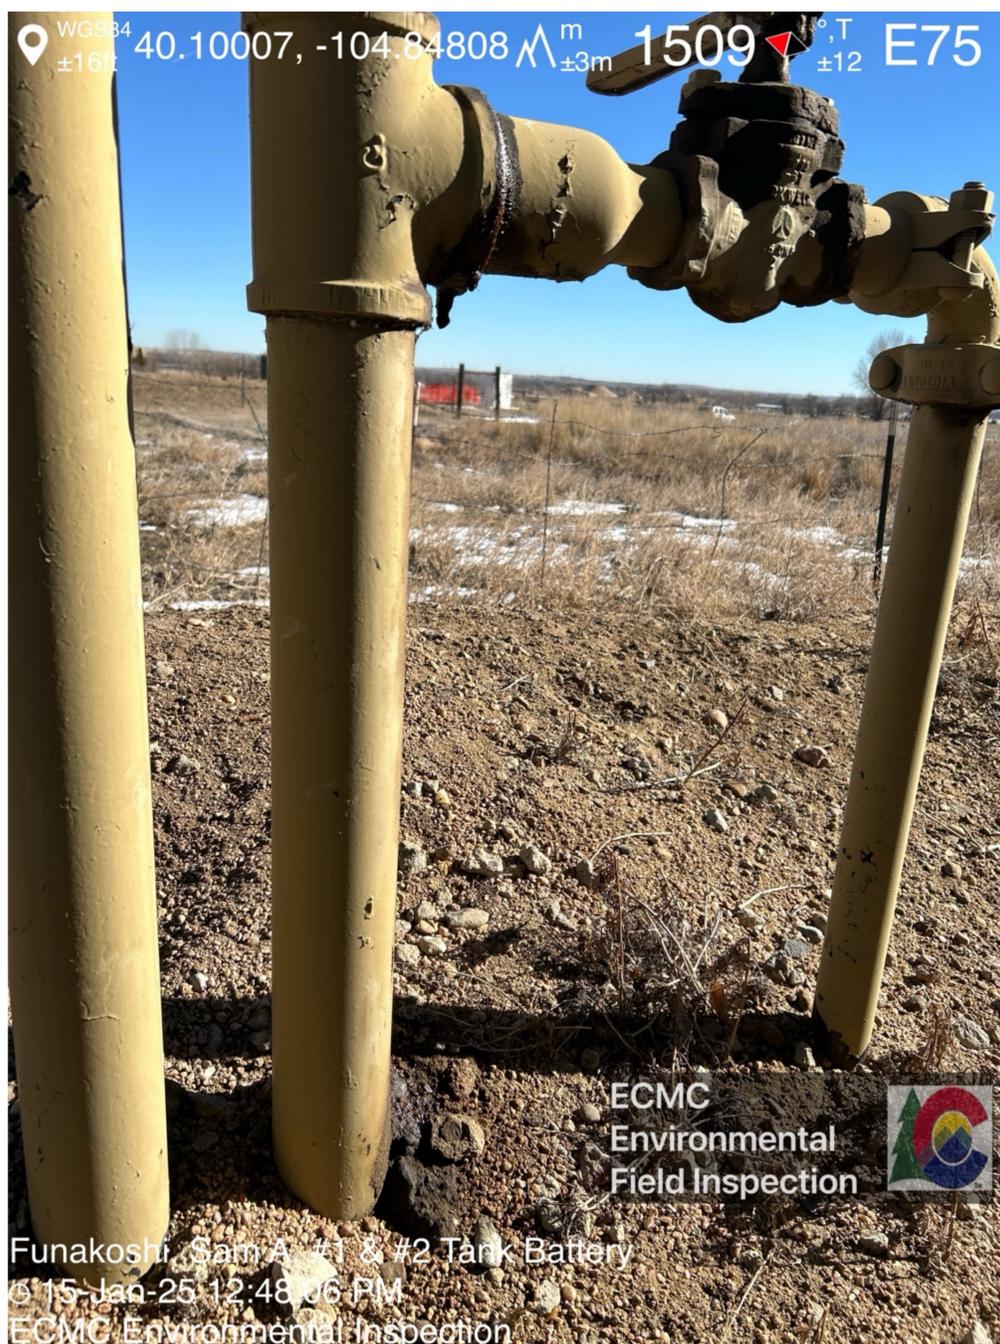
Petroleum hydrocarbon staining and odor observed on and beneath pipe manifold valve.

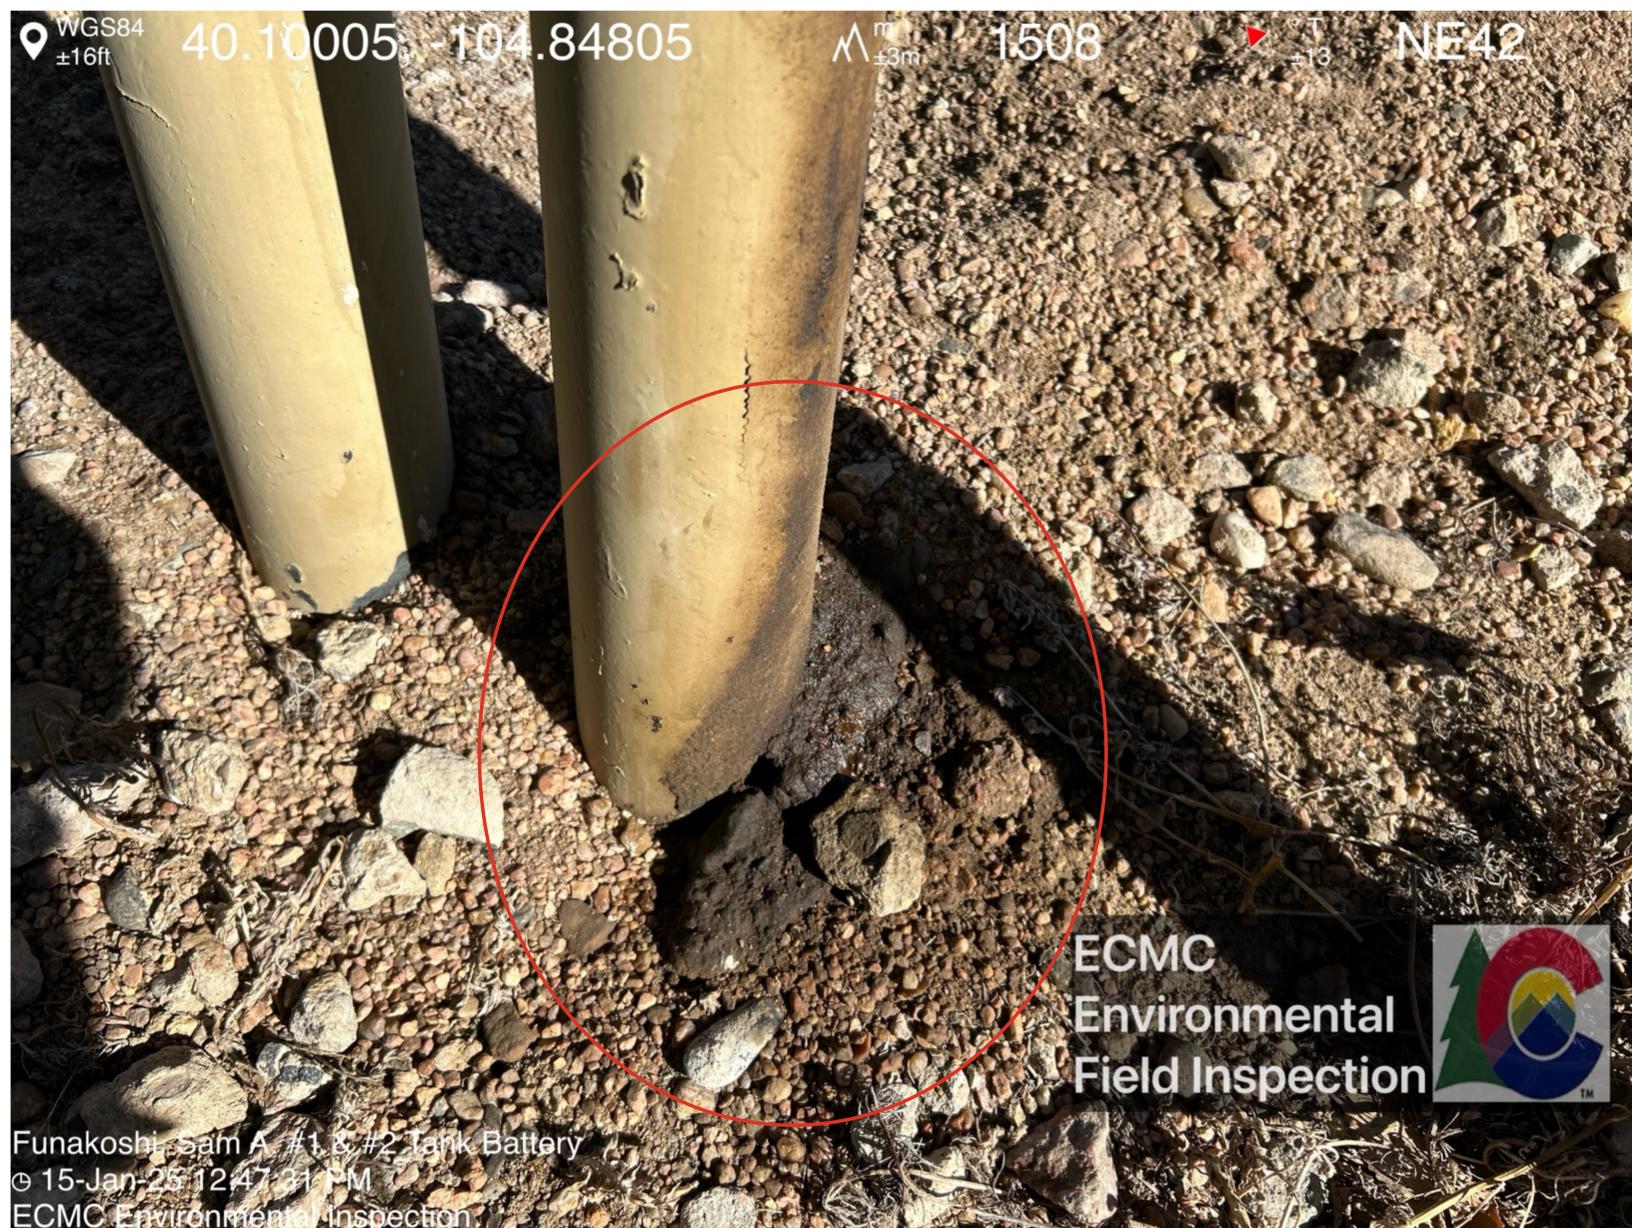
Strong petroleum hydrocarbon odor observed on stained soil.

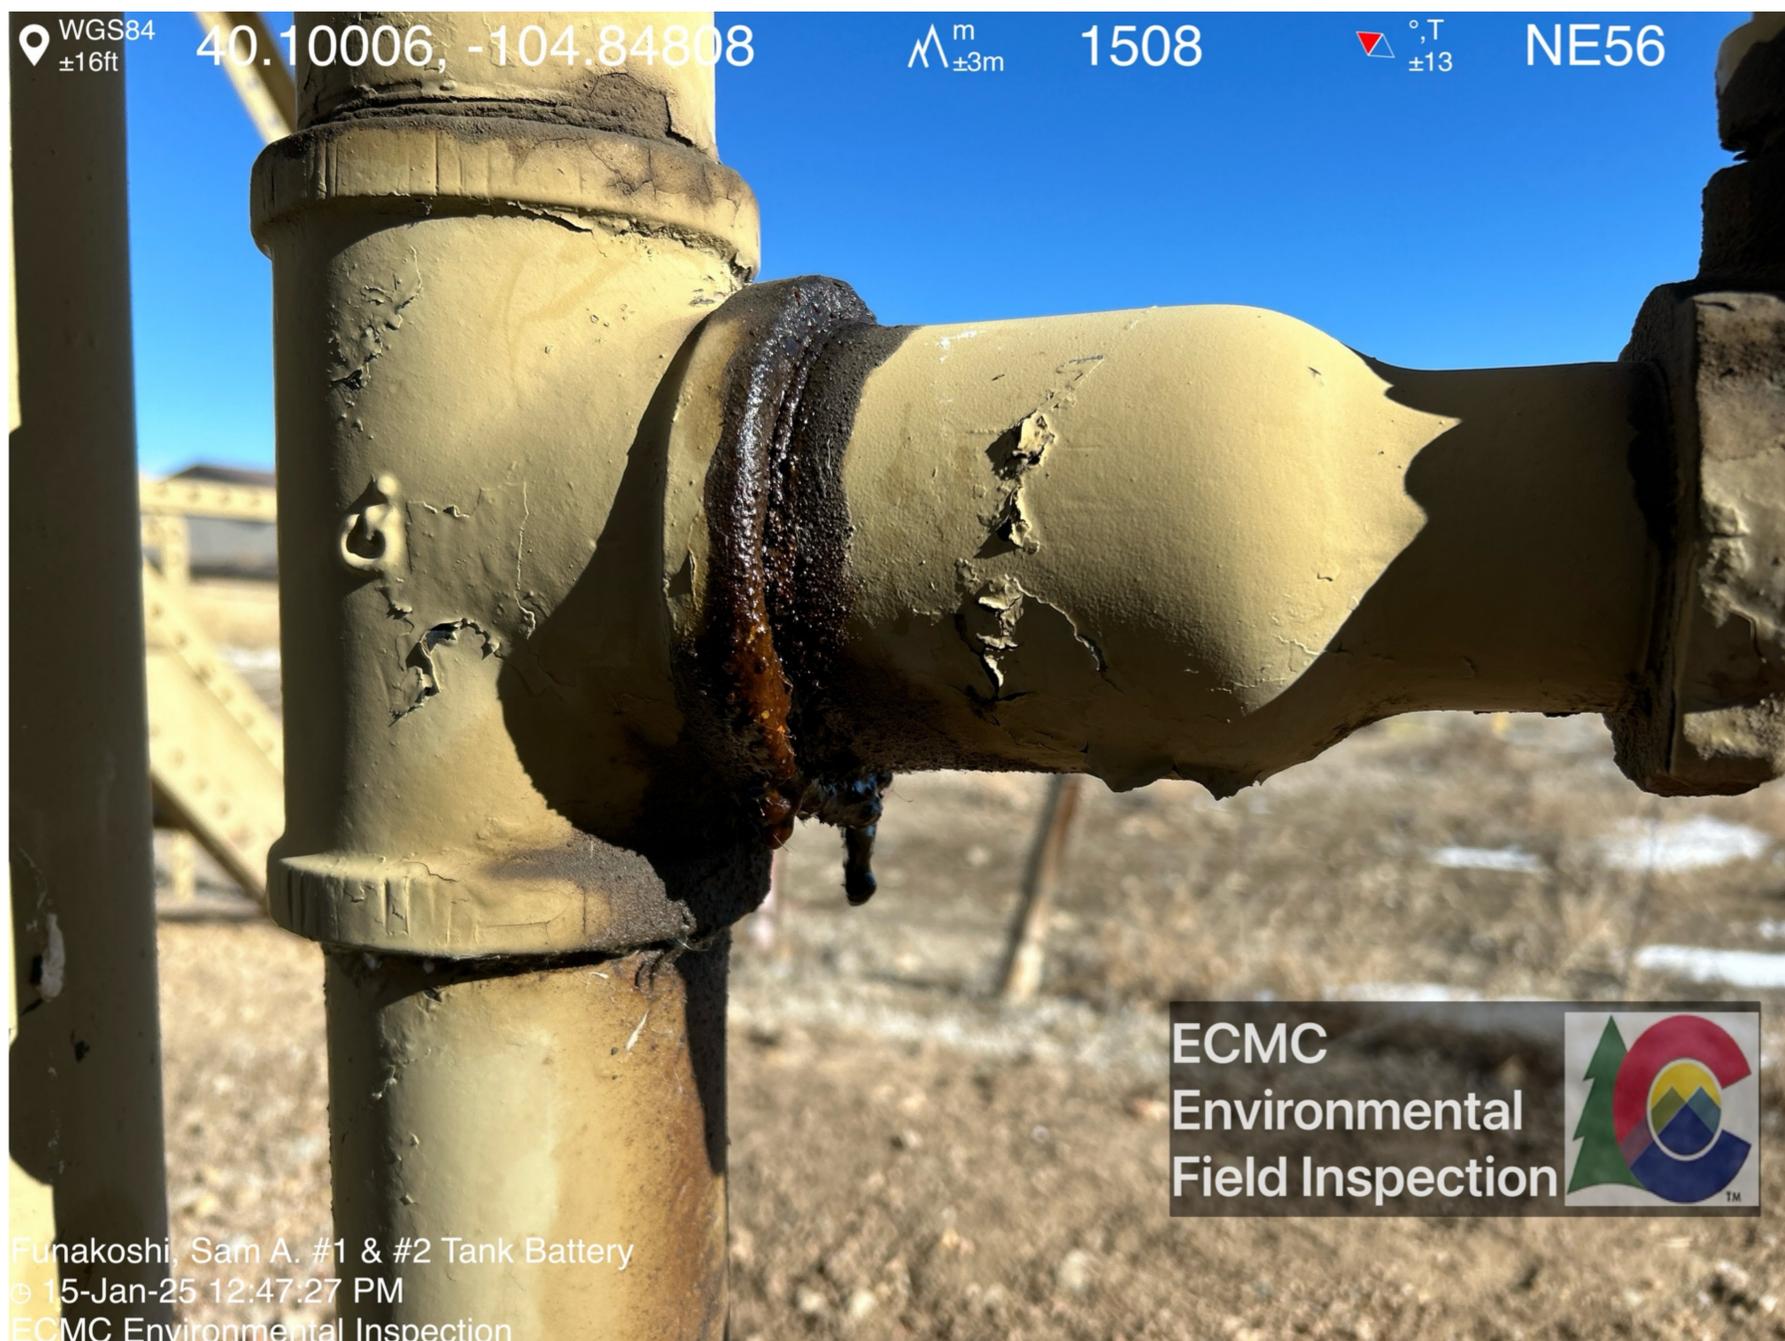
Petroleum hydrocarbon staining visible around valve.

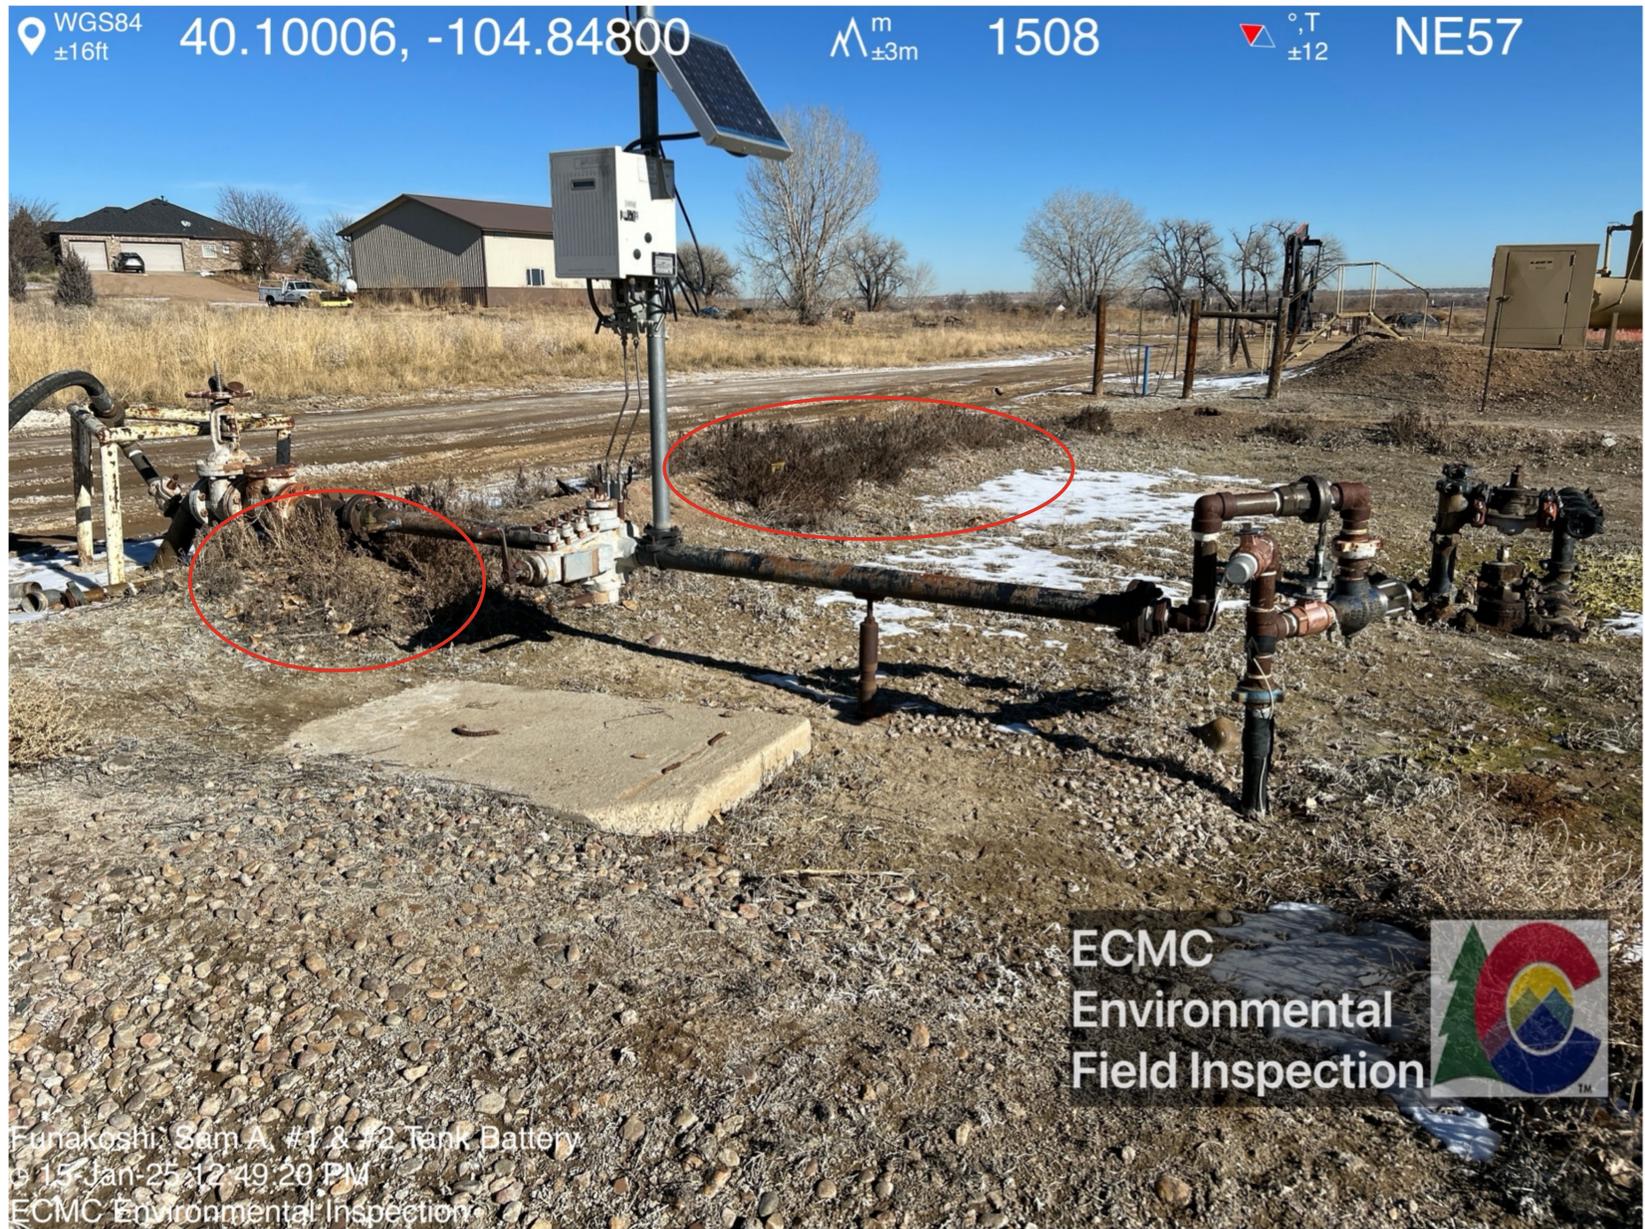
Weeds are present on ancillary equipment berm.

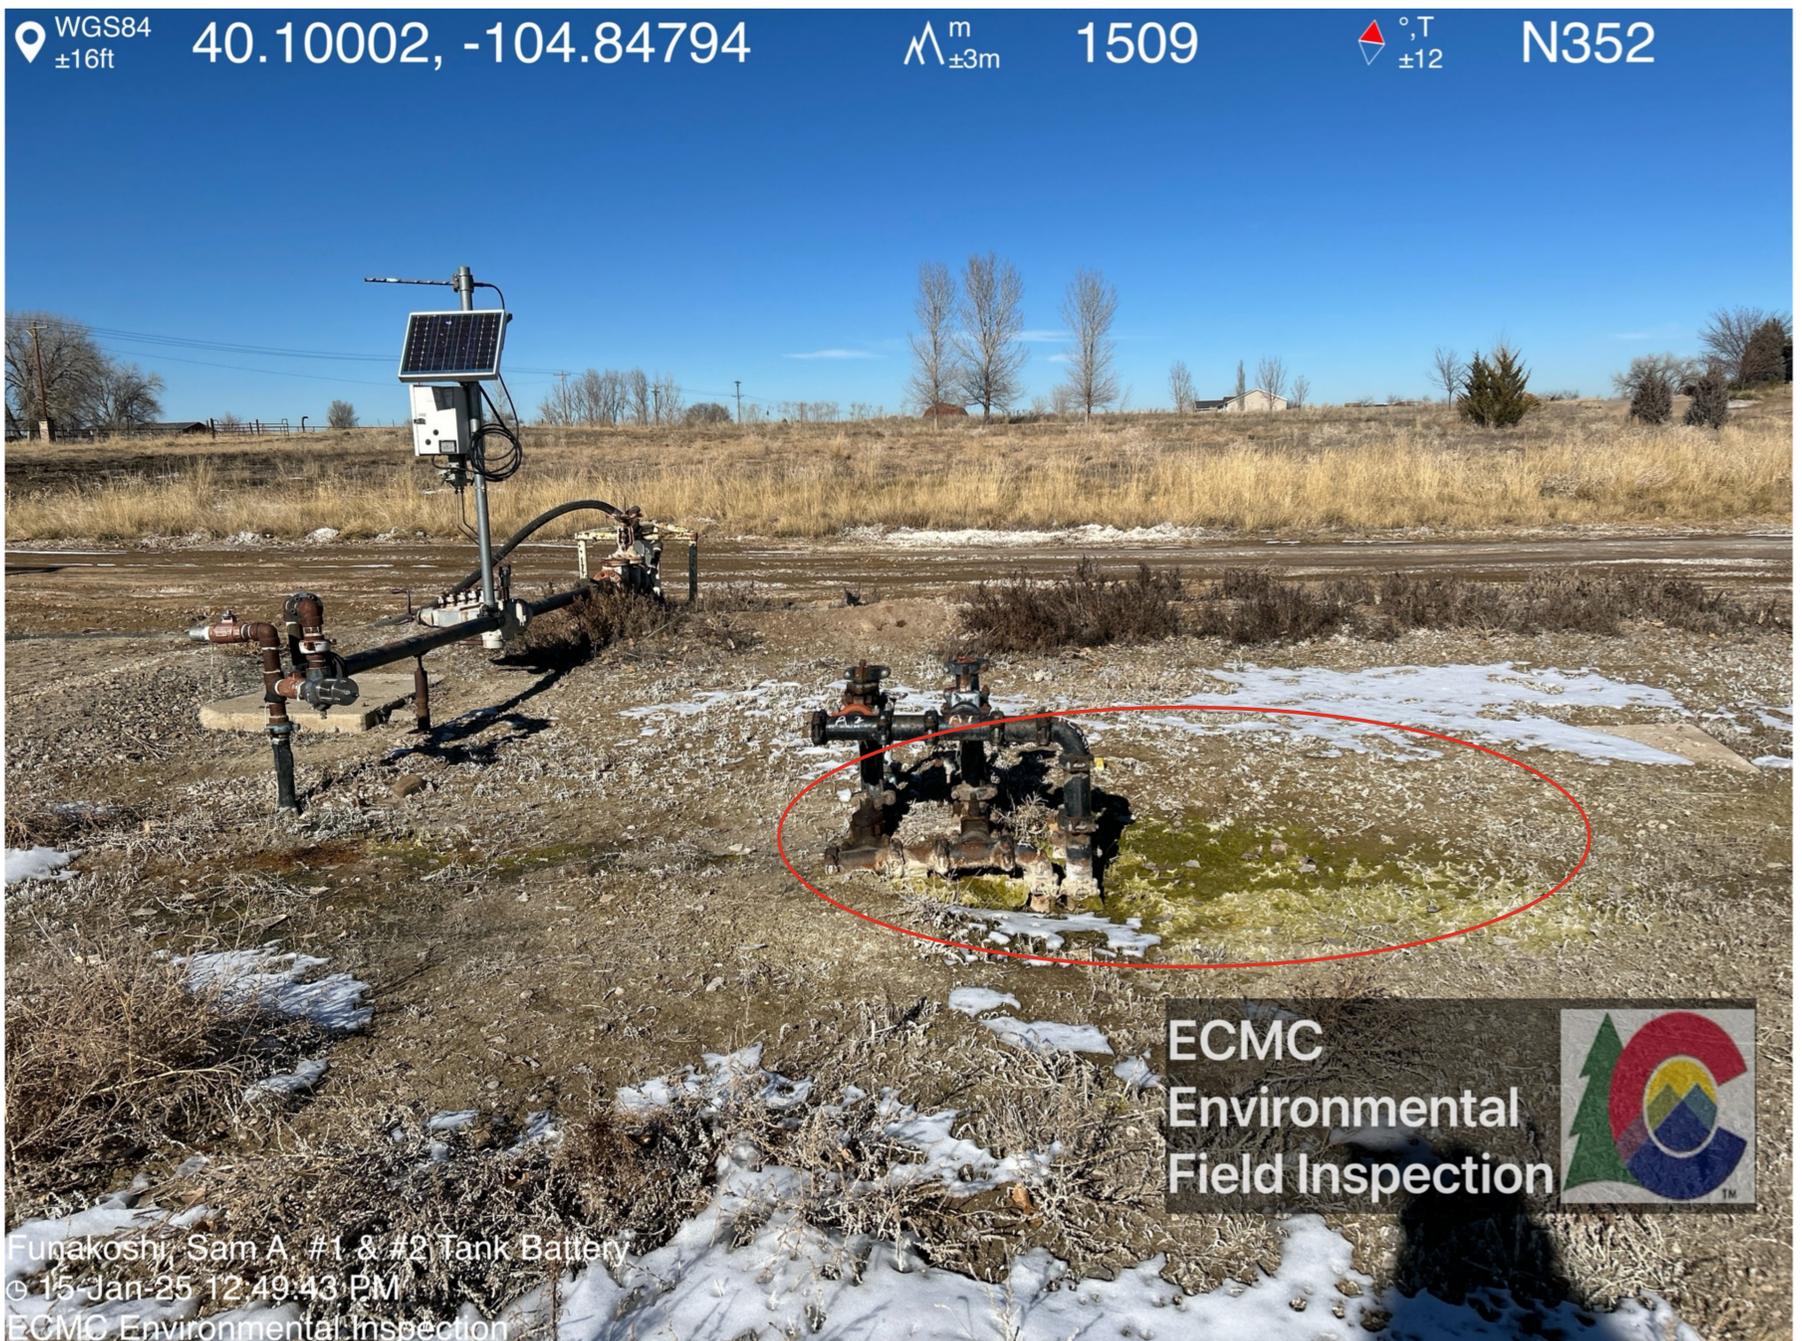
Green staining in location of stagnant water visible in previous inspection photo log.

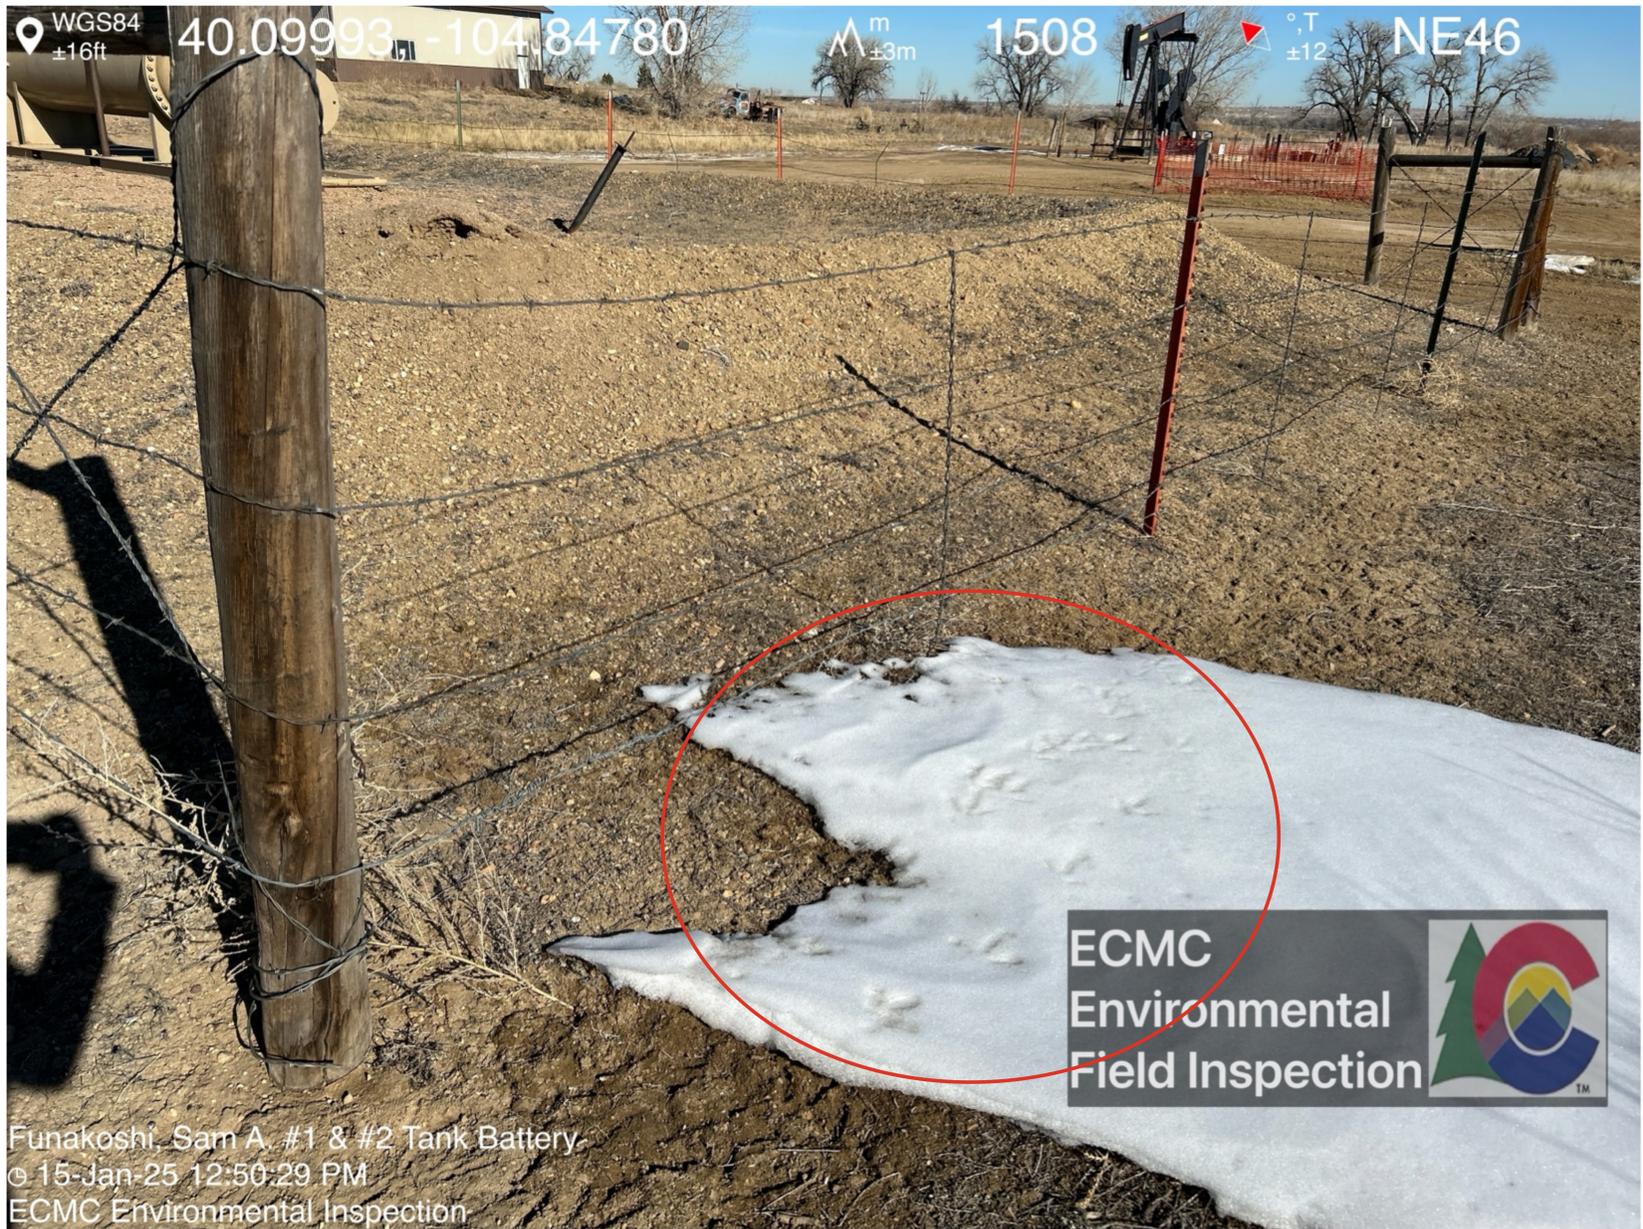
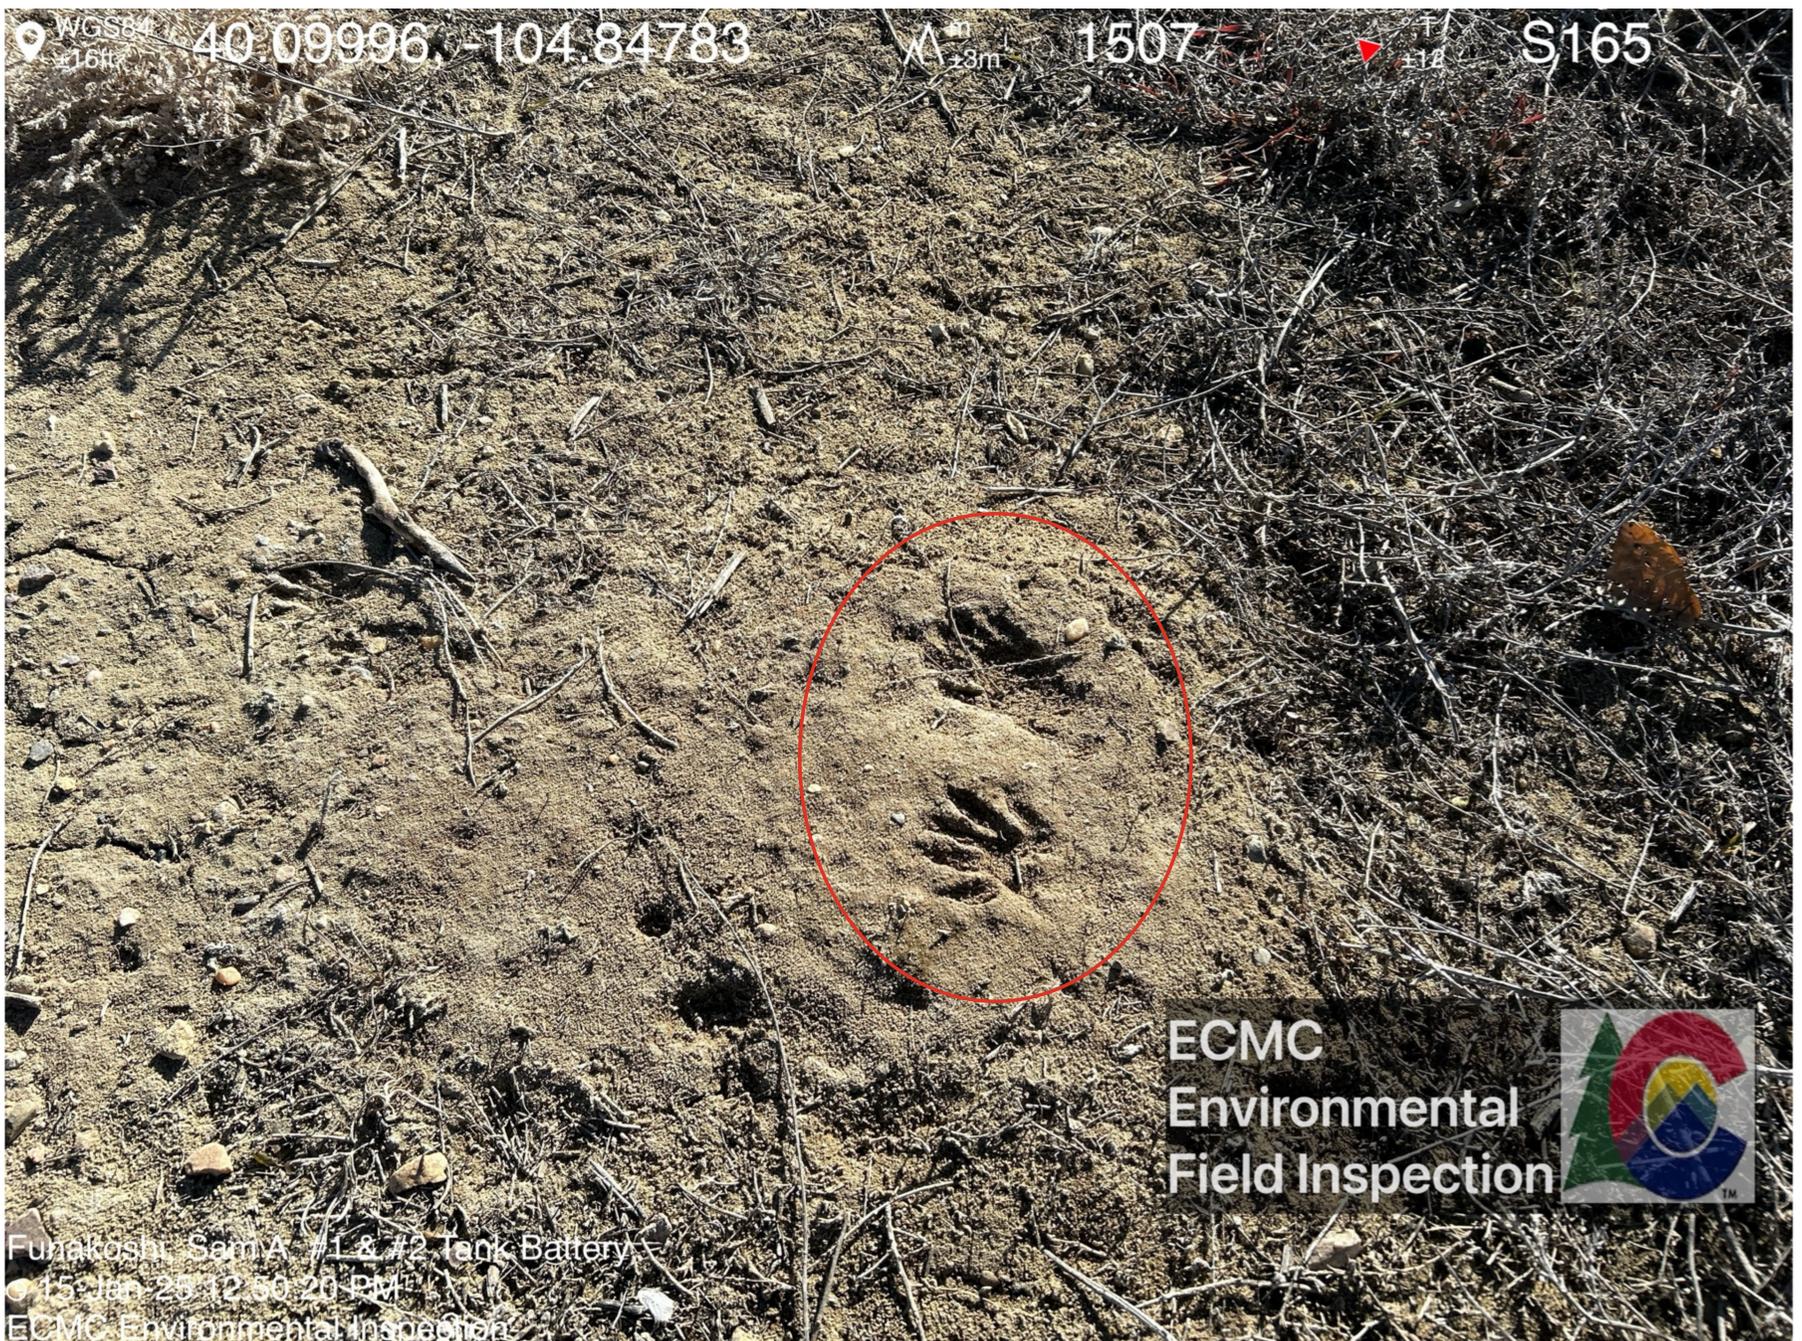
Wildlife tracks observed on location.
