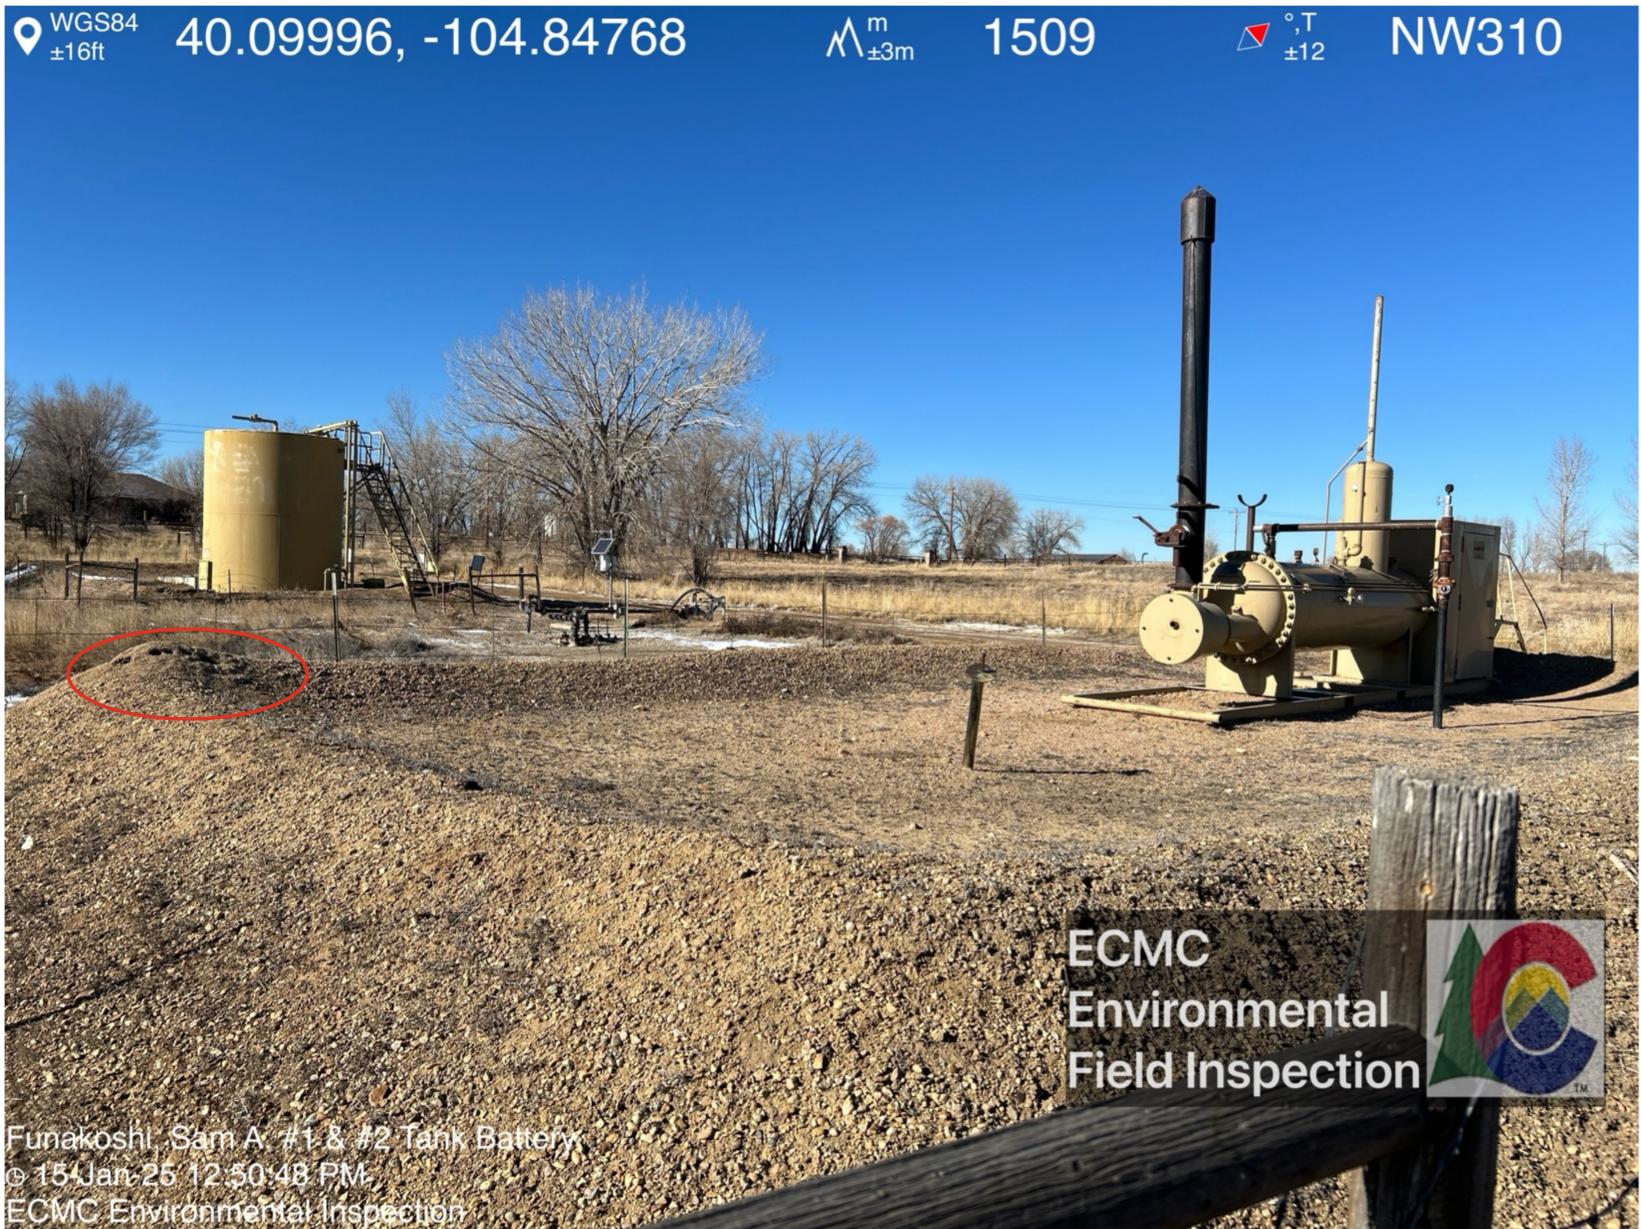
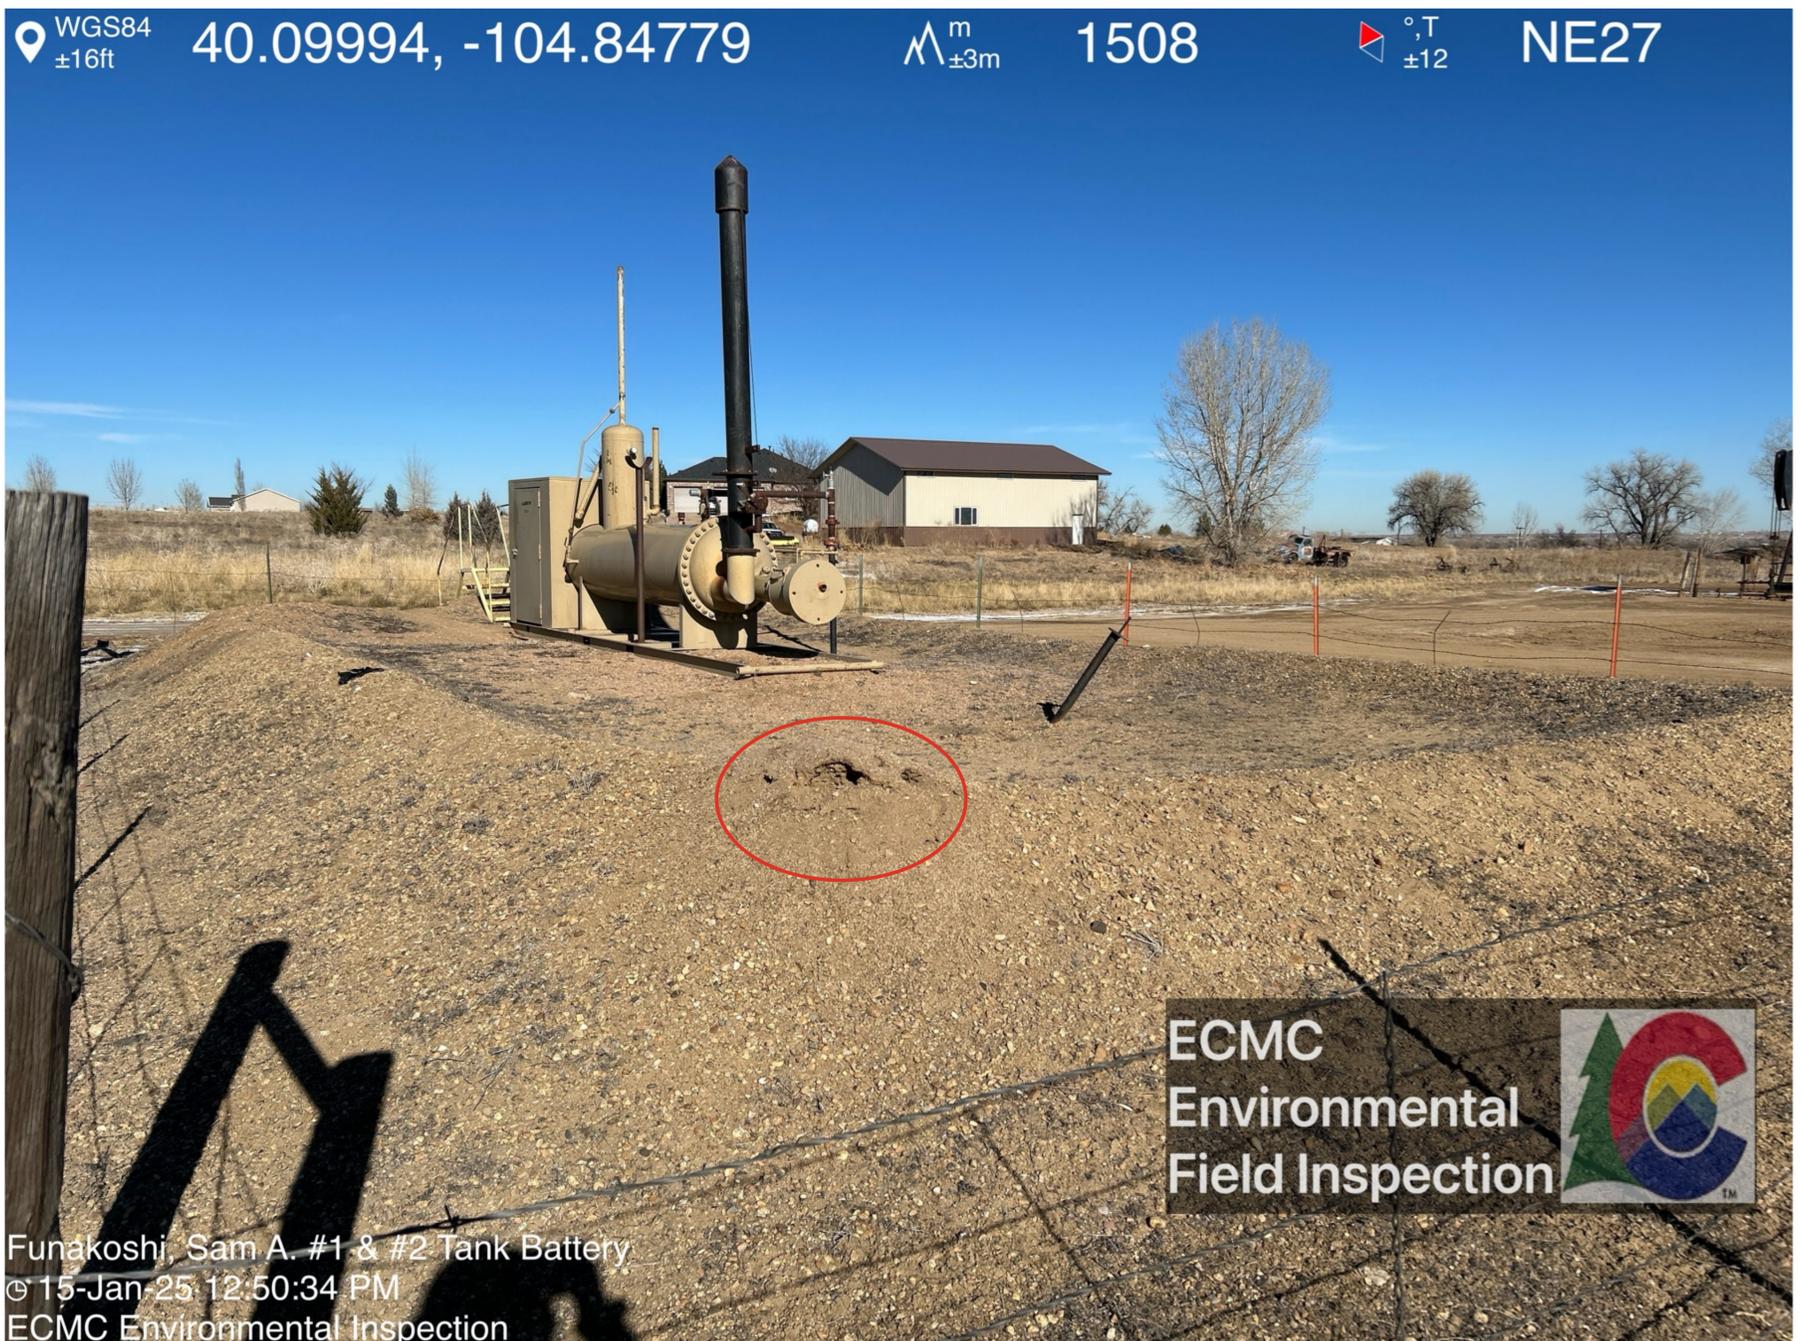
Wildlife burrow visible on separator berm.
